Continuously Reinforced Bonded Concrete Overlay of Distressed Jointed Concrete Pavements

Sungwoo Ryu, Hoonill Won, Moon C. Won

Report #: 5-4893-01-1
www.techmrt.ttu.edu/reports.php

March 2011

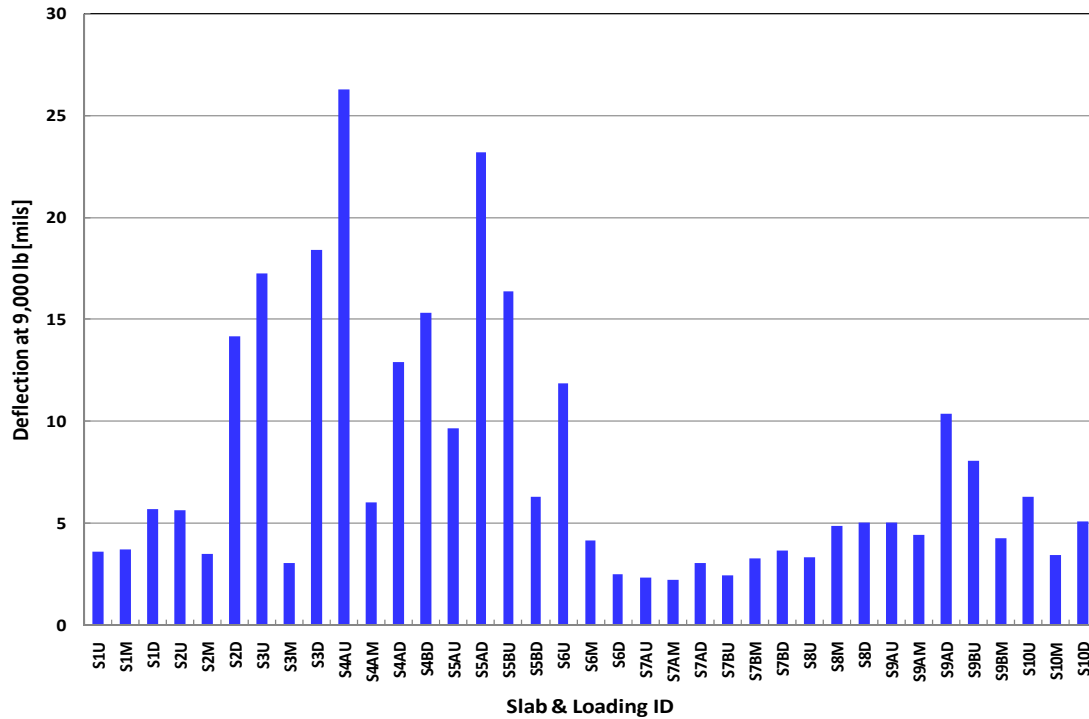
Figure 2.2 Slab deflections at various locations in Slab 1 thru Slab 10

three locations in each slab – upstream, middle of the slab, and downstream. If there were repairs, additional testing was conducted at the repaired transverse joints. Figure 2.2 illustrates the deflections in the first 10 slabs. In the x-axis, in SnU, S stands for Slab, n indicates the slab number, and U stands for Upstream (D is for Downstream). Where there were repair joints in the slabs, A or B is inserted between the slab number and the location of the drop (Upstream or Downstream). For example, S4AM indicates the drop at slab number 4, middle between upstream joint and first transverse repair joint. The crack map in Appendix A should be consulted when interpreting the deflection data. Figure 2.2 shows that there is a large variation in deflections, depending on the location of the FWD drops – smallest at the middle of the slab and largest at the upstream or downstream at transverse or repair joints. Two deflections with more than 20mils were both at repair joints, which indicates poor LTE at repair joints. The large deflections at transverse repair joints resulted most probably from poor tie bar insertion practice. Deflection information for the rest of the slabs is included in Appendix B.

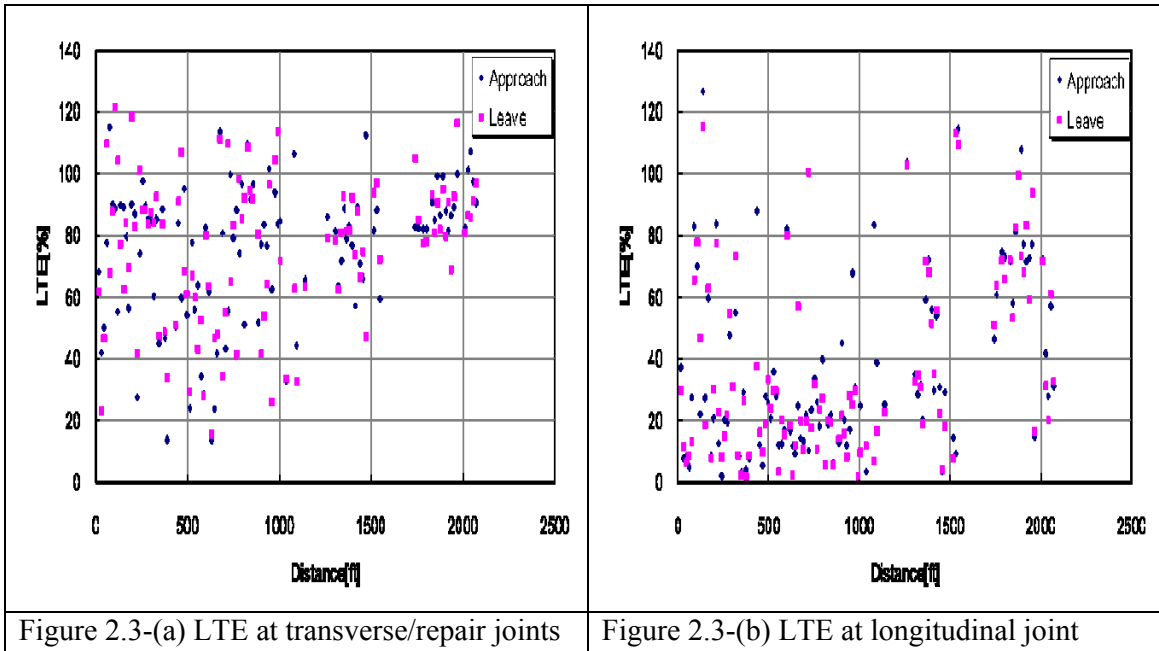
Figure 2.3-(a) illustrates LTE at transverse contraction and repair joints. It shows that LTEs were low in many joints, even though dowels were used. The low LTEs are of concern because the potential for reflection cracking at transverse and repair joints will be more likely, unless things are done to prevent or minimize the reflection cracking. Figure 2.3-(b) shows LTE along the longitudinal joint between outside lane and outside shoulder, which was retrofitted in 1998.

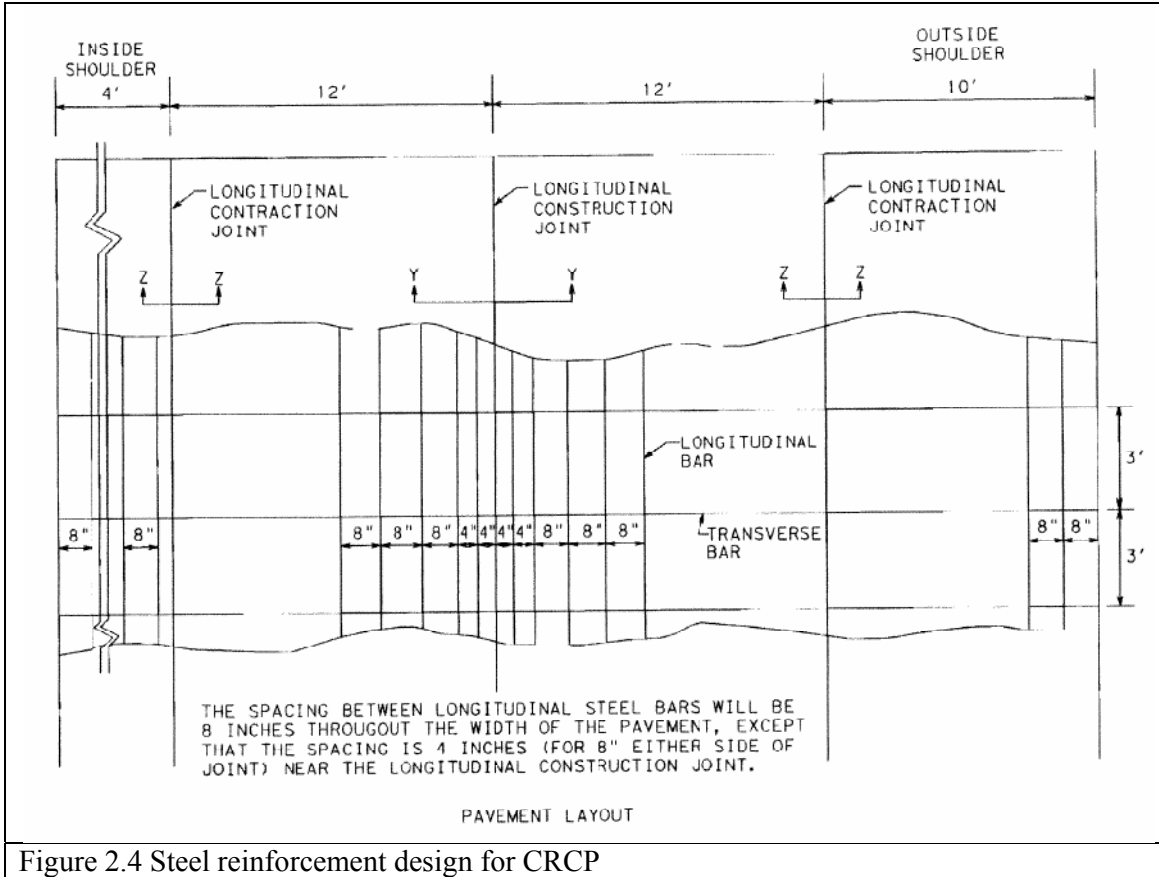
Figure 2.4 Steel reinforcement design for CRCP

Longitudinal steel was determined based on the experience in Texas. Currently in TxDOT, 0.68% of longitudinal steel is used for 15-in CRCP. The combined slab thickness was 17-in and it was decided that 0.7% steel would be used. In new CRCP, this steel percentage is based on the cross-sectional area of the whole section. In the bonded overlay, a decision has to be made as to whether the combined cross-sectional area or just the new CRCP overlay cross-sectional area should be used. The purpose of the longitudinal steel in CRCP is to induce transverse cracks due to temperature and moisture variations in concrete and hold them tight for good load transfer. It can be assumed that there will be little further drying shrinkage that will develop in the existing CPCD, since the concrete is more than 15 years old. Also, after 7-in concrete over the CPCD, the temperature variations in CPCD will be minimal. Most of the transverse cracks occur in places other than transverse joints. Accordingly, the load transfer efficiency at cracks in CRCP will be enhanced. As a result, it was decided that the use of CRCP cross-sectional area was appropriate for the estimation of the amount of longitudinal steel. Number 6 bars were used for longitudinal steel. Steel was placed 4-in from the surface of CRCP, which is 0.5-in lower than mid-depth. The reason for lowering the steel was to provide more restraint on concrete volume changes in the lower half of the CRCP slab, which will enhance the bonding of new concrete to old concrete. The spacing for transverse steel was at 3-ft with No. 6 bars. Transverse steel was placed below longitudinal steel, as in normal CRCP construction. Figure 2.4 shows the steel reinforcement design for this project.

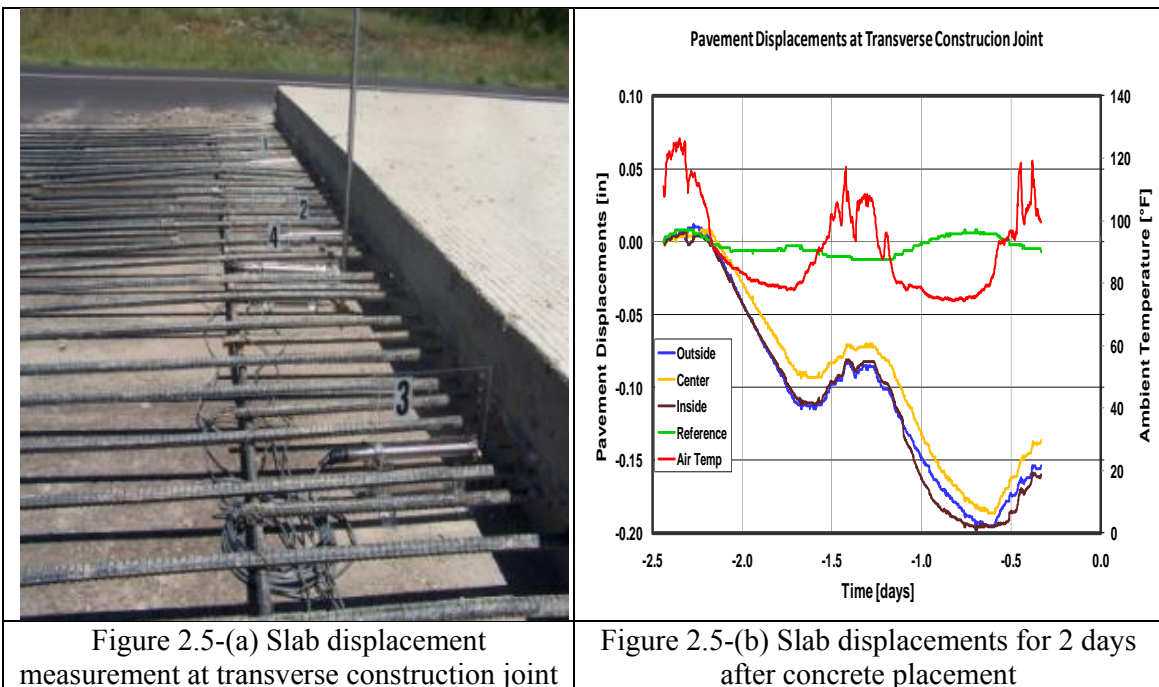
Figure 2.5-(a) Slab displacement measurement at transverse construction joint

Figure 2.5-(b) Slab displacements for 2 days after concrete placement

Large contractions of concrete were noted. In the x-axis, a whole number indicates midnight. Minus 2.0 indicates midnight on Friday. Minus 1.5 and -1.0 indicate Noon Friday and midnight on Saturday, respectively. By Sunday morning, there was about 0.2 in. of concrete contraction. Based on the ambient temperature history, it appears that drying shrinkage played a dominant role in concrete displacement. As will be discussed later, wet-mat curing was specified in the rehabilitation project to minimize shear stress at the interface between old and new concrete in the transition area, and to minimize potential wide transverse cracks. Concrete contraction of this magnitude could cause substantial stresses in concrete at the interface in the transition area.

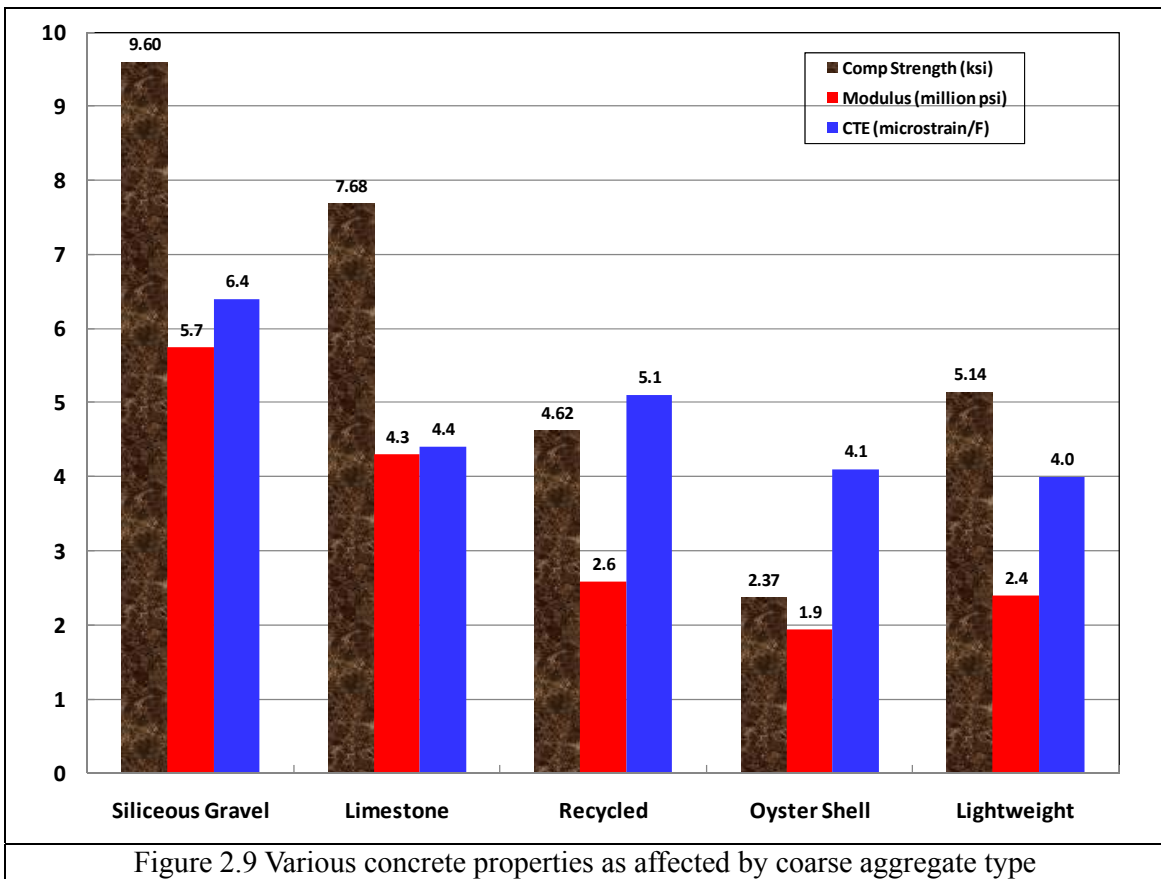
conducted by TxDOT engineers in the early 2000s to identify the causes of good and poorly performing CRCs. Figure 2.9 illustrates the findings. It shows the substantial effects that coarse aggregate type has on modulus of elasticity and CTE. Siliceous river gravel gives high values in modulus of elasticity and CTE. Oyster shell and lightweight aggregate provide low values for the two properties. Also, there is a loose correlation among aggregate type, modulus of elasticity and CTE – the smaller the modulus of elasticity, the smaller the CTE. From an engineering standpoint, oyster shell or lightweight aggregate concrete would be ideal for this rehabilitation project. From a practical standpoint with a fixed budget for this project, a coarse aggregate that would provide a maximum concrete CTE of 4.6 microstrain per F was specified. It was expected that by specifying a maximum CTE value, the concrete would have reasonably low modulus value as well, which is expected to lower the concrete stresses at the interface between old and new concrete in the transition area.

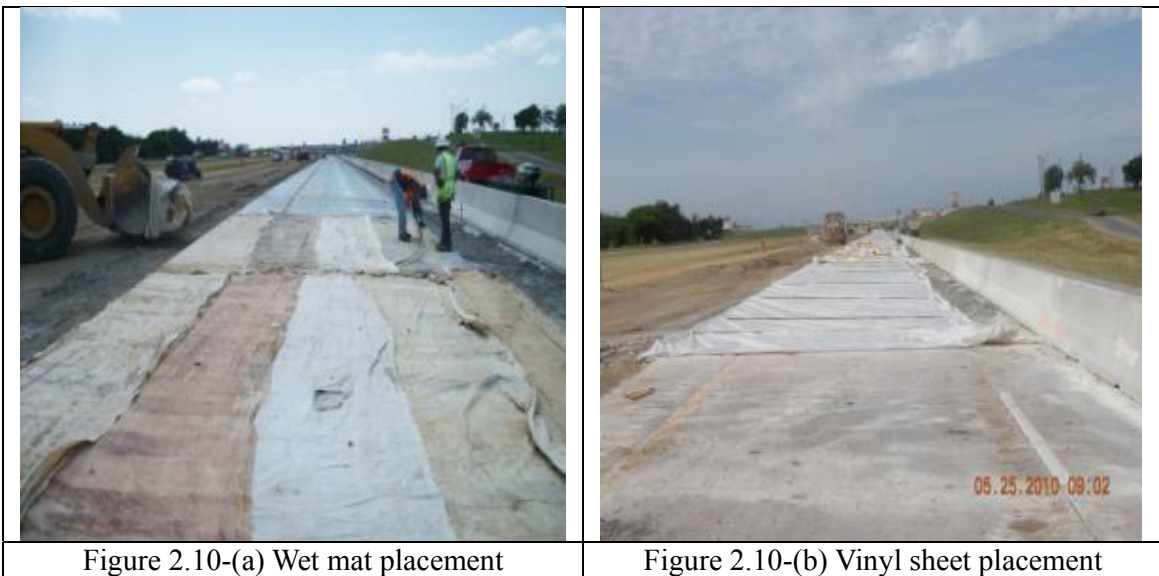
Figure 2.10-(a) shows the wet-mat curing applied in this project on the day of concrete placement (May 24, 2010). Cotton mat was placed and kept wet by water spraying. On the same day, vinyl sheet was placed on top of the cotton mat to prevent drying of cotton mat, as shown in Figure 2.10-(b). Steel rebar was placed to keep vinyl sheet in place. Cotton mat was kept in place for 7 days.

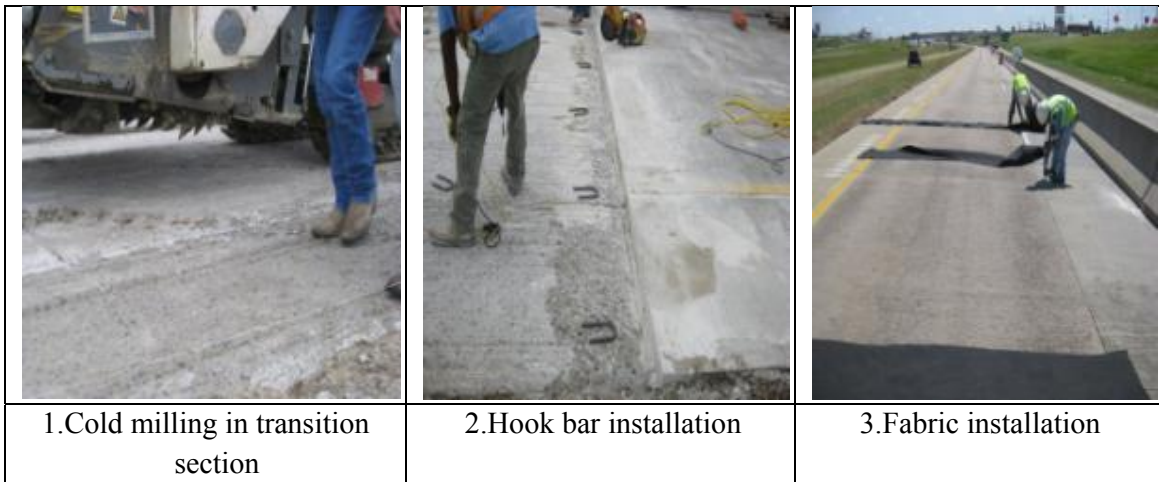
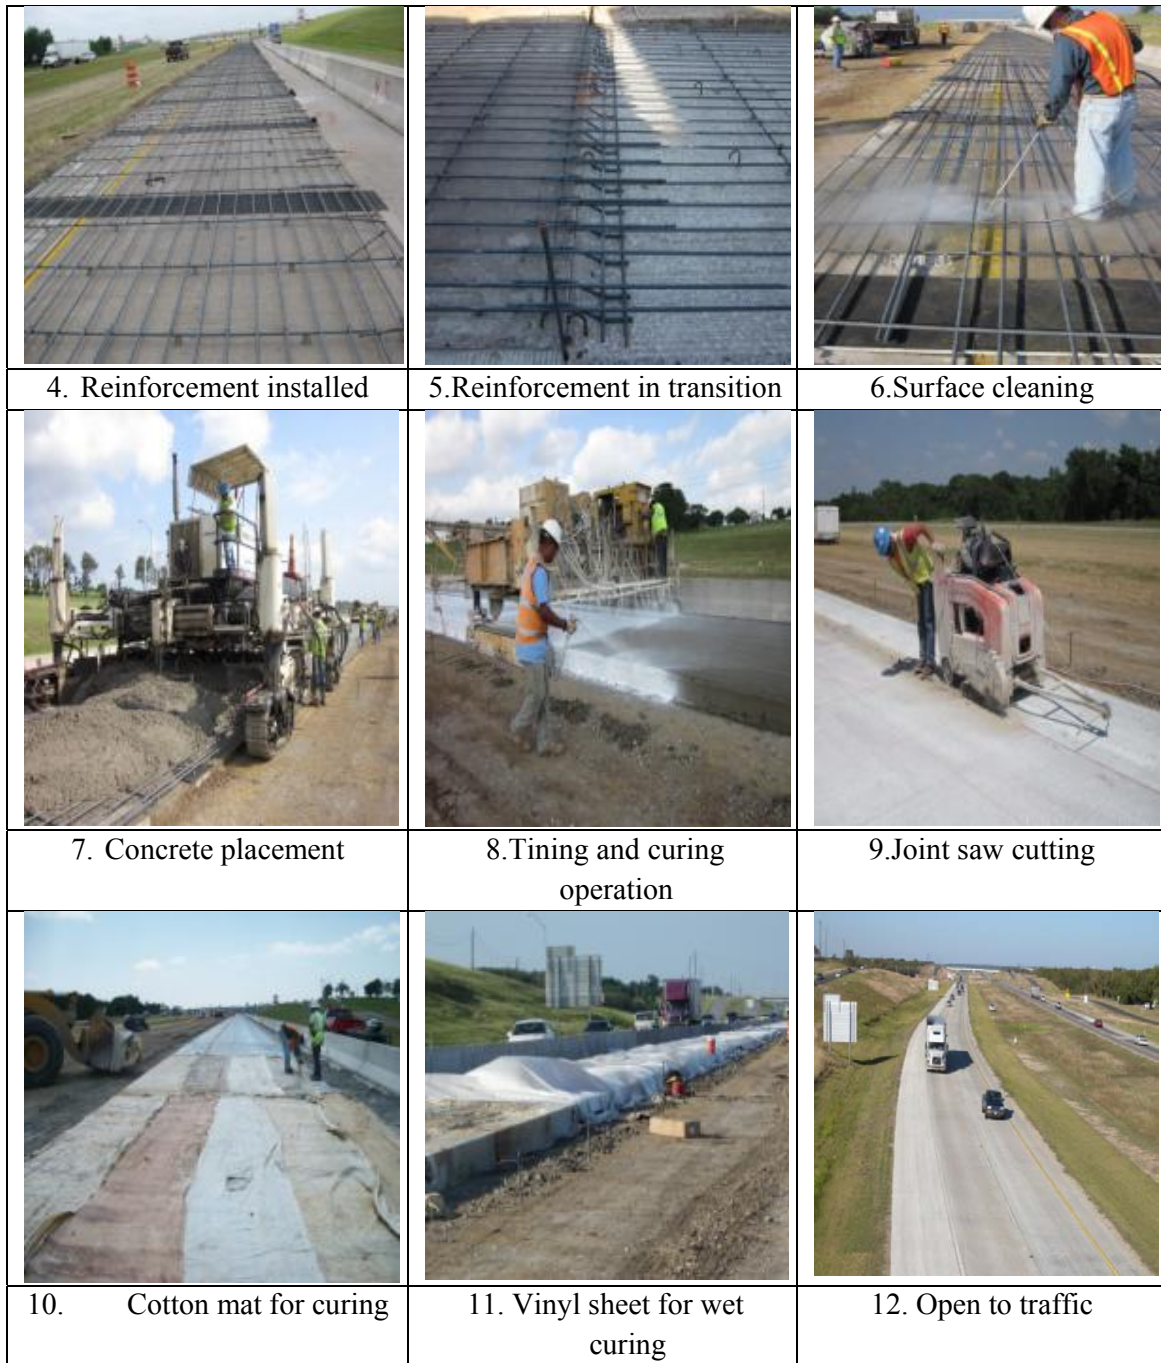
Figure 3.1 Construction sequence of CRCP BCO

Figure 3.1 shows the sequence of the construction utilized in the Phase 1 construction.

Transition sections in the north and south ends consisted of three slabs plus half a slab each, for a total of 52.5 ft long. The top 5 in. of concrete was removed by cold milling. Hook bars were installed every 4 ft in both directions in the transition sections, and longitudinal steel was placed. Non-woven fabric, 2 ft wide and 16 ft long, was installed at transverse contraction joints with nails and epoxy. Longitudinal and transverse steel was placed with

chairs. Female multi-piece tie bars were installed at transverse steel location. At the same time, steel bars were placed in the transition areas. Before concrete was placed, the surface of JCP was cleaned with pressurized water jets. Lane marking was not completely removed. While the surface of JCP was still in saturated, surface dry (SSD) condition, concrete was placed. Once concrete attained enough stiffness, the tining operation was done, followed by curing membrane applications. Joint saw cutting was done at longitudinal contraction joint and transverse contraction joints in the transition areas. After the saw cutting was completed, cotton mat was placed and water sprayed. Afterwards, vinyl sheet was placed to keep the cotton mat wet. Cotton mat and vinyl sheet were placed on the same day (May 24, 2010). The wet mat curing system continued until June 1.

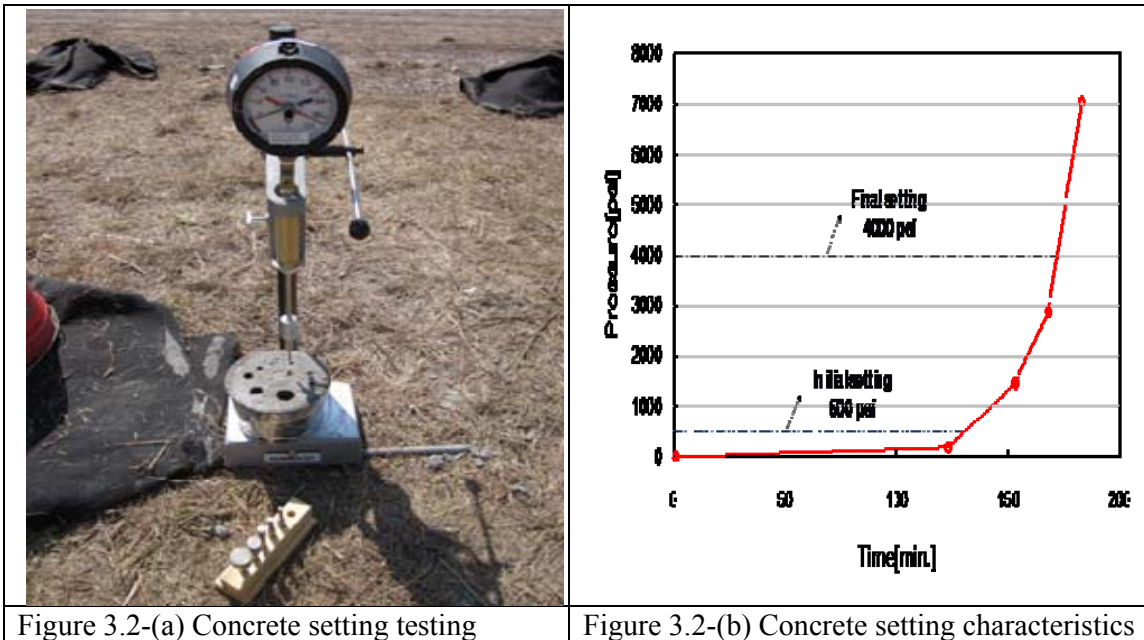
Concrete compressive strength values were 2,800 psi at 1 day, 3,030 psi at 3 days and 3,880 psi at 8 days, which met the requirement of a minimum of 2,600 psi at 24 hours. Setting characteristics of concrete was evaluated as shown in Figure 3.2-(a) and the results are illustrated in Figure 3.2-(b). The initial setting was obtained in 2 hours and 10 minutes and the final setting was at about 3 hours. The setting information indicates this concrete set a little bit quickly compared with normal paving concrete, considering the concrete delivery time was less than 20 minutes.

Figure 3.2-(a) Concrete setting testing

Figure 3.2-(b) Concrete setting characteristics

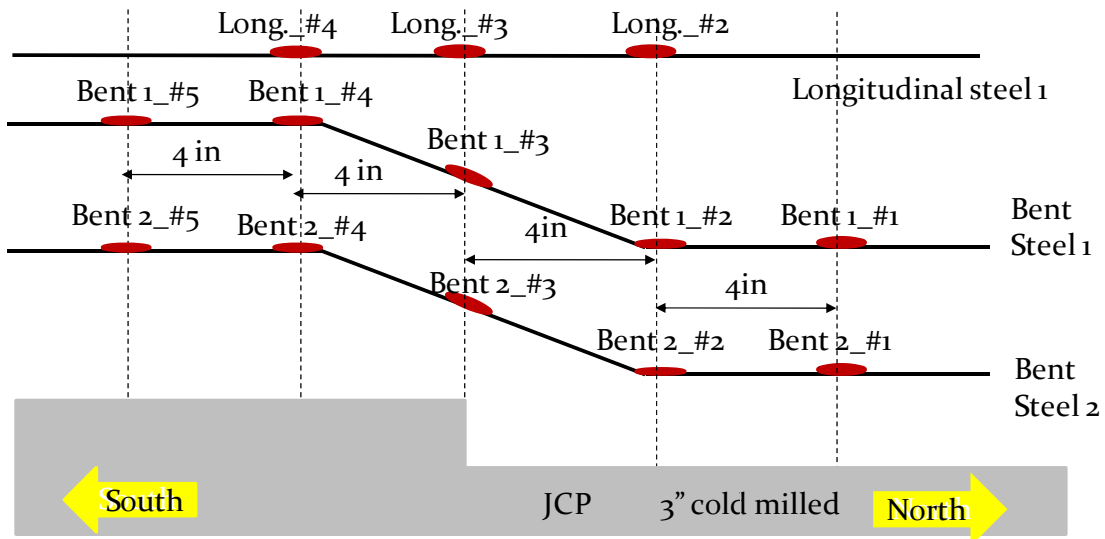
Figure 3.3 Steel strain gages installed in north transition section

Figure 3.3 illustrates SSGs installed in the transition area at the north limit of the project. A total of 13 SSGs were installed – 10 of them in the bent bars and three in the longitudinal steel.

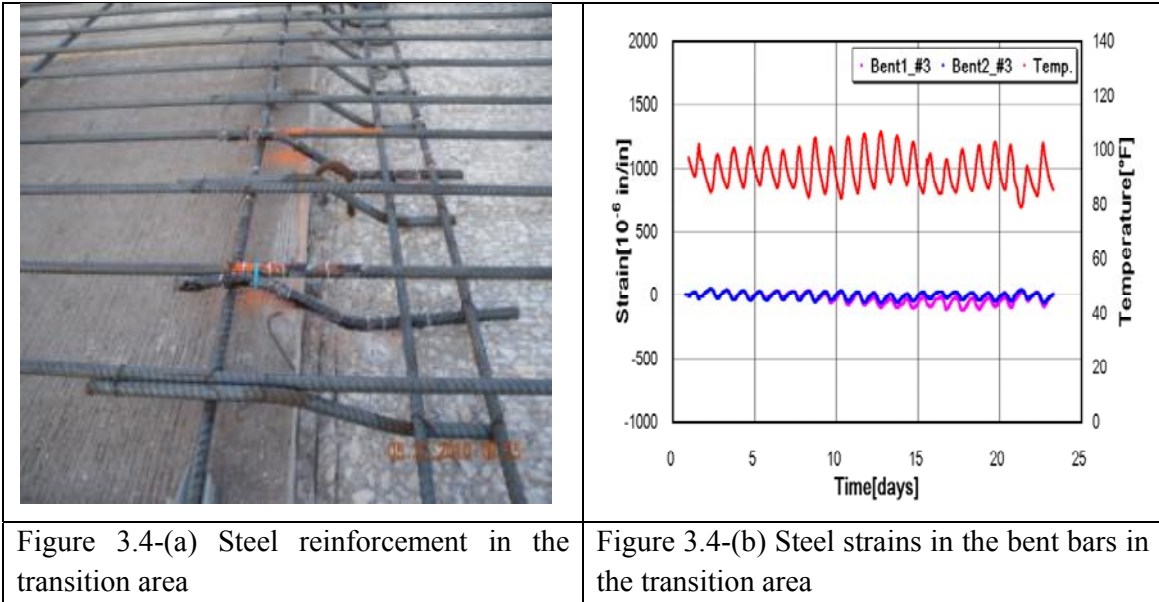
Figure 3.4-(a) illustrates steel configuration at the intersection between normal overlay and transition area. Bent bars were installed to strengthen the rigidity of the concrete in this area, because of the differences in structural rigidity of concrete slabs (7 in. vs 12 in. thick slabs). The comparison of steel strains in bent bars 1 and 2 are shown in Figure 3.4-(b). There is little variation in steel strains in the bent bars at location #3, where concrete thickness varies from 7 in. to 12 in. It should be noted that the direction of the steel at this location is not horizontal, and that the steel strains measured are in the inclined direction.

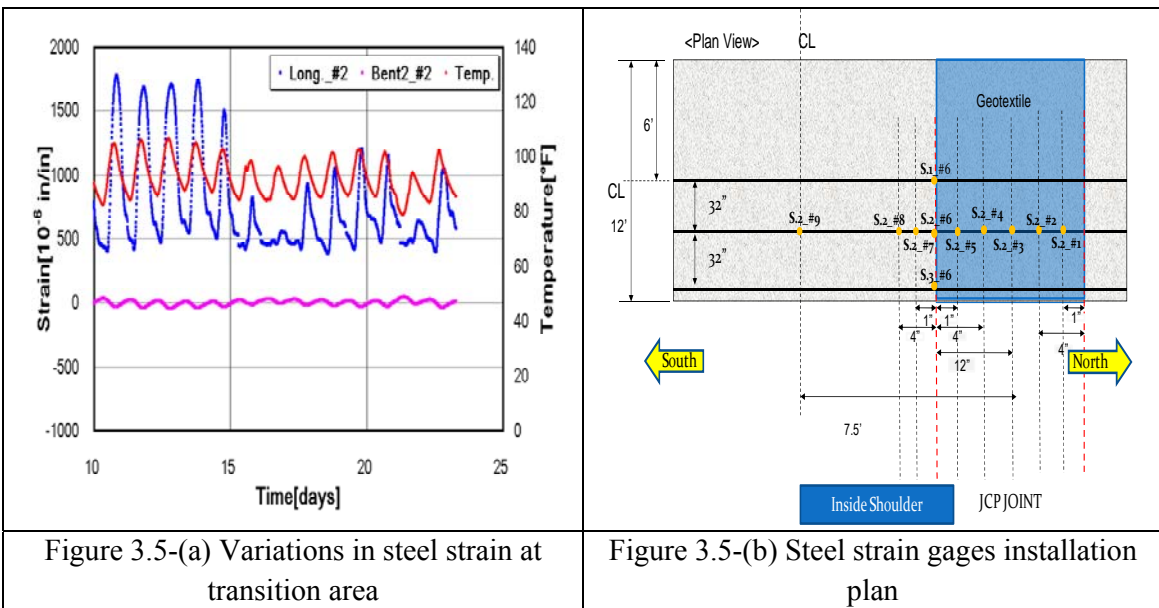
Figure 3.5-(a) compares steel strains at longitudinal steel and bent bar at location 2, which is 4 in. north from the intersection between normal overlay and transition area. Very little variation was observed in the steel strain in the bent bar, whereas quite large variations in steel strain, up to 1,300 $\mu\epsilon$ a day, were observed in the longitudinal steel.

Large strain variations in the longitudinal steel could have been caused by transverse micro-cracks in concrete in this area, even though no cracks were visually observed in this area at that time. Temperature and moisture variations, and resulting concrete strains and stresses, were maximum in the concrete near the surface. Once micro-cracks develop, the stresses in the concrete are relieved and cracks do not propagate. Low steel strains in the bent bar, which is below the mid-depth of 7 in. concrete slab, indicate the micro-cracks did not

propagate below the mid-depth of the slab. In CRCP, most of the transverse cracks on the surface propagate up to 2 to 3 in. below the surface and stresses are dissipated. No cracks are observed at the mid-depth of the steel. In this section, the bond between old and new concrete in the transition area is enhanced by rough texture from cold milling and hook bars. Enhanced bond will further restrain concrete volume changes and micro-cracks on the surface won't propagate into the bottom of the slab as well as they might in concrete with low bond strength.

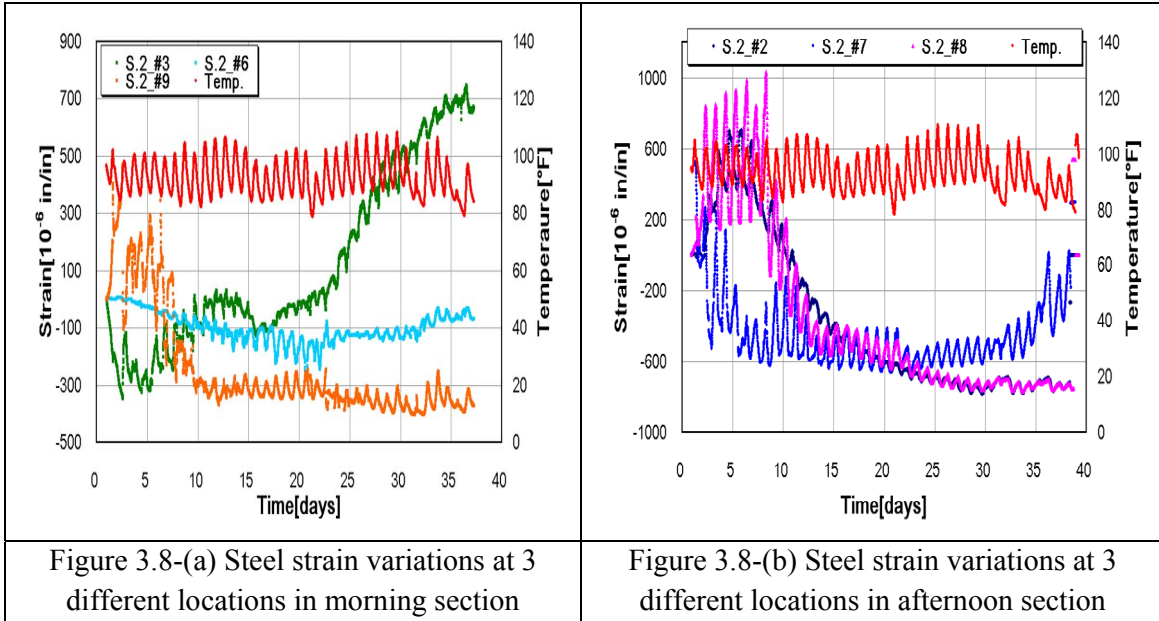
Figure 3.8-(a) Steel strain variations at 3 different locations in morning section

Figure 3.8-(b) Steel strain variations at 3 different locations in afternoon section

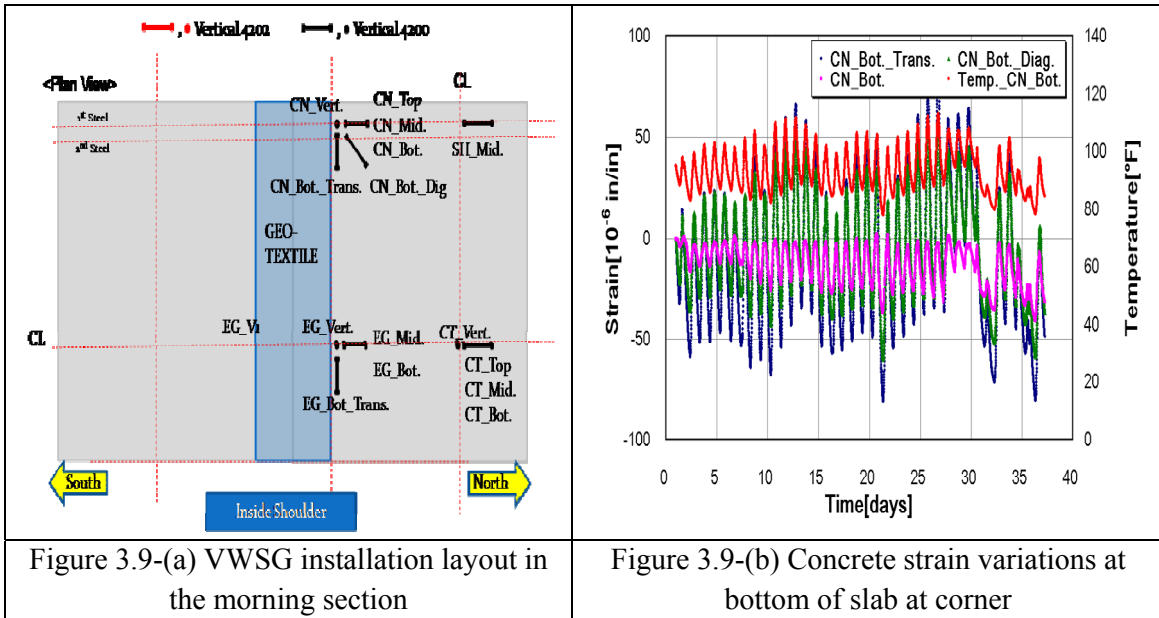
To investigate the concrete behavior at the corner location, three VWSGs were installed at the bottom of the slab in three different directions – transverse, diagonal, and longitudinal. In Figure 3.9-(a), they are shown as CN_Bot_Trans, CN_Bot_Dig and CN_Bot, respectively.

Figure 3.9-(b) illustrates the concrete strain at the bottom of the slab at the corner in three directions. It is noted that the concrete strains move in compression direction in the morning and in tension direction in the afternoon. In other words, in the graph, concrete temperatures and concrete strains are in the same direction. The temperature shown here is the concrete temperature at the bottom of the 7 in. CRCP slab. This appears to be contrary to what would be expected considering curling effect. In the morning, concrete temperature at the top of the slab is normally lower than that at the bottom, resulting in curling up of the slab. If the curling effect is dominant and the bond between old and new concrete is not perfect due to fabric, it is expected that the concrete at the bottom of the 7 in. CRCP slab will be in tension in the morning and compression in the afternoon. Figure 3.10-(a) shows the temperature variations through the depth of 7 in. CRCP slab, which indicates quite small temperature variations through the depth compared with daily temperature variations. In normal concrete pavement slabs on regular subbase, the temperature variations through the slab depth are larger than those shown here. One of the reasons could be that the 7 in. CRCP slab is resting on 10 in. JCP slabs, which reduces the temperature variations through the slab depth. Small temperature variations through the slab depth explain why the concrete strains in Figure 3.10-(b) move in the compression direction in the morning and in the tension direction

in the afternoon. The axial component of the concrete displacement is much larger than the curling component. It should be also noted that the subbase under the 10 in. JCP in this project is aggregate base, which has a small frictional coefficient. The order of concrete strains in three directions – transverse, diagonal followed by longitudinal – also supports the dominant effect of axial component of concrete displacement. Large concrete strains in the transverse direction indicate relative free movement in that direction, and accordingly quite small concrete stresses result in that direction, with a low probability of longitudinal cracking. On the other hand, small concrete strains in the longitudinal direction indicate large concrete stress in that direction, and a high potential for transverse cracking.

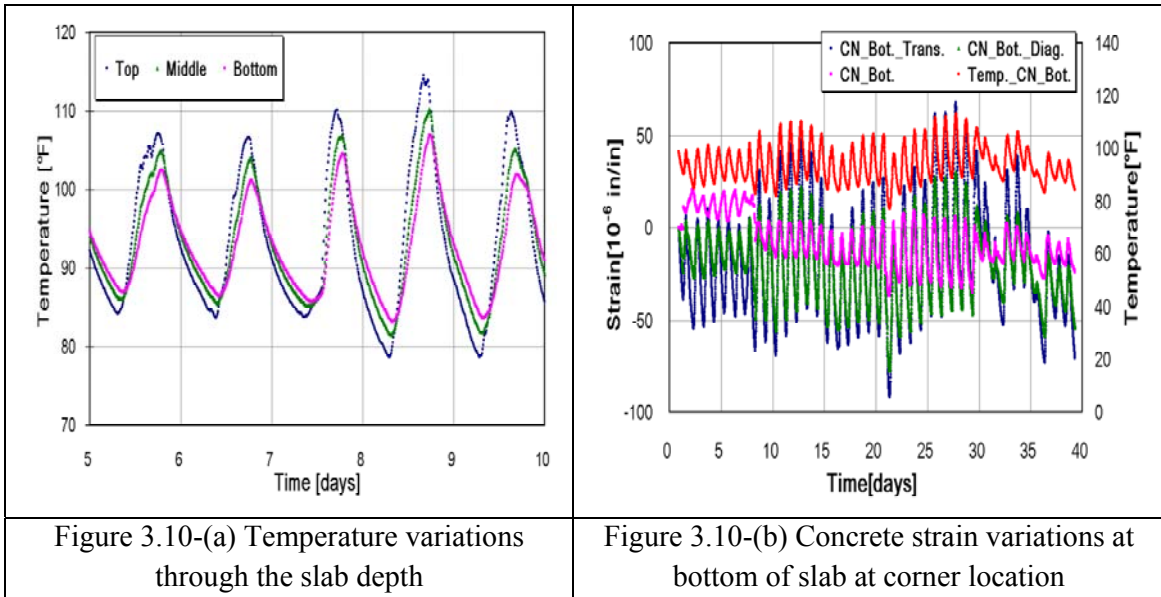
Figure 3.10-(b) shows the concrete strains at the bottom of the 7 in. CRCP at the corner in three directions in the afternoon section where fabric was removed. Compared with Figure 3.9-(b), the same trend is observed and it appears that the interface bond condition doesn't affect the bottom concrete strains at the corner.

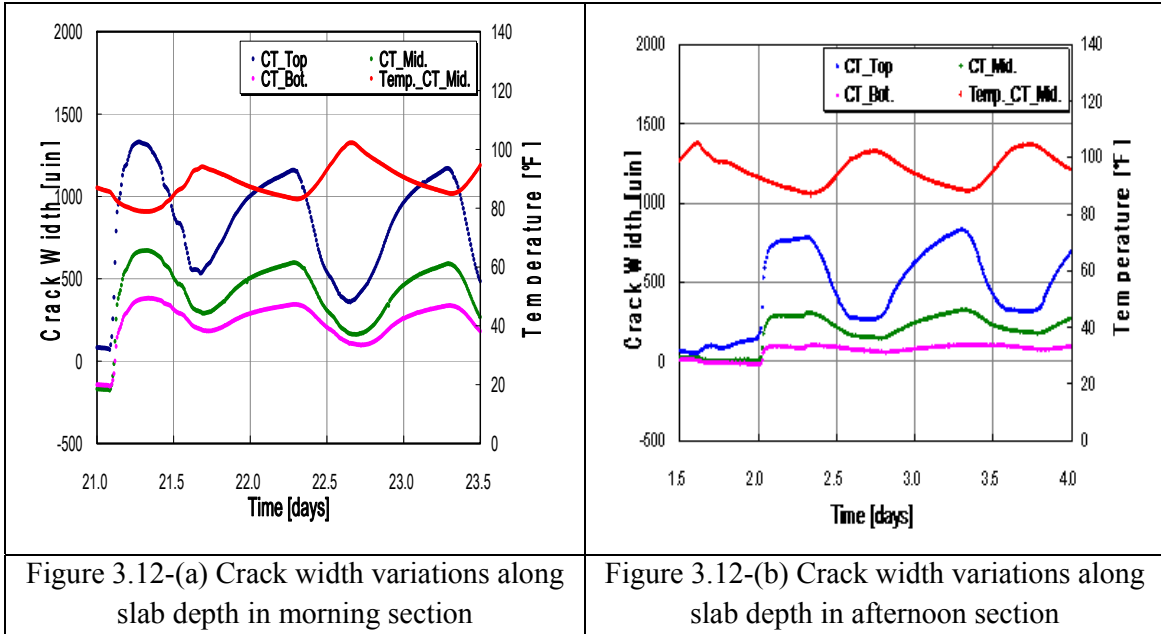
Figures 3.12-(a) and 3.12-(b) show the crack width variations for 2.5 days after cracks occurred in the morning and afternoon sections, respectively. It is observed that cracks occurred while concrete temperature was going down, not at the lowest concrete temperature. The concrete temperature here is at the mid-depth of the 7 in. CRCP slab. The widths of cracks were quite small, even at the top of the slab. Cracks were less than 0.0015 in. in the morning section and less than 0.0008 in. in the afternoon section, even though with the further drying shrinkage and temperature drop, these crack widths might increase. Also interesting are the crack width variations through the slab depth. It is noted that, in both sections, crack widths at all three depths moved in the same direction. In other words, crack widths at all three depths followed the same variations over time. This is quite different from crack width variations through a slab depth observed in normal CRCP.

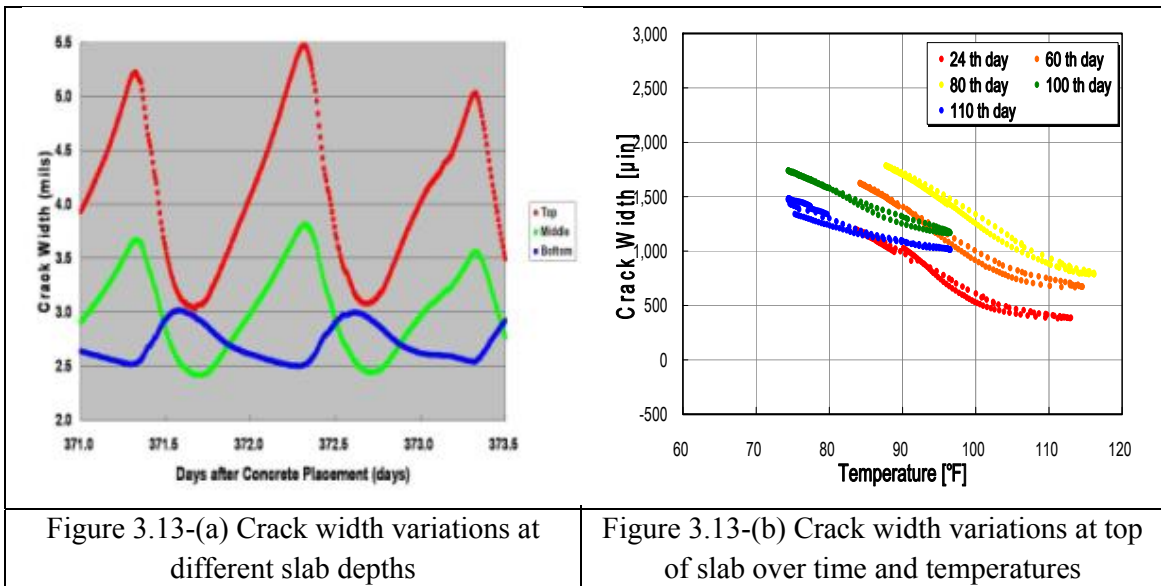
Figure 3.13-(a) illustrates crack width variations through the slab depth observed in normal CRCP. This 13 in. CRCP section is on US 59 in Cleveland, Houston District.

Concrete was placed on July 20, 2004.⁽⁵⁾ It shows that the crack width at the bottom of the slab (1 in. from the slab bottom) varies in the opposite direction with the crack widths at the top (1 in. from the slab surface) and middle of the slab. The crack width variations through the depth of the slab in normal CRCP indicate bending action with a neutral axis a little below the depth of the steel (mid-depth of the slab). On the other hand, those in CRCP BCO indicate bending action with a neutral axis below the bottom of the slab. The difference in crack width variations through the slab depth between BCO and normal CRCP appears to be due to the interface bonding condition at the bottom of CRCP and the layer below.

Figure 3.13-(b) shows the crack width variations at the top of the slab over time of the crack in the morning section. Crack width increased from day 24 to day 60 to day 80. On the other hand, crack width actually decreased on day 100 and further on day 110, even though concrete temperature decreased in that time period. This finding is consistent with the observations made in other CRCP sections, where crack widths decreased over time.⁽¹⁾ The difference is that the observations made in Reference 1 were at an induced transverse crack, while in this project, the crack occurred naturally. The prevailing current theory on CRCP crack behavior is that crack width increases over time, and load transfer decreases with the increase in crack width, ultimately resulting in punchouts. The findings in this study and reference (5) indicate otherwise. Long-term monitoring will be made on the behavior of this crack and included in the report under TxDOT Project 0-6274.

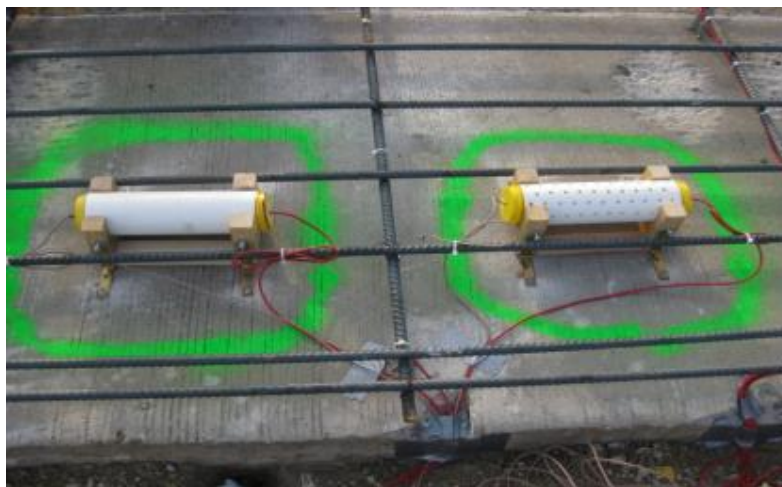
Figure 3.14 Impervious (left) and pervious (right) NSC

Non-stress cylinders (NSC) were installed in the morning and afternoon concrete sections. Two NSCs were installed in each location – one with impervious NSC (INC) and the other with pervious NSC (PNC), as shown in Figure 3.14. The center of the NSCs was 4 in. from the surface of the CRCP. In Figure 3.14, the cylinder on the left is INC and the one on the right is PNC. The concrete inside of the INC remains almost saturated, since it does not lose any moisture and initially sufficient moisture is provided on the inside wall of the INC. The only shrinkage in the concrete in INC could be chemical and autogenous shrinkage. Since excess water was provided in the INC using cotton, both shrinkages are assumed to be negligible, and the concrete strains in INC are due to temperature variations only. The slope of a line between concrete temperatures and concrete strains in INC, therefore, will be in-situ CTE. On the other hand, the concrete in PNC will lose or gain moisture through holes by moisture exchange with the surrounding concrete and it is assumed that there is moisture equilibrium in concretes inside and outside of the PNC. Accordingly, the concrete strains in the PNC will be due to both thermal and moisture variations. The difference in concrete strains in INC and PNC will be drying shrinkage.

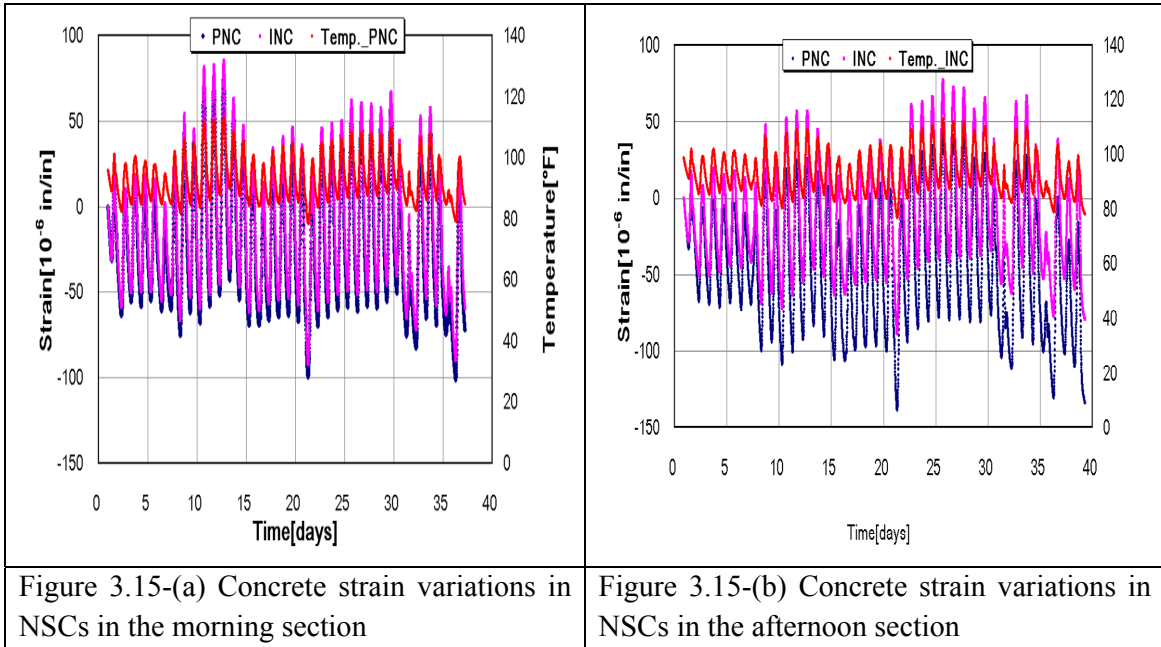
Figures 3.15-(a) and 3.15-(b) show the INC and PNC data from the morning and afternoon sections, respectively. They show that concrete strains vary along with concrete temperature. Also, the difference in concrete strains between INC and PNC in the morning section is much smaller than that in the afternoon section. This indicates that the drying shrinkage in the morning section would be smaller than that in the afternoon section.

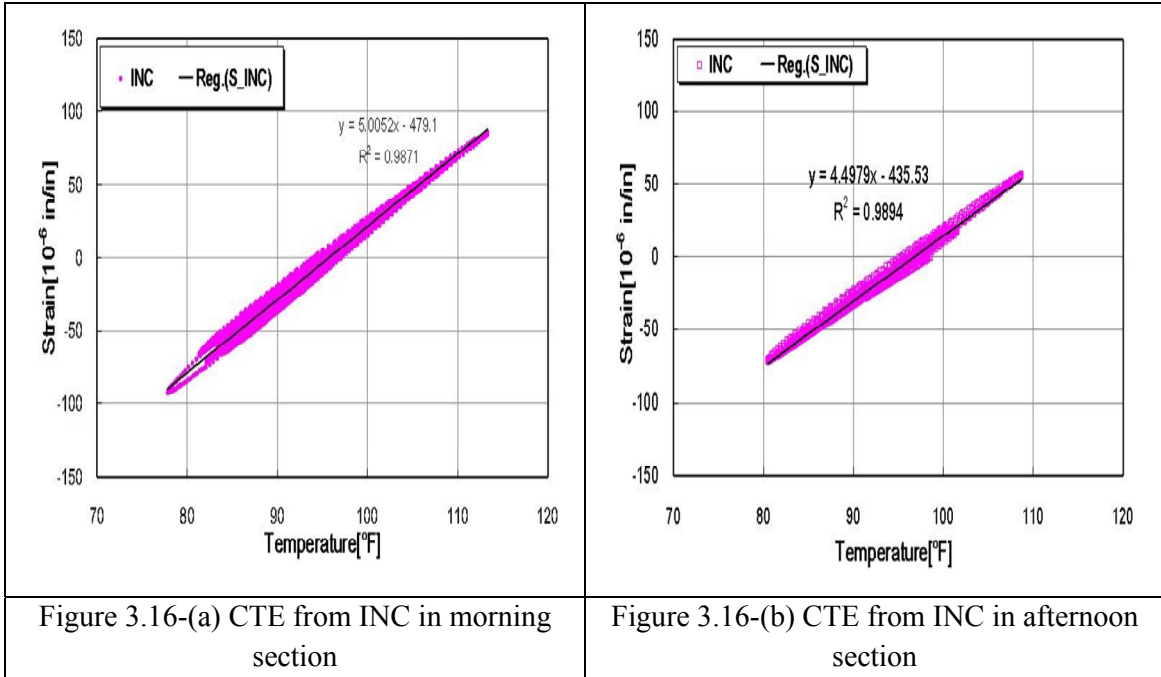
3.3.2.3.1 In-situ CTE Evaluation: In-situ CTE was estimated from the data in INC in the morning and afternoon sections, as shown in Figure 3.16-(a) and 3.16-(b), respectively. CTE values of 5.0 and 4.5 microstrain/ °F were obtained in the morning and afternoon sections, respectively. A difference of 0.5 microstrain/ °F was observed between morning and afternoon sections. It is well known that concrete paste has higher CTE than coarse aggregate. ^(6,7) It could be that, when concrete was put into INC in the morning section, the proportion of cement paste was larger than that in the mix design. The CTE value of concrete with this coarse aggregate as evaluated by CSTMP was less than 4.6 microstrain/ °F. For the accurate evaluation of in-situ CTE, efforts should be made to ensure that the proportions of the concrete mixture in the non-stress cylinders are similar to those of the concrete supplied. This finding also illustrates the requirement of a fixed mix design for the evaluation of CTE of coarse aggregate.

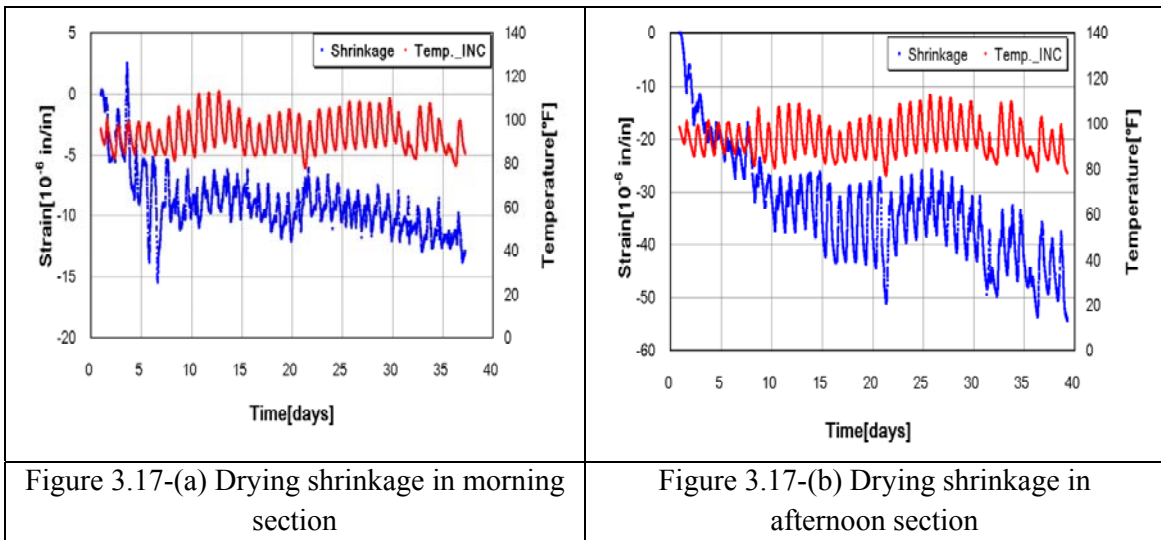
3.3.2.3.2 In-situ drying shrinkage evaluation: In-situ drying shrinkage was estimated from the data in INC and PNC in the morning and afternoon sections, as shown in Figure 3.17-(a) and 3.17-(b), respectively. Since the NSCs were installed in the lower part of the CRCP overlay (the center of NSCs was 4 in. from the surface of the slab), it is expected that the drying shrinkage will not be high. Figures 3.17-(a) and 3.17-(b) show that, overall drying shrinkage is quite small, less than 15 and 60 microstrains in the morning and afternoon sections, respectively. These values are much smaller than drying shrinkage of concrete exposed to normal ambient condition. Wet-mat curing of the concrete surface might have contributed to the small drying shrinkage. The smaller drying shrinkage in the morning section could be due to the larger CTE value in that section compared with that in the afternoon section.
