Continuously Reinforced Bonded Concrete Overlay of Distressed Jointed Concrete Pavements

Sungwoo Ryu, Hoonill Won, Moon C. Won

Report #: 5-4893-01-1
www.techmrt.ttu.edu/reports.php

March 2011

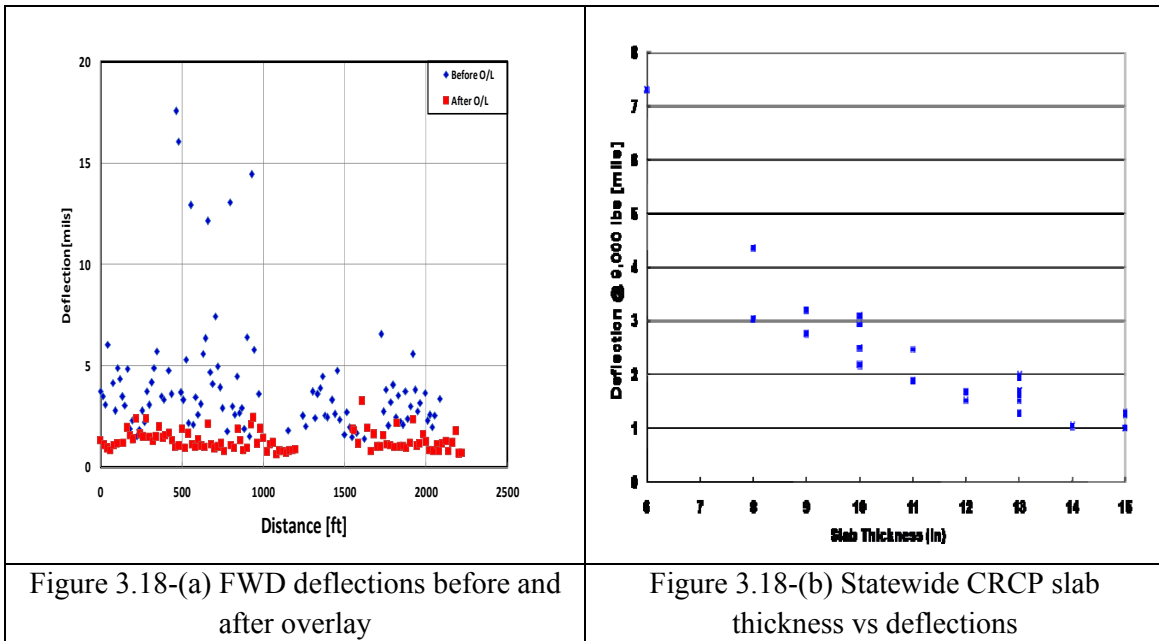
The primary benefit of bonded concrete overlay (BCO) is to enhance the structural capacity of the existing pavement system. The structural capacity of the JCP was evaluated using FWD (falling weight deflectometer) along the project before and after the overlay. Figure 3.18-(a) shows the testing results in the FWD deflections at the mid-slab conducted in the outside lane. The distance is from the beginning of the project in the north limit. Before overlay, overall deflections were large, and deflections larger than 10 mils were observed in several locations. After overlay, the deflections were reduced substantially. The average deflection at 9,000 lb loading after overlay was 1.02 mils. Figure 3.18-(b) illustrates the deflections in CRCP with various slab thicknesses in Texas. This information was obtained from the testing in Research Project 0-6274. The average deflection of 1.02 mils after overlay in this project is comparable to the deflections of 14 in. or 15 in. CRCP. The performance of 14 in. and 15 in. CRCP in Texas has been excellent and it is expected that this rehabilitation section will provide good performance for years to come. This section will be included in 0-6274 as an experimental section and deflection testing will be conducted on a regular basis.
