Optimizing Maintenance Activities
Fourth Report

REPAIR OF CONTINUOUSLY
REINFORCED CONCRETE PAVEMENT

Report FHWA-TS-78-215

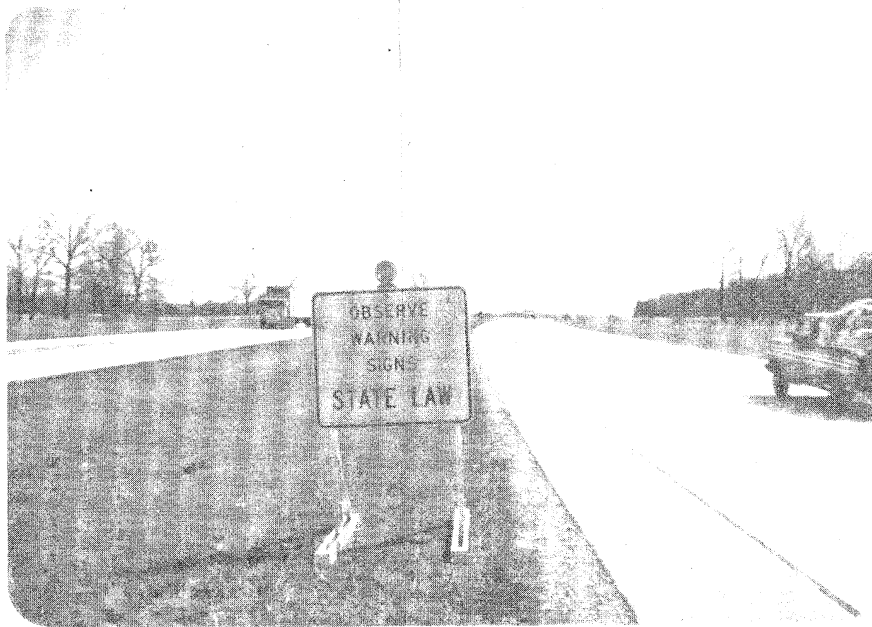
Figure 1. Advance warning sign (on both sides of the road).

1. Provide for detouring traffic. Many suggestions for improving current practices were investigated but any procedure used will have to comply with State and Federal standards for controlling and handling traffic through construction or maintenance zones. Much additional consideration must be given to detouring procedures on projects where patching is an almost continuous or recurring operation. Figures 1 through 5 show typical detour signing.

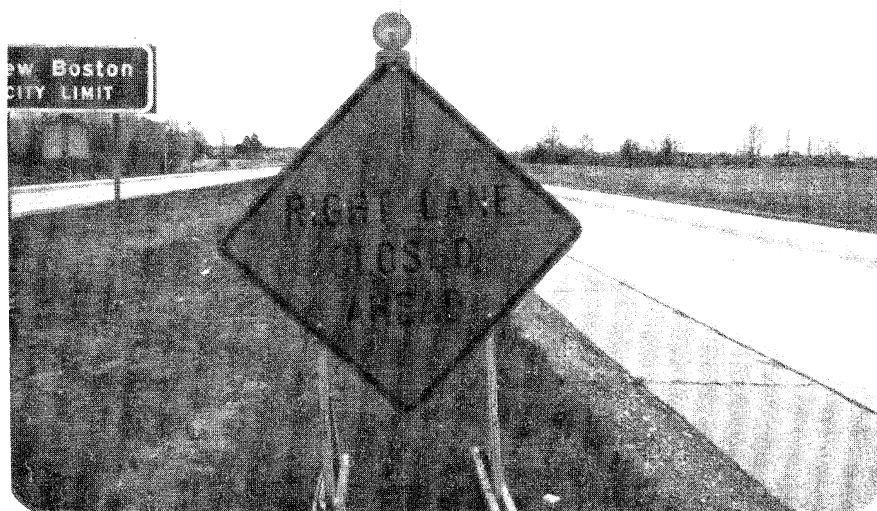
Figure 3. Right lane closed ahead (on both sides of the road).

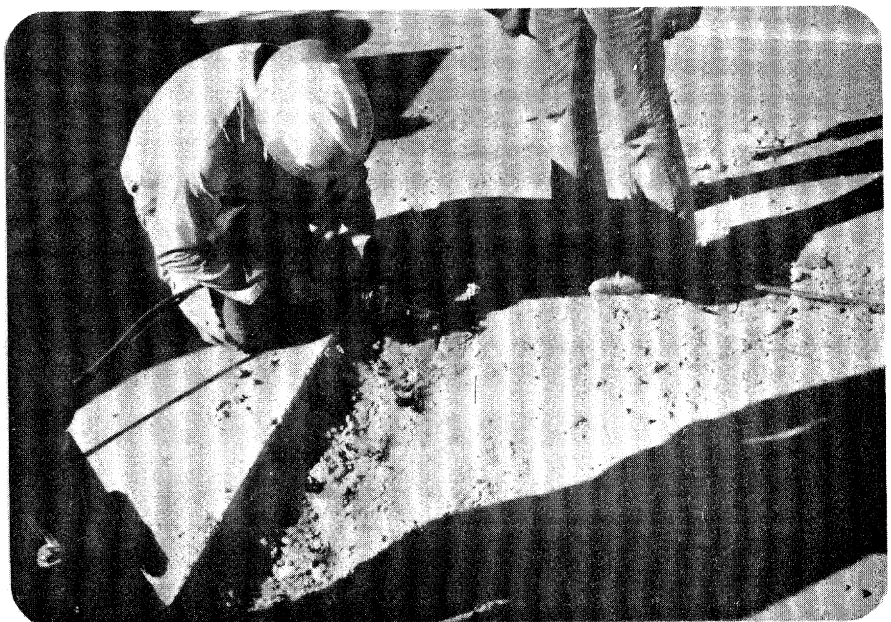
Figure 8. Cutting the steel.

4. Cut steel to provide sufficient length for lap splicing or welding. Some of the States preferred welding while others preferred tying. The

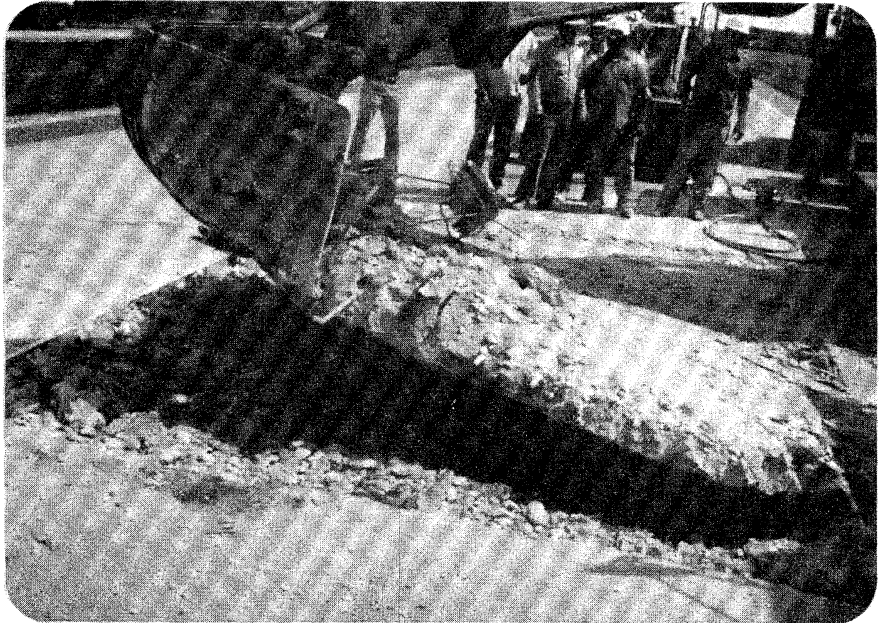
Figure 10. Raising the slab.

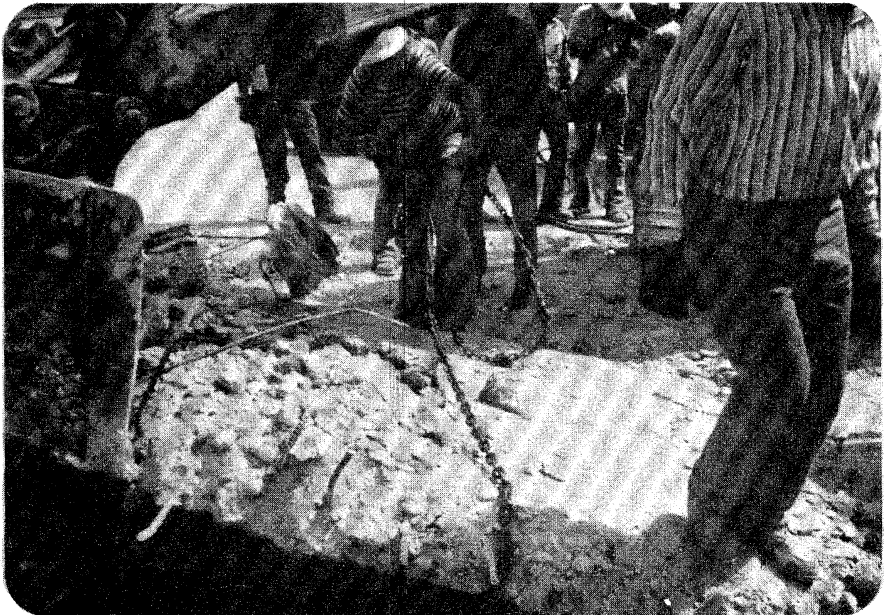
Figure 11. Putting a chain around the slab.

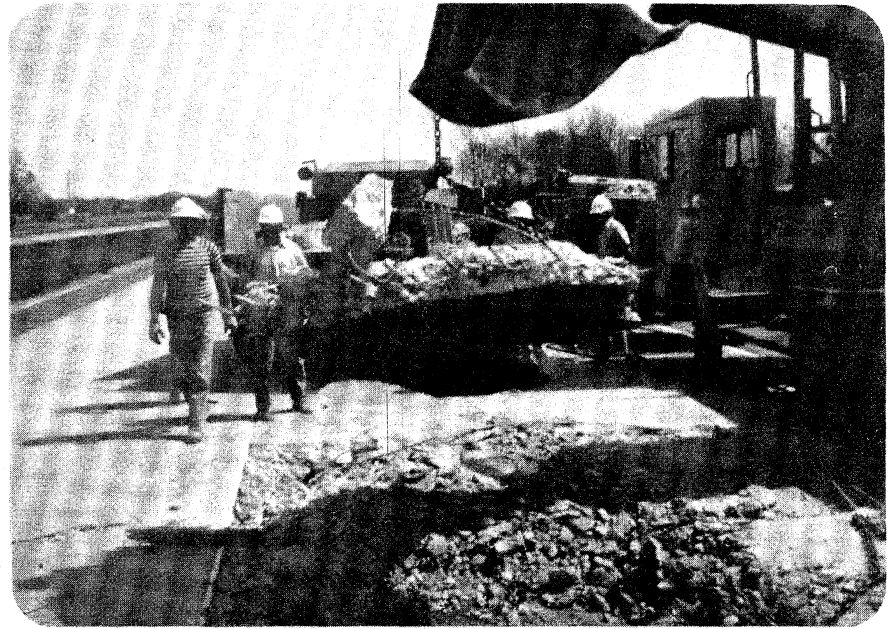
Figure 12. Lifting the slab.

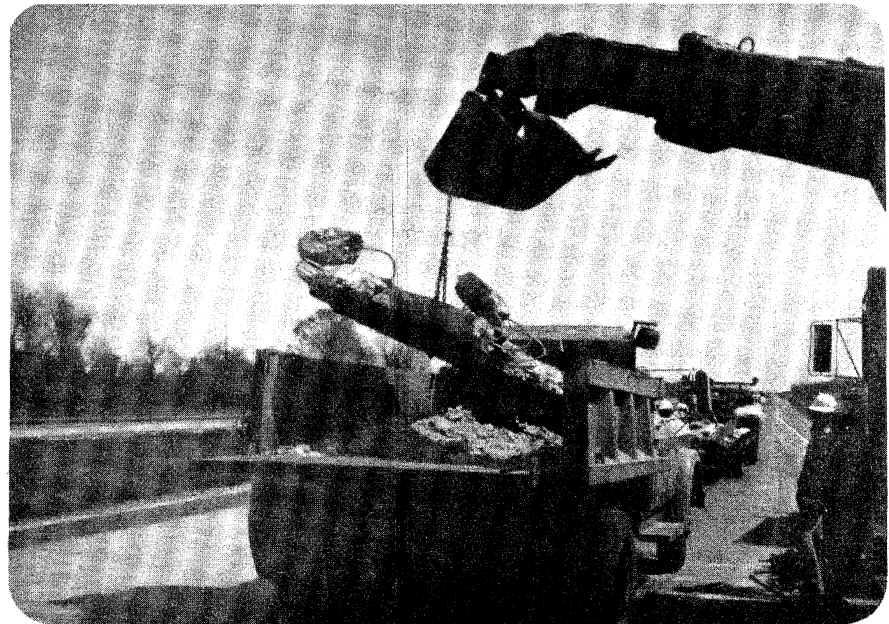
Figure 13. Loading the slab for disposal.

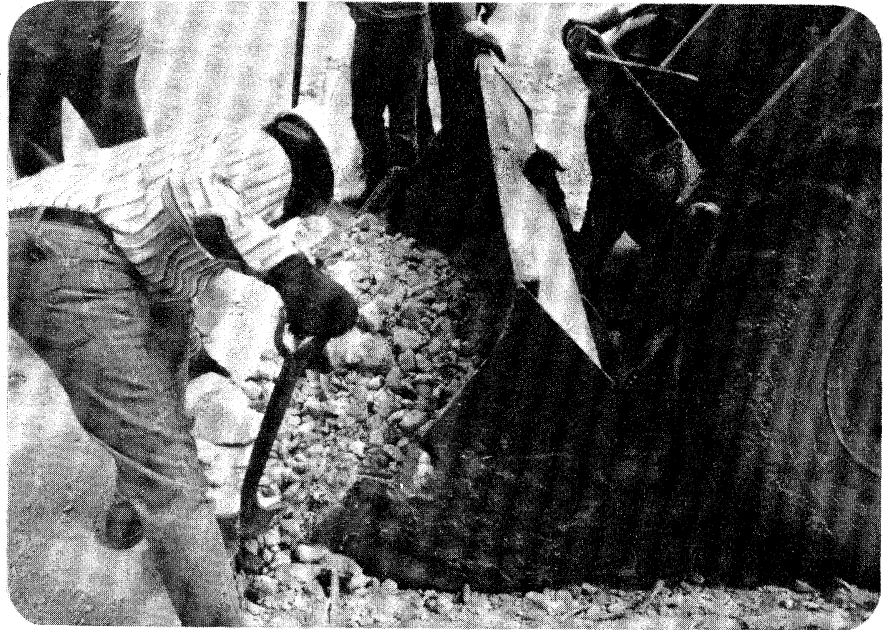
Figure 15. Loading debris.

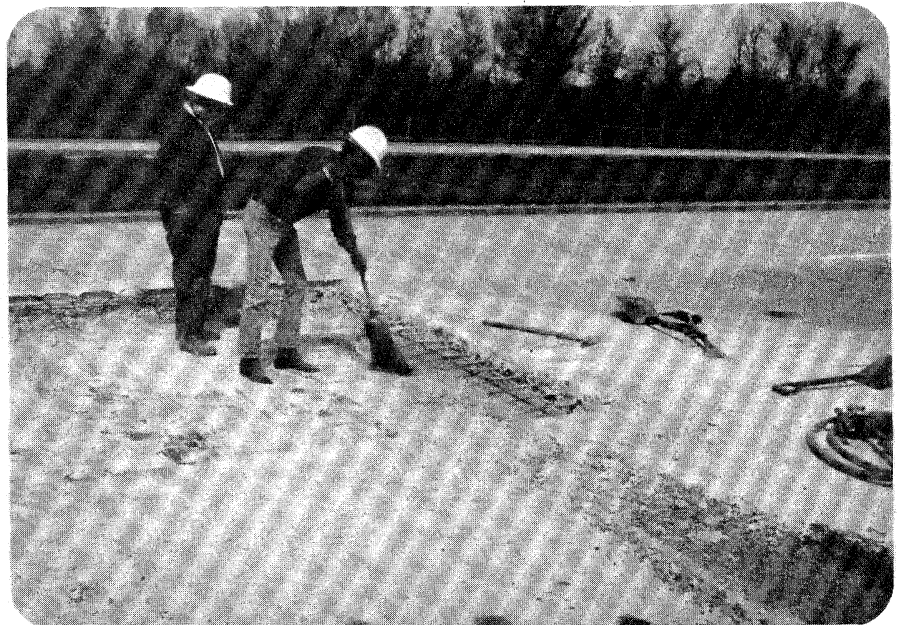
Figure 16. Final cleanup.

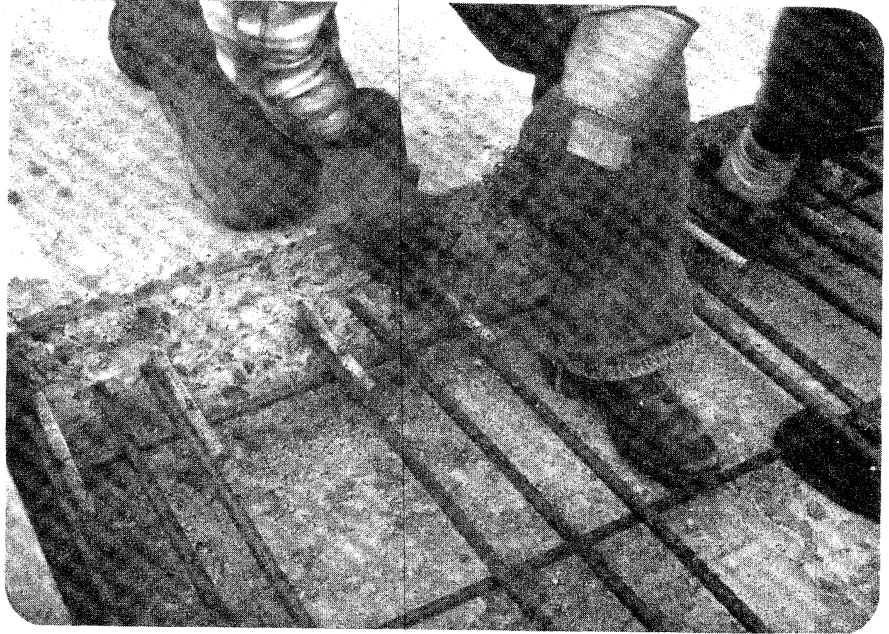
Figure 17. Tying steel for welding.

advantages of welding to maintain positive continuity of the steel were acknowledged. Tying the steel eliminates the need for a welder on the job thus reducing the cost of the patch. The existing steel could be left in place if the unsound concrete can be removed without breaking the steel. The practice of cutting the steel in the middle, bending it up to remove the concrete, then bending it back down for reuse is considered unsatisfactory. Figures 8 and 17 through 20 show examples of steel being cut and spliced by welding and tying.

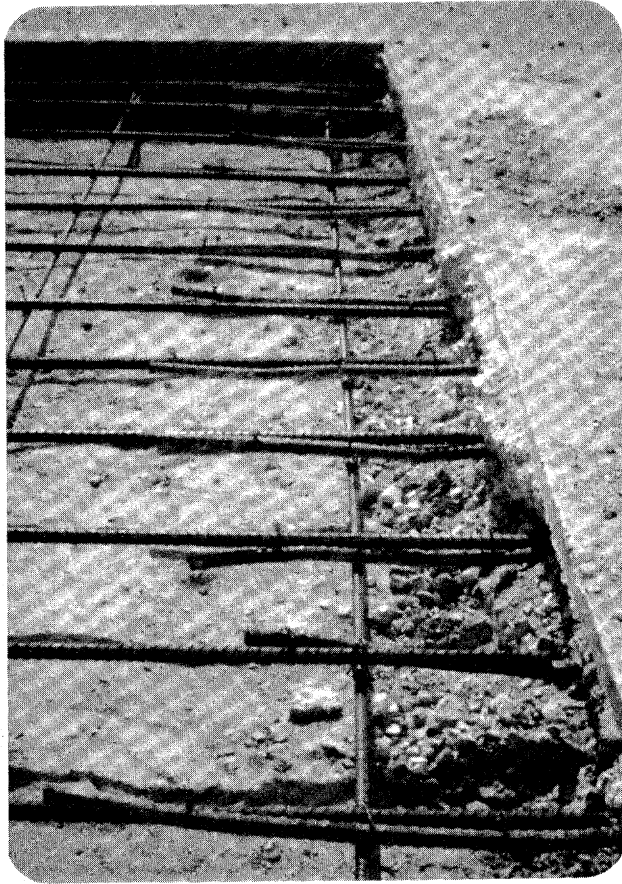
Figure 19. Typical tied steel splice.

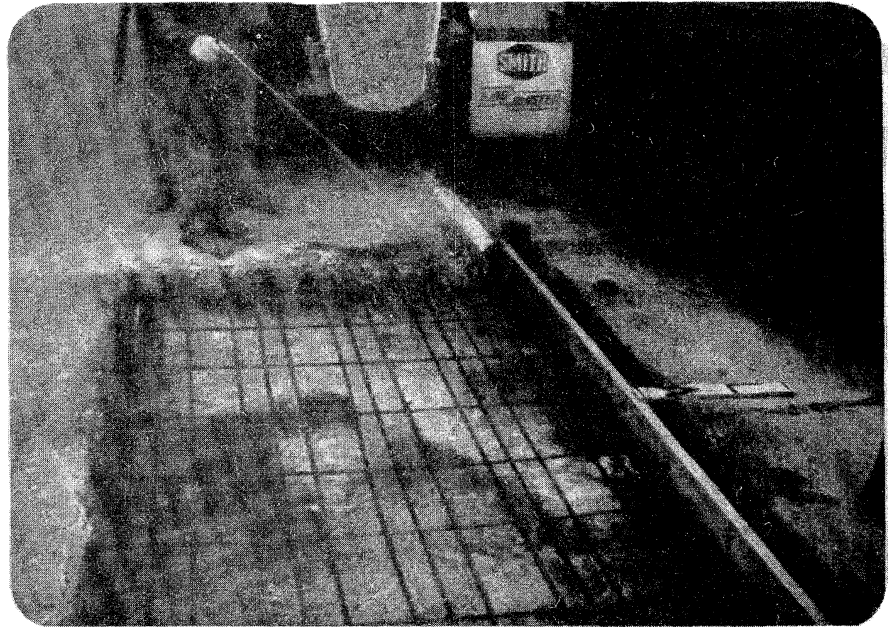
Figure 23. Spraying with water before placing concrete (note the side form being used).

8. The subbase, existing concrete faces and steel should be sprayed with water before the concrete is replaced. The use of grout, or epoxies, on the concrete faces was not considered to be cost effective by a majority of the States. Figure 23 shows the patch area being sprayed with water from a ready-mix truck. Note the side form in place.

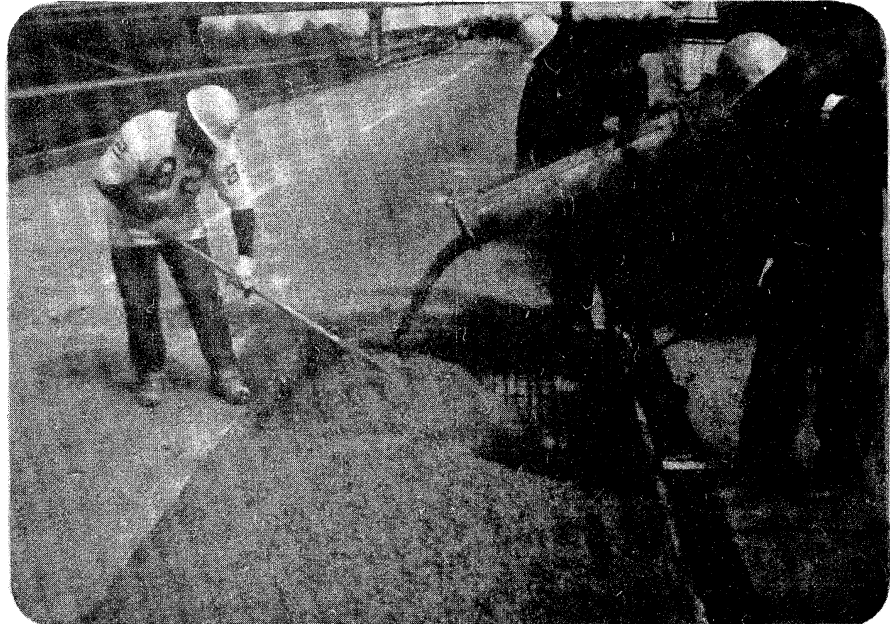
Figure 24. Placing concrete from a ready-mix truck

9. Fill the excavated area with concrete using a design to provide for quick setting where needed. Figure 24 shows the concrete being placed from a ready-mix truck. In most cases, it is desirable to return the road to traffic service as soon as possible for the convenience and safety of

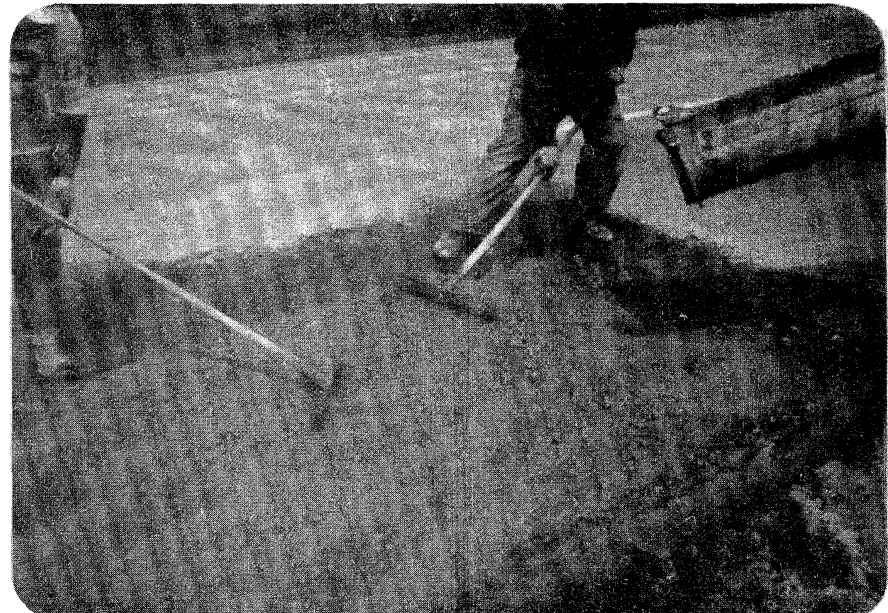
Figure 25. Spreading concrete.

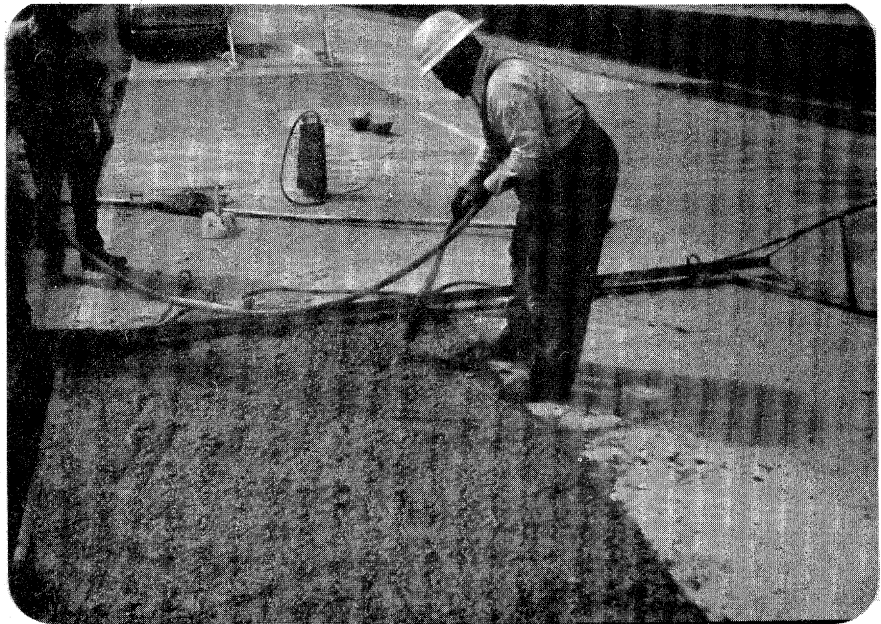
Figure 27. Vibrating the concrete.

10. Consolidate the concrete by mechanical vibration and screed the surface for riding quality. Adequate consolidation of the concrete is imperative and this can best be assured by mechanical vibration. Also, it is unnecessary to provide for a surface finish in excess of the condition of the existing concrete. Figures 25 through 27 show the concrete being spread, struck off and consolidated.
11. Use a sprayed membrane curing compound to cure the concrete patch. Other curing methods provide for a satisfactory patch but the use of a curing compound is the most practical. Figures 28 and 29 show the patch being finished and cured.

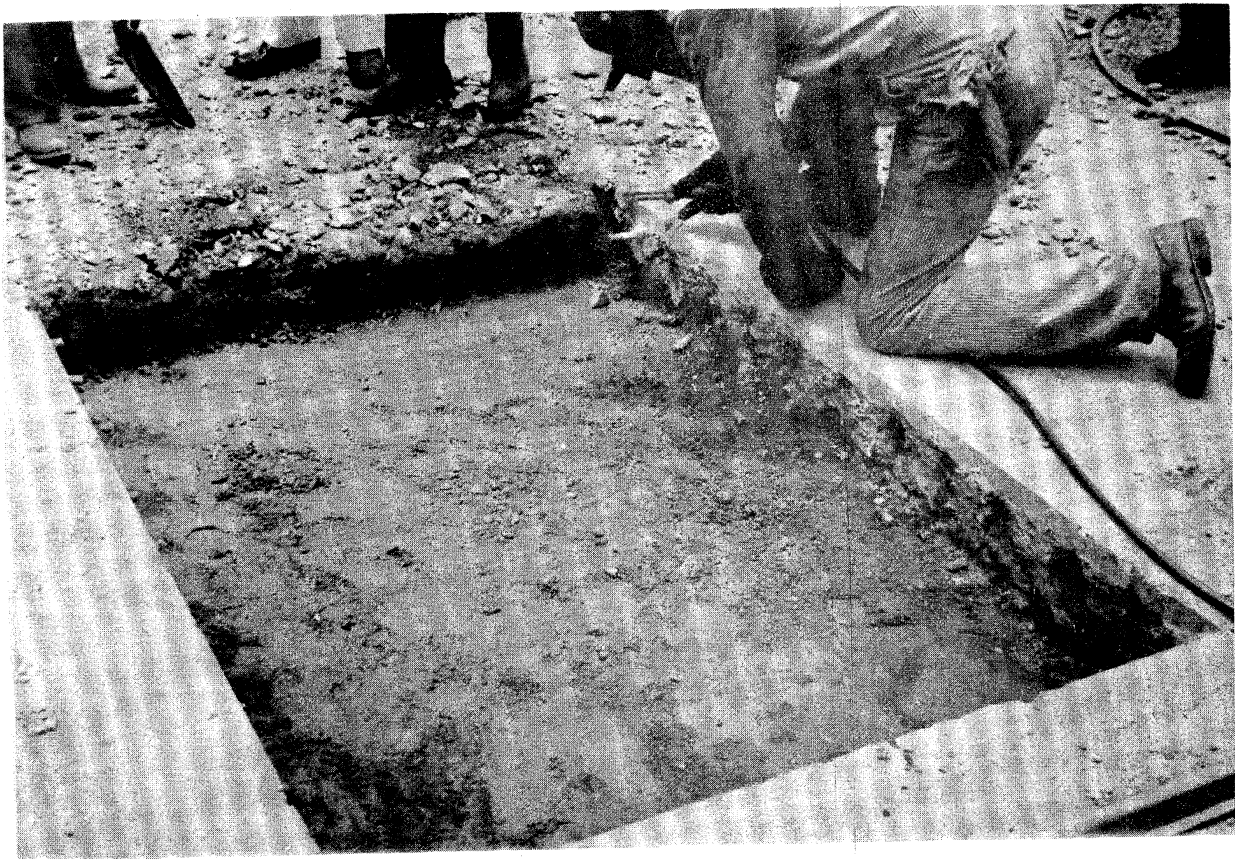
Figure 30. Preparing hole for precast patch.

with CRCP is more difficult due to the absence of joints and the need to retain continuity of the steel. However, the advantage of being able to complete a repair within one day makes precast patching an attractive possible alternative for CRCP repair. Such patches have been placed experimentally by the State of Mississippi. More time will be required to fully develop and evaluate this method of repair. The monetary saving for this type of patch is not expected to be great when compared with conventional patching methods. However, full development and utilization of this technique should permit much more rapid repairs. Figures 30 through 37 demonstrate some of the operations involved and the appearance of the finished patch. In this case, no attempt was made to maintain the continuity of the steel.

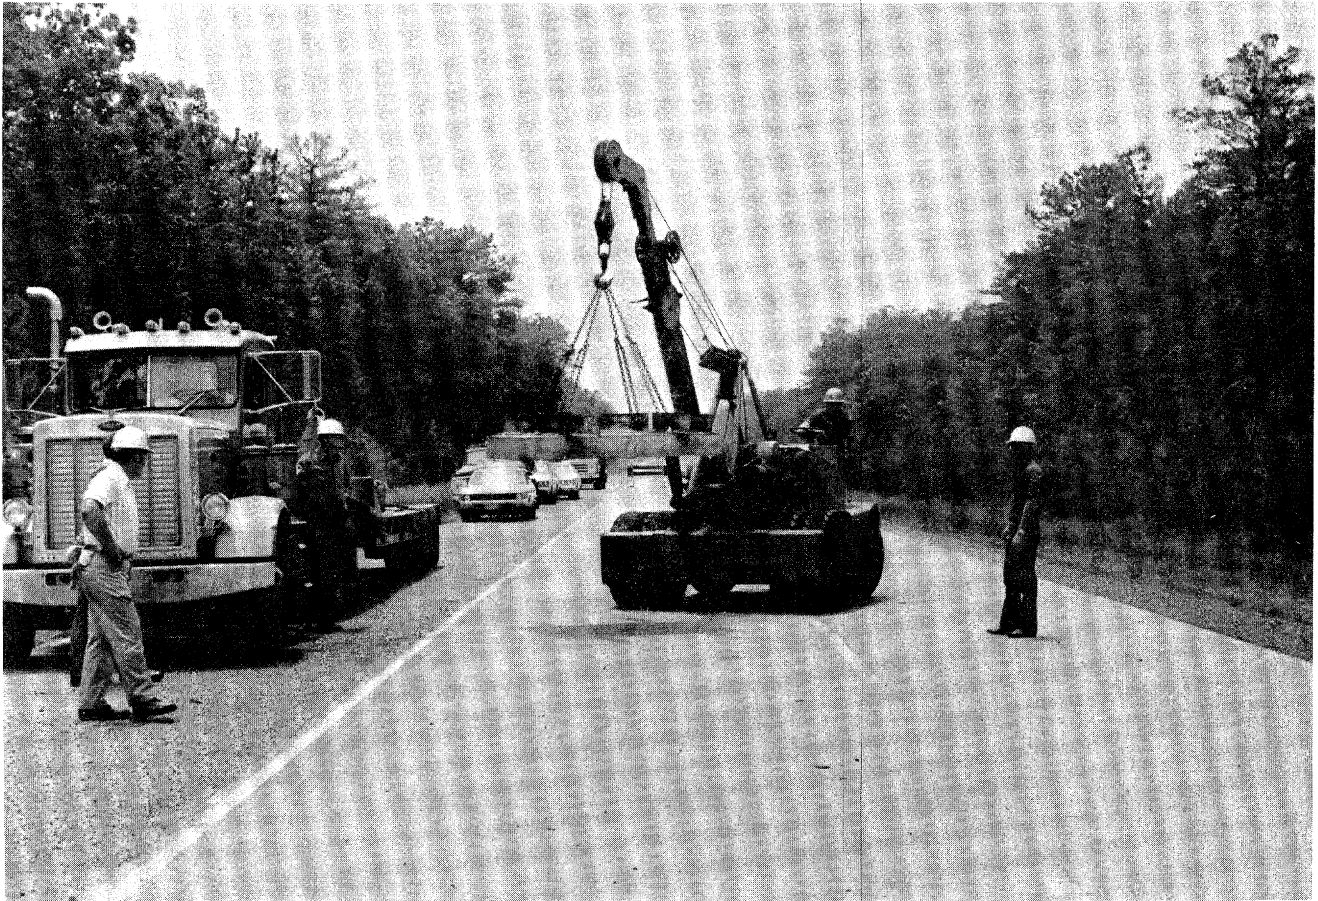
Figure 33. Taking the precast slab from truck to the hole.

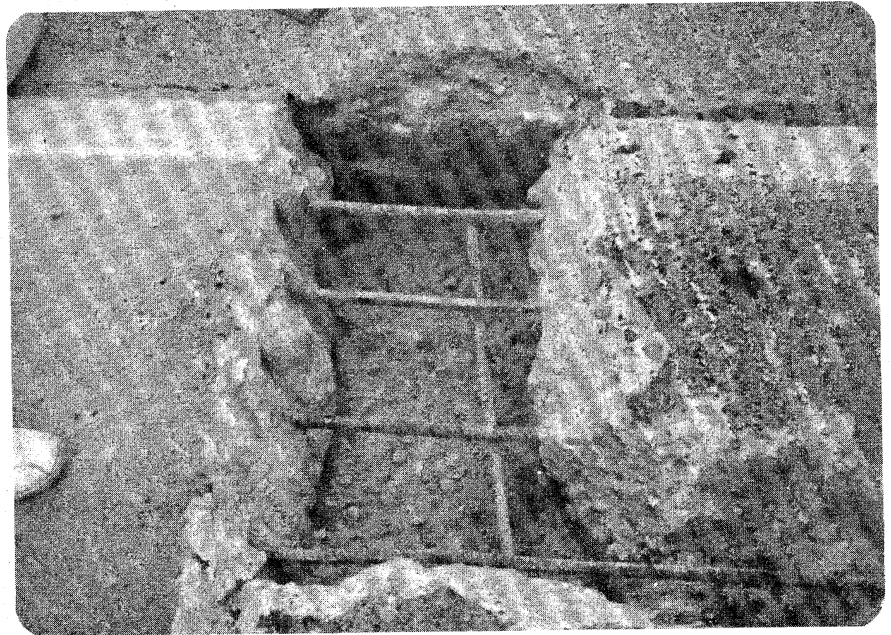
Figure 38. Hole prepared for polymer patch.

12. Polymer Concrete Patch. Polymer concrete offers the possibility of fast setting with higher strength and better bonding than normal concrete. Research in Texas has demonstrated the practicality of the use of polymer concrete for bridge deck repair. Experimental patches have also been made on CRCP. The high cost of this material combined with the specialized equipment and knowledge required for handling precludes it from being readily adopted for CRCP repair. Experimentation and further development and evaluation of this technique is being pursued in Texas. Figures 38 through 44 show the installation and results of polymer patching.

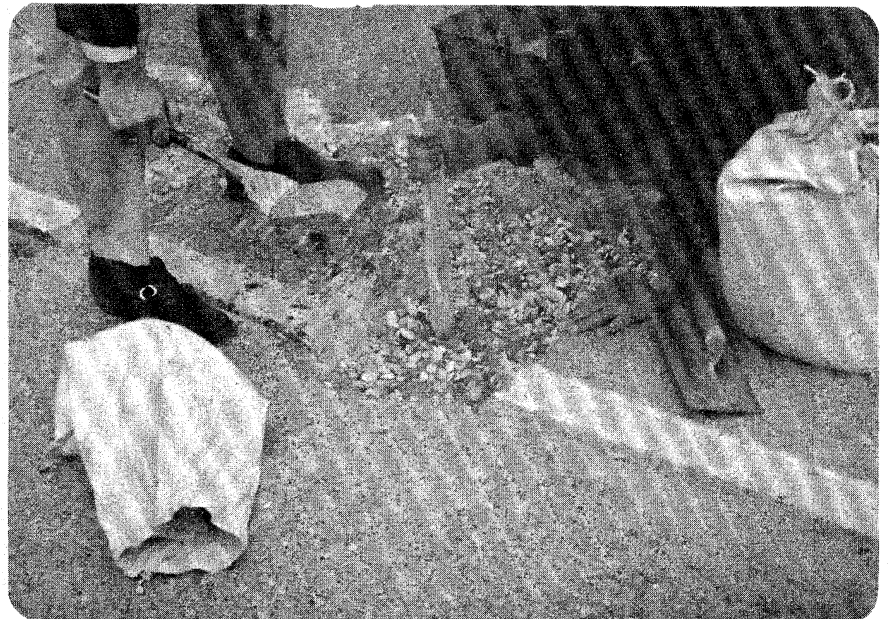
Figure 40. Placing fine aggregate.

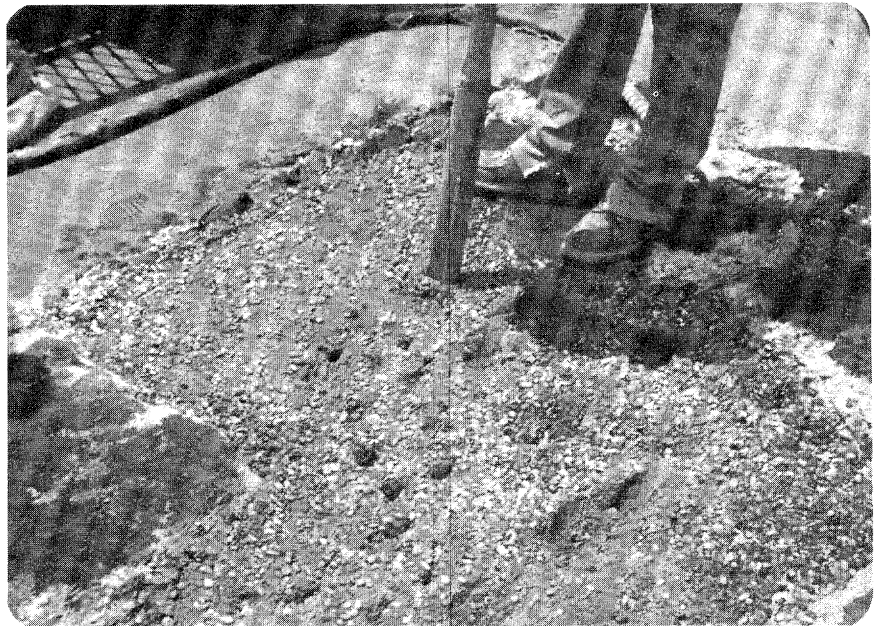
Figure 42. Vibrating a typical polymer patch.

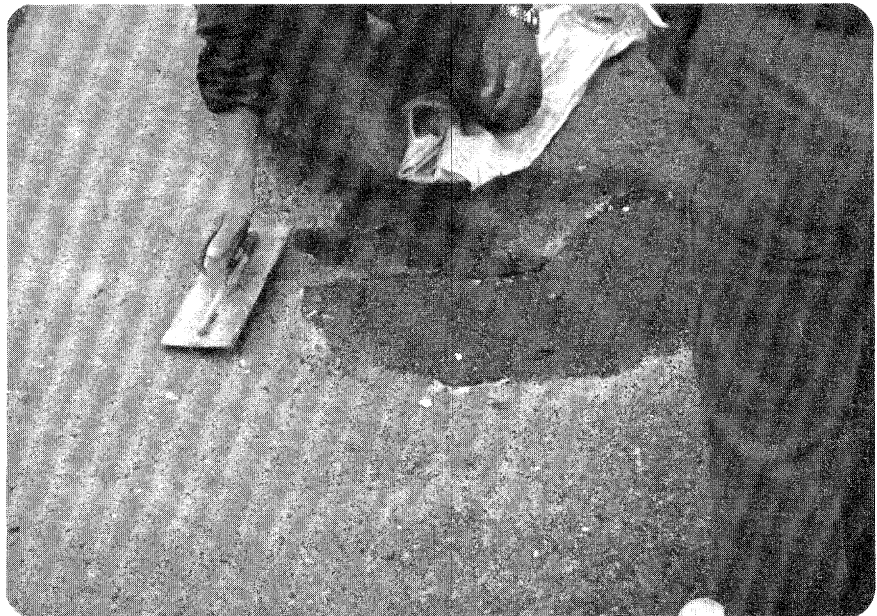
Figure 43. Finishing a polymer patch.

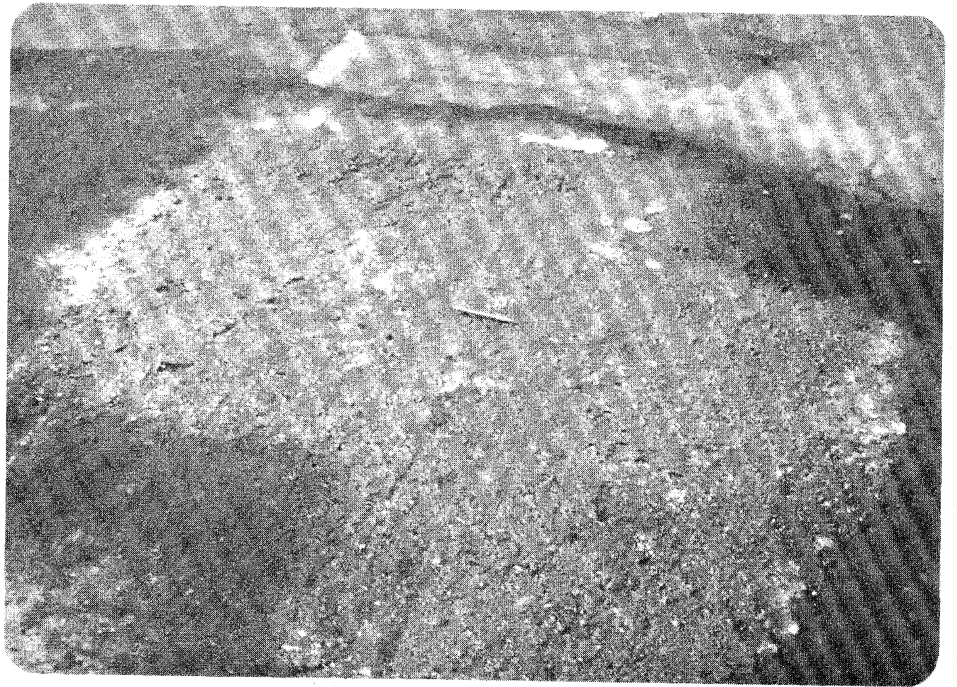
Figure 44. Typical finished polymer patch.
