TECHBRIEF

Safety Evaluations of Innovative Intersection Designs for Pedestrians and Bicyclists

FHWA Publication No.: FHWA-HRT-23-033

This document is a technical summary of the Federal Highway Administration report *Safety Evaluations of Innovative Intersection Designs for Pedestrians and Bicyclists* (FHWA-HRT-23-033).

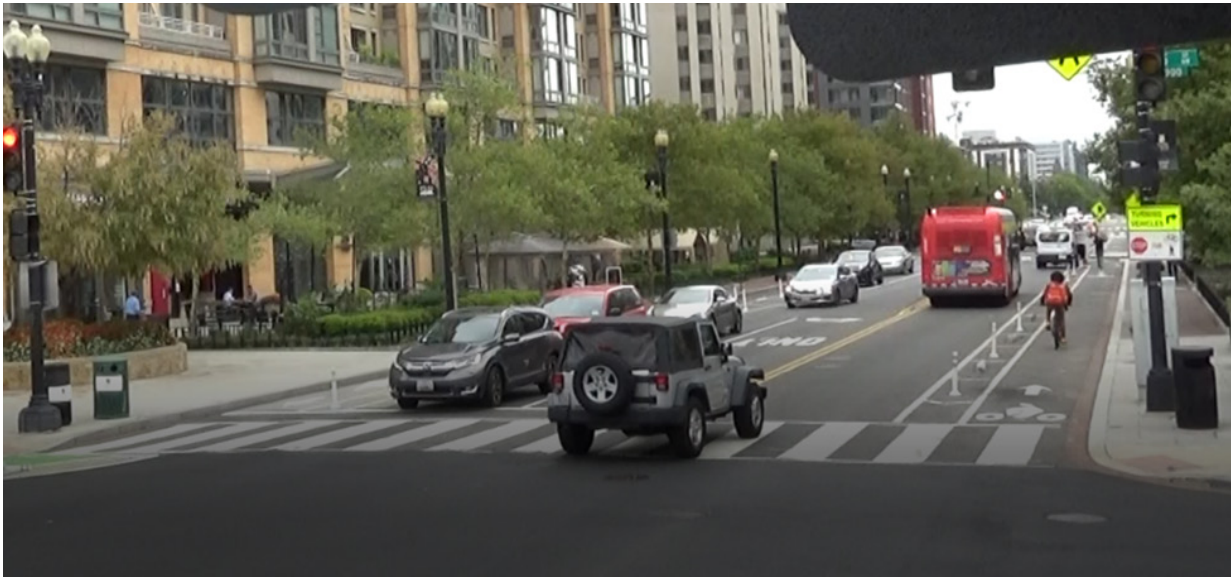
Figure 1. Photo. Example of video view for one of the cameras at DC-WAS-03-Aft (after).

For the Washington, DC, sites, the research team installed four video cameras on streetlight poles on October 12 or October 13, 2020, to capture the before modifications condition. The installations occurred October 20 to 22, 2021, for the after condition. Each camera covered one crosswalk at the intersection. Figure 1 shows the video from one of the cameras.

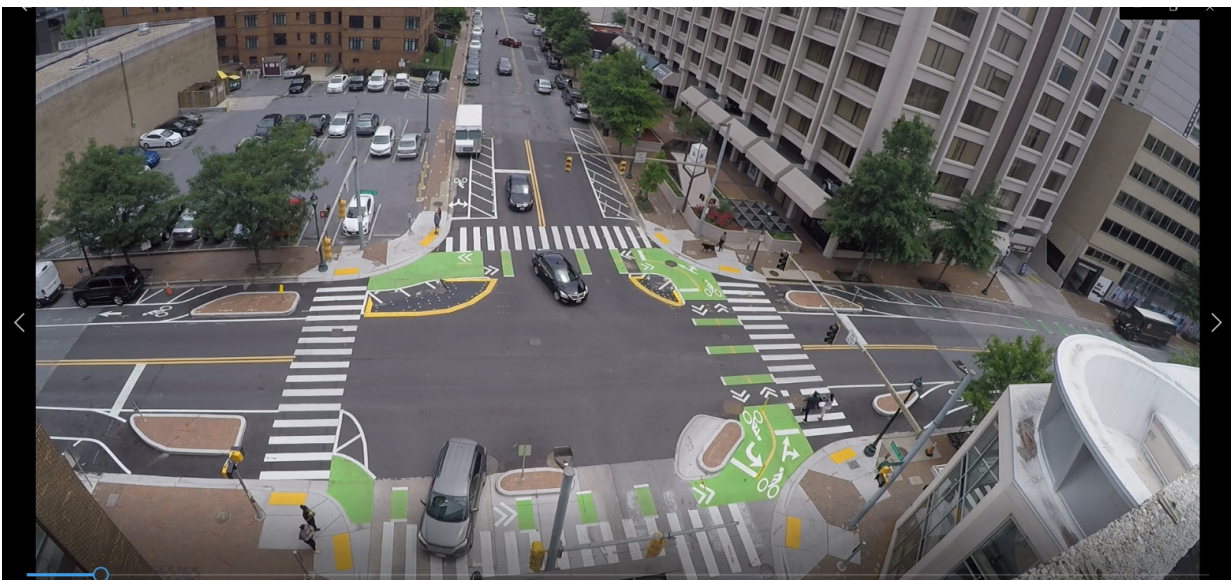
Figure 2. Photo. Example of view for rooftop camera at MD-SSP-02-Aft.

For the College Station, TX, site, a camera used to monitor traffic conditions on campus was used to collect the video data. The video for MD-SSP-02 was a mix of drone video and video recorded from the top story of a parking garage. Figure 2 provides an example of the video view from the rooftop camera.

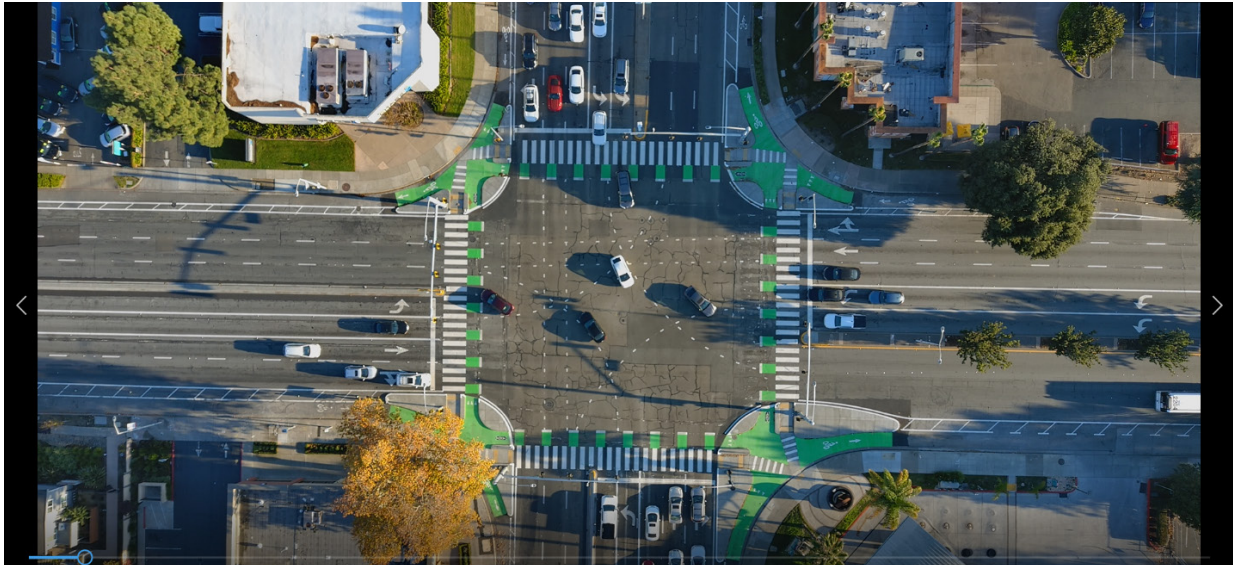
Figure 3. Photo. Example of view from drone camera of CA-FRE-11-Aft.

For the remaining study site, video data were collected using a drone-mounted video camera. The drone-enabled camera permitted all crosswalk data to be collected in one view. Figure 3 shows an example.

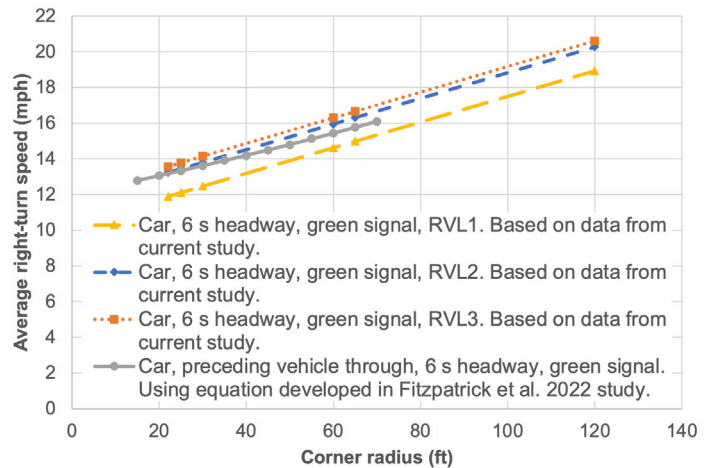
Figure 4. Graph. Comparison of findings between this current study (lines with squares, diamonds, and triangles) and the Fitzpatrick et al. 2022 study (lines with circles).

Figure 4 compares the findings between this study and the Fitzpatrick et al. (2022) study. The range of radii included in the Fitzpatrick study was 15–70 ft, while the range of radii included in this evaluation was 22–120 ft. As shown in figure 4, the plot of the equation from both studies shows similar trends. The current study provided the opportunity to illustrate the difference in speeds between vehicles turning into different receiving lanes. The middle receiving lane (RVL2) and the outer side receiving lane (RVL3) had significantly higher turning speed values than the inner side receiving lane (RVL1).
