**Federal Highway
Administration**

Publication No. FHWA-RD-88-001
December 1988

More Effective Cold, Wet-Weather Patching Materials for Asphalt Pavements

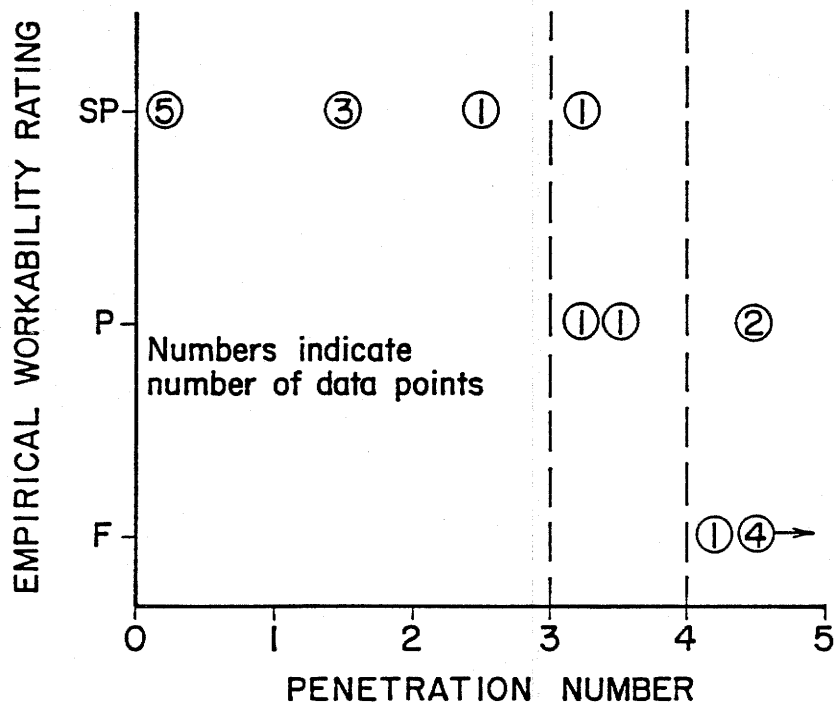
Figure 3. Rating from the PennDOT Workability Test versus penetration number.

Table 30 summarizes the results of the PTI Workability Test conducted on the candidate mixes. A comparison of these test results with results obtained from the PennDOT Workability Test (table 22) is shown in figure 3. A reasonable correlation between the two test procedures is shown. Based on the figure, a penetration number greater than 4 would indicate a mix with unacceptable workability, whereas penetration numbers of 3 or less would ensure good workability.

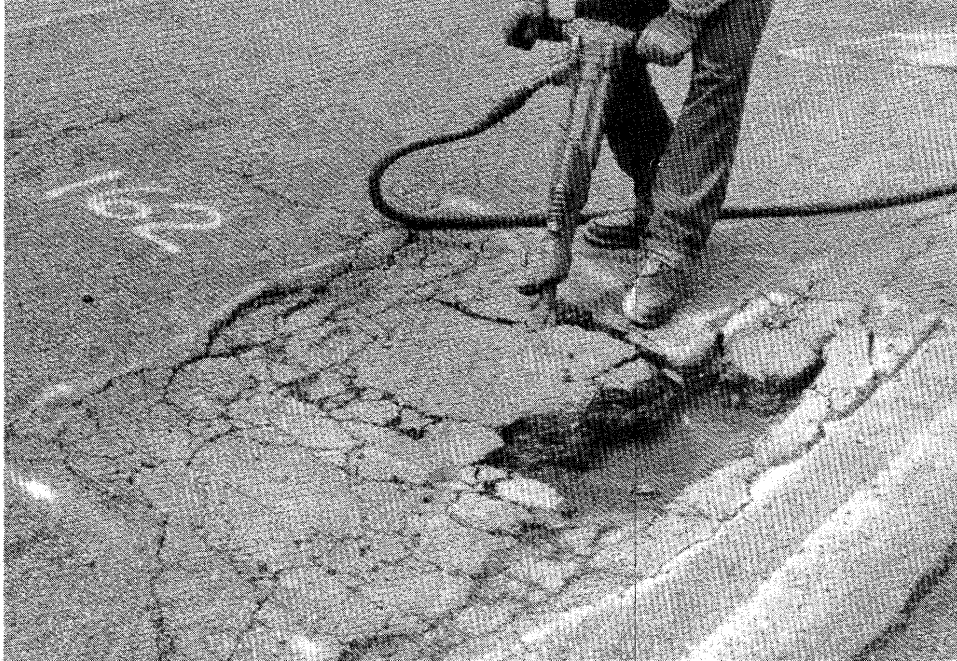
Figure 7. Cutting operation for standard procedure.

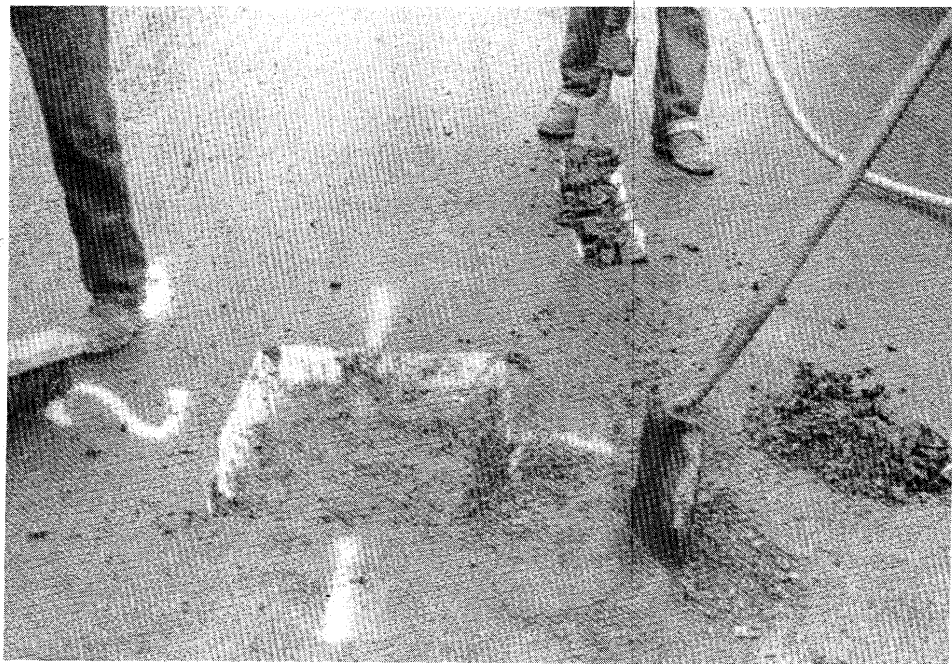
Figure 8. Cleaning operation for standard procedure.

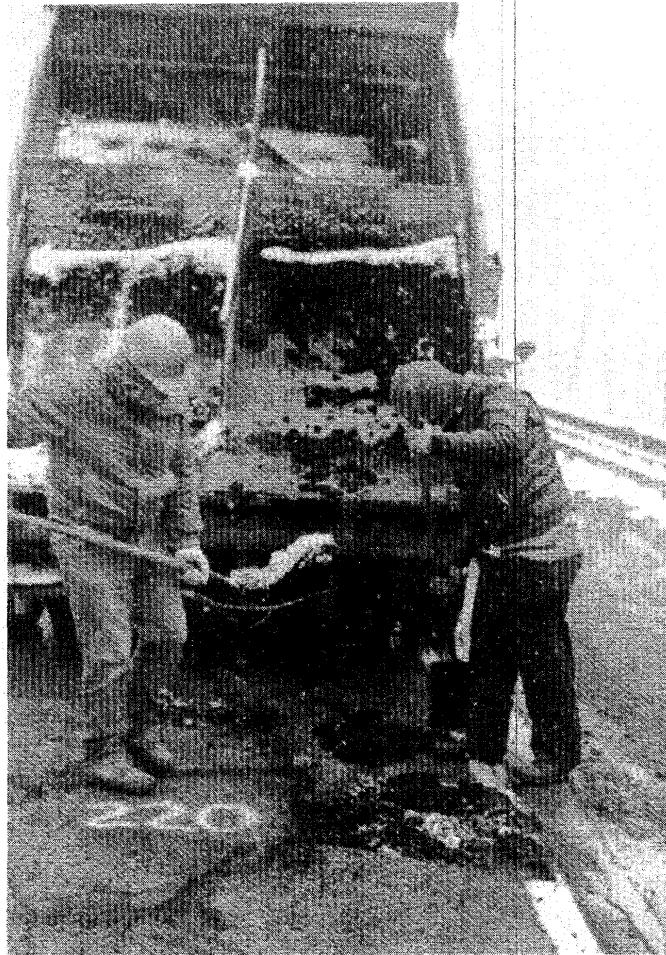
Figure 10. Nonstandard repair procedure.

The nonstandard strategy, illustrated in figure 10, does not involve cutting out the affected area. Loose material is removed with a shovel or broom, and patching material is shoveled into the hole. Compaction is usually accomplished by a few passes with the repair truck or a few blows with the back of a shovel. In this study, for the nonstandard method, compaction was performed with the truck.

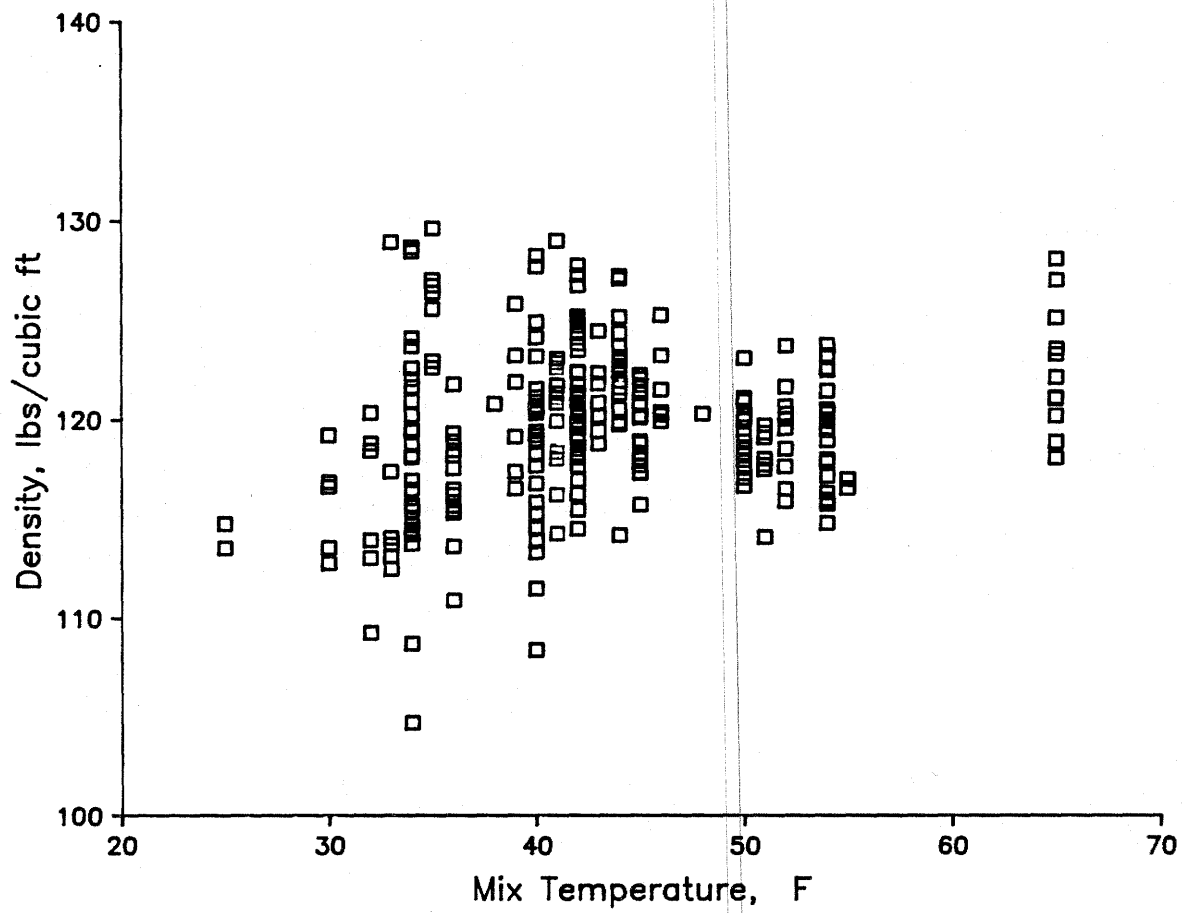
Figure 15. Mix density versus mix temperature.
