Langdon Walkability Assessment 2022

Final Report

Prepared for:
Cavalier County Health District
Langdon, ND

Prepared by:
Kshitij Sharma
Advanced Traffic Analysis Center
Upper Great Plains Transportation Institute
North Dakota State University
Fargo, North Dakota

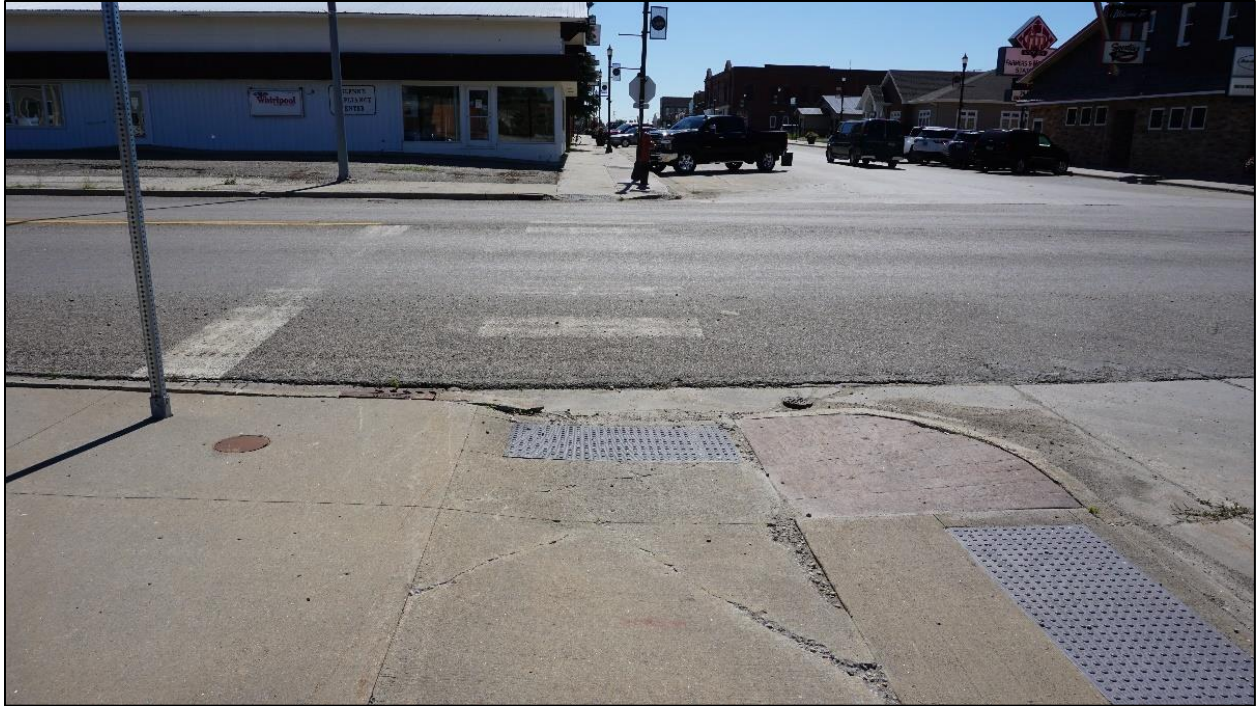
Figure 4. Ramps, sidewalk and crosswalk at Third Street across ND Highway 5

At several locations, as seen in Figure 4, the pedestrian related infrastructure was found to be in a general state of disrepair. Cracked concrete, exposed aggregates, and worn out crosswalk/pavement markings were observed.

Sections of the sidewalks that are in poor condition should be rebuilt to current standards. New facilities should be installed in locations where missing. In doing so, special attention needs to be paid to state highways. Although outside of town, these highways provide high-speed connectivity over long distances but within built-up albeit rural areas, the same highways need to accommodate access to businesses and other functions for all users including non-motorized users.

- Repair of ramps and displaced sidewalks
- Pavement/crosswalk marking updates/maintenance
- Sign post relocation
- Ensuring clear demarcation of various zones within the right-of-way

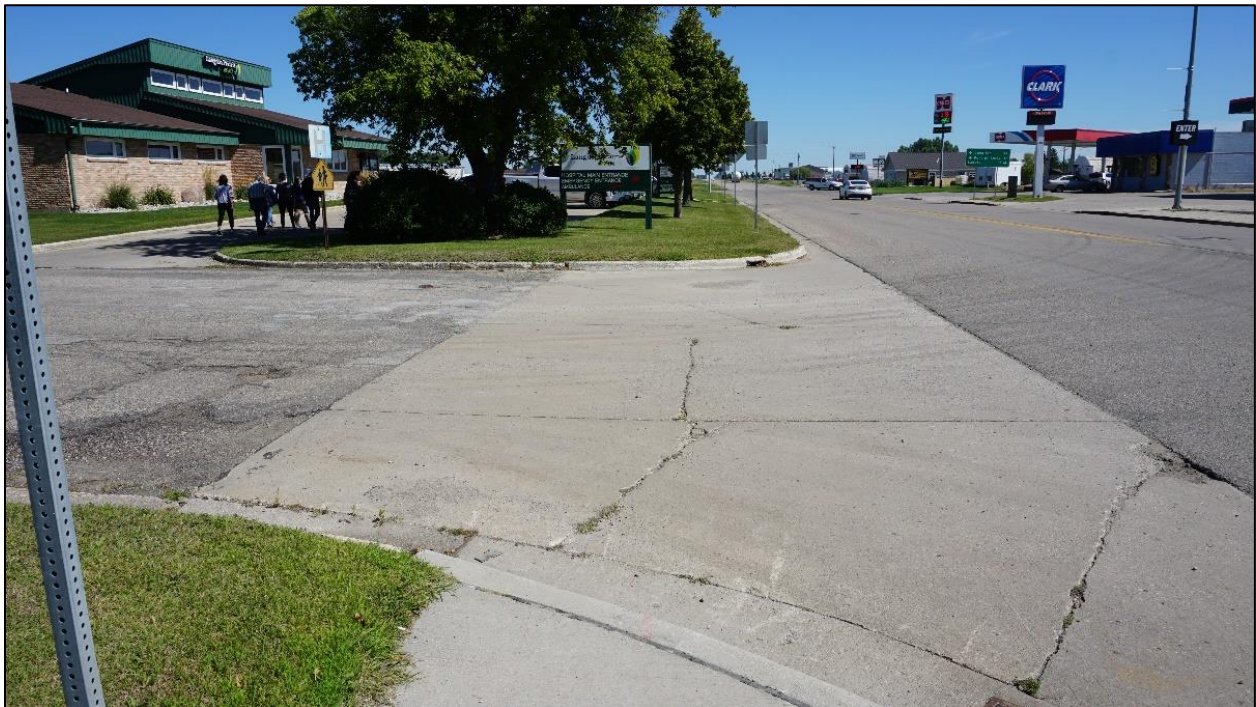
Figure 5. Missing ramps, crosswalk and sidewalk along ND Highway 5

At several locations, as seen in Figure 5, the sidewalks/crosswalks were never installed. The participants are seen walking through parking lots instead.

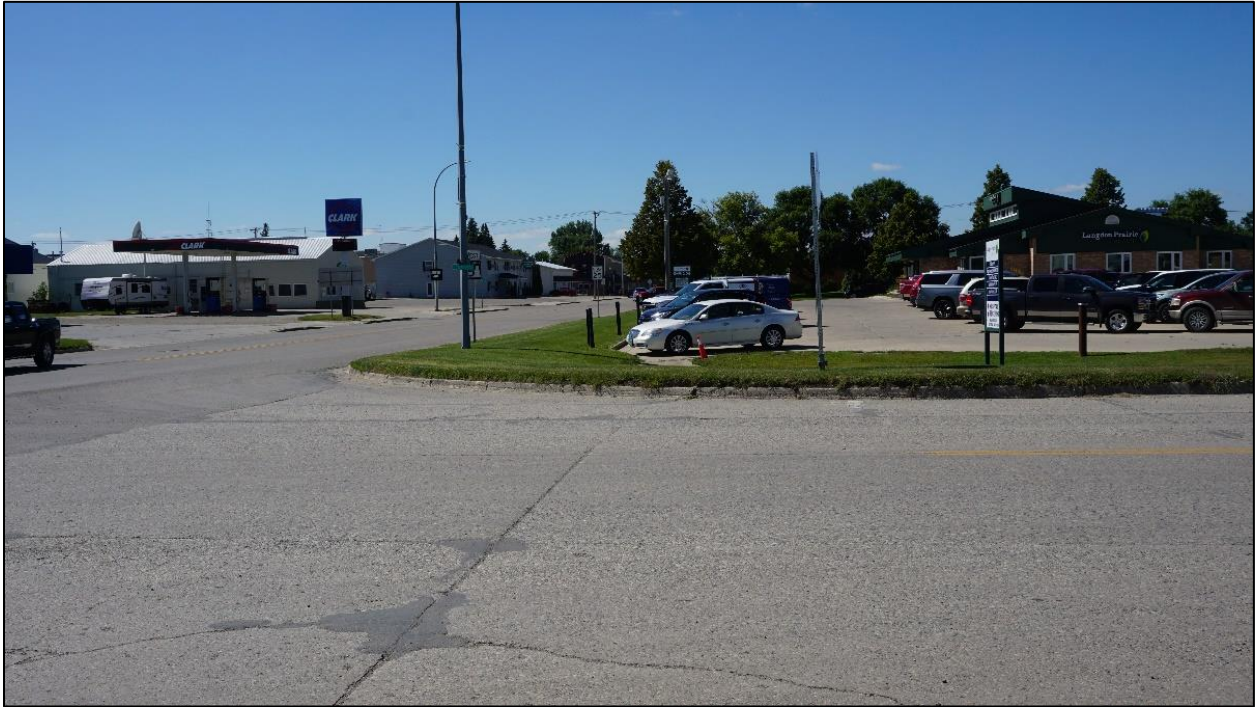
Figure 7. A view of the northwest quadrant and the southbound leg of the intersection of ND Highway 1 and ND Highway 5

There is no sidewalk along ND Highway 5 on the north side of the street as it passes through Langdon, as seen in Figure 7.

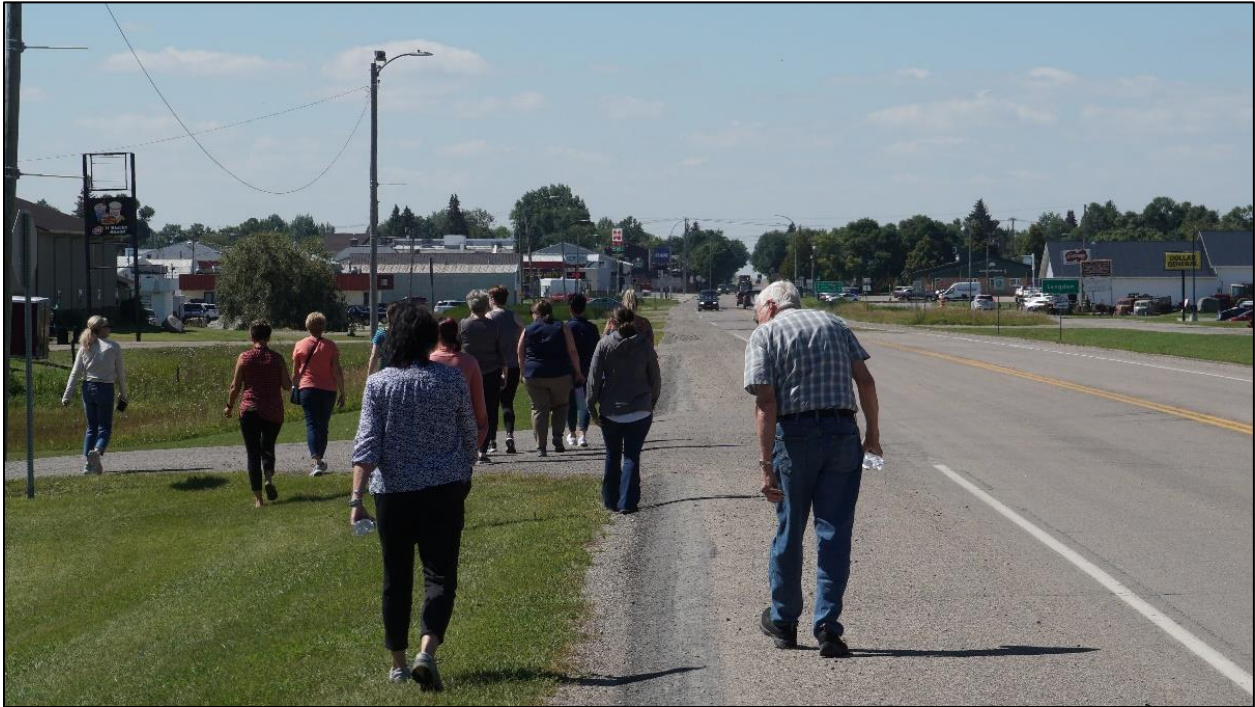
Figure 10. Participants continuing assessment along south side of ND Highway 5

A lot of debris, mud and road hazards were observed especially along ND Highway 5 during the assessment as participants continued the walk facing traffic along the south side of the road as seen in figures 10 and 11.

A review of current maintenance practices should be completed to see if additional litter removal needs to be scheduled for state highways through the City of Langdon. Road users should be highly discouraged from tracking mud and debris onto the paved lanes and shoulder, thereby reducing road hazards.

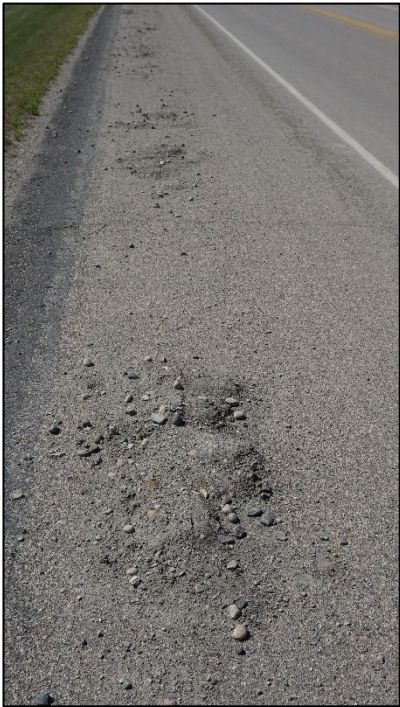
Figure 11. Debris and mud along the south side shoulder of ND Highway 5

Most of the debris was observed on the shoulder where a pedestrian/bicyclist may be using the roadway.

Concerned citizens from the area should consider participating in the North Dakota Department of Transportation's Adopt-A-Highway program thereby reducing litter/road hazards and saving taxpayers' dollars.

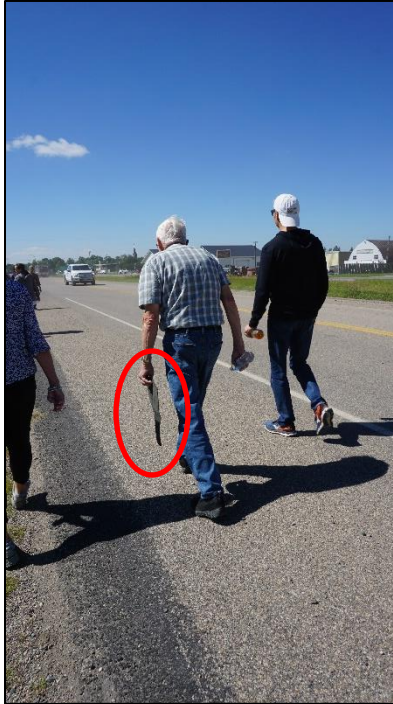
Figure 12. Participants helping in picking up metal debris from the shoulder

Participants, at times, were observed picking up debris from the roadway. As seen in Figure 12, the debris picked up included metal that could be dangerous for all types of road users. As seen in Figure 13, a puddle of water was observed at the southeast quadrant of the intersection of ND Highway 1 and ND Highway 5. Participants reported that no rain had been received.

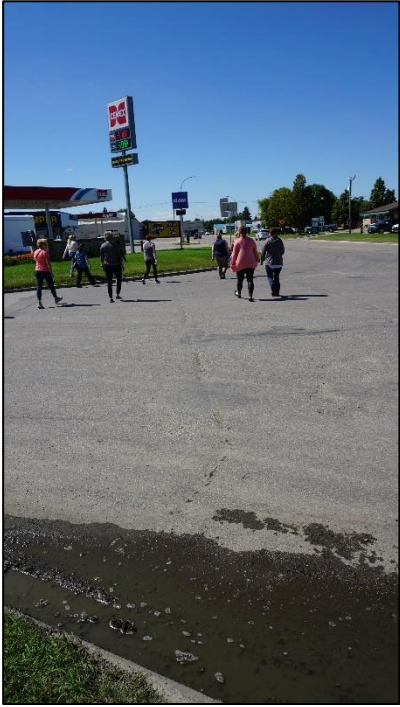
Figure 14. Lack of crosswalk/sidewalk on the south side of ND Highway 5 at ND Highway 1

Due to the lack of crosswalk/sidewalk, the participants were observed scattered across the south side of ND Highway 5 while crossing ND Highway 1 as seen in Figure 14.

As and when traffic volume grows, a needs assessment should be completed to determine if a traffic signal is warranted at the intersection of ND Highway 1 and ND Highway 5. Also, a needs assessment should be completed to determine if a midblock crosswalk is warranted along ND Highway 5, especially where such a crosswalk would connect high-pedestrian-demand locations such as where grocery shops are across the highway from residential areas.

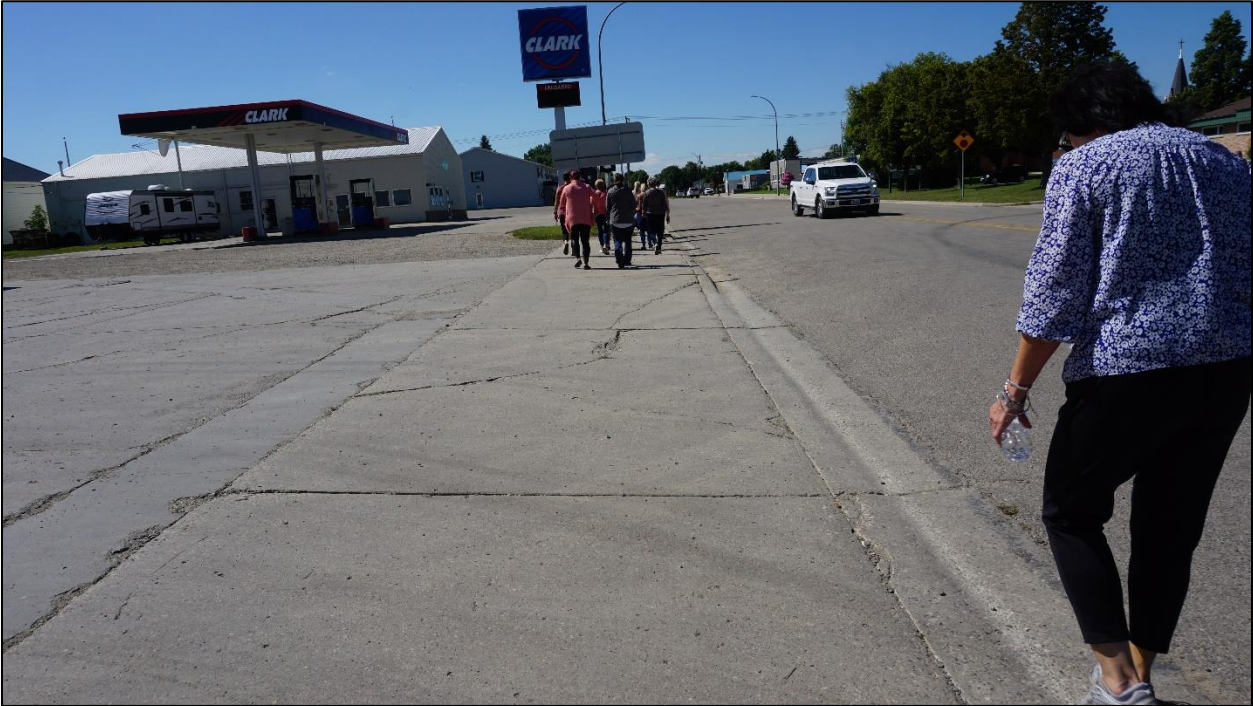
Figure 15. Sidewalk along the south side of ND Highway 5

As seen in Figure 15, in some locations along the south side of ND Highway 5, the differences among greenspace/furnishing zone, pedestrian zone, and frontage zone/parking lot were not apparent.

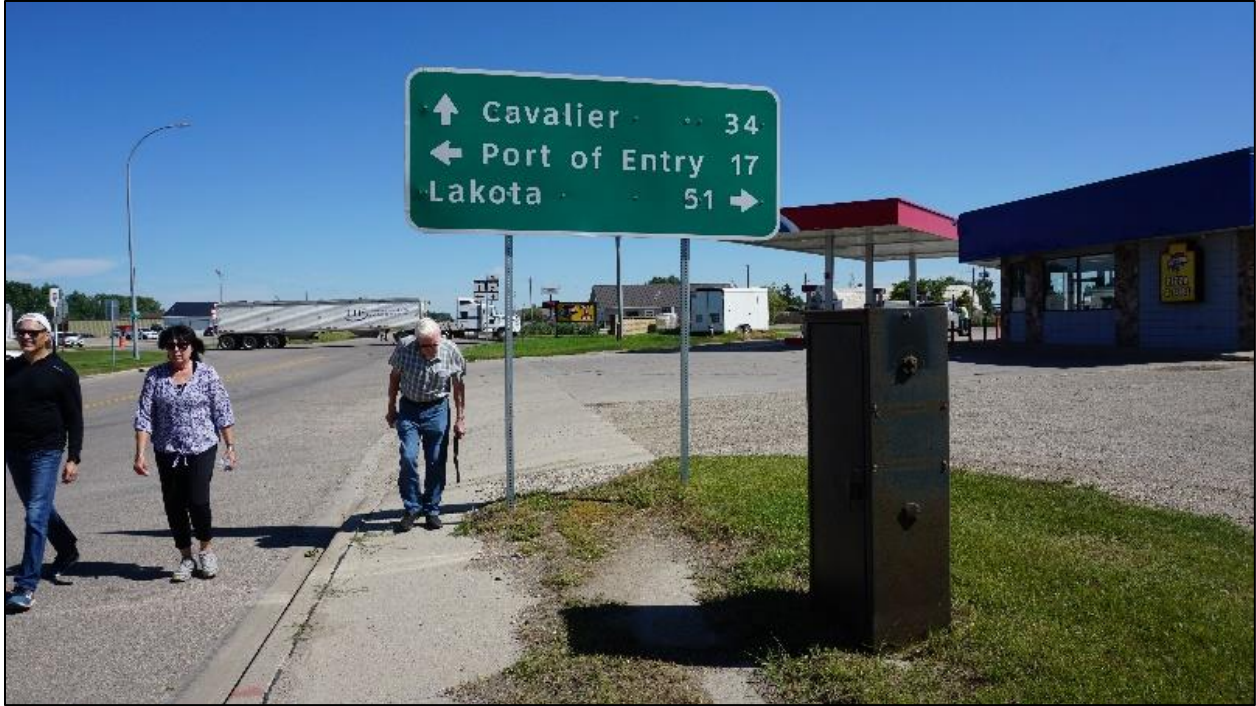
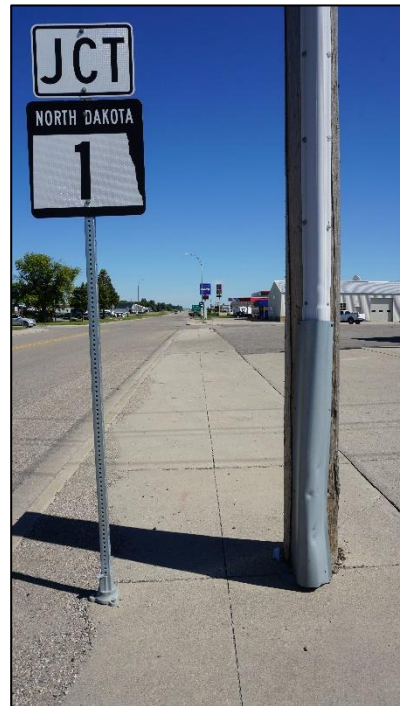
Figure 16. Guide sign obstructing the sidewalk

Figure 17. Route sign and utility pole obstructing sidewalk

In some locations along the south side of ND Highway 5, guide signs and utility poles were observed obstructing the sidewalk as seen in figures 16 and 17, forcing pedestrians off of the sidewalk and otherwise posing splinter- and creosote-related dangers.

Obstructive utility poles should be relocated to provide a clear pedestrian zone for non-motorized users. In this case close collaboration between transportation agencies and electric service providers would be paramount.

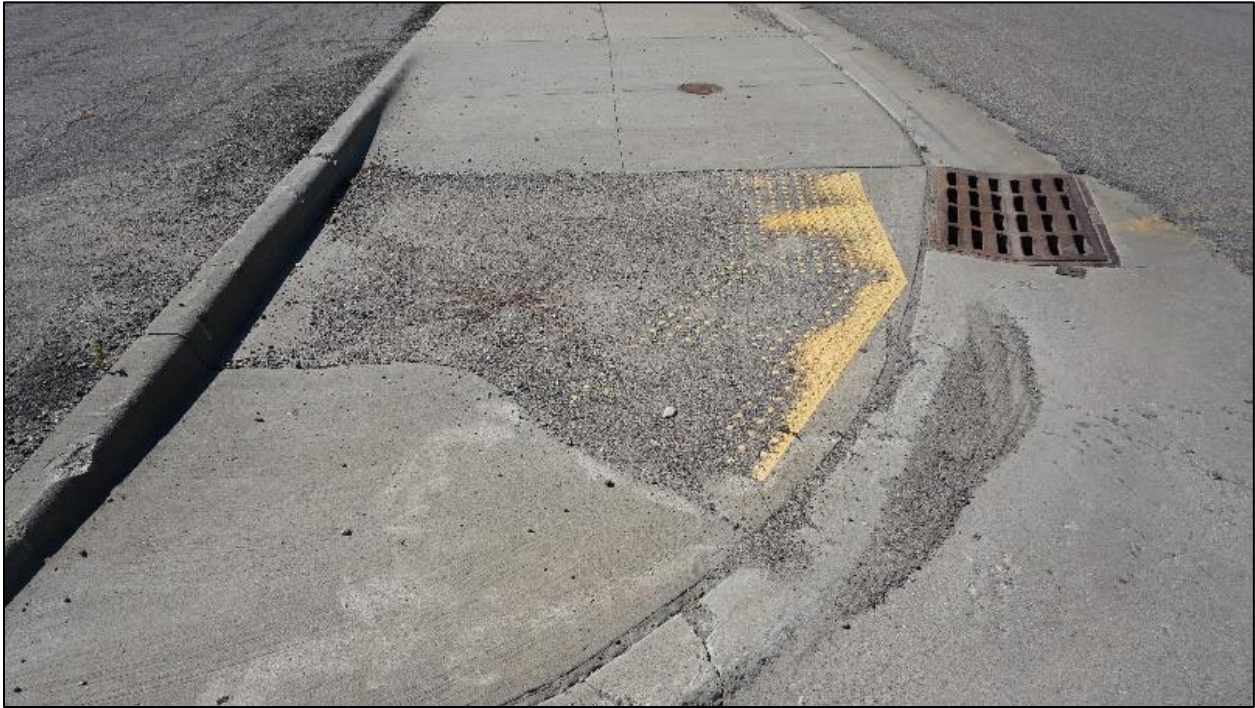
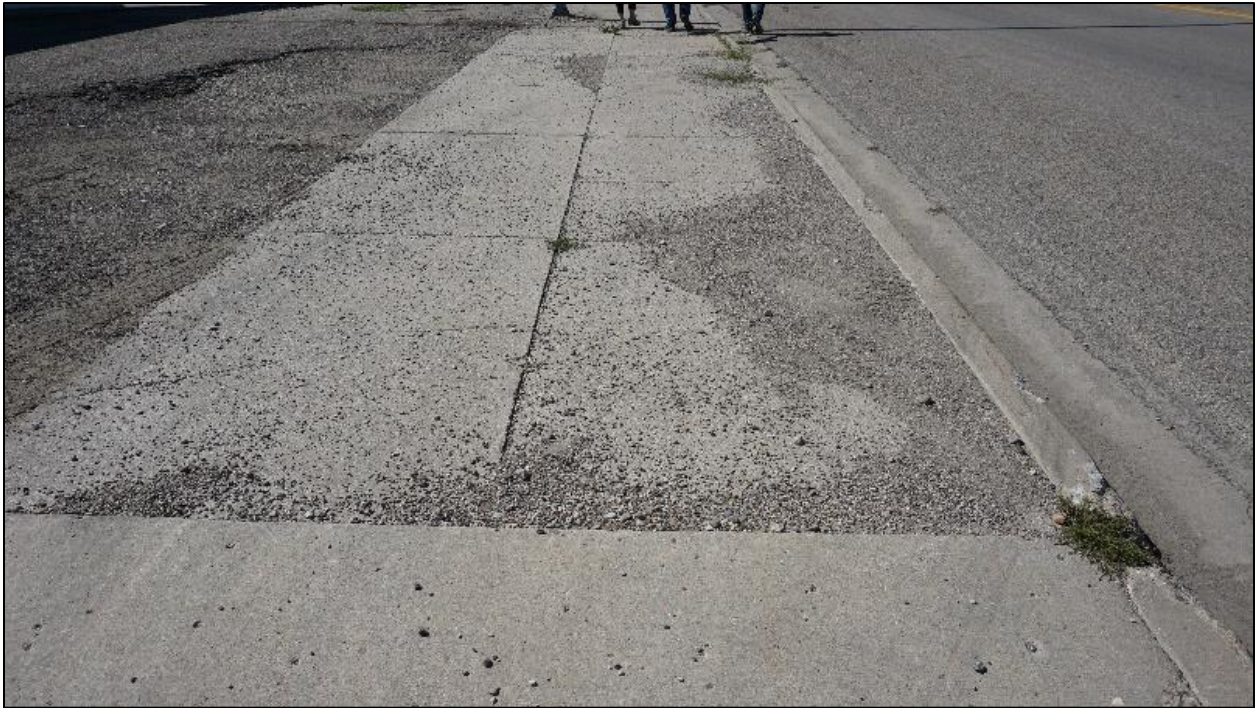
Figure 18. Debris strewn across ramp and potentially hazardous grate

Figure 19. Debris and weeds on the sidewalk

In some locations, truncated domes in curb ramps and the sidewalk were strewn with gravel, debris, and weeds as seen in figures 18 and 19. Also, at the same location, an almost parallel storm water grate was observed.

Other nearby areas should also be assessed to ensure that grates for storm water drainage are such that they are not parallel to the direction of travel for bicyclists.

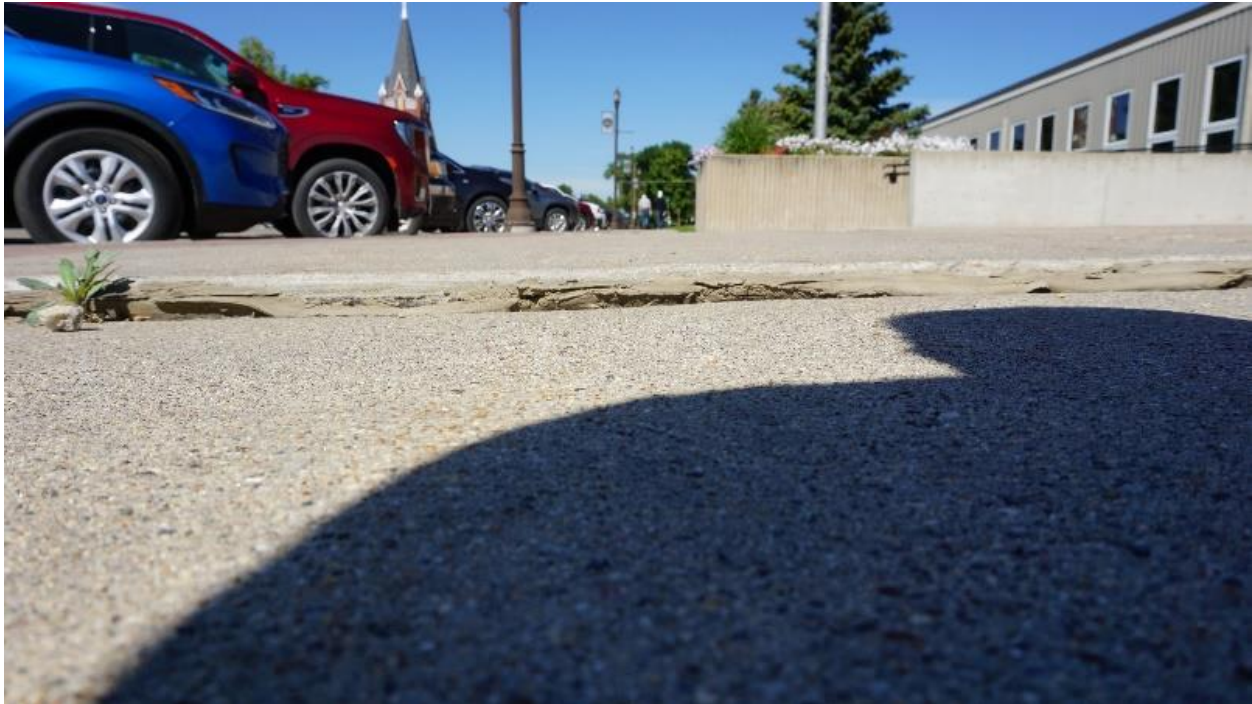
Figure 20. Sidewalk displacement along Third Street

Along Third Street, sidewalk displacements, likely due to frost heaving, were observed presenting potential tripping hazards as shown in Figure 20.
