Waterproofing Details of Connections for Adjacent Precast Concrete Box-beam Bridges

State Job Number 134847 and 2015 ORIL2

October 2018

Final Report

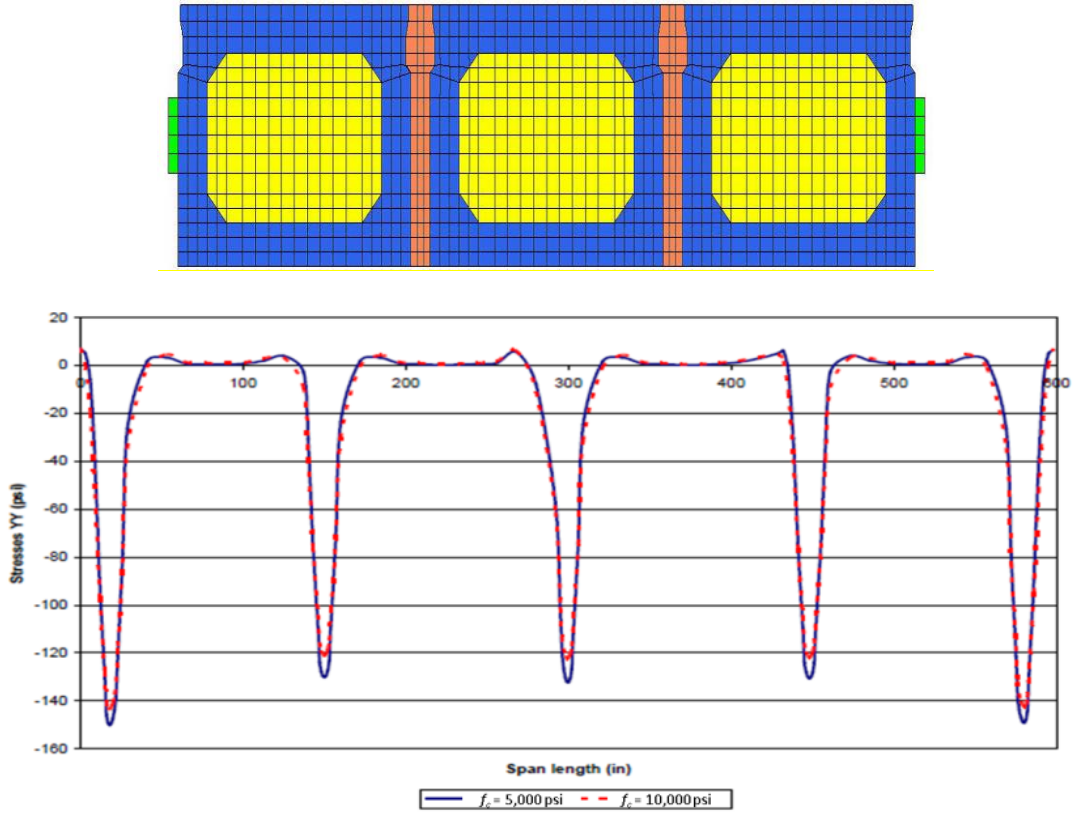
Figure 7-3. Clamping stress along the length of shear key for different grout materials (Note: stresses are taken at mid-depth of the beam)

The current practice of ODOT requires one tie-rod at the top third of the girder height that might act as a rotational pin. A better application of tie rods is given by PCI (2009) where two tie rods are used to prevent separation under tensile stresses, as shown in Fig. A.17. In “direct” vertical shear, the increase of the load will reduce the friction contribution due to lateral separation and vertical slip, unless the concrete blocks are supported in the horizontal direction to maintain full surface contact. This is common practice in the case of precast-prestressed box beam girders used in bridge design when ties or horizontal prestressing strands are used to provide horizontal support in the case where ties are used or to provide lateral compression in the case where tension prestressed strands are used. The tie elevation and the compressive force applied to the box beams will influence the friction contribution and width of the crack between the units.

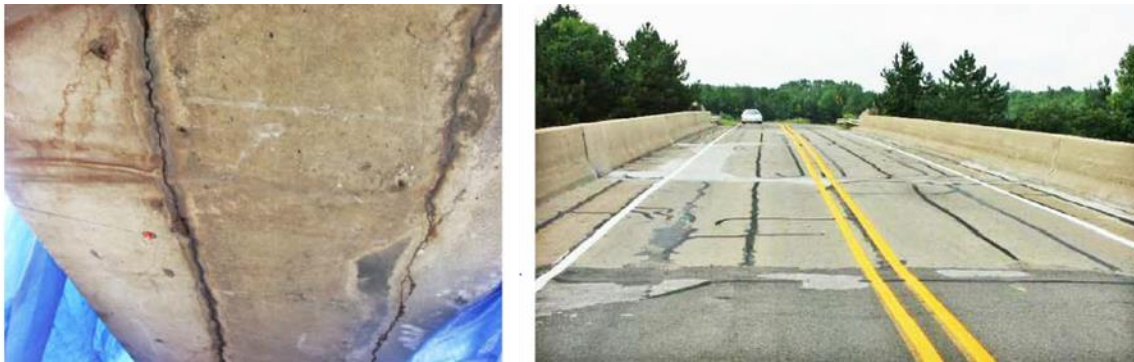
Fig. A.18 50-Year-Old Tested Two-Cell Box Beam (Upul et al., 2005)

A severely distressed fascia two-cell box beam from the Hawkins Road Bridge in Jackson County, Michigan was removed and tested. The bridge was found to be safe to operate in these conditions (Upul et al., 2005), Figure A.18 shows the underside of the bridge (left) and the top surface of the bridge (right).

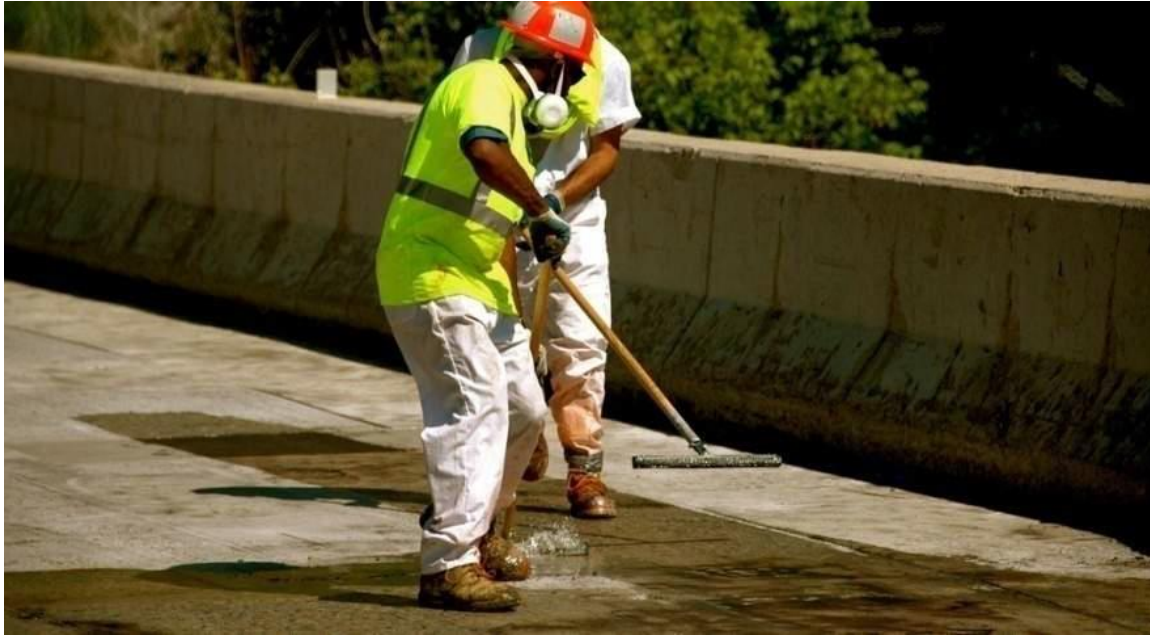
Fig. A.37 Application of Primer by Squeegeeing (Strandquist, 2012)

In most cases, a primer can be specified for either liquid application or preformed membrane application. For either type, the primer may be poured and spread by squeegee or sprayed. Figure A.37 shows the application of primer by squeegee.

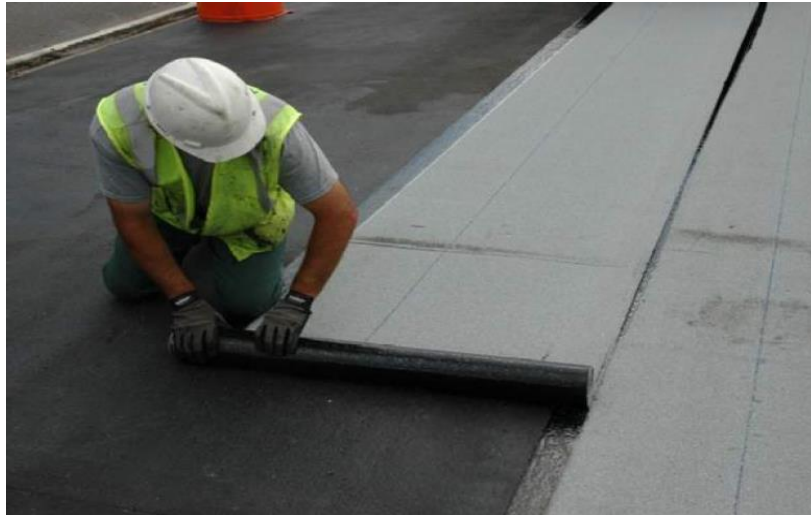
Fig. A.38 Preformed System Installation (Strandquist, 2012)

In terms of preformed (often called sheet/membrane systems) versus applied-in-place (often called liquid systems), the classification is very general; these systems are most commonly used in practice. Preformed membranes are typically produced in sheets, usually come in rolls, and are laid on the concrete surface. The membranes are laid on the concrete surface after the application of adhesive materials or the membrane sheets can be self-adhering (often called “peel and stick” membranes). Figure A.38 shows the preformed system. Figure A.39 shows the applied-in-place systems. Both systems have advantages and disadvantages, which are summarized in Table A.9.

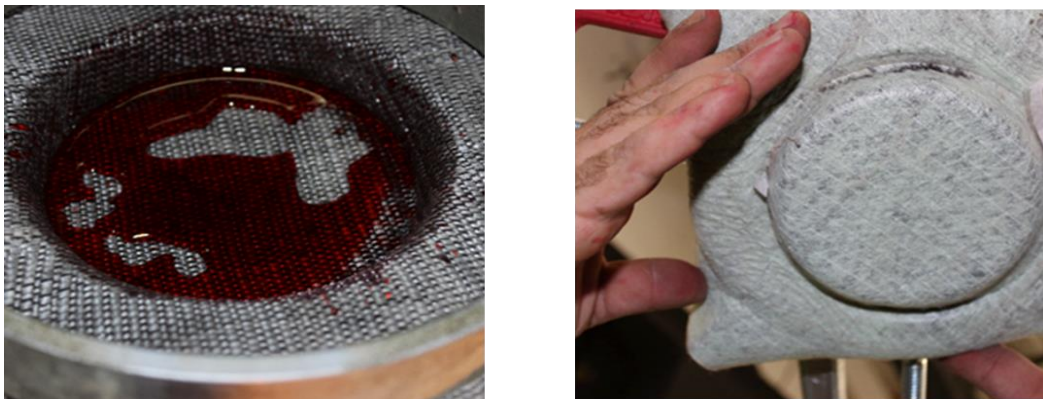
Fig. B.13 Top (*left*) and Bottom (*right*) Views of a Typical Test Specimen after the Test, Showing no Leakage at the Bottom

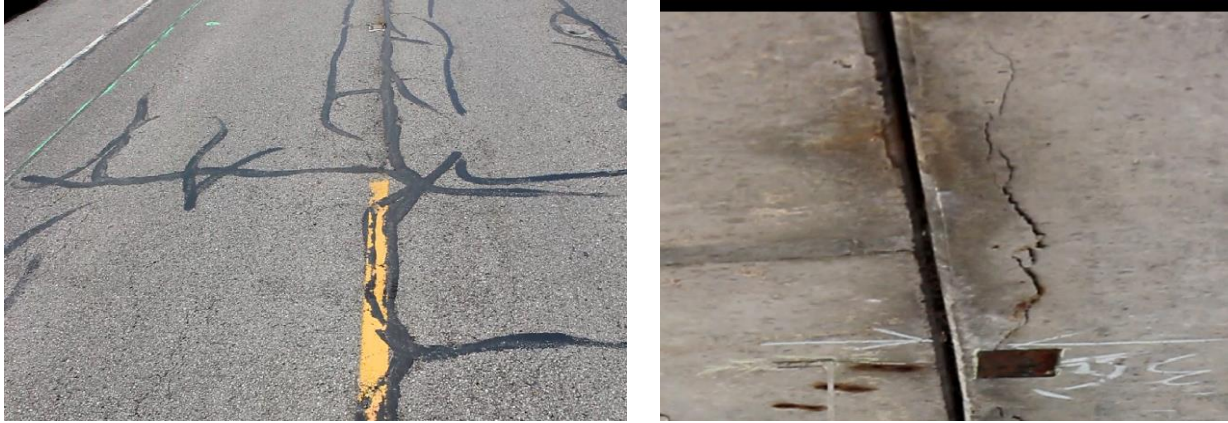
Fig. C.2 Surface Cracks and Path of Truck Wheels (*left*) and Typical Cover Spalling on Bottom Surface (*right*)

50 or 70 mph following specifically marked paths. The loaded truck was guided to drive on the beam next to the longitudinal joint where the gage readings were taken. The differential deflections and the lateral spread were videotaped and later analyzed to obtain measurements of the maximum movements.

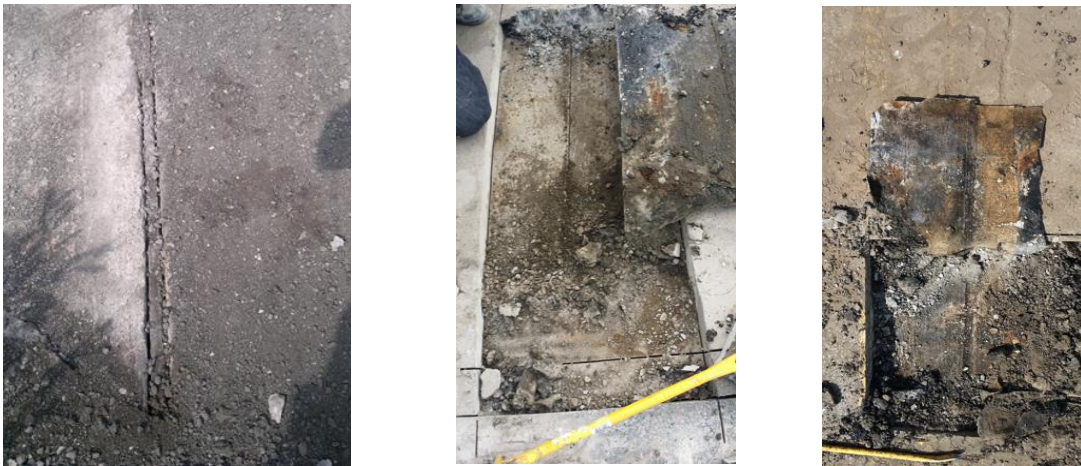
Fig. C.5 Condition of a Typical Joint and Deck Surface

box beams were wide and were visible throughout the bridge deck (Fig. C.5). Where provided, the membrane was in very poor condition.

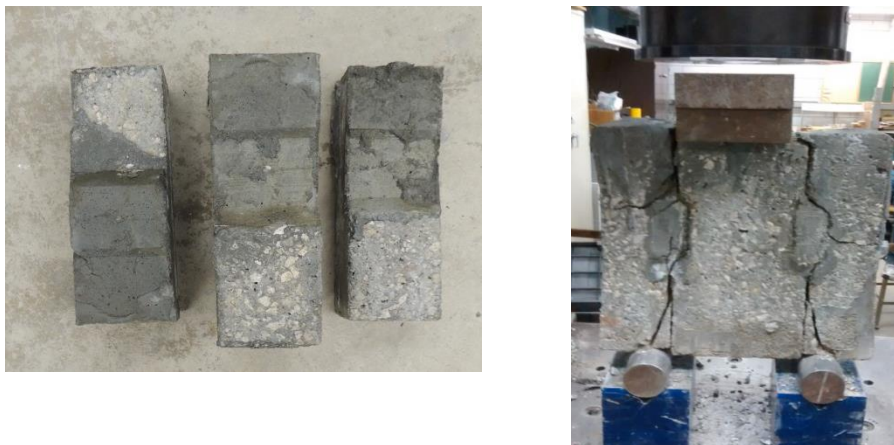
Fig. D.3 Typical Failure Mode, Specimens without Ties (left)
Specimen with Tie Rod (right)

A sudden failure took place at the shear interface between the grout material and the concrete unit for the specimens without a tie rod; concrete units and grout were not damaged or cracked. For specimens with a tie rod, the specimens could be loaded until the concrete units were cracked or the tie rod yielded. For the specimen size used in this study, the concrete failed before the tie rod failed, as shown in Fig. D.3.

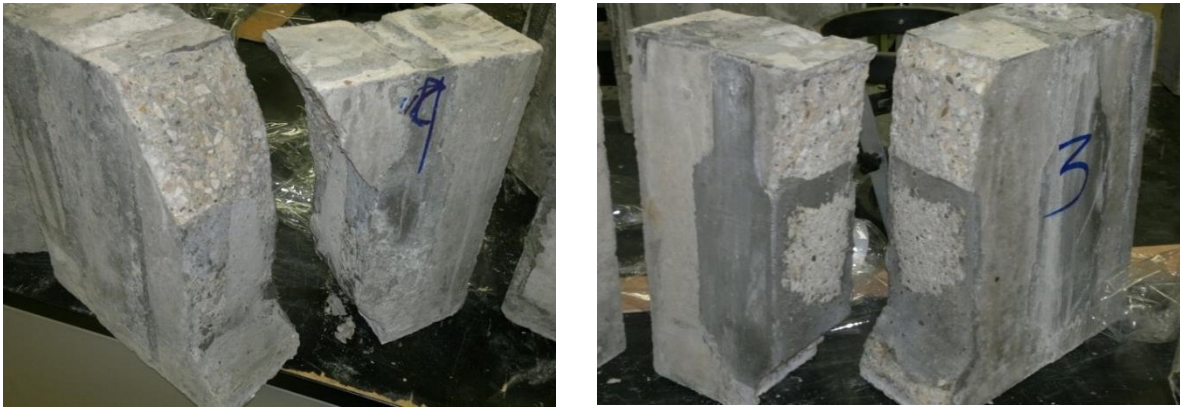
Fig. D.13 Failure Mode C - Failure in UHPG with Cement Slurry and Sandblasted Surface through Concrete and Grout Interface

- Failure in UHPG with cement slurry and sandblasted surface: Typical failure occurred by de-bonding and diagonal shear in the middle concrete unit for specimens with UHP grout with cement slurry and sandblasted surface. Average cracking load was 24,067 lb with failure mode as shown in Fig. D.13.

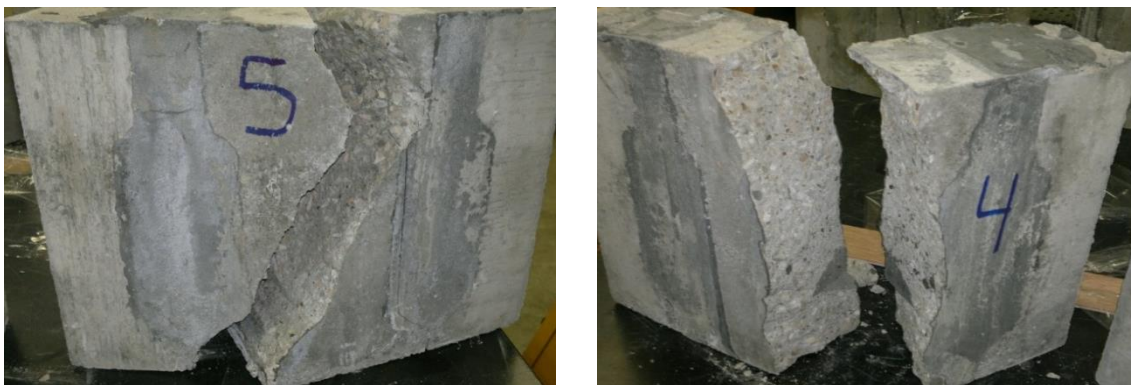
Fig. D.14 Failure Mode C - Failure through Concrete in Specimens with UHP Grout with Sandblasted Surface

- Failure in UHPG with sandblasted surface: Typical failure for specimens with UHP grout with sandblasted surface. Failure occurred in the middle concrete unit, but not in the grout material. Average cracking load was 34,700 lb. The failure load was limited by the strength of the concrete units, and not the strength of the grout with failure mode as shown in Fig. D.14.

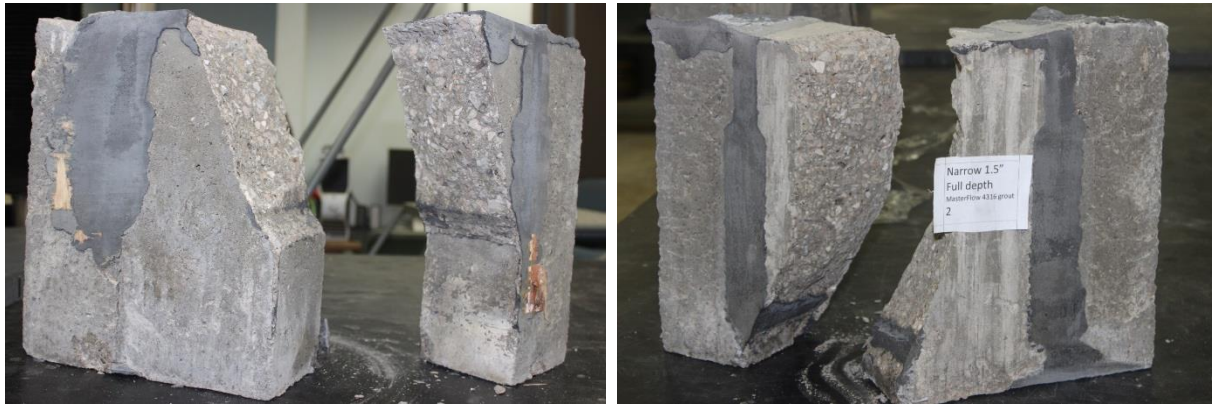
Fig. D.15 Failure Mode C - Failure in Polymer Grout: Narrow-Partial Depth Key Way (Left), Full Depth Key Way (Right)

- Polymer Grout For partial depth key way, the shear failure plane extended from the middle concrete unit to the bottom slope of the key way. The failure plane showed different slopes depends on the key way depth as seen in Fig. D.15. For the case of partial depth, and in this figure, for full depth key way. The deeper the key way, the larger the ultimate load.

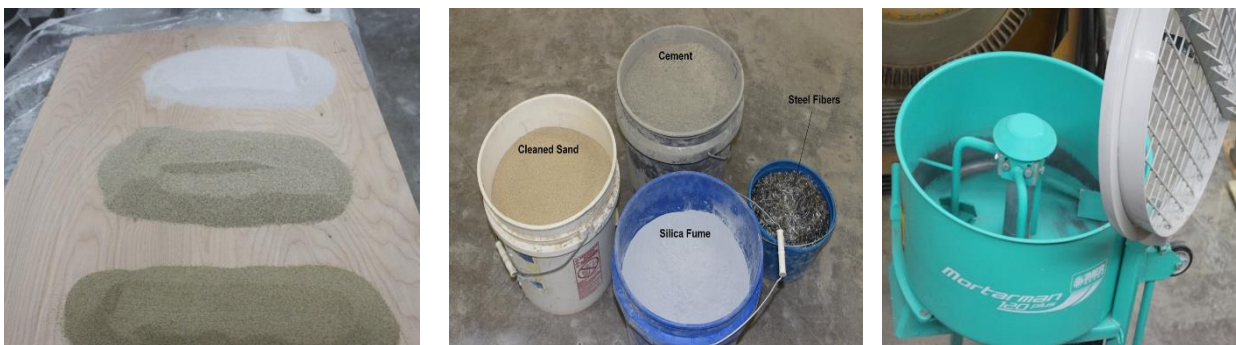
Fig E.3 Mix Ingredient and High Shear Mixer

The use of large size gravel was not found to be suitable for ultra-high performance grout. Different types of cements, undensified silica fume, water content, high-range water reducing agents, and steel fibers were used in the trials.

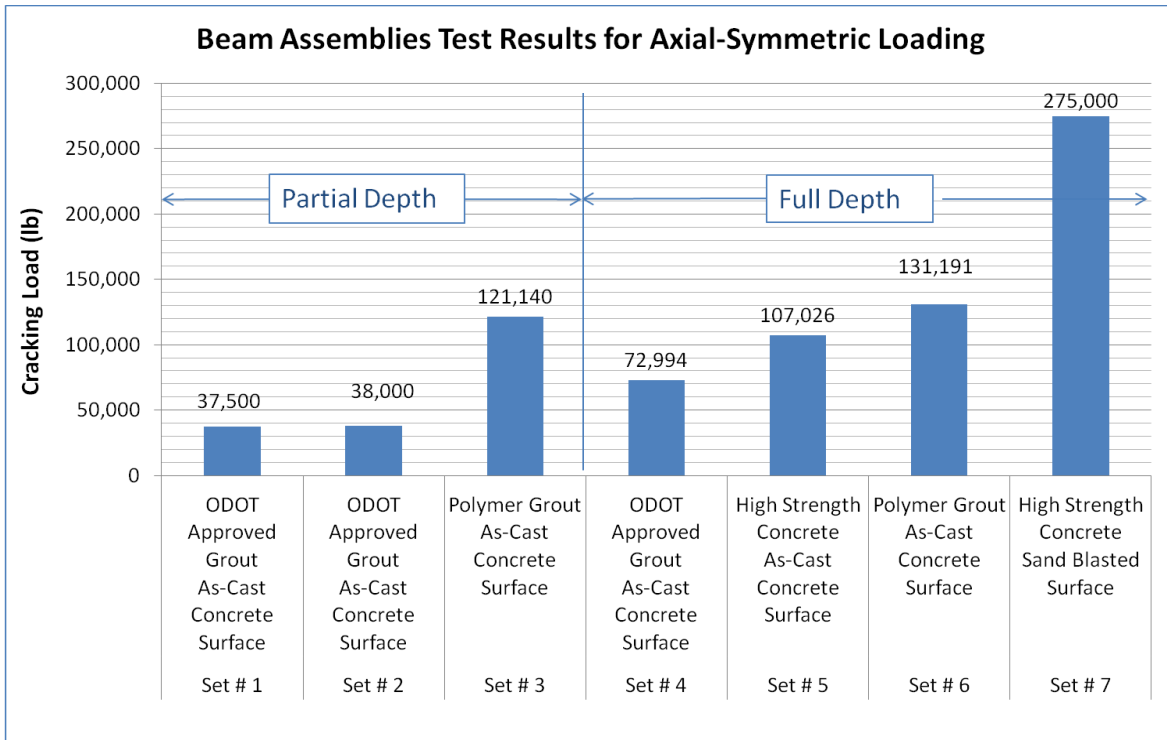
Fig. F.12 First Crack Load of Tested Assemblies

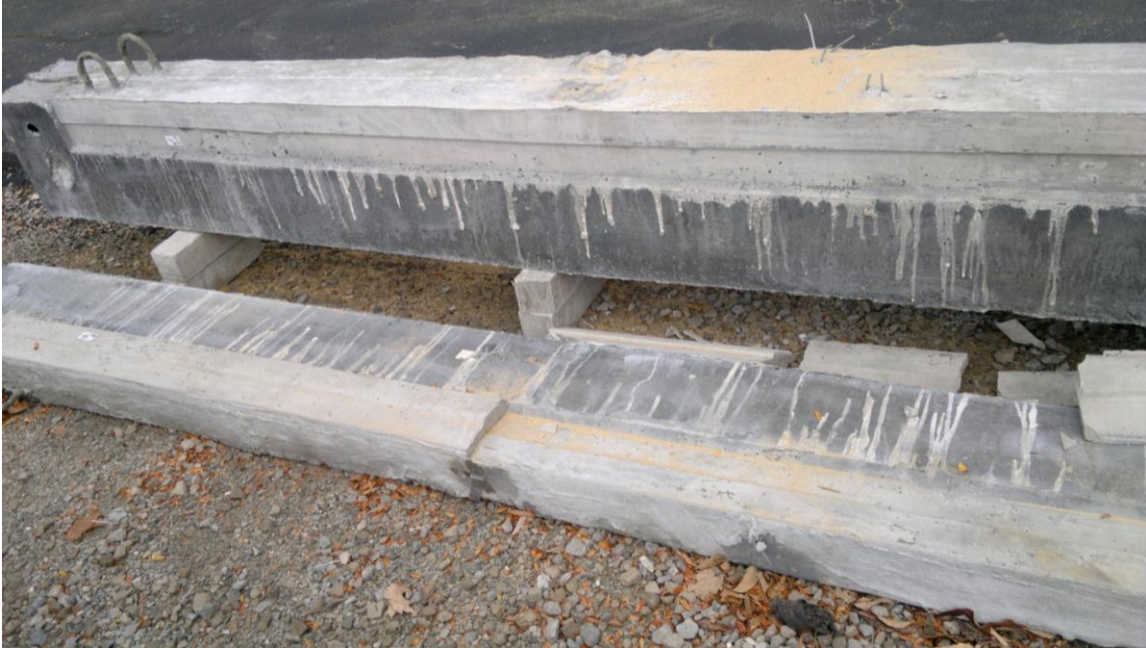
Fig. F.16 Set# 1 - Failed Joint After Testing

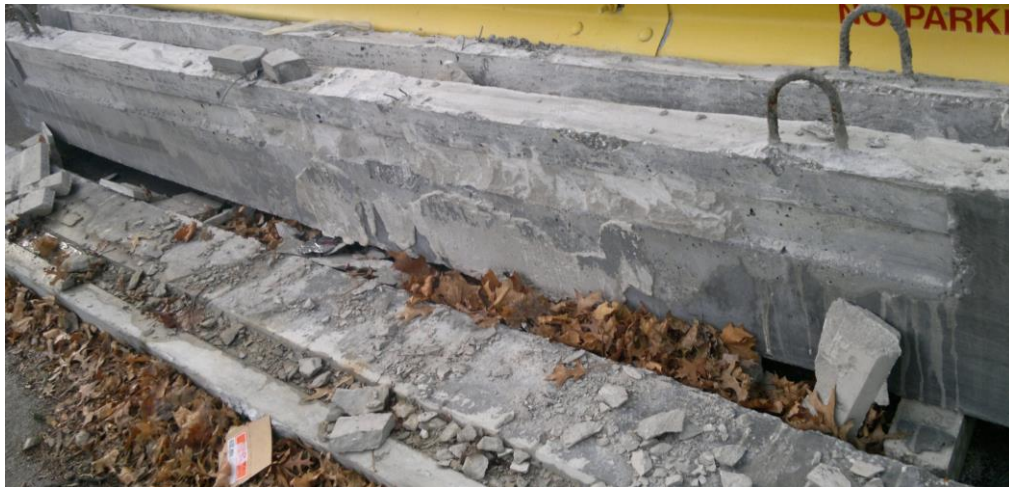
Fig. F.17 Set # 2 Failed Joint After Testing

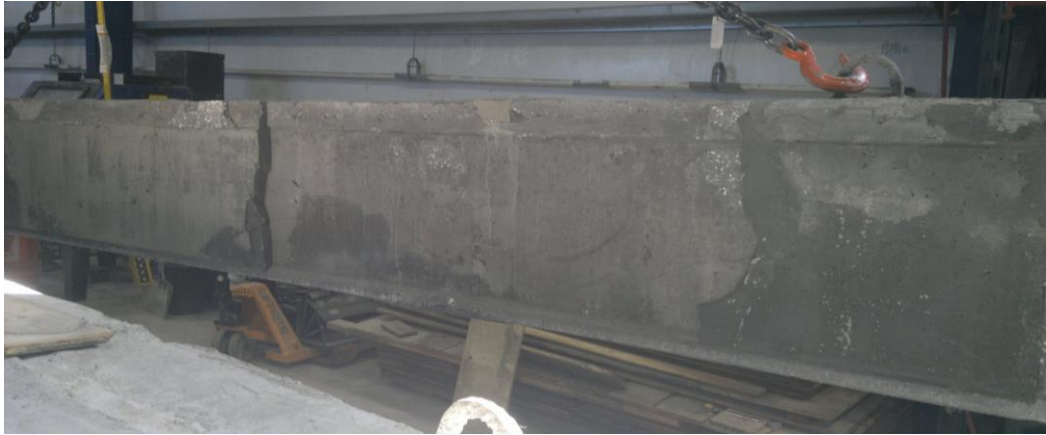
Fig. F.18 Set # 6 Middle Concrete Unit After Failure

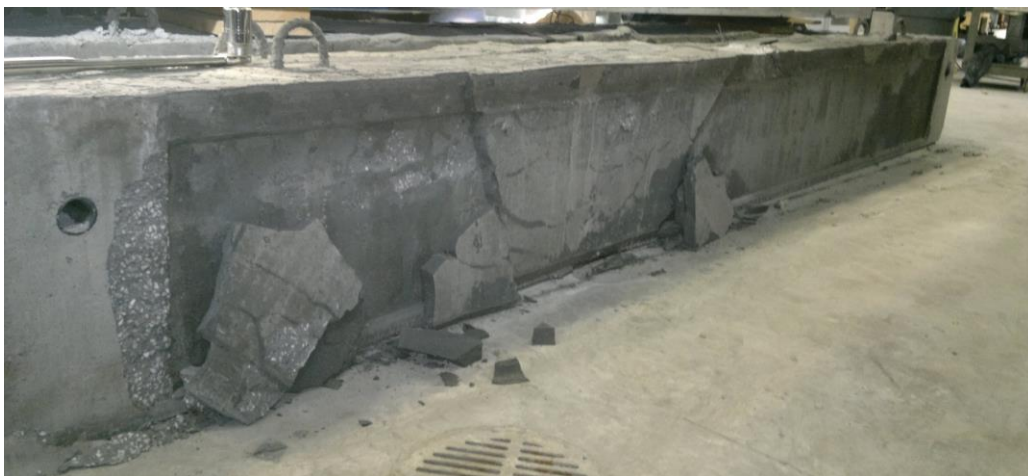
Fig. F.19 Set # 6 External Concrete Unit After Failure

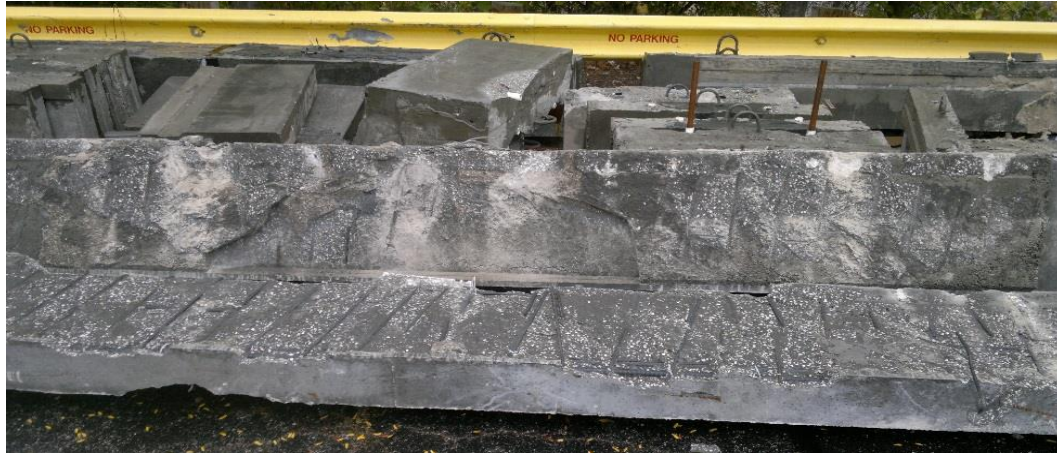
Fig. F.21 Set#7 Separation of Concrete Cover After Testing

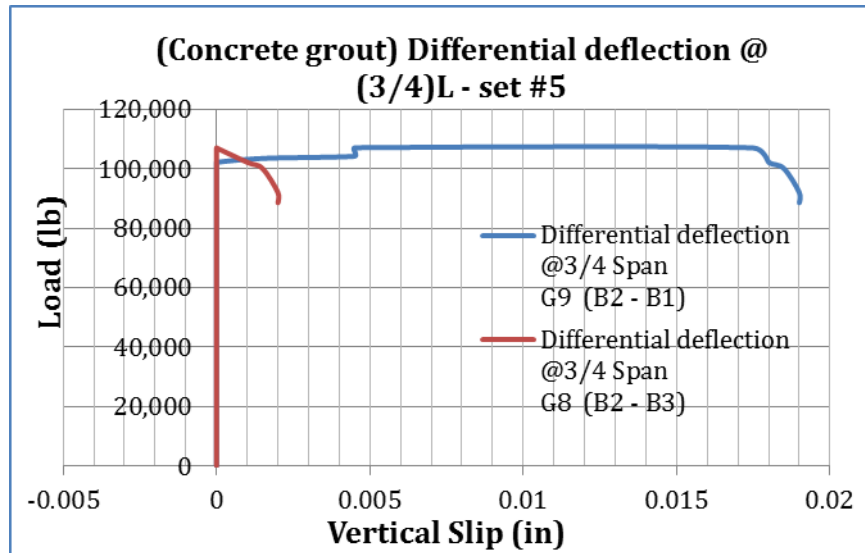
Fig. F.28 Set # 5 Differential Deflection at Three Quarter Span

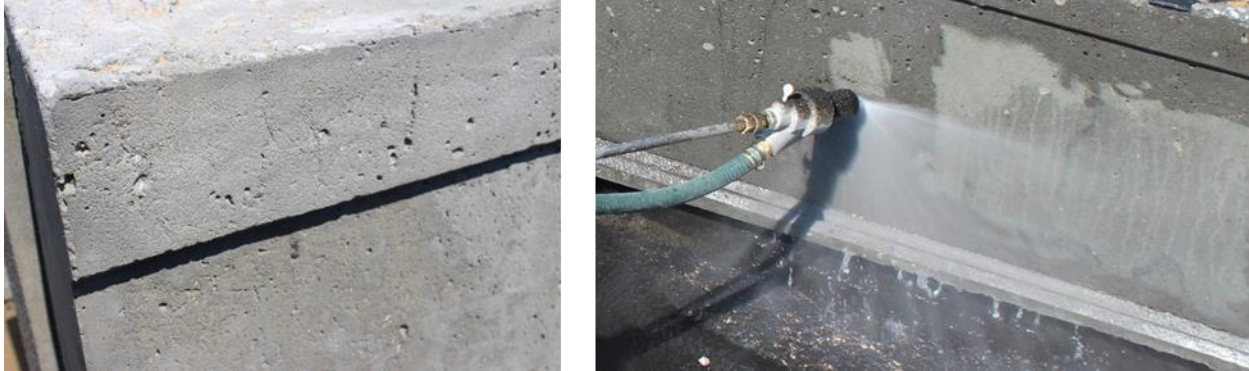
Fig. H.7 Sandblasted Surface Preparation for Eccentric Load Tests

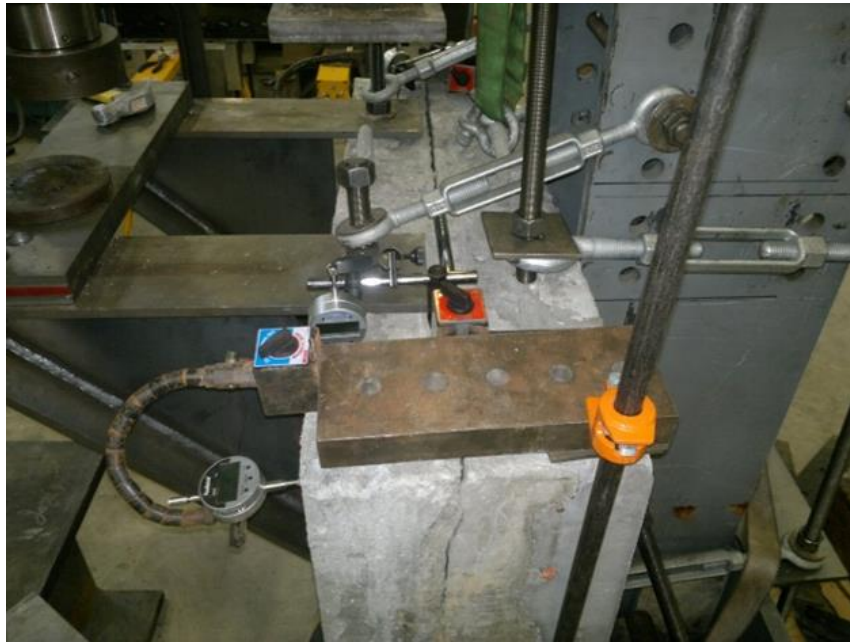
Fig. H.9 Failure of the Test Specimen with Kuhlman Grout under Self-Weight

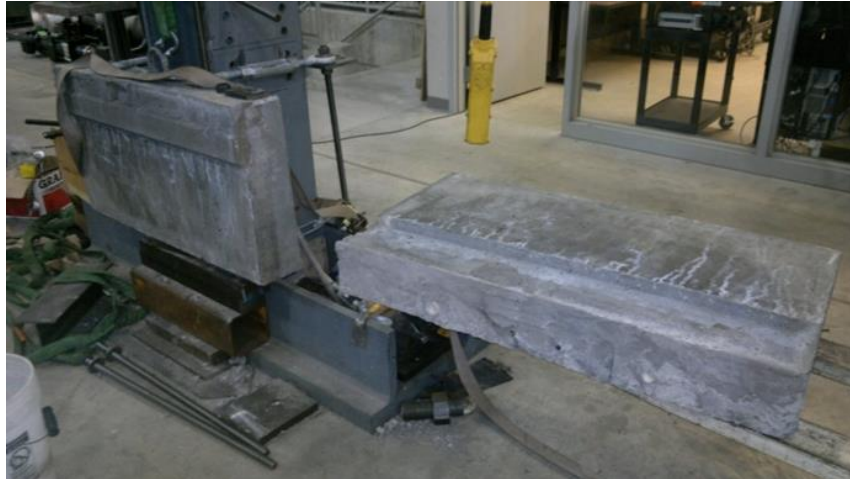
Fig. H.10 Failure of the Test Specimen with Kuhlman Grout and Partial Depth Keyway

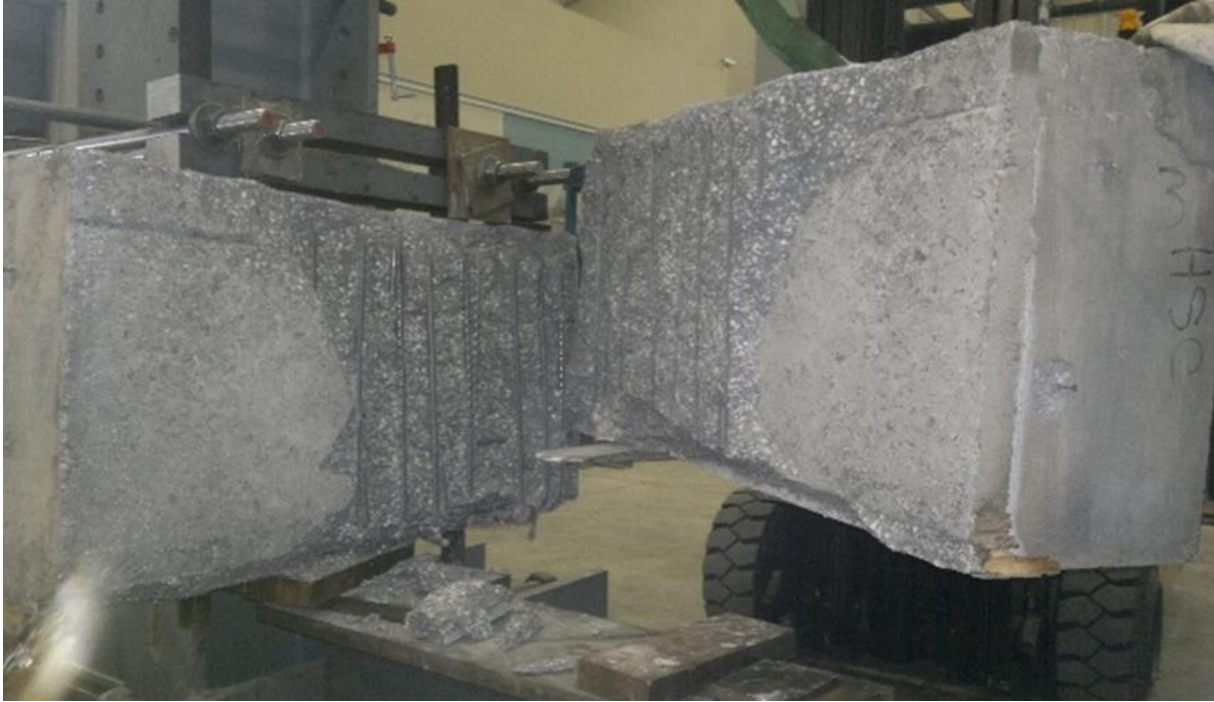
Fig. H.17 Failure of Specimens with HSC Grout

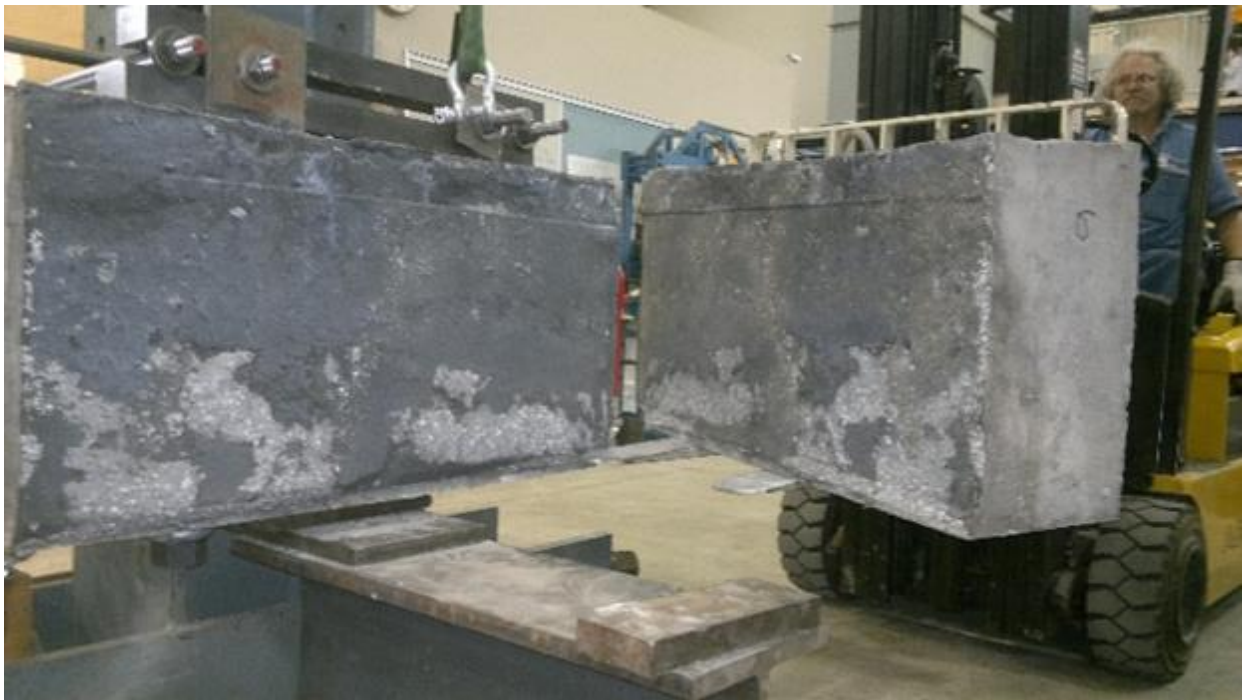
Fig. H.18 Failure of Specimens with Polymer Grout

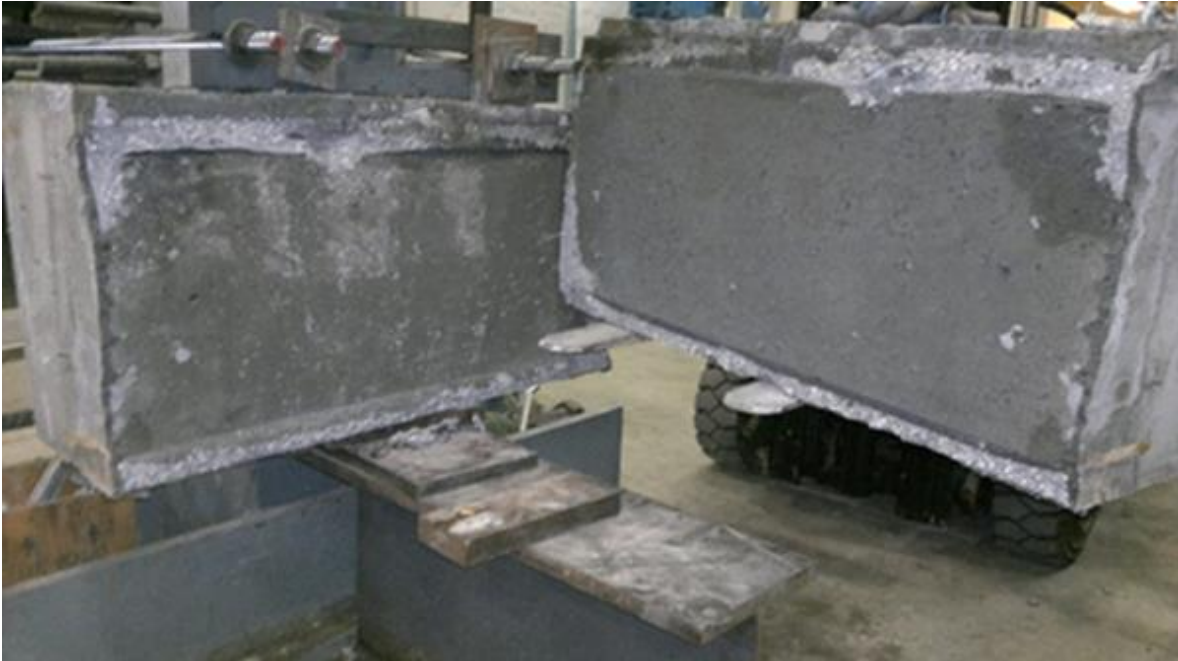
Fig. H.19 Failure of Specimens with UHPG

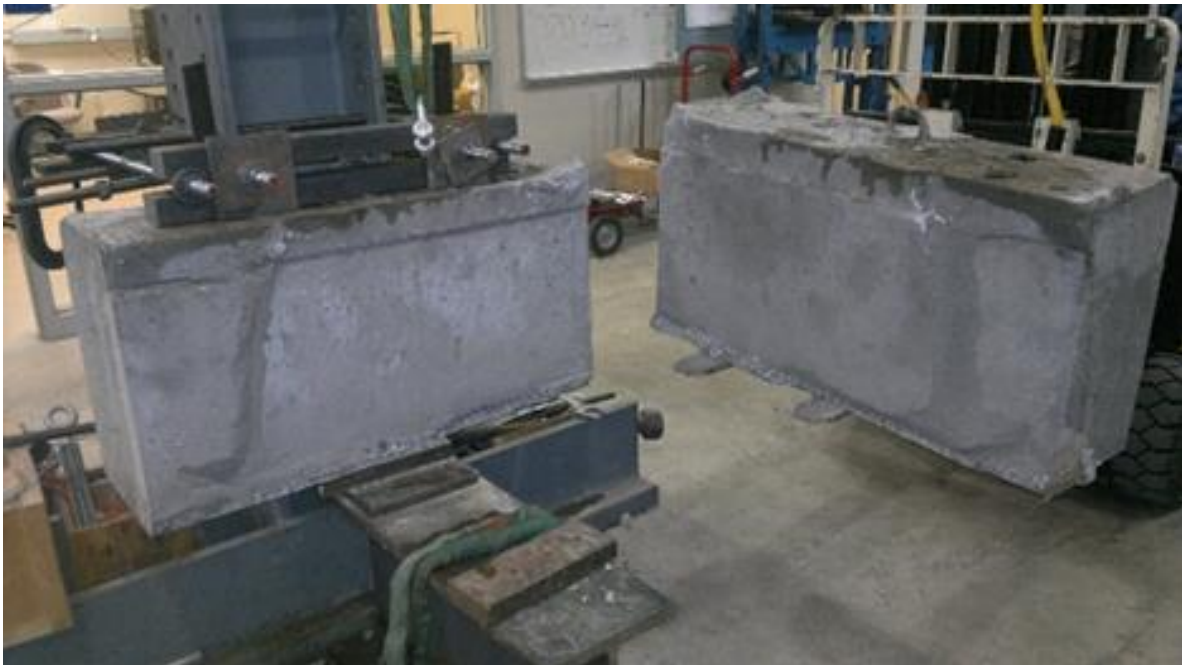
Fig. H.20 Failure of Specimens with ODOT-approved Grout

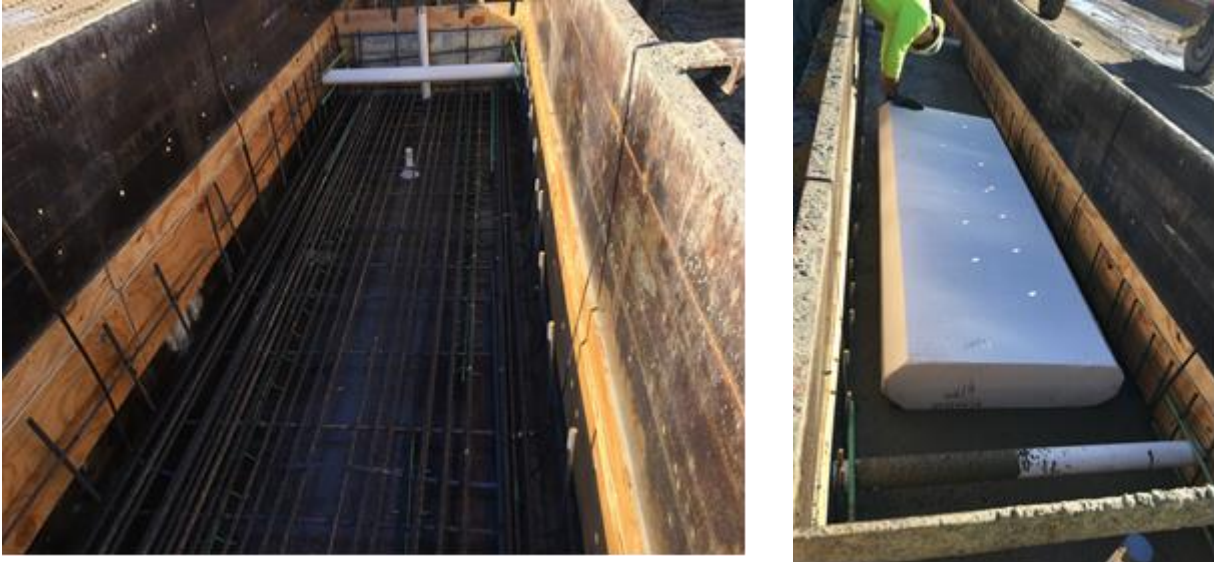
Fig. J.2 Key Way Profile Using Plywood (Left); Styrofoam Block for Creating a Void (Right)

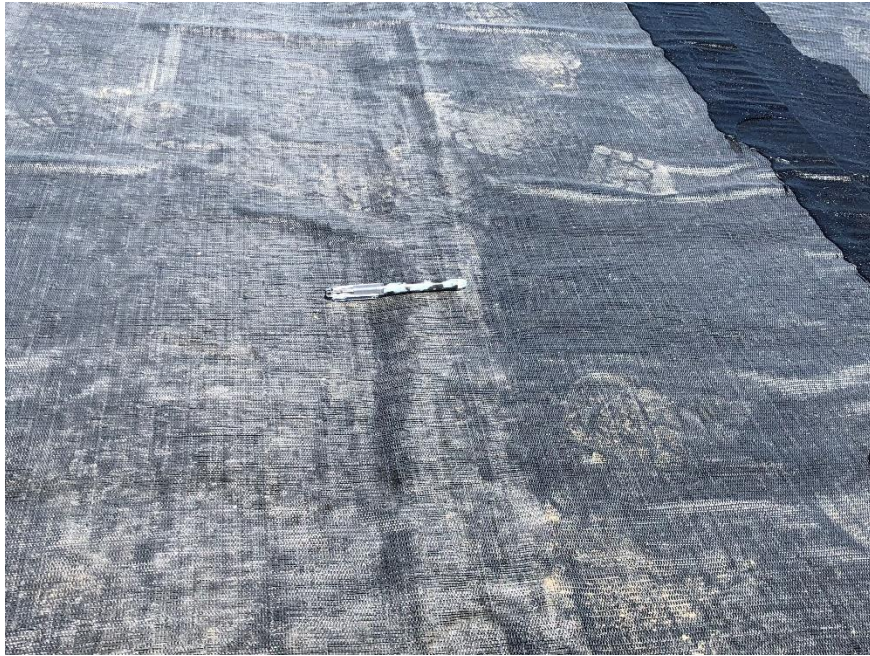
Fig. J.8 Membrane Over Adjacent Beams That were not Level
