# EFFECTIVENESS OF WILDLIFE MITIGATION TREATMENTS ALONG THE NELSONVILLE BYPASS

The Ohio Department of Transportation,  
Office of Statewide Planning & Research

1. Report No. <b>FHWA/OH-2018-8</b>		2. Government Accession No.		3. Recipient's Catalog No.	
4. Title and Subtitle <b>Effectiveness of Wildlife Mitigation Treatments along the Nelsonville Bypass</b>		5. Report Date (Month and Year) <b>June 2018</b>		6. Performing Organization Code

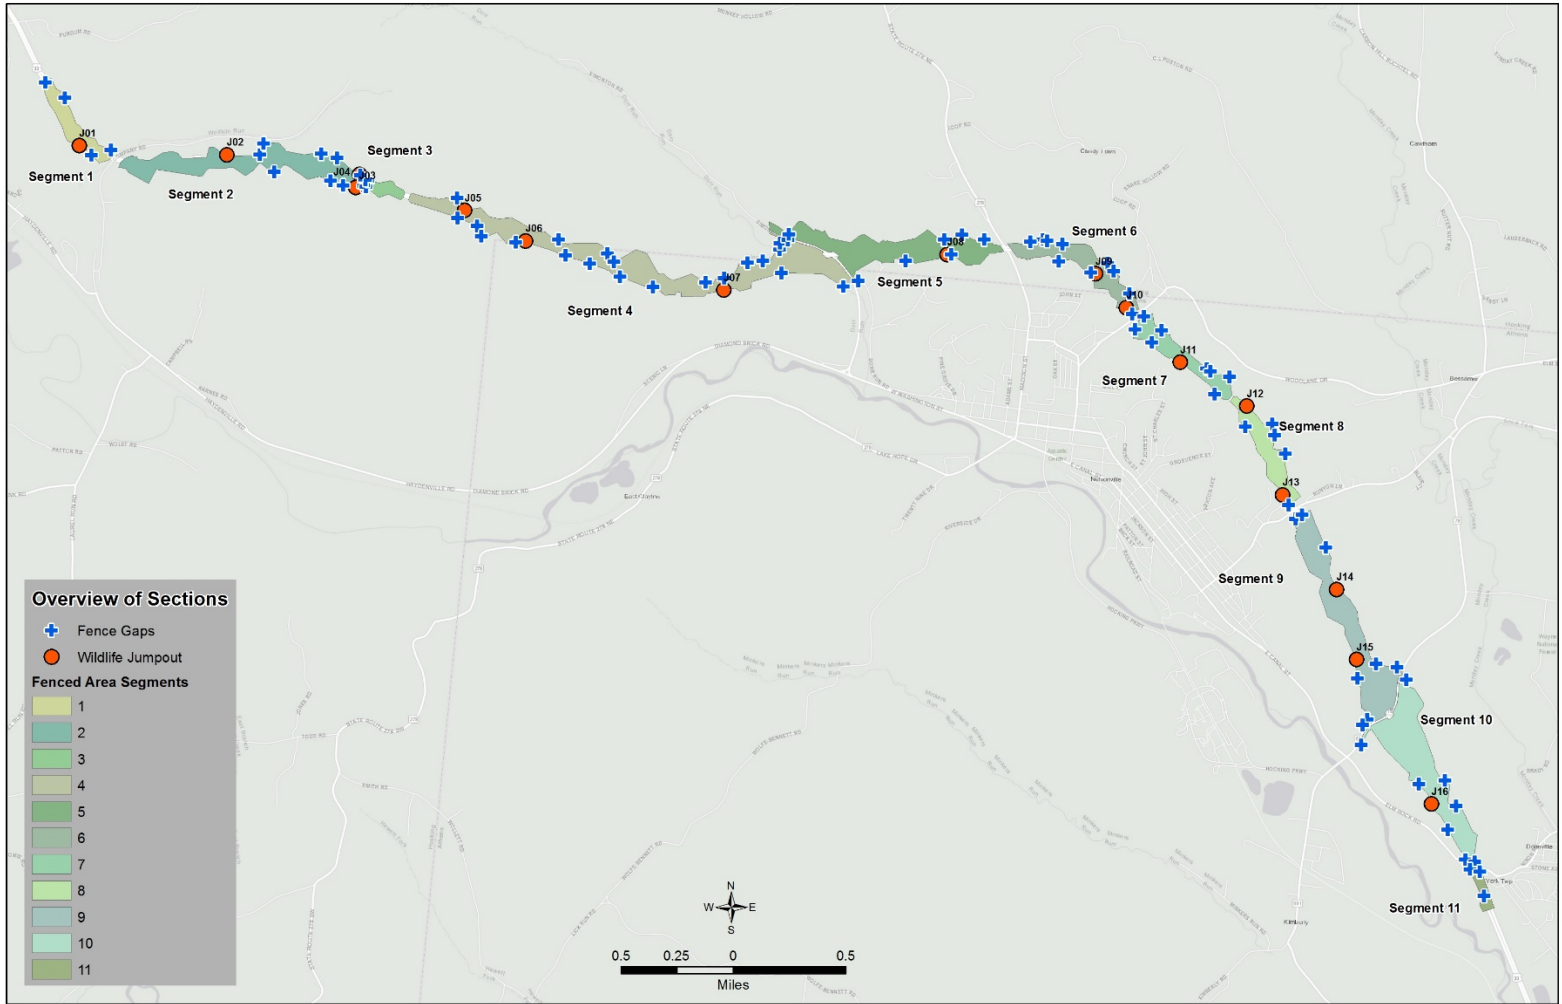
Figure 2-2. Map of the area within the U.S. 33 Nelsonville Bypass right-of-way (ROW). Road segments 1-11 are labeled and color coded. The map also depicts the locations of the one-way jump out mitigation structures (red dots) and fence gaps (blue plus signs).

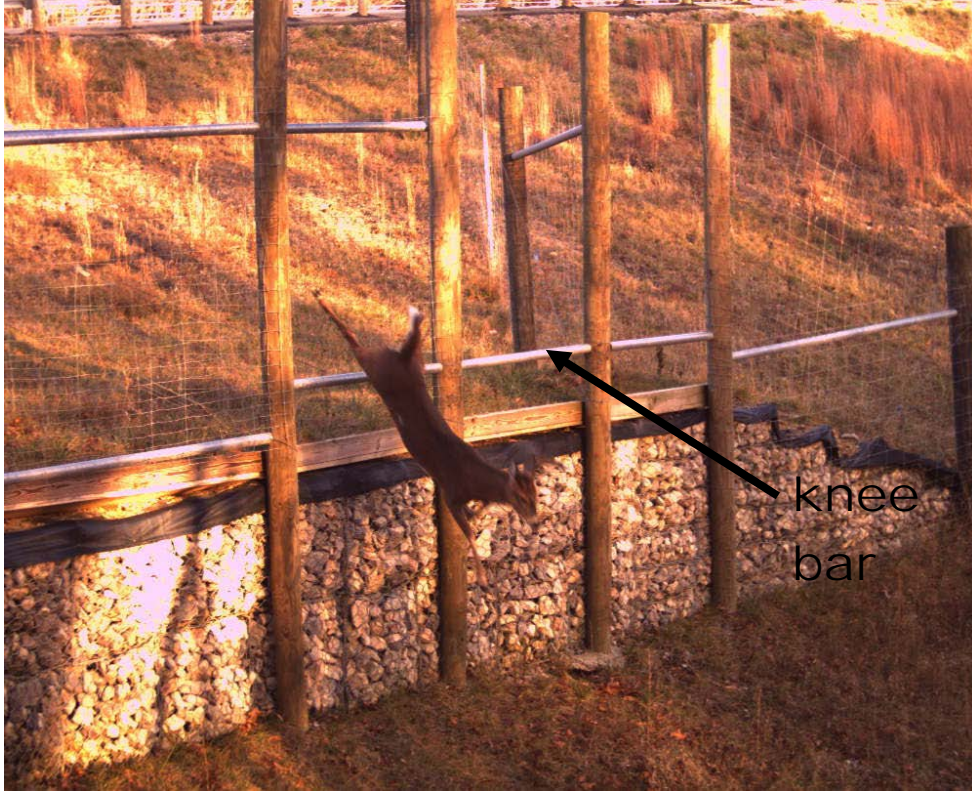
Figure 2-16. White-tailed Deer exiting the U.S. 33 Nelsonville Bypass right-of-way through a one-way jump out. This jump out does have a knee bar. This jump out has no apparent landing pad.

Jump Out 9 (J9) is on the south side of the bypass between highway stations 286+00 and 287+00. There are two wing fences and three chutes with knee bars (Figure 2-16). The distance of the jump wall to the travel lanes is 70 ft. Wing fences are 65 ft. and 75 ft. long, the gap between the wing fence ends to the active travel lane is 25 ft. J9's jump out wall is 5 ft. tall. The

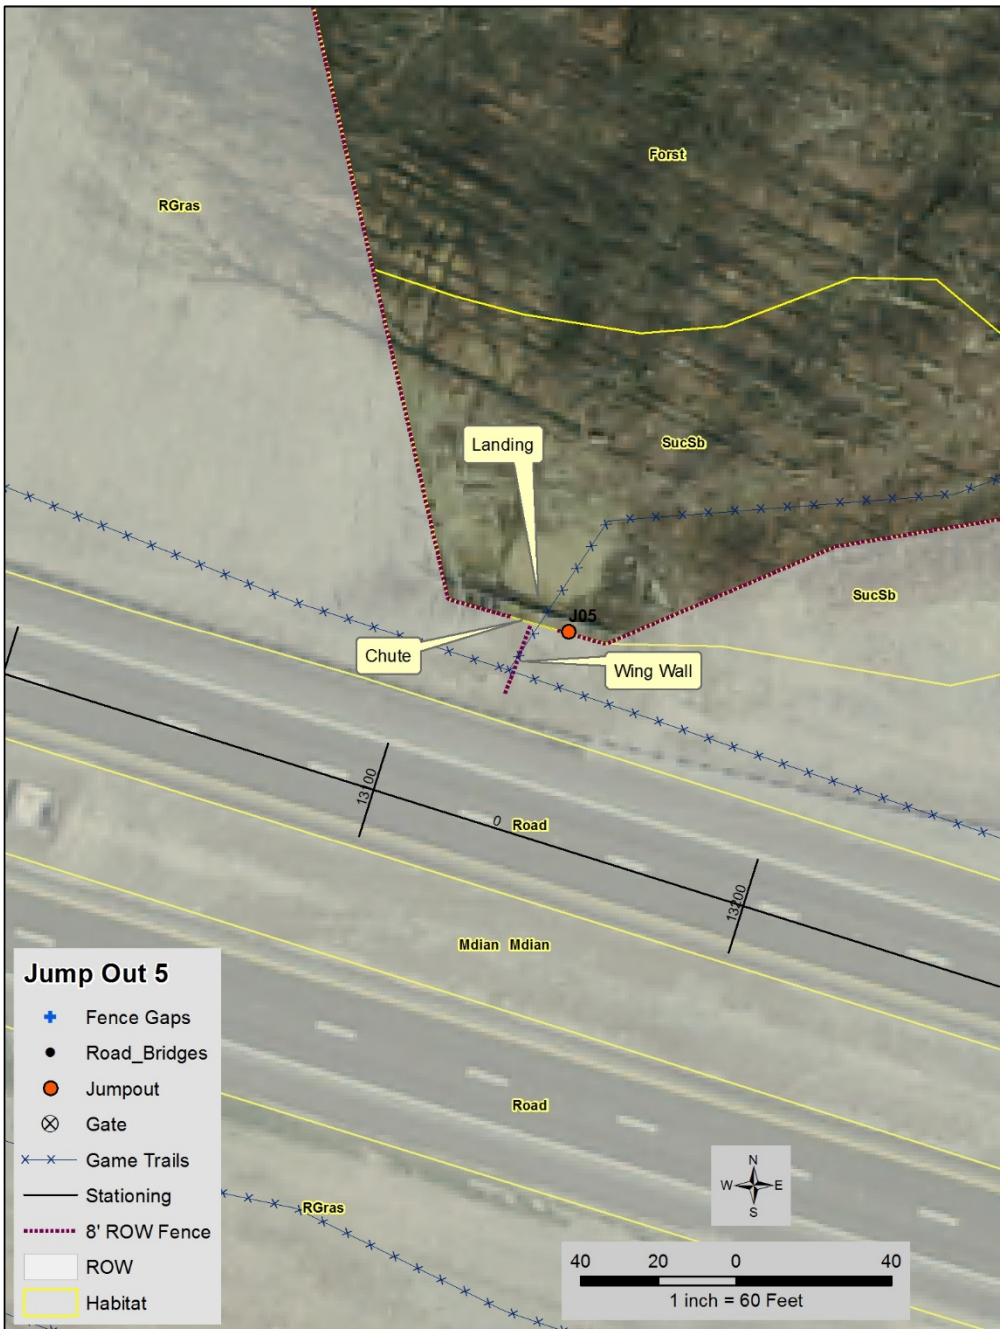
Figure 2-21. Schematic of Jump Out 5 showing wing walls, escape chute, and landing pad. Habitat mapping codes are in Table 2-1.

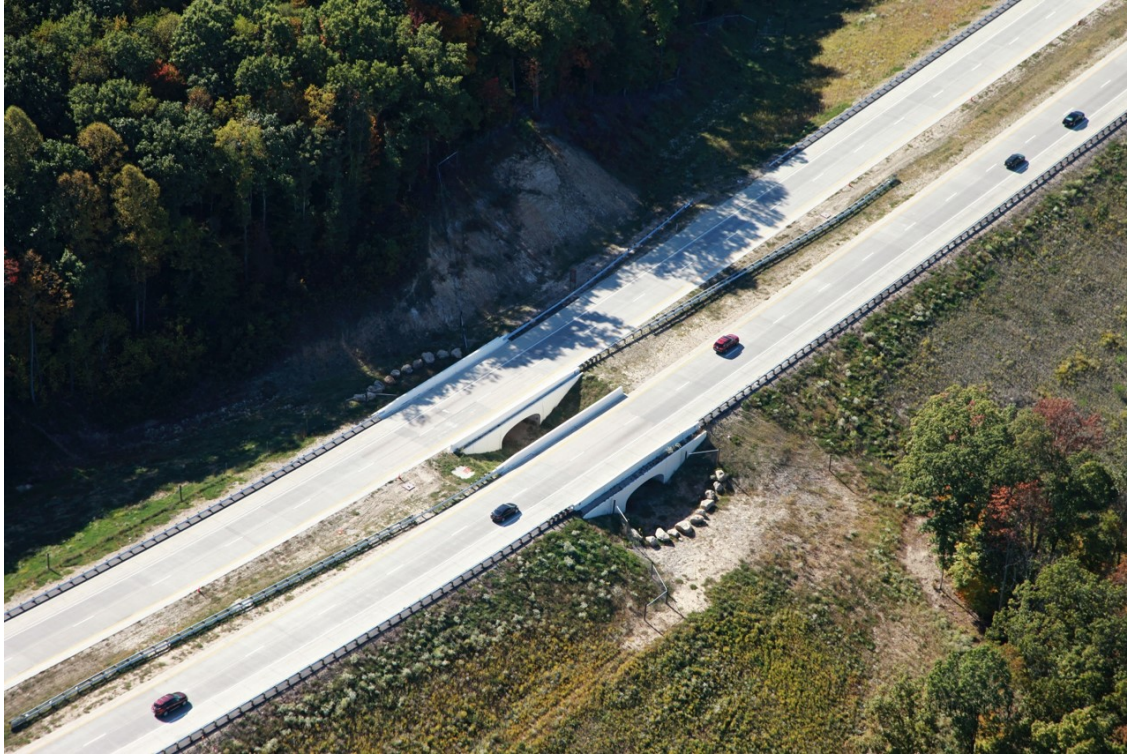
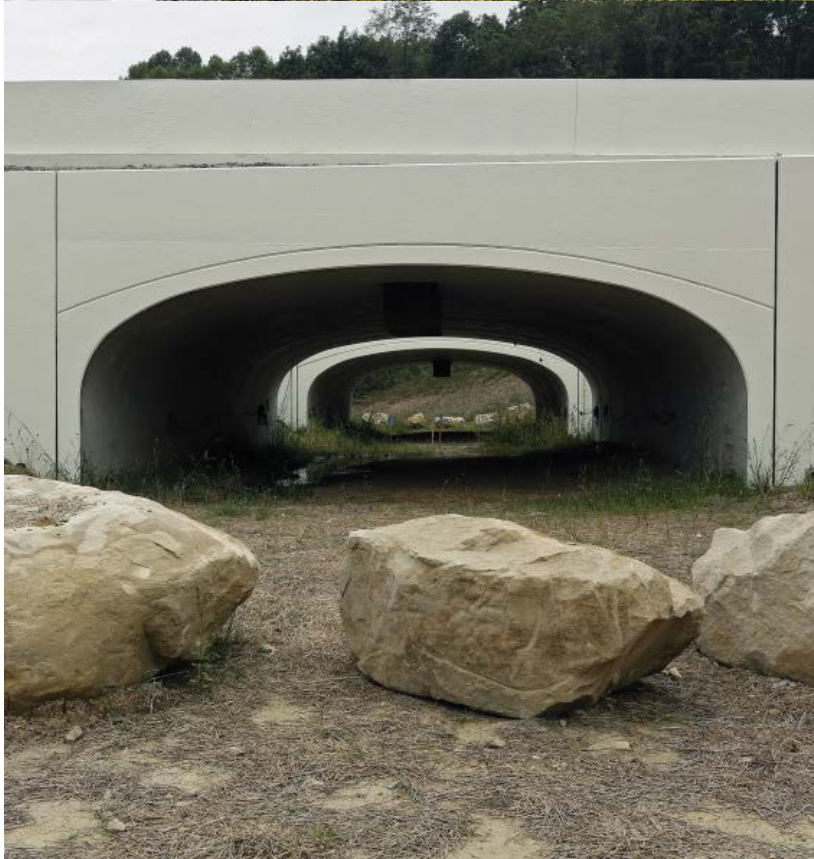
Figure 2-33. Images of Wildlife Underpass 2 (UP2) for large wildlife use, along the U.S. 33 Nelsonville Bypass in Hocking County, Ohio. UP 2 is 125 ft. across with a bottom width of 35 ft. and a maximum height of 9 ft. Aerial photo of UP2 (top) and ground photo (bottom).

Wildlife Underpass 2 (UP2) is fully dedicated to wildlife usage and is located at highway station 329+60. UP2 separates highway segments 7 and 8 (Figures 2-9 and 2-10). UP2 spans a 95-ft. highway width and serves as the dividing bridge between highway segments 7 and 8. The passage itself is 125 ft. across. The underpass is a pair of box-culvert structures with a 35-ft. wide, level tunnel floor and an arched ceiling starting from 7 ft. tall at the edges and increasing up to 9 ft. tall in the middle of the tunnel. A 20-ft. wide opening provides light between the eastbound and westbound highway lanes. An arc of 3-5 ft. diameter, closely spaced boulders is placed around each end to prevent use of the structure by ORVs (Figure 2-33). There is also a bat roosting structure on the ceiling of UP2. The structure allows wildlife to travel between the woodland valley corridor to Monday Creek to the north and the Nelsonville, Ohio residential neighborhoods to the south.

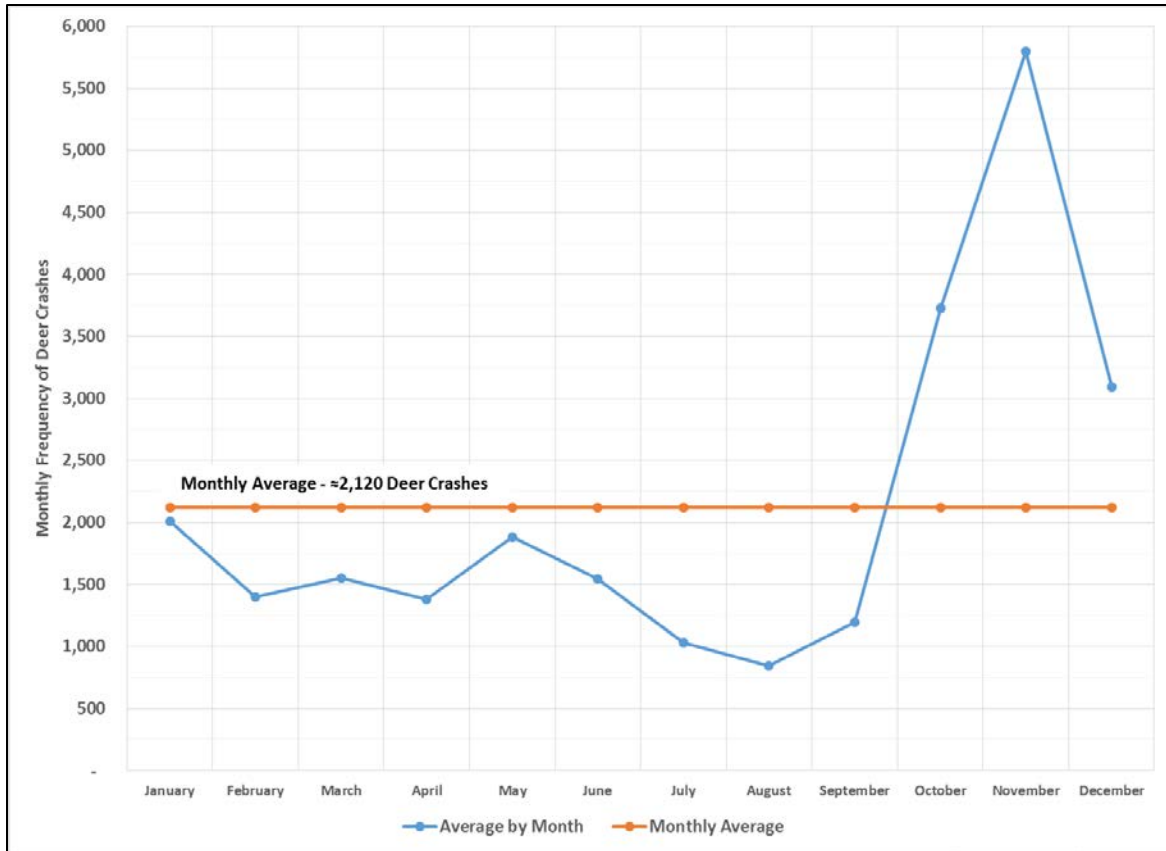
Figure 3-1. Average deer-vehicle crashes by month and annual monthly average for State of Ohio, 2001 – 2015 (Data Source: Ohio Department of Public Safety)

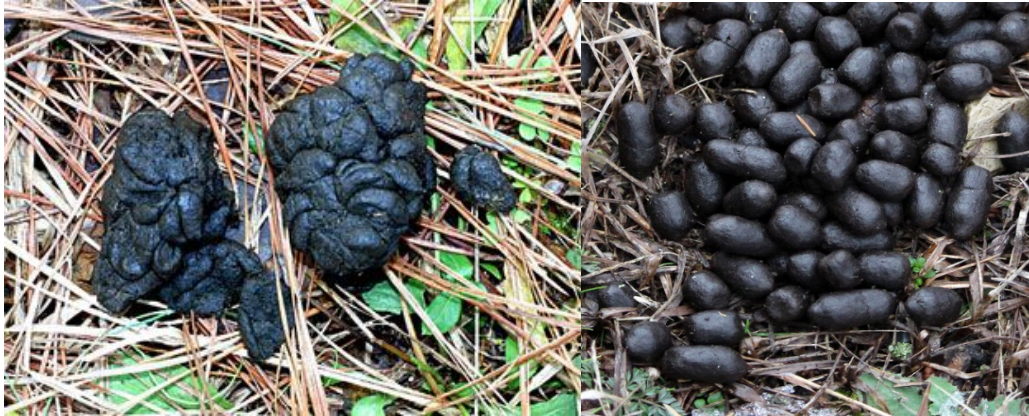
Figure 4-1. White-tailed deer scat. Left - clumped group (diet rich in green forbs) versus Right - pellet group (diet rich in grasses).

We estimated the abundance of deer inside the ROW via pellet counts performed using the FAR method. We considered >6 pellets to form a “pellet group” (Figure 4-1). Pellet counts were implemented inside ROW by revisiting 50 164 ft. x 6.6 ft. strip transects evenly distributed between the Eastbound and Westbound habitats. The transects also were distributed proportionally to the three main types of microhabitats within the ROW: herbaceous vegetation, regenerating woody vegetation, and forest (Table 4-1).

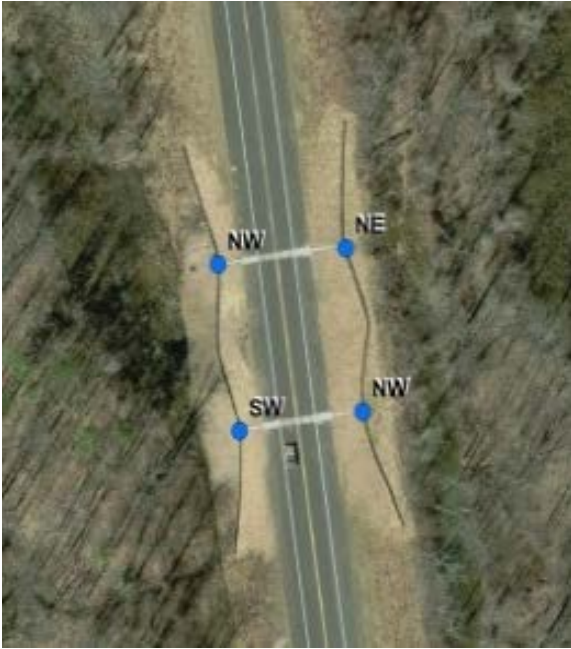
Figure 5-1. Aerial view of the barrier-ecopassage system in place along State Route 78, Athens County, Ohio.

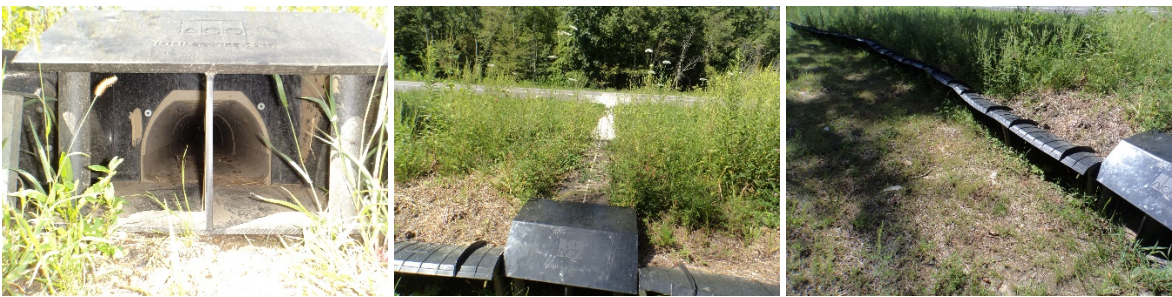
Figure 5-4. Images of the ecopassage opening (left), ecopassage crossing under the road, perforations in the top can be seen (middle), and curved plastic fencing (right) in place along State Route 78, Athens County, Ohio.

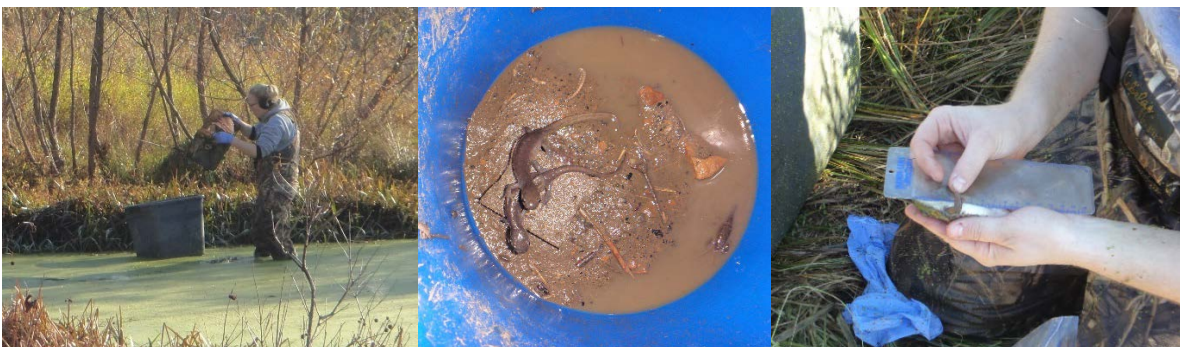
Figure 5-5. Images of C. B. Hopkins checking a minnow trap (left), two Jefferson Salamanders in a pitfall trap (middle), and a Green Frog being measured (right).

- (5) PITFALL TRAPPING – Pitfall traps are five-gallon buckets buried in the ground so that they are level with the surface (Figure 5-5). Twelve traps were placed along a 500-ft. barrier, which guide animals to the traps, in an area of high amphibian movement along SR 78. Pitfall traps contained some soil and a sponge at the bottom to prevent desiccation of amphibians. The bottoms of buckets were perforated to allow excess rainwater to drain and to prevent drowning of captured animals (Heyer et al. 1994, Dodd 2010). Traps had plywood covers that were 3 in. off the ground and held in place by a rock to block sunlight, mediate trap conditions, and prevent predation on trapped animals (Enge 2001). Traps were checked daily February 22-June 24, 2016 and September 5-November 14, 2016. Traps were checked a total of 195 times for a total of 2,340 trap nights (195 nights times 12 traps).

All adult animals captured using dip net, minnow trap, spot light, and pitfall trap methods were measured, weighed, sexed, and marked using a batch marking technique (Figure 5-5) (United States Geological Survey 2001, Ferner 2007). Adult animals captured or detected were used to generate population estimates. Population size estimates were generated via mark-recapture methods and area-density methods (Heyer et al. 1994, Dodd et al. 2010). The programs Microsoft Excel and R (R Development Core Team, 2008) were used to process data and estimate population sizes from collected data. Adult breeding population estimates were calculated for eight amphibian species; seven of these estimates were calculated using simple Lincoln-Petersen and Chapman methods, for the Spring Peeper the population estimate was calculated by multiplying animal density by suitable habitat area. Spring Peeper suitable breeding habitat was identified as water less than 12 in. deep with vegetation present for egg deposition; suitable habitat was identified in the field and mapped into ArcMap to calculate area size (Figure 5-6).

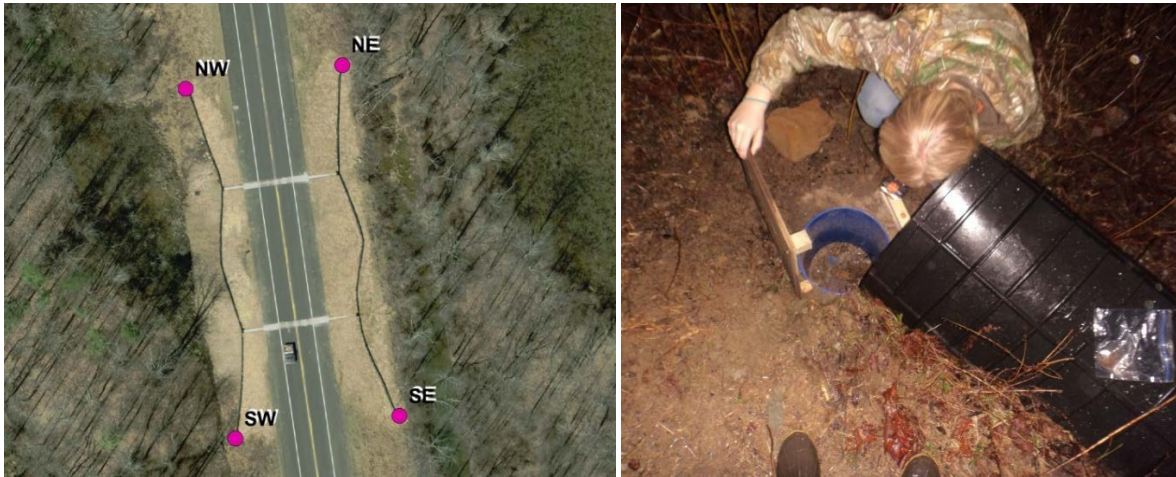
Figure 5-7. Aerial image showing placement of the four barrier pitfall traps (left) and image of volunteer M. Ingle checking a pitfall trap (right).

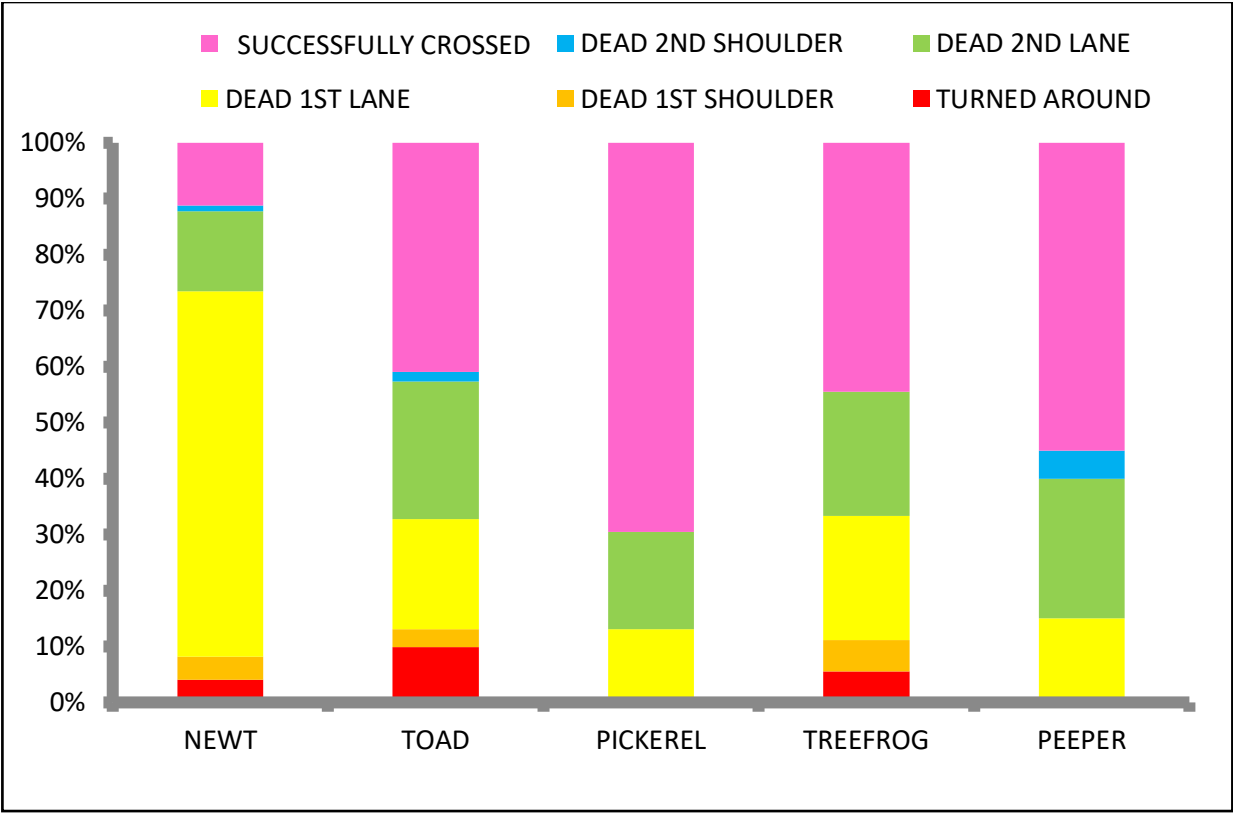
Figure 5-17. Percentage of individuals observed that successfully crossed the road, turned around and aborted the crossing attempt, or died for each of five species (Red-spotted Newt, American Toad, Pickerel Frog, Gray Treefrog, and Spring Peeper).

In our observations of 220 individual animals (Red-spotted Newts=98, American Toads=61, Pickerel Frogs=23, Spring Peepers=20, and Gray Treefrogs=18), we found that even the fastest species still only had a 69.8% chance of surviving a crossing attempt (Figure 5-17). For Red-spotted Newts, only 11.2% made it successfully across the road. We observed that some animals would turn around and return to the side they started on. Most animals died in the traffic lanes, although some were hit on the shoulder.

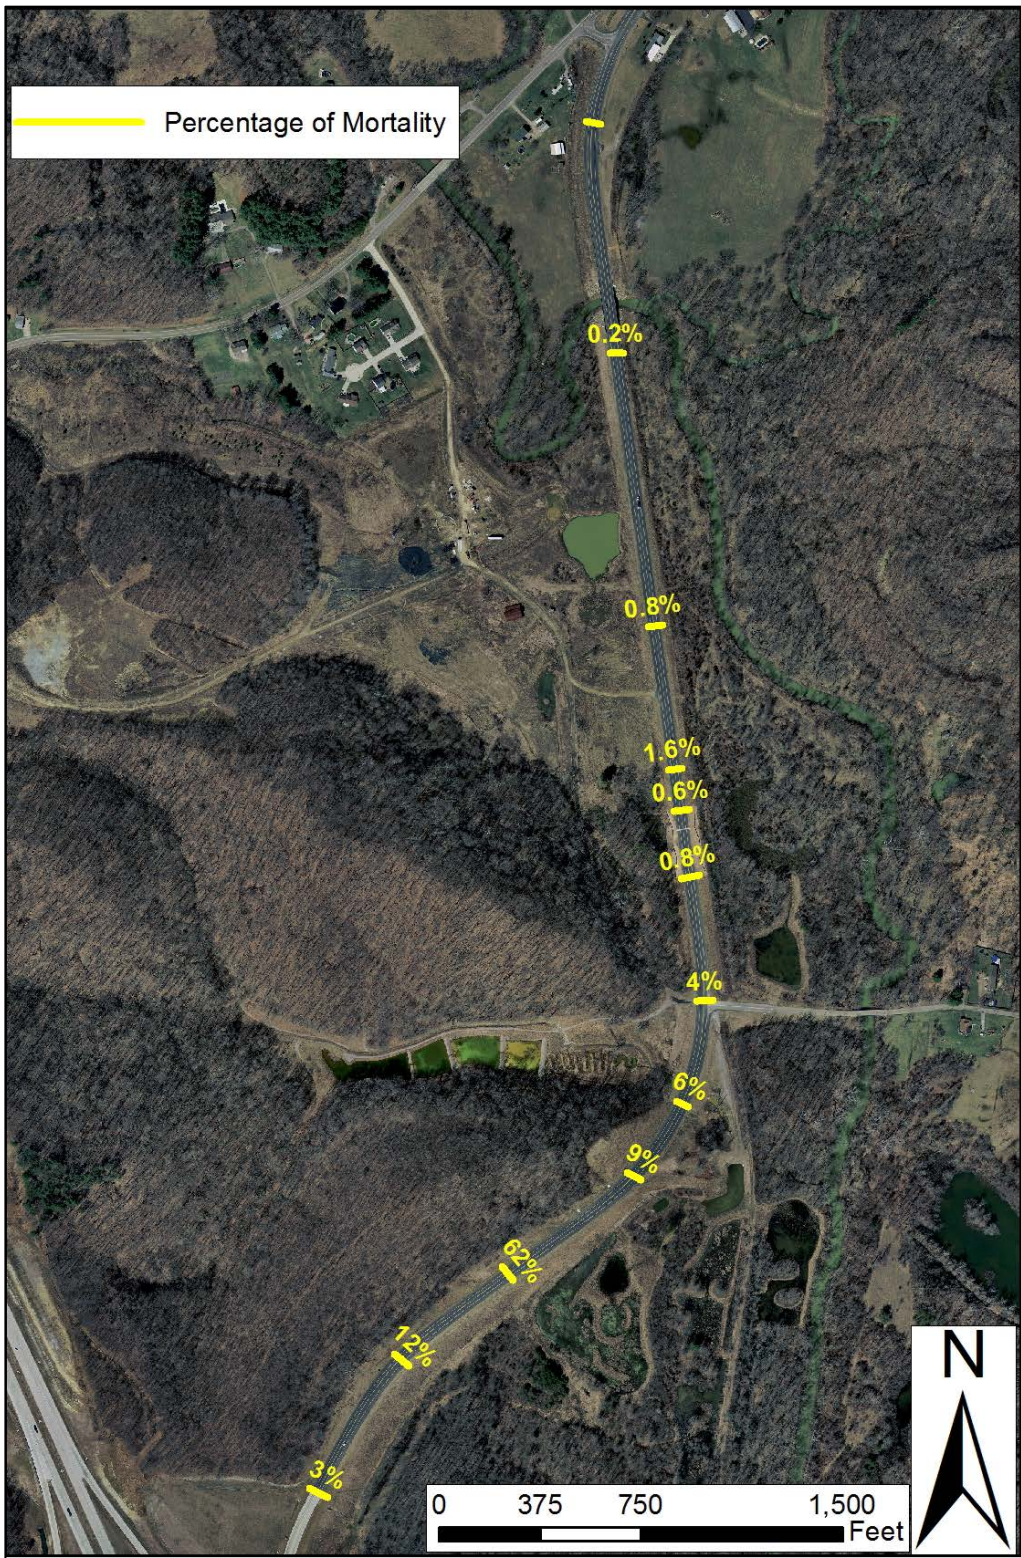
Figure 5-27. Percentage of amphibian mortality from 2015-2016 occurring in each section of roadway along State Route 78, Athens County, Ohio. One section is based on where the mitigation structure is located and the other sections were defined based on habitat near the roadway.

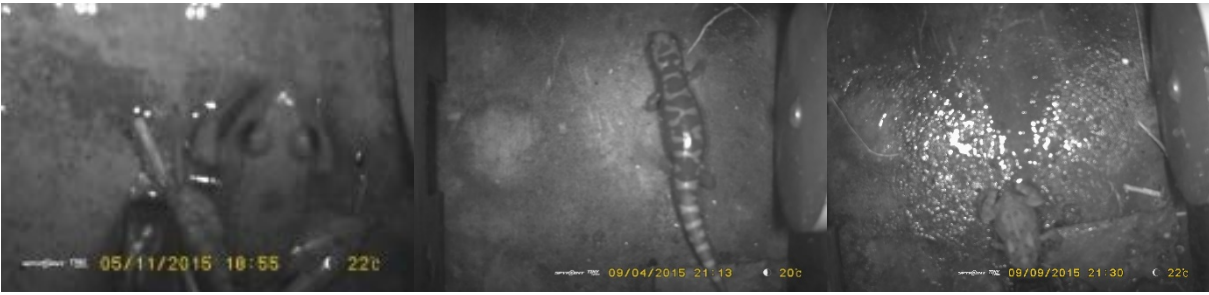
Figure 5-28. Amphibians detected by the ecopassage camera traps (Green Frog-left, Marbled Salamander-middle, and American Toad-right).

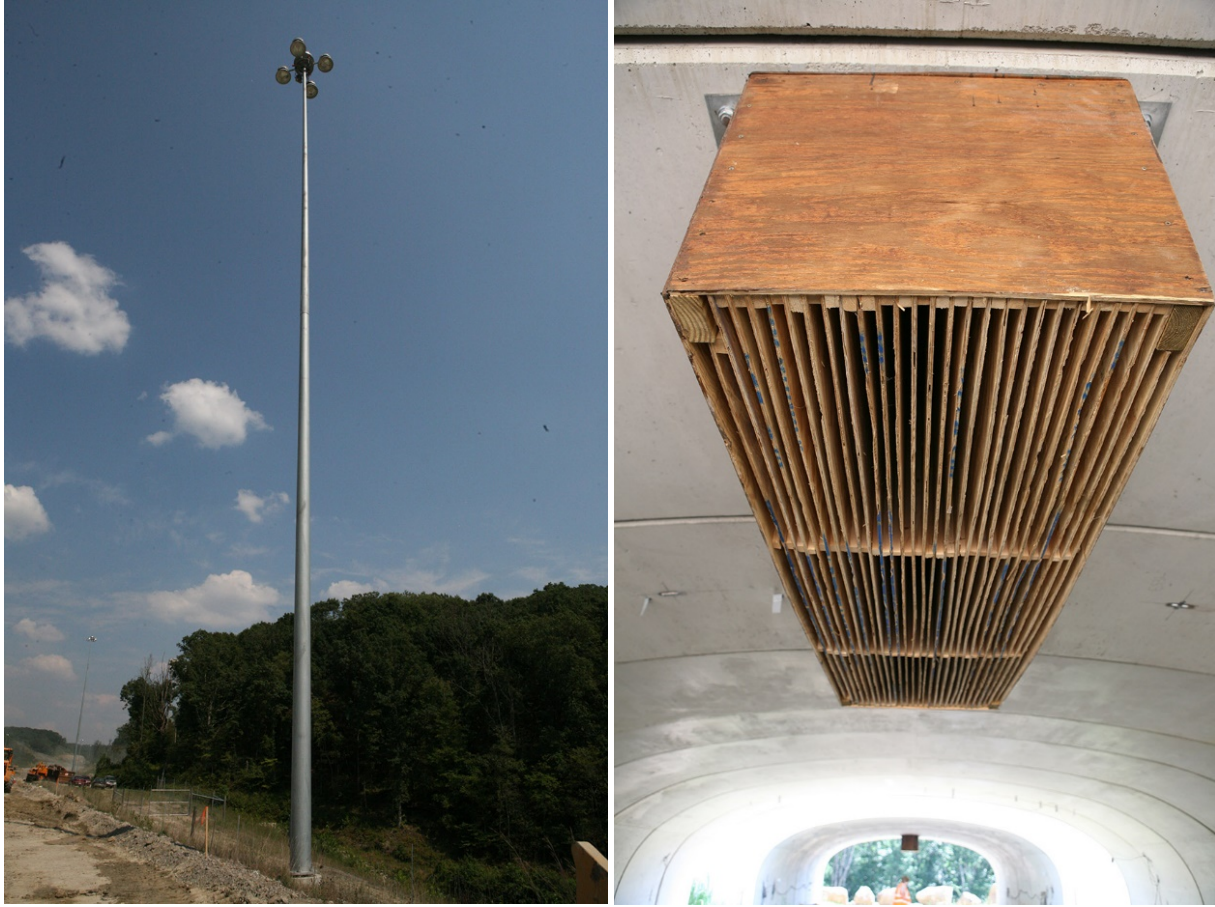
Figure 6-1. Image of high-mast lighting (left) and lattice style bat roosting boxes (right) employed along the U.S. 33 Nelsonville Bypass, Athens and Hocking Counties, Ohio. High-mast lighting is designed to lure bats away from the flow of traffic and bat roosting boxes are intended to replace habitats removed during construction.

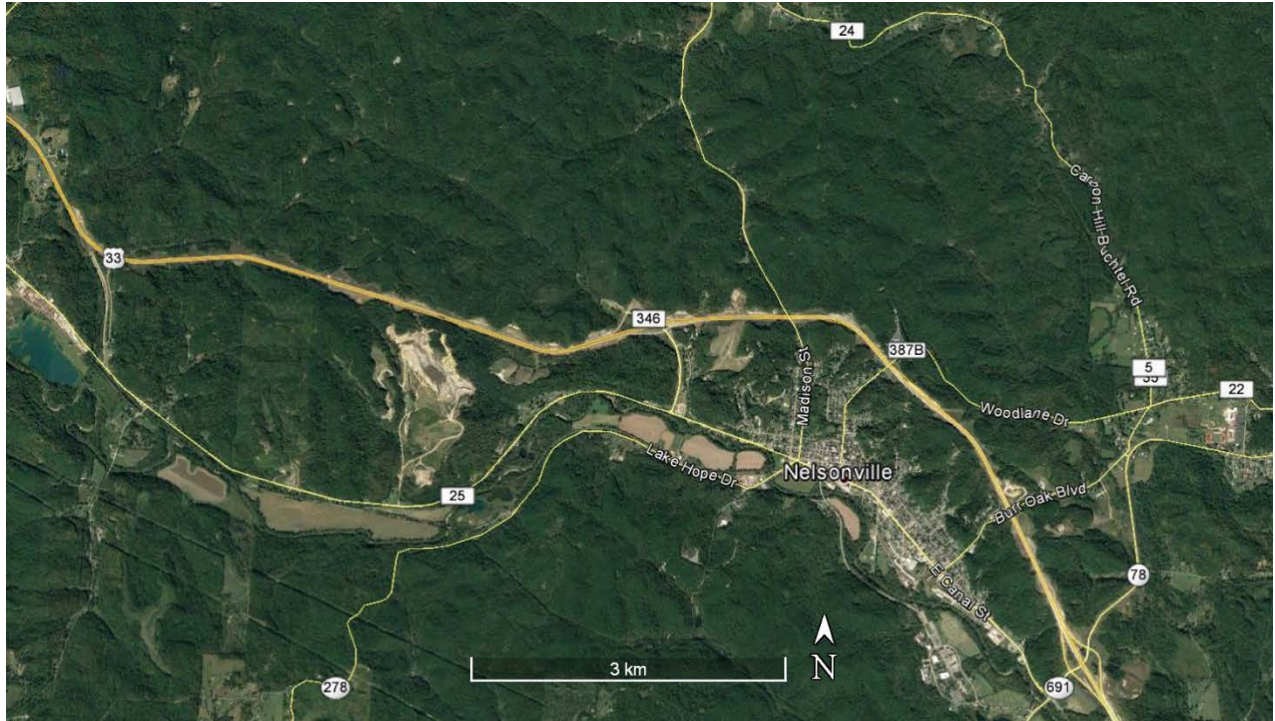
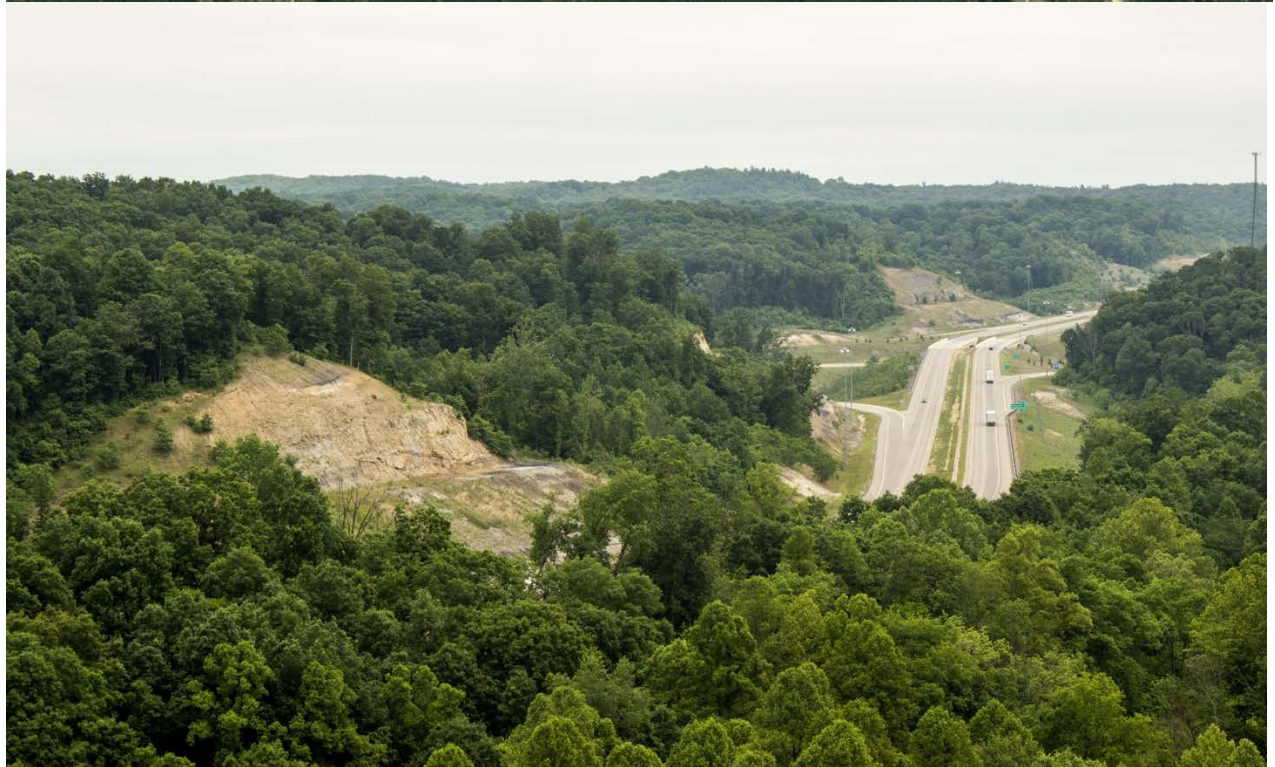
Figure 7-1. The U.S. 33 Nelsonville Bypass Study Site, Athens and Hocking Counties, Ohio. Top: aerial imagery of the U.S. 33 Nelsonville Bypass study site, Bottom: photo taken at the study site showing the forest, right-of-way, and bypass itself.

The Nelsonville Bypass (“NVBP” or “bypass”) is an 8.5-mile segment of U.S. 33 that passes through Athens and Hocking Counties, Ohio (Figure 7-1). The bypass is a high speed (70 mph), high volume (~17,000 vehicles/day), four-lane divided highway. Construction of the NVBP began in 2007, and the entire length was opened to traffic in October 2013. The NVBP bisects the Athens Unit of the WNF, which includes more than 67,000 non-contiguous acres in five counties of southeastern Ohio. The WNF is an eastern deciduous forest (primarily Oak-Hickory-Maple forest at the NVBP) with outcroppings of Pennsylvanian sandstone.

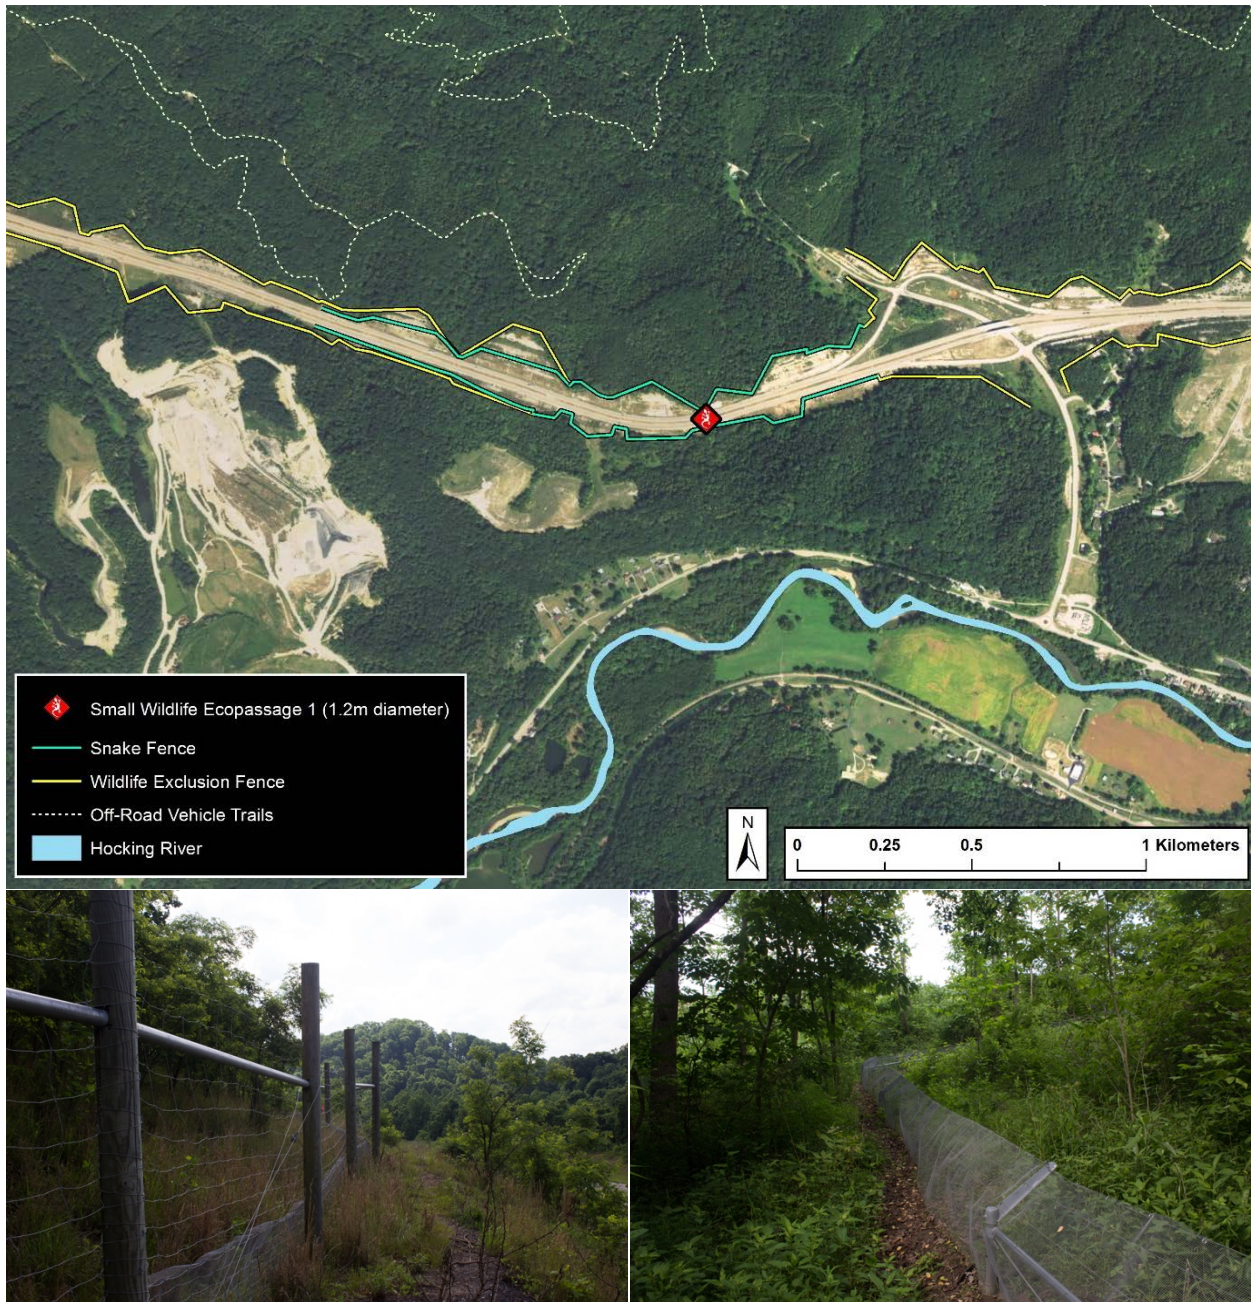
Figure 7-2. Snake exclusion fence along the U.S. 33 Nelsonville Bypass, Hocking County, Ohio. Top: map showing extent of snake exclusion fence, Bottom Left: snake fence attached to the 8-ft. tall wildlife exclusion fence, Bottom Right: snake fence installed independently from the 8-ft. tall wildlife exclusion fence.

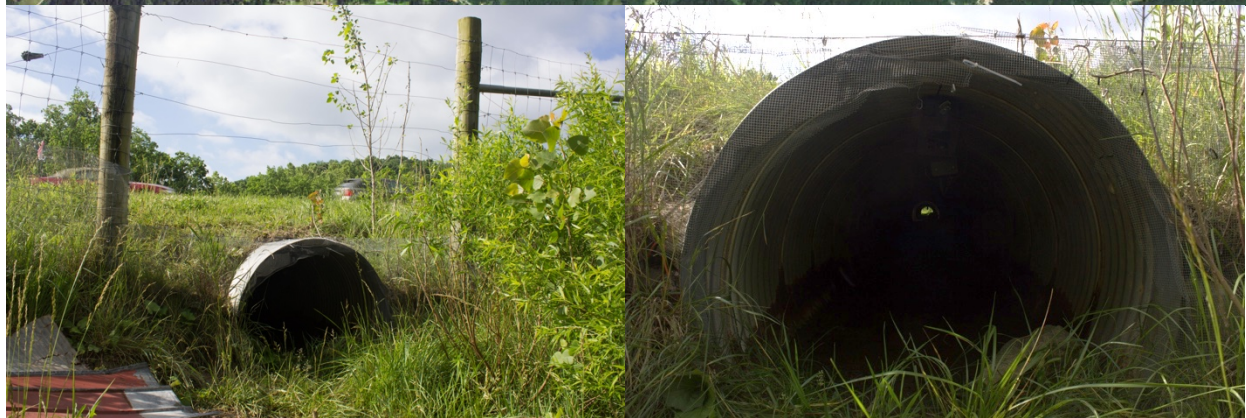
Figure 7-3. Ecopassages (i.e. wildlife crossing structures) along the U.S. 33 segment of the Nelsonville Bypass. Top: ecopassages locations along the U.S. 33 Nelsonville Bypass, Bottom Left: Small Wildlife Ecopassage 1 entrance integrated into snake fence, Bottom Right: a look inside the ecopassages reveals a long, dark tunnel.

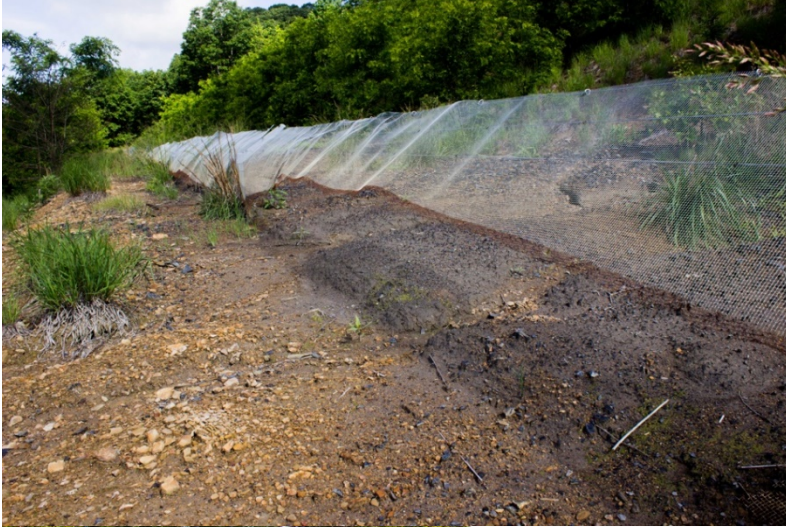
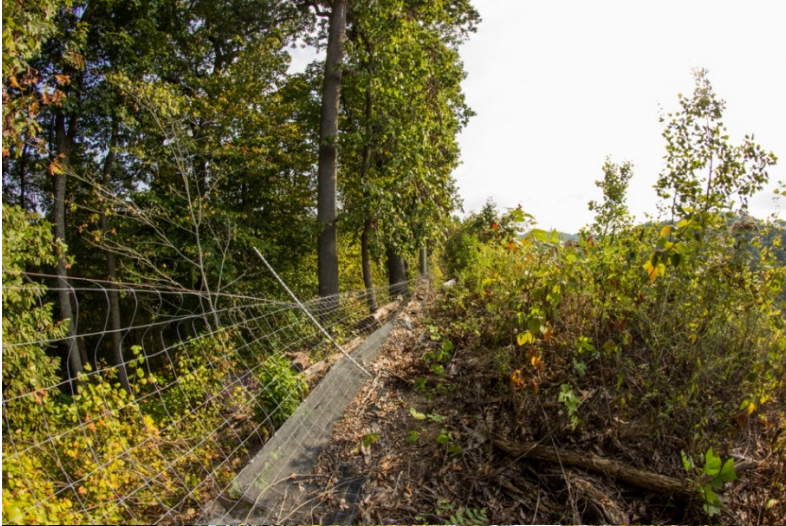
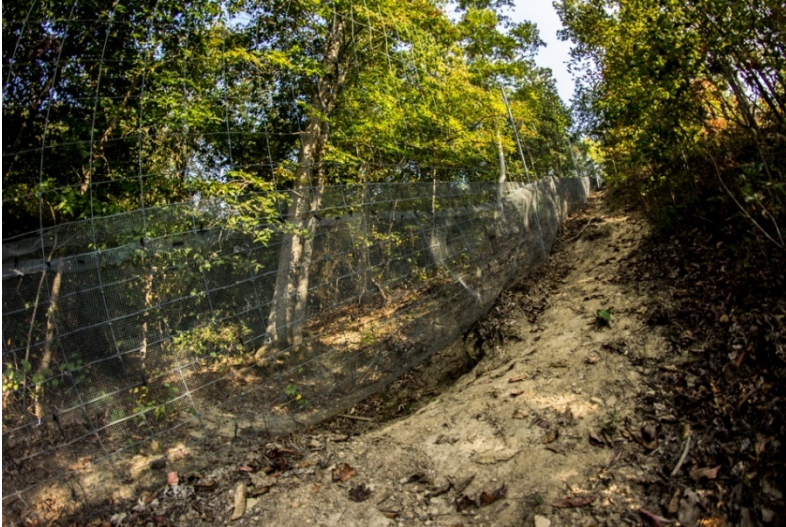
Figure 7-11. Damage to the snake fence. Top: corrosion damage, Middle: tree fall damage, Bottom: erosion damage.
