**Engineered Log Jam Monitoring along  
NH Route 16 in Errol, New Hampshire**

**Final Report**

Prepared by University of New Hampshire Department of Civil and Environmental Engineering, College of Engineering and Physical Sciences, in cooperation with the U.S. Department of Transportation, Federal Highway Administration

1. Report No. FHWA-NH-RD-26962W		2. Gov. Accession No.	3. Recipient's Catalog No.
4. Title and Subtitle Engineered Log Jam Monitoring along NH Route 16 in Errol, New Hampshire		5. Report Date March 2023

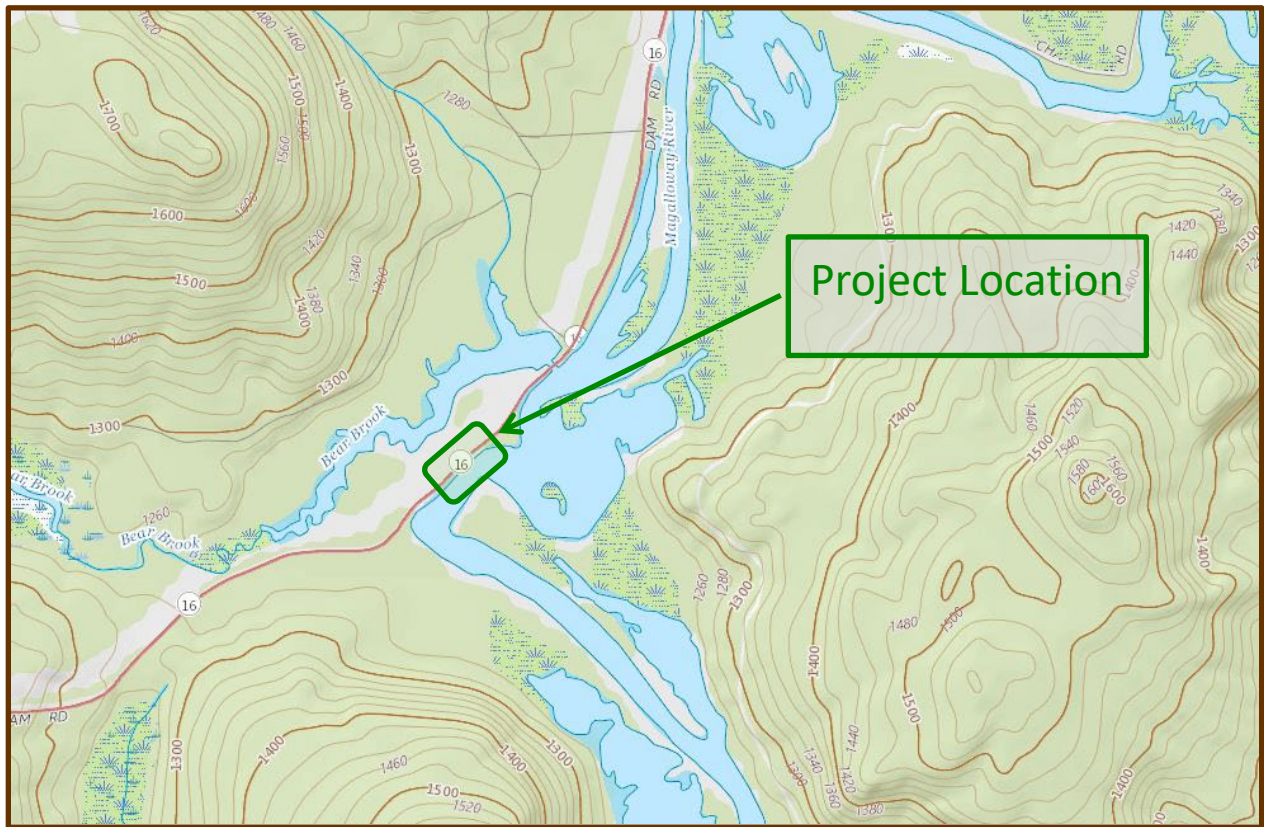
Figure 1. Project location along Route 16.

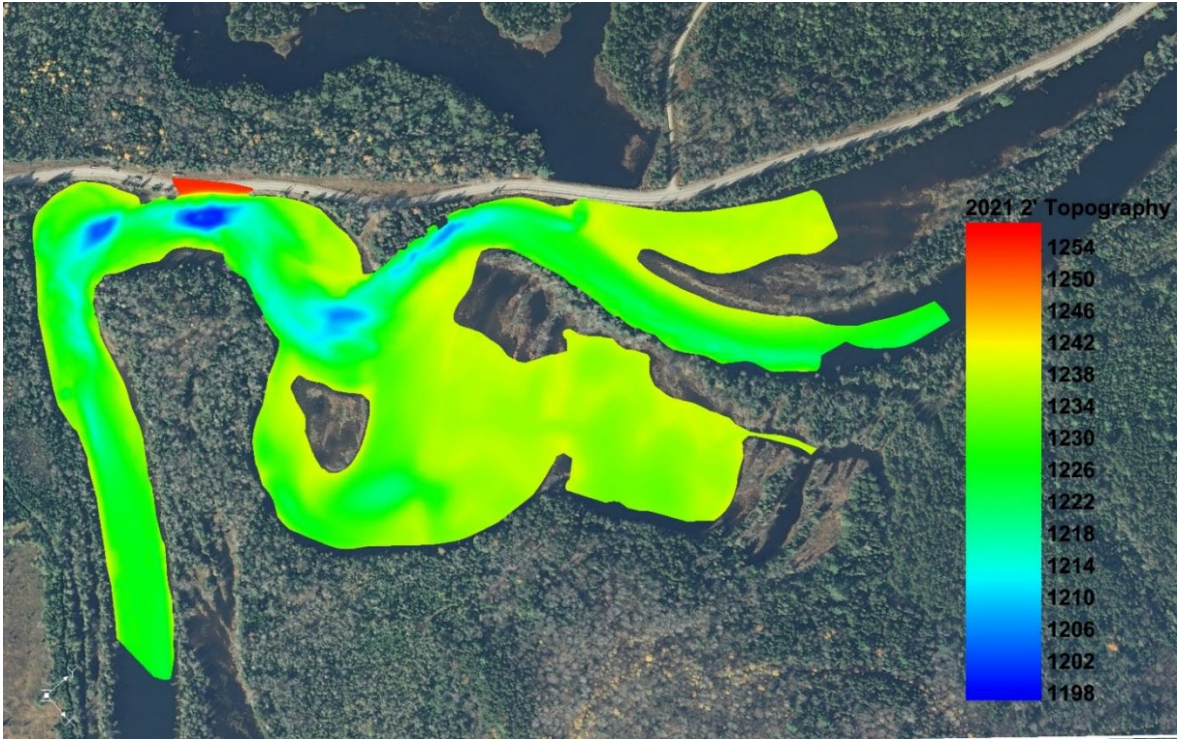
Figure 4. Model Domain Topography and Bathymetry 2021. Legend values are in Feet NAVD88.

Bathymetric surveys with the Zego boat were performed on: 10 July 2019, 17 June 2020, 24 April 2021, and 26 May 2022. Figures 2 through 5 depict the model domain annually from 2019 to 2020. In these Figures, North is rotated 48 degrees clockwise, indicated by the arrows at the bottom left of the Figures. There are no contour lines, but the elevations (feet MSL) are represented by a continuous color fill shown in the legend. Pre-construction images/figures are 2019 and 2020. The post-construction images/figures are 2021 and 2022.

In all Figures 2 through 9, a very deep hole is evident in the river immediately in front of the ELJ. This feature is most likely the direct result of hydraulic attack at this location as a direct consequence of the very tight meander bend.

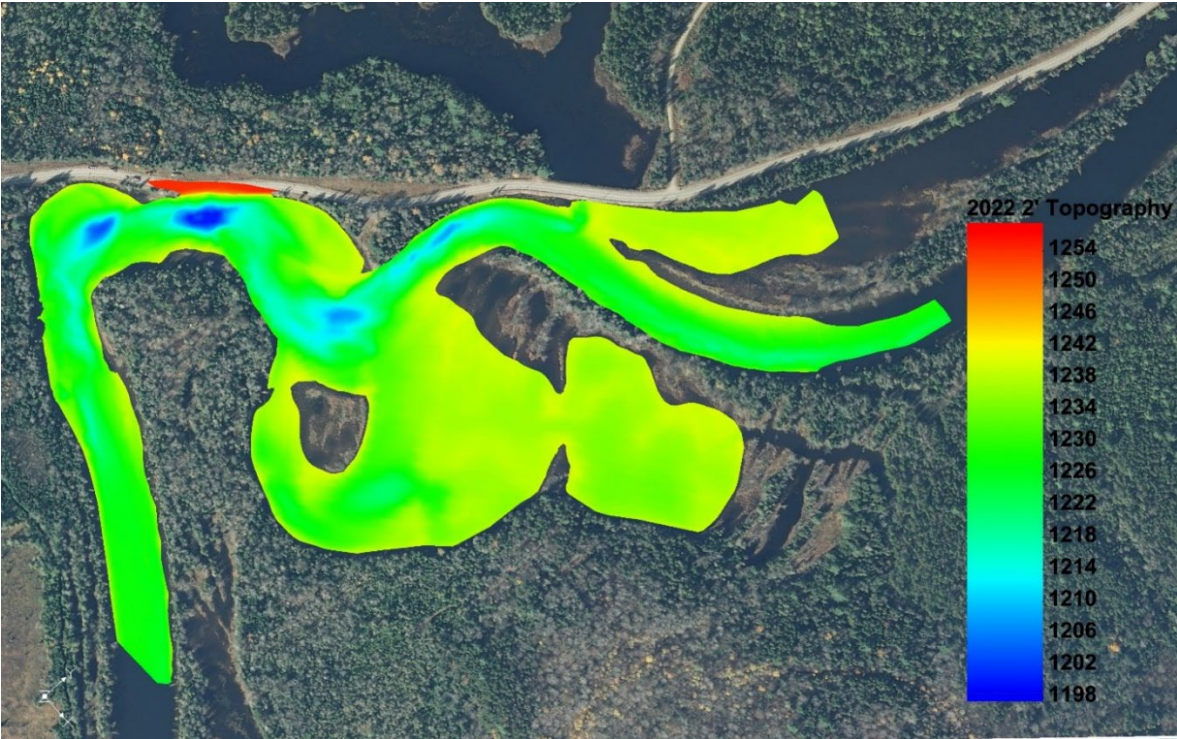
Figure 5. Model Domain Topography and Bathymetry 2022. Legend values are in Feet NAVD88.

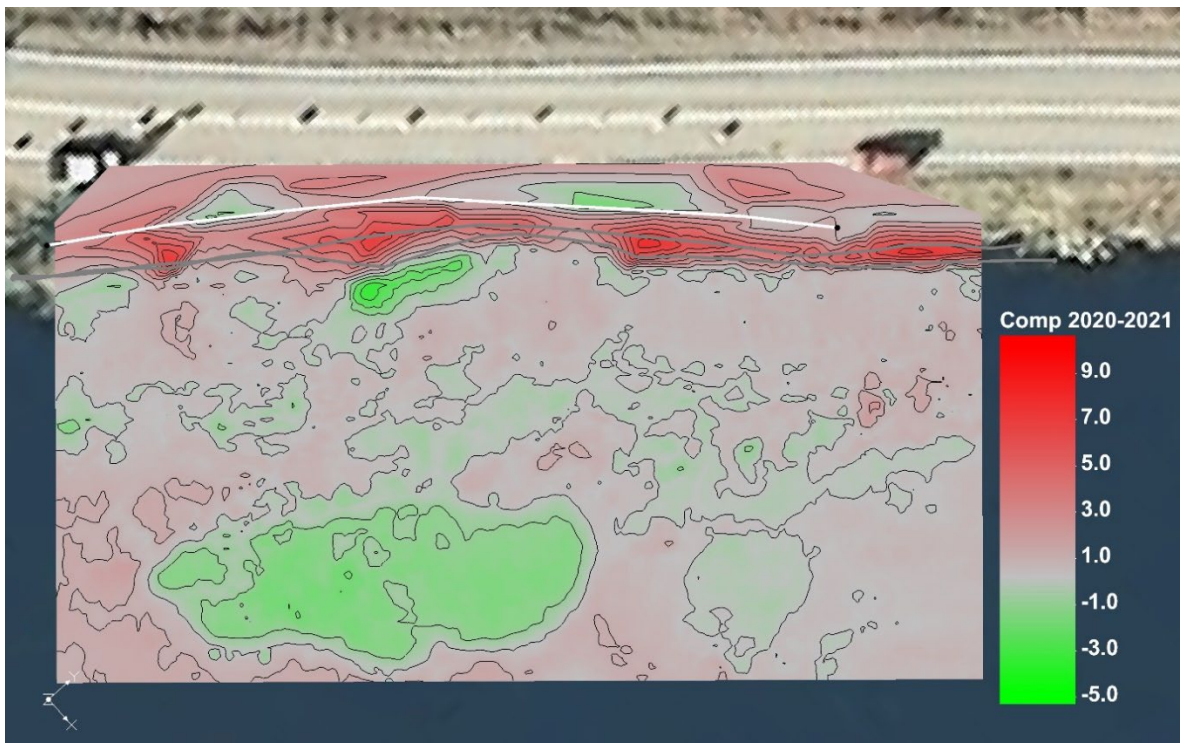
Figure 11. Surface elevation comparison from 2020 to 2021 Red means deposition from 2020 to 2021, Green is erosion. Values are in feet.

The data from Figures 6 through 9 were compared year to year in order to assess overyear changes in the vicinity of the ELJ (Figures 10 – 12). Each image has the base elevation set to the earlier of the two years listed in the Figure title, and the comparison surface is the later year. For example, Figure 10, the comparison between 2019-2020, the elevation from 2019 is the base and 2020 is compared to this base. The comparison is then the difference between surfaces via the later year's elevation minus the earlier years' elevation. Therefore the Figures show the net gain or loss in elevation from one year to the comparator year. Red coloring indicates a higher elevation (deposition) in the later year compared to the earlier year, and green indicating a lower elevation (erosion). Gray indicates a net zero change. Contours are one-foot intervals and are in feet, north is rotated 48 degrees clockwise, indicated by the arrows at the bottom left of the Figures. In these Figures, the white line represents the ELJ location, and the two gray lines represent the break point between two different data sources (the total station bank survey and the Zego boat bathymetry). Notice that most of the largest differences between surfaces occur at the break point between surveys – for the most part, these locations should be ignored, as the surveys (especially the total station of the bank) rarely have overlapping points and the triangulation and connection of the bank survey to the bathymetric points can yield some large differences year to year. This is simply a source data fault. A large loss of material is evident between 2020-2021, which is simply due to the fact that the ELJ was installed by cutting back into the streambank. Interestingly, it might be noticed that the comparisons of 2020-2021 and 2021-2022 are almost inverted. Comparing 2020-2022, the image evens out more showing some aggradation and erosion but not in the inverted fashion of the year-to-year comparisons. This could be in part due to: construction in 2021 altering sediment transport (the floating silt fence was still in place during the 2021 bathymetric survey) with a more natural regime establishing in 2022 after the floating sit fence was removed; natural or seasonal/hydrologic variations in sediment transport; and/or the seasonal operations of the dam.

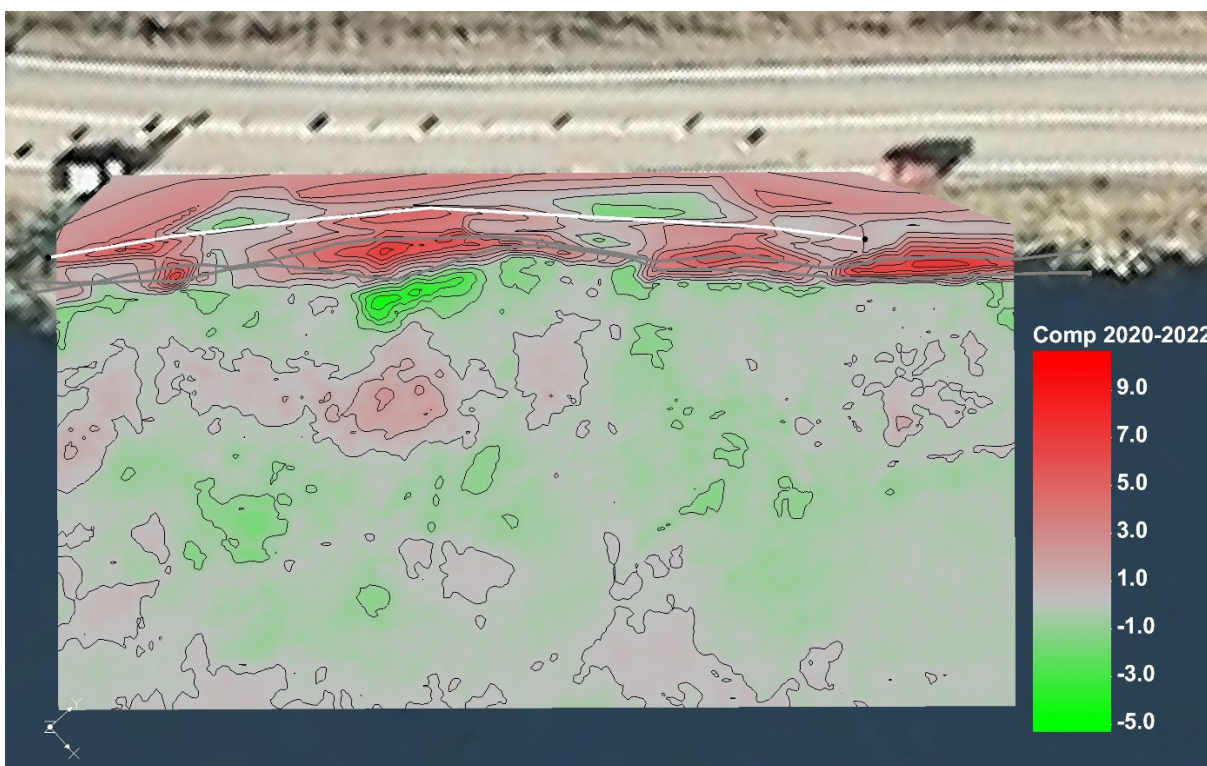
Figure 12. Surface elevation comparison from 2020 to 2022 Red means deposition from 2020 to 2022, Green is erosion. Values are in feet.

An interesting observation from the 2020 to 2022 comparison is away from the ELJ in the river. Approximately 40 feet away from the ELJ, there is an almost continuous parallel line of erosion under the water.

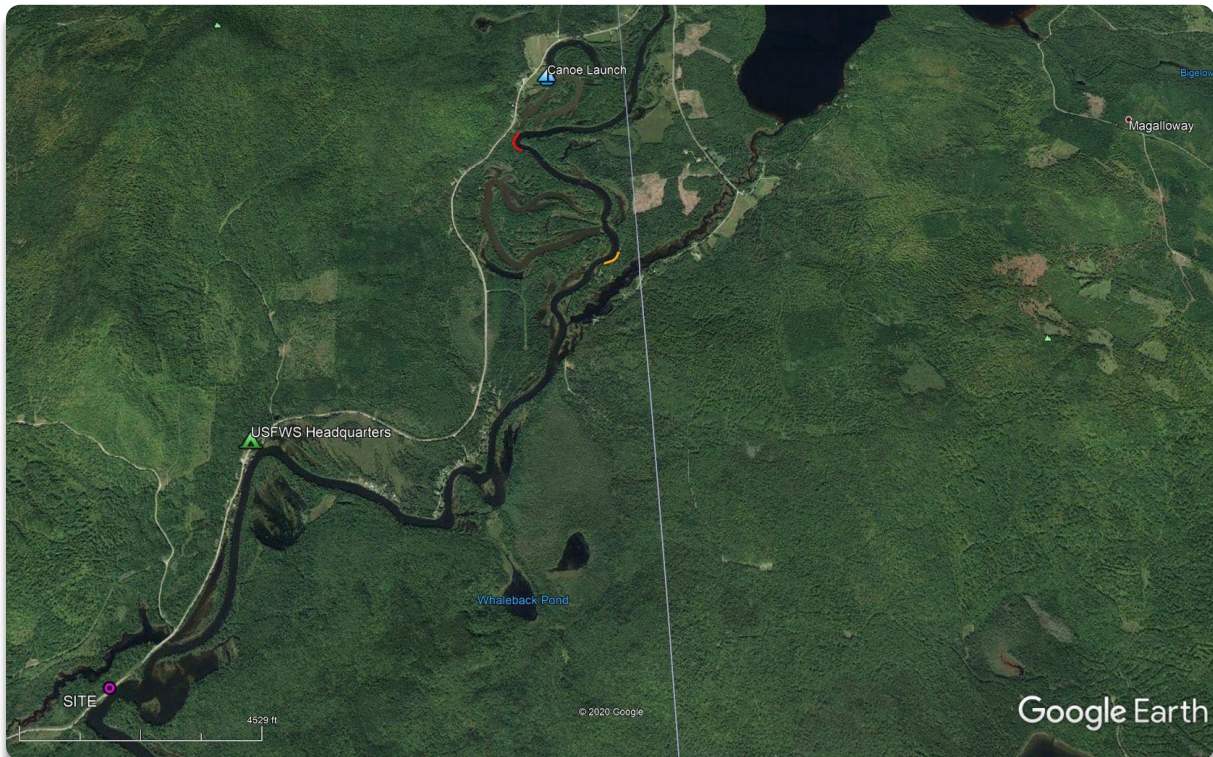
Figure 13. Reference streambank erosion sites (red = Campground, Orange = State Line)

In 2019, personnel with USFWS assisted in the selection of reference streambanks where erosion was evident, and which could be compared to the ELJ site and how erosion proceeded at those sites after it was arrested at the ELJ site. Two sites upstream from the ELJ were selected (Figure 13). The first site was close to a campground site and referred to as the Campground site (Figure 14). The second site was just on the New Hampshire side of the Maine-New Hampshire border and referred to as the State Line site (Figure 16). The Campground site did not have as extreme a bank height as the ELJ, however was on a very tight meander bend like the ELJ. Unvegetated, failed banks and fallen trees bore witness to erosion there. The State Line site was not on a tight meander bend but has a bank height greater than the ELJ. The State Line site demonstrated excessive erosion evidenced by undercut, unvegetated, steep banks and fallen trees.

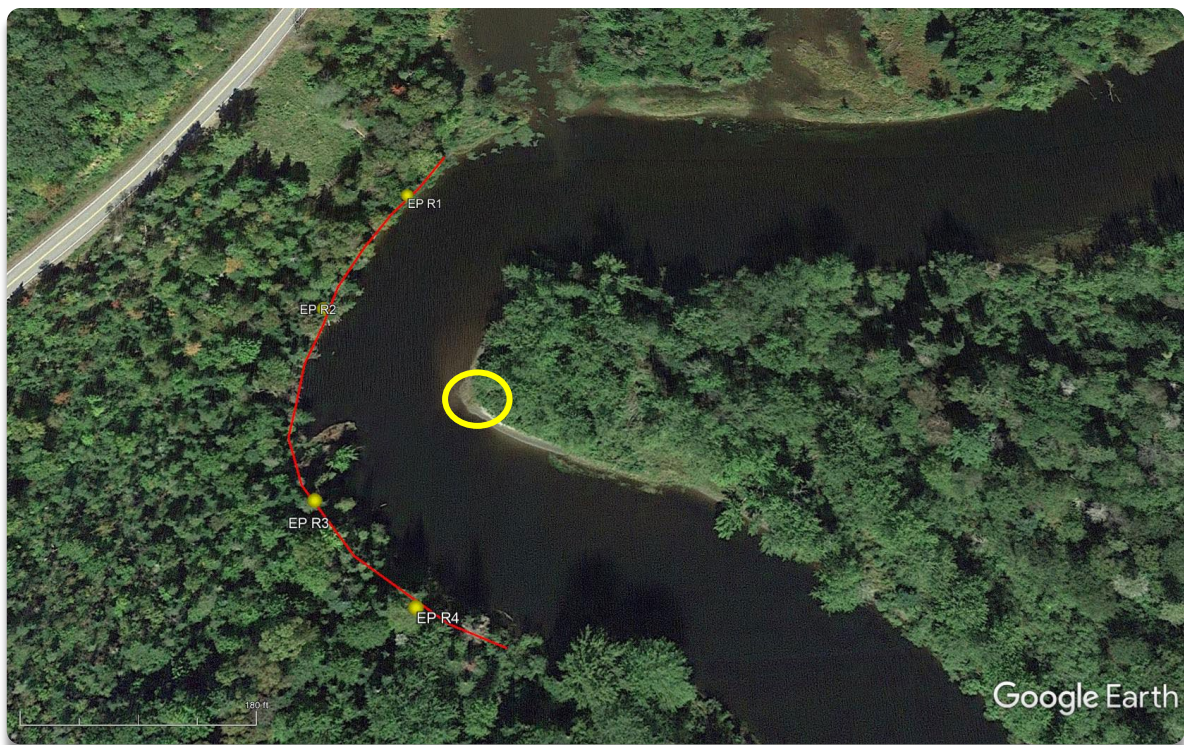
Figure 14. Campground streambank reference site. Yellow circle is location of bar sediment samples

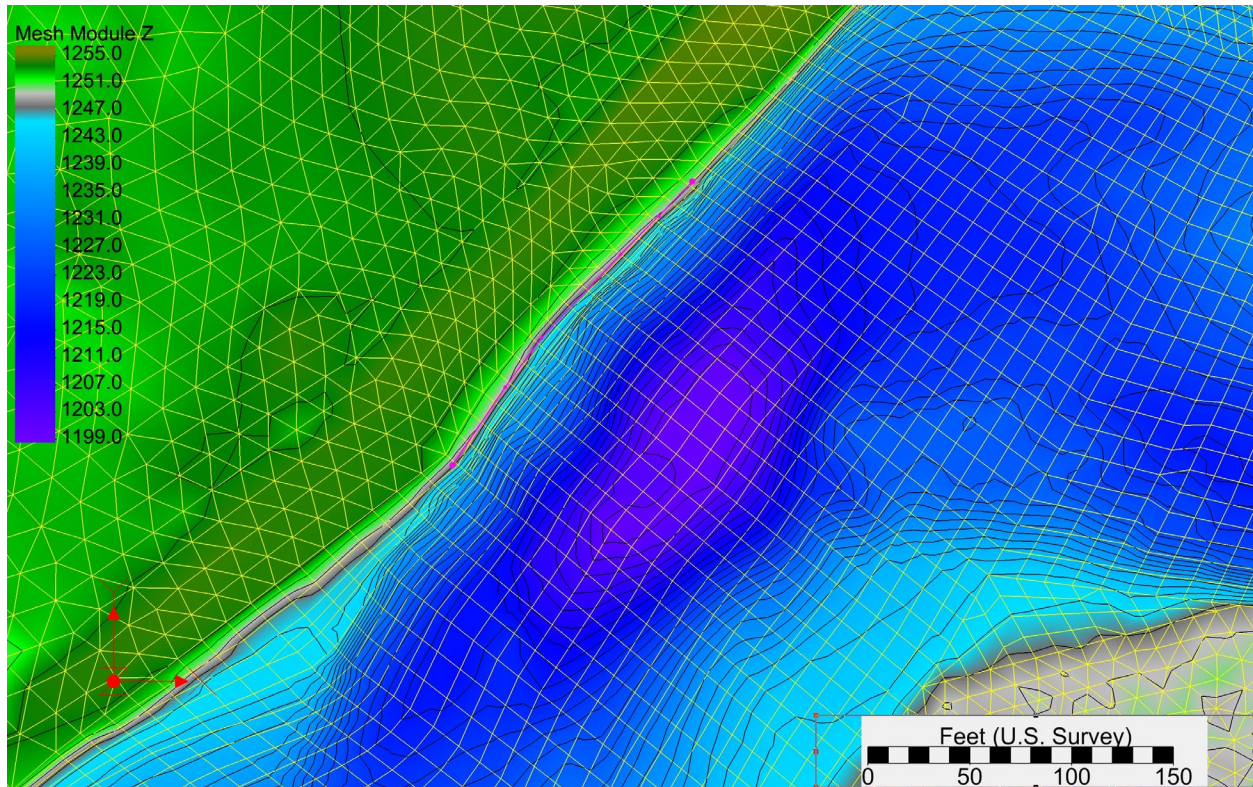
Figure 24 – Model terrain (for 2022 conditions) and mesh elements (for both models). Legend elevations are in feet NAVD88.

Discrete elements (calculation locations) for the model were made using polygons containing boundary lines with defined vertices. The boundary lines follow important and/or notable topography and enclose individual polygons, and vertex spacing defines element size within each polygon. Within the channel, elements are primarily quadrilaterals, which improve modeling accuracy and generally align with the direction of flow. Floodplains and connected oxbows consist of triangular elements which are better for locations where flow direction is variable and/or unknown. For the area surrounding the project site, elements are shown in Figure 24 in yellow lines, overlaying the topography. Topography is displayed with 2-ft interval black contour lines and continuously color-filled as defined by the legend, with the shading indicative of elevation relative to the average WSEL, 1245'. The constructed ELJ is represented by the magenta line near the center of the image, and the scale shown at the bottom-right corner. Elements remained the same between the two models so comparisons could be directly made.

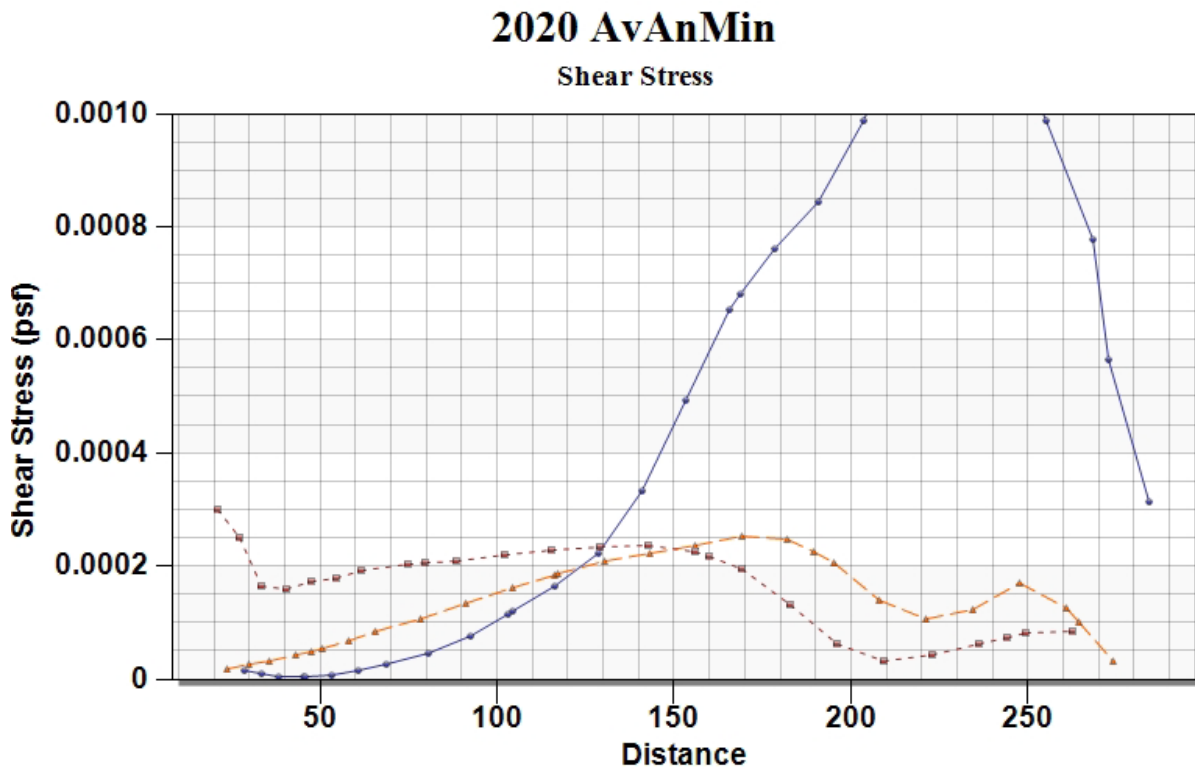
Figure 26. Bed shear stress for transects in Figure 25.

Looking at the pre-construction site in Figures 25, 26, 27, and 28, the first scenario (Figures 25 and 26) is a low flow at a low water surface elevation and the second scenario (Figures 27 and 28) a very high flow and a high-water surface elevation. In the first scenario, streambank particles are stable, and in the second the particles are mobile. These two scenarios bracket the range of sediment stability conditions over a normal year.

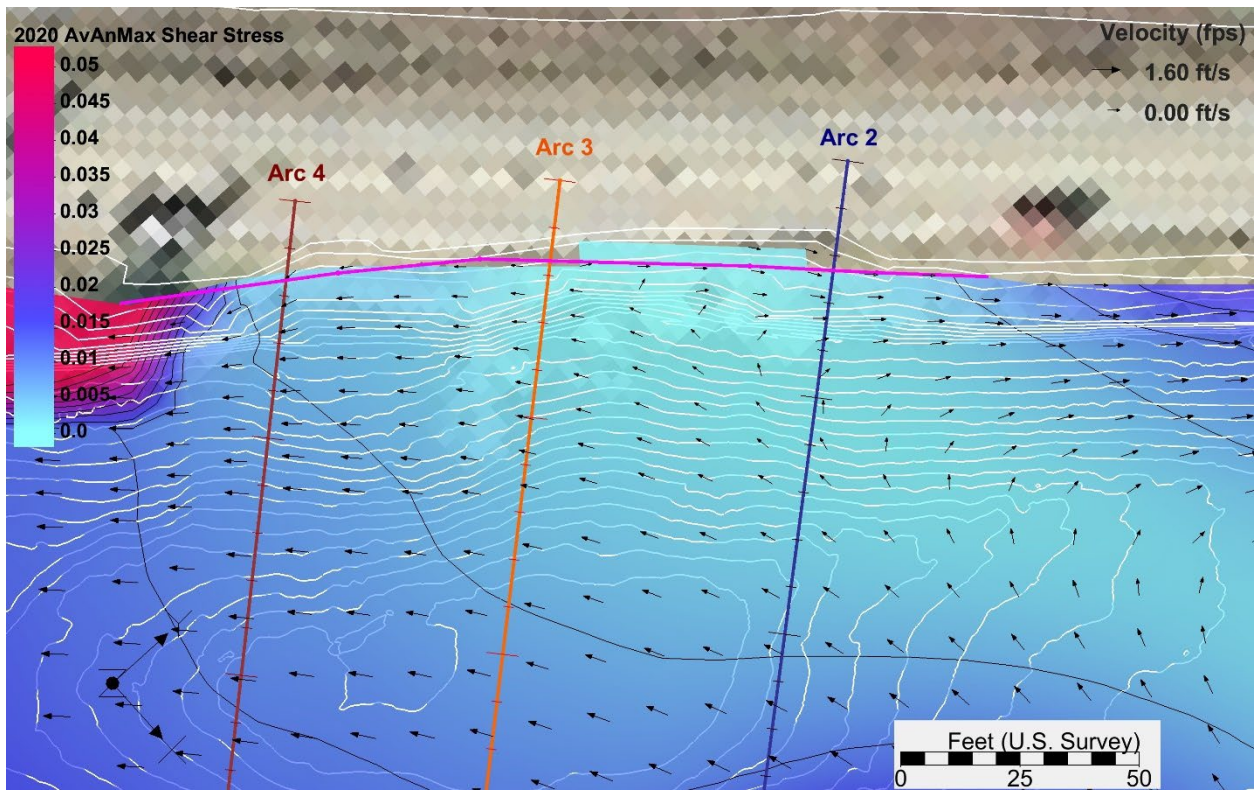
Figure 27. Pre-construction bank shear stress for the AvAnMin scenario. See Table 3 for the flow and water stage information. Coloration legend is shear stress (psf)

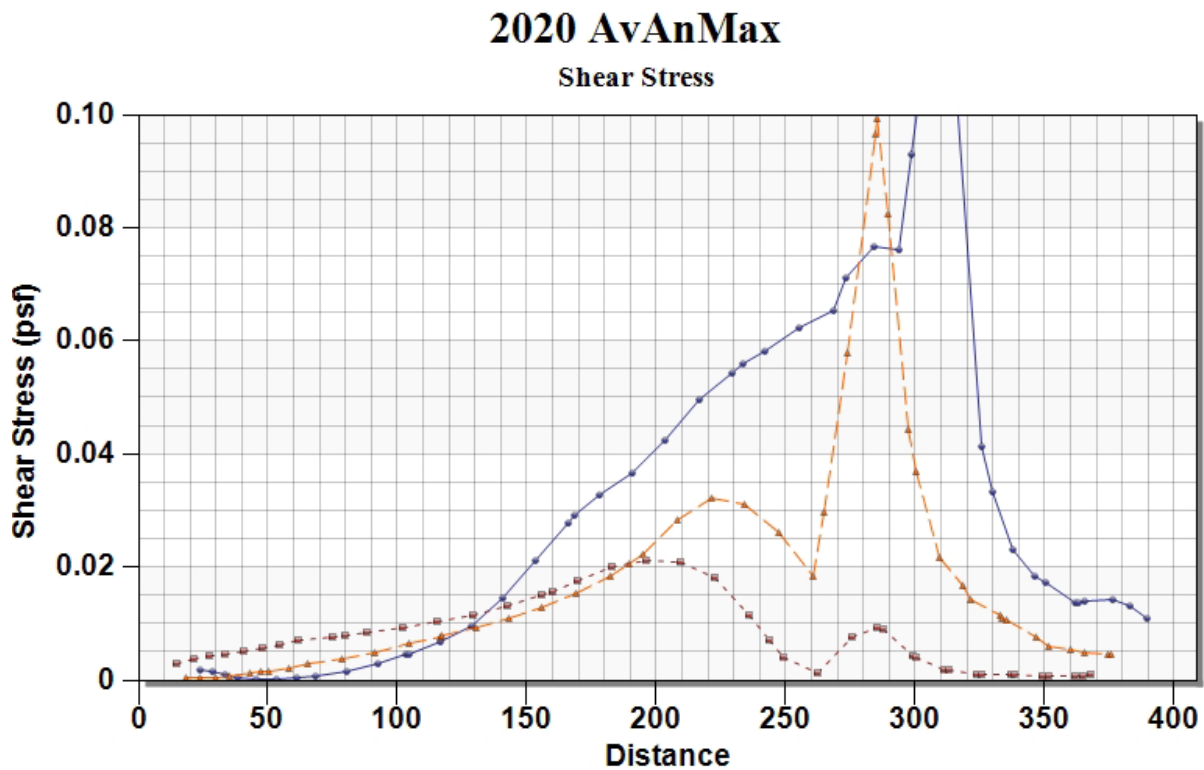
Figure 28. Bed shear stress for transects in Figure 27.

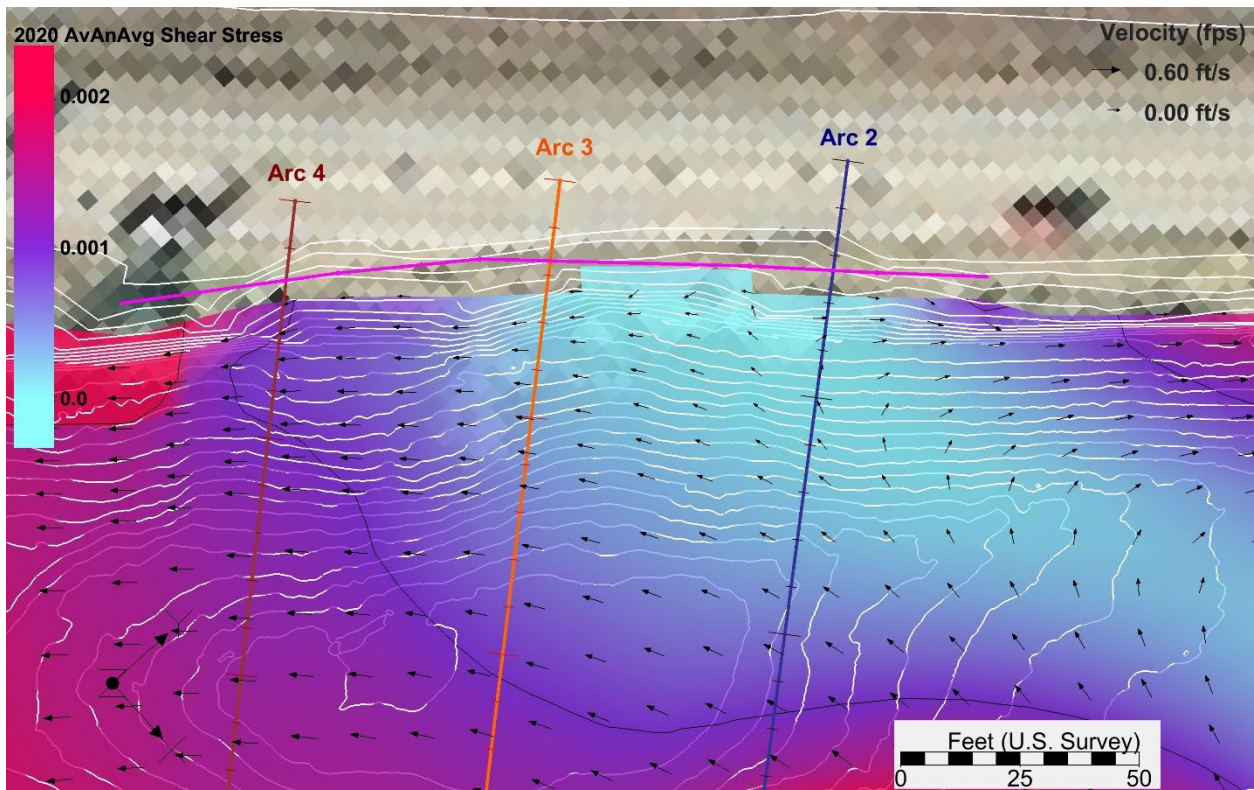
Figure 29. Pre-construction bank shear stress for the AvAnAvg scenario. See Table 3 for the flow and water stage information. Coloration legend is shear stress (psf)

In Figures 29 to 32, low water surface elevation and high flow (Figures 31 and 32) result in smaller cross-sectional area and therefore higher velocities and near bank shear stress compared to higher water surface elevation and lower flow.

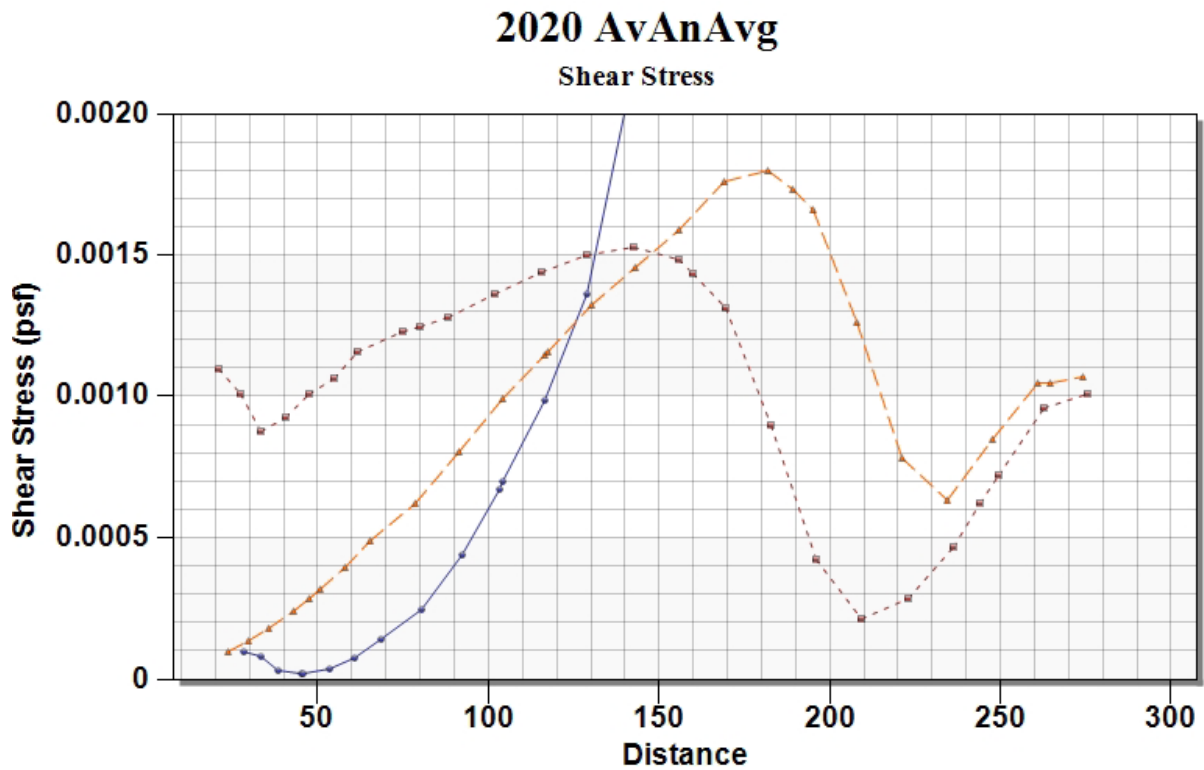
Figure 30. Bed shear stress for transects in Figure 29.

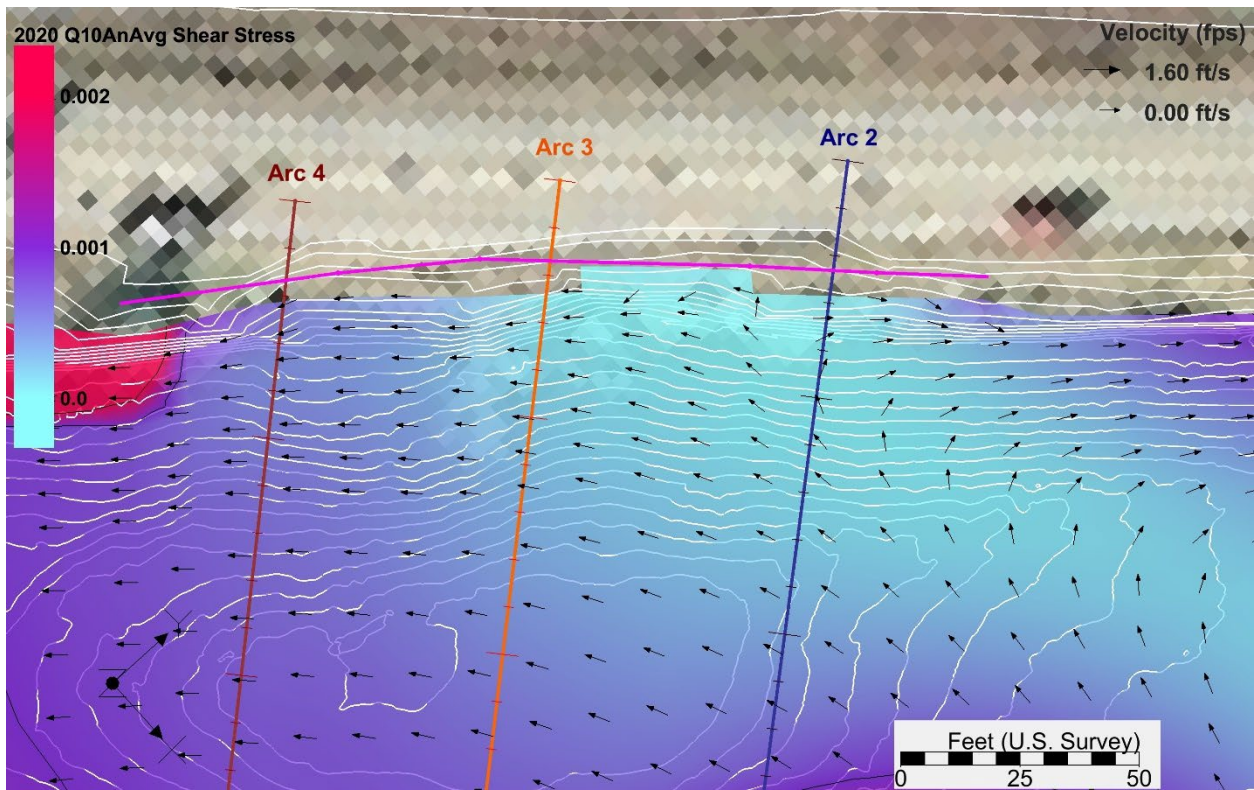
Figure 31. Pre-construction bank shear stress for the Q10AnAvg scenario. See Table 3 for the flow and water stage information. Coloration legend is shear stress (psf)

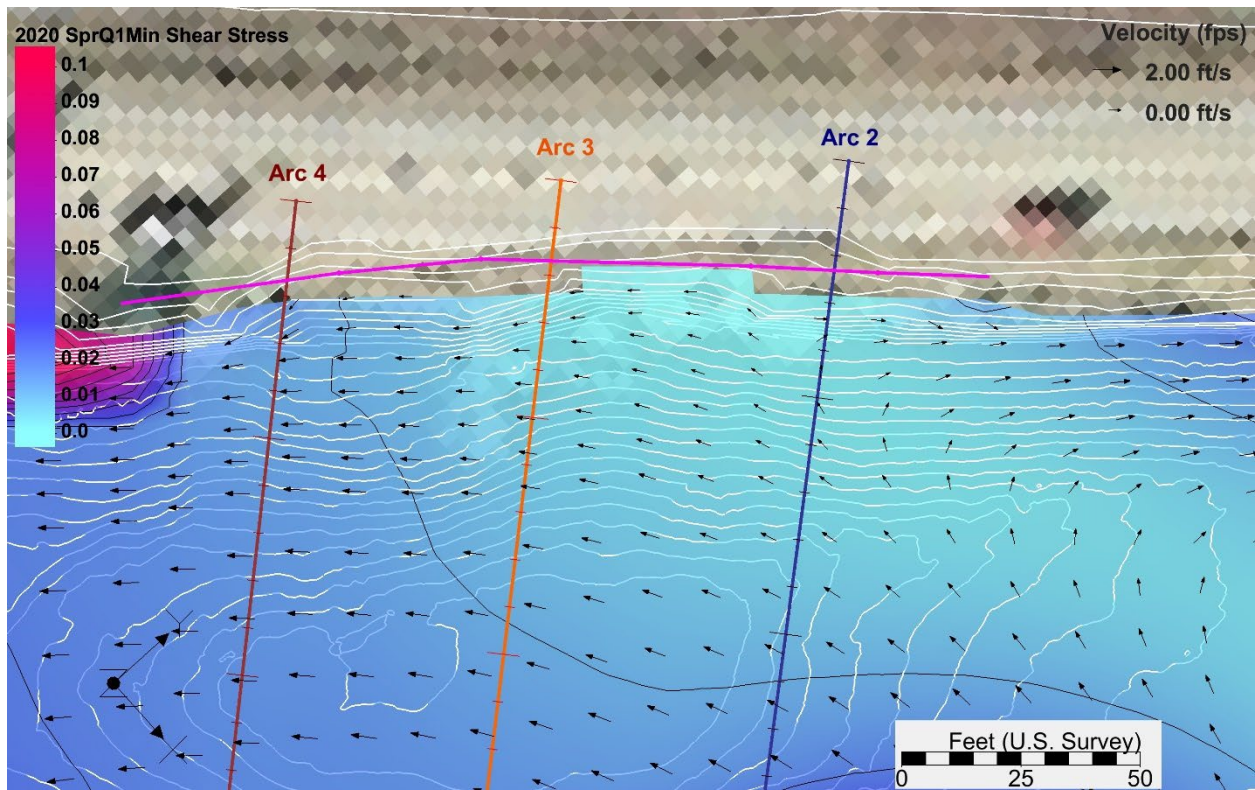
Figure 33. Pre-construction bank shear stress for the SprQ1Min scenario. See Table 3 for the flow and water stage information. Coloration legend is shear stress (psf)

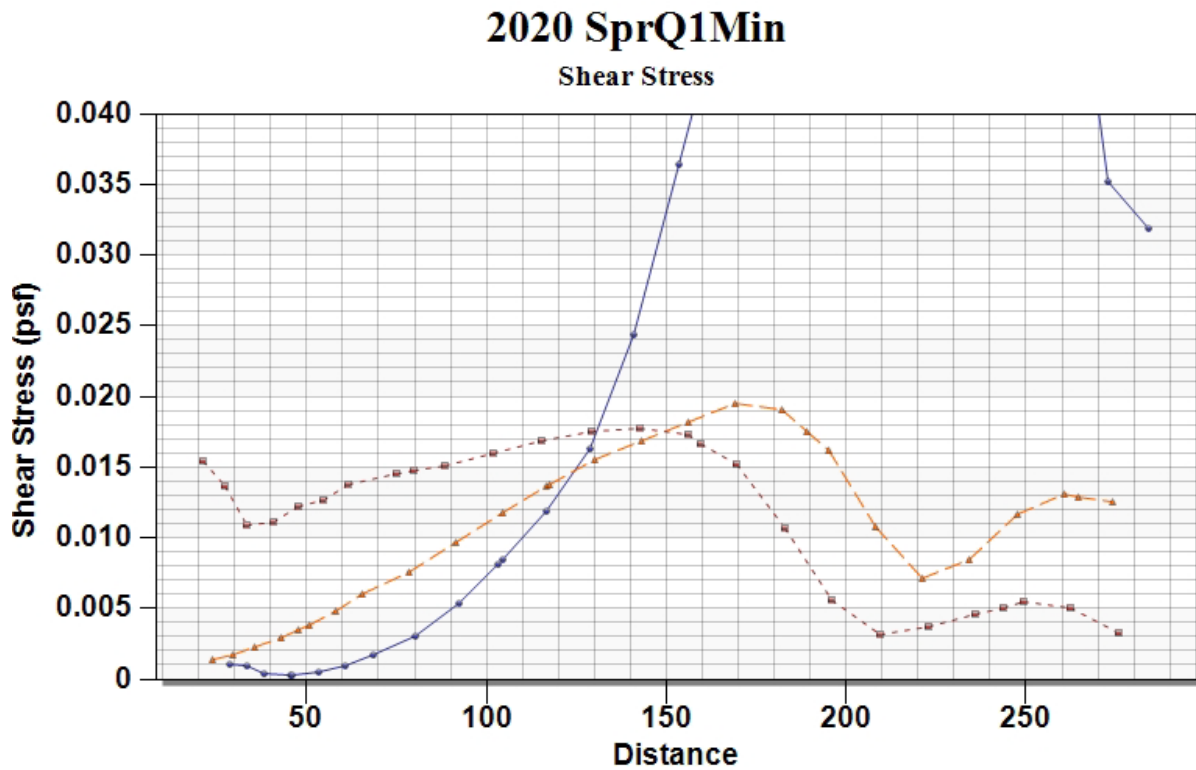
Figure 34. Bed shear stress for transects in Figure 33.

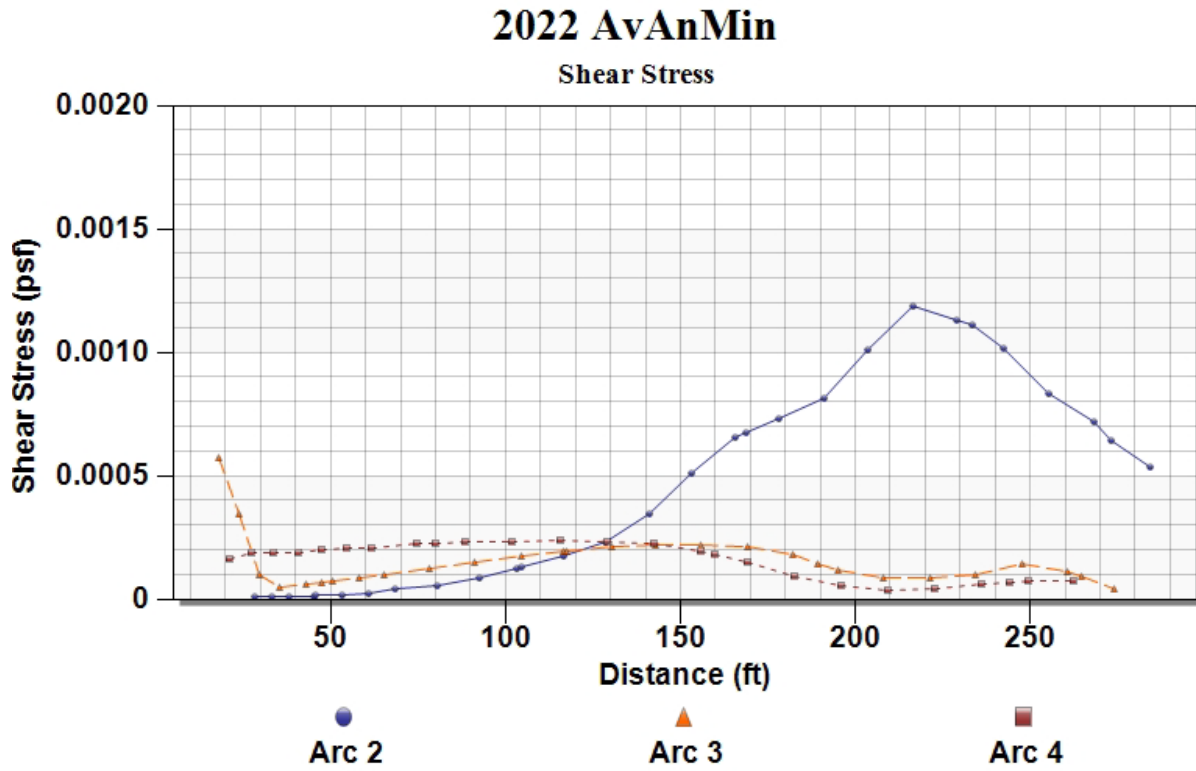
Figure 36. Bed shear stress for transects in Figure 35.

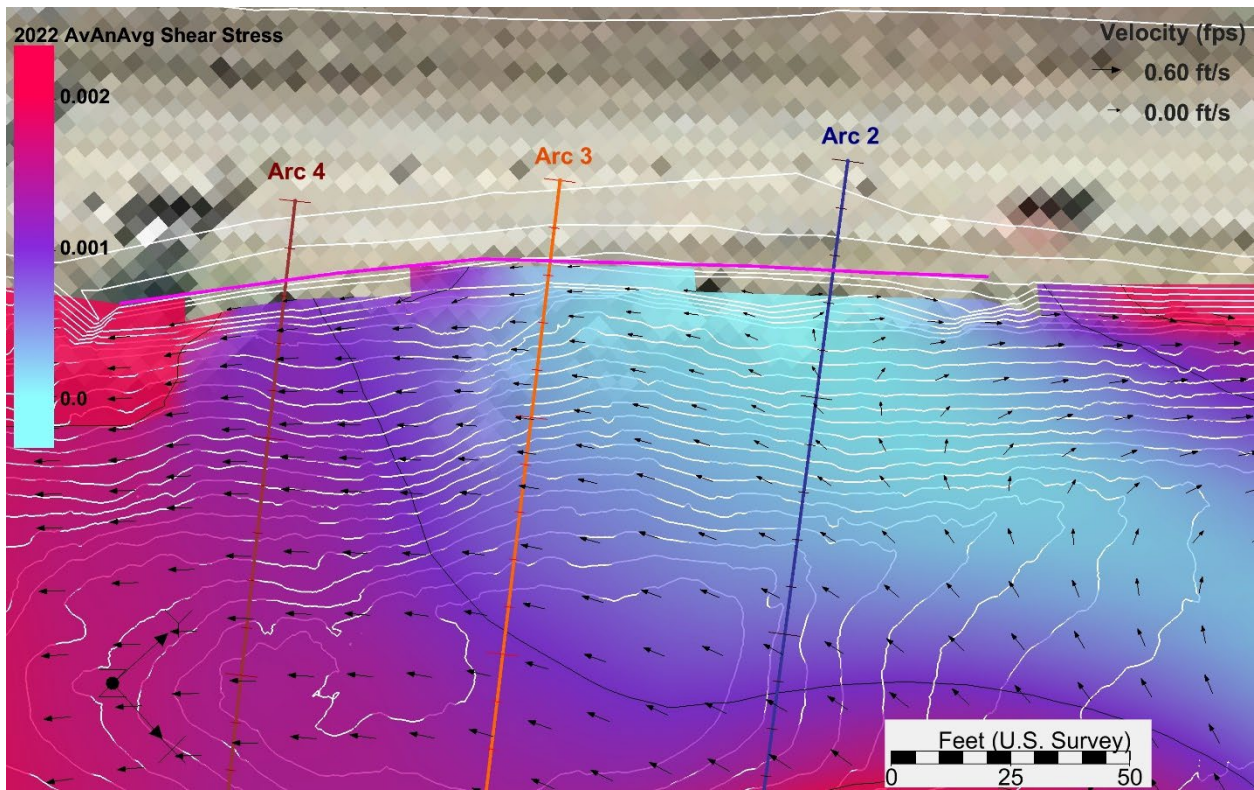
Figure 39. Post-construction bank shear stress for the AvAnAvg scenario. See Table 3 for the flow and water stage information. Coloration legend is shear stress (psf)

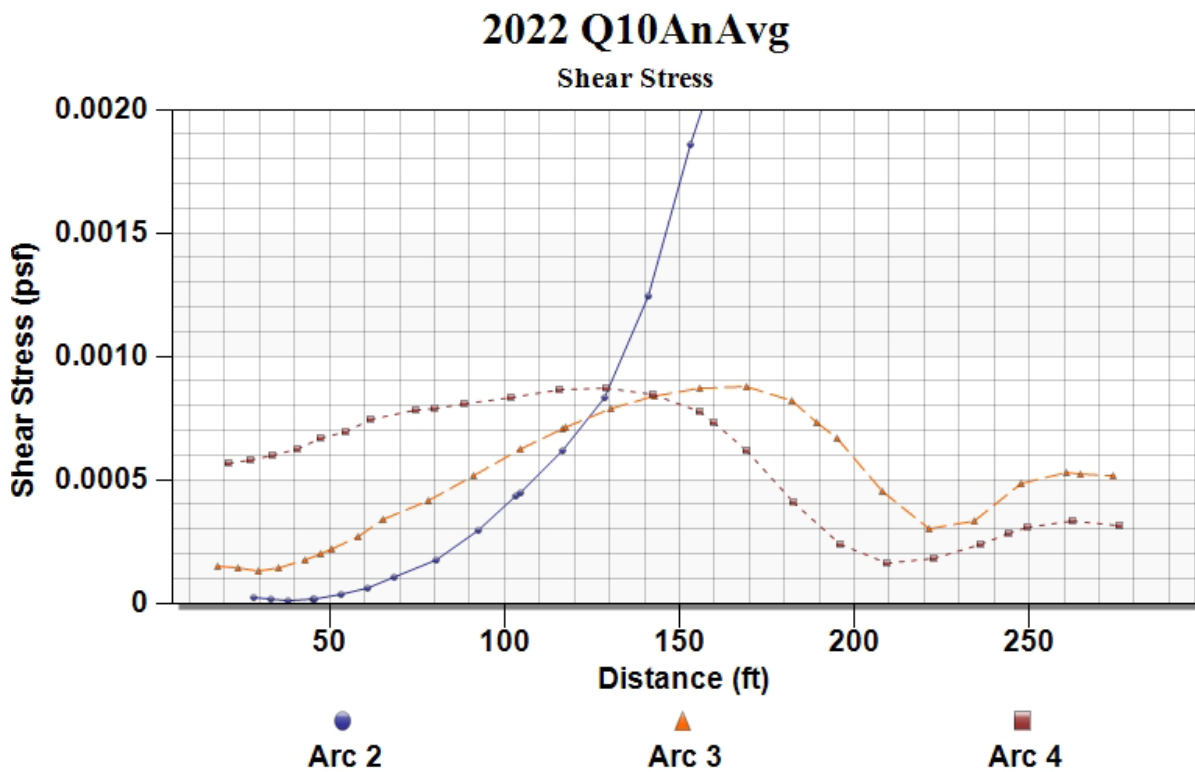
Figure 42. Bed shear stress for transects in Figure 41.

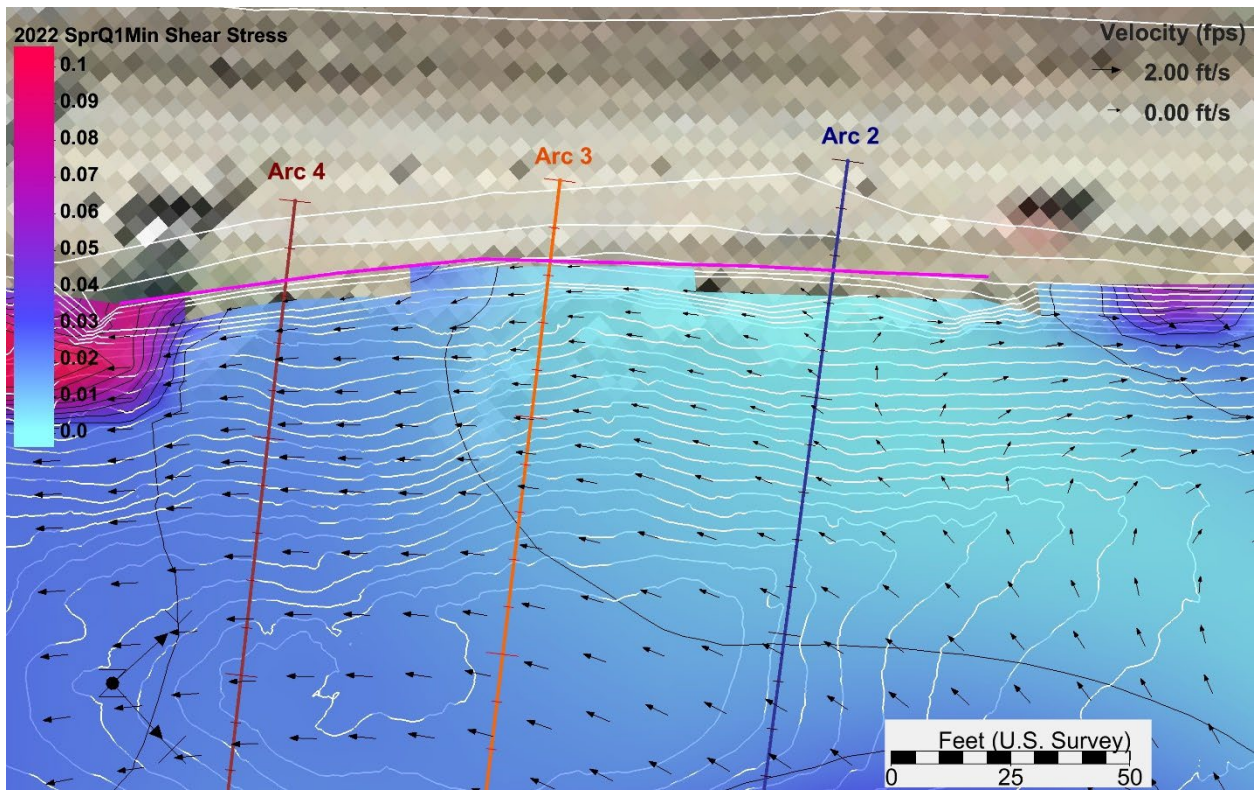
Figure 43. Post-construction bank shear stress for the SprQ1Min scenario. See Table 3 for the flow and water stage information. Coloration legend is shear stress (psf)

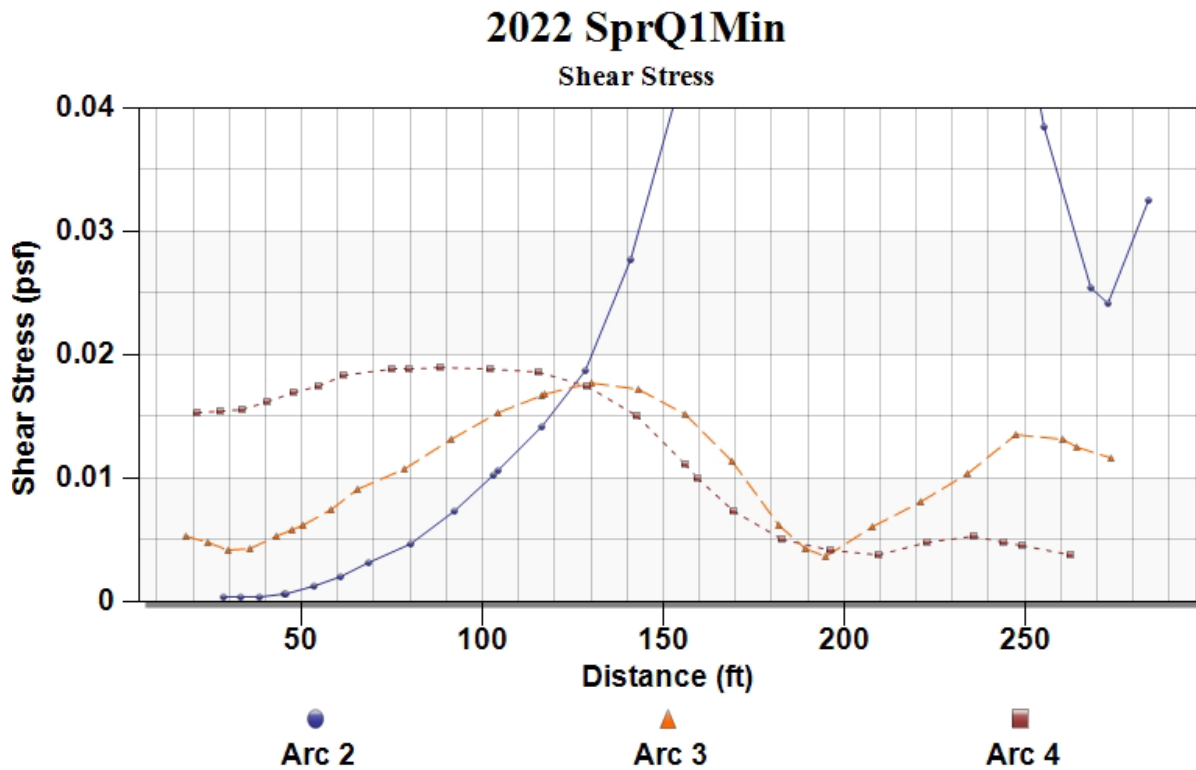
Figure 44. Bed shear stress for transects in Figure 43.

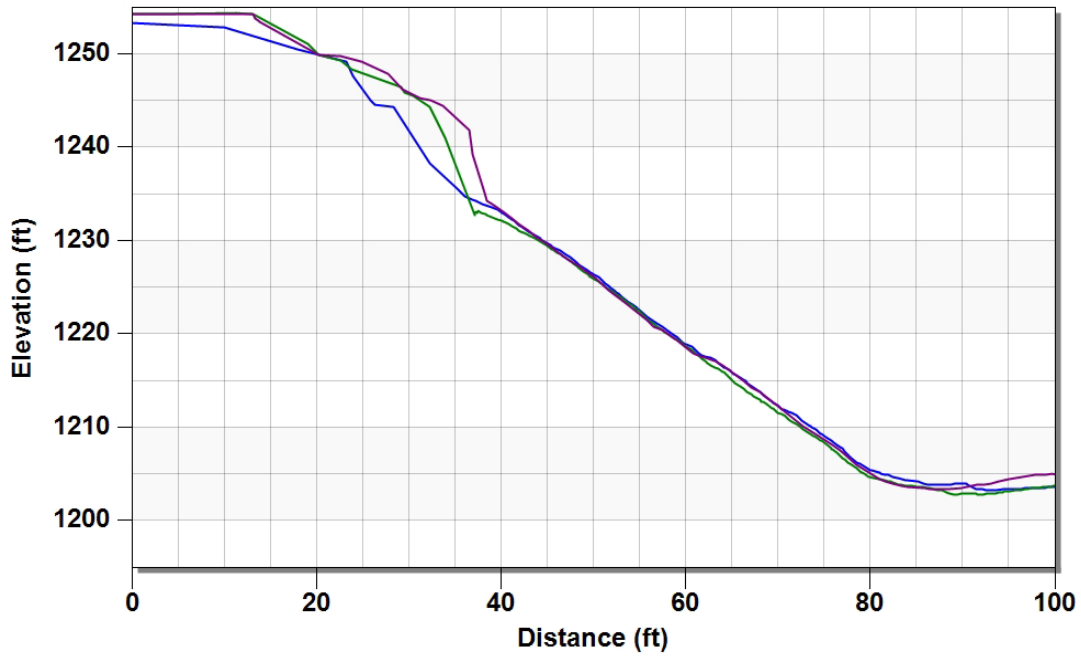
### Arc 2 Bank Elevation Comparison

Figure 48. Time series of Arc 2 slope. BLUE colored line is 2022 elevation, the GREEN colored line is 2020, and the PURPLE colored line is 2019. ELJ is at Distance 23.25 ft to 26.25 ft
