**Engineered Log Jam Monitoring along  
NH Route 16 in Errol, New Hampshire**

**Final Report**

Prepared by University of New Hampshire Department of Civil and Environmental Engineering, College of Engineering and Physical Sciences, in cooperation with the U.S. Department of Transportation, Federal Highway Administration

1. Report No. FHWA-NH-RD-26962W		2. Gov. Accession No.	3. Recipient's Catalog No.
4. Title and Subtitle Engineered Log Jam Monitoring along NH Route 16 in Errol, New Hampshire		5. Report Date March 2023

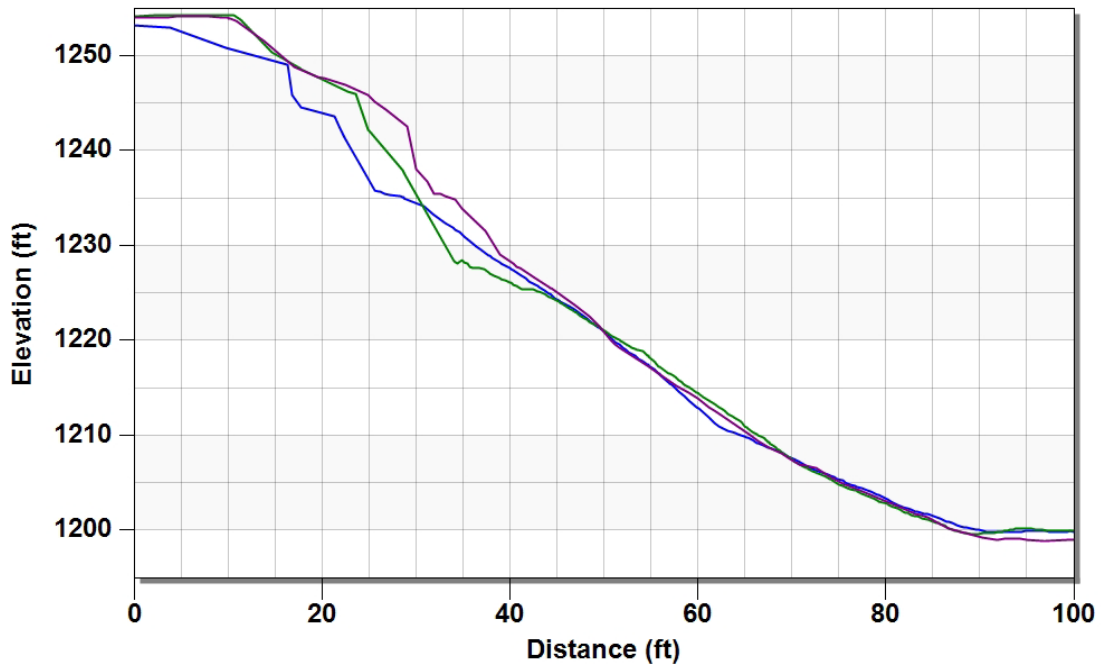
### Arc 3 Bank Elevation Comparison

Figure 49. Time series of Arc 3 slope. BLUE colored line is 2022 elevation, the GREEN colored line is 2020, and the PURPLE colored line is 2019. ELJ is at Distance 16.25 ft to 18.25 ft.

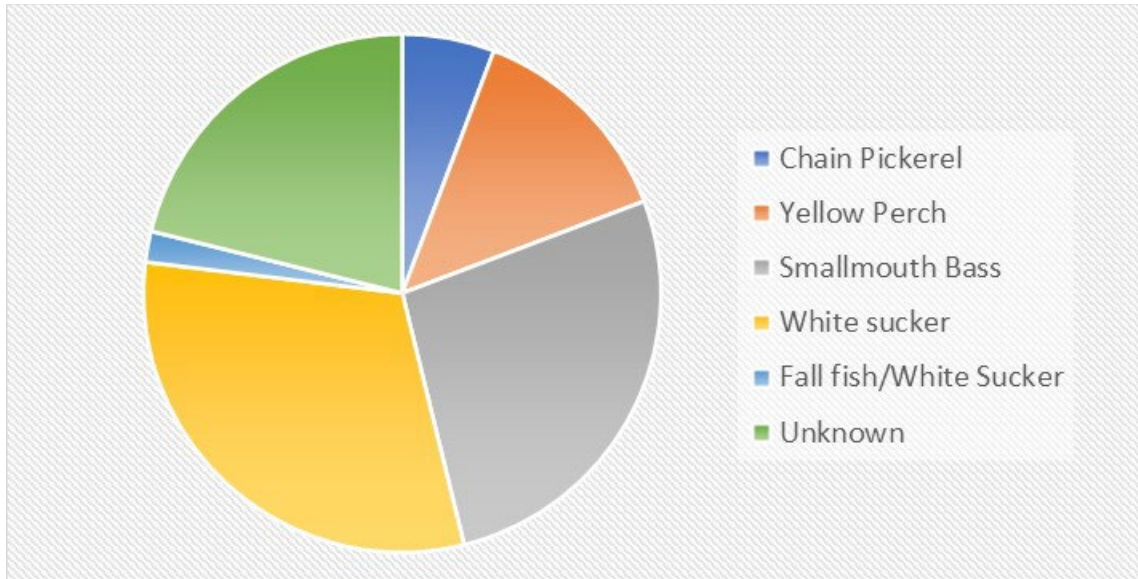
Figure 49. 2020 Observed fish results (n = 52)

ten hours. and shot continuous videos. The videos were then downloaded, and any fish caught in the videos had a still image cropped from the video. The fish in still images were then identified with the aid of USFWS and NHF&G personnel. In general during the pre-construction periods, water clarity was on the order of ten feet for the Go Pros. Prior to construction, dozens of fish were caught on the videos and included: chain pickerel, yellow perch, smallmouth bass, white sucker, and fall fish (Figure 49). During the lone post construction video deployment, the water clarity was poor, with visibility less than one foot. Four perch were detected on the post construction videos.
