Stabilized Full Depth Reclamation (SFDR)

Evaluation of Two Products:

Base One[®]
Engineered Emulsion

Report 2022-06

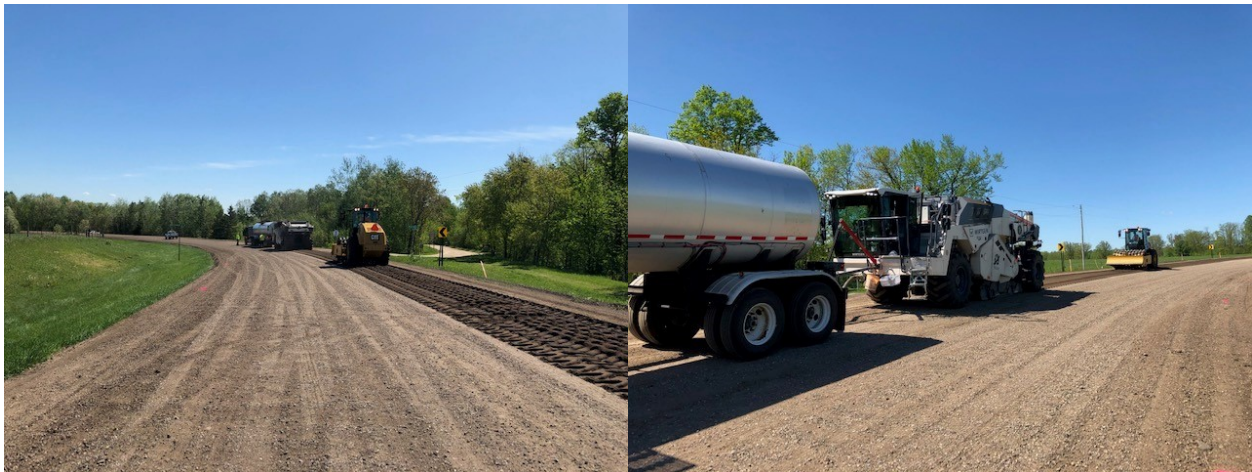
A pavement engineer from Braun Intertec Corporation visited the project on June 28, 2020. Figure 2-1 documents the SFDR construction on Beltrami CSAH 4.

Figure 2-1 SFDR Construction on Beltrami CSAH 4.

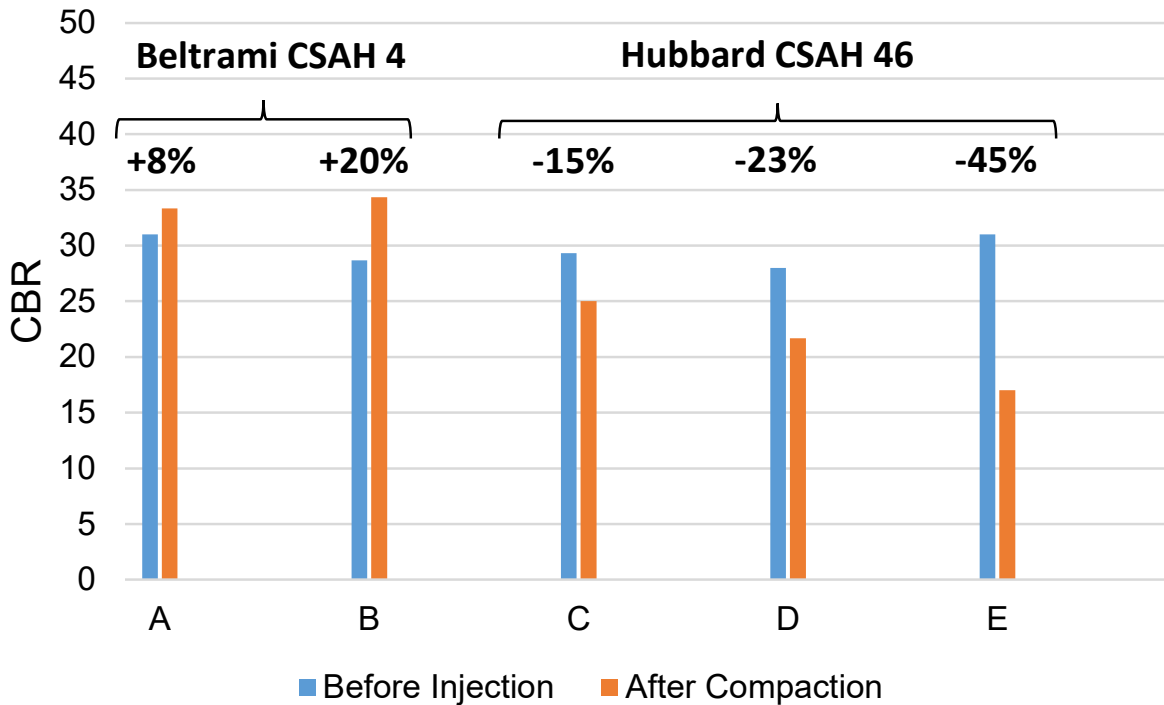
Figure 3-2 compares before injection and after compaction DCP results. As this graph shows, after compaction CBR slightly increases on Beltrami CSAH 4 by 8% and 20% which could be related to the short-term stiffening effect of the engineered emulsion. On the contrary, Hubbard CSAH 46 CBR shows a decrease in CBR value which was unexpected and not consistent with another LRRB report: [MN/RC 2018-33 \[1\]](#). Without additional testing/analysis, there is no way to know why the values decreased; one possible explanation is that the DCP tests were done within 2-days of the injection which may have added additional moisture to the pavement leaving little time for the additional moisture to dissipate.

Figure 3-2 CBR Values for Beltrami CSAH 4 and Hubbard CSAH 46

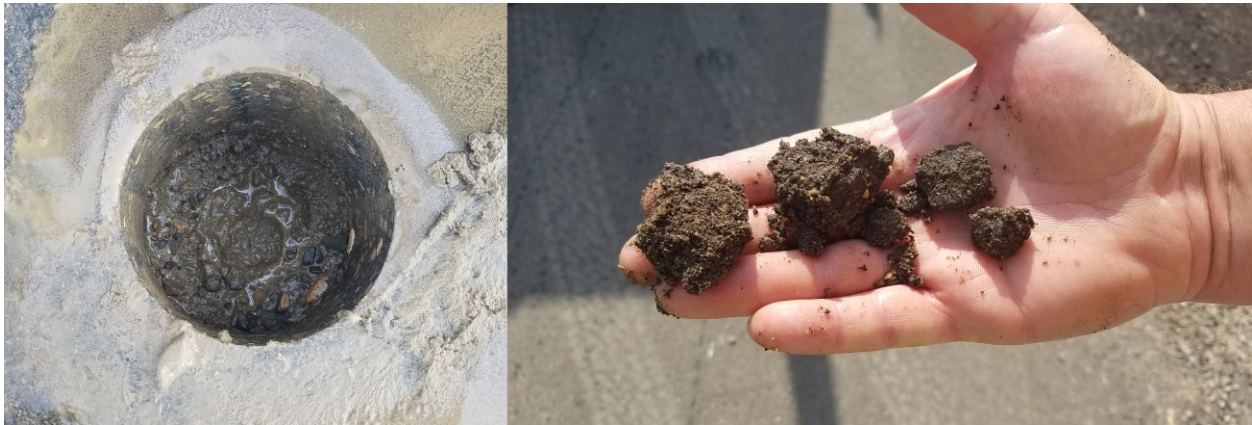
On both Hubbard CSAH 8 and Hubbard CSAH 46 which were injected with BASE ONE®, no intact core could be recovered from the SFDR layer; the material below the HMA overlay was not a bound layer. Figure 3-4 shows C-4 coring location from the BASE ONE® section along with the material retrieved from the core hole.

Figure 3-4 Core Hole and Material Obtained from BASE ONE® Section (Hubbard CSAH 46) at C-4.

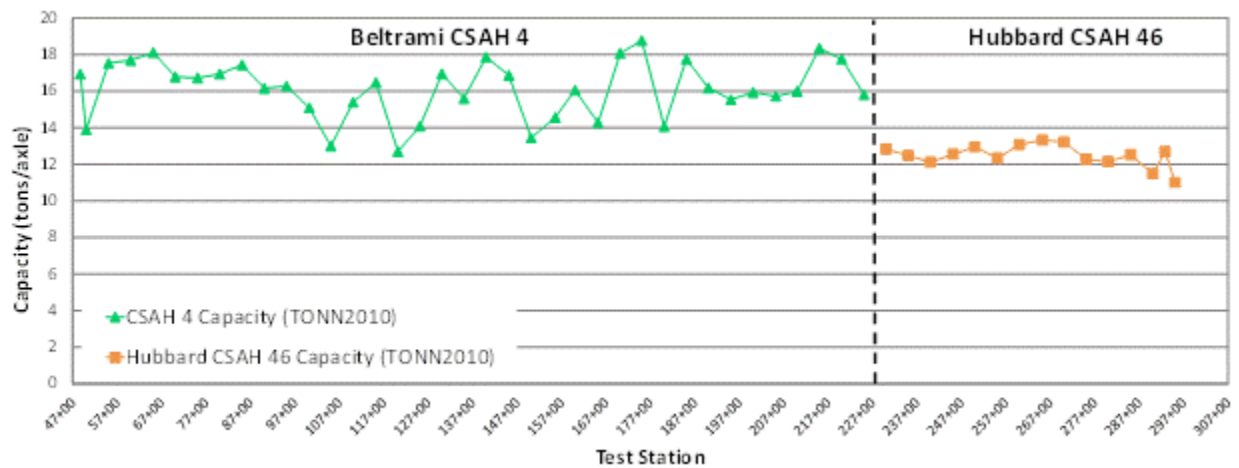
FWD data analysis was done by Braun Intertec using the TONN2010 program; for more detailed explanation of TONN2010 see [Appendix A](#) of this report. The TONN2010 capacity (tons/axle) was calculated at each testing location. Figure 3-8 presents the roadways capacities for Beltrami CSAH 4 and Hubbard CSAH 46. The 15th percentile (or “effective”) values are also compared in Table 3.4. Using the 15th percentile value is on the conservative side, as only 15 percent of the data points have lower R-values than this value.

As shown, the effective capacities exceeded the design capacity of 10-ton for both roadways. Beltrami CSAH 4 has a higher effective capacity than Hubbard CSAH 46.

Figure 3-8 Beltrami CSAH 4 and Hubbard CSAH 46 Capacities (2020)
