Best Practices for Historic Masonry Repair and Rehabilitation

Final Report VTRC 23-R10

FINAL REPORT
BEST PRACTICES FOR HISTORIC MASONRY REPAIR AND REHABILITATION

Virginia Transportation Research Council
(A partnership of the Virginia Department of Transportation
and the University of Virginia since 1948)

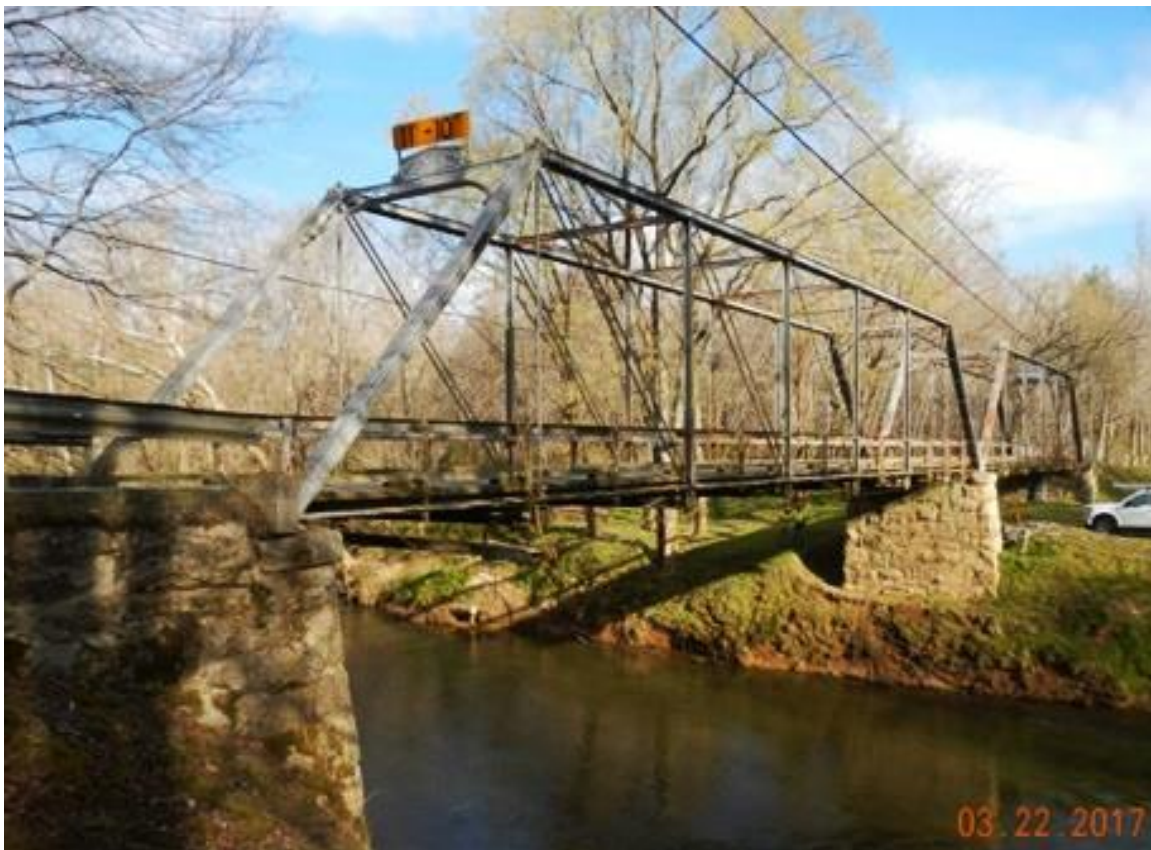
Figure 1. Stone Masonry Piers and Abutments Supporting an 1884 Truss Bridge (Brunswick County Structure No. 6104)

Typically, the earliest examples of stone abutments and piers supported wooden bridge elements (such as the floor beams and deck, and in some cases, wooden trusses). By the mid- to later 19th century, wooden trusses were being succeeded by combination (wood and metal) trusses and metal trusses. Stone masonry continued to be used for abutments and piers on truss bridges through the end of the 19th century and into the very early 20th century. In Virginia, examples are not uncommon, particularly on 19th century and early 20th century truss bridges and small beam bridges. Examples of stone masonry piers and abutments on two of Virginia's historic truss bridges (Brunswick County Structure No. 6104 and Alleghany County Structure No. 9007) are shown in Figures 1 and 2.

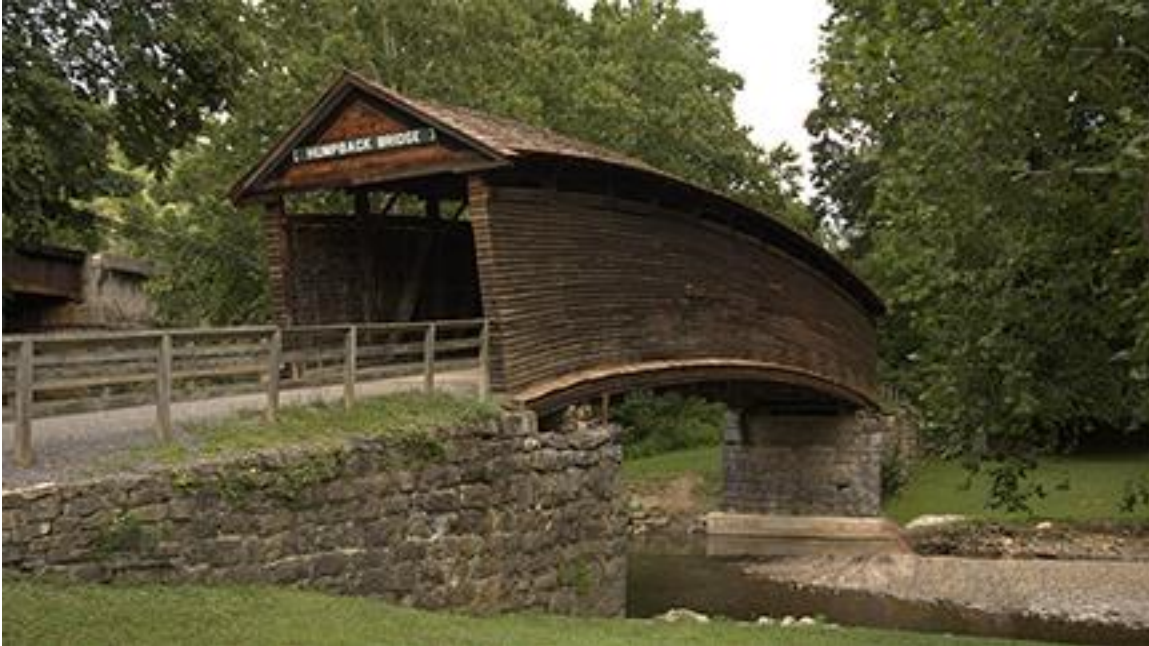
Figure 2. Stone Masonry Abutments and Stone Masonry Approaches on Humpback Bridge, 1857 (Alleghany County Structure No. 9007)

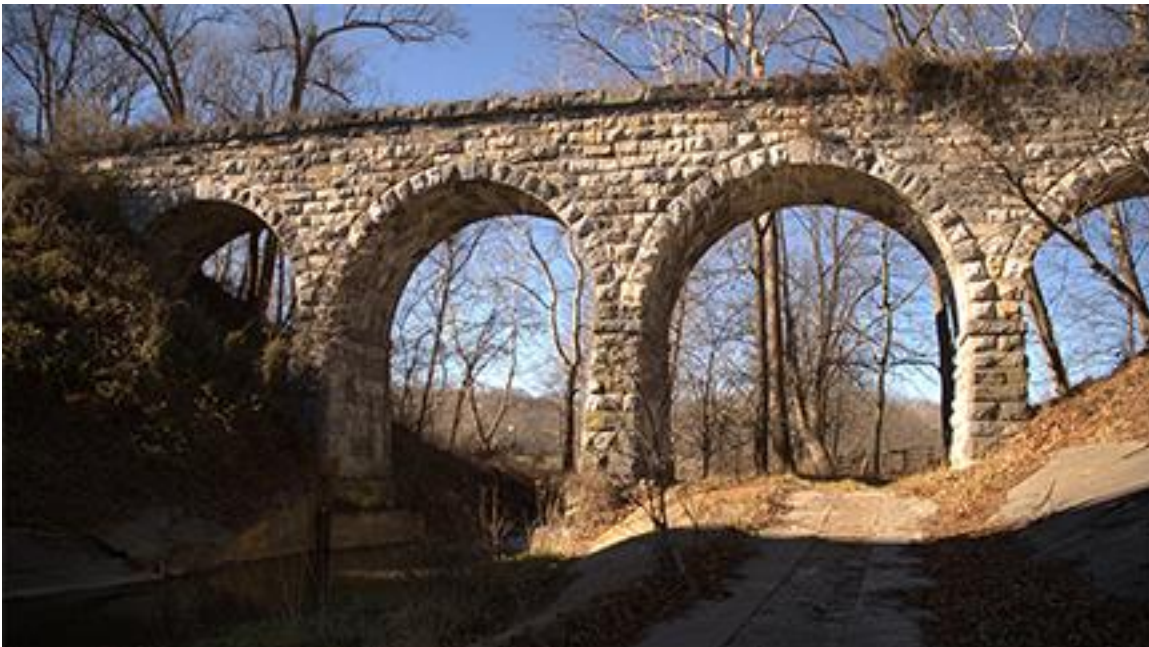
Figure 3. Stone Masonry Arch, Built as a Railroad Bridge, 1874 (Augusta County Structure No. 6997)

Six historic Virginia bridges in the management plan are of stone masonry arch construction: these variously were constructed by turnpike companies (the Southwest Turnpike Company bridge in Wythe County, the Falling Creek bridge in Chesterfield County, Loudoun County Structure No. 1025, and Loudoun County Structure No. 6088); canal companies (Nelson County Structure No. 6070); and railroads (the Valley Railroad bridge, Augusta County Structure No. 6997). All of the original builders were organizations that could marshal the funds, the engineering talent, the additional skilled craftsmen, and the materials needed to produce stone arch bridges. Three of these stone masonry arch bridges, i.e., Augusta County Structure No. 6997, Nelson County Structure No. 6070, and Loudoun County Structure No. 1025, are shown in Figures 3, 4, and 5, respectively.

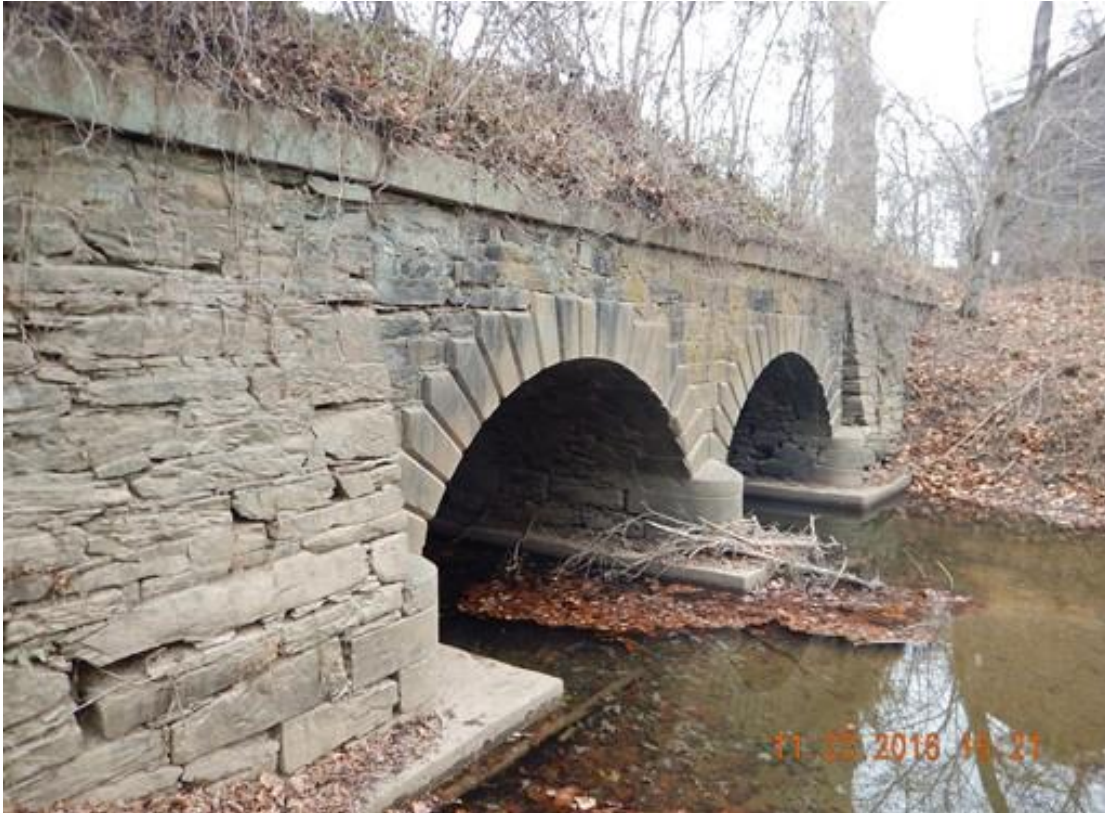
Figure 4. Stone Masonry Arch, Originally Built as a Canal Viaduct, 1835 (Nelson County Structure No. 6070). Note the particularly fine finishing of the voussoirs.

At the exterior of the arch ring, and forming the face of the arch at that point, are the wedge-shaped voussoirs that define the curve of the arch and rise to a central keystone. Treatment of the voussoirs can range from utilitarian (such as stone finished in the same manner as the rest of the masonry, as seen on the ca. 1850 Southwest Turnpike bridge in Wythe County) to decorative (such as the voussoirs made from a stone of contrasting color to that of the rest of the bridge on the old turnpike bridge carrying Rt. 50 at Aldie [Loudoun County Structure No. 1025] and the notable smooth, beautifully shaped voussoirs on the former James River and Kanawha Canal viaduct in Nelson County [Nelson County Structure No. 6070]).

Some older stone masonry arch bridges were repaired or enlarged with concrete in the 20th century. The Nelson County structure noted above exhibits one such enlargement: a concrete arched extension.

A notable example of issues caused by vegetation was seen in the late 1990s on the former James River and Kanawha Canal viaduct in Nelson County (Nelson County Structure No. 6070). Several large trees growing near and on the structure were impacting the stonework; these trees had to be removed before further damage was done. The large size of the trees necessitated greater effort for removal of the trees and repair of the structure than would have been necessary if the trees had been removed when small.

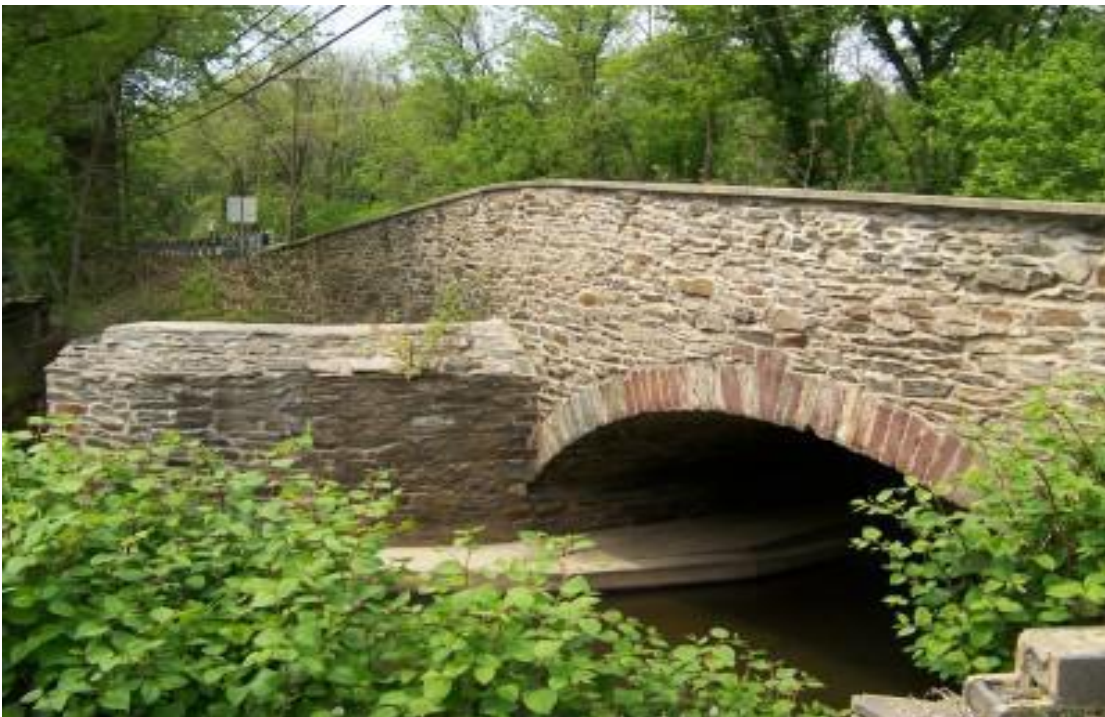
Figure 5. Stone Masonry Arch, Built as a Turnpike Bridge in the First Quarter of the 19th Century (Loudoun County Structure No. 1025). A contrasting color of stone was used in the voussoirs for decorative effect. Note the relatively flat arch that is seen in many stone masonry bridges of this era.

A grouted anchor process was used in 2001 on Loudoun County Structure No. 1025 (the Little River Turnpike bridge). An inspection had revealed that a portion of the bridge's wing wall and buttress required reconstruction due to severe deterioration of the mortar between the stones. Accordingly, portions of the wing wall and buttress were reconstructed, and the proprietary (Cintec) grouted anchor system was used to repair and strengthen the bridge. The system has worked well.

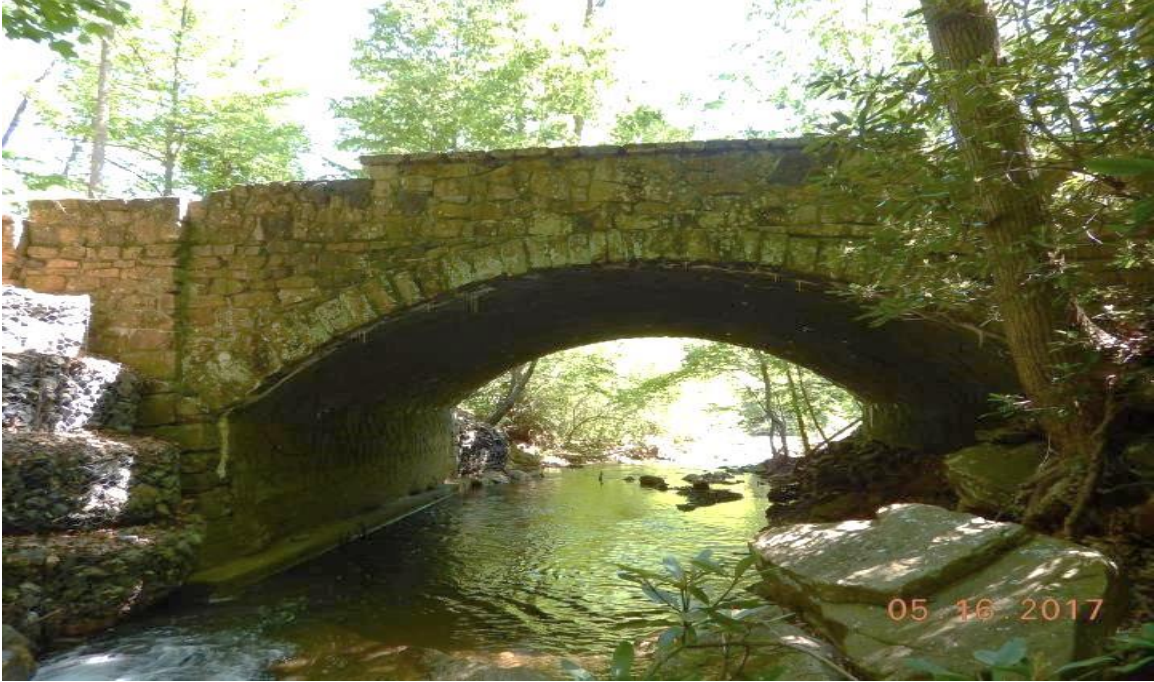
Figure 6. Stone Masonry Veneer on a Concrete Bridge in a Rustic Setting, 1940 (Rockbridge County Structure No. 1012)

Two of the bridges noted in this report (Rockbridge County Structure No. 1012 and Arlington County Structure No. 5020) are of concrete rigid frame construction with stone veneer and date to the 1940s (see Figures 6 and 7). Other structures, often not individually eligible for the National Register, are contributing structures to larger historic districts or to designated route categories such as scenic roads or parkways. Many of these structures, and their associated projects, were designed and built by the federal government in the second and third quarters of the 20th century. The structures were designed to blend aesthetically into and harmonize with the surroundings of historically or scenically significant areas and parks such as national military parks and battlefields. Examples include a sizable number of bridges along the Blue Ridge Parkway, with stone veneer over, variously, both rigid frame and concrete arch bridges. In such contemporary federal projects, Bureau of Public Roads engineers and National Park Service landscape architects worked together to produce structures that harmonized with the surrounding environments.

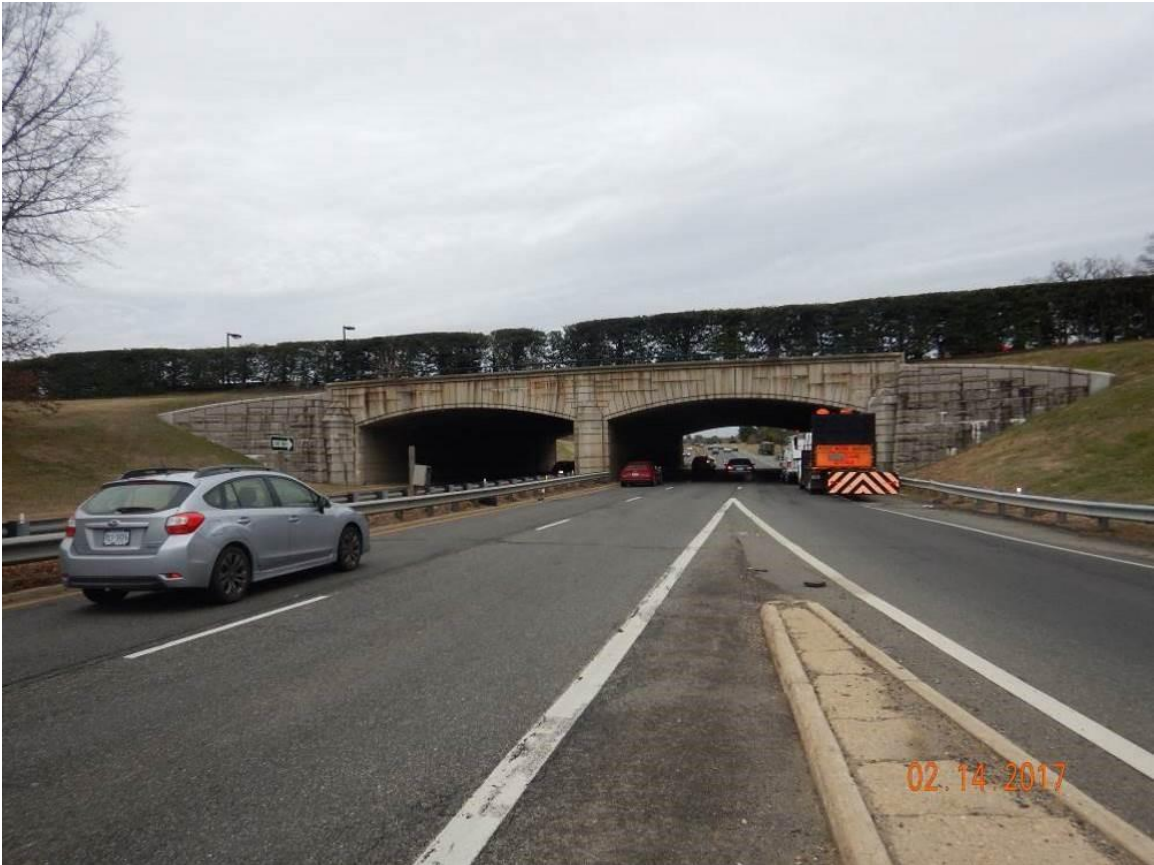
Figure 7. Stone Masonry Veneer on a Concrete Rigid Frame Bridge in an Urban Setting, 1945 (Arlington County Structure No. 5020)
