Assessment of Bridge Decks with Glass Fiber-Reinforced Polymer (GFRP) Reinforcement

MARCH 2023

Research Report

Final Report 2023-13

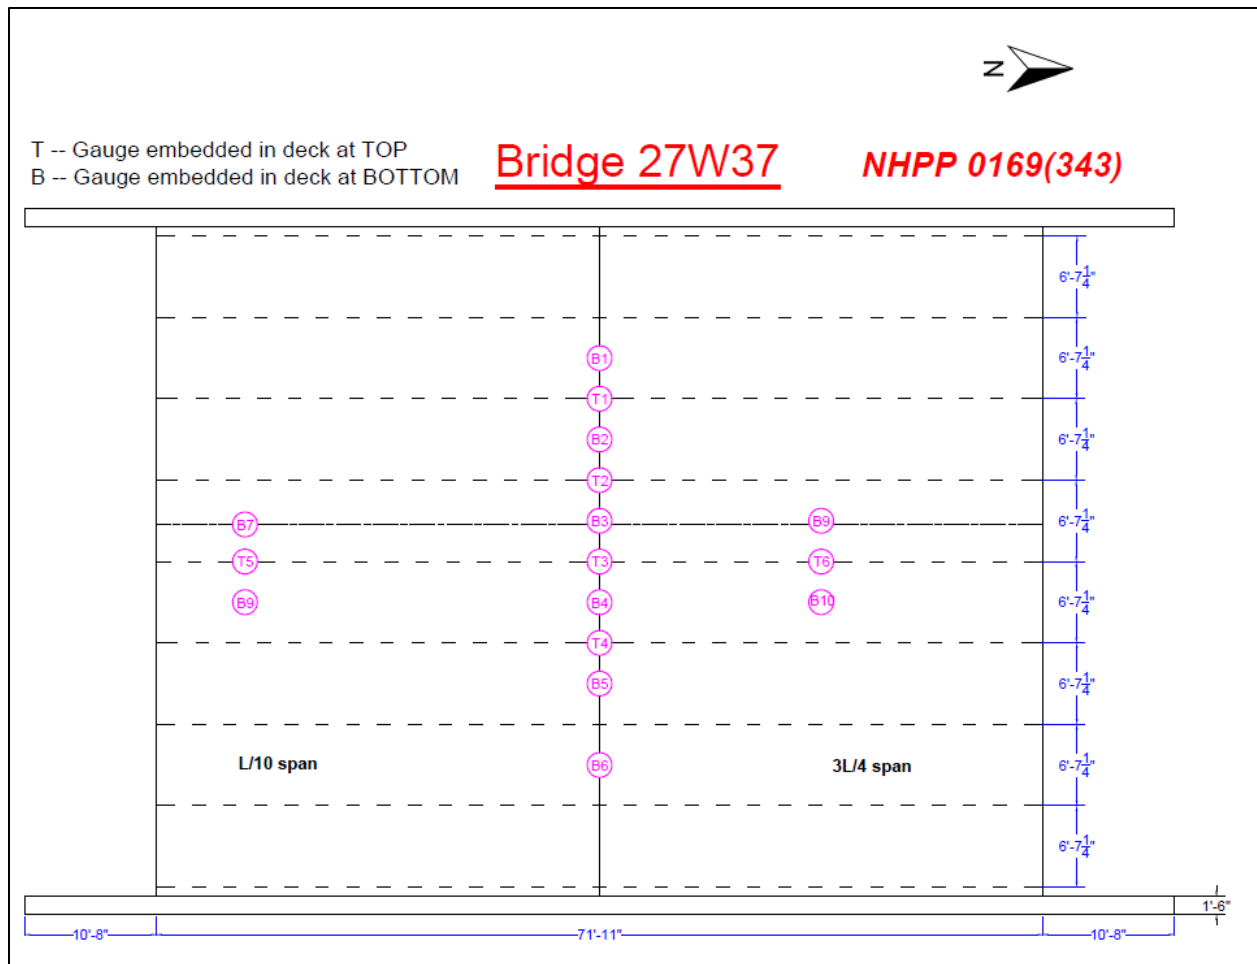
Figure 3.2. Instrumentation layout for long-term monitoring in GFRP-reinforced bridge deck (27W37)

A total of 16 VW strain gauges were installed on each of the bridge decks during the construction phase. Figures 3.1 and 3.2 show the locations of the VW strain gauges embedded inside the two bridge decks during construction.

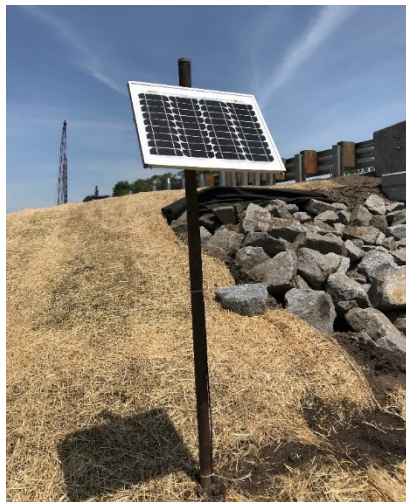
Figure 3.6. Solar panel installed at the bridge site

This system can be used for extreme temperature conditions and is reliable enough for remote environments. The data logger is powered with an uninterruptible power supply. To maintain the supply of power to the data-acquisition system, a solar panel was installed on site (Figure 3.6).

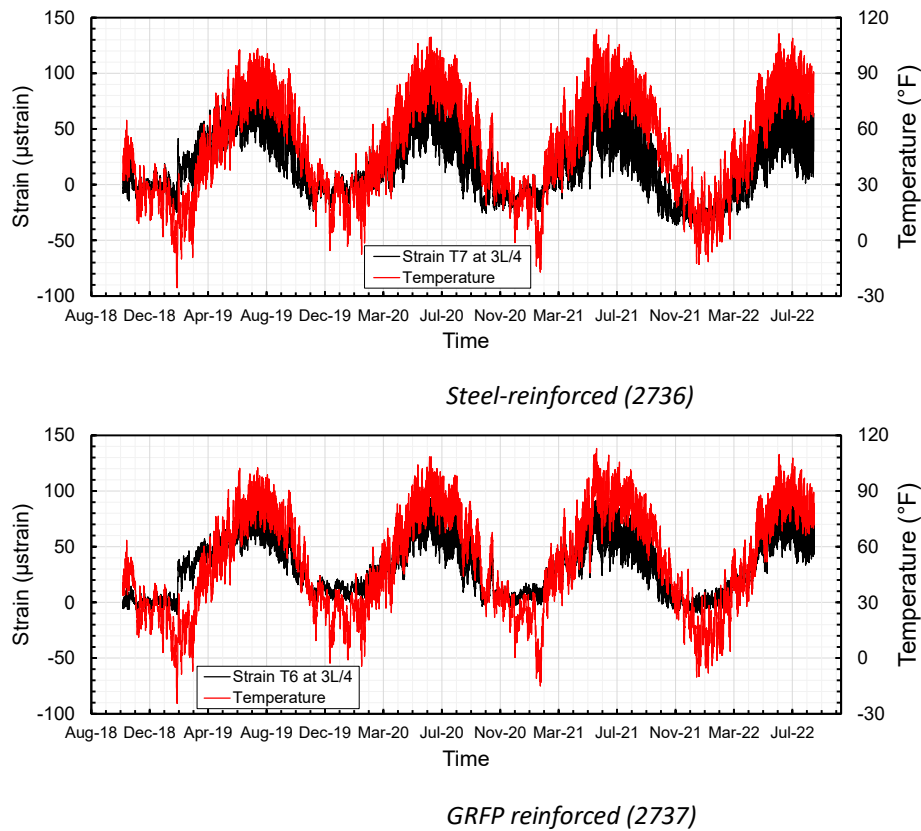
Figure 3.11. Strain time histories of gauges at the quarter span of both bridge decks

Figure 3.11 shows the strain time histories of the gauges at the quarter span of the steel-reinforced (27W36) and GFRP-reinforced (27W37) bridge deck.

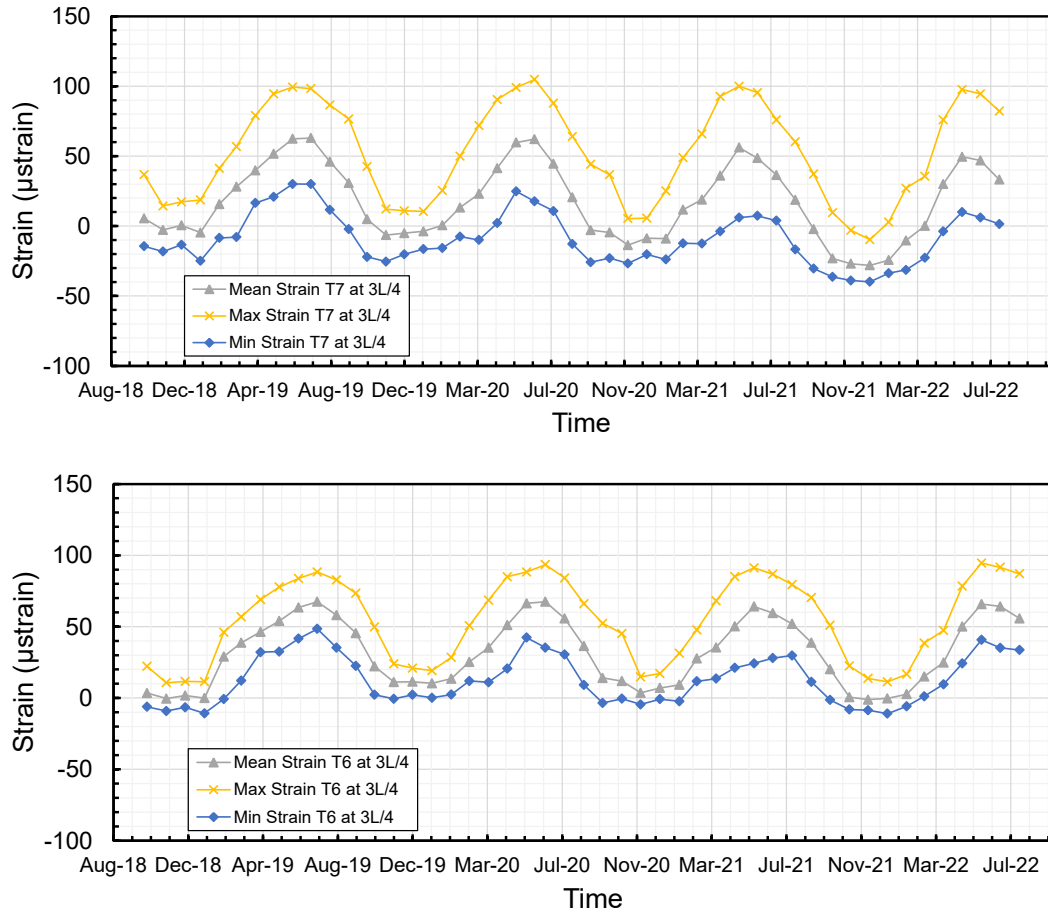
Figure 3.24. Strain time histories of gauge T7 of steel-reinforced bridge deck (27W36) and gauge T6 of GFRP-reinforced bridge deck (27W37)

The monthly average, maximum, and minimum of the strain values at gauges T7 of the steel-reinforced bridge deck (27W36) and gauge T6 of the GFRP-reinforced bridge deck (27W37) are shown in Figure 3.24.

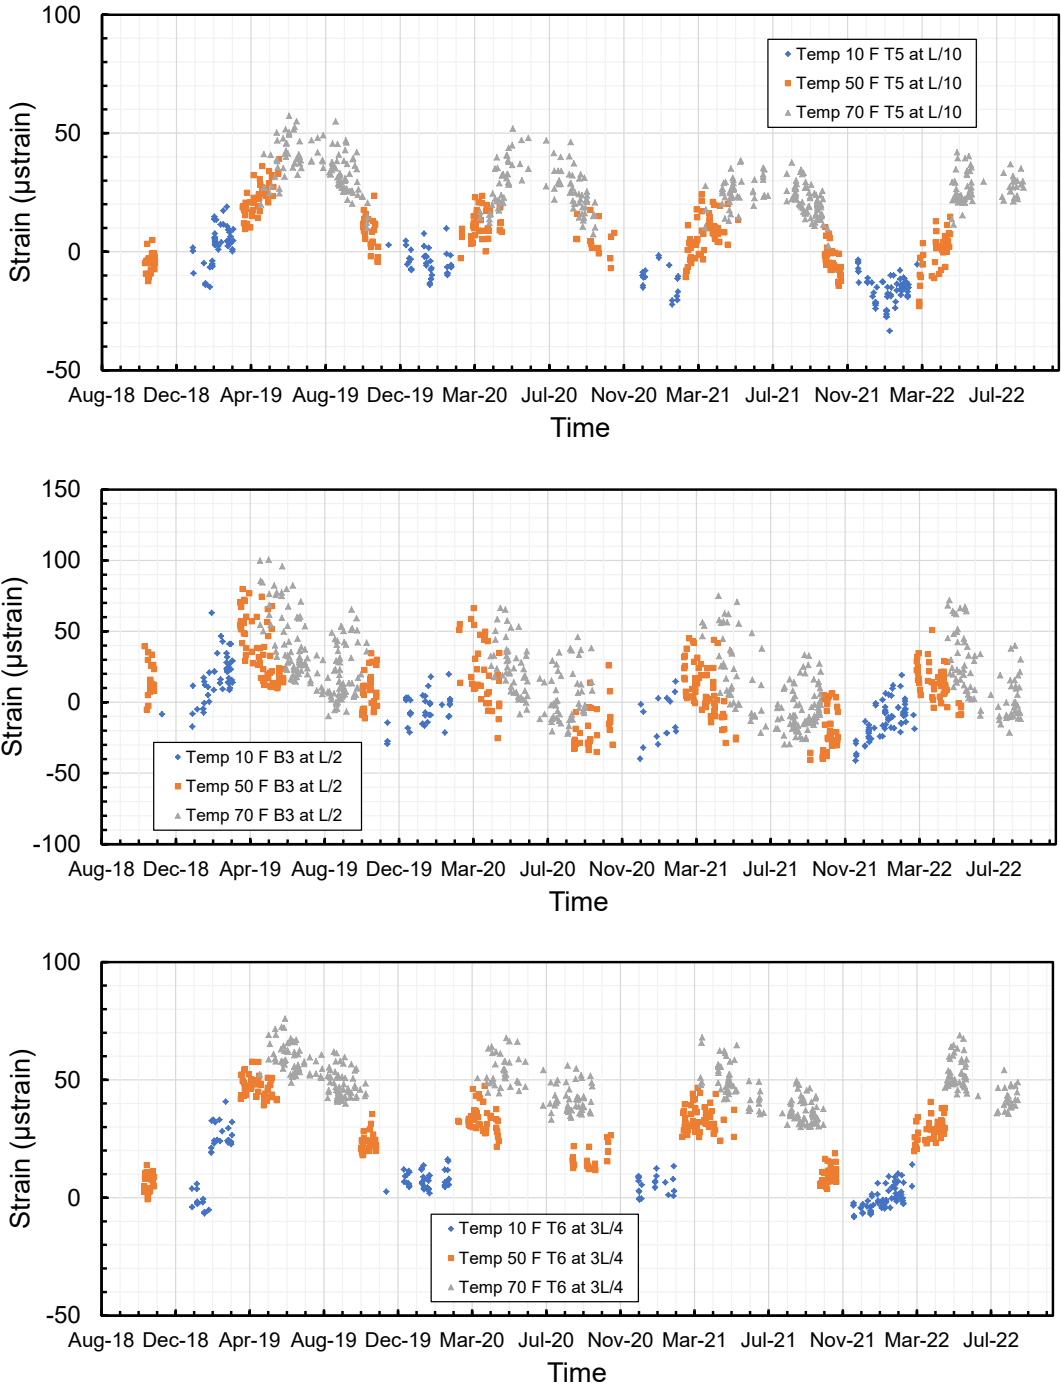
Figure 3.26. Strain time histories of gauges T5, B3, and T6 of GFRP-reinforced bridge deck (27W37) at 10°F, 50°F, and 70°F

Figure 3.26 shows the strain values from the GFRP-reinforced bridge deck (27W37) for temperatures of 10°F , 50°F , and 70°F at gauges T5, B3, and T6.

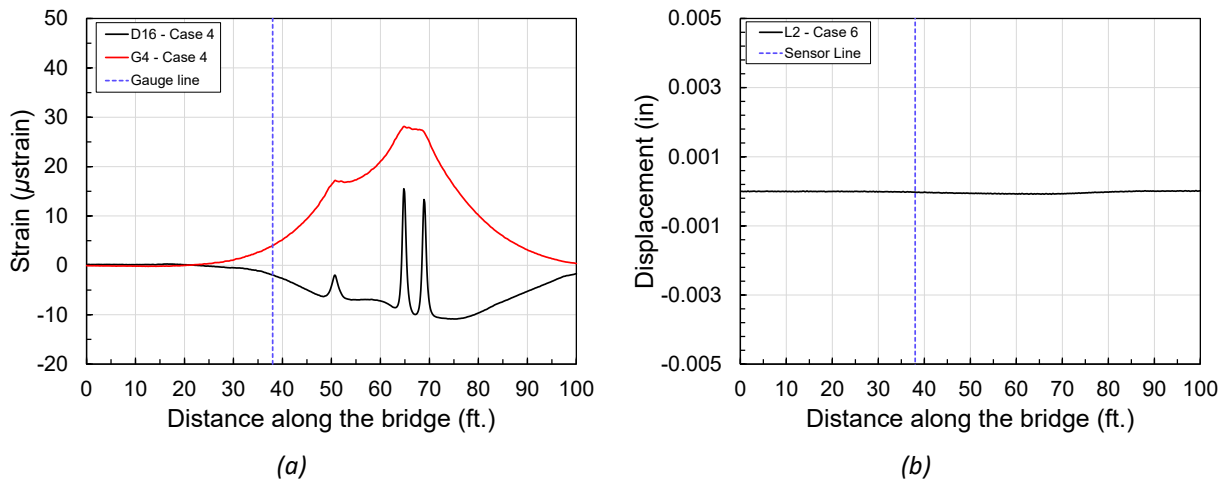
Figure 4.21 Bridge response for GFRP-reinforced bridge deck (27W37) measured during the first load test: (a) strain time history under load 4 and (b) displacement time history load 6

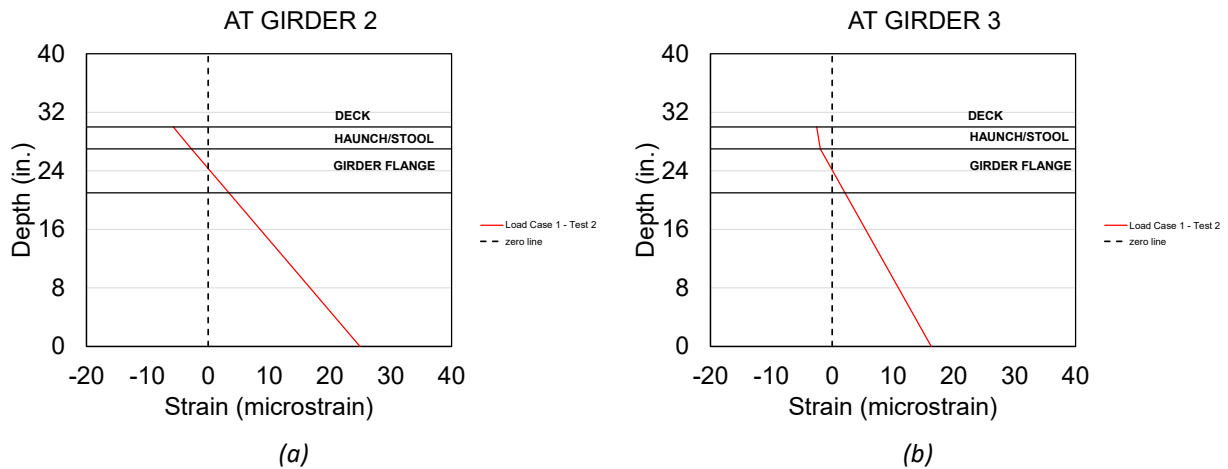
Figure 4.31 Neutral axis locations in steel-reinforced bridge deck (27W36) for load case 1: (a) girder 2 and (b) girder 3

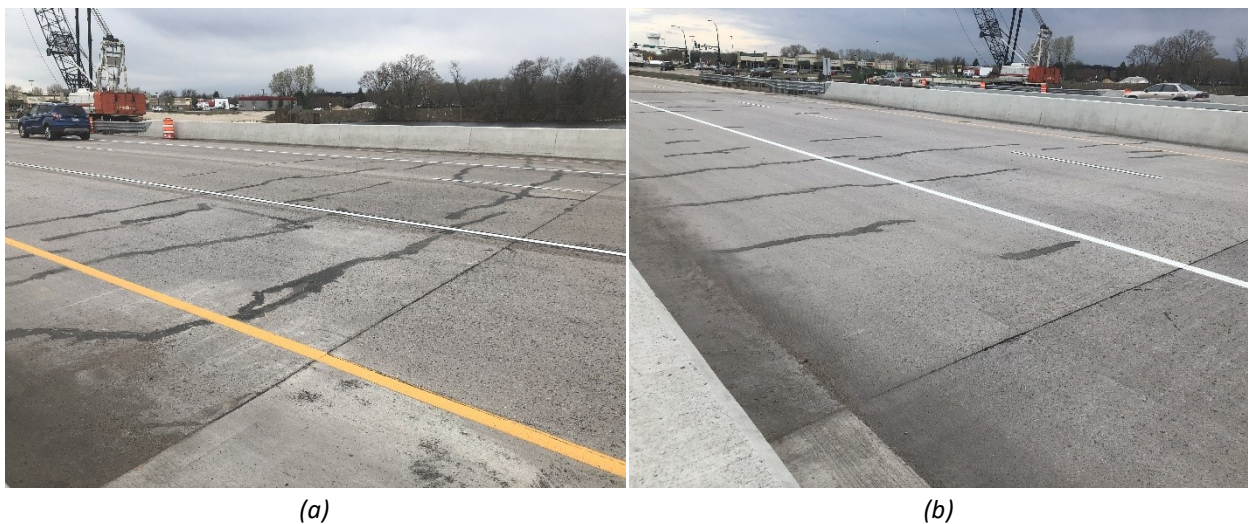
Figure 5.1 Top surface cracks in the bridge decks: (a) steel-reinforced bridge deck (27W36) and (b) GFRP-reinforced bridge deck (27W37)

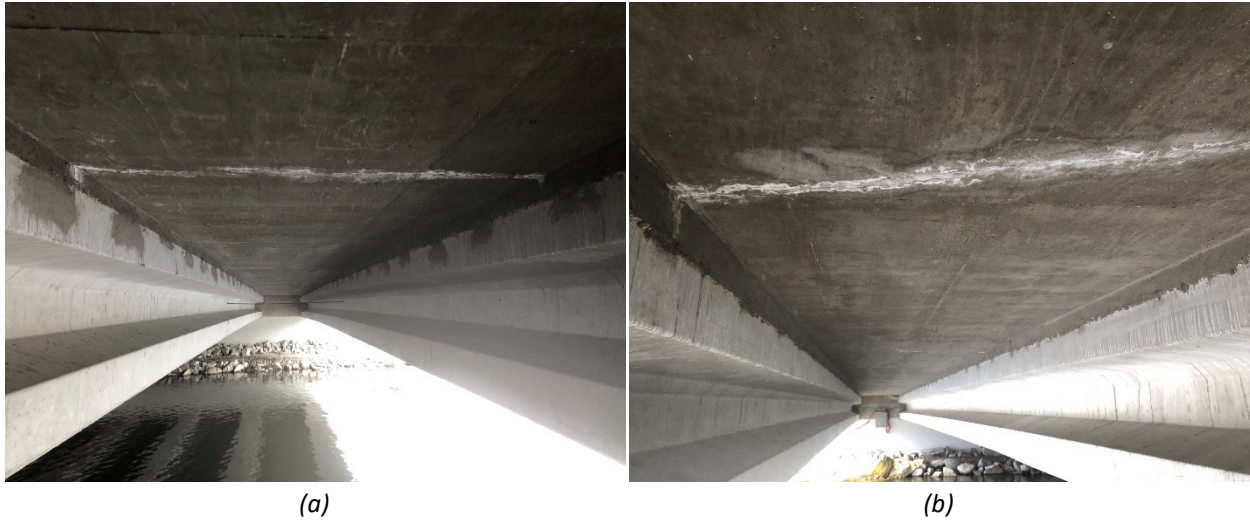
Figure 5.2 Full-depth cracks in the bridge decks: (a) steel-reinforced bridge deck (27W36) and (b) GFRP-reinforced bridge deck (27W37)

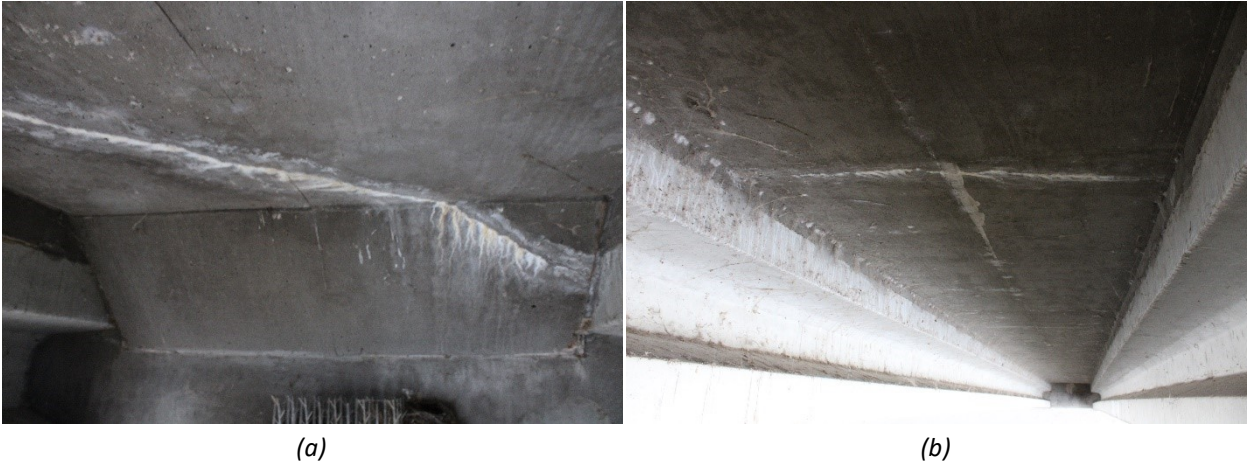
Figure 5.4 Full-depth cracks in GFRP-reinforced bridge deck (27W37)

Figure 5.4 shows the cracks underneath the GFRP-reinforced bridge deck (27W37).

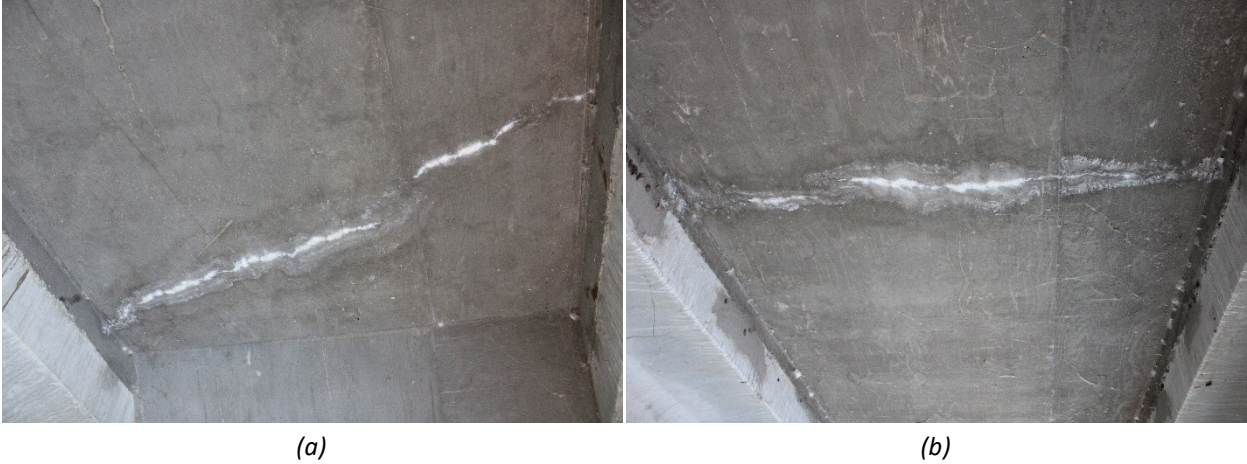
Figure 5.5 Full-depth cracks in steel-reinforced bridge deck (27W36)

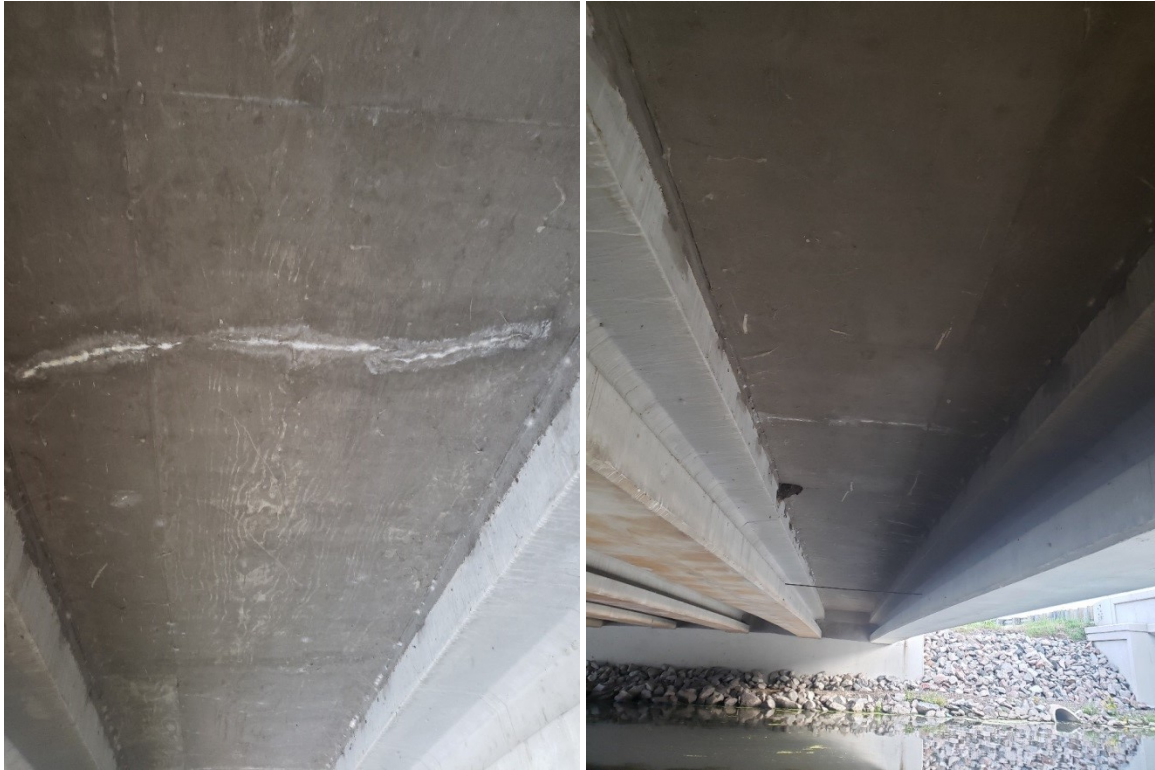
Figure 5.6 Cracks on the bottom surface of steel-reinforced bridge deck (27W36)

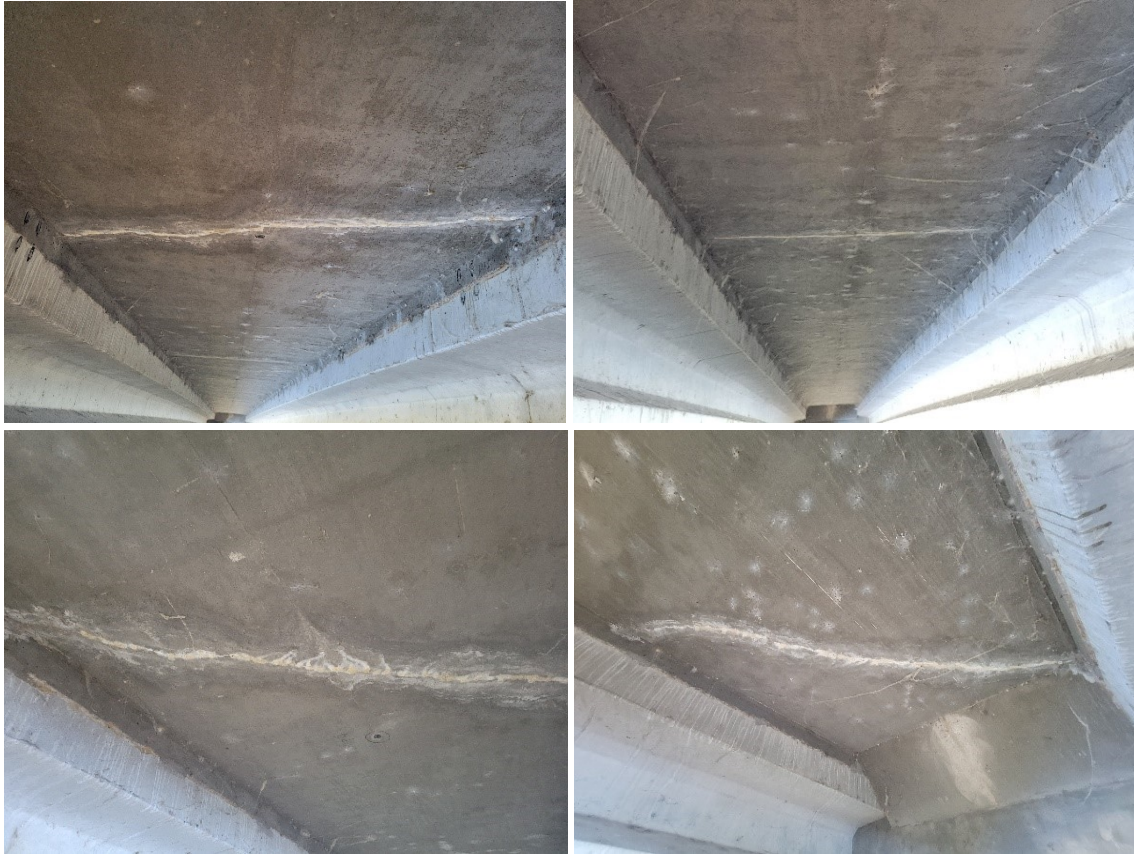
Figure 5.7 Cracks on the bottom surface of GFRP-reinforced bridge deck (27W37)

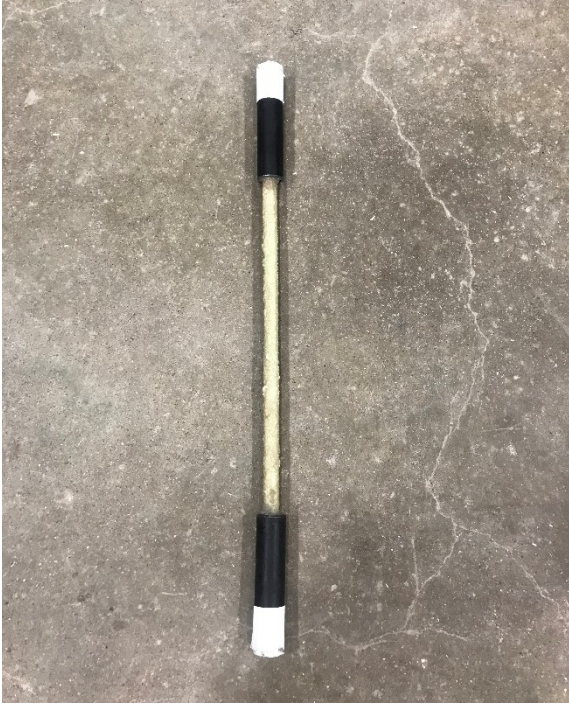
(a) GFRP specimen before testing

Figure 6.2 GFRP rebar test pictures

A GFRP rebar specimen with attached grips can be seen in Figure 6.2(a). Specimens were placed in the SATEC Systems, Inc. Universal Testing Machine with the displacement rate set to 0.15 in./min (Figure 6.2(b)).

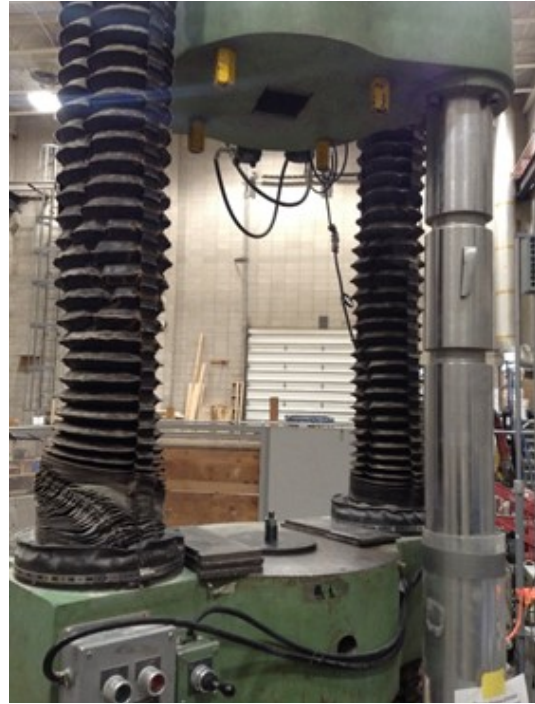
(b) Testing machine

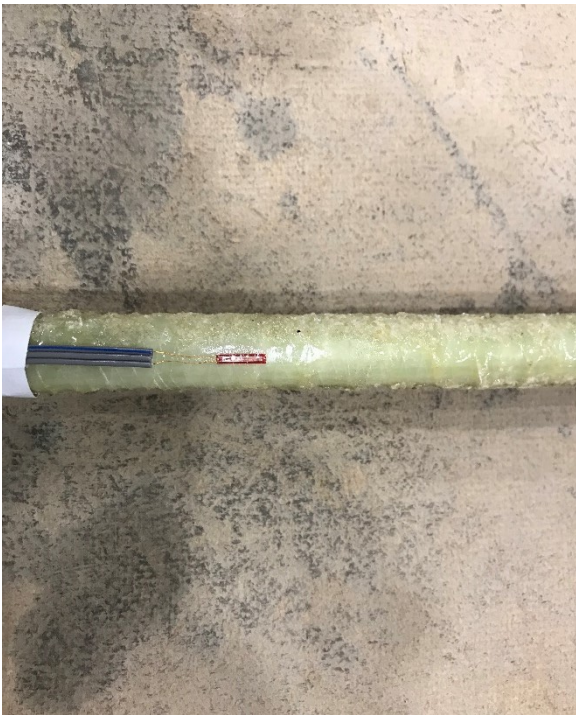
(a) Specimen instrumented with strain gauge

Figure 6.3 Tensile testing procedure for GFRP rebar

Each 28 in. specimen was instrumented with one longitudinal 350 Ohm strain gauge (Figure 6.3(a)).

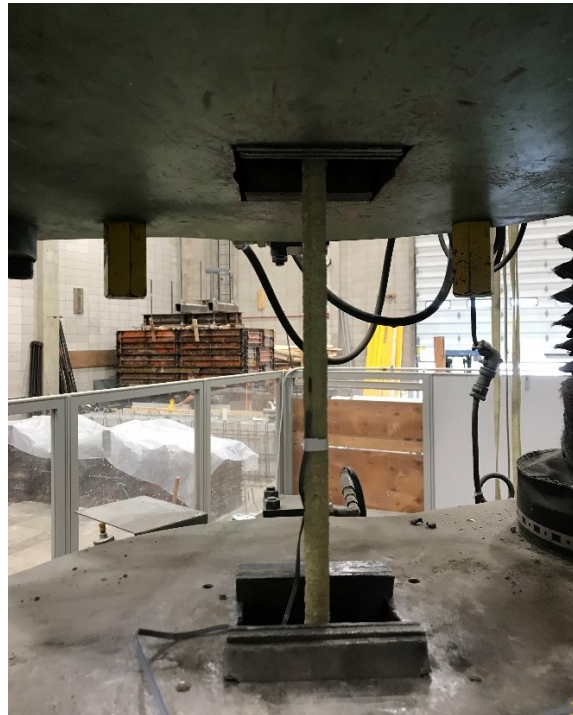
(b) Specimen mounted in testing machine

The displacement rate was calculated as per ASTM D7205, which calls for a strain rate of 0.01 min^{-1} , or a displacement rate of $(0.01 \text{ min}^{-1}) \times (\text{free length})$. Specimens were loaded in tension until failure, while force, strain, and displacement were measured.
