Transportation Research Synthesis

TRS 2302

February 2023

USE OF HOT WATER PRESSURE WASH SURFACE PREPARATION AND HRCSA COATINGS IN BRIDGE MAINTENANCE

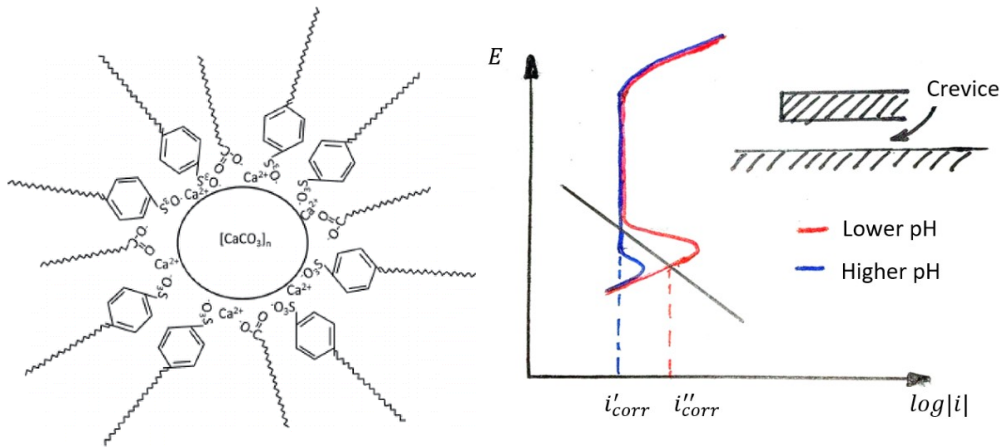
Figure 1. Left: the main active component of CSA/HRCSA: crystalline calcium carbonate stabilized by alkyl sulfonate (from reference [11]); right: corrosion current shifting with the crevice pH; higher crevice pH corresponding to lower corrosion current, thus slower corrosion.

Pack rust, a consequence of crevice corrosion, could happen at any joint of two materials (one being the corroding metal) that forms an occluded narrow space [12]. When crevice corrosion products accumulate (pack) to the extreme, it could bend joints or impede the movement of a bearing mechanism, causing catastrophic incidents [13]. Crevice corrosion initiates with a differential concentration cell, the anode being inside of the crevice, with lower oxygen concentration due to hindered mass transport. As the crevice corrosion propagates, the lower pH and chloride ions inside the crevice create a very corrosive internal electrolyte (Figure 1 right). The hygroscopic nature of the pack rust makes the mitigation even more difficult.

To mitigate pack rust, the ideal solution is its complete removal, but the more practical and effective approach is to wash the crevice, balance the pH, then seal the crevice. High pressure water cleaning is often recommended because it can reach occluded narrow space better than abrasive blasting. Using hot water, soap, and flash rust inhibitors can also enhance the cleaning efficiency but may cause environmental concerns. Combined with an initial pressure water wash, the application of a low viscosity penetrating sealer is often an effective solution, especially CSA sealers that can increase crevice pH by slowly releasing calcium carbonate as a corrosion inhibitor. HRCSA is expected to perform even better according to the company's description because it has higher total base number and active sulfonate than generic CSAs [14]. On the other hand, sealing/caulking a crevice without changing the internal corrosive electrolyte (flushing out the pack rust and salt contamination) is likely to worsen the corrosion [15]. The requirement of applying a penetrating sealer and caulking with stripe coat also makes the application of the one-coat CSA/HRSA system a multi-step process. Even though the waiting time is minimum between these steps, attributed to the system's wet-on-wet capability, it should not be overlooked.

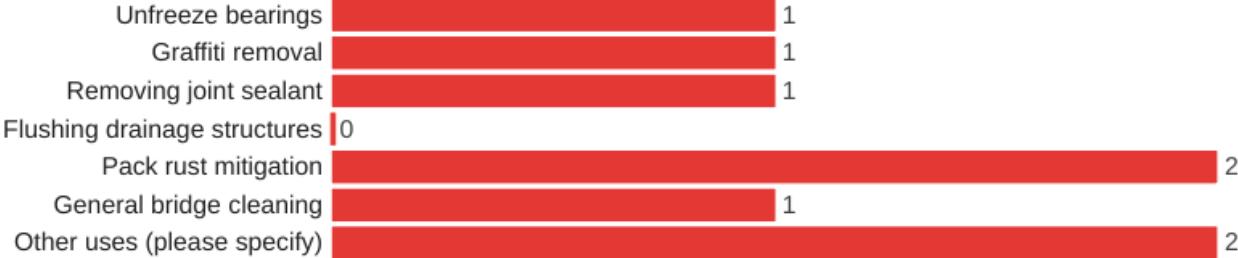
Q5.1 - Do you use the hot water pressure wash equipment for any other purpose listed below? Select all that apply.

Field	Choice Count
Unfreeze bearings	1
Graffiti removal	1
Removing joint sealant	1
Flushing drainage structures	0
Pack rust mitigation	2
General bridge cleaning	1
Other uses (please specify)	2
Total	8

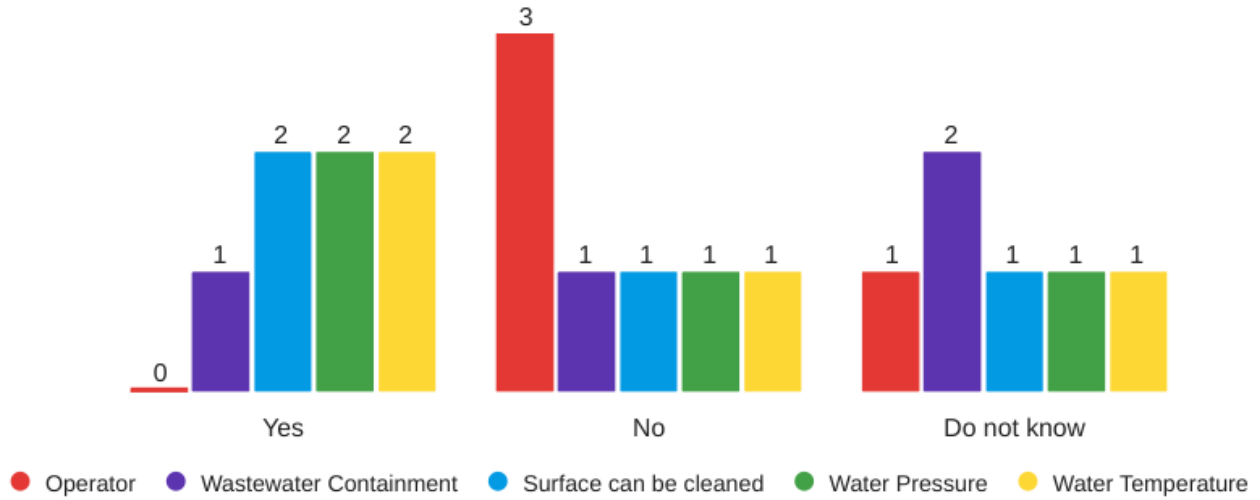
Q5.2 - Do you have any limitations on using hot water pressure wash?
 Select all that apply.

Field	Yes	No	Do not know	Total
Operator	0	3	1	4
Wastewater Containment	1	1	2	4
Surface can be cleaned	2	1	1	4
Water Pressure	2	1	1	4
Water Temperature	2	1	1	4

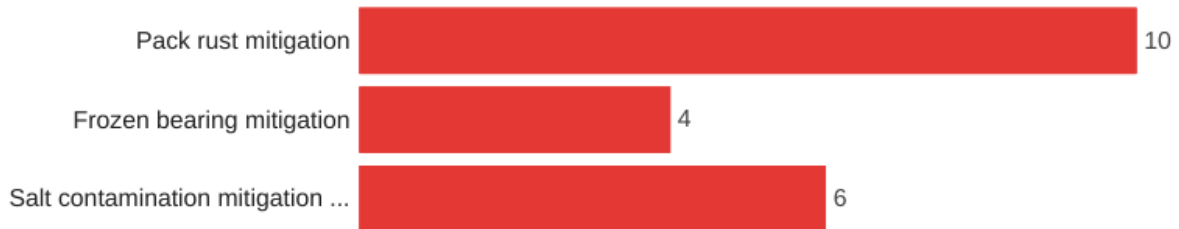
Q6.2 - Do you perform any of the following bridge maintenance tasks?
Please provide details in the text boxes. Select all that apply.

Field	Choice Count
Pack rust mitigation	10
Frozen bearing mitigation	4
Salt contamination mitigation (e.g., rust inhibitors, vinegar, soap, or other methods)	6
Total	20

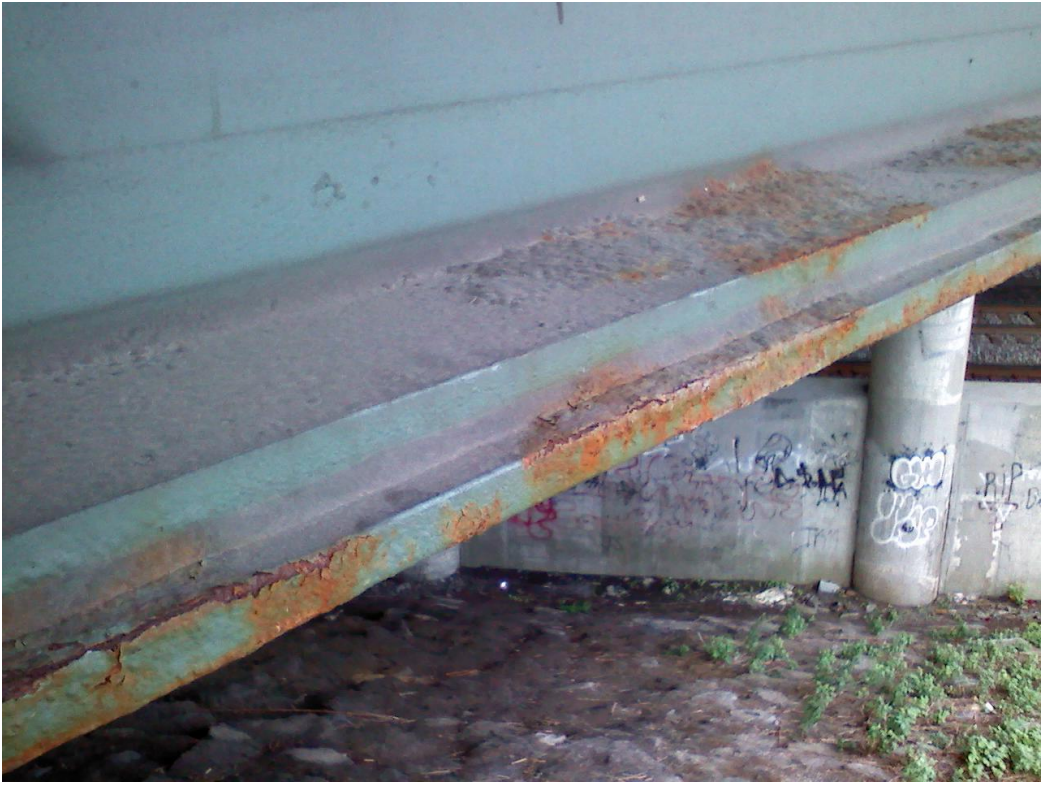
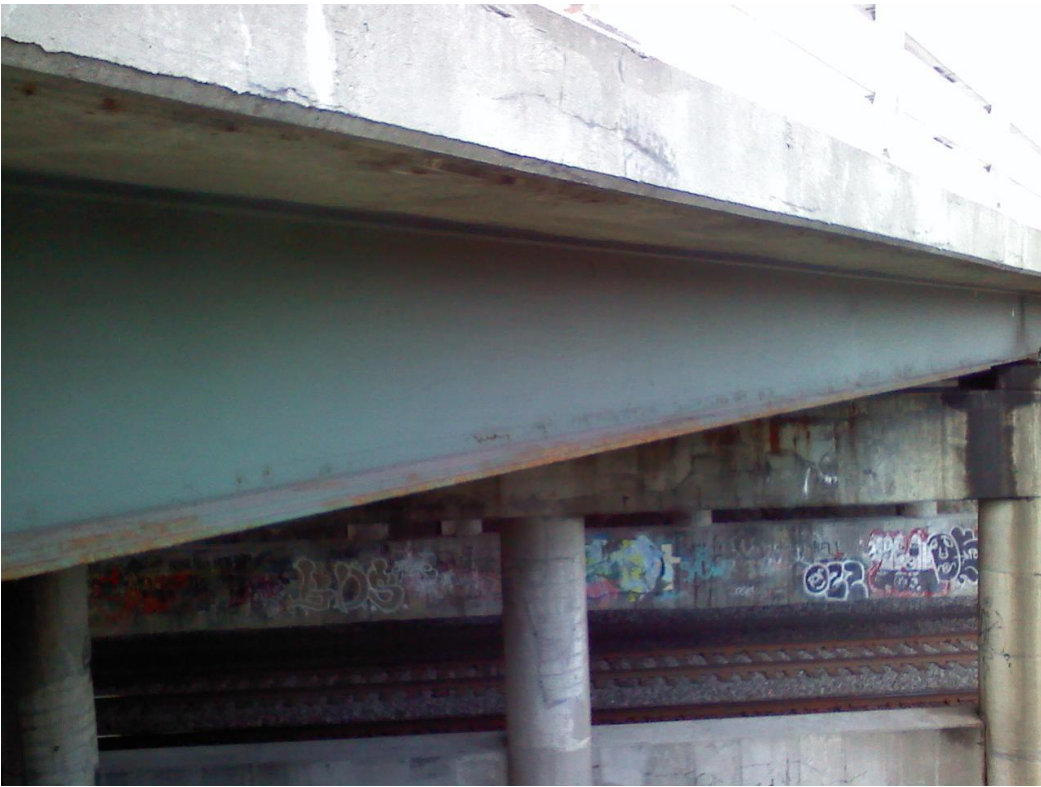
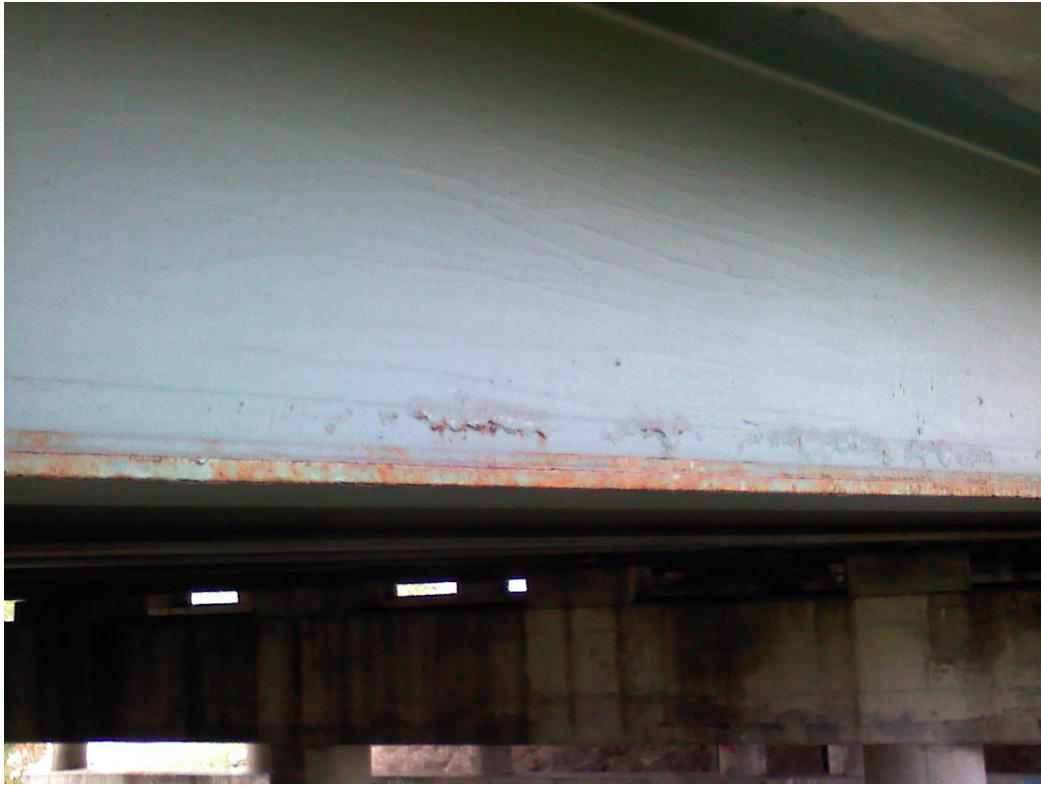
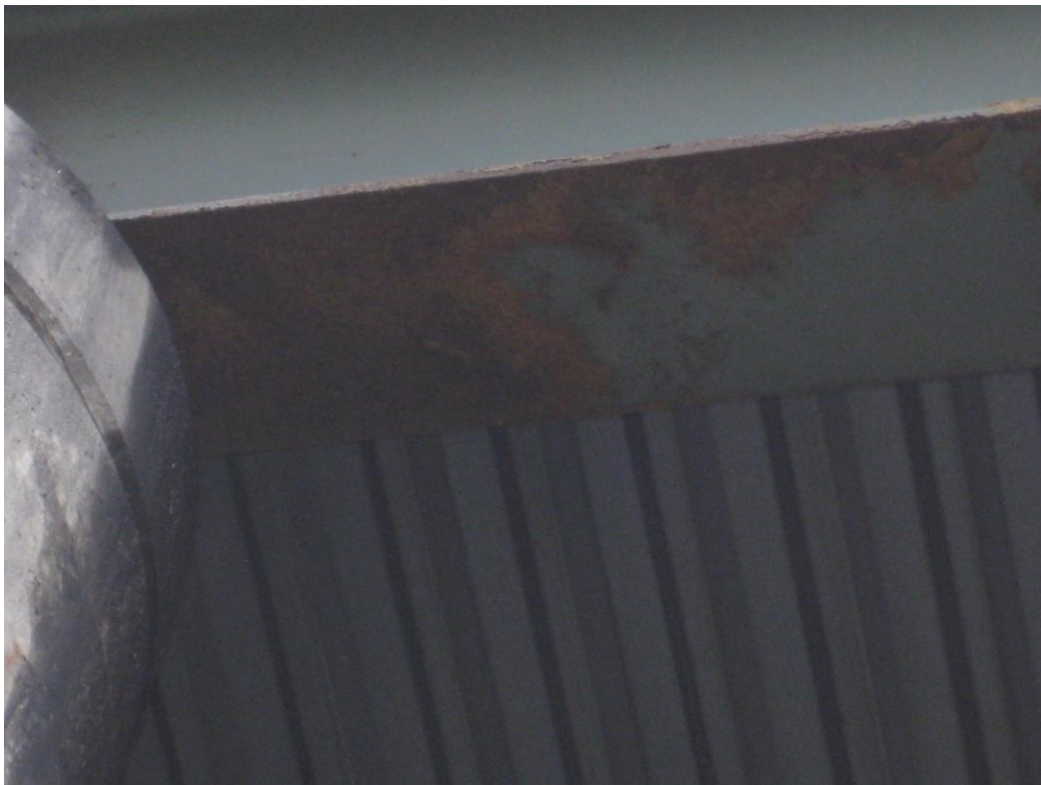
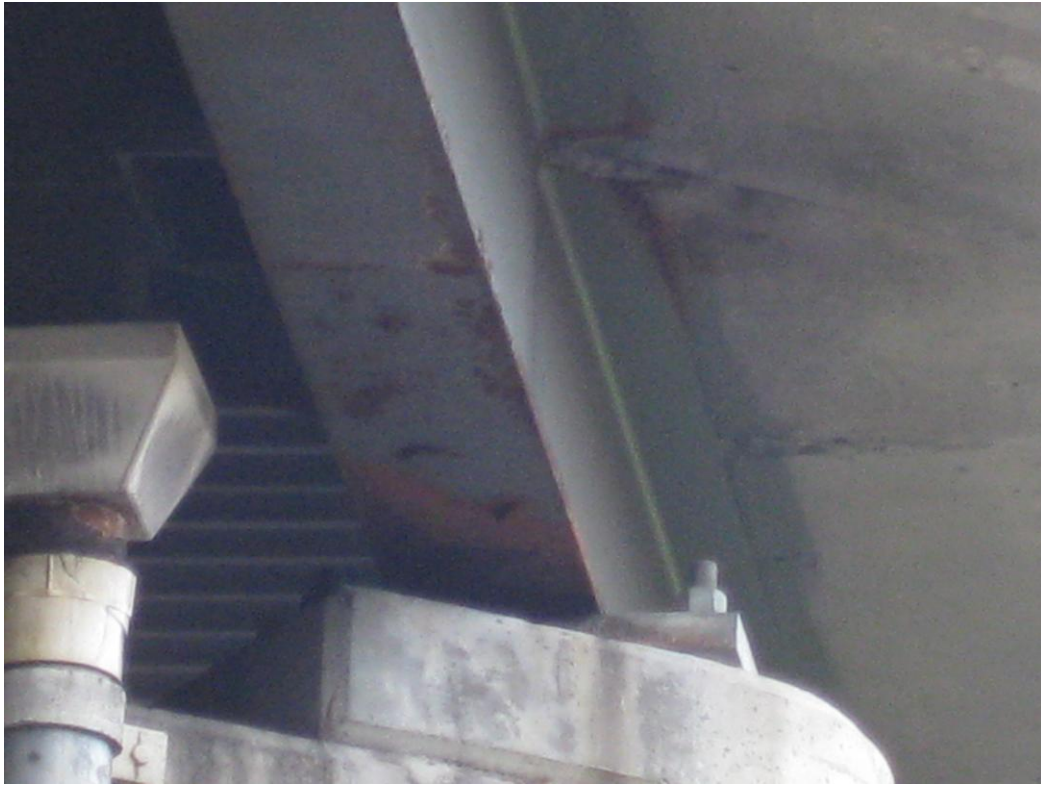
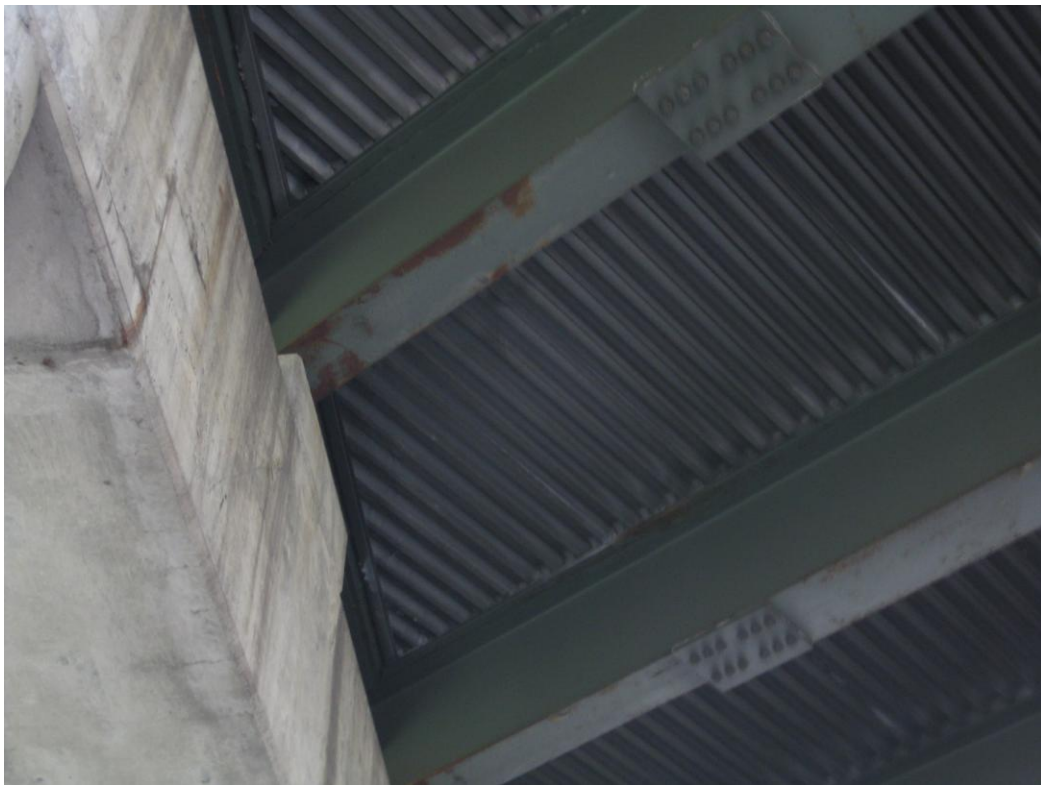
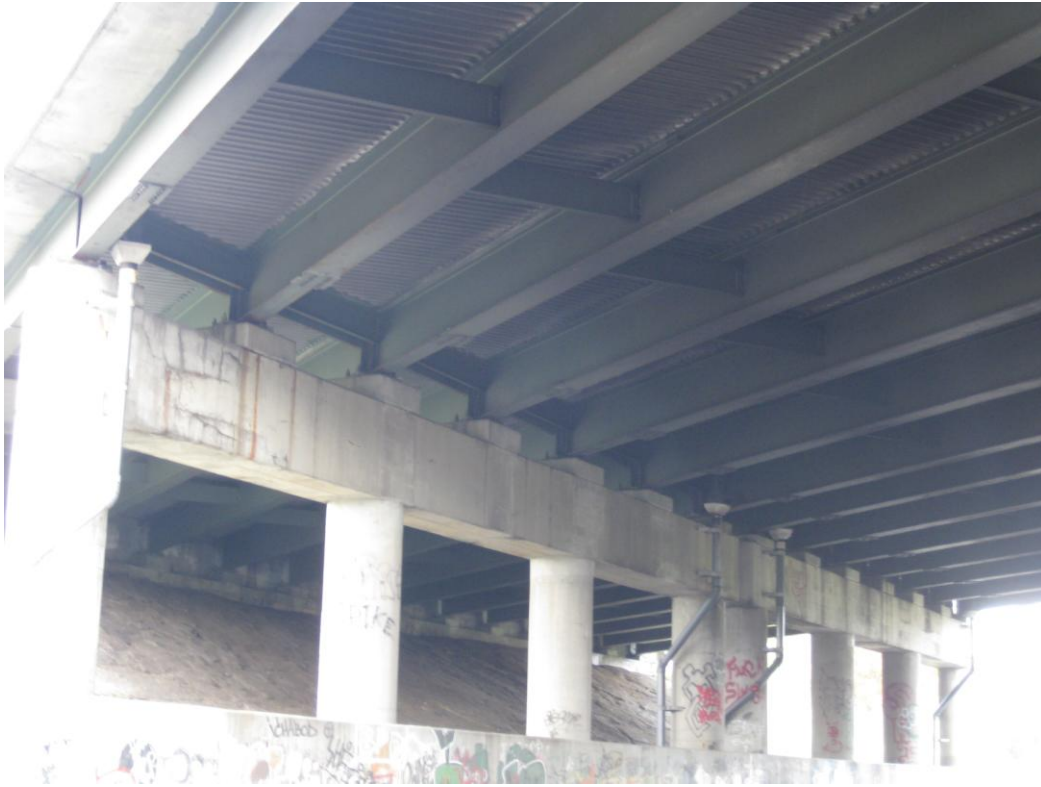
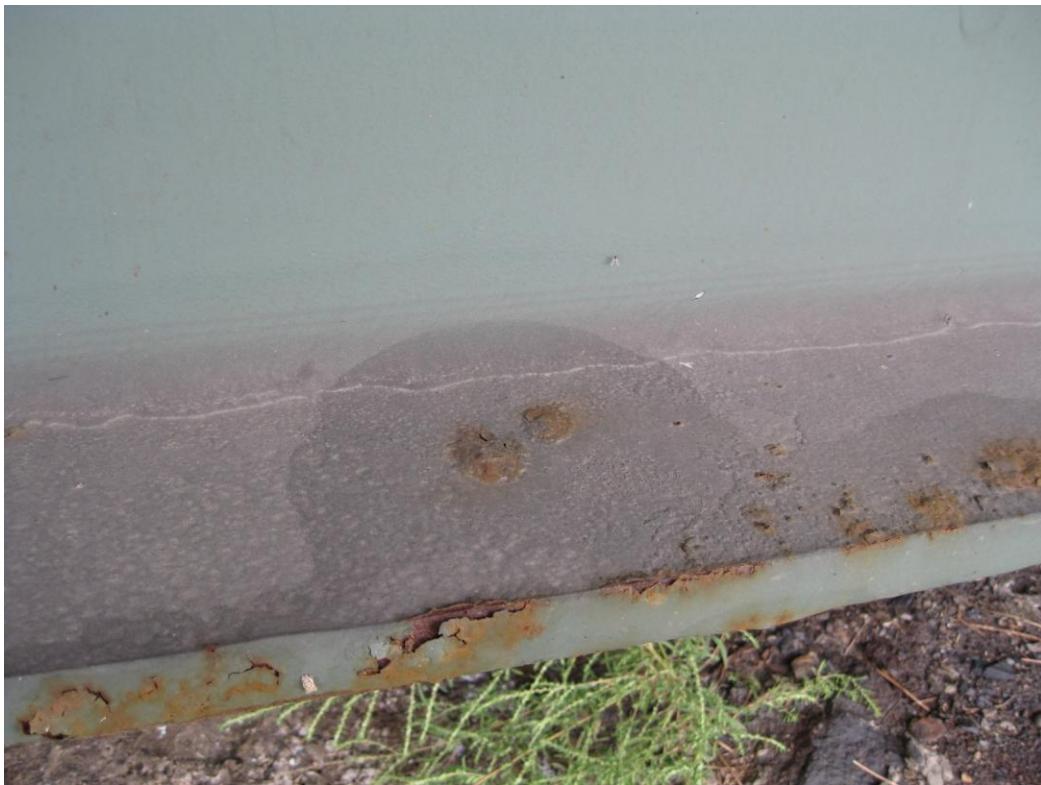
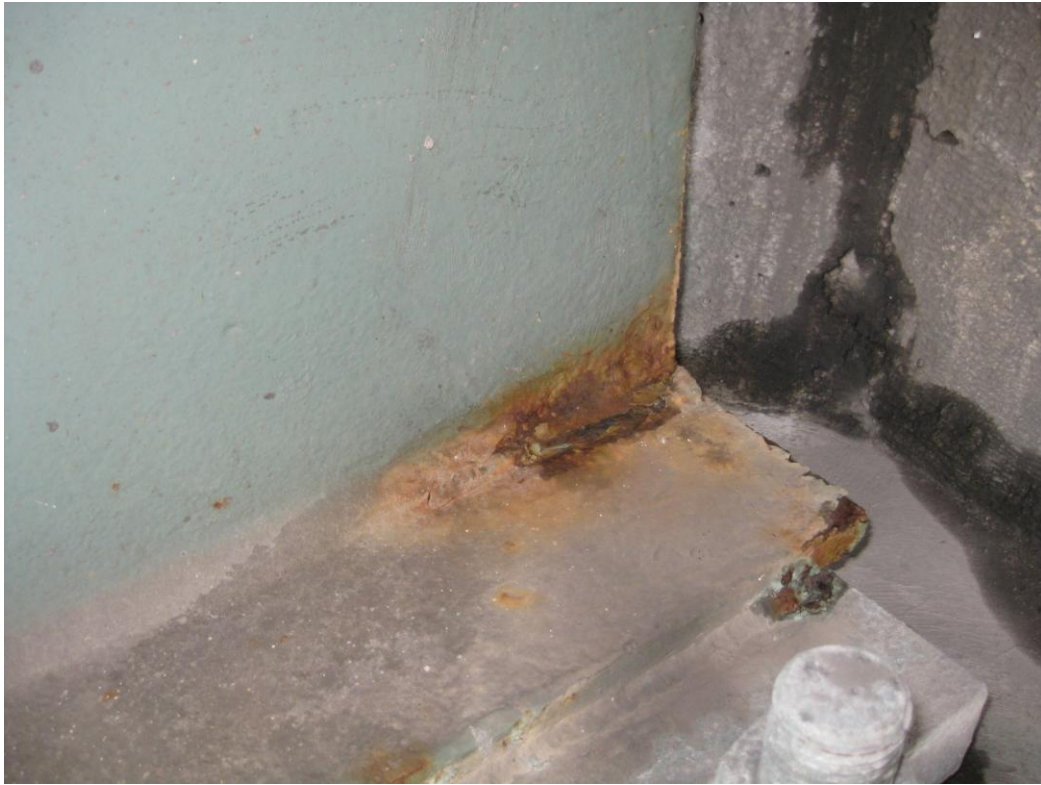
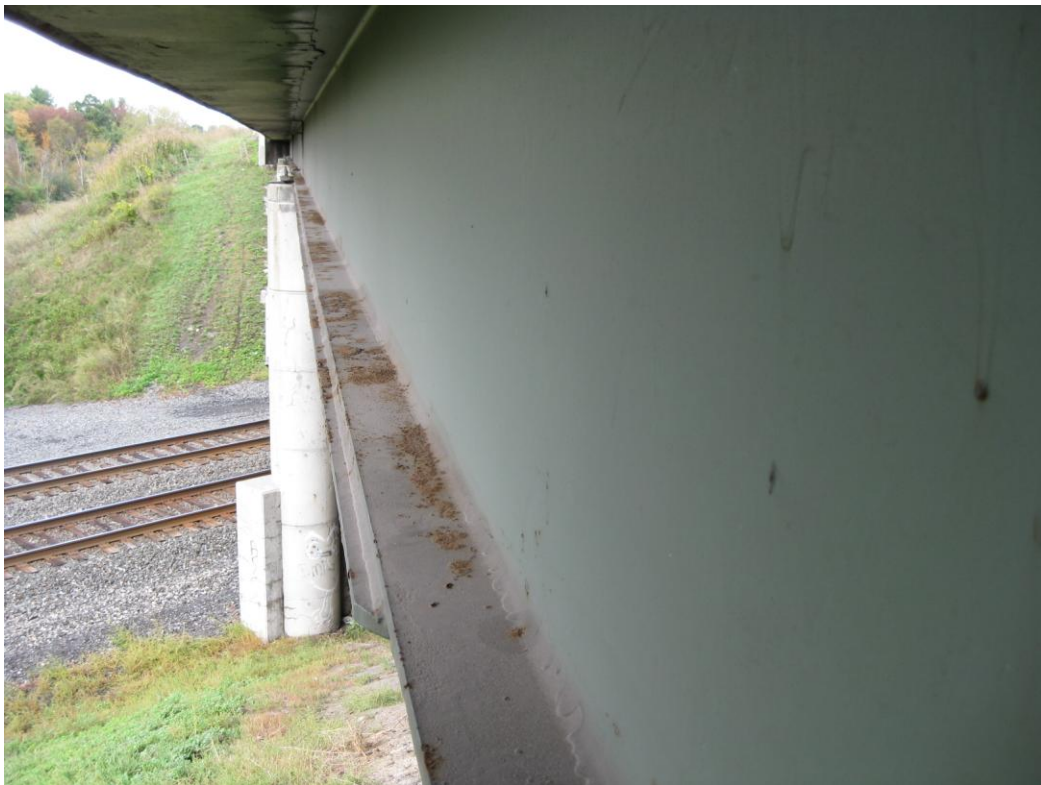
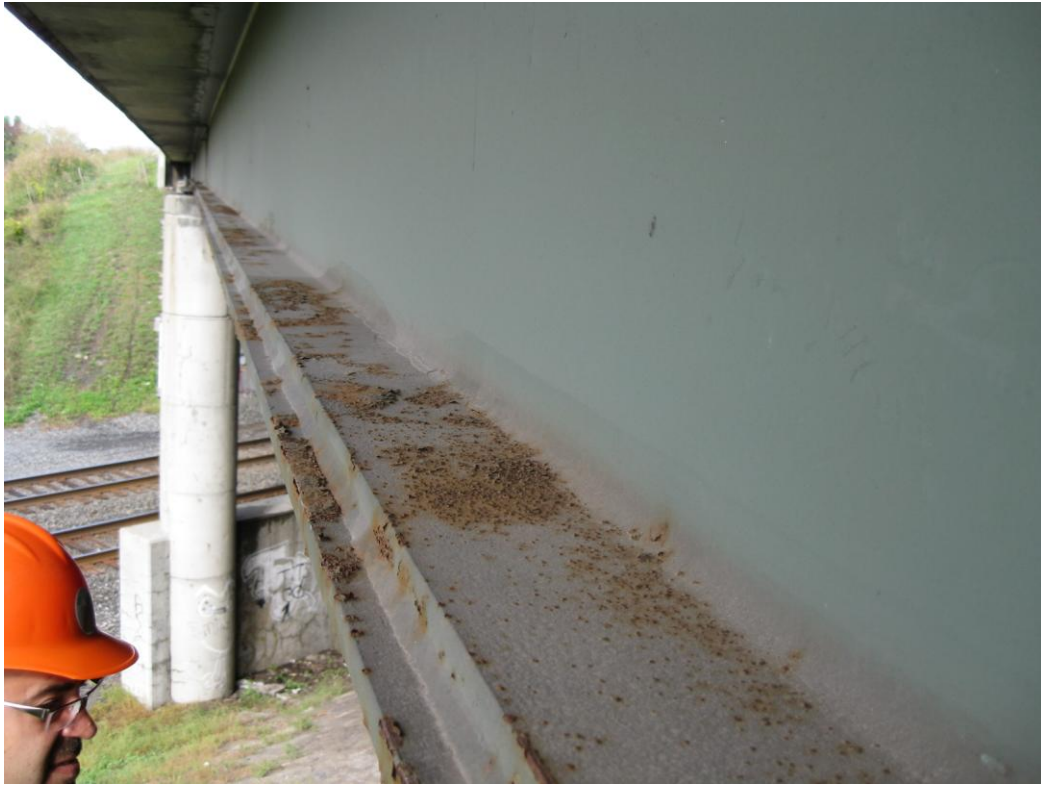
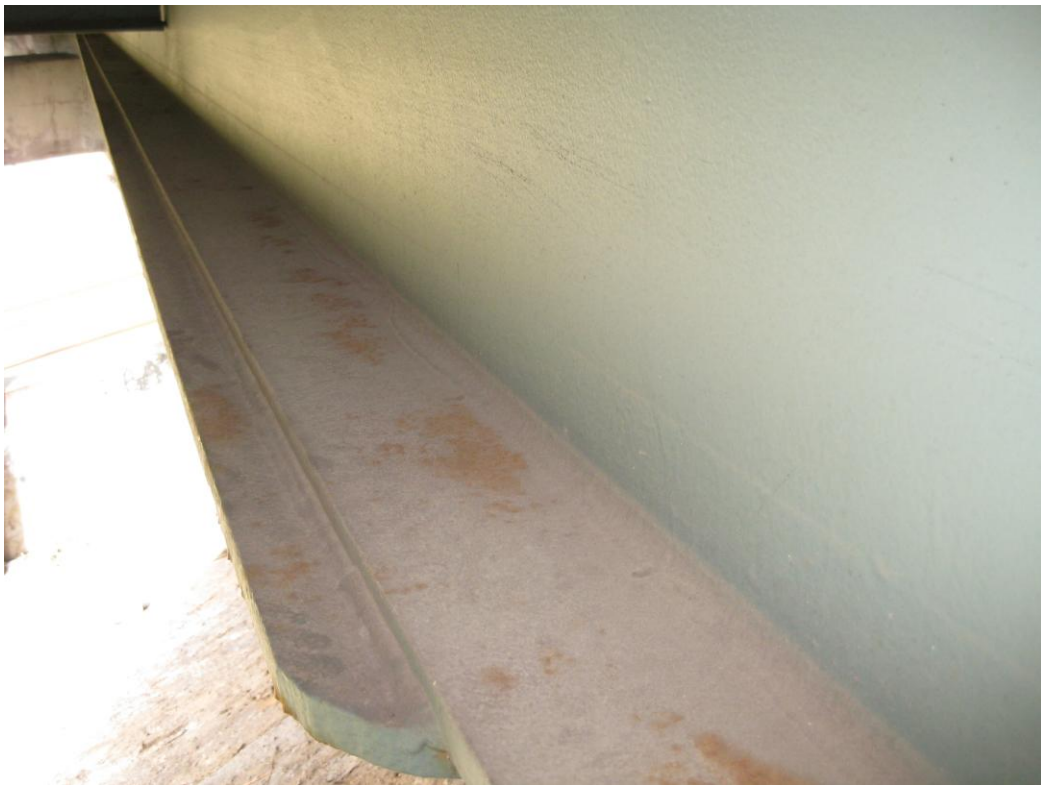
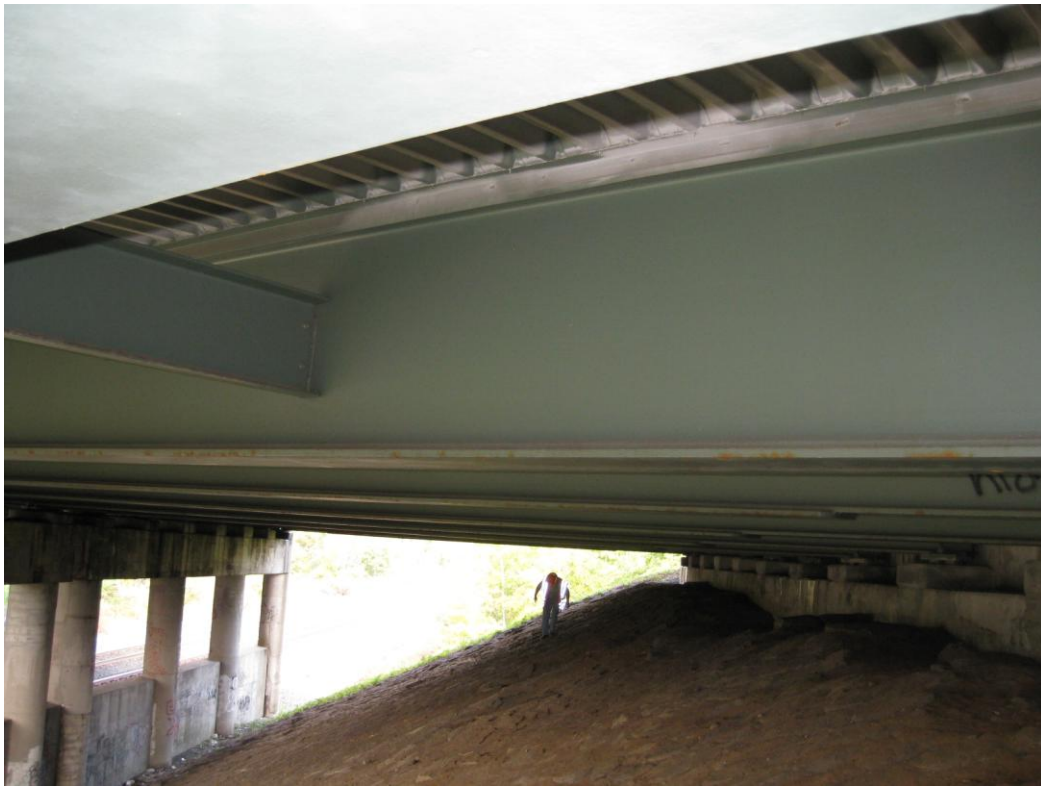
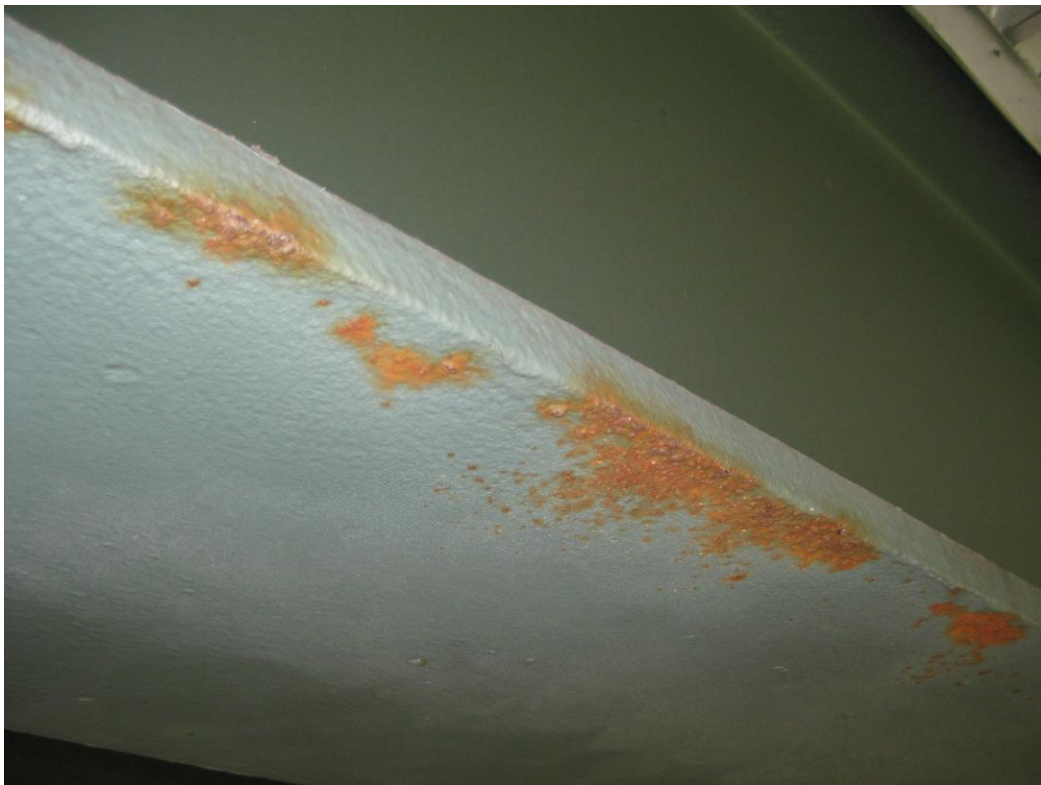
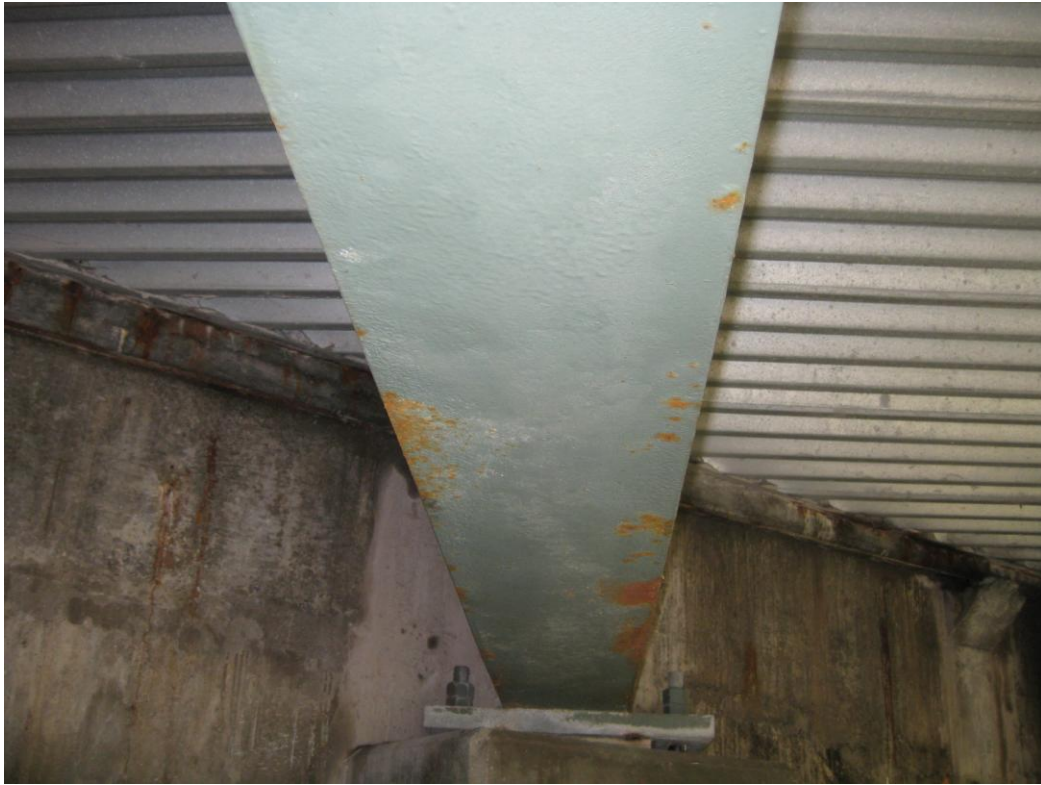
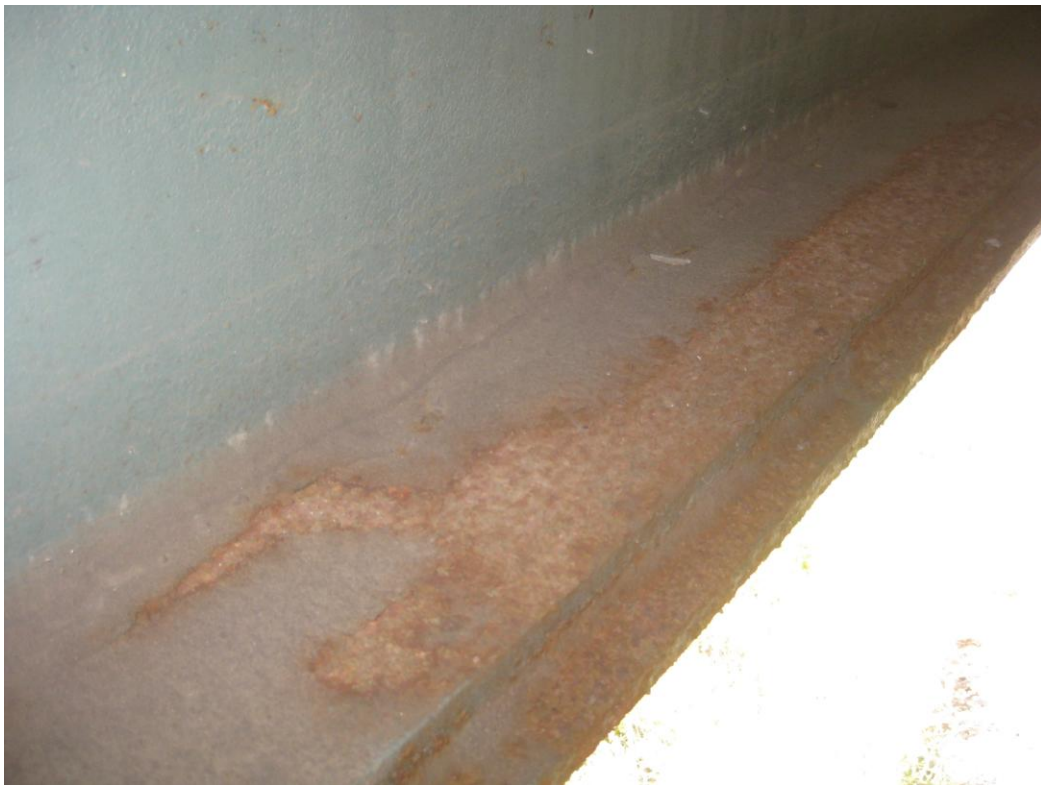
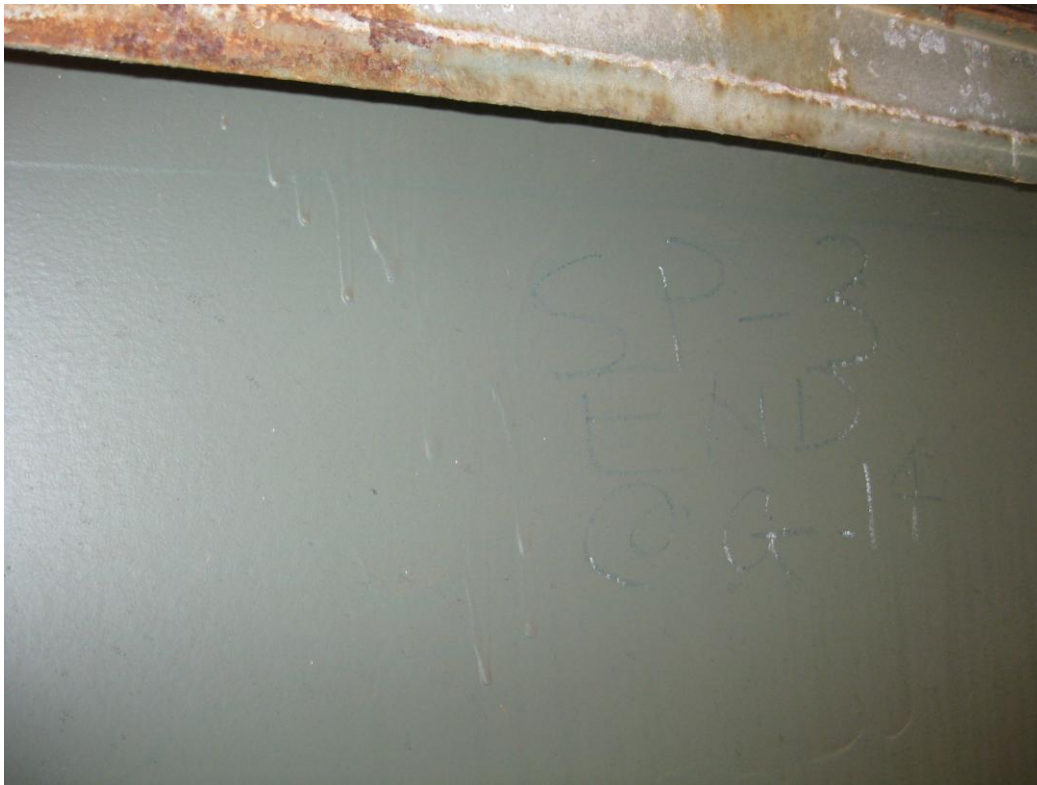
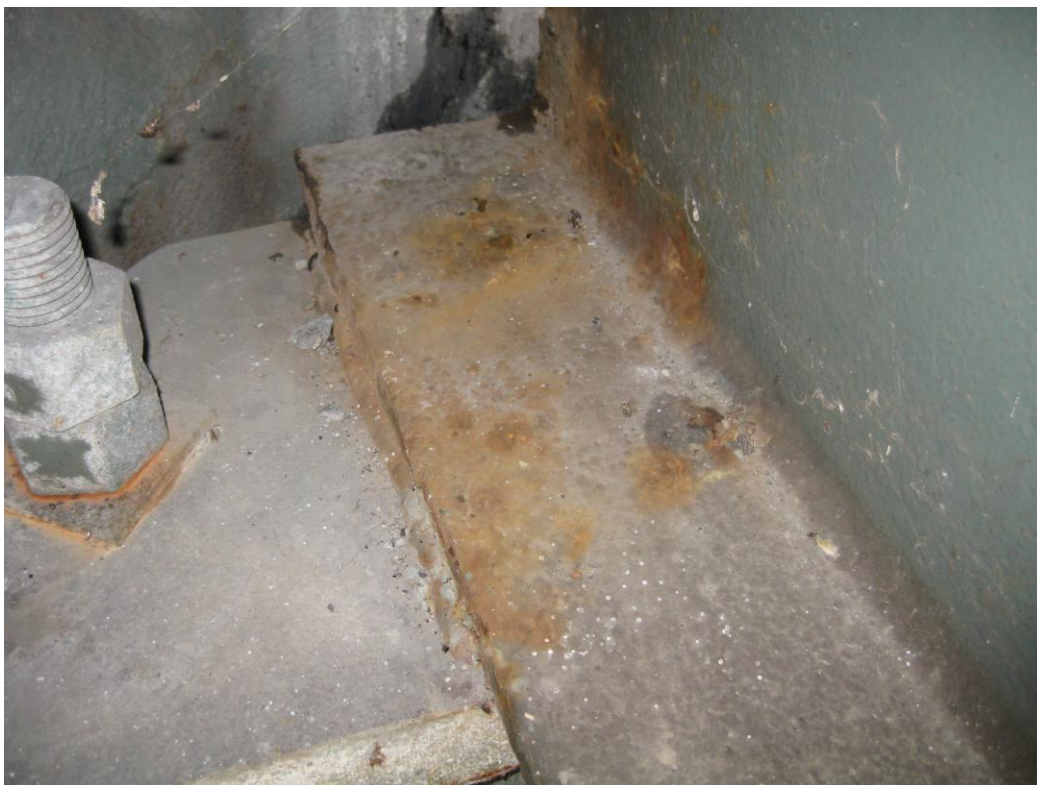
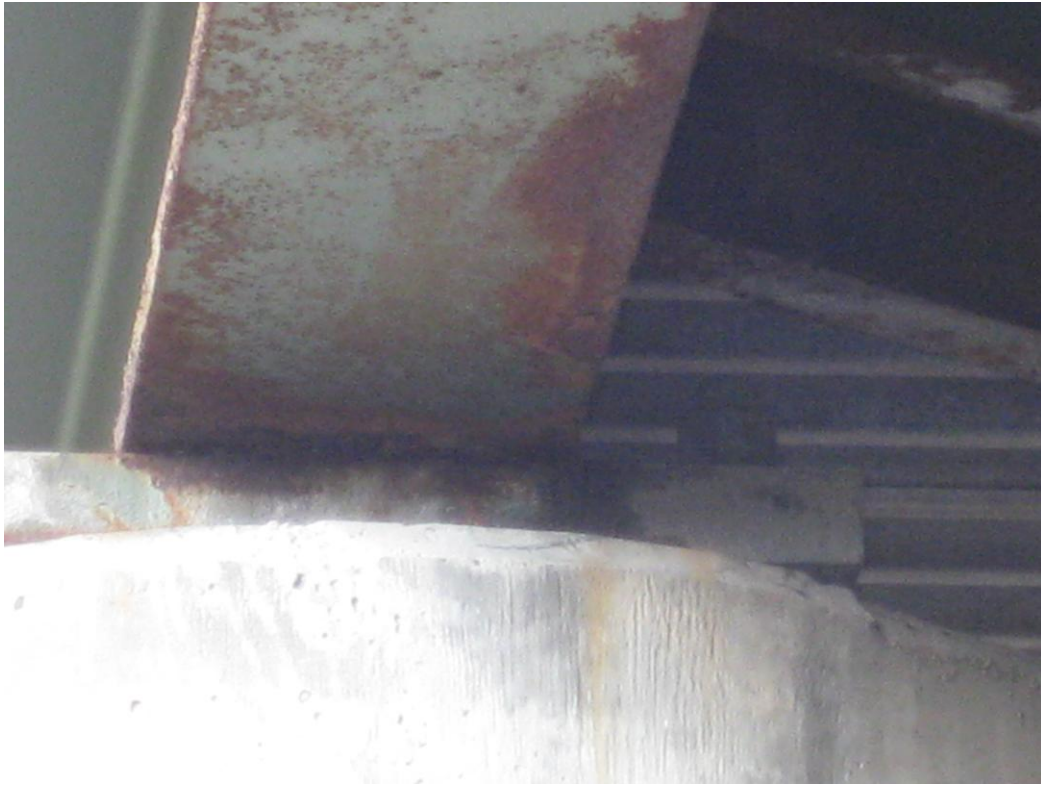
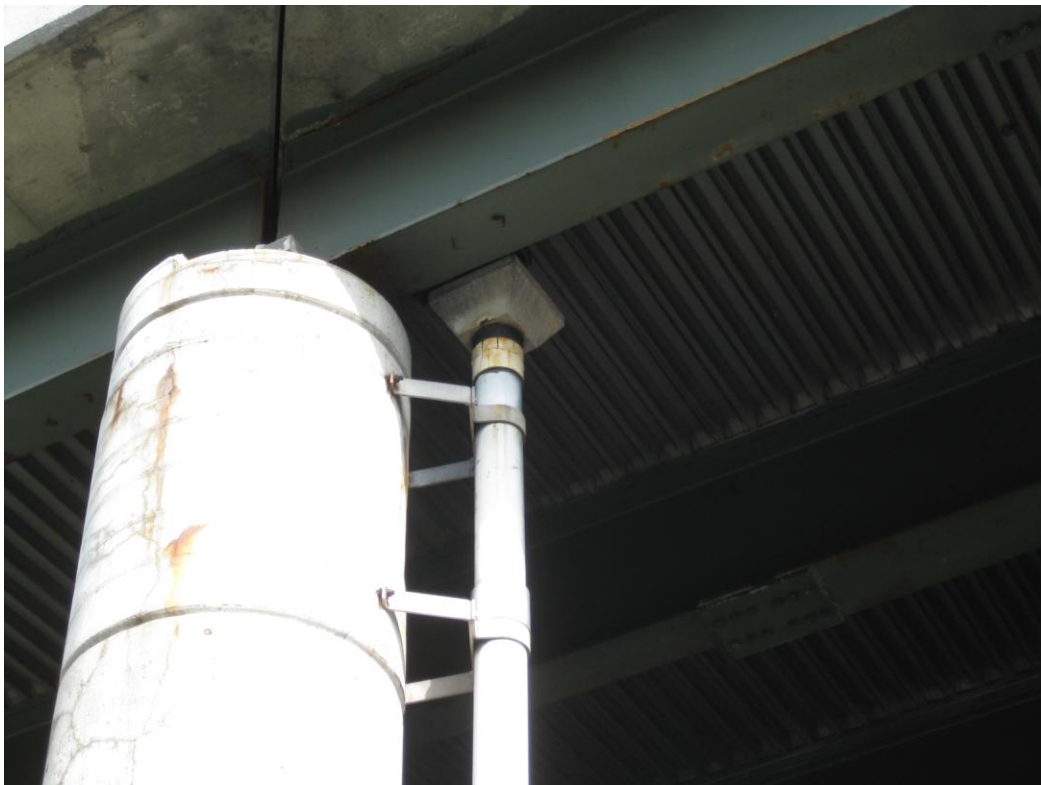
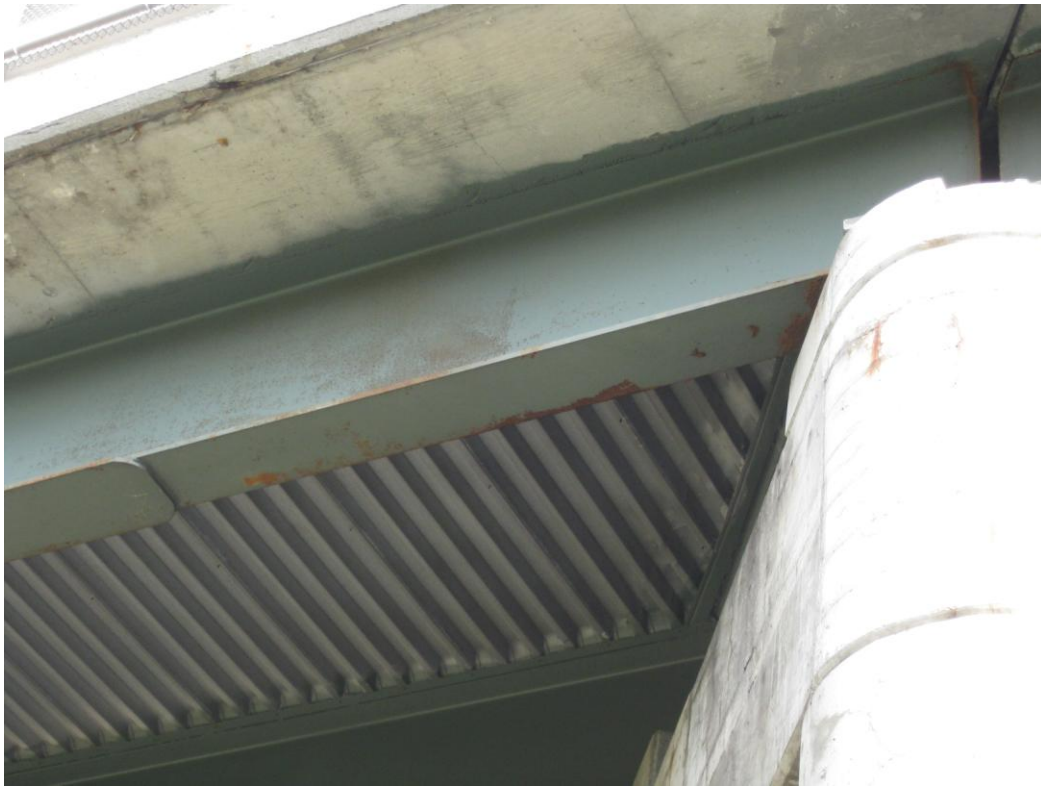
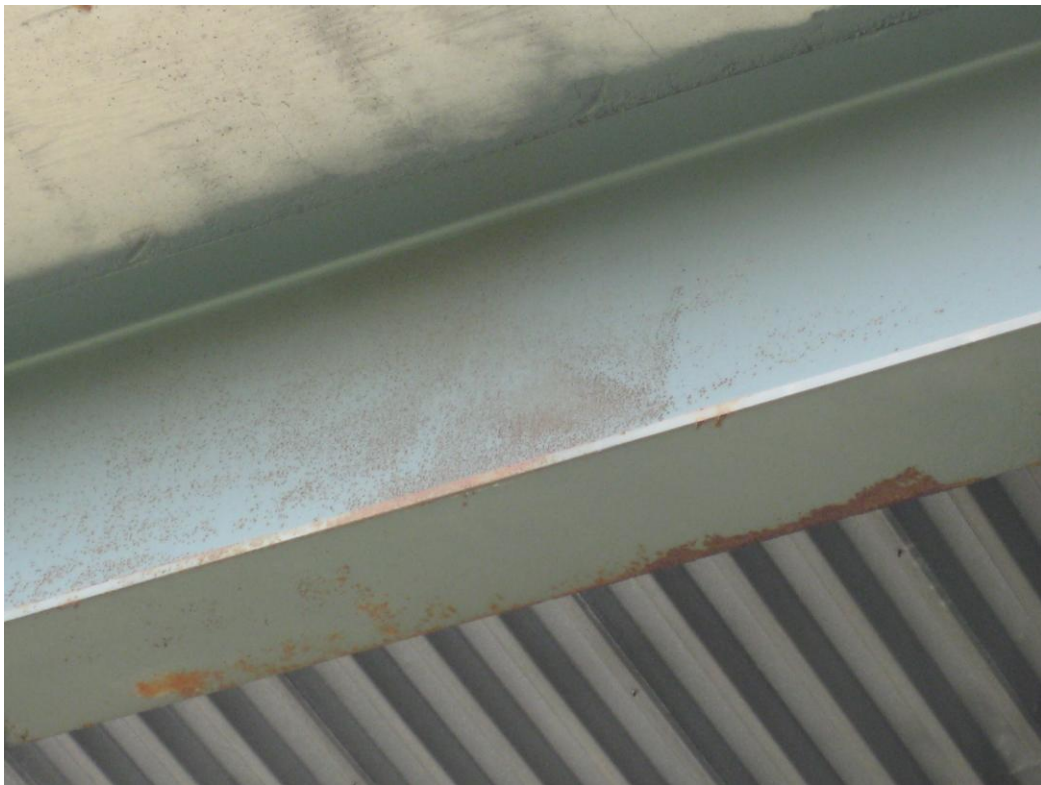
General Paint Condition 10 9 8 7 6 5 4 3 2 1
 Rusting; especially on bottom flanges, at joints (despite scuppers & SP-5 prep), & at bearings. Paint still soft & waxy, dull & dirty, especially bottom flange. (see figures 1 – 38, pages 3 – 21) Details of late 2002 paint prep and application are presented on page 2.

Surface Rust 10 9 8 7 6 5 4 3 2 1
 Rusting; especially on bottom flanges, at joints & at bearings (see figures 1 – 29 & 33-38, pages 3 – 17 & 19 – 21)

General Remarks: (10 = excellent; 1 = poor)
 Considering the relatively mild conditions presented by this bridge (high bridge over low traffic, slow freight trains with scuppers at joints), the performance after ten years was disappointing, especially in comparison to our 3-coat organic zinc-rich / epoxy / urethane system. Rusting was evident even at the support piers, which were SP-5 blasted, and protected from leaking bridge deck joints by drainage scuppers.
