Transportation Research Synthesis

TRS 2302

February 2023

USE OF HOT WATER PRESSURE WASH SURFACE PREPARATION AND HRCSA COATINGS IN BRIDGE MAINTENANCE

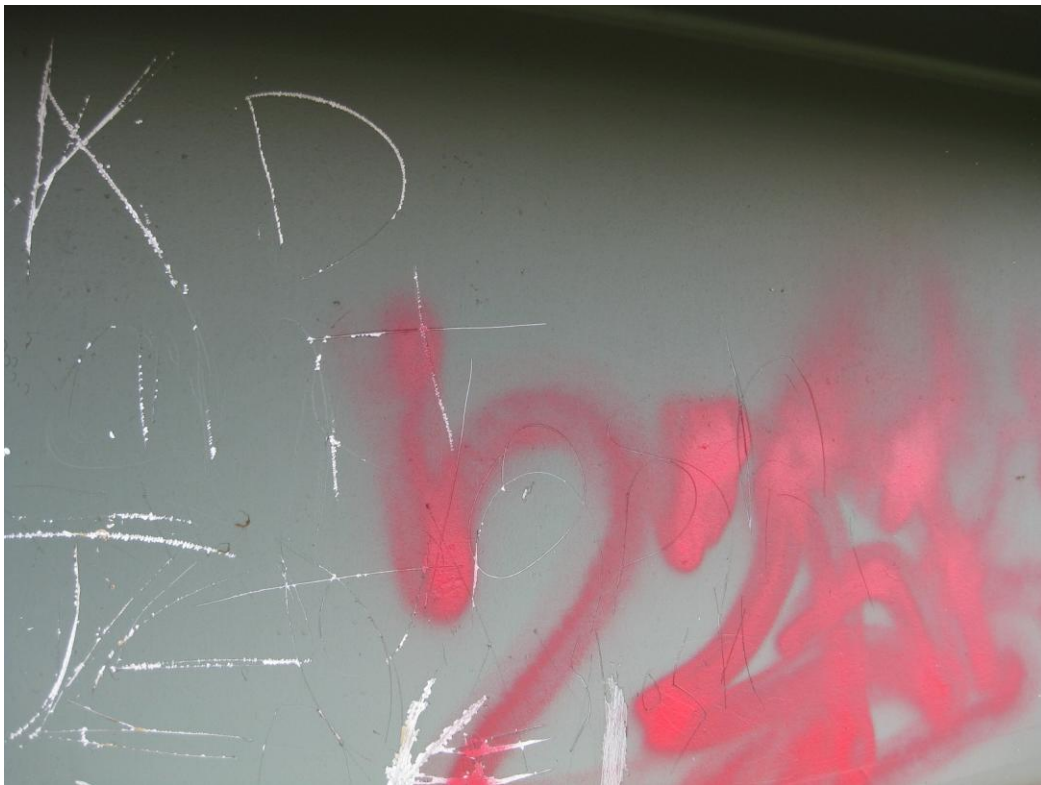
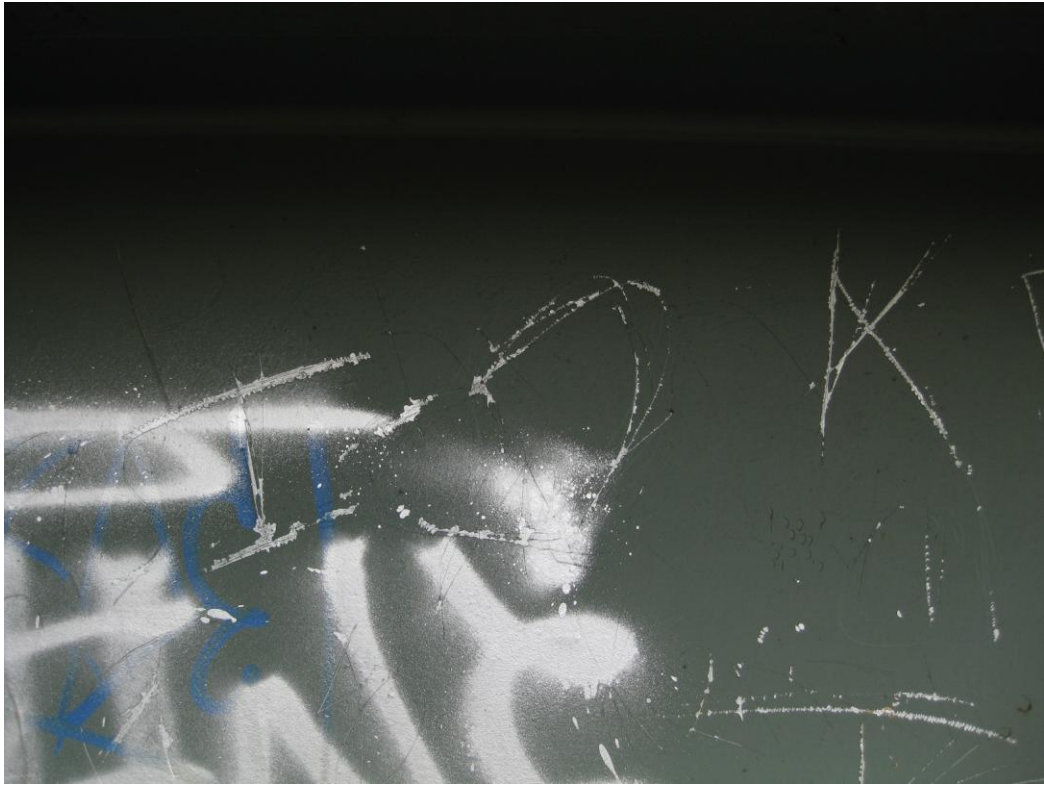
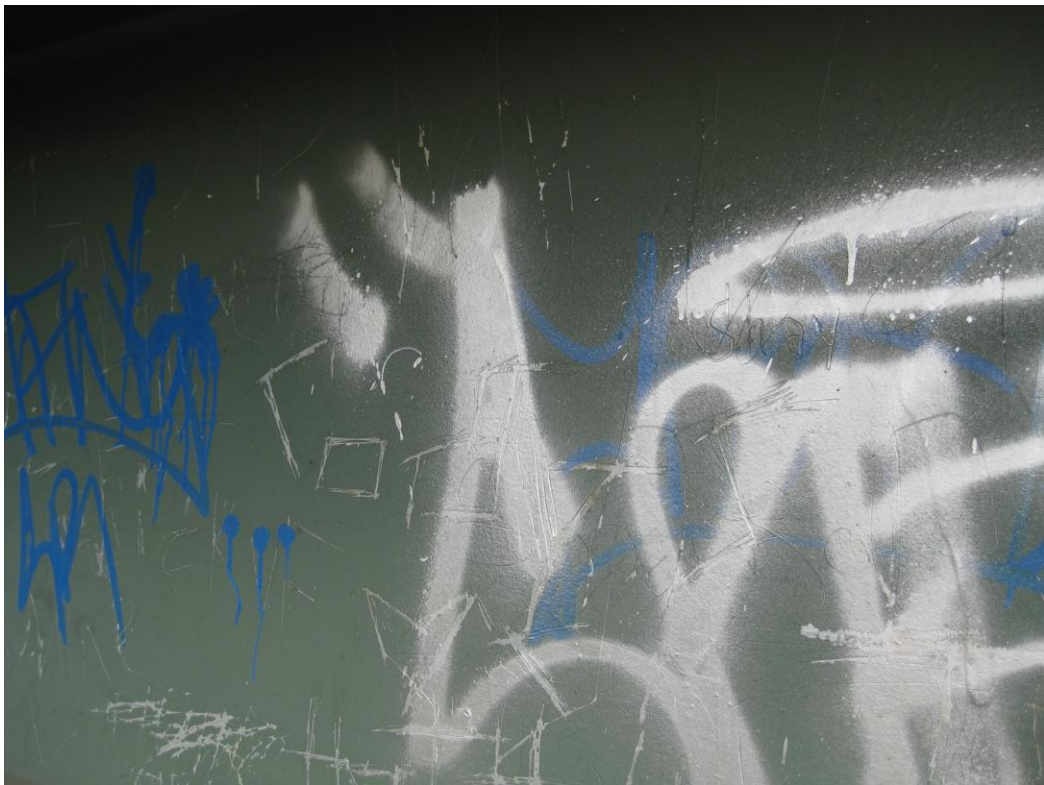
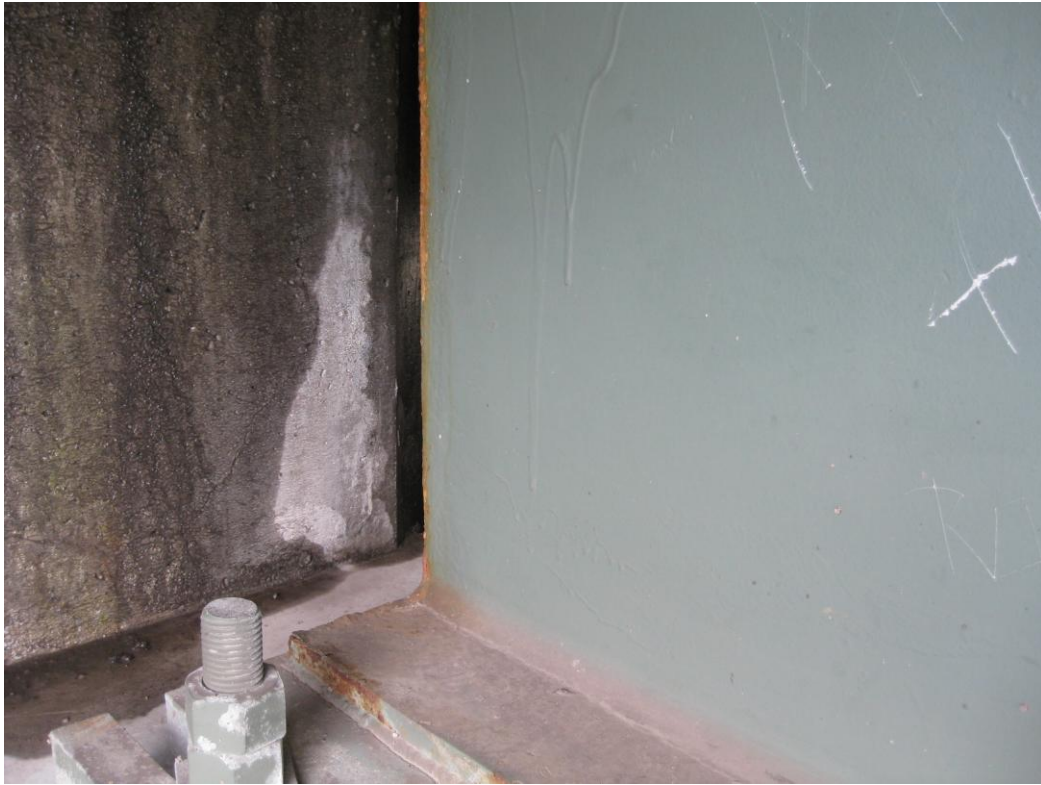
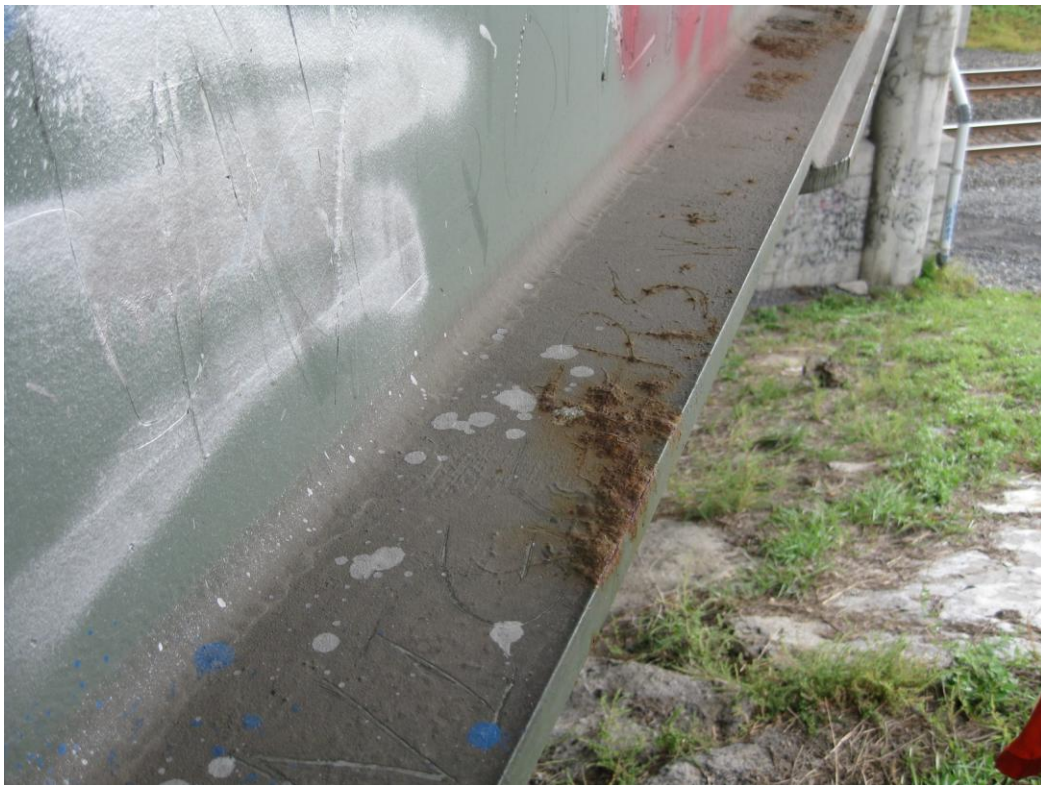
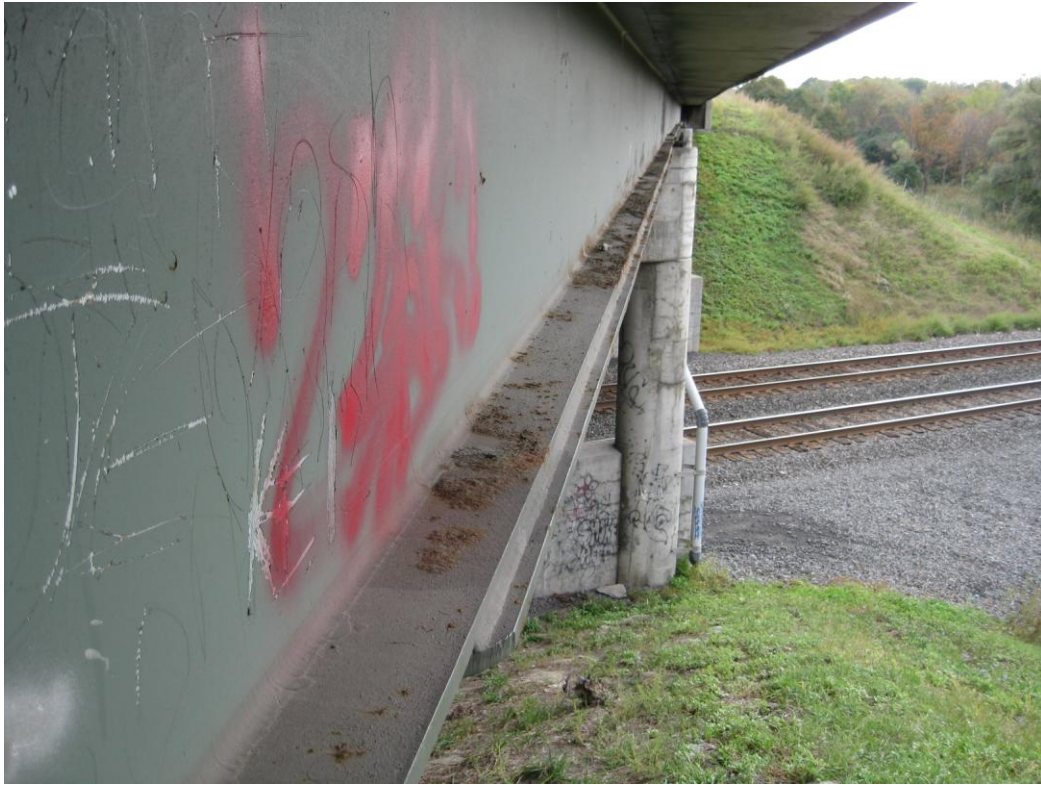
General Paint Condition 10 9 8 7 6 5 4 3 2 1
 Rusting; especially on bottom flanges, at joints (despite scuppers & SP-5 prep), & at bearings. Paint still soft & waxy, dull & dirty, especially bottom flange. (see figures 1 – 38, pages 3 – 21) Details of late 2002 paint prep and application are presented on page 2.

Surface Rust 10 9 8 7 6 5 4 3 2 1
 Rusting; especially on bottom flanges, at joints & at bearings (see figures 1 – 29 & 33-38, pages 3 – 17 & 19 – 21)
