Performance of Concrete Overlays over Full Depth Reclamation

MARCH 2023

Final Report NRRRA202301

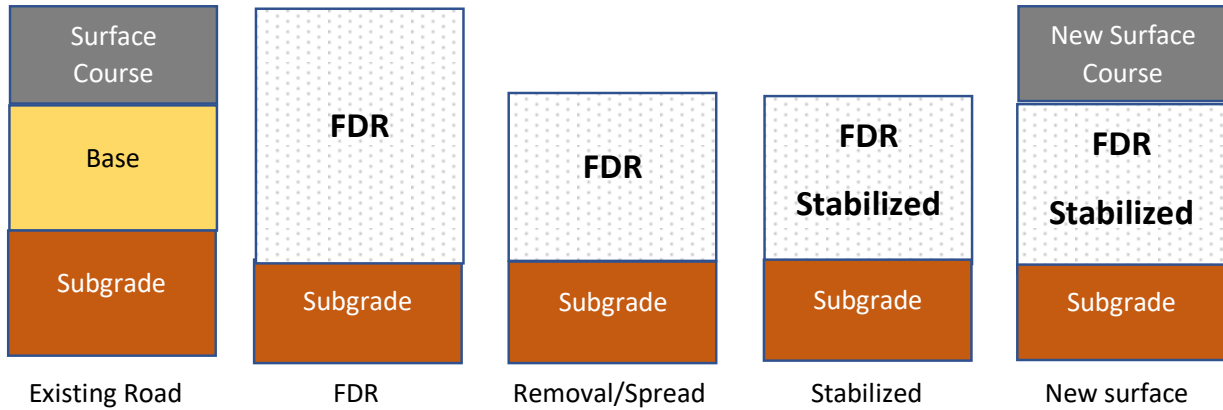
Figure 1.2 FDR construction process for asphalt pavement sections

The FDR construction process is shown in Figure 1.2. Depending on the desired geometry and level of the existing pavement surface, part of the existing surface course may be removed prior to reclamation to lower the pavement profile. Additionally, extra pulverized material can be used to build shoulders, turn lanes, etc. A stabilizing agent may also be added to the FDR material to increase stiffness.

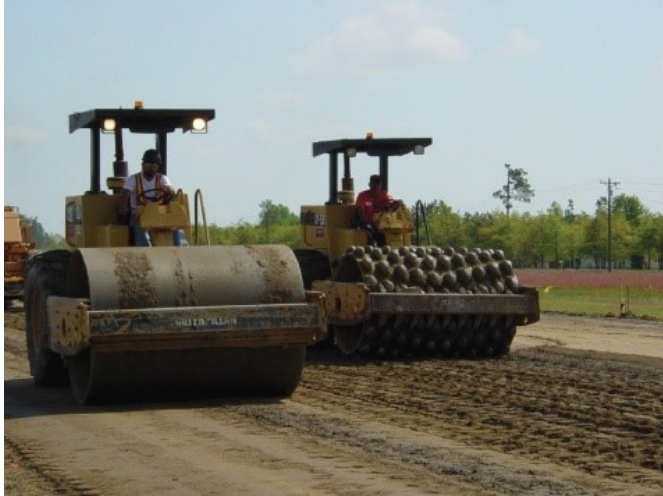
Figure 1.6 Final compaction (4)

Figure 1.5 shows two examples of the pulverized base left behind the reclaimer. After pulverizing the FDR layer and (if specified) adding the stabilizing agent, the FDR layer is compacted as close as possible to the maximum dry density. An example of compaction of FDR is shown in Figure 1.6.

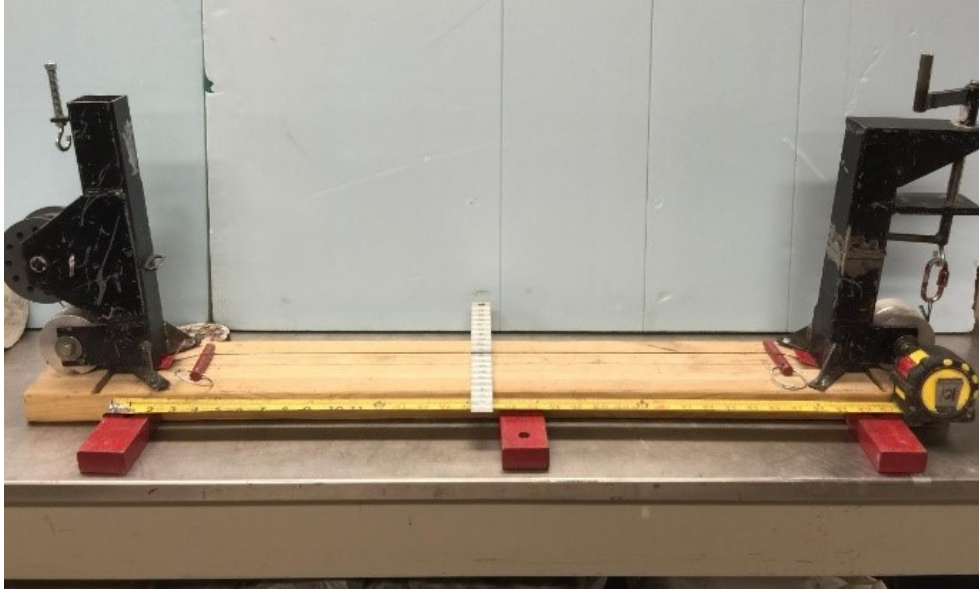
Figure 2.1 Portable device for measuring curling and warping (14)

At the Freeborn County, MN project, a visit was made to perform a visual survey to document typical field conditions of the CSAH 46 project by taking photos and noting distresses such as transverse and longitudinal cracking. Slab curling measurements were also performed using a portable device developed by Ceylan et al. (14). The device consists of a string connected by hollow steel columns that are placed at the edges or corners of the slab, allowing for measurements of the displacement between the string and the surface of the pavement. The curling behavior can be characterized by looking at the difference between the displacement at the interior of the slab compared to the edges of the slab. This device is pictured in Figure 2.1.

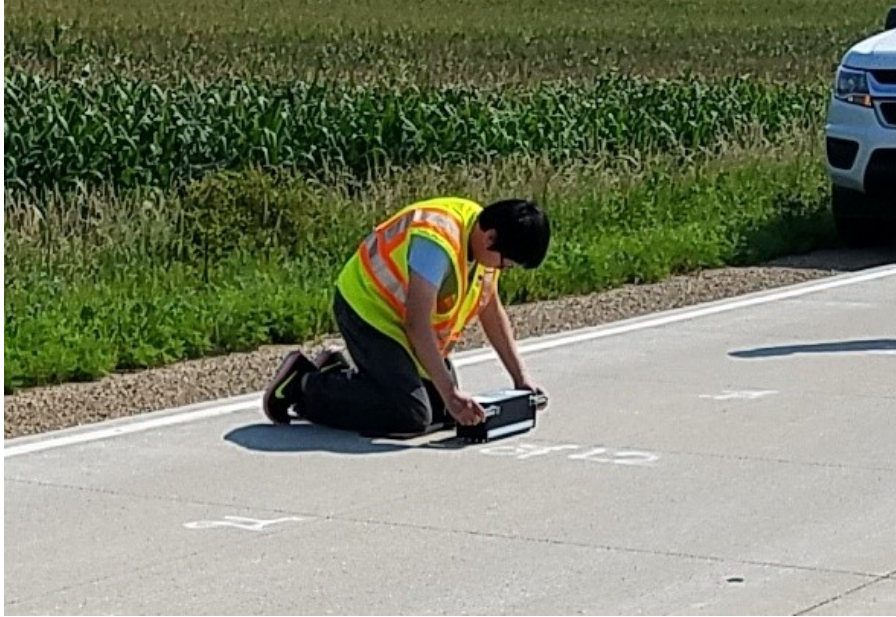
Figure 2.4 Testing of a concrete pavement surface with MIRA

Two common applications of MIRA for concrete pavements include determination of layer thickness (18) and evaluation of bond between two layers (19). The MIRA device was used in this study to estimate the thickness of the concrete overlay. In the case of this project, the different natures of the concrete and FDR layers were such that it was likely not possible to use MIRA to infer whether they might be physically bonded to each other. Testing of a concrete pavement surface with the MIRA device is pictured in Figure 2.4.

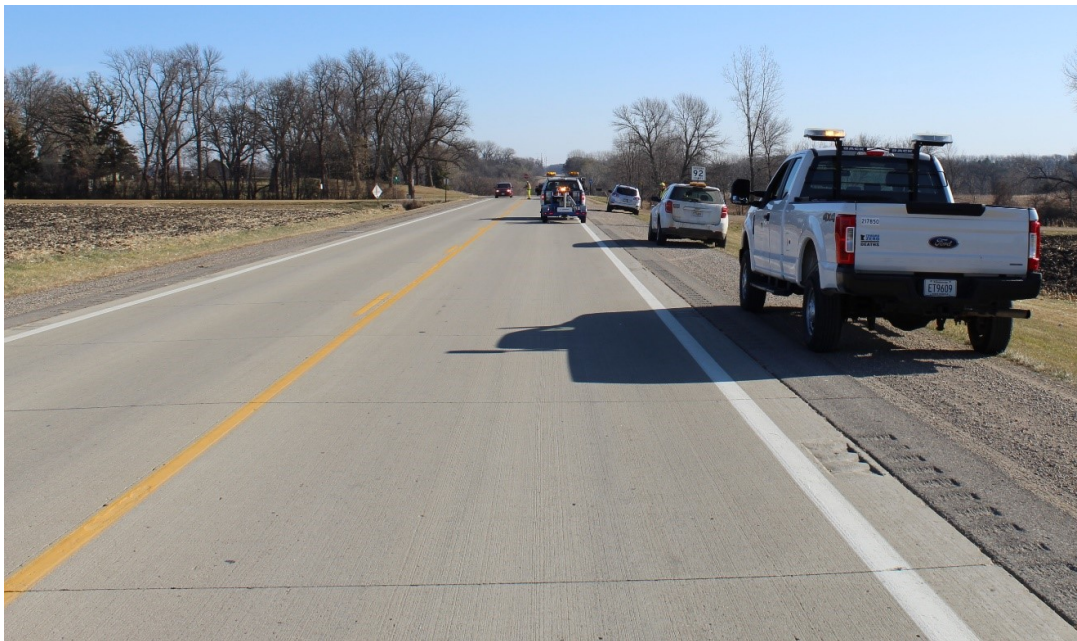
Figure 2.7 CSAH 46 typical project conditions

On November 5th, 2020, the research team and MnDOT personnel visited this project to perform a visual survey, FWD testing, and to collect MIRA measurements. Figures 2.7 through 2.10 contain photos showing the typical condition of the pavement at the time of the survey. While no detailed distress survey was carried out to categorize and quantify the prevalence of different distress types, etc., a number of instances of longitudinal cracking were noted throughout the project, as shown in Figures 2.8 through 2.10.

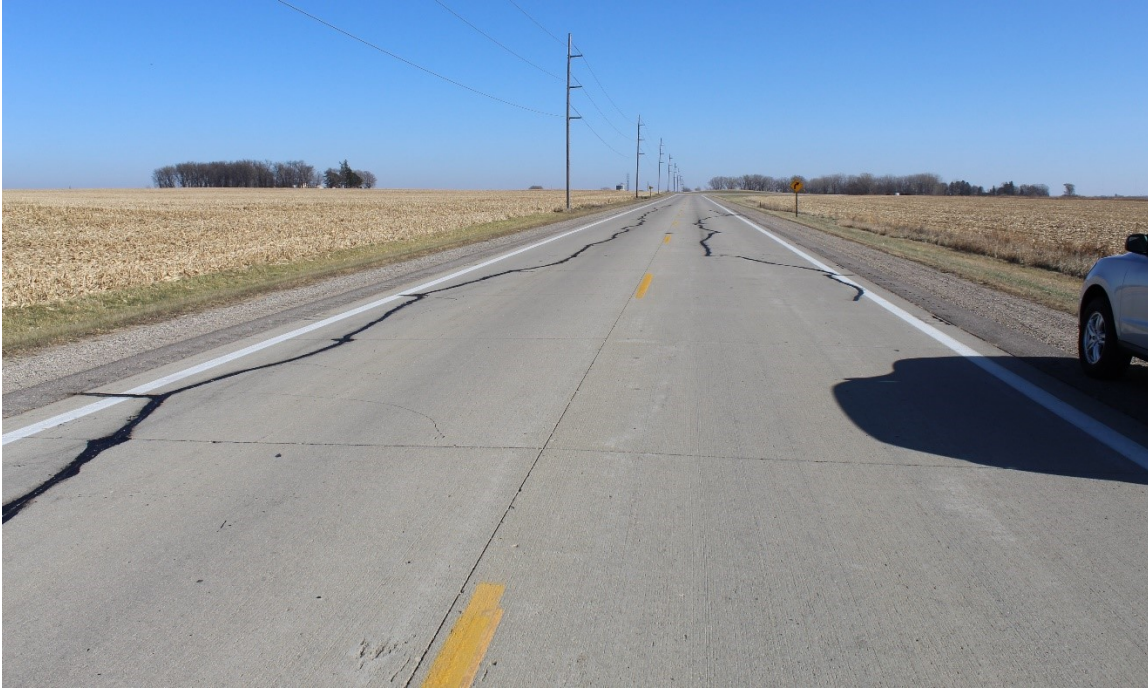
Figure 2.8 CSAH 46 typical project conditions showing longitudinal cracking

The longitudinal cracks occurred both at mid-panel locations as well as closer to the edge of the slab under the outer wheel path. Cracks tended to run continuously through several slabs at a time, continuing across the transverse joints for lengths ranging from 45 to 150 ft. Cracks sometimes terminated at transverse joints, like in Figure 2.9, while other times they turned out and terminated at the pavement edge or developed branches that ran to the edge, which can be seen in Figures 2.8 and 2.10.

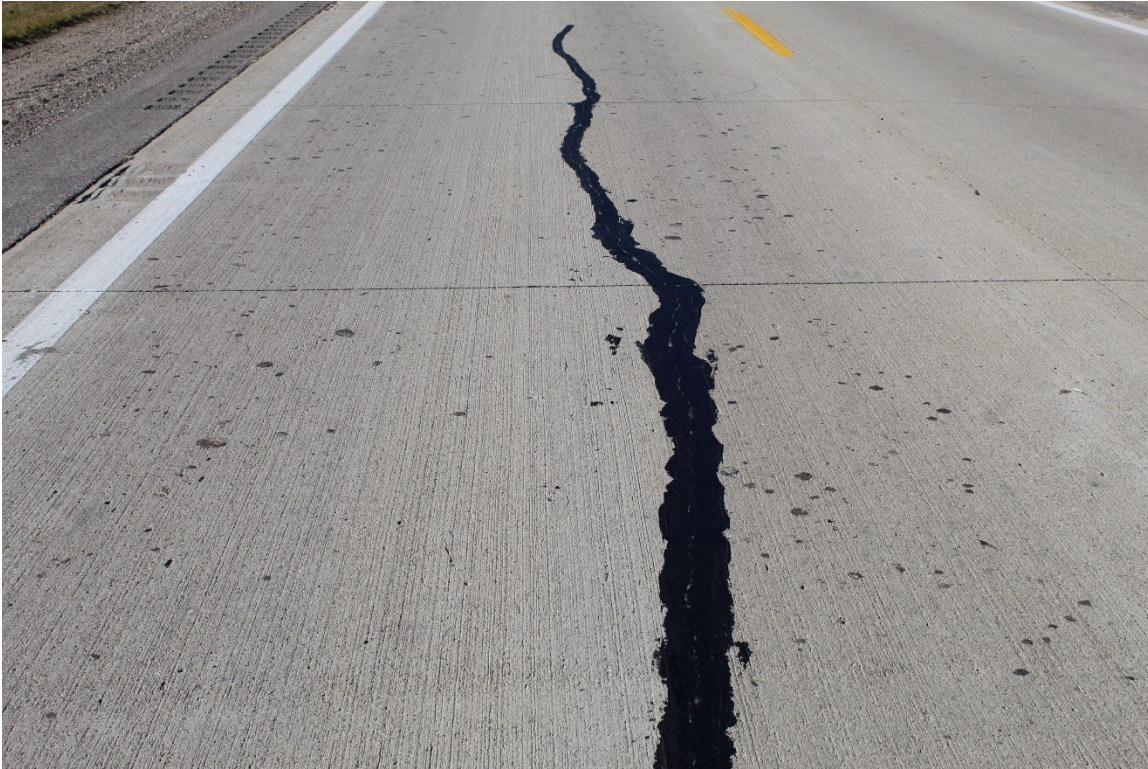
Figure 2.9 Close-up view of longitudinal crack filled with sealant

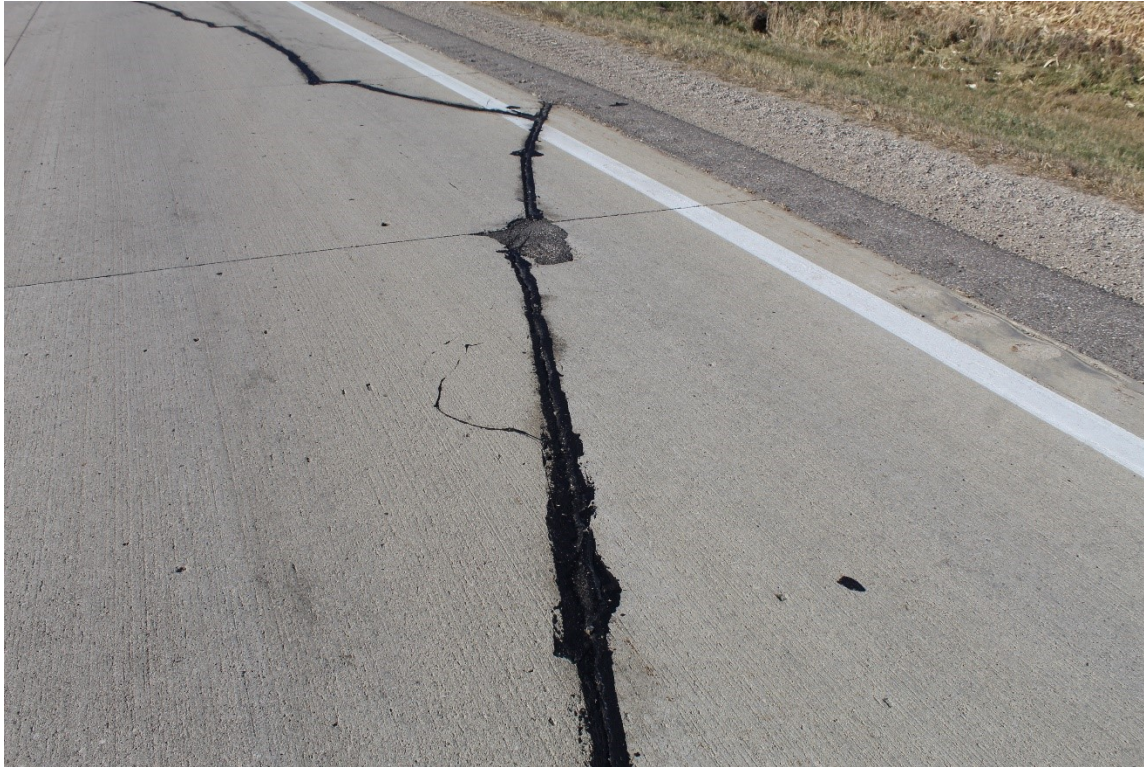
Figure 2.10 Longitudinal crack with spalling at intersection with transverse joint near location of dowel bars

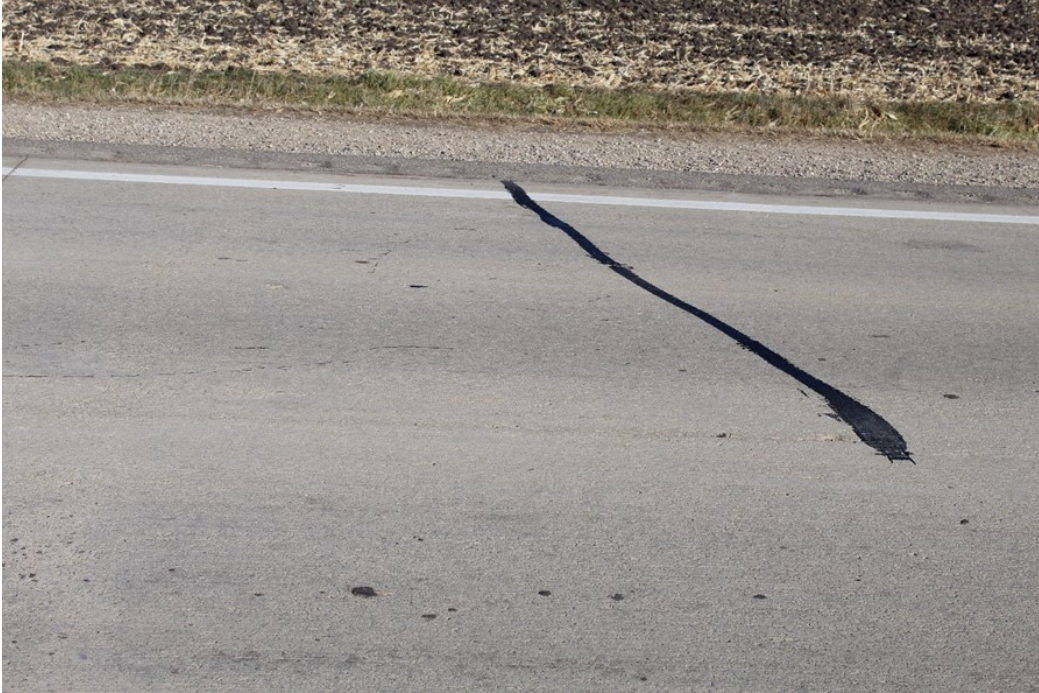
Figure 2.11 Transverse crack on CSAH 46

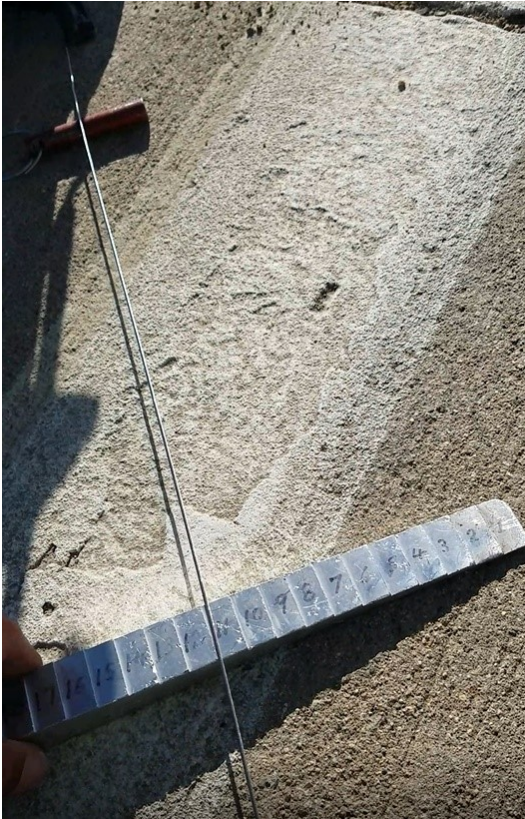
Figure 2.12 Curling measurement performed at slab corner on CSAH 46

During the visual survey, curling measurements were performed on four slabs using the portable device developed by Ceylan et al. (14). The measurements were performed between 10:00 am and 2:30 pm. Curling was measured longitudinally along the outside edge of the slab, longitudinally down the middle of the slab, and diagonally across the slab. Each slab was only measured once, so these measurements only provided an indication of slab curling in the middle of a late fall day without insight into how the profile might change at different times or seasons. Figure 2.12 shows a diagonal curling measurement performed at the slab corner.

Each slab was curled upward. The maximum changes in elevation between the interior of the slab and the edges/corners of the slab ranged from 0.05 to 0.10 inches when measured longitudinally, to 0.10 to 0.15 inches when measured diagonally. While this test method does not have an established scale to correlate the readings to the degree or severity of curling, these measurements were consistent with typical measurements for full-depth concrete pavements included in the study by Ceylan et al. (14). In the context of the pavement smoothness and joint load transfer measurements (which are discussed in the next section), it did not appear that the extent of curling at this project was notably small or large.

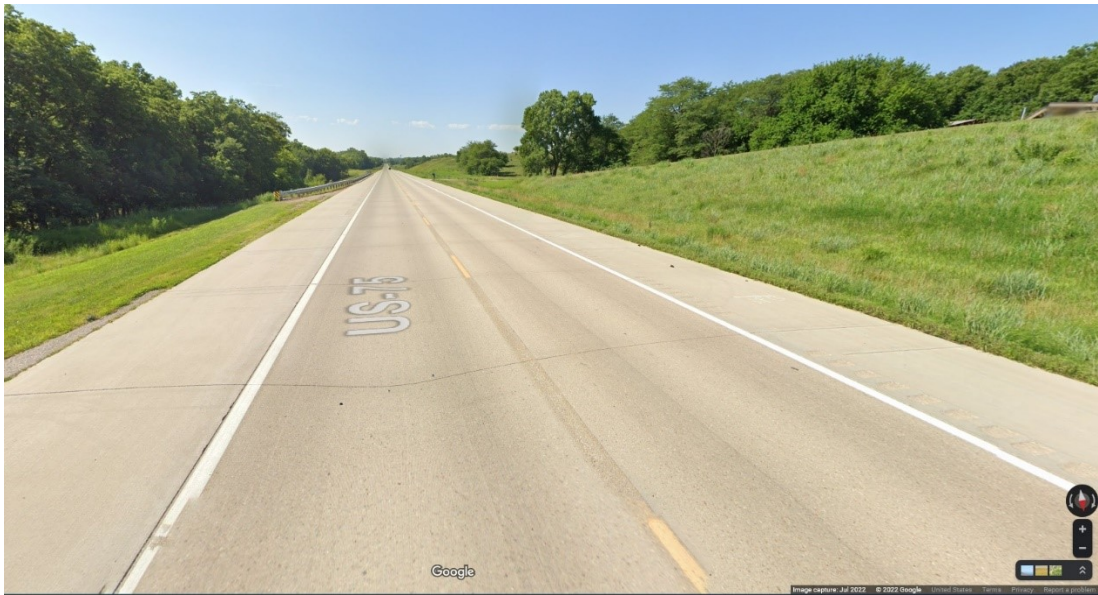
Automated pavement condition data collected for US 75 in 2015 and 2020 are listed in Table 2.9. Measurements include IRI and average faulting. As seen in the table, pavement roughness has increased over time, but the ride was very smooth from an early age thanks to the initial diamond grinding and has remained smooth with low average faulting values. As of 2022, no significant distresses have been reported for this pavement, and a current Google street view image is included in Figure 2.15.

Figure 2.15 Current condition of US 75

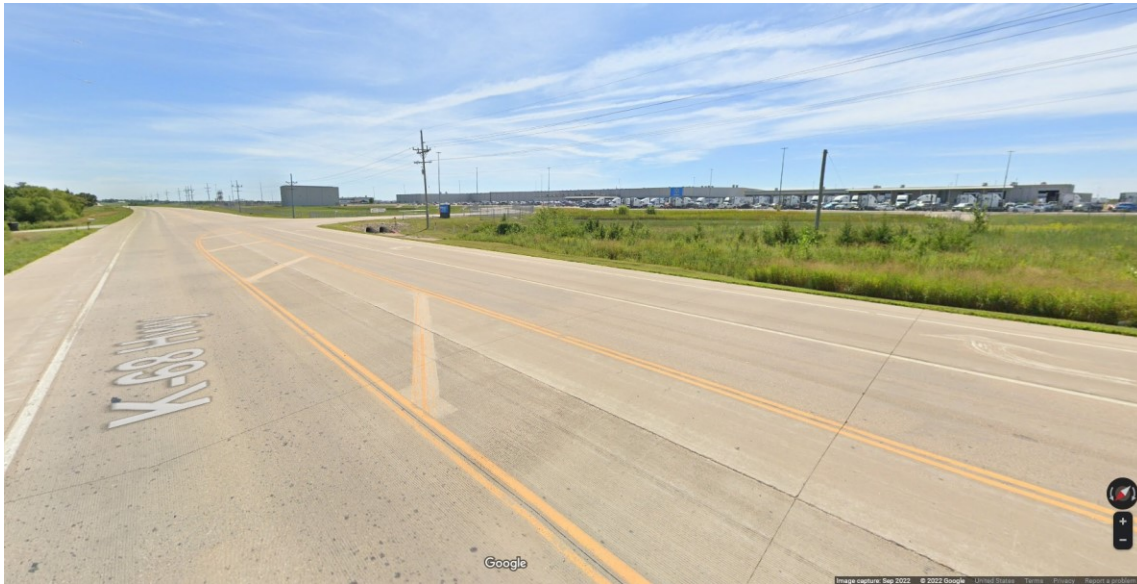
Automated pavement condition data collected for K-68 in 2015 and 2020 are listed in Table 2.11. Measurements include IRI and average faulting. As seen in the table, the pavement has exhibited good ride quality and IRI and faulting has remained steady with time. As of 2022, no significant distresses have been reported for this pavement. A current Google street view image is included in Figure 2.18.

Figure 2.18 Current condition of K-68

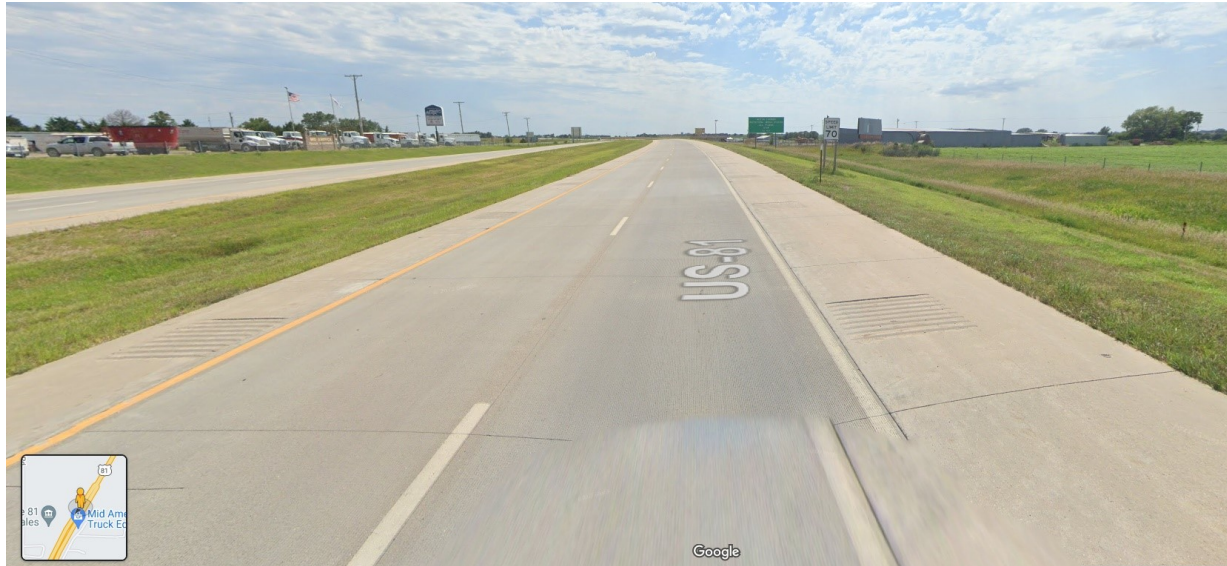
Automated pavement condition data collected for US 81 in 2018 and 2020 are included in Table 2.13. Data include IRI and average faulting, which were averaged across both the NB and SB lanes of the divided highway. As seen in the table, both IRI and faulting have remained steady since construction. As of 2022, the only distresses that have been reported for this pavement are some joint deterioration and cracking in pavement placed at a center turn lane area. No distresses have been reported in the mainline pavement, which is pictured in Figure 2.20.

Figure 2.20 Current condition of US 81

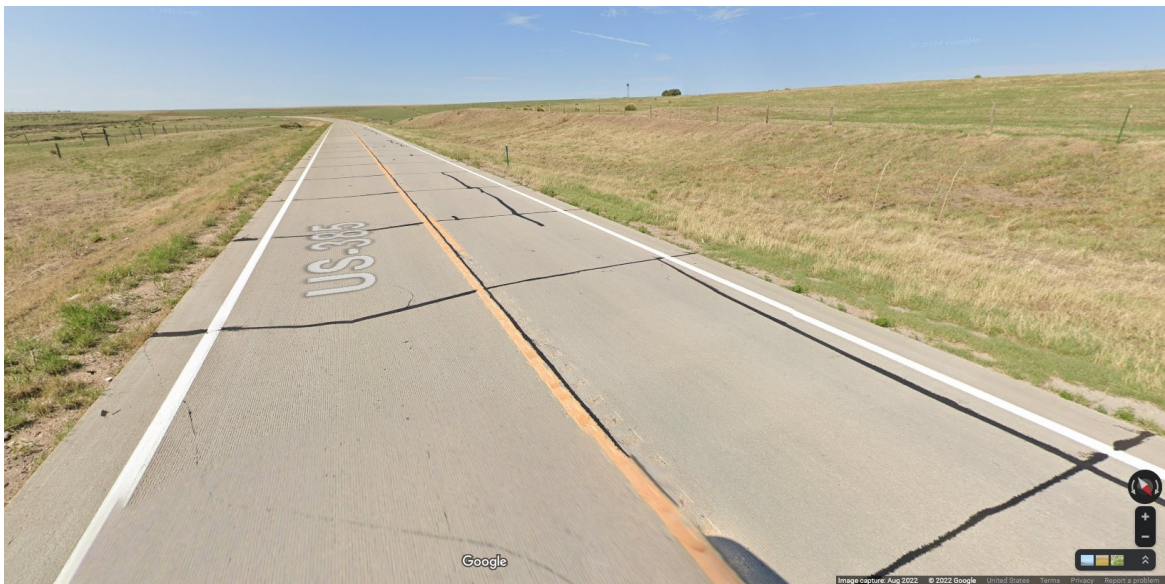
This pavement has also appeared to experience some longitudinal cracking, although the severity and extent of this cracking is not clear. A Google street view image of the current condition of the pavement is shown in Figure 2.25, which shows that the longitudinal cracks and transverse joints have been filled with sealant.

Figure 2.25 Current condition of US 385

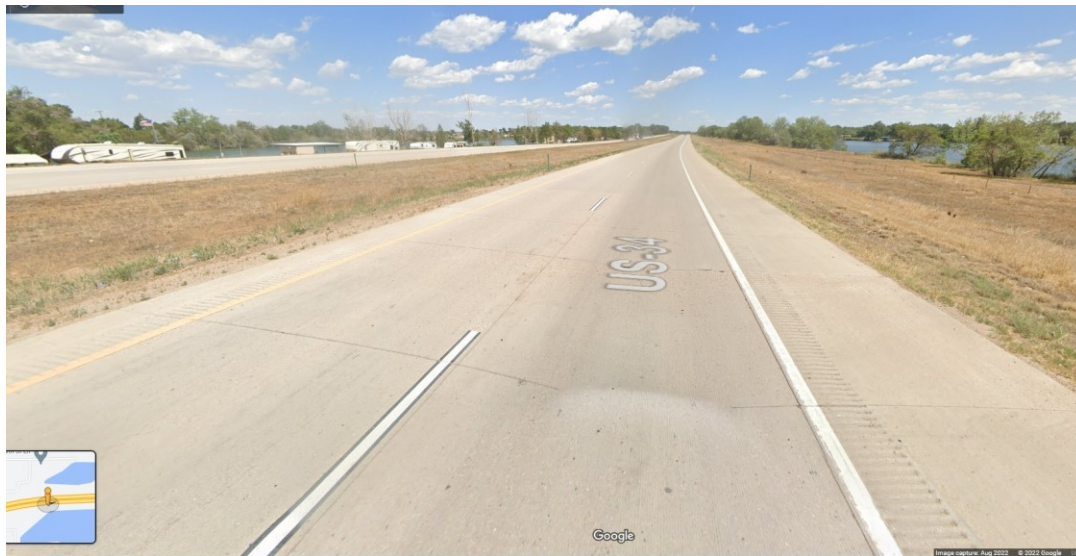
As of 2022, no other distresses have been reported for this pavement. A Google street view image of its current condition is shown in Figure 2.27.

Figure 2.27 Current condition of US 34

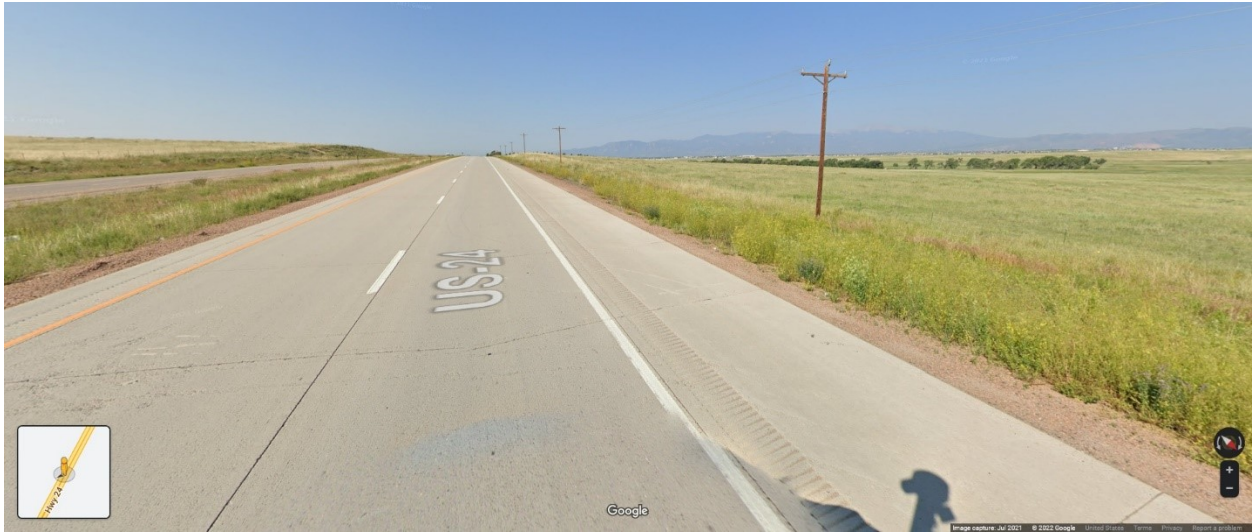
Pavement condition data for the US 24 project collected between 2018 and 2020 are included in Table 2.21. Only IRI data were available this project, with measurements taken on an annual basis. As seen in the table, this project demonstrated dips/spikes in IRI in its first 3 years in service. During construction, the contractor noted significant curling behavior shortly after placement similar to the US 34 project, including significant variations in the profile between the morning and afternoon. No distresses have been reported for this pavement as of 2022, and a Google street view images of its current condition is shown in Figure 2.29.

Figure 2.29 Current condition of US 24

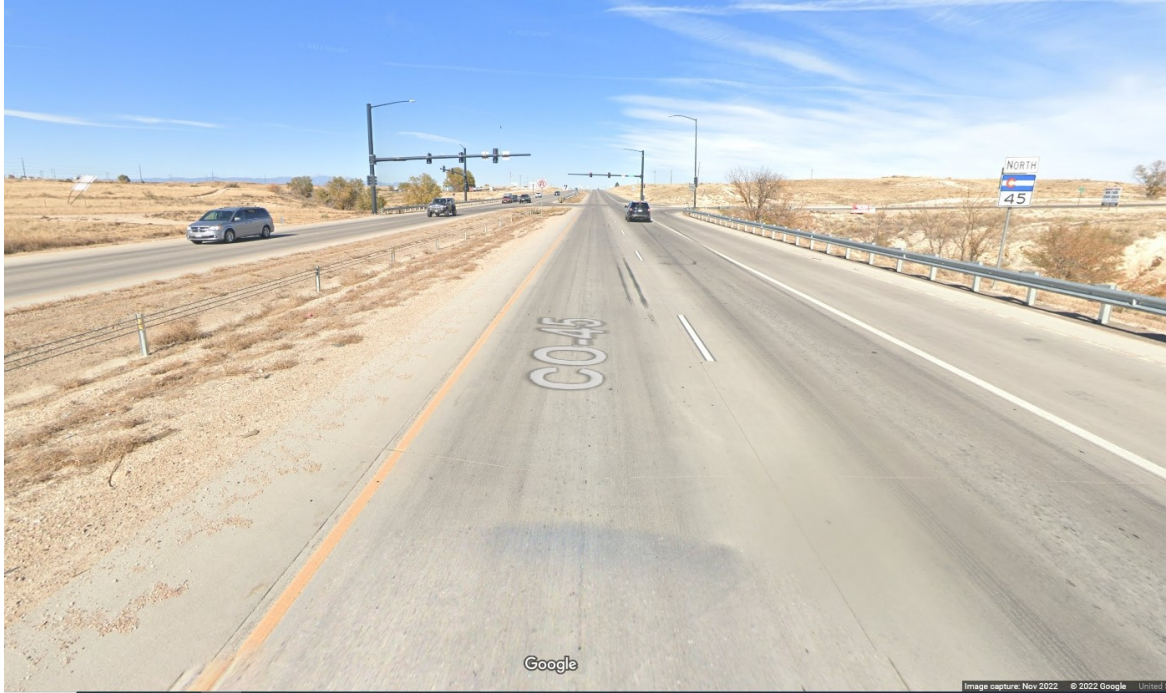
Pavement condition data for SH 45 collected between 2018 and 2020 are included in Table 2.23. Only IRI data were available for this project, with measurements taken on an annual basis. This project demonstrated a rapid increase in IRI in its first 3 years in service. The contractor also noted significant curling behavior on this project shortly after placement, so it is difficult to distinguish whether pavement roughness might be increasing with time or whether significant curling is causing large variations in data collected year-to-year. In either case, IRI values over 100 in/mi after 2 to 3 years in service are unusually high. No other distresses have been reported for this pavement as of 2022, and a Google street view image of its current condition is shown in Figure 2.31.

Figure 2.31 Current condition of SH 45

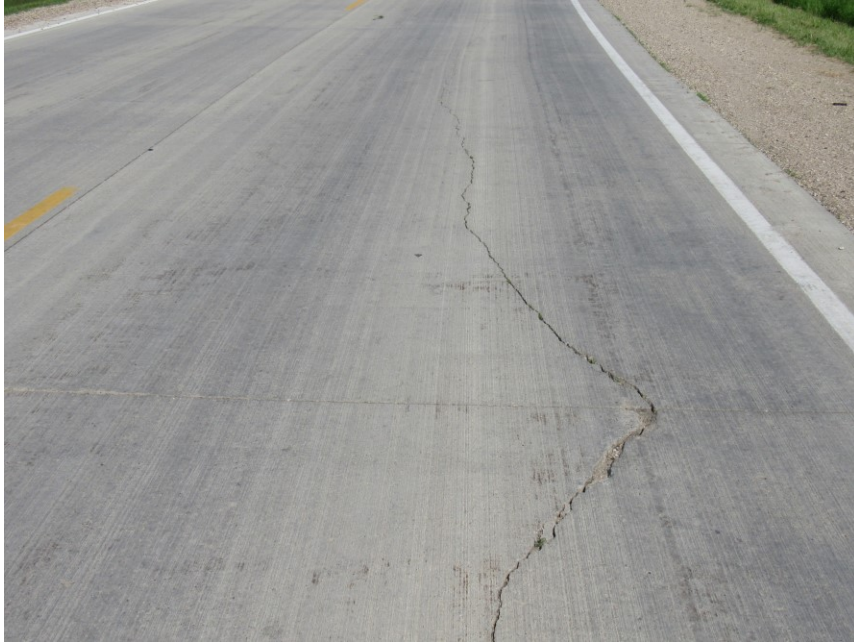
Figure 2.33 Longitudinal cracking on a COA overlay on a different section of CSAH 46 in Freeborn County, MN

A cause was not determined for the longitudinal cracking at CSAH 46 or US 385. The cracking on the overlay of FDR on CSAH 46 actually closely resembled longitudinal cracking that also occurred on a conventional COA overlay that was 6 inches thick on a different section of CSAH 46 in Freeborn County west of Albert Lea. An example of the longitudinal cracking on the COA overlay section is pictured in Figure 2.33.
