FINAL REPORT ~ FHWA-OK-22-04

# SHRINKAGE INDUCED DEFORMATIONS IN STEEL BRIDGES MADE COMPOSITE WITH CONCRETE DECK SLABS

Civil Engineering and Environmental Science  
Oklahoma State University  
Stillwater, Oklahoma

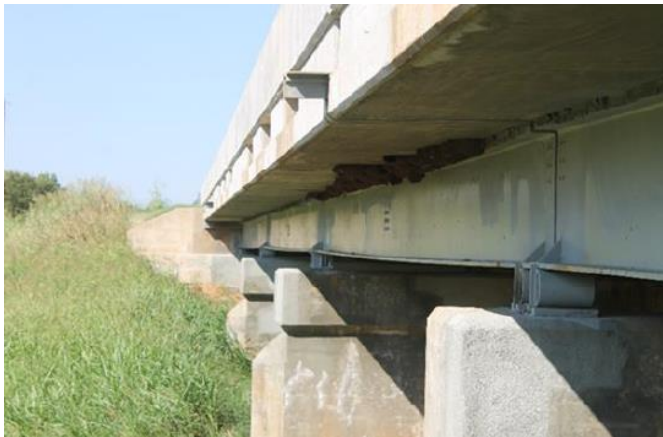
**Figure 3.1. SH 14 Over Eagle Chief Creek, Bridge "A", Woods Co., Oklahoma. View lkg South**

elevation changes within the driving lanes, and to also help determine causes for possible adverse beam deflections. In **Error! Reference source not found.**, the girders possess a visible sag, perhaps in place from earlier construction or perhaps developed over the period of long service prior to the retrofit. Elevations at the bottoms of the beams were measured, and these confirmed that the bottoms of the beams have lower elevations at midspan than at supports.

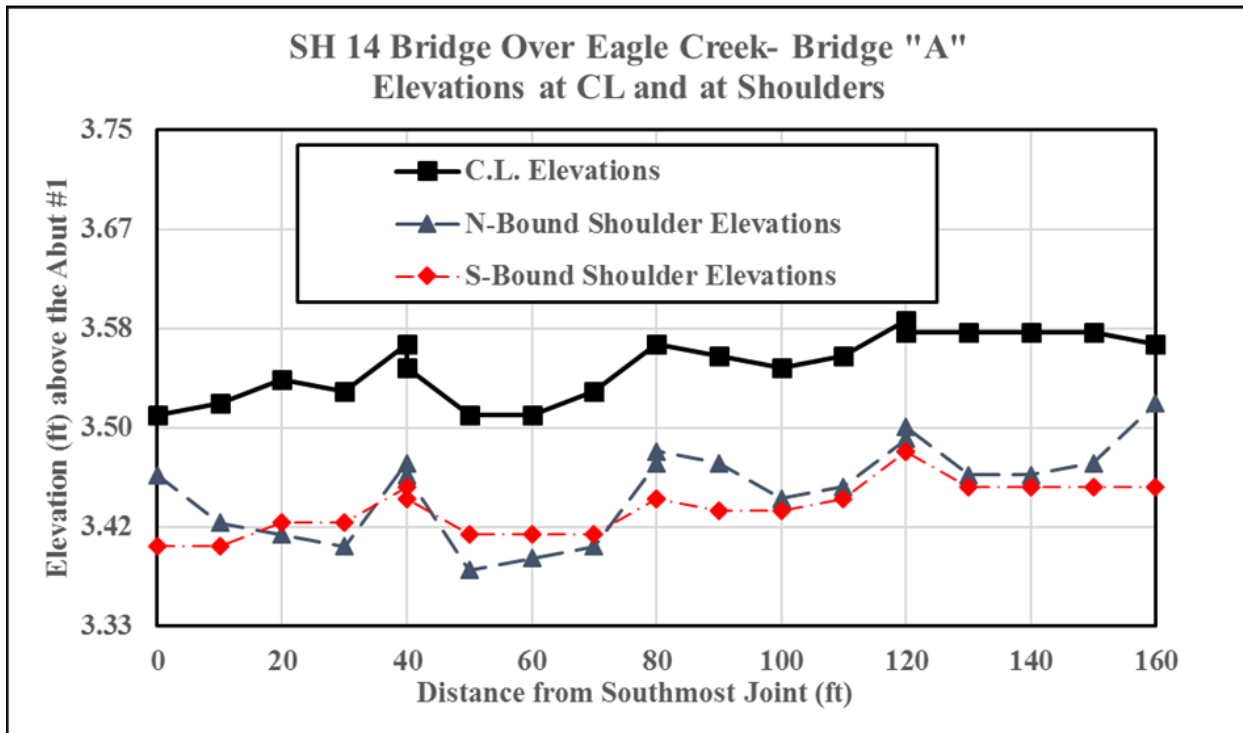
Figure 3.2 Elevations of the Bridge Deck, C.L. and Shoulders (ft. above the S. Abutment)

Figure 3.2 charts the elevations of the Bridge Deck at Centerline (C.L.), and at both shoulders. Elevations are shown in feet (ft) above the South Abutment. The chart shows the “dips” that occur in the middle portions of each of the three spans, and also shows that the “dips” for each span are evident at the Roadway C.L. where Span 2 “dips” from 3.57 ft. to 3.51 ft., or 6 in. The charts in Figure 3.2 also shows that the “dips” occur at both the N-Bound Shoulder and the S-Bound Shoulder. Figure 3.2 essentially shows the “picture” of the data found in Table 3.1

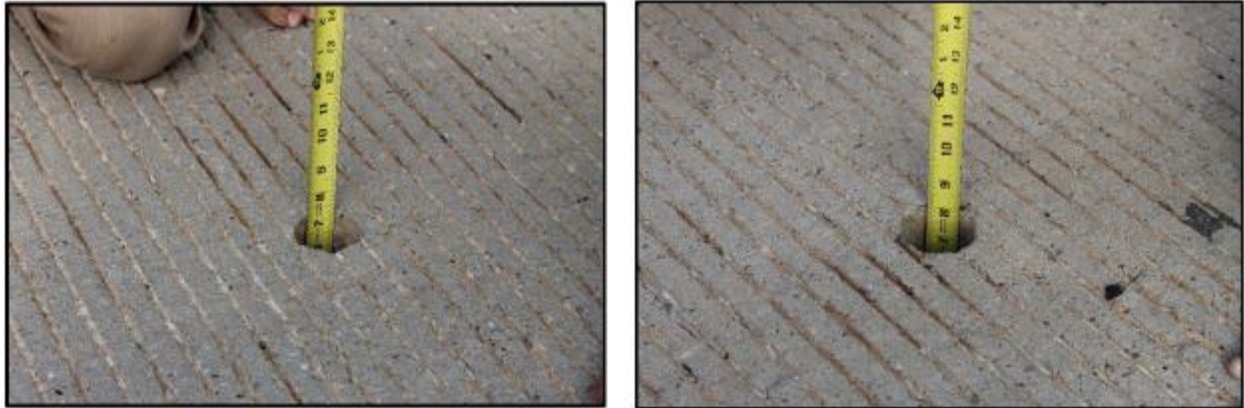
Pre-existing core holes were discovered in Span #2 and Span #4 at the center of the northbound driving lane. Figure 3.3 shows photographs of measurements made on deck thickness at two separate holes found pre-existing in the deck slab. Thicknesses at the core holes were measured at approximately 7.25 in. in Span #2 and approximately 8.25 in. in Span #4. The measured thicknesses match the slab thicknesses computed in **Error! Reference**

**Figure 3.3 Direct Measurement of Bridge Deck Slab Thickness at Pre-Existing Core Holes in Span #2 (left) and Span #4 (right)**

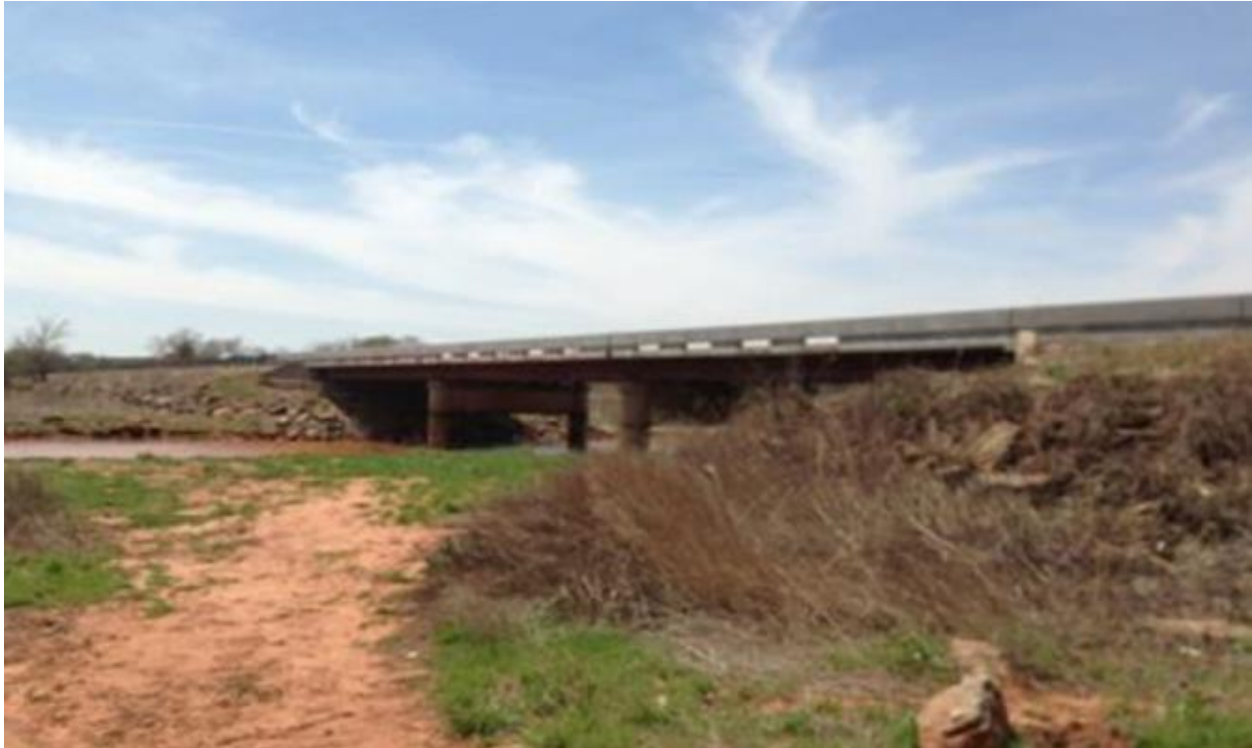
**Figure 3.4 SH 86 over Stillwater Creek, Payne Co., Oklahoma, View Lkg SW**

The SH 86 Bridge was reported by witness accounts as having ride-ability issues immediately after construction. Interviews were conducted with both the Contractor's representative and the ODOT Field Engineer. **Error! Reference source not found.** shows a photograph of the SH 86 Bridge looking southwest and spanning Stillwater Creek.

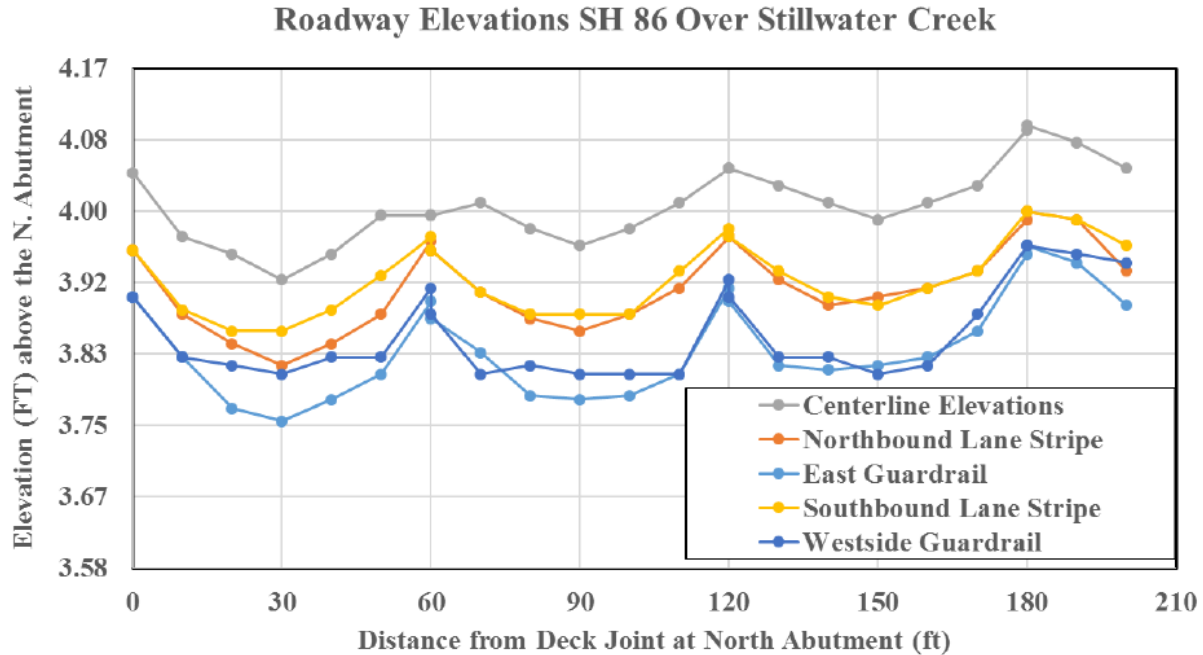
**Error! Reference source not found.** clearly shows the patterned changes in roadway elevations where the roadways “dip” approximately 0.75 in. to 1.3 in. at midspan. **Error! Reference source not found.** also shows elevation changes at the outside lane markers and at the guardrails. The figure shows a clear pattern of lower elevations at the mid-regions of the spans and “humps” at the pier supports. These elevation changes are noticeable to drivers operating at highway speeds, and likely cause concerns for safety. **Error! Reference source not found.** reports elevations measured to the bottoms of the deck slab. Elevations on the bottom of the bridge deck were taken only on the northern most span as the other two spans were inaccessible due to water from the lake. Measurements between girders were made at mid-distance between beams. Two measurements were made outside of the outside girders. One measurement was made immediately adjacent to the outside girder at approximately 13 ft – 4 in. from C.L. The measurement shown as “East (or West) Deck Edge” was made at the edge of the deck slab, taken approximately 16 ft – 6 in. from the C.L. of the bridge deck.

**Figure 3.5 Elevations of Top of Concrete Driving Surfaces, SH 86 Bridge over Stillwater Creek, Payne Co. Oklahoma**

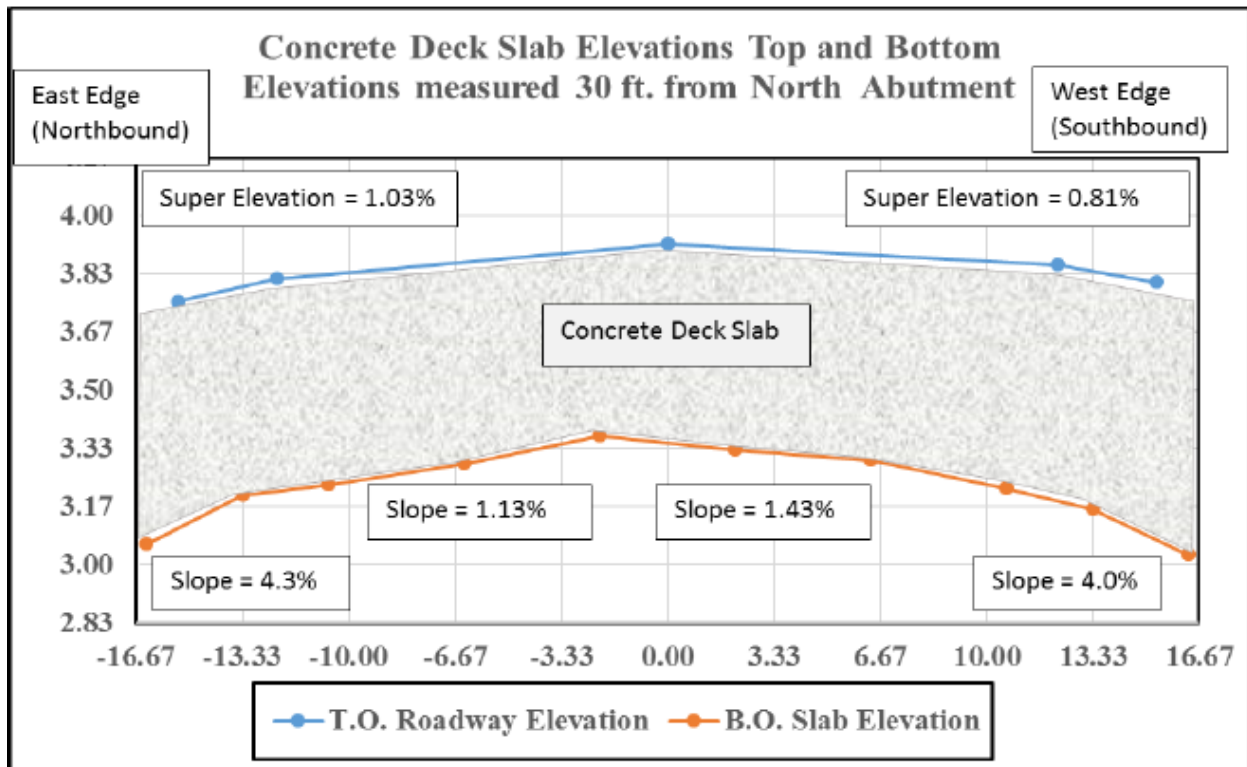
Figure 3.6 Deck Slab Profile of SH 86 Bridge, @ Mid-span of the North Span, based on Elevation Readings (0.00 = T.O. N. Abutment)

Error! Reference source not found. also charts the elevations measured at the B.O. of the concrete deck that correspond to values reported in Error! Reference source not found. at 30 ft – 0 in. from the North Abutment. Those elevations in Error! Reference source not found. are reported as: 3.06, 3.20, 3.23, 3.29, 3.37, 3.33, 3.30, 3.22, 3.16 and 3.03 feet. The concrete bridge deck resides within the space between the T.O. Deck and the B.O Deck, and the difference between the two sets of elevations provides a direct measure of the bridge deck thickness.

Error! Reference source not found. also shows the slopes on the bottom side of the cast deck slab. Slopes measured from Roadway C.L. to the outside girders are 1.13 percent and 1.43 percent on the Southbound and Northbound sides, respectively. More importantly, Error!

**Reference source not found.** reports larger slopes measured from the outside girder to the outside edge. On the Northbound side the slope is 4.3% and on the Southbound side the slope is 4.0 percent. The slopes at the bottom of the slabs are more severe, or steeper, near the edges of the slab. These regions corresponds to portions of the deck slab formwork that cantilevered from the outside girder to the edge of the slab. These intensified slopes indicate unusually large deflections of the bracing and formwork outside of the outside girder. This is significant because the screeds that set elevation controls for the finished elevations of the deck slabs are set directly upon the formwork at the outside edge of the deck slab. The data clearly show that the formwork is inadequately braced, which results in steeper slopes on the bottom of the bridge deck. In turns, these deformations are the direct cause for poor elevation control over the mid-regions of the bridge spans. Not only is poor elevation control the cause for poor ride quality, but it is also the cause for thin bridge decks which will negatively impact service life.

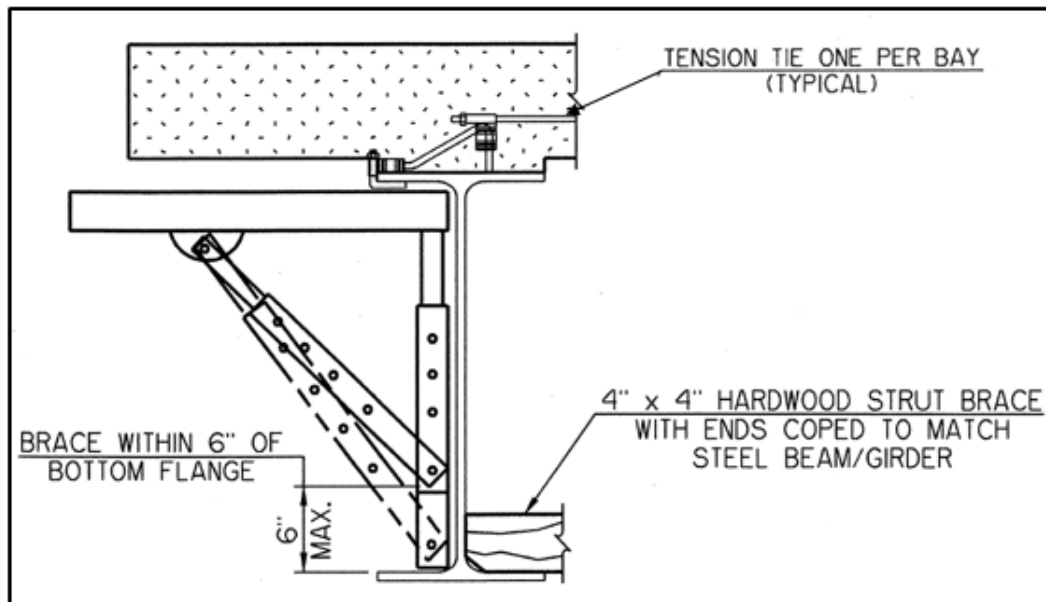
Figure 4.1: ODOT standard detail drawing for Bridge Deck Overhang Formwork Bracing (Dayton Superior Bridge Deck Handbook 2017)

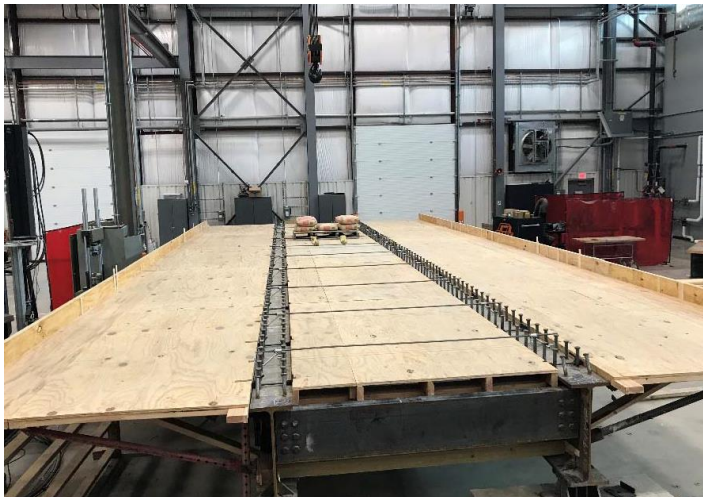
In Figure 4.3 below, the photograph shows the formwork with bracing that includes both the typical standard issue adjustable steel braces augmented with some wooden braces. Load vs. deflection measurements of the formwork were obtained with the five sacks of cement shown on the pallet that is supported by the bridge deck.

**Figure 4.3: Formwork being prepared for casting the bridge deck on the prototype bridge**

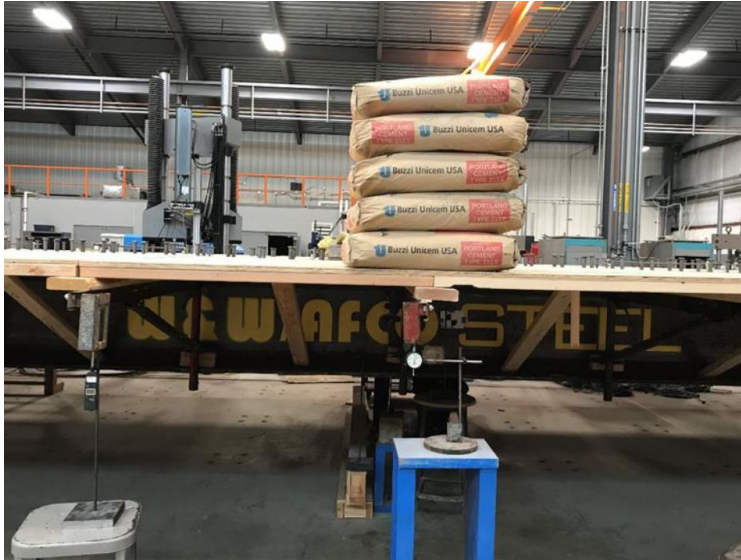
The brackets were loaded on top of the formwork at the bracing locations with increments of one cement bag at the time. Dial gages were installed to monitor the deflections in the overhang formwork and the steel girders. In addition, the lateral deflection of the steel girders due to the overhang loads were also monitored. The test was performed on both the walkway and deck locations for comparative study. For the walkway loading the overhang brackets were loaded at 5 ft. from the centerline of the girder on both sides. Both the North and South areas of the overhang formwork were loaded at mid-span bracket (about 9 ft- 5 in. from the end support), end bracket close to the East and West supports and at one quarter point bracket locations (about 4 ft- 8 in. from end support). The spacing of the overhang brackets was not varied during the time of testing. The continuity between the formwork panels and 2x4 framing was maintained and often extended on either sides of formwork panel joints.

**Figure 4.4: Cement sacks are being used to provide eccentric loading to the formwork and bracing systems in order to measure the load effects on temporary structures.**

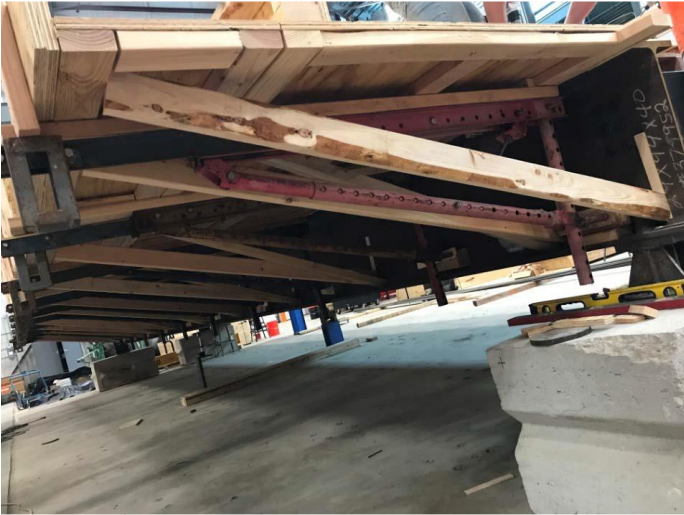
**Figure 4.5: Bracing of formwork for the cantilevers. Additional bracing shims were added to help reduce construction deflections.**

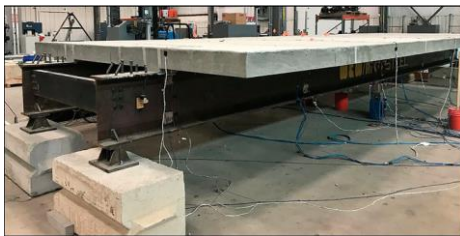
A full-sized prototype bridge was built at the Bert Cooper Engineering Laboratory. The bridge was constructed to replicate the Eagle Chief Creek Bridge “A” on SH 14 in Woods Co., Oklahoma (Figure 4.6). The Woods Co. bridge is shown in, and the full-sized prototype at the Cooper Lab is shown in Figure 4.7 . Both bridges span 40 ft from center-to-center (c/c) of bearings with 203 mm concrete decks supported by W24 × 94, ASTM A572 Grade 50 steel girders. The Woods Co. Bridge is 30'-8 wide measured out-to-out (o/o) and supported by five girder lines with 3'-8 cantilevered overhangs. The prototype bridge at the Cooper Lab has a deck 14 ft wide supported by two girders with 4 ft. cantilevered overhangs.

**Figure 4.7: Full-sized prototype at the Bert Cooper Engineering Laboratory at Oklahoma State University**

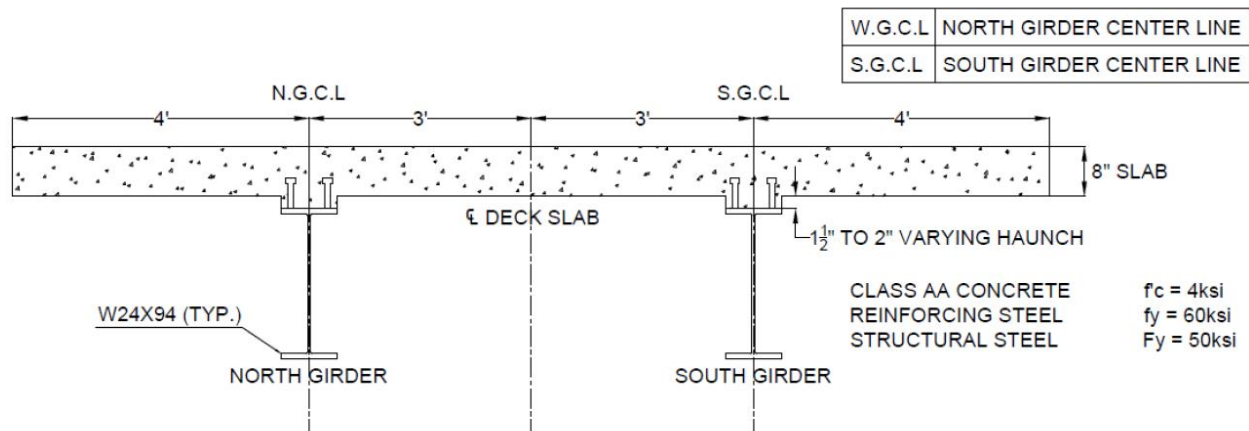
**Figure 4.8: Cross section of composite bridge section from the full-sized prototype**

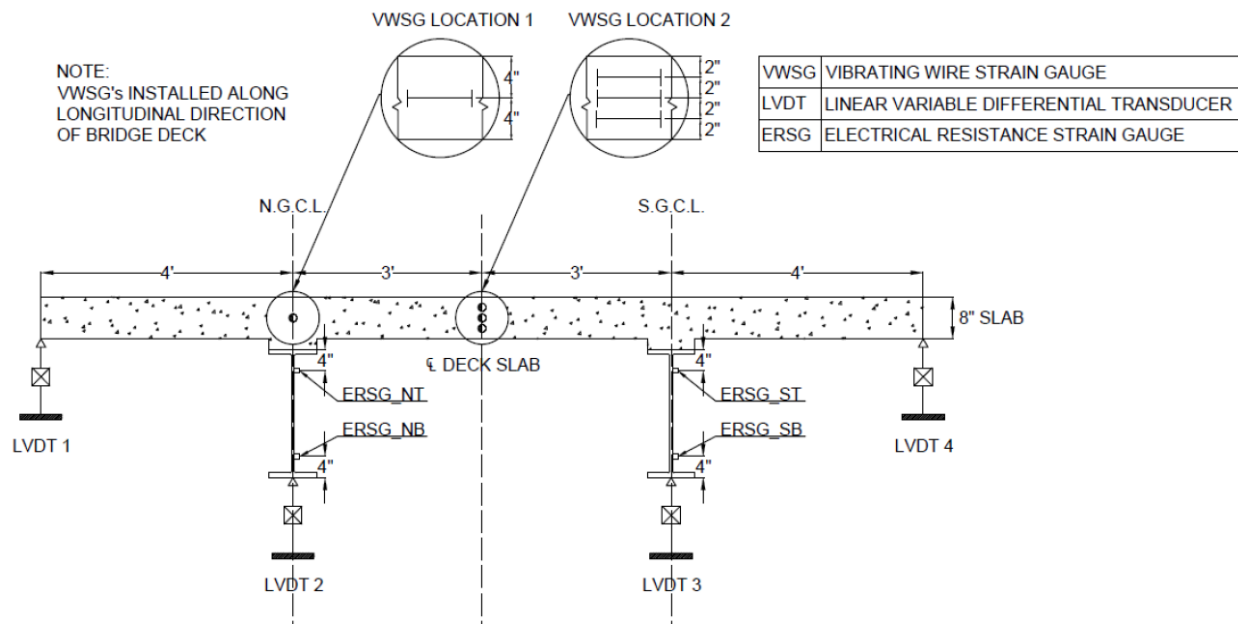
**Figure 4.9: Prototype Bridge Cross Section at Mid-span (View Looking East) showing location of sensors.**

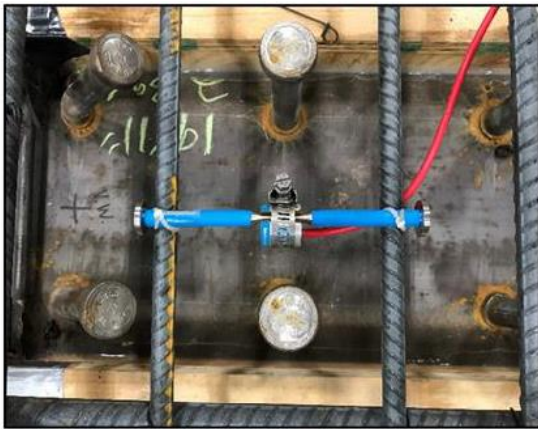
a) VWSG Location 1 Aligned with NGCL

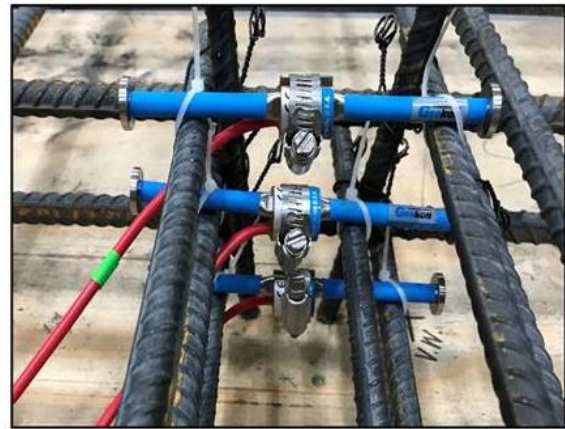
b) VWSG Location 2 at CL of Deck Slab

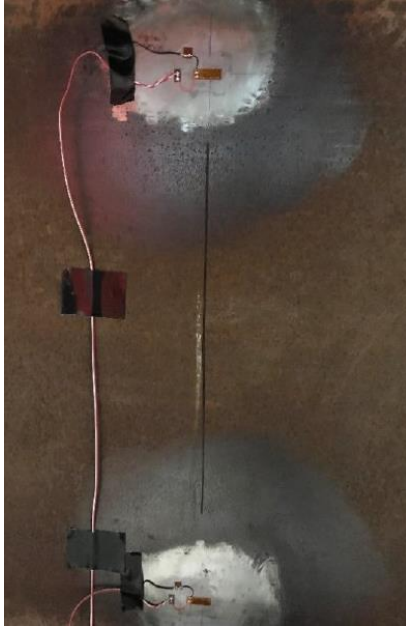
Electrical resistance bonded foil strain gages were attached to the top and bottom of the webs of the North and South girders to capture the steel girder strains. As shown in Figure 4.12 NT & NB, and ST & SB represents the Electrical Resistance Strain Gages (ERSG) bonded to the top and bottom webs of the North and South girders respectively. The gages were about 16 in. apart and bonded at 4.0 in from the top and bottom of the flanges of the steel girder.

**Figure 4.12: Location of Bonded Foil Electrical resistance strain gages on steel girder (NT/ST and NB/SB)**

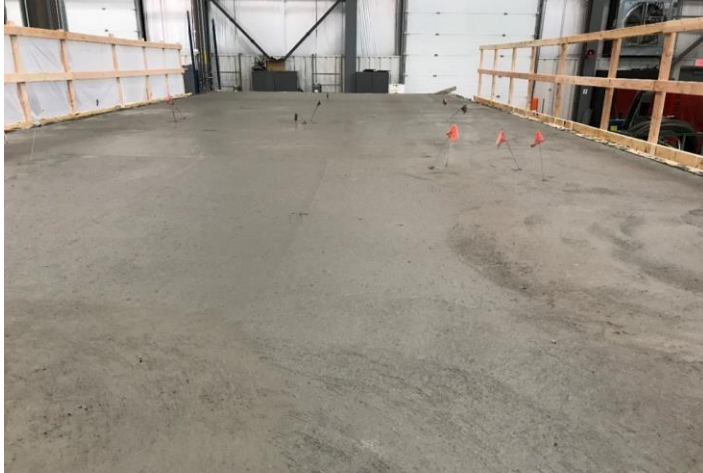
The concrete deck was cast on July 13, 2017, beginning at 10:55 a.m. The concrete placement was completed in 2.0 hrs. and broom finish was completed at 4.0 hrs. Concrete placement started at the West support and proceeded to the east. Concrete was placed via a  $\frac{3}{4}$  CY bucket supported by the overhead crane at the Cooper Lab. There was no delay in using two trucks for the pour. Figure 4.13 shows the concrete deck immediately after casting and prior to finishing. A broom finish was applied to the deck.

**Figure 4.13: Bridge deck after casting and finishing concrete. A broom finish was applied.**

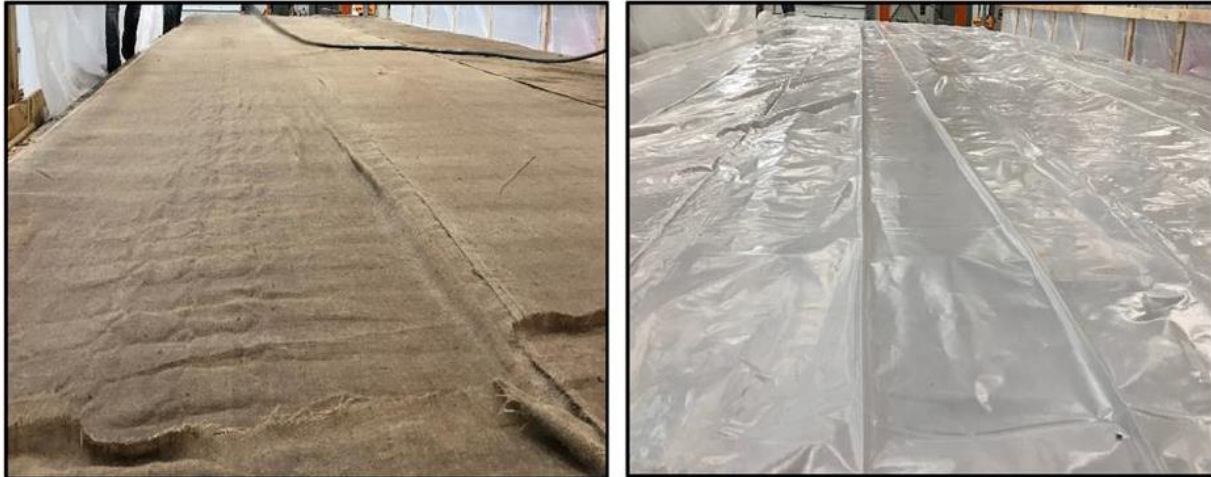
The ODOT specifies a curing regimen that requires wet curing for 10 days. Figure 4.14 shows that wet burlap was placed directly on the surface of the concrete. The burlap was subsequently covered with plastic sheeting. Curing was applied at 4.0 hrs. after the beginning of casting. Prior to the application of burlap, the concrete deck surfaces were inspected. No early age cracking was reported. The deck was wet cured for 14 days after casting, and during that time the deck was covered by wet burlap on the top and by formwork on the bottom. Formwork on the underneath of the deck and on the sides of the deck remained in place during curing. Removal of formwork and bracing began after 11 days, but the wet burlap and plastic sheeting remained in place for 14 days. After removal curing materials, the concrete deck was inspected for cracking. No cracks were found.

**Figure 4.14: Wet burlap and 2 mil plastic was applied for 14 days**

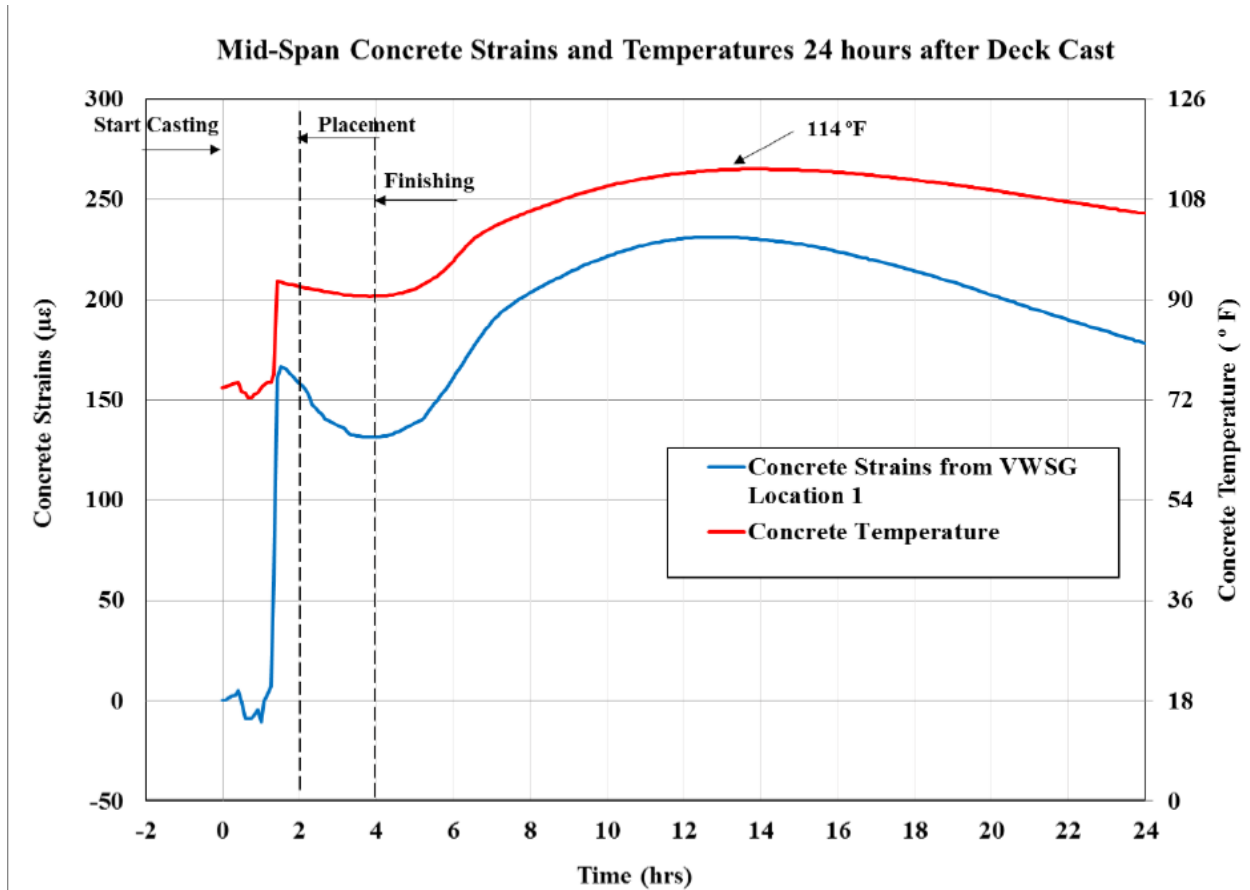
**Figure 4.15: Concrete Temperatures and strains measured at mid-height of deck slab recorded until 24 hours after deck cast**

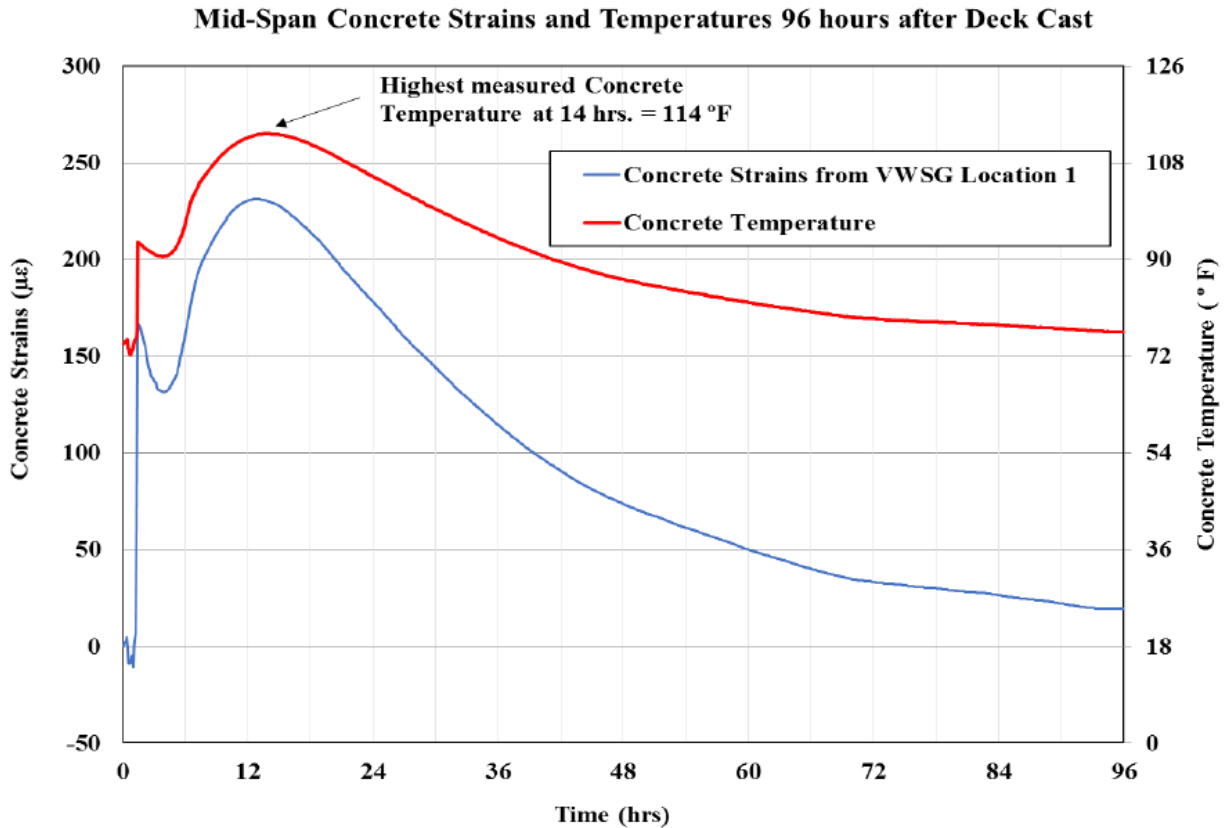
After initial set, the concrete gains stiffness during the cooling cycle. At the end of the heating cycle, concrete will begin to cool and shrink which is indicated by the decrease in thermal strains and increase in compressive concrete shrinkage strains. This shrinkage can be caused by either or both thermal strains and shrinkage strains. As the steel girders restrain the shrinkage of concrete, tensile stresses within the concrete will begin to develop immediately at the end of the temperature rise. However, no cracking on the surface of concrete deck was reported during this time. Hence it is seeming evident that the tensile stresses caused by the restrained shrinkage are not sufficient to cause bridge deck cracking on the prototype full-sized bridge, at least using these constituent materials subject to these atmospheric conditions.

**Figure 4.16: Concrete Temperatures and strains measured at mid-height of deck slab recorded for 96 hours after deck cast.**

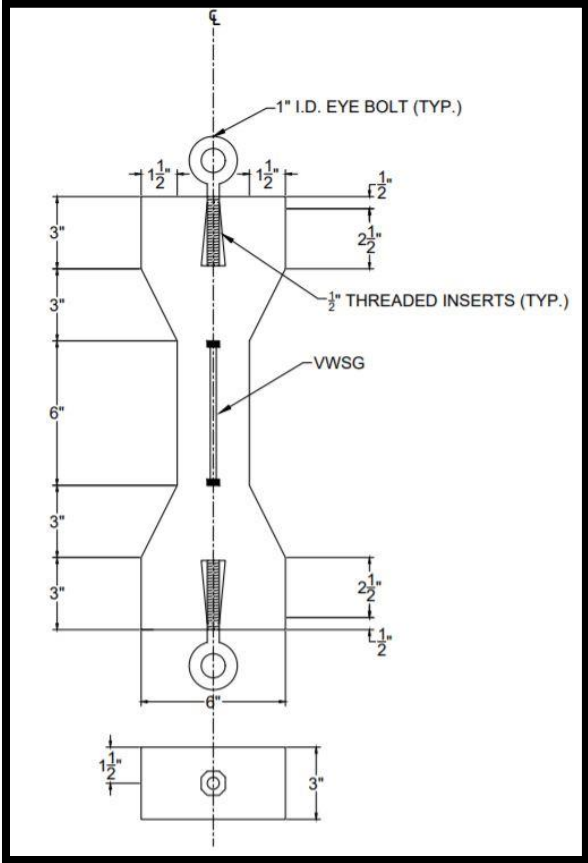
**Figure 5.1 Dogbone Design Schematic and Dimensions**

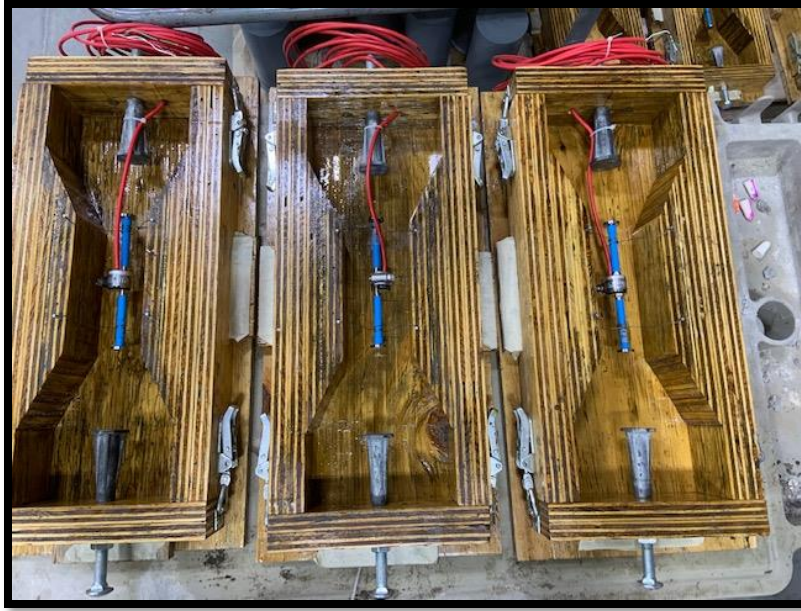
**Figure 5.2 Dogbone Forms Prior to Casting with Vibrating Wire Gages Installed**

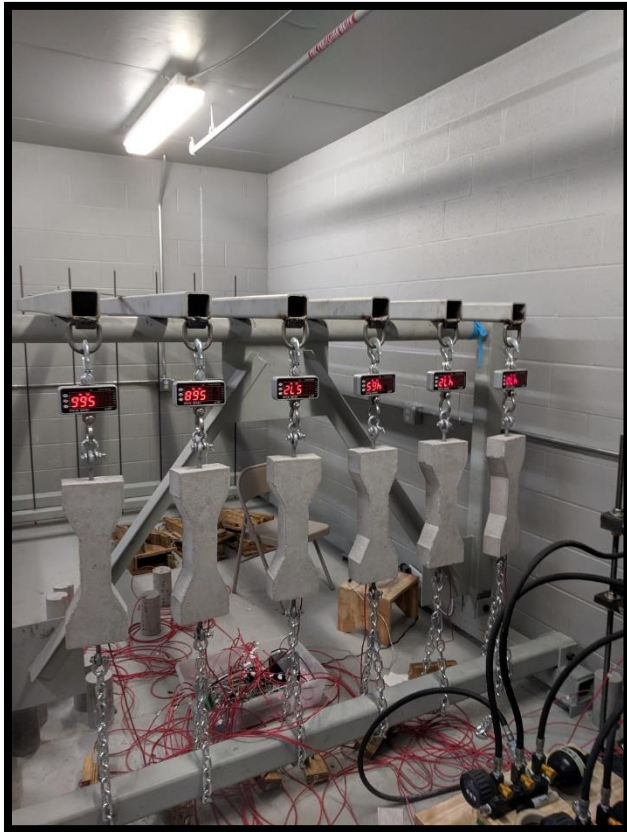
Figure 5.3 shows the Dogbone Specimens loaded in the Tensile Creep Frame. The frame allowed adjustment of tension forces on each individual Dogbone specimen. Total tension force applied was the product of the target stress times the measured cross-sectional area.

**Figure 5.3: Dogbone Specimens Loaded in the Tensile Creep Frame**

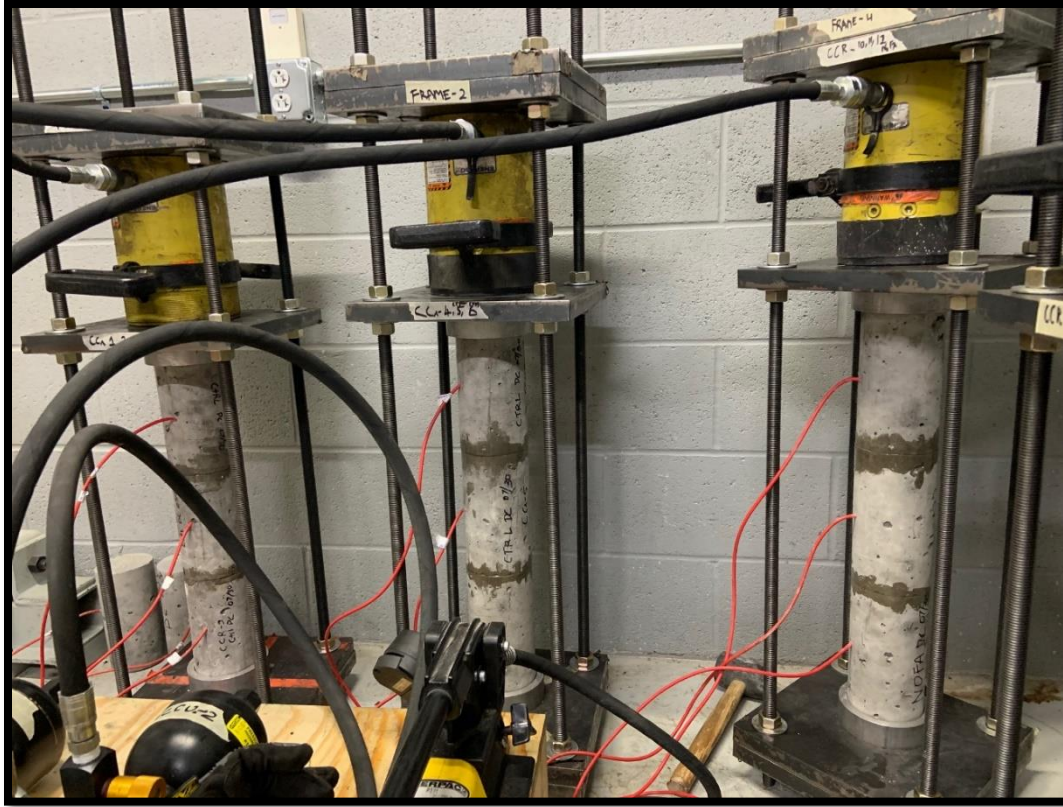
Frames for testing the creep of concrete in compression were designed based on recommendations from ASTM C512. Each frame consisted of 5 steel plates attached to 3/4” diameter threaded steel rods. An Enerpac RCH603 hydraulic cylinder jack was used to apply the load to the concrete cylinders and hydraulic accumulators were employed to help maintain constant hydraulic pressure in the system. Each frame was loaded with three cylinders from a specific concrete mixture. These cylinders were lapped to make their tops and bottoms planar, then they were subsequently fixed together using quick-setting epoxy. This epoxy helped keep the columns rigid in order to prevent buckling in the column. After the epoxy had achieved a strong enough hold (usually after about 10 -20 minutes) the cylinders were placed in the frame and loaded. Several creep frames loaded with cylinder columns are shown in Figure 5.4.

**Figure 5.4 Compression Creep Frames Loaded with Concrete Cylinder Specimens**

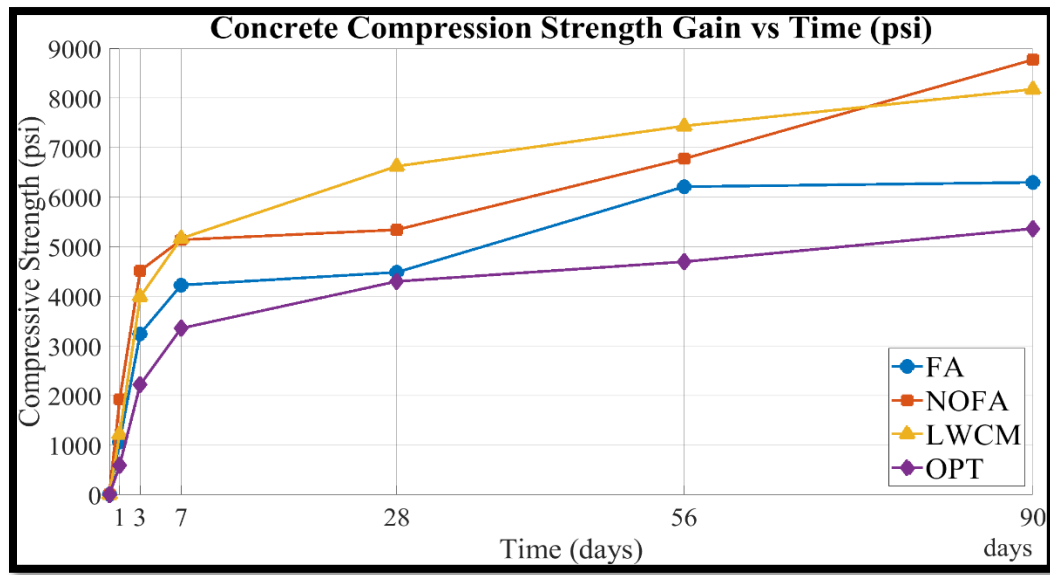
**Figure 5.5: Concrete compressive strength gain over time (averaged between tensile and compressive batches)**

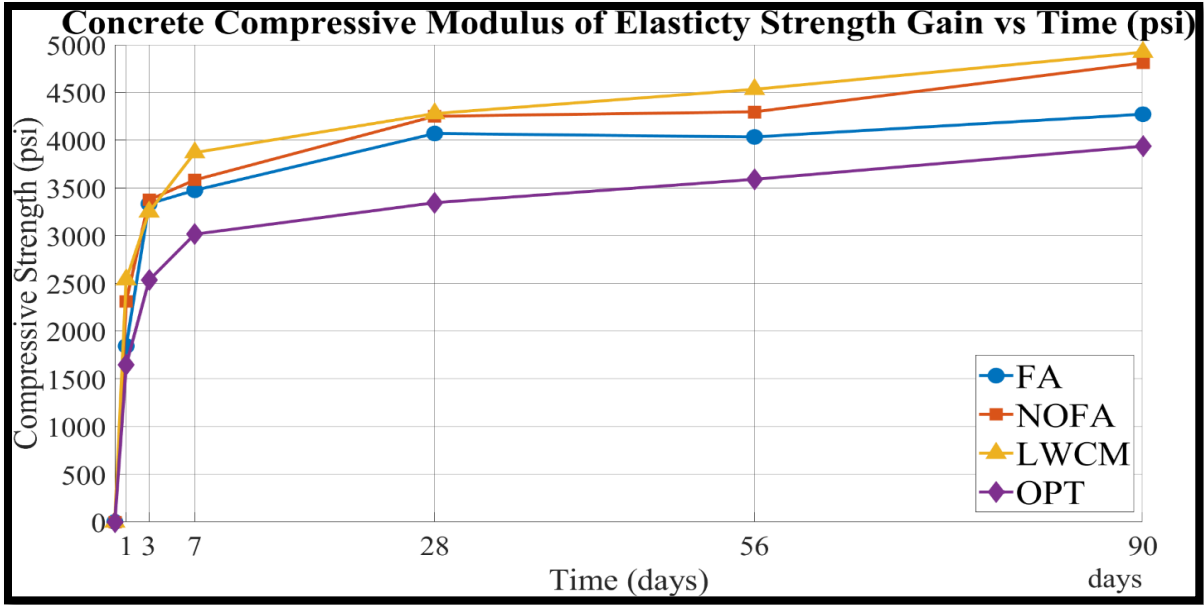
Figure 5.6 Concrete Elastic Modulus (ksi) vs. Time (days)

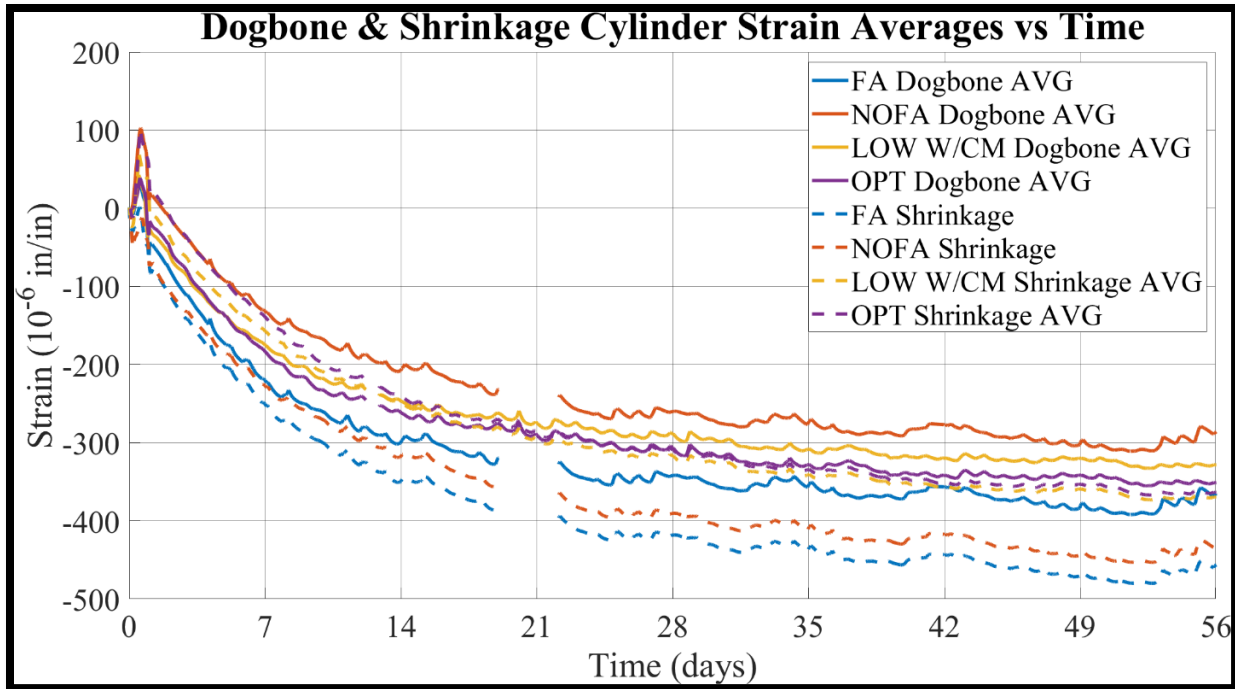
The tension dogbones were loaded at 1-day of age and were monitored over a duration of 56 days. Both the tension dogbones and the companion shrinkage cylinders were maintained in the dry-curing room at 50% RH. Note that each specimen's strain values were zeroed at the time of casting. The temporary gaps in strain data readings seen in the figure were due to power losses in the data logger. By subtracting the shrinkage strain values from the raw total strain values, the net strain due to loading for each specimen can be determined.

**Figure 5.7 Concrete Strains vs. Time. Tension Dogbones and Companion Shrinkage Cylinders.**

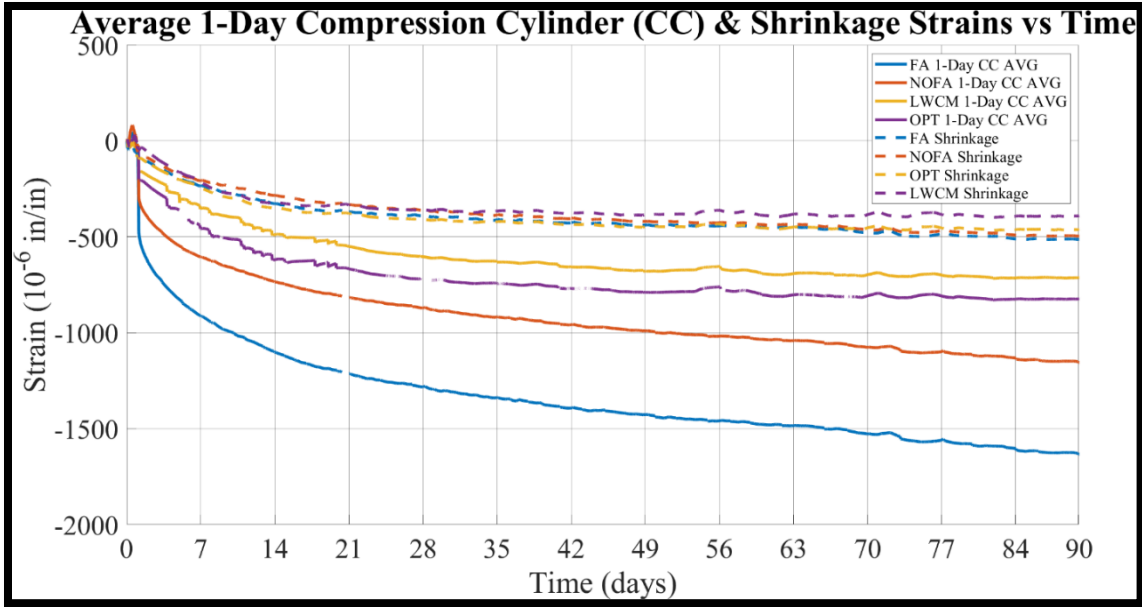
**Figure 5.8 Concrete compression creep strains plus strains of the shrinkage cylinder specimens.**

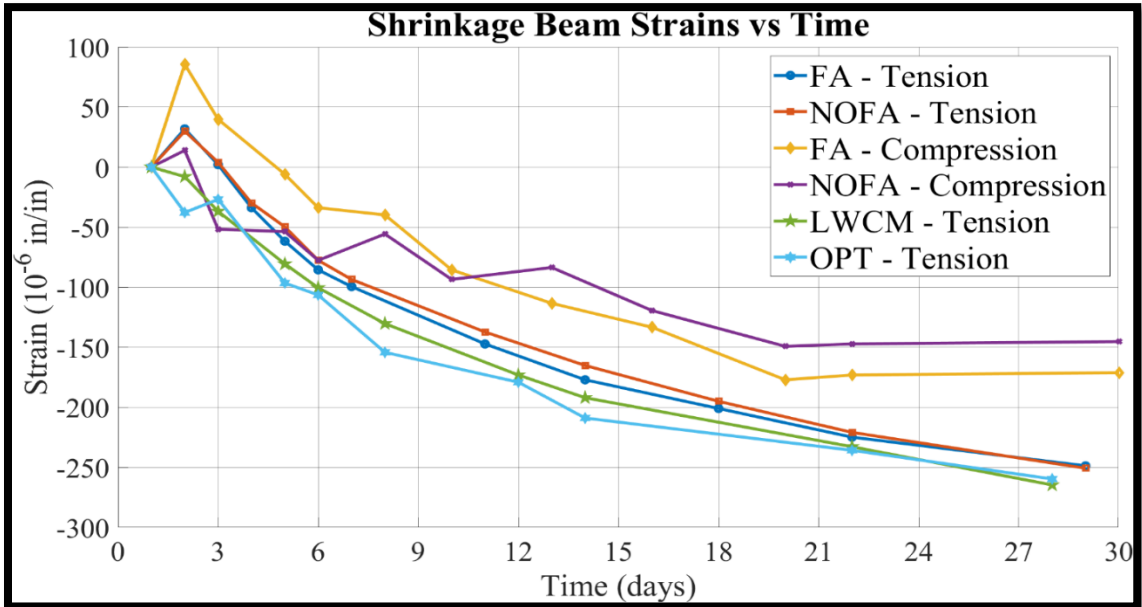
In order to verify that the strains measured in the concrete shrinkage cylinders are reasonable accurate, strain readings from the shrinkage beams were also monitored throughout the first month after casting. The DEMEC strain readings from these beams are shown in Figure 5.9.

**Figure 5.9 Strains measured by DEMEC gages on rectangular shrinkage prisms.**

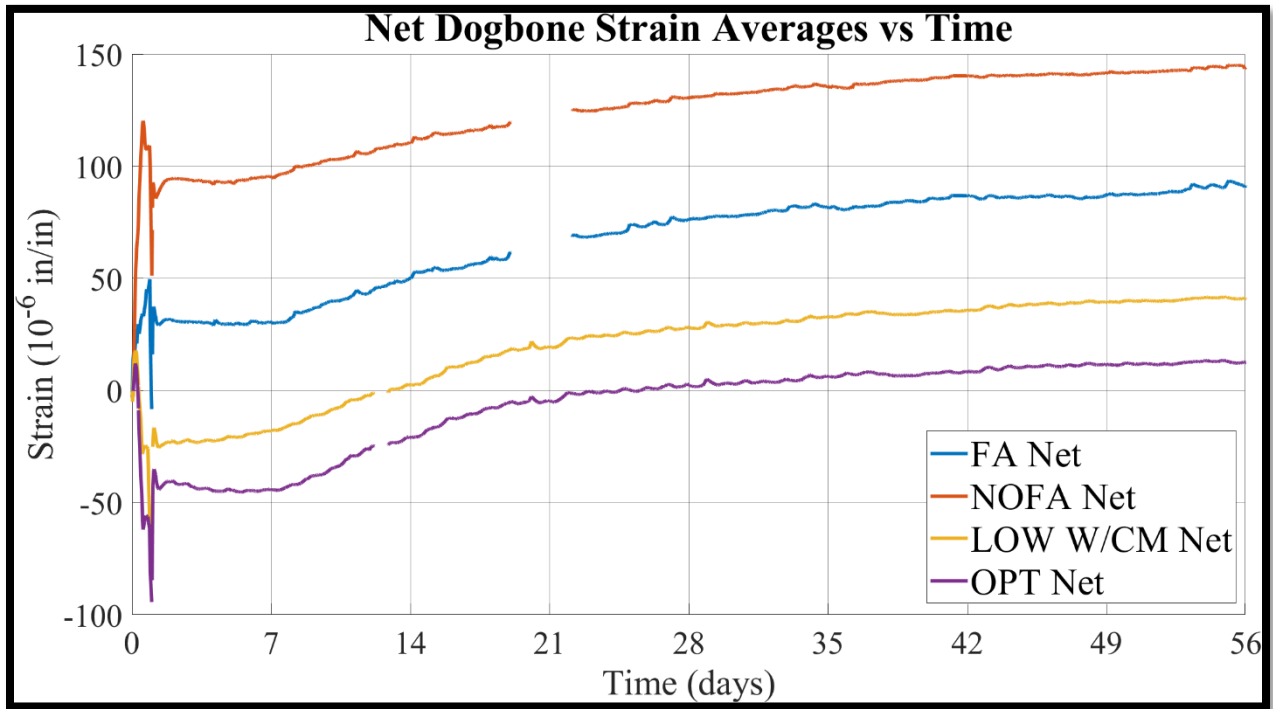
Figure 5.10 Net Tensile strain in Dogbone specimens.

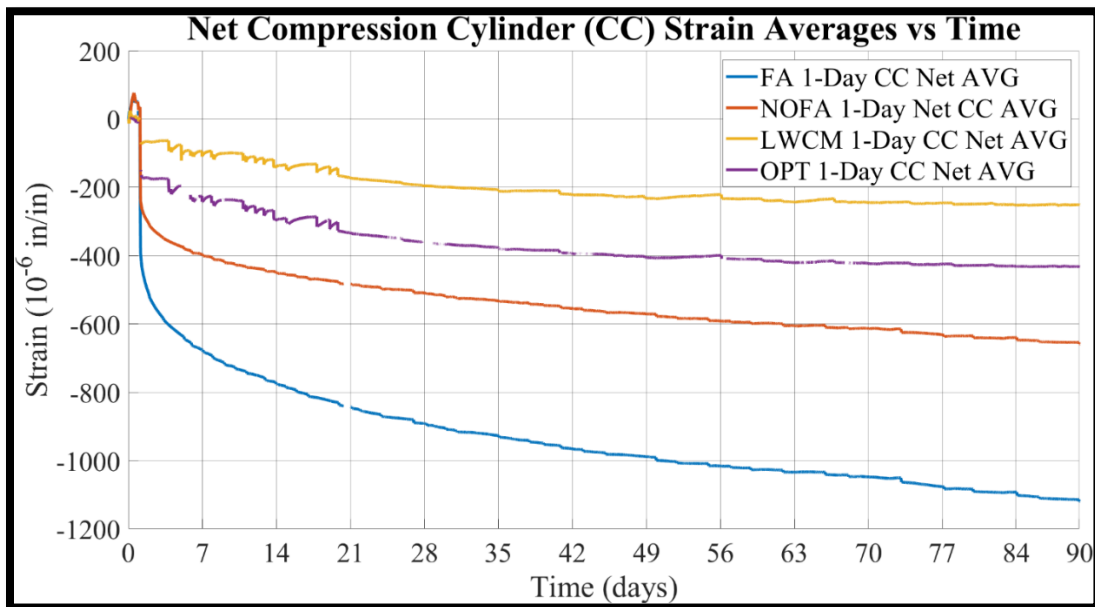
Figure 5.11 Net Compression Strain vs. Time.
