FINAL REPORT ~ FHWA-OK-22-04

# SHRINKAGE INDUCED DEFORMATIONS IN STEEL BRIDGES MADE COMPOSITE WITH CONCRETE DECK SLABS

Civil Engineering and Environmental Science  
Oklahoma State University  
Stillwater, Oklahoma

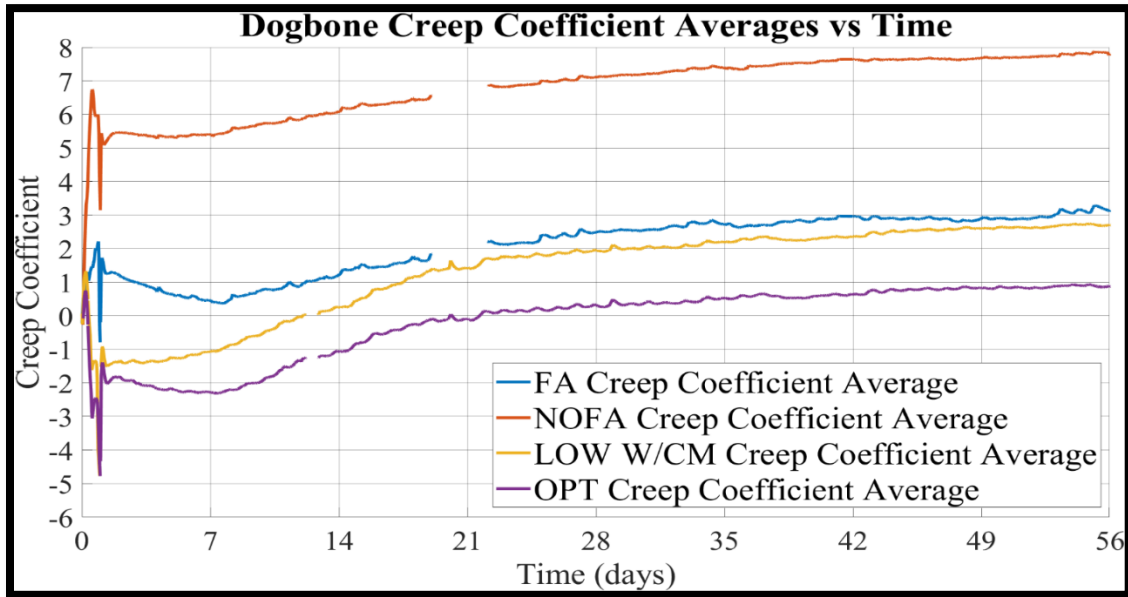
From these data, at least theoretically, the creep coefficient can then be determined for each set of test specimens and plotted over time. These data are shown in Figure 5.12 for the tensile creep test specimens and Figure 5.13 for the compression creep specimens. Creep coefficients were calculated by dividing the initial elastic strain by the net strain for each set of specimens. The computed creep coefficients are found in Table 5.7. One can observe considerably more variation in the tensile creep specimens, most likely caused by the smaller differences in measured shortening strains.

Figure 5.12 Tensile Creep Coefficient over time.

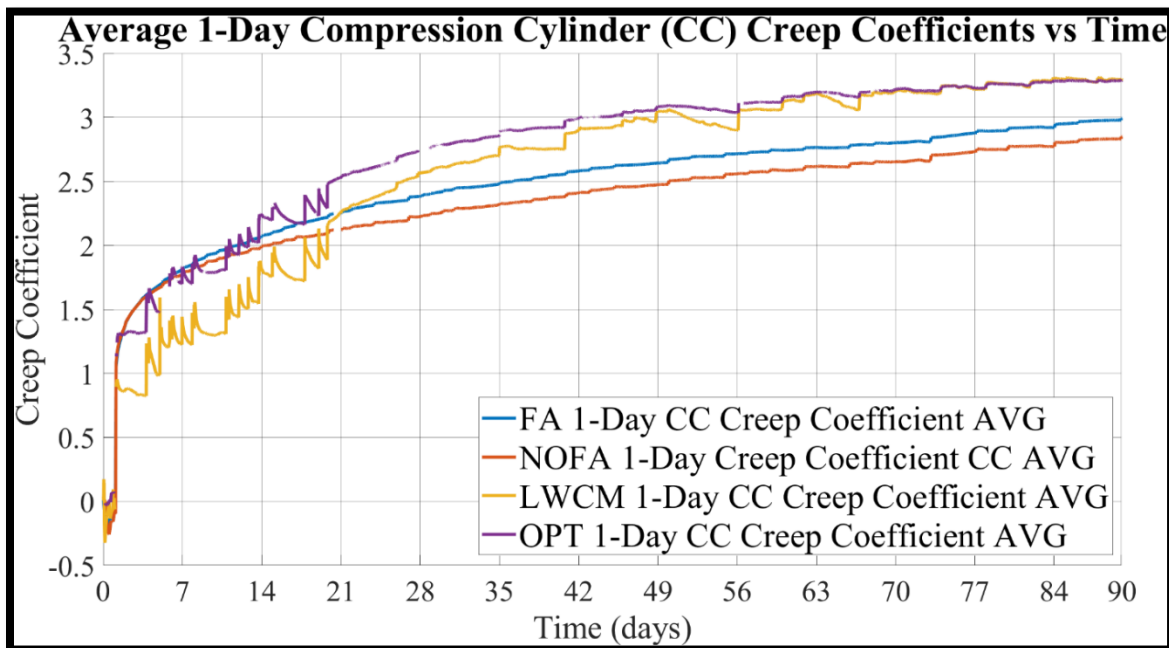
Figure 5.13 Creep Coefficient Average vs. Time (Compression)

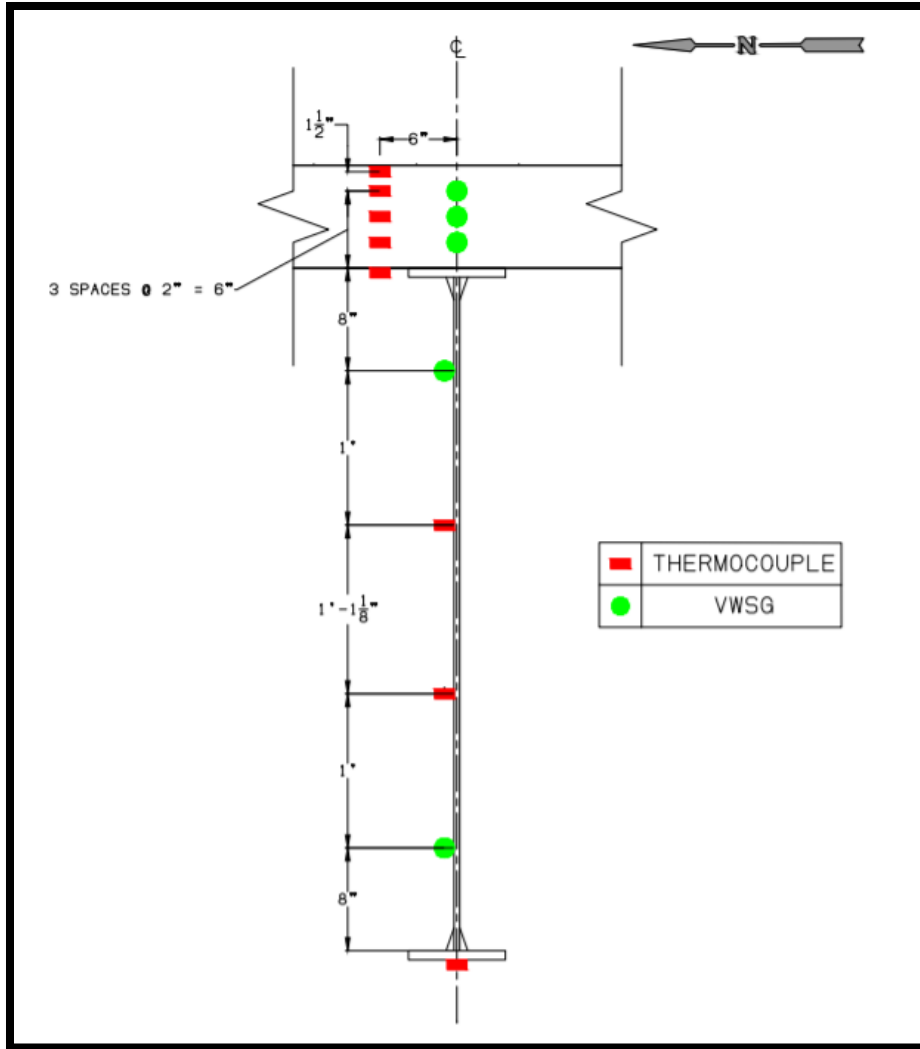
In order to adequately capture the variation of temperature in the concrete and steel throughout the depth of the cross-section, Type J thermocouples were installed at strategic locations to complement the temperature data obtained via the thermistors on the VWSGs. These thermocouples were both cast into the concrete deck as well as fixed to the steel girders. Figure 6.1 below shows the locations of the thermocouples and VWSGs on each girder.

**Figure 6.1: VWSG & thermocouple locations on each girder**

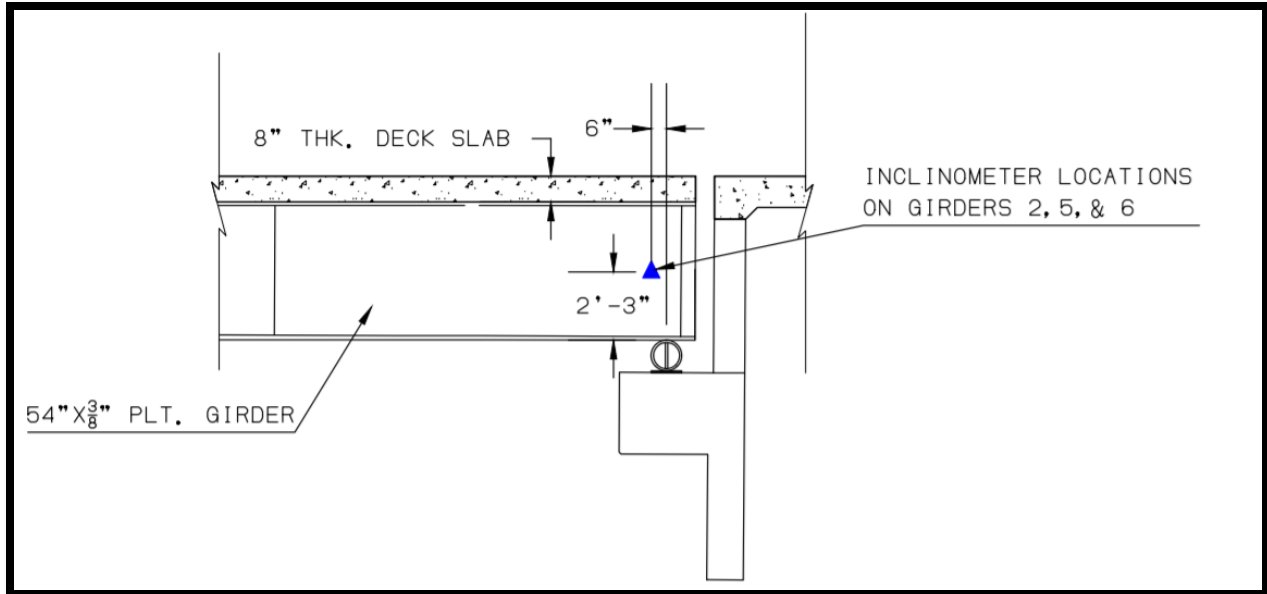
The final sensor type employed on this project were inclinometers. InclInometers are specialized sensors that measure minute changes in angles. By gluing them to the girder webs near the supports, we were able to obtain slope readings that would allow us to approximate deflections in the bridge deck. A diagram describing the locations of each inclinometer are show in Figure 6.2 below.

**Figure 6.2: Inclinometer sensor location drawing**

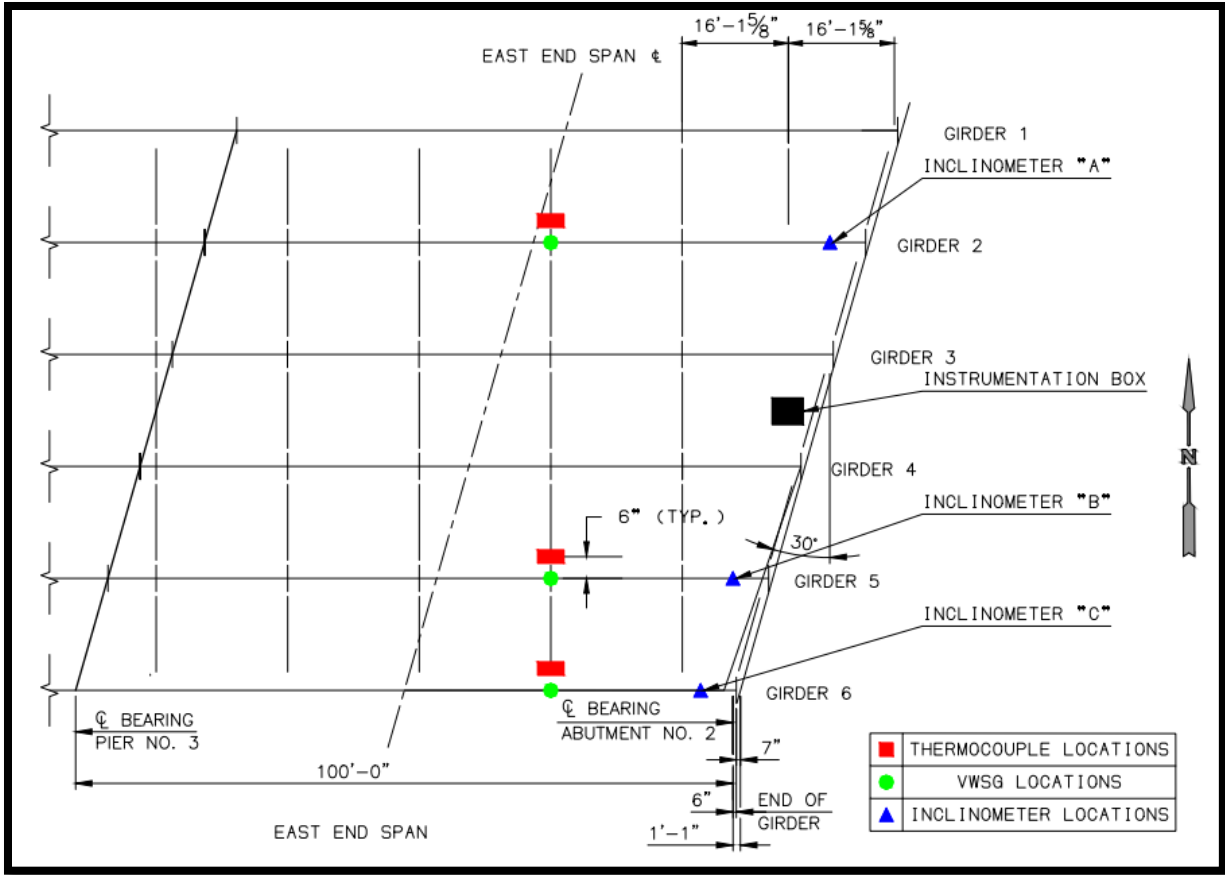
Three girders were selected to be instrumented, along with the concrete directly above them. These were the two south-most girders (Girders 5 & 6), as well as the second north-most girder (Girder 2). The WVSG and thermocouple sensors were installed at the locations shown in Figure 6.3 below. These girders were instrumented

Figure 6.3: Sensor locations and girder numbers

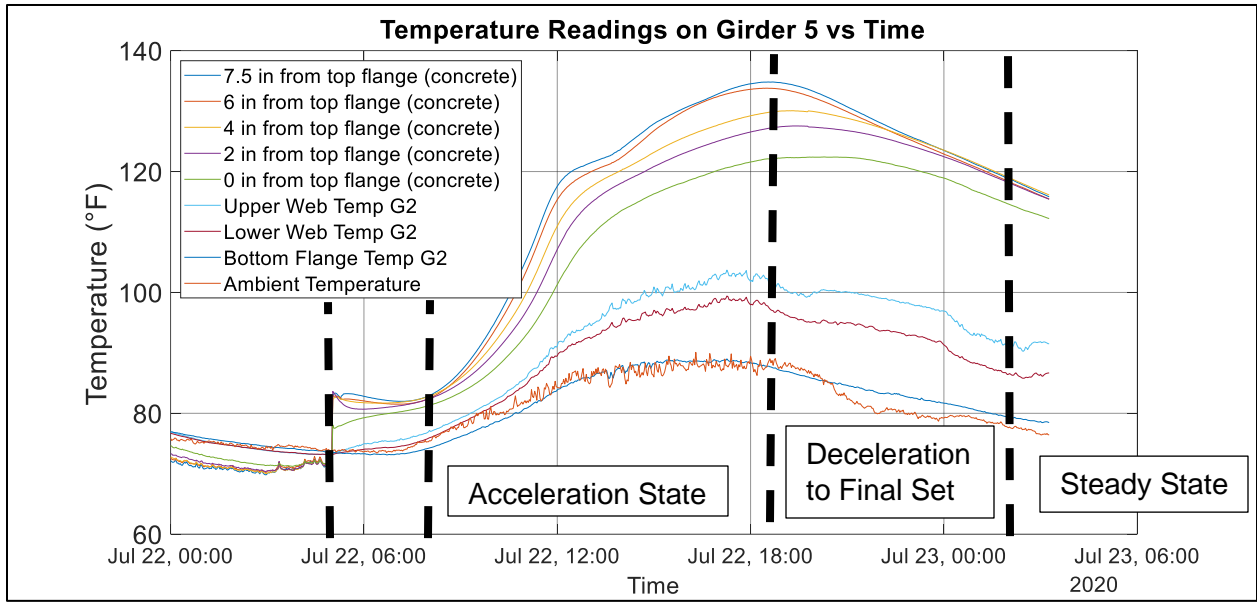
Figure 6.4 and Figure 6.5 show the bridge recorded temperature over time. Figure 6.4 shows the recorded temperatures for Girder 5. Concrete was cast on July 22<sup>nd</sup>. We note that the ambient temperature during that cast was about 80°F. This figure shows that the concrete temperature reaches 135 degrees peak temperatures at approximately 6:00 pm which is approximately 12 hours after the pour. We note that the deck was cast around 5:20 am in the morning. The concrete was in its induction state and dormant period until 8:00 am. Then, the concrete goes through an acceleration phase until it reaches its peak around 6:15 pm.

Figure 6.4: Temperature for 24h vs Time girder 5 (South Side)

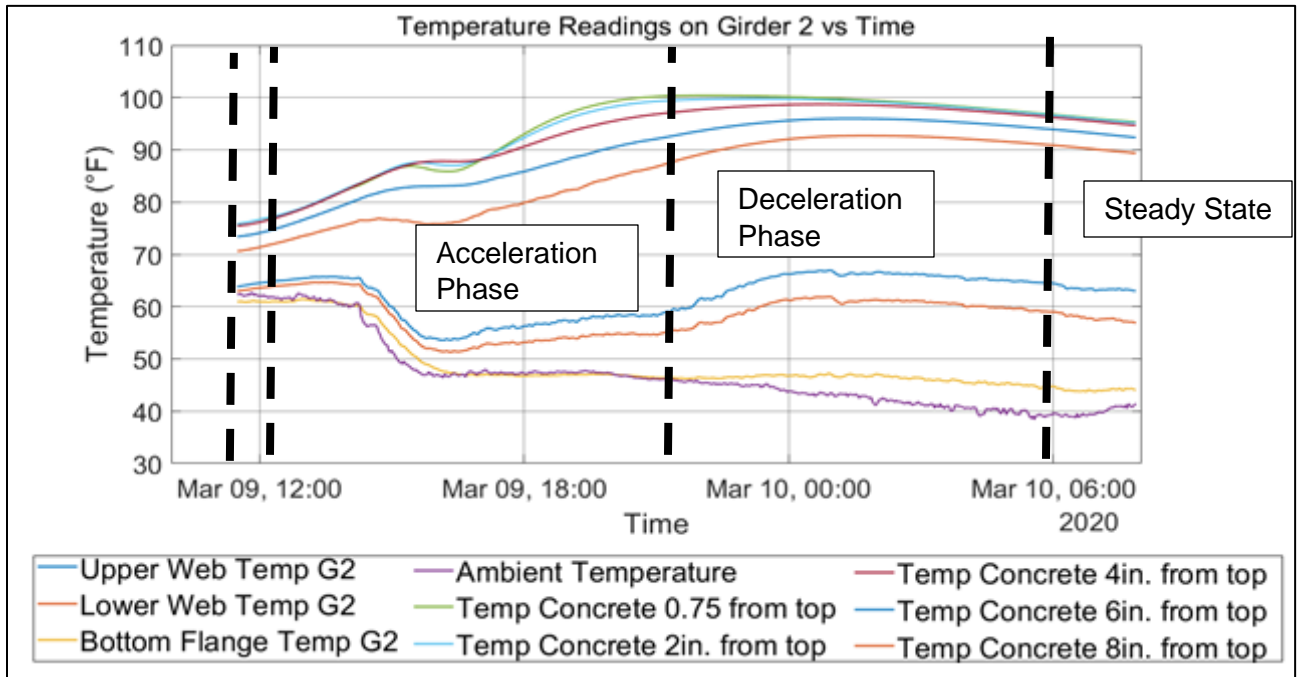
Figure 6.5: Temperature for 24h vs Time girder 2 (North Side)

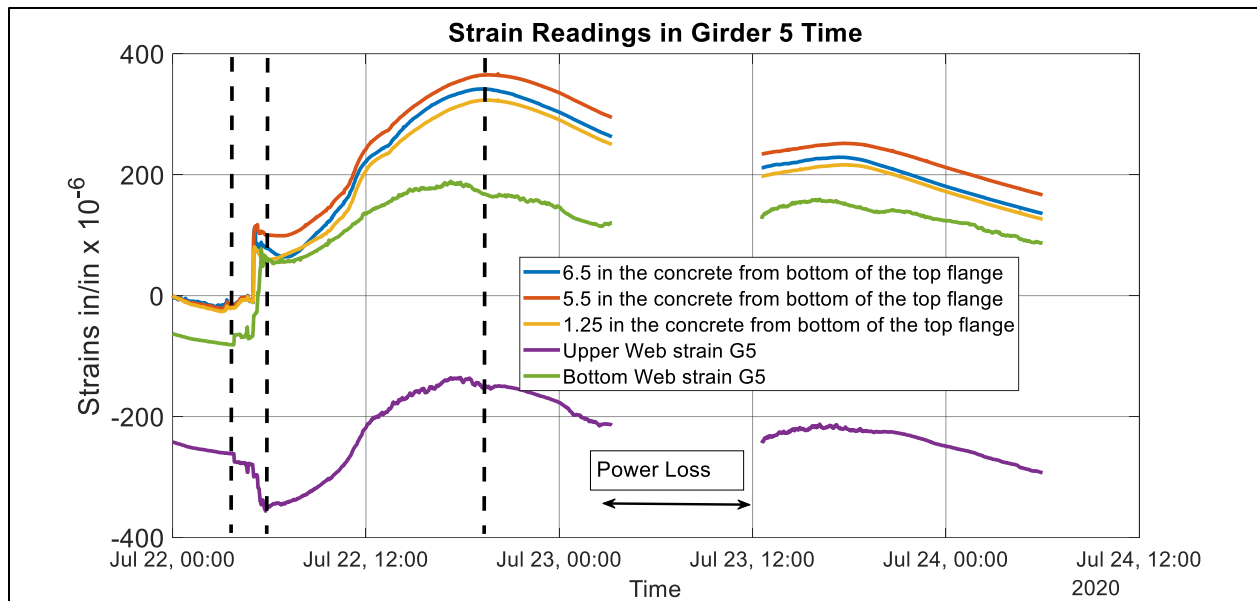
Figure 6.6: Strain vs Time in Girder 5

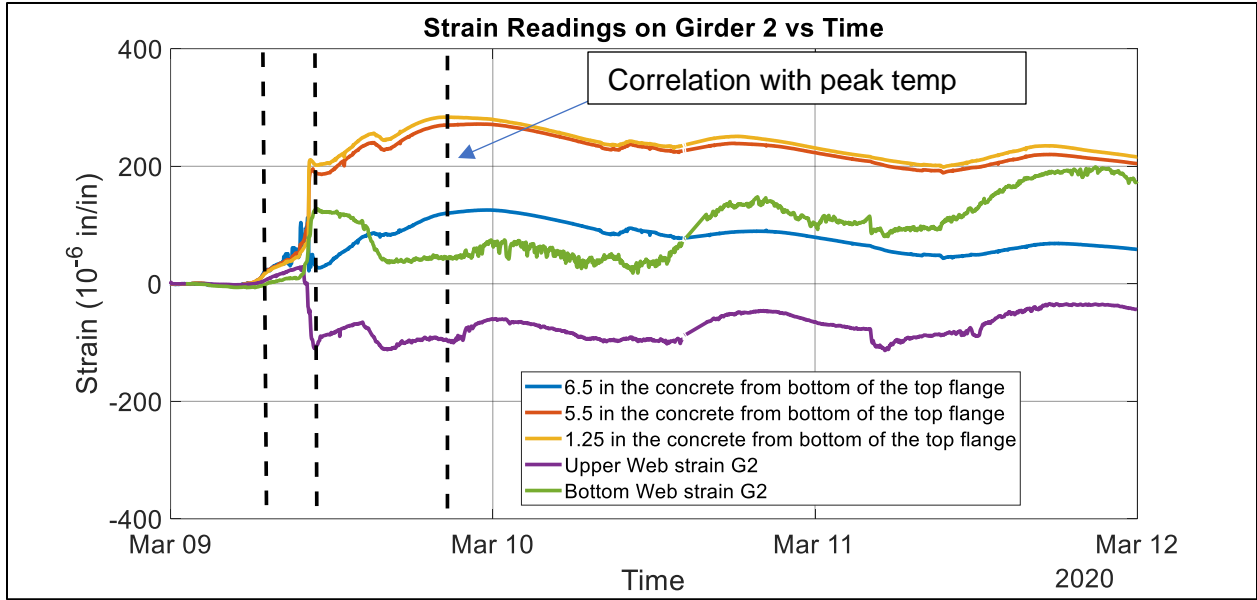
**Figure 6.7: Strain vs Time in Girder 2**

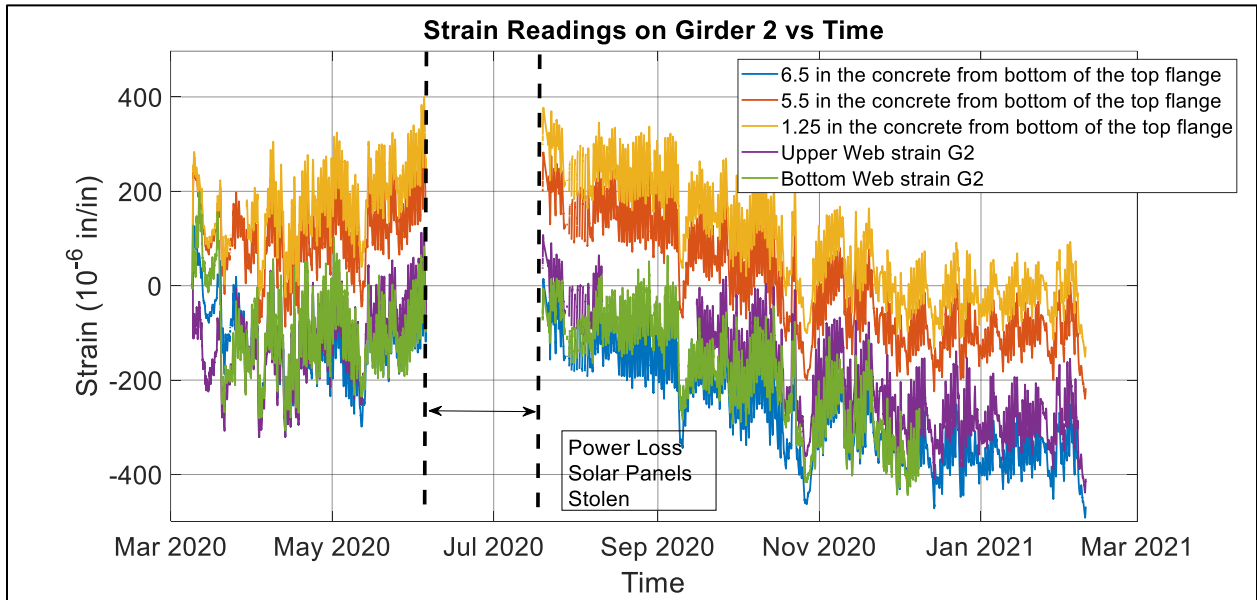
**Figure 6.8: Strain Readings in Girder 2 since Deck Cast March 9th, 2020.**

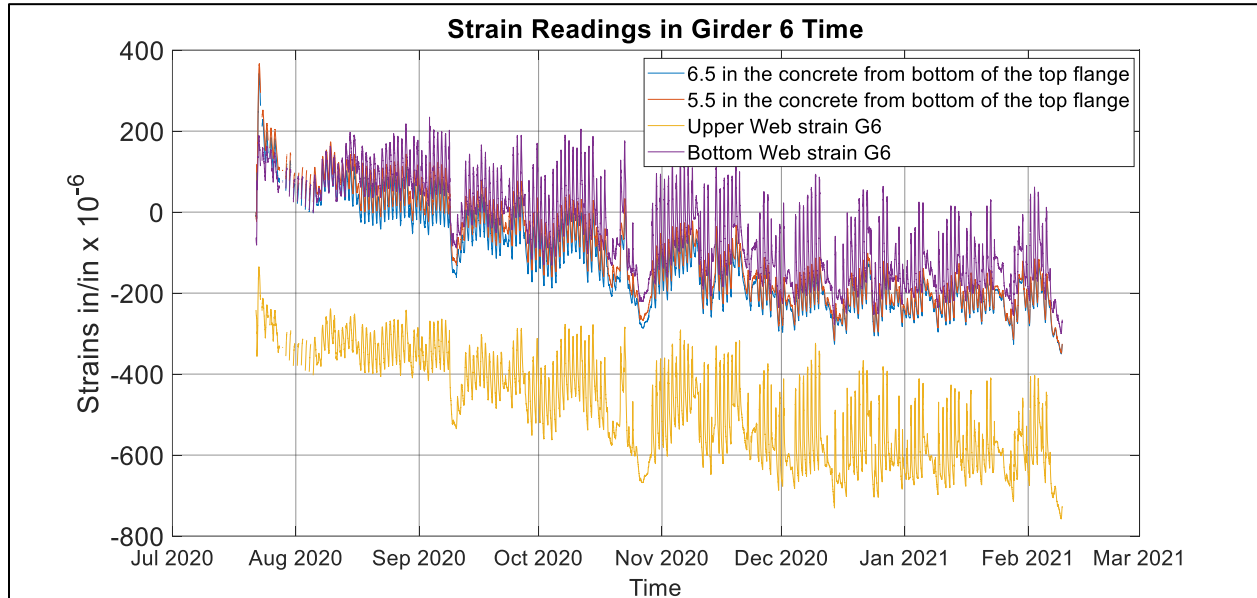
Figure 6.9: Strain Readings in Girder 6 since Deck Cast July 22nd, 2020.

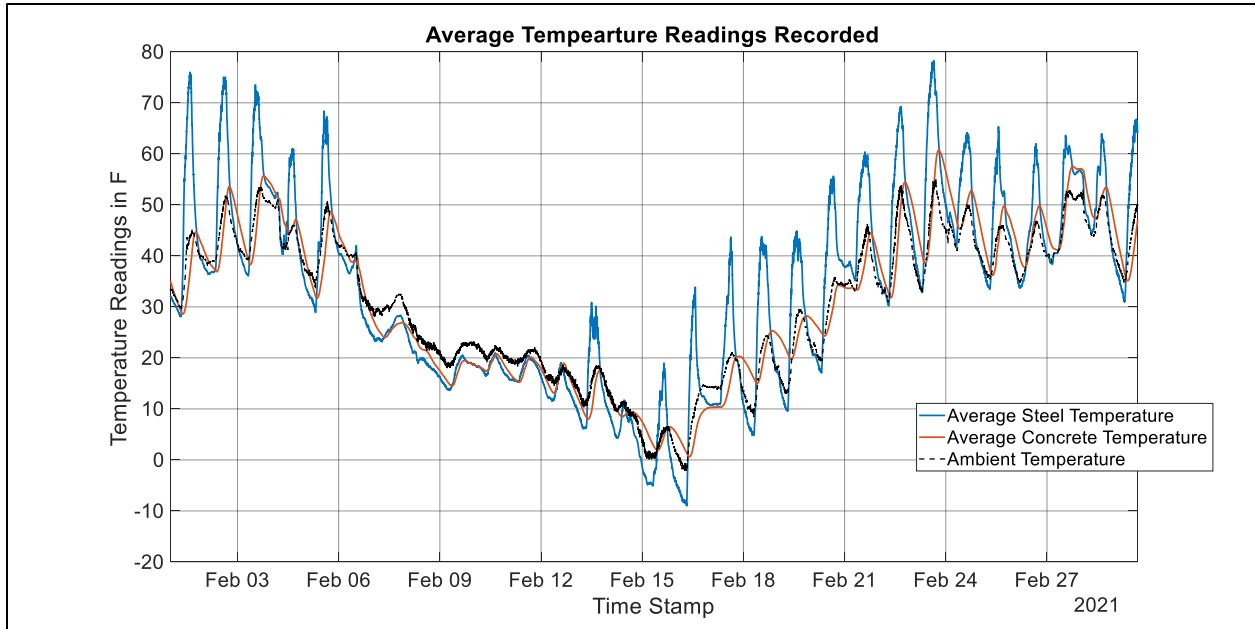
**Figure 6.10: Steel and Concrete and Ambient Temperature Record for February 2021, SH 11 Bridge, Blackwell Co., OK**

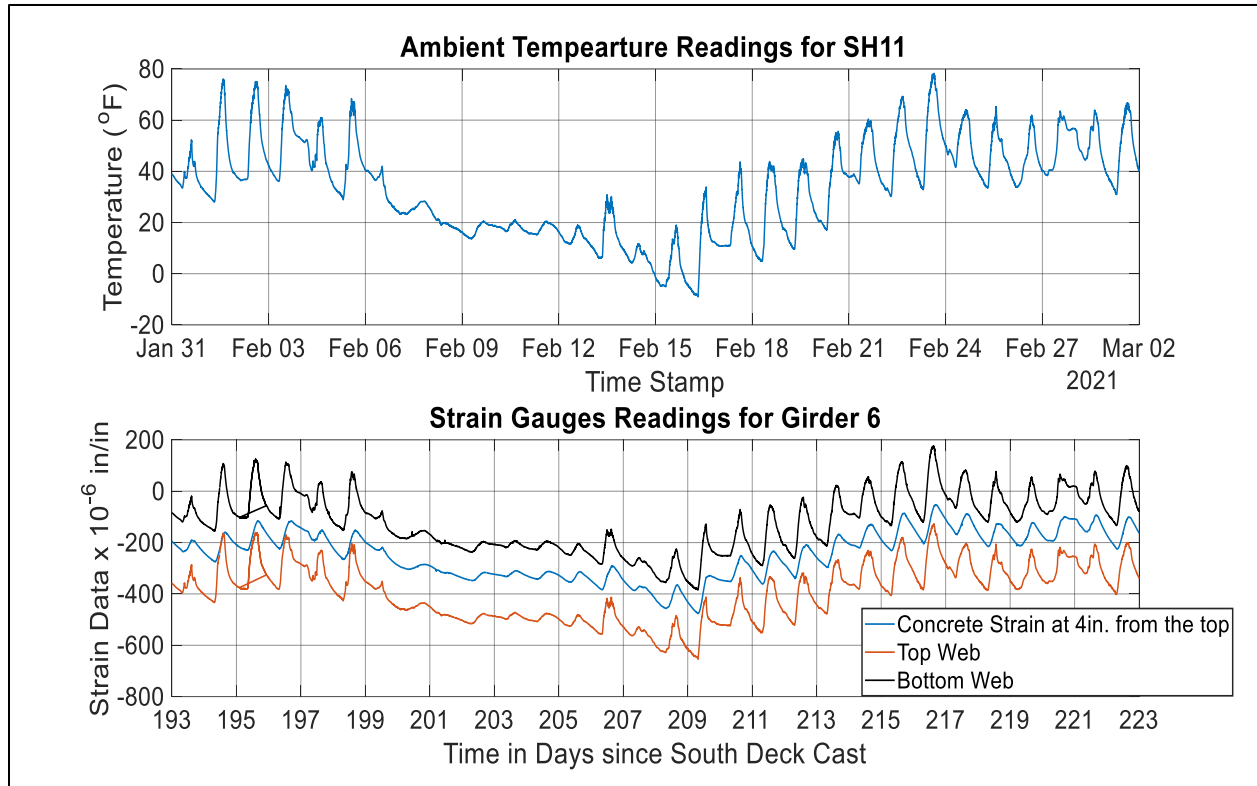
**Figure 6.11: Steel and Concrete Strains Due to Extreme Weather Changes. Note that @ time = 193 days is compatible with January 31<sup>st</sup>, 2021. Note that the time = 0 is equivalent to July 22<sup>nd</sup>, 2020 (Concrete deck cast of the south side of the bridge)**

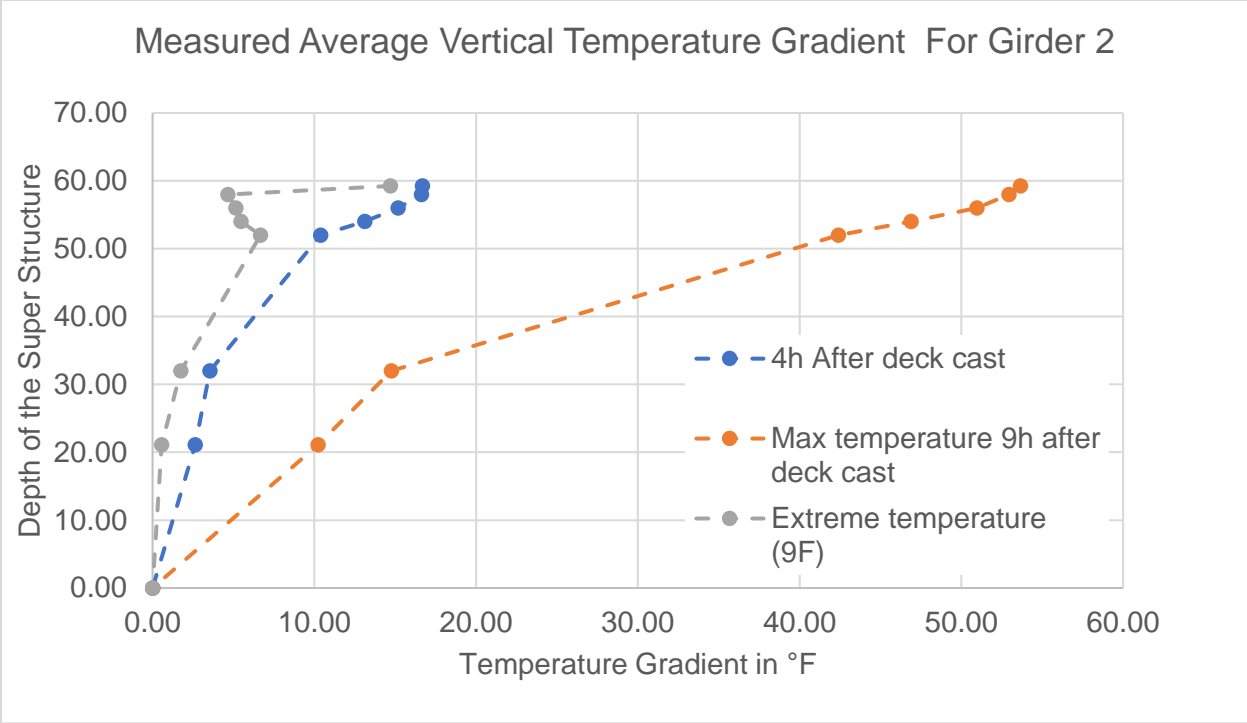
**Figure 6.12: Measured Average Positive Vertical Temperature gradient for Girder 2**
