Statewide Implementation of the Surface Performance Graded (SPG) Specification for Chip Seal Binders in Service: Implementation Report

Implementation Report 5-6616-01-R1

TEXAS A&M TRANSPORTATION INSTITUTE
COLLEGE STATION, TEXAS

sponsored by the
Federal Highway Administration and the
Texas Department of Transportation
<https://tti.tamu.edu/documents/5-6616-01-R1.pdf>

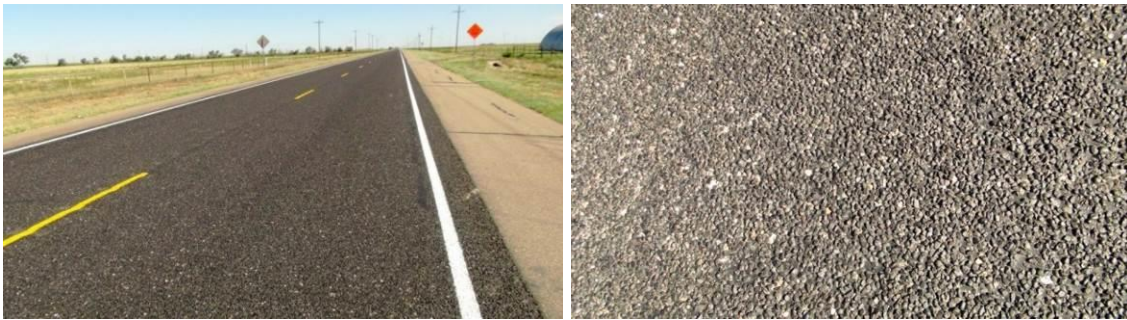
Figure 10. Example of Adequate Performance on 16-AMA-1 after the First Winter.

An example of adequate field performance is shown in Figure 10 for 16-AMA-1 after the first winter in service. This section is located on US83 in Ochiltree County in the AMA district. The SPG climatic requirement in that county is 64-25, and the binder specified for construction was a SPG 64-25. The binder used for construction was graded as a SPG 64-34 with the continuous phase angle meeting the SPG requirement of less than 80° . The 2016 AADT was approximately 3500 on this section with 28 percent trucks. This HS exhibited adequate performance in terms of aggregate loss ($\text{SCI}_{\text{AL}} = 100$) and bleeding ($\text{SCI}_{\text{BL}} = 96$) as shown Figure 10.

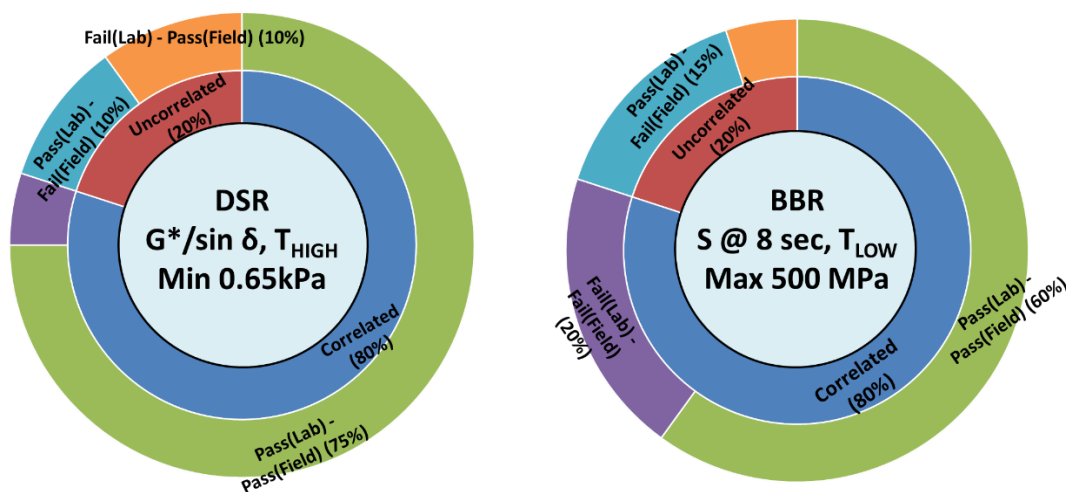
Figure 13. Special Provision (2016, 2017) Laboratory vs. Field Correlation.

Table 21 also indicates that 10 HSs included in the comparison and 16-PHR-1 produced failing field performance results ($Fail_{Field}$) based on inadequate resistance to bleeding ($SCI_{BL} < 70$) [16-ABL-1, 16-AUS-3, 16-PAR-1, and 16-PHR-1] or aggregate loss ($SCI_{AL} < 70$) [16-AUS-1, 16-BWD-1, 16-CRP-1, 16-CRP-2, 16-PAR-3, 17-AMA-1, and 17-AMA-2]. As shown in

As discussed previously, 16-ABL-1, 16-AUS-1, 16-PAR-1, and 16-PAR-3 may have failed in the field due to construction issues or high traffic levels. 16-AUS-2 and 17-AMA-4 exhibited unexpected resistance to bleeding, but the corresponding binders passed the phase angle requirement ($< 80^\circ$), which may indicate sufficient polymer modification that contributed to marginal field performance.

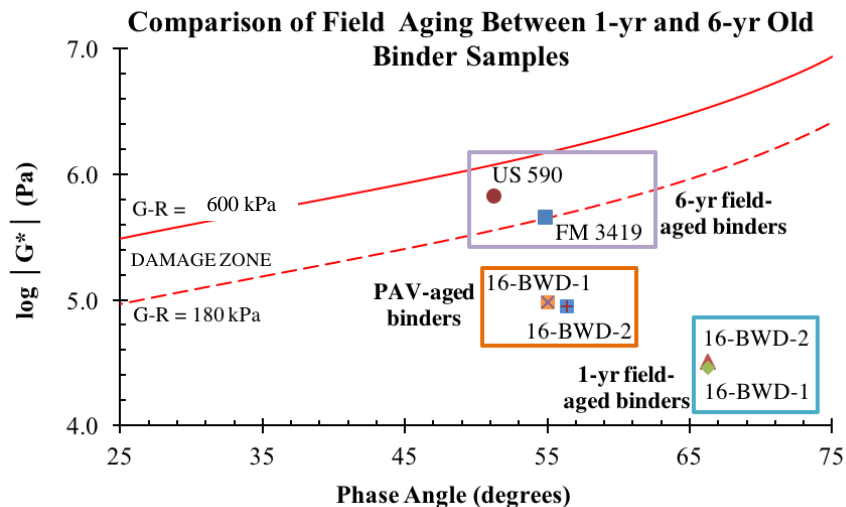
Figure 14. Black Space Comparing PAV-Aged and Field-Aged Chip Seal Binders.

Based on this small study, laboratory aging is important to capture the condition of chip seal binders when they are most susceptible to aggregate loss, but further evaluation for additional materials and climates is needed to quantify the tie between laboratory and field aging and capture the individual binder response to aging.

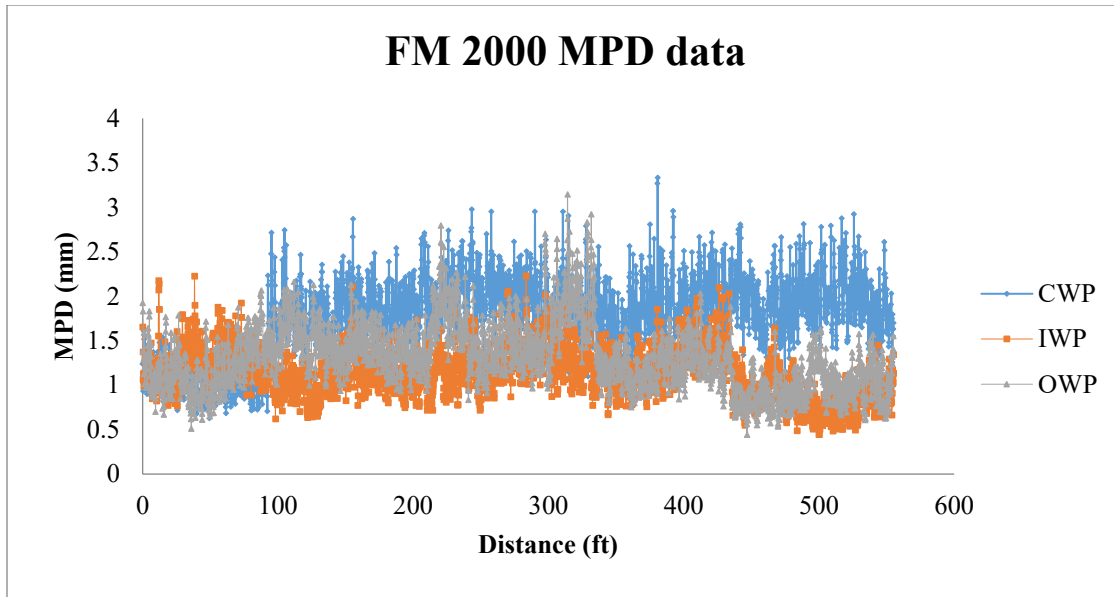
Figure 16. MPD Data for Different Locations on FM 2000 in the K1 Lane.

The aggregates used in the FM 2000 and FM 0487 field sections were both Grade 4, which according to TxDOT specifications has 95–100 percent passing the #4 (4.75 mm) sieve (2). This aggregate size was selected as representative to compare against the MPD peaks. The ED was then calculated (using MATLAB) by subtracting the representative aggregate size (4.75 mm) from the peak points, and then dividing by the predominant aggregate size.

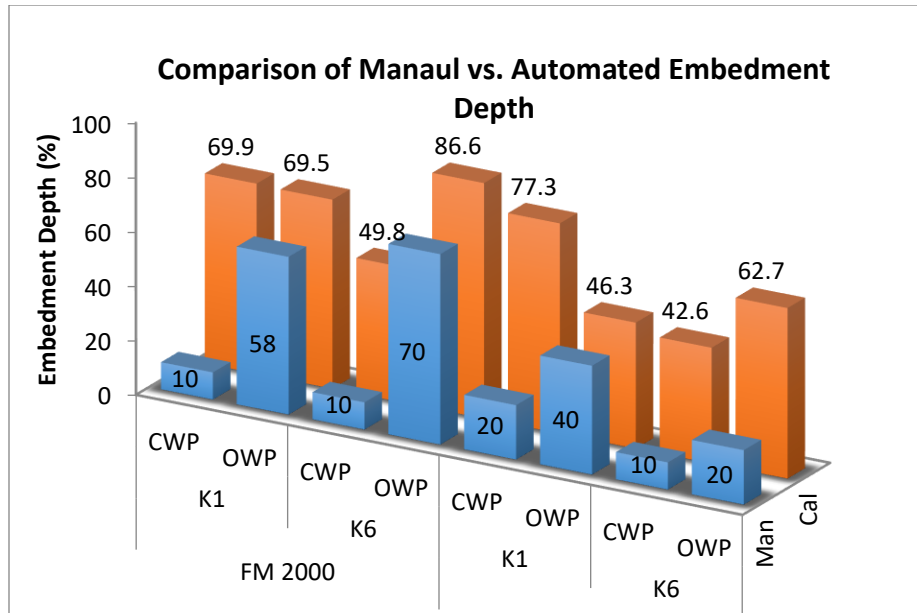
Figure 17. Comparison of Automated versus Manual ED.

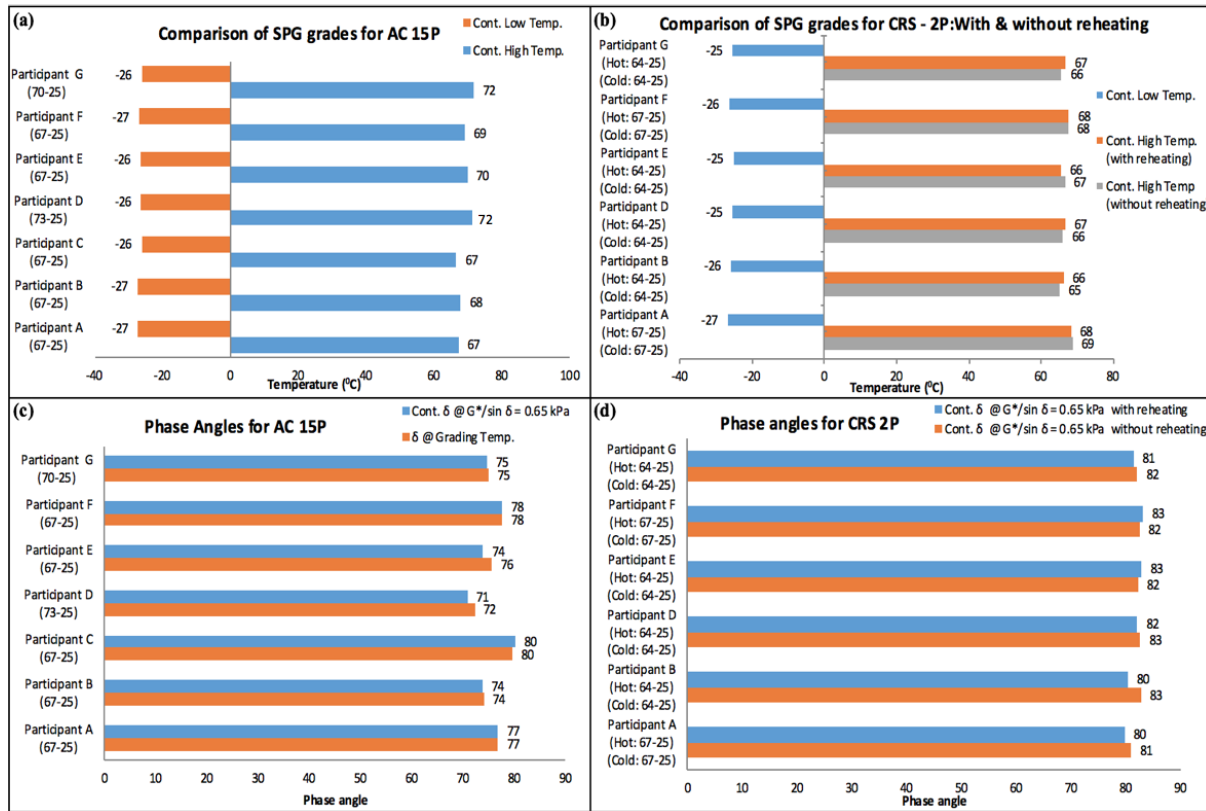
Figure 20. Round Robin 1 Results: (a) SPG for AC-15P, (b) SPG for CRS-2P with and without Reheating, (c) Phase Angle for AC-15P, and (d) Phase Angle for CRS-2P with and without Reheating.

Participants G and D, who reported high temperature grades 2°C higher than 70°C. All the participants reported a low temperature grade of -25°C, showing very good agreement.

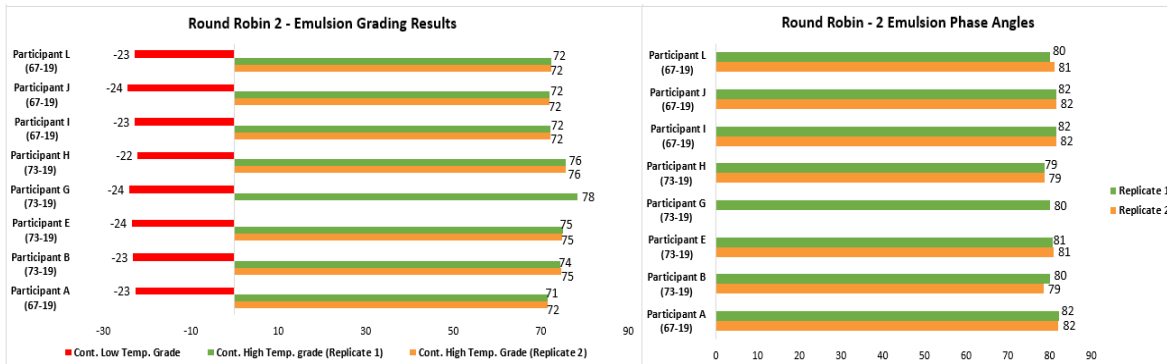
Figure 22. Round Robin 2 Results for Emulsion.

Figure 22 shows the SPG results for the emulsion sample. Four out of eight participants reported a T_{high} of 67°C , and the remaining four reported 73°C . However, except participant G, all the participants' continuous high temperature grades were within 5°C ranging from 71°C to 76°C . In addition, the continuous low temperature grades (-22°C to -24°C) and the phase angles (79° to 82°) were in very good agreement with each other.

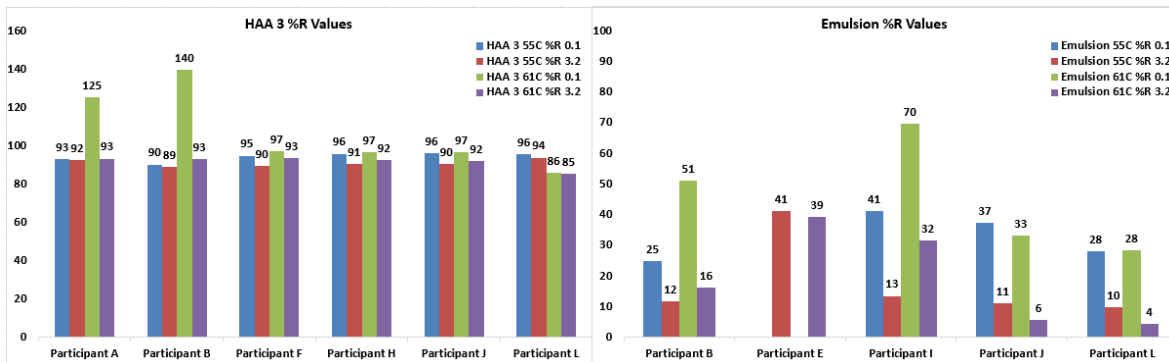
Figure 23. MSCR %R and J_{nr} Results at 0.1 and 3.3 kPa and 55°C and 61°C for HAA 3 and the Emulsion.

Figure 23 shows the MSCR %R values for HAA 3 and the emulsion at 55°C and 61°C. Similar to the SPG and %ER results, HAA 3 exhibited very consistent results whereas the emulsion %R values were variable. The %d2s analysis performed (using thresholds from a SEAUPG Inter Laboratory Study) on the %R values showed that for HAA 3, the %R values @ 0.1 kPa and 3.2 kPa at 55°C and @ 3.2 kPa at 61°C are equivalent whereas the corresponding values @ 0.1 kPa at 61°C are not (34). For the emulsion, none of the %R values were statistically equivalent.

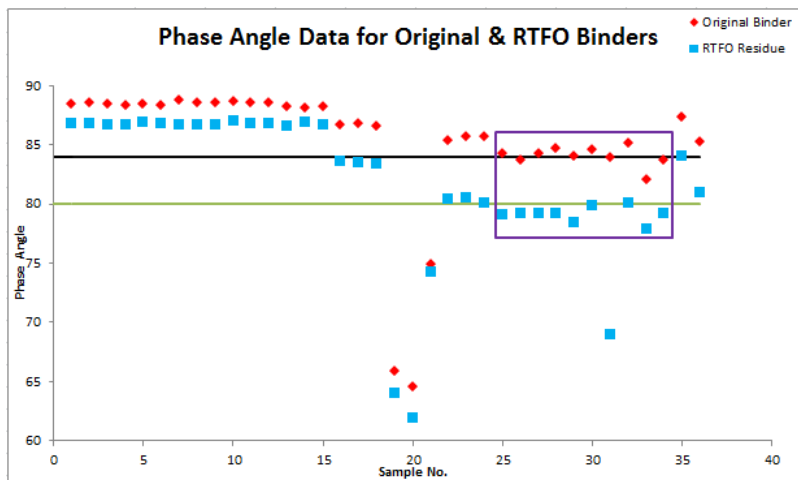
Figure 26. Phase Angle Data for Original and Corresponding RTFO Aged Binders from TxDOT.

Another issue that was explored was the possibility of pre-aging a binder to meet the phase angle requirement in the current SPG specification. To check this possibility preliminarily, TxDOT phase angle data for original and corresponding RTFO aged binders as shown in Figure 26 was examined. The highlighted box shows that the majority of the RTFO aged binders with phase angles close to the current 80° threshold had phase angles between 80° and 84° in their original state. Excluding one outlier, the change in phase angle from original to RTFO-aged ranged from 0.7° to 5.6° for the same sample. Thus, binders that are unmodified or poorly modified may pass the phase angle threshold if pre-aged.

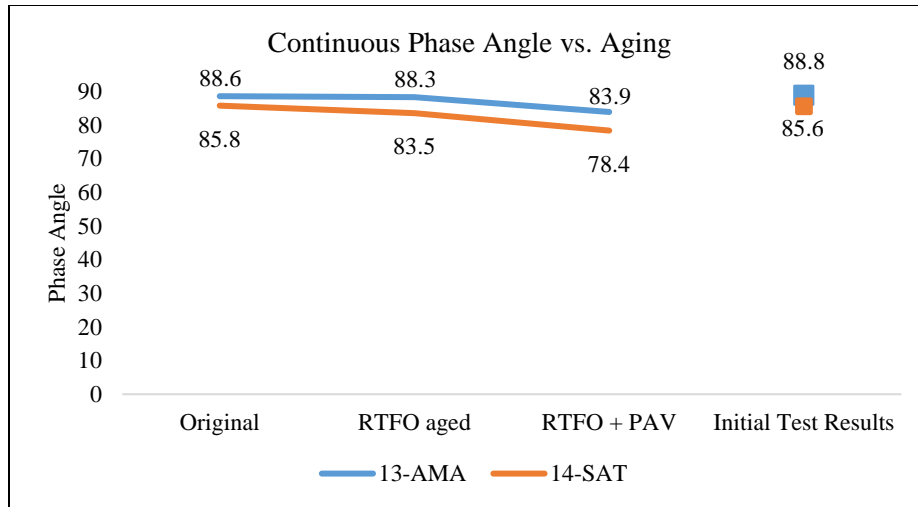
Figure 27. Change in Continuous Phase Angle (δ at 0.65 kPa) with Aging.

To further explore this issue and the ability of the low temperature SPG threshold to preclude pre-aged binders, a small study was conducted with two unmodified AC-10 binders from 2013 and 2014 (13-AMA and 14-SAT). Both binders were tested in the DSR in three different aging states: original, RTFO aged, and RTFO+PAV aged. Figure 27 shows the change in phase angles with aging for both unmodified binders. Phase angles measured on both the binders in their original state when initially received (in 2013 and 2014) are also included. Laboratory aging reduced the phase angle exhibited by both binders, but there was no difference between the original results and the initial test results with the binders stored at cold temperature.

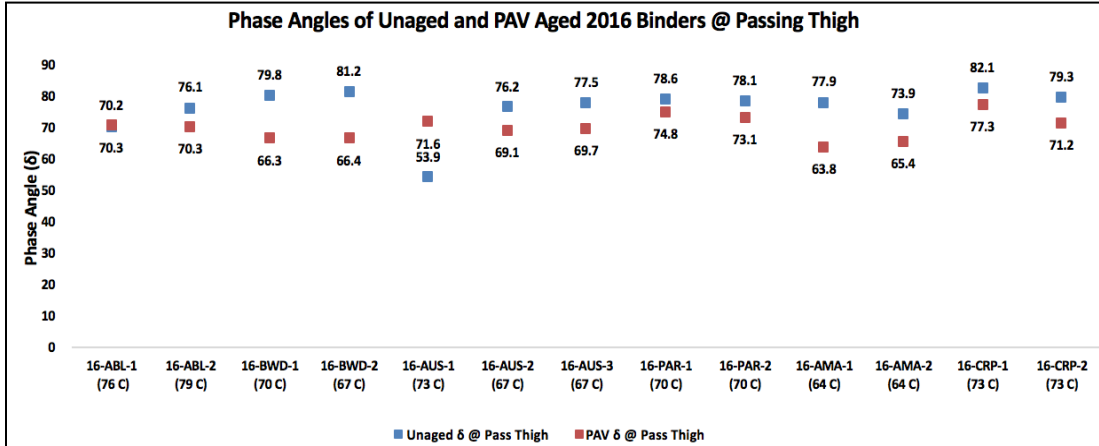
Figure 28. Phase Angles of Original (Unaged) and PAV-Aged 2016 Binders @ Passing Thigh of the Unaged Binders.

angles between 80° and 84° and those with phase angles less than 80° after PAV aging, possibly due to the fact that all of the 2016 binders are modified and that each binder can have a different rheological response to aging.

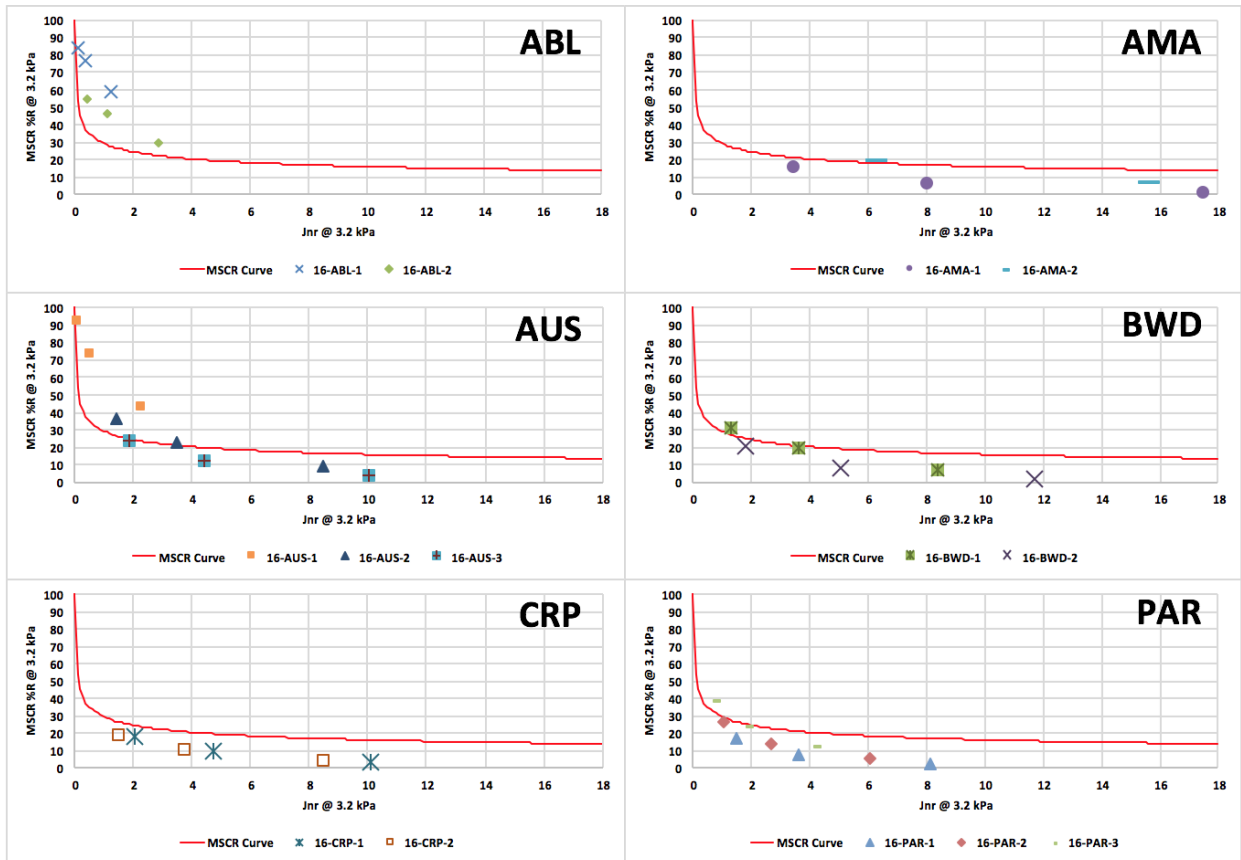
Figure 31. MSCR Test Results of 2016 Binders at 55°C, 61°C, and 67°C Analyzed by the AI Polymer Method.

Except for the ABL binders and one AUS binder, none of the binders exhibited sufficient delayed elastic response at any of the three temperatures. Although the FTIR results indicated that all of the binders were modified, most binders were below the polymer curve, even at 55°C. Thus according to this analysis that was developed for HMA binders, only the binders from ABL and one from AUS are satisfactory in terms of the sufficiency of polymer modification and delayed elastic response. These results agree somewhat with phase angle values with the 16-ABL-1, 16-ABL-2, and 16-AUS-1 binders having three of the lowest six phase angles that are all less than 76°.

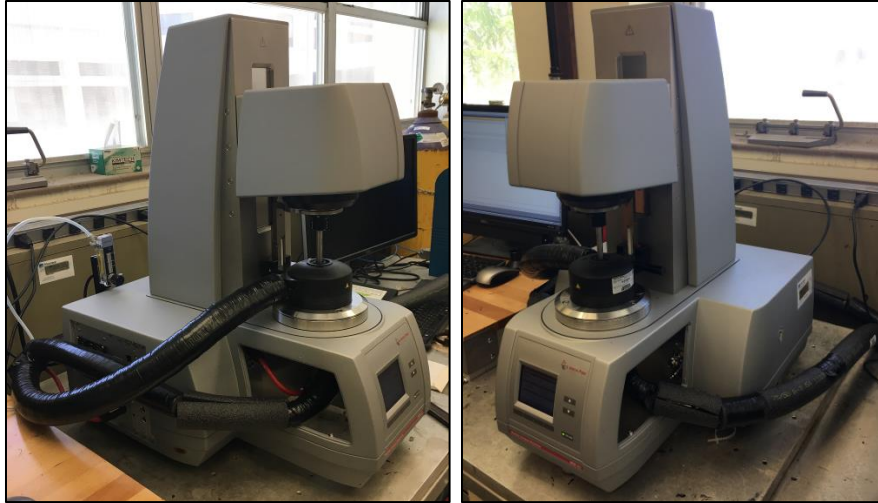
Figure 34. Anton Paar MCR 302.

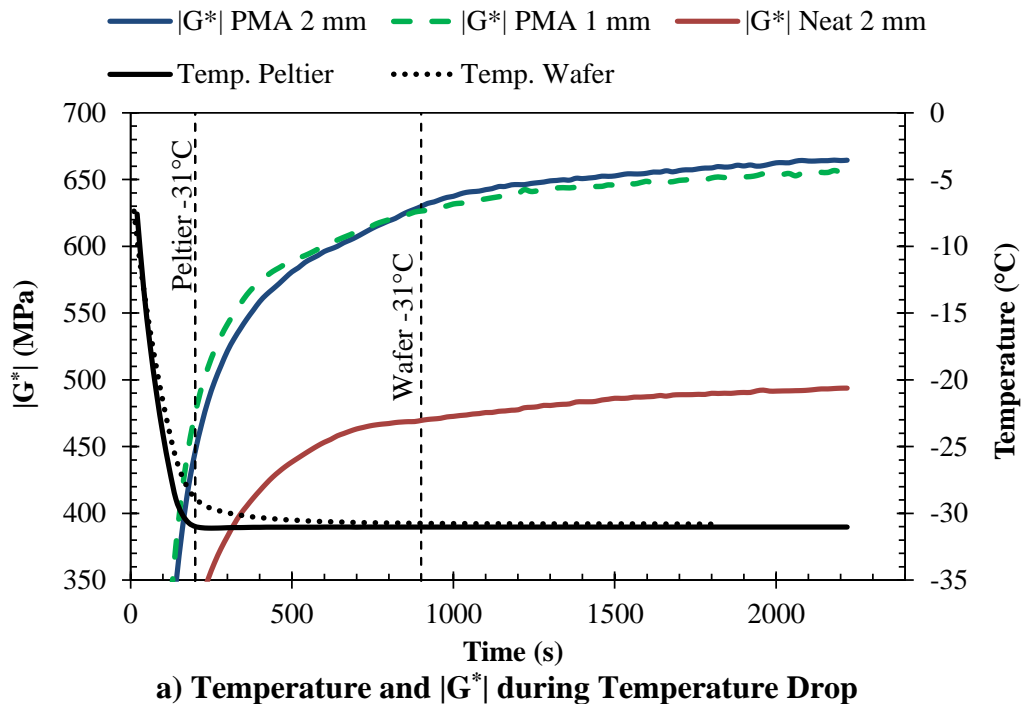
b) $\Delta|G^*|$: Temperature Equilibrium versus Physical Hardening
Figure 36. Selection of Equilibrium Time for Initial Temperature Step 0 to -31°C .

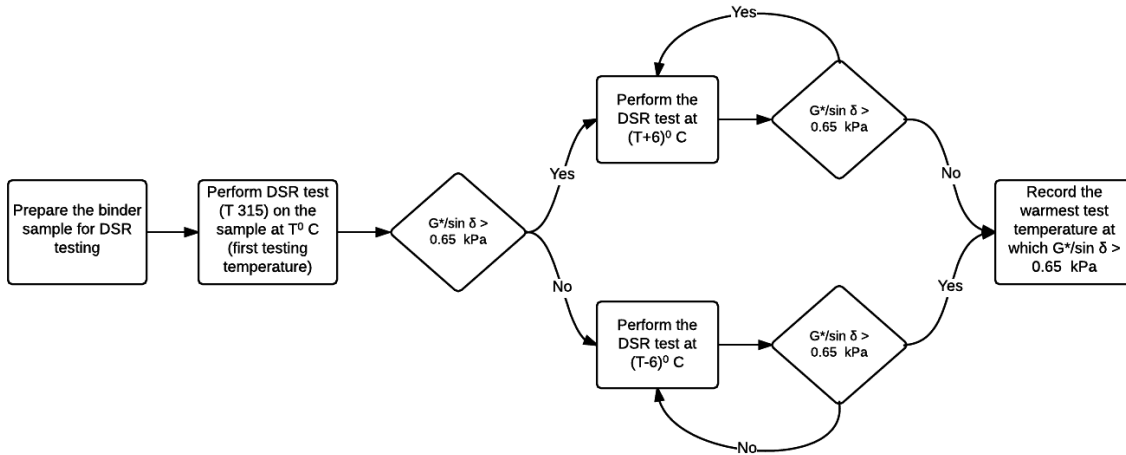
Figure D3. SPG High Temperature Grading of Hot-Applied Asphalt Binders and Emulsion Residues.
