Rehabilitation of Longitudinal Joints in Double-Tee Girder Bridges

**Study SD2014-20
Final Report**

**Department of Civil & Environmental Engineering
South Dakota State University
Brookings, SD 57007**

May 2018

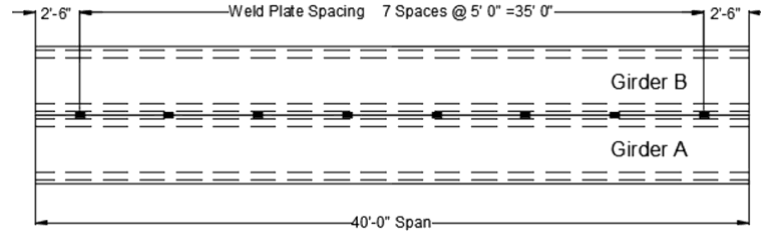
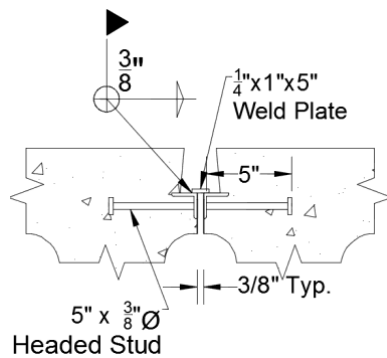
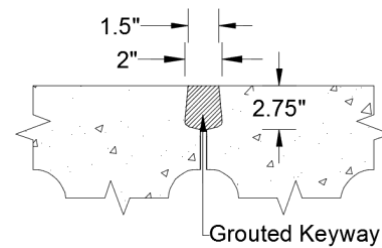
Figure 2-1. Conventional Double-tee Girder Longitudinal Joint Detail (after Konrad, 2014)

The conventional joint detailing currently used for double-tee girders in South Dakota (SD) utilizes discrete welded connections spaced every 5 ft along the length of the bridge and embedded in a shear key filled with non-shrink grout (Figure 2-1).

a. Plan View of Conventional Double-Tee Bridge Girder

b. Section Detail of Welded Connection

c. Section Detail of Grouted Keyway

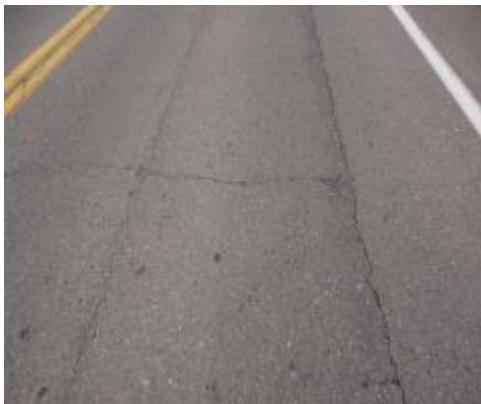
a. Reflective Cracking of Asphalt Overlay

A common problem with the existing double-tee bridges is the deterioration of the girder longitudinal joints. The inspection of bridges built less than 40 years ago has revealed that there are large reflective cracks along these joints causing corrosion of the reinforcement as well as the welded connections. The corrosion expedited the double-tee girder's rate of deterioration (Fig. 2-2).

Figure 2-2. Reflective Cracking and Deterioration of Double-Tee Girder Bridges (Konrad, 2014)

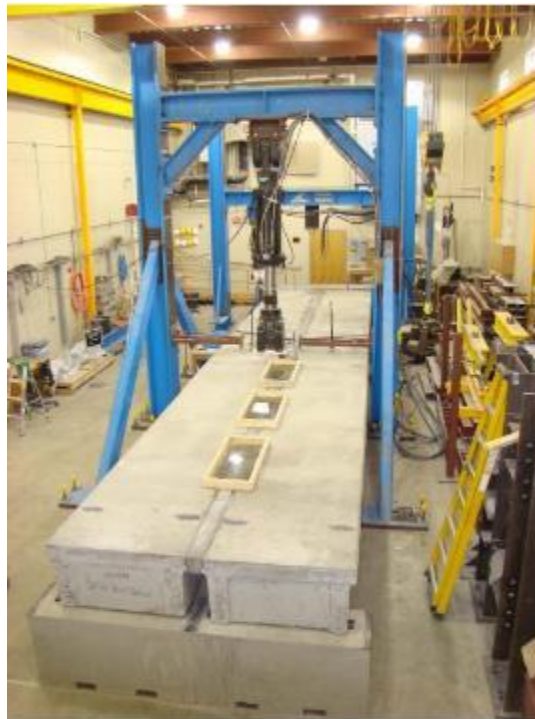
Wehbe et al. (2016) experimentally investigated the behavior of a full-scale conventional double-tee bridge under fatigue and strength loading (Fig. 2-3). The bridge test specimen consisted of two, 40-ft long interior double-tee girders connected longitudinally using the conventional joint detailing discussed above. The fatigue test was carried out by applying a 21-kip half-cycle loading at a frequency of one cycle per second to the mid-span with a slight offset to maximize the shear force demand on the joint. The strength testing was done by applying an increasing monotonic loading to the girders to failure. Water leaked through the girder-to-girder joint at a load cycle of 19,500 during the fatigue testing (equivalent to 3.5 years of service). The welded connections failed near the mid-span at 62,000 cycles of the fatigue loading (equivalent to 11 years of service). Furthermore, the two girders acted as individual members under the strength testing, indicating that the girder-to-girder joint is the weak link in the system. The study concluded that the current double-tee joint detailing is insufficient to meet current AASHTO service, fatigue, and strength limit state requirements.

Figure 2-3. Full-Scale Conventional Double-Tee Girder Test Specimen (after Konrad, 2014)

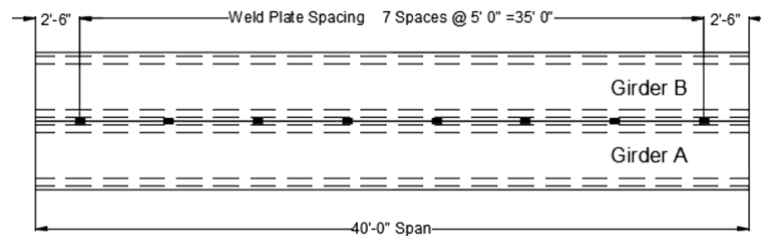
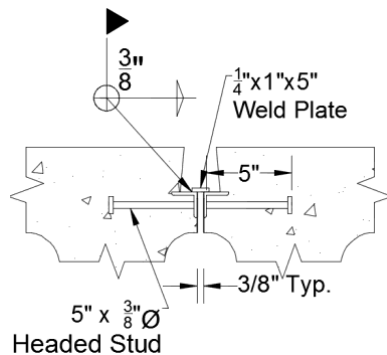
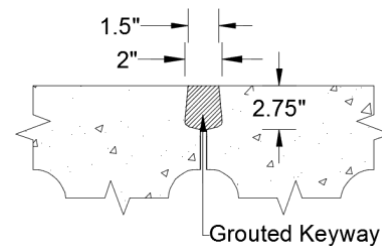
Figure 5-1. Conventional Double-tee Girder Longitudinal Joint Detail (after Konrad, 2014)

Conventional double-tee longitudinal joint detailing (Fig. 5-1), which is common in SD, utilizes discrete welded steel plate connections spaced every 5 ft (Fig. 5-1b) and grouted longitudinal keyways (Fig. 5-1c) to complete the girder-to-girder connections.

a. Plan View of Conventional Double-Tee Bridge

b. Section Detail of Welded Connection

c. Section Detail of Grouted Keyway

Konrad (2014) studied the fatigue performance of the SD conventional (Fig. 5-1) and the new double-tee girder-to-girders joints (Fig. 5-6) through full-scale testing of double-tee bridges. The concern was reflective cracking of the longitudinal joints that might affect the structural performance of the bridge superstructure. The experimental results, based on AASHTO fatigue loading, showed that the discrete welded steel connections were inadequate. Bridges are designed for a lifespan of 75 years. Nevertheless, the test result of the conventional bridge showed joint failure at 62,000 load cycles, equivalent to 11.3 years of service. Figure 5-7a shows the measured girder load-displacement relationship for the conventional specimen. The failure mode was the headed stud pulling out from the girders (welded connection failure) at approximately 70 kips. The relative deflection between the two adjacent girders showed the inability of the welded connections to transfer the shear between girders. In other words, the conventional longitudinal joints acted as pin connections early in the test. The new continuous joint detailing (Fig. 5-6) was tested for more than 800,000 load cycles with insignificant stiffness degradation. The load carrying capacity of the specimen with continuous joint (Fig. 5-7b) was 1.5 times greater than the conventional specimen. The bridge with the new joint detailing failed in flexure. The results showed that the proposed connection can provide adequate load path between the double-tee girders, and the deck system acts monolithically.

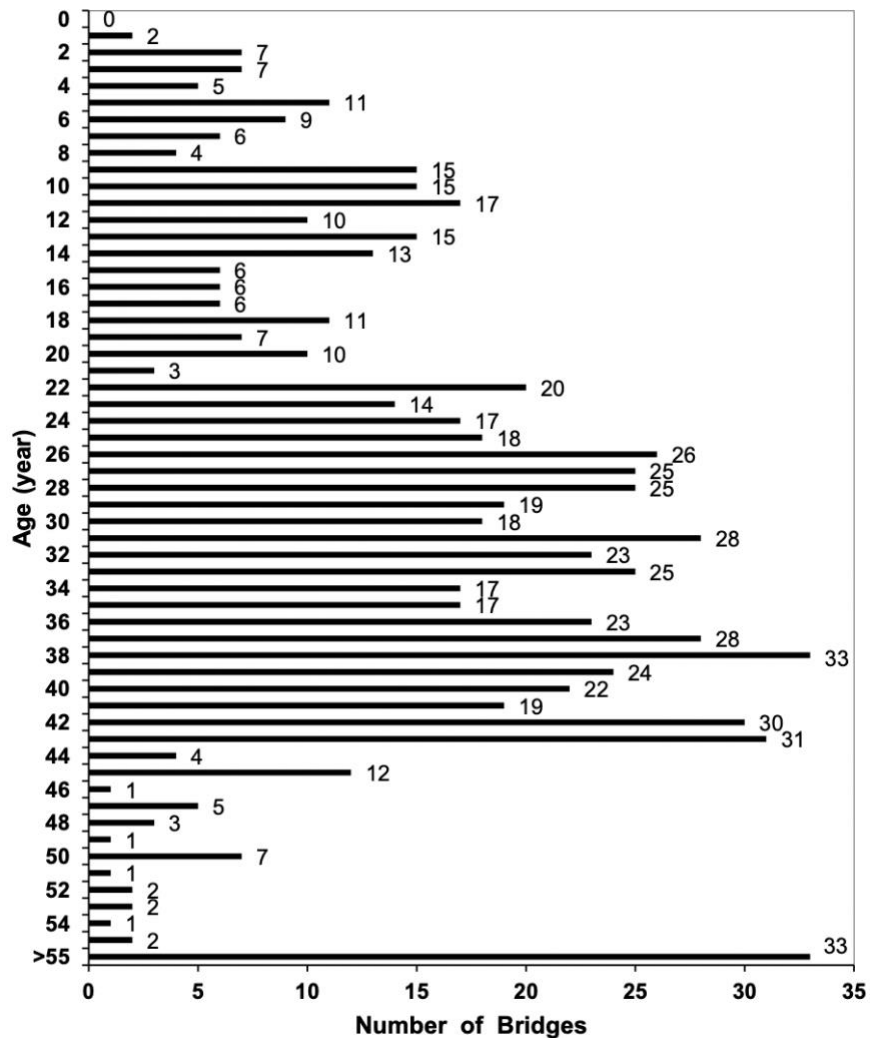
on double-tee bridges. More than 750 in-service double-tee bridges were identified. Figure 5-2 shows the age distribution of these bridges with a majority of them from 20- to 45-year old.

Figure 5-2. South Dakota Double-Tee Bridge Age Distribution

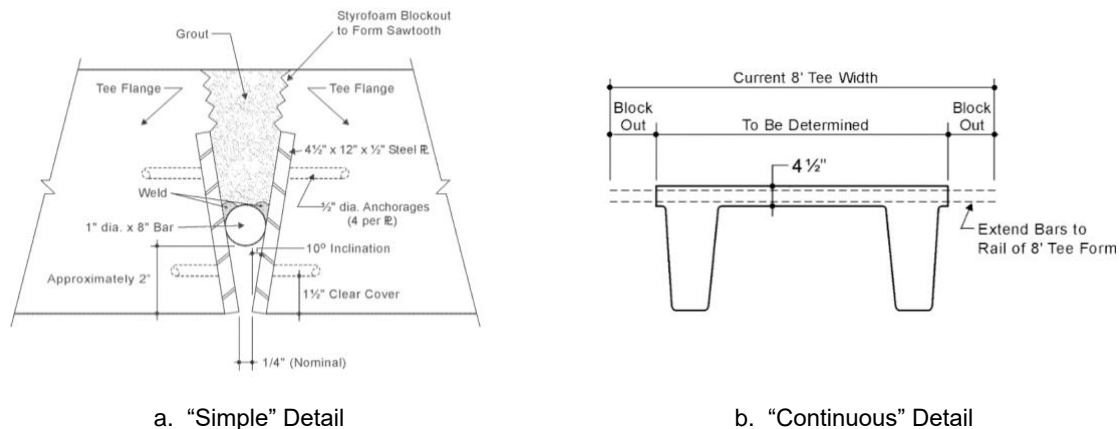
The “simple” connection detail was determined to be the most cost-effective alternative. Subsequently, the “simple” detail was tested for static and fatigue loading. Vehicle loads of 16 kips to a peak of 24 kips were applied to the specimen for a total of 1.5 million cycles. Overall, no sign of failure and degradation was reported.

Figure 5-3. Recommended Longitudinal Joint Detailing (after Jones, 2001)

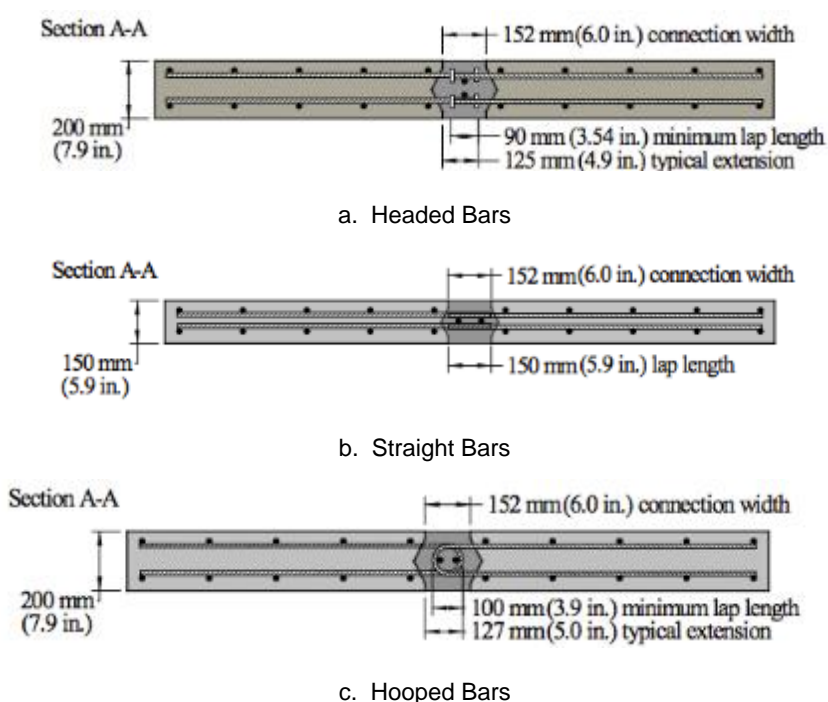
cementitious material developed in recent decades with superior properties such as higher strength, better durability, and improved ductility over conventional concrete. The UHPC also provides an excellent bond to the reinforcement as well as the existing concrete. Graybeal’s research was focused on the performance of the longitudinal and transverse connections under both fatigue and static wheel loads. The connections were fabricated utilizing straight lapped bars, headed bars, and intersecting hoop bars. Four specimens were built with transverse joints and two with longitudinal joints. Headed and straight bars were incorporated in the longitudinal connections (Fig. 5-4). Each specimen consisted of a female-female diamond shaped shear key that was 6-in. wide at the top and bottom. The lap-splices for the headed bar, the hooped bar, and the straight bar specimens were respectively 3.5, 3.9, and 5.9 in. Cyclic loads were applied using a servo-hydraulic controlled actuator with a load frequency of 6 Hz. A sinusoidal loading protocol was used to apply 2 and 16-kip forces for two million cycles and 2 and 21.3-kip forces for the remaining cycles to failure.

Figure 5-4. UHPC-Filled Deck Panel-to-Panel Longitudinal Joint Detailing (after Graybeal, 2010)

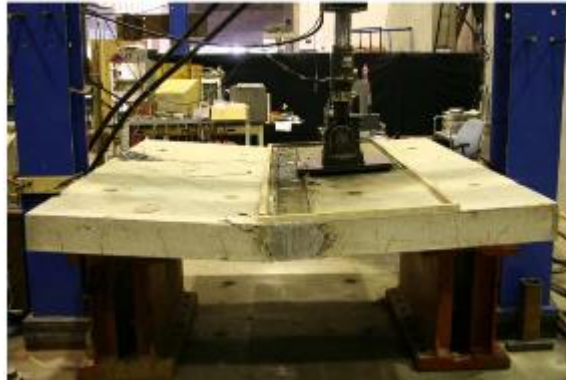
The specimens with the headed bar in the longitudinal connection withstood two million load cycles under 2- and 16-kip loads and nearly seven million cycles of 2- and 21.3-kip loads. Throughout the cyclic testing, no cracks or leaks were observed in the UHPC connections. The same result was observed for the longitudinal joints with the straight bars. However, additional cyclic loading was applied to fail the specimen. More than 10.5 million load cycles were applied before the bar crossing the connection interface fractured (Fig. 5.5). No evidence was observed of bond failure of the UHPC to concrete or UHPC to rebar.

Figure 5-5. Failure of Longitudinal Deck Panel-to-Panel Joint with Straight Bars under Fatigue Loading (after Graybeal, 2010)

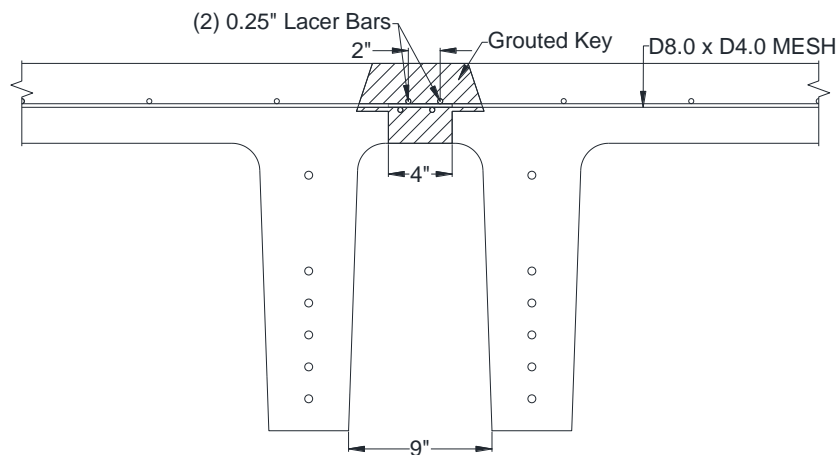
Figure 5-6. Continuous Joint Detailing for Double-Tee Bridges (after Konrad, 2014)

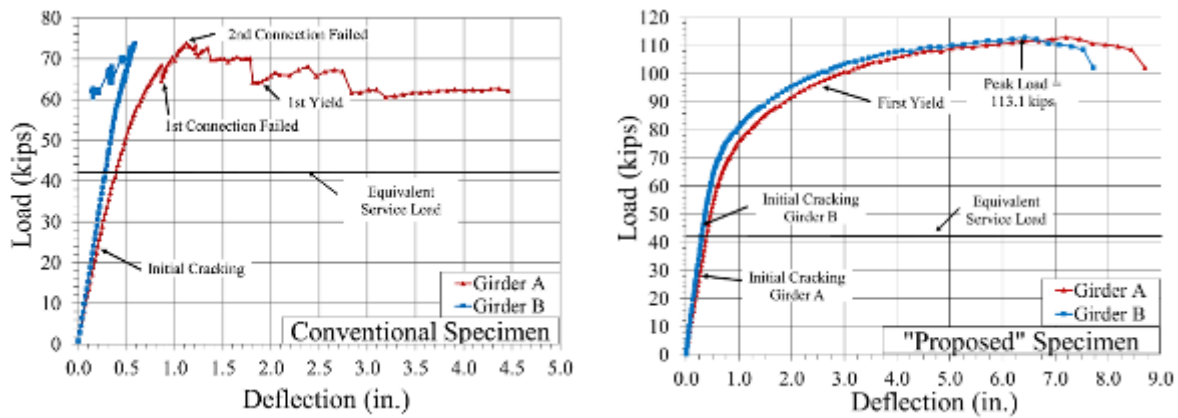
a. Conventional Double-Tee Bridge

b. Double-Tee Bridge with Continuous Joint

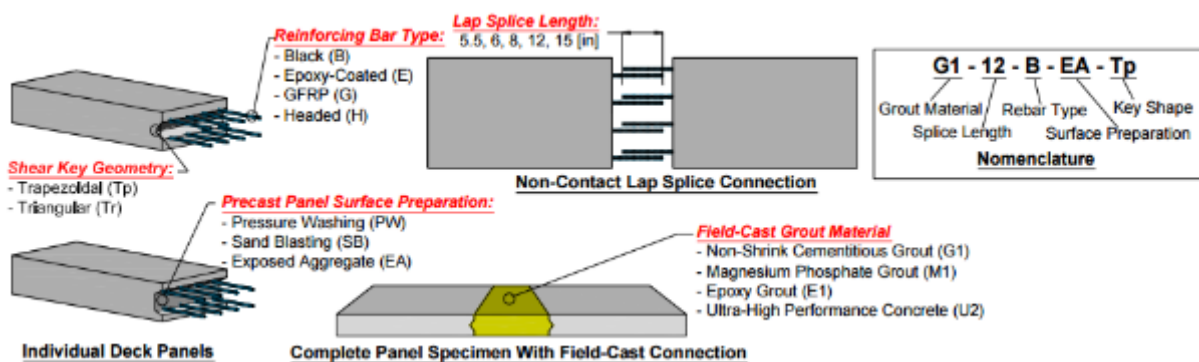
Figure 5-8. Test Variables Used for Precast Deck Panel Connections (after Haber and Graybeal, 2014)

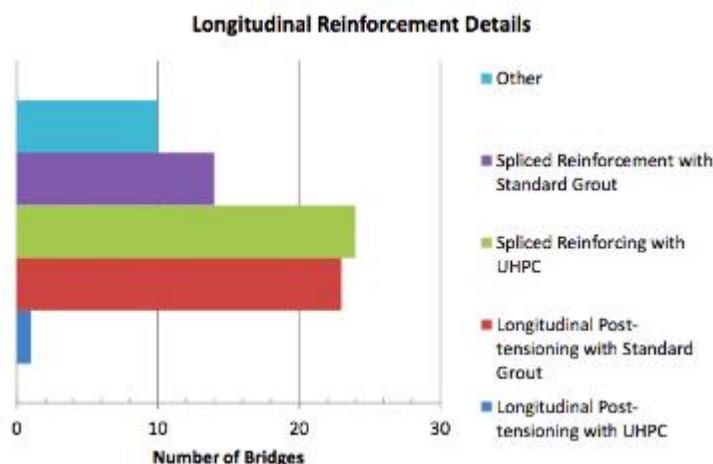
Jones et al. (2016) performed a survey of state DOTs regarding practical longitudinal and transverse joints suitable for precast bridge panels. Thirty-two DOTs participated in the survey. The survey concluded the most common type of longitudinal connections among DOTs are UHPC-filled joints with spliced reinforcement, and post-tensioned joints filled with standard grout (Fig. 5-9). Also surveyed was damage of existing deck panel connections for both full-depth and partial-depth deck systems. The most common issues reported by the participants were cracking of filler materials and joint leakage.

Figure 5-9. Survey Results for Various Longitudinal Joint Detailing (after Jones et al., 2016).

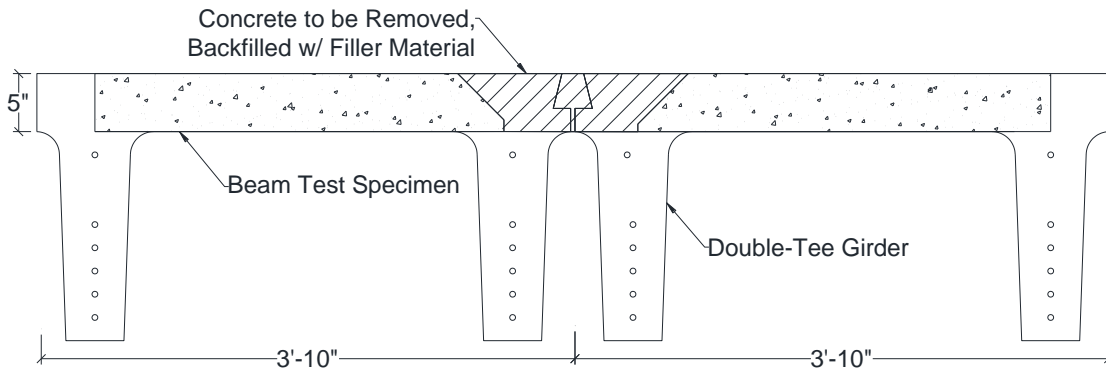
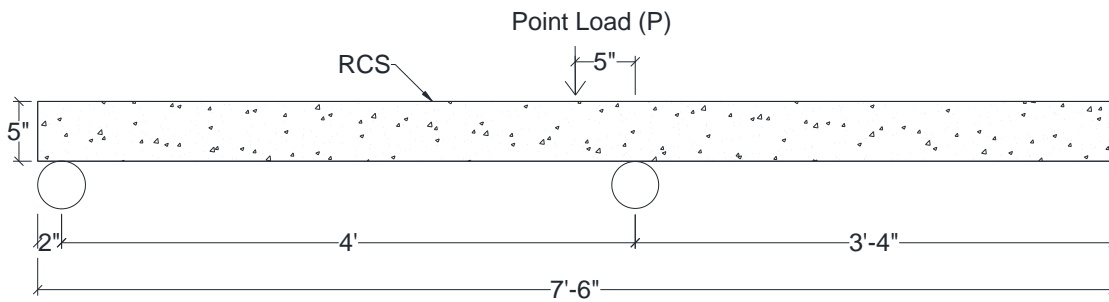
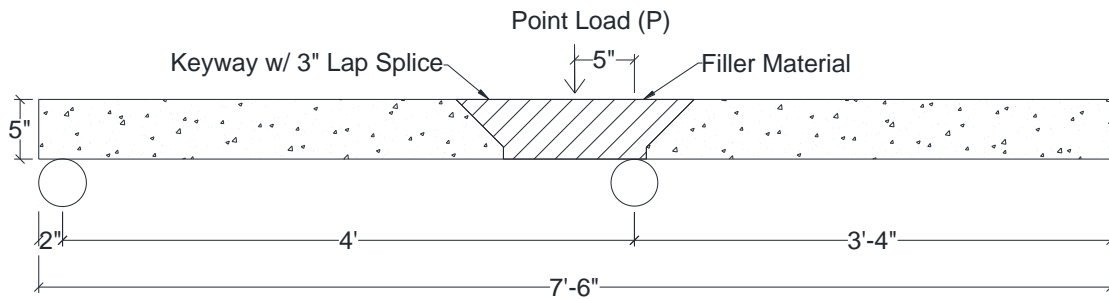
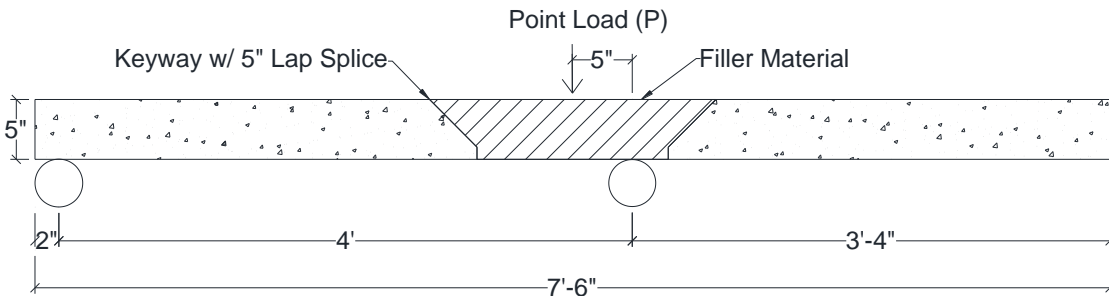
Figure 6-1. Geometry of Beam Test Specimens

The geometry selection criteria for the beam test models was based on the two-adjacent prototype double-tee girders (Figure 6-1). The thickness of the beam was the same as the girder flange thickness. The length of the beam was approximately 7.5 ft based on the centerline to centerline of the two exterior stems of the two girders. A 12-in. slice of the prototype bridge was selected as the width of the test specimens. The test beams were placed on two roller supports simulating the two left stems of the two girders. A point load was applied approximately at the right edge of the left girder to maximize the shear demand. The effect of the right exterior stem as a support was ignored to maximize shear force demands on the joint. The RCS had the same geometry as the spliced beams, but it was reinforced with a continuous wire mesh with the same size, type, and spacing as those that are currently utilized in actual double-tee girders.

a. Profile View of Beam Test Extracted from a Double-tee Girder

b. Reference Concrete Slab (RCS) Test Specimen

c. Test Specimen with 3-in. Lap-Splice

d. Test Specimen with 5-in. Lap-Splice

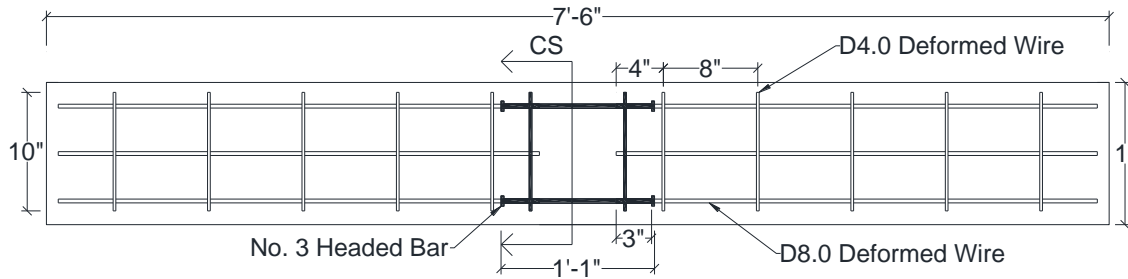
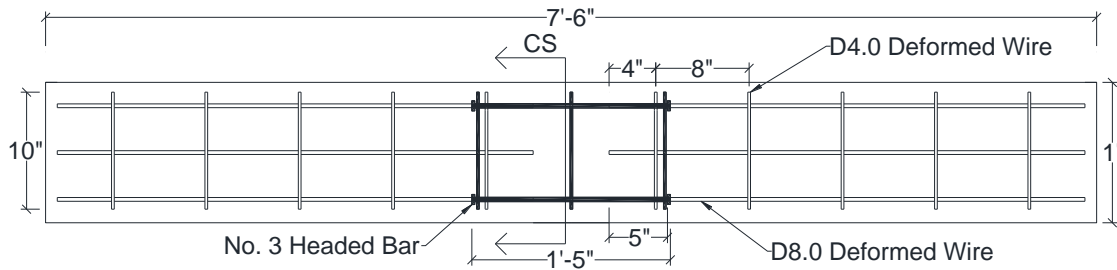
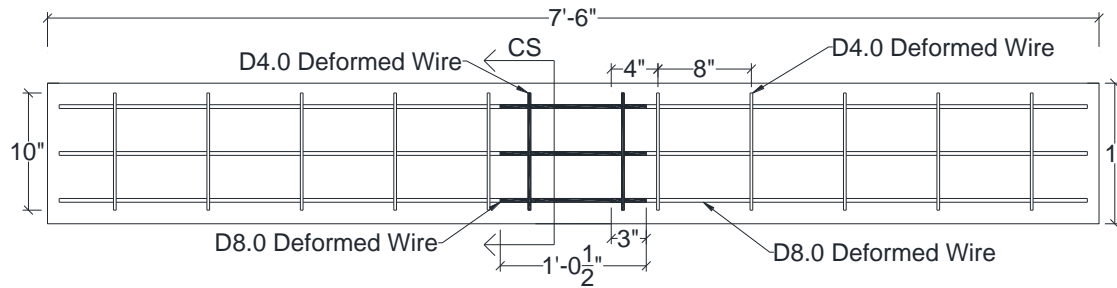
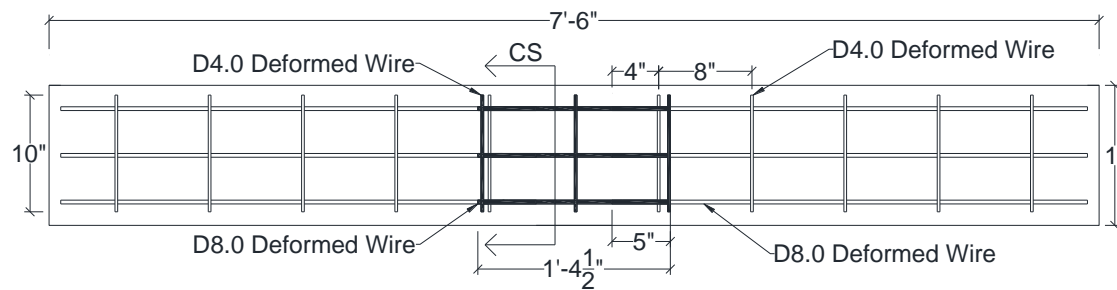
Figure 6-2. Splice Detailing of Beam Test Specimens

a. Test Specimen with 3-in. Splice Lengths Utilizing No. 3 Headed Bars

b. Test Specimen with 5-in. Splice Lengths Utilizing No. 3 Headed Bars

c. Test Specimen with 3-in. Splice Lengths Utilizing D8/D4 Wire Mesh

d. Test Specimen with 5-in. Splice Lengths Utilizing D8/D4 Wire Mesh

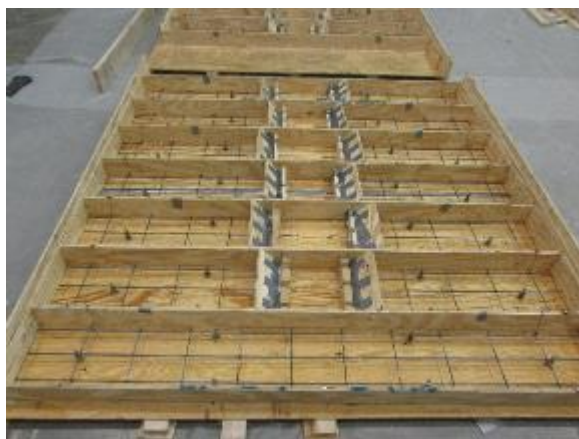
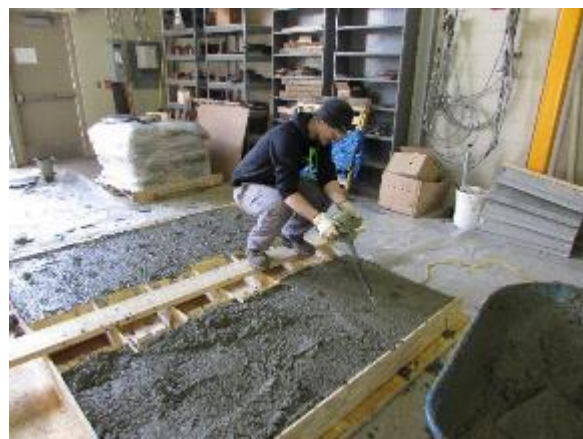
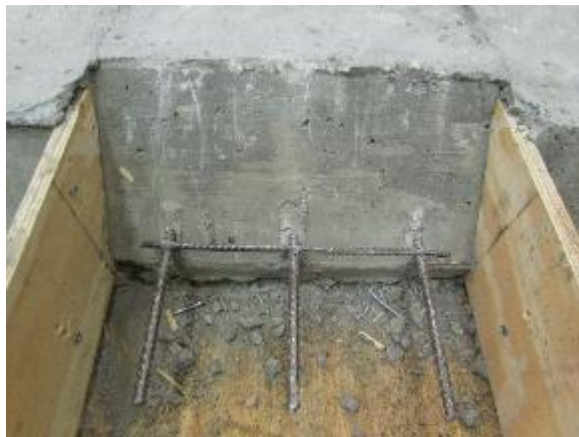
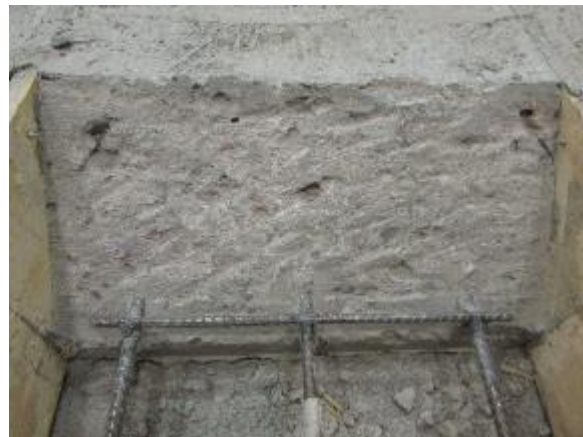
Figure 6-3. Construction of Beam Test Specimens

The beams were fabricated (Fig. 6-3) in the Lohr Structures Laboratory at South Dakota State University (SDSU). Ready mix concrete was utilized for construction. The fresh concrete temperature was 64°F with a slump of 6.0 in. The mix design was based on the current double-tee mix design provided by the manufacturer, targeting 6,000-psi compressive strength at 28-days. After 7 days of curing, the inner formwork was stripped in order to place the joint reinforcement. A previous study showed that roughening and pre-wetting the surface for 24 hours increases the bond between two cementitious materials (Graybeal, 2014). Since the concrete is usually demolished by hammer chipping in South Dakota, a hammer drill was used to roughen the splice surface (Fig. 6-3a and 6-3b) to best resemble demolishing conditions.

a. Formwork

b. Pouring Concrete

c. Original Joint Surface

d. Roughened Joint Surface

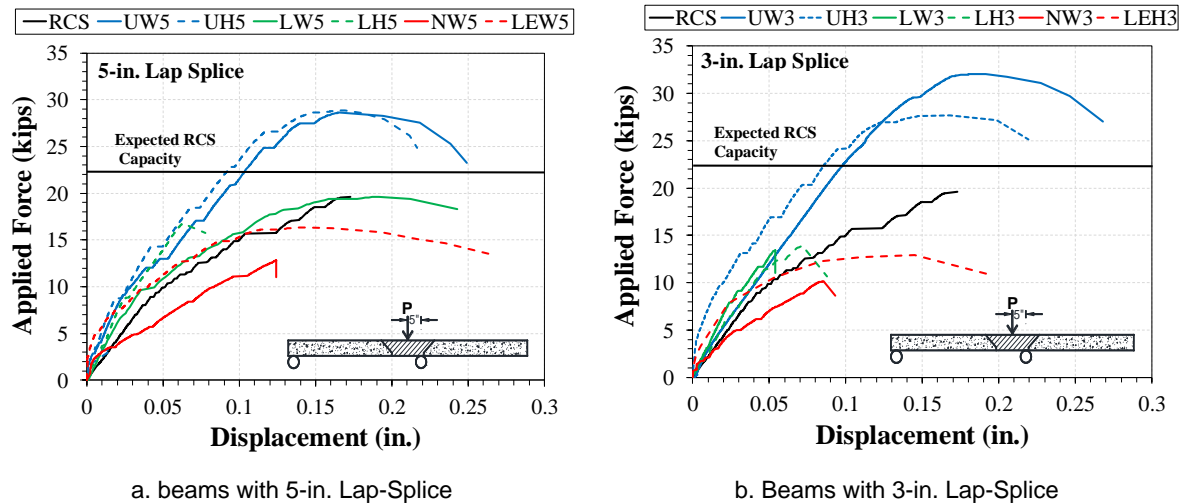
Specimen ID	Measured P_{crack} (kips)	Measured P_u (kips)	Mode of Failure
RCS	8.8	22.3	Bar rupture in joint
LW5	9.9	20.1	Bar rupture in joint
UW5	13.3	29.4	Bar rupture in precast concrete segment
LEW5	7.2	16.8	Bar rupture in joint
NW5	3	13.6	Bar pullout
LH5	14.3	16.4	LMC compressive failure
UH5	14.7	29.6	Bar rupture at interface
LW3	12	13.8	Bar pullout
UW3	16.4	32.9	Bar rupture at interface
NW3	9.1	10.4	Bar pullout
LH3	11.7	14.9	Bar pullout
UH3	13.5	28.5	Bar rupture at interface
LEH3	10.5	12.9	Bar pullout

Figure 6-4. Load-Displacement Relationships for Beam Test Specimens

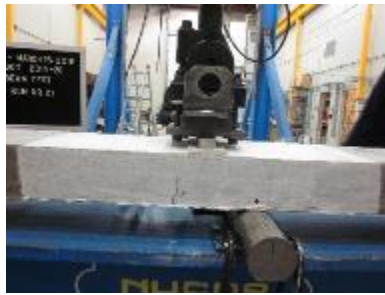
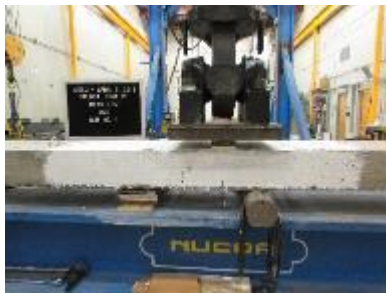
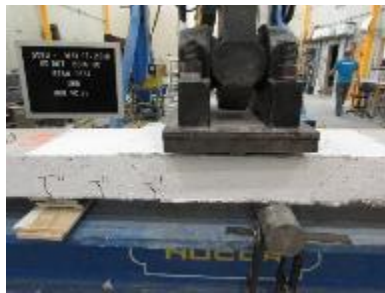
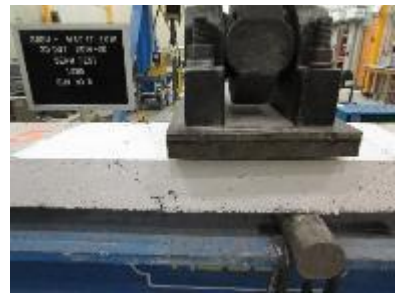
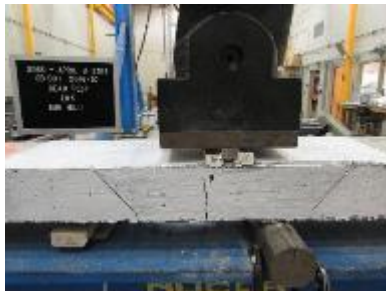
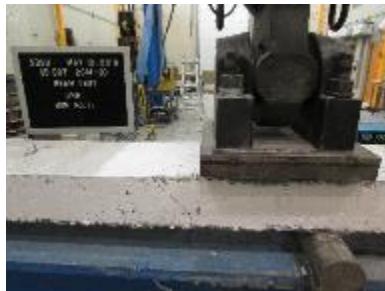
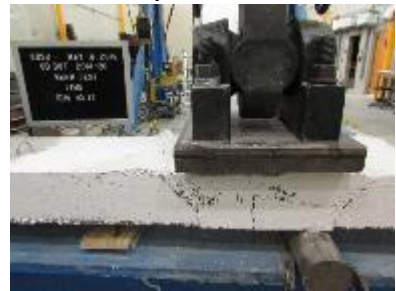
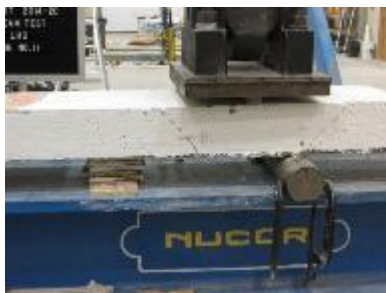
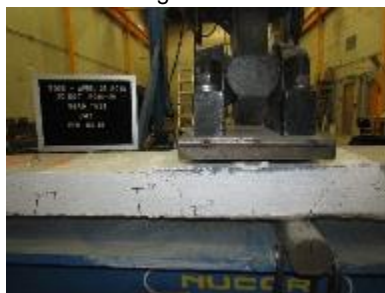
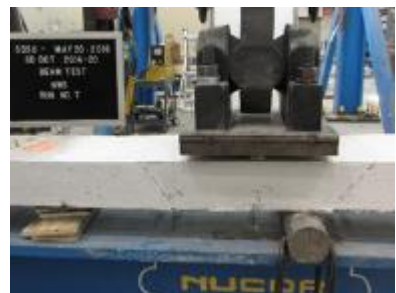
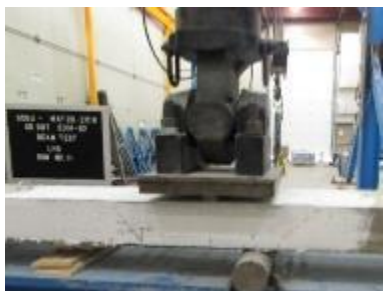
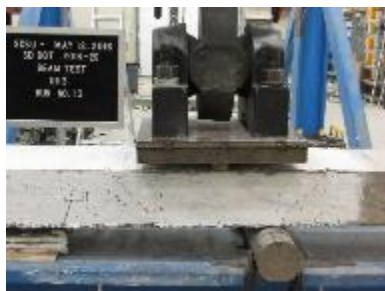
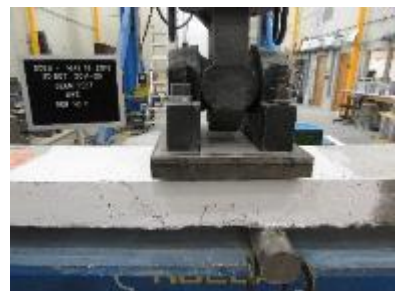
Figure 6-5. Beam Test Specimens at First Cracking

The UHPC test specimens had a 30% higher load carrying capacity than the reference specimen. This may be attributed to the 400% higher compressive strength and additional tensile strength provided from the 2% volumetric ratio steel fibers. The first crack (Fig. 6-5) then failure (Fig. 6-6) of all specimens except those incorporating UHPC, occurred inside the joint directly under the applied load where the bending moment was maximum. In the UHPC specimens, all of the flexural cracking was shifted outside the joint.

The LH5 had a different failure mode compared to the rest of the specimens in which LMC crushed directly under the applied load. This was attributed to the lower effective depth for LH5 (3.2 in.) compared to that for LW5 (3.7 in.), as well as the 50% higher strain capacity for No. 3 headed bar reinforcement, compared to that of the D8 reinforcement. The combination of the two parameters resulted in a condition in which the beam concrete (LMC) failed in compression in a brittle manner. On the other hand, the LW5 exhibited bar fracture. The LEW5 had an effective depth of 3.2 in. that resulted in 16% lower capacity compared to LW5.

Overall, it can be concluded from the beam test results that either UHPC or LMC might be viable filler materials for the rehabilitation of double-tee bridges. Full-scale bridge testing will reveal the best material for field applications. The splice length for UHPC and LMC should be at least 3 and 5 in., respectively. The use of non-shrink grout and extended LMC cannot guarantee bar fracture inside the joint; thus, they should be avoided in the rehabilitation of double-tee bridge longitudinal joints.

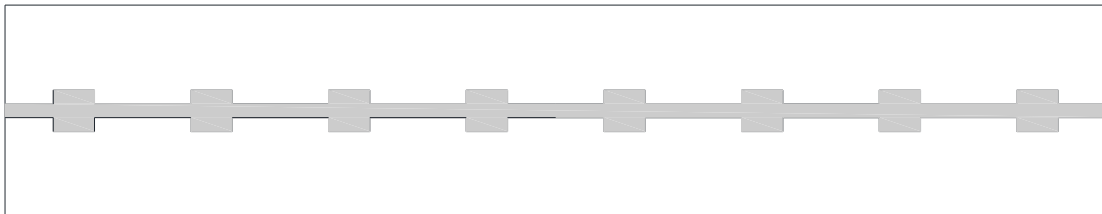
Option II – “pocket” concept (Fig. 6-7b) consisted of discrete pockets exposed by demolishing the girder flange concrete and reinforcing with steel bars. In between the pockets the damaged material in the longitudinal joint is removed and replaced with a filler material such as UHPC.

b. Plan View of Option II (Pocket Detailing)

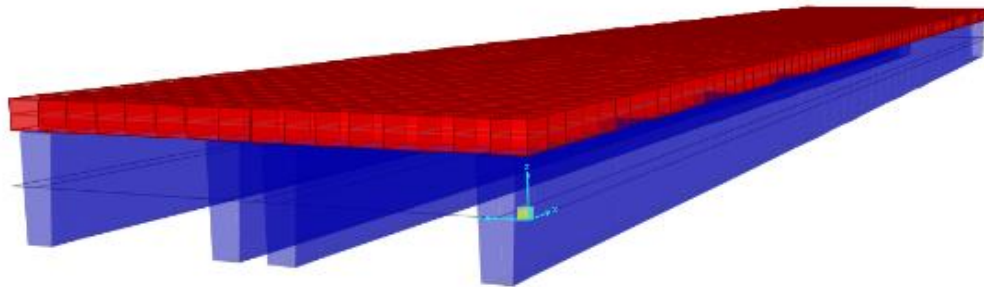
Linear Finite Element Analyses (FEA) were performed on two adjacent 23-in. deep double-tee girders (Fig. 6-8a). The double-tee stems are 18-in. tall, 5-in. wide at the bottom while tapered to 6.125 in. at the top. The double-tee deck is 5-in. thick and 46-in. wide. The SAP2000 (2016) was selected for the analytical study. The stems were modeled with frame elements. Pin supports were assigned to the end of each stem. The deck (the flange of the girders) was modeled using solid shell elements. The connection between the frame and shell elements was provided utilizing body constraints fixing all degrees of freedom (DOFs) between the two end nodes. The connection allows the deck and stems

to act compositely. The section properties for each girder was according to the actual double-tee section with an area of 426 in² and a moment of inertia of 18,640 in⁴ about the strong axis. The compressive strength (f'_c) for the deck and stems was 6,000 psi based on the target 28-day compressive strength of the actual double-tee girder mix design. The concrete modulus of elasticity (E_c) was 4,415 ksi.

a. Extruded View of FEA Model for Continuous Joint

- i. "Continuous" model (Fig 6-8a) in which the longitudinal joint of the girders was monolithically constructed with shell elements
- ii. "Pocket" model (Fig 6-8b) in which the girders were connected by a series of links representing the pockets spaced along the length of the longitudinal joint

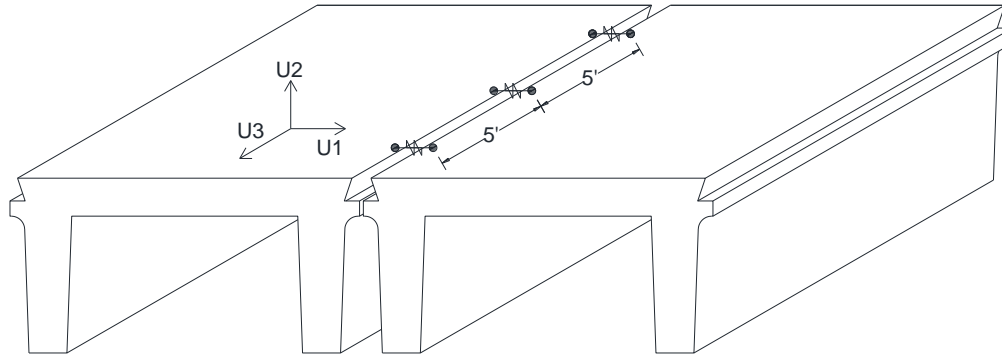
b. Link locations and Local Axis for Pocket Detailing

The "pocket" model was constructed using "link" elements consisting of linear springs in all six DOFs to connect the girders as shown in Fig. 6-8b. The spring properties (Table 6-5) were based on the

The performance of two adjacent double-tee girders connected with pocket detailing (Fig. 6-8b) was evaluated by comparing the amount of load being transferred to stems of each girder (Figure 6-9). Three different pocket (link) spacing of 5, 8, and 13 ft were included in the analyses, and the response was compared to that of a monolithic (continuous) bridge model. Results indicated that the difference between the stem forces for the monolithic and pocket models increases when the pocket spacing increases. For example, the end reaction of stem B of the pocket model with a 13-ft link spacing was 30% higher than that in the model with a 5-ft pocket spacing.

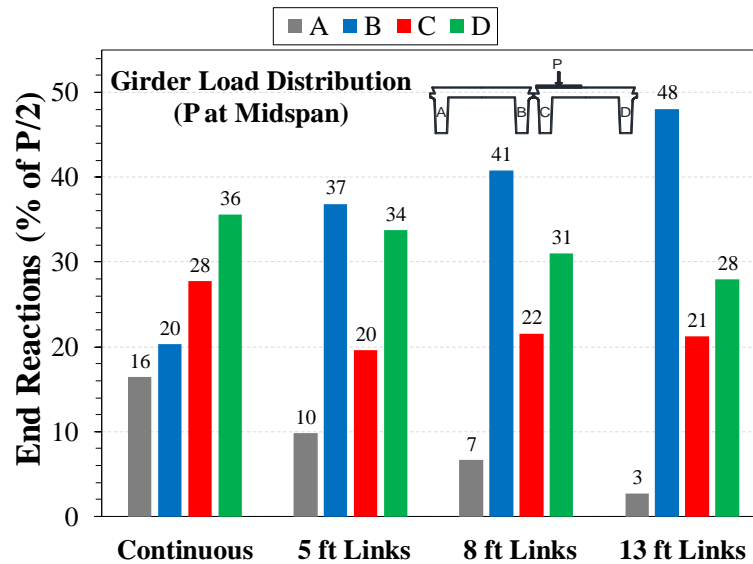
The stem force differences in the monolithic model and the model with 5-ft pocket spacing were within 10% for all stems, and the maximum stem forces between the two models were less than 3% in difference. It can be concluded, therefore, that the pocket spacing of 5 ft results in a monolithic behavior for a double-tee bridge rehabilitated with the pocket option. This pocket spacing was selected for further analysis.

Figure 6-9. Effect of Pocket Spacing on Double-Tee Girder Load Distribution

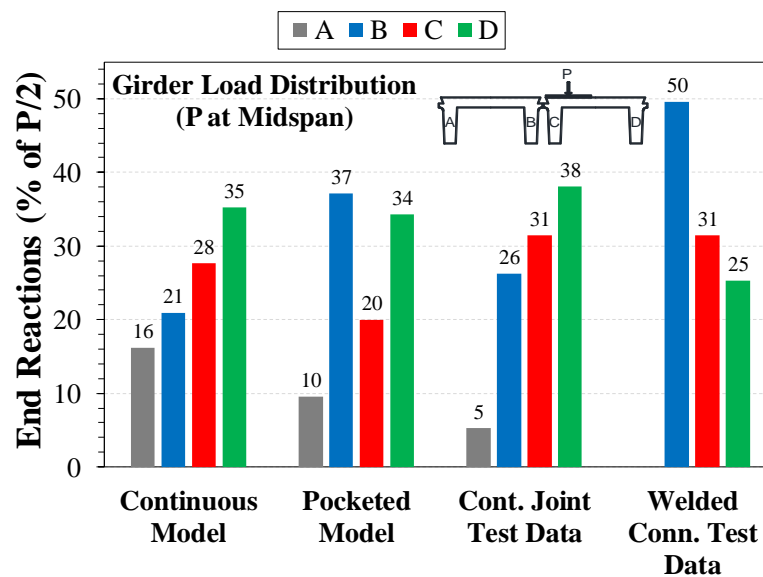
To better comment on the suitability of rehabilitated bridges with 5-ft pocket spacing, the calculated stem forces of the rehabilitated bridge were compared with those measured in previous experimental studies (Fig. 6-10). Two full-scale double-tee bridge models were tested by Konrad (2014), one specimen with continuous joint detailing (which behaved as a monolithic bridge) and one specimen with welded plate detailing (conventional double-tee bridge detailing that is currently used in practice). Results indicated that the girder stem end reactions for the analytical continuous model were close to those measured in the test (8% difference in the peak stem forces). The peak stem force calculated for the pocket model was 2.6% lower than that measured in the test for the continuous joint. Overall, the pocket model performed better compared to the original double-tee specimen with welded plates in terms of the load transfer mechanism.

Figure 6-10. Calculated and Measured Double-Tee Girder Load Distribution

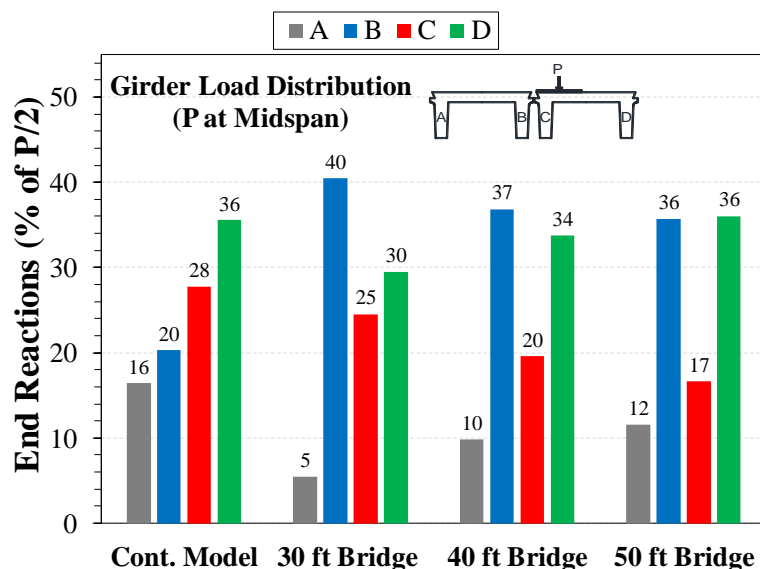
Currently, double-tee bridges with span lengths other than 40 ft are in-service in South Dakota (SD). To investigate the feasibility of the “pocket” detailing on bridges with different span lengths, the stem load distribution of “pocket” models with span lengths of 30 to 50 ft were analytically studied (Fig. 6-11). Results indicated that peak stem load slightly decreases when the span length increases. Overall, the effect of the span length on the stem peak forces was approximately 10% for the practical span lengths.

Figure 6-11. Rehabilitated Double-Tee Girder Load Distribution vs. Span Length

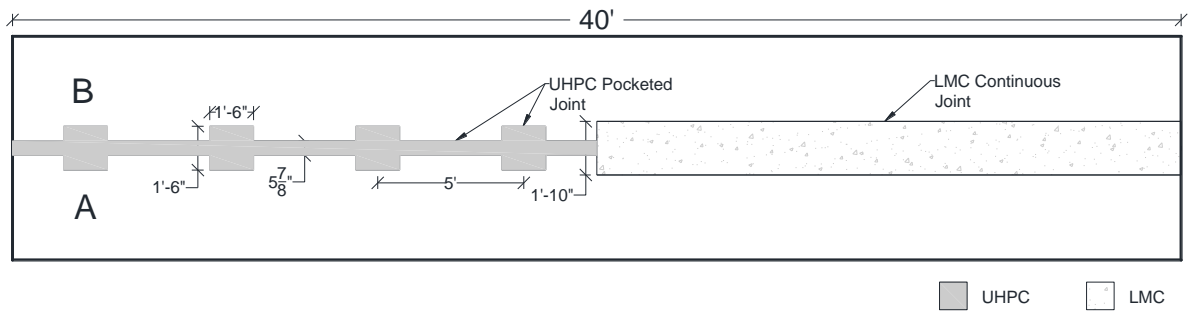
to evaluate the performance of both joint rehabilitation alternatives using only one test specimen, one half of the bridge test specimen was rehabilitated with the “pocket” detailing utilizing UHPC, and the other half of the bridge was rehabilitated with the “continuous” detailing incorporating LMC (Fig. 6-12). Hammer-chipping demolition technique was selected for concrete removal.

Figure 6-12. Proposed Rehabilitation for Double-Tee Bridge Test Specimen- Plan View

- Prepare 18 by 18 in. pockets to be filled with UHPC. The pocket spacing should not exceed 5 ft (Fig. 6-12) center-to-center.
- Pockets should be reinforced with four ASTM A706/A615 Grade 60 No. 4 bars in both longitudinal and transverse directions (Fig. 6-13).
- A minimum of 3-in. lap-splice between the pocket reinforcement and the deck’s existing wires is required to ensure full development (Fig. 6-13).
- A 5.875-in. continuous shear key filled with UHPC and longitudinally reinforced with two No. 4 bars should be provided (Fig. 6-14).

- Prepare a 22-in. wide continuous opening to be filled with LMC (Fig. 6-12).
- Continuous joint should be reinforced with ASTM A497 Grade 70, 4 by 4 in. D8/D8 welded wire mesh (Fig. 6-15).
- A minimum of 5-in. lap-splice between the new and existing reinforcement should be provided to fully development the wires (Fig. 6-15).
- If wire mesh is not continuous over the length of the bridge, the mesh should be spliced as shown in Fig. 6-16.

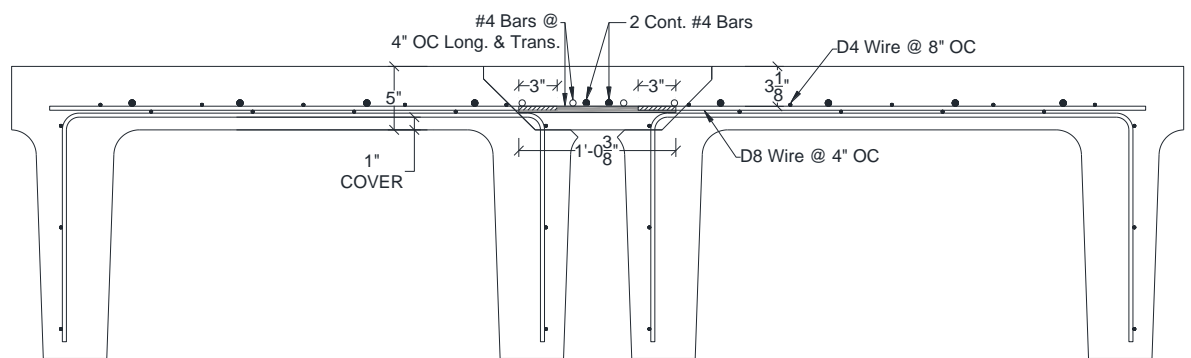
Figure 6-13. Proposed UHPC Pocket Detailing

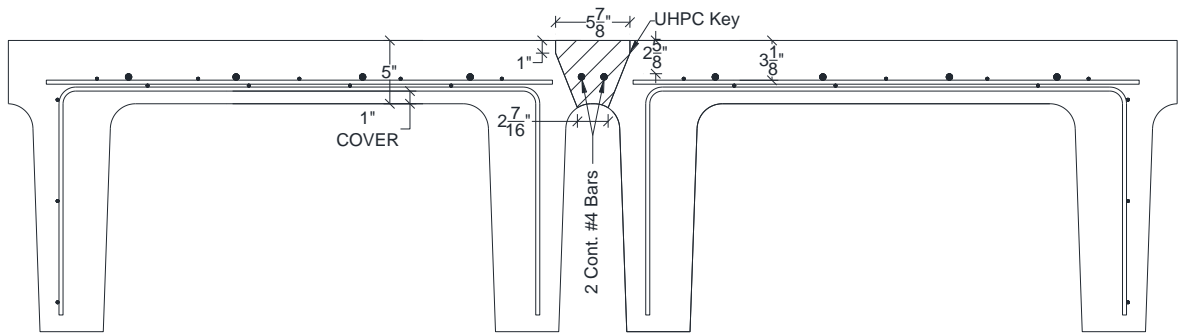
Figure 6-14. Proposed UHPC Intermediate Pocket Detailing

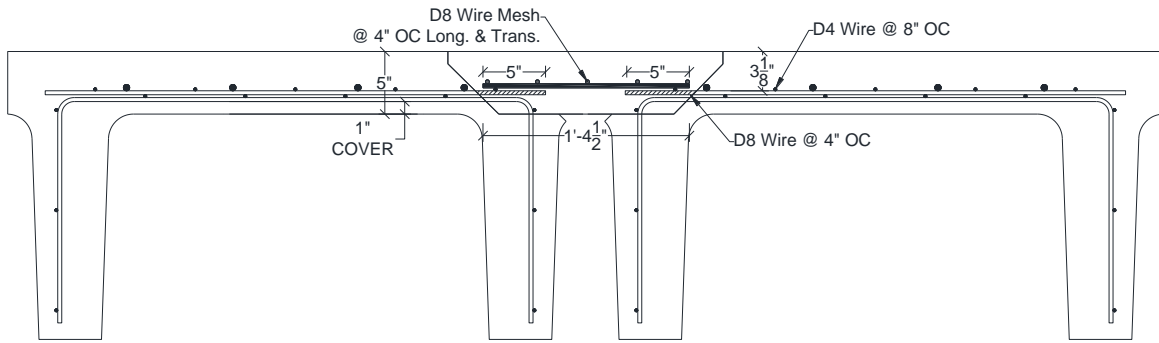
Figure 6-15. Proposed LMC Continuous Joint Detailing

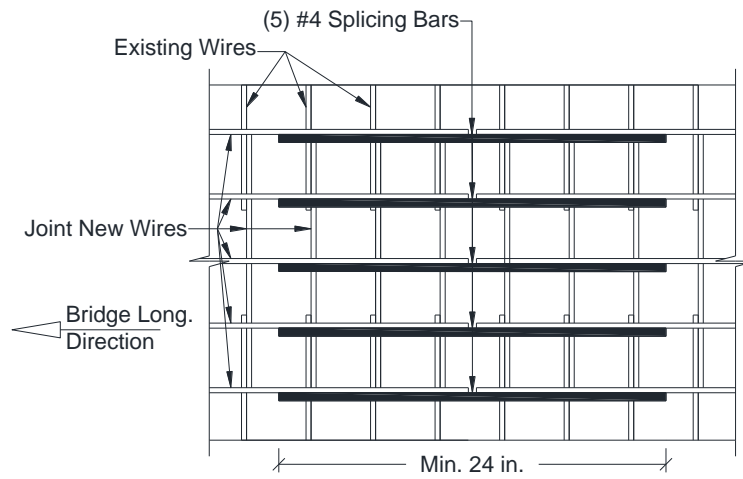
Figure 6-16. Proposed Continuous Joint Splice Detailing

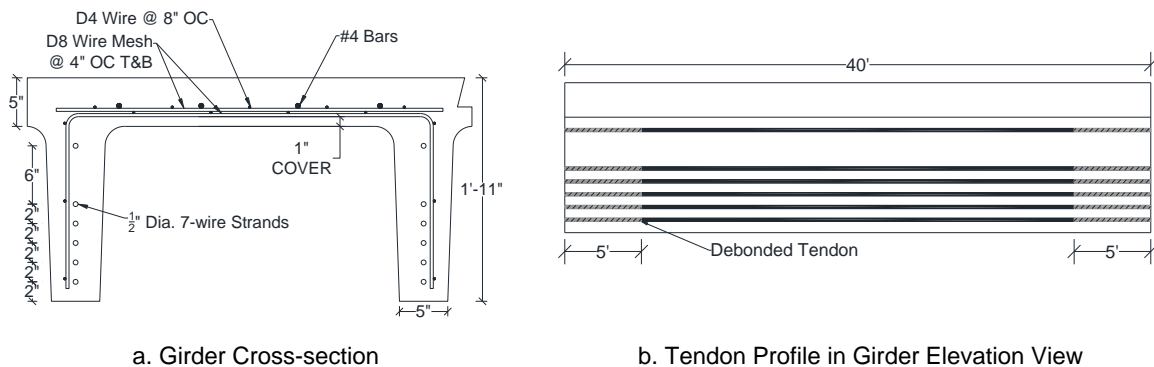
The design led to a double-tee girder (Fig. 7-2) with a depth of 23 in., a width of 46 in., and a length of 40 ft. The deck was 5-in. thick reinforced with a 4 by 8 in. ASTM A-497 D8/D4 welded wire mesh. D8 wires provided 0.24 in² per foot steel reinforcement in the transverse direction of the bridge. Each stem was 5-in. thick at the bottom tapering to 6.25 in. at the top, and was reinforced with six 0.5-in. diameter ASTM-416 Grade 270 low relaxation 7-wire strands. The tendons were straight over the length of the girder (Fig. 7-2b). The tendons were de-bonded 5 ft from each girder end and were initially pulled 10.75 in., equivalent to 202.6-ksi stress (or 31-kip force) per tendon. The girder shop drawings are provided in Attachment A (Bohn, 2017).

a. Girder Cross-section

b. Tendon Profile in Girder Elevation View

Figure 7-2. Detailing of 23-in. Deep Double-Tee Girders

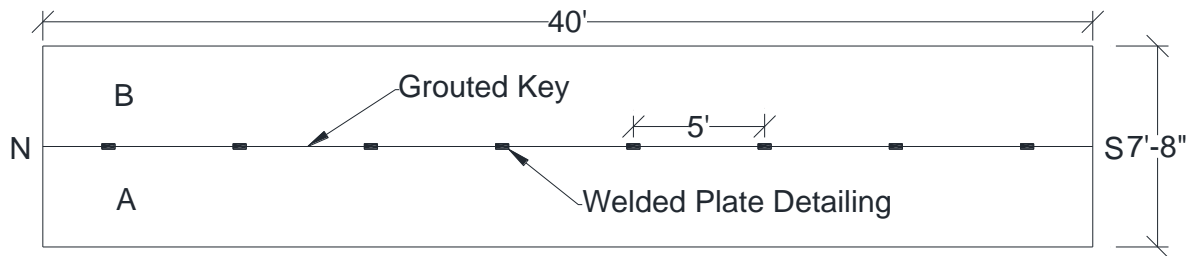
The longitudinal joint of the conventional bridge specimen (Fig. 7-3) consisted of discrete welded plates spaced at 5 ft with a continuous grouted keyway. The welded plate detailing (Fig. 7-4) consisted of two 1 ¼ in. X 1 ¼ in X 3/16 in. steel angles, each 6-in. long and embedded in the concrete with two 3/8 in. diameter X 4 in. long headed studs. The angles of the two adjacent girders were connected using 1/4 in. thick 1in. by 5 in. steel plates with 3/8 in. field weld. A non-metallic non-shrink grout, preapproved by South Dakota Department of Transportation (SDDOT) with a minimum compressive strength of 4,500 psi (SDDOT Standard Specification for Roads and Bridges, 2004), was used to fill the keyway.

Figure 7-3. Plan View of Conventional Test Specimen

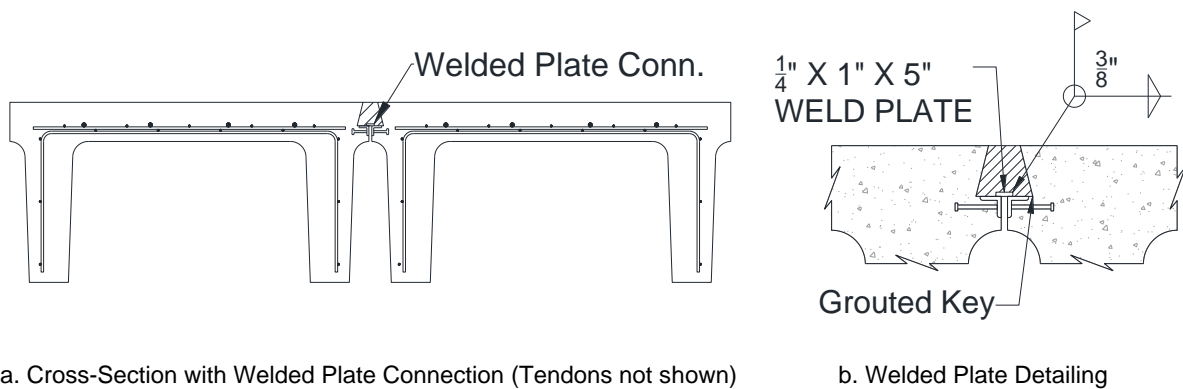
a. Cross-Section with Welded Plate Connection (Tendons not shown)

b. Welded Plate Detailing

Figure 7-4. Conventional Test Specimen Details

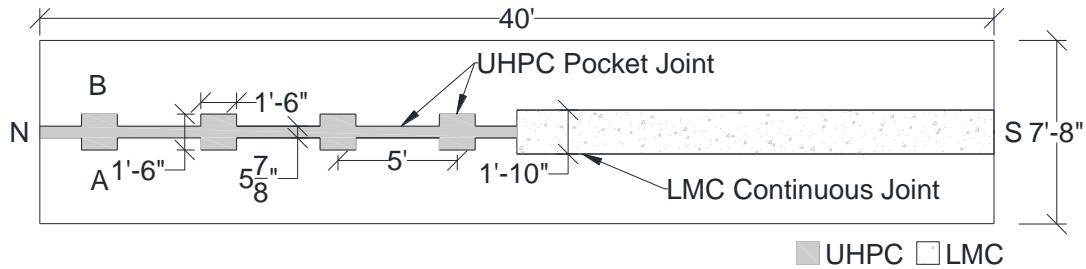
The LMC continuous joint was 5-in. deep and 22-in. wide, reinforced with 4 in. by 4 in., D8/D8 welded grid mesh. The new wire mesh was spliced to the deck's existing wire mesh with at least a 5-in. splice length in the transverse direction of the bridge. Two 10-ft long meshes were lap-spliced with No. 4 bars in the longitudinal direction of the bridge to complete the joint and to provide continuity.

Figure 7-5. Plan View of Rehabilitated Test Specimen
