Rehabilitation of Longitudinal Joints in Double-Tee Girder Bridges

**Study SD2014-20
Final Report**

**Department of Civil & Environmental Engineering
South Dakota State University
Brookings, SD 57007**

May 2018

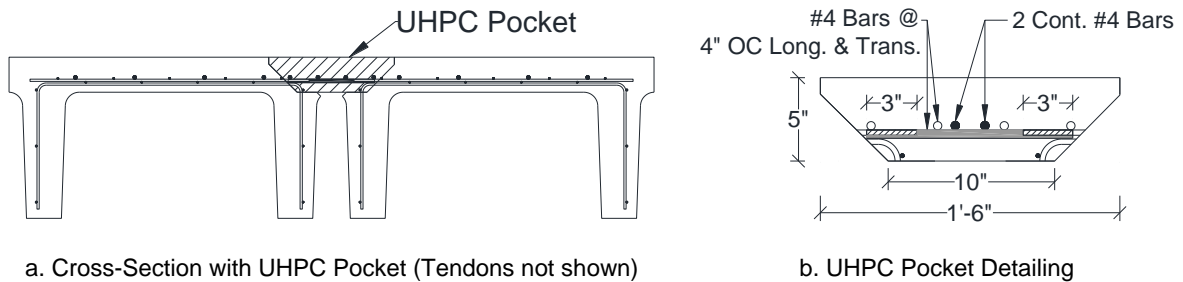
The UHPC pockets were 5-in. deep (the same as the deck thickness), 18-in. wide, and 18-in. long, reinforced with a mesh of four No. 4 bars in each direction of the bridge. The pocket spacing was 5 ft, and the pocket side slope was 45 degrees. The new steel bars were lapped three in. with the exposed deck D8 wires. This splice length is sufficient to fracture the new reinforcement, based on the beam test data in Chapter 6. The intermediate UHPC keyway (between the pockets) was 5-in. deep and 5.87-in. wide with a side slope of 20 degrees. The UHPC keyway was longitudinally reinforced with two No. 4 continuous bars passing the pockets to improve the integrity of the joint.

Figure 7-6. UHPC Pocket Rehabilitation Detailing

After testing the conventional bridge specimen, the longitudinal girder-to-girder joint was rehabilitated with two different methods (Fig. 7-5): Ultra-High Performance Concrete (UHPC) pocket detailing (Fig. 7-6 and 7-7), and Latex Modified Concrete (LMC) continuous detailing (Fig. 7-8).

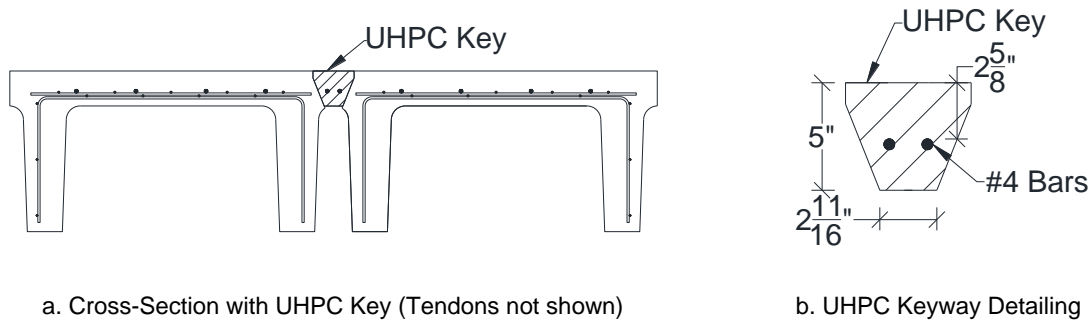
Figure 7-7. UHPC Intermediate Pocket Rehabilitation Detailing

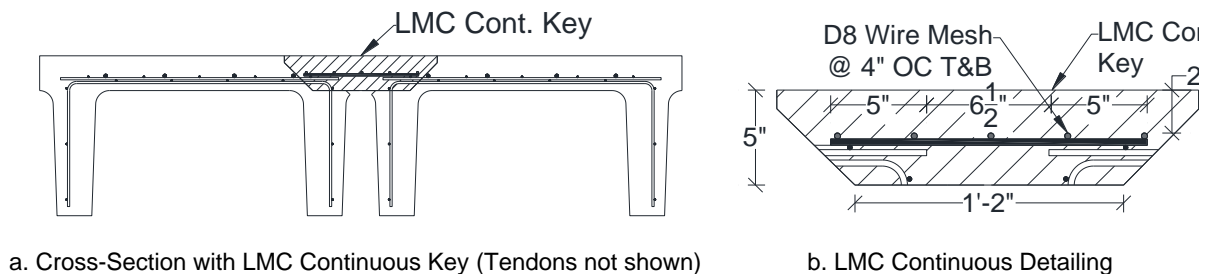
Figure 7-8. LMC Continuous Rehabilitation Detailing

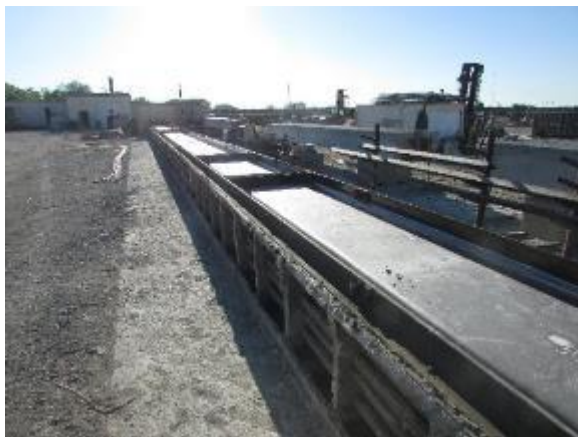
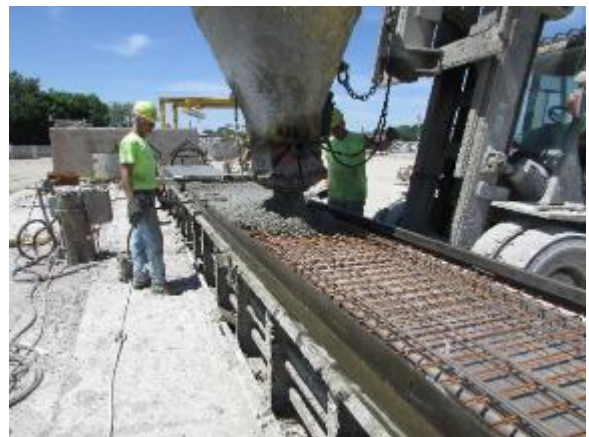
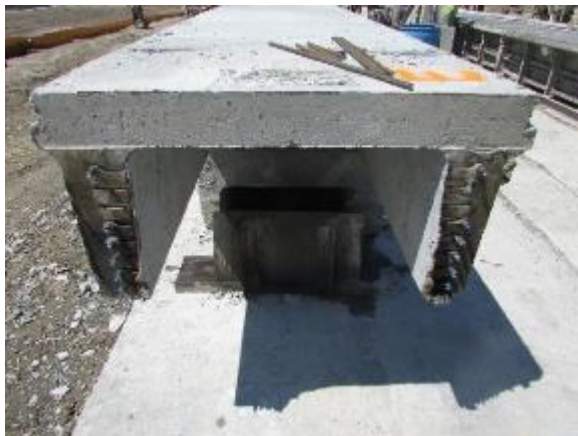
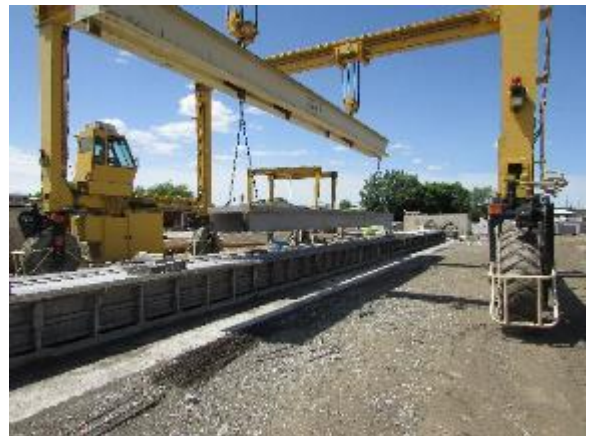
Figure 7-9. Fabrication of Double-Tee Girders

The girders were fabricated in Mitchell, SD. The girders were prepared and cast in four days on a 140-ft long prestressing bed (Fig. 7-9a). On day one, the prestressing strands were initially tensioned to 3,000 lb. to remove slack in the tendons, and strain gauges were installed on the tendons. On day two, the strands were jacked to 31 kips; then wire mesh and longitudinal joint anchors were placed in the prestressing bed. On day three, the embedded concrete strain gauges were installed in the deck between wires in the mesh. Subsequently, the girders were cast (Fig. 7-9b). Fresh concrete properties (e.g. slump, air, density, and temperature) were measured, and 18 standard cylinders were collected. The girders were covered and steam cured overnight. On day four, the concrete strength was 5,680 psi, which was higher than the minimum release strength of 5,000 psi. Subsequently, the strands were cut with a torch (Fig. 7-9c); then the girders were removed from the prestressing bed (Fig. 7-9d). Strain data was measured during various stages of construction to determine elastic shortening losses.

a. Prestressing Bed

b. Concrete Casting

c. Cross-section with Torched Stands

d. Removal from Formwork

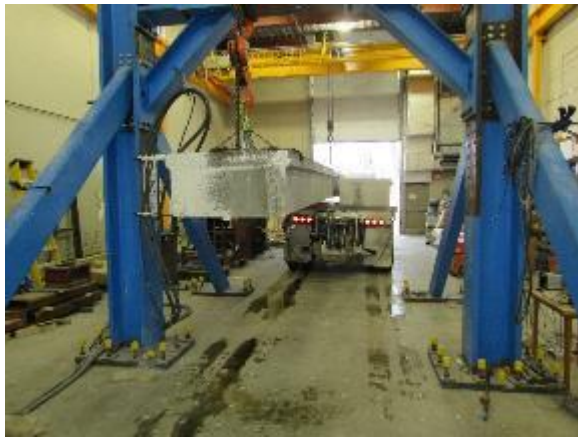
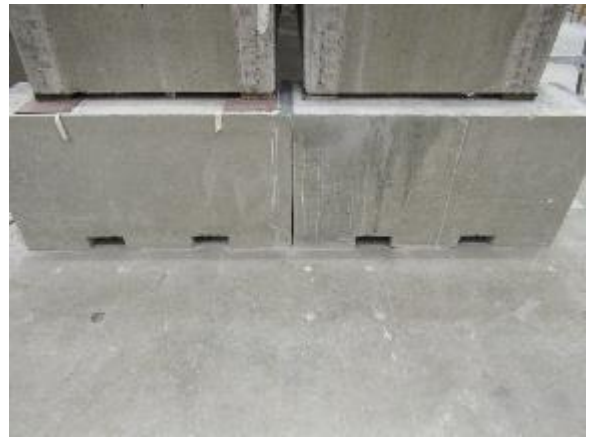
Figure 7-10. Unloading and Placement of Girders

The test girders were stored in the manufacturer's yard for six months and then delivered to the Lohr Structures Laboratory at South Dakota State University (SDSU) with a semi-truck trailer. The girders were unloaded using a 15-ton overhead crane (Fig. 7-10a) and then were placed on reaction blocks (Fig. 7-10b)

a. Unloading

b. Placement on Abutment

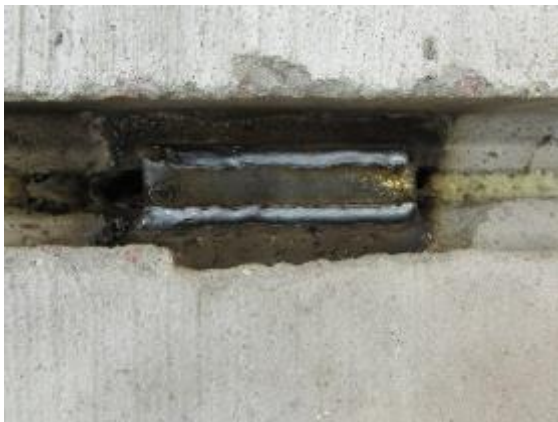
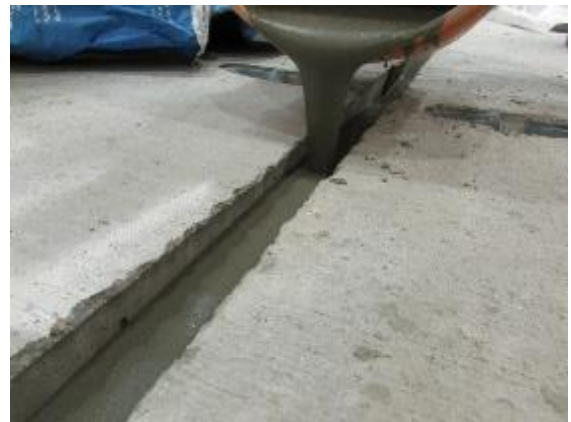
Figure 7-11. Fabrication and Grouting of Conventional Joint Detailing

The girder steel angles and steel plates were welded in the Lohr Lab (Fig. 7-11a) by a certified welder to connect the adjacent girders. Subsequently, the keyway was filled with non-shrink grout (Fig. 7-11b) to complete the joint. The grout was cured for three days and reached a compressive strength of 5,853 psi.

a. Welding Steel Plate to Angles Embedded in Girders

b. Grouting Girder-to-Girder Keyway

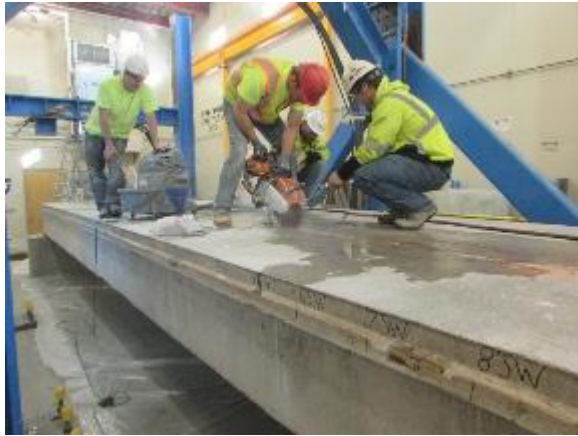
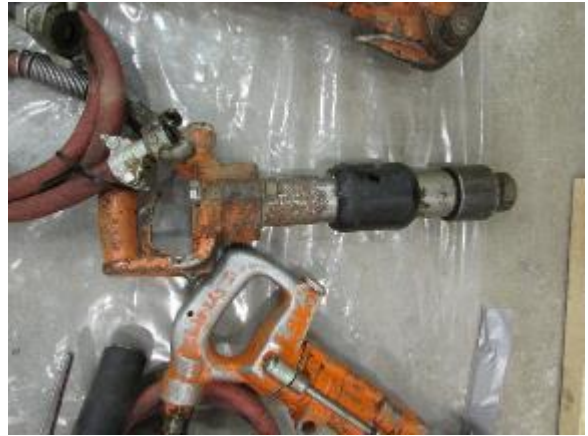
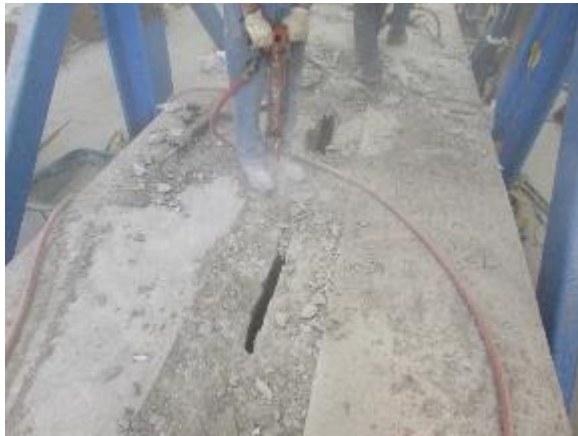
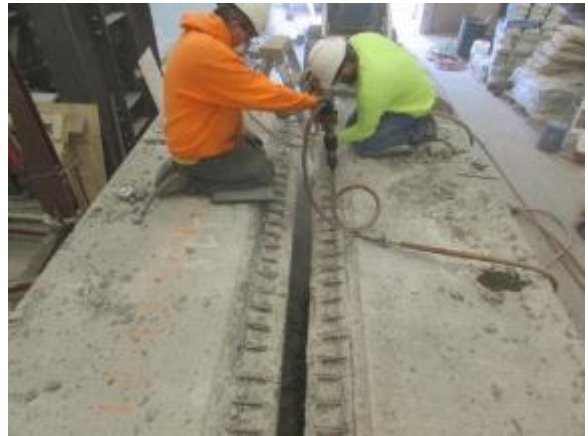
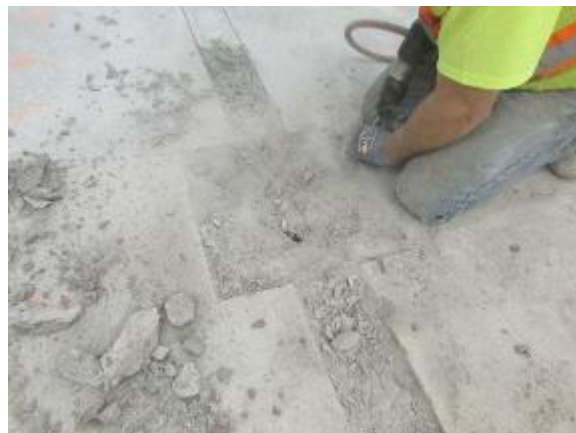
Figure 7-12. Demolition of Longitudinal Joint of Double-Tee Bridge Test Specimen

The continuous joint was demolished and cast in two segments to avoid bridge instability. An actual double-tee girder with continuous exposed bars at the both sides of the girder may become unstable in the field. Each segment covered 25% of the bridge length. The rehabilitation began with saw-cutting

(Fig. 7-12a) the perimeter of the joint to a depth of 1 in. Then, 15- and 30-lb pneumatic hammer chippers (Fig. 7-12b) were utilized to remove the deck concrete with a 45-degree side slope for both the continuous (Fig. 7-12c and 7-12d) and pocket joints (Fig. 7-12e).

a. Saw-cutting

b. Pneumatic Hammer Chipper

c. Continuous Joint Demolishing – Segment I

d. Continuous Joint Demolishing – Segment II

e. Pocket Demolishing

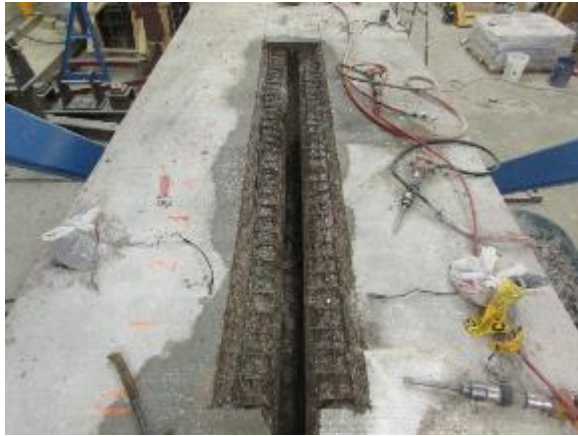
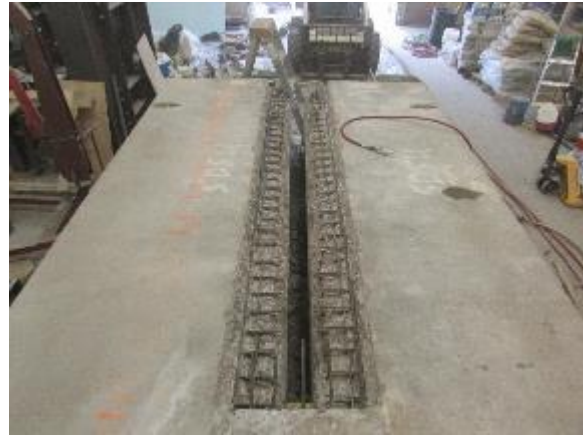
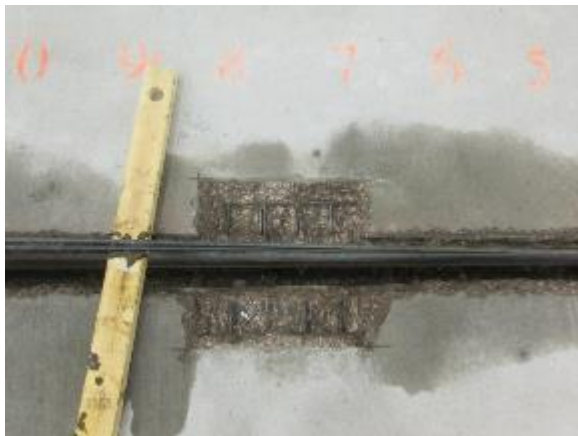
Figure 7-13. Rehabilitated Joint Surface Preparation in Double-Tee Bridge Test Specimen

After chipping the concrete and exposing the deck reinforcement, the surface was cleaned with compressed air, then wetted for 24 hours (Fig. 7-13). Sand-blasting should be used to improve the bond; however, it was not feasible in this experimental study due to Lohr Lab restrictions.

a. Continuous Joint Surface Preparation – Segment I

b. Continuous Joint Preparation – Segment II

c. Pocket Joint and Intermediate Keyway

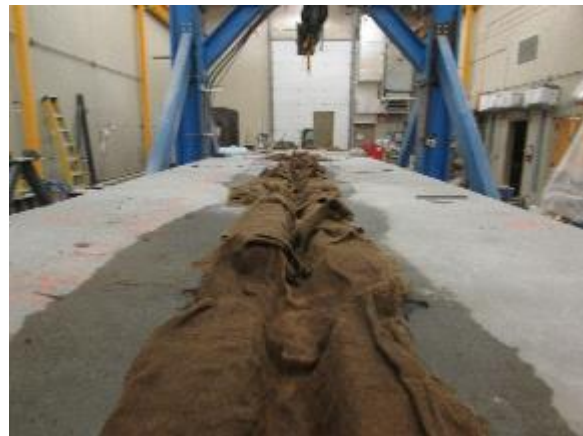
d. Wet Burlap

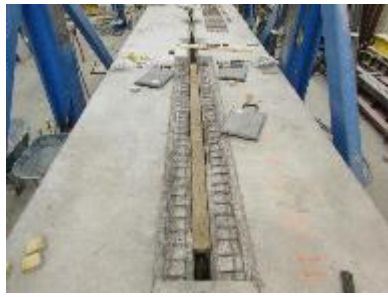
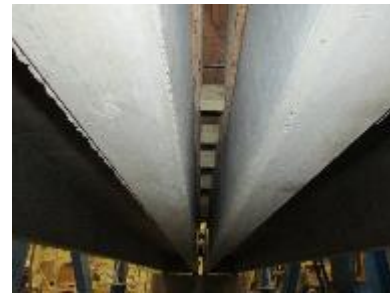
a. Top View, Continuous Joint Segment I Formwork

b. Underneath View, Continuous Joint Segment I Formwork

Figure 7-14. Formwork and Reinforcement of Rehabilitated Joints in Double-Tee Bridge Test Specimen

The formwork for Segment I of the continuous joint was made with plywood with intermediate blocking (Fig. 7-14a-b). Styrofoam (Fig. 7-14c) was used to separate the segments. A significant LMC leak was noticed using this method. For Segment II of the continuous joint, the formwork was modified using Styrofoam (Fig. 7-14d), and no leak was observed.

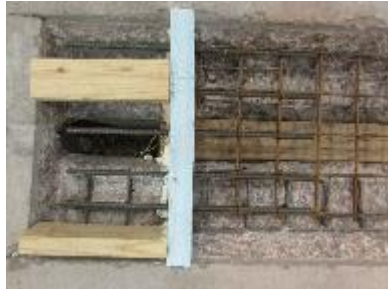
c. Block-out Formwork

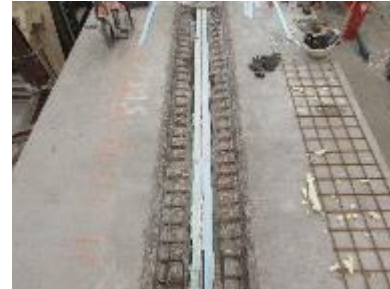
d. Continuous Joint Segment II Formwork

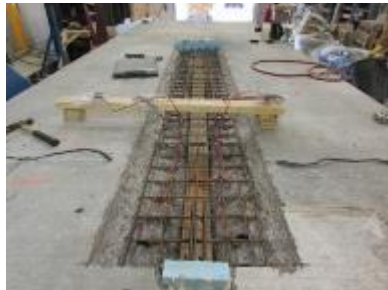
e. Continuous Joint Reinforcement

The as-built continuous joint reinforcement (Fig. 7-14e) was 4 by 4-in., D8/D8 welded wire mesh with a total width of 16 in., installed 2.25 in. below the deck surface. A minimum splice length of 5 in. was provided on the both sides of the joint. The pocket reinforcement (Fig. 7-14f) was 12.5-in. long in both directions and was installed with a clear cover of 2.75 in. from the top of the deck. A minimum splice length of 3 in. was provided in the transverse direction of the bridge in each pocket.

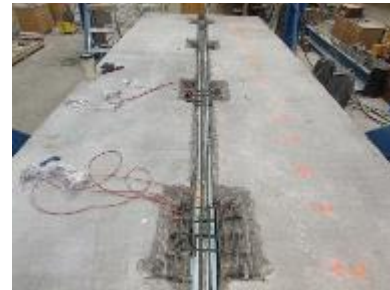
f. Pocket Reinforcement

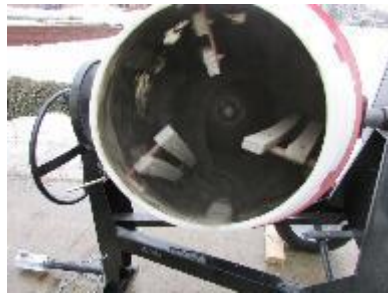
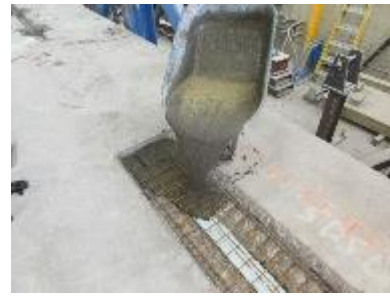
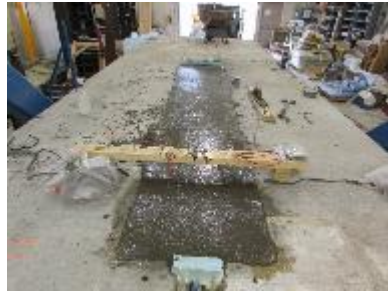
a. Mixing LMC

b. Pouring LMC

c. Finished LMC

Figure 7-15. Casting UHPC and LMC in Rehabilitated Joints of Double-Tee Bridge Test Specimen

The continuous joint was poured with a premix LMC using a 12-cubic ft drum mixer (Fig. 7-15a), batching six 50-lb bags for three minutes. As previously mentioned, the continuous joint was poured in two segments. Wheelbarrows (Fig. 7-15b) were lifted onto the bridge, using a forklift to pour the joints. Figure 7-15c shows the finished continuous joint poured with LMC. The pocket joint was poured with a premix UHPC (with 2% steel fibers). The average batching time for four bags of UHPC was 20 minutes, using a seven cubic ft mortar mixer (Fig. 7-15d). The average static flow of the UHPC was 8 inches. Figures 7-15e to 7-15f show the pouring and the finishing of the pocket joint.

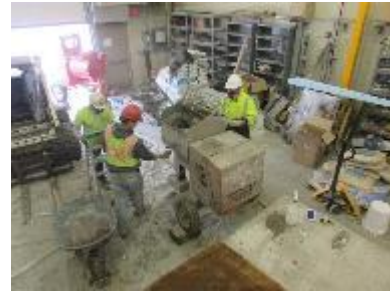
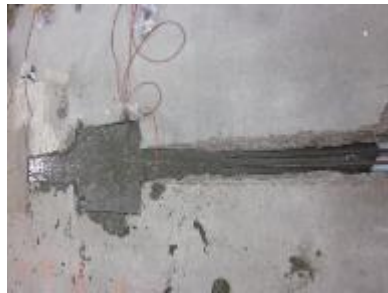
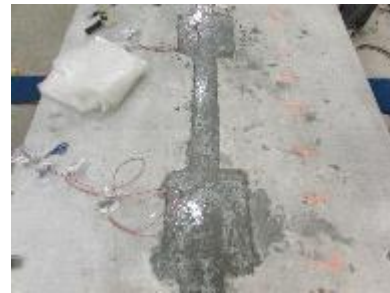
d. Mixing UHPC

e. Pouring UHPC

f. Finished UHPC

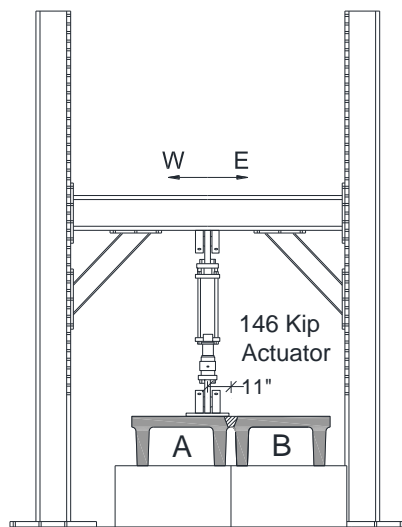
a. Cross-Section View of Test Setup

Figure 7-16 shows the full-scale bridge test setup. A 146-kip hydraulic actuator was used to apply point loads at the mid-span on girder A (Fig 7-16a) with 11-in. offset from the joint centerline. The load was applied on a 1.5 by 10 by 20-in. steel plate, which was seated above plaster (Fig. 7-16b). The plate area represents the truck tire loading area. Water dams (Fig. 7-17) were formed above the rehabilitated longitudinal joint to identify leakage.

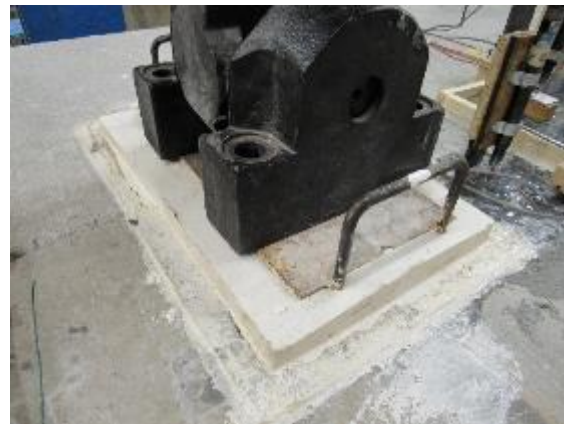
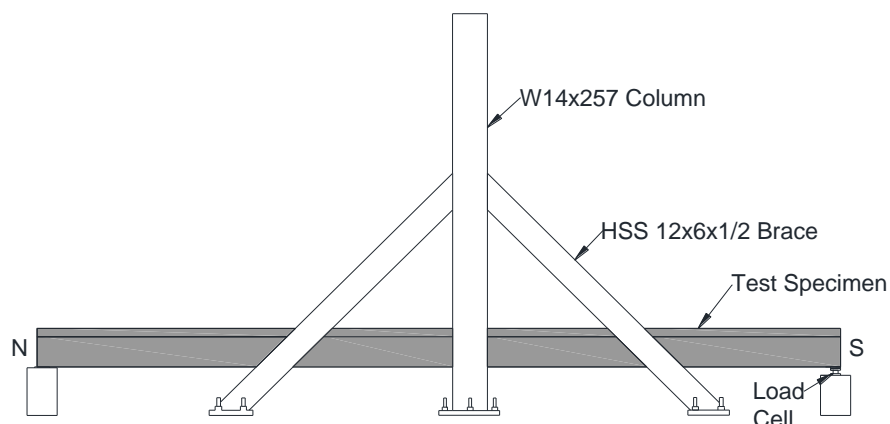
b. Actuator Head with Loading Plate

c. Elevation View of Test Setup

Figure 7-16. Full-Scale Double-Tee Bridge Test Setup

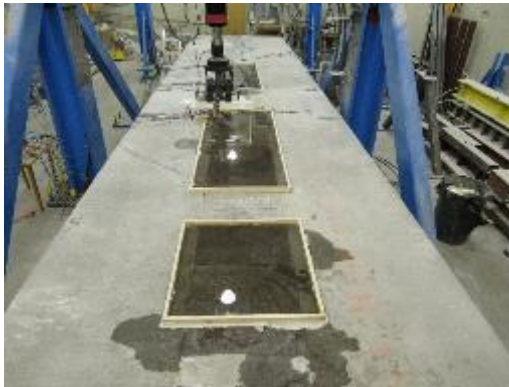
Figure 7-17. Water Dams on Rehabilitated Joint of Double-Tee Bridge Test Specimen

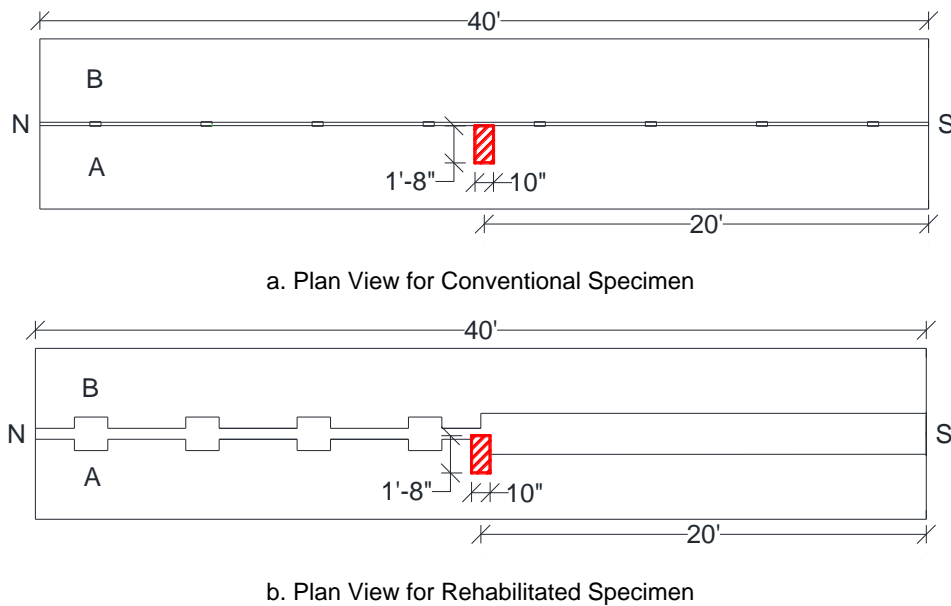
Testing Phase	Bridge Model	Load Type	Load Amplitude	No. of Cycles
I	Conventional Specimen	Cyclic Fatigue	21 kips	250,000
II	Conventional Specimen	Monotonic	50 kips	-
III	Rehabilitated Specimen	Cyclic Fatigue II	21 kips	500,000
IV	Rehabilitated Specimen	Cyclic Fatigue I	42 kips	100,000
V	Rehabilitated Specimen	Monotonic	To Failure	-

Figure 7-18. Applied Load Configuration and Location

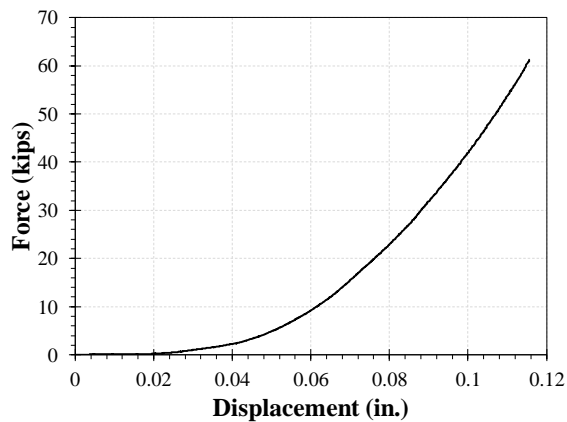
Figure 8-1. Measured Force-Displacement Relationship of Elastomeric Bearing Pad (after Mingo, 2016)

Mingo (2016) tested a 6 by 6 by 3/8-in. elastomeric neoprene bearing pad in compression to determine the force-displacement relationship of the bearing pads used at the supports (Fig 8-1). The same neoprene pads were used in this study. The stiffness of the linear region of the force-displacement relationship was 1,128 kip/in.

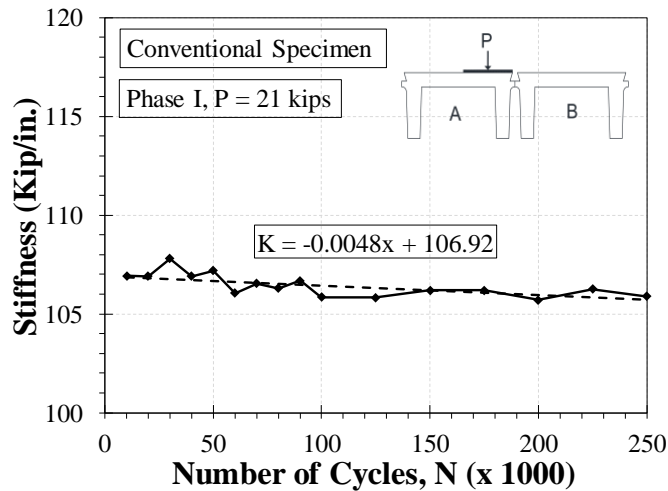
Figure 8-2 shows the measured stiffness versus the number of the load cycles during AASHTO Fatigue II testing. The stiffness of the specimen was defined as the slope of the measured load-displacement relationship. The net mid-span deflection (subtracting the total deflection and the compression of the bearing pads) of only girder A was used for the stiffness calculation since it was the loaded girder. Results indicated that the bridge stiffness essentially remained constant during the fatigue II testing, and no damage of the longitudinal joint or any other members of the bridge throughout 250,000 cycles of loading was observed.

Figure 8-2. Stiffness Degradation during Fatigue II Testing of Conventional Double-Tee Bridge Specimen

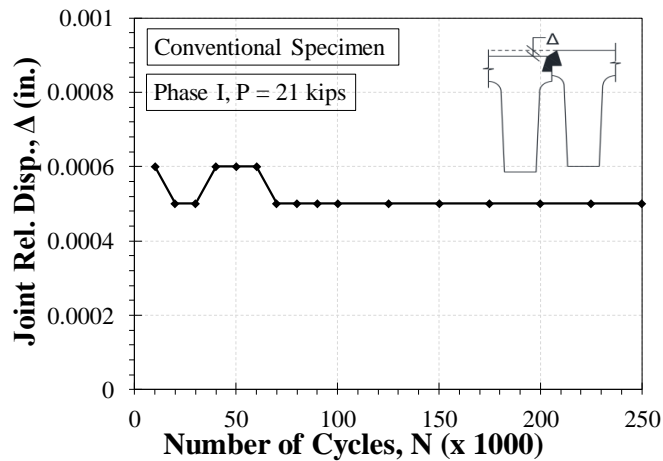
Girder-to-girder joint relative vertical displacements were measured 2.0 ft away from the mid-span (Fig. 8-3). It can be seen that the measured joint relative displacements were negligible throughout the fatigue testing indicating no girder-to-girder joint damage.

Figure 8-3. Longitudinal Joint Relative Displacement for Conventional Double-Tee Bridge Specimen during Fatigue II Testing

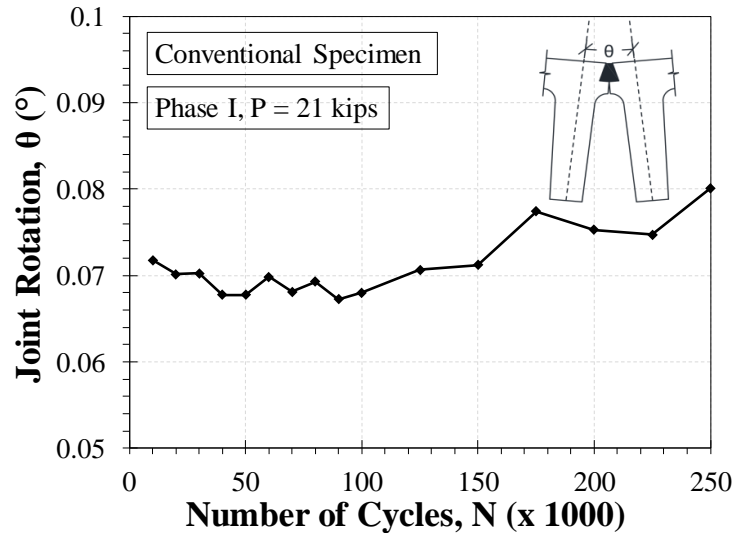
Girder-to-girder joint rotations (Fig. 8-4) in the transverse direction of the bridge were also measured 1.5 ft away from the midspan. The rotations were measured using two LVDTs: one was installed at the top of the deck (LVDT TR-1), and another was installed at the bottom of the stems (LVDT TR-2). Results indicated that the measured joint rotations were negligible throughout fatigue testing indicating the girder-girder joint did not degrade at this level of loading.

Figure 8-4. Girder-to-Girder Joint Rotation for Conventional Double-Tee Bridge Specimen during Fatigue II Testing

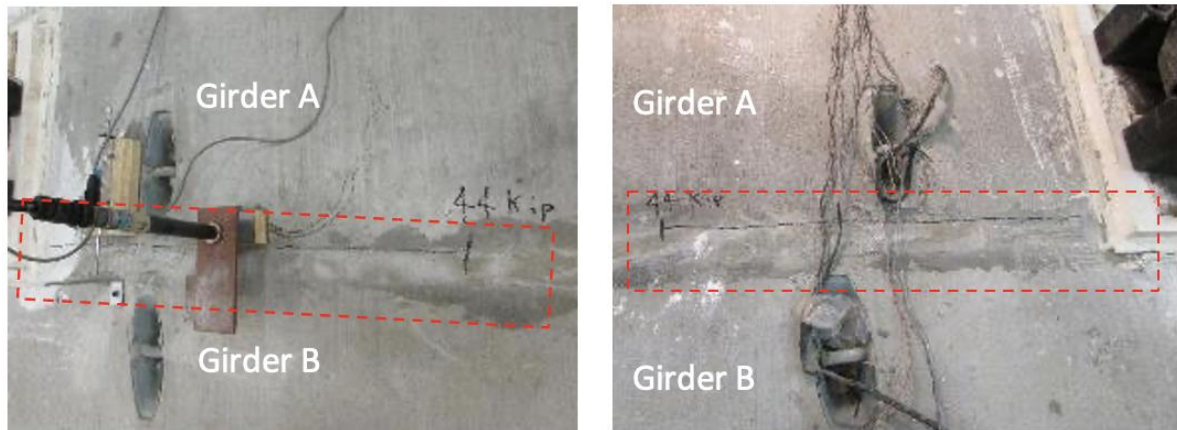
a. First Crack, North of Mid-span

The first crack in the joint was observed in the longitudinal direction of the bridge at the mid-span at a load of 44 kips (Fig. 8-5). More cracks were observed at the peak load of 48.5 kips, where the test was stopped to avoid girder cracking.

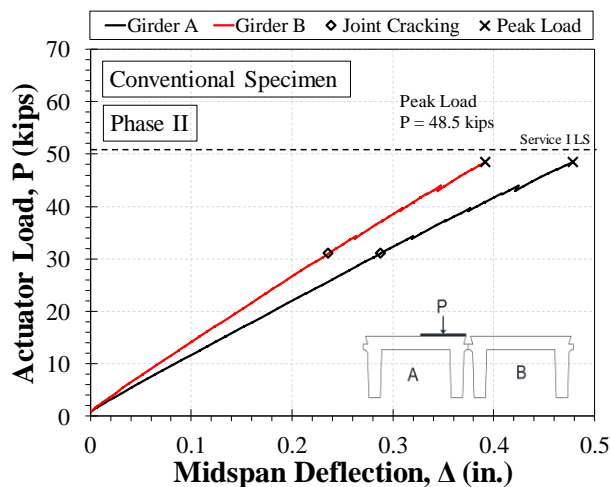
44 kips. Joint cracking occurred, therefore, before reaching the AASHTO Service I limit state, which was equivalent to a mid-span point load of 51 kips. This indicates that the current girder-to-girder joint detailing for double-tee bridges is not sufficient, even for the service loads.

Figure 8-6. Force-Displacement Relationship for Conventional Double-Tee Bridge Specimen during Joint Crack Strength Testing

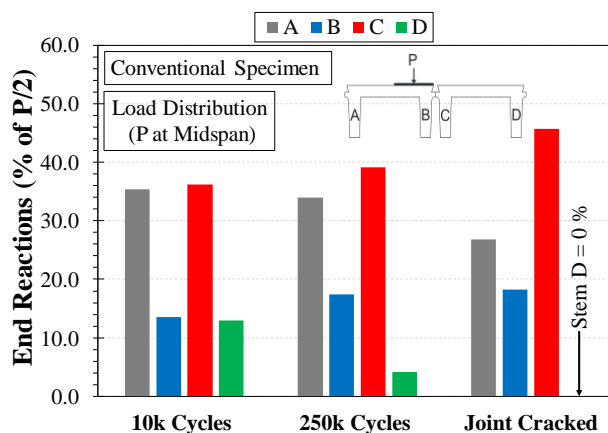
Load cells were used to measure south end reactions of the girders, one load cell per stem. The reactions were used to determine the girder load distribution based on a percentage of the applied load ($P/2$ per girder end). The girder end reactions at the beginning of the fatigue testing, after the fatigue testing, and at the joint cracking were compared in Fig. 8-7. Results indicated that the load distribution slightly changed during fatigue testing, but the change was significant when the longitudinal girder-to-girder joint cracked. In this case, Stem D did not resist any force resulting in an increase in forces of the other stems. This change in load transfer mechanism may crack the stems at higher loads or in the field.

Figure 8-7. Girder Load Distribution for Conventional Double-Tee Bridge Specimen

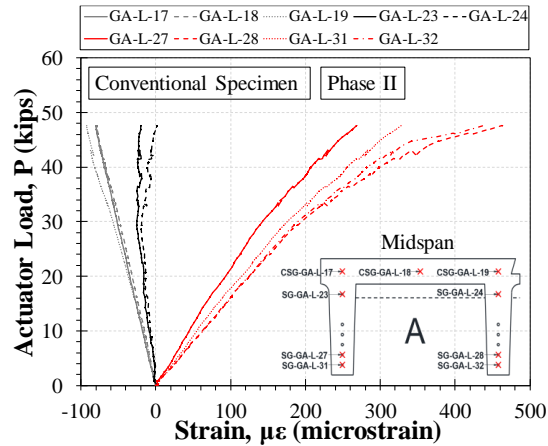
The estimated initial strain without any losses from 31-kip pre-tensioning is 7,109 micro-strain from structural mechanics. The yield strain of Grade 270 strands is 8,772 micro-strain. The summation of the strain demand and the prestressing strains suggested that the strands did not yield. The maximum compressive strain in the girder flange concrete was 92.1 micro-strain at the peak load of 48.5 kips. The embedded concrete strain gauges were located 3.5 in. below the girder surface.

Figure 8-8. Measured Strains of Loaded Girder in Conventional Double-Tee Bridge Specimen during Joint Crack Strength Testing

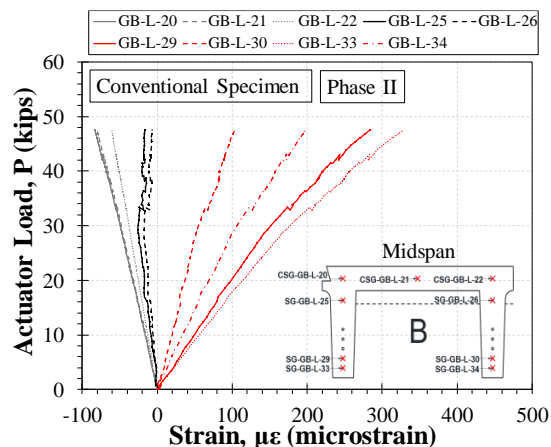
Figure 8-9. Measured Strains of Girder B in Conventional Double-Tee Bridge Specimen during Joint Crack Strength Testing

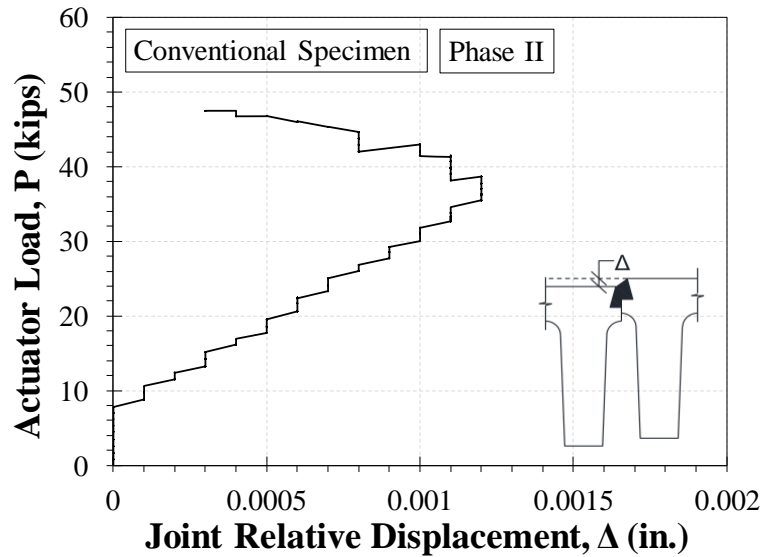
Figure 8-10. Longitudinal Joint Relative Displacement for Conventional Double-Tee Bridge Specimen during Joint Crack Strength Testing

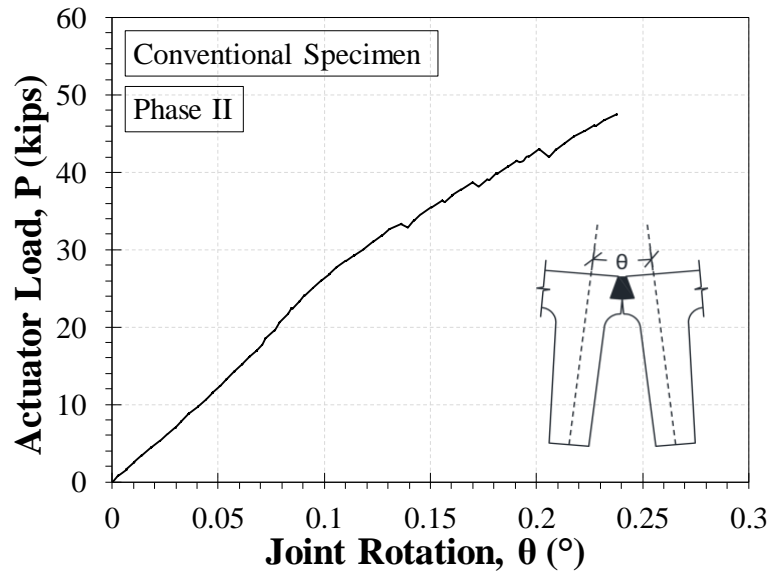
Figure 8-11. Girder-to-Girder Joint Rotation for Conventional Double-Tee Bridge Specimen during Joint Crack Strength Testing

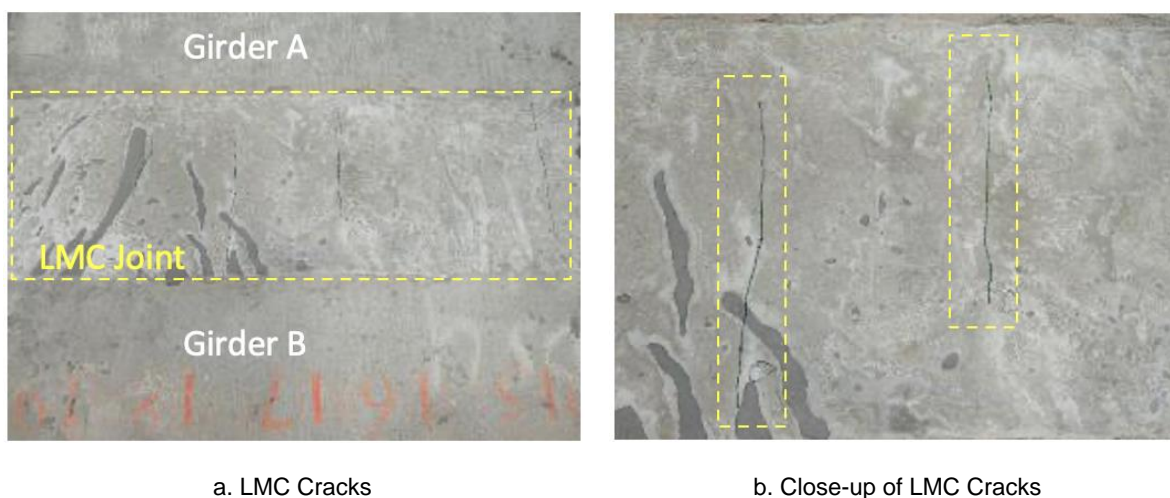
Figure 8-12. Transverse Cracks in Continuous Joint of Rehabilitated Double-Tee Bridge Specimen Prior to Testing

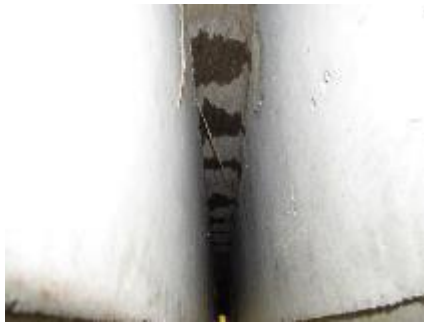
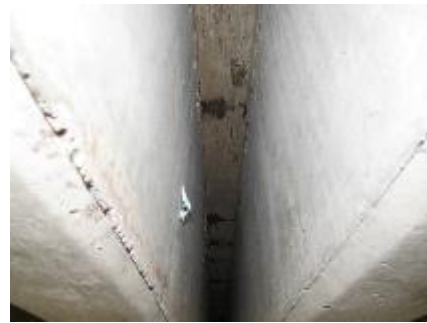
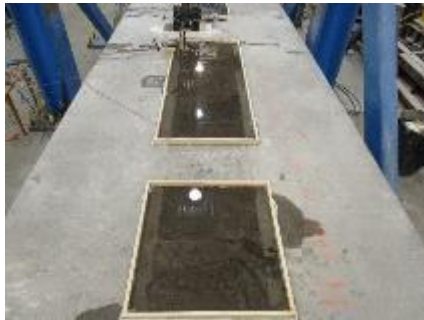
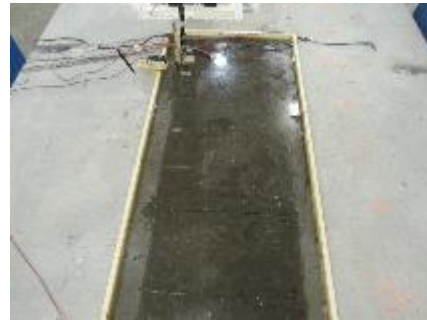
a. Leak in LMC before Testing

b. Leak in LMC after Fatigue Testing

c. Before Testing – Top of Bridge

d. After Testing – Top of Bridge

Figure 8-13. Damage of Continuous Joint of Rehabilitated Double-Tee Bridge Specimen during Fatigue II Testing

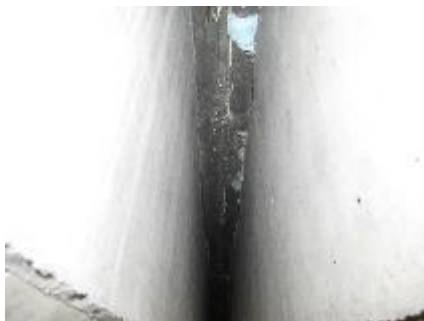
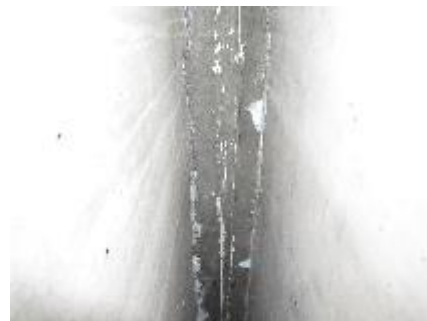
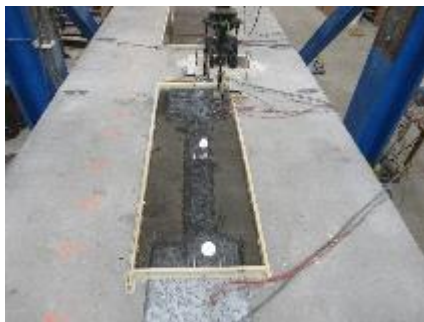
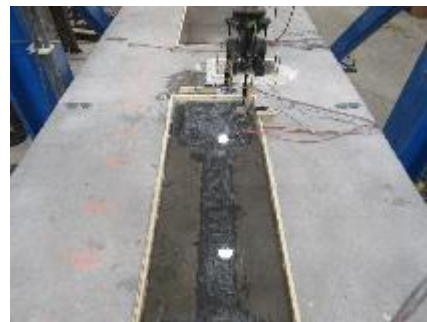
a. Before Testing – Beneath Bridge

b. After Testing – Beneath Bridge

c. Before Testing – Top of Bridge

d. After Testing – Top of Bridge

Figure 8-14. Damage of UHPC Pocket Joints of Rehabilitated Double-Tee Bridge Specimen during Fatigue II Testing

Water was seeping through the LMC continuous joint cracks before the initiation of the fatigue II testing (Fig. 8-13a). The water seepage beneath the joint reduced after 500,000 cycles of the fatigue testing (Fig. 8-13b) perhaps because of the rehydration of LMC when the water penetrated. No additional leaks or any other damage was observed during the fatigue testing. The pocket joints that filled with UHPC did not damage or leak during the entire 500,000 cycles of the Fatigue II testing (Fig. 8-14a and b).

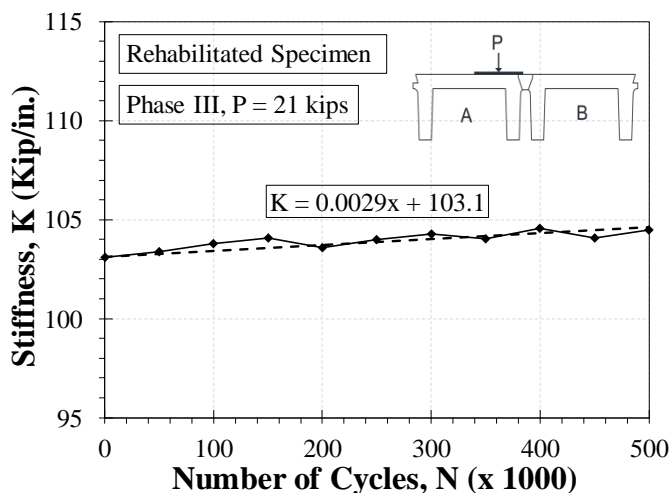
Figure 8-15. Stiffness Degradation during Fatigue II Testing of Rehabilitated Double-Tee Bridge Specimen

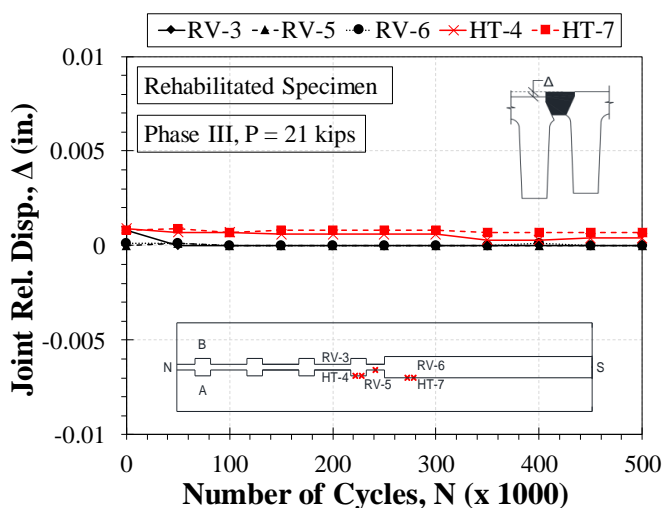
Figure 8-16. Longitudinal Joint Relative Displacements for Rehabilitated Double-Tee Bridge Specimen during Fatigue II Testing

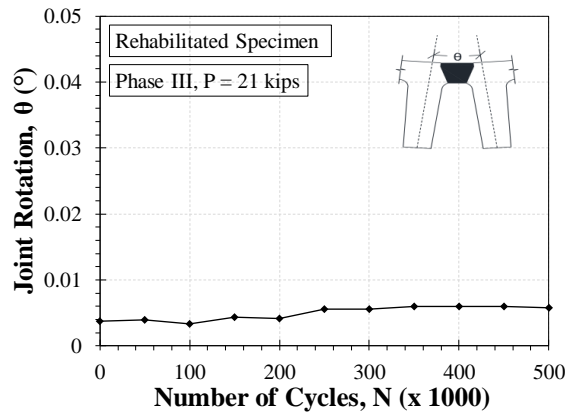
Figure 8-17. Girder-to-Girder Joint Rotation for Rehabilitated Double-Tee Bridge Specimen during Fatigue II Testing

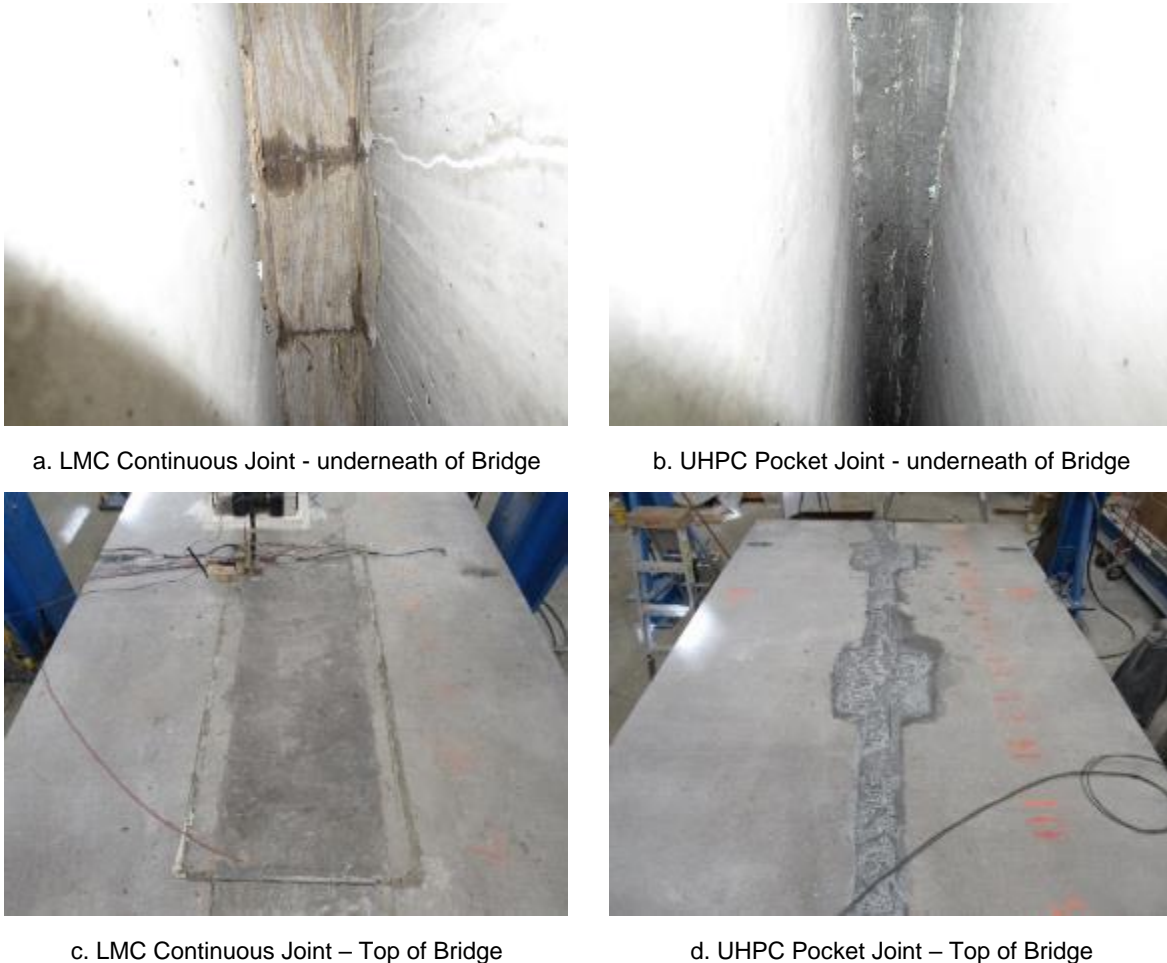
Figure 8-18. Damage of Rehabilitated Double-Tee Bridge Specimen after Fatigue I Testing

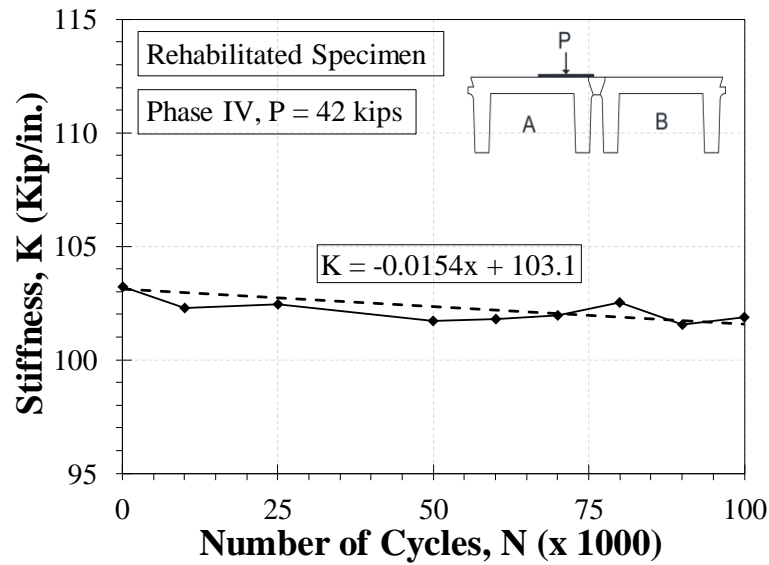
Figure 8-19. Stiffness Degradation for Rehabilitated Double-Tee Bridge Specimen during Fatigue I Testing

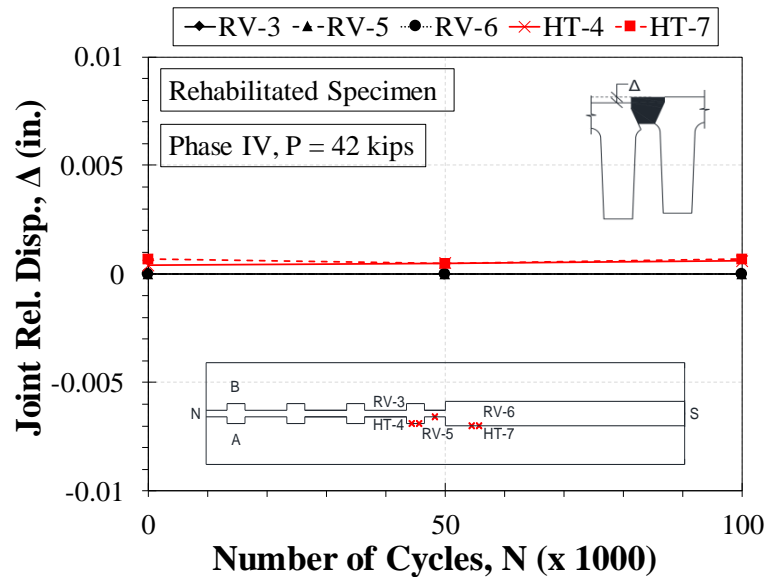
Figure 8-20. Longitudinal Joint Relative Displacement for Rehabilitated Double-Tee Bridge Specimen during Fatigue I Testing

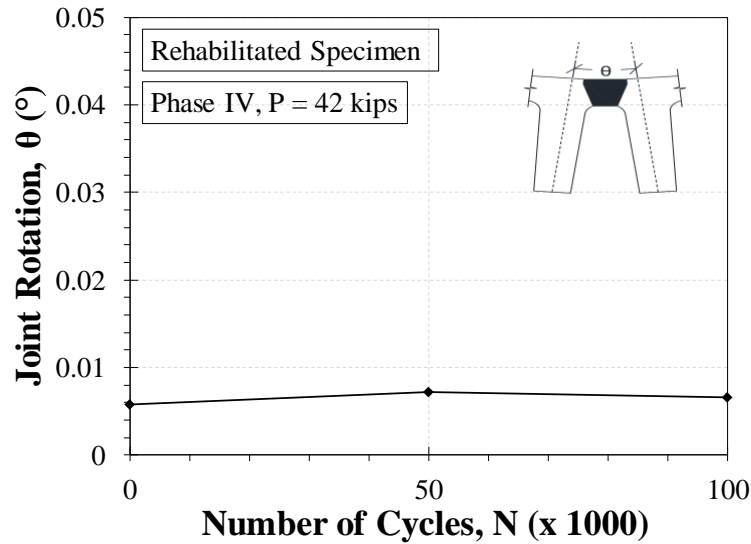
Figure 8-21. Girder-to-Girder Joint Rotation for Rehabilitated Double-Tee Bridge Specimen during Fatigue I Testing

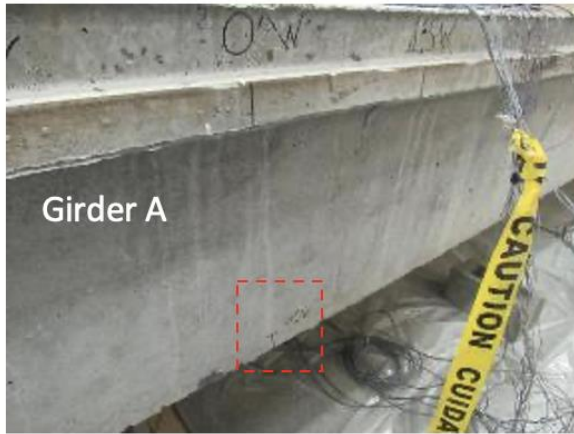
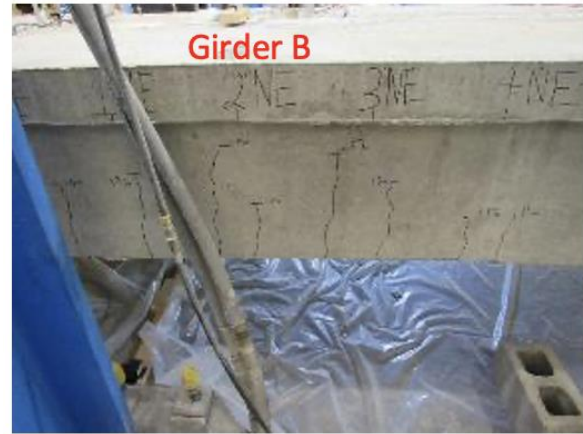
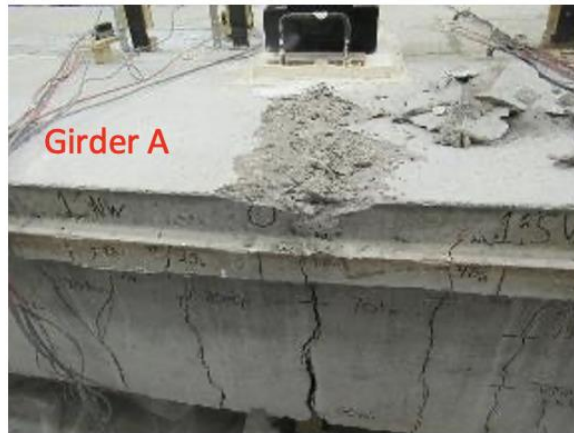
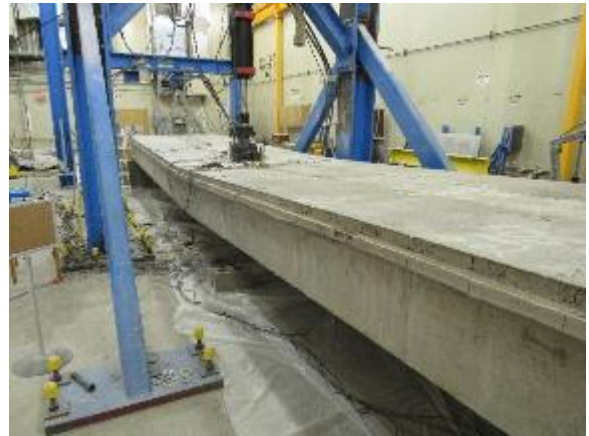
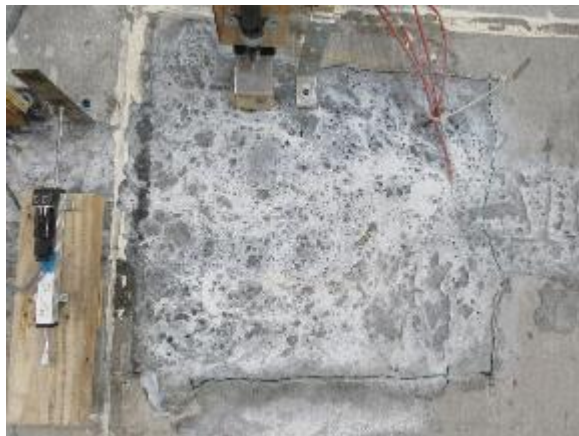
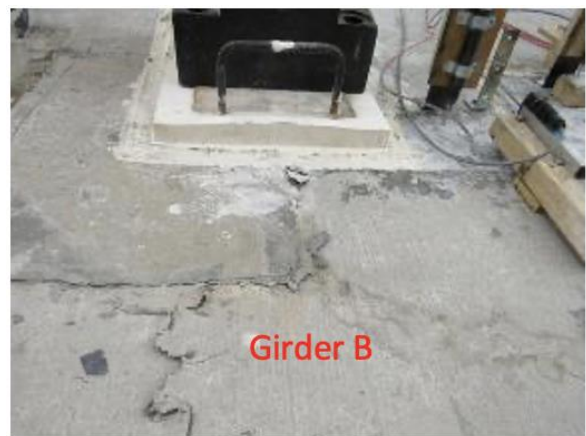
a. First Crack During Loading to 60 kips on West Girder

b. East Side of Girder B Damage at 1.5-in. Deflection

c. Compressive Failure of Concrete at 9.5-in. Deflection

d. Bridge Condition at Failure

e. UHPC Pocket Joint after Testing

f. LMC Continuous Joint after Testing
