Rehabilitation of Longitudinal Joints in Double-Tee Girder Bridges

**Study SD2014-20
Final Report**

**Department of Civil & Environmental Engineering
South Dakota State University
Brookings, SD 57007**

May 2018

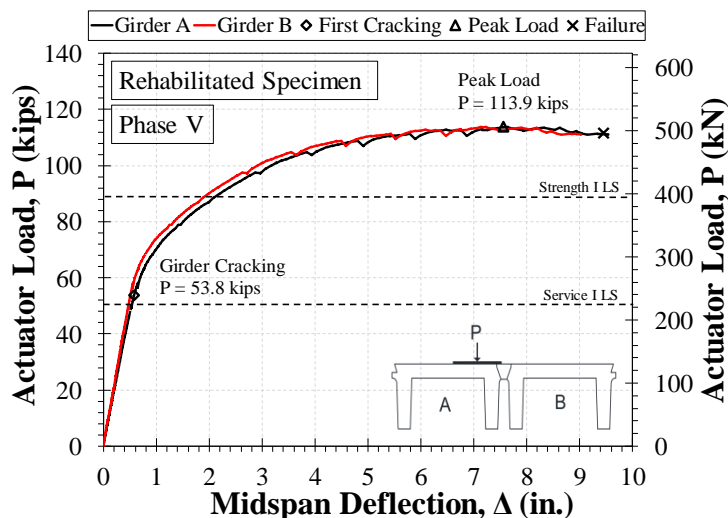
Figure 8-23. Force-Displacement Relationship for Rehabilitated Double-Tee Bridge Specimen During Strength Testing

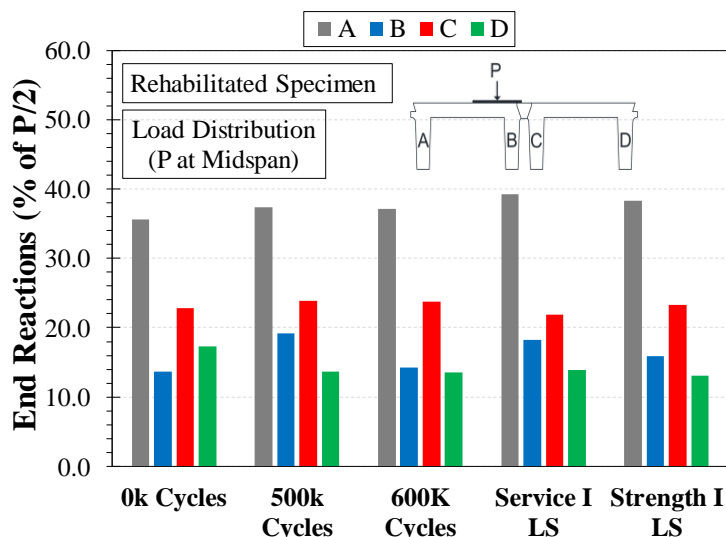
Figure 8-24. Girder Load Distribution for Rehabilitated Double-Tee Bridge Specimen

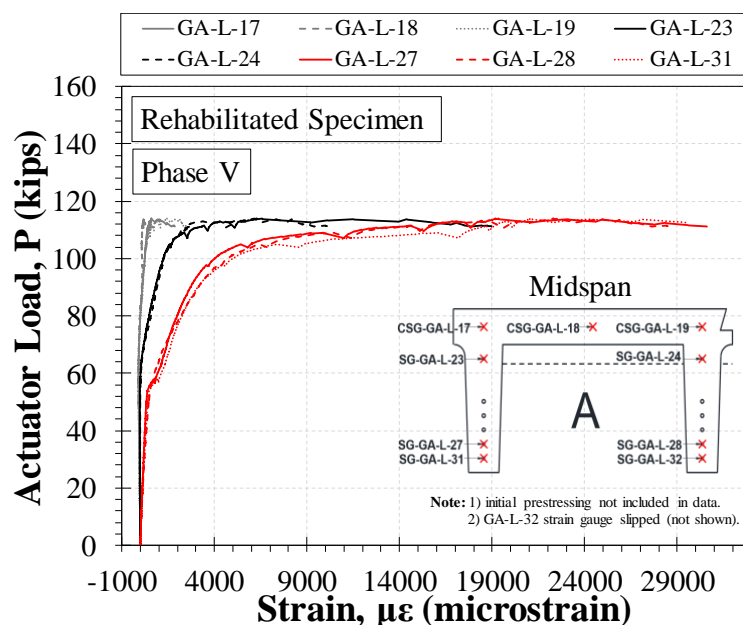
Figure 8-25. Measured Strains of Loaded Girder in Rehabilitated Double-Tee Bridge Specimen during Strength Testing

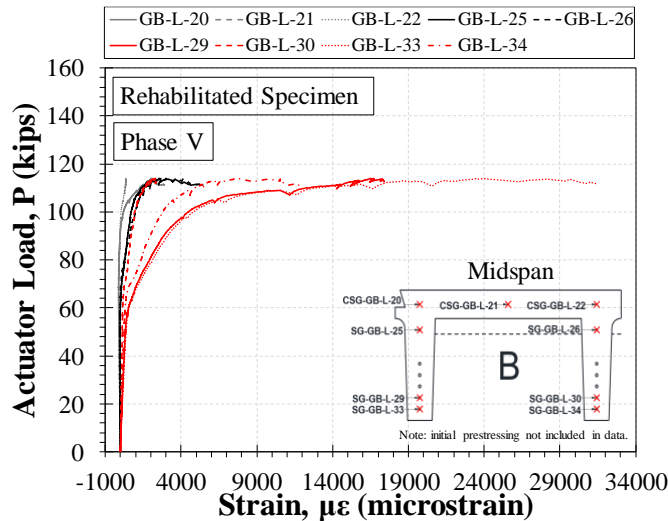
Figure 8-26. Measured Strains of Girder B in Rehabilitated Double-Tee Bridge Specimen During Strength Testing

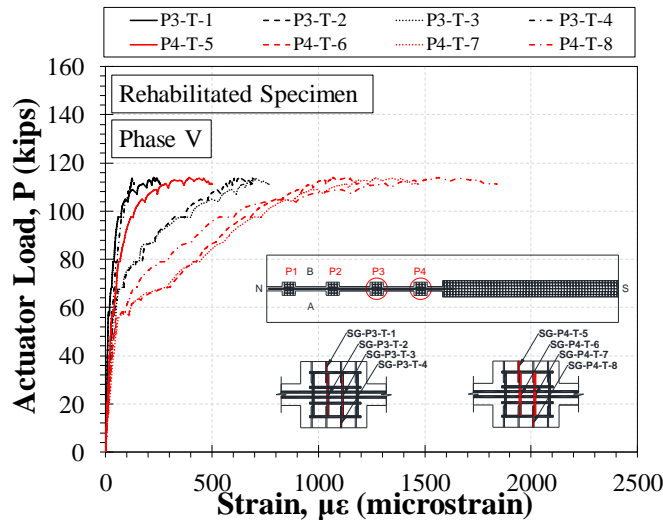
Figure 8-27. Measured Strains of Transverse Reinforcement in UHPC Pockets of Rehabilitated Double-Tee Bridge Specimen During Strength Testing

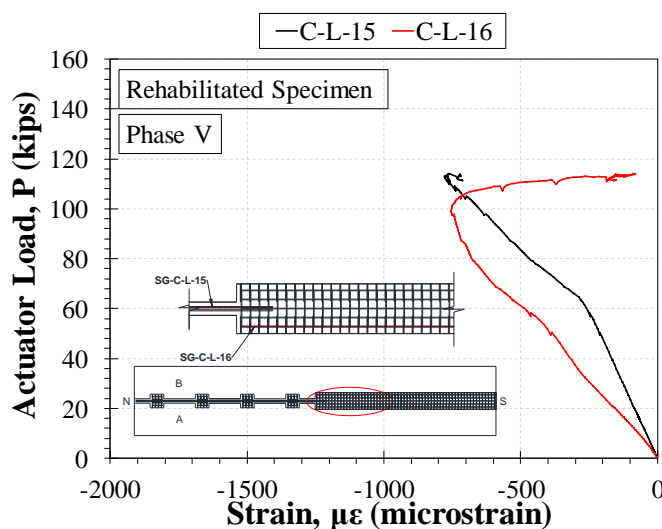
Figure 8-29. Measured Strains of Joint Longitudinal Reinforcement in Rehabilitated Double-Tee Bridge Specimen during Strength Testing

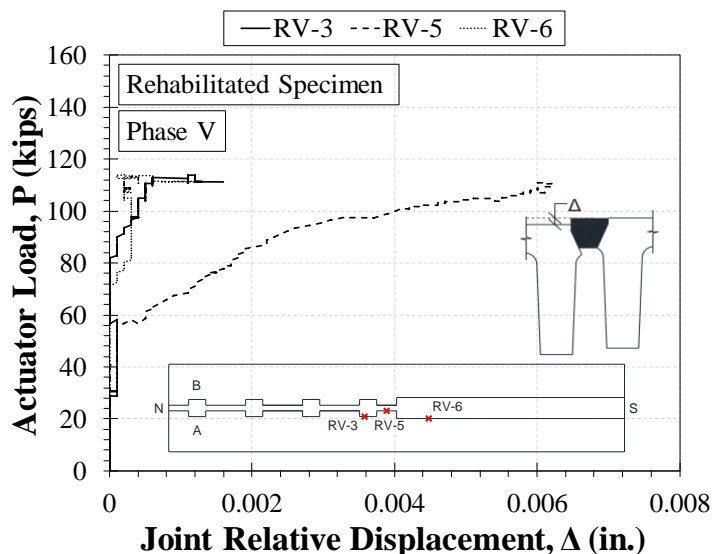
Figure 8-30. Girder-to-Girder Joint Relative Displacement for Rehabilitated Double-Tee Bridge Specimen during Strength Testing

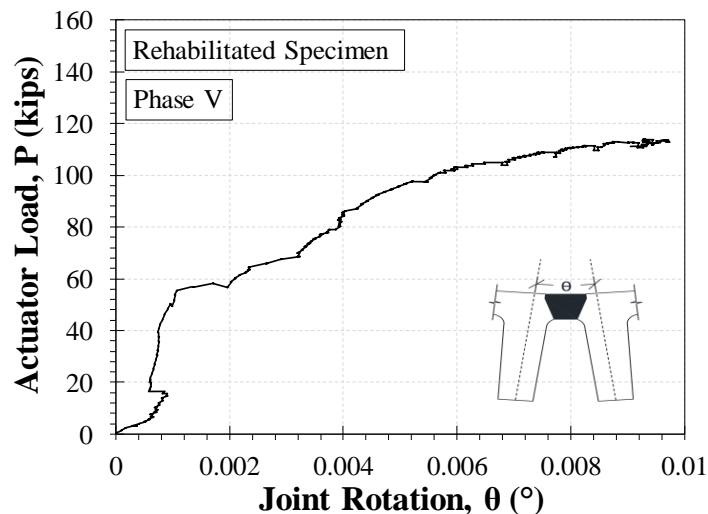
Figure 8-31. Girder-to-Girder Joint Rotation for Rehabilitated Double-Tee Bridge Specimen during Strength Testing

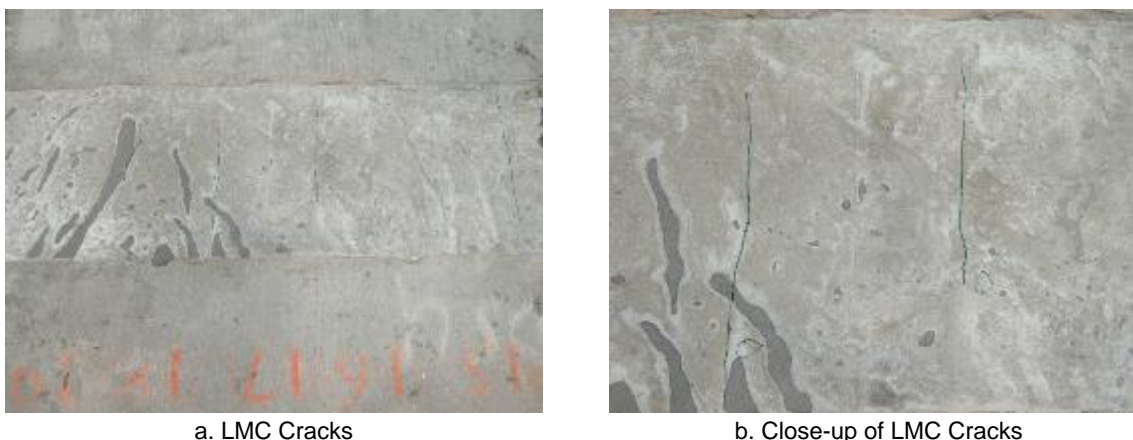
Figure 8-32. Transverse Cracks of Continuous Joint in Rehabilitated Double-Tee Bridge

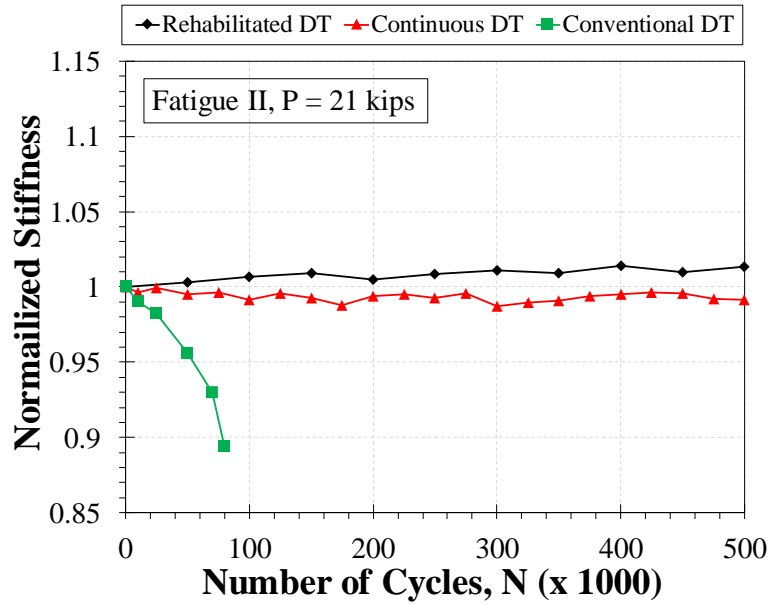
Figure 8-33. Stiffness Degradation for Different Double-Tee Bridges under AASHTO Fatigue II Loading

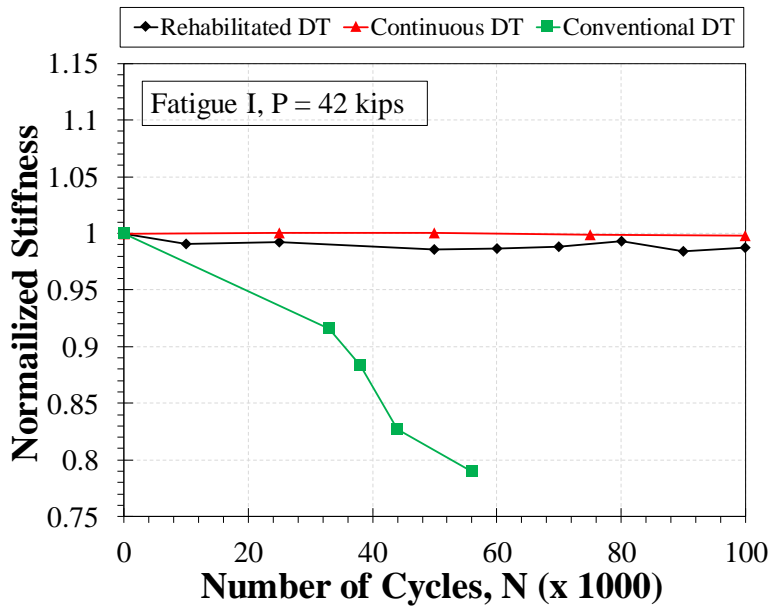
Figure 8-34. Stiffness Degradation for Different Double-Tee Bridges under AASHTO Fatigue I Loading

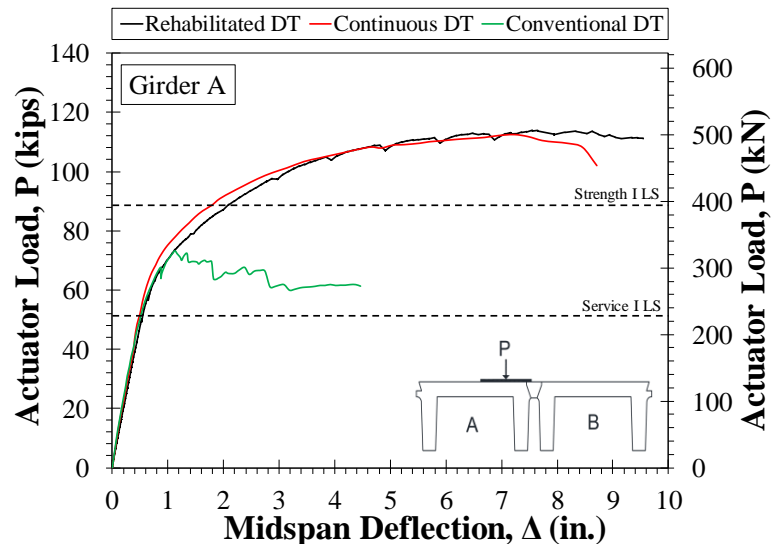
Figure 8-35. Force-Displacement Relationships for Loaded Girders of Different Double-Tee Bridges

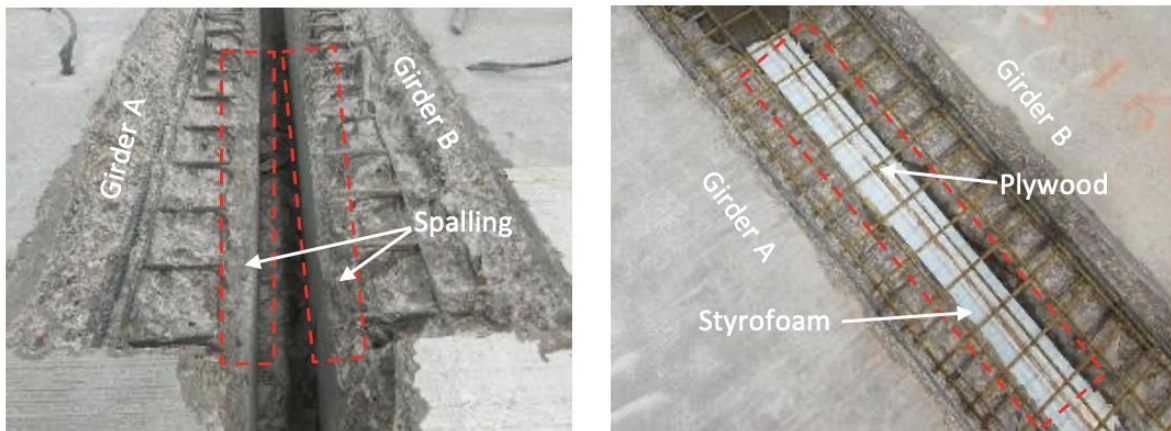
a. Girder Concrete Spalling

b. Formwork Placement

The perimeter of the pocket and continuous joint was saw-cut using a portable, gas powered diamond-blade concrete saw. This process was very easy. The longitudinal joint was demolished using hammer-chipping at a 45-degree inclination. The hammer-chipping was somewhat tedious since the girders were new and relatively undamaged and built with concrete with a compressive strength of 9,000 psi. The hammer-chipping was more effective when using a 30-lb pneumatic hammer-chipper. A 30-lb pneumatic hammer-chipper should not be used, however, when exposing the reinforcement and finishing the joint. Some minor spalling of the concrete stem was noticed during demolition (Fig. 8-36a). The disturbed areas were patched with the filler material using a formwork consisting of Styrofoam and plywood (Fig. 8-36b). The formwork was installed from the top and removed relatively easily from the bottom of the bridge. A significant amount of concrete debris fell through the joint during demolition. To catch falling debris, a catcher could be placed beneath the bridge. Overall, the hammer-chipping demolition process was found to be a viable method for field applications for both continuous and pocket joints.

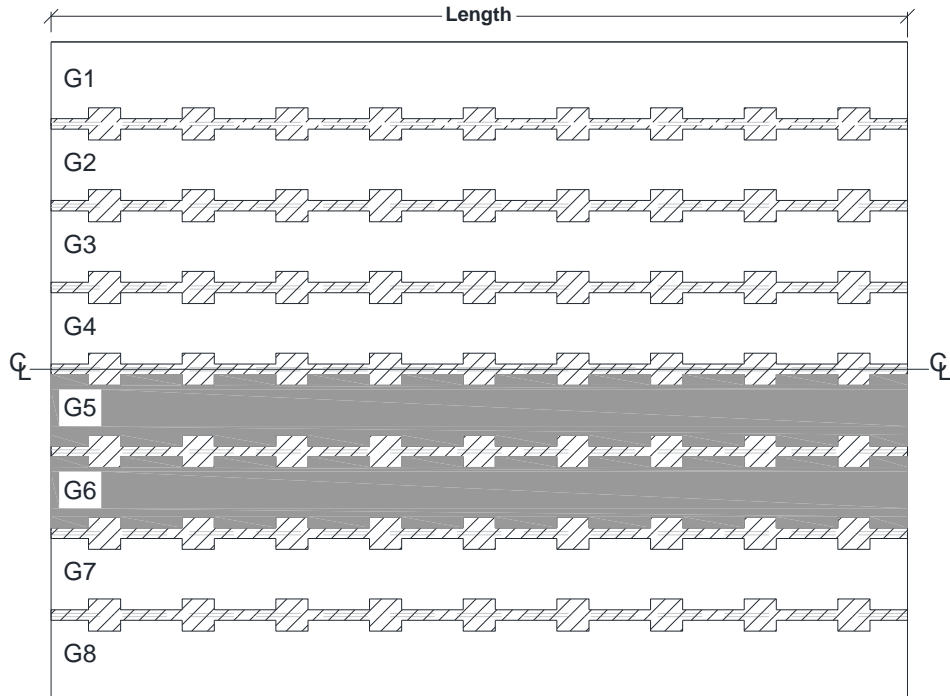
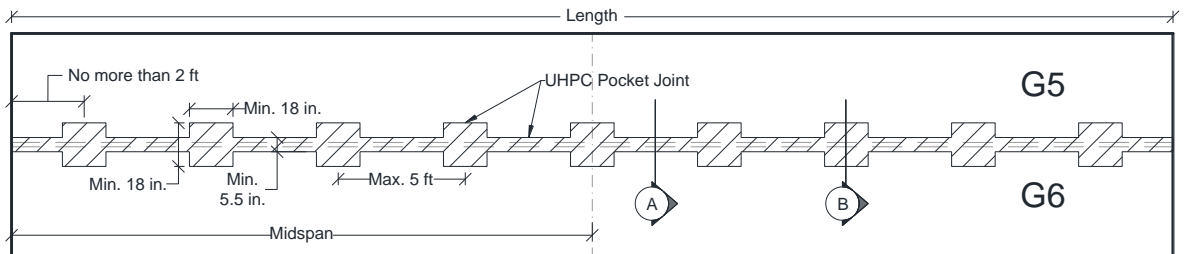
b. Plan view of Rehabilitated Double-Tee Bridges

c. Dimensions for Rehabilitated Longitudinal Pocket Joint Detailing

Figure 9-1. Geometry Requirements for Proposed UHPC Pocket Joint Rehabilitation Method

1. Square pockets, each with a minimum side dimension of 18 in., shall be formed meeting the preparation requirements. For each girder-to-girder joint, one pocket shall be placed at the mid-span of the bridge, and two pockets shall be placed no more than 24 in. away from the ends of the bridge (Fig. 9-1). The spacing of pockets between the mid-span and the end-span pockets shall not exceed 5 ft center-to-center. The pocket shall be filled with UHPC with a minimum 28-day compressive strength of 18 ksi.

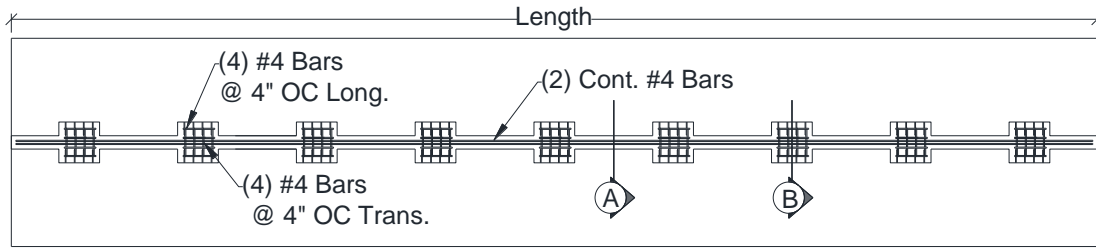
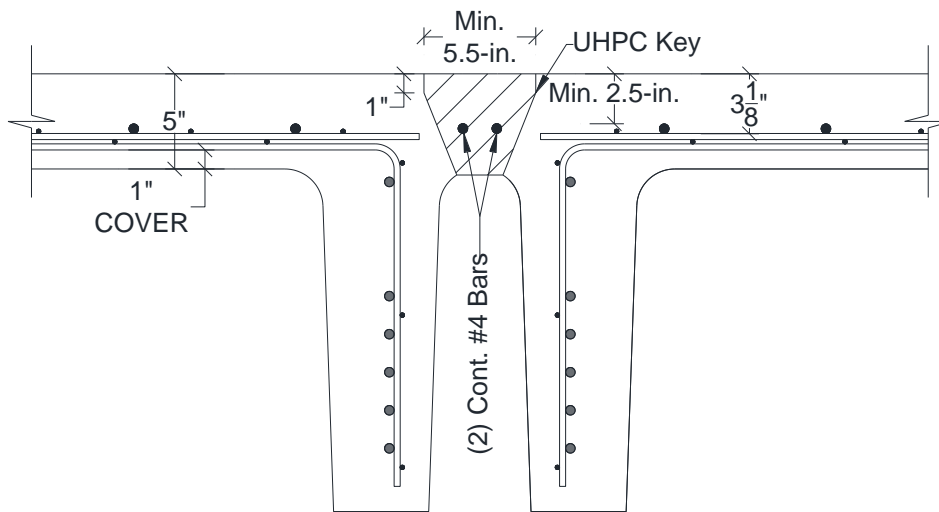
a. Pocket and Shear Key Reinforcement – Plan View

c. Section A – Shear key Detailing

Figure 9-2. Detailing for Proposed UHPC Pocket Joint Rehabilitation Method

2. The square pockets shall be reinforced with at least four ASTM A706 (or A615) Grade 60 No. 4 reinforcing steel bars in both the longitudinal and transverse directions of the bridge (Fig. 9-2b).

3. A continuous shear key with a minimum width of 5.5 in. shall be formed meeting the preparation requirements then be filled with UHPC. The UHPC intermediate keyways shall be longitudinally reinforced with at least two ASTM A706 (or A615) Grade 60 No. 4 bars (Fig. 9-2c) for the entire length of the bridge. A minimum of 2.5 in. clear cover shall be provided for the longitudinal reinforcement.

4. A minimum of 3 in. lap-splice between the pocket reinforcement and the deck exposed wires shall be provided in the transverse direction of the bridge. This length ensures full bar development to fracture (Fig. 9-2b and c).

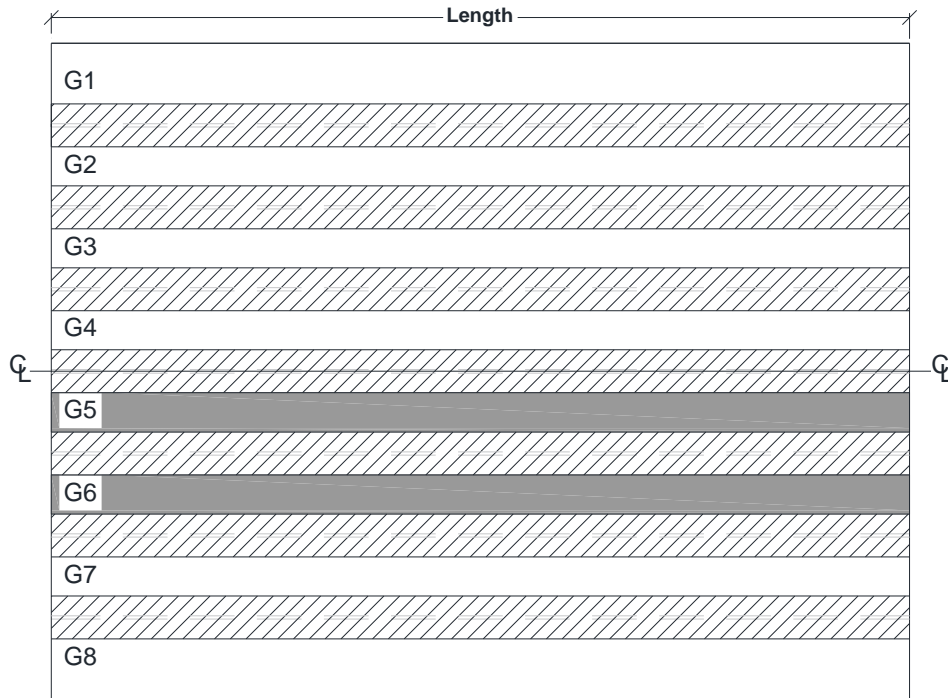
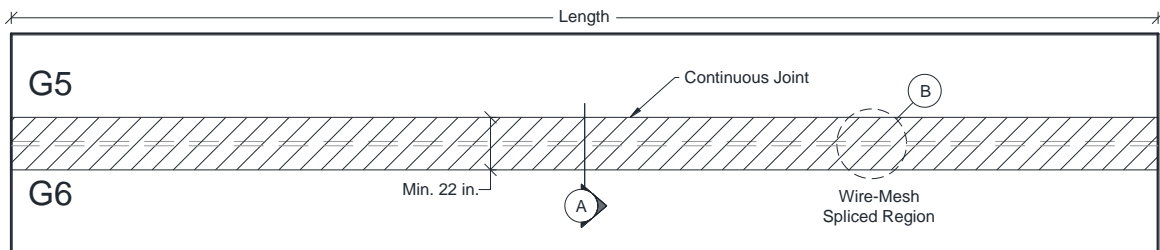
b. Plan view of Rehabilitated Double-Tee Bridges

c. Dimensions for Rehabilitated Longitudinal Joint Detailing

Figure 9-3. Geometry Requirements for Proposed Continuous Joint Rehabilitation Method

2. A continuous opening with a minimum width of 22 in. shall be formed (Fig. 9-3) meeting the preparation requirements. The joint shall be filled with UHPC with a minimum 28-day compressive strength of 18 ksi.

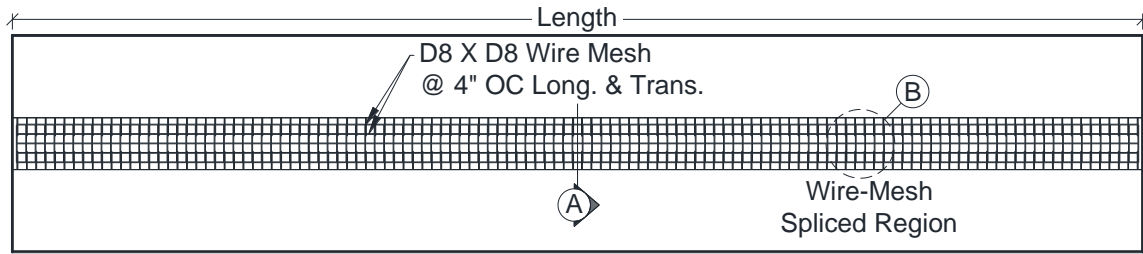
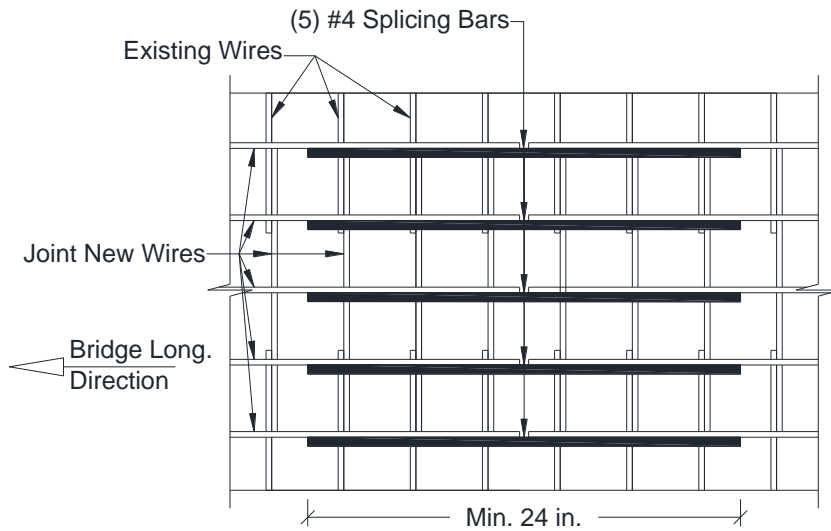
a. Continuous Joint Reinforcement – Plan View

c. Section B – Wire Mesh Splice Detailing

Figure 9-4. Detailing for Proposed Continuous Joint Rehabilitation Method

4. The continuous joints shall be reinforced with ASTM A497 Grade 70, 4 by 4 in. D8/D8 welded wire mesh (Fig. 9-4).
5. A minimum of a 5-in. lap-splice between the new and existing reinforcement shall be provided in the transverse direction of the bridge to ensure full development of the wires to fracture (Fig. 9-4b).

6. If wire meshes must be spliced over the length of the bridge, at least five No. 4 ASTM A706 (or A615) Grade 60 reinforcing steel bars shall be used to splice the wires in the longitudinal direction of the bridge with a minimum splice length of 12 in. per wire (Fig. 9-4c).
