MPC 23-497 | J. Seo, E. Jeong and N. Wehbe

SUSTAINABLE  
ALTERNATIVE TO  
STRUCTURALLY  
DEFICIENT BRIDGES

**Technical Report Documentation Page**

# **Sustainable Alternative to Structurally Deficient Bridges**

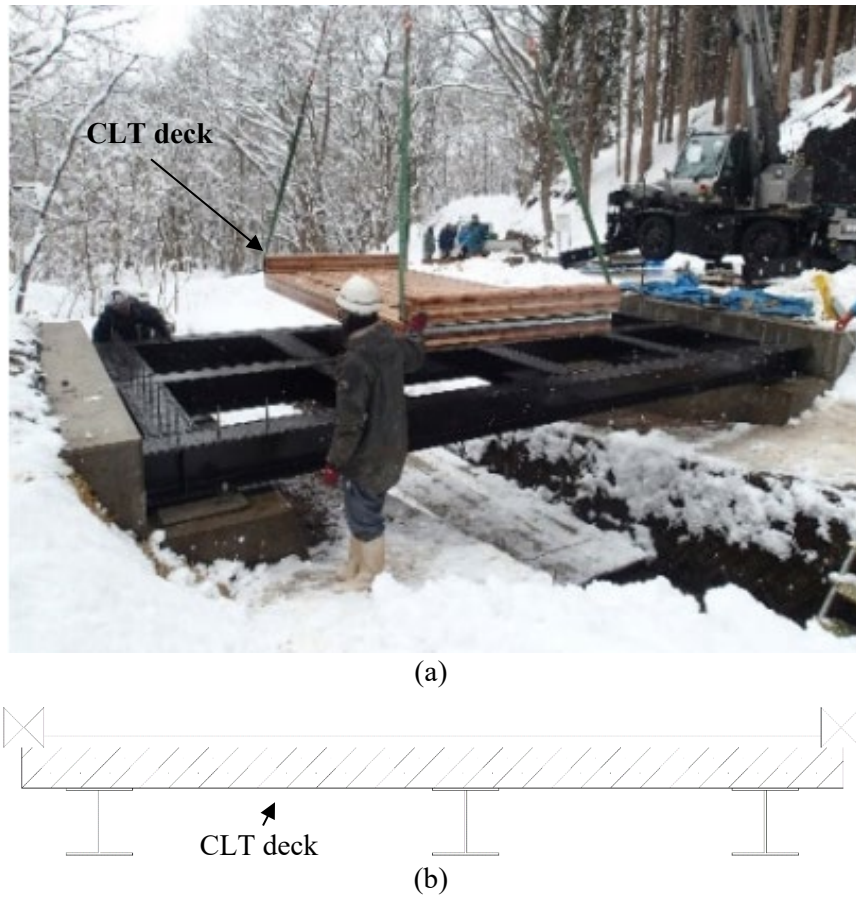
**Figure 2.3** Ishikurazawa Bridge (Sasaki et al. 2017): (a) overall bridge and (b) cross-section

The Ishikurazawa Bridge in Akita, Japan, is a forest road bridge, which used CLT for the deck as shown in Figures 2.3a and 2.3b. This bridge has a dimension of 7 m length and 3.5 m width, and the considered design load is 140 kN. Concrete abutments, steel girders, and CLT decking were applied to build the bridge system. It is well known that high moisture can cause visible damage on timbers. To improve water-resistance of CLT decking, fiber-reinforced plastic (FRP)-based waterproof treatments with spread type wood antiseptic, urethane painting, and polymer cement waterproofing were applied to the CLT bridge decking. To observe the treatment effects on the bridge, a load test was performed with trucks loaded with logs. In addition, Sasaki et al. (2017) carried out a study for practical use of CLT with the observation of its coating performance.

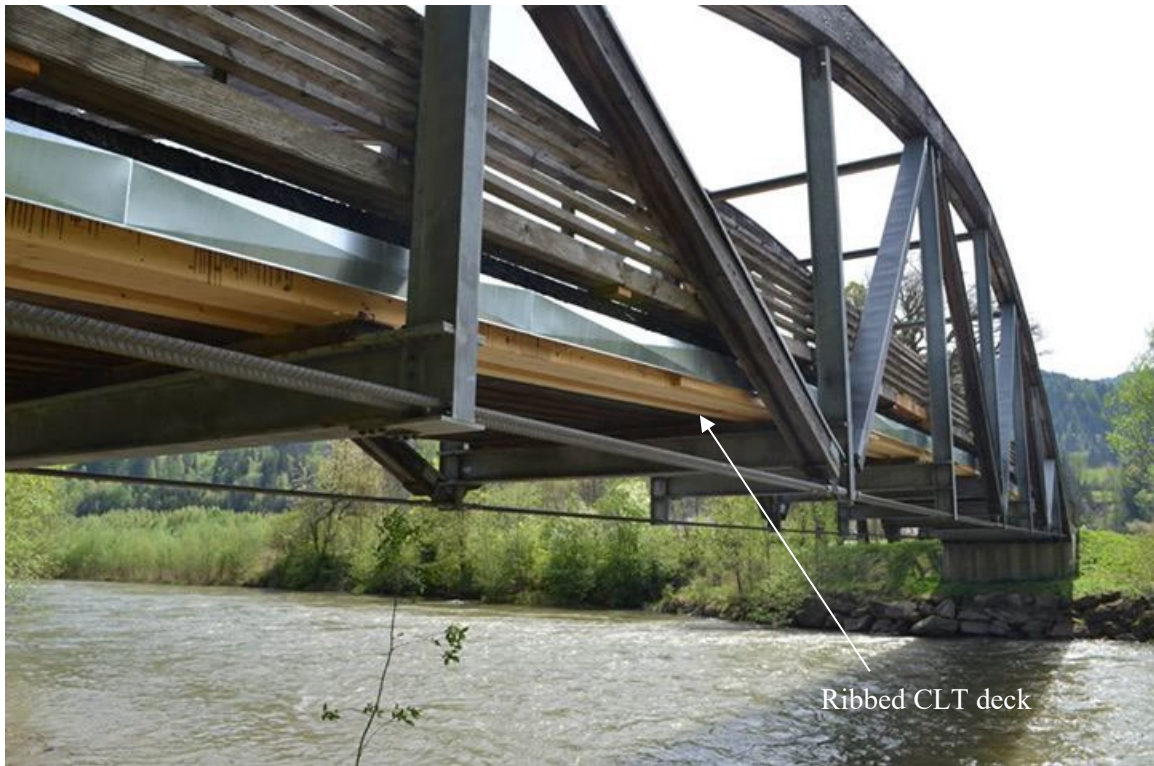
Several timber bridges have been constructed over the river Mur in Austria. Among these, two bridges were constructed using CLT. For instance, Figure 2.4 shows an arch bridge with the ribbed CLT deck. This bridge was constructed for roadway use. Metal cladding was utilized to protect the CLT deck of this bridge.

**Figure 2.4** Arch bridge with CLT deck over River Mur, Austria (Behrens and Benner 2015)

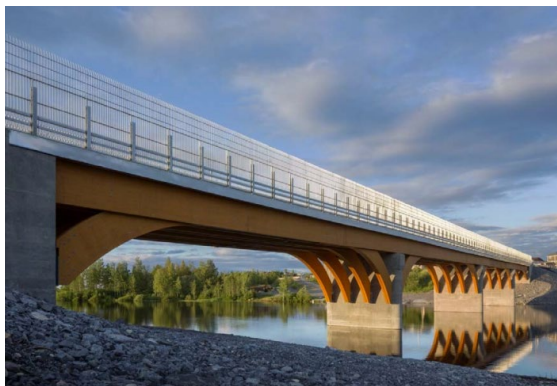
The Mistassini CLT Bridge (refer to Figures 2.5a and 2.5b) built in 2014 is located in Québec, Canada. This bridge used CLT as walkway decking (Lefebvre and Richard 2014). This bridge has a total 160m length. For the other components, glulams were applied to resist a design truck equivalent to 80 kN.

**Figure 2.5** Mistassini Bridge (Lefebvre and Richard 2014): (a) picture and (b) sketch

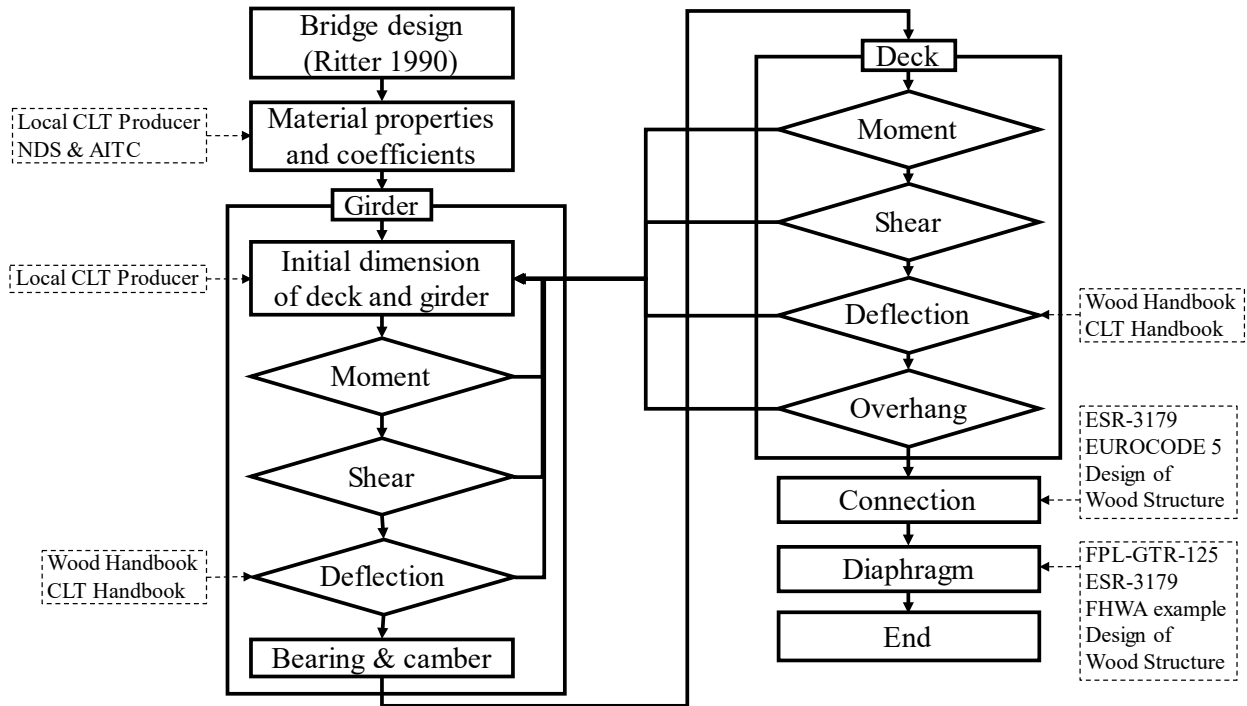
Figure 2.11 CLT bridge design flowchart with design codes

Particularly, the CLT bridge was designed following the procedures provided in Timber Bridge (Ritter 1990) and some design procedures referenced other CLT design codes such as CLT Handbook, as shown in Figure 2.11. For instance, the research team referred to Wood Handbook (Forest Products Laboratory 2010) and CLT Handbook (Karacabeyli and Douglas 2013) for prediction of deflections of CLT beams and decks rather than Timber Bridge (Ritter 1990). This was because the deflection check in Timber Bridges (Ritter 1990) was based on the conventional timbers such as glulam and sawn lumber. To check deflection in conventional timbers, bending stiffness,  $EI$ , was required, while the CLT bridge needed apparent modulus of elasticity,  $EI_{app}$ , that can be calculated by the effective bending stiffness,  $EI_{eff}$ , and the shear deformation adjustment factor. Wood Handbook (Forest Products Laboratory 2010) and CLT Handbook (Karacabeyli and Douglas 2013) were referred to obtain the CLT effective bending stiffness and shear adjustment factor. Details on how to design the CLT bridge are provided in the next sections.

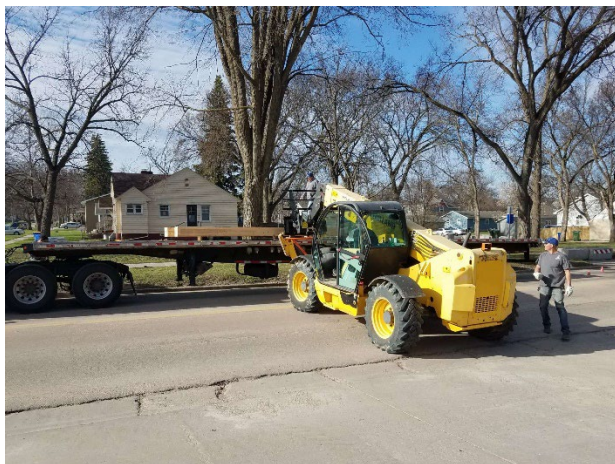
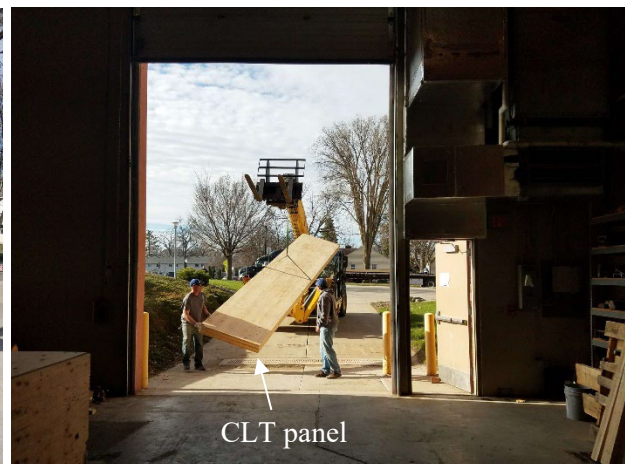
All the CLT components with the complete dimensions, including eight 7-ply CLT beams, one 5-ply CLT panel, and two 7-ply CLT diaphragms, were manufactured in Smartlam, and they were delivered to the SDSU Structural Laboratory on April 24, 2019. The CLT components were then stacked in the SDSU Structural Lab with a forklift crane vehicle (Figures 2.23a, 2.23b, and 2.23c). After the CLT components were delivered, all the dimensions of each CLT component were measured to ensure the manufactured and measured dimensions were identical, as shown in Figure 2.23d. The quotation of all the delivered CLT components is shown in Appendix B.

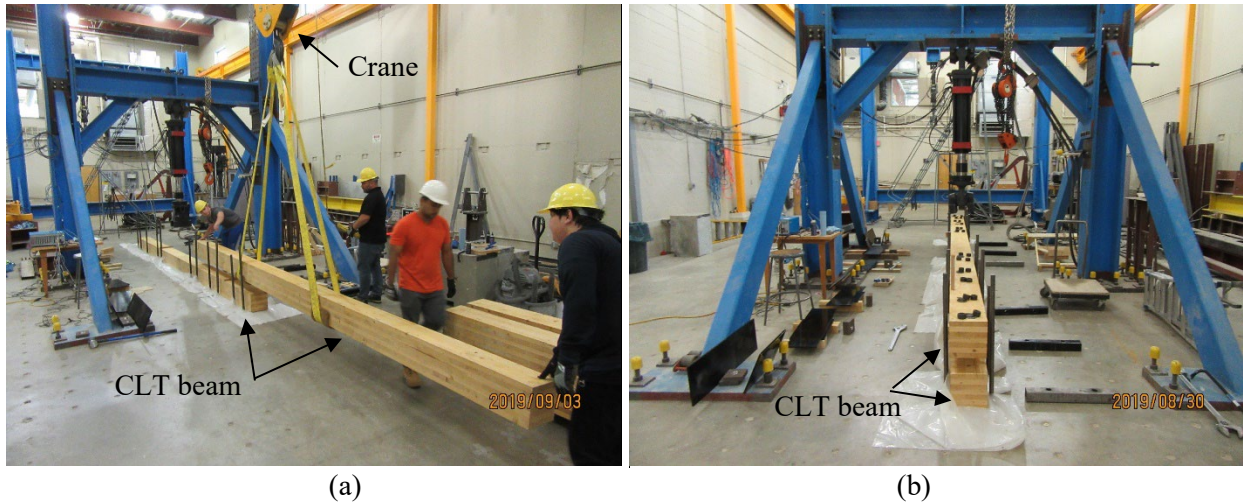
As shown in Figure 2.26, fabrication of CLT girders with bonding of the CLT beams was conducted in five steps based on the aforementioned clamping processes: 1) CLT beam shipping; 2) CLT bonding set-up; 3) spreading adhesive on CLT beam; 4) clamping two CLT beams; and 5) adhesive curing.

**Figure 2.26** Adhesive CLT girder fabrication: (a) CLT beams shipping; (b) CLT bonding set-up; (c) spreading adhesive glue on CLT beam; (d) clamping two CLT beams; and (e) adhesive curing.

All the CLT beams were moved using a crane in the SDSU Structural Lab, as shown in Figure 2.26a. For safety, all members wore steel toe shoes and hard hats while working in the lab during fabrication of girders. All items necessary for clamping, including steel plates, anchor bolts, nuts, and load cells, were placed on the side of the CLT beams after moving the CLT beam, as shown in Figure 2.26b. Spreading adhesive (Figure 2.26c) and clamping two CLT beams (Figure 2.26d) were accomplished within 45 minutes following the guidelines of polyurethane adhesive specification (Appendix C). According to the adhesive guidelines, the CLT girders were clamped with the loads for four hours and left to cure for additional two hours (Figure 2.26e).

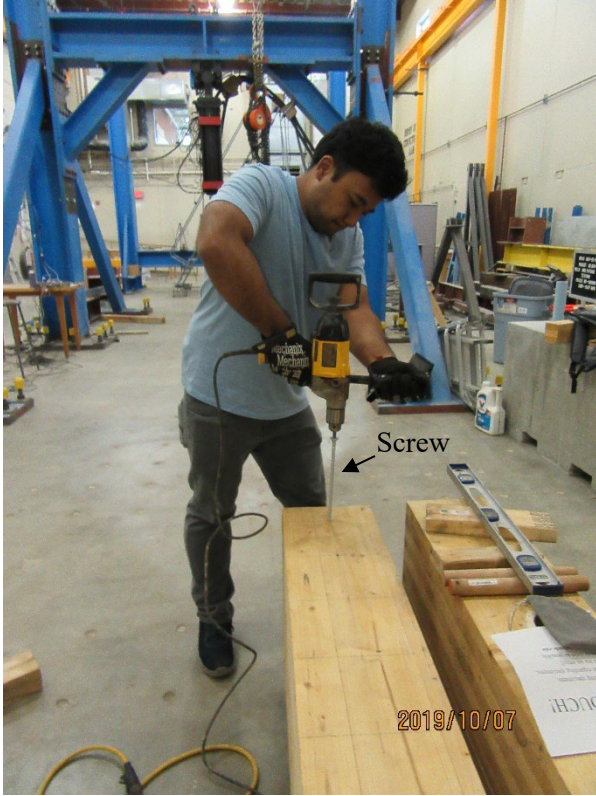
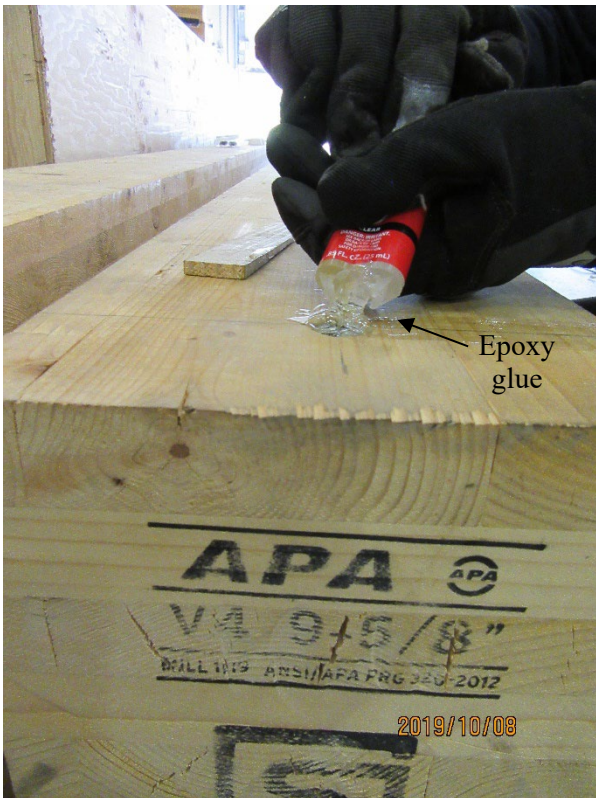
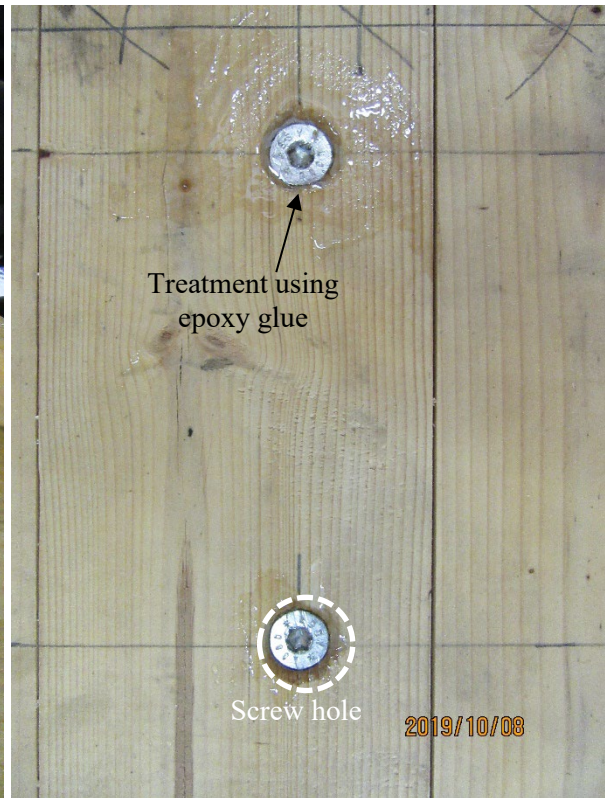
Fabrication of the adhesive CLT girders with fasteners has eight steps (Figure 2.31): 1) marking hole locations on the girder; 2) making pre-drill holes; 3) tightening the fasteners; 4) cleaning girder surface; 5) filling the gap between the hole and fastener using epoxy glue; 6) curing epoxy glue; 7) filling the holes using the epoxy-based wood filler; and 8) curing epoxy-based wood filler.

**Figure 2.31** CLT girder fabrication using fasteners: (a) marking hole locations on the girder; (b) making pre-drill holes; (c) tightening the fasteners; (d) cleaning girder surface; (e) filling the gap between the hole and fastener using epoxy glue; (f) curing epoxy glue; (g) filling the holes using the epoxy-based wood filler; and (h) curing epoxy-based wood filler.

As described above, the research team first marked the hole locations on the CLT girder, as shown in Figure 2.31a. The team made pre-drill holes using the 3D printed drill guide, as shown in Figure 2.31b. A drill bit 6.35 mm in diameter and 457.2 mm in length was used to make pre-drill holes (Figure 2.31c). The fasteners 12.7 mm diameter and 381 mm length were screwed into the CLT girder after pre-drilling (Figure 2.31c). Because drill holes in the timber can, in general, cause decay, the team used two different epoxy-based products, including epoxy glue (Appendix E) and epoxy-based wood filler (Appendix F), to fill the holes. This application of epoxy products to the drill holds was based on the finding by Avent (1985), recommending that sealing the hole gaps with epoxy helped prevent timber decay. The surface of the girder was cleaned up (Figure 2.31d) to pour the epoxy glue in the gaps between holes and fasteners, as displayed in Figure 2.31e. The epoxy was applied first since it can penetrate the small gaps due to low viscosity. The surface was left for one hour for effective epoxy curing, as exhibited in Figure 2.31f. The holes were further filled with epoxy-based wood filler (Figure 2.31g) and cured for an additional six hours, as illustrated in Figure 2.31h.

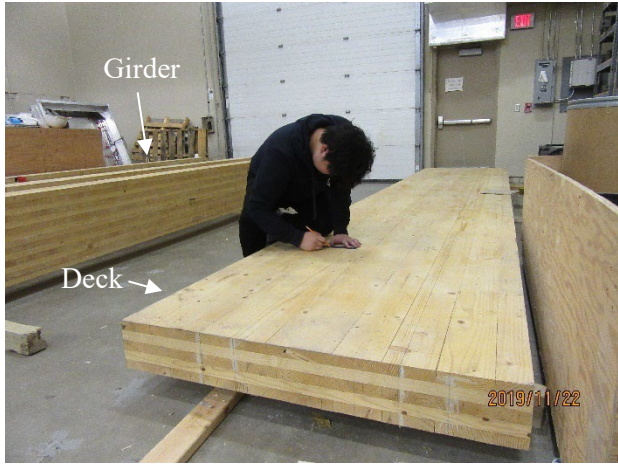
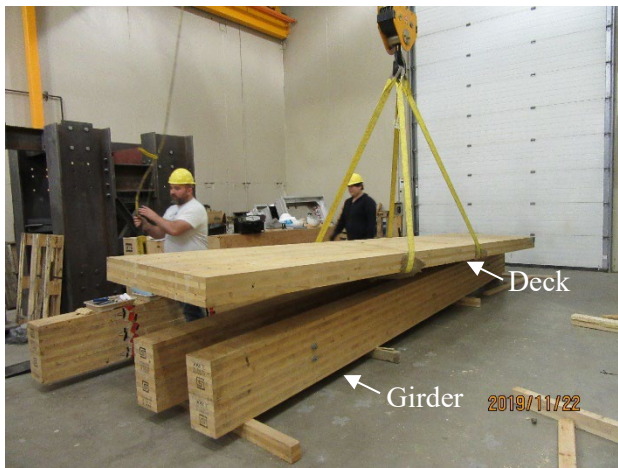
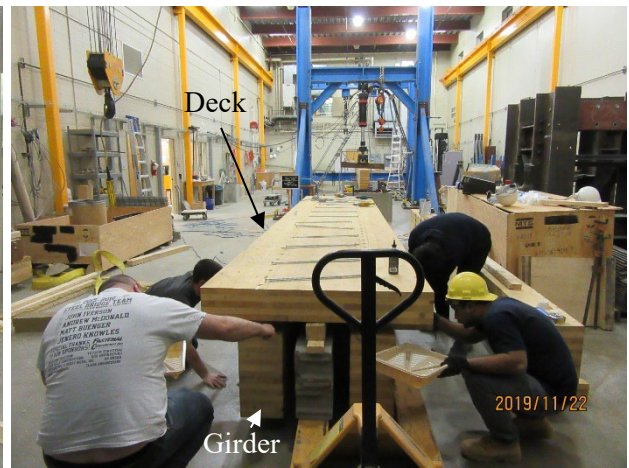
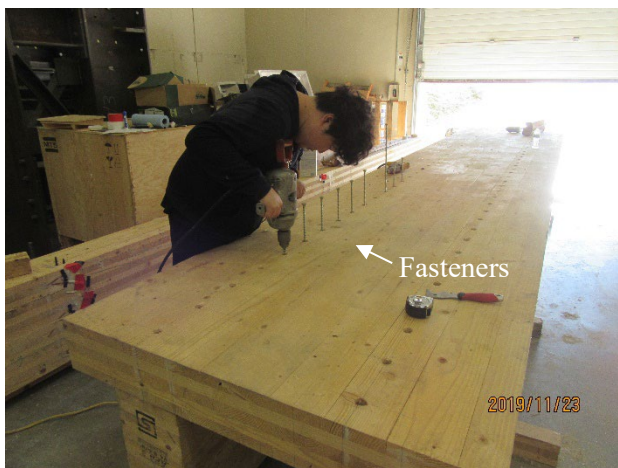
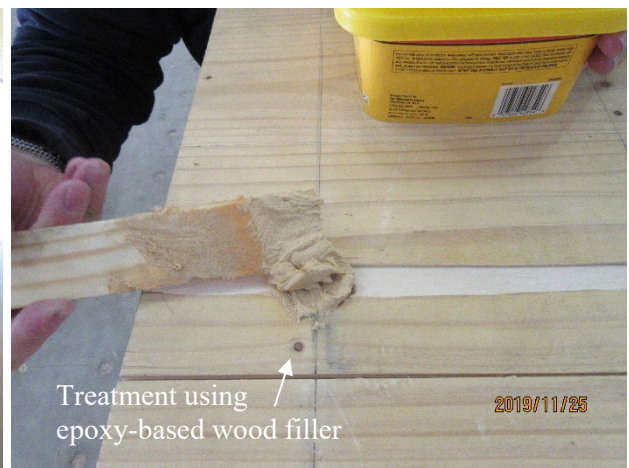
The 5-ply CLT deck 6400.8 mm long, 1219.2 mm wide, and 174.63 mm deep was used to fabricate the entire CLT girder bridge system. Both polyurethane glue, adhesive (Appendix C), and carbon steel fasteners (Appendix D) for wood connection purposes were used to make a connection between the CLT girders and CLT deck. The 14-ply CLT girders were fabricated with the adhesive, as referred to in Section 2.3.2. The CLT girders and CLT deck were marked at specific locations where the carbon steel fasteners 12.7 mm in diameter and 584.2 mm in length needed to be screwed (Figure 2.33a). Each marked location on the girders and deck was pre-drilled with 9.53 mm holes for effective screwing of the fasteners (Figure 2.33b). The deck was moved on top of the girders and wood blocks were placed between the deck and girder temporarily (Figure 2.33c). The adhesive was spread on top of the girder and wood blocks were removed (Figure 2.33d). The carbon steel fasteners 12.7 mm in diameter and 584.2 mm in length were screwed through the deck and girder (Figure 2.33e). In total, 39 fasteners were screwed for each of the CLT girders for fabrication of the CLT bridge system. The research team further applied epoxy glue to the gaps in the holes to prevent any decay in the timber (Figure 2.33f). Figures 2.33g and 2.33h show the epoxy filler curing on the CLT girder and the fabricated CLT bridge system, respectively.

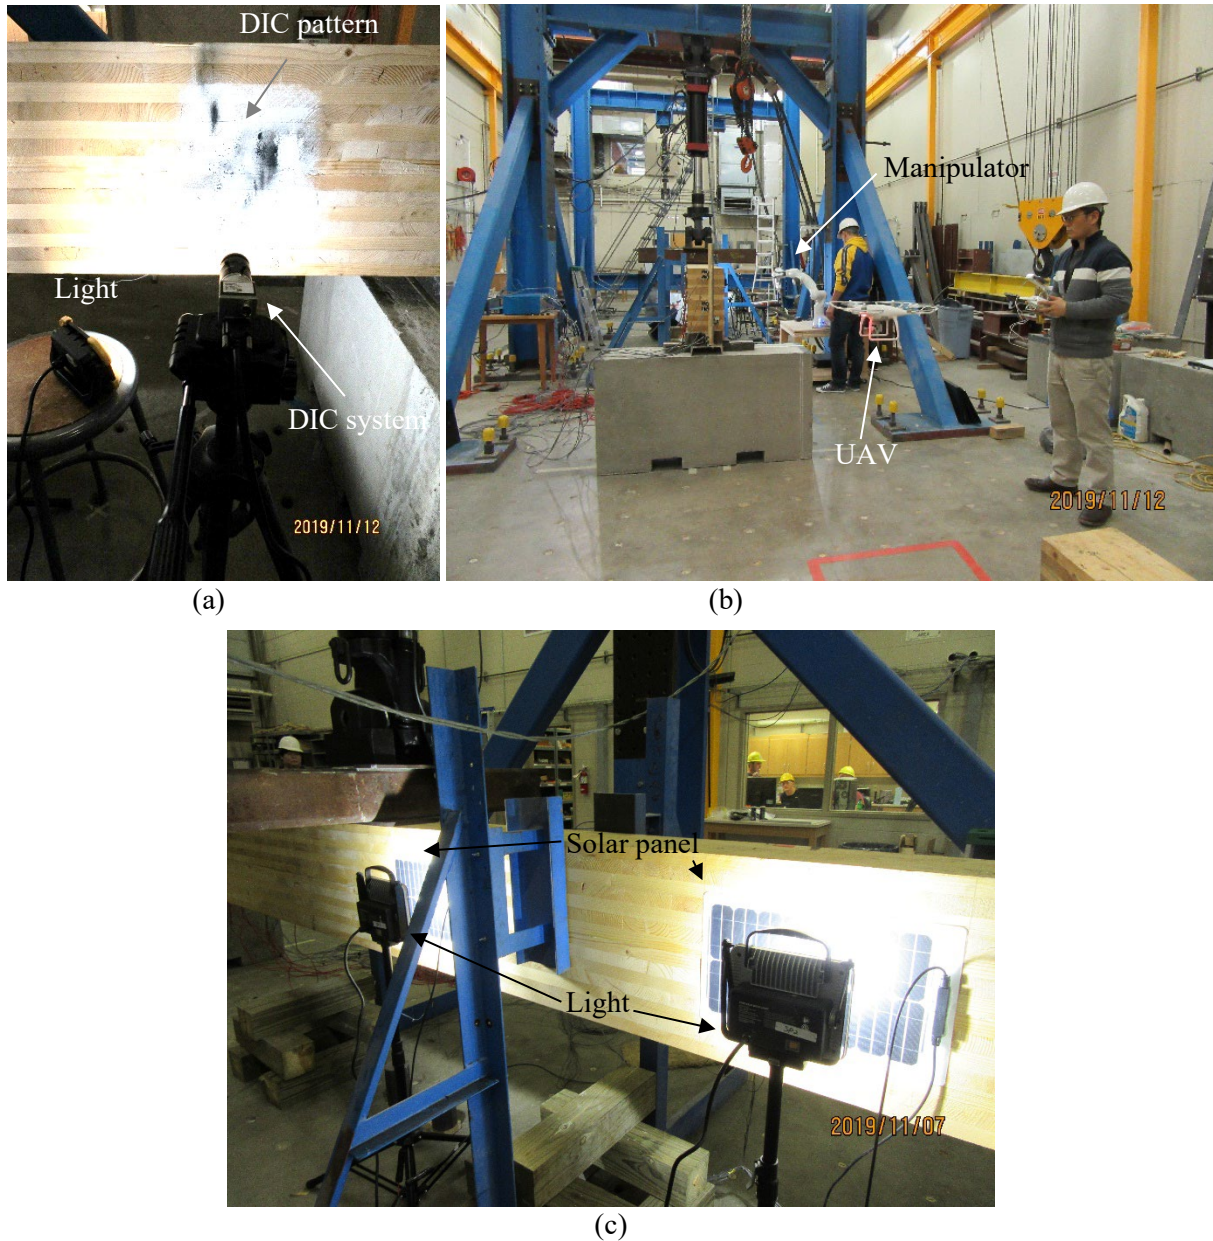
**Figure 2.37** Non-contact sensor: (a) DIC system; (b) UAV and manipulator; and (c) solar panel

In addition to the contact and non-contact sensor installation, two solar panels (Nuzamas portable 20W, Appendix K) were installed on the east side of the CLT girder to examine the correlation between solar energy harvesting and girder behavior resulting from the testing, as seen in Figure 2.35c. In Figure 2.37c, one solar panel, “solar panel 1,” was located at a distance of 2.55 m to collect the solar energy at the most critical damage location, while the other solar panel, “solar panel 2,” was mounted 1.33 m from the north edge of the girder. To explore an amount of solar energy harvested during the testing, two lights were installed, where each was capable of harvesting the maximum voltage of 16.91 V.

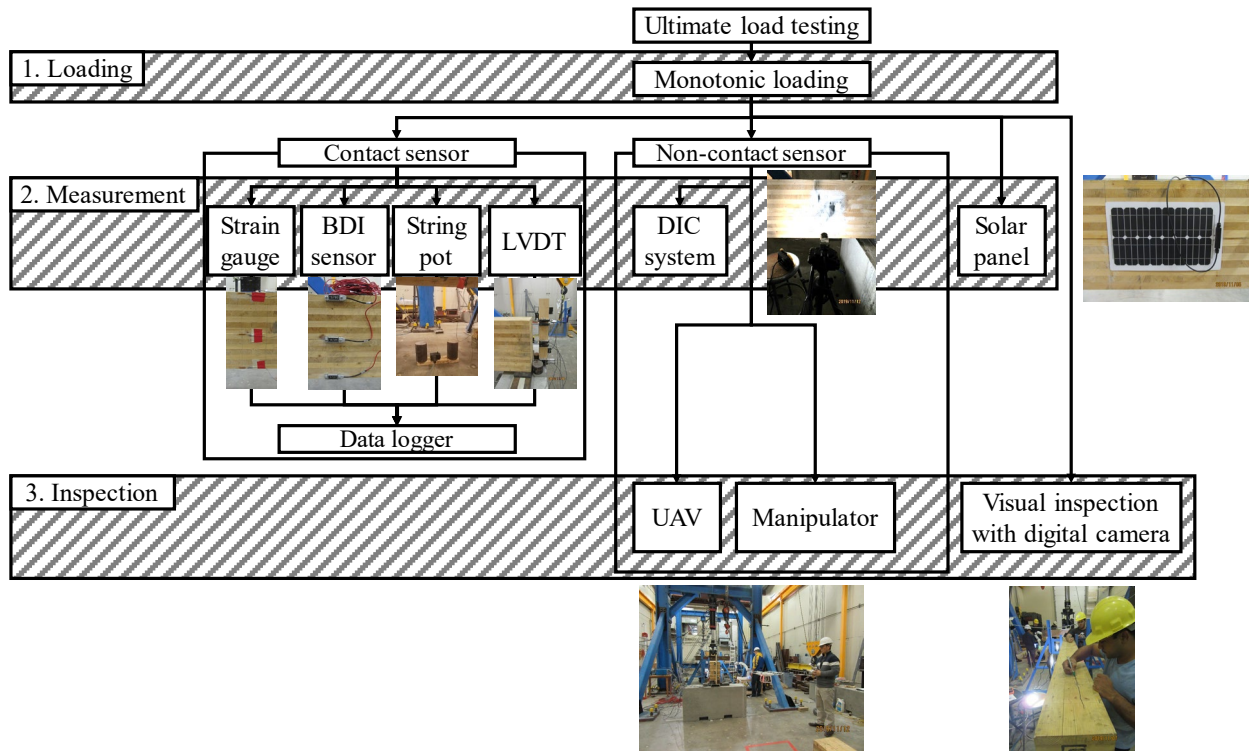
**Figure 2.38** Testing and data collection procedure of CLT girder with adhesive

As the final step, the CLT girder was inspected at regular loading intervals. When it was necessary to identify damage and/or to capture associated images at a certain test run, visual inspection was conducted. For example, when a cracking sound was heard, the inspection was carried out. The visual inspection was performed on all sides of the girders using the UAV, manipulator, and digital cameras. During this test, the girder was tested with 185 test runs and 14 inspections, including the initial inspection before the testing was conducted.

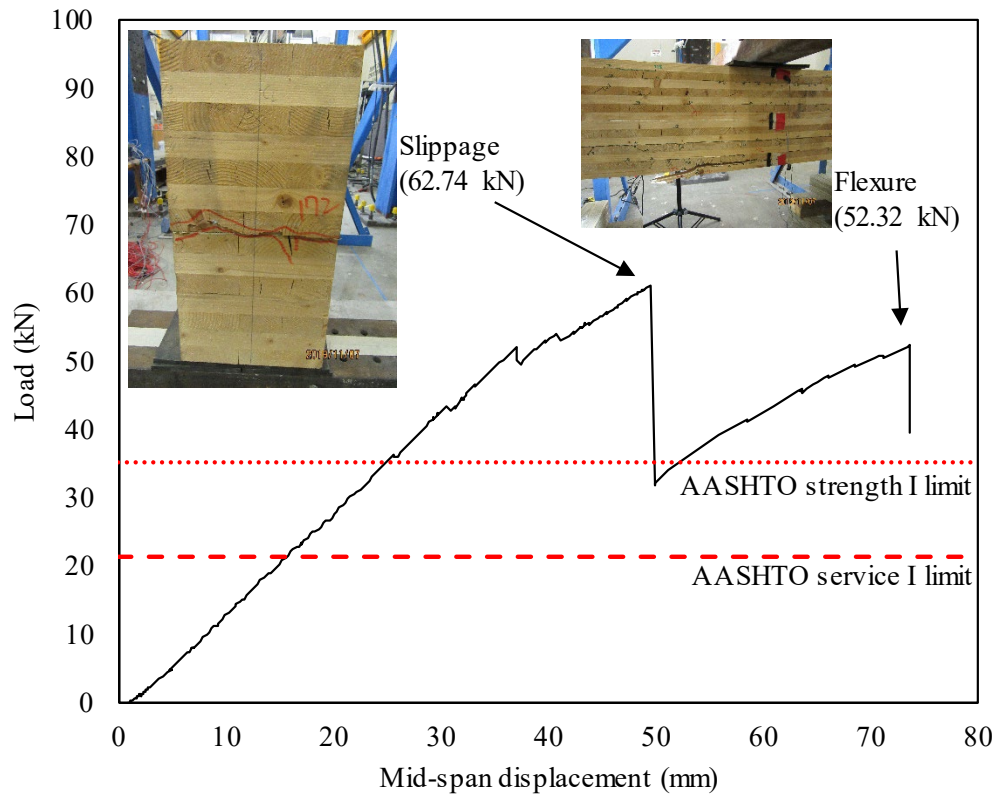
**Figure 2.39** Load-displacement curve of CLT girder with adhesive

A load-displacement curve is presented in Figure 2.39, where two different failures, slippage failure at 49.53 mm resulting from 62.74 kN and flexural failure at 73.66 mm corresponding to 52.32 kN, can be observed.

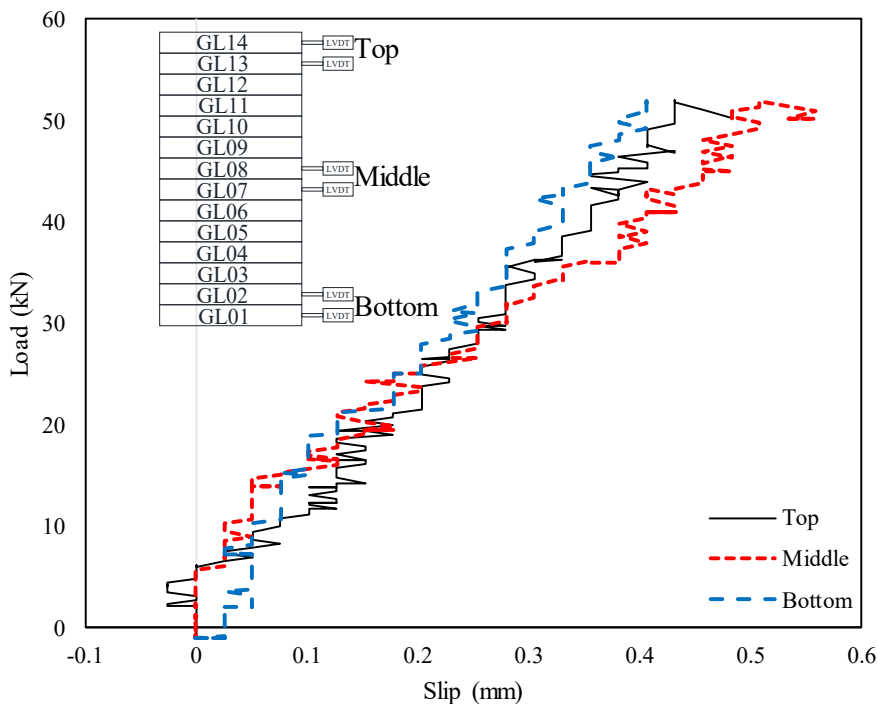
**Figure 2.42** Slippage between lams obtained by LVDTs

In Figure 2.41, the LVDT sets showed positive values of slippage except for the initial negative slippage at the top of the girder during the test. As expected, as the load increased, the slippages increased at the top, middle, and bottom of the CLT girder, as shown in this figure. Note, the LVDTs were removed before the first failure due to slippage to avoid any damage to the instruments. The maximum slippages at the top, middle, and bottom of the girder were 0.48 mm, 0.56 mm, and 0.41 mm, respectively, before the first failure. With these results, it was concluded that the maximum value was reached before the slippage failure between the two 7-ply beams (GL07 and GL08).

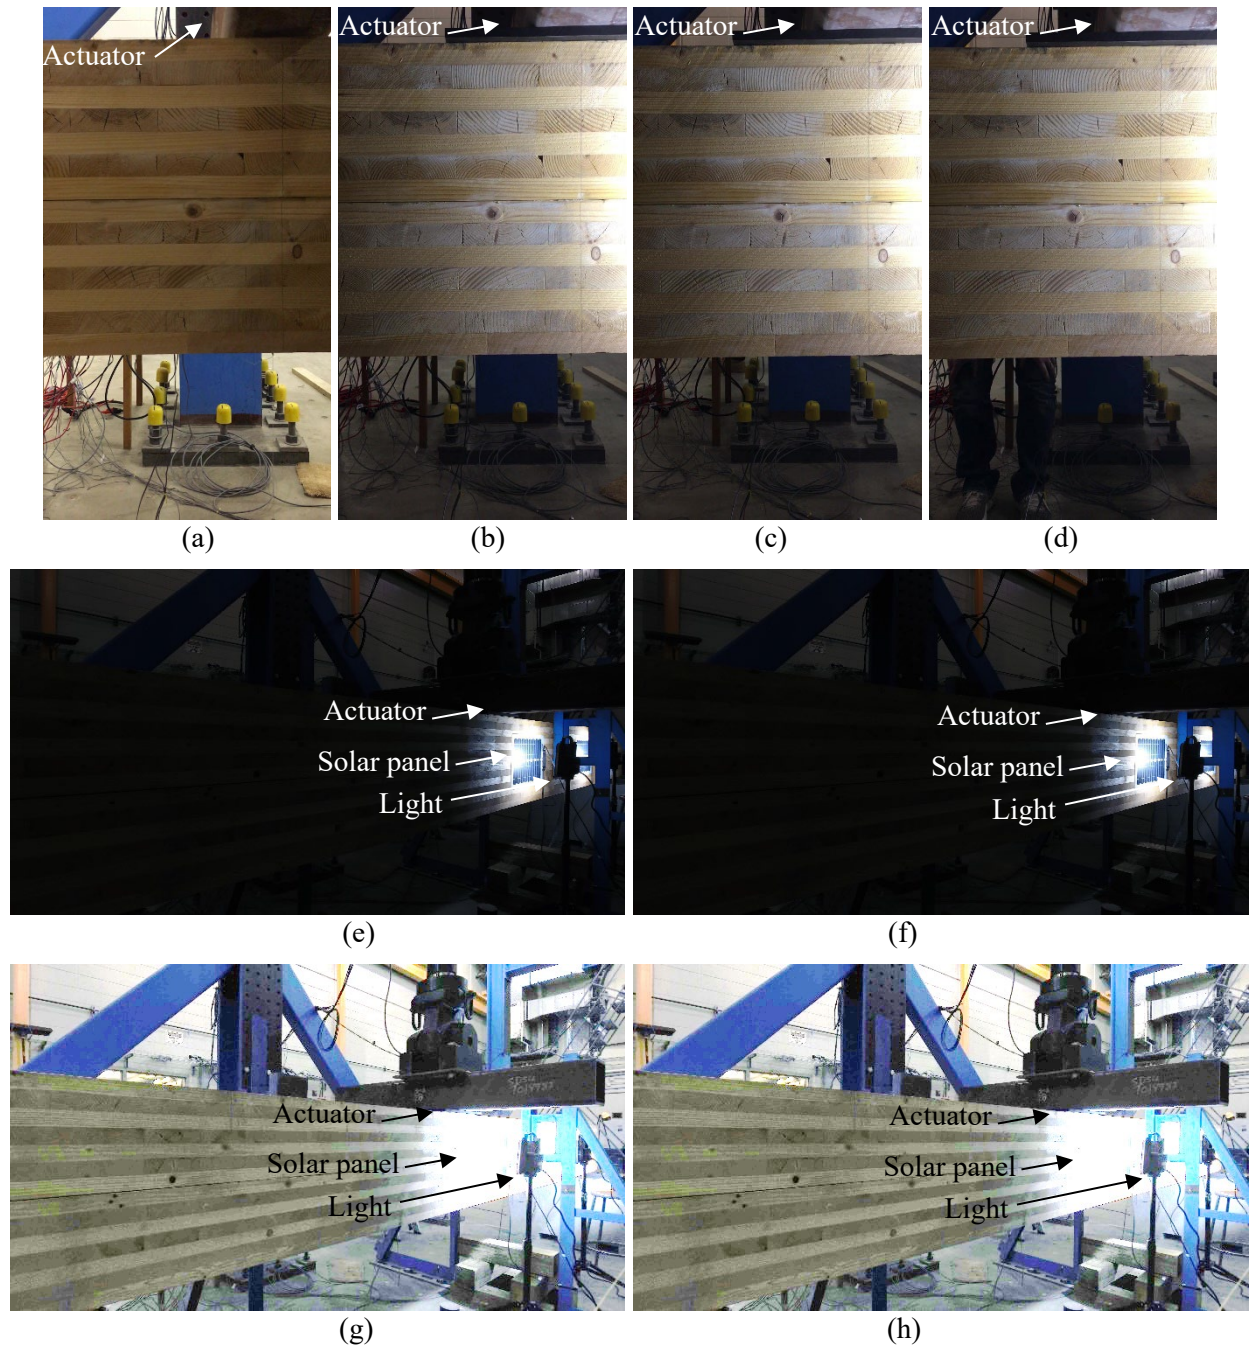
**Figure 2.53** Inspection images captured by the manipulator and UAV: (a) 0 mm (manipulator); (b) 13.97 mm (manipulator); (c) 22.10 mm (manipulator); (d) 37.34 mm (manipulator); (e) 0 mm (UAV); (f) 37.34 mm (UAV); (g) Figure 53e adjusted with brightness 85% and contrast -10%; and (h) Figure 53f adjusted with brightness 85% and contrast -10%.

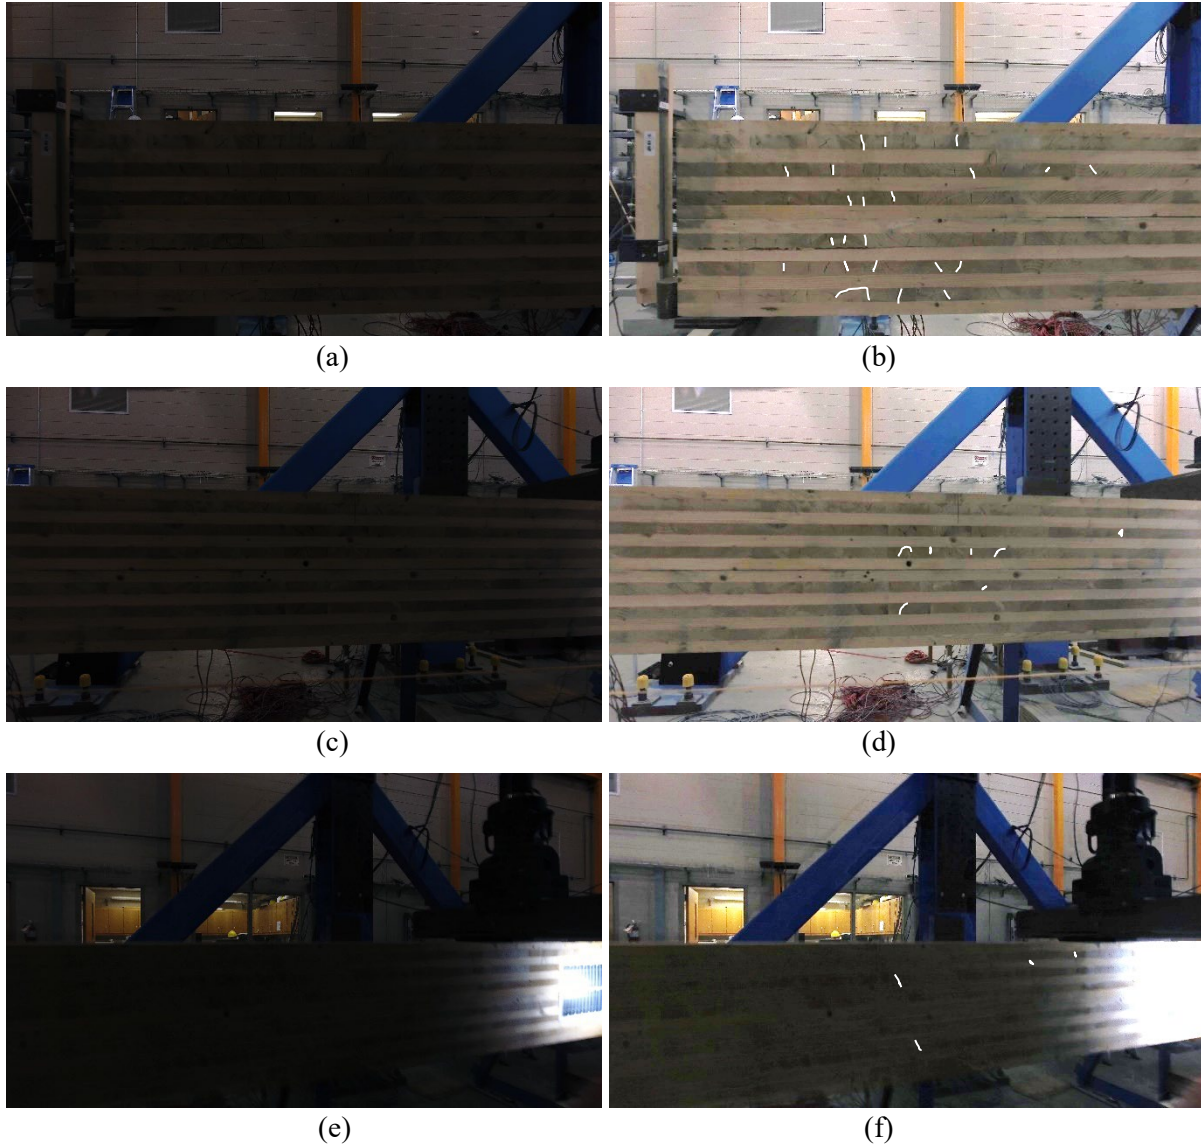
**Figure 2.56** Southeast sections of CLT girder before the testing was captured by UAV: (a) Sections 1 through 4; (b) Figure 2.56a adjusted with brightness 70% and contrast -10%; (c) Sections 2 through 6; (d) Figure 2.56c adjusted with brightness 70% and contrast -10%; (e) Sections 4 through 8; and (f) Figure 2.56e adjusted with brightness 60% and contrast 10%.

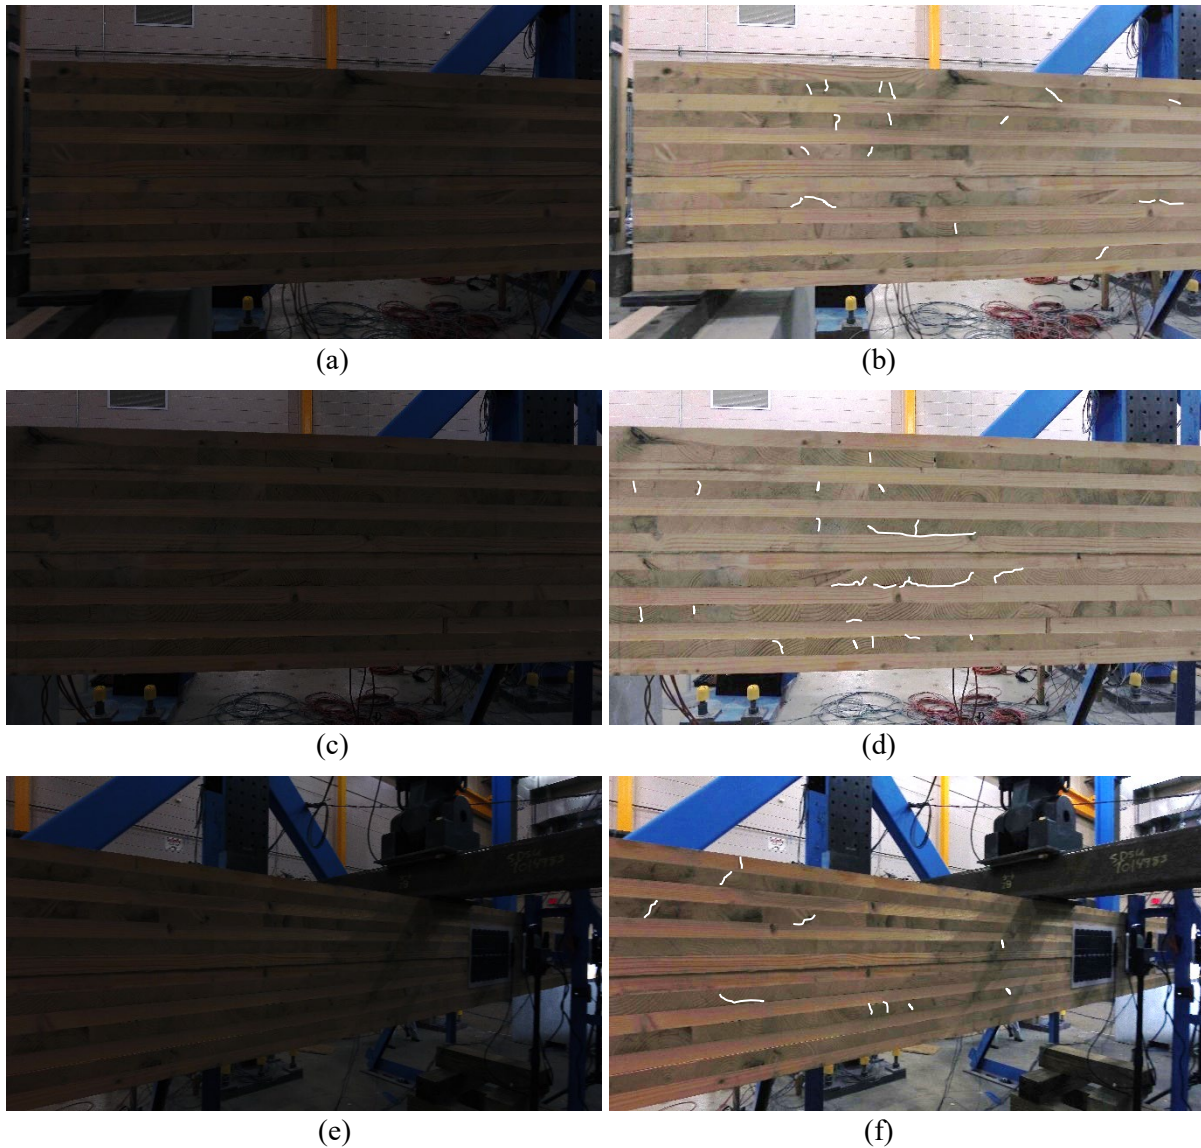
**Figure 2.83** Southeast sections of CLT girder before the testing captured by UAV: (a) Sections 1 through 4; (b) Figure 2.83a adjusted with brightness 70% and contrast -10%; (c) Sections 2 through 6; (d) Figure 2.83c adjusted with brightness 70% and contrast -10%; (e) Sections 4 through 8; and (f) Figure 2.83e adjusted with brightness 60% and contrast 10%.

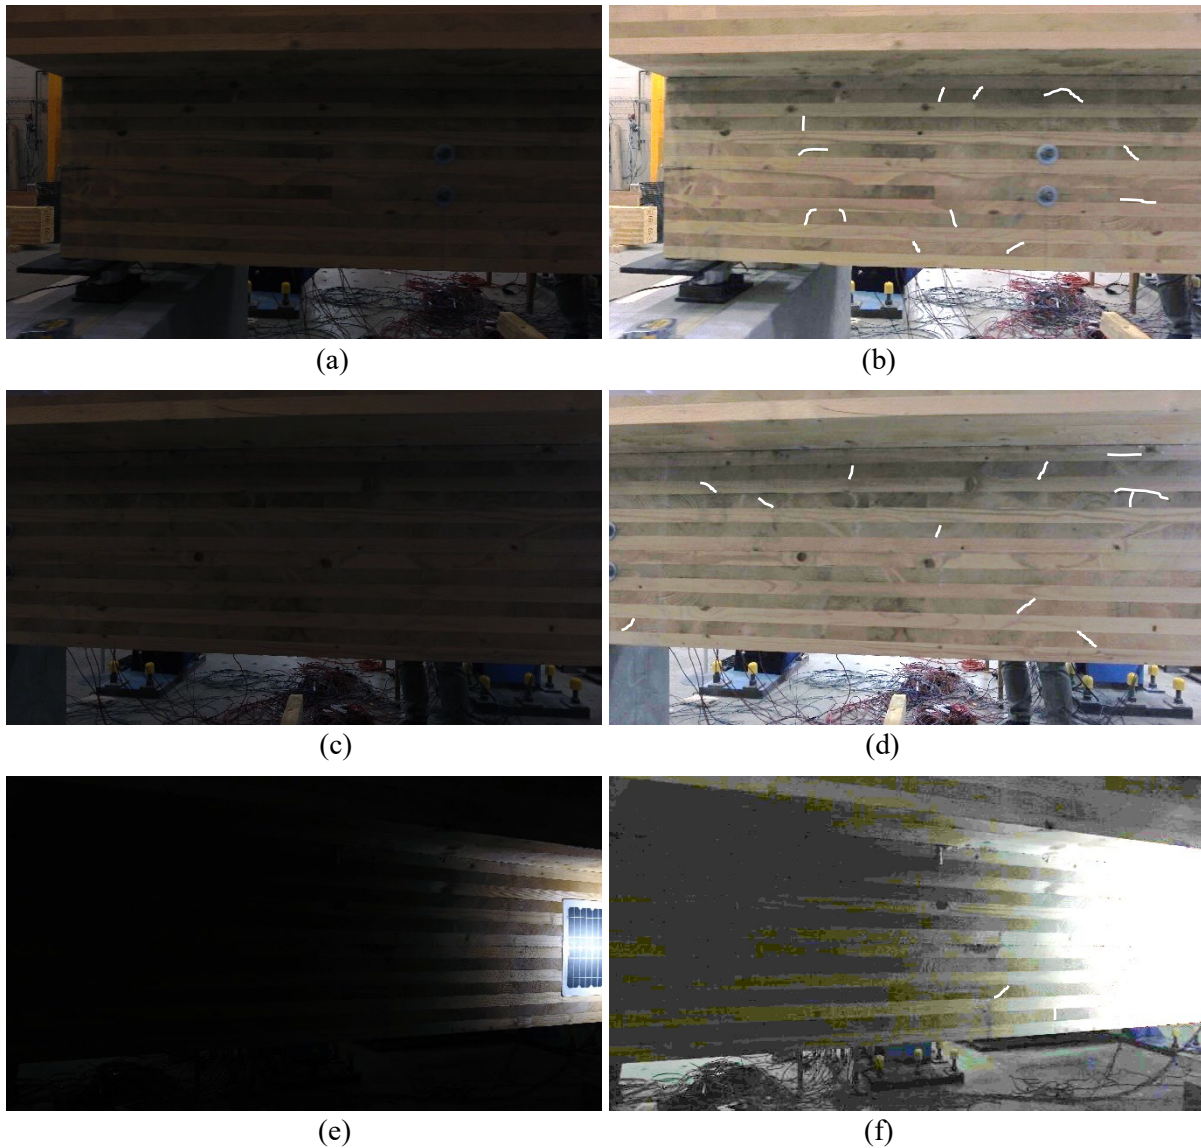
**Figure 2.108** South east sections of the east girder of the CLT bridge system before the testing captured by UAV: (a) Sections 1 through 4; (b) Figure 108a adjusted with brightness 70% and contrast -10%; (c) Sections 2 through 6; (d) Figure 108c adjusted with brightness 70% and contrast -10%; (e) Sections 4 through 8; and (f) Figure 108e adjusted with brightness 90% and contrast -20%
