Illinois Center for Transportation Series No. 23-006

Optimized Hot-Mix Asphalt Lift Configuration for Performance

Research Report No. FHWA-ICT-23-005

ICT PROJECT R27-204

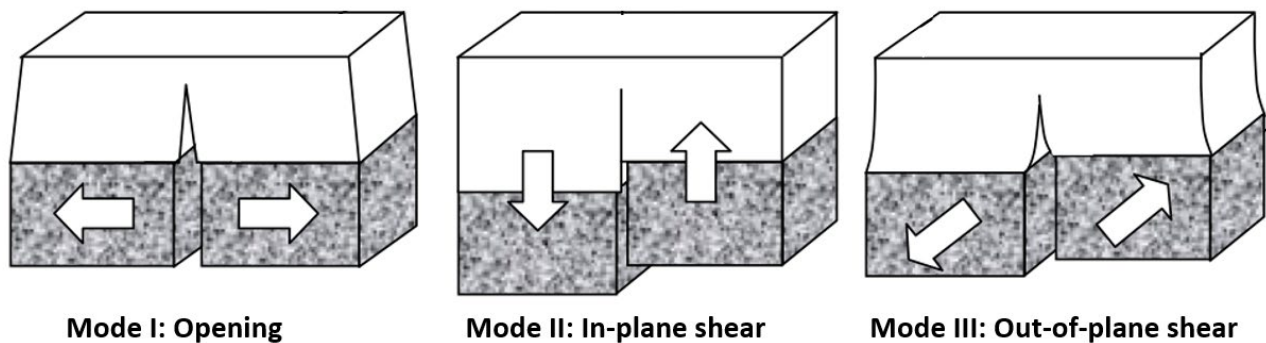
Cracks are categorized based on three loading modes. For Mode I (opening), principal loading is generally applied to a crack plane, and cracks grow perpendicular to the crack plane. For Modes II and III, cracks occur in in-plane and out-of-plane shear directions, respectively. Figure 2 presents the three reflective cracking modes for an HMA overlay on a PCC layer.

Figure 2. Schematic. Fracture modes of reflective cracking.

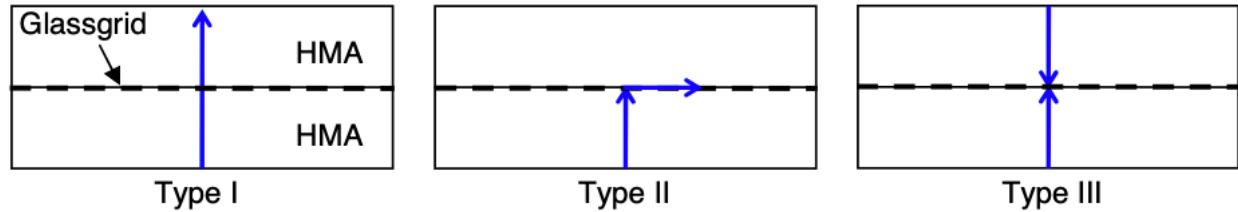
Although reflective cracking is considered a bottom-up phenomenon, other crack patterns have been observed in field investigations, laboratory testing, and numerical simulations. As presented in Figure 3, Jayawickrama et al. (1987) observed three reflective cracking types in laboratory tests where horizontal loading was applied to two HMA layers with a glass-grid interlayer. Type I cracks initiate from the bottom of the overlay and propagate directly upward. Type II cracks initiate from the bottom but redirect at the interface. Type III cracks, in contrast, comprise of two cracks developed simultaneously from the bottom and top of the HMA overlay and head to the interface.

Figure 3. Schematic. Crack patterns: HMA and HMA structure with a glass-grid interlayer.

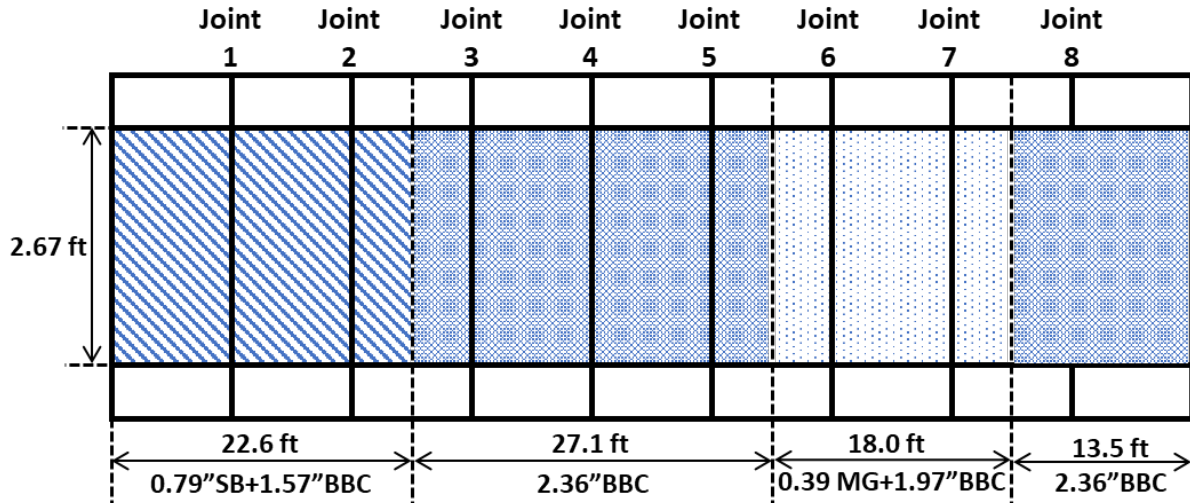
Perez et al. (2007) conducted accelerated pavement testing (APT) to study traffic-induced reflective cracking in France. The tests were performed on a 98 ft (30 m) long track with eight discontinuities in the base layers, as presented in Figure 5. Three overlay configurations were considered: a 2.36 in (6 cm) regular bituminous (BBC) layer; a 0.79 in (2 cm) sand bituminous (SB) binder layer and a 1.57 in (4 cm) BBC surface layer; and a 0.39 in (1 cm) metallic grid (MG) reinforced binder layer and a 1.97 in (5 cm) BBC surface layer.

Figure 5. Schematic. Test track and overlay configurations.

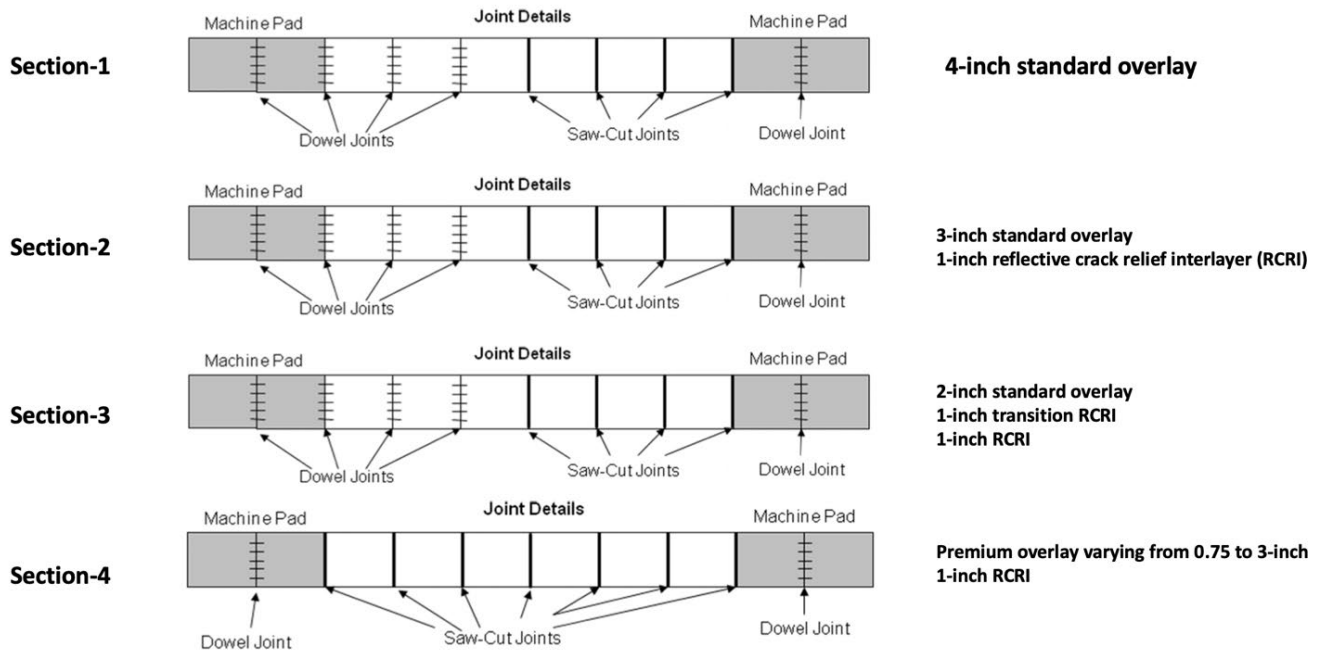
Dave et al. (2010) performed testing using the Accelerated Test Loading Assembly (ATLAS) to study the jumping and offsetting mechanisms of reflective cracking. Four 125 ft (38 m) long pavement sections were constructed with the same underlying structure, consisting of a 6 in (152 mm) thick newly jointed plain concrete pavement (joint spacing at 12.5 ft [3.8 m]) on top of a 12 in (304 mm) granular subbase). Figure 6 summarizes the joint conditions and test section configurations. Instrumentation was installed to measure ground moisture levels, temperature profiles, and horizontal and vertical displacements at the PCC joints. They used ATLAS to apply 65,300 passes of varying load levels (5–30 kips [22.24–133.45 kN]) during the winter.

Figure 6. Photo. Joint conditions and test section configurations.

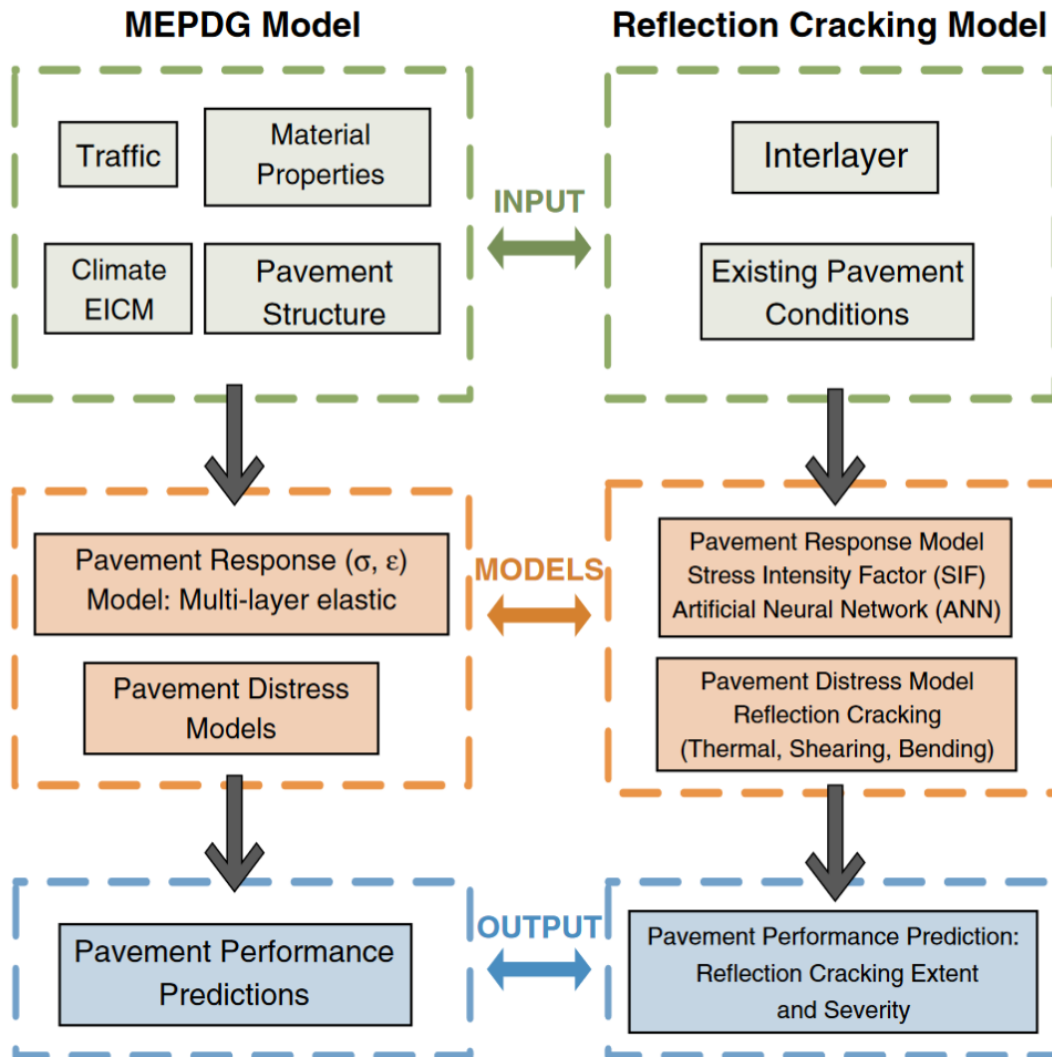
Figure 7. Diagram. The reflective cracking model is integrated as a subroutine of the MEPDG software.

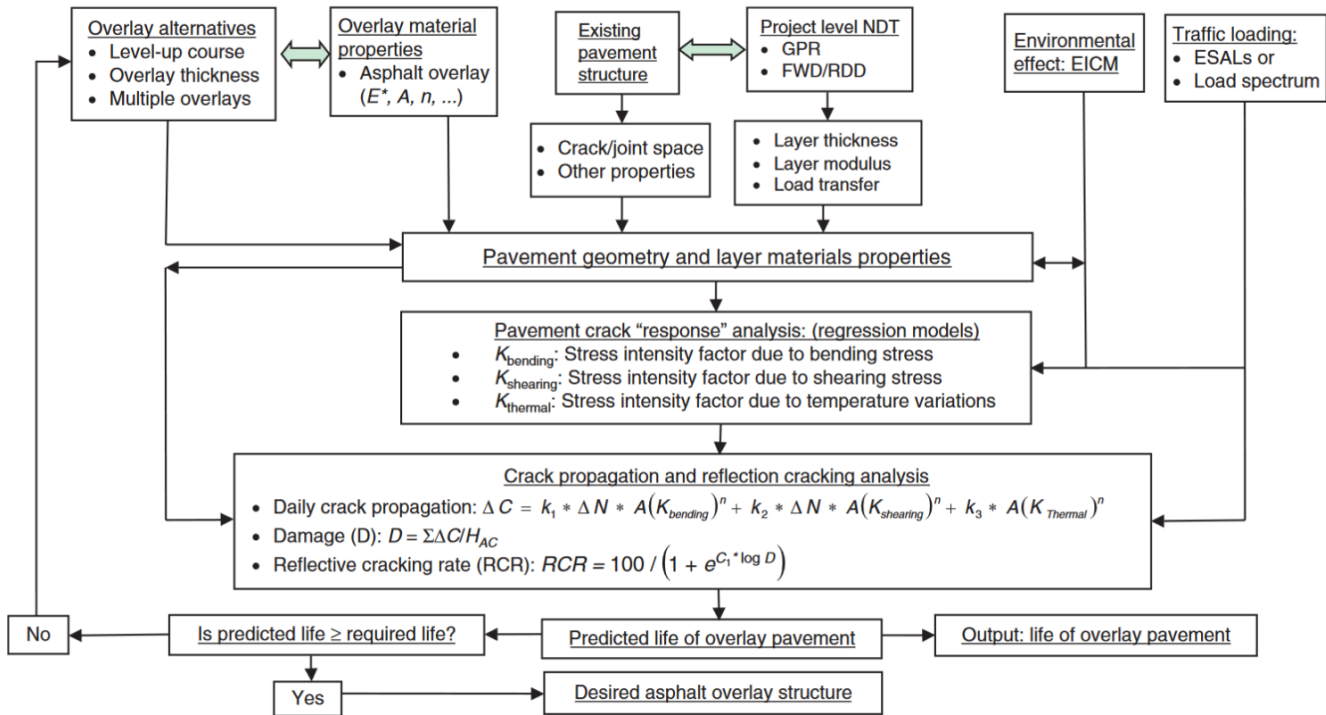
Zhou et al. (2010) developed an ME reflective cracking model, which was then integrated into an HMA overlay thickness design and analysis system, as presented in Figure 8 (Hu et al., 2010). The reflective cracking model was based on Paris' law. It uses the stress intensity factor (SIF) and HMA fracture properties (A and n parameters) obtained from the Texas overlay test. For traffic-induced reflective cracking, 32 regression equations were developed to predict the SIF of HMA overlays with various traffic-loading spectra (bending and shearing) and different load transfer efficiencies. For thermal-induced reflective cracking, the viscoelastic properties of HMA were considered through the thermal stress at the "far field," which was tied with the SIF determined through regression equations.

Figure 8. Diagram. Reflective cracking-based asphalt overlay thickness design and analysis system.

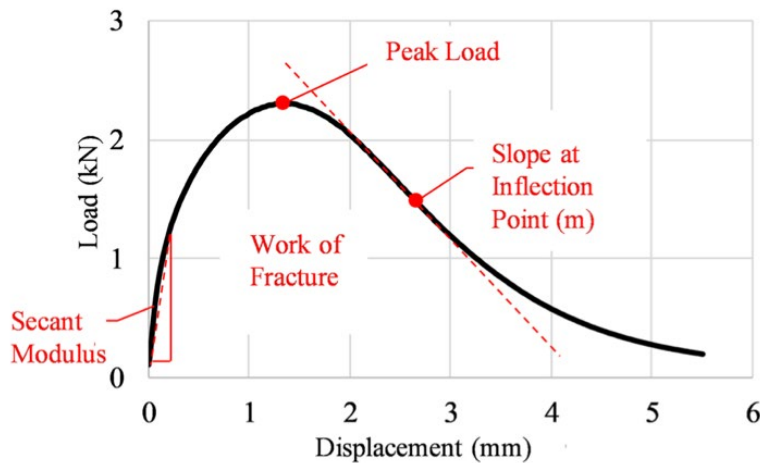
Figure 14. Diagram. Example load-displacement curve obtained from I-FIT.

Figure 14 presents the main output of the test.

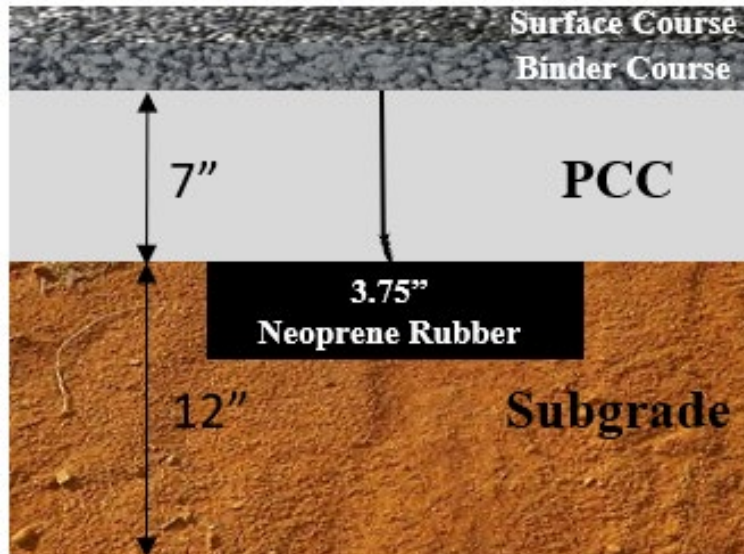
As presented in Figure 20, each test slab had four layers: a 12 in (305 mm) fine sand subgrade, a 7 in (178 mm) PCC slab, a binder course, and a wearing surface. Each test slab had a similar PCC slab and the same subgrade to ensure a fair comparison between HMA overlays.

Figure 20. Diagram. Test slab.

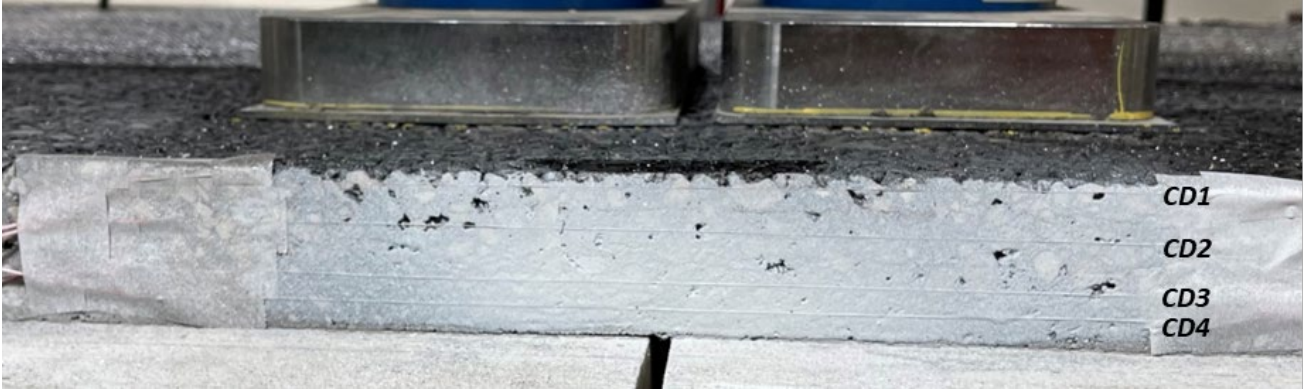
The crack detector (CD) is a single strand of copper wire. Any erratic change in the recorded voltage indicates a discontinuity, meaning a crack propagates through. Multiple copper wires were glued on the clean and smooth surface of the potential crack zone, as presented in Figure 22. A thin layer of adhesive coating was applied afterward for protection. The copper wires were connected to a laboratory power supply. A data acquisition system was used to record output signals throughout a test.

Figure 22. Photo. Copper wires glued on an HMA surface (CD1–CD4).

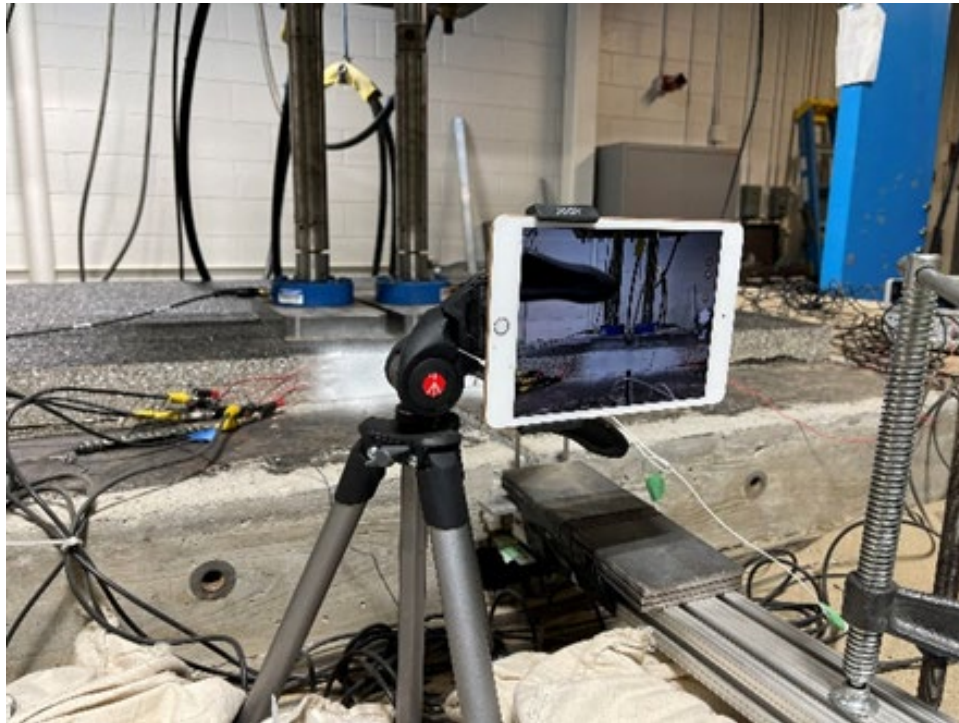
A crack detector provides localized information and may not describe the complex cracking phenomenon. To overcome this limitation, an iPad was used to take pictures of potential crack zones every 100 loading cycles (i.e., 70 sec) during the testing, as presented in Figure 23.

Figure 23. Photo. An iPad taking pictures during a test.

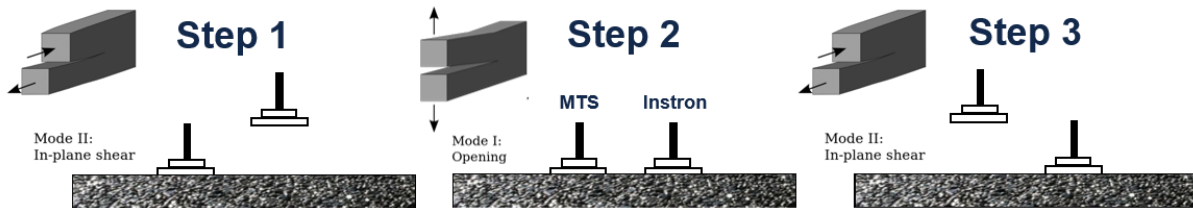
Figure 27. Diagram. Steps of load.

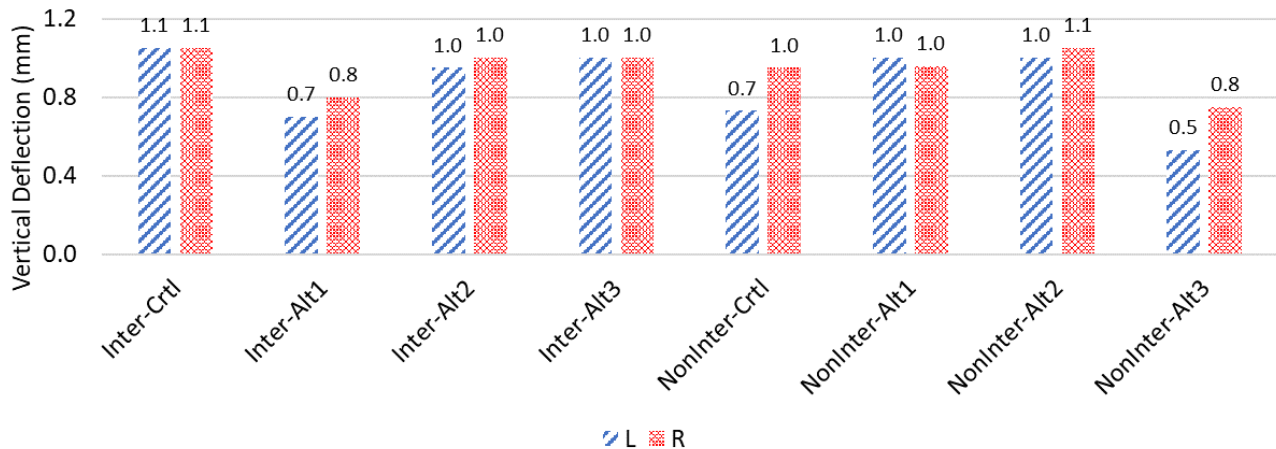
However, non-interstate alternative 3 had notably smaller PCC deflections, especially its left half. Also, the left and right halves of the PCC slab did not always have identical movement. The above observations were primarily because of the difference between the bottoms of the PCC slabs. Wood forms were used to cast over 3,000 lb (1,360 kg) of concrete, causing distortions in the wood that resulted in non-flat PCC bottoms. It is a reasonable assumption that under the same loading, smaller vertical movement resulted when less void existed beneath the PCC slab (i.e., better PCC–subgrade contact).

Figure 31. Chart. Vertical deflections of PCC slabs at the start of each test.

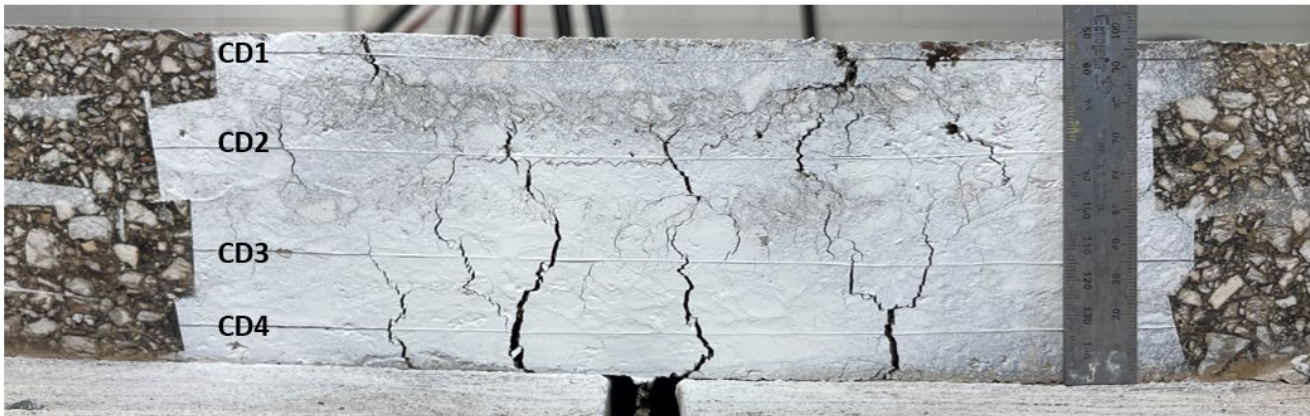
The test section consisted of a 1.5 in (38 mm) thick IL-9.5 surface course and a 2.25 in (58 mm) thick IL-19.0 binder course. As presented in Figure 32, multiple cracks were observed, and the crack paths were not well defined.

Figure 32. Photo. Interstate control scenario: cross-section after testing.

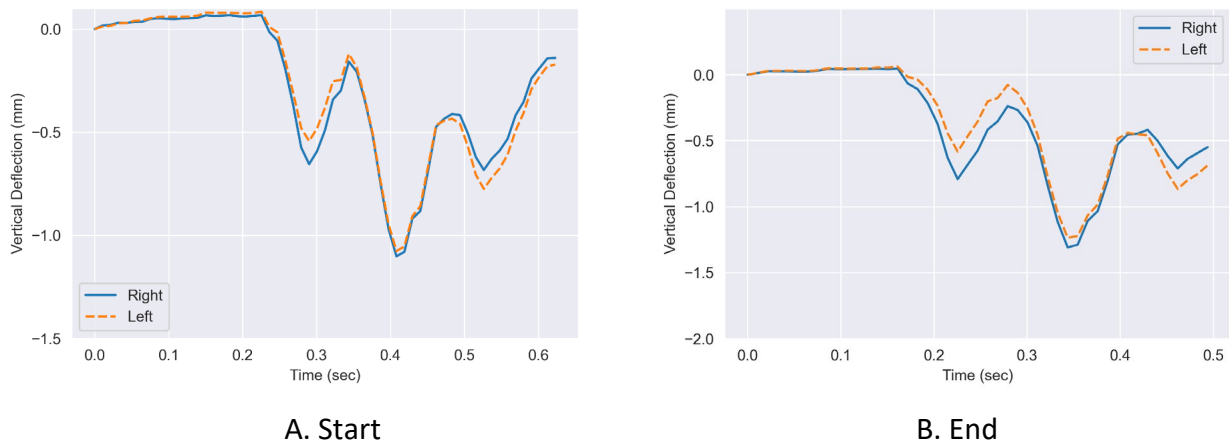
Figure 33 presents the vertical deflections observed in one loading cycle for both the left and right halves of the PCC slab at the start and end (i.e., all crack detectors broke) of the test. Because of the thick design, a relatively high load transfer efficiency was observed. Load transfer efficiency slightly decreased with crack development.

Figure 33. Chart. Interstate control scenario: vertical deflections of the PCC slab.

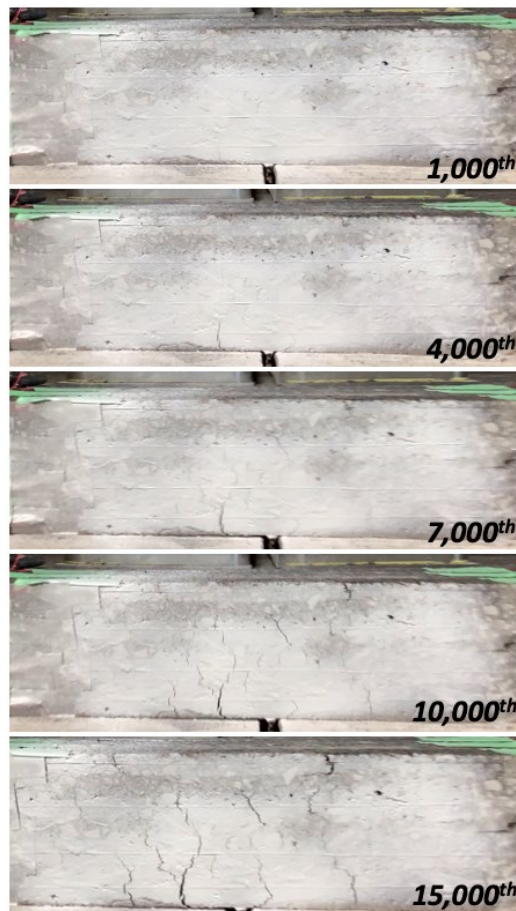
Because of cyclic loading, the joint opened significantly (0.36 in [9 mm]). Because of excessive tension, as presented in Figure 34, multiple reflective cracks initiated at the bottom of the overlay and propagated upwards, and multiple cracks initiated near the surface and propagated downwards before the cracks reached CD3. With more loading, cracks started to connect, forming full-depth cracks. After the test slab was fully cracked, mild debonding was observed between the binder course and the left half of the PCC slab. No slab faulting was observed. The slab was the worst-performing scenario among all interstate cases. *The poor performance is likely due to the HMA layer's relatively low FI and comparably low surface course modulus, despite the relatively thick overlay.* It is noteworthy that the utilization of non-polymer modified surface in this specific configuration is uncommon on interstates situated in Illinois. Polymer-modified constitutes the prevailing composition of interstate surface mixtures.

Figure 34. Photo. Interstate control scenario: crack development.

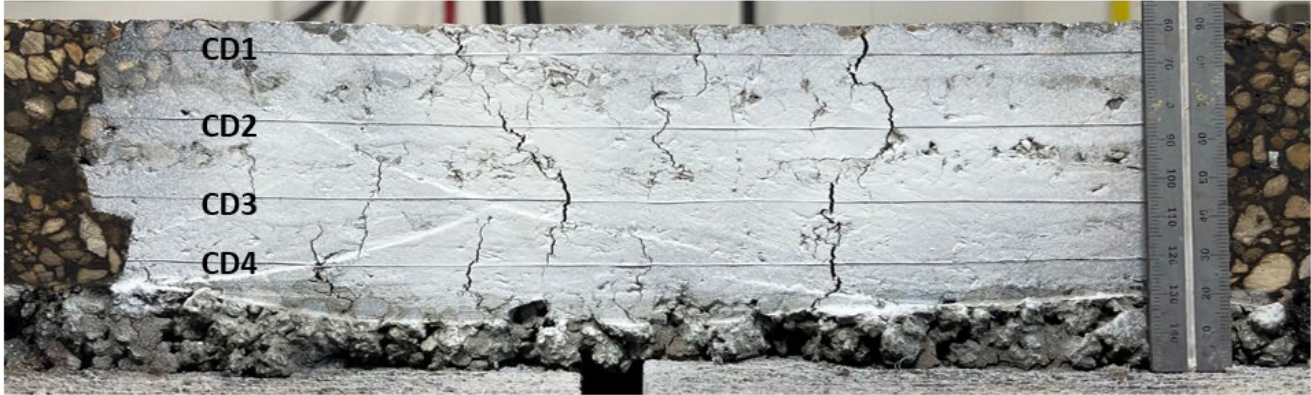
The test section consisted of a 1.5 in (38 mm) thick SMA-9.5 surface course and a 2 in (51 mm) thick SMA-12.5 binder course. As presented in Figure 35, multiple cracks were observed, and the crack paths were not well defined.

Figure 35. Photo. Interstate alternative scenario 1: cross-section after testing.

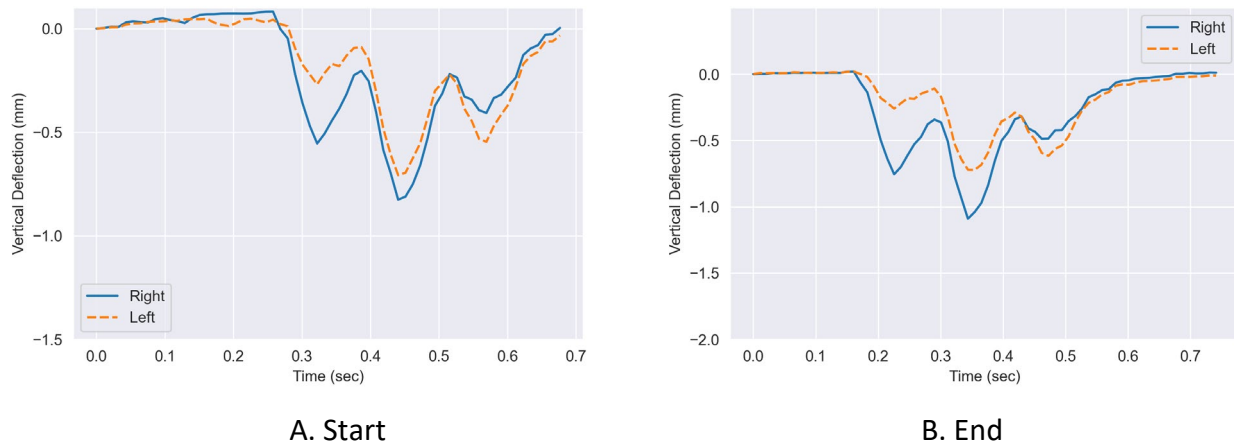
Figure 36 presents the vertical deflections of the left and right halves of the PCC slab at the start and end of the test. Compared to other interstate scenarios, the slab had less vertical movement. This was likely because of a flatter PCC bottom, resulting in better PCC–subgrade contact and less void space beneath the PCC slab. The load transfer efficiency was notably smaller than in other interstate scenarios. Load transfer efficiency decreased with crack development.

Figure 36. Chart. Interstate alternative scenario 1: vertical deflections of the PCC slab.

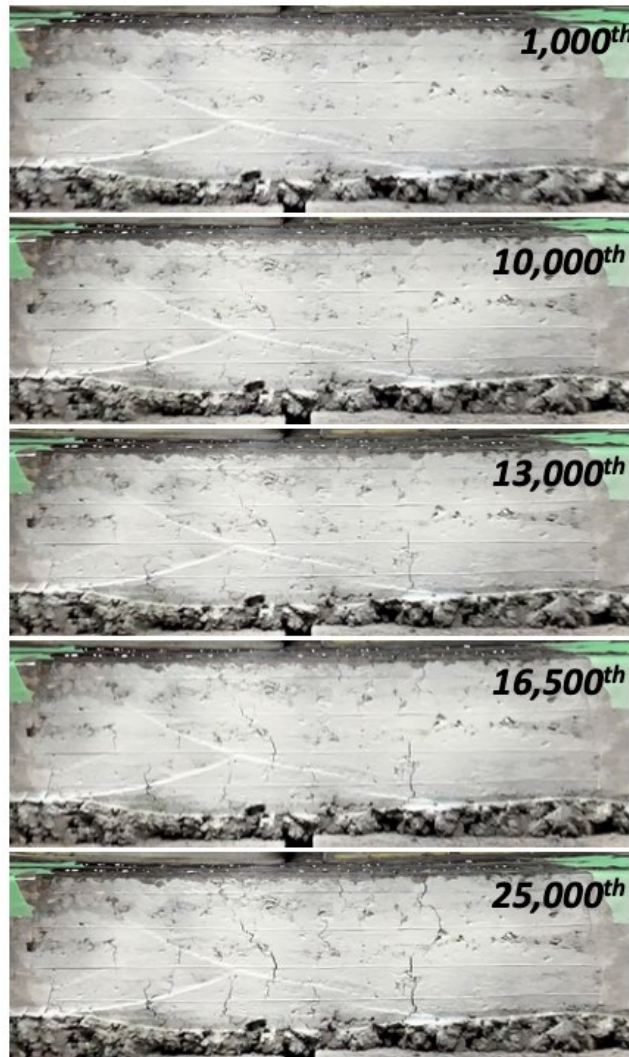
Like the interstate control scenario, a significant joint opening of 0.36 in (9 mm) was observed. Because of the excessive tension, as presented in Figure 37, multiple reflective cracks initiated at the bottom of the overlay and propagated upwards. Before they reached CD2, multiple cracks initiated within the layers. Afterward, the cracks started to connect, forming full-depth cracks. No slab faulting was observed. Although the slab was 0.25 in (6.5 mm) thinner than the control scenario, it performed significantly better against reflective cracking. *The relatively good performance is likely due to the SMA's relatively high FI and the comparably high surface course modulus.*

Figure 37. Photo. Interstate alternative scenario 1: crack development.

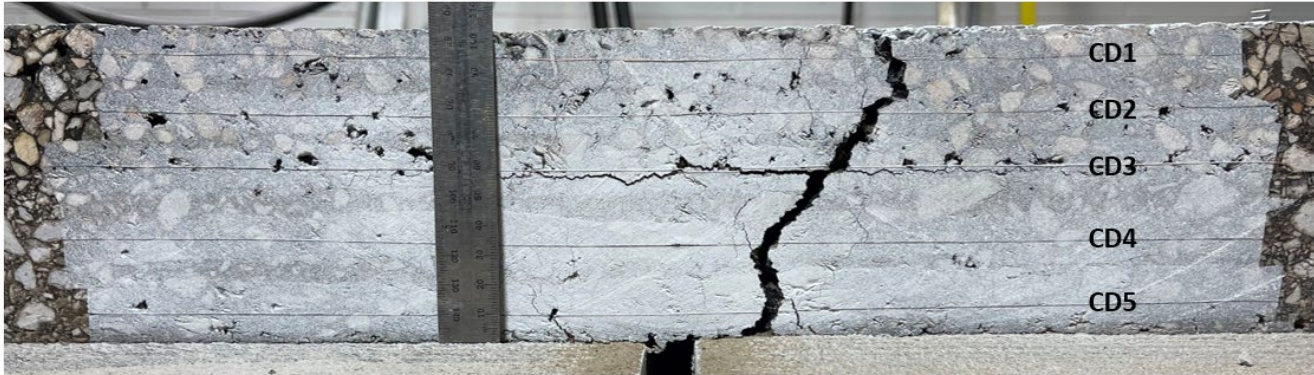
The test section consisted of a 2 in (51 mm) thick SMA-12.5 surface course and a 2.25 in (58 mm) thick IL-19.0 binder course. It was the thickest overlay scenario among all slabs. It differed from the control scenario by surface course only. A well-defined reflective crack was observed, as presented in Figure 38.

Figure 38. Photo. Interstate alternative scenario 2: cross-section after testing.

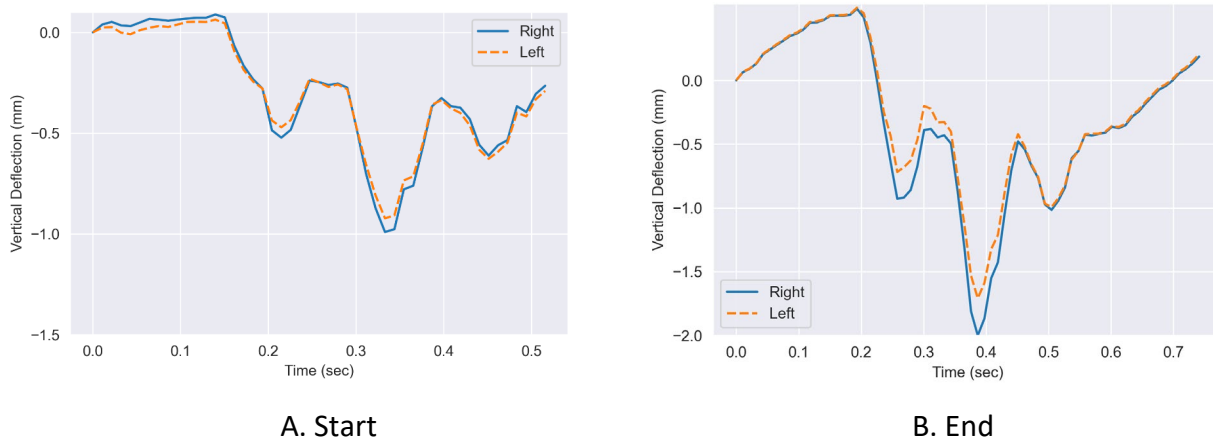
Figure 39 presents the vertical deflections of the left and right halves of the PCC slab at the start and end of the test. Because of the relatively thick overlay design, high load transfer efficiency was observed. Load transfer efficiency decreased with crack development. Compared to other tests, significantly more deflections were seen at the end of the test than at the start. This could be due to the wide crack.

Figure 39. Chart. Interstate alternative scenario 2: vertical deflections of the PCC slab.

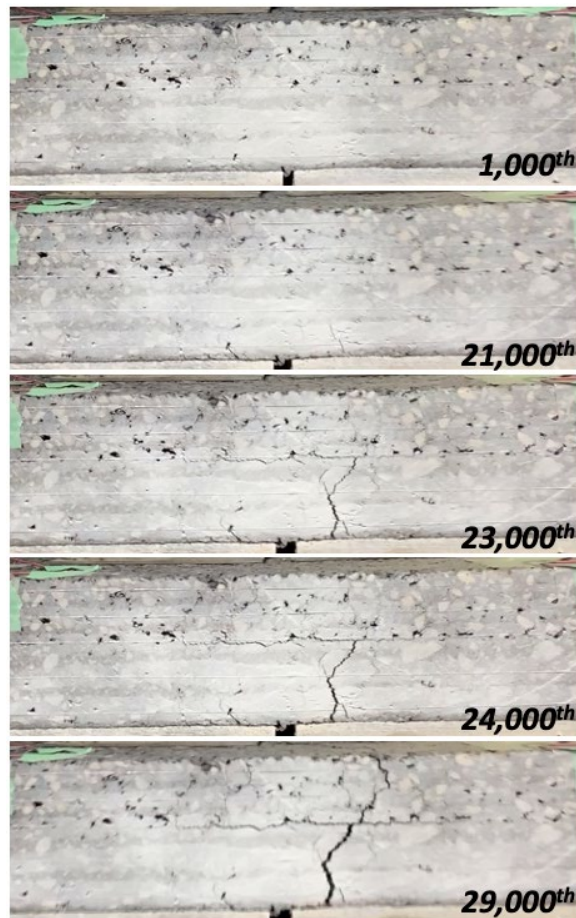
Although the joint opened significantly (0.36 in [10 mm]), unlike other interstate scenarios, a primary reflective crack initiated at the bottom of the overlay and propagated upwards (Figure 40). The crack initiated about 1.3 in (32 mm) right of the joint. The crack path did not follow a vertical trajectory, indicating mixed-mode fracture. Significant debonding occurred when the crack reached the surface–binder interface and stopped propagating. Shortly after, multiple hairline cracks were observed within the surface layer, causing CD1 and CD2 to break. The primary crack started to propagate upwards again after another few thousand loading cycles. A slight offset toward the right was observed at the surface–binder interface. No slab faulting was observed. *The test slab was the best-performing scenario among interstate cases. The overlay thickness and high FI SMA surface contributed to its superior performance against reflective cracking.*

Figure 40. Photo. Interstate alternative scenario 2: crack development.

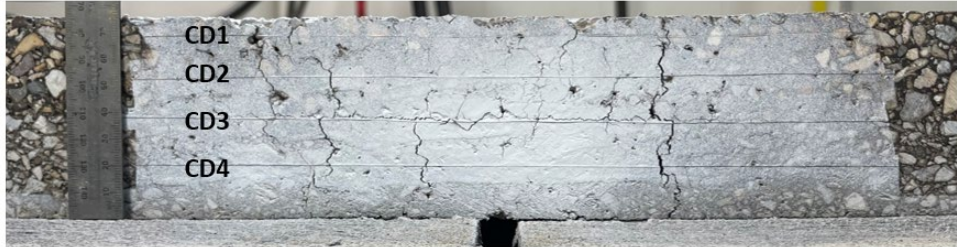
Figure 41. Photo. Interstate alternative scenario 3: cross-section after testing.

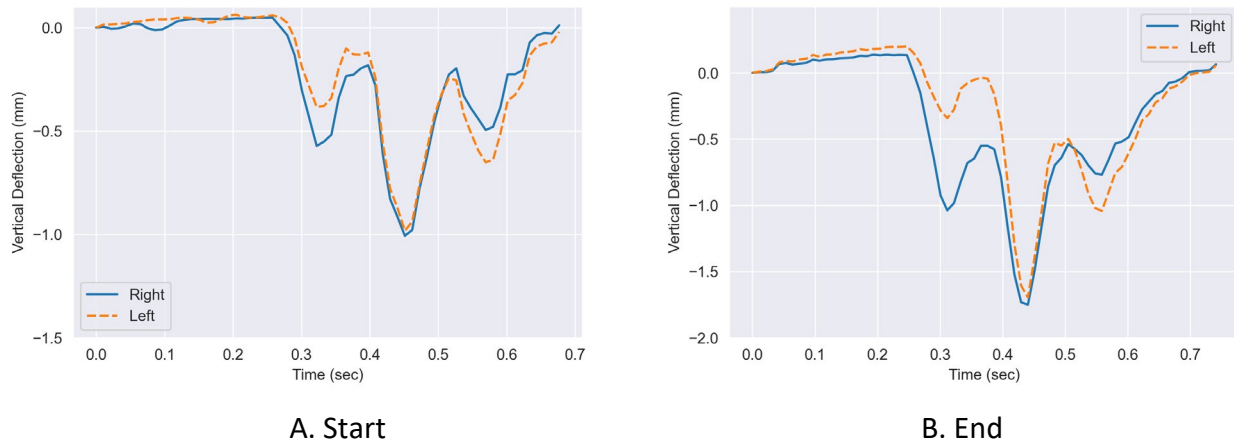
Figure 42. Photo. Interstate alternative scenario 3: vertical deflections of the PCC slab.

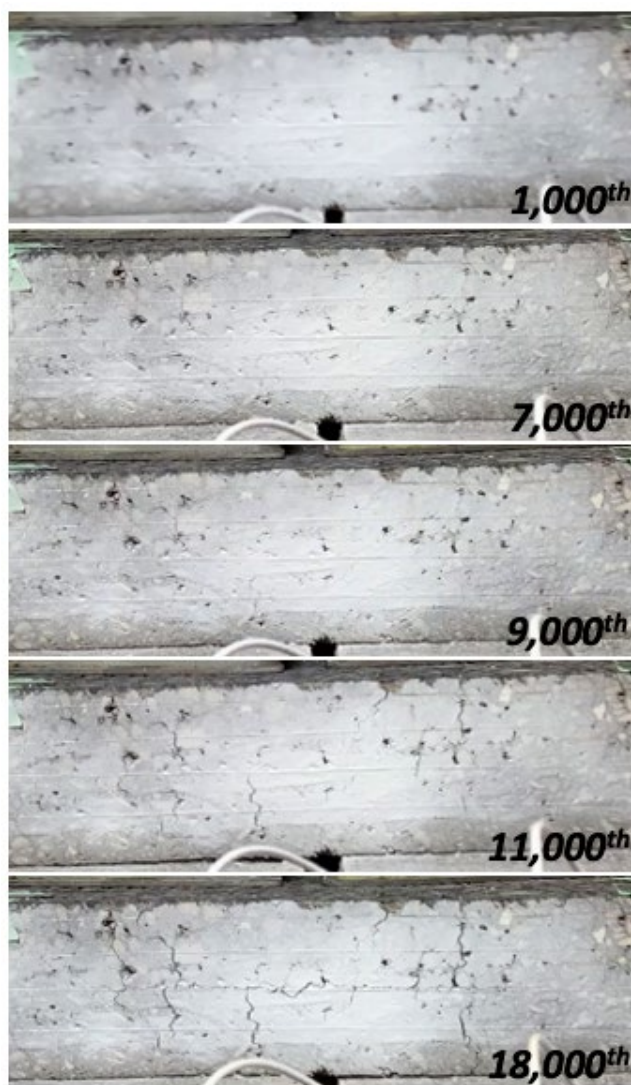
Figure 43. Photo. Interstate alternative scenario 3: crack development.

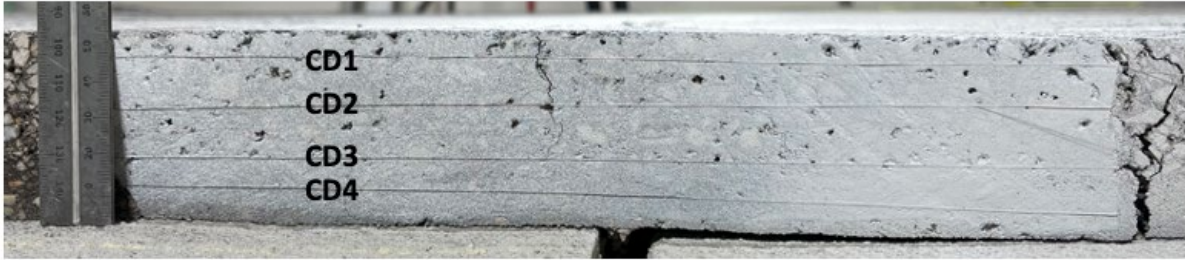
Figure 44. Photo. Non-interstate control scenario: cross-section after testing.

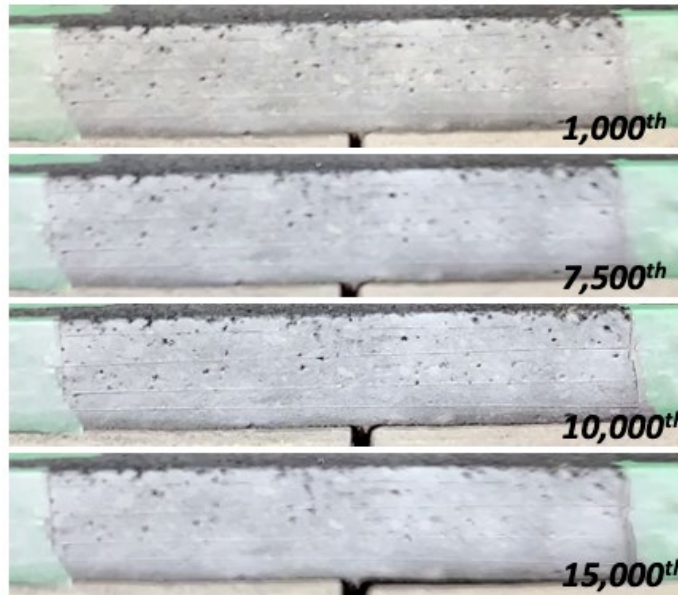
Figure 46. Photo. Non-Interstate control scenario: crack development.

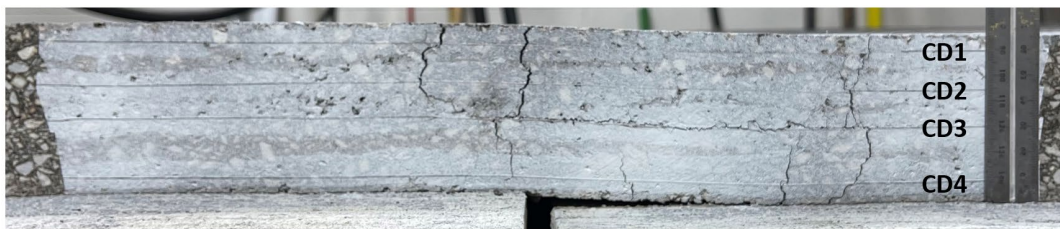
Figure 47. Photo. Non-interstate alternative scenario 1: cross-section after testing.

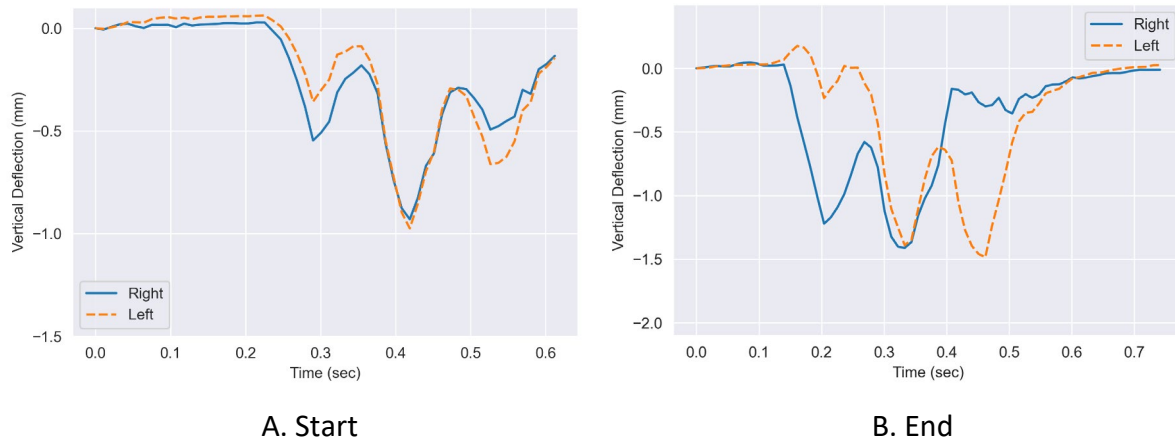
Figure 48. Chart. Non-interstate alternative scenario 1: vertical deflections of the PCC slab.

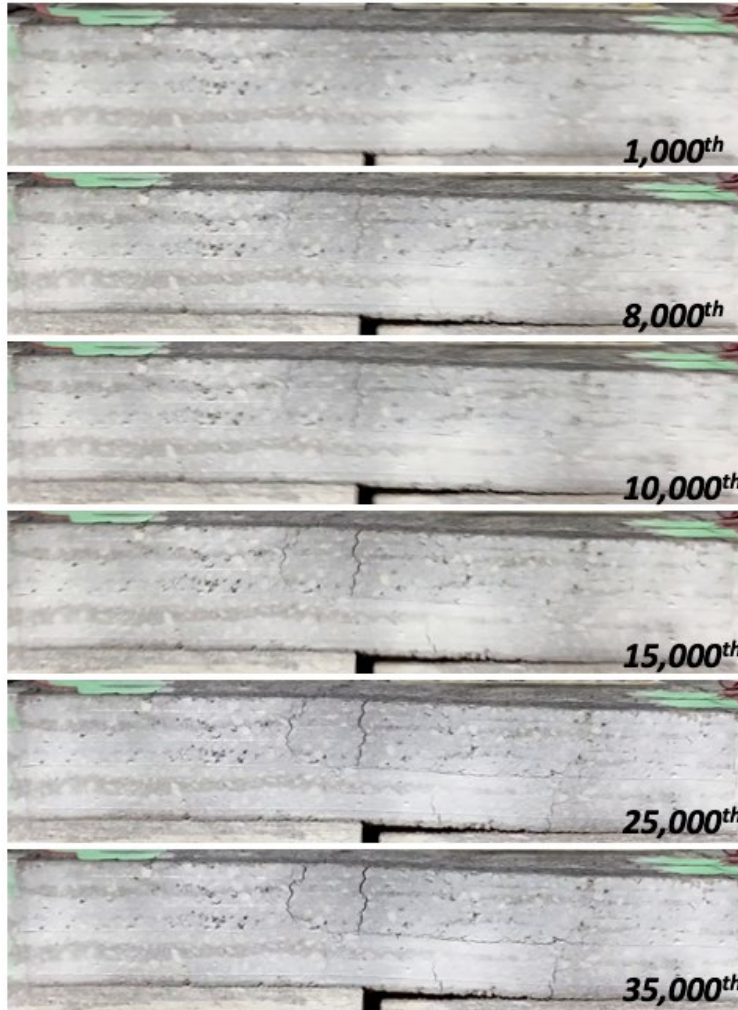
Figure 49. Photo. Non-interstate alternative scenario 1: crack development.

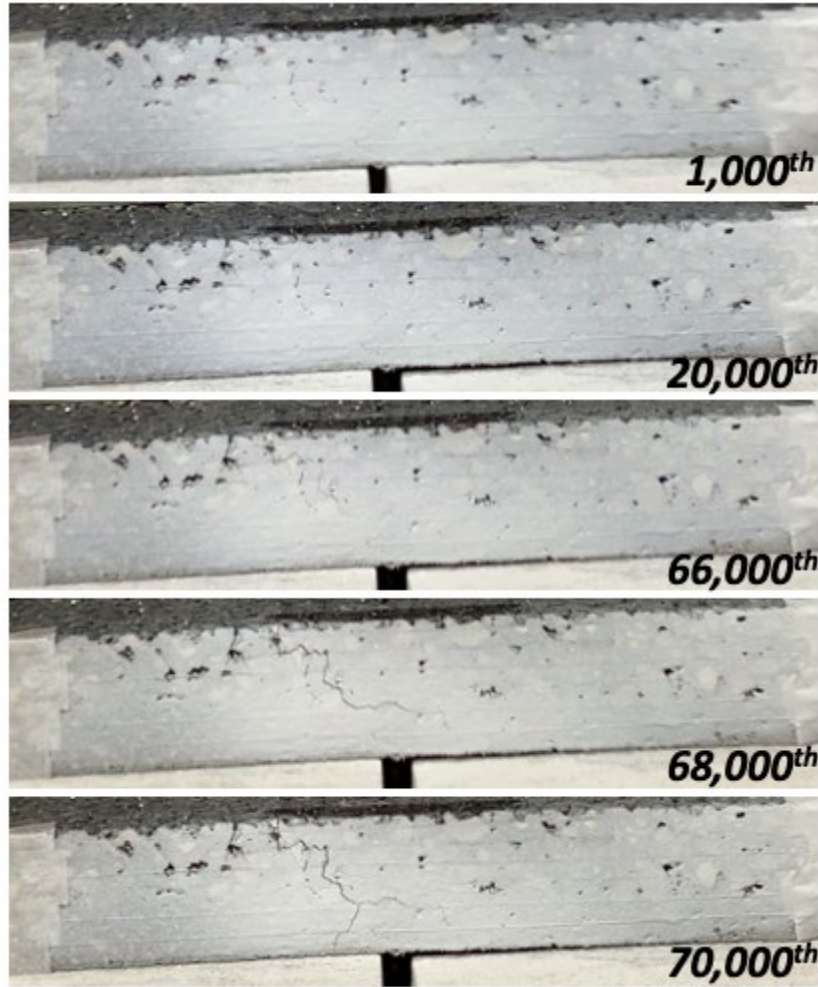
Figure 52. Photo. Non-interstate alternative scenario 2: crack development.

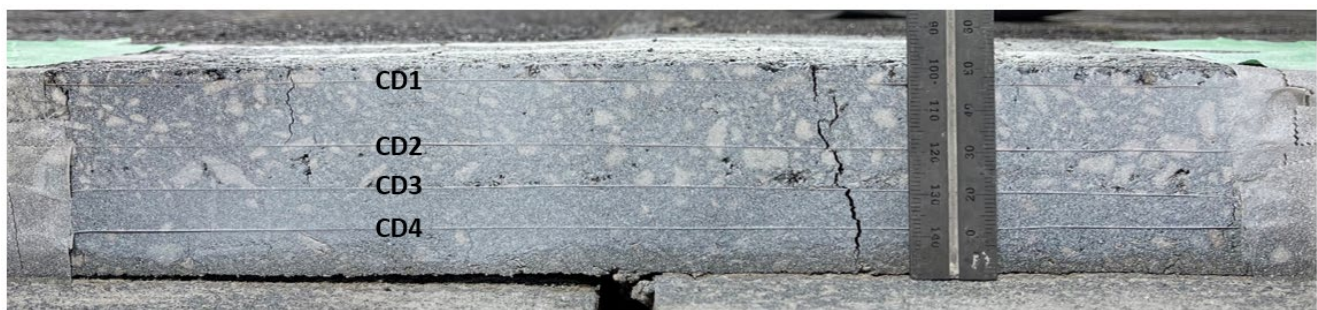
Figure 53. Photo. Non-interstate alternative scenario 3: cross-section after testing.

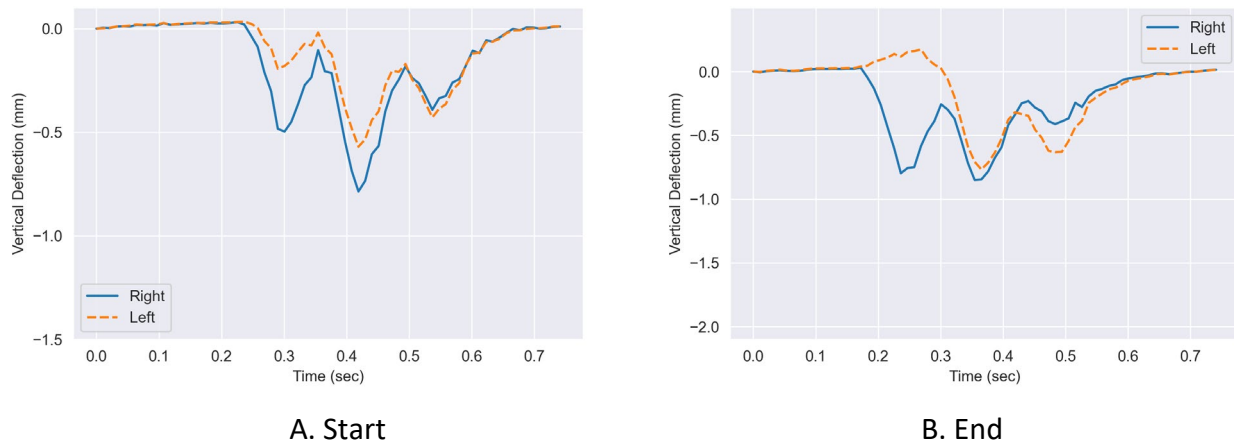
Figure 54. Chart. Non-interstate alternative scenario 3: vertical deflections of the PCC slab.

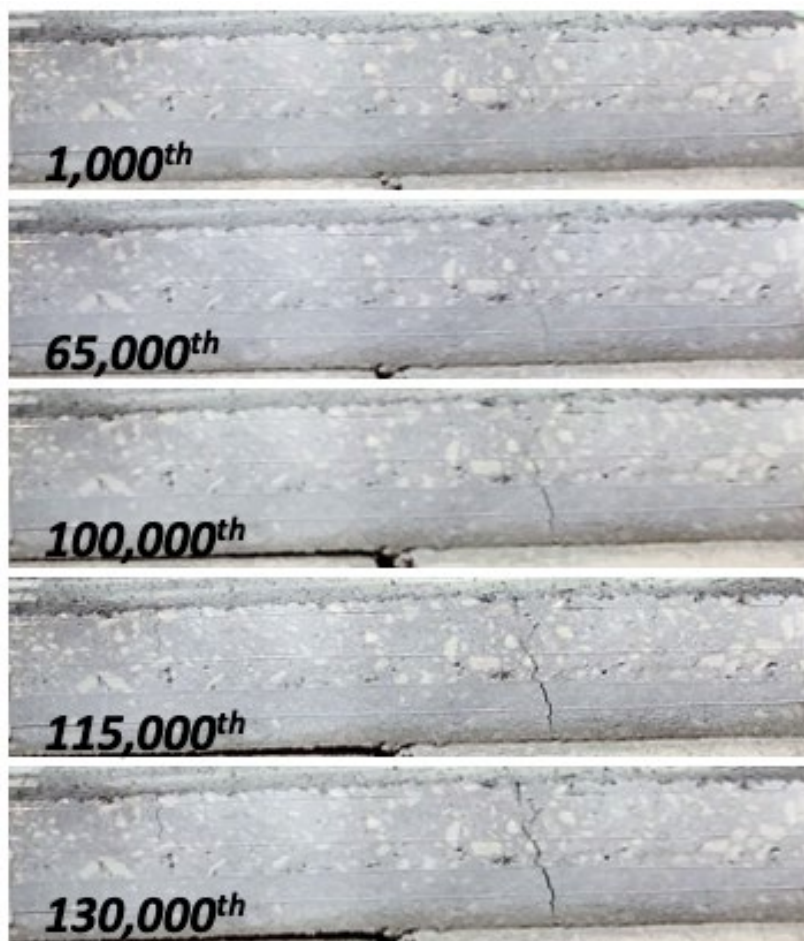
Figure 55. Photo. Non-interstate alternative scenario 3: crack development.

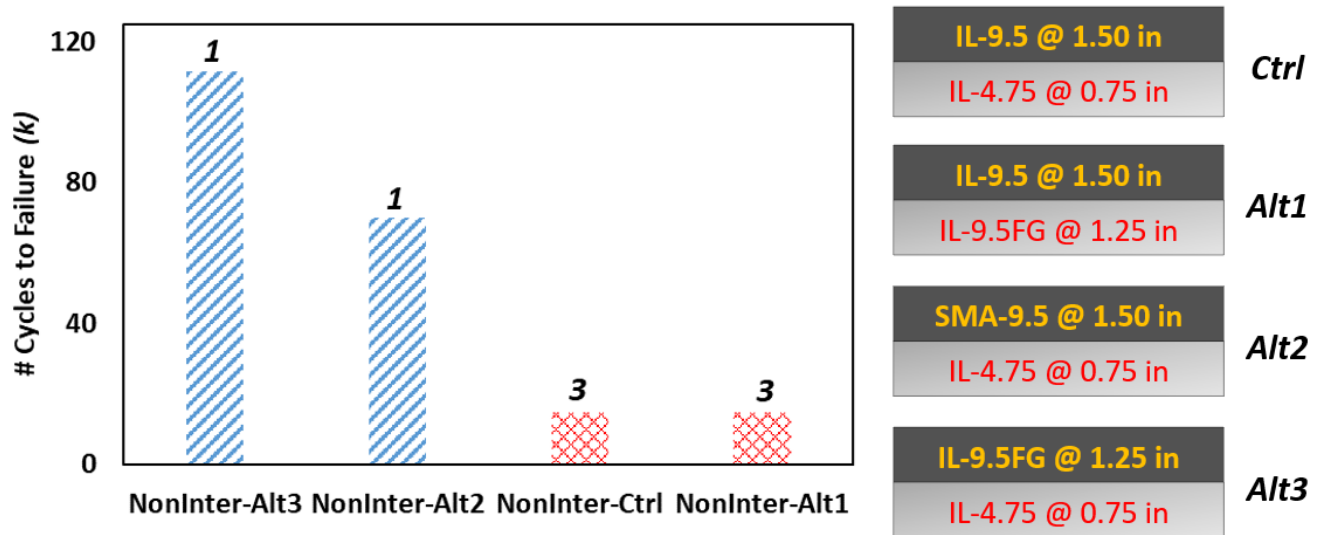
Figure 56. Chart. Number of cycles to failure and ranking of non-interstate scenarios.

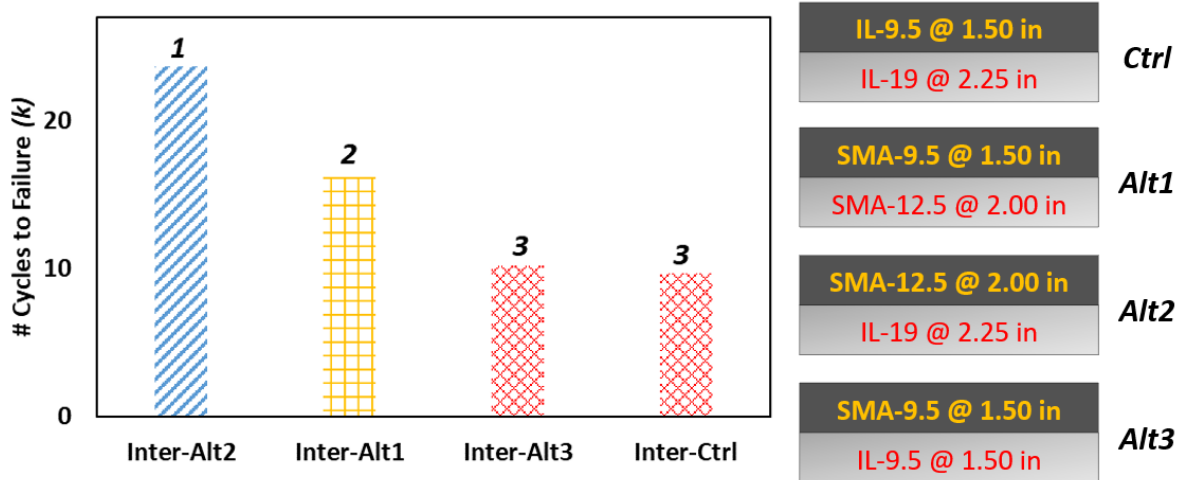
Figure 57. Chart. Number of cycles to failure and ranking of interstate scenarios.
