Illinois Center for Transportation Series No. 23-006

Optimized Hot-Mix Asphalt Lift Configuration for Performance

Research Report No. FHWA-ICT-23-005

ICT PROJECT R27-204

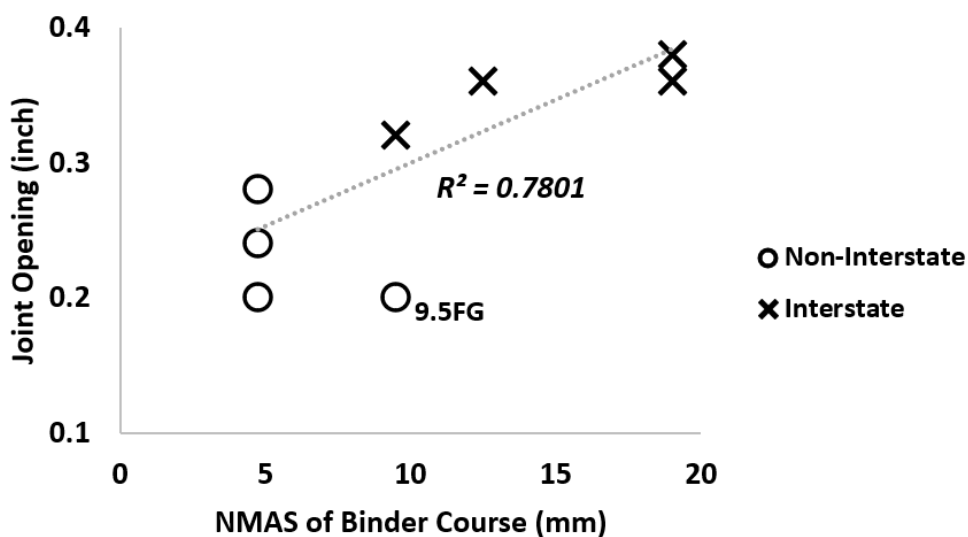
Figure 58. Chart. Relationship between joint opening and NMAS of binder course.

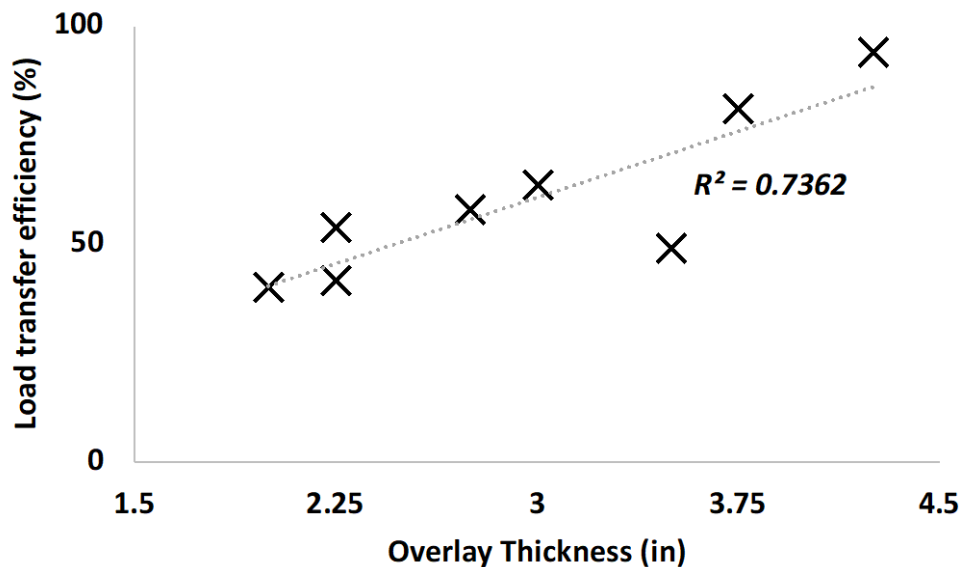
Figure 60. Chart. Relationship between total overlay thickness and load transfer efficiency.

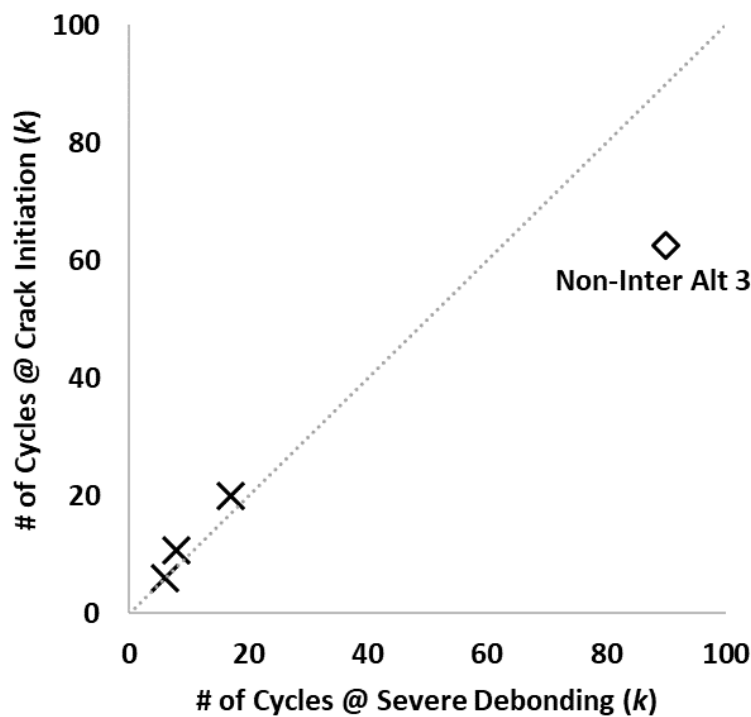
Figure 61. Chart. Relationship between crack initiation and severe debonding in non-interstate scenarios.

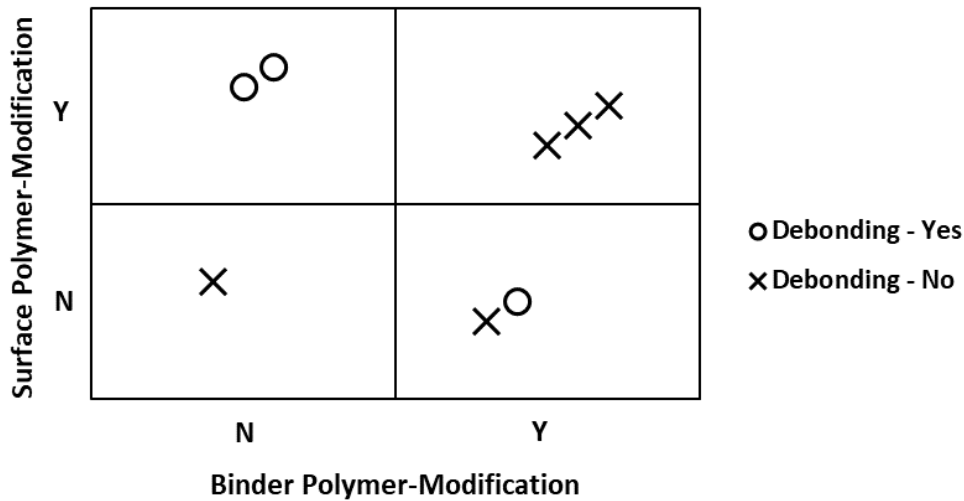
Figure 62. Chart. Relationship between polymer-modification and debonding at the surface–binder interface.

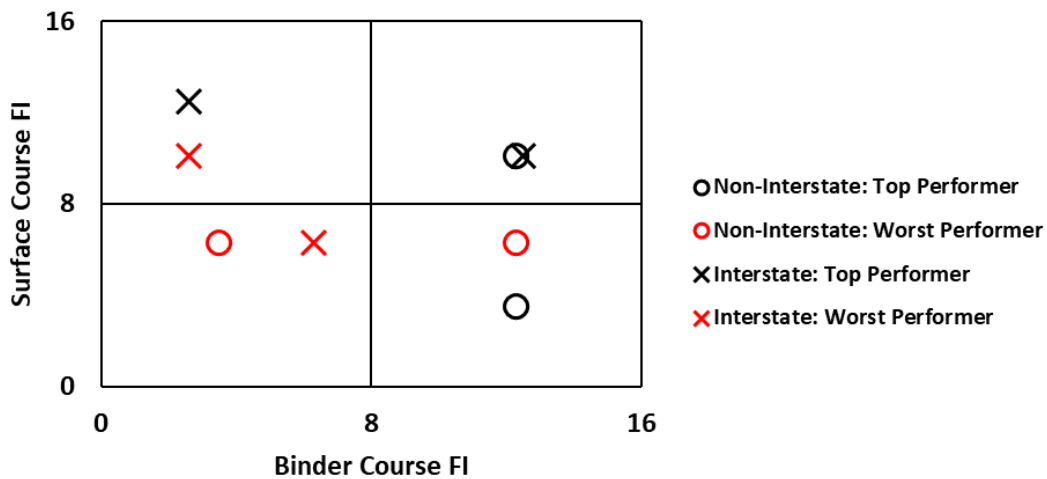
Figure 63. Chart. Effect of FI on overlay performance against reflective cracking.

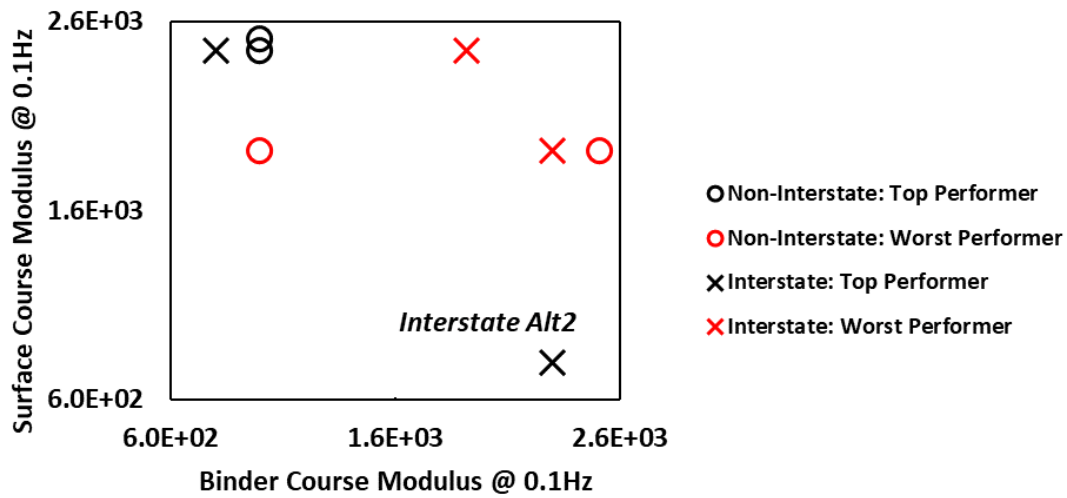
binder course, its premium SMA surface and relatively thick design (4.25 in [107.9 mm]) that provided bridging contributed to its superior performance against reflective cracking.

Figure 64. Chart. Effect of HMA modulus on overlay performance against reflective cracking.

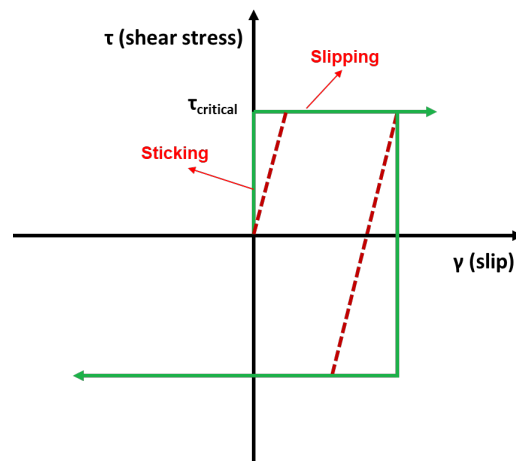
Figure 65. Illustration. Stick-slip model.

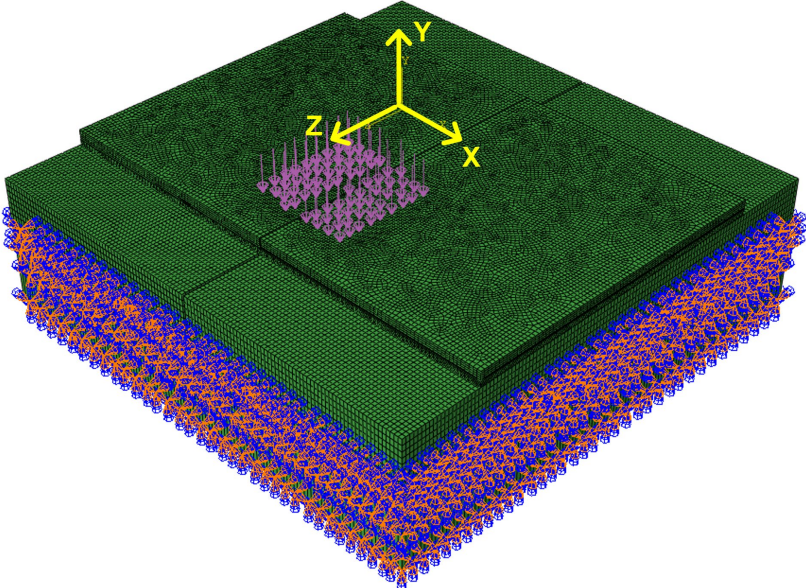
Figure 66. Illustration. 3D FE testbed model.

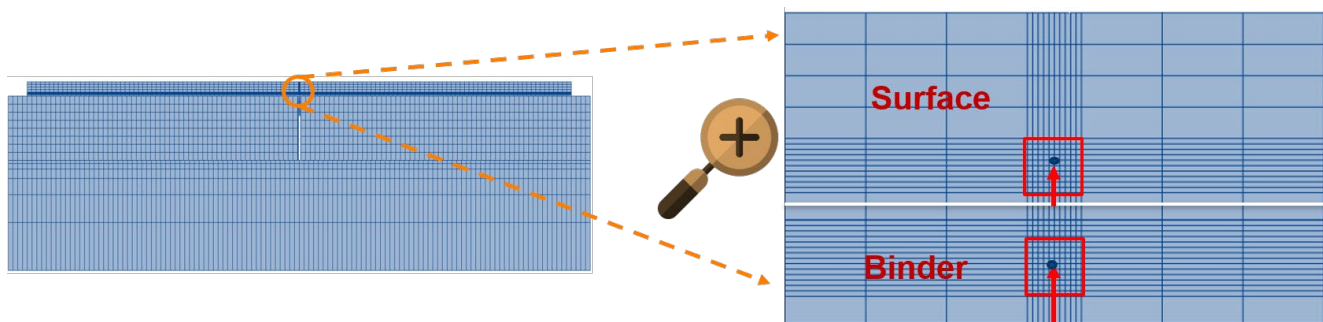
Figure 68. Illustration. Assigned crack front on the FE model (side view).

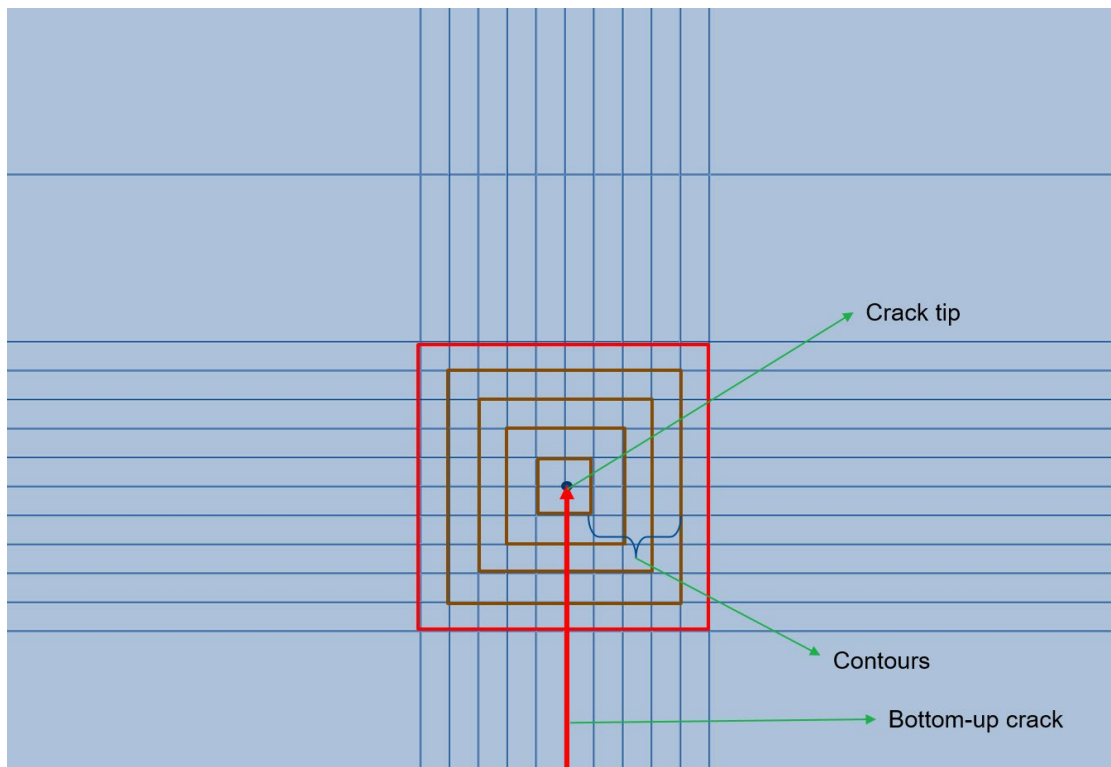
Figure 69. Illustration. Contours around the crack tip.

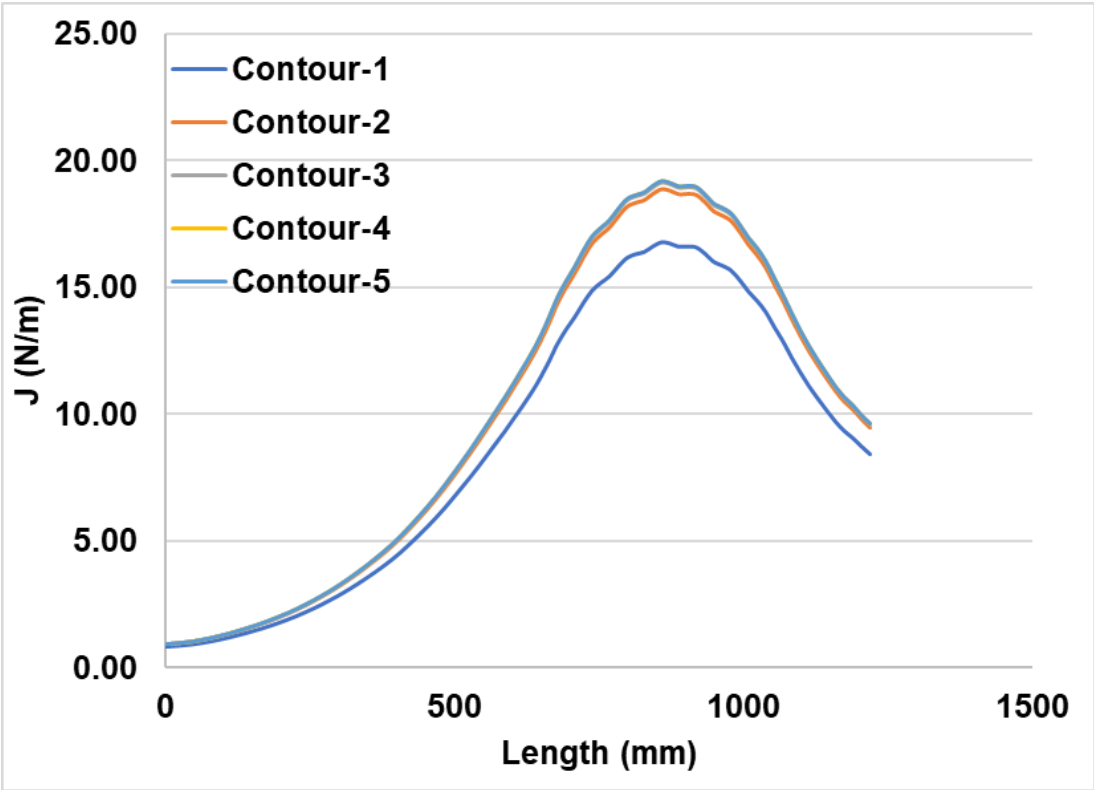
Figure 70. Graph. J-integral values for different contours.

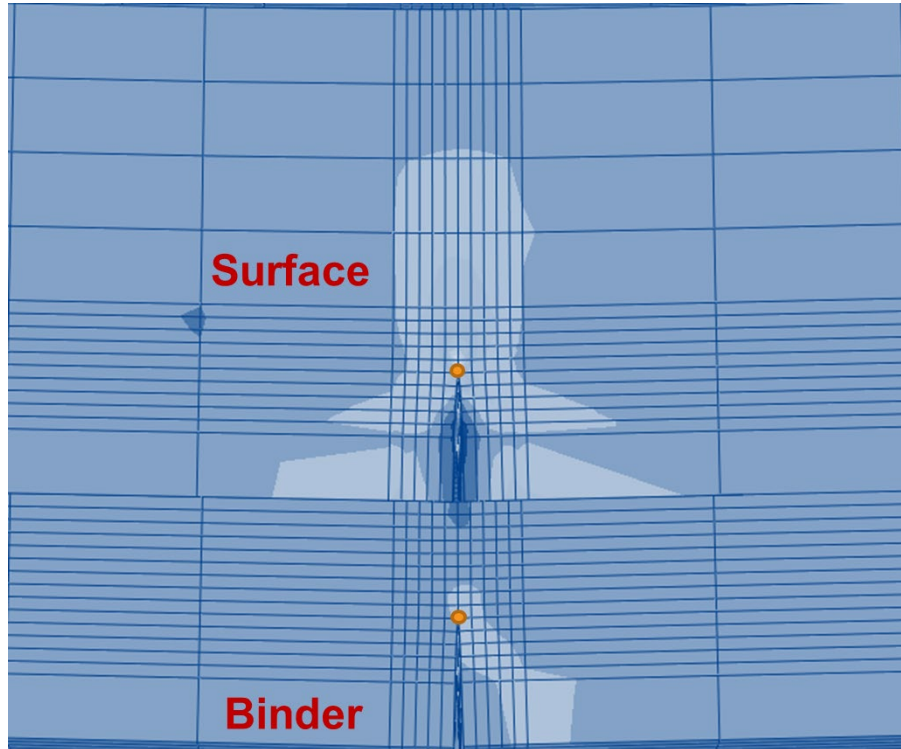
Figure 71. Illustration. Cracked FE model for non-interstate control scenario.

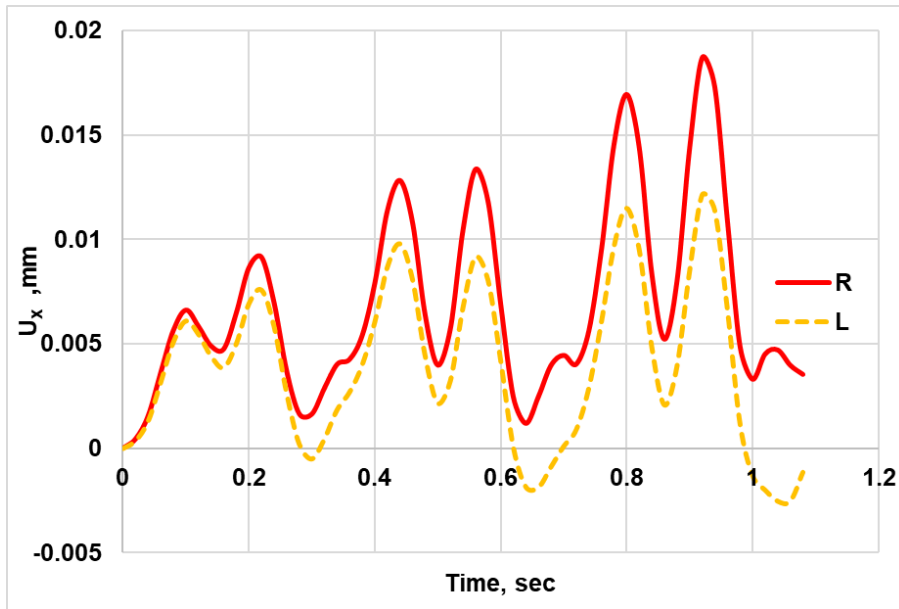
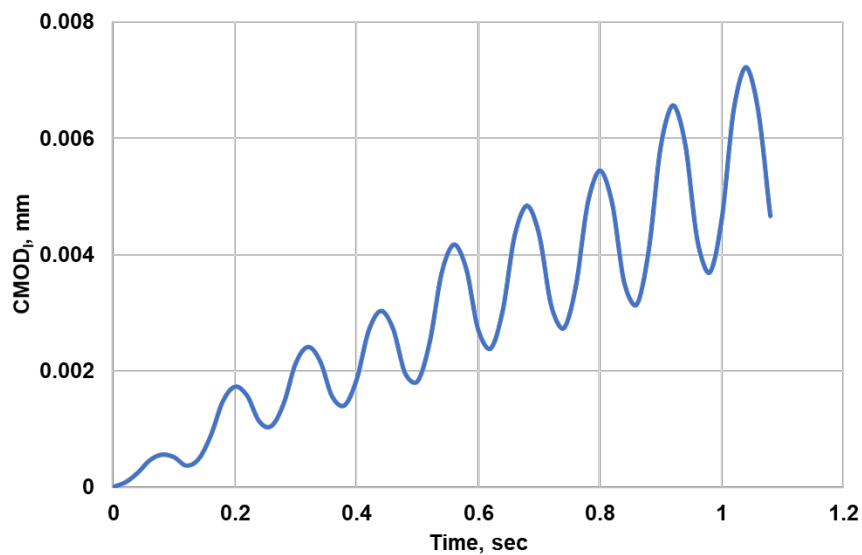
Figure 73. Plots. Displacement and CMOD for mode I cracking. 61

A. Displacement of elements on either side of the crack along the X direction

B. $CMOD_I$ for the given model.

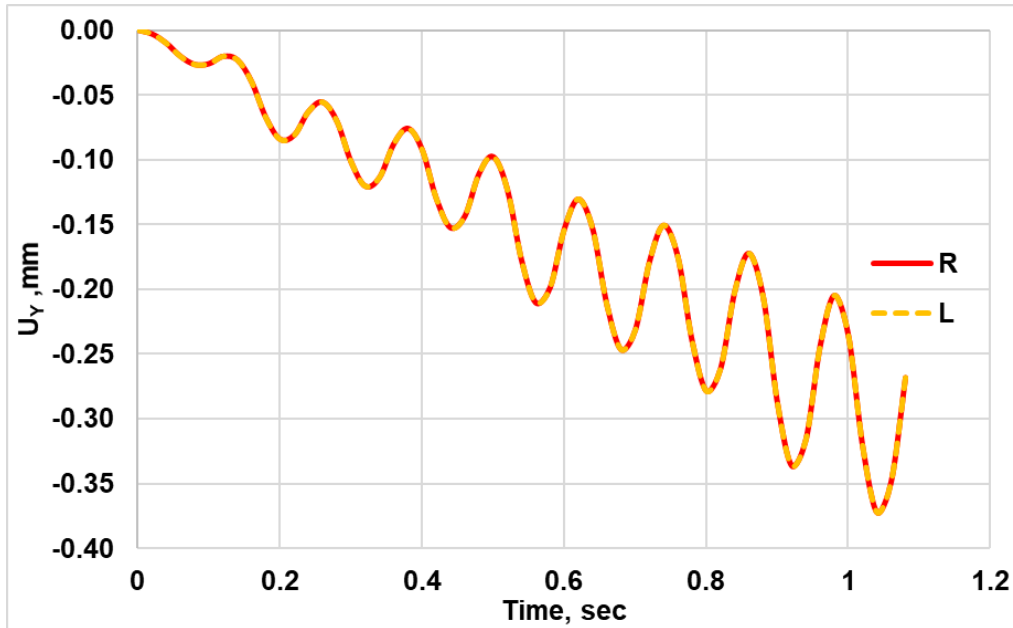
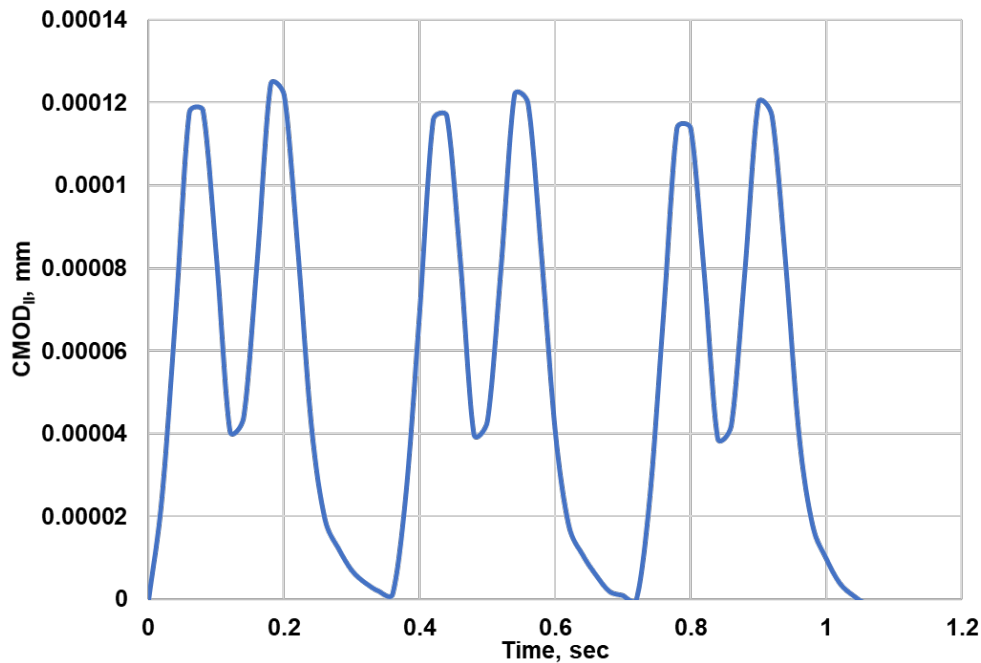
Figure 74. Plots. Displacement and CMOD for mode II cracking. 62

A. Displacement of elements on either side of the crack along the Y direction

B. $CMOD_{II}$ for the given model

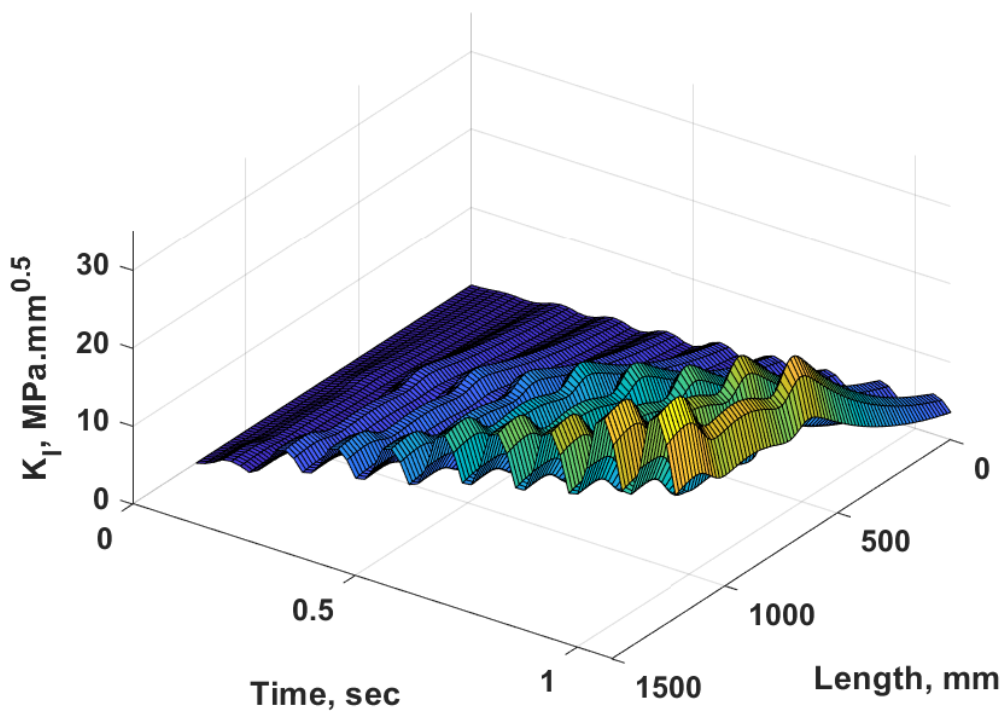
Figure 75. Plot. 3D plot of SIF versus time and length of the model ($1 \text{ MPa}\cdot\text{mm}^{0.5} = 28.8 \text{ psi}\cdot\text{in}^{0.5}$).

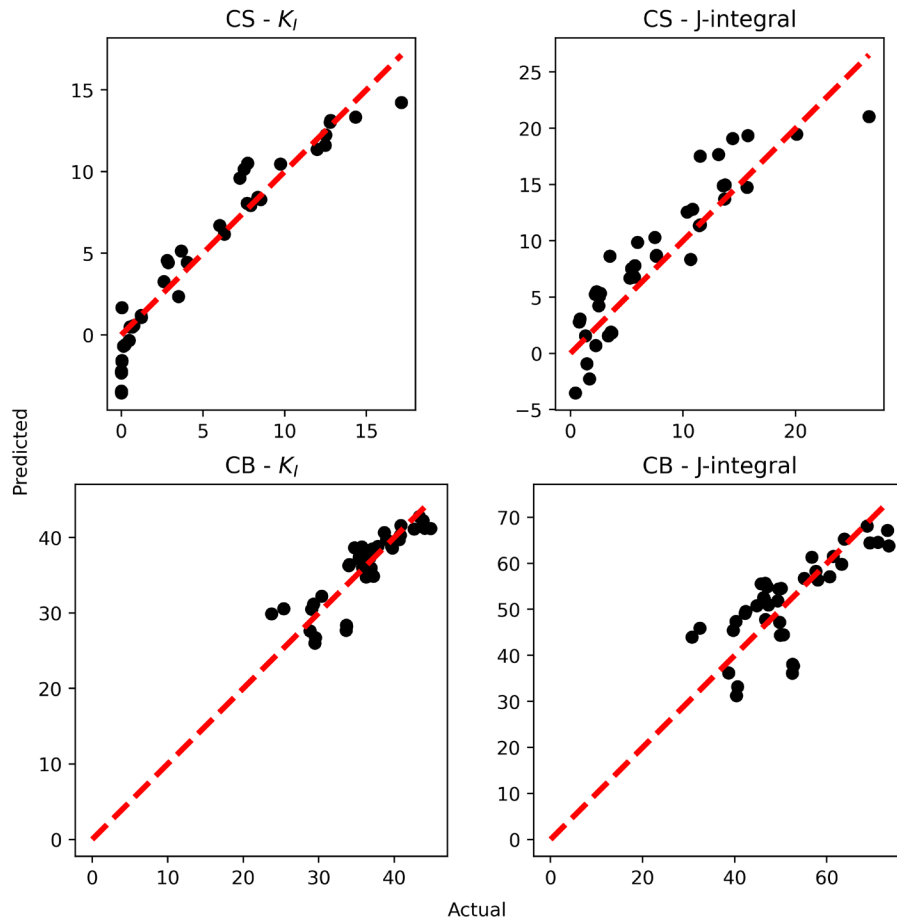
Figure 78. Graphs. Predicted versus actual fracture parameters using regression.

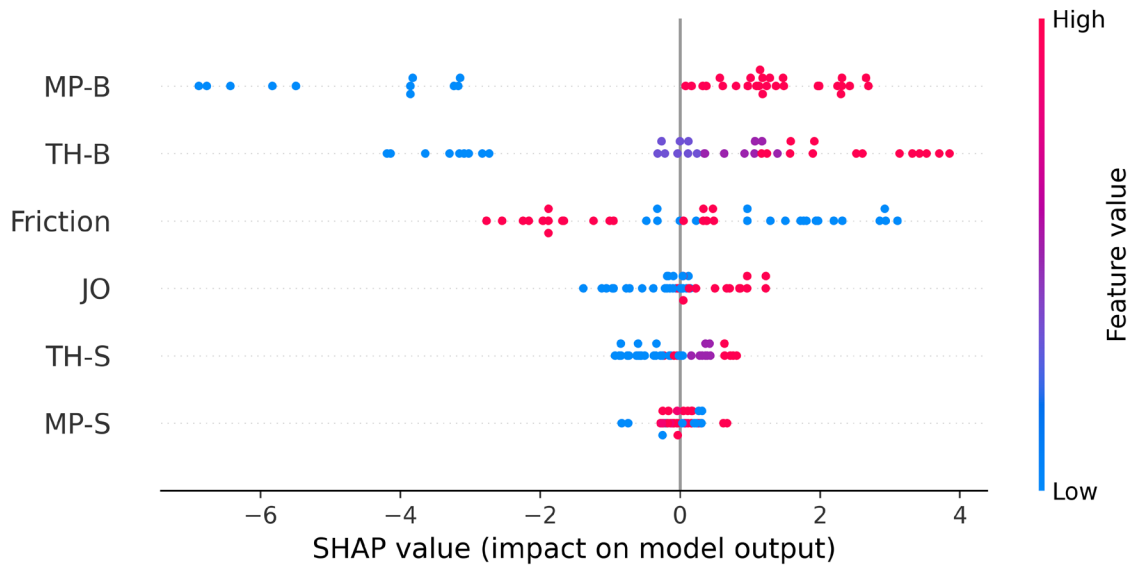
Figure 80. Plot. Summary plot of neural network model for K_I using test dataset.

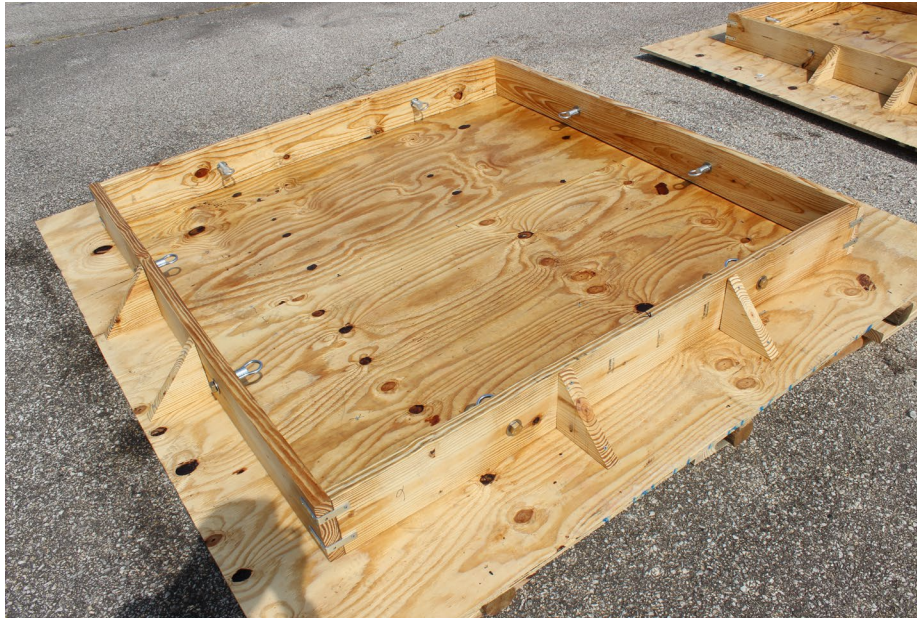
Figure 90. Photo. Wood forms with ferrule loops.

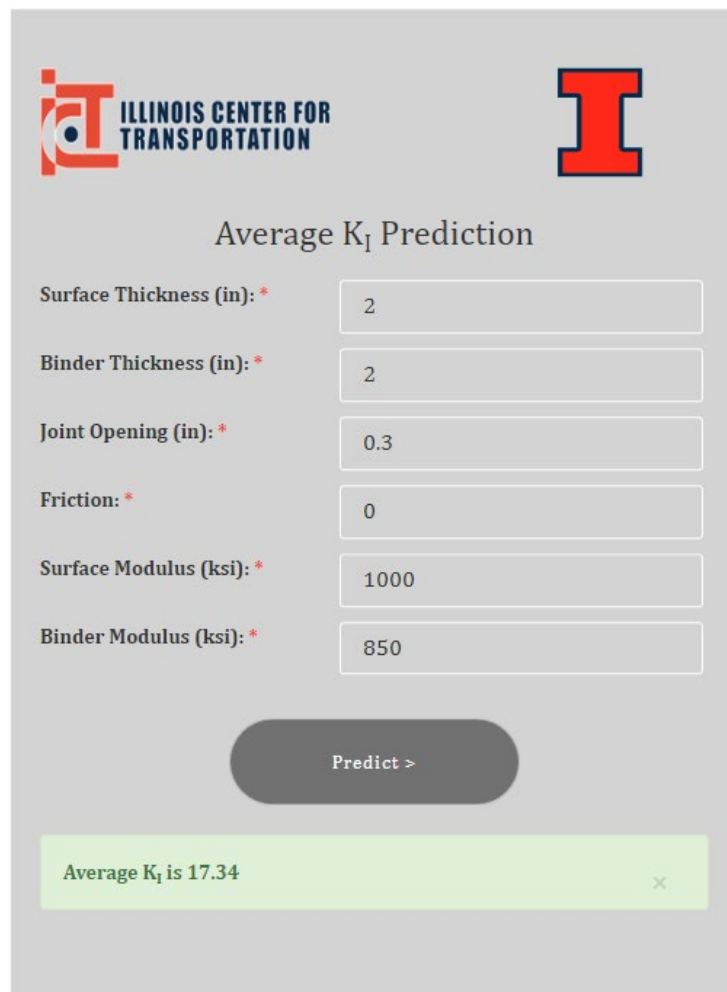
The screenshot shows the user interface for the Average K_I Prediction tool. At the top left is the logo for the Illinois Center for Transportation, and at the top right is a large red letter 'I'. The title 'Average K_I Prediction' is centered. Below the title are six input fields, each with a label and a value: Surface Thickness (in): * 2, Binder Thickness (in): * 2, Joint Opening (in): * 0.3, Friction: * 0, Surface Modulus (ksi): * 1000, and Binder Modulus (ksi): * 850. A 'Predict >' button is located below the input fields. At the bottom, a green box displays the result: 'Average K_I is 17.34' with a close button (x).
