Evaluation of Right-of-Way Fence Tags to Reduce Animal-Vehicle Collisions

SPR-758
May 2023

Arizona Department of Transportation
206 S. 17th Avenue
Phoenix, AZ 85007

9. Performing Organization Name and Address Arizona Game and Fish Department Wildlife Contracts Branch 5000 W. Carefree Highway Phoenix, AZ 85086	
11. Contract or Grant No.

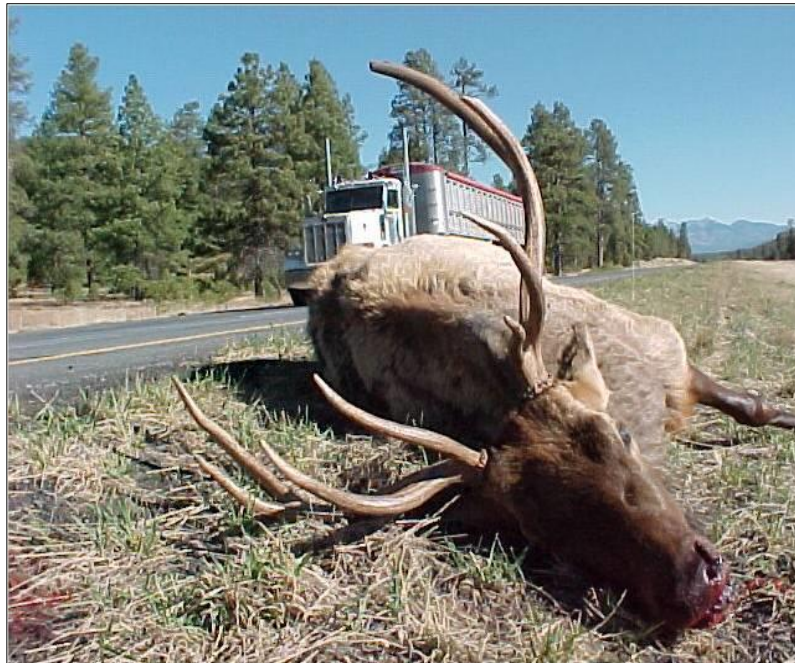
Figure 1. Bull elk killed by a vehicle along Interstate-17 in Flagstaff

Between Stoneman Lake and Flagstaff on Interstate 17 (I-17) from 2007 to 2010, researchers documented an annual average of 86 collisions with elk (Figure 1; *Cervus canadensis*) and 14 collisions with mule deer (*Odocoileus hemionus*) (Gagnon et al. 2013). Along Interstate 40 (I-40) between Williams and Winona, an average of 91 collisions with large ungulates were documented per year from 2007 to 2011 (Gagnon et al. 2012), though these were not document on a per-species basis.

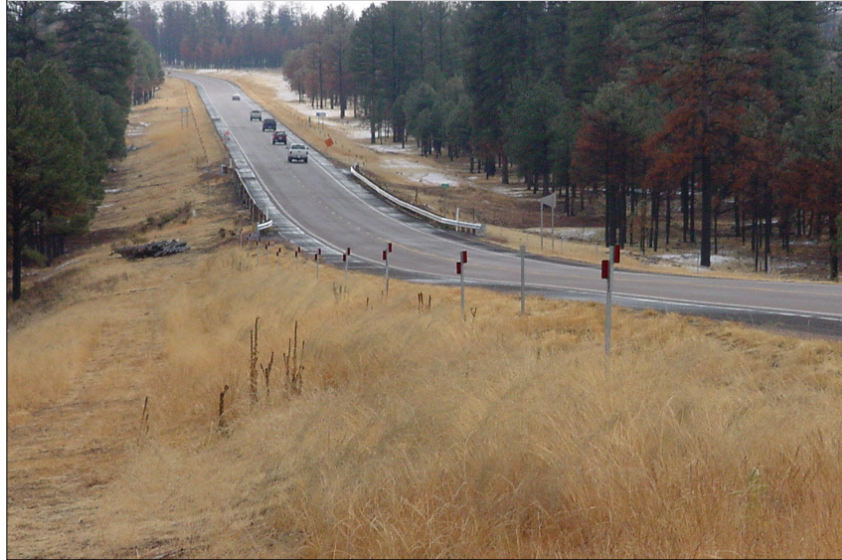
Figure 2. Roadside reflectors along SR 260 east of Heber (photo courtesy of ADOT)

Roadside reflectors, also called light-reflecting devices, are a visual-stimuli option for reducing AVC that have been frequently evaluated and may have potential for success. Aside from a manufacturer's claims or studies that show success, most research has shown minimal effectiveness. Reflectors require "activation," whereby the headlights of oncoming vehicles cause the reflector to shine or scatter light in a manner intended to scare deer away or cause them to hesitate long enough to allow vehicles to pass before attempting to cross the road (Brieger et al. 2016). Two attempts to use reflectors in Arizona have occurred in the past few decades, one along I-17 in the 1970s and one along SR 260 east of Heber in the early 2000s. According to a former AZGFD Regional Supervisor, the I-17 reflectors were quickly destroyed by snowplows and no solid results were obtained (in person interview, August 10, 2014). The second study was conducted by ADOT to evaluate reflectors along SR 260 (Figure 2); this study also showed inconclusive results. Reflectors were implemented in an area affected by a recent fire, and the new vegetation growth attracted more deer and elk to the area, which increased AVC (Gagnon et al. 2017).

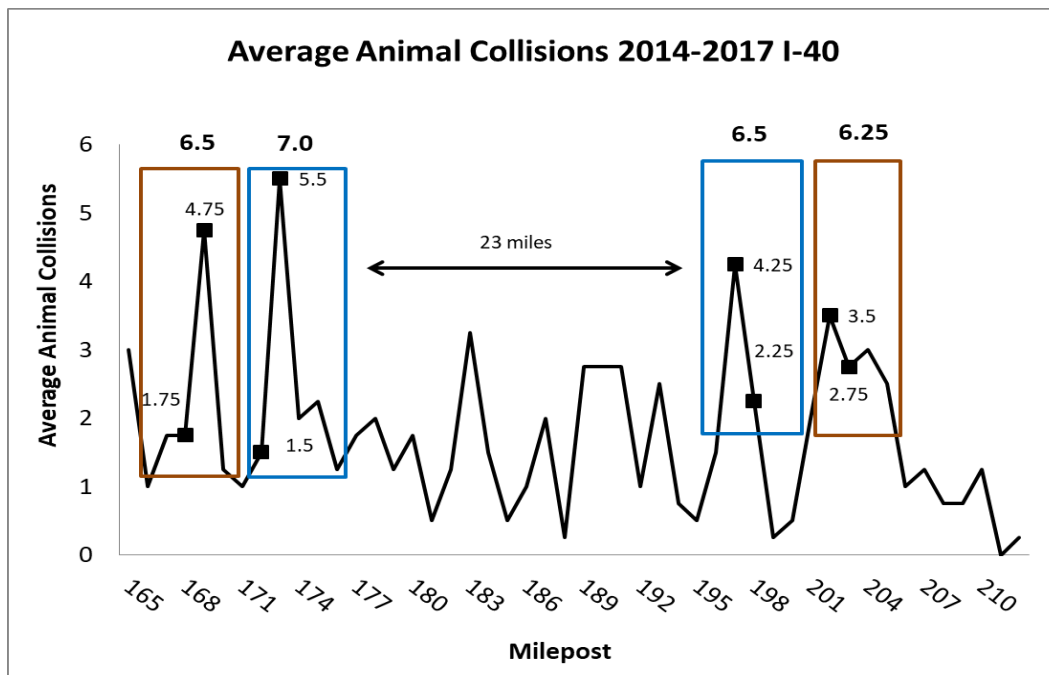
Figure 5. Two-mile stretches of highway selected along I-40 for fence tags (brown boxes) and controls (blue boxes) and their respective number of AVC (black markers) and total number of AVC for each two-mile section

- I-40 W, Fence Tags 1, MP 168.00–MP 169.99; I-40, Control 1, MP 172.00–MP 173.99
- I-40 E, Fence Tags 2, MP 202.00–MP 203.99; I-40, Control 2, MP 197.00–MP 198.99
- I-17, Fence Tags 1, MP 328.00–MP 329.99; I-17, Control 1, MP 334.00–MP 335.99
- SR 260 W, Fence Tags 1, MP 312.00–313.99; SR 260 W, Control 1, MP 317.00–MP 318.99
- SR 260 W, Fence Tags 2, MP 323.00–324.99; SR 260 W, Control 2, MP 326.00–MP 327.99

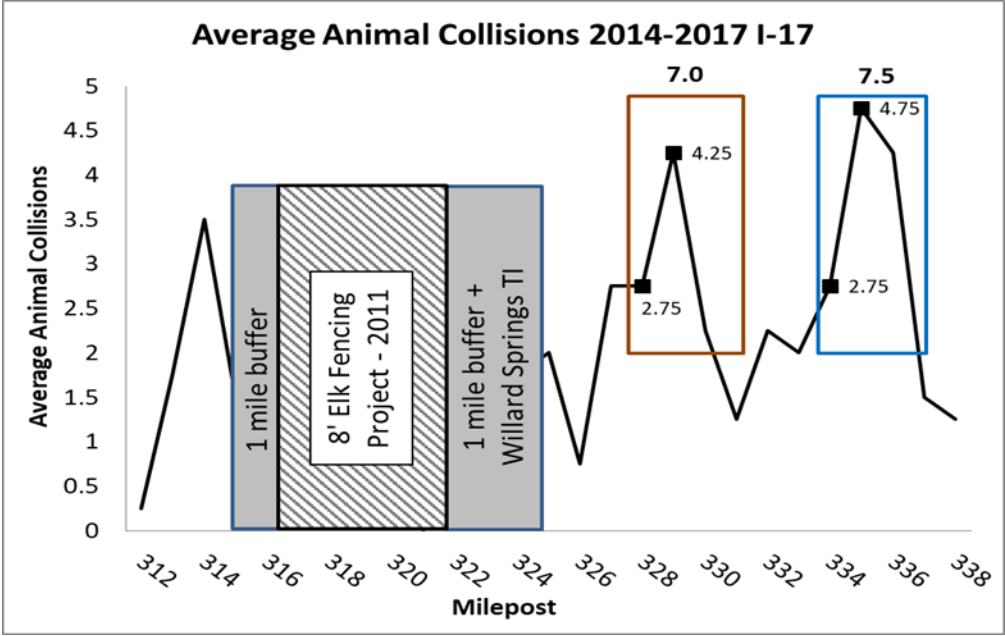
Figure 6. Two-mile stretches of highway selected along I-17 for fence tags (brown boxes) and controls (blue boxes) and their respective number of AVC and total AVC for each section, with avoidance areas for fence tags with an 8-foot elk fence and surrounding one-mile buffers

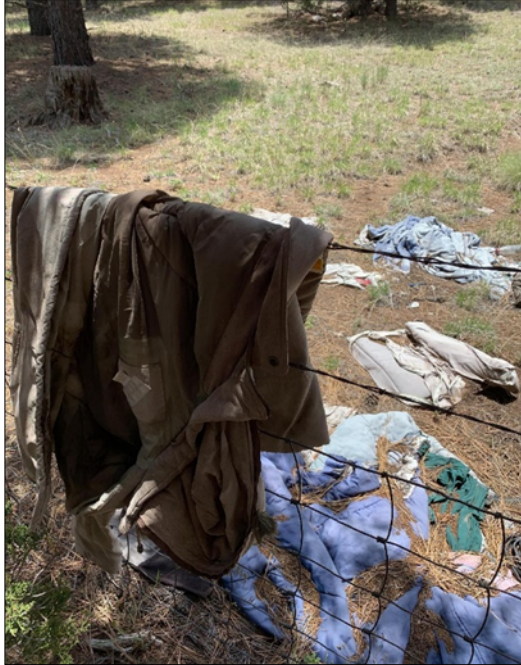
Figure 9. Trash covering both sides of a fence tag, blocking visibility

- **Following the completion of maintenance work, such as fence repair or replacement.** The research team observed that multiple missing tags found in short distance of each other usually occurred in areas where maintenance work was reported. For example, during the May 30, 2019, inspection of SR260 EB MP 323-325, the research team found four missing tags around a recently repaired section of fence.
- **When a fence is damaged.** For example, on December 6, 2019, a downed tree at SR260 EB MP 312-314 along a section of fence where tags used to be installed required new fence tags to be reinstalled on the repaired fence (Figure 9).
- **Presence of human disturbances.** The research team observed several instances of trash or large windblow objects obstructing the fence tags (Figure 9).

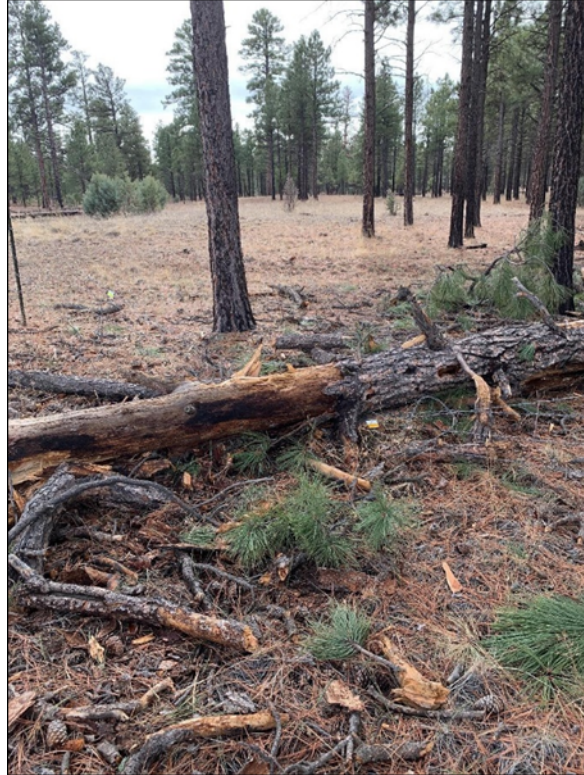
Figure 10. A downed tree blocking the visibility of a fence tag on SR 260

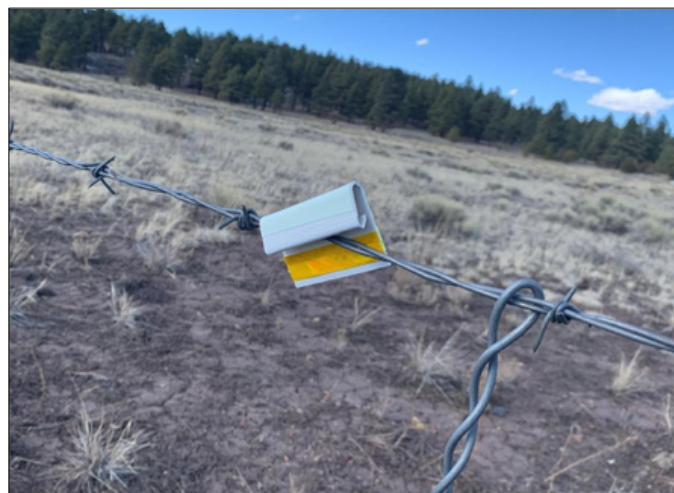
Figure 11. A dislodged fence tag from the February 24, 2021, inspection

In some situations, the original tag was dislodged and had to be reinstalled. For example, on February 24, 2021, a stretch of 12 tags in the eastern portion of I-40 WB MP 168-170 were discovered to be dislodged, likely due to wind (Figure 11). However, all tags still appeared to be functional (Figure 12), and the tags were re-installed on the fence.

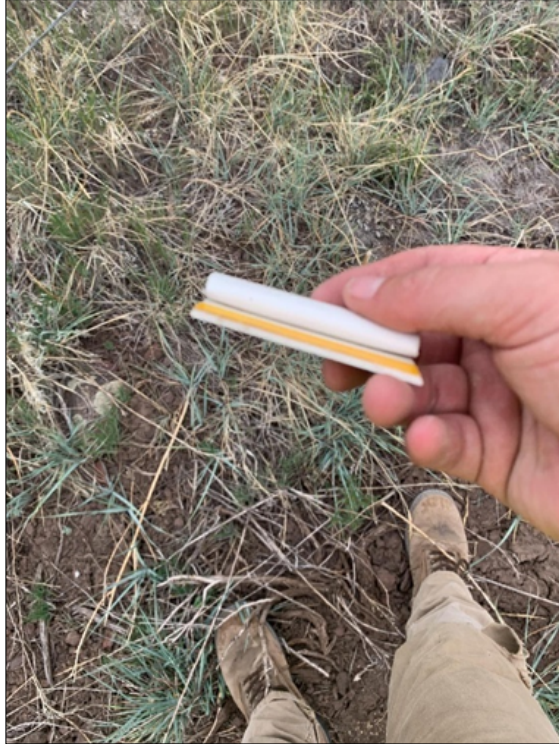
Figure 12. A tag that appears undamaged but was likely blown off by the wind; it can be reinstalled

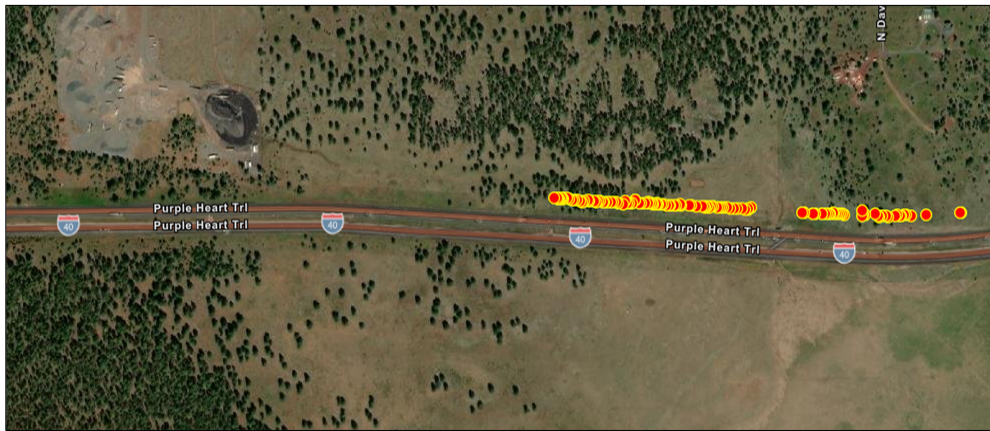
Figure 13. Locations of missing or damaged tags from the June 2, 2021, inspection

Most missing and damaged tags were noted on fences lining open plains and pastures. The tags surrounded by vegetation were better protected from disturbances caused by weather and livestock. The February 24, 2021, and June 2, 2021, inspections confirmed this assumption. On these dates, a half-mile stretch of missing or damaged tags was found on a relatively open fenceline along I-40 (Figure 13).

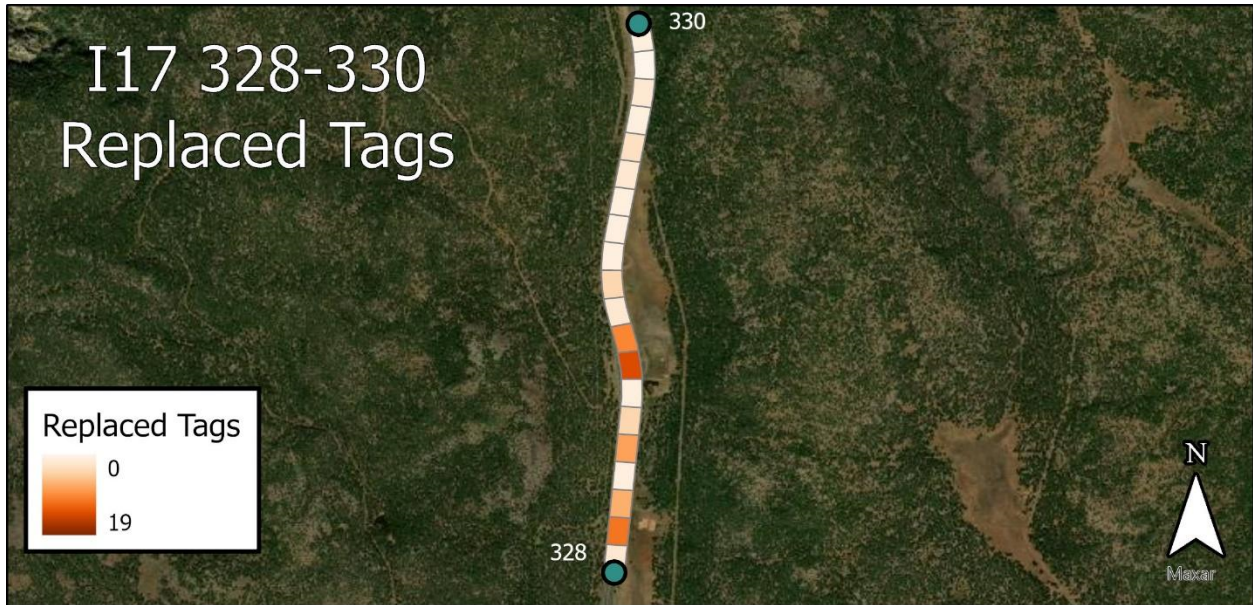
Figure 15. A heat map of replaced tag locations along I-17 mileposts 328 to 330

To visualize the geographic pattern of fence tag replacement that took place during the three-year inspection period, heat maps were developed for each study area. Due to the variance in distance between mileposts, road segments between the beginning and end of each study area were split into 20 evenly sized segments. The count in each segment represents the combined number of missing or damaged tags replaced on both sides of the highway within that segment over the three-year study period (Figure 15 Figure 19).

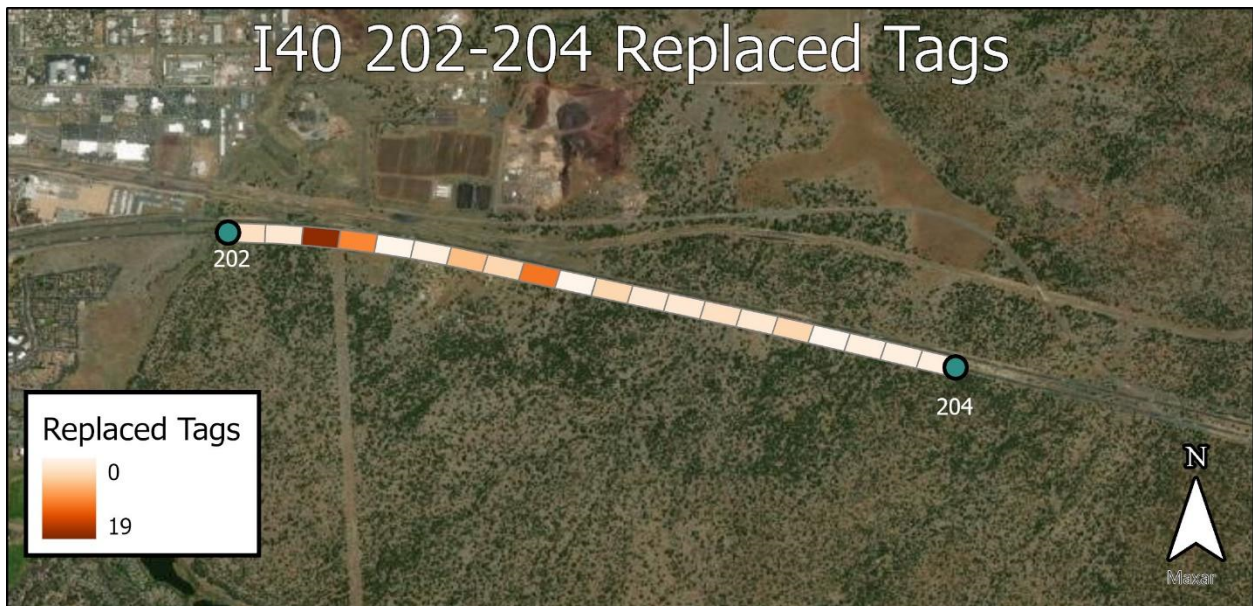
Figure 16. A heat map of replaced tag locations along I-40 mileposts 202 to 204

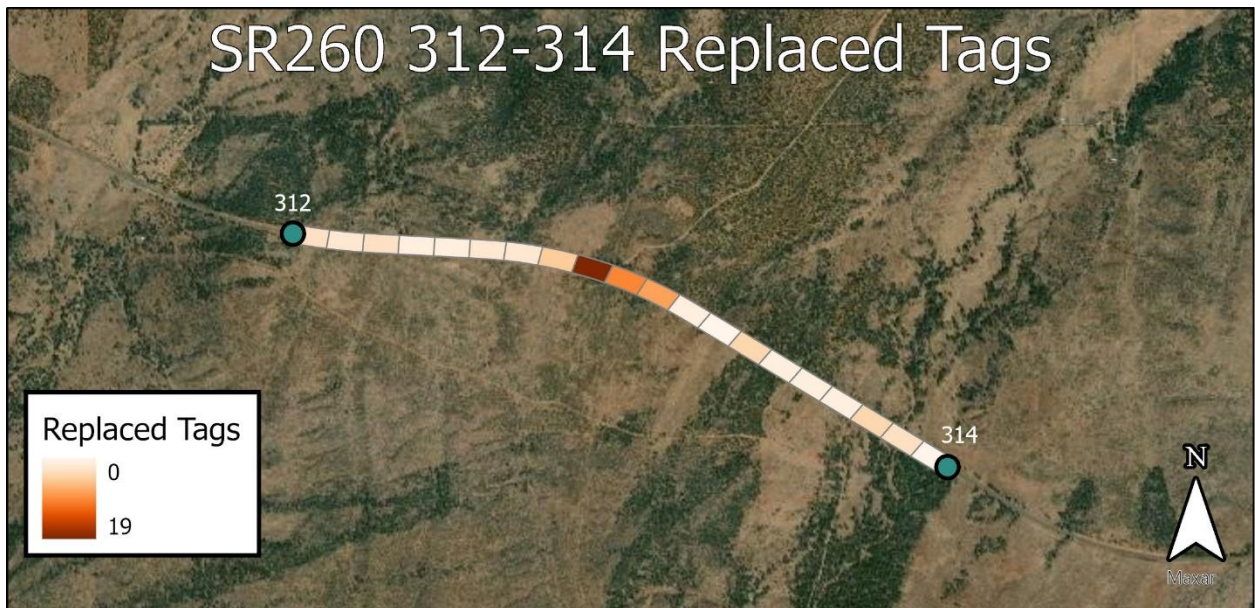
Figure 18. A heat map of replaced tag locations along SR 260 mileposts 312 to 314

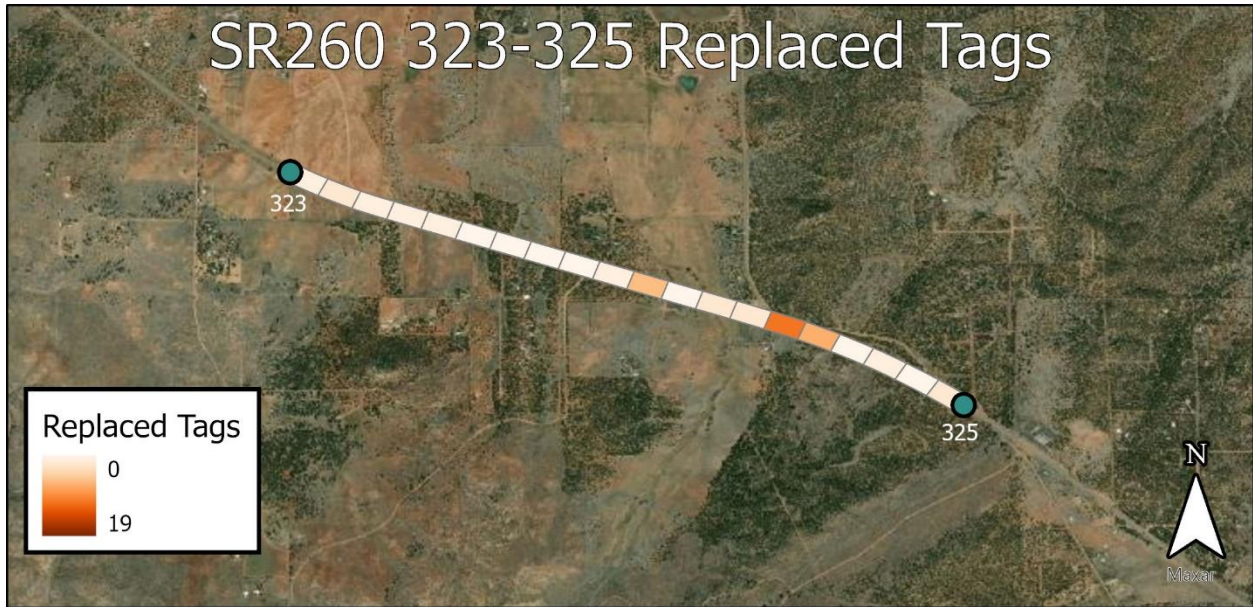
Figure 19. A heat map of replaced tag locations along SR 260 mileposts 323 to 325

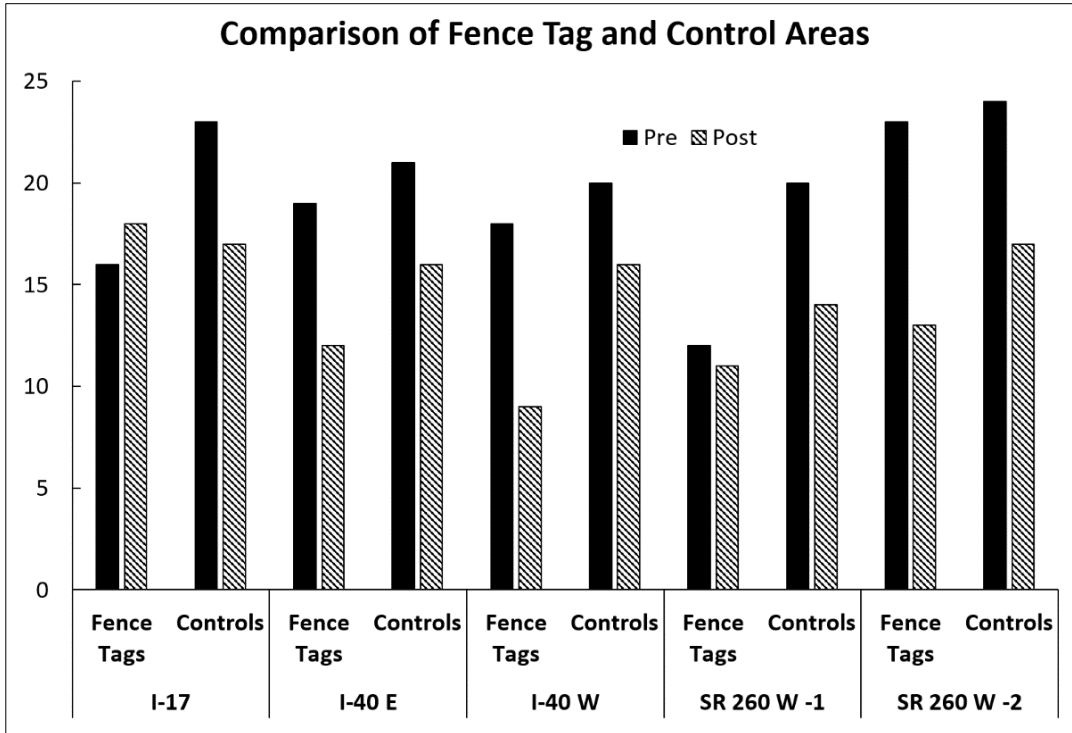
Figure 19. The number of AVC both before and after fence tag installation along treatment and control areas for all five study sites

A total of 339 AVC were reported on the evaluated segments during the study period from July 2015 through June 2021. This number is broken down into 196 total crashes between July 2015 and June 2018 and 143 between July 2018 and June 2021. A total of 151 AVC occurred on treatment segments where fence tags were installed, and 188 occurred on control segments where fence tags were not installed.

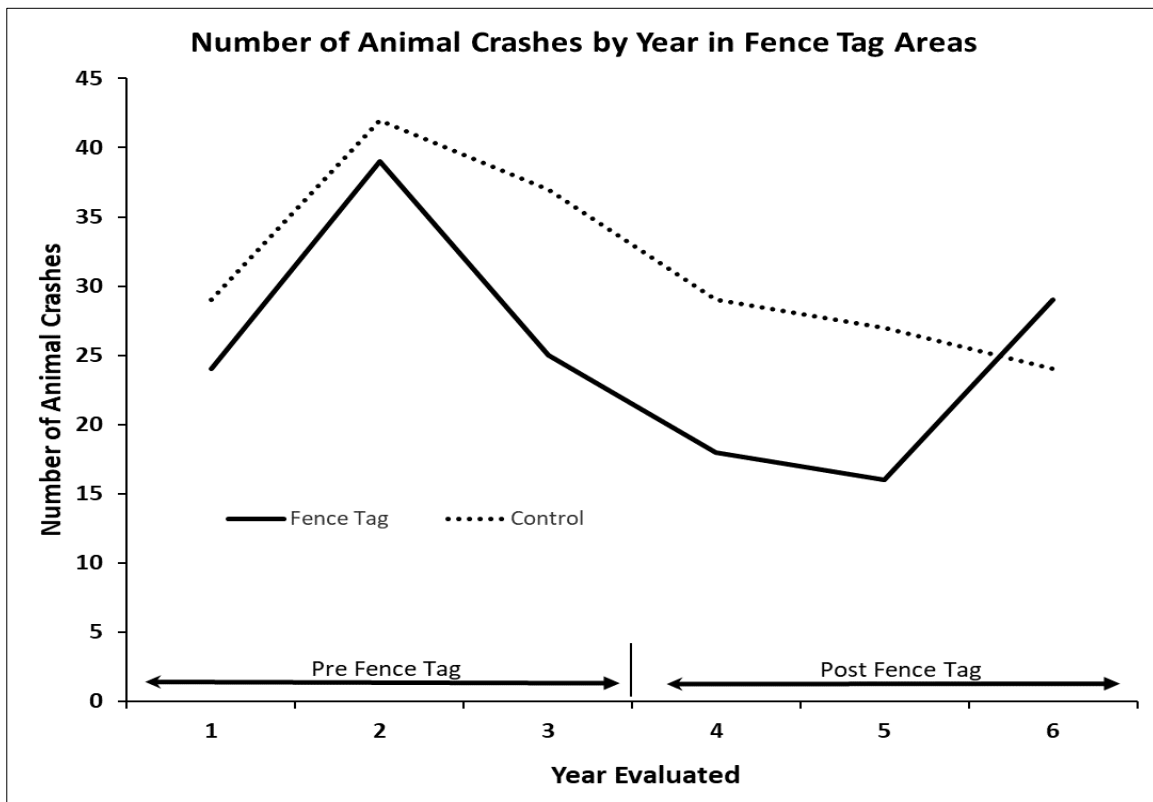
Figure 20. The number of AVC by year along the combined treatment and control areas for all five study sites

Fluctuations in annual reported AVC were observed over the six-year evaluation period. The highest increase in AVC occurred in Year 2 across both treatment (63 percent) and control (45 percent) segments, followed by a downward trend, except for treatment segments that reported a sudden average increase of 80 percent in Year 6 (Figure 20). All of the test segments combined increased by 80 percent on average from Years 5 to 6. A breakdown by year and road segment are shown in Figures 21 and 22.

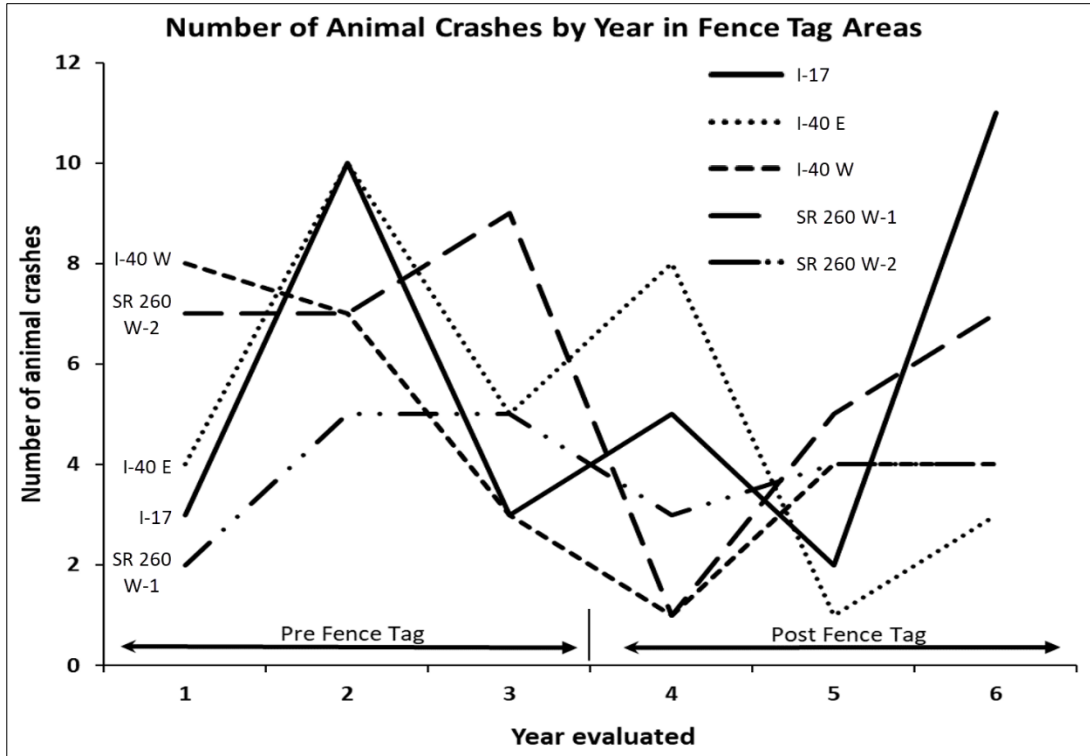
Figure 21. The number of AVC by year along fence tag areas for all five study sites

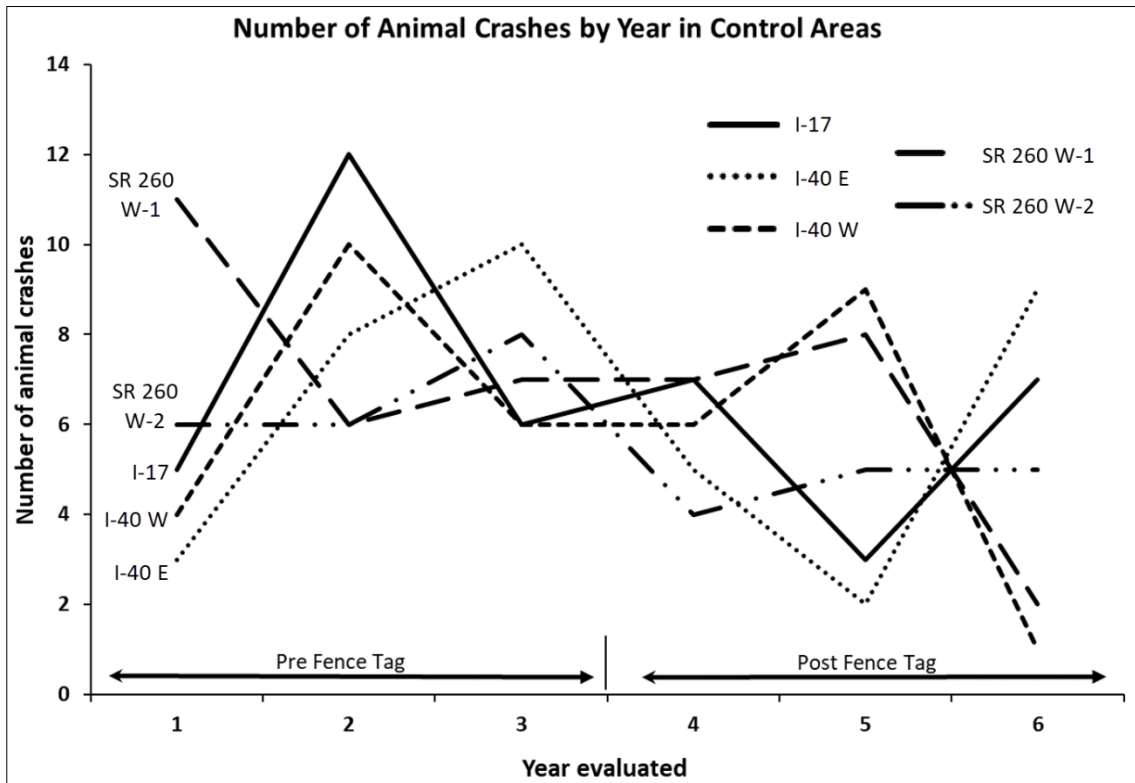
Figure 22. The number of AVC by year along control areas for all five study sites
