## 0-7084: Develop Improved Methods for Eliminating Striping on Roadway Surfaces

### Background

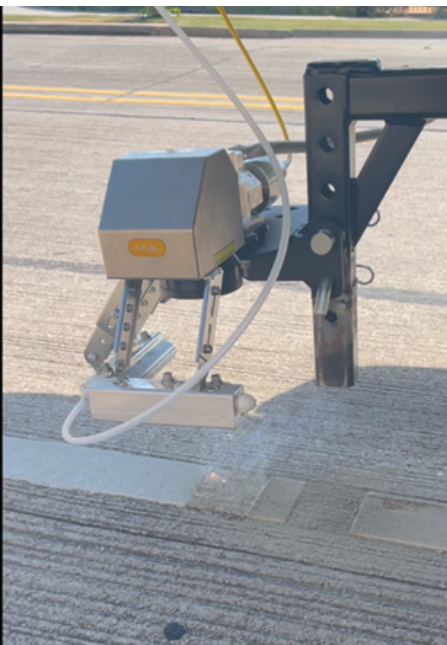
The project aimed to investigate current removal techniques and to put together and test a pulsed solid state fiber laser system as an alternative method for road markings removal. Figure 1 shows the system in operation, with the laser scanner in use during a white thermo stripe ablation.

**Figure 1. Laser system in operation: white thermo stripe removal from a concrete surface.**

Secondly, a laser system was put together consisting of a pulsed fiber laser with a wavelength of 1064 nm and 200 W average output power, a chiller, a laser scanner, air knives, a generator, and a compressor. The system was tested in both a laboratory environment and in the field. Concrete samples made using three different white stripes types (i.e. thermo, hot tape, and paint) were tested in the lab. In addition, paint stripes were ablated
