Report No. FHWA-RD-77-40

UPGRADING SAFETY PERFORMANCE IN RETROFITTING TRAFFIC RAILING SYSTEMS

September 1976
Final Report

Prepared for
FEDERAL HIGHWAY ADMINISTRATION
Offices of Research & Development
Washington, D. C. 20590

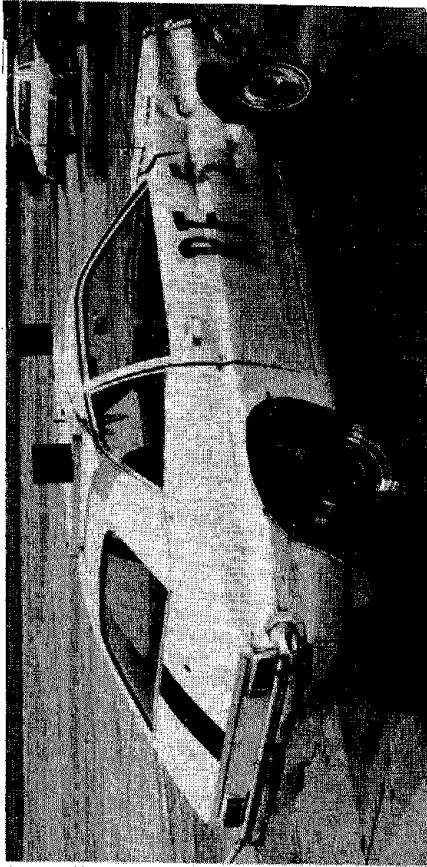
FIGURE 15. SUMMARY OF RESULTS, TEST RF-5

Test No.	RF-5	Vehicle	1971 Ford Pinto
Date	7/15/75	Vehicle Mass	2250 lb (1021kg)
Drawing	SwRI 03-3717-14	(w/instrumentation)	
Rail (front)	Steel Tubular Thrie Beam (10 ga.)	Impact Speed	58.0 mph (25.9m/s)
Rail (backup)	Concrete, 9 in. (0.23m) x 11 in.	Impact Angle	+17.1 deg
	(0.28m) x 69.8 ft (21.3m)	Exit Angle	-6.8 deg
Post	Concrete, 12 in. (0.30m) x 10 in.	Vehicle Accel (max 50ms avg)	
	(0.25m) x 12 in. (0.30m)	Lateral(elect)	-8.4g
Steel Tubes	0.125 in. (3.1mm) thk x 6 in.	Longitudinal(elect)	-4.1g
	(0.15m) O.D. x 22 in. (0.56m) long	Vehicle Rebound Distance	15.0 ft (4.57m)
Bridge Post Spacing	8.83 ft (2.69m)	Vehicle Damage	
Tube Spacing	8.33 ft (2.54m)	TAD	1-RFQ-4
Length of Installation	126 ft (38.4m)	VDI	01RFES2
Pavement Conditions	Dry	Max Dynamic/Permanent Rail Deflection	0.5 in. (12.7mm)/0.5 in. (12.7mm)

Test RF-5. This was the initial test of the R(II)-1 retrofit system. The vehicle used was a 2250-lb (1021 kg) 1971 Ford Pinto, and impact conditions were 58.0 mph (25.9 m/s) and 17.1-deg angle. As shown in Figure 15, the vehicle impacted midway between tubes 5 and 6 (tubes are numbered consecutively beginning at the upstream end) and was smoothly redirected. Maximum 50-ms average vehicle accelerations determined from accelerometer data were -4.1 -g longitudinal and -8.4 -g lateral; maximum permanent rail deflection was 0.5 in. (12.7 mm). Installation and vehicle damage is shown in Figure 16. The vehicle was driven back to the impact area following the test.

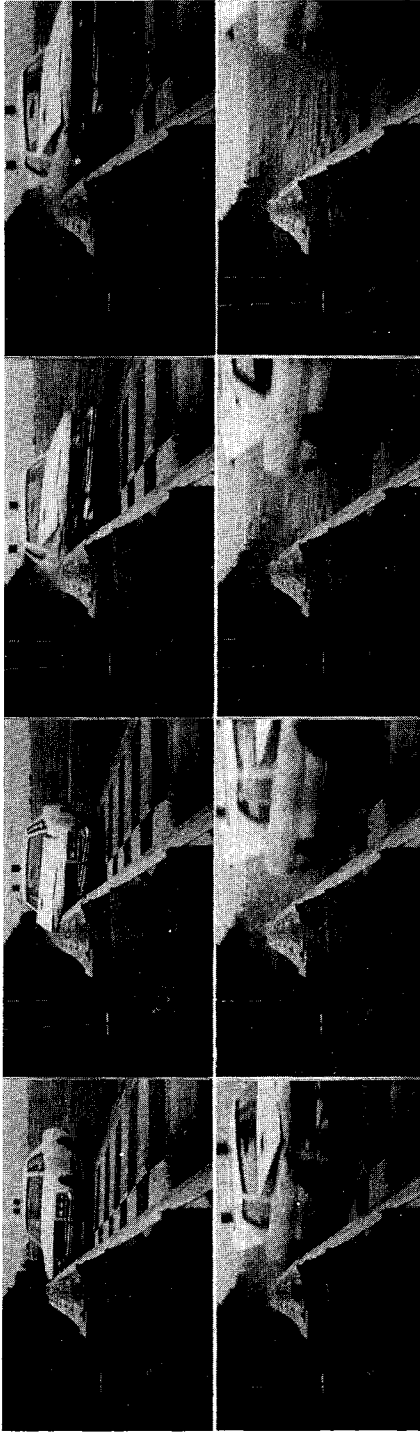
FIGURE 17. SUMMARY OF RESULTS, TEST RF-6

Test No.	RF-6	Vehicle	1973 Mercury Monterey
Date	7/16/75	Vehicle Mass	4500 lb (2041kg)
Drawing	SwRI 03-3717-14	(w/instrumentation)	
Rail (front)	Steel Tubular Thrie Beam (10 ga.)	Impact Speed	60.6 mph (27.1 m/s)
Rail (backup) ...	Concrete, 9 in. (0.23m) x 11 in.	Impact Angle	+25.0 deg
	(0.28m) x 69.8 ft (21.3m)	Exit Angle	-6.0 deg
Post	Concrete, 12 in. (0.30m) x 10 in.	Vehicle Accel (max 50ms avg)	
	(0.25m) x 12 in. (0.30m)	Lateral (elect)	-11.7g
Steel Tubes	0.125 in. (3.1mm) thk x 6 in.	Longitudinal (elect)	-5.9g
	(0.15m) O.D. x 22 in. (0.56m) long	Vehicle Rebound Distance	20 ft (6.1m)
Bridge Post Spacing	8.83 ft (2.69m)	Vehicle Damage	
Tube Spacing	8.33 ft (2.54m)	TAD	1-RFQ-5
Length of Installation	126 ft (38.4m)	VDI	01RFES2
Pavement Conditions	Dry	Max Dynamic/Permanent Rail ..	5.0 in. (127mm)/5.0 in.
		Deflection	(127mm)

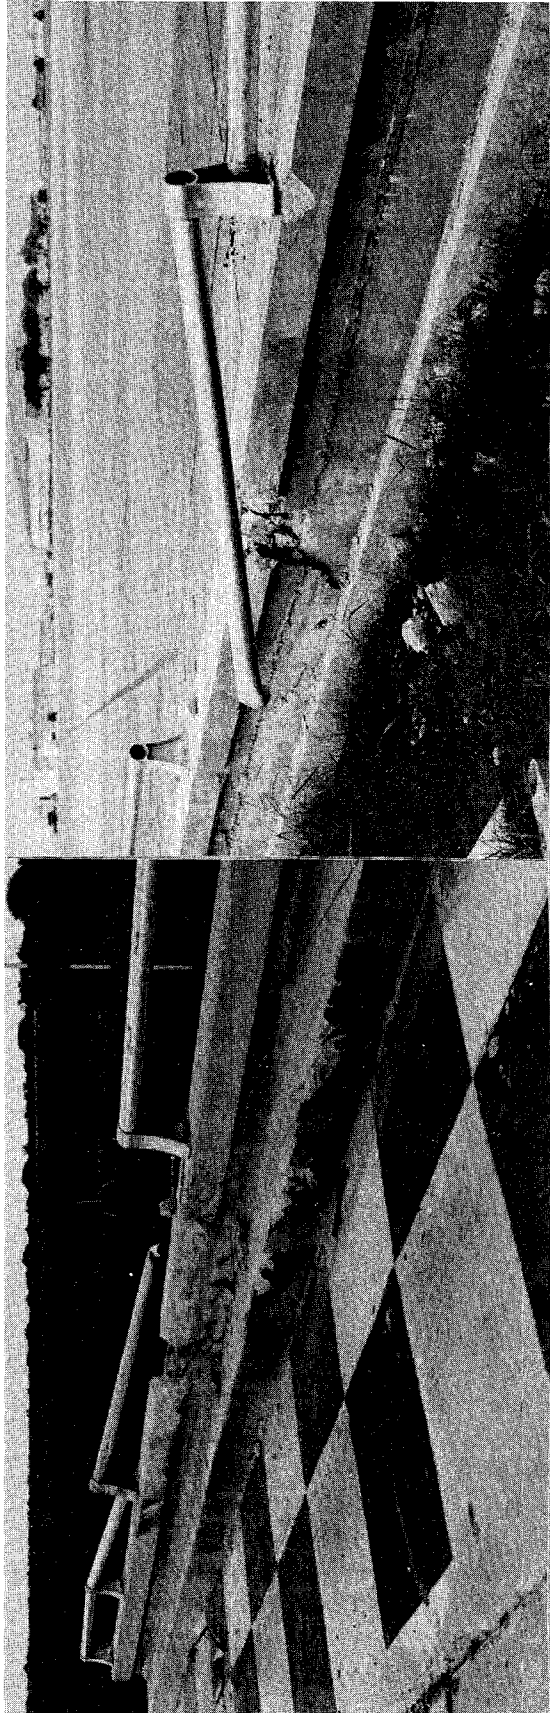
FIGURE 26. VIEWS OF VEHICLE BEFORE AND AFTER TEST RF-9

(b) Vehicle damage

A summary of test information is presented in Figure 25. Maximum 50 ms average vehicle accelerations were -4.2-g lateral and -9.6-g longitudinal, as determined from high-speed cine. The longitudinal value is moderately high but not unexpected with the 29-deg impact angle. Vehicle and installation damage are shown in Figures 26 and 27, respectively.

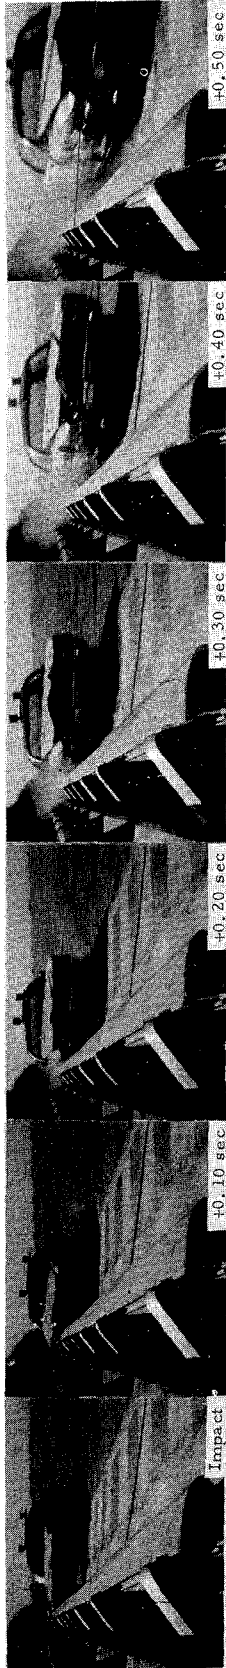
FIGURE 41. SUMMARY OF RF-10 TEST RESULTS

Test No.	RF-10
Date	12/2/75
Drawing	SwRI 03-3717-17
Rail	Semi Elliptical Alum Alloy 6061-T6 or 6351-T5
Parapet, 25-in. (0.64m) conc. with 10 in. (0.25m) high x 18-in. (0.46m) wide walk	
Length of Installation ...	153.5 ft (46.8m)
Pavement Condition	Dry
Vehicle Mass	1969 Chrysler
(w/instrumentation)	4352 lb (1974kg)
Impact Speed	60.0 mph (26.8m/s)
Impact Angle	+21.7 deg
Exit Angle	-3.5 deg
Vehicle Accel (max 50 ms avg)	
Lateral (cine/elect)	-5.9g/n.a.
Long. (cine/elect)	-4.2g/n.a.
Resultant (elect)	n.a.
Vehicle Rebound Distance ...	15 ft (4.6m)
Vehicle Damage	
TAD	1-FR-6
VDI	1FREW5
Max. Rail Deflection	(dynamic/permanent)
	0

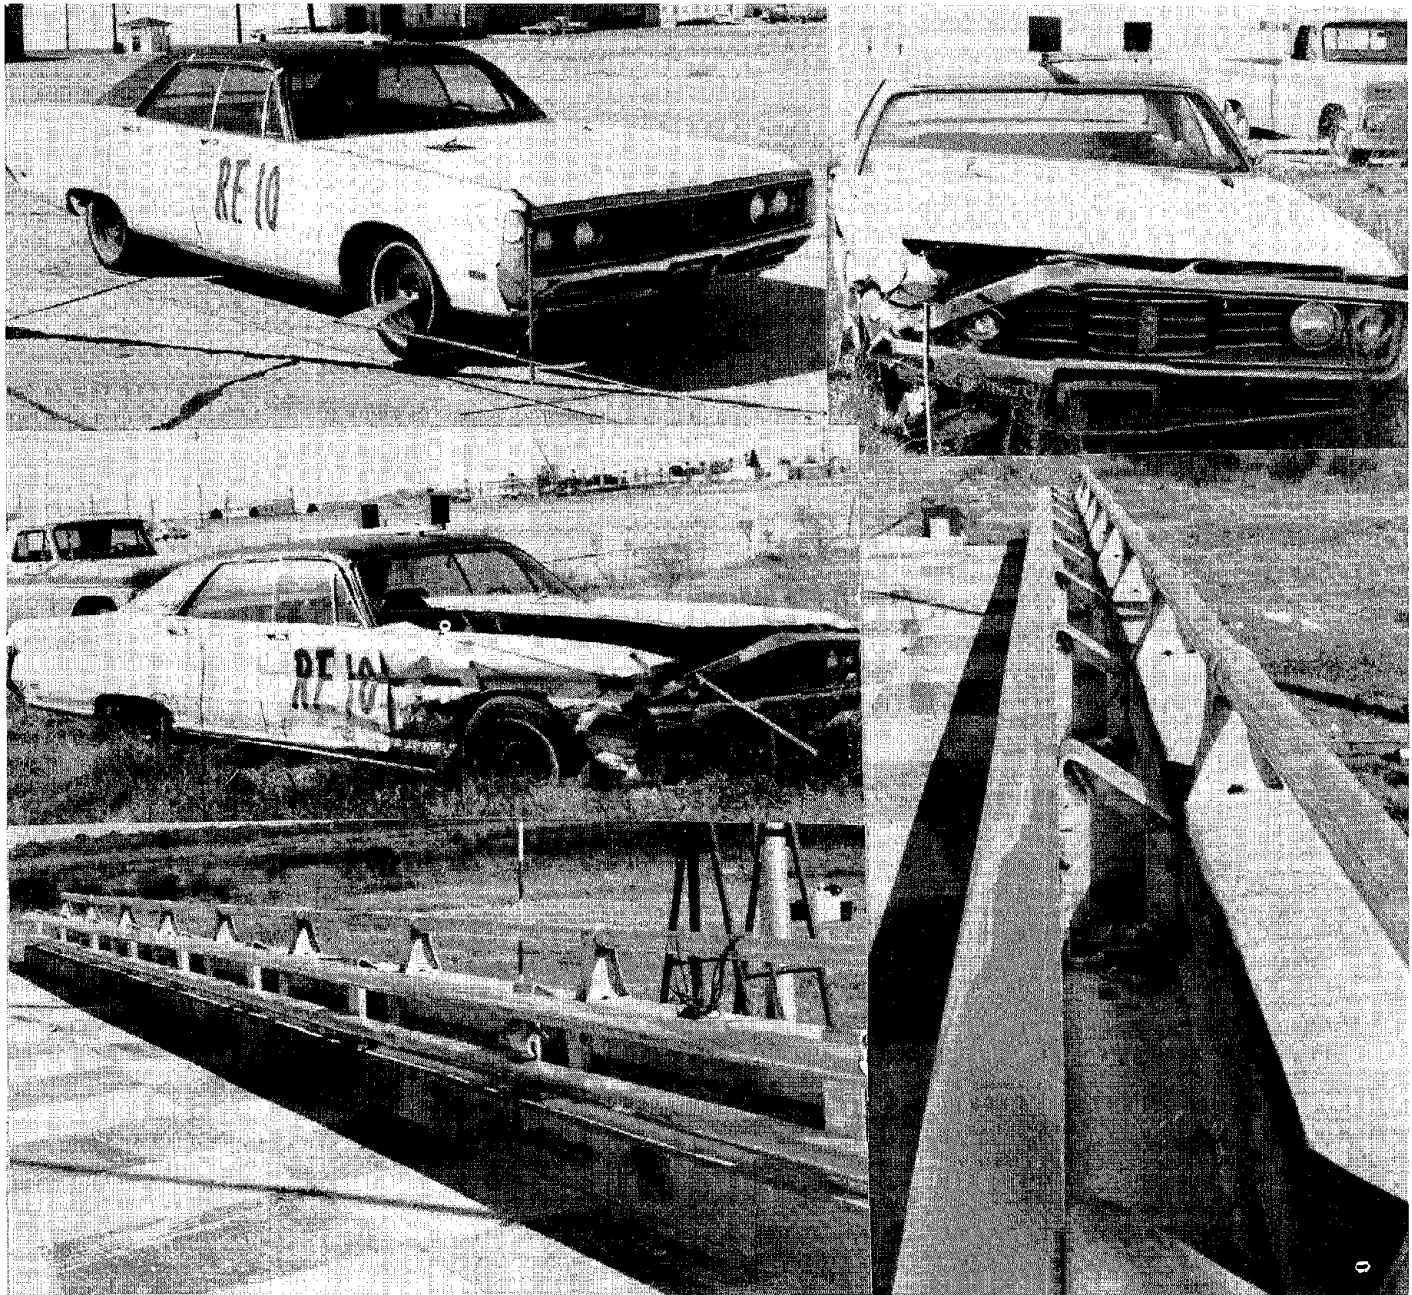
Impact Speed	60.0 mph (26.8m/s)
Impact Angle	+21.7 deg
Exit Angle	-3.5 deg
Vehicle Accel (max 50 ms avg)	
Lateral (cine/elect)	-5.9g/n.a.
Long. (cine/elect)	-4.2g/n.a.
Resultant (elect)	n.a.
Vehicle Rebound Distance ...	15 ft (4.6m)
Vehicle Damage	
TAD	1-FR-6
VDI	1FREW5
Max. Rail Deflection	(dynamic/permanent)
	0

A summary of test results is contained in Figure 41. Vehicle redirection was smooth. Maximum 50-ms average vehicle accelerations determined from high-speed cine data were 5.9-g lateral and -4.2-g longitudinal.

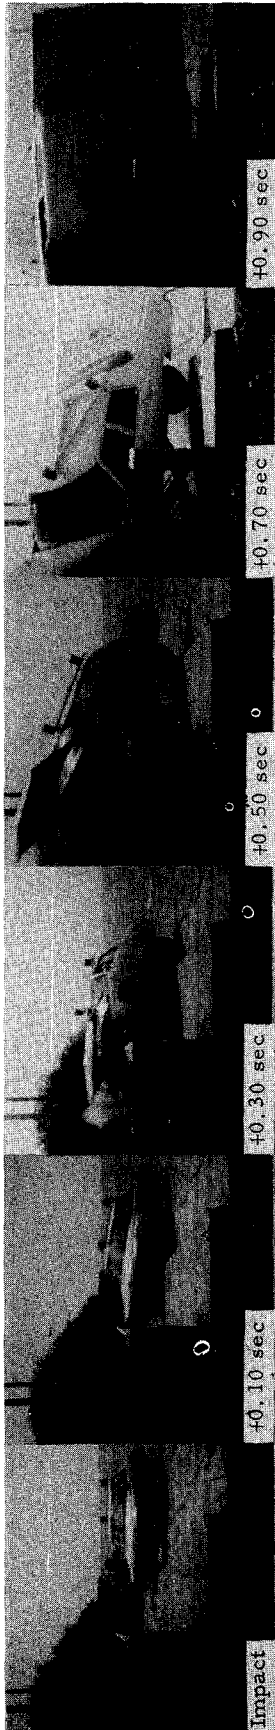
Test No.	RF-14	Impact Speed	61.9 mph (27.7m/s)
Date	3/26/76	Impact Angle	+25.3 deg
Drawing	SwRI 03-3717-24	Exit Angle	n.a.
Rail	Metal Panel System	Exit Speed	n.a.
Parapet	Metal w/Wide Walk	Vehicle Accel (max 50 ms avg)	
Length of Installation	76.2 ft (23.2m)	Lateral (cine/elect)	-3.3g/-7.0g
Pavement Condition	Dry	Long. (cine/elect)	-4.5g/-14.4g
Vehicle	1972 Buick Le Sabre	Resultant (cine/elect)	4.8g/14.5g
Vehicle Mass	4285 lb (1944kg)	Vehicle Rebound Distance	0 ft (0m)
(w/instrumentation)		Vehicle Damage	
		TAD	1-FR-7
		VDI	01FFEW9
		Max. Rail Deflection	n.a./n.a.
		(dynamic/permanent)

Test RF-14. Views of the test installation and vehicle are shown in Figure 61. Impact conditions for the 4285-lb (1944 kg) vehicle were 61.9 mph (27.7 m/s) and 25.3-deg angle. The vehicle contacted the curb 29.1 ft (8.9 m) from the upstream end of the bridge deck. The vehicle mounted the 9-in. (0.23 m) high safety curb and contacted the metal parapet 39.5 ft (12.0 m) from the upstream end of the bridge deck. Impacting the metal parapet, the vehicle began to roll away from the bridge rail. The metal parapet anchorage system failed, however, allowing the vehicle to continue over the walk. After the vehicle had traveled the length of the metal parapet, the left side of the passenger compartment contacted the concrete parapet located at the downstream end of the bridge deck. The vehicle immediately came to rest with the concrete parapet lodged inside the passenger compartment of the vehicle. A summary of findings is presented in Figure 62. Maximum, 50-ms average vehicle accelerations, determined from high-speed cine data, were -3.3 -g lateral, -4.5 -g longitudinal, and 4.8-g resultant.
