LABORATORY EVALUATION OF EXISTING BREAKAWAY STRUCTURES

Vol. 2. Technical Results

Prepared for
FEDERAL HIGHWAY ADMINISTRATION
Offices of Research & Development
Structures & Applied Mechanics Division
Washington, D.C. 20590

1. Report No. FHWA-RD-79-140		2. Government Accession No.		PB81-153769

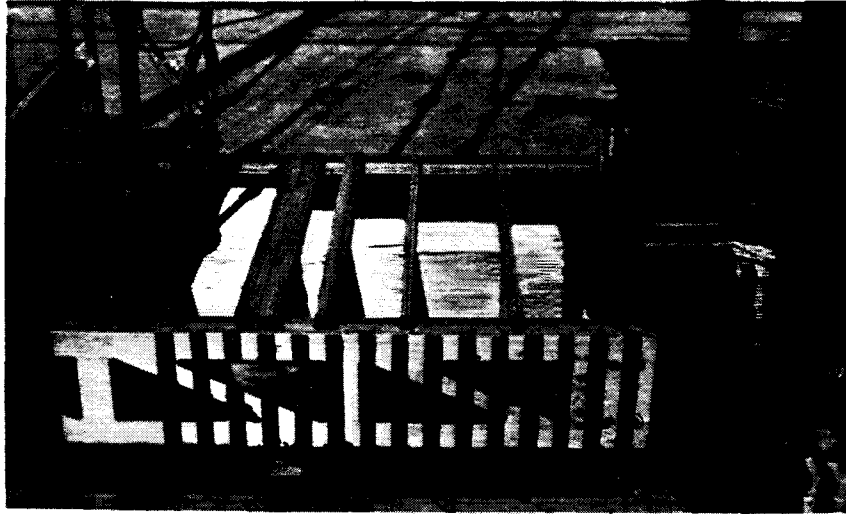
Fig. 13

Pendulum Nose Configuration as Evaluated in Test 1147-114

It was noticed in Test 1147-113 that the breakaway force being generated in the pendulum impact was almost identical to the force level of the fifth block of honeycomb. Since this block of honeycomb was the last to be crushed it was felt that perhaps there was some correlation between its crush force and the breakaway force level. In order to test this theory, the size of the fifth block was reduced in this test (see Fig. 13). This test resulted in a higher peak force, thereby disproving the theory. The momentum change was 659 lb-sec (2931.2 Ns).

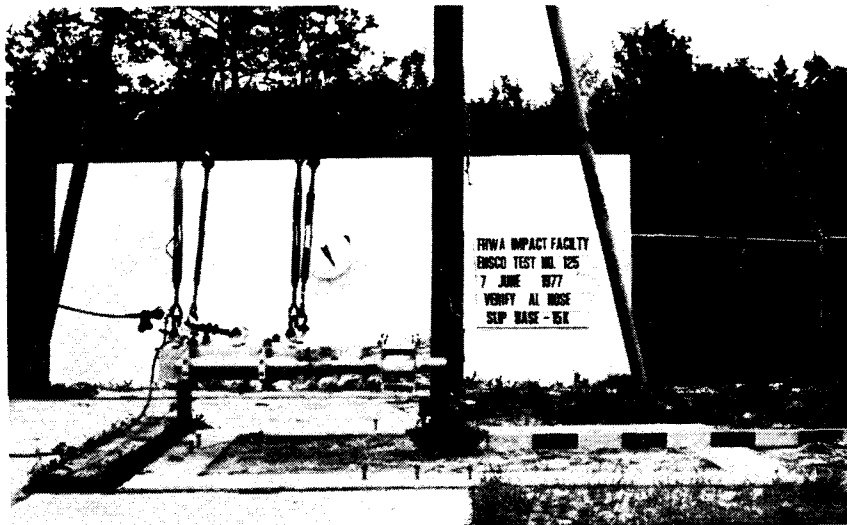
Fig. 24

Pendulum Nose Configuration as Evaluated in Test 1147-124

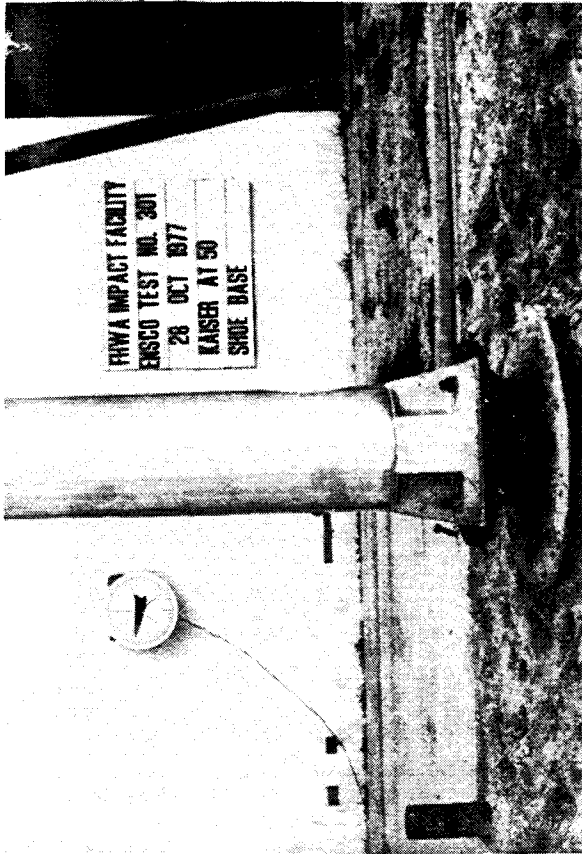
Fig. 31 also shows the portion of the shoe base which stayed on the mounting base and the pieces of the shoe base scattered around the test site. It should be noted that although the lugs

Fig. 31
Representative Photographs of Test 1147-301

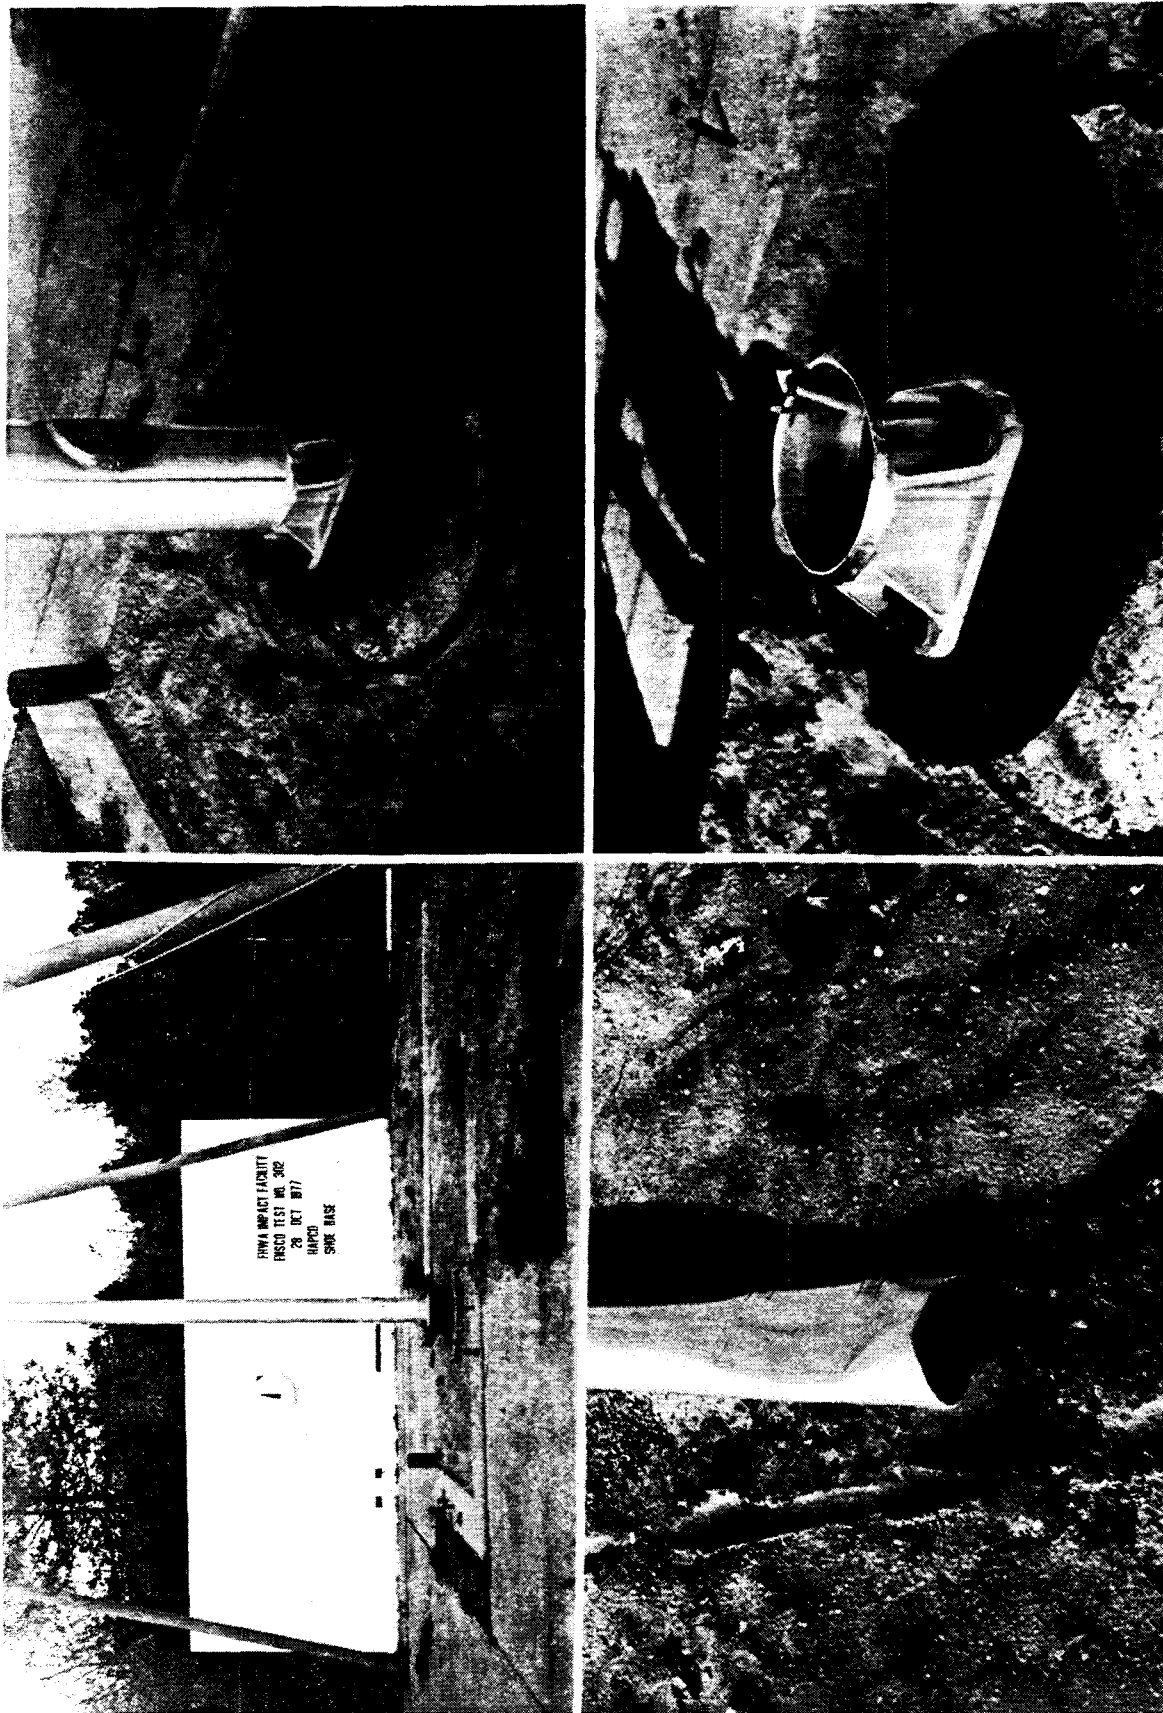
Fig. 32
Representative Photographs of Test 1147-302

During the impact the .188 in (.47 cm) wall tube sheared off just above the flange casting. Fig. 32 shows the test set-up and the post-test conditions. A summary of test results is shown in Table 9.

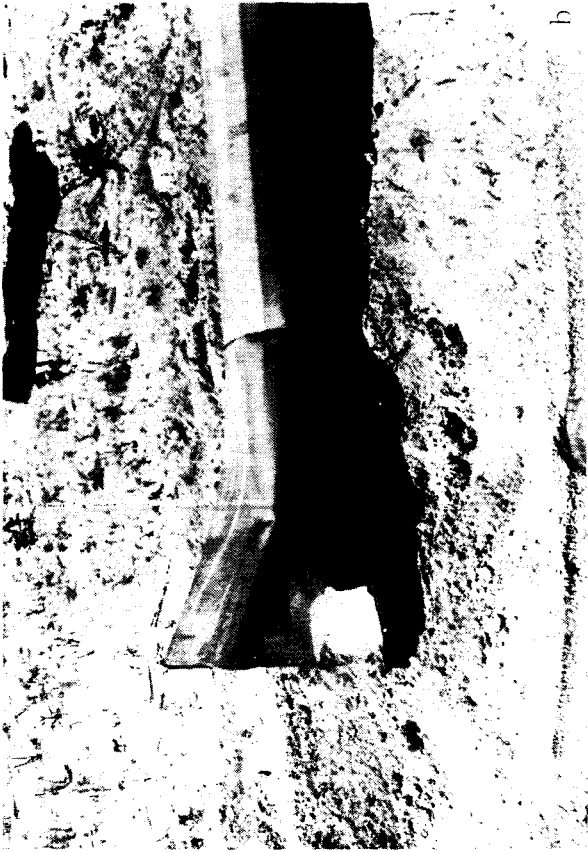
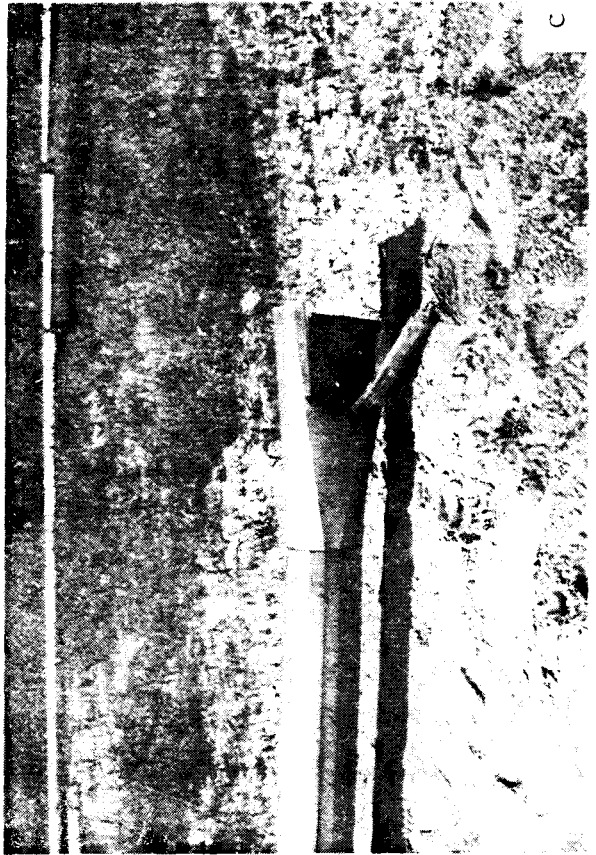
Fig. 34
Representative Photographs of Tests 1147-401 and -402

The stainless steel Millerbernd integral base shown in Fig. 34a is attached to a rigid bottom plate (d) by six rivets on each side. During an impact the base crushes and allows the rivets to shear in a progressive manner, whereas during wind loading the rivets act together as a unit for better strength.

The Millerbernd base behaved well in both tests. Crush of the impact side occurred and all rivets sheared off smoothly. Fig. 34b shows after impact photos of Test 1147-401 while Fig. 34c shows Test 1147-402.

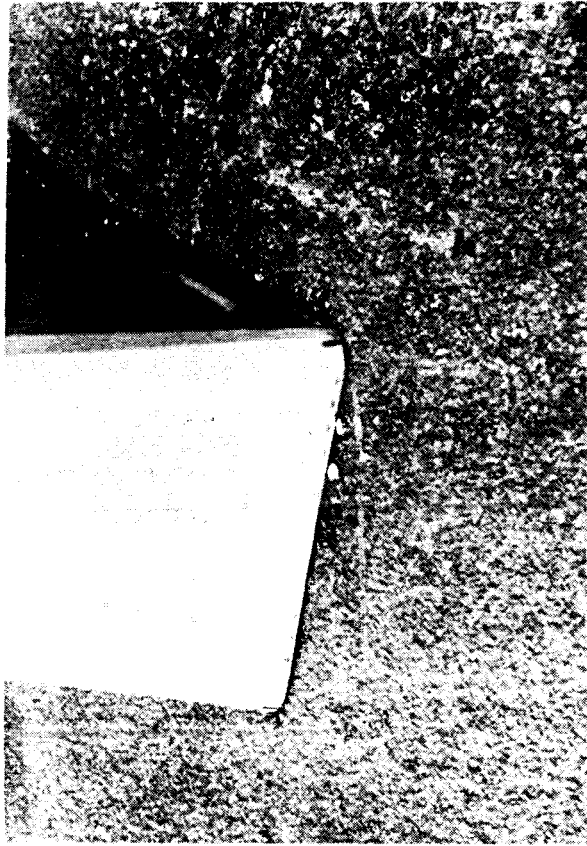
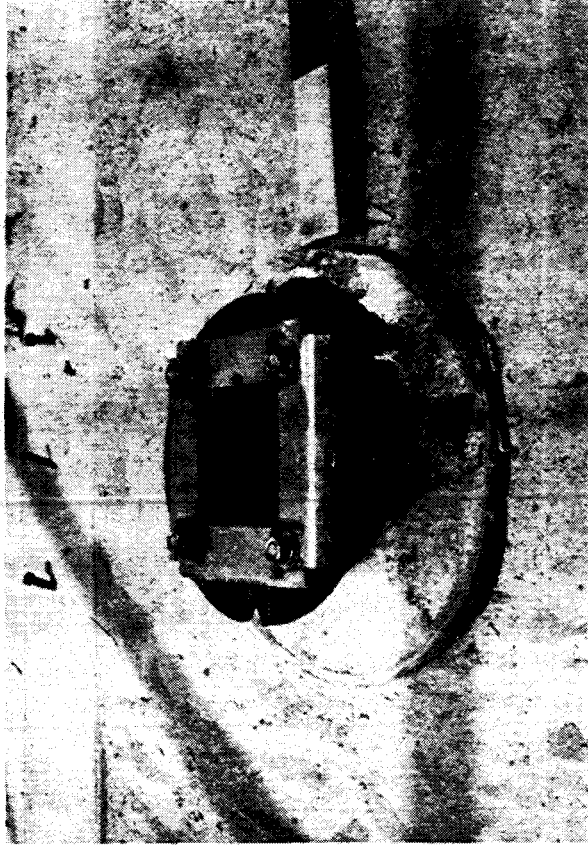
Fig. 35
Representative Photographs of Test 1147-403

same type. In addition to the generally larger size of this base (Fig. 35), there are eight rivets at each of the corners versus six in the smaller base. The base was run with the lower 35 ft (10.7 m) portion of a two piece 50 ft (15 m) MH base/pole combination.

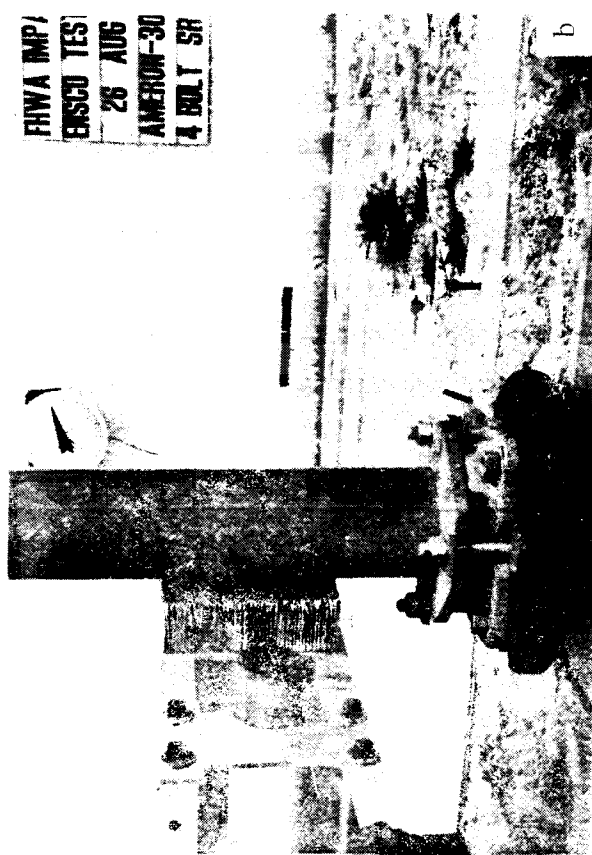
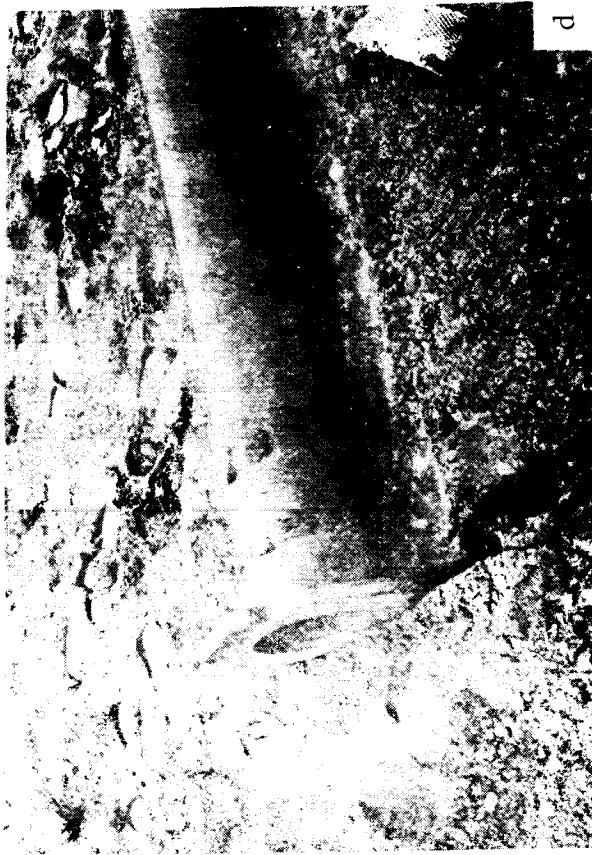
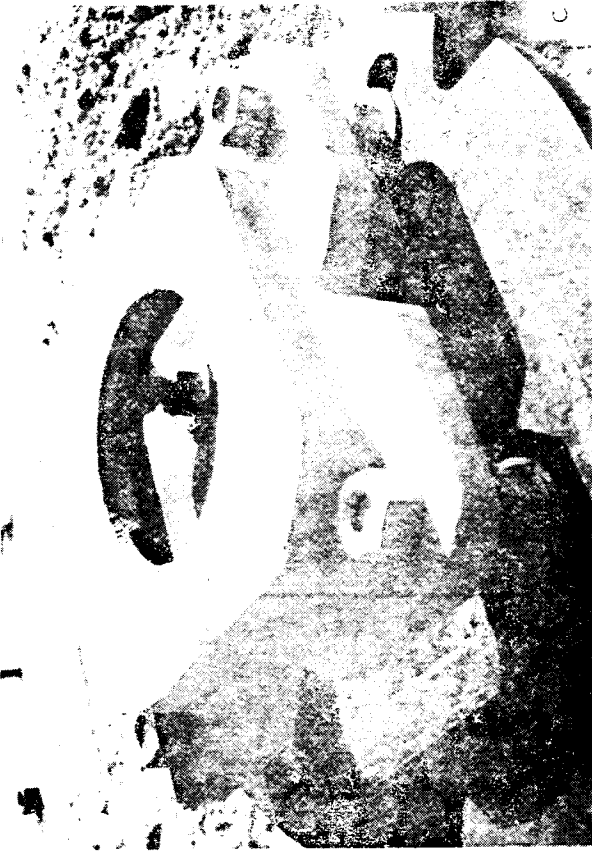
Fig. 38
 Representative Photographs of Tests 1147-501 and 1147-502

These tests were conducted on a steel luminaire support with a Utah four bolt slip base manufactured by Ameron. The support had a 30 ft (9 m) MH and utilizes a 16 in (.41 m) foundation bolt circle. Four 1 in (2.5 cm) diameter bolts with steel rectangular washers and 18 gauge keeper plate are used to hold the slip base together. In Test 1147-501 the slip base bolts were torqued to 80 ft-lb (108 Nm) as per Utah state plans. The four bolt slip base pole is shown in Fig. 38a and b.

The impact resulted in a very low momentum change of 223 lb-sec (992 Ns). Due to the low torque value specified by Utah, a second test (test 1147-502) was run to see if overtightened bolts would adversely effect the slip base performance. The torque was, therefore, increased to 120 ft-lb (163 Nm) in this test. This 50 percent increase in bolt torque increased the momentum change to 575 lb-sec (2558 Ns), an increase of 150 percent. Fig. 38c and d show the slip base halves after an impact.

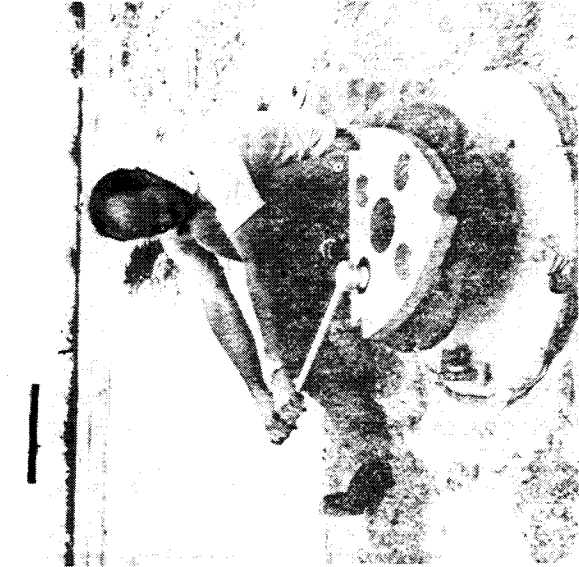
Fig. 39
Representative Photographs of Test 1147-503

poles to slip bases. Fig. 39 shows the assembly procedure for the insert base. This insert consists of a lower base which is mounted to the foundation, three clamping bolts and their keeper plate, and an upper plate which is clamped to the lower base by the bolts. The pole is mounted on the studs on the upper plate resulting in a pole with a three-bolt slip base. The three 7/8 in (2.2 cm) slip base bolts are torqued to 150 ft-lb. (203 Nm).

The impact resulted in an acceptable momentum change and the slip base functioned as designed. During the impact, the pole suffered severe deformation (Fig. 39).

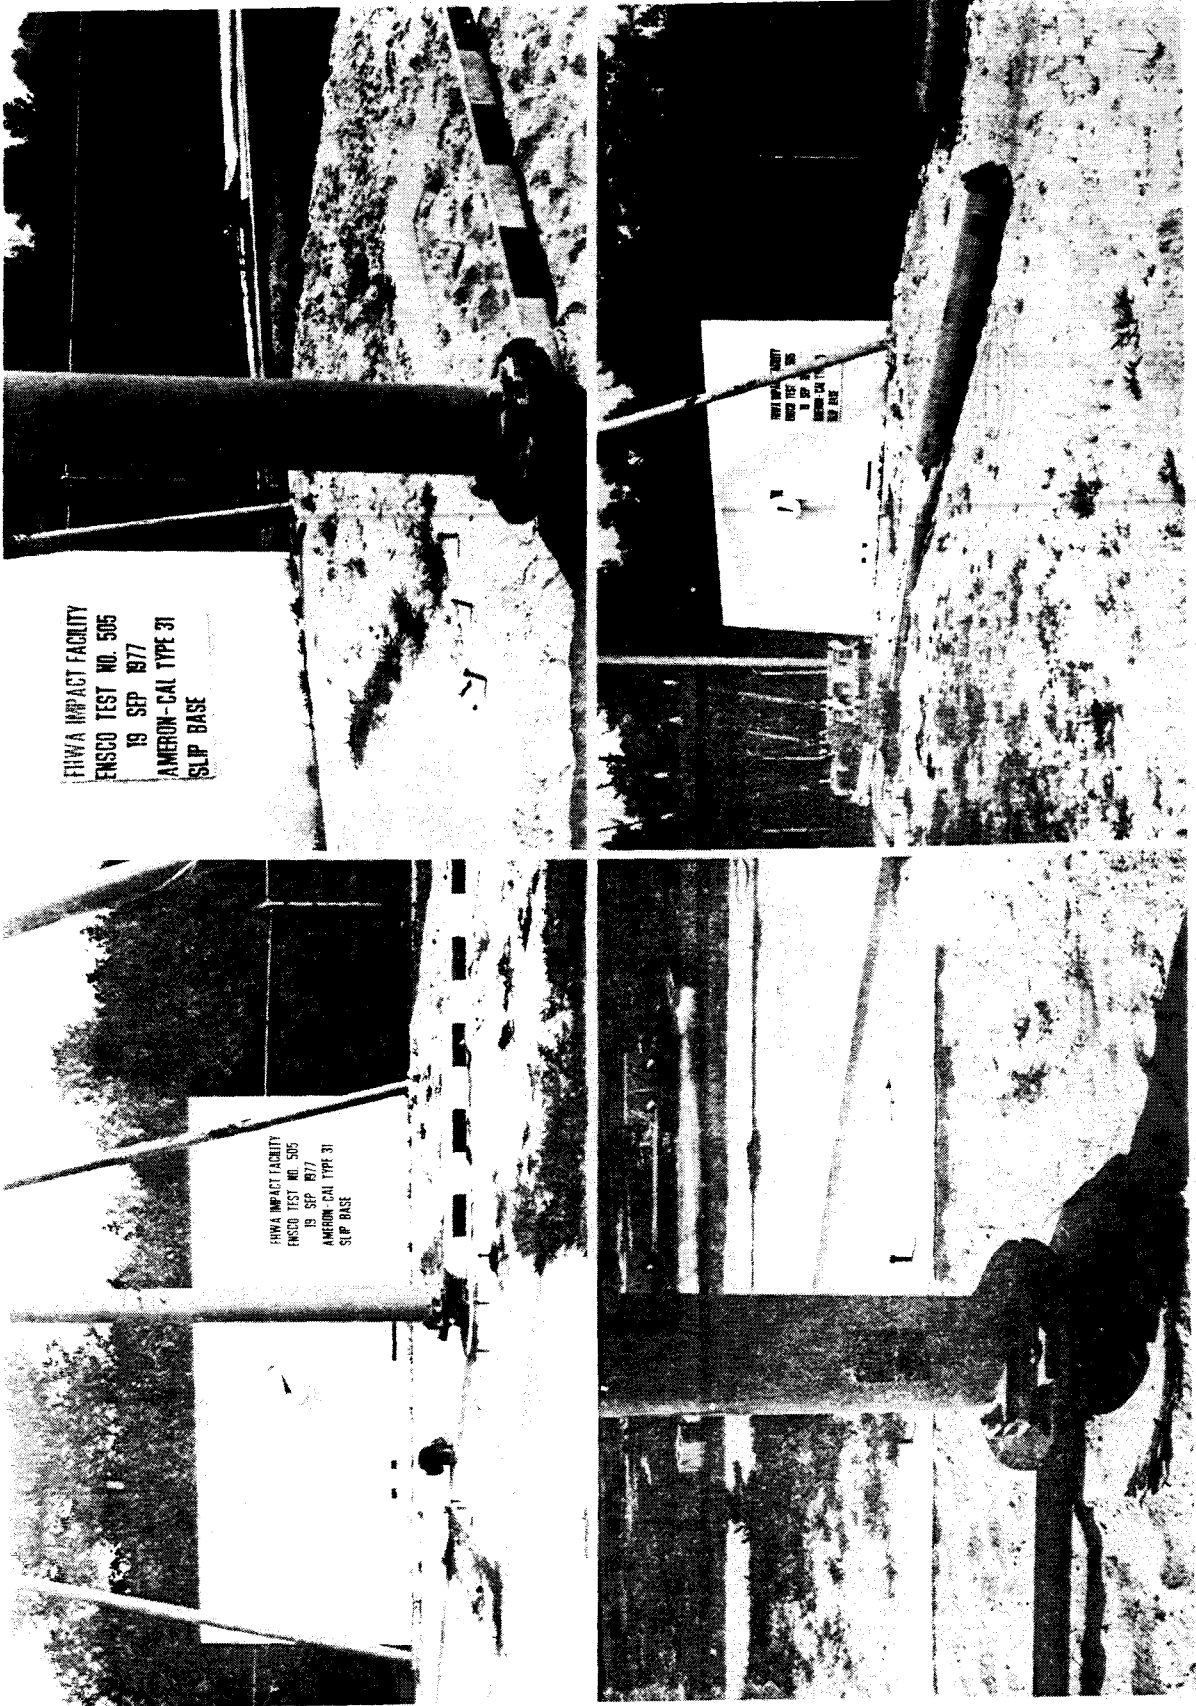
Fig. 41
Representative Photographs of Test 1147-505

Although no accelerometer traces were available from California Test 311 for comparison, the indications are that the two tests were very close to being equivalent. Photographs of the test, showing the test set-up and the pole after impact are shown in Fig. 41. Table 20 shows the result of Test 1147-505.

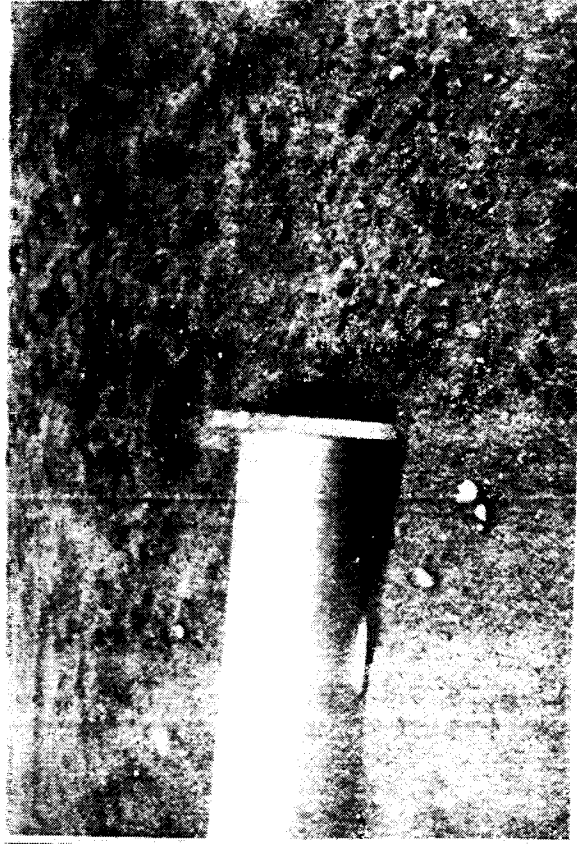
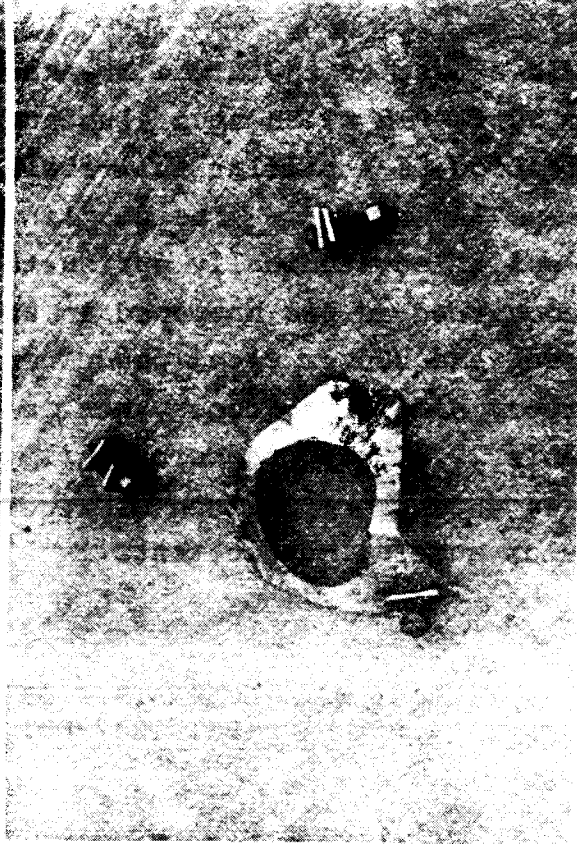
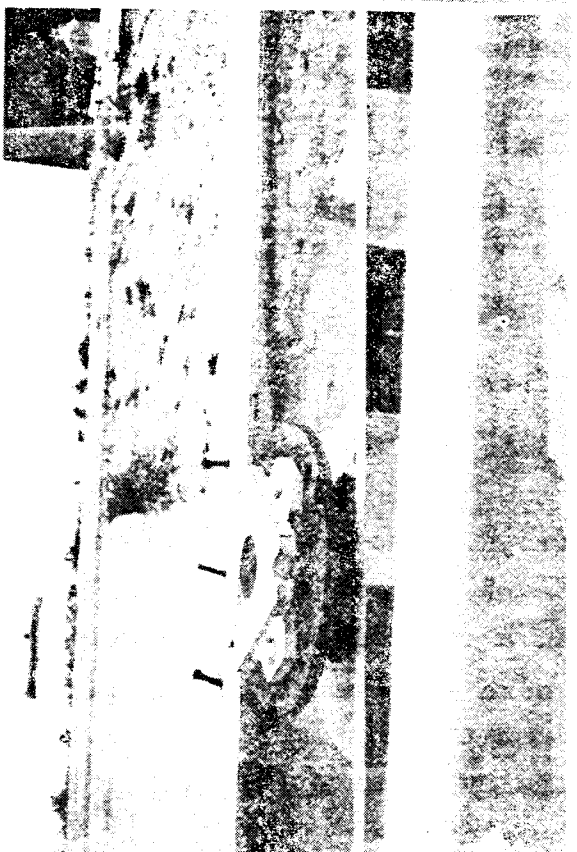
Fig. 42
Representative Photographs of Tests 1147-506 and 1147-507

Photographs showing the pole, mast arm, and simulated luminaire used in the tests are found in Fig. 42.

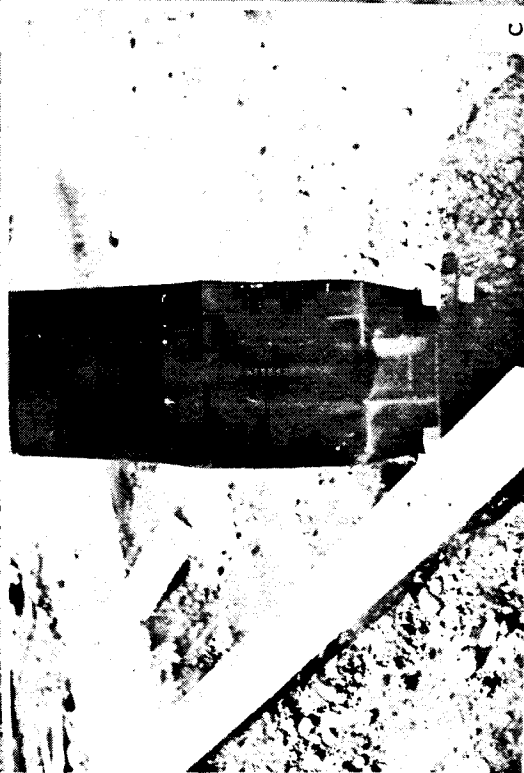
Fig. 51
Post-Test Photographs of Tests 1147-607 and 1147-608

The Test 1147-607 results showed the couplings breaking where designed, plus breaking two of the bolts that held them onto the foundation adaptor and also breaking two lugs off on the mounting flange of the pole. Besides destroying the pole the couplings caused a high momentum change. Figs. 51a and b show the impact results.

The test resulted in coupling breakage in the necked down area plus breaking two of the bolts that held them to the foundation adaptor. Failure of these bolts is analogous to the J-bolts in the foundation breaking. The pole was severely dented around the impact area. This can be seen in Figs. 51c and d. Table 28 presents the results for Tests 1147-607 and -608.

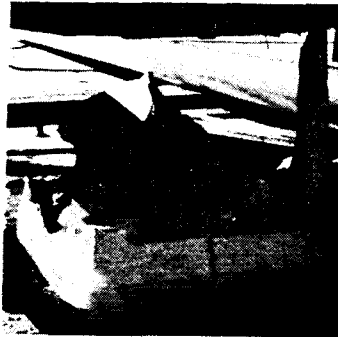
Test Description	:	Baseline
Pole Type	:	30 ft (9.2 m) aluminum
Mounting Washers	:	Al. trapezoidal
Base Failure	:	This base was completely destroyed by the impact, with the base being broken into 11 pieces. Fracture lines extended around the base at approximately 4 in (10.2 cm) up from the bottom and went diagonally up the sides
Momentum Change	:	2049 lb-sec (9114 Ns)
Peak Deceleration	:	17.7 g's
Honeycomb Crush	:	17 in (43.2 cm)
Sweeperplate Impact	:	No

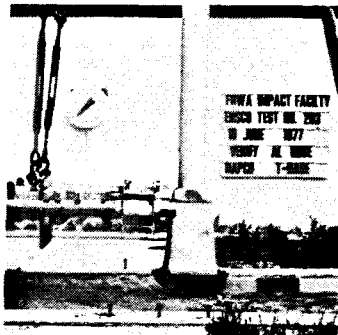
Test Description : Baseline
 Pole Type : 28 ft (8.5 m) aluminum pole
 Mounting Washers : Al. trapezoidal
 Special Test Features : None
 Base Failure : This base broke across the impact surface at about 4 in (10 cm) high. The break ran diagonally down toward the back of the base on each side. The front lugs were left on the foundation.

Momentum Change : 1532 lb-sec (6814 (Ns)
 Peak Deceleration : 22 g's
 Time to Peak Decel. : .070 sec
 Impact Duration : .120 sec
 Honeycomb Crush : 17 in (43.2 cm)
 Sweeperplate Impact : No

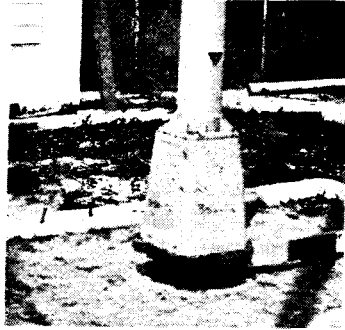
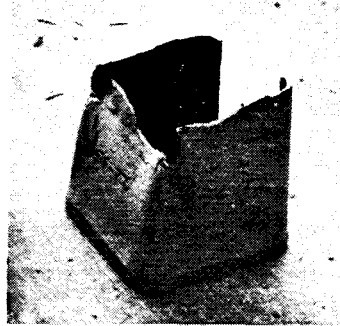
Test Description : Baseline
Pole Type : 28 ft (8.5 m) aluminum
Mounting Washers : Al. Trapezoidal
Special Test Features : None
Base Failure : The base fracture was very simple with one fracture going completely around the base at its mid-section. The bottom did not break away, thus it stopped the pendulum

Momentum Change : 2037 lb-sec (9061 Ns)
Peak Deceleration : 22 g's
Impact Duration : .063 sec
Time to Peak Decel. : .155 sec
Honeycomb Crush : 18 in (45.7 cm)
Sweeperplate Impact : No

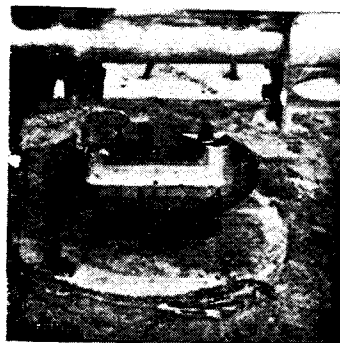
Test Description : Modified (1A4)
Modification : same as 215
Pole Type : 42 ft-6 in (13 m) aluminum
Mounting Washers : Al. trapezoidal
Special Test Features : None
This base failed when fracture allowed the front lugs to break free via the modification. Two of the three small panels between the side cuts were also broken away.

Momentum Change : 714 lb-sec (3176 Ns)
Peak Deceleration : 9.5 g's
Time to Peak Decel. : .068 sec
Impact Duration : .081 sec
Honeycomb Crush : 16.6 in (41.9 cm)
Sweeperplate Impact : No

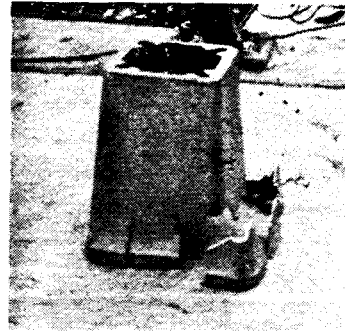
Test Description : Modified (1A4)
Modification : Same as 215
Pole Type : 42 ft-6 in (13 m) aluminum
Mounting Washers : Al. trapezoidal
Special Test Features : 45° hit
Base Failure : The front lug broke away via the modification. The two side lugs were broken in half and completely removed. All cuts made in the modification are activated.

Momentum Change : 965 lb-sec (4292 Ns)
Peak Deceleration : 19.0 g's

Time to Peak Decel.	: .060 sec
Impact Duration	: .095 sec
Honeycomb Crush	: 17.5 in (44.5 cm)
Sweeperplate Impact	: Yes

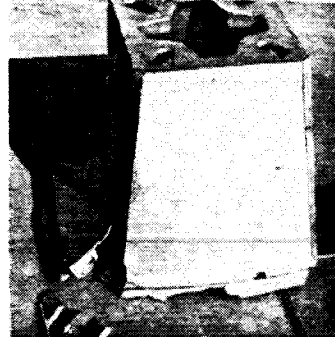
Test Description : Modified (1B5)
Modification : Closed mounting slots were opened
Pole Type : 36 ft (11 cm) aluminum
Mounting Washers : 3 in x 3/8 in (7.6 cm x .95 cm) thick round steel
Special Test Features : None
Base Failure : The base failed by breaking off the two front lugs and bending up the lower half of the upper section on the impact side. About 75% of the beltline weld was fractured.
Momentum Change: : 877 lb-sec (3901 Nm)
Peak Deceleration : 13.8 g's
Time to Peak Decel. : .061 sec
Impact Duration : .087 sec

Honeycomb Crush : 17.5 in (44.5 cm)
 Time to Peak Decel. : .061 sec
 Impact Duration : .087 sec
 Honeycomb Crush : 17.5 in (44.5 cm)
 Sweeperplate Impact : No

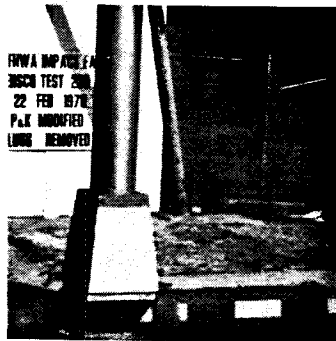
Test Description : Modified (1B5)
 Modification : Same as test 1147-232
 Pole Type : 36 ft (11.0 m) aluminum
 Mounting Washers : 3 in x 3/8 in (7.6 cm x .95 cm) thick round steel
 Special Test Features : None
 Base Failure : The beltline weld was completely fractured leaving most of the lower section on the foundation after the impact. The upper section was broken into several large pieces running from the weld to the top of the casting.

Momentum Change : 1084 lb-sec (4882 Ns)
 Peak Deceleration : 20.1 g's
 Time to Peak Decel. : .064 sec
 Impact Duration : .096 sec
 Honeycomb Crush : 17.5 in (44.5 cm)
 Sweeperplate Impact : Yes

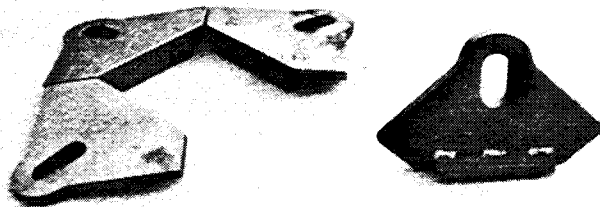
Fig. 62
Special Steel Clamps

(Fig. 62) were used to hold the base to the foundation. The four clamps were made to fit together in the bottom of the base and prevent movement once in place. A short sawcut was also made in each corner to act as a fracture starter. The T-base performed well in both tests with momentum changes of 665 lb-sec (2958 Ns) and 724 lb-sec (3220 Ns), respectively. Due to high manufacturing costs of this modification, additional modifications were investigated. In Test 1147-230 the corner sawcut was eliminated from the previous modification and resulted in a test that stopped the pendulum.

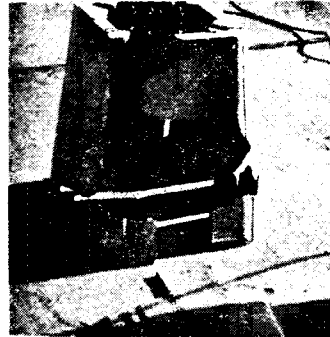
Test 1147-224

Test Description	:	Modified (1C1)
Modification	:	Same as Test 1147-223
Pole Type	:	45 ft (13.7 m) steel
Mounting Washers	:	2 in (5.1 cm) round steel
Special Test Features	:	Repeat of Test 1147-223
Base Failure	:	The fracture was similar to Test 1147-223. The base broke into several larger pieces. All cuts were activated and the front hold down lugs were left behind on the foundation.
Momentum Change	:	946 lb-sec (4208 Ns)
Peak Deceleration	:	20.5 g's
Time to Peak Decel.	:	.062 sec
Impact Duration	:	.095 sec

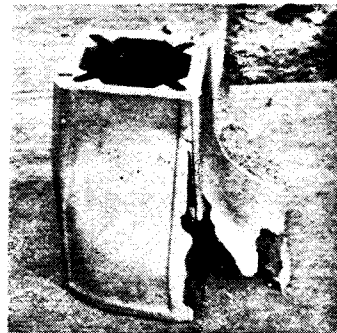
Test 1147-229

Test Description Modification : Modified (1C3)
: The mounting lugs were removed and saw cuts were made from the bottom of the lug to the inside edge of the casting. Special hold down clamps were fabricated to hold the base in place.

Special Test Features : None
Base Failure : Base impact resulted in a controlled failure. The front panel and one side panel broke away allowing the base to slide off the base and around the hold down clamps.

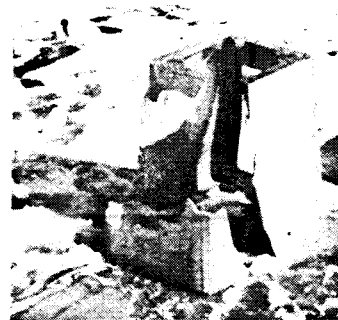
Test 1147-235

Test Description	: Modified (1C3)
Modification	: Same as Test 1147-229
Pole Type	: 45 ft (13.7 m) steel
Mounting Washers	: Special triangular steel clamps
Special Test Features	: Repeat of Test 1147-229
Base Failure	: The base failed very similarly to Test 1147-229.
Momentum Change	: 724 lb-sec (3220 Ns)
Peak Deceleration	: 10.6 g's
Time to Peak Decel.	: .064 sec
Impact Duration	: .076 sec
Honeycomb Crush	: 17 in (43.2 cm)
Sweeperplate Impact	: No

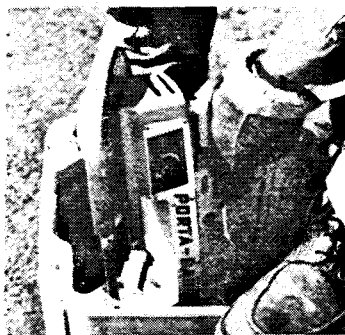
Test 1147-242

Test Description Modification : Modified (1C5)
: Each mounting lug was deepened to within $\frac{1}{2}$ in (1.3 cm) of the outside of the casting.

Special Test Features : None
Base Failure : The base failed as expected by breaking out the front panel via the deepened mounting slots. This allowed the base to slide off the foundation.

In Tests 1147-242 and -244 the anchor bolt slots were deepened to within $\frac{1}{2}$ in (1.27 cm) of the outside corner wall. Both tests gave similar results, with momentum changes of 992 lb-sec (4412 Ns) and 921 lb-sec (4097 Ns), respectively. In both cases the base fractured by breaking out the impact side panel starting at the deepened mounting slots. The fractures were controlled and repeatable. Although the momentum changes were above the desired level, the simplicity of the modification coupled with the repeatability of the fracture brought about the conclusion that this was the best modification.

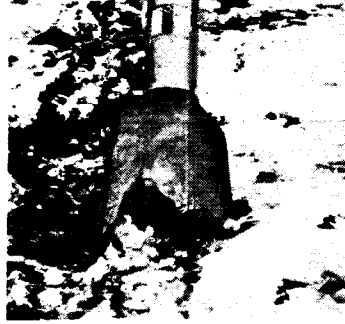
Test 1147-237

Test Description : Baseline
 Pole Type : 33 ft (10.1 m) aluminum
 Mounting Washer : 2 in (5.1 cm) round steel
 Special Test Features : Repeat of test 1147-236
 Base Failure : Very similar to Test 1147-236
 Momentum Change : 937 lb-sec (4168 Ns) (film data)
 Honeycomb Crush : 17.5 in (44.5 cm)

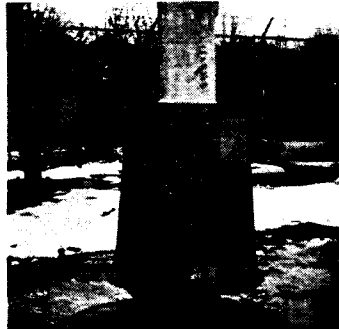
Test 1147-238

Test Description	: Modified (1D1)
Modification	: Two 3 in (7.6 cm) high vertical side cuts, 5½ in (14 cm) in from each corner on 3 sides with each cut terminated in a 3/8 in (9.5 mm) hole. (No cuts on the door side.)
Pole Type	: 33 ft-4 in (10.1 m) aluminum
Mounting Washers	: 2 in (5.1 cm) round steel
Special Test Features	: None
Base Failure	: The base failed by breaking around the front holddown lugs via the modification. One front lug was left on the foundation after the test. The base fractured around its circumference except between the side cuts. Large side sections were broken away.
Momentum Change	: 787 lb-sec (3501 Ns)
Peak Deceleration	: 7.6 g's
Time to Peak Decel.	: .055 sec
Impact Duration	: .086 sec
Honeycomb Crush	: 17.5 in (44.5 cm)
Sweeperplate Impact	: Yes

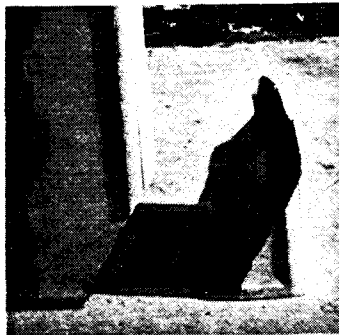
Test 1147-225

Test Description	:	Baseline
Pole Type	:	45 ft (13.7 m) steel
Mounting Washers	:	Special trapezoidal cast iron clamps
Special Test Features	:	Repeat of Test 1147-221
Base Failure	:	Similar to Test 1147-221
Momentum Change	:	672 lb-sec (2989 Ns)
Peak Deceleration	:	10.4 g's
Time to Peak Decel.	:	.059 sec
Impact Duration	:	.080 sec
Honeycomb Crush	:	17.0 in (43.2 cm)
Sweeperplate Impact	:	No

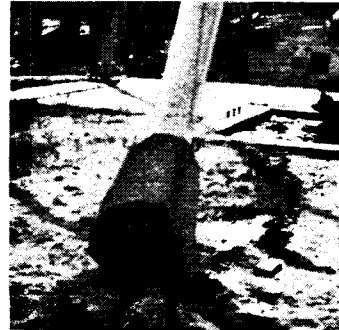
Test Description	: Baseline
Pole Type	: 50 ft-9 in (15.5 m) aluminum
Mounting Washers	: Al. Trapezoidal
Special Test Features	: None
Base Failure	: This base failed very similarly to Test 1147-245. The front panel broke away with the fracture running just around each front corner. This is a repeatable failure.

Momentum Change : 948 lb-sec (4217 Ns)
 Peak Deceleration : 24.7 g's
 Time to Peak Decel. : .067 sec
 Impact Duration : .077 sec
 Honeycomb Crush : 17.5 in (44.5 cm)
 Sweeperplate Impact : Yes

In Test 1147-246 the fracture lines were similar to Test 1147-245. The lower section of the front panel broke off about 6 in (15.2 cm) up from the base. The fracture started on each side about 2 in (5.1 cm) from the front mounting lugs, ran diagonally up and over the mounting lugs, and across the front. This section was broken by the sweeperplate at 3 in (7.6 cm) up. The momentum change for this test was 948 lb-sec (4217 Ns).

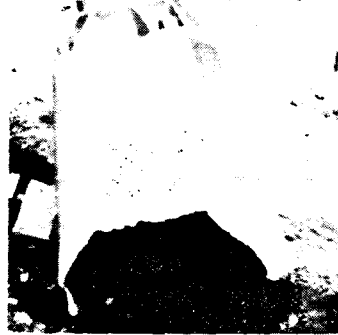
Test Description : Modified (2A1)
 Modification : Each mounting lug was deepened so it was within 1-1/8 in (2.9 cm) of the outside edge of the casting.
 Pole Type : 50 ft-9 in (15.5 m) aluminum
 Mounting Washer : Al. trapezoidal
 Special Test Features : None
 Base Failure : Here again as in both baseline tests, the fracture was across the front panel but in the test it ran through the deepened mounting slots instead of around them.
 Momentum Change : 1060 lb-sec (4715 Nm)
 Peak Deceleration : 22.2 g's
 Time to Peak Decel. : .067 sec
 Impact Duration : .083 sec
 Honeycomb Crush : 17.5 in (44.5 cm)
 Sweeperplate Impact : No

Test 1147-249 was a test of a modified type 2A base. The anchor bolt slots were deepened to within approximately 1-1/8 in (2.9 cm) from the outside edge. This test was run in an attempt to improve an already acceptable base, but showed no improvement on the momentum change when compared with the base line tests. The momentum change increased as a result of a higher peak deceleration which has not been understood at this time. Fracture was as expected with the impacted side breaking through the deepened mounting lugs. The fracture ran across this side about 4 in (10.2 cm) up from the base plate. There was no sweeperplate impact in this test.

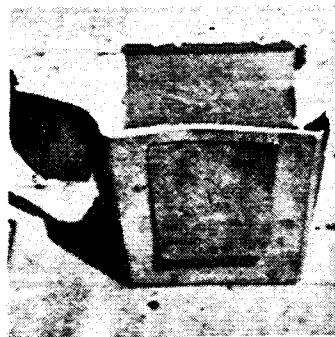
Test 1147-248

Test Description	: Modified (2B1)
Modification	: Opened mounting lugs and 8 bottom flange cuts which were 5½ in (14 cm) in from the corners and extended to the inside edge of the casting.
Pole Type	: 50 ft-9 in (15.5m) aluminum
Mounting Washers	: 3 in dia x 3/8 in (7.6 cm x 1.0 cm) thick round steel
Special Test Features	: None
Base Failure	: The front half of the lower section fractured via the side flange cuts. This allowed the base to slide off the foundation. The upper section stayed intact.

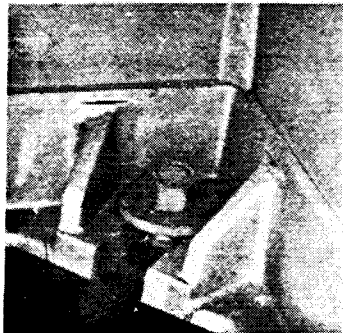
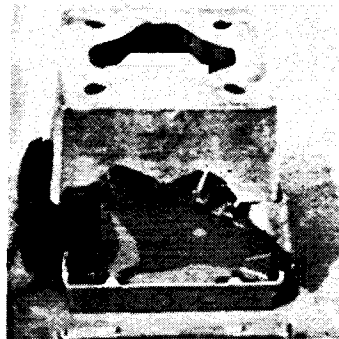
Test 1147-265

Test Description : Modified (2B2)
Modification : Mounting lugs were opened.
Each mounting lug received a cut from the bottom of the lug to the inside edge of the casting. Eight flange cuts (two per side) were made 5½ in (14 cm) in from the corner.
Pole Type : 50 ft-9 in (15.5 m) aluminum
Mounting Washers : 3 in dia x 3/8 in (7.6 cm x .95 cm) thick steel
Special Test Features : None
Base Failure : Base failed as expected. The front lugs broke through the opened and cut lugs and around the impact side. The back lugs twisted in, allowing the base to slide off the foundation.
Momentum Change : 833 lb-sec (3705 Ns)
Peak Deceleration : 18.9 g's
Time to Peak Decel. : .062 sec
Impact Duration : .080 sec
Honeycomb Crush : 17.5 in (44.5 cm)
Sweeperplate Impact : Yes

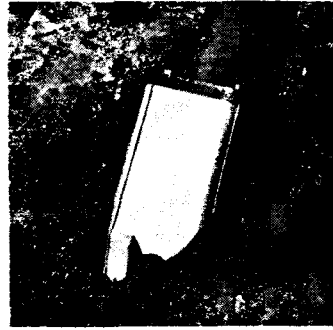
Test 1147-239

Test Description Modification	: Modified (3A2) : Each anchor bolt slot was deepened to within $\frac{1}{2}$ in (1.3 cm) of the outside edge of the casting.
Pole Type	: 45 ft (13.7 m) steel
Mounting Washers	: 2 in dia. (5.1 cm) steel
Special Test Features	: None
Base Failure	: The base failed as expected by breaking out the front panel through the corners via the deepened mounting lugs. The back of the base broke out one lug then twisted and slid off the foundation. This was a very controlled failure.
Momentum Change	: 705 lb-sec (3136 Ns)
Peak Deceleration	: 10 g's
Time to Peak Decel.	: .060 sec
Impact Duration	: .087 sec
Honeycomb Crush	: 17.5 in (44.5 cm)
Sweeperplate Impact	: No
Static Load	: 33,790 lb-ft (45819 Nm) (Test 1147-S205)
Static Failure	: The base failed by breaking out the top pole mounting lug which was in tension. The modified static load was 97% of the base line tests.
Fatigue Life	: Greater than 35,264 cycles (Test 1147-F207)

Fatigue Failure	: There was no failure at 35,264 cycles.

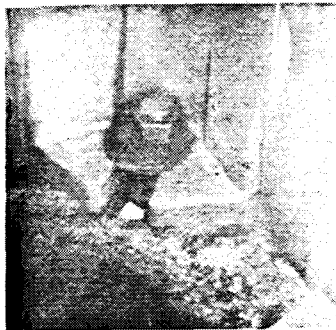
Test 1147-256

Test Description	: Modified (3A2)
Modification	: Same as Test 1147-239
Pole Type	: 42 ft-6 in (13 m) aluminum
Mounting Washers	: Special "off center hole" round steel

: Repeat of Test 1147-251
: Failure was not as expected since the front lugs did not split open through the deepened lugs. One back lug split open while both broke off the base. The base was generally deformed.

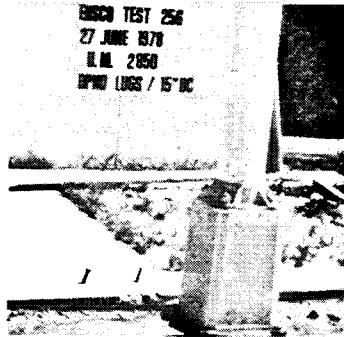
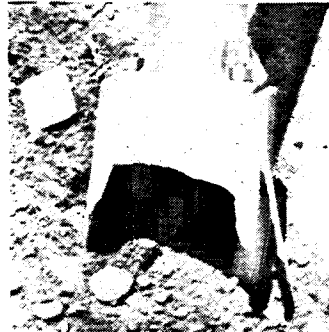
Test 1147-258

: Modified (3A2)
: Same as Test 1147-239
: 42 ft-6 in (13 m) aluminum
: 2 in (5.1 cm) round steel
: 45° hit
: The base failed as expected with the front lug splitting up the corner. The half of the two side lugs which resisted impact broke away. This was a very controlled impact.

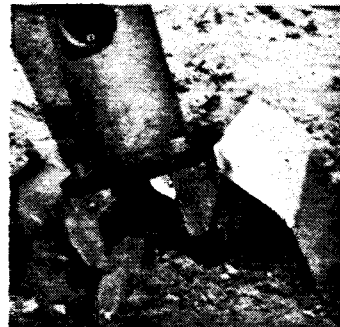
Test Description : Prototype Baseline
Pole Type : 47 ft (14.3 m) galvanized steel
Mounting Washers : 2 in x 3 in x $\frac{1}{4}$ in (5.1 x 7.6 x .63 cm) rectangular steel
Special Test Features : None
Base Failure : Similar to 1147-261
Momentum Change : 1619 lb-sec (7201 Ns)
Peak Deceleration : 20.6 g's
Time to Peak Decel. : .064 sec
Impact Duration : .174 sec
Honeycomb Crush : 17.5 in (44.5 cm)
Sweeperplate Impact : No

In Test 1147-261 the impact resulted in all four corners breaking off about 2 in (5.1 cm) from the bottom of the base plus three of the four corners also breaking just below the top. The momentum change was 1113 lb-sec (4951 Ns). In Test 1147-262 the failure was similar with a momentum change of 1617 lb-sec (7192 Ns).

The poor performance was a result of the ductility of the base which could literally "bend over" without fracturing, thus absorbing more energy than the typical brittle T-base. The failure was similar in character to the first modified Hapco 45964 (1A1), Test 1147-204.

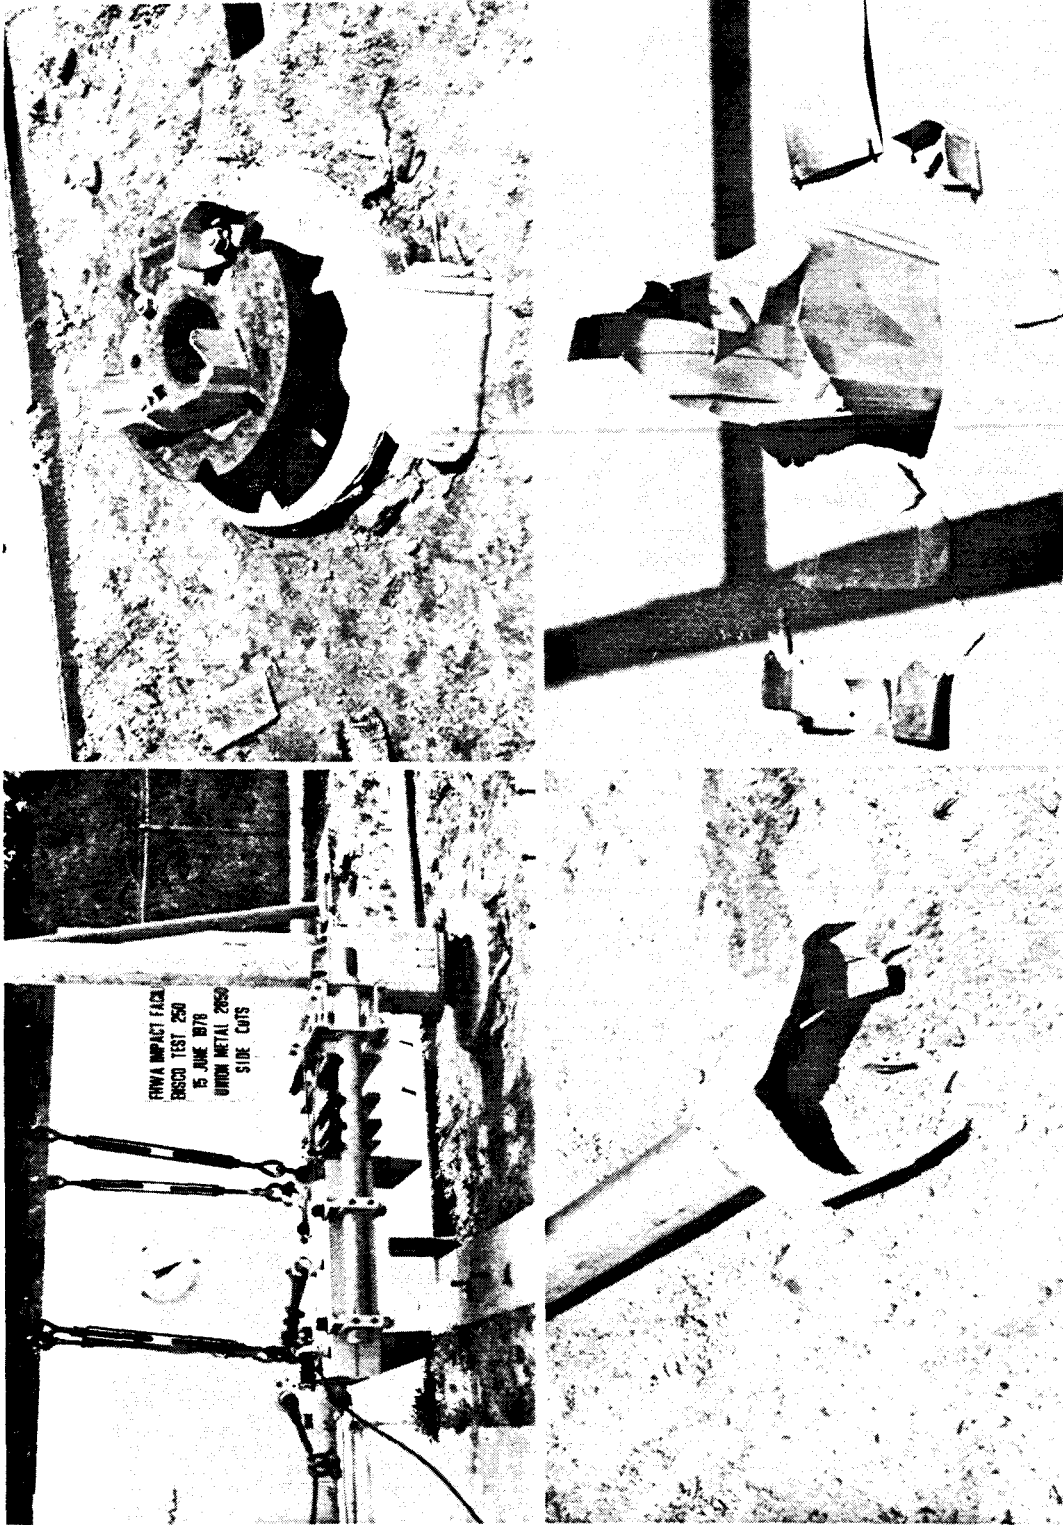
Fig. 63
Representative Photographs of Test 1147-250 0

The first concept to be tested (Test 1147-250) was a variation of the vertical side cut modification. In essence, the cuts were not continued through to the bottom of the base. To modify the base, two 3/8 in (.95 cm) dia. holes were made approximately 5 in (9.7 cm) in from each edge. One hole was at a height of 4 in (10.2 cm), the other at a height of 1 in (2.5 cm) from the bottom. Then the holes were connected with a saw cut made using a reciprocating saw. This modification was made on a Union Metal 2850 base (type 3A). (See Fig. 63.)

The results of Test 1147-250 were encouraging, however, further testing is required. A momentum change of 932 lb-sec (4146 Ns) was recorded which is lower than that found on the same modification made all the way through the bottom, 1058 lb-sec (4706 Ns). This leaves open the question of what the data scatter would be. The encouraging part was that the failure mechanism worked as intended, with the crack originating at a side cut and continuing around the impact face to the other side cut.

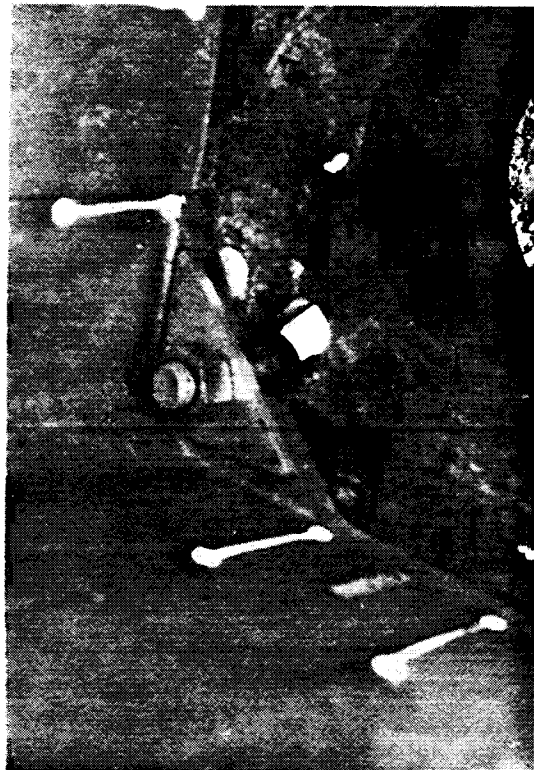
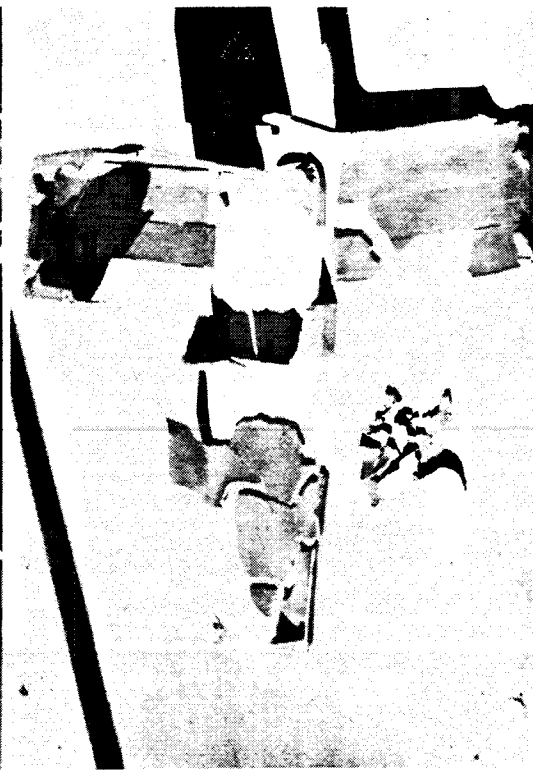
Fig. 64
Representative Photographs of Test 1147-252

The same modification was also tested on a Hapco 45964 T-base (see Fig. 64). Since this is the base that worked so well when the cuts extended through the bottom, it was believed that this retrofit modification would also work. The results were not as expected. The fracture was basically uncontrolled. Although the front lower corners did break out and were left on the foundation, the rest of the base was shattered into many pieces. It is believed that a very high force was required to initiate the corner tear out which caused the extensive damage. The high force level can be verified by the 23.8 g's peak deceleration level. The momentum change in Test 1147-252, was 1258 lb-sec (5596 Ns). The reason for the high force level in this test as compared to Test 1147-258 is believed to be due to the much thicker section at the bottom of the base on the Hapco design. If the cuts had been made 1½ in (3.9 cm) closer to the center, the thinner section may have provided easier fracture.
