LABORATORY EVALUATION OF EXISTING BREAKAWAY STRUCTURES

Vol. 2. Technical Results

Prepared for
FEDERAL HIGHWAY ADMINISTRATION
Offices of Research & Development
Structures & Applied Mechanics Division
Washington, D.C. 20590

1. Report No. FHWA-RD-79-140		2. Government Accession No.		PB81-153769

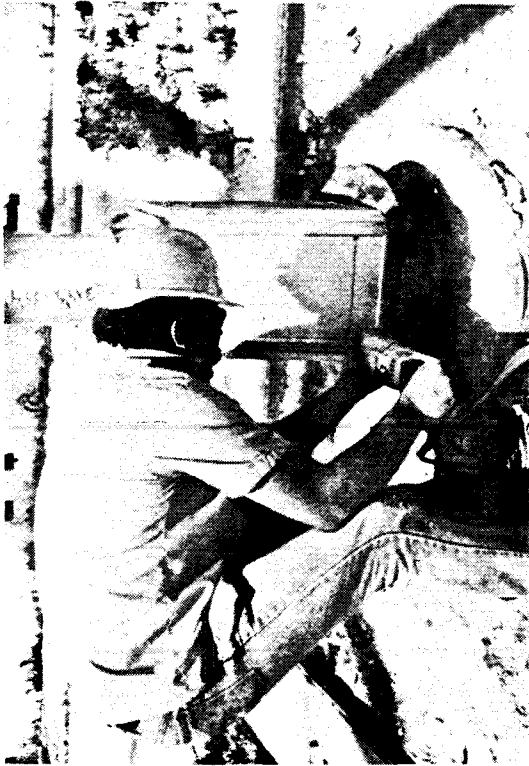
Fig. 66
Representative Photographs of Test 1147-254

The third retrofit concept, tested in Test 1147-254 on a Union Metal 2850 base consisted of horizontal saw cuts centered on three sides (not on the door side). The cuts were made at a height of 3½ in (8.9 cm) and were 9-3/4 in (25 cm) long. The saw cut was terminated with a 3/8 in (.98 cm) dia. hole on each end. This modification is shown in Fig. 66. From a breakaway standpoint this modification was excellent. The fracture ran completely around the base at the saw cut height. The momentum change was 591 lb-sec (2629 Ns) with a peak deceleration of 8.2 g's. However, the static strength of the base was reduced to 16,090 lb-ft (21818 Nm) which is 46% of the original strength.

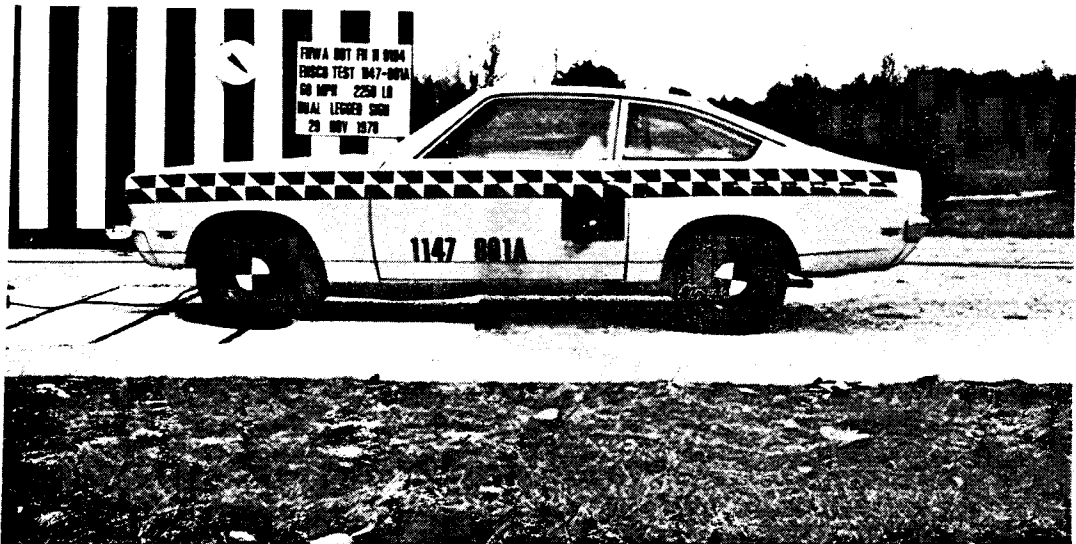
Fig. 72
Representative Pre-test Photographs of Test 1147-801A

In Tests 1147-801A and -802, 1973 Chevrolet Vegas were impacted into a breakaway dual-legged sign. The sign design was taken from Texas state plans and consisted of a reinforced 5/8 in (1.6 cm) thick plywood sign blank measuring 10 ft high by 15 ft wide (3 m x 4.5 m) mounted on 8WF20 breakaway supports. This sign design is shown in Fig. 71 for more details.

Table 31 summarizes the results from the test. Representative test photos are shown in Fig. 72 through 74.

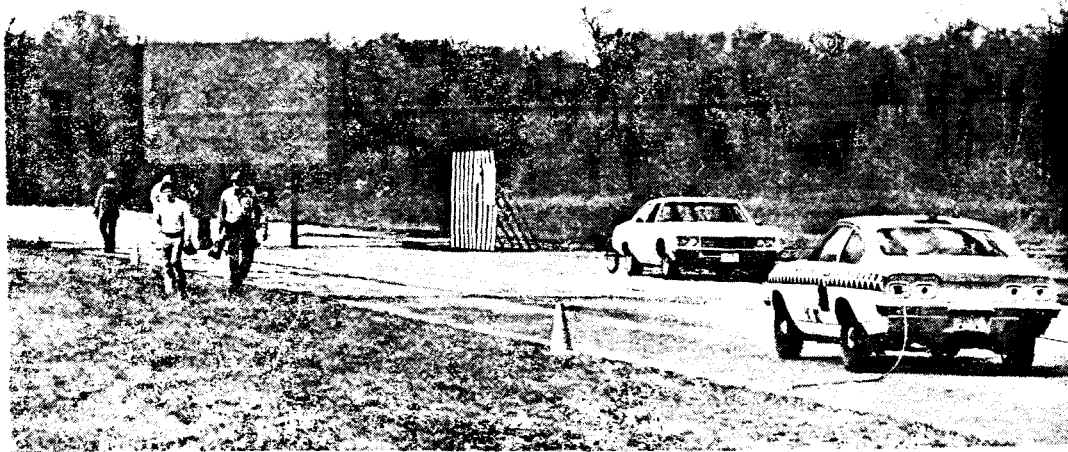
Fig. 75
Pre-test and Test Photographs from Test 1147-802

The results of this test are also summarized in Table 31. Test photographs are shown in Fig. 75 through 77.

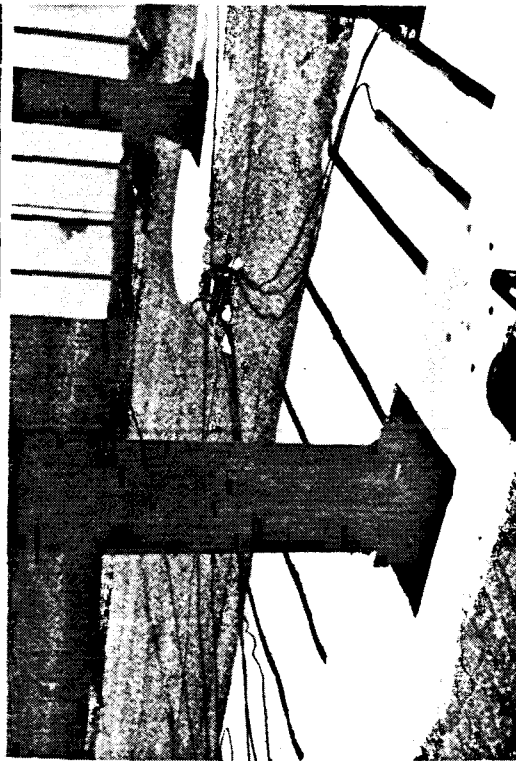
Fig. 81
Representative Pre-test Photographs of Test 1147-1008

Test photographs are shown in Figs. 81 and 82.

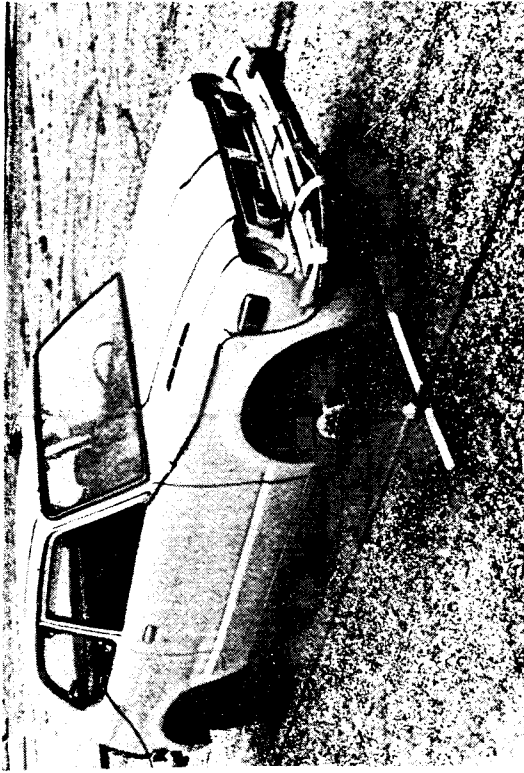
Fig. 83
Representative Pre-test Photographs of Test 1147-1009

The breakaway sign leg functioned as it did in the previous Test 1147-1008. The hinge opened more than 90° allowing the car to pass without secondary collision. Photographs of this test can be found in Figs. 83 and 84.

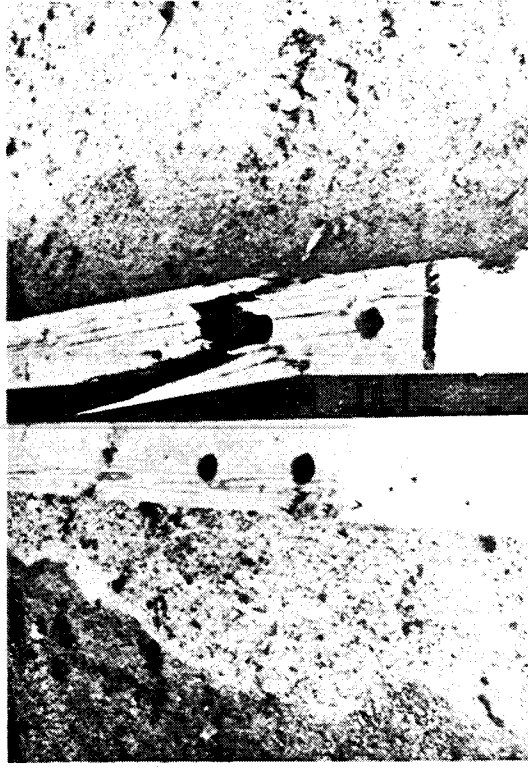
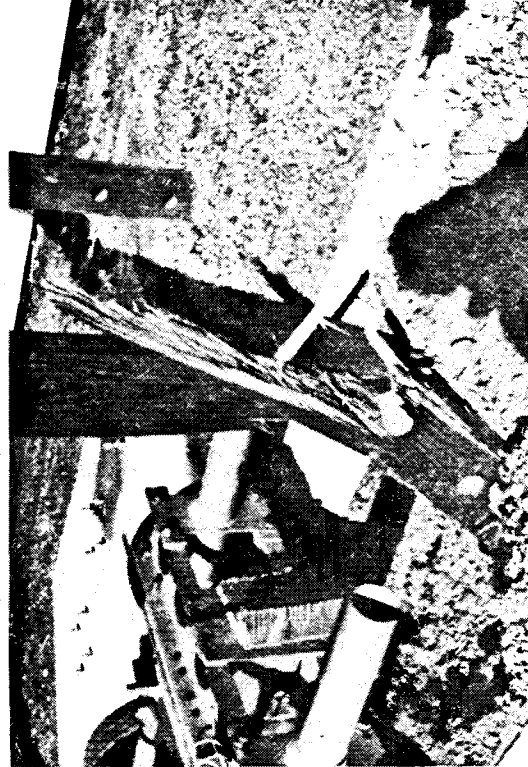
Fig. 90
Representative Photographs of Test 1147-902

This test is on a Union Metal 3-bolt slip base luminaire support. The support was a 35 ft MH steel pole with a 14 in (35.6 cm) lower bolt circle. The slip base bolts were loaded to 15,000 lbs (66,720 N). This test is very similar to ENSCO Test 1147-125 with the pendulum and TTI Test D15 with a Vega sub-compact car.

The results of the test were as expected with the pole sliding off the mounting base. The sweeperplate did hit the leading slip base bolt which caused an additional 55 lb-sec (245 Ns) momentum change according to the accelerometer trace.

Photographs of the test are found in Fig. 90. Test results are given in Table 35.

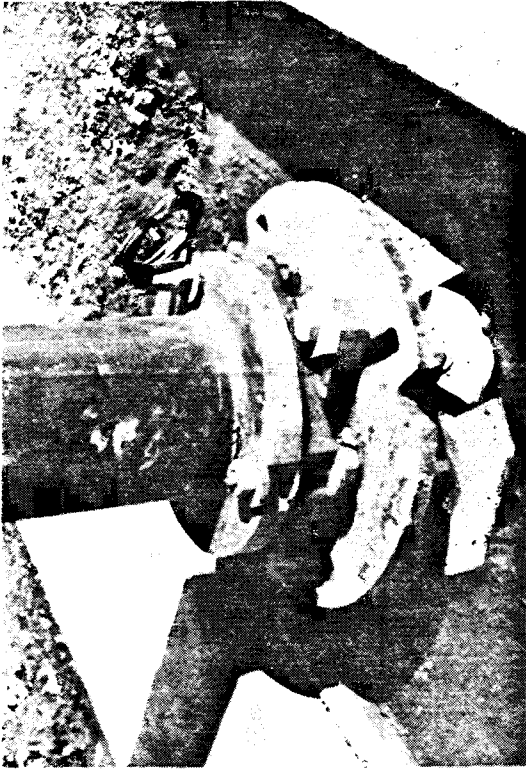
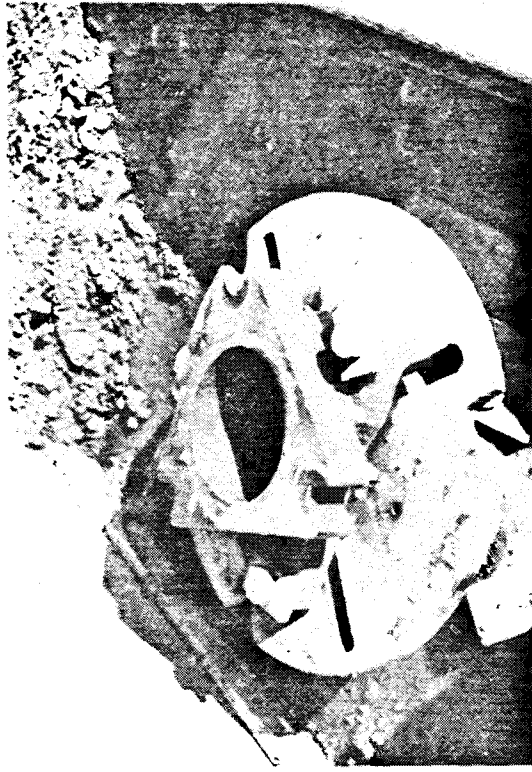
Fig. 92
Representative Photographs of Test 1147-903

Fig. 91 shows the accelerometer traces of the Bogie Test (1147-903), the Pendulum Test (1147-125) and Full-Scale Vega Test (TTI D15). Fig. 92 shows test photographs and Table 36 gives results of the three related tests.

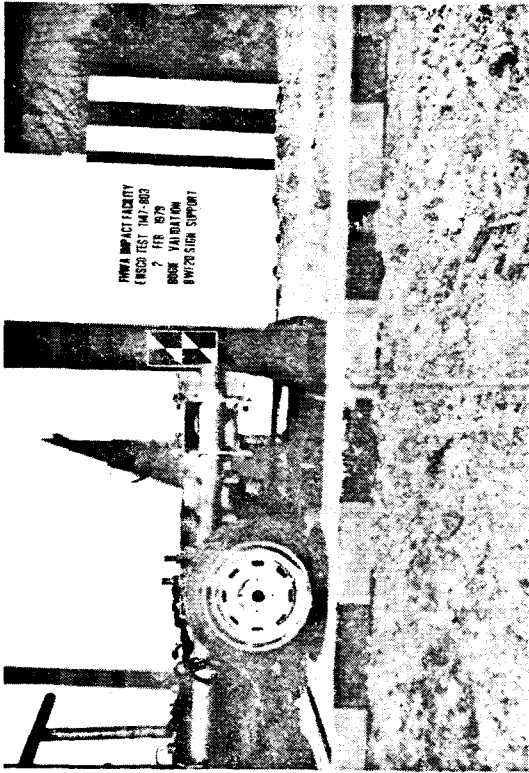
Fig. 93
Representative Photographs of Test 1147-803

Test 1147-803 was the first bogie test utilizing a dual-legged sign support with steel legs. This sign is made of a 10 ft x 15 ft x 5/8 in (3 m x 4.5 m x 1.6 cm) plywood blank, 4 aluminum stiffeners and 2 steel 8WF20 legs as shown in Fig. 78. Photographs of the sign, leg, and bogie to sign interface are shown in Fig. 93. This is the same sign leg system used in full-scale Tests 1147-801A and -802.

The impact of the support was as expected with the bogie honey-comb nose crushing followed by slip base activation and then hinge activation. Hinge activation occurred after the bogie lost contact with the support. The sign then rotated about the standing leg breaking away the aluminum clips and bolts which held it to the leg. The bogie veered off to the left during impact and was then stopped using the onboard braking system. Photographs of the sign following the test are presented in Fig. 93.
