Pavement Condition Survey using Drone Technology

Report 23-12

June 2023

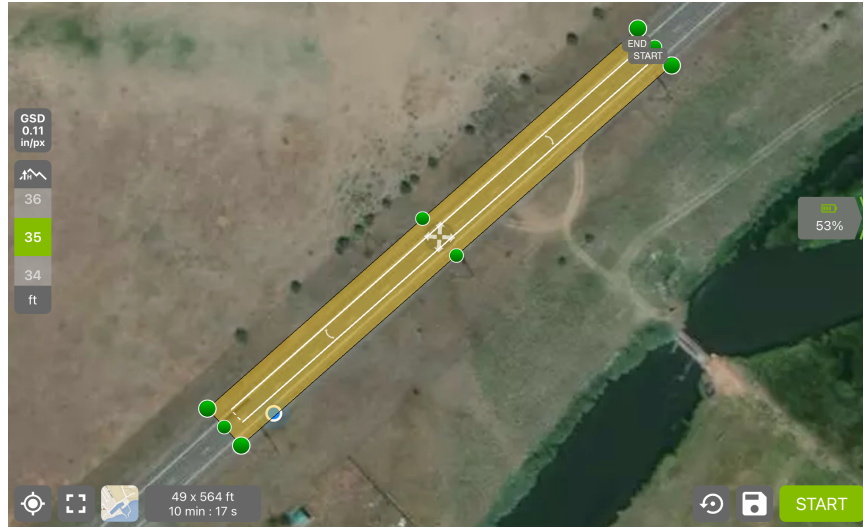
Figure 1. Flight Plan for PES

Prior to performing the drone survey, a flight plan, as shown in Figure 1, must be established by the drone pilot. The flight plan requires checking for weather conditions on the day and time of flight and coordination between the surveyors, drone pilot, and any agencies that are involved. An onsite review should be performed by the drone pilot to determine if there are any obstacles or hazards.

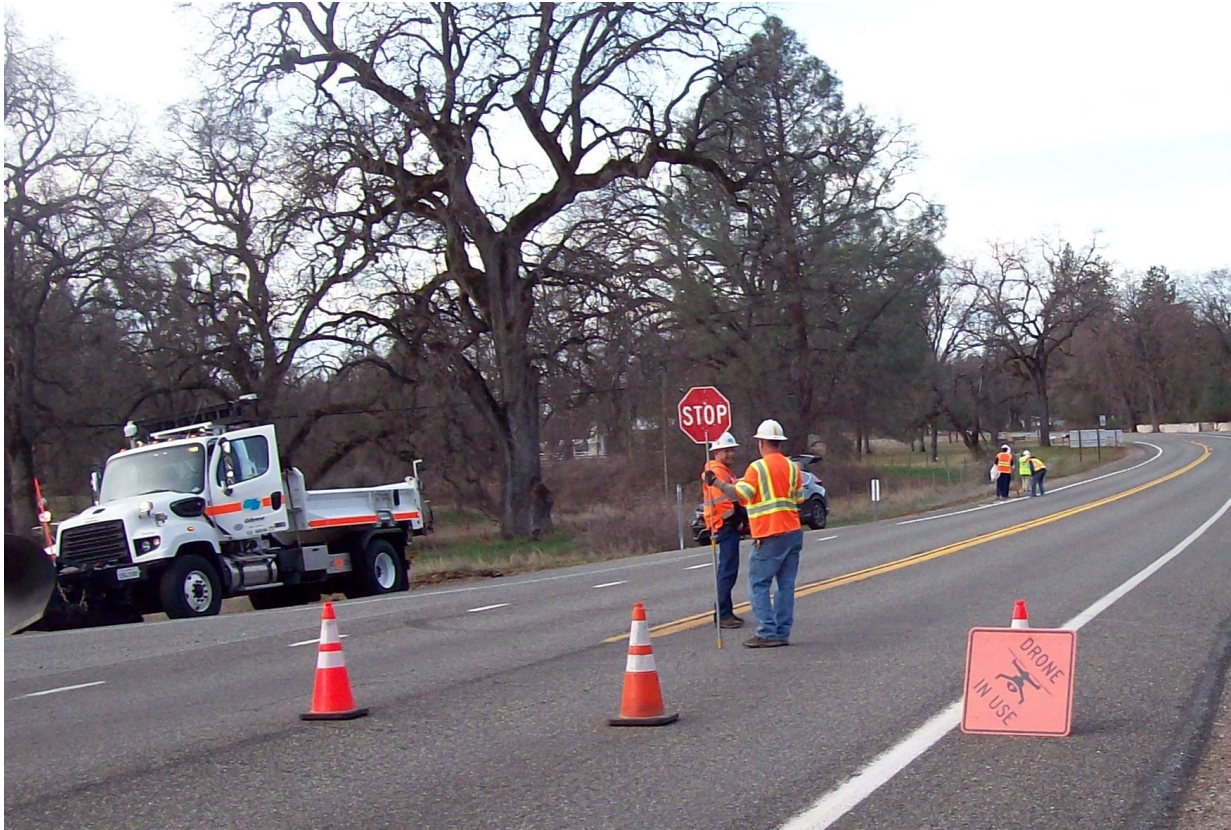
Figure 2. Caltrans Traffic Control for PES Drone Survey

Signing for motorists identifying a drone operation were placed in addition to the traffic control signs. GCPs were placed at increments of 25–50 feet on each PES. Some comparisons were done with the manual surveys on PESs on SR 36 in Tehama County. Figure 2 shows Caltrans traffic control for the CP² Center’s drone survey. The CP² Center’s staff is laying out the GCPs for a PES in the background.

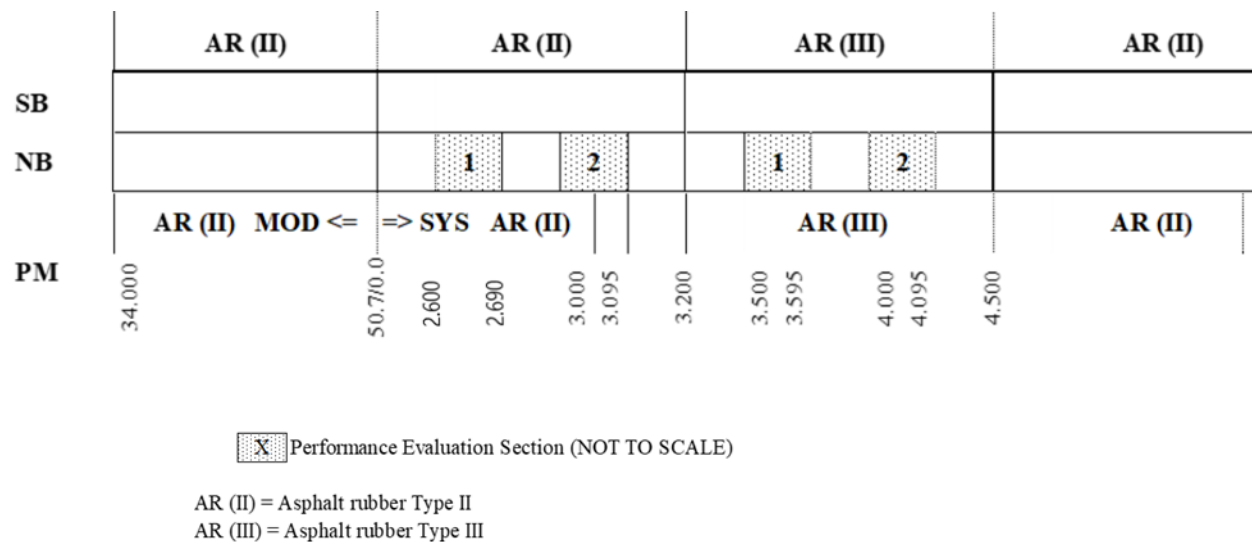
Figure 3. PES Locations for Asphalt Rubber Chip Test Strips on SR 139 (02-1J5204)⁸

This pilot project includes four test sections as shown in **Figure 3**. Within each test section, two PESs were established for the AR (Type II) and the AR (Type III) for performance monitoring. Each PES is 500 feet long, and the existing condition of each PES was evaluated by the CP² Center with detailed crack mapping and photographs.

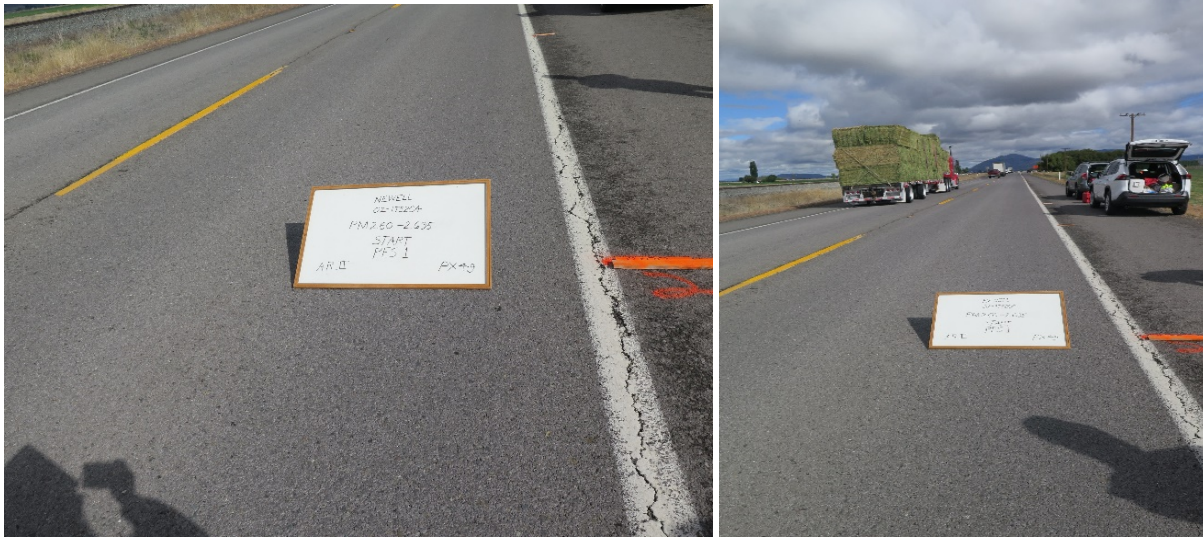
Figure 4. Ground Photos (Lt.) Start PES 1 AR (Type II) Identification Board, (Rt.) Looking North

Figure 4 shows the ground photos of the start of PES 1 AR (Type II) with the identification board.

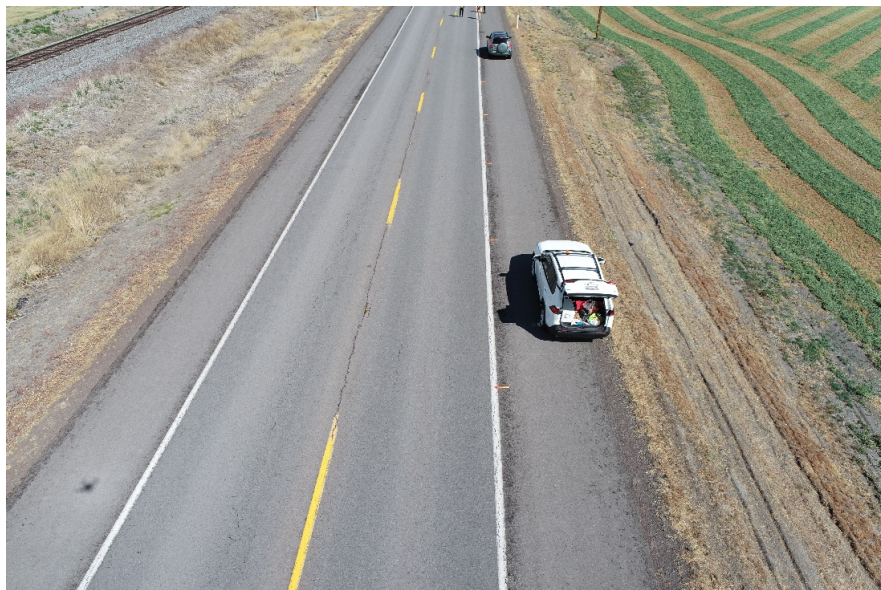
Figure 5. PES 1 AR (Type II) Right Lane Drone Photo Looking North from PM 2.6⁸

Figure 5 shows PES 1 AR (Type II) a right lane photo looking north from PM 2.6 from the overhead drone. Figure 6 in the left photo shows PES 1 AR (Type II) lane drone photo between Station 1+00 and 1+25, and the right ground photo at Station 1+50. The fatigue cracking is much more apparent from the overhead drone photo than the ground photo taken from the right side of the lane.

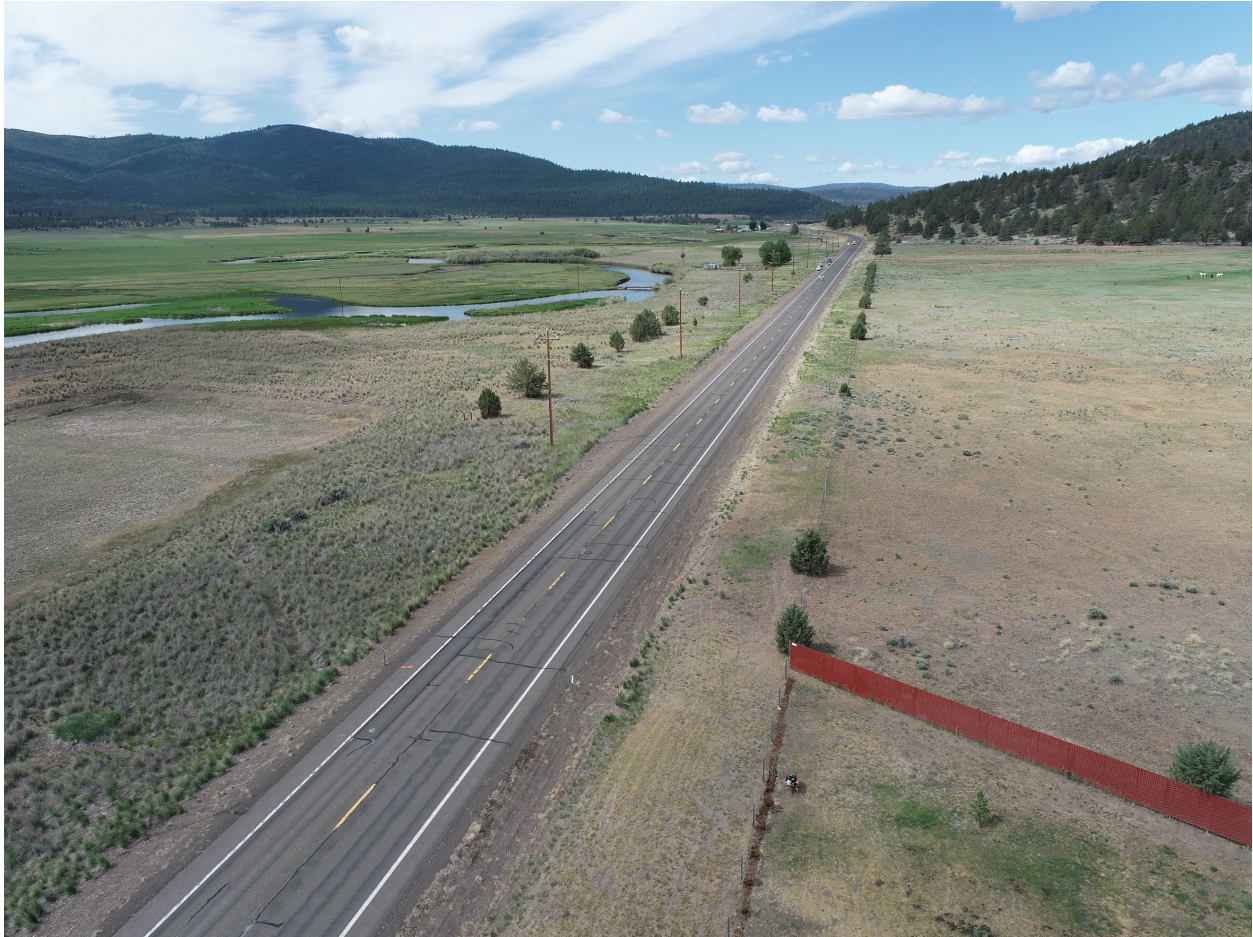
Figure 11. Drone Overview (Raw photo) of PES 1 AR (Type II), and PES 1 AR (Type III)
Look West Prior to Construction of Chip Seal Coats⁹

Figure 11 shows an overhead drone photo looking west covering the area of both PES 1 AR (Type II) and PES 1 AR (Type III) prior to construction of the chip seal coats.

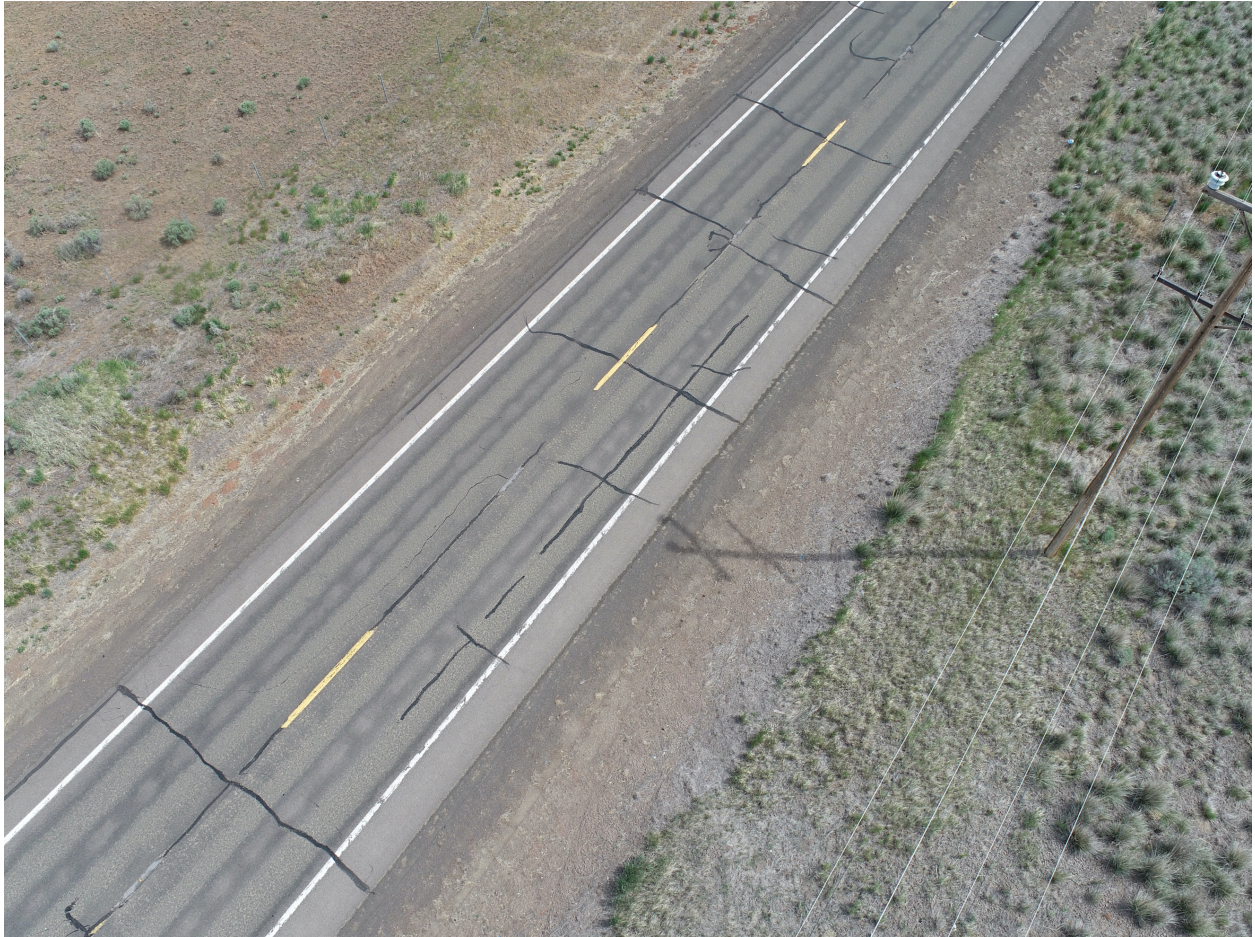
Figure 12. Raw Drone Photo Showing Typical Highway Distresses⁹

Figure 12 is a raw drone photo showing the typical highway distresses for this section of SR 299 near Canby, CA. The rutting and rock loss from chain wear shows, as well as the transverse thermal cracking and longitudinal cracking. Canby is in a high desert environment in northern California.

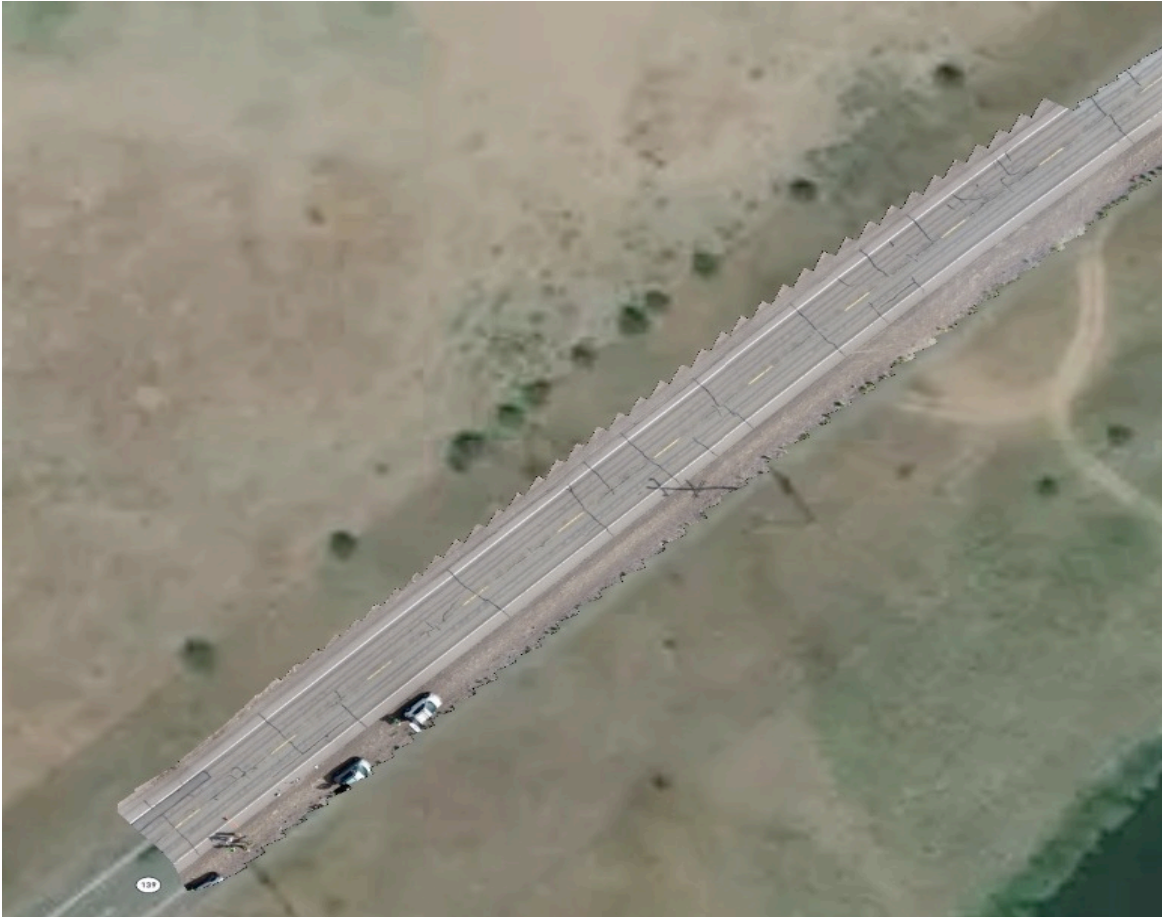
Figure 13. Stitched Photo of PES 1 AR(II)

Figure 13 is a stitched photo showing PES 1 AR(II). The distresses are also apparent in the stitched photo. With proper overlap of the raw photos, the stitched photo may appear clearer than the raw photos. Recommended photo overlap may be as much as 80 percent.

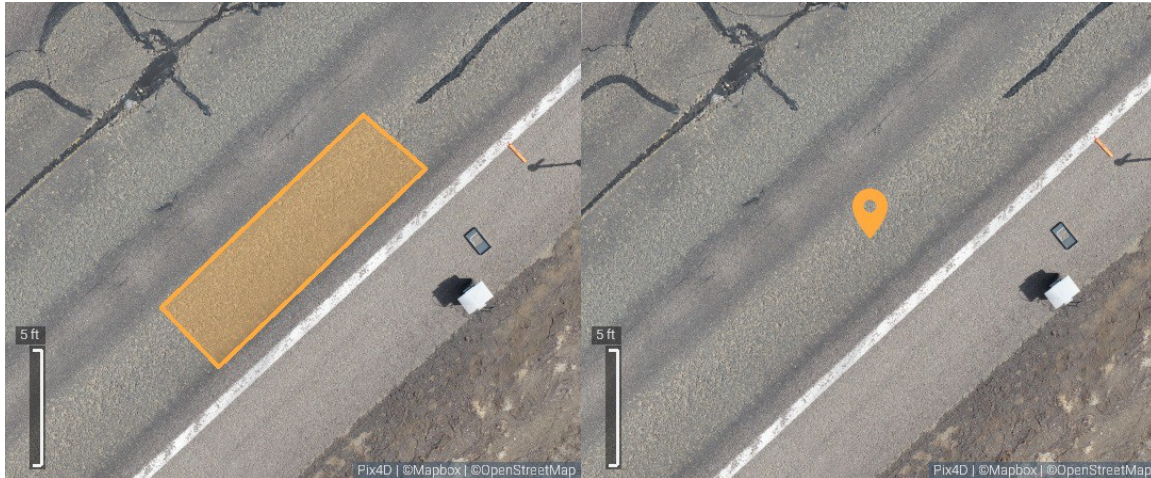
Figure 14. (Lt.) Rutting Area of 37.769 Ft² as Annotated with PIX4D Software, (Rt) Location: 41.4258291, -120.8965235, US National Grid Reference: 10T FL 75767 88165⁹

In Figure 14, the left photo shows a depicted rutting area of 37.769 ft² as annotated with PIX4D software. The right photo shows the latitude and longitudinal location as 41.4258291, -120.8965235, based on the US National Grid Reference: 10T FL 75767 88165. This is typical information captured in a drone survey.

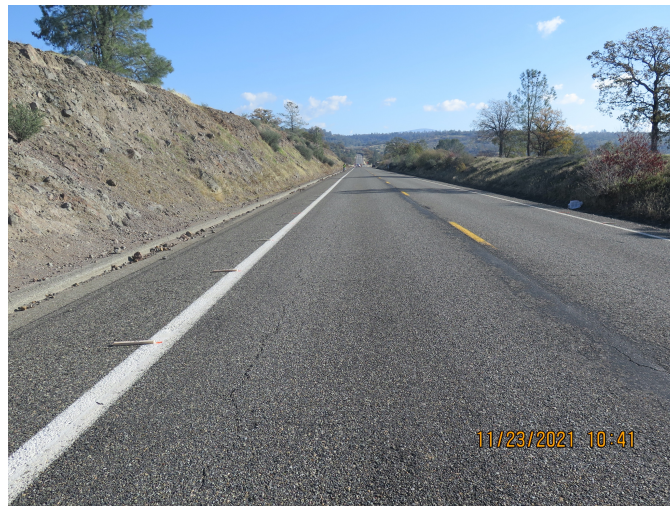
Figure 20. CRR18MB PES 3, Typical Longitudinal Cracking between Station 4+90 and Station 5+00

Figures 20 and 21 show more typical photos used to supplement either a manual survey or an overhead drone survey.

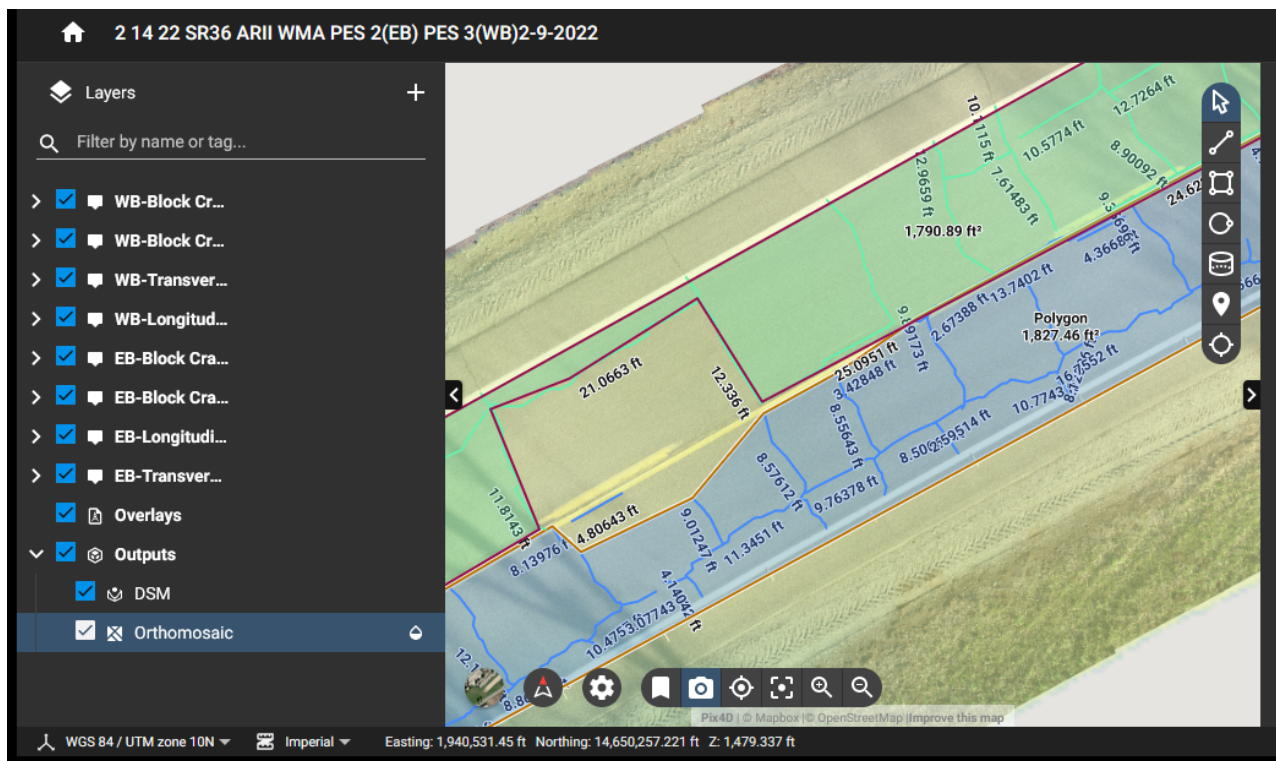
Figure 23. Typical PIX4D Programs used for Data Collection, Process, and Analysis12

This review allowed the CP2 Center to perform a more detailed analysis of the distresses from the overhead photos that were taken with a drone. The **PIX4Dreact** photogrammetry program stitched the individual drone photos together for a detailed analysis of each PES. Besides having the overall view, the user of this program could “zoom in” and electronically measure each individual crack or distress. This allows the different individual distress types to be summarized in a table within the program which can be exported. It was confirmed that with the drone photos and photogrammetry technology, the data was more refined and accurate. Furthermore, the distress summaries could be made in the office. By reducing the time on the highway, it minimizes traffic control costs and keeps all staff safer. **Figure 23** shows an example of distress analysis performed from a drone photograph on an AR(II) WMA and shows the latitude, longitude, and elevation above sea level. This drone photo was taken from an approximate elevation of 40 feet above ground level (AGL). The technical advantage of the drone photo analysis is that it is repeatable with a high degree of accuracy.
