JOINT TRANSPORTATION RESEARCH PROGRAM

Long-Term Project and Network-Level NDT Implementation Plan for Indiana

Yunhui Jia, Christopher S. Williams, Prince Baah, Mark D. Bowman

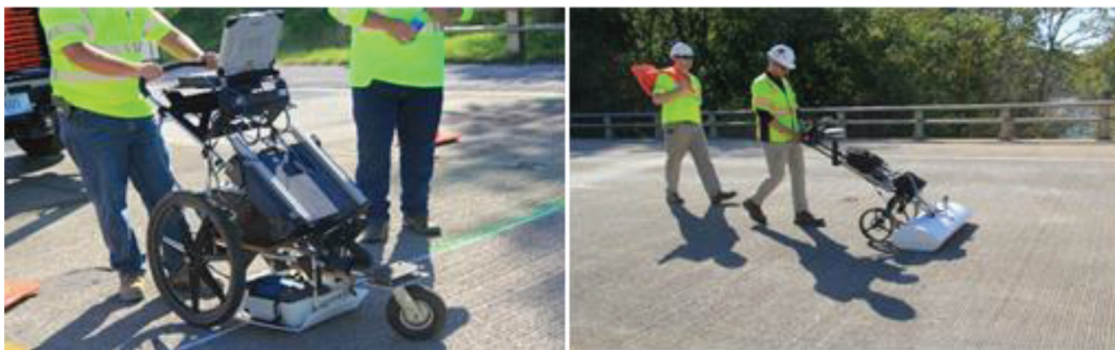
Figure 2.2 Example of ground-coupled GPR equipment.

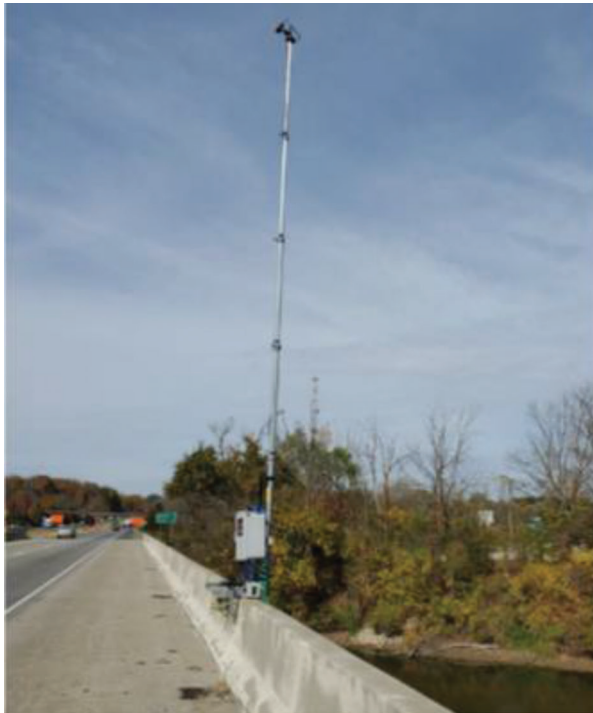
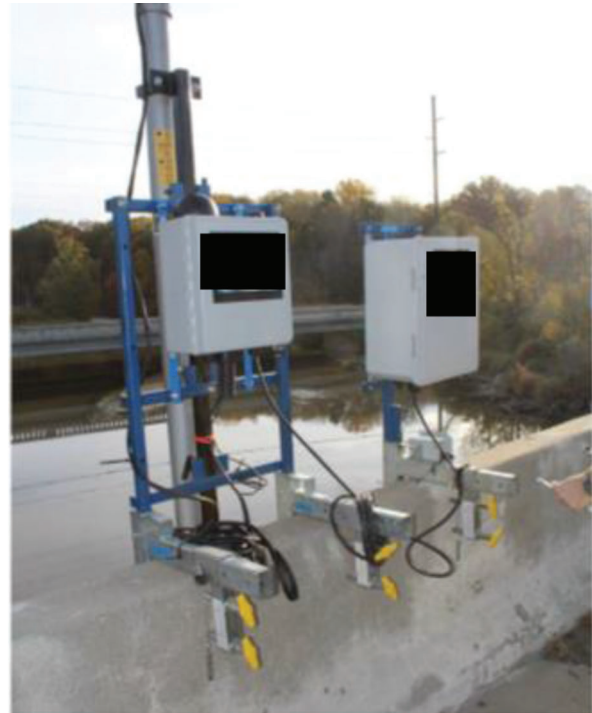
Figure 2.8 Example of pole-mounted IRT equipment (used with permission from consultant).

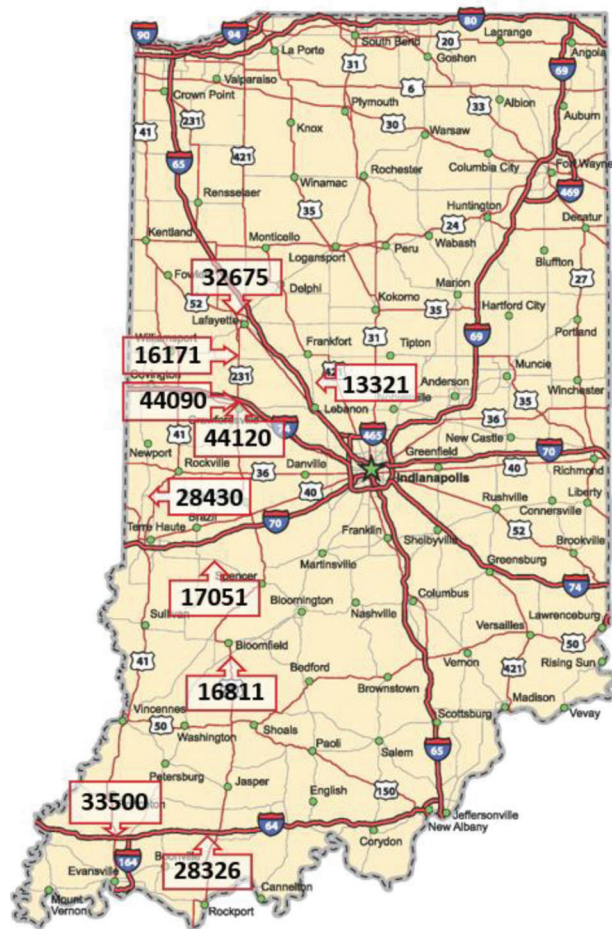
Figure 3.3 Locations of bridges listed by structure number for reinforcing bar cover depth measurement.

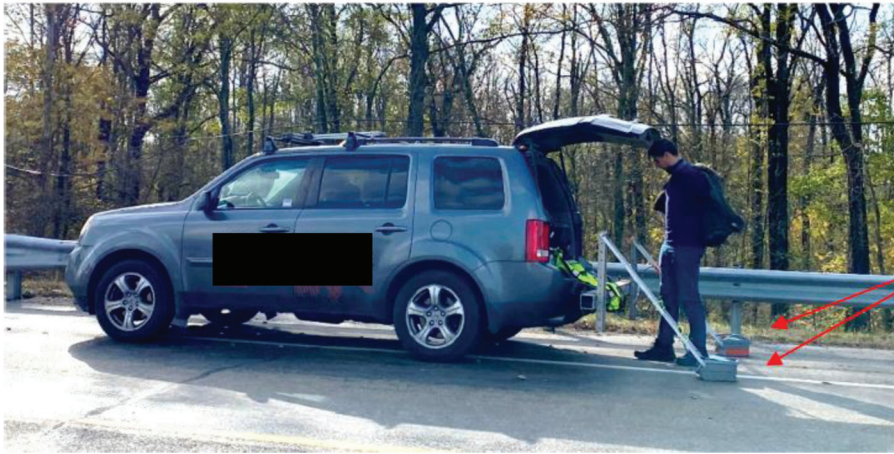
1.6 GHz GPR Antennas

Figure 3.13 Ground-coupled PL GPR survey—antenna mounting to vehicle (used with permission from consultant).

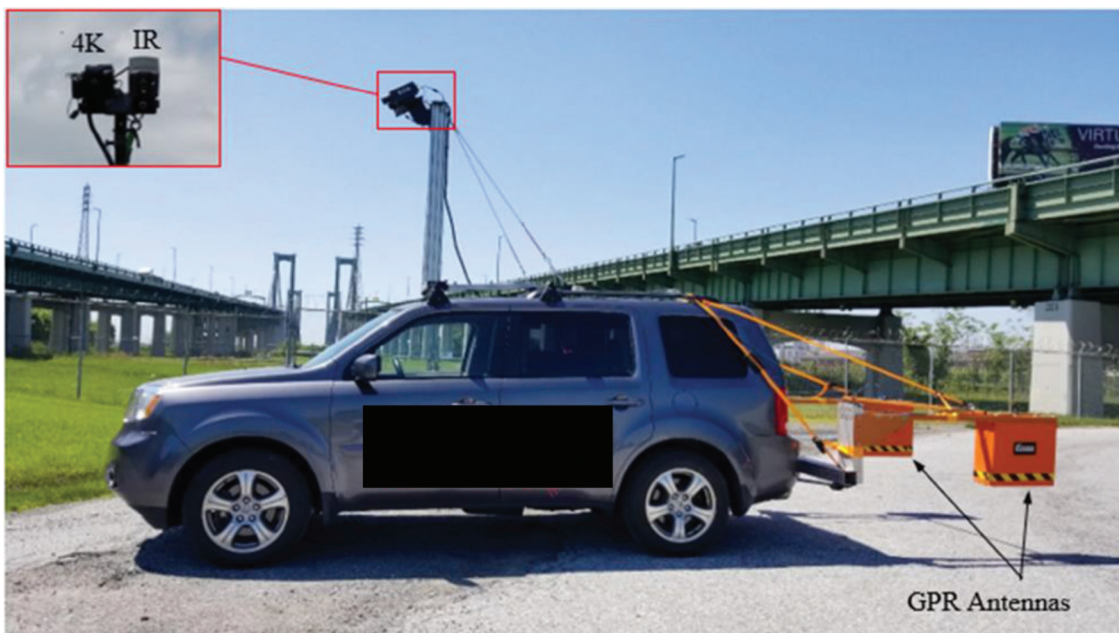
GPR Antennas

Figure 3.15 Consultant D survey vehicle with GPR, HRV, and IR equipment (used with permission from consultant).

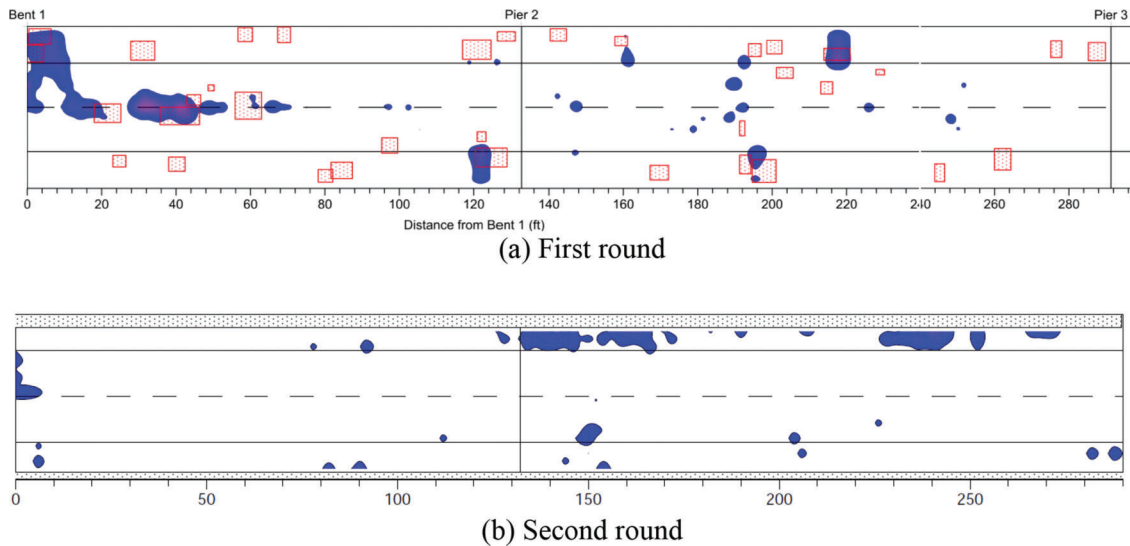
Figure 4.4 Air-launched GPR result maps for Bridge 20610 (used with permission from consultant).

Bridge 20610 was selected for the comparison between the first round and the second round of testing. Consultant D participated in both rounds, so the result map collected with a conventional GPR was compared to the 3D GPR result map. Figure 4.4a shows the result map from the first round of testing, and Figure 4.4b shows the map from the second round of testing.

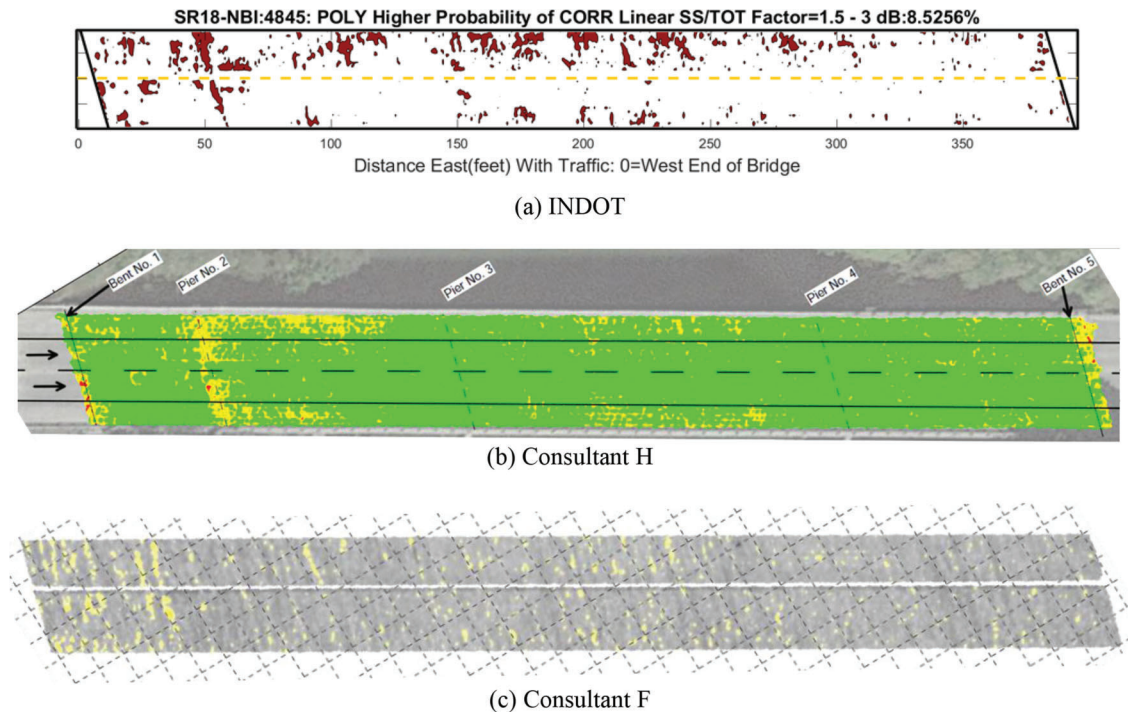
Figure 4.8 Ground-coupled GPR result maps for Bridge 04845 (used with permission from consultant).

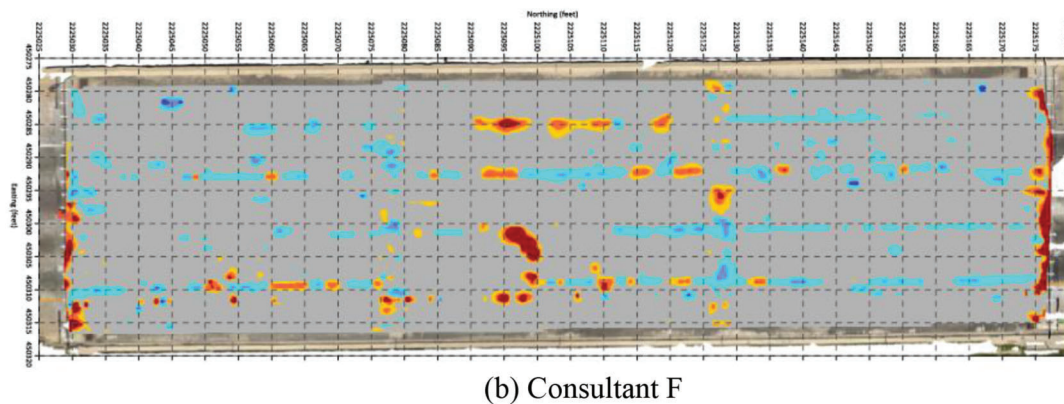
Figure 4.10 IE result maps for Bridge 01347 (used with permission from consultant).

For the map comparison, Bridge 01347 and Bridge 24220 are selected as examples for the second round of testing. Figure 4.10a shows the result map from INDOT for Bridge 01347. The location of delamination can be observed on the plan view map. The map has a 10-ft increment distance scale along the length and a 5-ft increment distance scale along the width of the bridge

deck. The result map provided by Consultant F for Bridge 01347 is presented in Figure 4.10b. The map includes a distance scale in 5-ft increments throughout the length and width of the bridge deck. Similarly, Figure 4.11 shows result maps for Bridge 41810 from the two entities.

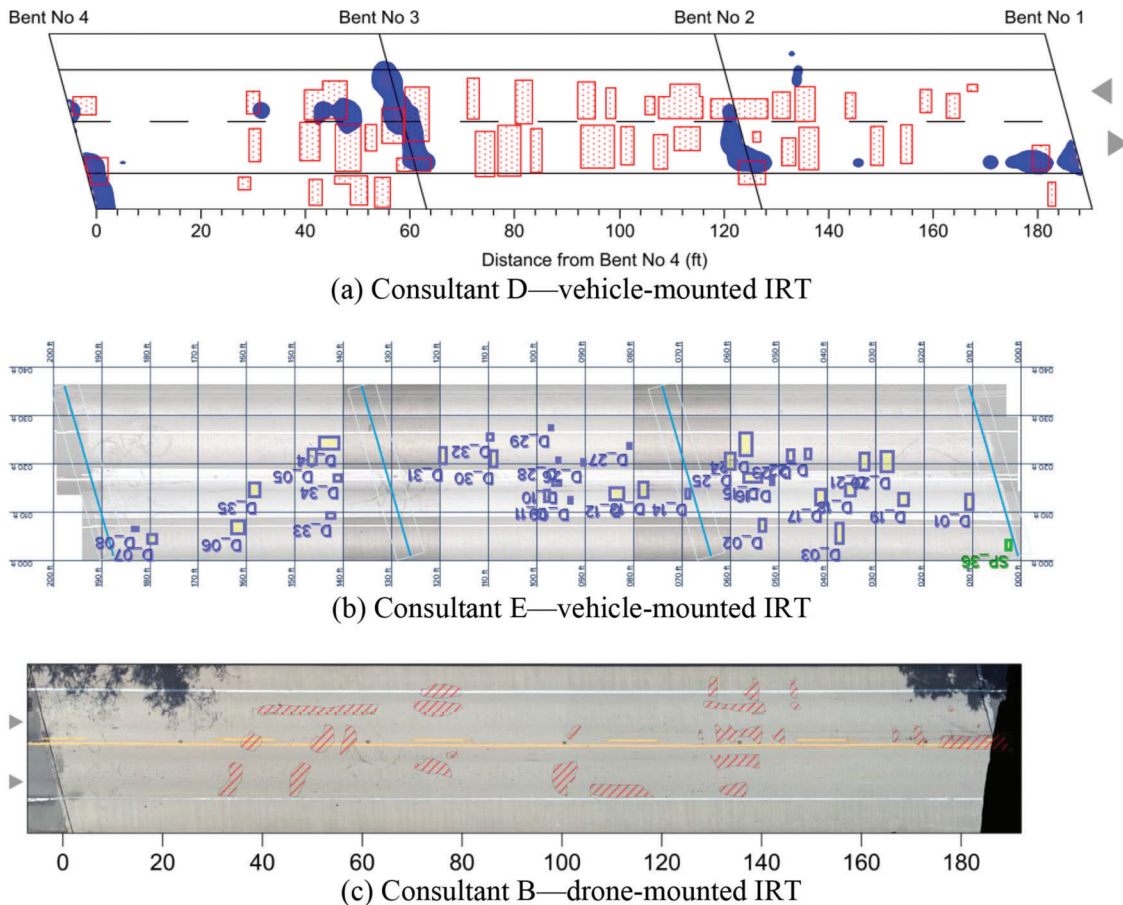
Figure 4.13 IRT result maps for Bridge 31080 for the comparison of the first round of testing (used with permission from consultant).

The third result map provided in Figure 4.13c is from Consultant B. The plan view map shows the location of bridge deck concrete deterioration and a 20-ft increment distance scale along the length of the bridge deck. For the second round of testing, Consultant E, Consultant C, and Consultant D are chosen, and the results maps for Bridge 04930 are shown in Figure 4.14. The result maps from Consultant C are shown with a 5-ft grid. Bridge 19640 is chosen for the comparison between the first round and the second round, and the result maps from Consultant E (both rounds), Consultant C (second round), and Consultant D (first round) are presented in Figure 4.15.
