Transverse Rumble Strips at Rural Intersections

Research Project
Final Report 2023-17

TRANSVERSE RUMBLE STRIPS AT RURAL INTERSECTIONS

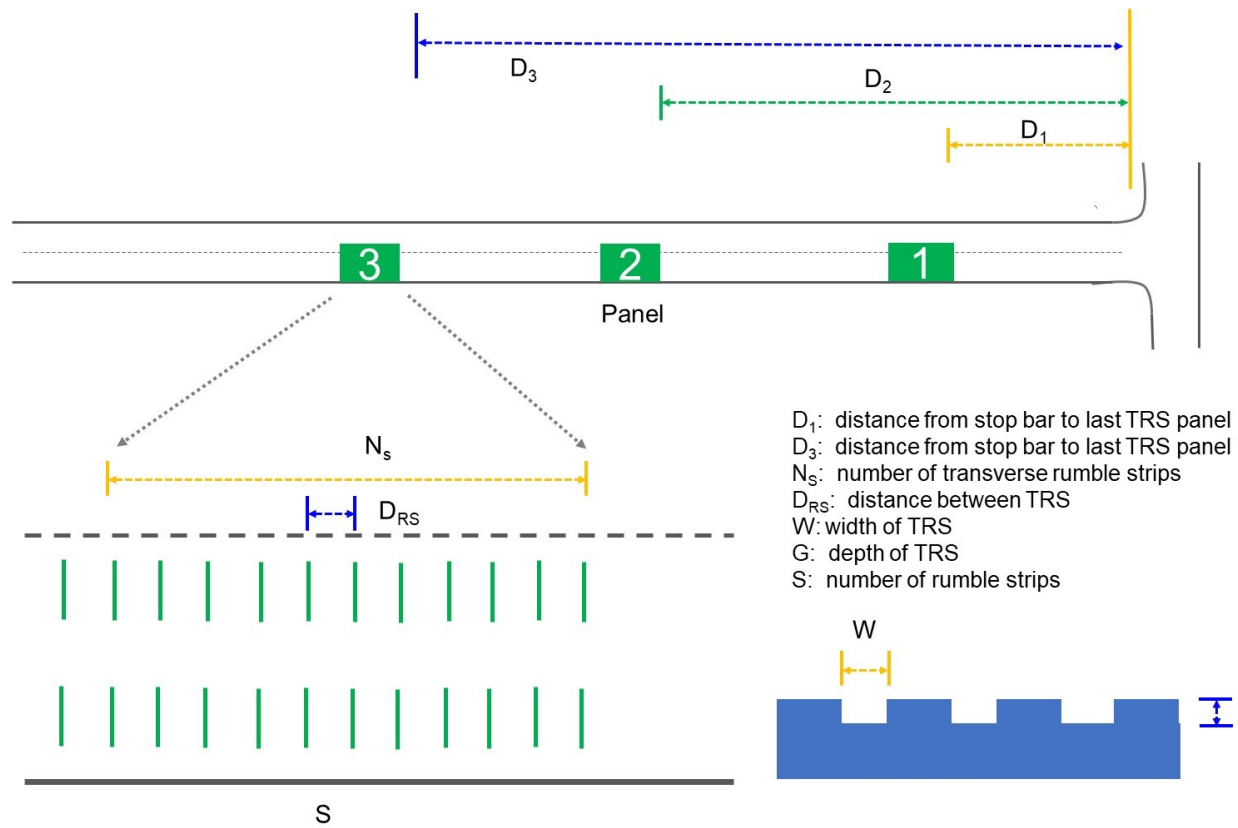
Figure 1-3. Schematic of rumble strip design

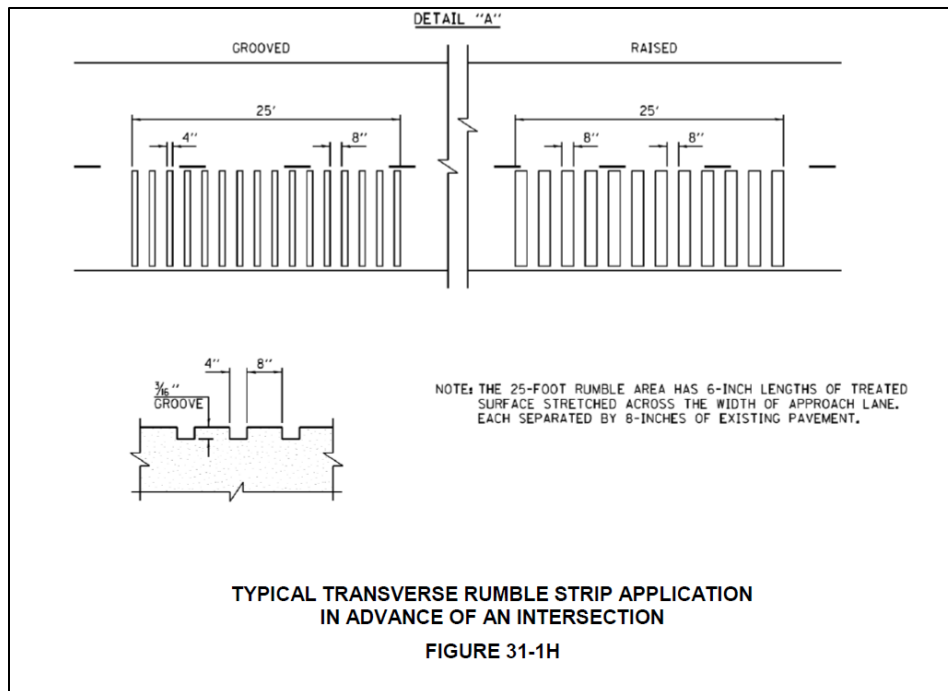
Illinois provides guidance on the use of transverse rumble strips as part of the state's *Bureau of Local Roads and Streets Manual*. The manual states that TRS should be placed in advance of either a Stop Ahead sign or stop sign. However, guidance was unable to be found on the exact location upstream. Rumble strip configurations should include three panels of strips, with each panel being 25 ft long. Recommendations for spacing between the strips was unable to be located. The dimensions of the strips themselves vary based on whether they are grooved in or raised, as seen in Figure 1-9. If they are grooved in, they are 4 in. wide by 3/8 in. deep and spaced 8 in. apart. If they are raised, they are 8 in. wide with an 8 in. spacing.

Figure 1-9. Typical dimensions of Illinois transverse rumble strips

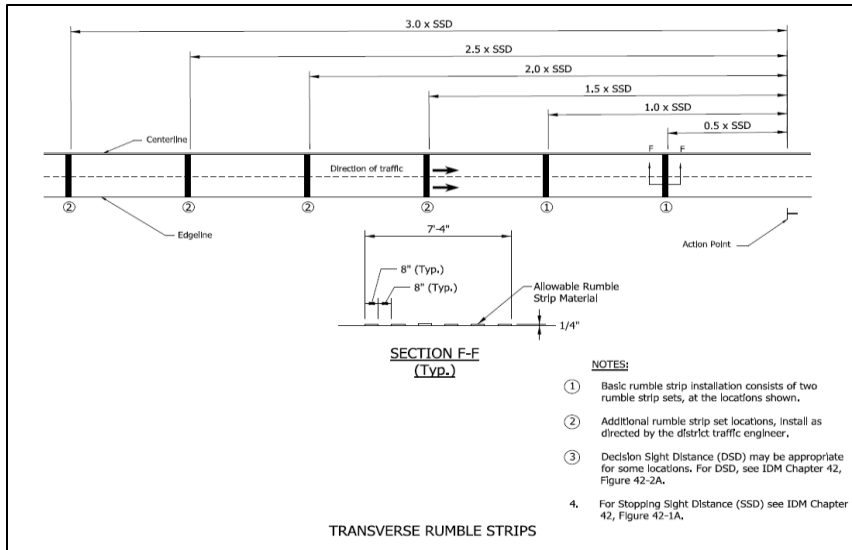
Indiana provides guidance on the use of transverse rumble strips upstream of the area where drivers are about to encounter unexpected traffic conditions such as an intersection with the approval of the district traffic engineer. As shown in Figure 1-10, the typical application consists of two panels of strips consisting of six strips each that are located 0.5 times the stopping sight distance (SSD) upstream from the action point and 1 times the SSD upstream from the action point. However, up to five panels of rumble strips can be utilized if additional warning is necessary. These rumble strips are typically 1/4 in. deep by 8 in. wide with an 8 in. spacing (INDOT 2019).

Figure 1-10. Indiana typical transverse rumble strip application

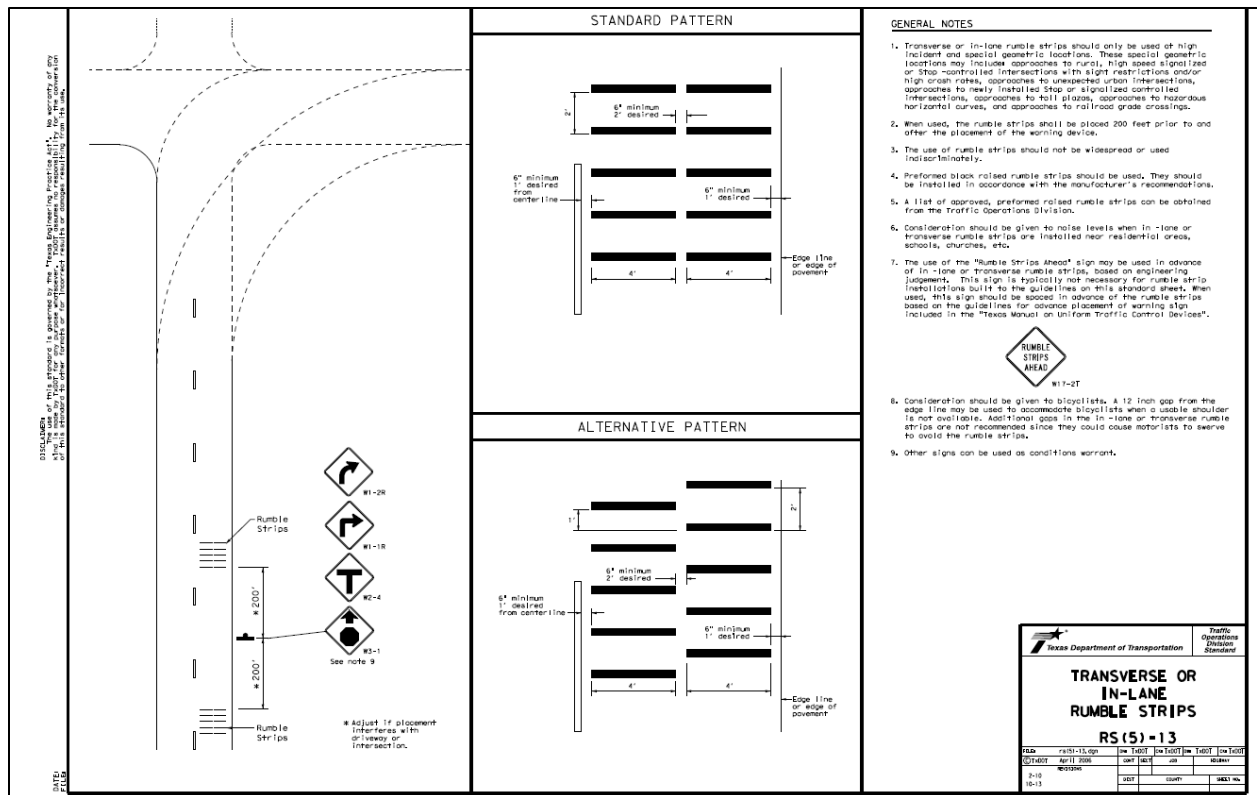
Texas standard plans for TRS involve two panels of five strips each spaced 2 ft apart and placed 200 ft upstream and downstream of a W3-1 Stop Ahead sign. The guidance does not specify the width and depth of the rumble strips but does specify that they should be raised rumble strips made of preformed blocks. The configuration consists of a 4 ft long panel in each wheel path, with the two panels separated by section that is preferably 2 ft but that can be as small as 6 in. Either a standard pattern or an alternative pattern can be utilized, which can be seen in Figure 1-24 (TxDOT 2006).

Figure 1-24. Texas transverse rumble strip standard

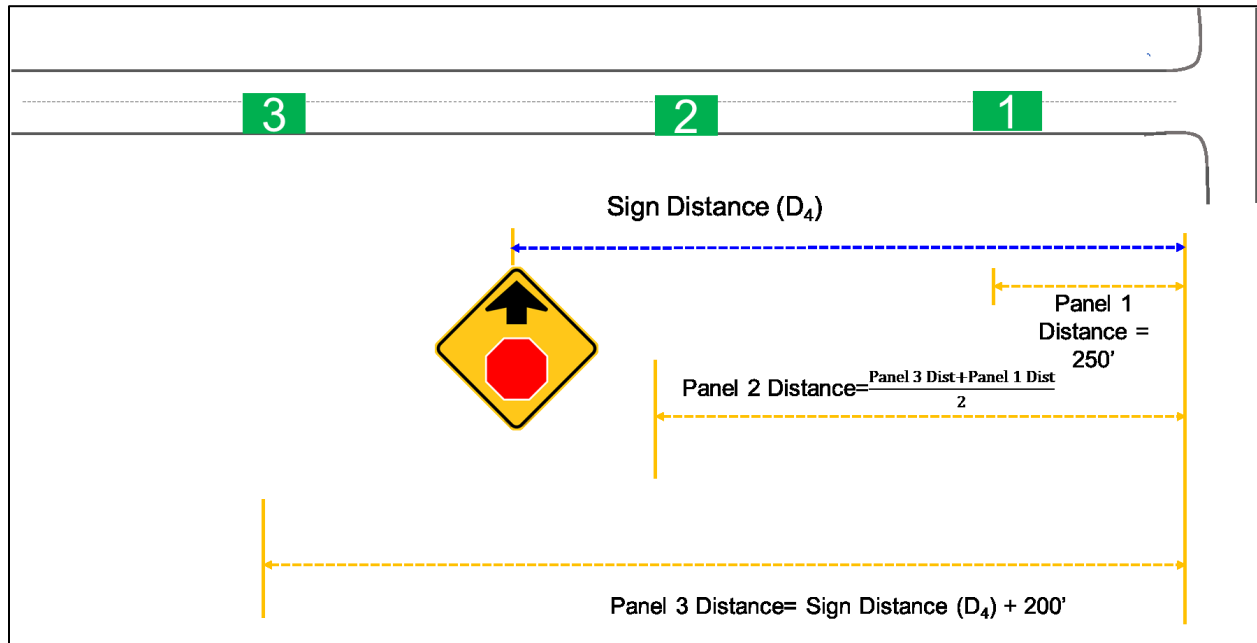
distance of these signs. The closest panel to the intersection would be 250 ft, again because it was within the legibility sight distance of the stop sign. If three panels were used, the third panel was located halfway between the first and last panels. These distances are shown in Figure 2-1.

Figure 2-1. Locations of panels

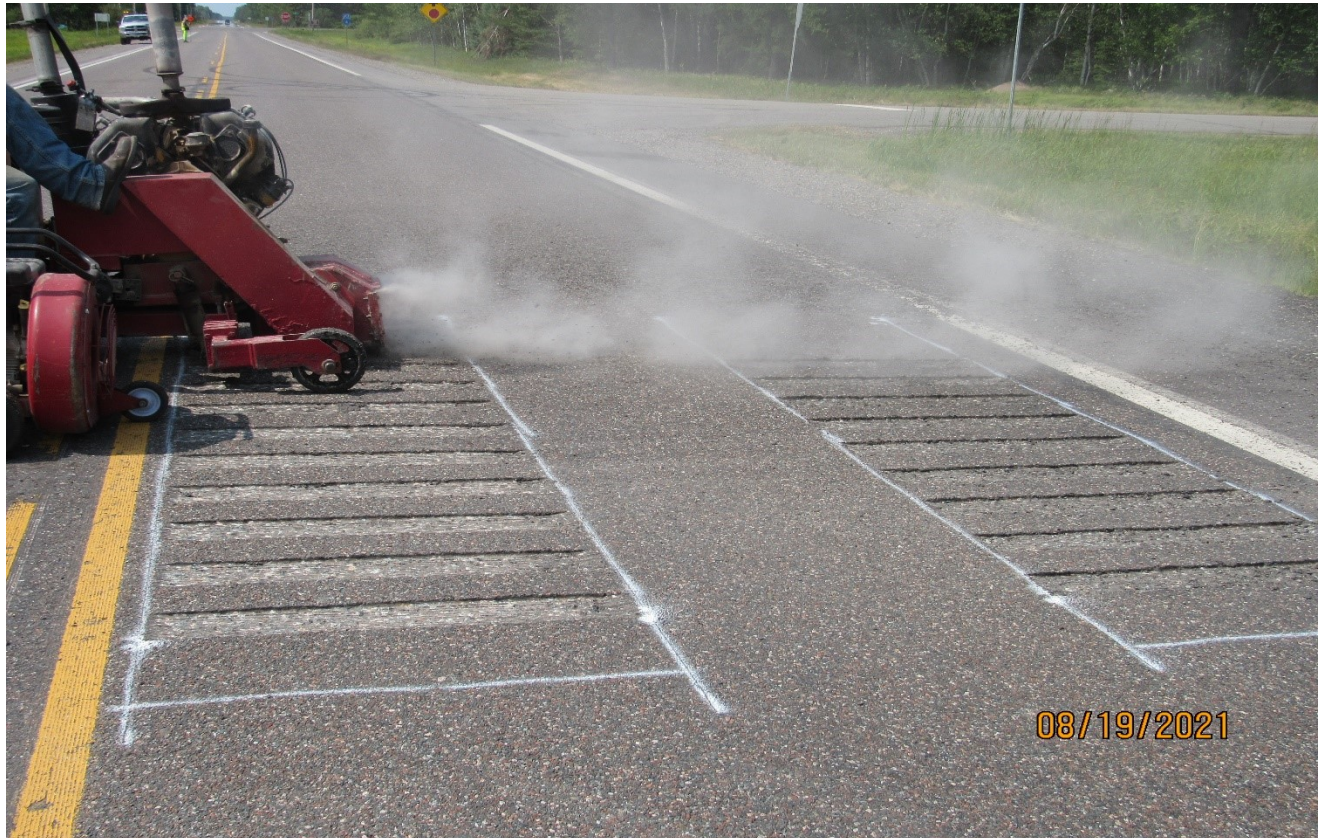
When milling, the contractor placed the rumble strips slightly closer to the centerline than to the edge line to provide additional space near the shoulder. This was done to encourage drivers who chose to circumvent the rumble strips to do so on the shoulder instead of in the opposite lane. A photo of the milled-in rumble strips is shown in Figure 2-2.

Figure 2-2. Transverse rumble strips being milled in

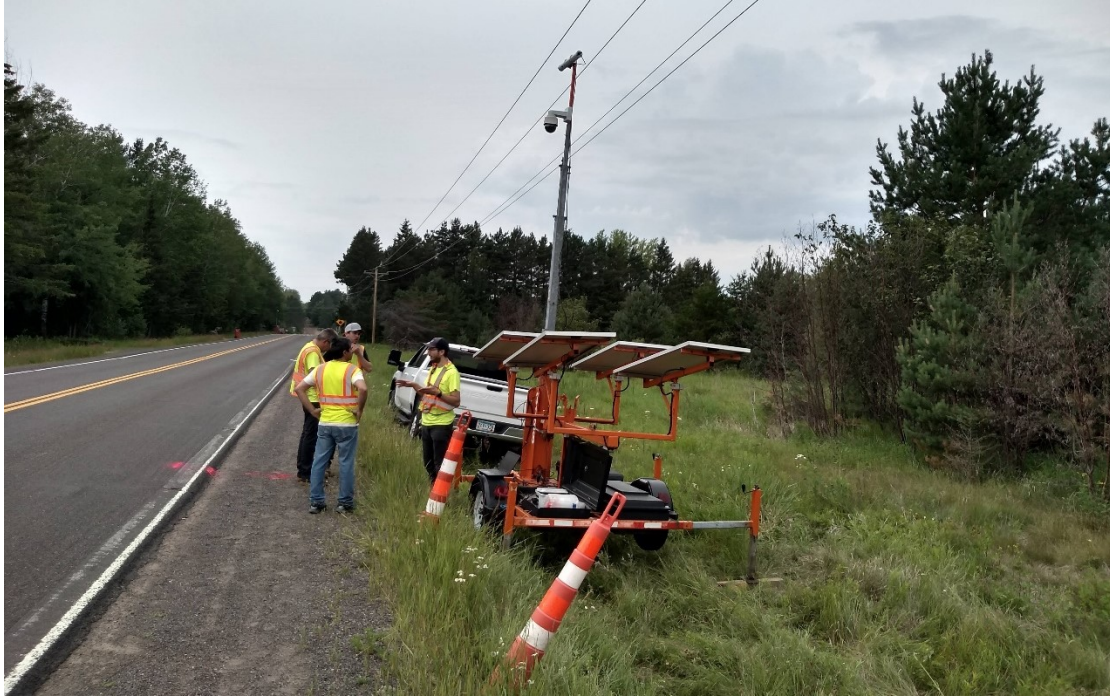
Data were collected approximately one week before installation and then approximately 1 month and 9 months after. Cameras and speed sensors mounted to trailers, as shown in Figure 2-3, were rented from a vendor (Street Smart).

Figure 2-3. Video data collection array

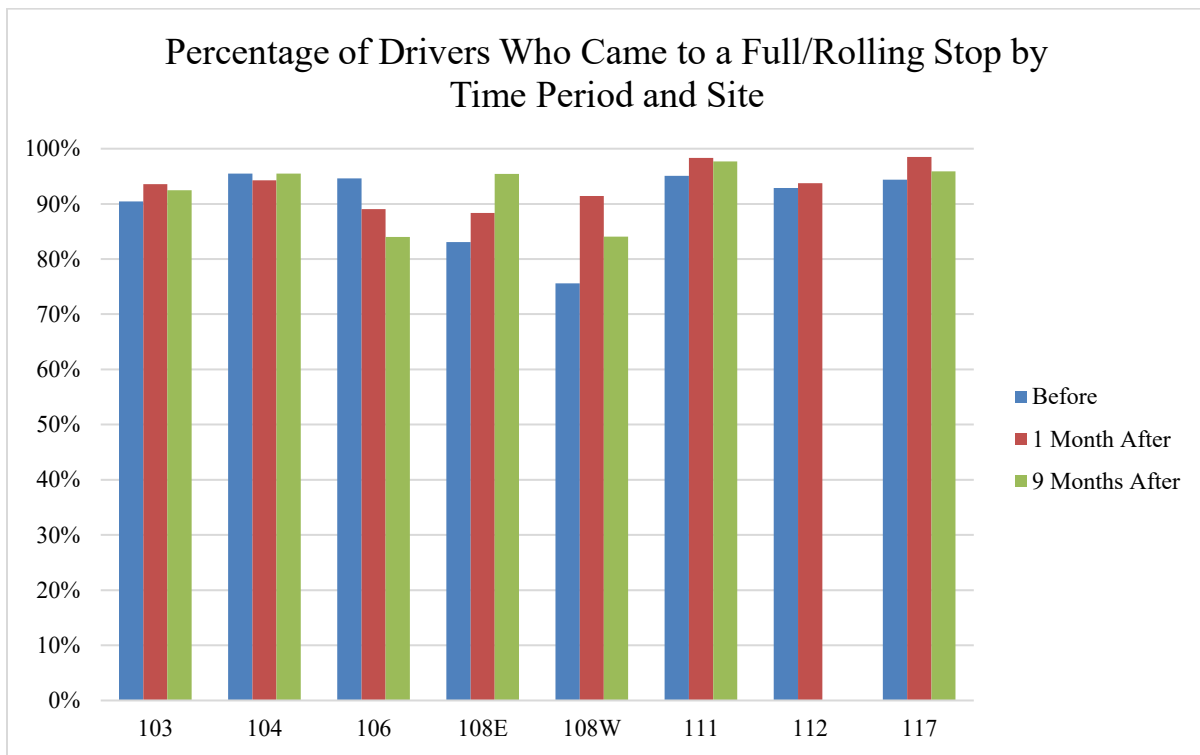
The percentage of drivers who came to a full/rolling stop before TRS installation and at 1-month after installation is shown as a comparison in Figure 3-1. In general, one site experienced little change at 1 month after installation (<1%), while five sites showed an increase in stops. Two locations experienced decreases in full/rolling stops. At 9 months after installation, five sites had increases in stops while one site experienced a decrease.

Figure 3-1. Percentage of drivers who came to a full stop or slow rolling stop by site and time period

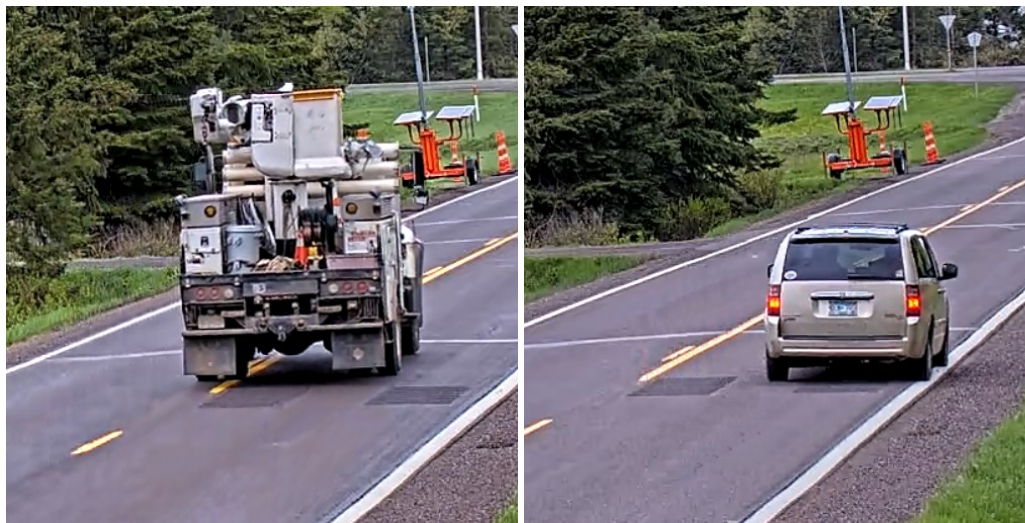
An analysis was conducted to assess the change in the number of drivers making evasive maneuvers in their approach to the intersection. An evasive maneuver was defined as the driver changing course to avoid something; in this case, drivers drove into the opposing lane or toward the shoulder to avoid the rumble strips. Examples of these maneuvers can be seen in Figure 3-3. At sites with a paved shoulder, most of the evasive maneuvers were found to be toward the shoulder. However, when the shoulder was not paved, drivers about half the time shifted toward the opposite lane, often driving over the centerline. Those who moved toward the shoulders in these cases sometimes drove onto the gravel shoulder, but most drove right on the edge line.

Evasive maneuver over center line

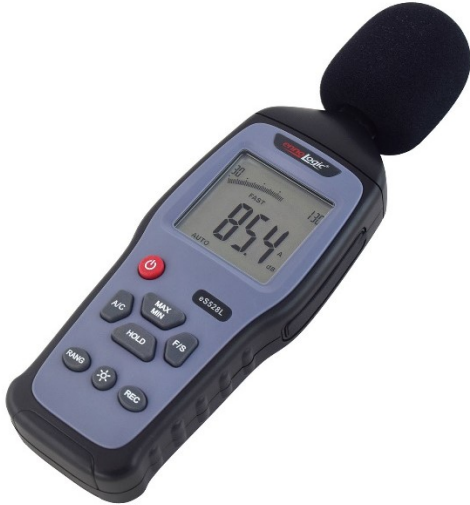
External noises were collected following the FHWA *Noise Measurement Handbook* (RSG et al. 2017). This was done using a Class 2 digital sound meter, the ennoLogic Decibel Meter (Figure 4-1), which sampled within a range of 30 to 130 dB with an accuracy of ± 1.5 dB. It had the ability to collect the maximum noise level every second based on samples taken every 125 milliseconds and allowed for A or C frequency rating. The noise meters were tested in the laboratory before being used in the field.

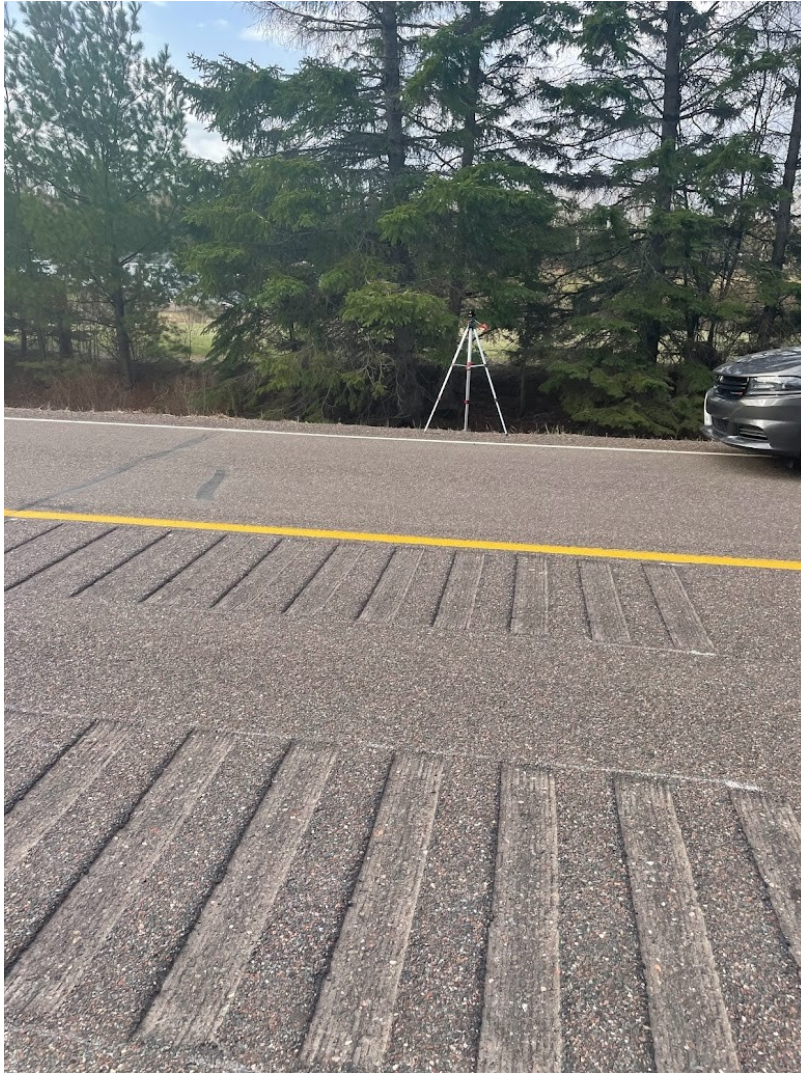
Noise meters were set up on the side of the road 14.5 ft from the lane line and 4 ft from the ground near the middle set of test rumble strips at each site. It was hoped to set the meters near the recommended 50 ft from the center of the lane; however, the available roadsides did not provide space for this, and therefore the meters were placed at a consistent distance as far as possible given the roadside (14.5 ft). The meters were placed at a height of 4 ft from the roadway surface instead of the recommended 5 ft in order to place the meters further from the rumble strips where the roadside began to slope. The in-field data collection setup is shown in Figure 4-2.

Figure 4-2. External noise meter setup in field

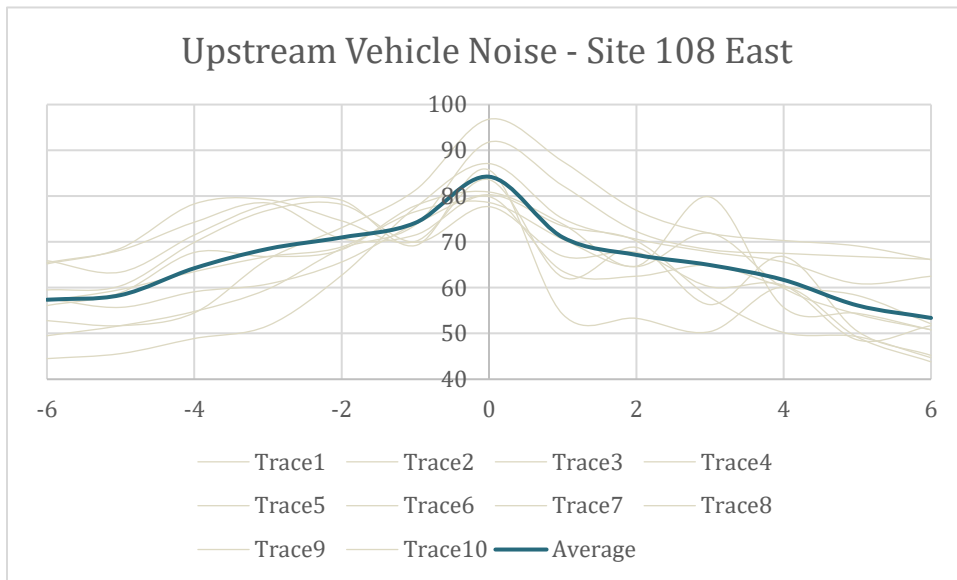
Figure 4-4. Noise pattern for Site 108 East (12-rumble strip panel)

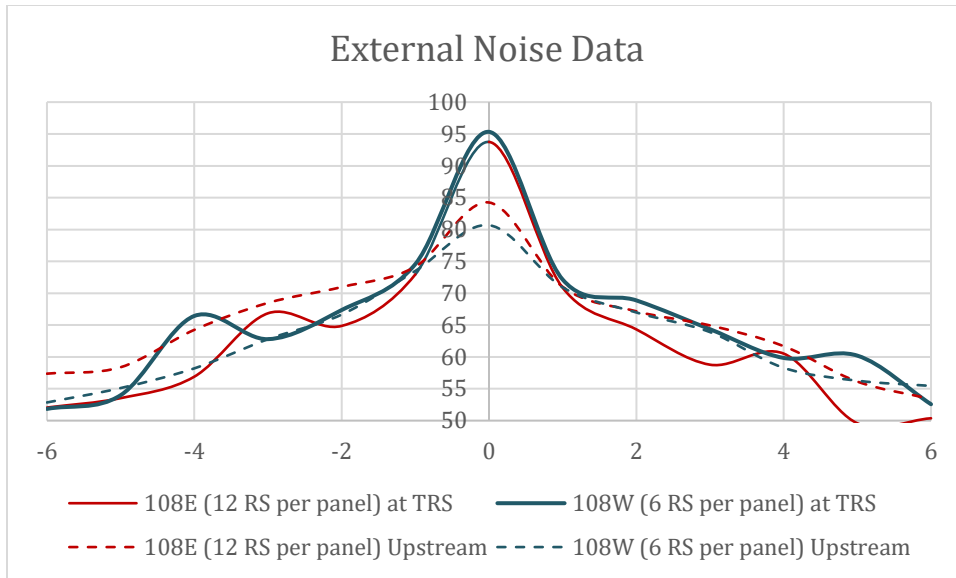
having a slightly lower standard deviation. As Figure 4-5 shows, external noise is reasonably consistent between the two patterns.

Figure 4-5. Noise pattern combined for both sites

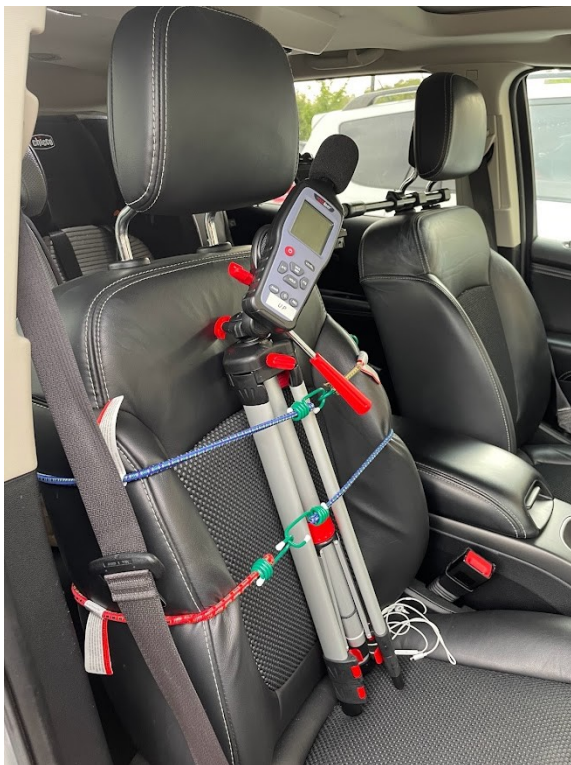
The critical factors noted above help ascertain the effectiveness of rumble strips and are typically measured using equipment that is placed inside the vehicle near the driver's seat. For this test, the ennoLogic Decibel Meter was strapped to the passenger seat (Figure 4-6) of a 2020 Dodge Journey (Figure 4-7). During the test, the radio was off, the fan was set to 3 to simulate interior noise, and the tires were inflated to 40 psi for the front tires, 41 for the rear driver's side tire, and 37 for the rear passenger's side tire. This was similar to the method used by Hurwitz et al. (2019).

Figure 4-6. Interior noise test setup

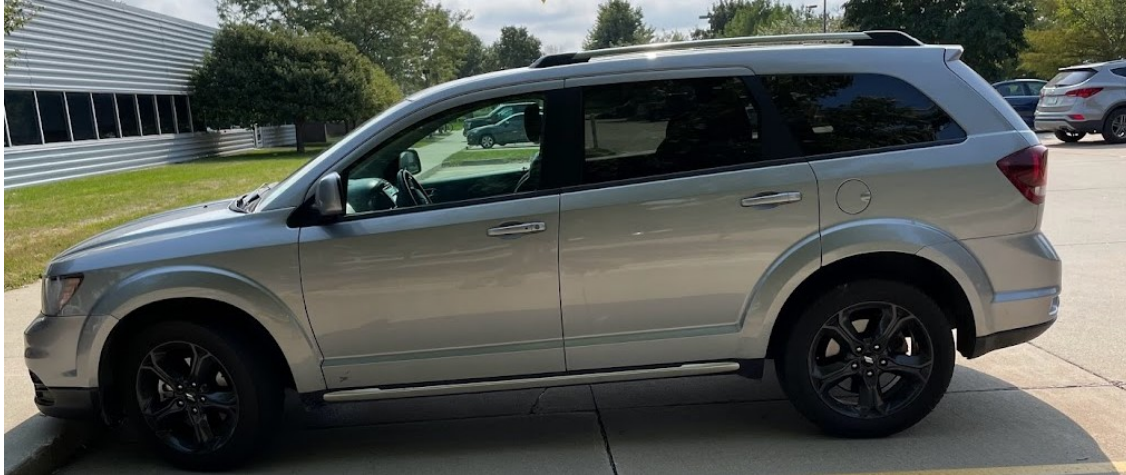
Figure 4-7. Interior noise test vehicle

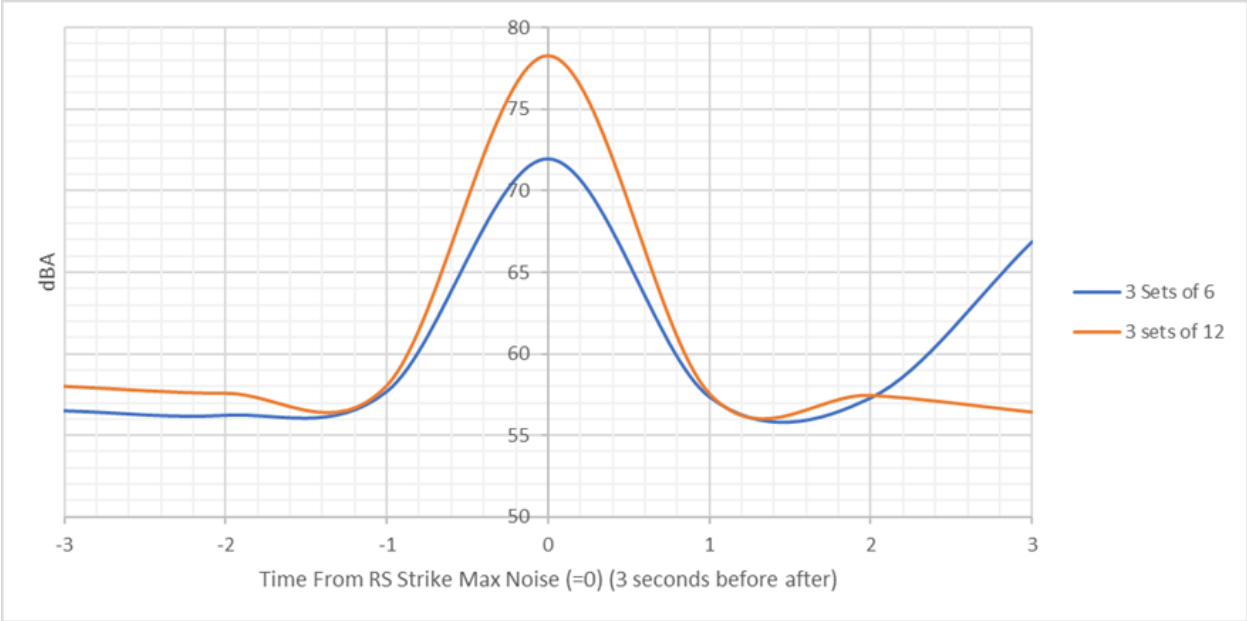
Figure 4-8 shows internal noise readings. As the figure shows, the average interior noise for the panel with 6 rumble strips was 72 dB, and the maximum for the 12-rumble strip panel was 78 dB. The average upstream (control) level was 56 to 58 dB. The 6-rumble strip pattern was approximately 15 dB higher, and the 12-rumble strip pattern was about 26 dB higher than the measured road noise. Both were higher than the suggested 6 dB for alerting a drowsy driver. As a result, no preference would be given to either rumble strip pattern to ensure that sufficient noise levels are present inside the vehicle. The noise levels reflect levels inside passenger vehicles. Levels would be lower for a heavy truck. As a result, anecdotally the 12-rumble strip pattern may be better for larger vehicles.

Figure 4-8. Internal noise patterns
