Evaluation of Snowplowable Markers

FHWA-TS-82-222

October 1982

16. Abstract The objective of this study was to evaluate available snowplowable markers under similar traffic and snowplowing operations. There were five different markers tested which included the following: 1) Stimsonite 96, 2) Dura-Brite, 3) recessed, 4) Kingray, and 5) Prismo Roadstud. The Stimsonite 96, Dura-Brite, and recessed markers were found to be acceptable snowplowable markers. All three of these markers were found to have adequate reflectivity during both dry and wet nighttime conditions. This reflectivity was maintained over the test period and the markers proved to be durable when subjected to snowplow operations. However, considering all available input, the recessed marker is the most functional and cost-effective.

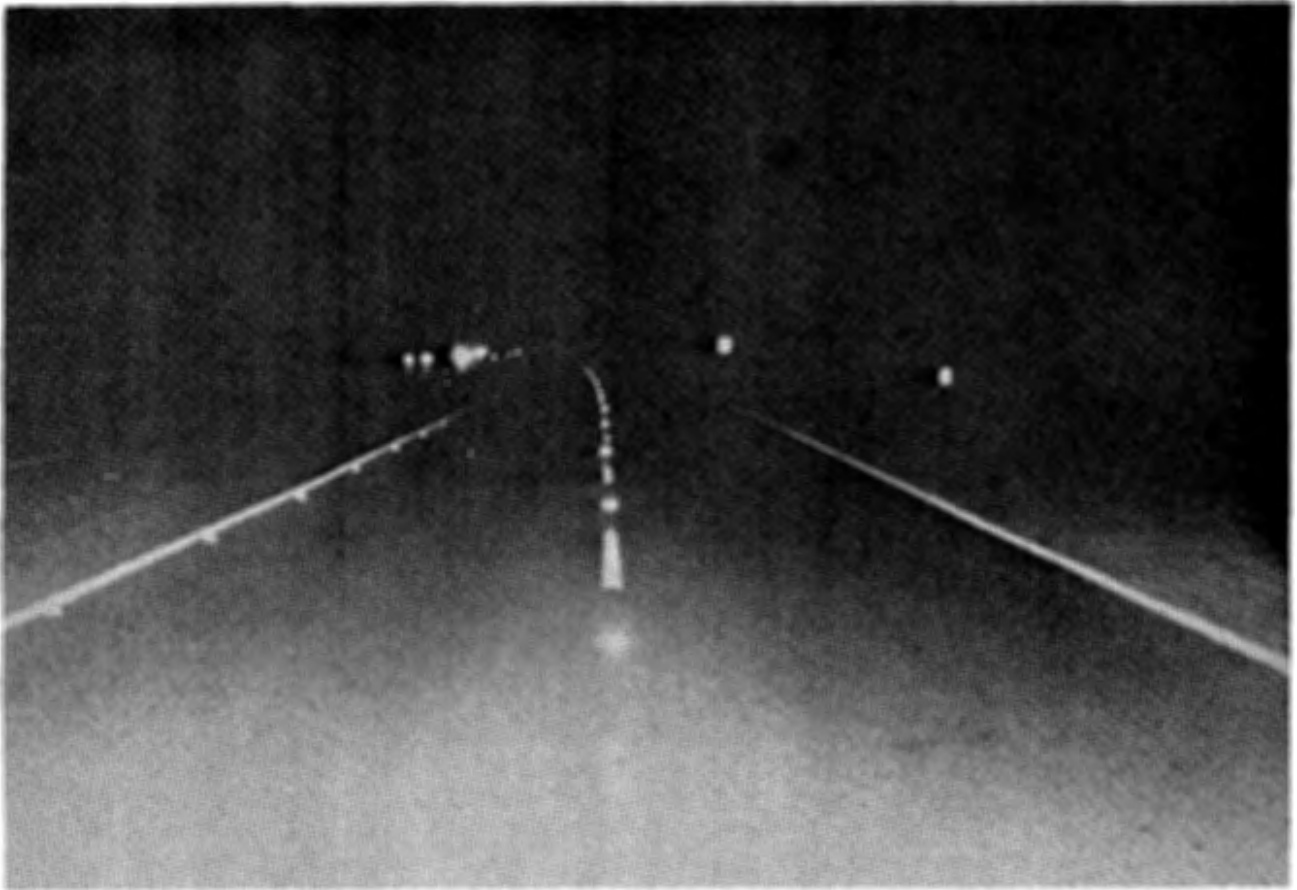
Figure 7. Photograph Taken in December 1980 at the Jessamine County Southbound Installation (Pattern of Markers is Recessed, Dura-Brite, Stimsonite 96, and Kingray).

The first inspection, immediately after installation, of the four original markers found all markers to be very effective. A photograph taken in December 1980 at the Jessamine County, southbound installation enables a comparison of reflectivity (Figure 7). Observations of the Prismo markers showed that this marker was also effective. While the Prismo marker was not as reflective as the others, it still provided adequate delineation and was particularly effective on curved sections.

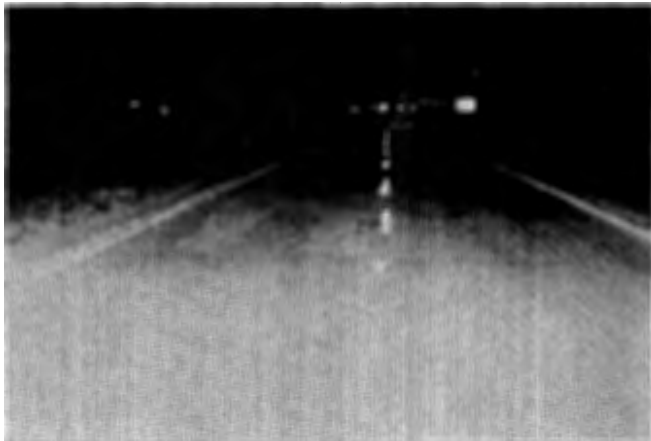
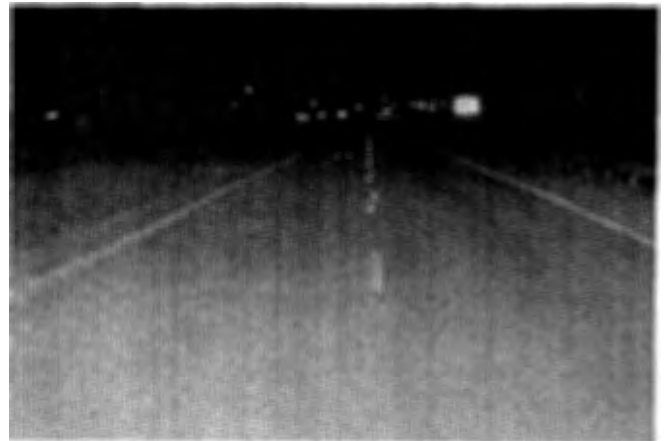
Figure 8. Photographs of Section of Dura-Brite Markers (Fayette County, Northbound Installation).

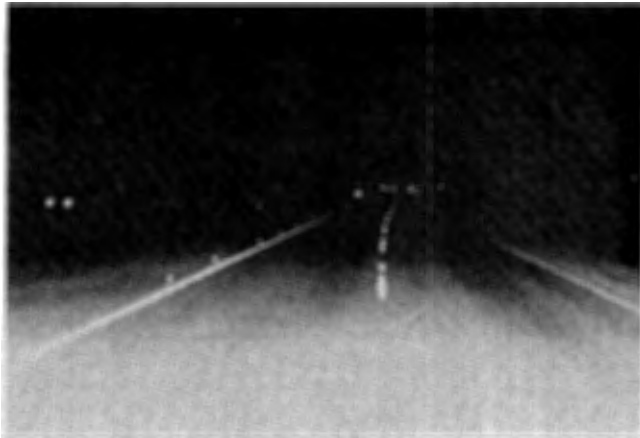
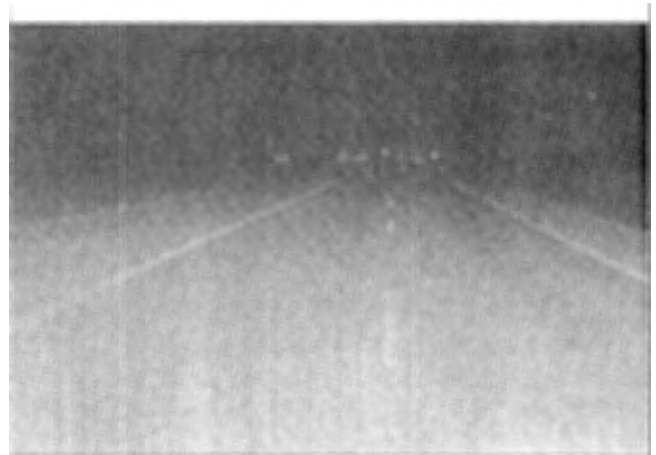
Figure 9. Photographs of Section of Kingray Markers (Fayette County, Northbound Installation).

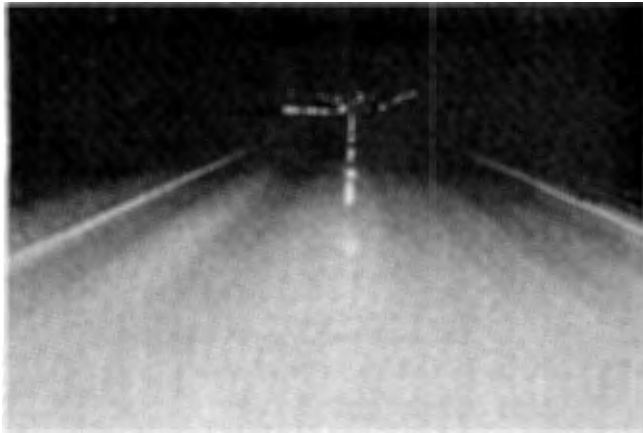
Figure 10. Photographs of Section of Recessed Markers (Fayette County, Northbound Installation).

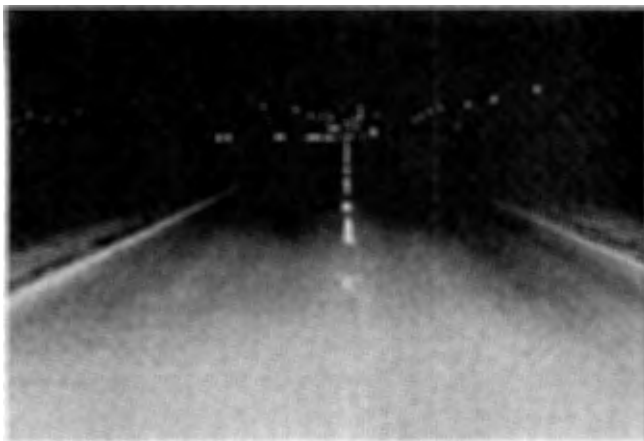
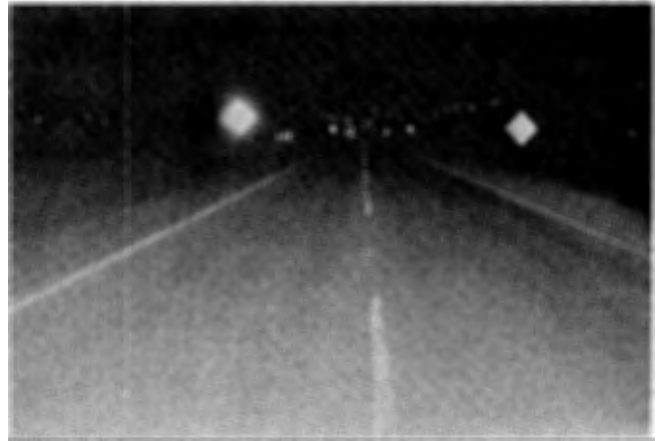
Figure 11. Photographs of Section of Stimsonite 96 Markers (Fayette County, Northbound Installation).

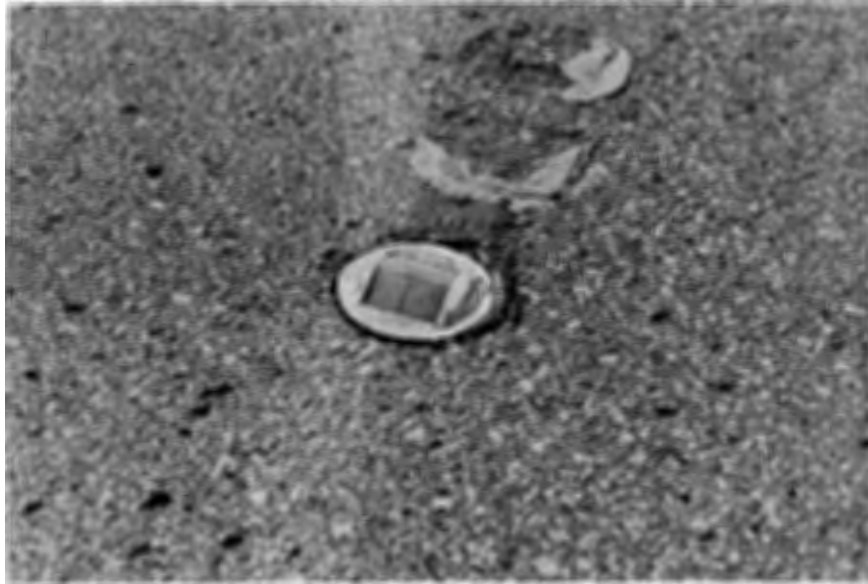
Figure 12. "Foggy" Appearance of Kingray Lens.

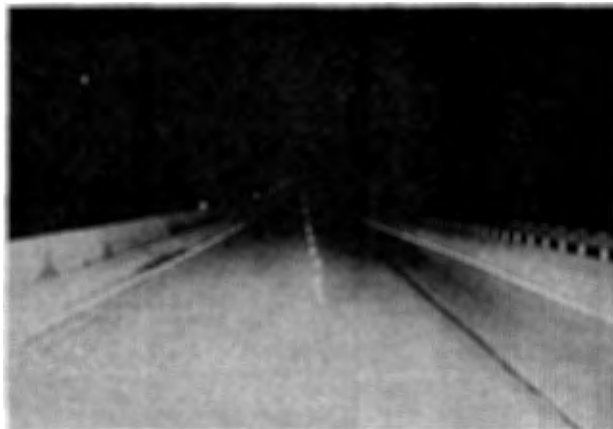
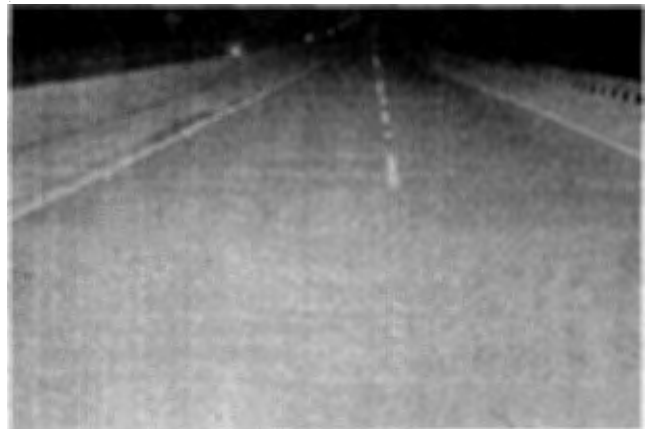
Figure 13. Photographs Taken at the Garrard County, Southbound Installation (Order of Markers is Kingray, Stimsonite 96, Dura-Brite, Recessed, and Prismo).

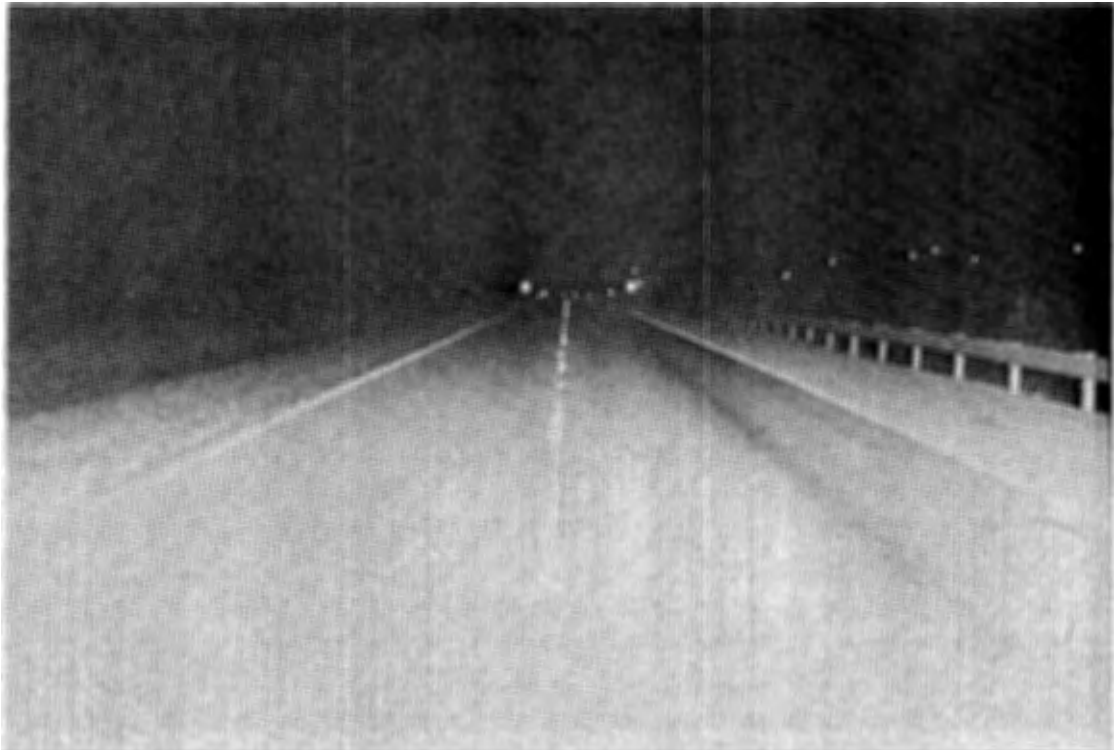
Figure 14. Photograph Taken at the Fayette County, Southbound Installation (Order of Markers is Kingray, Stimsonite 911, Stimsonite 96, Recessed, and Dura-Brite).

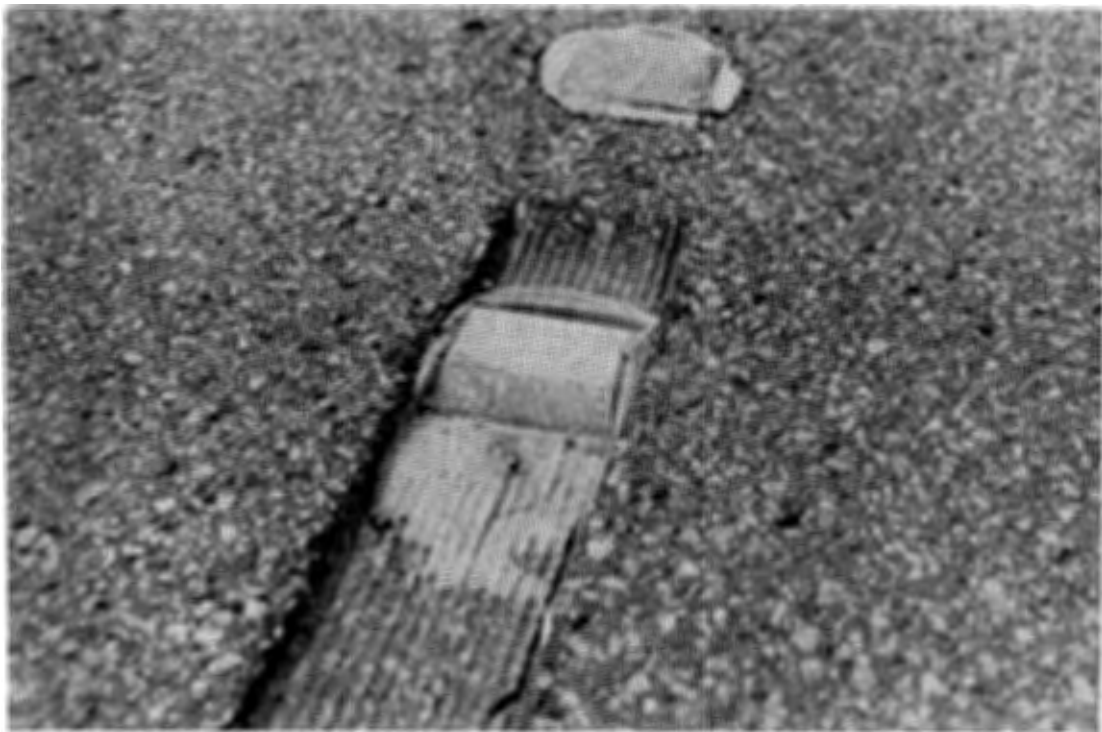
Figure 15. Recessed Marker after Approximately One Year in Service (Before Snowplowing).

The recessed marker is shown in Figure 15. This marker demonstrated good durability. Minor damage to the top of the lens was found at seven markers (five percent). Inspections during the year found that the groove remained relatively free of debris. Approximately the top one-half of the lens remained clean. The bottom one-half was not cleaned well by tires. Also, the abrasive coating on the top one-half of the lens was chipped more than the other snowplowable markers.

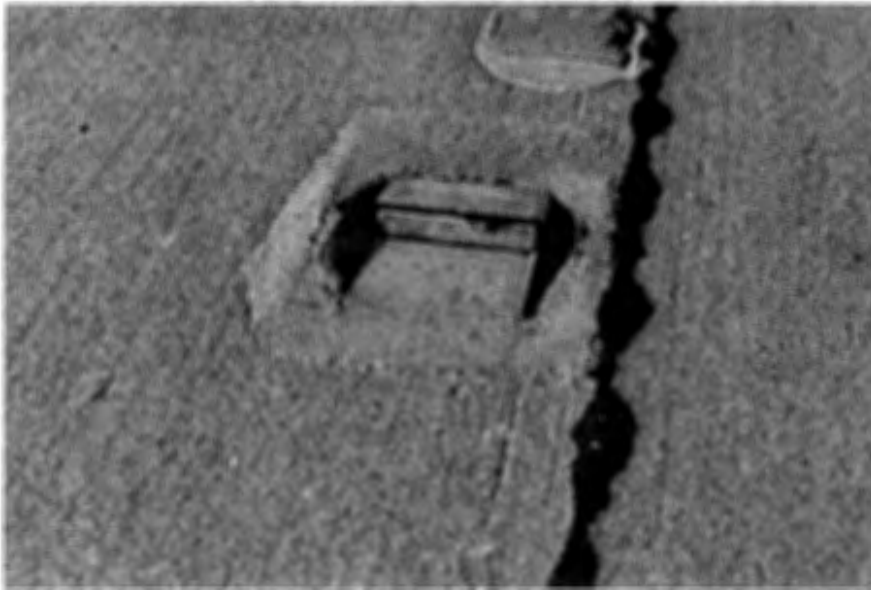
Figure 16. Dura-Brite Marker after Approximately One Year in Service (Before Snowplowing).

The Dura-Brite marker is shown in Figure 16. The durability of the Dura-Brite marker to traffic wear was found to be good. The lens remained clean with less chipping to the abrasive coating than the other markers. In some instances, the adhesive holding the lens covered part of the lens as shown. This was caused by using butyl tape which was too thick. The thickness of this tape has since been reduced by the manufacturer. It was also noted that the lens was loose in two markers.

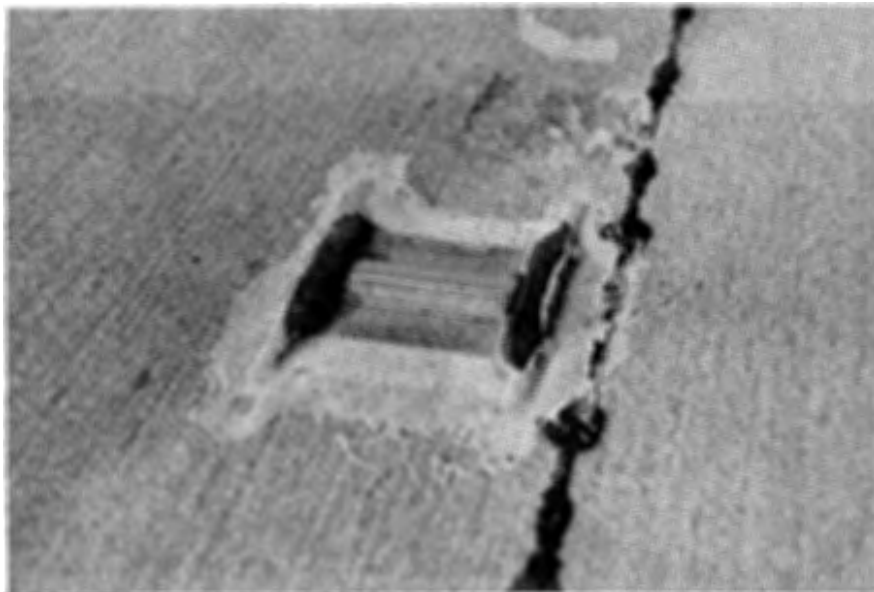
Figure 17. Stimsonite 96 Marker after Approximately One Year in Service (Before Snowplowing).

The durability of the Stimsonite 96 marker after being subjected to traffic was also found to be good (Figure 17). Minor damage to the lens was noted on 13 markers (nine percent). As shown in Figure 17, this damage was minor and did not adversely affect reflectivity. The lens remained clean with minor chipping of the abrasive coating.

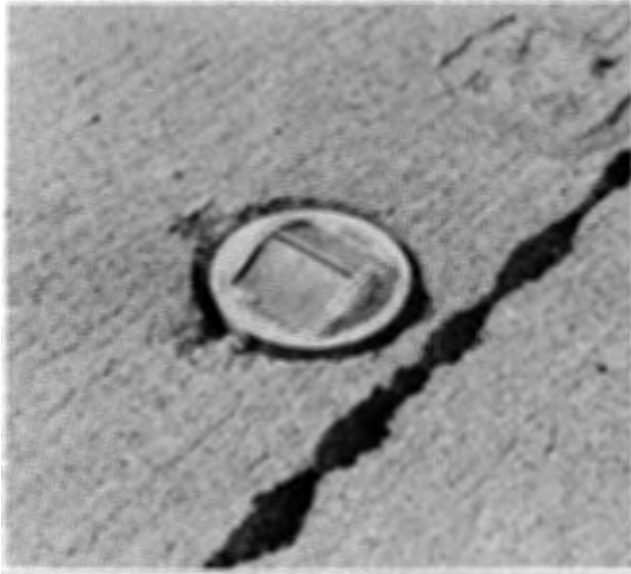
Figure 18. Kingray Marker after Approximately One Year in Service (Before Snowplowing).

Several problems were found with the Kingray marker (Figure 18). The bitumen material holding the marker cracked and, in many instances, a large amount of this

material was lost. This reduced the bond of the marker to the pavement. A possible reason for the loss of bitumen was failure to heat the hole to a sufficiently high temperature during the installation process. Six (four percent) of the markers were found to be missing after almost one year in service. The lens also tended to remain dirty because tires would depress and not clean the lens. A rain was necessary to clean the lens. Since the lens did depress upon impact, it sustained less abrasive damage to the lens surface than the other markers. About 15 percent of these markers had damage either to the lens or marker. All but two of the markers still recoiled as designed.

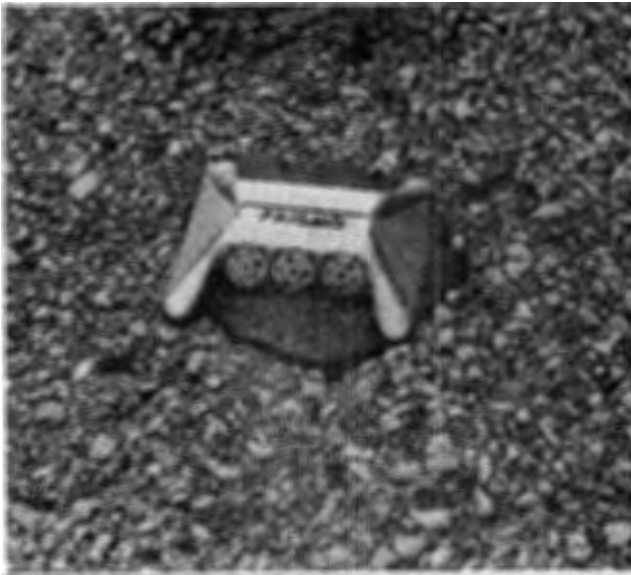
Figure 19. Prismo Marker after Approximately One Year in Service (Before Snowplowing).

The Prismo markers at the Fayette County site were removed by snowplows but observations of the markers at the Garrard County site were made (Figure 19). Five of the markers (17 percent) were missing. The remaining markers were generally in good condition. Several had minor damage to some of the glass lenses.

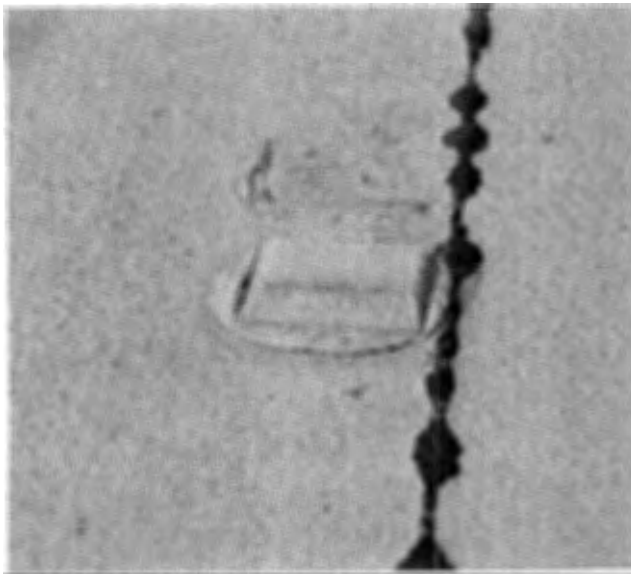
Figure 20. Stimsonite 911 Marker after Approximately One Year in Service (Before Snowplowing).

Twenty Stimsonite 911 markers were installed at the Fayette County site as a comparison to the snowplowable markers. After almost one-year, one of these markers was missing and one had major damage to the lens. There was significant chipping of the abrasive coating on the markers but they generally remained in good condition (Figure 20).

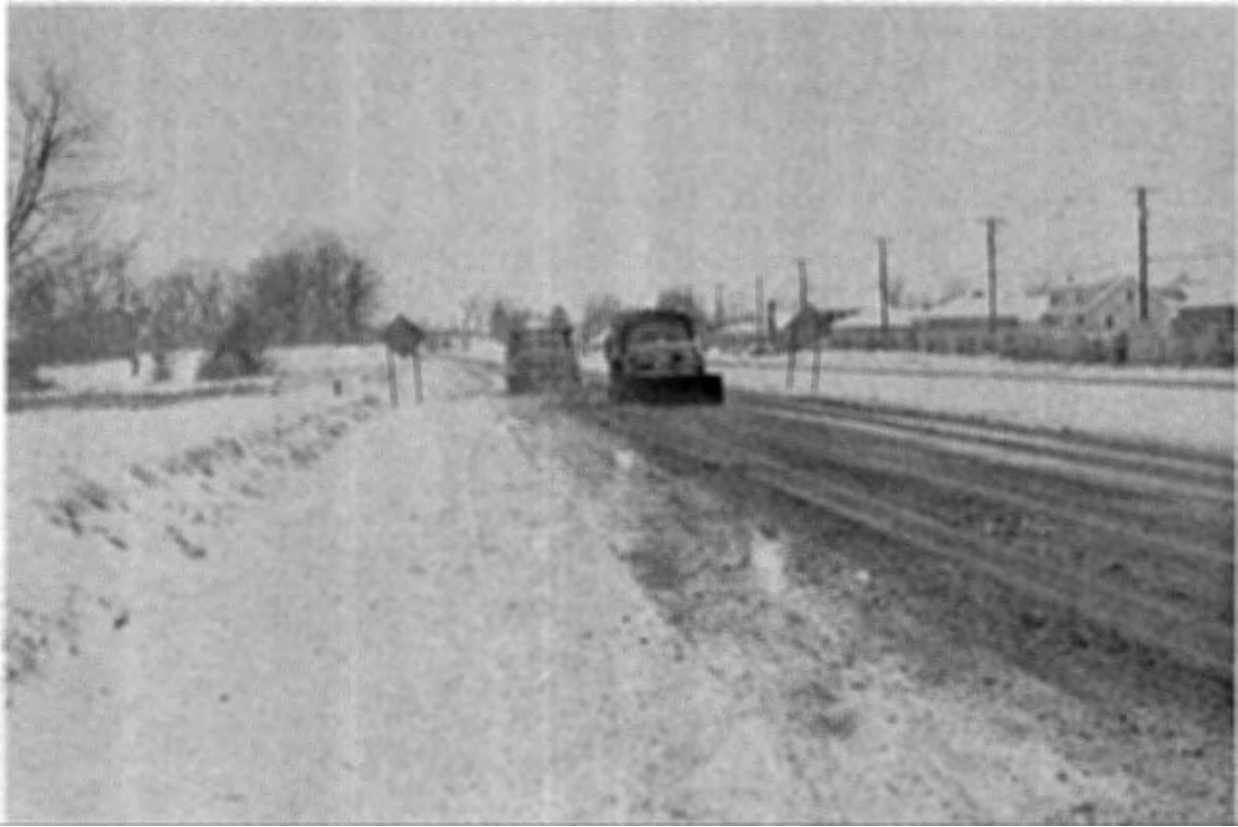
Figure 21. Snowplow Operation at Fayette County Location (US 68).

Snowplow Damage - During December 1981 and January 1982, there were between six and eight snowplow passes over the various test sections of markers (Figure 21). A steel blade was used during all operations. The only other snowplow tests were made during January 1981 when two passes were made northbound at the Fayette County location on a wet pavement. In the January 1981 test, the Prismo markers were removed and there was damage to three (14 percent) of the Kingray markers, while the Stimsonite 96, Dura-Brite, and recessed markers proved to be snowplowable with no damage.

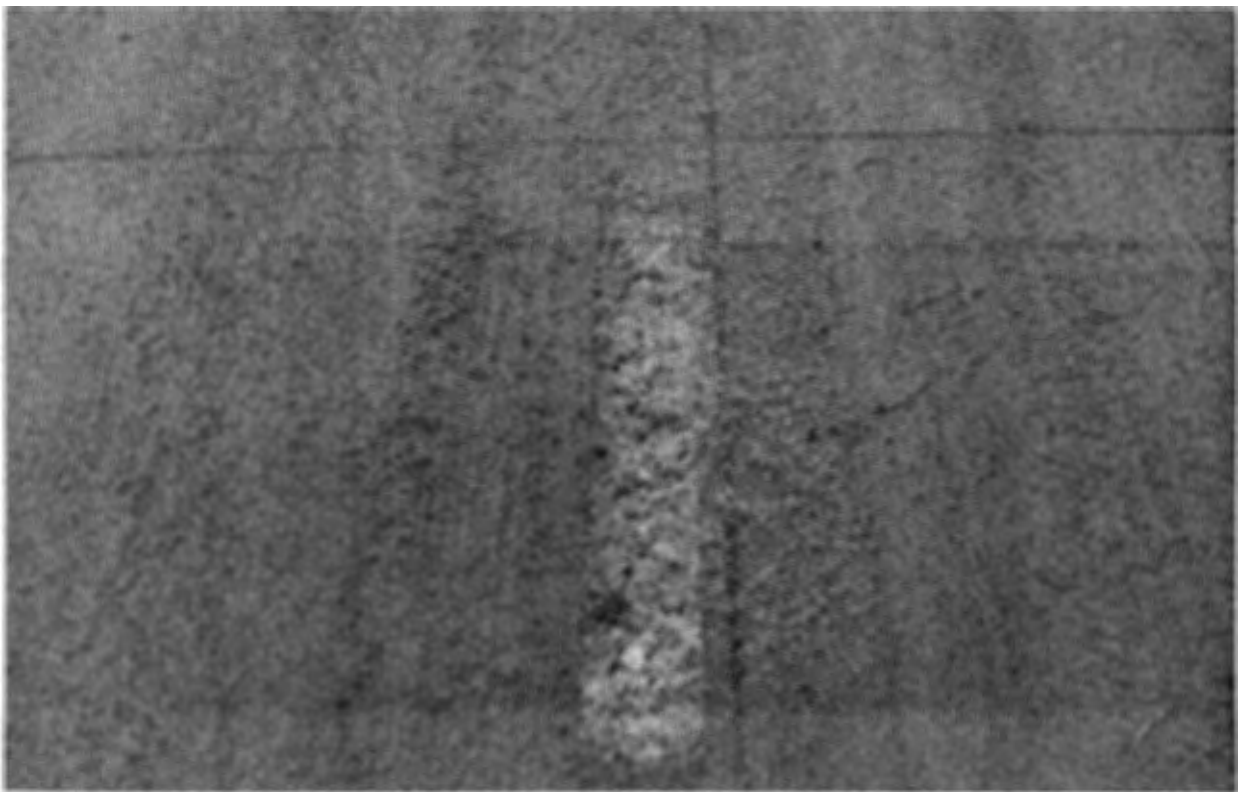
Figure 22. Recessed Marker Immediately after Snowplow Operation.

after approximately 16 months in service. As shown in Figure 22, the recessed marker was filled with snow after the snowplow operations, but the snow melted and the marker was visible again within a few hours (Figure 23). The recessed marker sustained no additional damage as a result of snowplowing. Neither the Stimsonite 96 or Dura-Brite markers sustained any damage to either the lens or the marker housing unit from the snowplowing. The final inspection found 13 Stimsonite 96 markers and one Dura-Brite marker with minor damage to the lens which was the result of traffic wear. Also, in two of the Dura-Brite markers, the lens was missing.

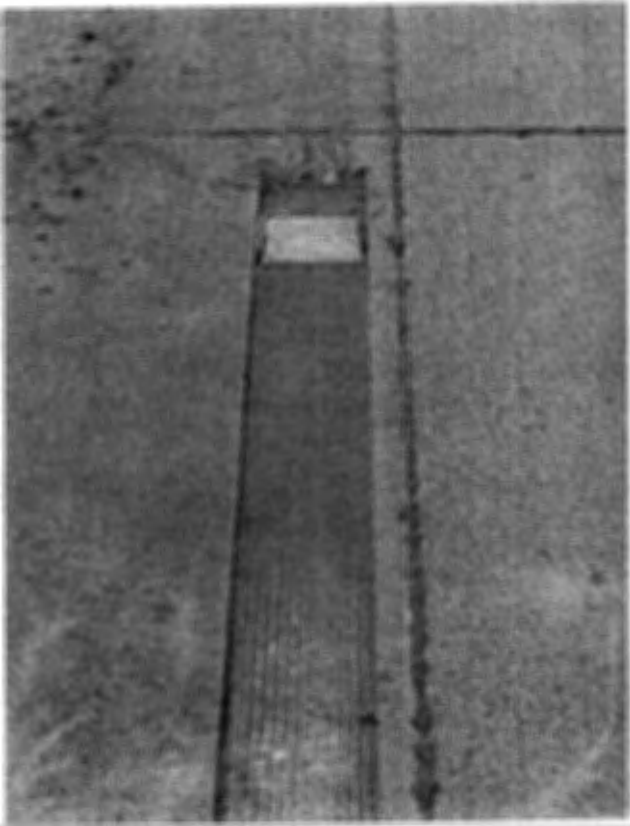
Figure 23. Recessed Marker a few Hours after Snowplow Operation.

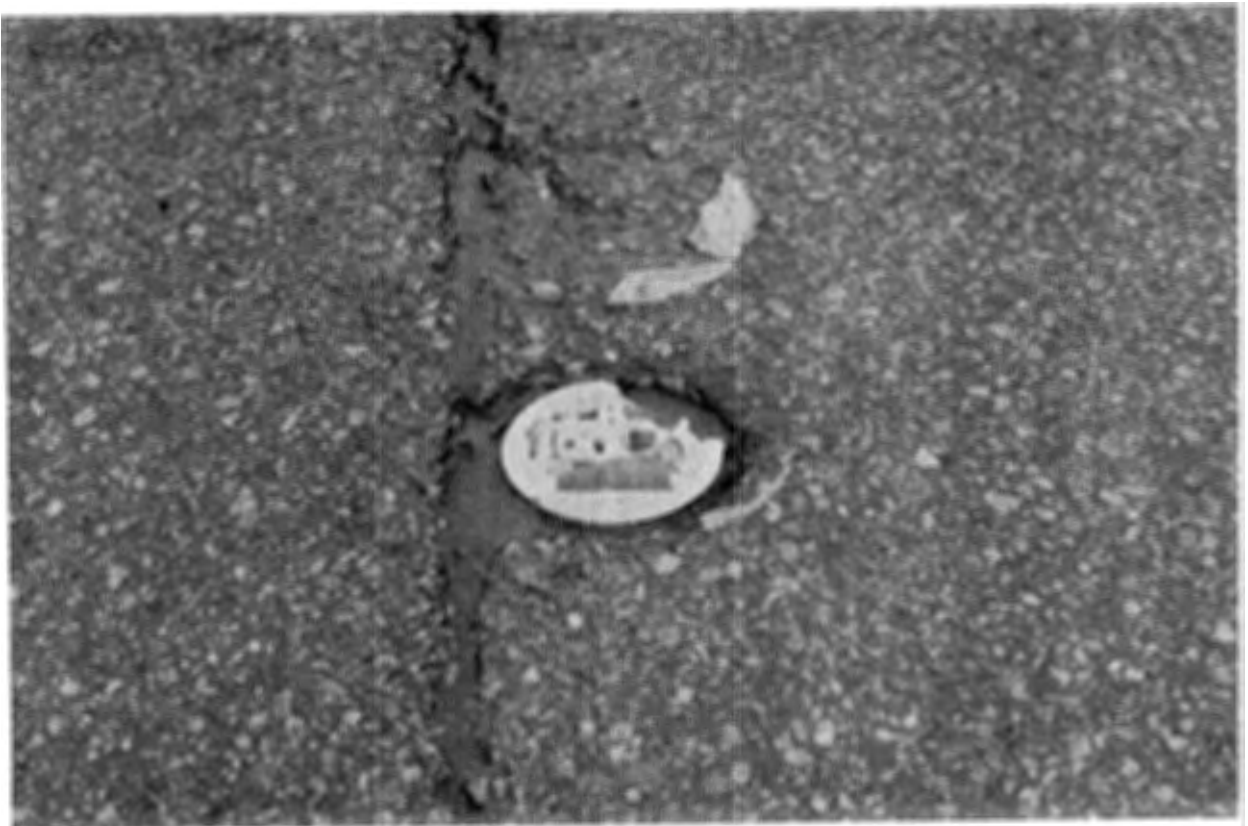
Figure 24. Damage to Kingray Marker by Snowplow.

The Kingray markers were also damaged by the snowplow operations (Figure 24). Even before the snowplows were used, several of the Kingray markers were either missing or damaged. An inspection after the snowplow operations revealed that 71 Kingray markers (47 percent) were missing, 43 (29 percent) were severely damaged, and 20 (13 percent) were moderately damaged. Only 11 percent were undamaged, and these remaining markers still recoiled as designed.

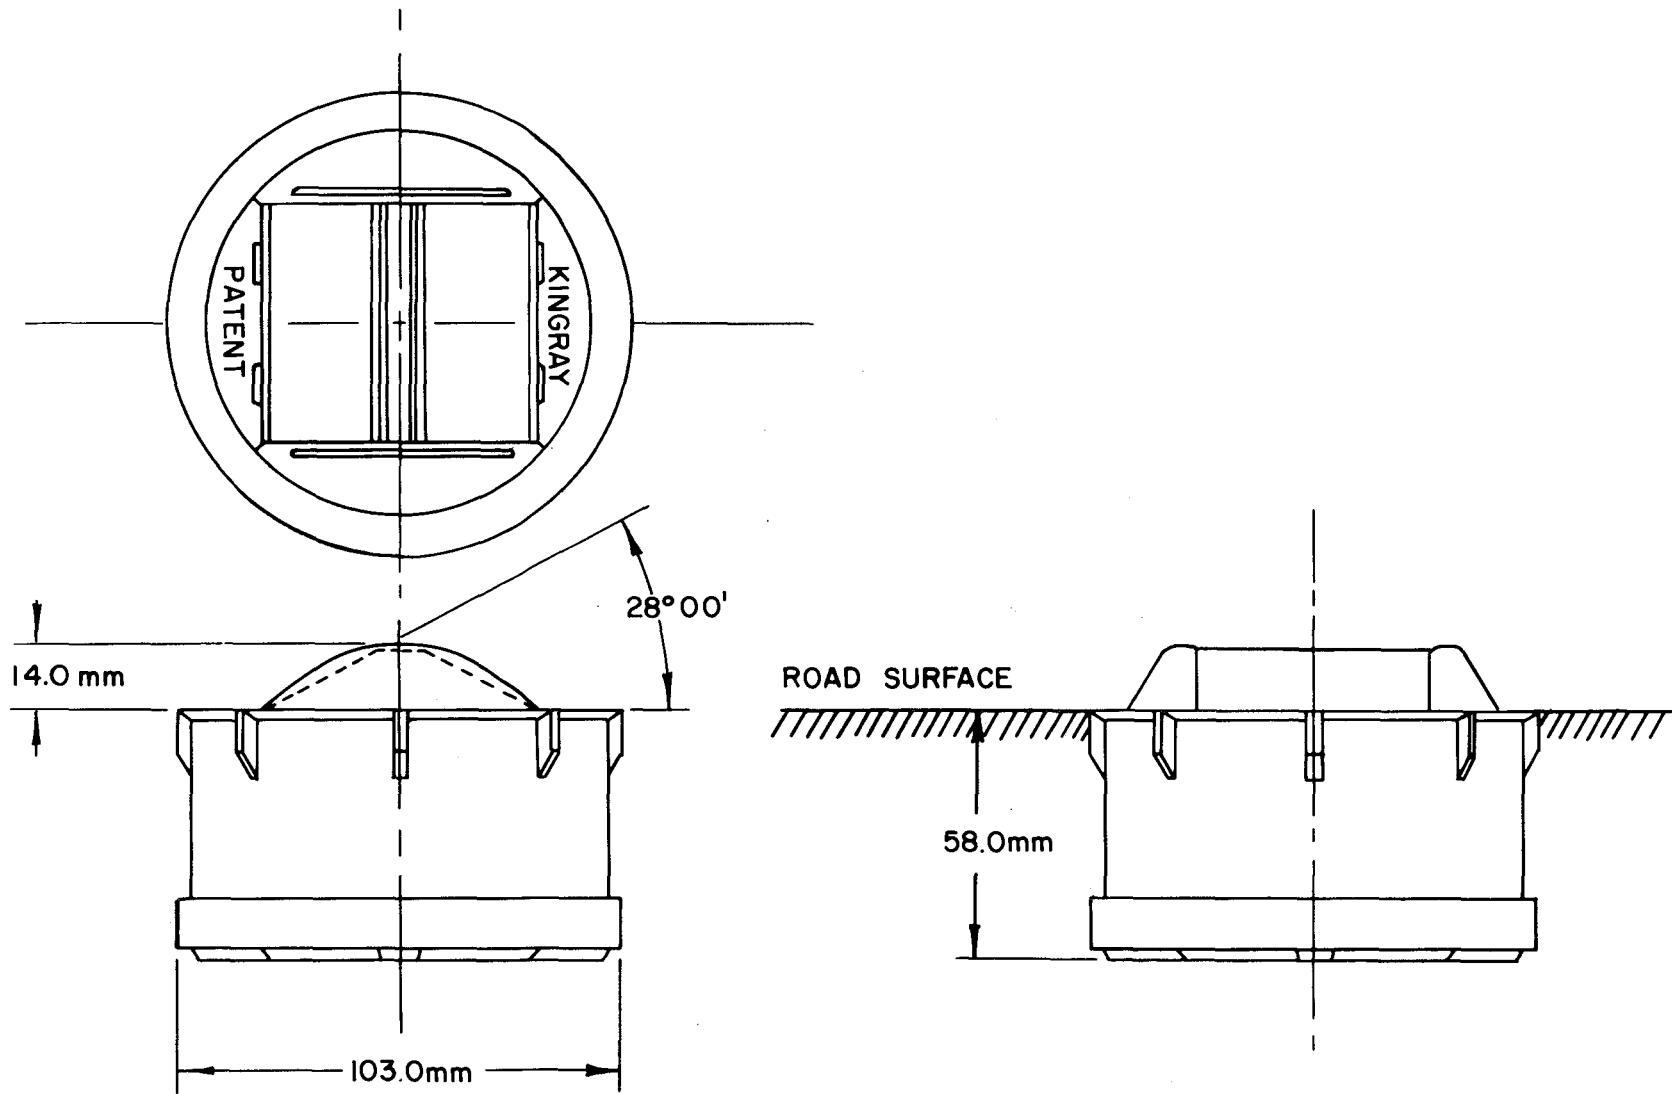
Figure A-1. Detail of Type A Marker (Kingray).

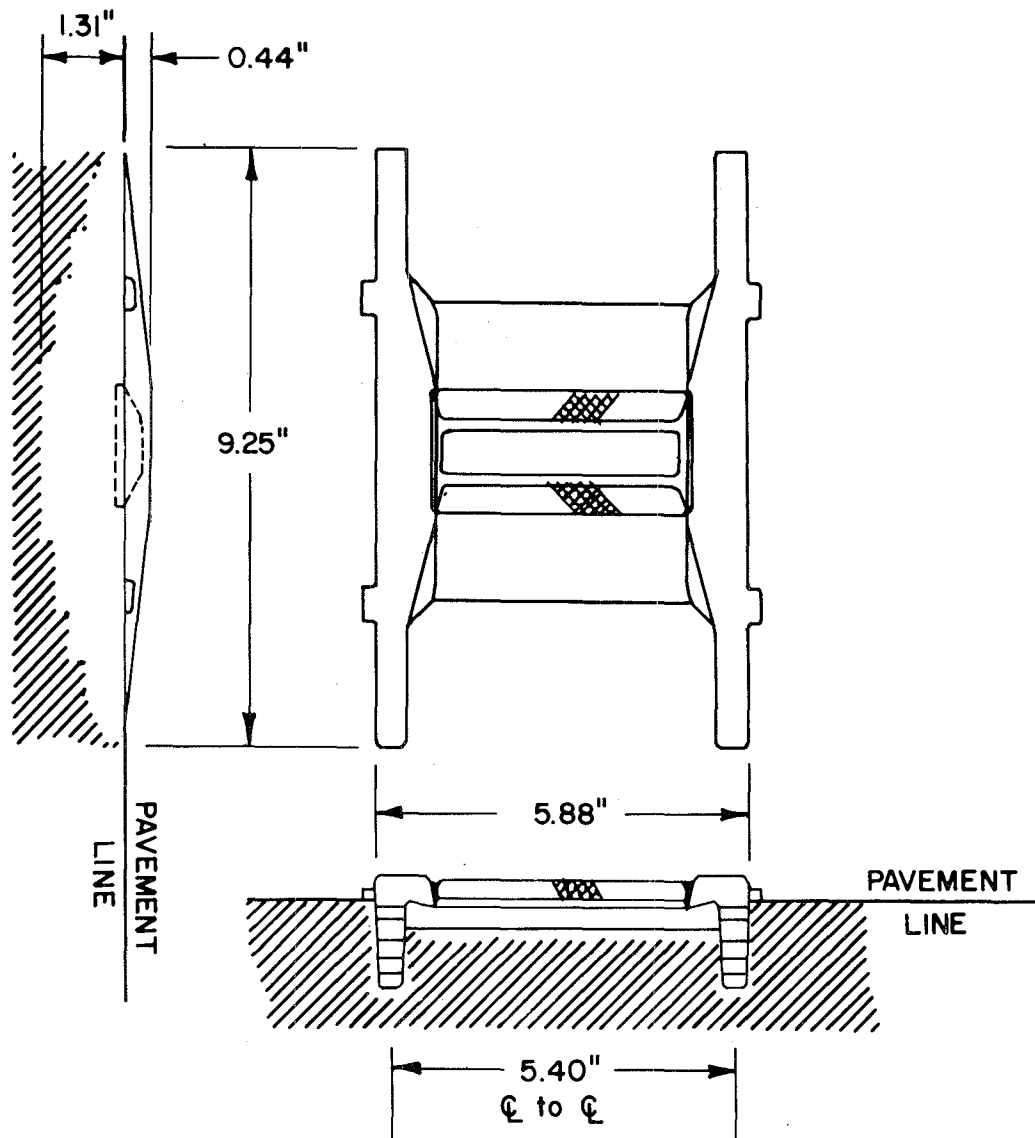
Figure A-2. Detail of Type B Marker (Stimsonite 96).

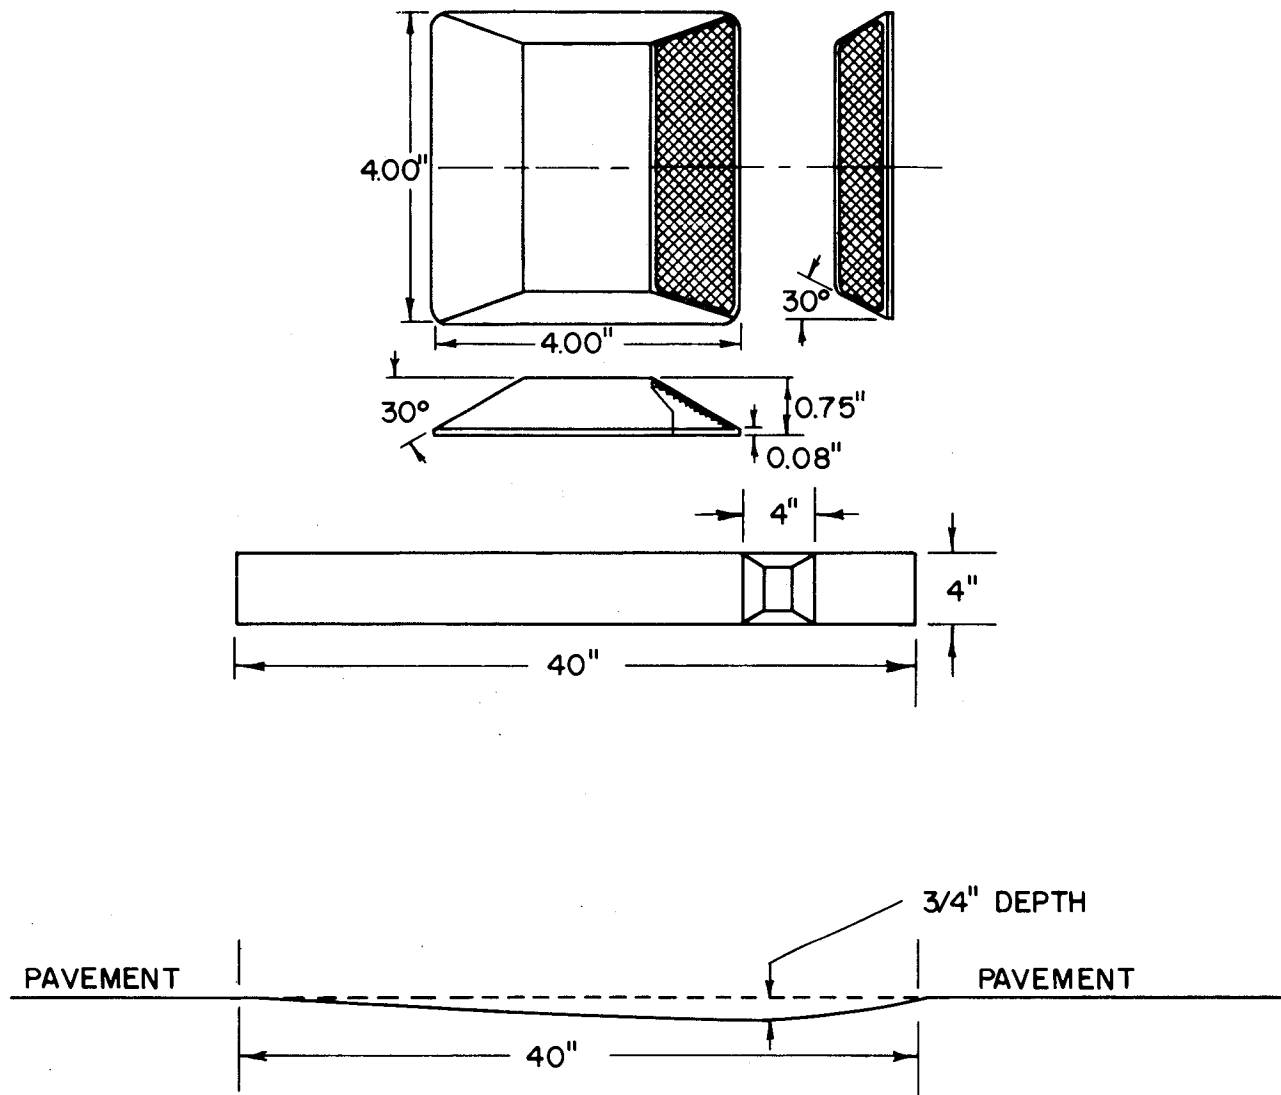
Figure A-3. Detail of Type C Marker (Recessed) and Sawed Groove

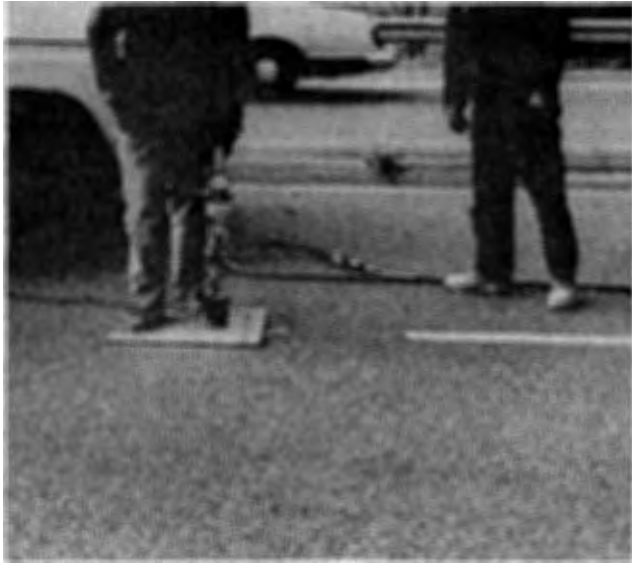
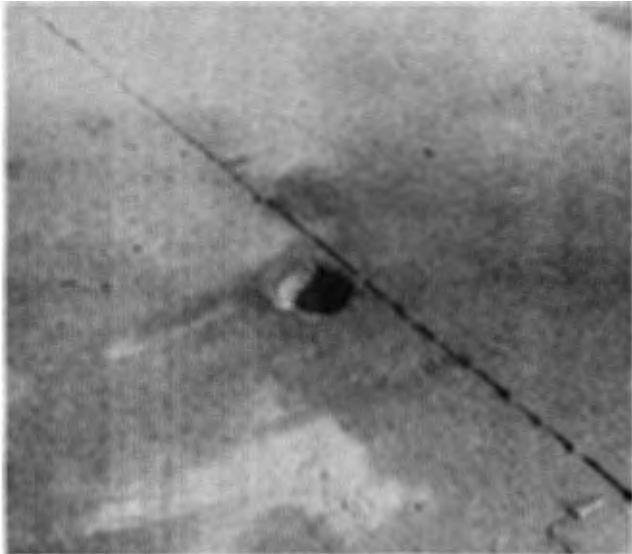
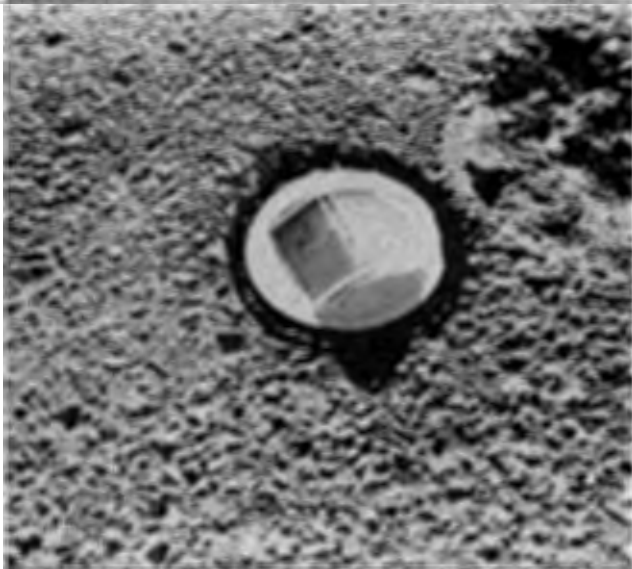
Drilling

Finished Hole

Installed Marker

Figure A-5. Installation of Kingray Marker.

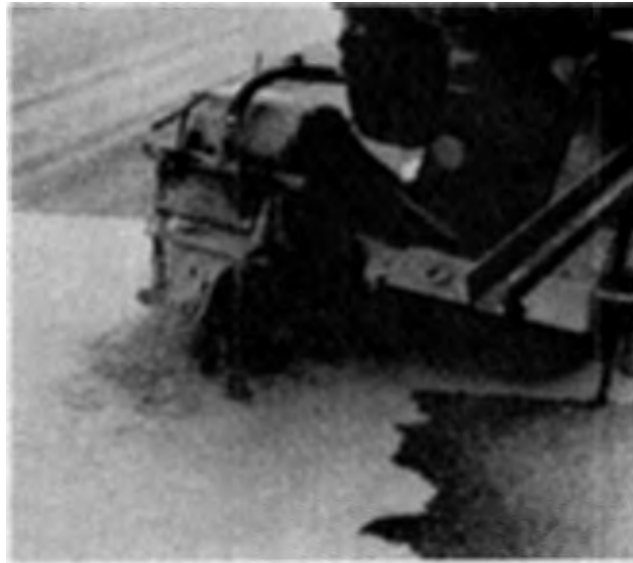
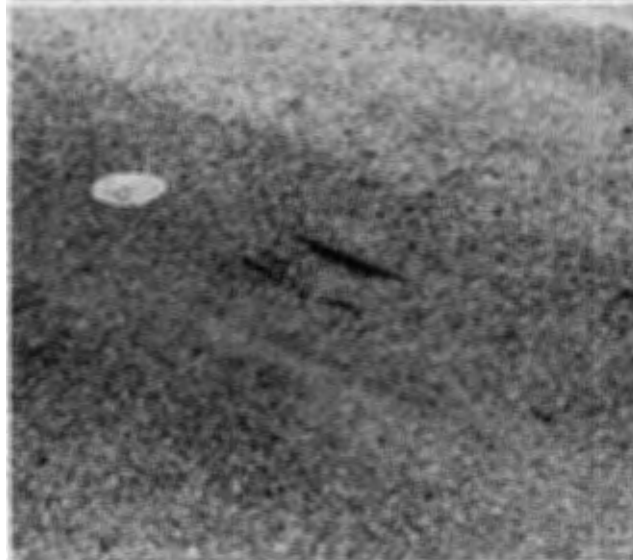
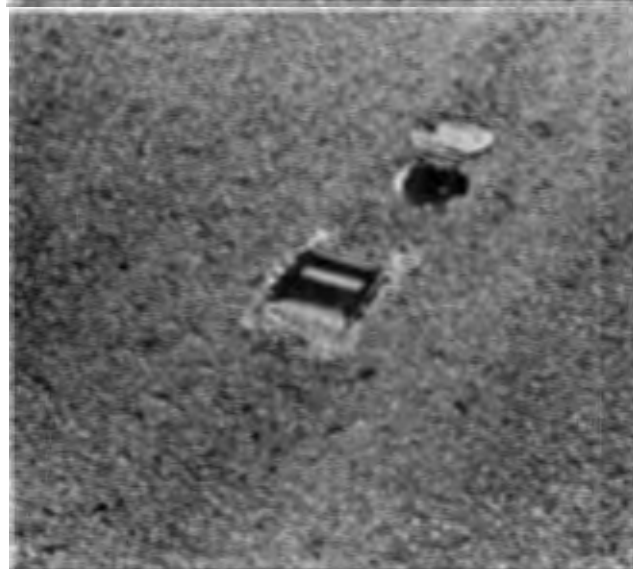
Sawing

Finished Cut

Installed Marker

Figure A-6. Installation of Stimsonite 96 Marker.

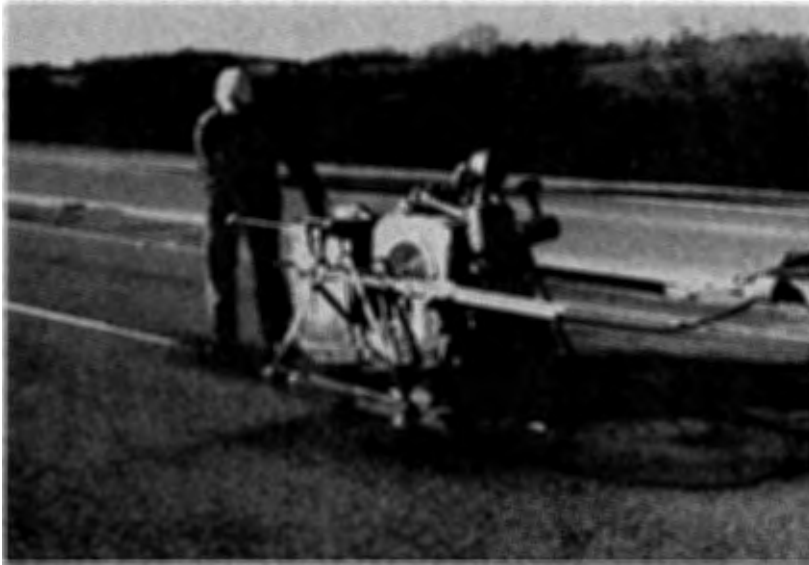
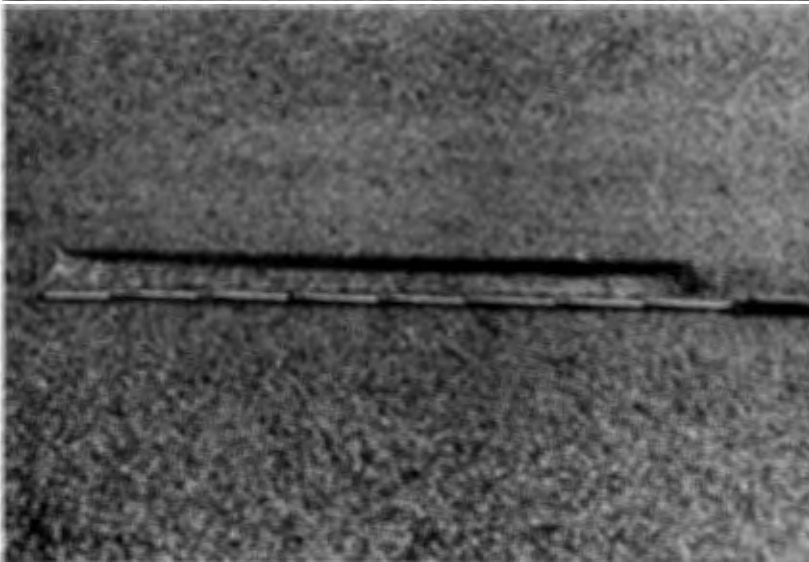
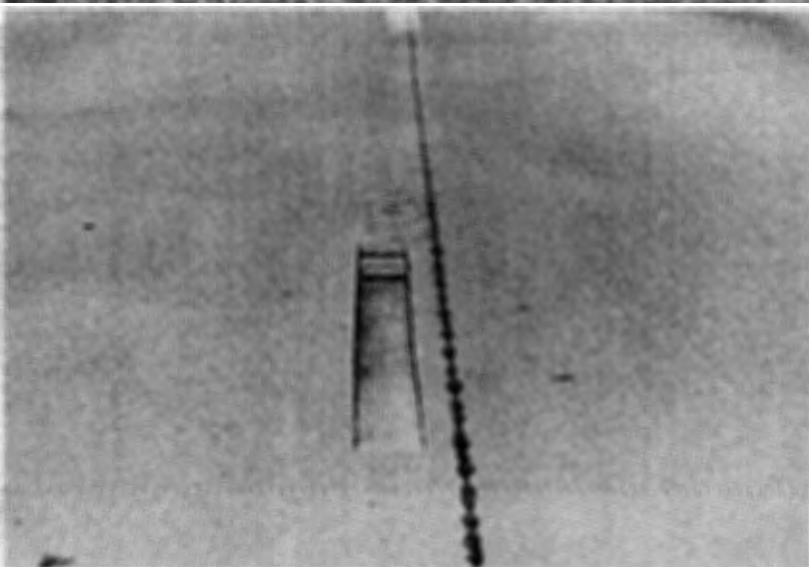
Sawing Groove

Finished Groove

Installed Marker

Figure A-7. Installation of Recessed Marker.

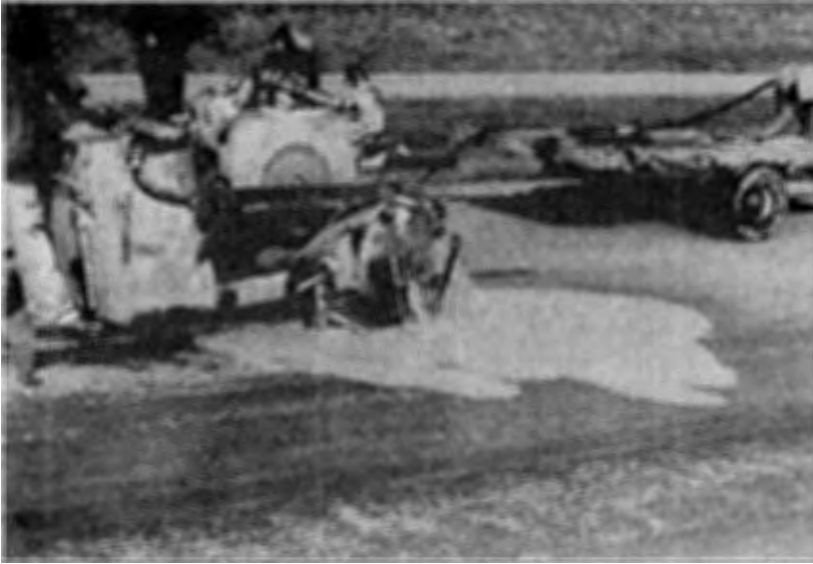
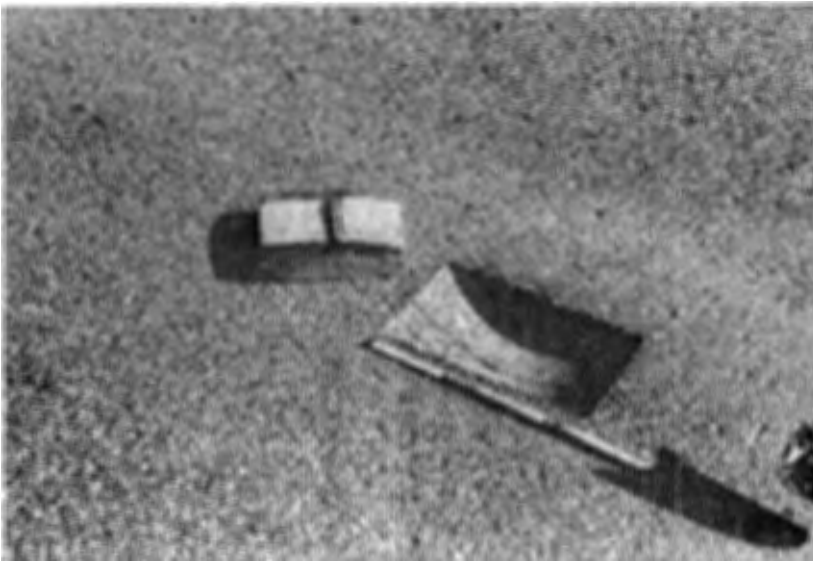
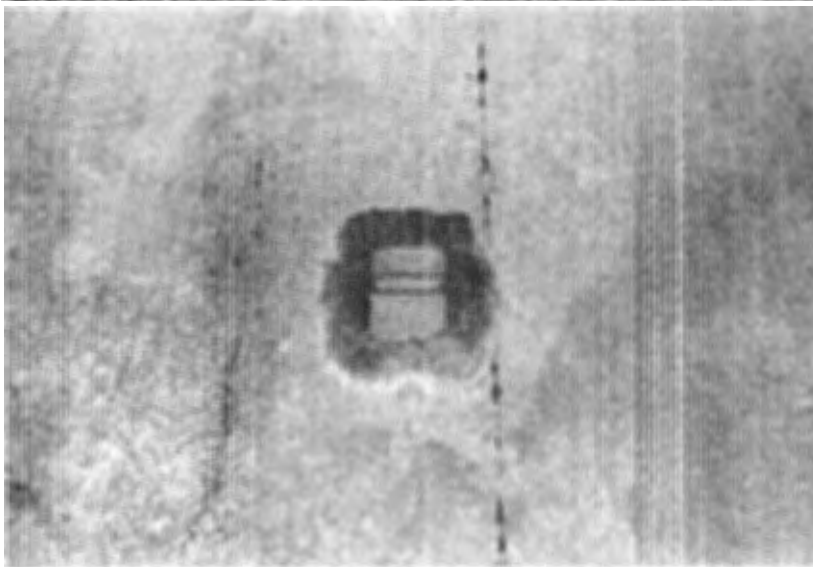
Sawing

Finished Cut

Installed Marker

Figure A-8. Installation of Dura-Brite Marker.
