Evaluation of Snowplowable Markers

FHWA-TS-82-222

October 1982

16. Abstract The objective of this study was to evaluate available snowplowable markers under similar traffic and snowplowing operations. There were five different markers tested which included the following: 1) Stimsonite 96, 2) Dura-Brite, 3) recessed, 4) Kingray, and 5) Prismo Roadstud. The Stimsonite 96, Dura-Brite, and recessed markers were found to be acceptable snowplowable markers. All three of these markers were found to have adequate reflectivity during both dry and wet nighttime conditions. This reflectivity was maintained over the test period and the markers proved to be durable when subjected to snowplow operations. However, considering all available input, the recessed marker is the most functional and cost-effective.

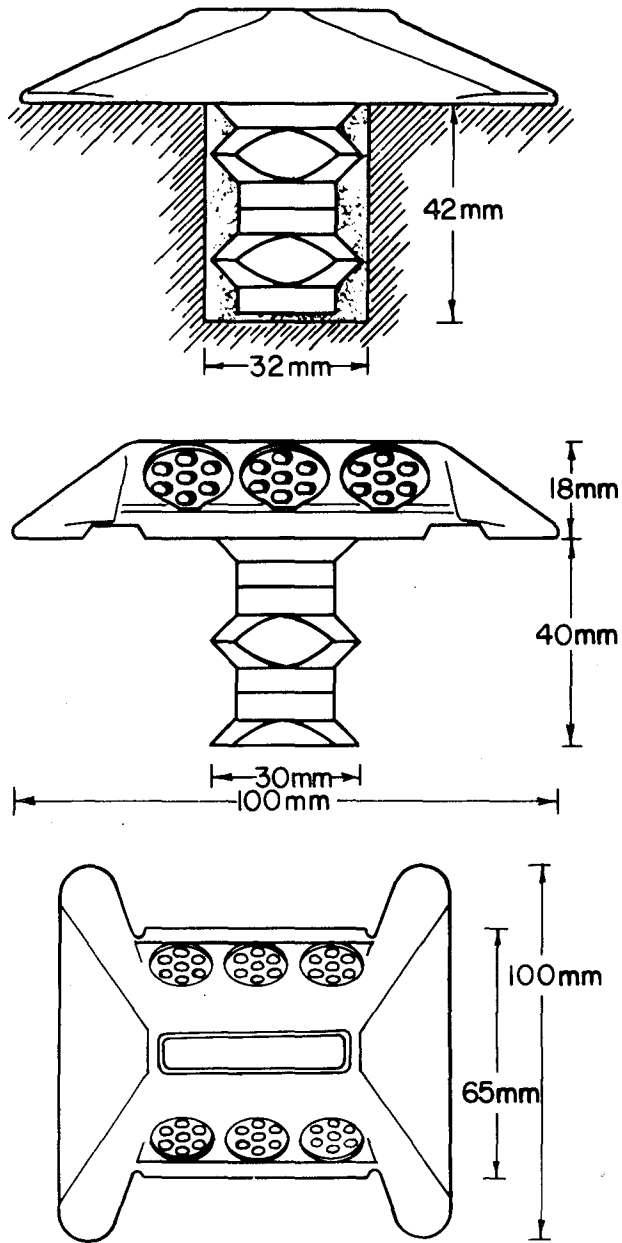
Figure A-9. Detail of Prismo Roadstud.

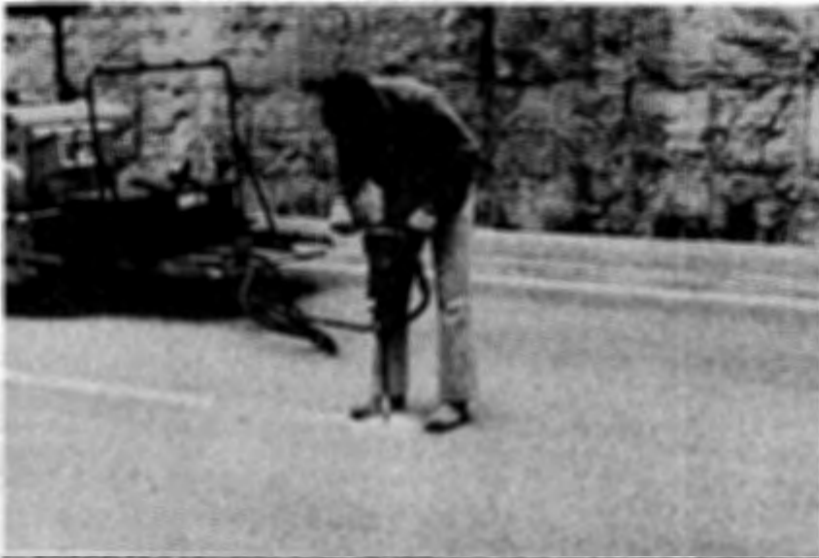
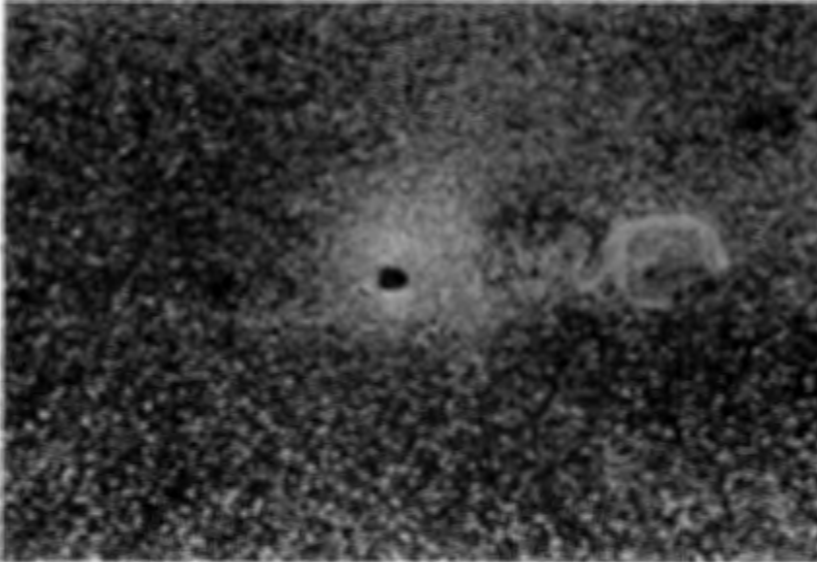
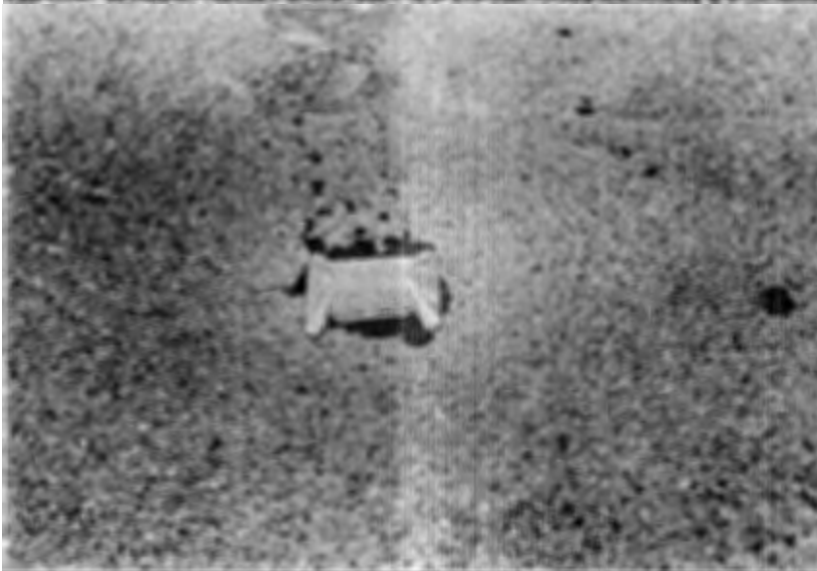
Drilling

Finished Hole

Installed Marker

Figure A-10. Installation of Prismo Marker.
