WASHINGTON STATE
DEPARTMENT OF TRANSPORTATION
MATERIALS OFFICE

PERMANENT LANE MARKING
(Recessed Lane Edge Stripe)

Materials Office
Report No. 170

July, 1981

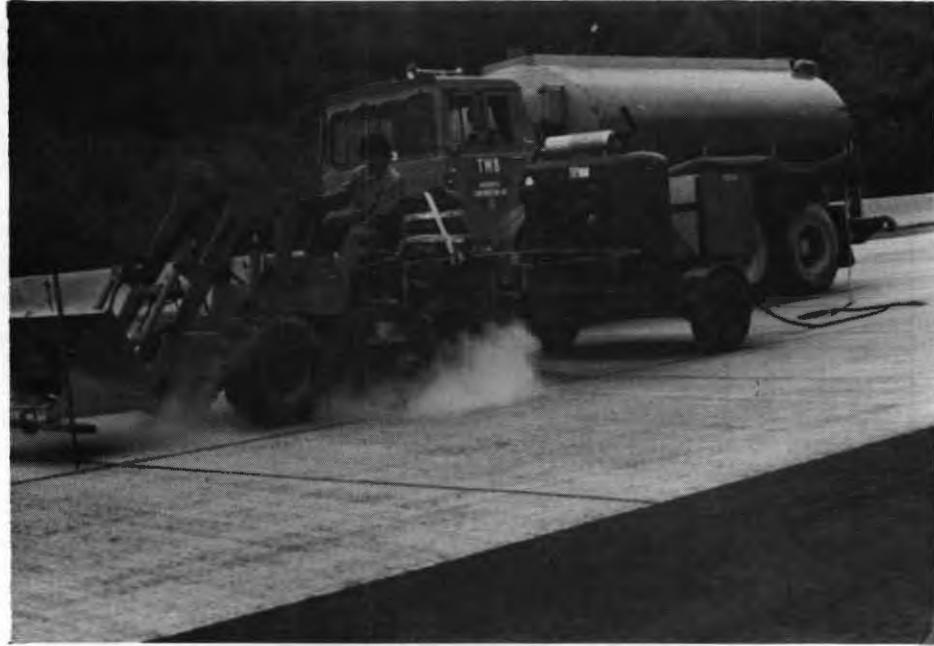
Figure 1. Flow Industries' water jet cutting system which includes a water truck, a trailer-mounted 60,000-psi intensifier powered by a diesel engine and an articulated front-end loader. The pressurized water is conveyed through a small pipe from the trailer to the cutting head.

The high-pressure water jet manufactured by Flow Industries was first to be evaluated. The equipment included a trailer-mounted 60,000-psi intensifier powered by a diesel generator. This was pulled by an articulated front-end loader which had the 4-inch-diameter, two-nozzle, rotating cutting tool. An externally mounted chain and sprocket regulated forward speed which in turn determined the depth of cut (see Figures 1 and 2).

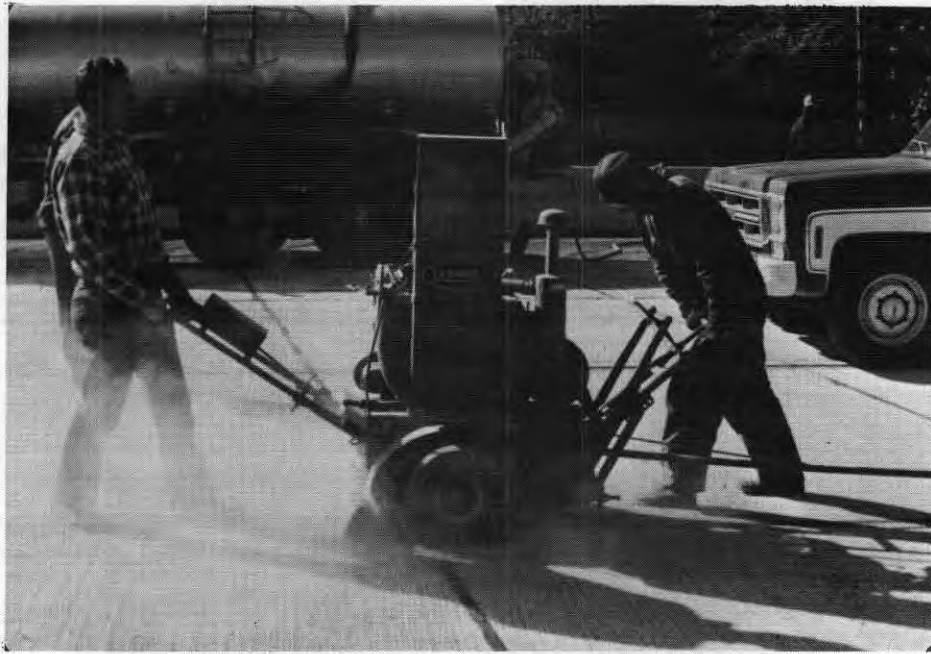
Figure 4. Tennant heavy-duty grinder (Model G). The operator of the machine could not keep true alignment; hence the laborer aided in guiding the machine.

The grinder, a Tennant Heavy-Duty Model G, was the second method tried. Figure 4 shows the operation of the machine which required two men due to the difficult job it is to control. The cutting head, Figure 5, has offset carbide-tipped star washers which chip at the pavement. These washers wear unevenly, resulting in an uneven fracturing of the pavement as shown in Figure 6. The first set of cutters was replaced after only 18 sections (180 lineal feet) of 1/2-inch grooving. In all, only 24 sections of 1/2-inch depth and 4 sections of 1/4-inch depth were accomplished in one day's work. A trial cut in the asphalt shoulder had equally poor results.

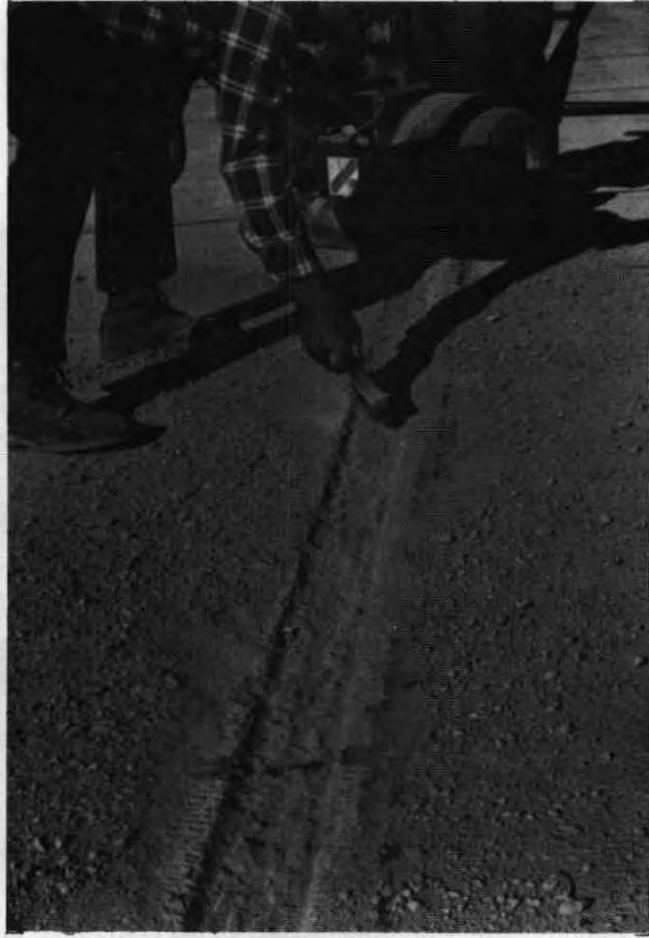
Figure 6. Recess formed by Tennant grinder. Note the uneven edges and variable cutting depth. A test cut in the asphalt shoulder had the same results.

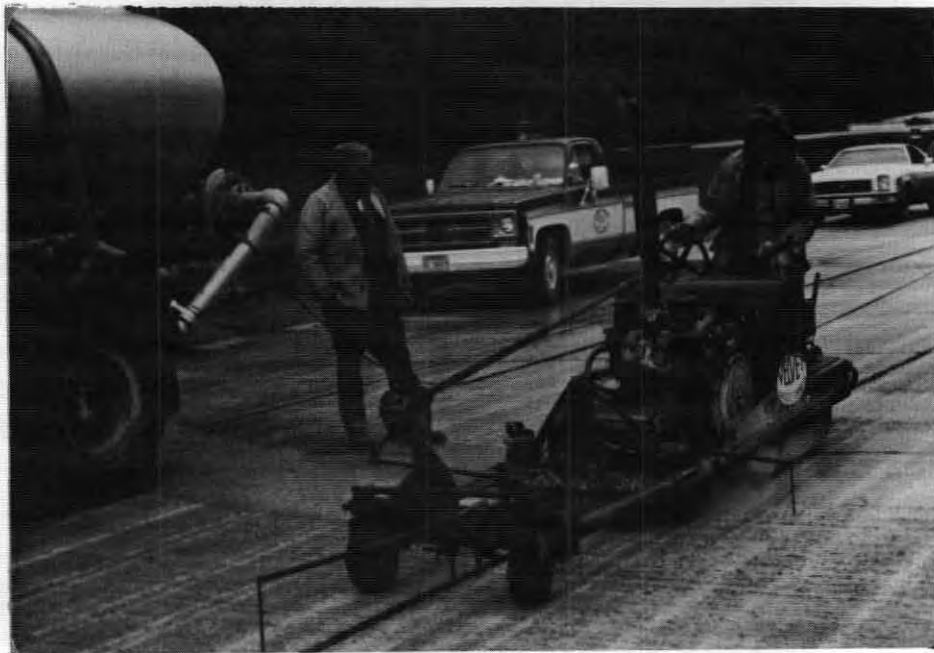
Figure 7. Concut diamond saw. This self-propelled machine was easy to operate, easy to keep in alignment, and made a very uniform recess. The truck on the left supplied the water to the saw via a hose.

cutting width. It was self-propelled, compact, and yet heavy enough to drag the water supply hose without affecting the alignment control (Figure 7). Production rates varied with the depth of cut, but for a 1/4-inch groove, it averaged 100 to 120 lineal feet (10-12 sections) per hour (Figure 8). All remaining grooving was accomplished with this method.

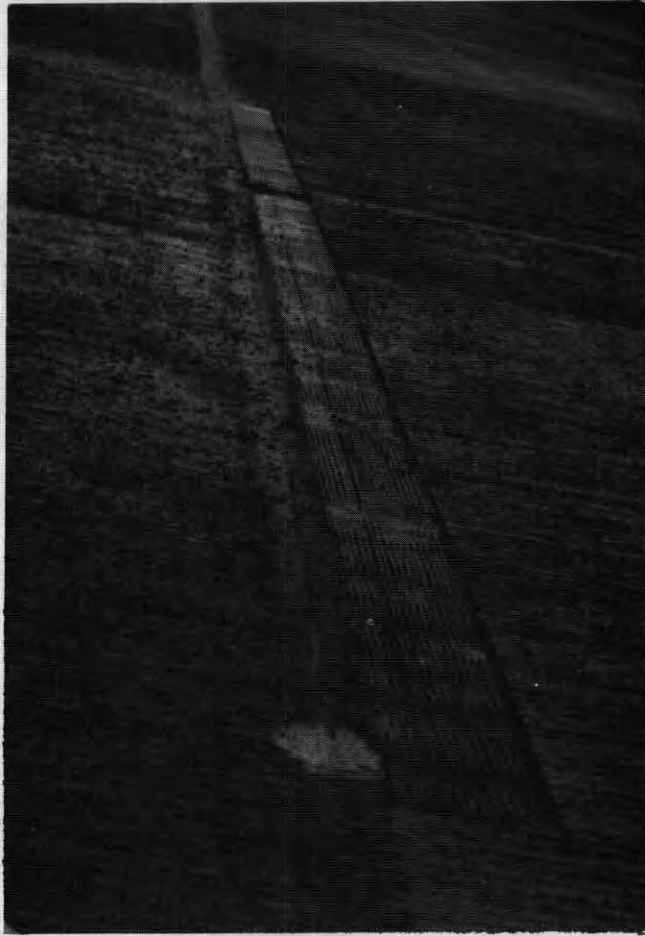
Figure 8. Recess formed by the Concut diamond saw. This method produced the truest vertical edges of the three methods used.

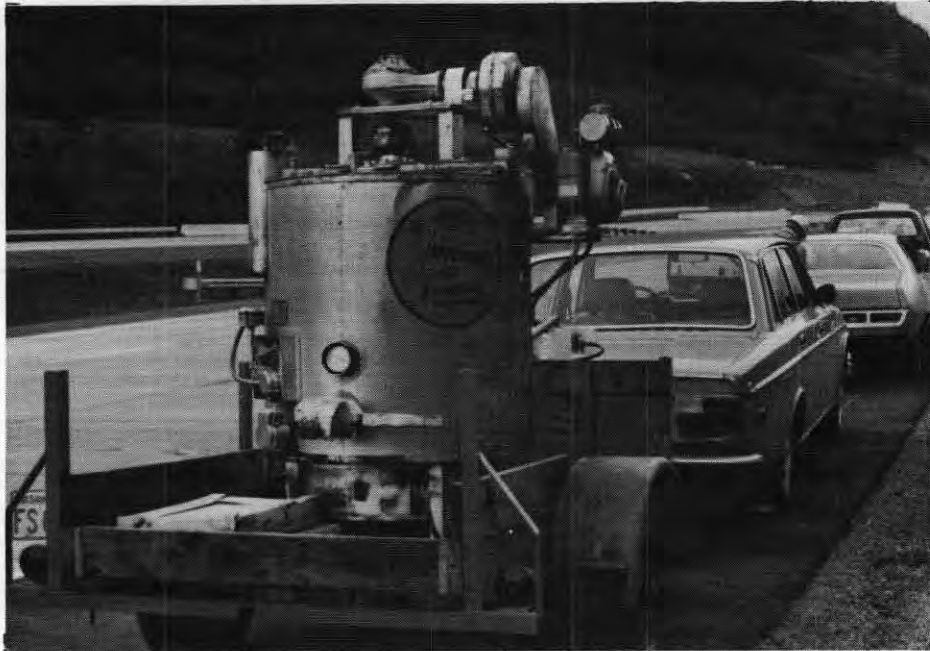
Figure 9. Trailer-mounted heating vat for liquifying Cleanosol. Solid ingots of Cleanosol are visible in the cardboard boxes behind the heater. The applicator machine is filled from the dispenser on the rear of the vat.

Cleanosol is a hot extruded thermoplastic product from Sweden. It comes as a solid component which is liquified by heat and dispensed at about 175°C into a small hand applicator as shown in Figures 9 and 10. A filling of the applicator would cover approximately 100 lineal feet of the 1/4-inch-deep recesses. The material cools rapidly to a solid and is ready to accept traffic in a very short time. A total of 75 sections was filled with the Cleanosol material, all 1/4-inch deep.

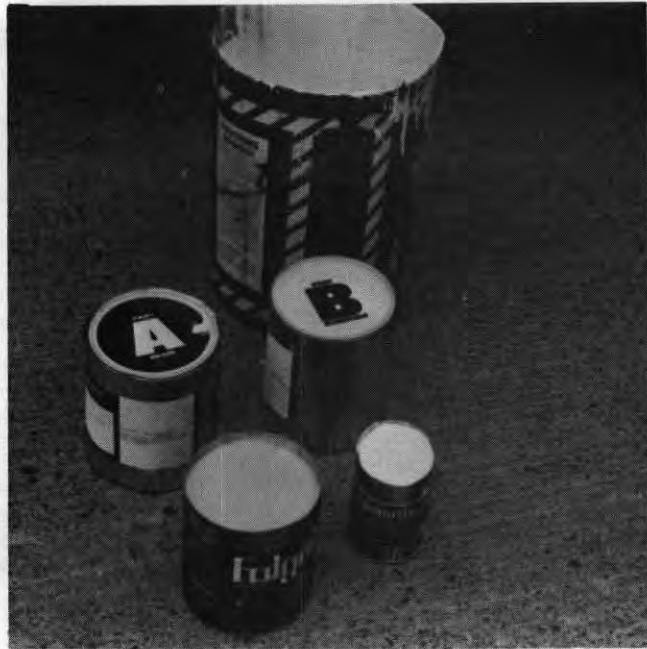
Figure 11. Two-part Concrecive 1064 components, glass beads, and 5-gallon mixing bucket.

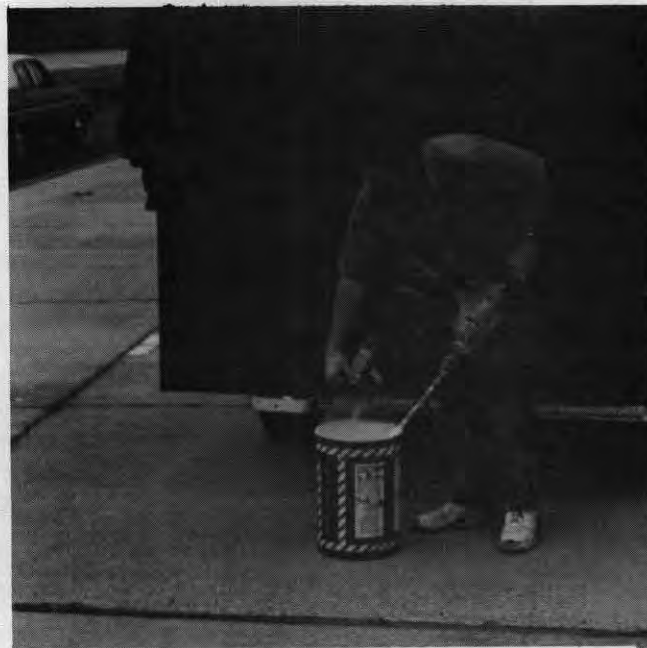
Figure 12. Mixing of Concrecive 1064 components and glass beads using a drill with mixer attachment. A generator in the trailer provided the power for the drill.

The installation of the third material, Adhesive Engineering's Concresive 1064 white, was delayed one year by our desire to have a two-white-component epoxy. The standard Concresive epoxy mix is a combination of one black and one white component, yielding an end product which is grey in color. A special factory order had to be made with the two-white-component mixture because of our desire for the whitest stripe possible. This special order of material did not arrive on the project site until the late fall of 1977 which was past the time when daytime temperatures were warm enough to properly cure the epoxy mixture. In March and June of the following year, 371 sections (3710 lineal feet) were filled with the Concresive 1064 mixture using the procedure shown in Figures 12, 13, 14, and 15.

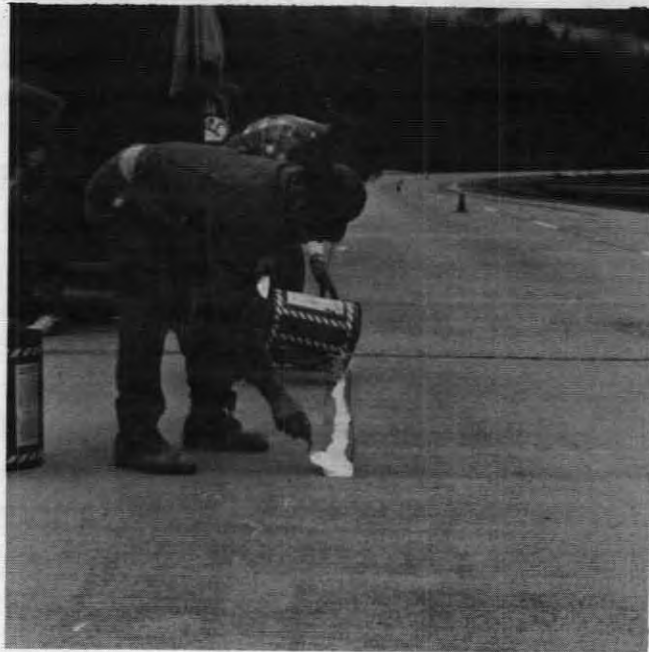
Figure 13. Workmen spreading Concrete 1064 material into a grooved pavement recess. The workman in foreground is using a trowel to spread the liquid epoxy. On a grade as shown (3%), it took extra care to distribute the epoxy and maintain a full-depth section throughout the recess.

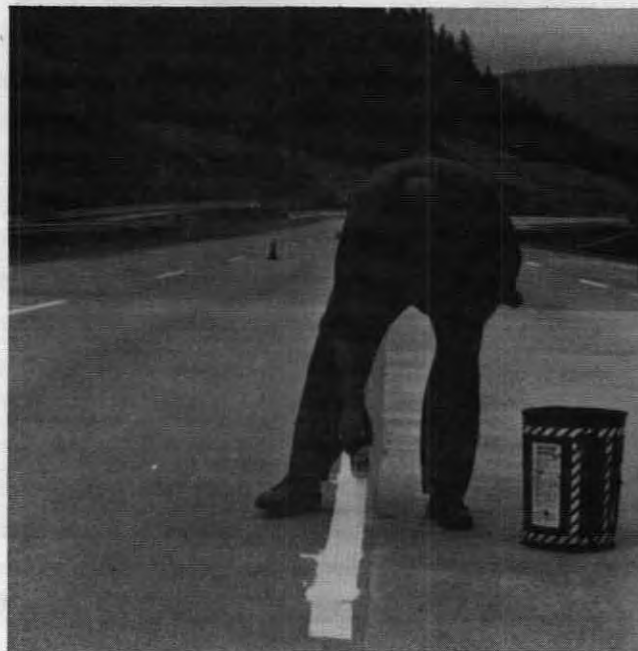
Figure 14. Workman sprinkling a topical application of glass beads over a completed section of Concrete 1064. Cure time on the epoxy is temperature-sensitive which means more traffic disruption on cool days.
