DEVELOPMENT OF A NEW SACRIFICIAL CATHODIC PROTECTION SYSTEM FOR STEEL EMBEDDED IN CONCRETE

(U.S.) CORRPRO COMPANIES, INC., MEDINA, OH

PUBLICATION NO. FHWA-RD-96-171

MAY 1997

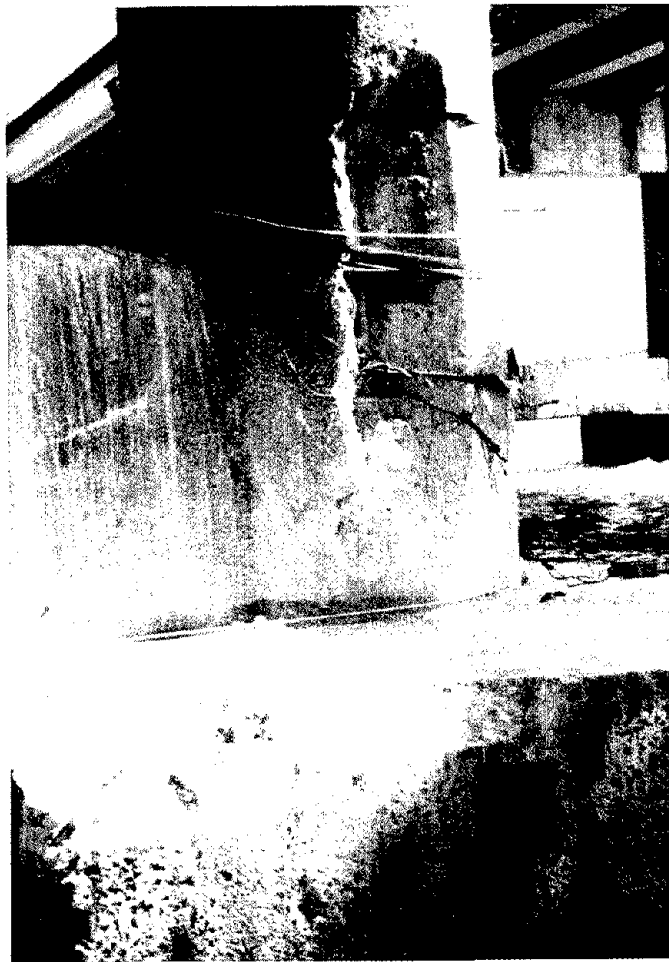
Figure 13. Zinc anode coating applied to exposed rebar on Bahia Honda Bridge (bands were used to hold reference cells onto the column).

Sprayed zinc was applied to one pile of the Bahia Honda Bridge. The concrete and exposed steel reinforcing was first abrasive blasted, then the zinc coating was applied directly to exposed reinforcing steel and concrete (figure 13). Twelve rebar probes were installed in the pile tested. Ten probes were installed in two vertical rows of five probes each at approximately 2-ft (60-cm) intervals in the column, and two probes were installed in the footing, as shown in figure 14. Six probes were connected to the CP system, and the other six probes had not been connected as controls. Since the zinc was sprayed directly onto exposed rebar, the anode could not be separated from the rebar to conduct tests. However, anode tests could be conducted at “windows” cut into the anode. A total of six 1-ft x 1-ft (30-cm x 30-cm) windows of zinc coating were isolated from the bulk zinc coating by saw-cutting. Four of the six windows are located on the column in one vertical row separated by approximately 1.5 ft (45.7 cm), as shown in figure 20. One window was located on the vertical surface of the footing, and another window was located on the top surface of the footing. A 0.75-in- (2-cm-) wide stainless steel band was used to provide electrical continuity between the window and the surrounding zinc coating.

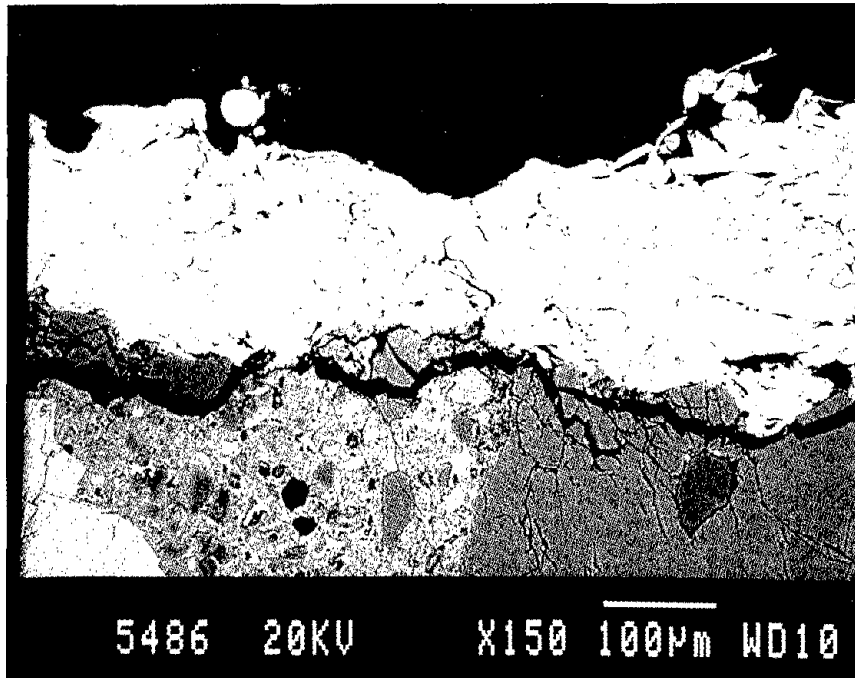
Figure 48. Cross section of Al-10Zn-0.2In alloy-to-concrete interface.

Figures 48 and 49 show cross sections of the Al-10Zn-0.2In alloy-concrete interface obtained by a scanning electron microscope immediately after the alloy was sprayed. The photographs of the concrete-alloy interface show that the new alloy penetrated into almost all concrete pores during the spray application. The average bond strength of this alloy was approximately 235 lbf/in² (1.62 MPa). The range was 180.3 to 294.1 lbf/in² (1.24 to 2.03 MPa). The strong bond strength of the new alloy may result from the low surface tension of the alloy. Note that the separation between the coating and concrete in the photographs occurred during the specimen preparation process for the microscopic examination, not at the concrete-alloy interface. This indicates that the bond strength of the alloy to the concrete exceeded the tensile strength of the concrete.
