# Testing of New Bridge Rail and Transition Designs

Volume XI: Appendix J

42-in (1.07-m) F-Shape Bridge Railing

PUBLICATION NO. FHWA-RD-93-068

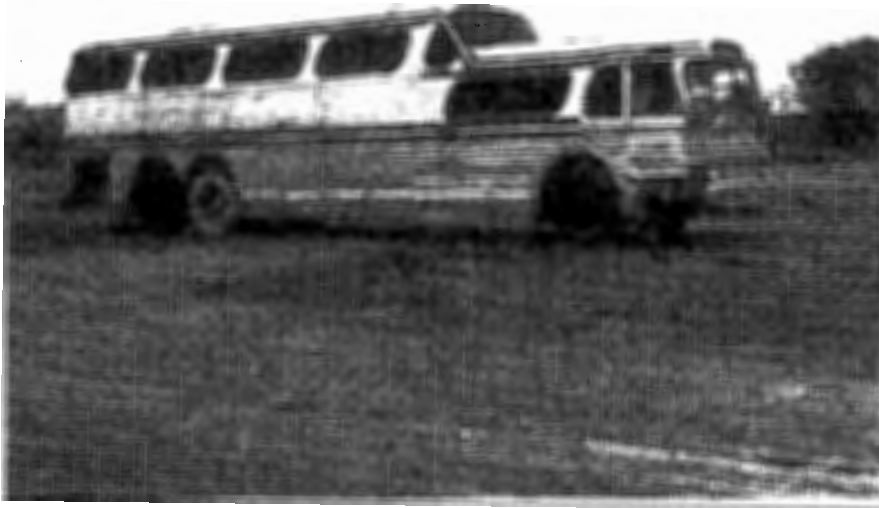
Figure 2. Vehicle before test 7069-7 .

The 1954 GMC Scenicruiser bus (figure 2) was directed into the 42-in (1.07-m) F-shape bridge railing (figure 3) using a remote control guidance system. Test inertia mass of the vehicle was 29,840 lb (13 547 kg) and its gross static mass was 40,560 lb (18 414 kg). The height to the lower edge of the vehicle bumper was 25.0 in (635 mm) and it was 38.25 in (972 mm) to the top of the bumper. Other dimensions and information on the test vehicle are given in figure 4. The vehicle was free-wheeling and unrestrained just prior to impact.

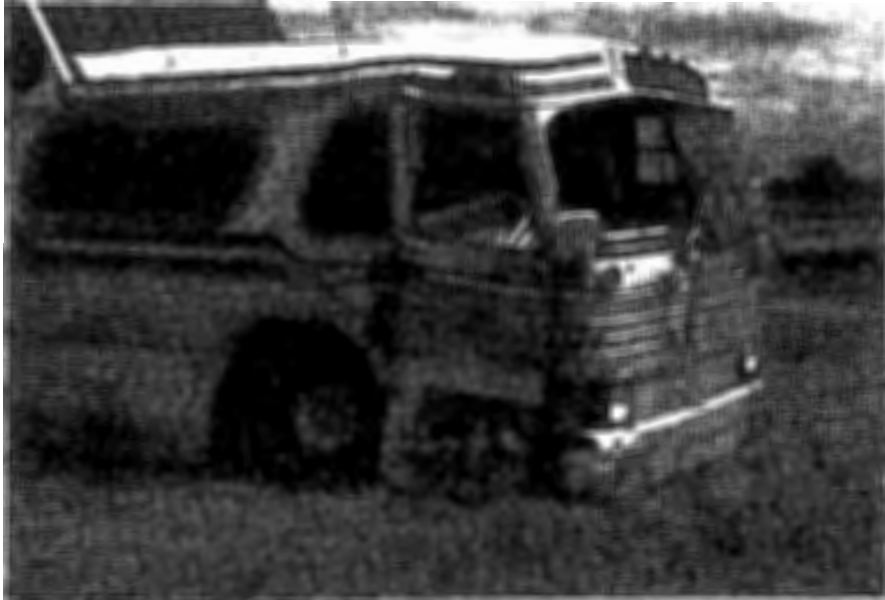
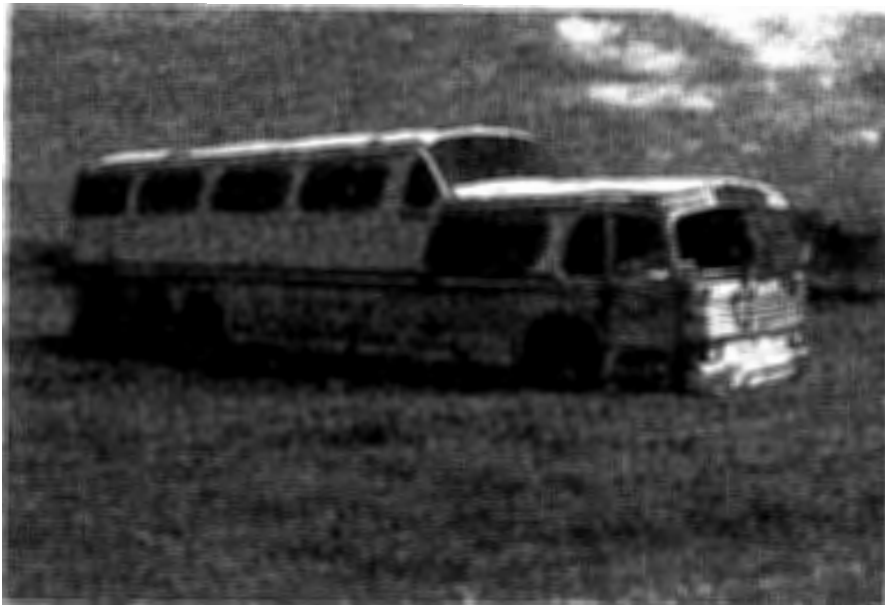
Figure 6. Vehicle after test 7069-7.

The vehicle sustained extensive damage to the right side as shown in figure 6. Maximum crush at the right front corner at bumper height was 4.0 in (102 mm). The right front and right rear wheel rims were scratched. The front wheel assembly and suspension was damaged. The door was bent and the windshield was broken out. The right rear panel was dented and scraped.

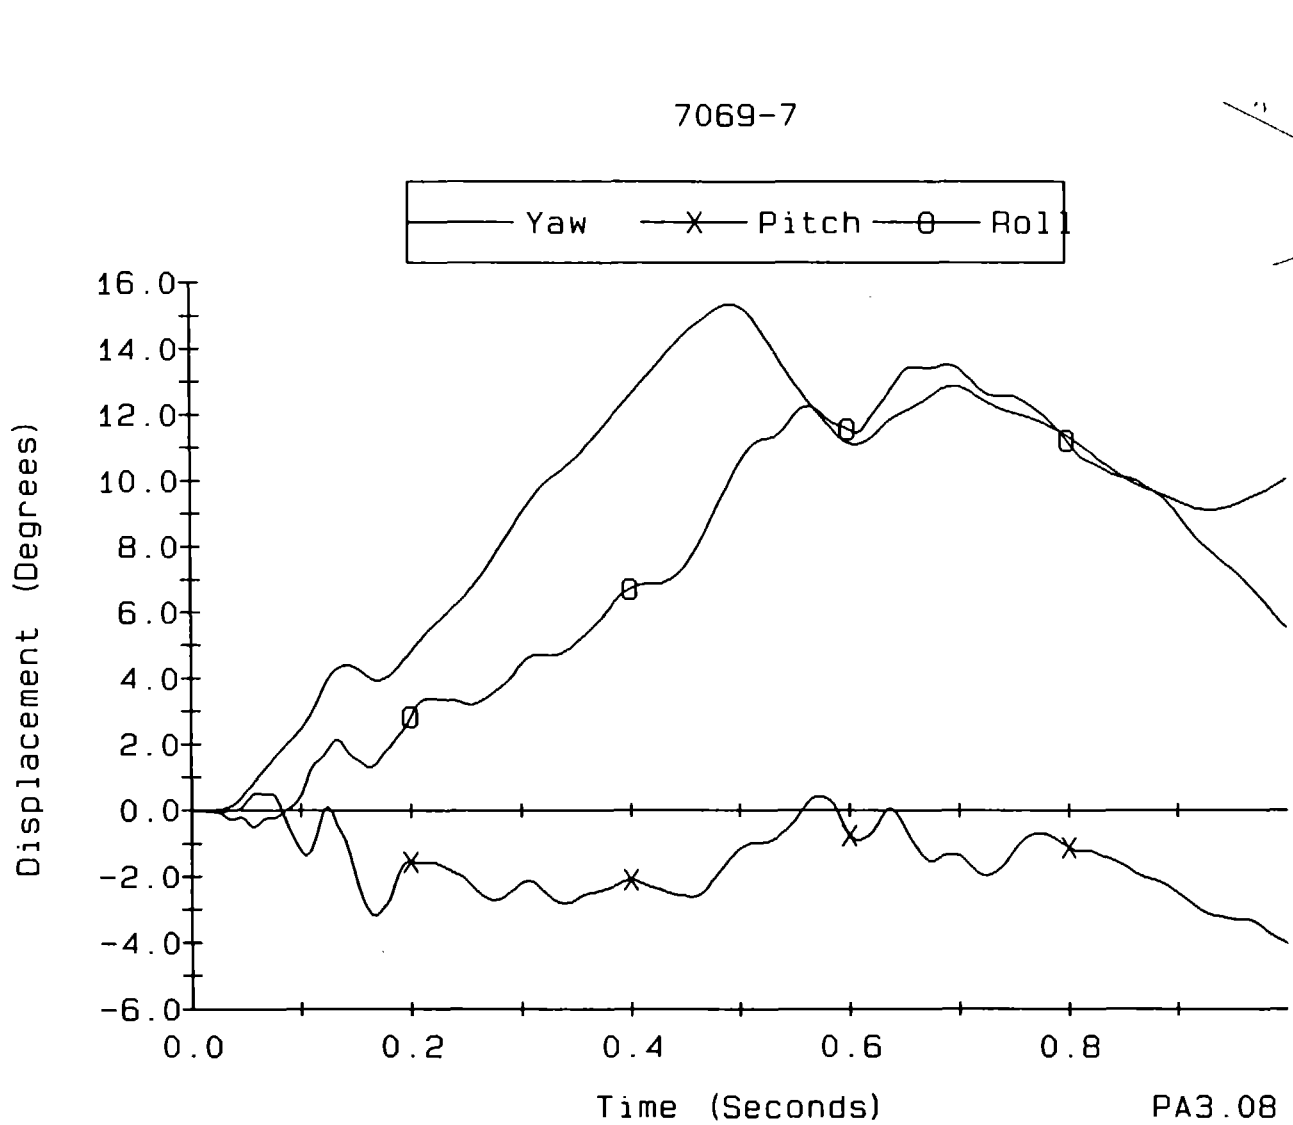
Figure 10. Vehicle angular displacements for test 7069-7.

Axes are vehicle fixed.  
Sequence for determining orientation is:

1. Yaw
2. Pitch
3. Roll

The PLOTANGLE program uses the digitized data from the yaw, pitch, and roll rate charts to compute angular displacement in degrees at 0.001-s intervals and instructs a plotter to draw a reproducible plot: yaw, pitch, and roll versus time. It should be noted that these angular displacements are sequence dependent with the sequence being yaw-pitch-roll for the data presented herein. These displacements are in reference to the vehicle-fixed coordinate system with the initial position and orientation of the vehicle-fixed coordinate system being that which existed at initial impact.

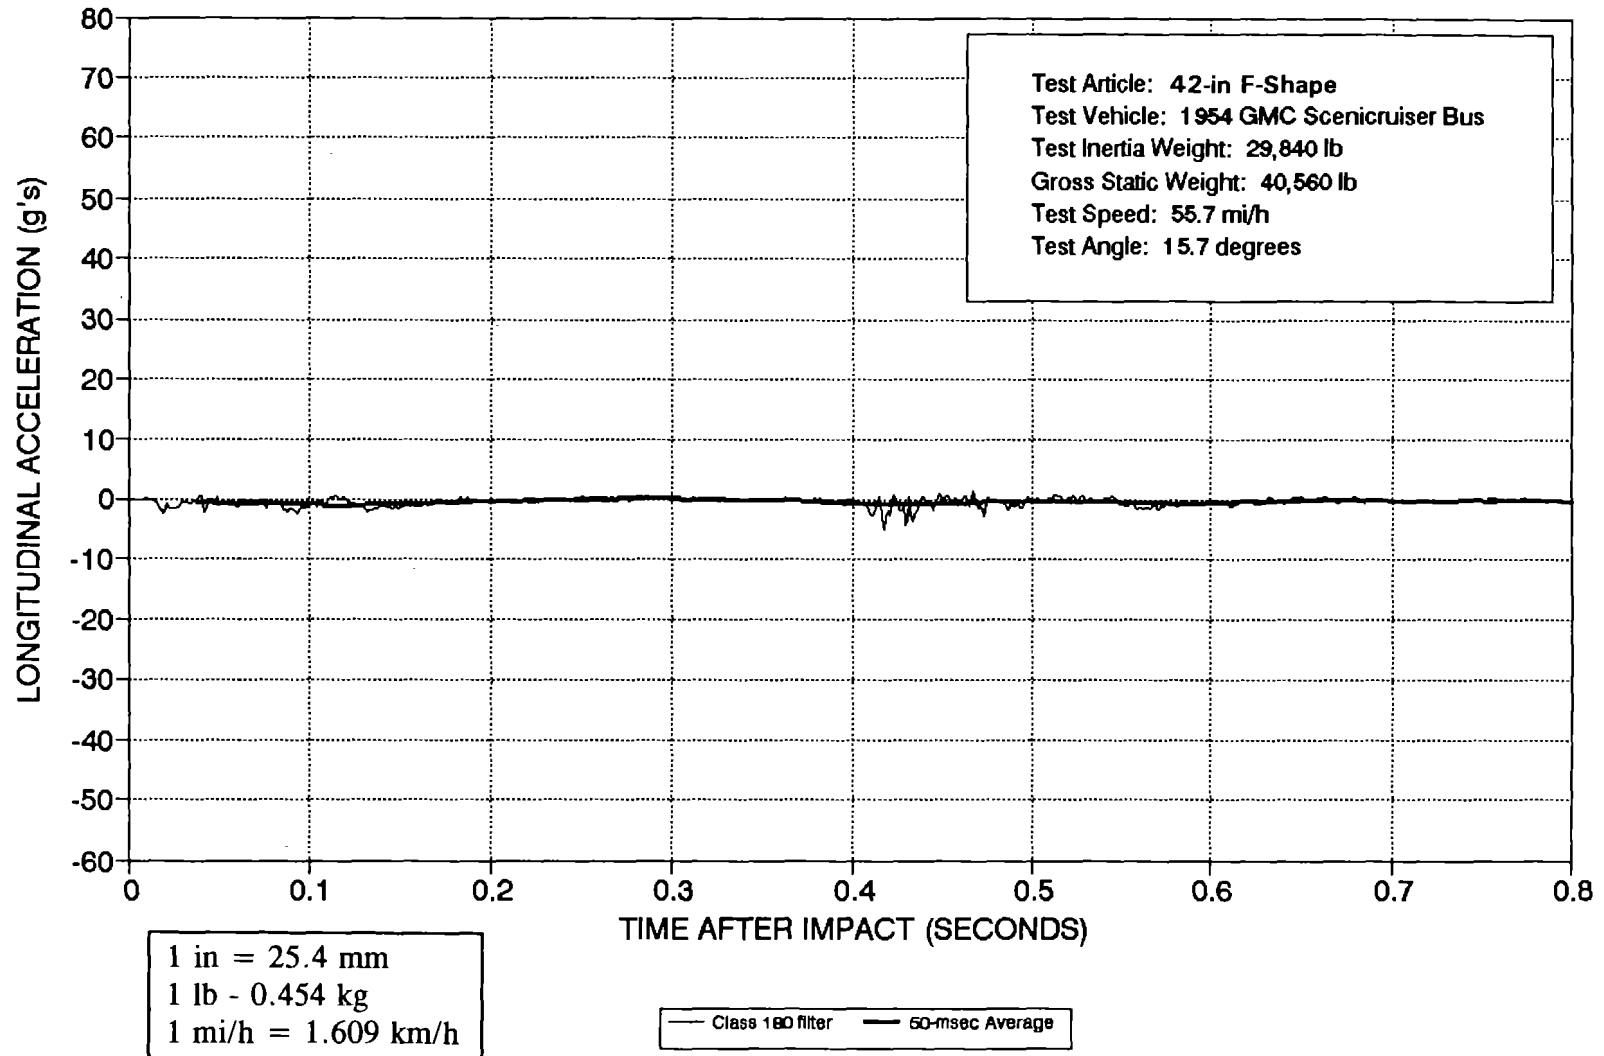
Figure 11. Vehicle longitudinal accelerometer trace for test 7069-7 (accelerometer located near center-of-gravity).

**CRASH TEST 7069-7**  
Accelerometer near center-of-gravity

The DIGITIZE program digitizes the data from vehicle-mounted linear accelerometers and uses these data to compute occupant/compartiment impact velocities, time of occupant/compartiment impact after vehicle impact, highest 0.010-s average of vehicle acceleration after occupant/compartiment impact, and time of highest 0.010-s average. The DIGITIZE program also calculates a vehicle impact velocity and the change in vehicle velocity at the end of a given impulse period. In addition, maximum average accelerations over 0.050-s intervals in each of three directions are computed. Acceleration versus time curves for the longitudinal, lateral, and vertical directions are then plotted from the digitized data of the vehicle-mounted linear accelerometers using a commercially available software package (QUATTRO PRO). For each of these graphs, a 0.050-s average window was calculated at the center of the 0.050-s interval and then plotted with the first 0.050-s average plotted at 0.026 s.

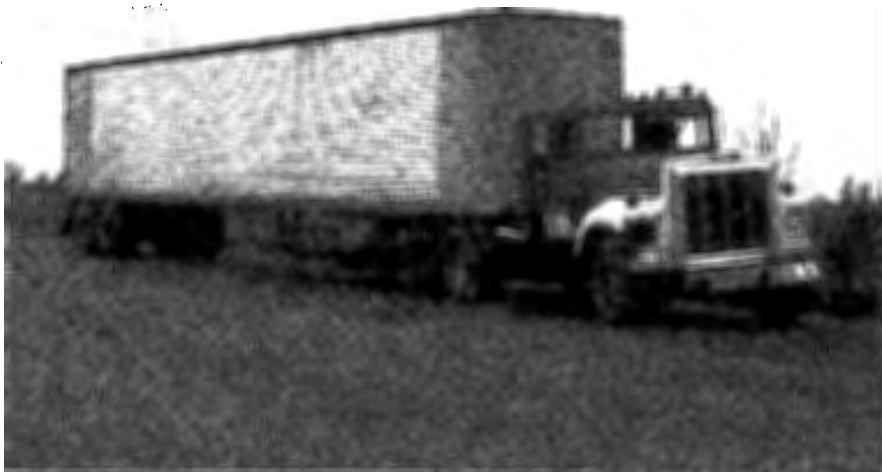
Figure 25. Vehicle after test 7069-10.

The vehicle sustained extensive damage to the right side as shown in figures 25 and 26. Maximum crush at the right front corner at bumper height was 18.0 in (457 mm). Both outside right rear wheel rims were bent and the tires aired out. The front wheel assembly and suspension was damaged. The shock mounts were broken, the tie rods bent, the steering rod was bent, and the springs were loose. The right side door was dented.

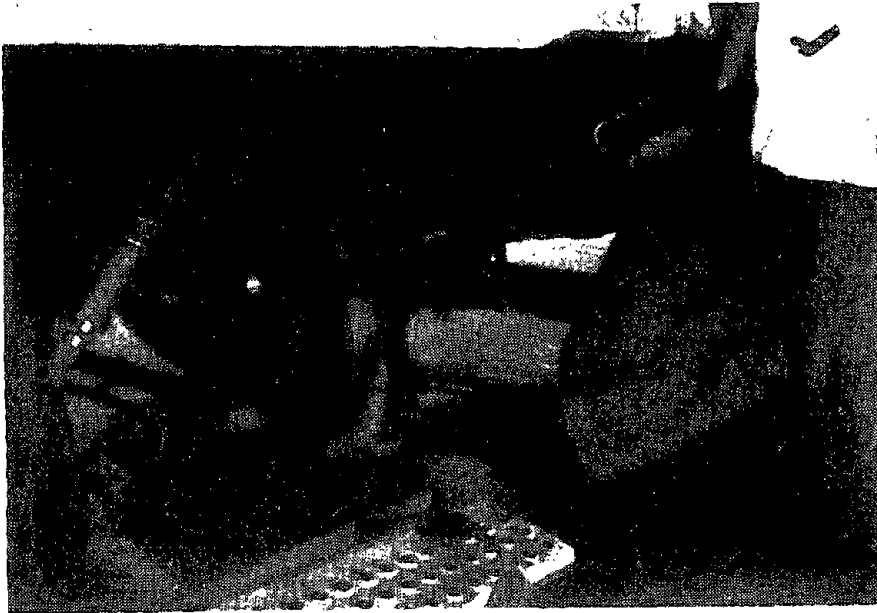
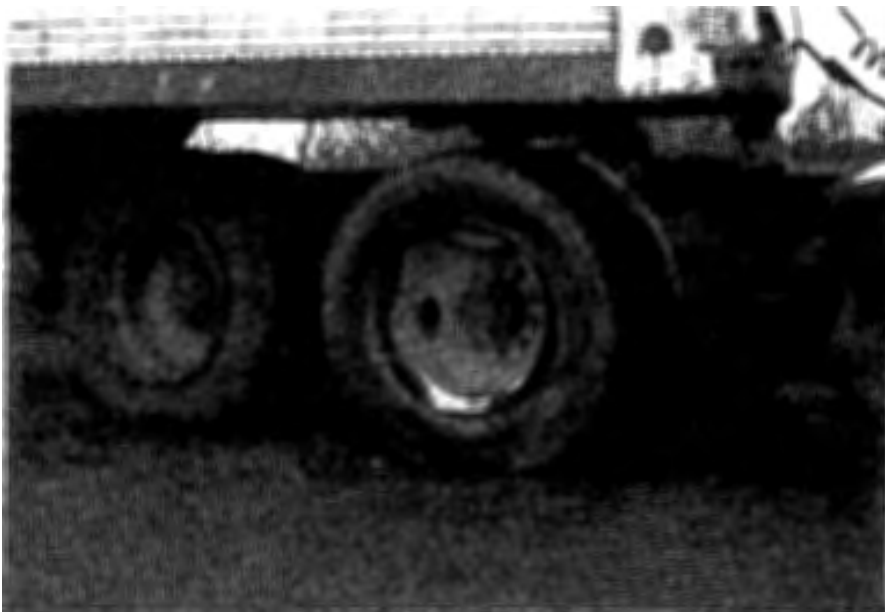
Figure 26. Details of damage to vehicle after test 7069-10.

Right Front Tractor

Right Rear Tractor

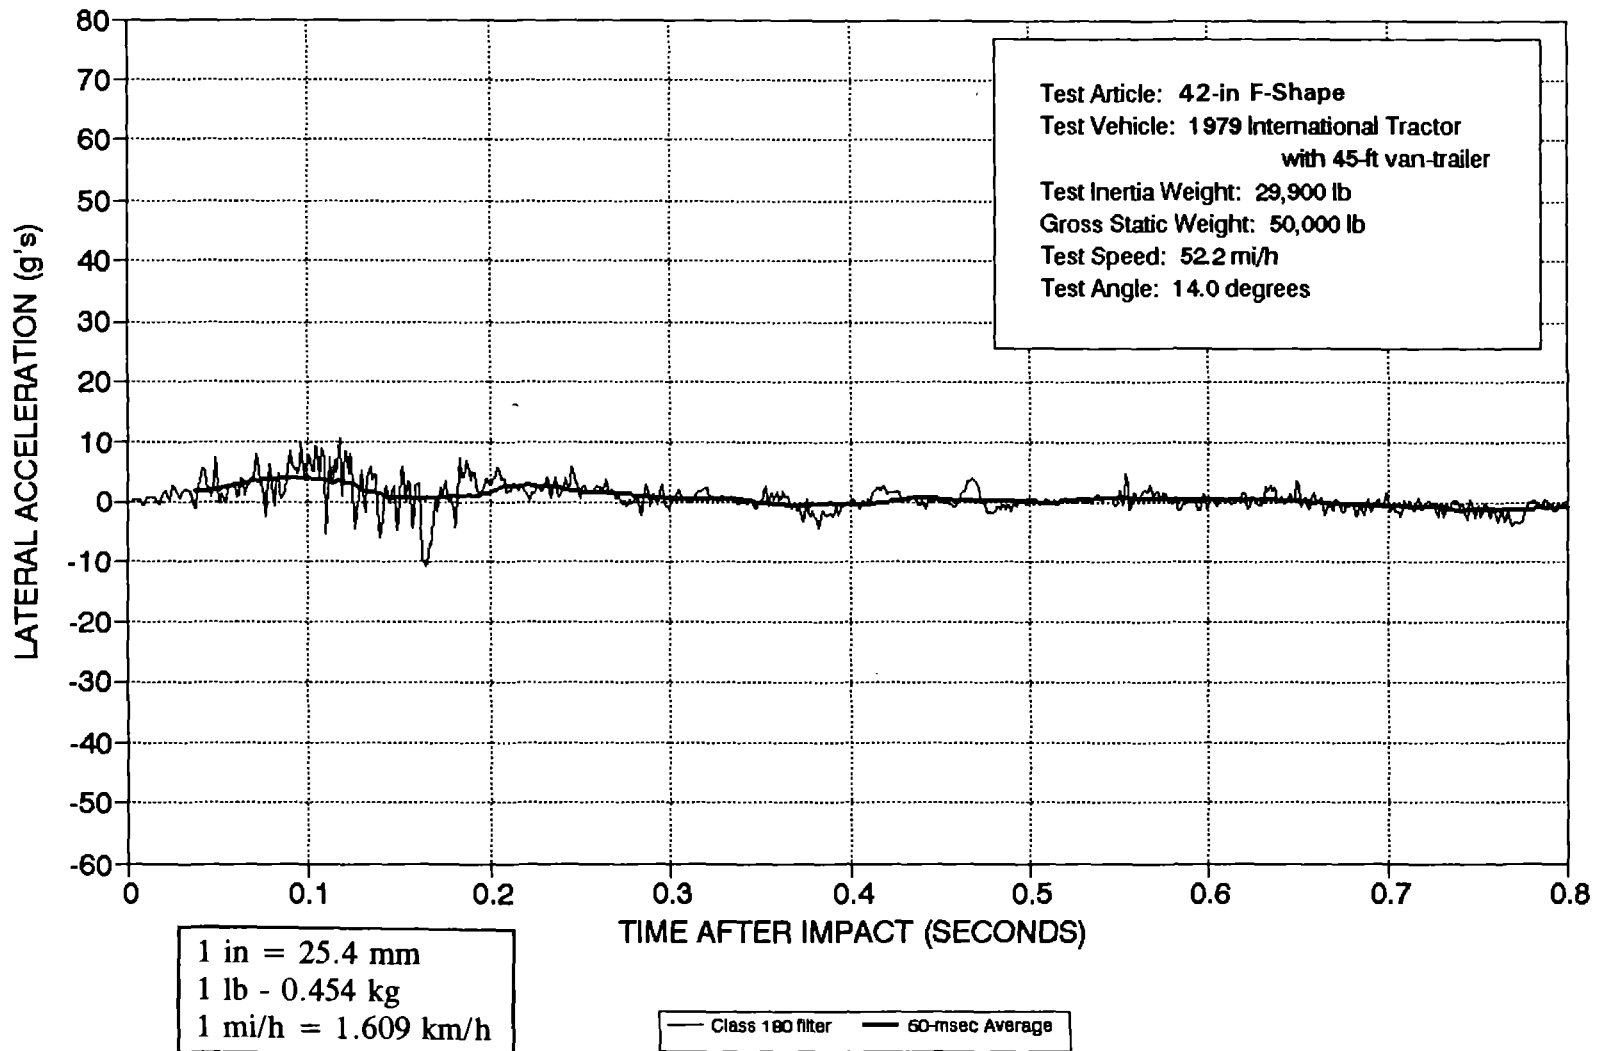
Figure 32. Vehicle lateral accelerometer trace for test 7069-10 (accelerometer located near tractor center-of-gravity).

CRASH TEST 7069-10  
Accelerometer near center-of-gravity
