Testing of New Bridge Rail and Transition Designs

Volume XII: Appendix K

Oregon Transition

PUBLICATION NO. FHWA-RD-93-069

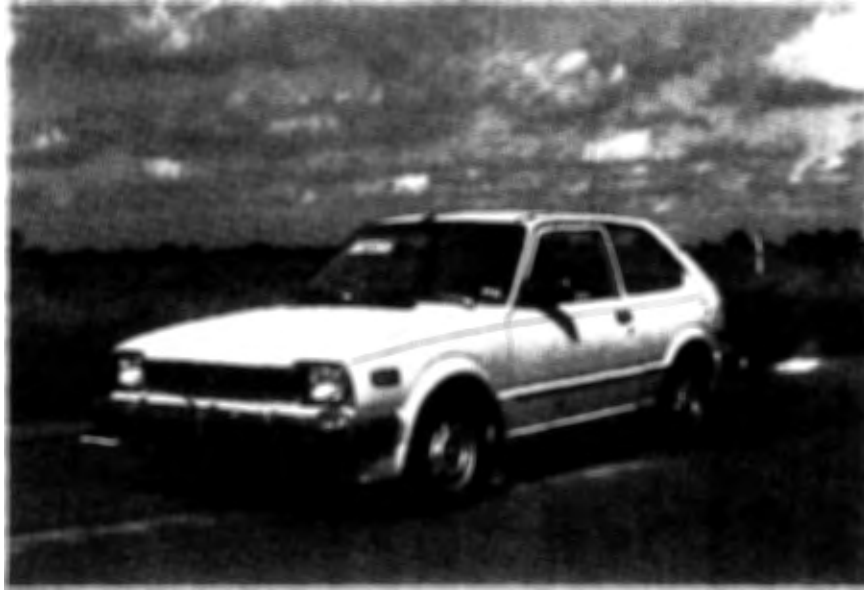
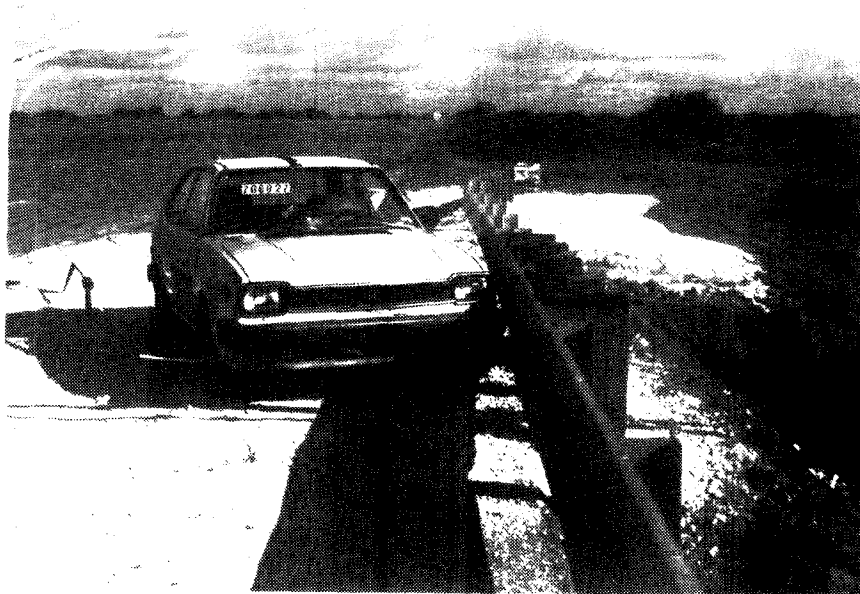
Figure 3. Vehicle before test 7069-27.

A 1983 Honda Civic (figure 3) was used for the crash test. Test inertia mass of the vehicle was 1,800 lb (817 kg) and its gross static mass was 1,970 lb (894 kg). The height to the lower edge of the vehicle bumper was 13.0 in (330 mm) and it was 18.75 in (476 mm) to the top of the bumper. Additional dimensions and information on the test vehicle are given in figure 4. The vehicle was directed into the Oregon transition (figures 5 and 6) using the cable reverse tow and guidance system and was released to be free-wheeling and unrestrained just prior to impact. The vehicle impacted the transition 5 ft (1.5 m) from the end of the bridge deck at a speed of 51.6 mi/h (83.0 km/h) and the angle of impact was 19.9 degrees.

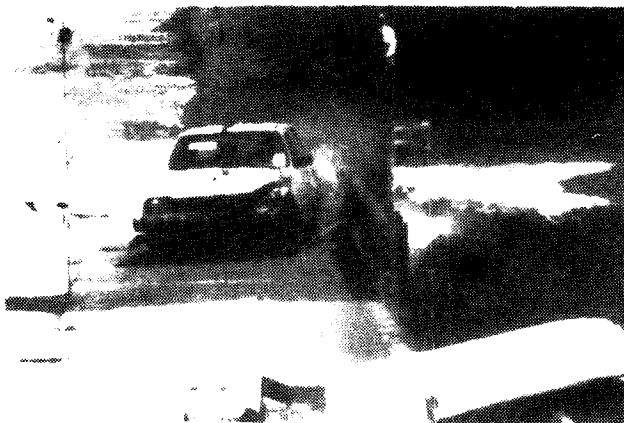
Figure 8. Vehicle after test 7069-27.

The vehicle sustained damage to the left side as shown in figure 8. Maximum crush at the left front corner at bumper height was 8.0 in (203 mm) and the driver door was deformed outward approximately 8.0 in (203 mm). The driver side window was broken out and the door was jammed. Also, damage was done to the front bumper, hood, grill, left front quarter panel, left rear quarter panel, and left front tire and rim.

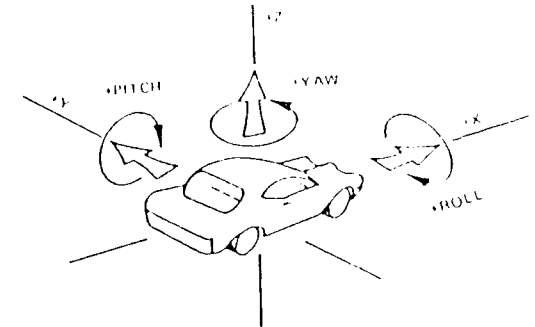
Axes are vehicle fixed.
Sequence for determining orientation is:

1. Yaw
2. Pitch
3. Roll

Figure 12. Vehicle angular displacements for test 7069-27.

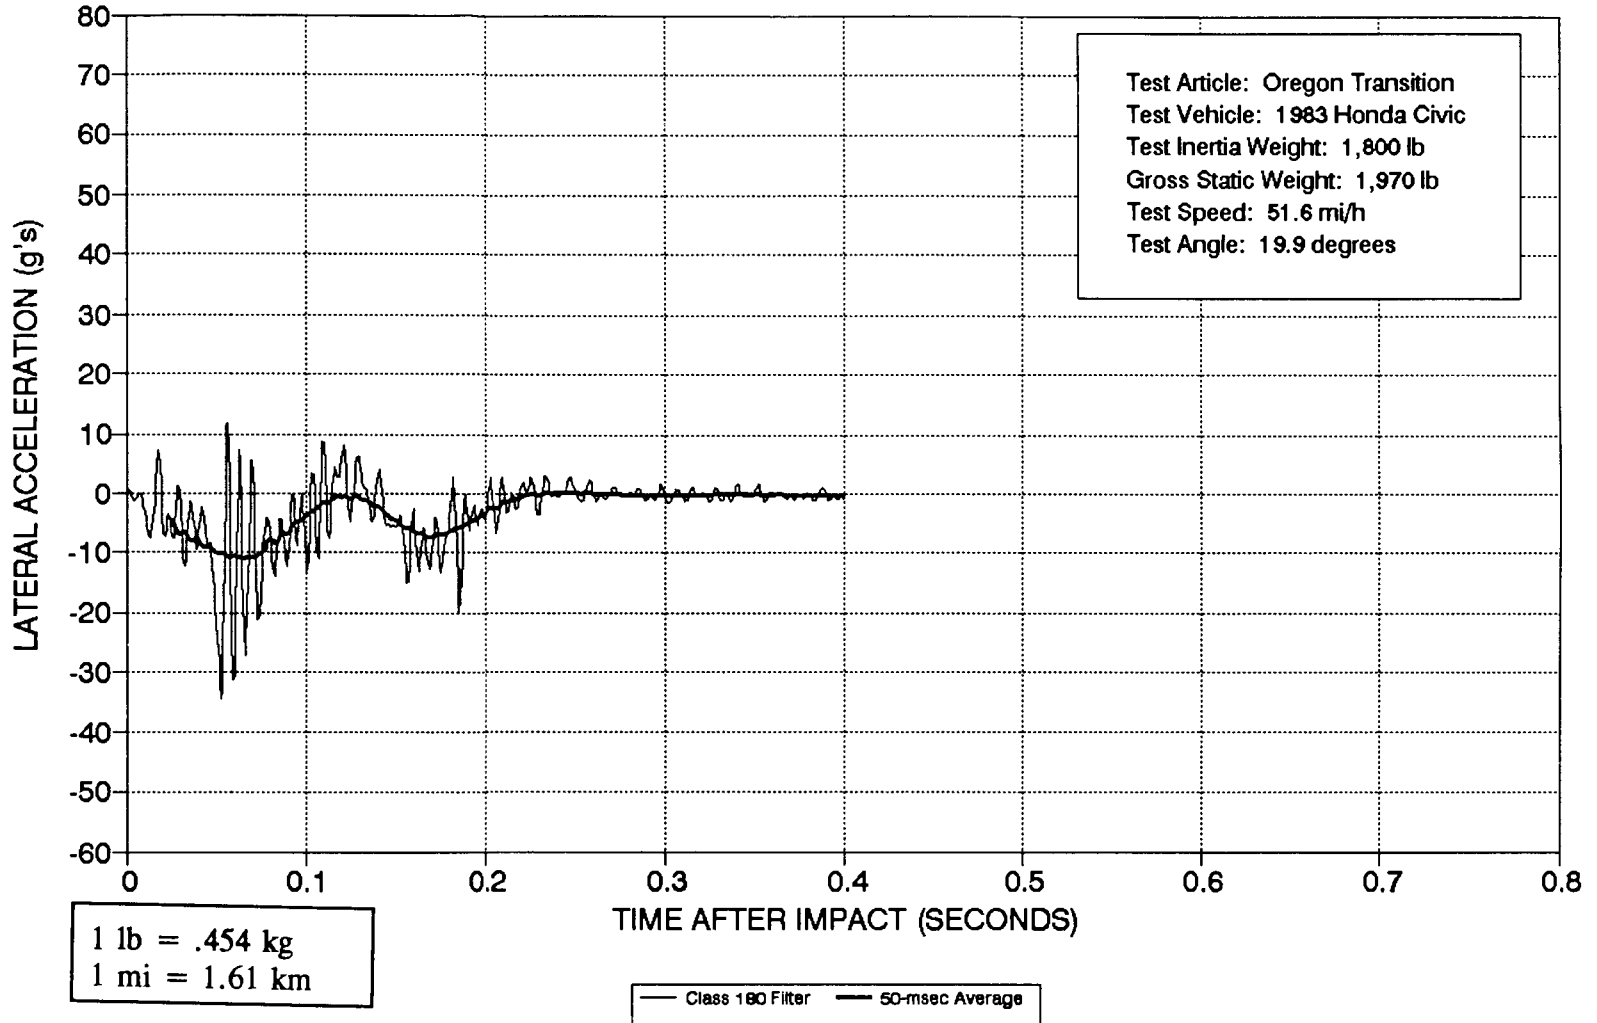
Figure 14. Vehicle lateral accelerometer trace for test 7069-27 (accelerometer located at center-of-gravity).

23.7 ft/s (7.2 m/s) at 0.103 s, the highest 0.010-s occupant ridedown acceleration was -9.6 g between 0.161 and 0.171 s, and the maximum 0.050-s average acceleration was -10.9 g between 0.041 and 0.091 s. The change in vehicle velocity at loss of contact was 7.3 mi/h (11.7 km/h) and the change in momentum was 598 lb-s (2,662 N-s). These data and other pertinent information from the test are summarized in figure 9 and tables 1 and 2. Sequential photographs are shown in figures 10 and 11. Vehicular angular displacements are displayed in figure 12. Vehicular accelerations versus time traces filtered at SAE J211 (Class 180) are presented in figures 13 through 15.

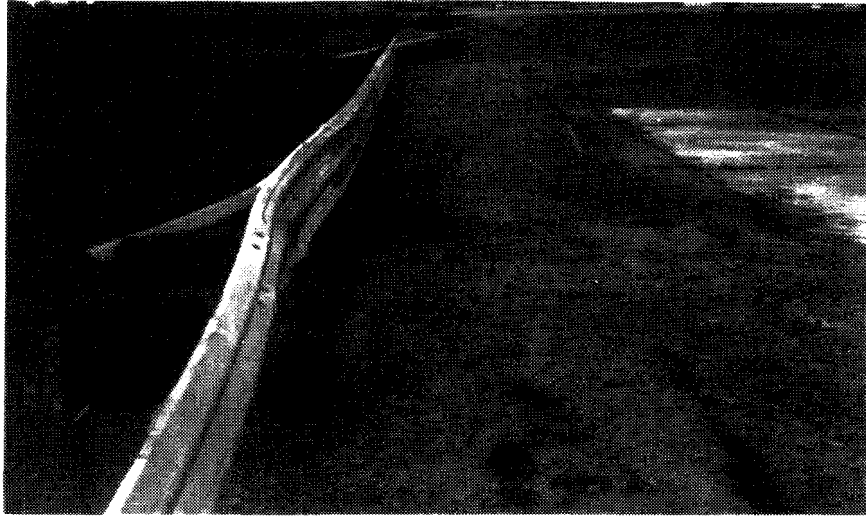
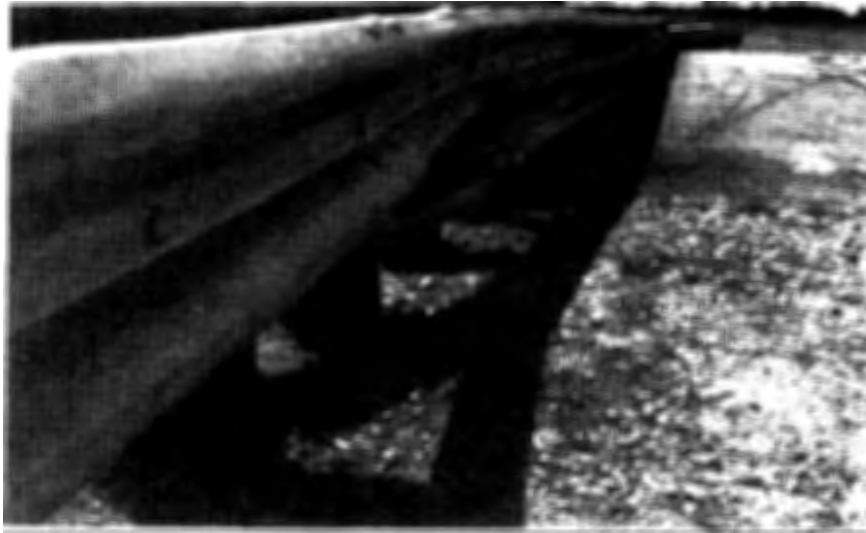
Figure 20. Oregon transition after test 7069-28.

As can be seen in figure 20, the transition received minimal damage. Maximum lateral permanent deformation was 3.5 in (89 mm). The vehicle was in contact with the transition for 14.0 ft (4.3 m).

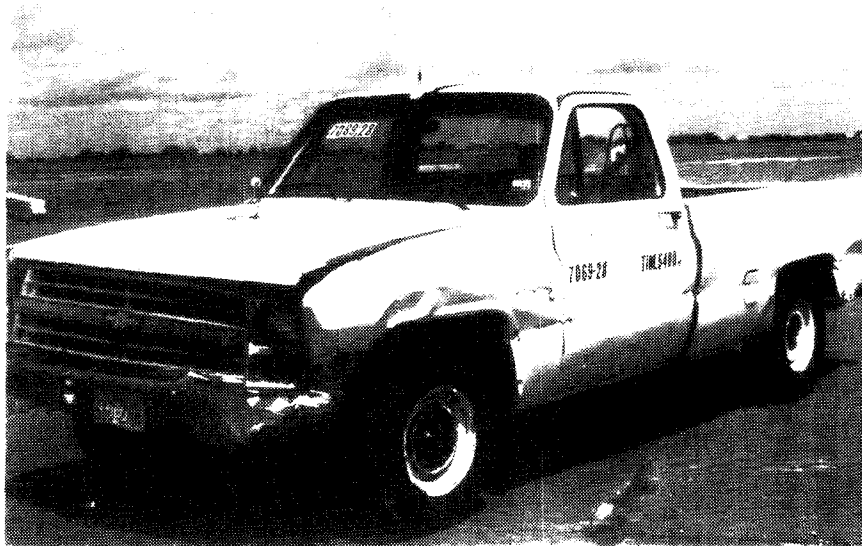
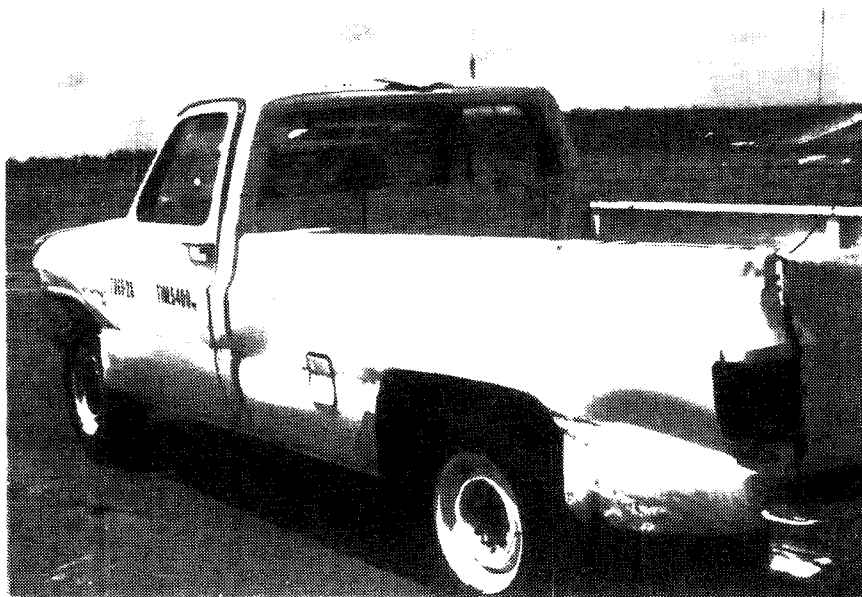
Figure 21. Vehicle after test 7069-28.

The vehicle sustained damage to the left side as shown in figure 21. Maximum crush at the left front corner at bumper height was 8.0 in (203 mm) and the driver door was deformed outward approximately 1.0 in (25 mm). The frame was bent and the cab was deformed. The driver side window was broken out and the door was jammed. Also, damage was done to the front bumper, hood, grill, left front quarter panel, left rear quarter panel, rear bumper and left front tire and rim.

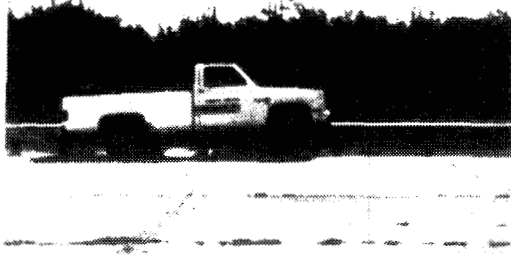
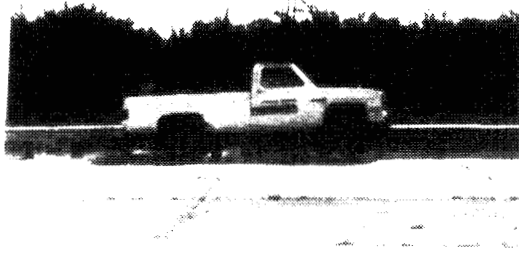
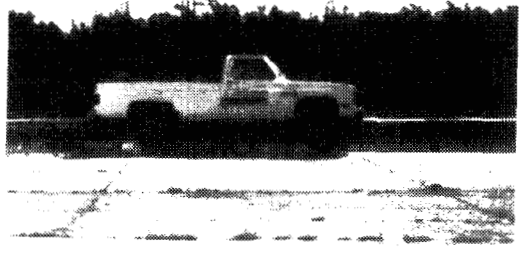
Figure 24. Sequential photographs for test 7069-28 (perpendicular and interior views continued).

Figure 24. Sequential photographs for test 7069-28
(perpendicular and interior views).
