**Federal Aviation
Administration**

DOT/FAA/AM-23/18
Office of Aerospace Medicine
Washington, DC 20591

Effect of Pelvic Loading during Anthropomorphic Test Device Storage

January 2023

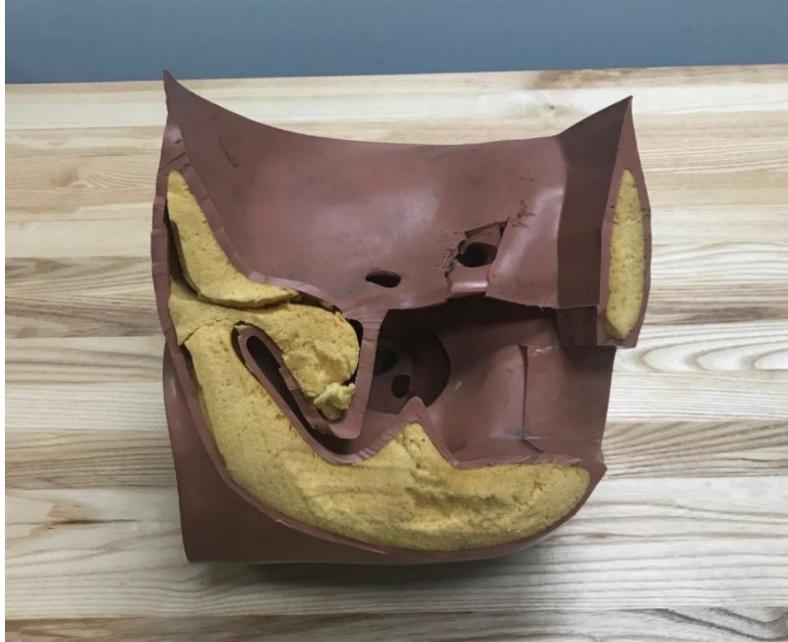
Figure 1: Pelvis Foam and Rubber Shell Cross Section

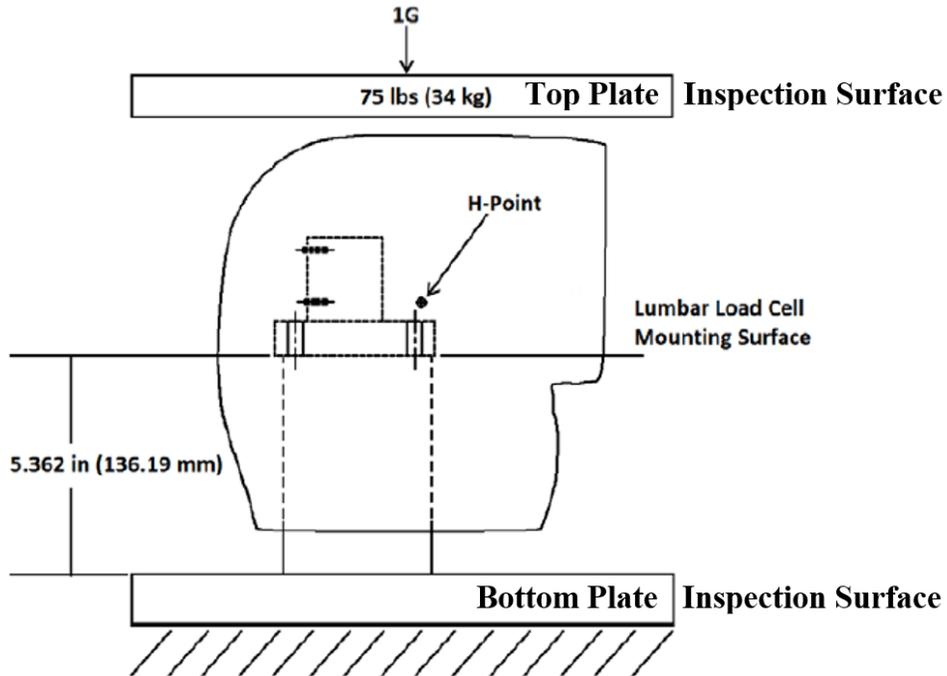
While a vertical calibration test to determine the suitability of the pelvis does not exist, a manufacturing tolerance is defined. This evaluation is conducted by mounting the pelvis upside down on a 5.362-in tall pedestal and setting a static load of 75 lbs onto the pelvis (see Figure 2). Following a five-minute wait, the distance from the pelvis's top surface to the pedestal's bottom surface (referred to as an inspection surface) is recorded. For the Hybrid II pelvis, this measurement should be between 10.802 in and 10.402 in, resulting in a tolerance of ± 0.2 in about the nominal height. For the Hybrid III pelvis, this height range is 10.242 in and 10.362 in. This number is based on GM drawing 78051-58, which specifies the distance from the H-point to the inspection surface must be 3.620 ± 0.060 in (Figure 3).

Figure 2: SAE ARP 5765B – Pelvis Compression Illustration

The pedestals used for this project are shorter than the height defined in SAE ARP 5765B to minimize the system's overall height. SAE ARP 5765B (see [Figure 2](#)) specified a height of 5.362 in, while the pedestals used for this test series were 4.858 and 4.863 in. Direct comparisons should not be made between these test series measurements and those using the pedestal height outlined in [Figure 2](#).

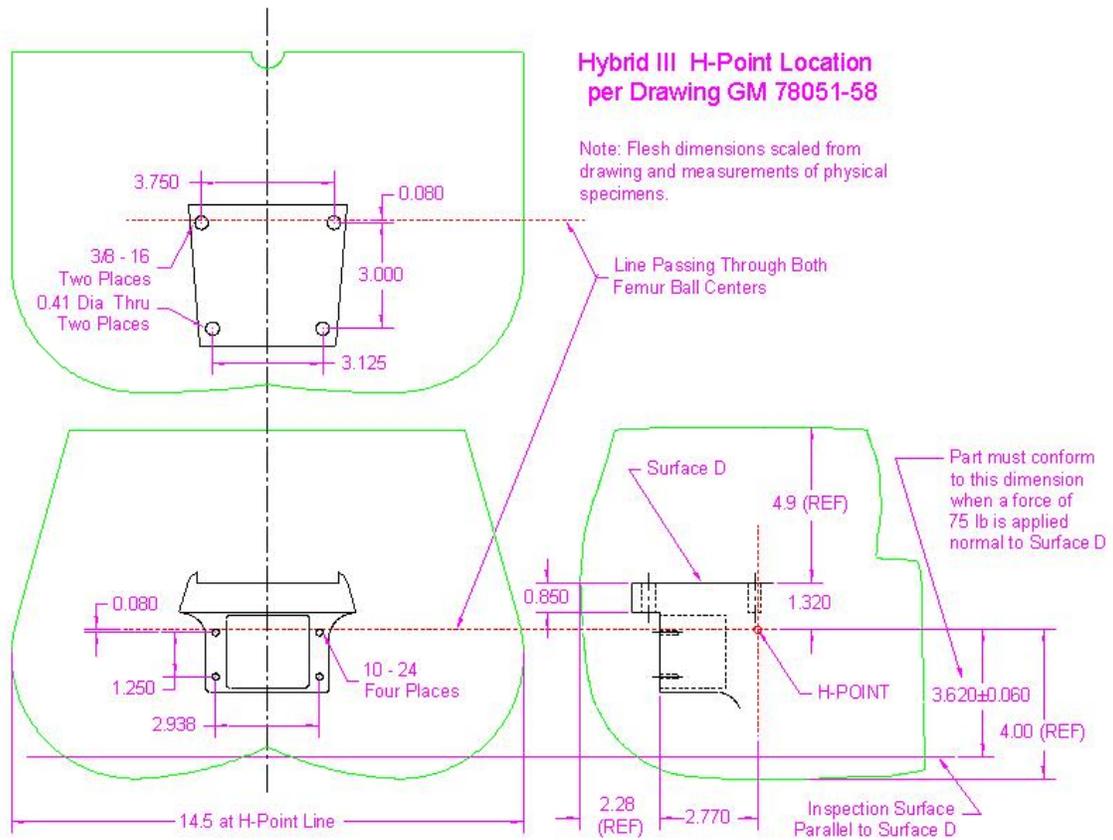
Figure 3: Hybrid III H-Point Location Drawing based on GM drawing 78051-58

For the Hybrid III pelvis, the distance from the H-point to the inspection surface must be 3.620 ± 0.060 in to be conformed for use. Measurement A, as detailed in *Figure 3*, *Figure 8*, and *Figure 9*, can be directly correlated to the conformed distance once the following distances are subtracted from the A measurements: the pedestal height (varies from left to right) and height from the top of the pedestal to the H-point (1.320 in). In this series of measurements, the loaded pelvis, DZ0225, compressed enough (0.292 in on the left and 0.165 in on the right) to fall outside of that tolerance in the first three months. This suggests that a conformed pelvis will likely become nonconformed if stored so that the pelvis is loaded. For the unloaded pelvis (DY9938), the difference in the A measurement over the one year was essentially zero; however, some measurements showed differences (i.e., 0.043 in on the left and 0.032 in on the right at three months). This suggests that individual measurements could produce measurements outside the conformed corridor, although the risk is lower than with the stored loaded pelvis.

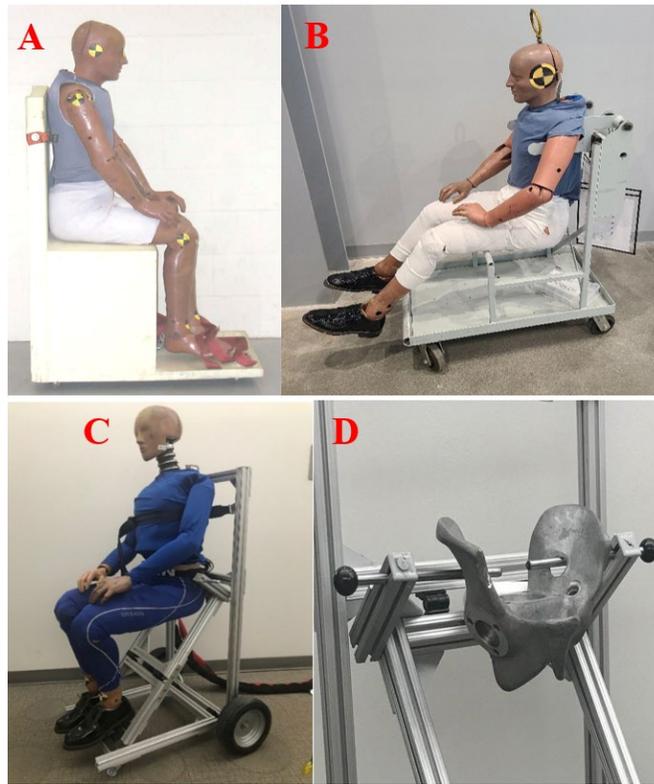
A common method of storing ATDs is to place them in a chair, as shown in *Figure 4-A*. The feet may or may not be in contact with a support surface. When the ATD is seated on a flat surface with its feet firmly supported, approximately 125 lbs of force loads the bottom of the pelvis. Because of this constant loading, there is concern that the pelvic foam and rubber shell could degrade. An alternate seating method is supporting the ATD by its armpits (*Figure 4-B*). This method is not recommended for the Hybrid II because a pair of pots in the chest extend when the ATD is hung by the armpits, which causes the pots to degrade. Given these concerns, a chair was designed to use the holes in the pelvis cover and bone casting to support the ATD without loading the pelvis or the shoulder pots (*Figure 4-C and Figure 4-D*). Drawings of the chair are included in the appendix. Care must be taken utilizing the pin-through-pelvis method when using this seating method. If a pin is installed too far into the pelvis, damage can occur to the lumbar load cell and wiring routed near the load cell. Storing the ATD by the sides of the pelvis—where the metallic bone supports the ATD weight—would be preferred if loading the bottom of the pelvis during storage causes significant degradation of the rubber and/or foam. Therefore, as a first step of evaluating pelvis degradation and developing a vertical calibration test, phase one of this project is a yearlong study of the effects of loading the ATD pelvis during storage.

Figure 4: ATD Storage Examples: (A) ATD Seated on Chair, (B) ATD Supported Under Arms (Photo Courtesy of National Institute for Aviation Research), (C) Seated ATD with Pins Through Pelvis, and (D) Bare Pelvis Casting with Pins to Identify Points of Loading

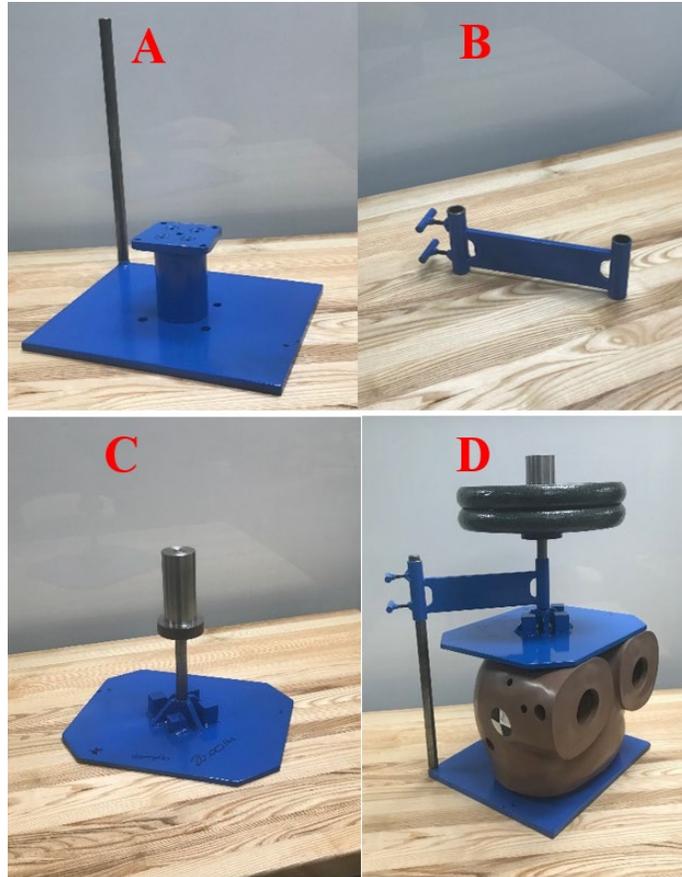
To evaluate the effects of loading the ATD pelvis during storage, two identical test stands were developed based on the pedestal used for checking the manufacturing tolerance. The stands allowed a static load to be applied to an ATD pelvis for long-term storage and allowed length measurements to be collected. Each test stand consists of three main components: base plate with pedestal, support arm, and top plate with weight mount (see *Figure 5*). The base plate served three purposes: ATD pelvis mounting fixture, measurement reference points, and support arm guide. The pelvises were attached to the pedestal using the bolt pattern that connects the lumbar load cell mounting surface to the pelvis. The height of the two pedestals used for this project were 4.863 inches for the pedestal used with pelvis serial number DY9938 and 4.858 inches for the pedestal used with pelvis serial number DZ0225. The pedestals are shorter than specified in *Figure 2* (5.362 in) to mount the pelvis as close to the surface as was practical while preventing contact between the rubber cover and the bottom surface. As such, the criteria (10.242 in and 10.362 in) were adjusted for the difference in the pedestal heights: for the DY9938 fixture, 9.743 to 9.863 in, and for the DZ0225 fixture, 9.738 to 9.858 in. The support arm aligned the guide rods for both the base plate and the top plate to hold the two surface planes of the plates parallel. The support arm also prevented the rotation of the top plate around the X-axis and Y-axis about the ATD pelvis (see *Figure 6* for the ATD coordinate system). The top plate served as the weight mount and measurement reference point and distributed the weight evenly over the bottom of the pelvis. The top plate, weighing 25 lbs, was designed to hold a maximum of four 25-lb Olympic-style plate weights. The test stand could apply a load to the pelvis at the nominal weight of an ATD sitting on a flat surface (125 lbs) and the weight used for the manufacturing evaluation (75 lbs).

Figure 5: Test Stand Components: (A) Base Plate with Pedestal, (B) Support Arm, (C) Top Plate with Weight Mount, and (D) Complete Assembly with 75 lbs of Load

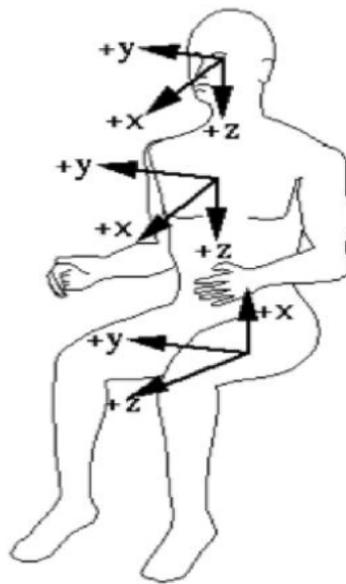
Figure 6: ATD Coordinate System SAE International

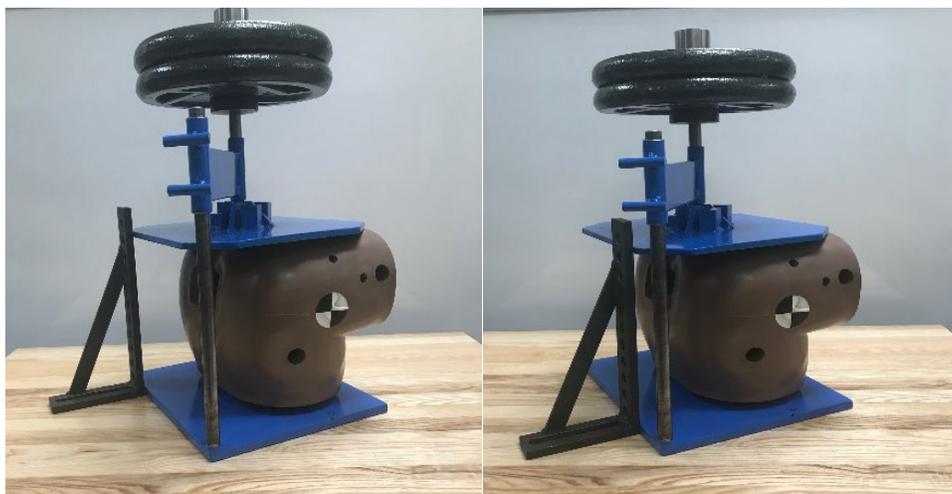
Due to a communication error, the test stand was manufactured narrower in length and width than the pelvises. The pelvises overhung the front and side edges. A 90-degree bracket was used to align the back edges of the top, and bottom plates of the test stand to assist in the repeatability of test fixture setup and alignment. Once assembled, both the left and right edges were checked to verify that the back edges of the top plate and bottom plate were on the same plane, as shown in *Figure 7*. A precaution to minimize binding in the support arm was taken. A thin film of grease was used inside the support arm tubes to mitigate the binding of sliding parts on the top and bottom plate guide rods. The support arms were checked for binding routinely throughout the 12 months of testing. No issue of binding was noted throughout the test series.

Figure 7: Test Stand Back Edge Alignment

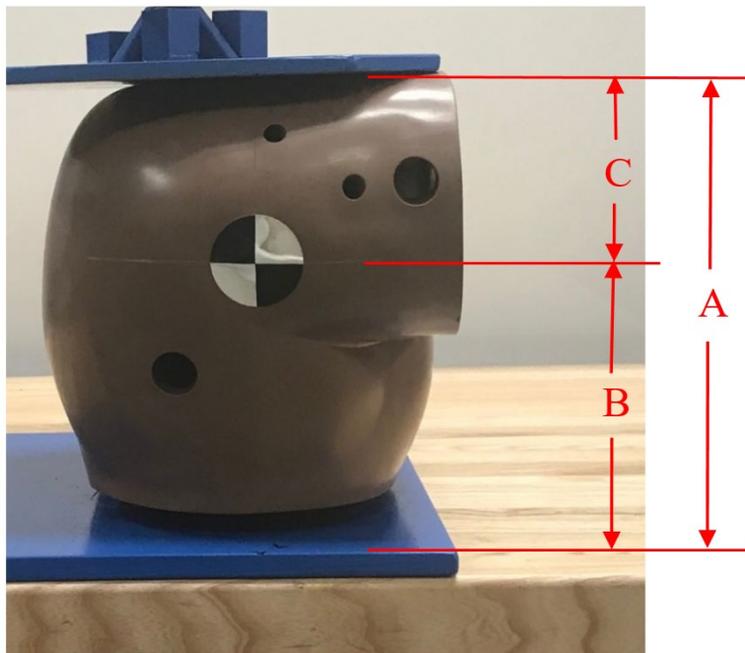
Three distance measurements were collected on each side of the pelvis for each loading cycle (*Figure 8*, *Figure 9*). Those measurements consisted of the bottom plate to the top plate (A), the bottom plate to H-point (B), and H-point to the top plate (C). The A measurement is the distance specified in the manufacturing tolerance. Measurement B is the distance from the base plate to the H-point on the pelvis used to measure rubber cover migration on the sides of the pelvis concerning the loading of the bottom of the pelvis. Measurement C is the distance between the H-point and the top plate to determine the change in pelvis compression. Due to the pelvis overhang on the edges of the test stand, the distance measured is not solely in the vertical direction for both measurements B and C; thus, B plus C is not equal to A. Measurements were taken with 12-in dial calipers (Mitutoyo, Aurora, IL; S/N: 14501520, with a readout to 0.001 in). The same calipers were used for all the measurements taken in this report. *Figure 8* and *Figure 9* show the location of the A, B, and C dimensions; *Figure 10* shows the measurement method with the calipers.

Figure 8: Measurement Locations, Side View, Left to Right: A, B, and C

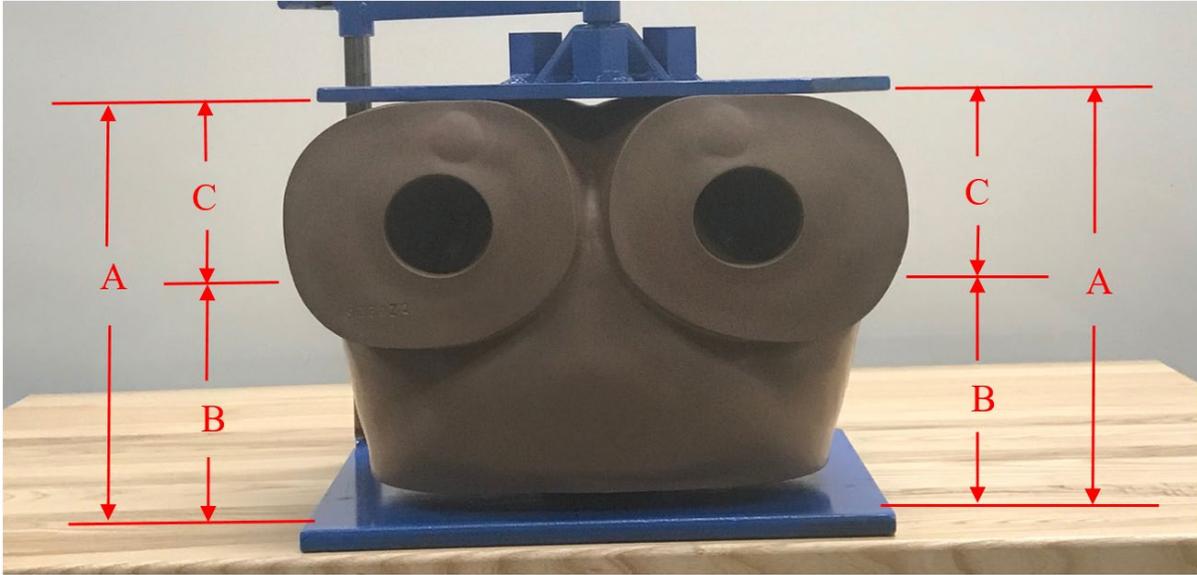
Figure 9: Measurement Locations, Front View

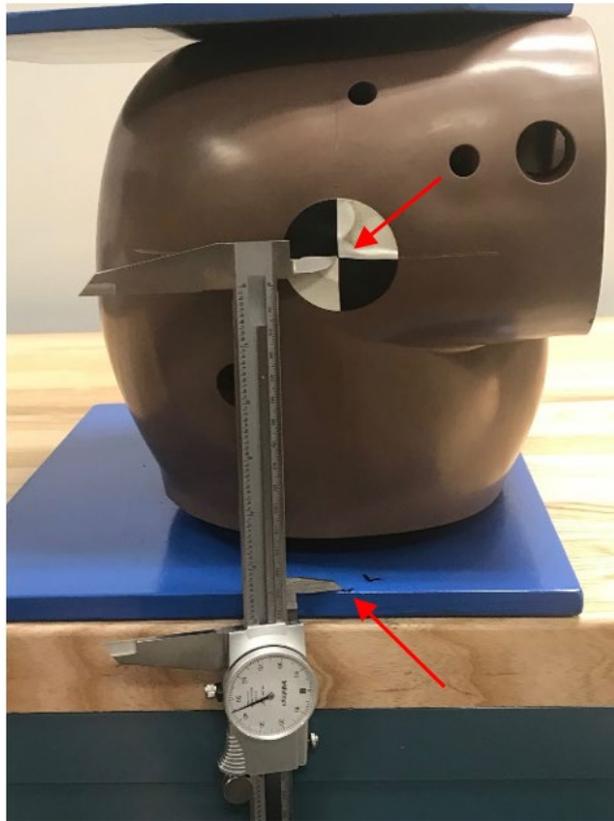
Figure 10: Caliper Measurement Methods

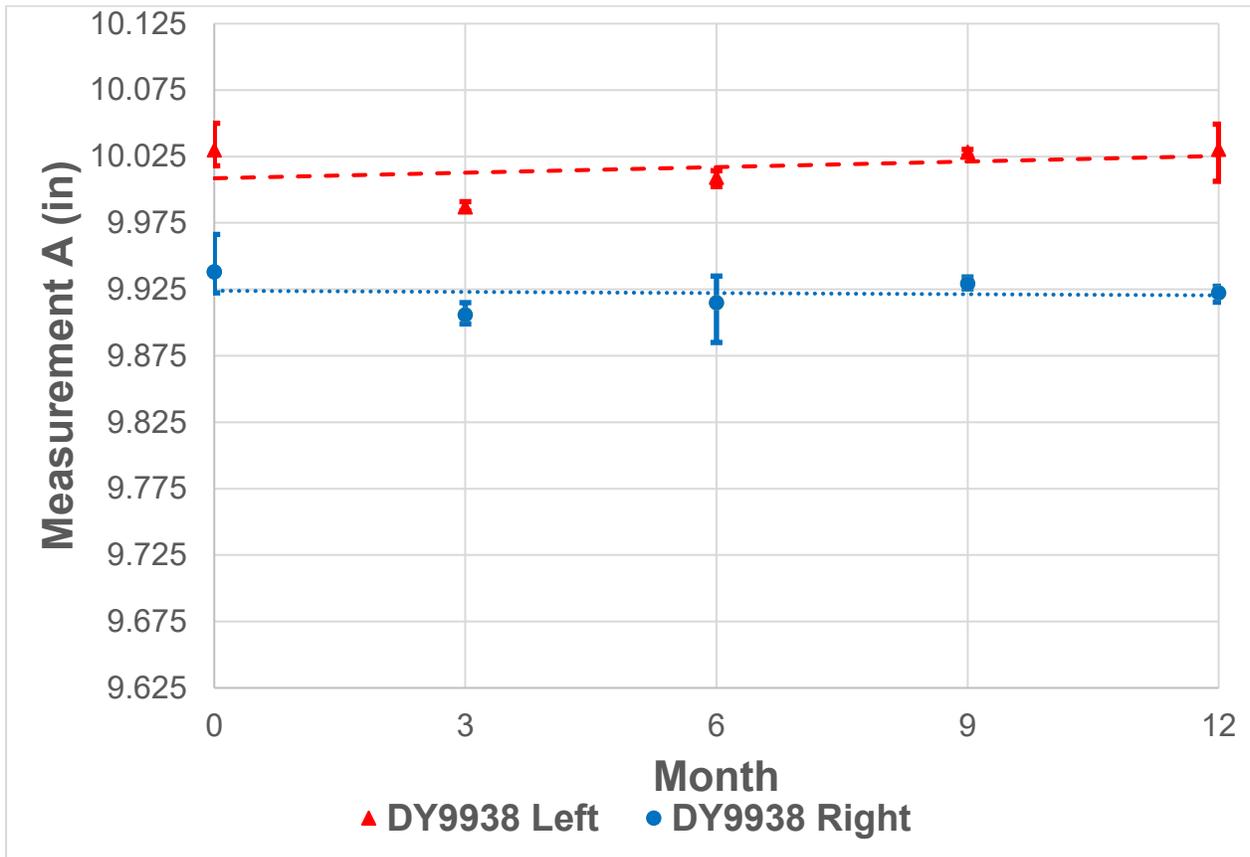
The average value of measurement A was used to determine the amount of compression over the 12 months. *Figure 11* and *Figure 12* show the average values of measurement A with range bars versus time and trend line. For the unloaded pelvis (DY9938), the difference in the average A measurement from month 0 to month 3 was 0.043 in for the left side (*Figure 11*). However, the difference from month 0 to month 12 was 0.000 in. The average values at six months and nine months fell between the three-month and 12-month average. For the right side, the difference in the average A measurement was 0.016 in from 0 to 12 months, with a max of 0.032 in for 0 to 3 months. Therefore, it appears that the pelvis did not appreciably change during the year of storage (i.e., the linear trend lines are flat). The maximum difference of 0.043 in suggests some variation in either the pelvis performance in this test or the measurements themselves.

Figure 11: Unloaded Pelvis (DY9938) Measurement A versus Time

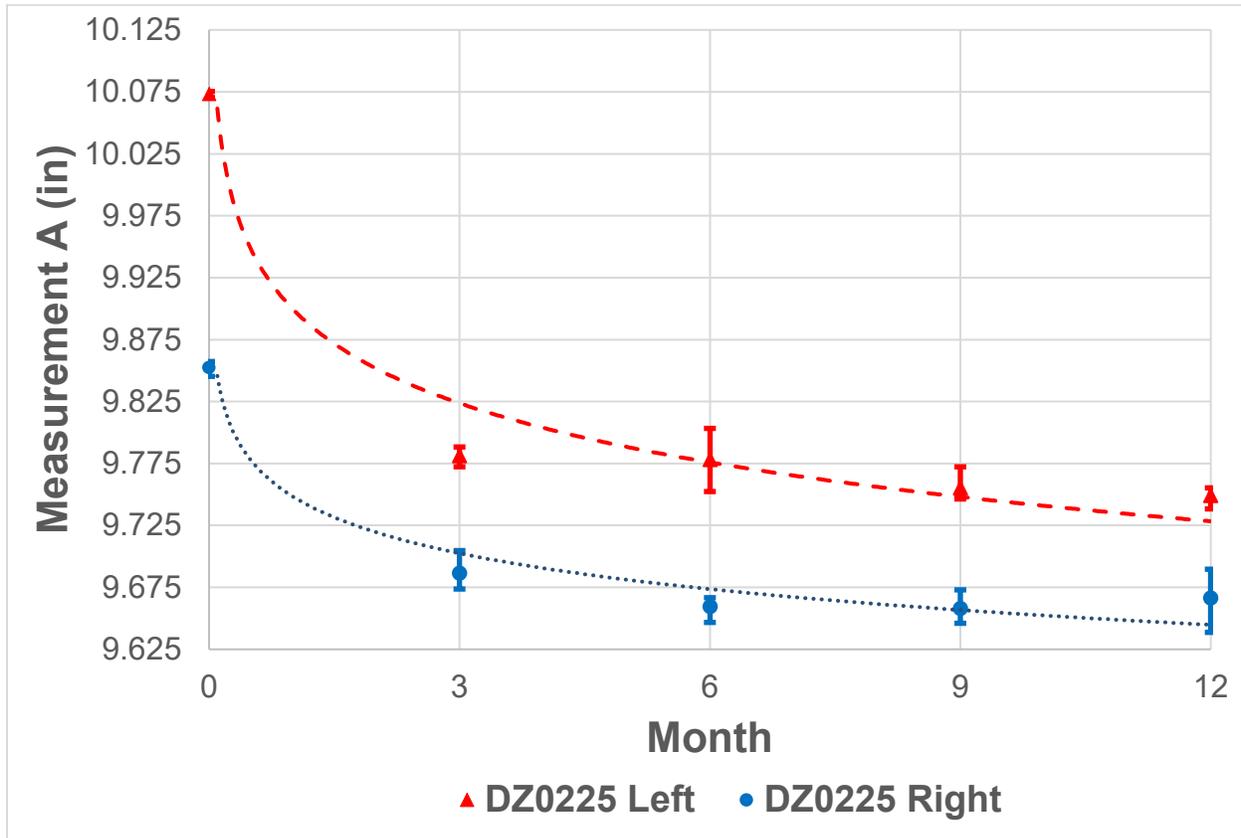
For the loaded pelvis (DZ0225), the difference in the average A measurement from month 0 to month 3 was 0.292 in for the left side (*Figure 12*). The difference from month 0 to month 12 was 0.324 in. The average values at six months and nine months were less than the 12-month average. For the right side, the difference in the average A measurement was 0.185 in from 0 to 12 months, with a maximum of 0.192 in for 0 to 6 months. The difference over the first three months was 0.165 in. Therefore, it appears that the pelvis did appreciably change during the year of storage, with the majority of this change occurring in the first three months (approximately 90%), as shown

with the power trend line.

Figure 12: Loaded Pelvis (DZ0225) Measurement A versus Time

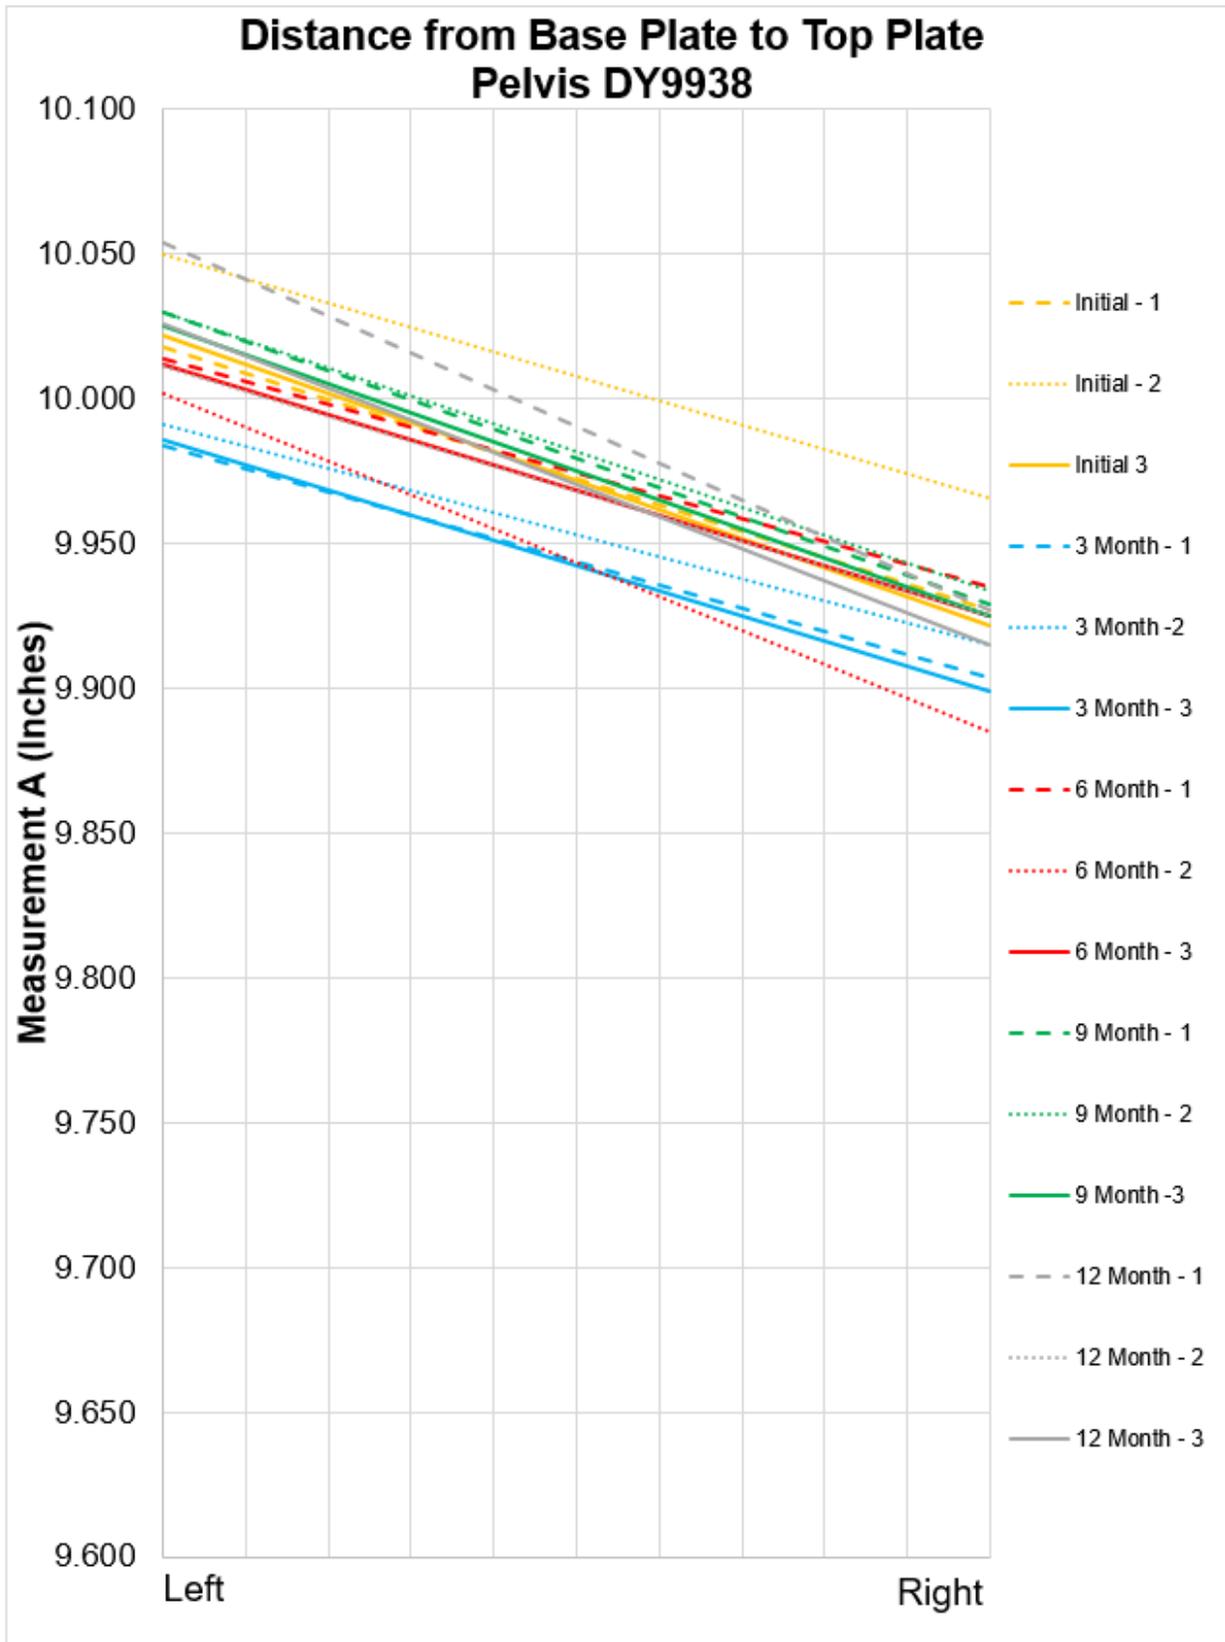
The test stand was designed to apply the weight directly over the center of the lumbar mounting point on the pelvis. Due to the overhang of the pelvis on the front and sides, aligning the top and bottom plate's backside allowed for consistent setup and repeatability. All the A-length measurements during the test series showed a notable side-to-side lean. The lean was consistent for both pelvises, and both tests stands, with the pelvis left side higher than the right side for all the data collected. *Figure 12* and *Figure 13* are plots of the A measurements to illustrate the lean. The vertical distance in *Figure 12* and *Figure 13* is exaggerated due to the zooming in of the vertical axis. Both plots have the same Y-axis range for comparison. The height difference was calculated for each loading and measuring cycle, subtracting the right A measurement from the left A measurement. The average of those differences was 0.109 in.

Figure 13: Pelvis DY9938 Measurement A Data Points for Months 0-12

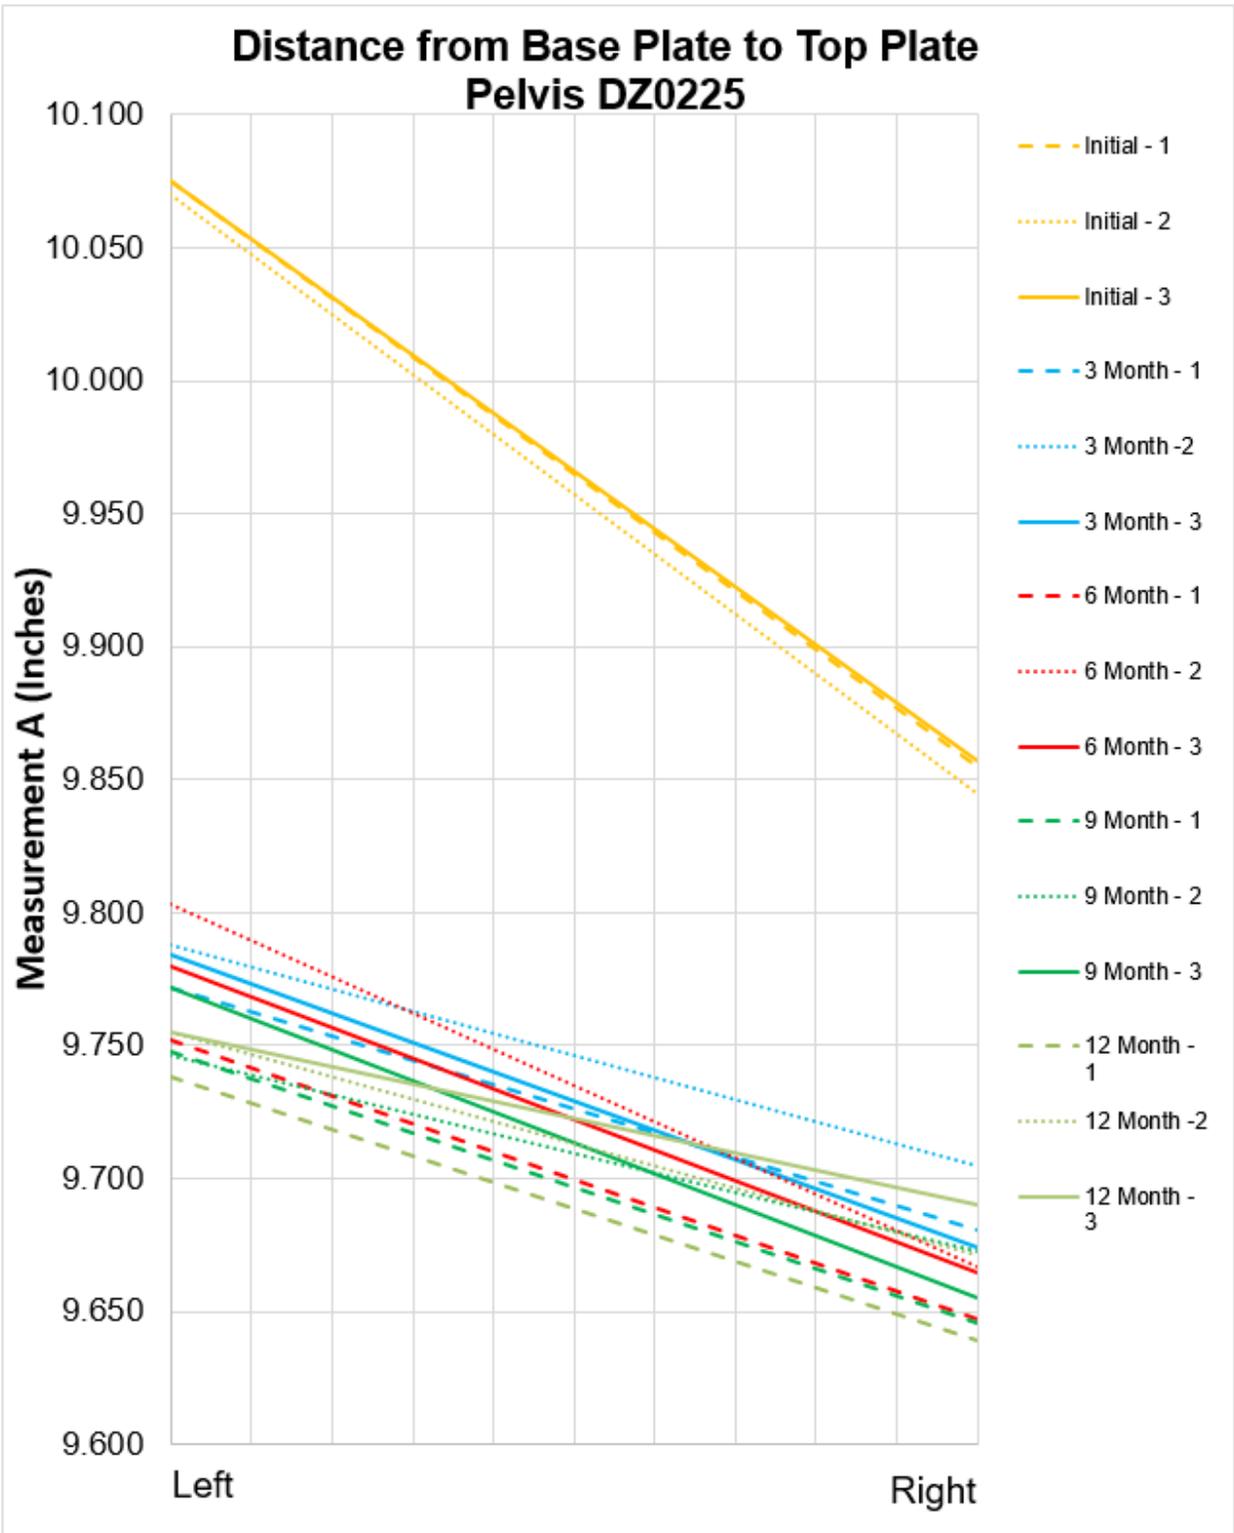
Figure 14: Pelvis DZ0225 Measurement A Data Points for Months 0-12

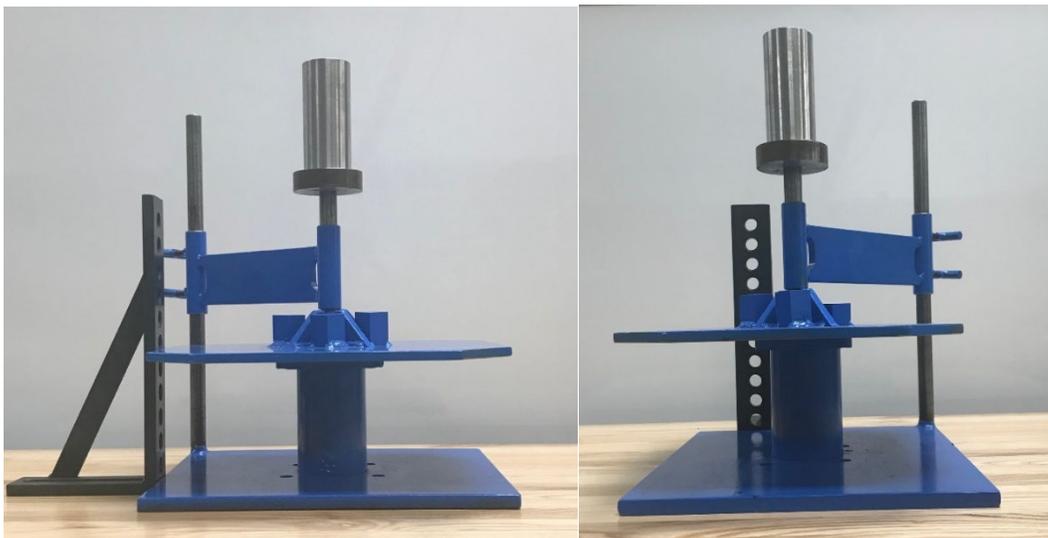
The following checks were conducted on the test stand to investigate the lean between the right and the left. For the first check, the test stand was aligned on the side with a 90° bracket between the lumbar mount and the top plate weight holder aligned to the same cylindrical centerline axis. The test stand was measured with no weight, no pelvis, and the top plate resting on the lumbar mounting point (*Figure 15*). The length of the test stand is 14 in. The distance between the top and bottom plate was 4.914 in on the left and 4.876 in on the right side. The second check used the same setup but the back edges of the top and bottom plates were aligned (*Figure 16*). Aligning the test stand on the back edge shifted the position of the top plate 0.63 in to the right and 0.25 in to the rear of the lumbar mount cylindrical centerline. The distance between the top plate and bottom plate on the left side was 4.869 in, and the right was 4.935 in. Side alignment produced a difference of 0.038 in with the left side higher. Back alignment produced a difference of 0.066 in, with the right side higher. The support arm rod was checked for deflection while the test stand was completely assembled with 50 lbs of weight, in the same manner as shown in *Figure 7*. The support arm rod deflected 0.012 in toward the pelvis's right side. The deflection was measured at 11.60 in from the base plate, creating an angle of deflection of approximately 0.06°. Finally, the test stand's bottom plate and pedestal mount were checked for parallel along the Y-axis of the ATD coordinate system. There was a 0.2° difference between the bottom plate and the pedestal mount, allowing the right side of the pelvis to contact the top plate before contacting the left side of the pelvis. A 0.2° lean over the 14-in plate length is 0.048 of an inch, almost half of the average difference (0.109 in). The 0.109-in asymmetric lean of the pelvis measurements contributed to three identified factors: the pelvis mount and base plate out of parallel, the deflection of the support arm rod when loaded, and the weight center of gravity is offset to the right of the pelvis by 0.63 in.

Figure 15: Side Alignment of Empty Test Stand. Front View (Left), Side View (Right)

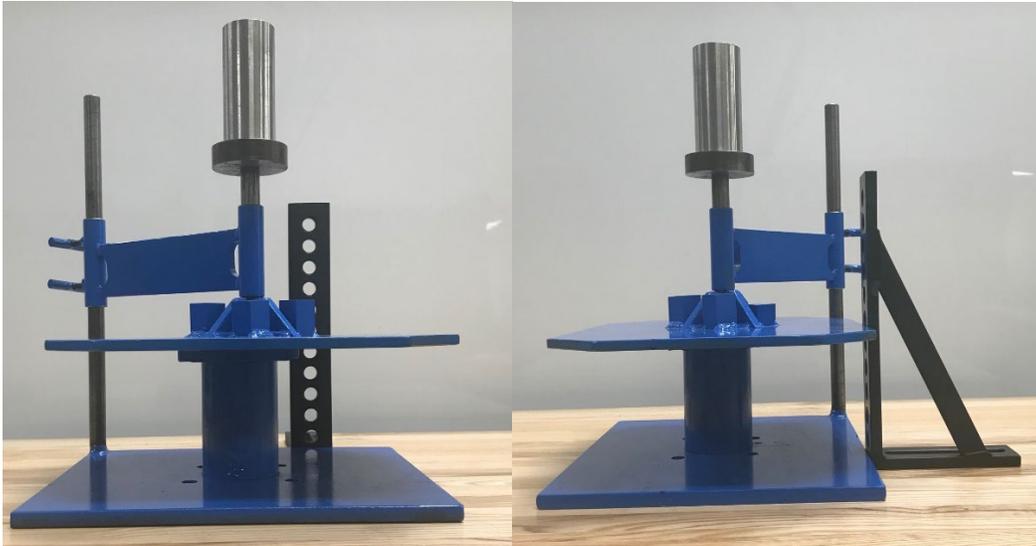
Figure 16: Back Alignment of Empty Test Stand. Front View (Left), Side View (Right)

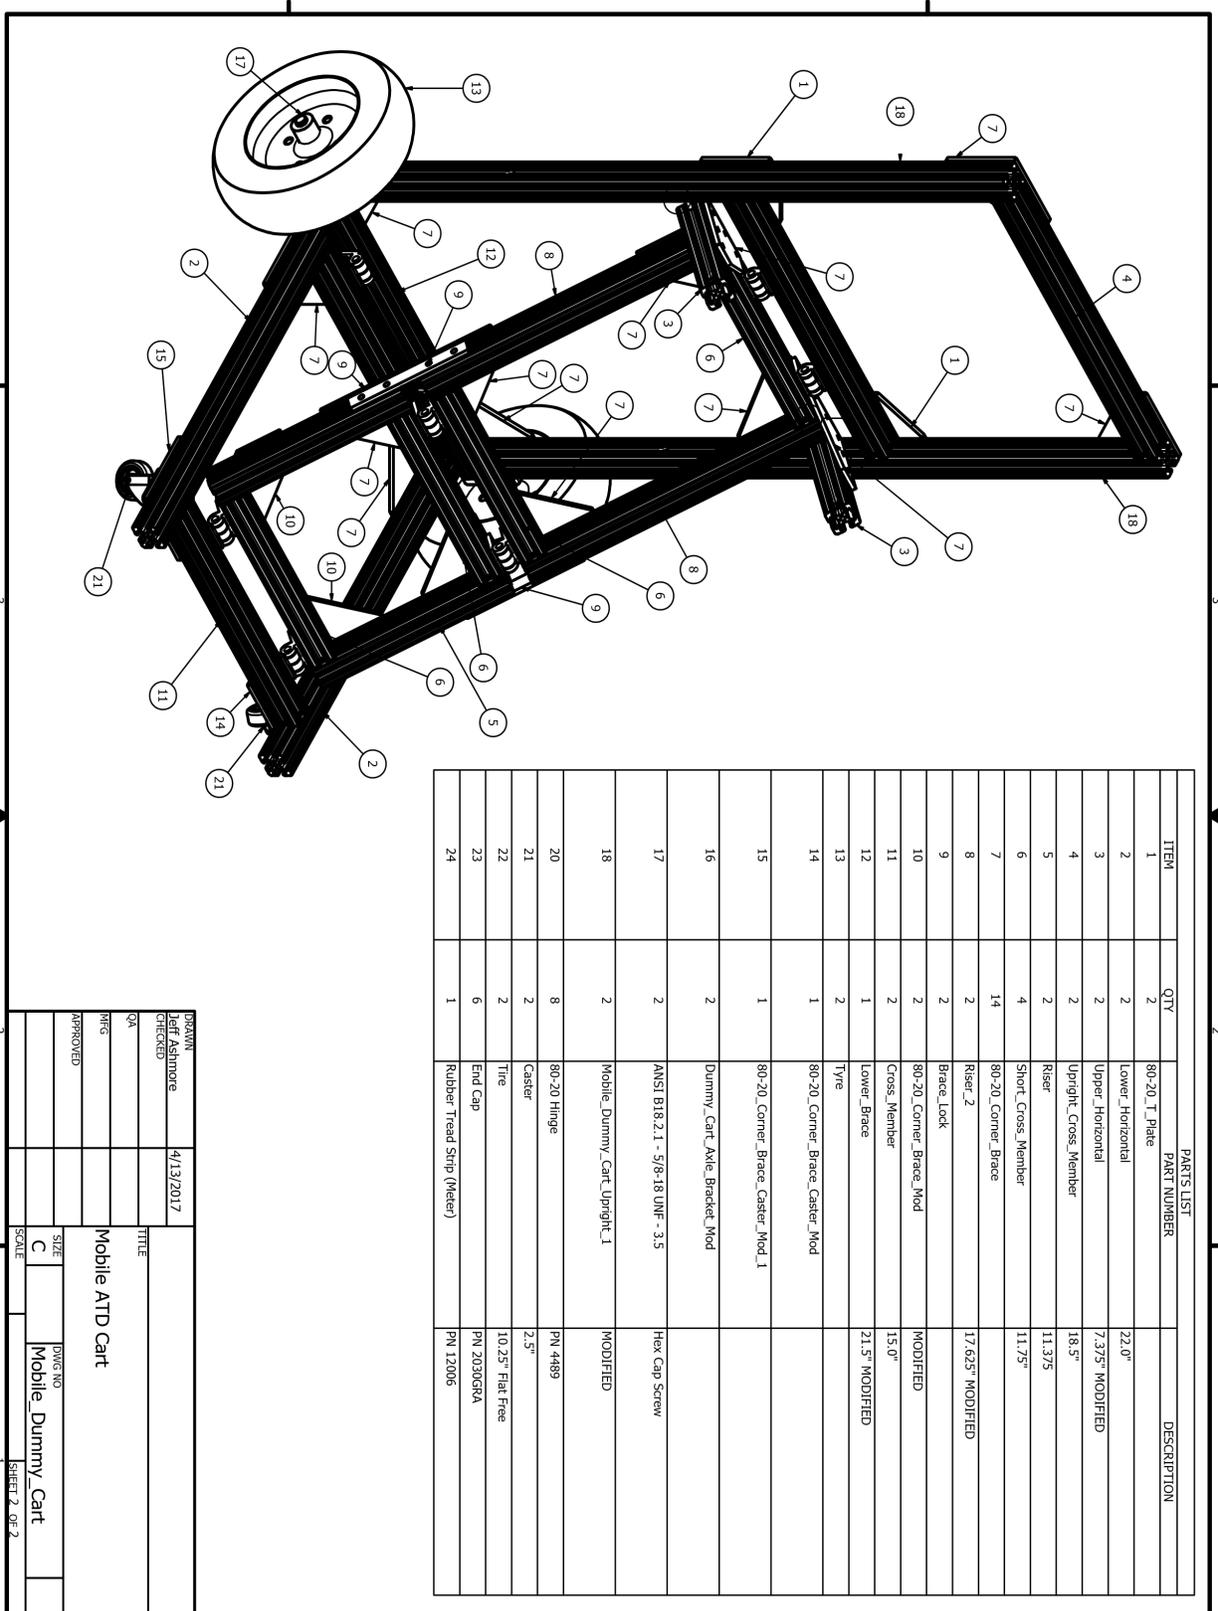
DRAWN	4/13/2017	TITLE	Mobile ATD Cart
CHECKED		DATE	
QA		APPROVED	
DATE		SCALE	
SIZE	C	DWG NO	Mobile_Dummy_Cart
SCALE		SHEET 2 OF 2

PARTS LIST			
ITEM	QTY	PART NUMBER	DESCRIPTION
1	2	80-20_T_Plate	22.0"
2	2	Lower Horizontal	7.375" MODIFIED
3	2	Upper Horizontal	18.5"
4	2	Upright_Cross_Member	11.375"
5	2	Riser	11.75"
6	4	Short_Cross_Member	17.625" MODIFIED
7	14	80-20_Corner_Brace	
8	2	Riser_2	
9	2	Brace_Lock	
10	2	80-20_Corner_Brace_Mod	MODIFIED
11	2	Cross_Member	15.0"
12	1	Lower_Brace	21.5" MODIFIED
13	2	Type	
14	1	80-20_Corner_Brace_Caster_Mod	
15	1	80-20_Corner_Brace_Caster_Mod_1	
16	2	Dummy_Cart_Axle_Bracket_Mod	
17	2	ANSI B18.2.1 - 5/8-18 UNF - 3.5	Hex Cap Screw
18	2	Mobile_Dummy_Cart_Upright_1	MODIFIED
20	8	80-20 Hinge	PN 4489
21	2	Caster	2.5"
22	2	Tile	10.25" Flat Free
23	6	End Cap	PN 2030GRA
24	1	Rubber_Tread Strip (Meter)	PN 12006

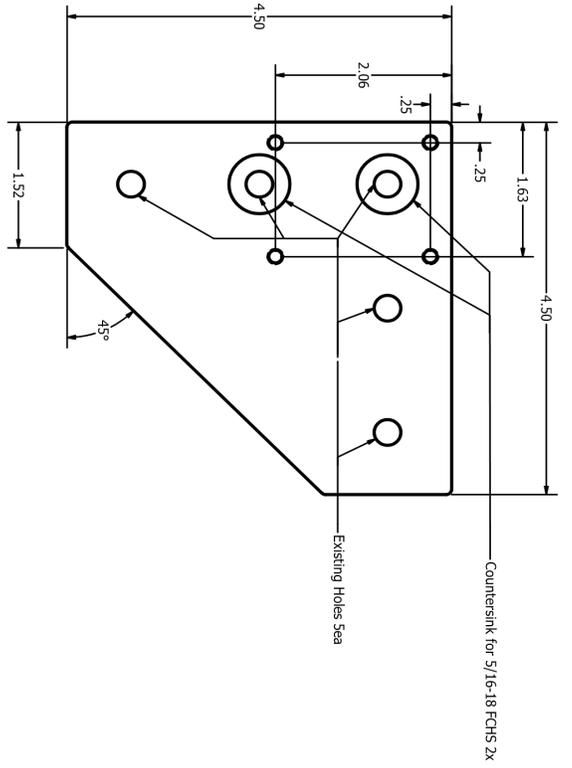
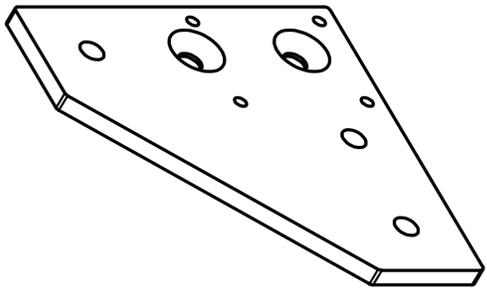
DESIGN	6/23/2017		
CHECKED			
QA			
APPROVED			
80-20_Corner_Brace_Caster_Mod_1, RH Side		SIZE	DWG NO
		C	15
		SCALE	1 OF 1

Note:
80/20 Part No. 4351,
Countersink 2X for clearance,
Tap drill thru 4X for 10-32 BHCS

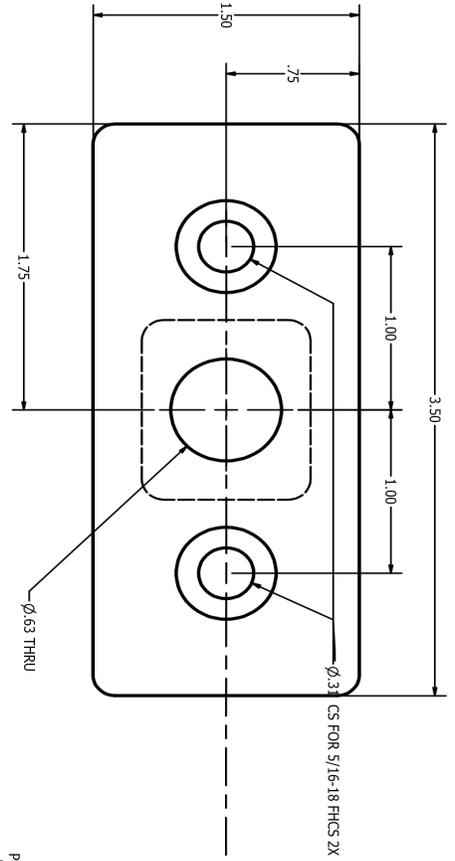
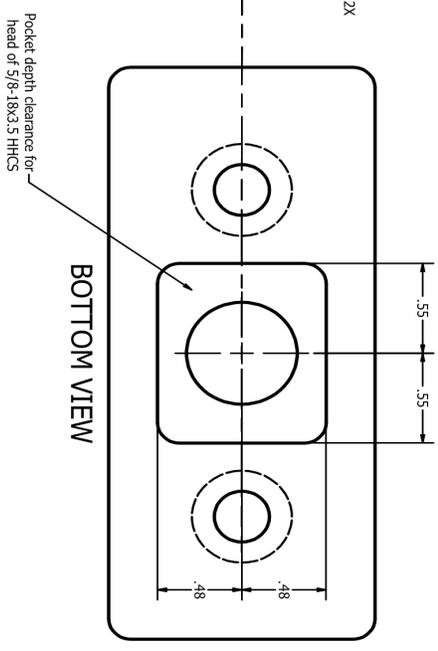
DESIGNED	6/26/2017	TITLE	
CHECKED		Dummy_Cart_Axle_Bracket_Mod	
QA		SIZE	DWG NO
MFG		C	16
APPROVED		SCALE	SHEET 1 OF 1

BOTTOM VIEW

MATERIAL:
6061-T6
