Testing of New Bridge Rail and Transition Designs

Volume XIV: Appendix M

Axial Tensile Strength of Thrie and W-Beam Terminal Connectors

PUBLICATION NO. FHWA-RD-93-157

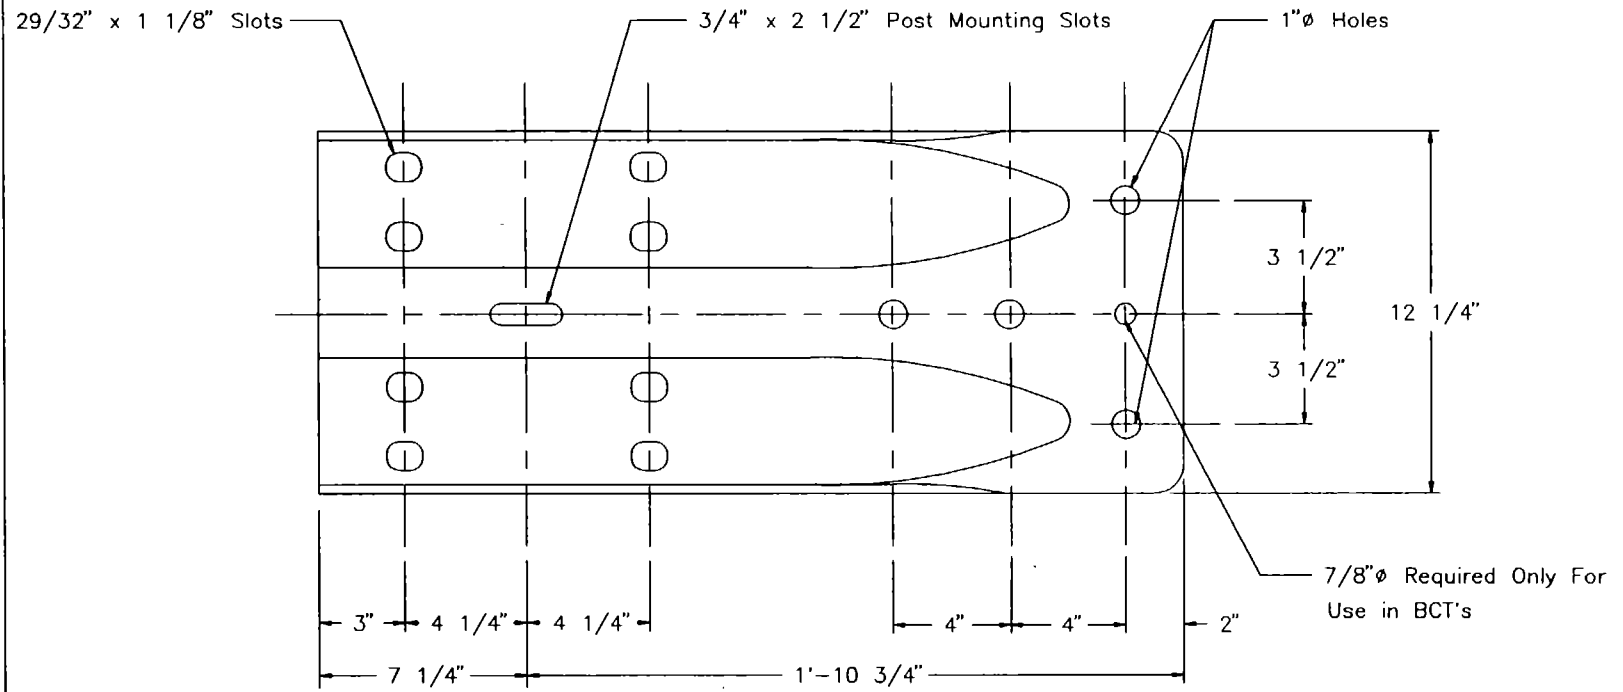
Figure 2. Standard W-beam.

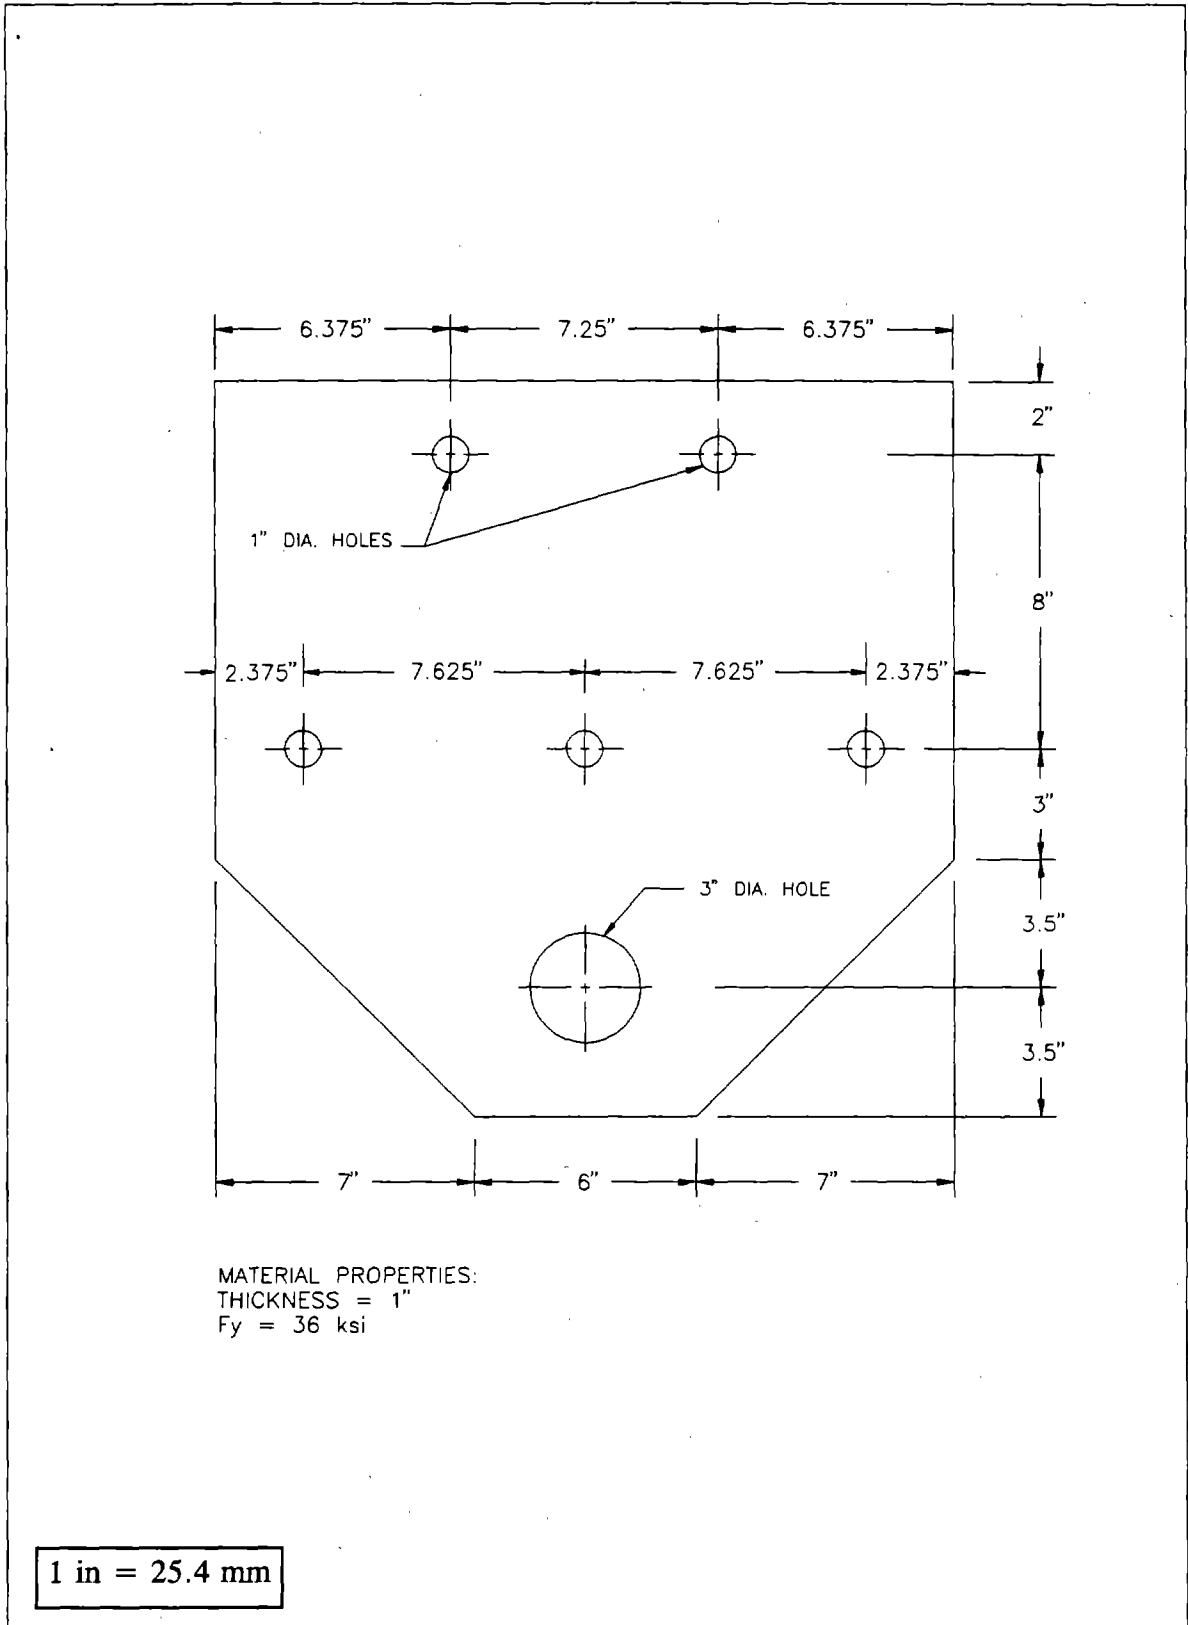
Figure 3. Steel plate attachment for flat section of terminal connector.

The plates were fabricated from ASTM A36 steel. One plate had predrilled holes to match the holes on the flat portion of the terminal connectors, while the other plate had predrilled holes for matching the holes in the test pieces (figures 3 and 4). Additionally, each plate had a 3-in (76.2-mm) diameter pin hole located near the throat of the plate.

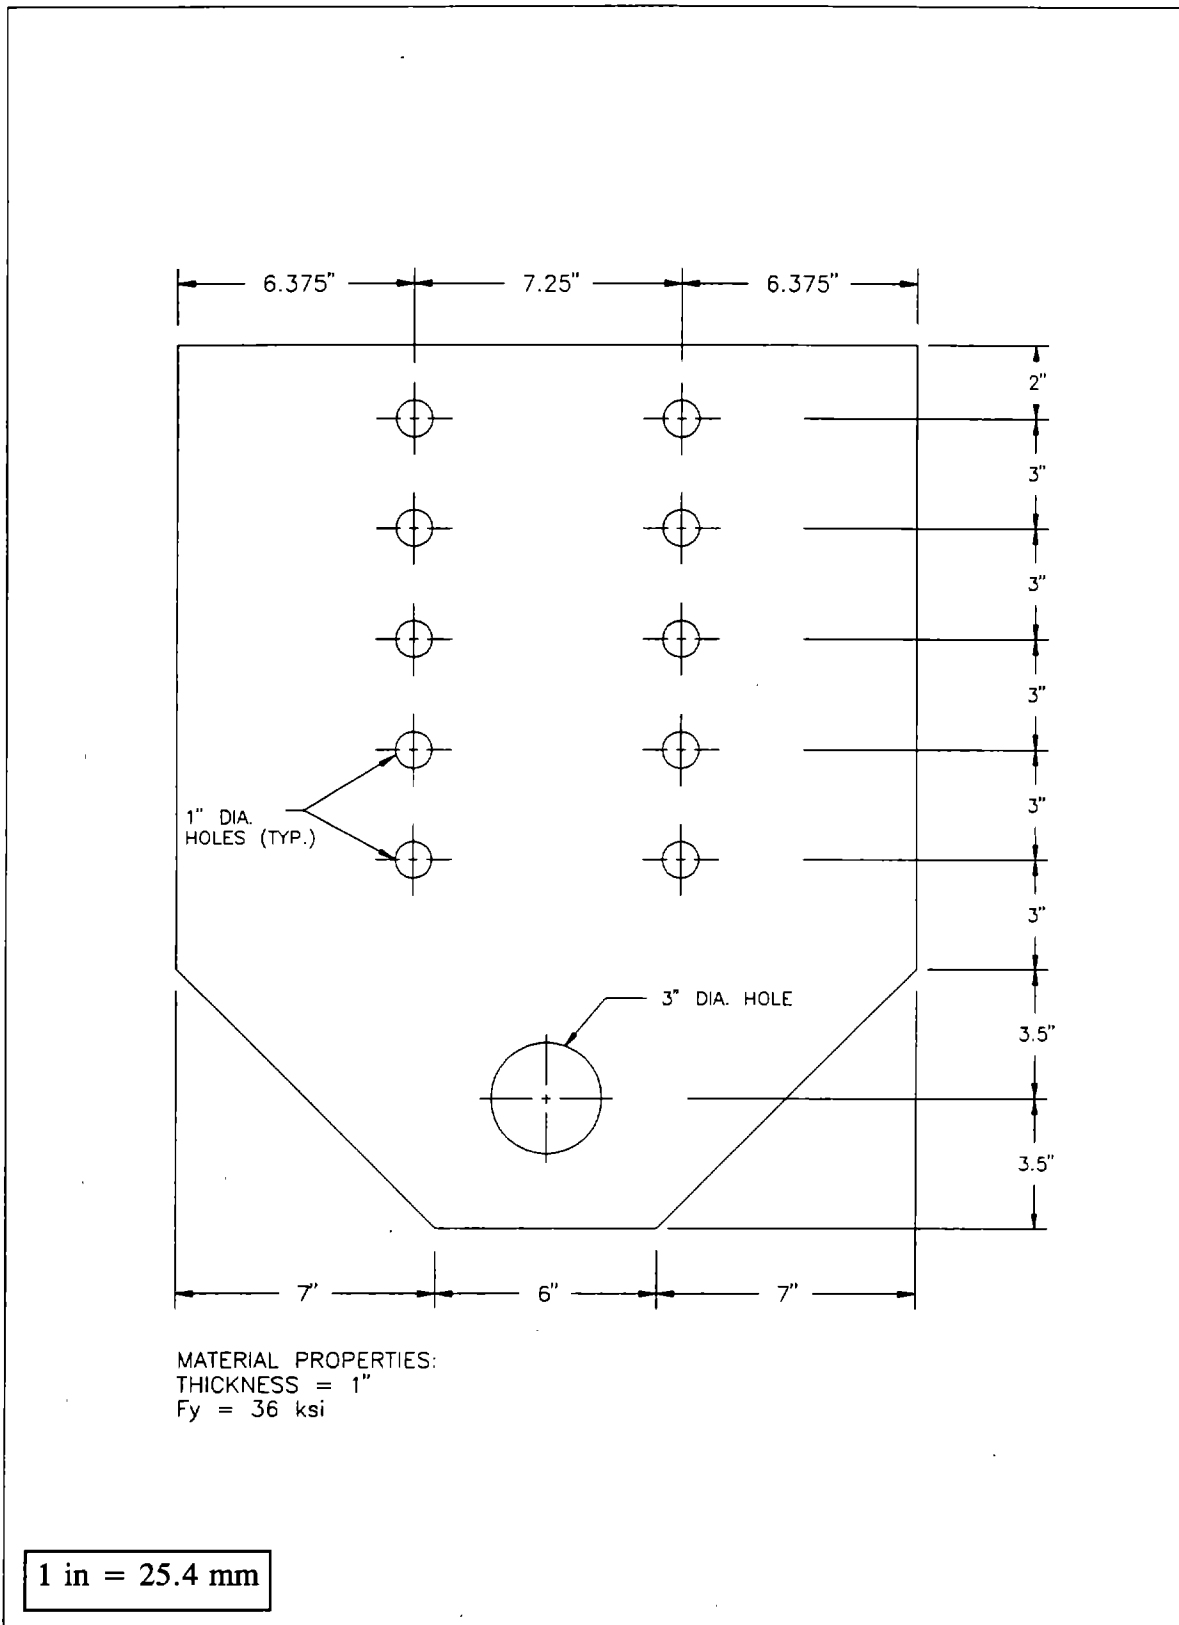
Figure 4. Steel plate attachment for test piece.

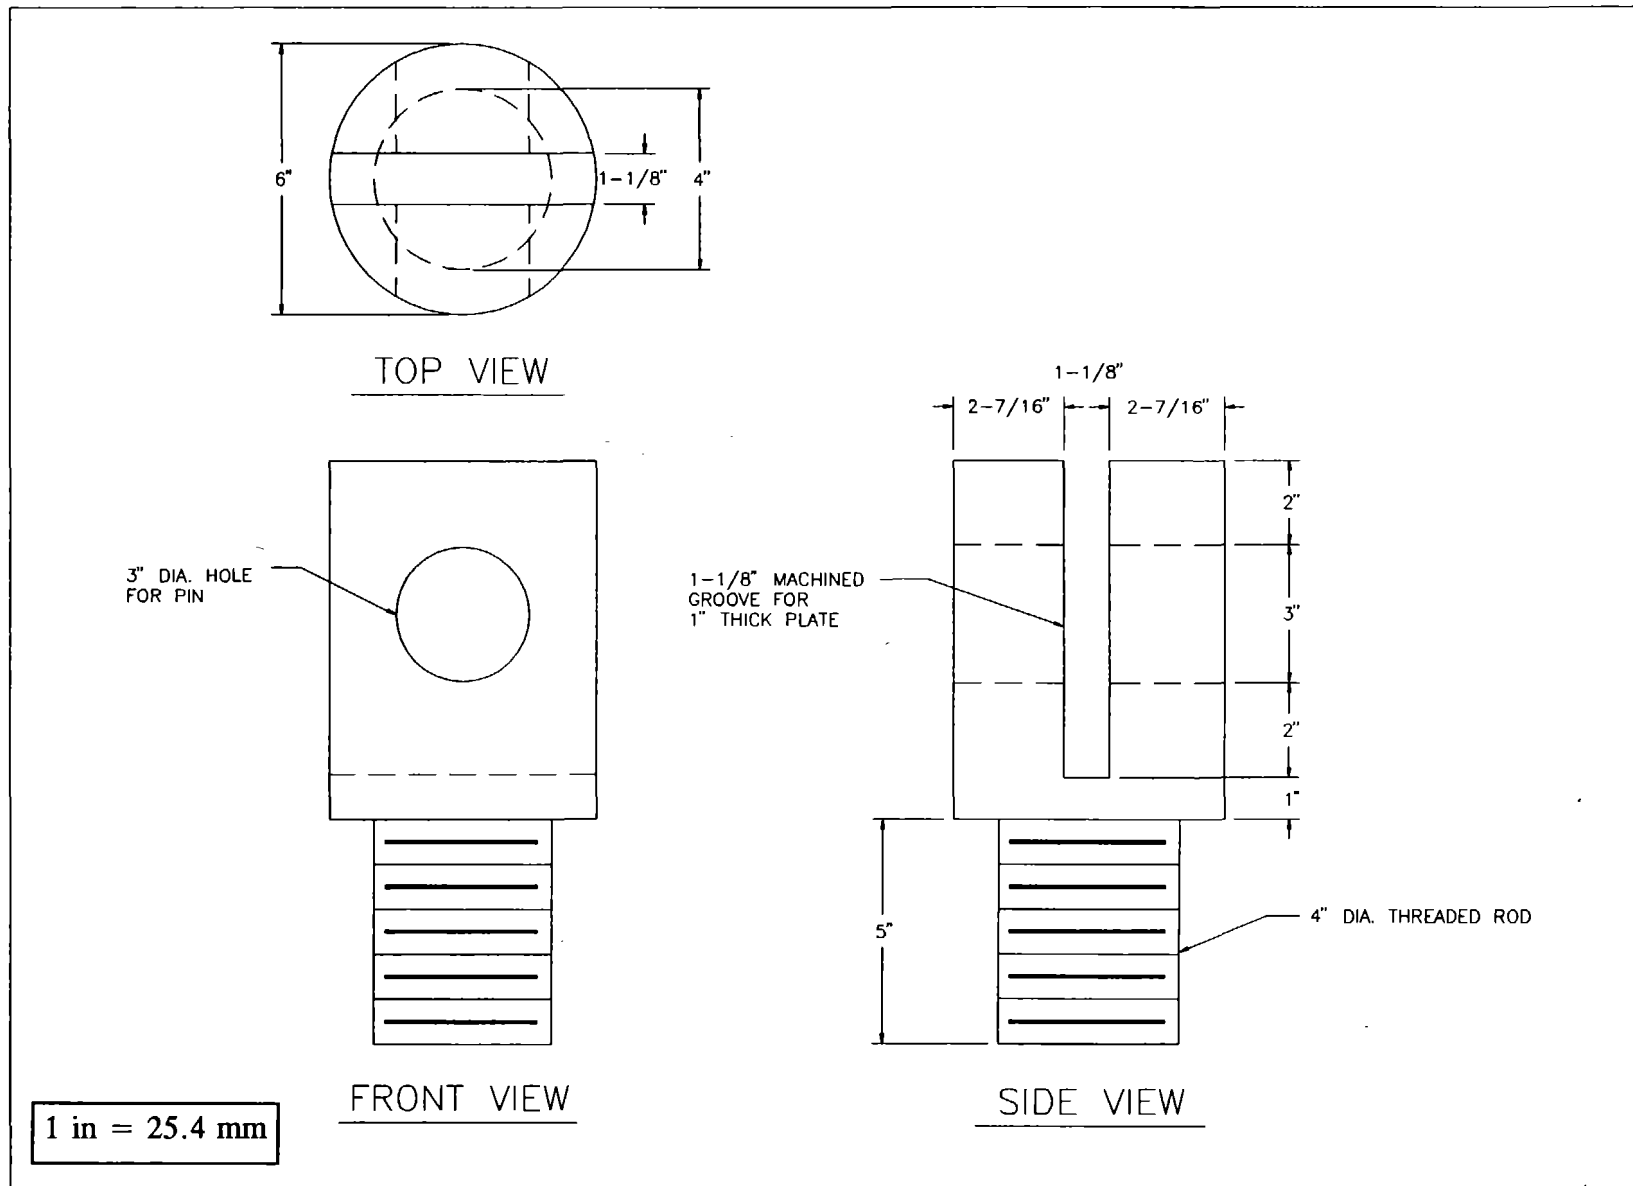
Figure 5. Views of SAE 4140 high strength steel yoke.

The yokes were machined from 6-in (152.4-mm) diameter SAE 4140 high strength steel (figure 5). One end of the yoke was threaded to match the 4-in (102-mm) diameter female couplings of the MTS 2000. A 1-in (25.4-mm) groove was machined in the other end of the yoke spanning the diameter, and a 3-in (76.2-mm) diameter pin hole was drilled perpendicular to the groove through the diameter of the yoke.

The pins for the "adapter" assembly were fabricated from 3-in (76.2-mm) diameter 17-4'PH H900 high strength stainless steel. The pins were 6-in (152-mm) long and spanned the diameter of the yoke.

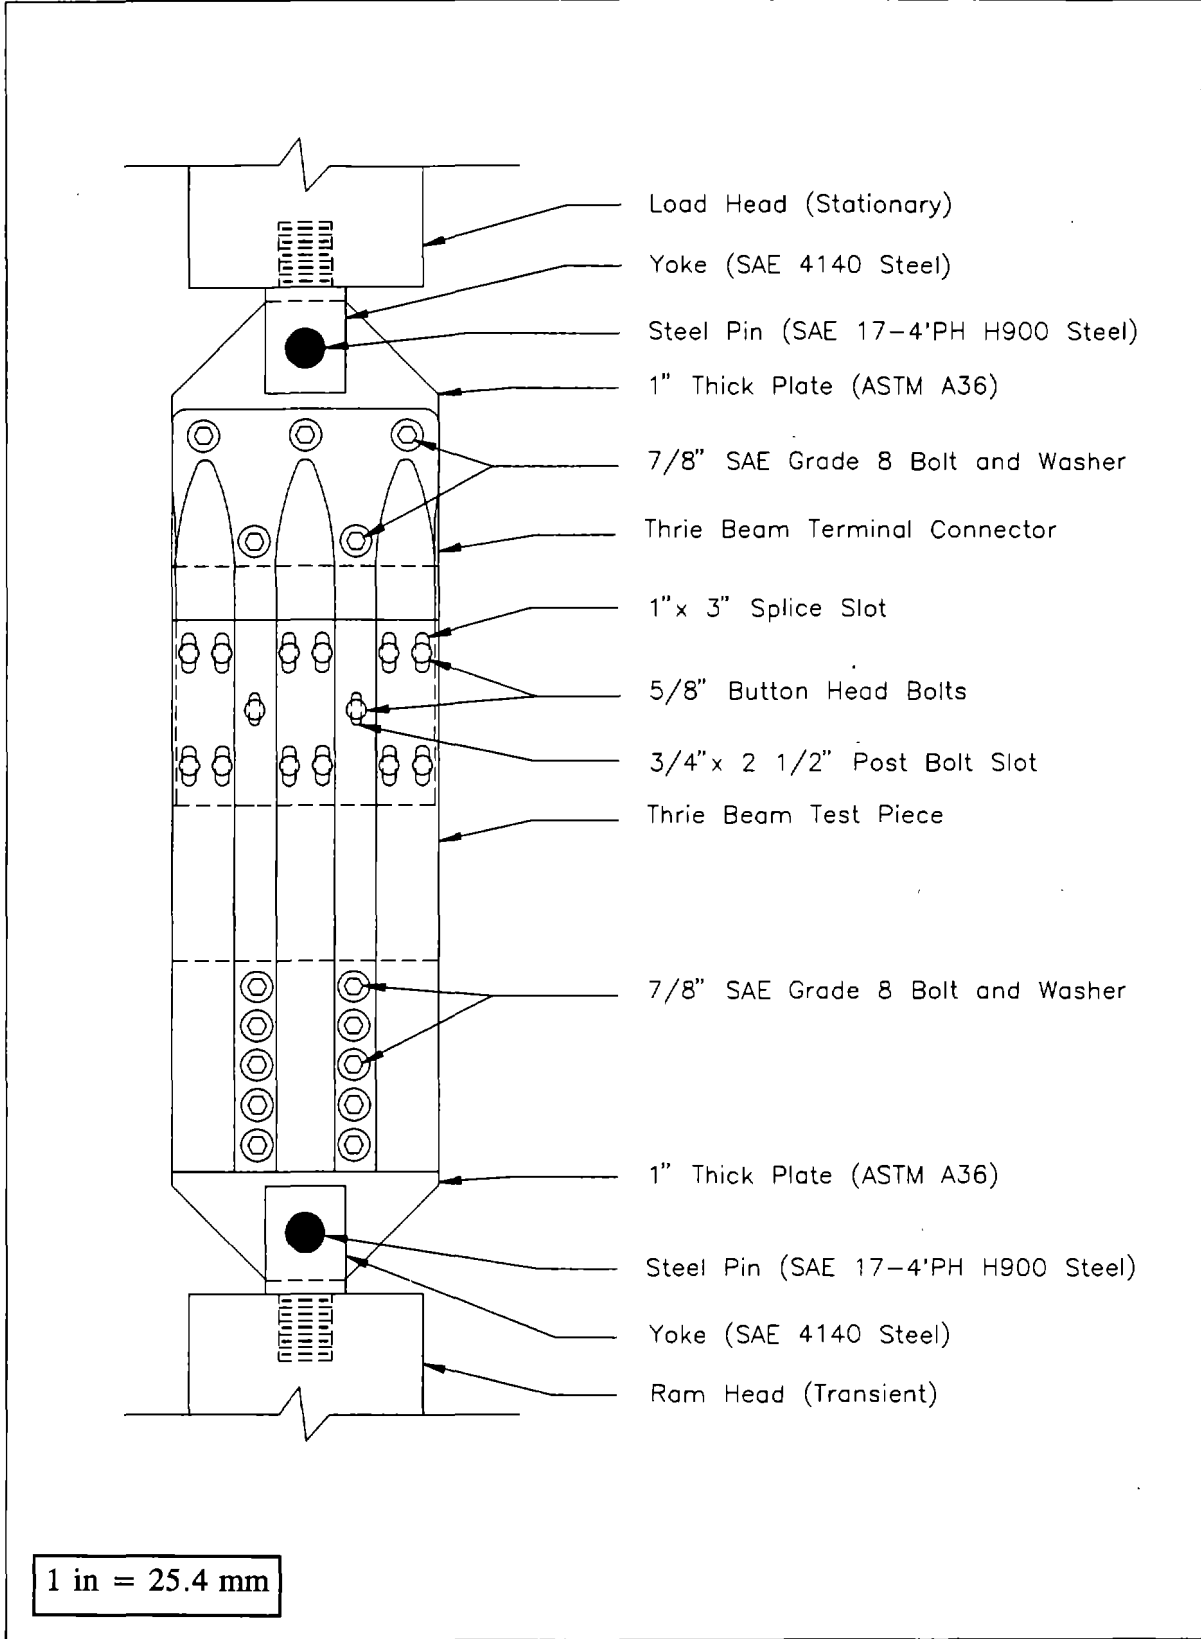
Figure 6. Terminal connector test assembly for a thrie-beam.

Each threaded male end of the yoke was placed into the female end of the MTS 2000. The steel plates were then placed in the groove of the yokes, aligning the pin holes. The pin was placed through both plate and yoke, allowing rotation about the Y-Y axis of the cross section of the terminal connector.

The terminal connector was bolted to the stationary (upper) plate at its flat section. The test piece, a 36-in (914-mm) long segment of guard rail, was bolted to the transient (lower) plate (see figure 6). SAE grade 8 high strength bolts, flat and lock washers, and nuts were used for all test samples at these connections. The test piece and terminal connector for all samples were spliced together using ASTM A307 button-head splice bolts and A563 flat washers and nuts. All high strength bolts were torqued to 473 ft-lb (632 N-m), and all mild steel bolts were torqued to 70 ft-lb (95 N-m). Each sample was loaded at the rate of 0.1 in/min (2.5 mm/min) and tested for ultimate strength under static, axial tension loading. A GS-2000 Servo Controller/Data Acquisition System was used for recording the load and ram head displacement data every second. An initial vertical position of the ram head was input into the system. Ram head displacement data was relative to that position, and many of the graphs in the results reflect this relative positioning. Additionally, each sample was subjected to a preloaded condition (maximum of 6 kips (27 kN)) to remove slack in the system.

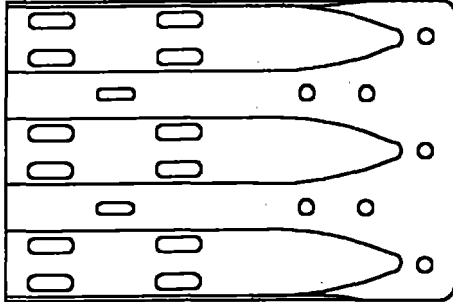
SAMPLES 8-9

Manufacturer #1
 Thickness = 10 gauge
 Splice slots - 1" X 3"

Samples eight and nine were 10-gauge thrie beam-terminal connectors fabricated by manufacturer #1 (figure 7). The flat sections consisted of seven 1-in (25.4-mm) diameter bolt holes, but only five 7/8-in (22.2-mm) diameter bolts were used in each of the samples (figure 27). The splice ends maintained longitudinally straight elongated slots.

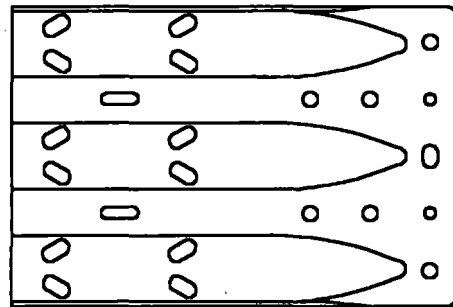
SAMPLES 13-14-15

Manufacturer #2
 Thickness = 10 gauge
 Splice slots - 1" X 1 7/8"

Samples thirteen, fourteen, and fifteen from manufacturer #2 were 10 gauge thrie-beam terminal connectors with angled slots at the splice end (figure 7). Failure was in bearing of the 7/8-in (22.2-mm) diameter bolts onto the flat section for all three specimens. Tearing of the steel at the upper right hand bolt hole occurred for all samples, particularly sample fourteen (figures 40, 41, and 42). There was virtually no structural damage at the splice ends on any of the specimens (figures 43, 44, and 45). There was local buckling at the top edge of the flat section near the upper three 7/8-in (22.2-mm) diameter bolts (figures 46, 47, and 48). Five 7/8-in (22.2-mm) diameter bolts were used in the flat portion of each terminal connector, and twelve 5/8-in (16-mm) mild steel button head bolts were used in the splice end of each connector. Unlike the other specimens, no bolts were included in the post mounting slots. Ultimate load capacities for samples thirteen, fourteen, and fifteen were 102.4 kips (455.5 kN), 99.3 kips (441.7 kN), and 101.8 kips (452.8 kN) respectively (table 1).

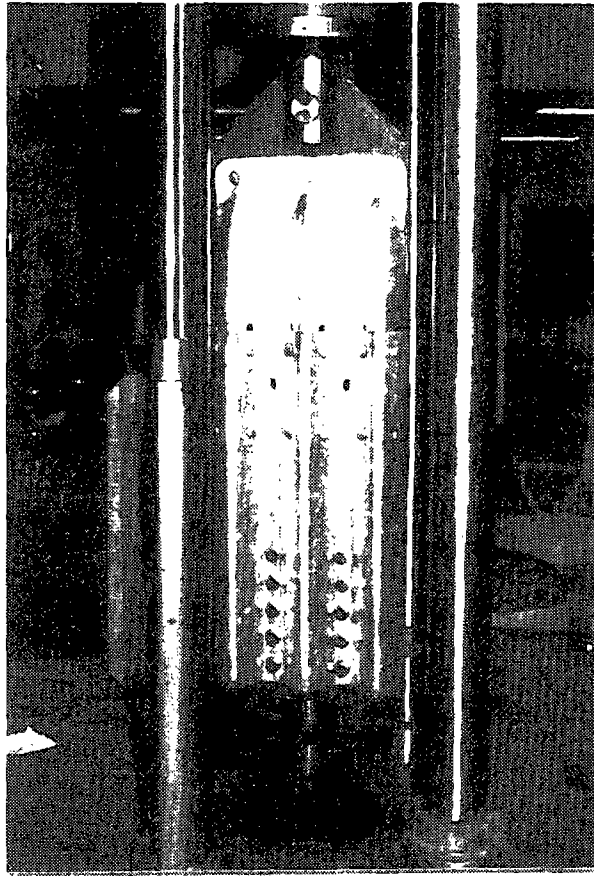
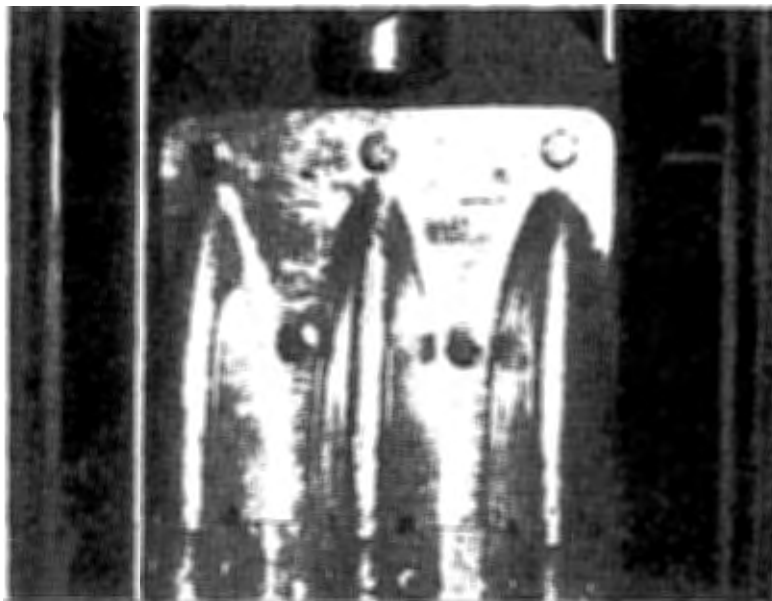
Figure 8. Connector and test piece prior to test, sample one.

Figure 9. View of flat section prior to test, sample one.

The first sample tested was a 10-gauge thrie-beam terminal connector fabricated by manufacturer #1 (figure 7). The flat portion of the terminal connector had five 1-in (25.4-mm) diameter bolt holes, and the rail end had twelve straight, elongated slots and two post mounting slots. Five 7/8-in (22.2-mm) diameter bolts were used in the flat section of the terminal connector, and fourteen 5/8-in (15.9-mm) diameter button-head bolts were used at the splice end (figures 8 and 9).

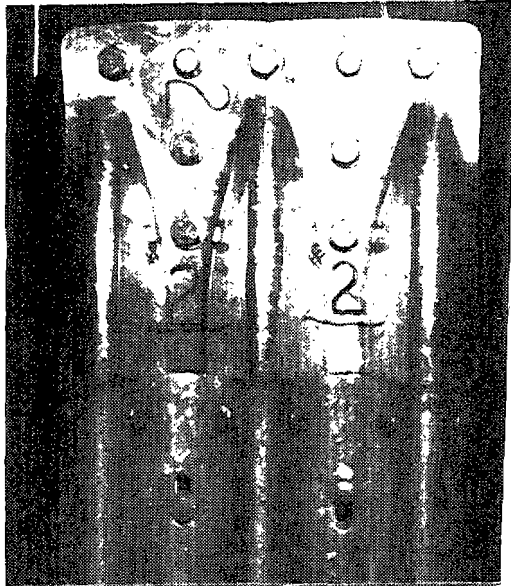
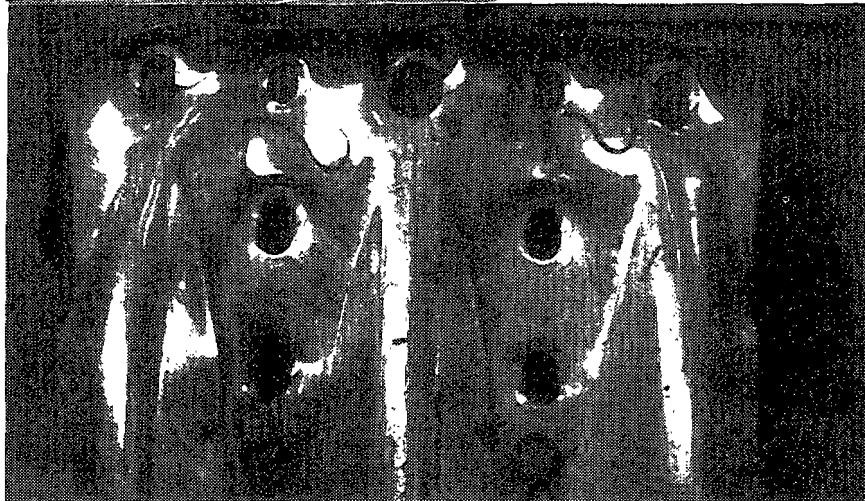
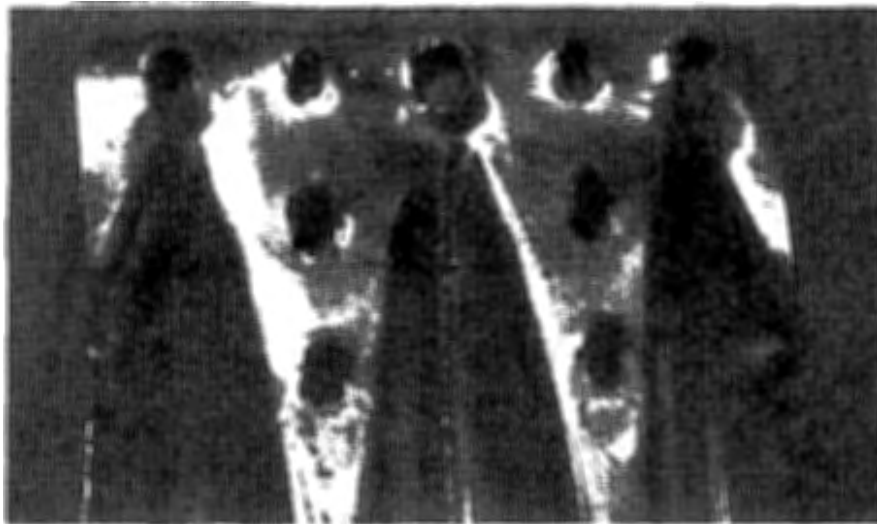
Figure 12. Connector and test piece prior to test, sample two.

Figure 13. Exterior damage to flat section, sample two.

Figure 14. Interior damage to flat section, sample two.

Samples two, three, and four were 12-gauge thrie-beam terminal connectors fabricated by manufacturer #2 (figure 7). The flat portion of each terminal connector had seven 1-in (25.4-mm) diameter holes and two 7/8-in (22.2-mm) diameter holes. The splice end had 12 angled splice slots and two post mounting slots. Seven 7/8-in (22.2-mm) diameter bolts and two 3/4-in (19.1-mm) diameter bolts were used in the flat section of the terminal connector, and fourteen 5/8-in (16-mm) diameter button-head bolts were used at the splice end (figures 12, 13, and 14).

Failure of sample two was in bearing of the 7/8-in (22.2-mm) diameter bolts onto the flat section. Further displacement caused tearing normal to the load at the outside two holes of the top row (figures 15 and 16). As in sample one, there was relatively little or no deformation at the splice bolt connection. The ultimate load capacity of this terminal connector was 132.6 kips (589.8 kN) (table 1). Note that sample two was fabricated from 12-gauge steel, yet its load capacity was approximately 40 kips (178 kN) greater than sample one fabricated from 10-gauge steel. The load capacity differential can be attributed to the difference in the number of bolts used in the two samples.

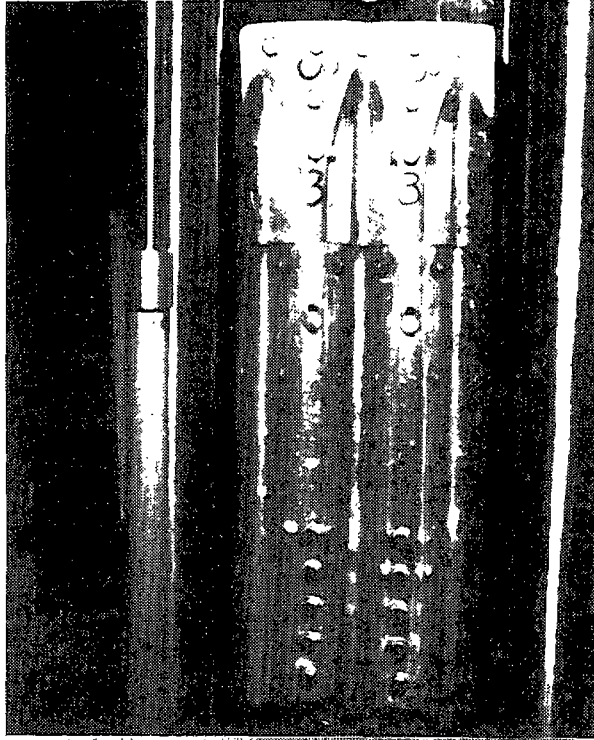
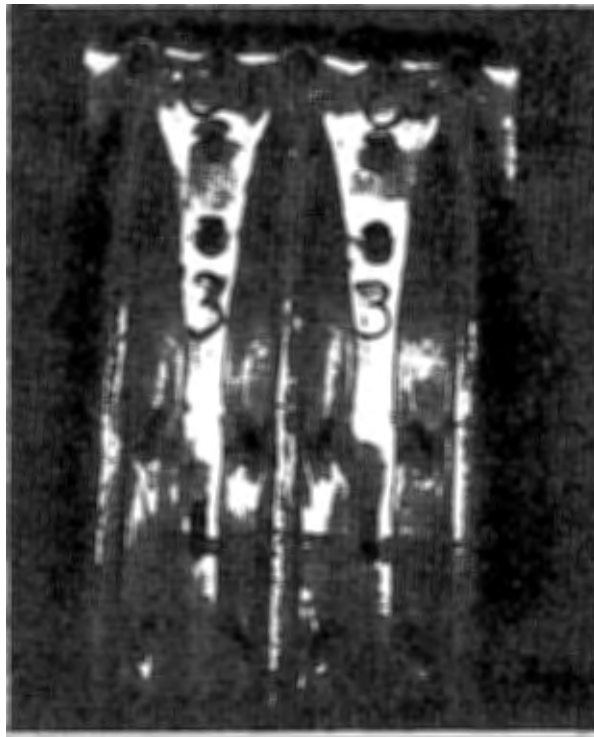
Figure 15. Connector and test piece prior to test, sample three.

Figure 16. Exterior view of damaged connector, sample three.

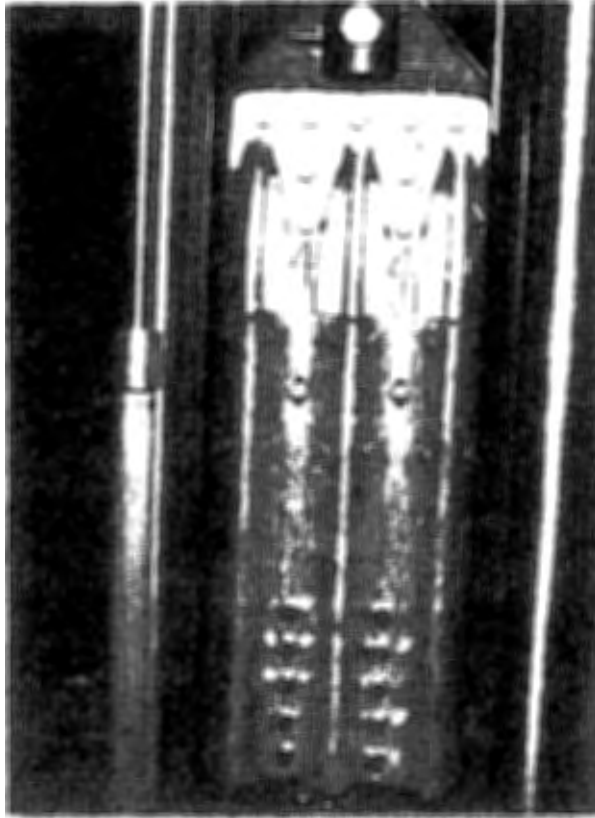
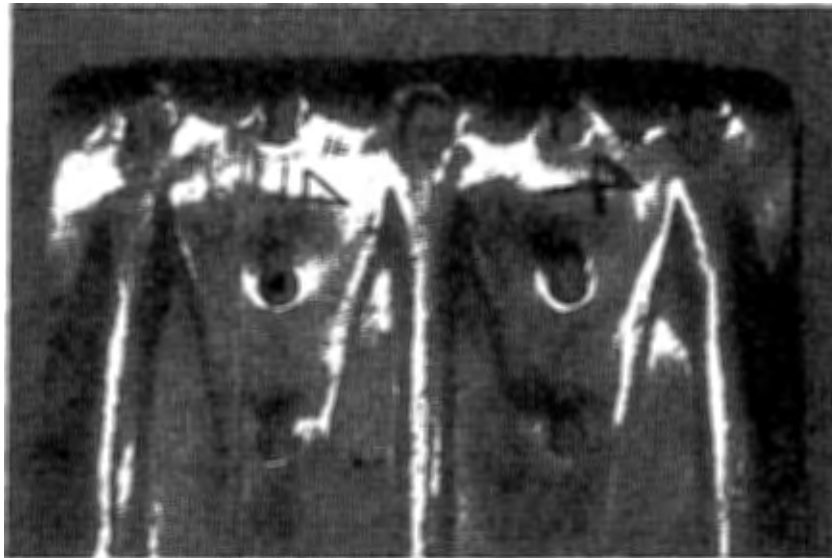
Figure 17. Connector and test piece prior to test, sample four.

Figure 18. Exterior damage to flat section, sample four.

Samples three and four were tested in precisely the same manner as sample two with similar results. Ultimate loads were 126.8 kips (564.0 kN) and 133.7 kips (594.7 kN), respectively (table 1). Failure for both was in bearing of the 7/8-in (22.2-mm) diameter bolts onto the flat portion of the terminal connector. Further displacement caused tearing at the outside two holes of the top row of the flat section. Sample three exhibited some deformation at the splice bolt connection, while sample four had relatively little or none (figures 17 and 18).

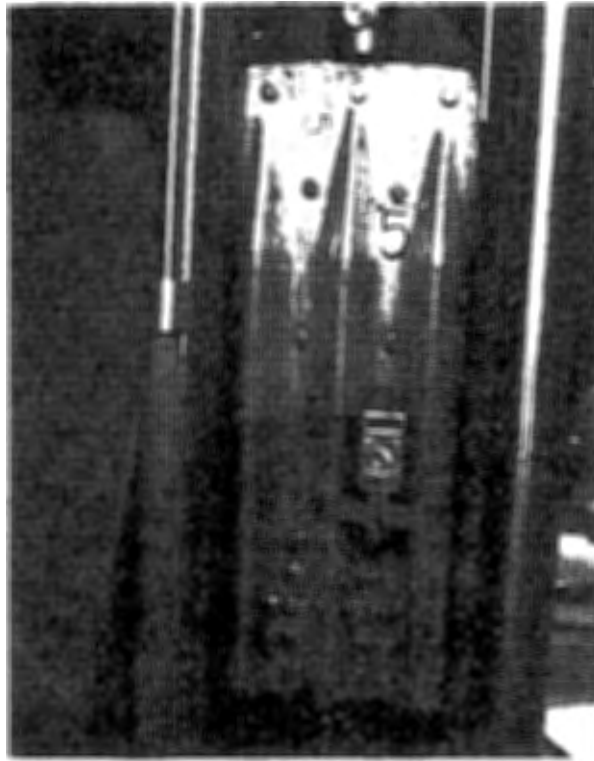
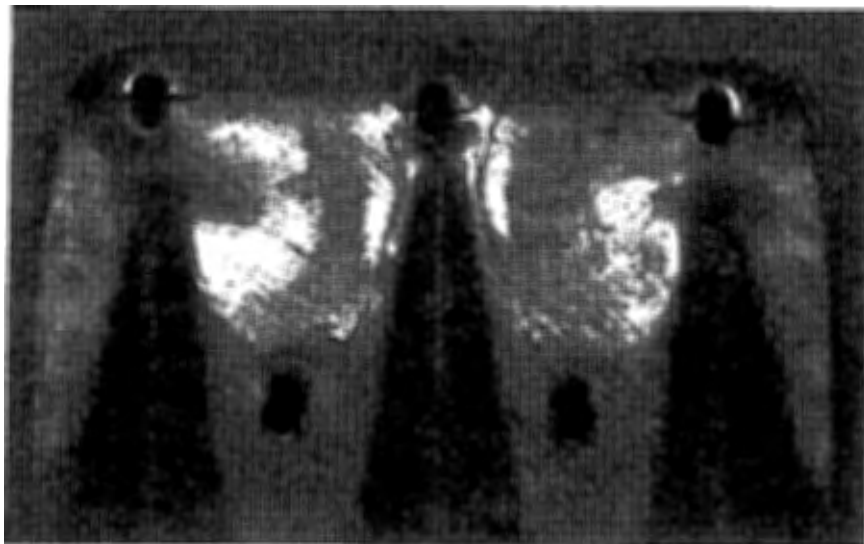
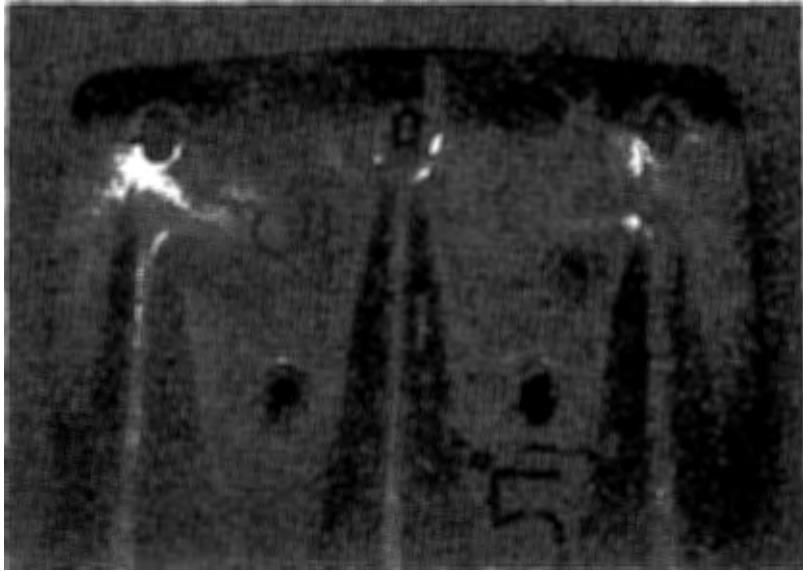
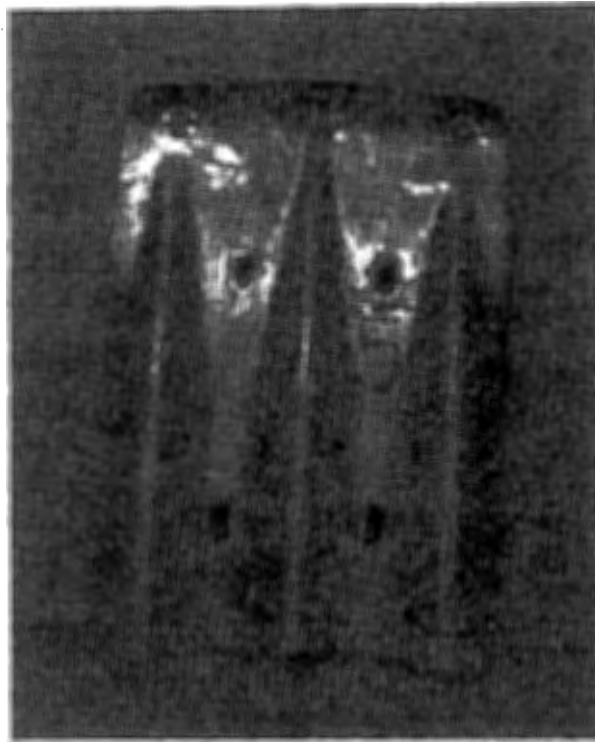
Figure 19. Connector and test piece before test, sample five.

Figure 20. Interior damage to flat section, sample five.

Figure 21. Exterior damage to flat section, sample five.

Figure 22. Full view of exterior damage, sample five.

structural damage occurred at the top three bolt holes. Bearing of the bolts onto the connector followed by tearing normal to the direction of the load accounted for most of damage prior to the ultimate load capacity of the connector. Deformation at the splice bolt connection was once again limited (figures 20, 21, and 22).

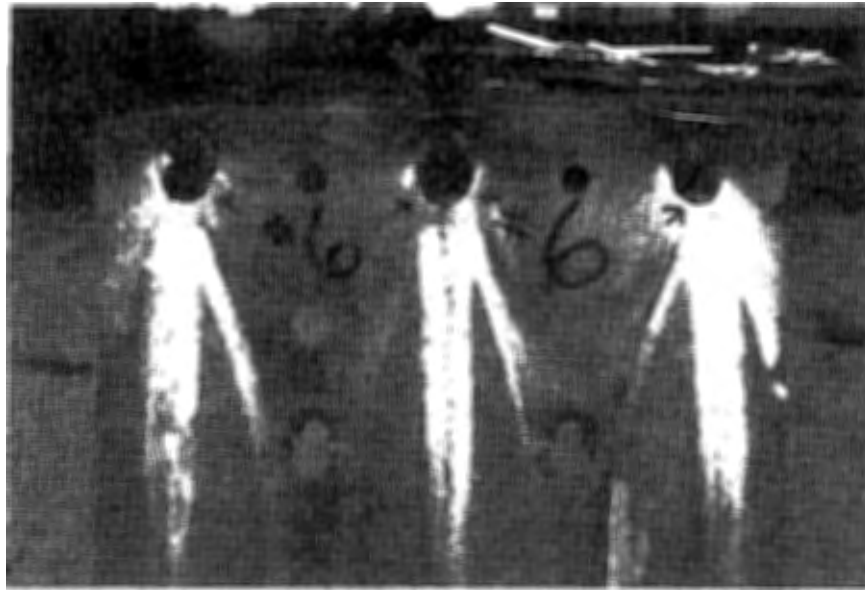
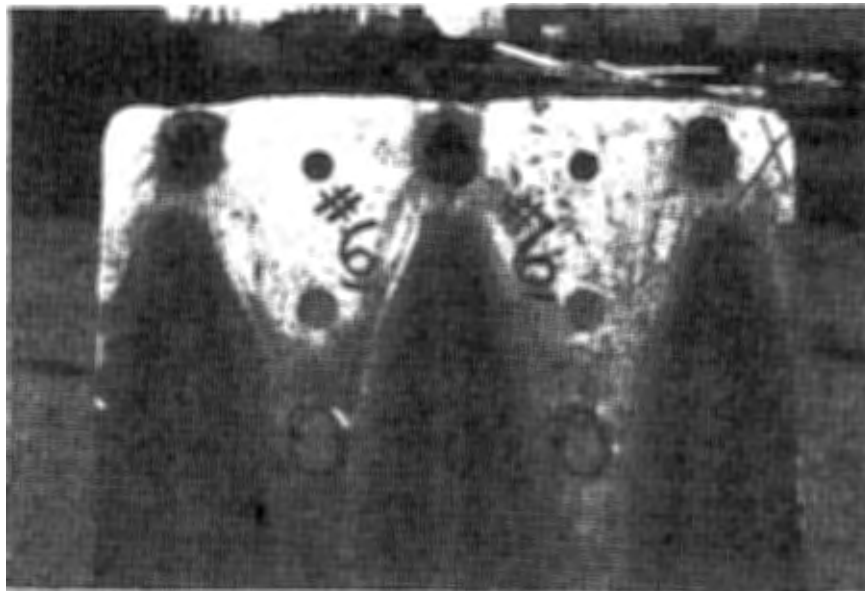
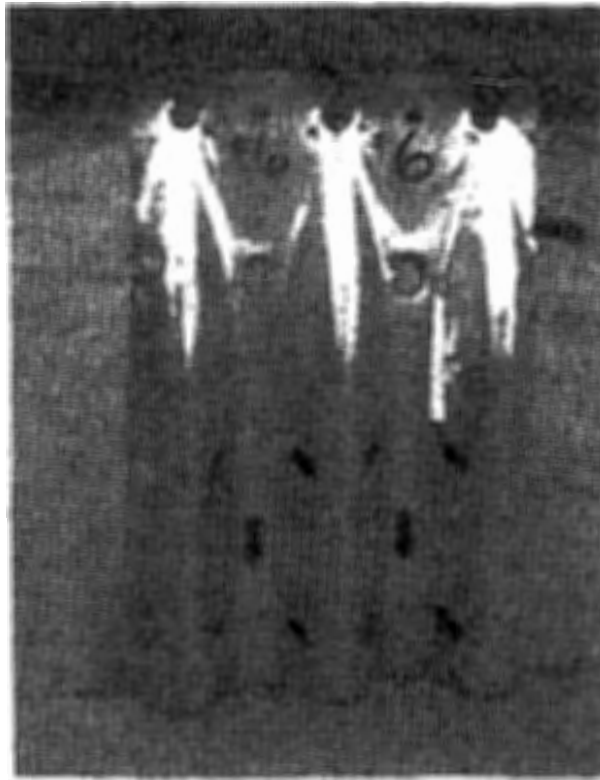
Figure 23. Exterior damage to flat section, sample six.

Figure 24. Interior damage to flat section, sample six.

Figure 25. Full view of damaged connector, sample six.

Figure 26. Damage at splice connection, sample six.

Sample six was a 12-gauge thrie-beam terminal connector fabricated by manufacturer #2. Its hole and slot patterns were identical to samples two, three, and four (figure 7); however, this sample was tested with only five 7/8-in (22.2-mm) diameter bolts in the flat section. Failure was in bearing at 83.3 kips (370.5 kN) (table 1) and occurred at the 1-in (25.4-mm) diameter holes in the flat portion of the plate. Most of the deformation was plastic flow; however, some tearing occurred at the uppermost right hand bolt hole of the connector (figures 23 and 24). Little or no deformation was observed at the splice bolt connection (figures 25 and 26).

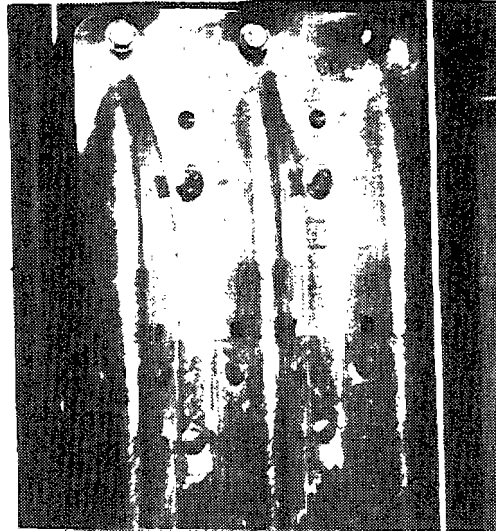
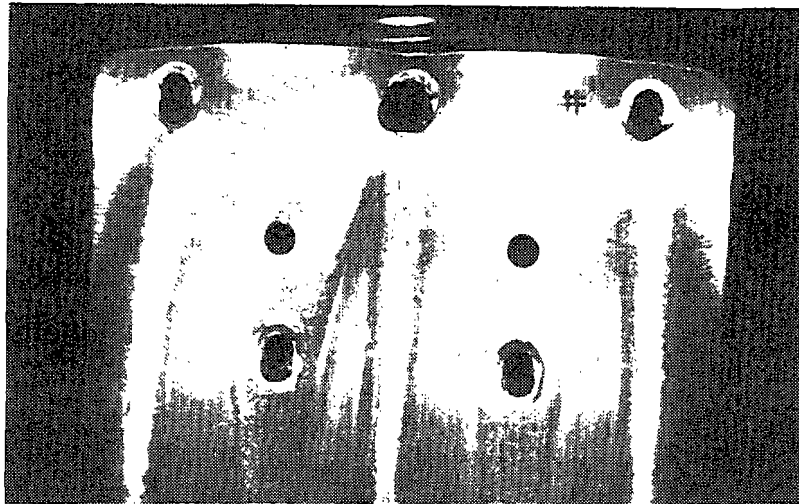
Figure 27. Terminal connector and test piece after test, sample eight.

Figure 28. Exterior damage to flat section, sample eight.

Figure 29. Local buckling at edge of connector, sample eight.

Sample eight failed in bearing at 93.8 kips (417.2 kN) (table 1). There was considerable plastic flow at all bolt holes in the flat section, and the voids created by the bolts were much straighter and smoother than in previous tests. After further displacement, there was tearing normal to the direction of loading at the top row of 1-in (25.4-mm) diameter bolt holes in the flat section (figures 28 and 29).

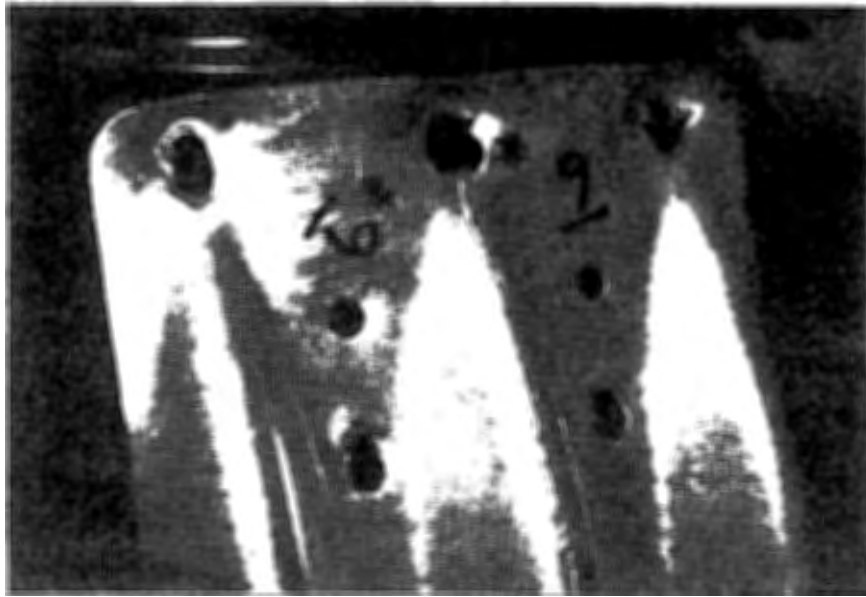
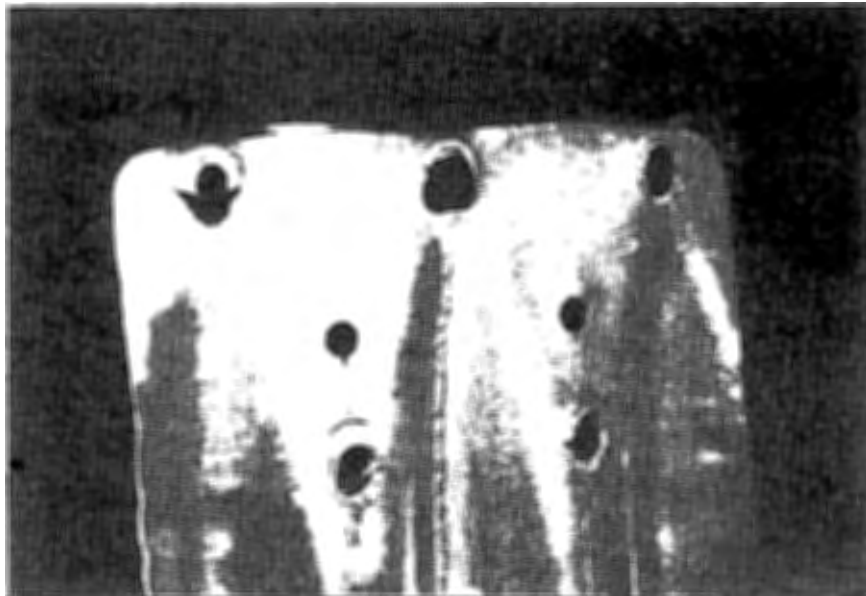
Figure 30. Exterior damage to flat section, sample nine.

Figure 31. Interior damage to flat section, sample nine.

Sample nine failed very similarly to sample eight at 87.7 kips (390.1 kN) (table 1). There was plastic flow at all bolt holes in the flat section of the terminal connector. The top row of 1-in (25.4-mm) bolt holes in the flat section showed extensive plastic deformation followed by tearing at the corners. There was no significant damage at the splice bolt connection (figures 30 and 31).

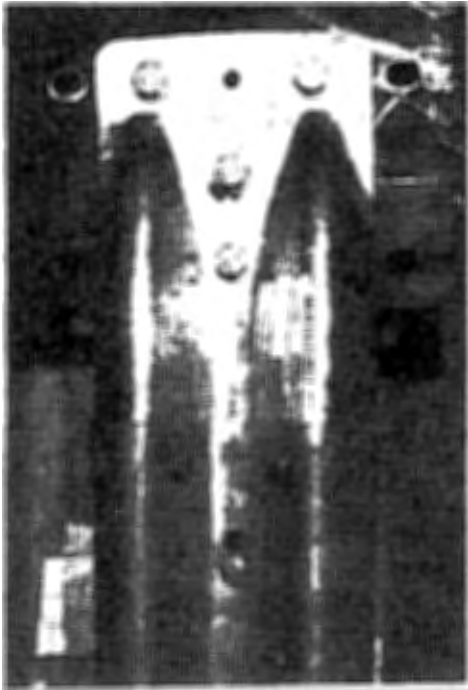
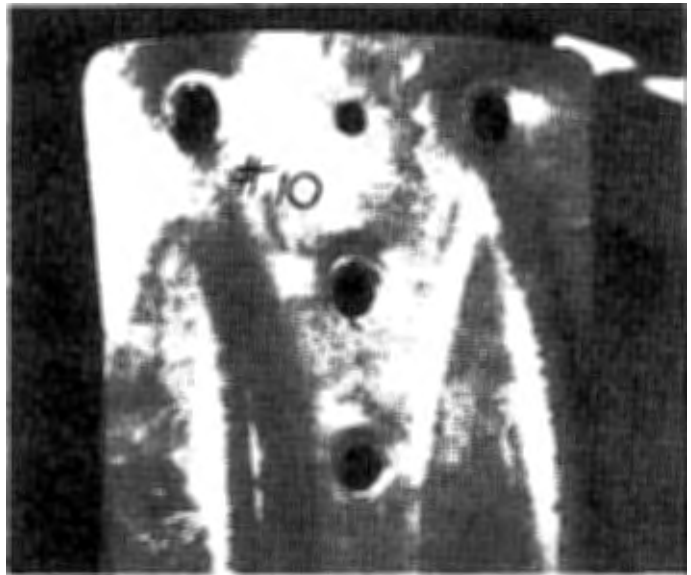
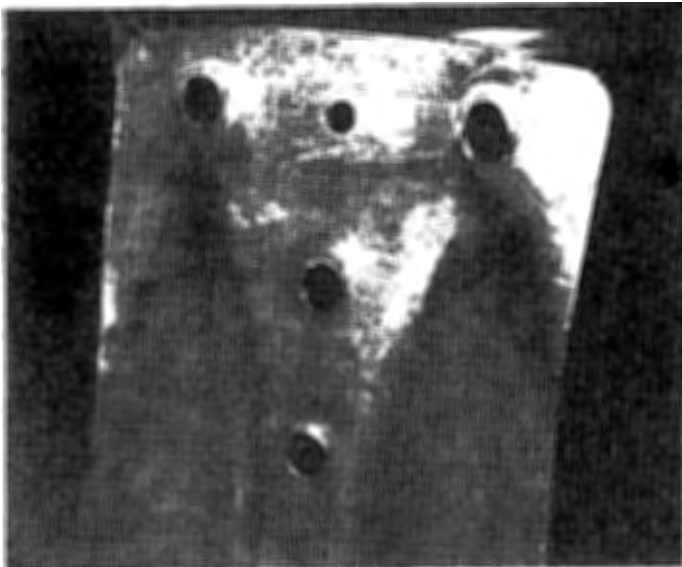
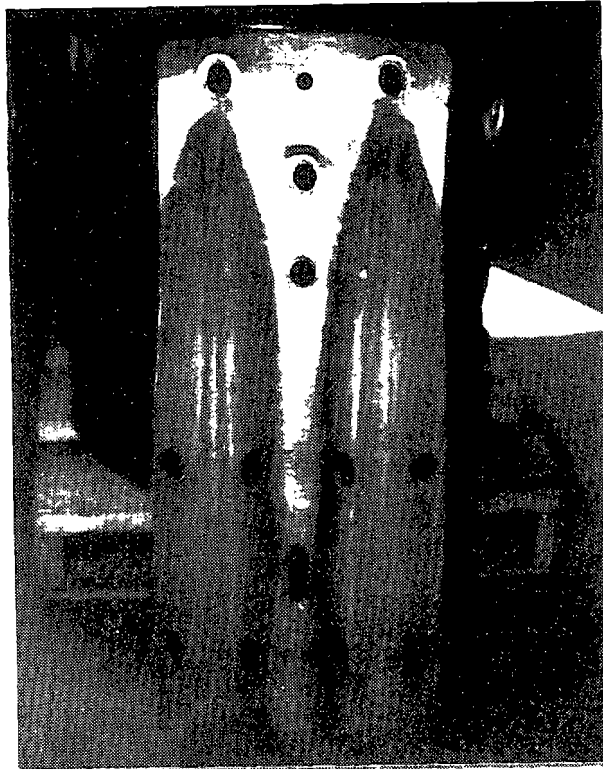
Figure 32. Terminal connector prior to testing.

Figure 33. Exterior damage at flat section, sample ten.

Figure 34. Interior damage of flat section, sample ten.

Figure 35. Interior view of terminal connector after test, sample eleven.

Figure 36. Exterior damage to flat section, sample eleven.

Samples ten and eleven were 12-gauge, w-beam terminal connectors fabricated by manufacturer #2. Each sample had four 1-in (25.4-mm) bolt holes in the flat section (figure 32). There were eight angled slots with one elongated post mounting slot at the splice end (figure 7). Each sample was tested with four 7/8-in (22.2-mm) diameter high strength bolts in the flat section and nine 5/8-in (16-mm) diameter button-head bolts at the splice end of the terminal connector. Both samples failed in bearing of the 7/8-in (22.2-mm) diameter bolts onto the flat section. The area between the top row of 7/8-in (22.2-mm) diameter bolts and the column of 7/8-in (22.2-mm) bolts buckled from differential deformation for both samples. The region near the top row of bolt holes, for instance, exhibited considerably more deformation than the region near the column of bolts (figures 33, 34, and 35). Unlike previous tests, sample ten exhibited no tearing at any of the bolt holes in the flat section of the terminal connector. There was, however, some deformation on all eight splice holes. Sample eleven had tearing in the upper row of bolt holes. The tearing was angled from the longitudinal axis, unlike most of the other samples in which the tearing was normal to the

load direction (figure 36). Failure occurred at 65.9 kips (293.1 kN) and 66.4 kips (295.3 kN) for samples ten and eleven, respectively (table 1).
