Testing of New Bridge Rail and Transition Designs

Volume XIV: Appendix M

Axial Tensile Strength of Thrie and W-Beam Terminal Connectors

PUBLICATION NO. FHWA-RD-93-157

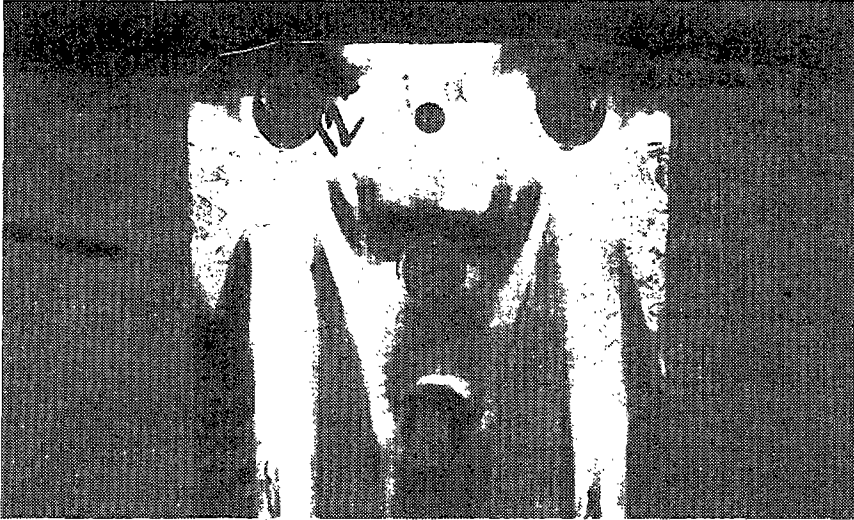
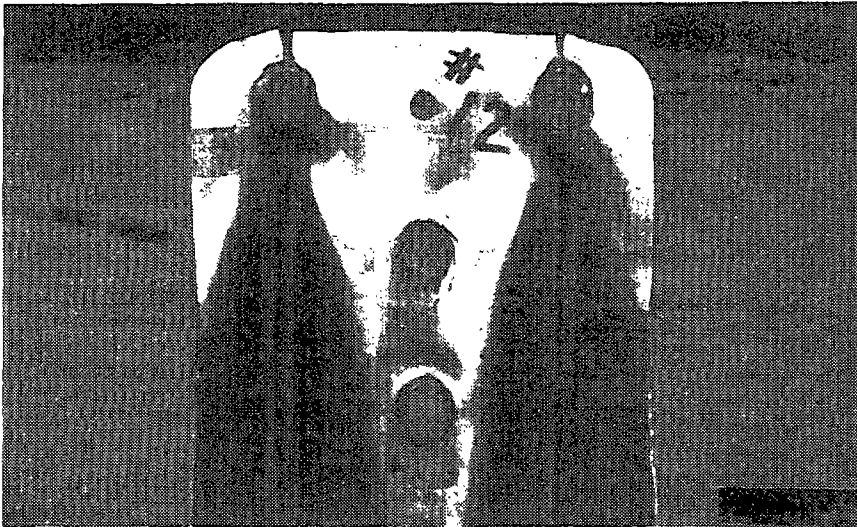
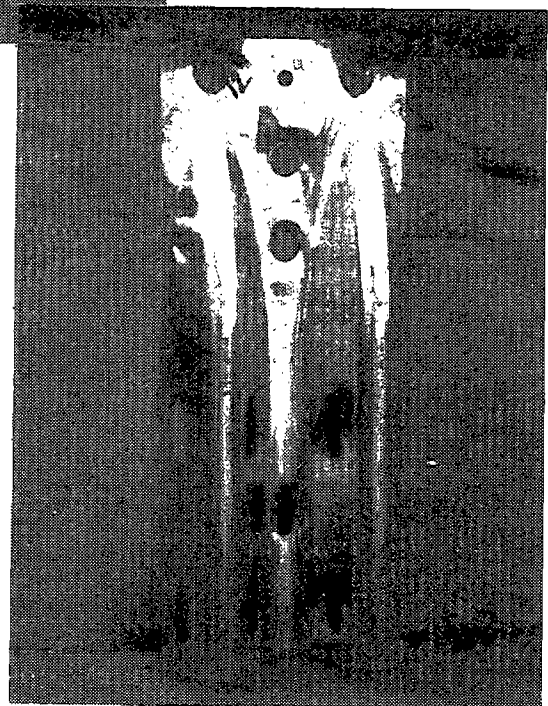
Figure 37. Exterior damage to flat section, sample twelve.

Figure 38. Interior damage to flat section, sample twelve.

Figure 39. Damage at splice end, sample twelve.

Sample twelve was a 12 gauge w-beam terminal connector with straight elongated slots at the splice end (figure 7). Failure was in bearing of the 7/8-in (22.2-mm) diameter bolts onto the flat section. Additionally, there was vertical tearing (parallel to the longitudinal axis and direction of the load) of each 1-in (25.4-mm) bolt hole on the top row of 1-in (25.4-mm) bolt holes. Buckling also occurred at the region between the upper row of 7/8-in (22.2m) bolts and the column of 7/8-in (22.2-mm) bolts in the flat section (figures 37 and 38). Deformation occurred at the splice connection but was limited to the interior slots on both the upper and lower rows (figure 39). The sample failed at 71.1 kips (316.2 kN) (table 1) which was somewhat larger than samples ten and eleven.

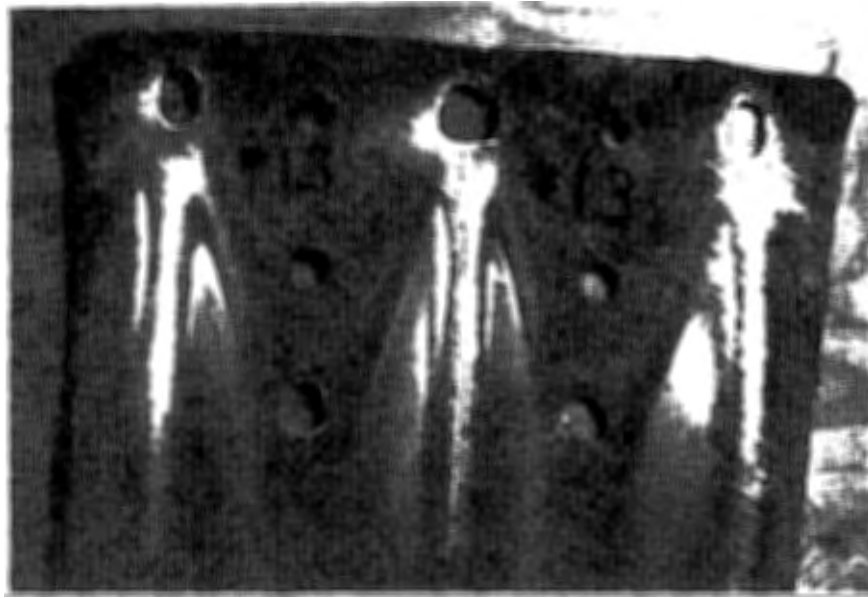
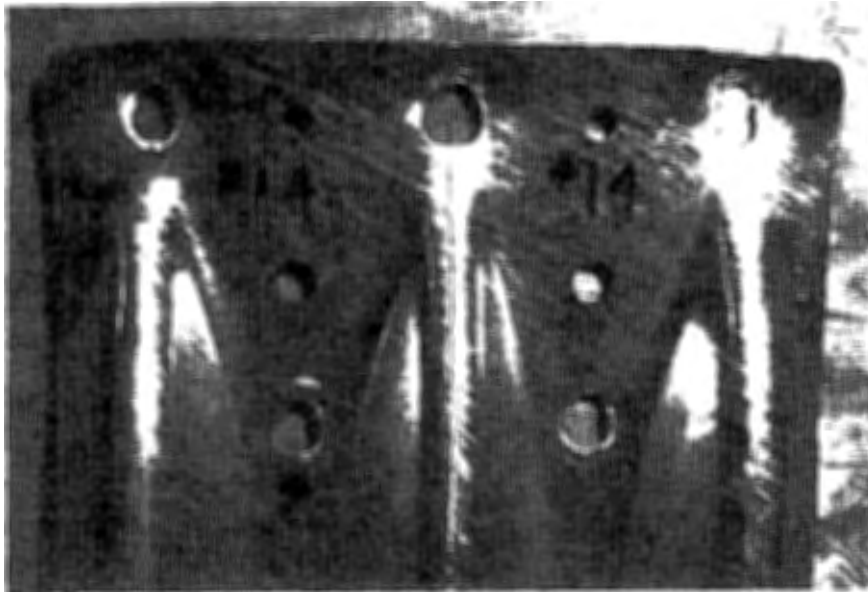
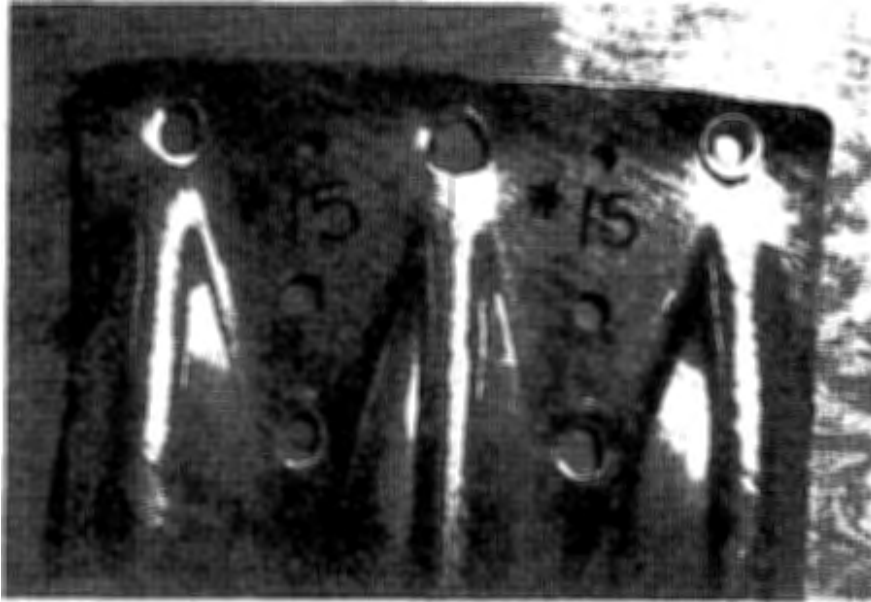
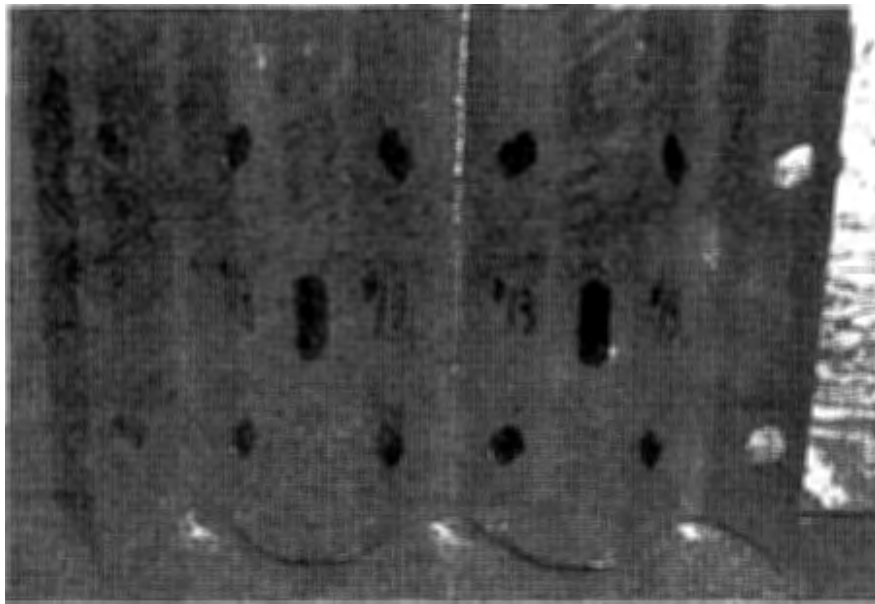
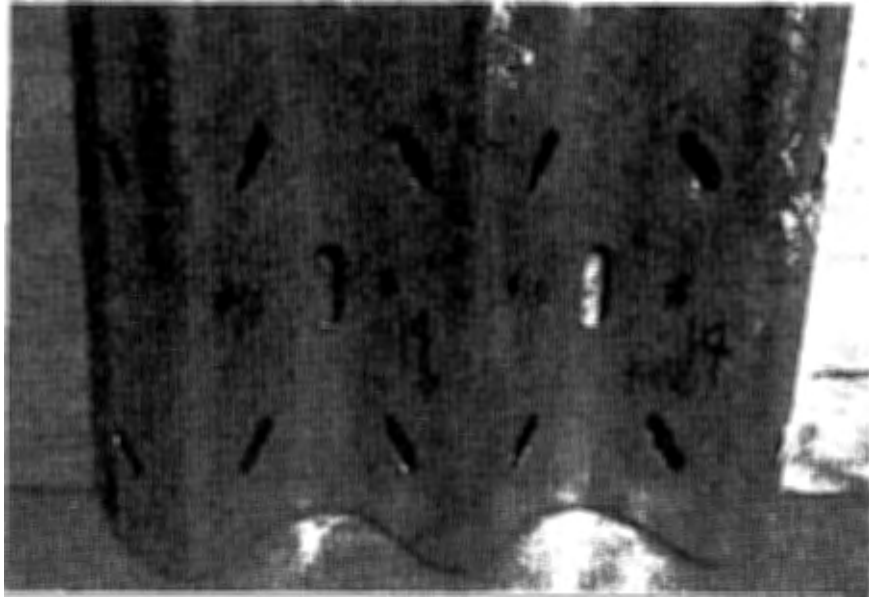
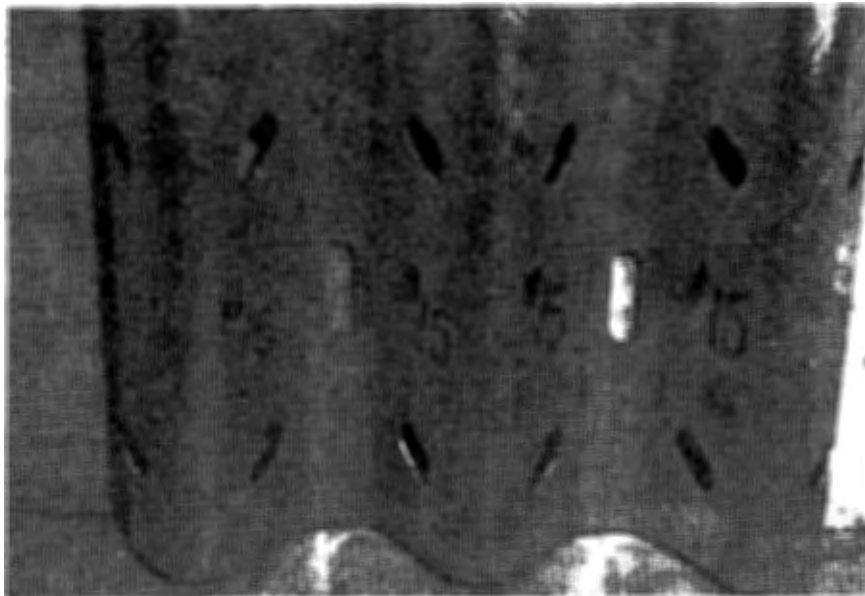
Figure 40. Damage at flat section, sample thirteen.

Figure 41. Damage at flat section, sample fourteen.

Figure 42. Damage at flat section, sample fifteen.

Figure 43. Damage at splice end, sample thirteen.

Figure 44. Damage at splice end, sample fourteen.

Figure 45. Damage at splice end, sample fifteen.

Samples thirteen, fourteen, and fifteen from manufacturer #2 were 10 gauge thrie-beam terminal connectors with angled slots at the splice end (figure 7). Failure was in bearing of the 7/8-in (22.2-mm) diameter bolts onto the flat section for all three specimens. Tearing of the steel at the upper right hand bolt hole occurred for all samples, particularly sample fourteen (figures 40, 41, and 42). There was virtually no structural damage at the splice ends on any of the specimens (figures 43, 44, and 45). There was local buckling at the top edge of the flat section near the upper three 7/8-in (22.2-mm) diameter bolts (figures 46, 47, and 48). Five 7/8-in (22.2-mm) diameter bolts were used in the flat portion of each terminal connector, and twelve 5/8-in (16-mm) mild steel button head bolts were used in the splice end of each connector. Unlike the other specimens, no bolts were included in the post mounting slots. Ultimate load capacities for samples thirteen, fourteen, and fifteen were 102.4 kips (455.5 kN), 99.3 kips (441.7 kN), and 101.8 kips (452.8 kN) respectively (table 1).

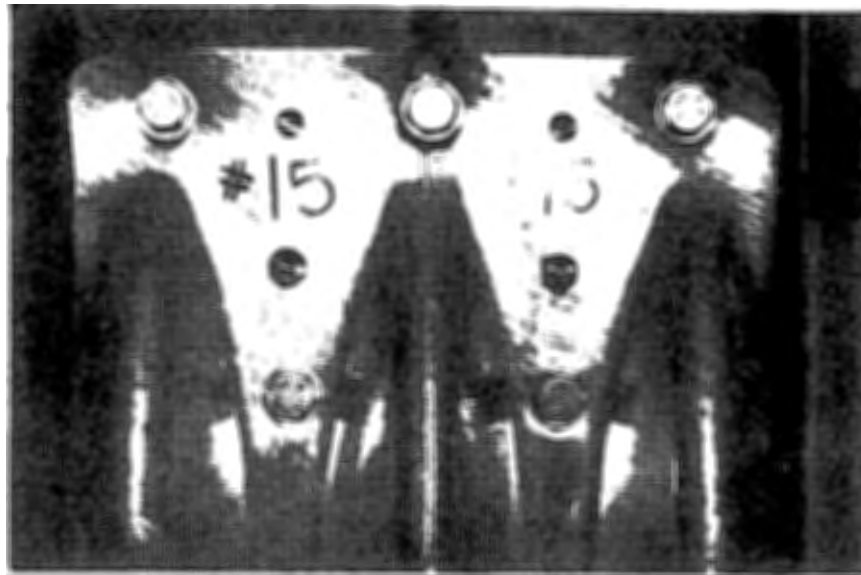
Figure 46. Local buckling of terminal connector, sample thirteen.

Figure 47. Local buckling of terminal connector, sample fourteen.

Figure 48. Local buckling of terminal connector, sample fifteen.

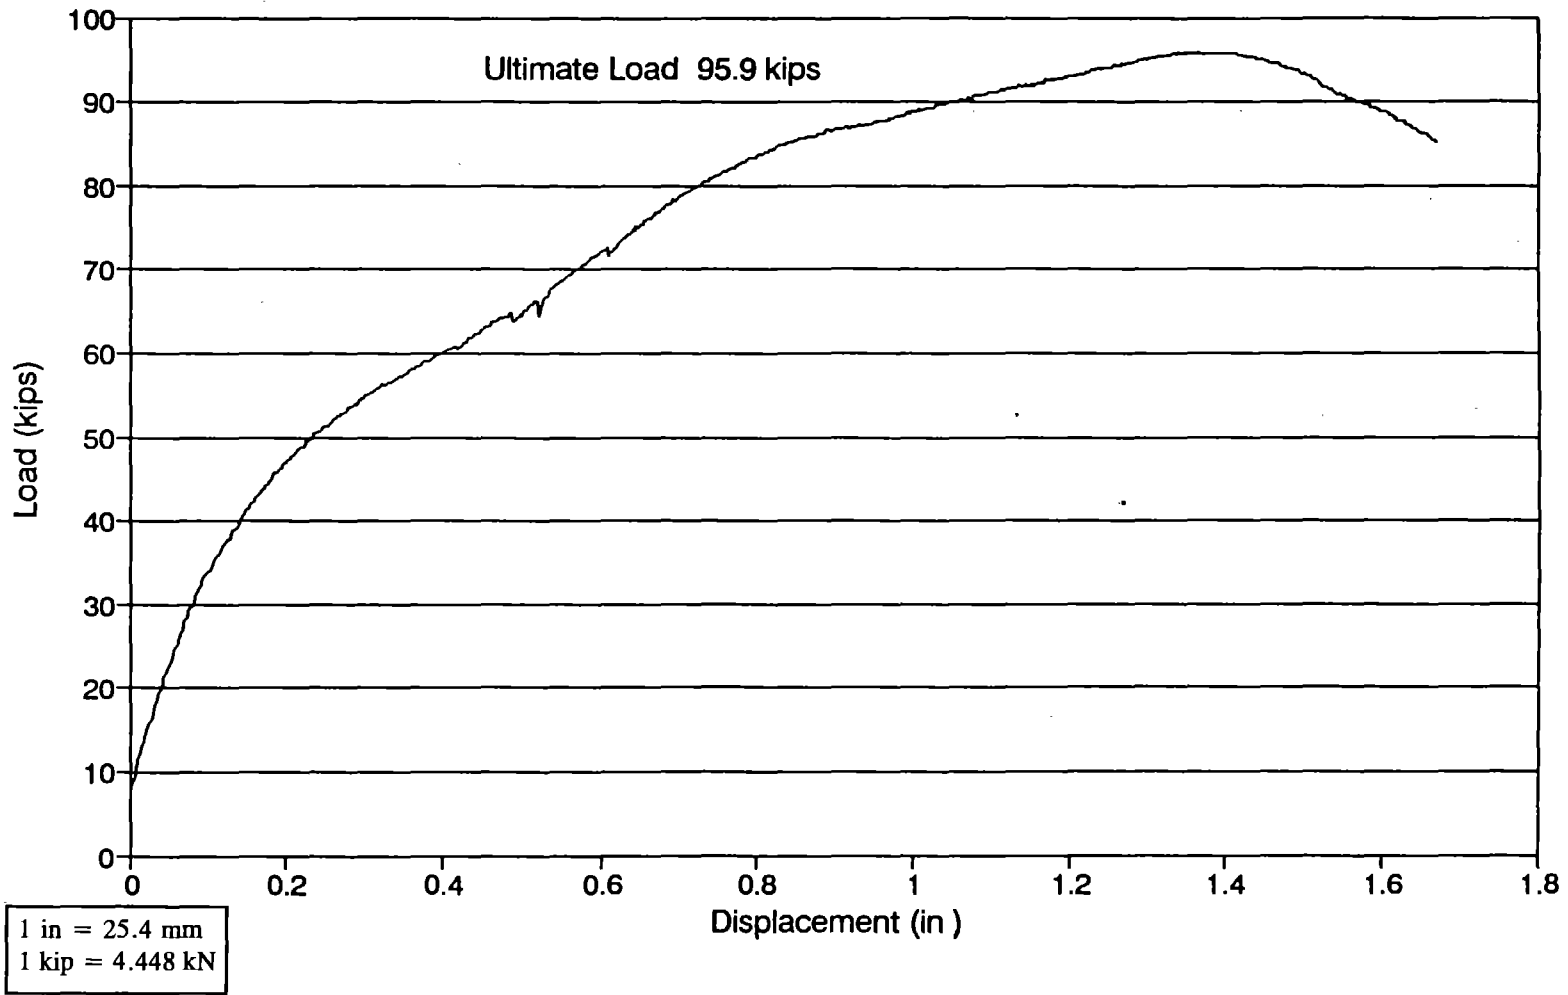
LOAD vs. DISPLACEMENT OF RAM HEAD SAMPLE 1

Figure 49. Load vs. displacement graph, sample one.

The graphs of samples one, five, six, eight, and nine revealed three distinct slopes. The steepest slope can be attributed to the elastic region of the material. The second slope exhibits bearing of the bolts into the flat section of the terminal connector. The third slope, leading to failure, exhibits plastic flow and tearing at the 1-in (25.4-mm) holes in the flat section of the terminal connector.

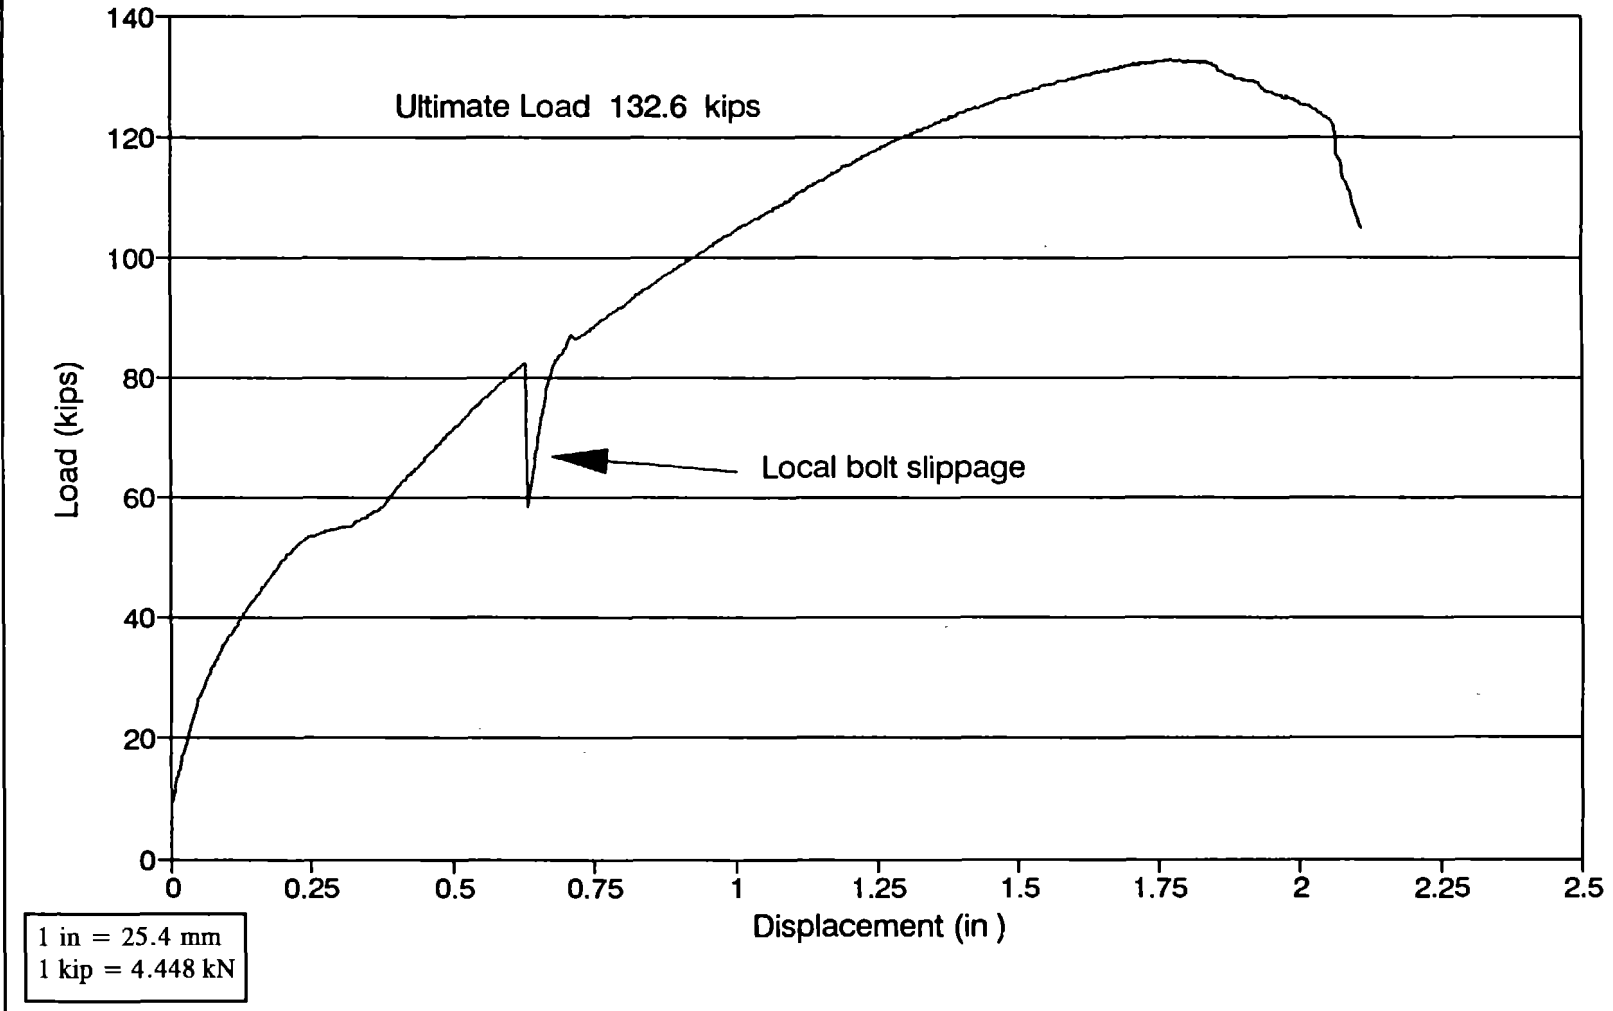
LOAD vs. DISPLACEMENT OF RAM HEAD SAMPLE 2

Figure 50. Load vs. displacement graph, sample two.

The graph of sample two in the appendix shows a sharp decrease in the load at approximately 80 kips (355.8 kN). One of the bolts at the splice connection slipped, resulting in a load decrease followed by an immediate recovery. The exact location of the slippage was unattainable. However, it can be attributed to the splice bolts because the bolts in the flat section were bearing against the terminal connector at the beginning of the test.

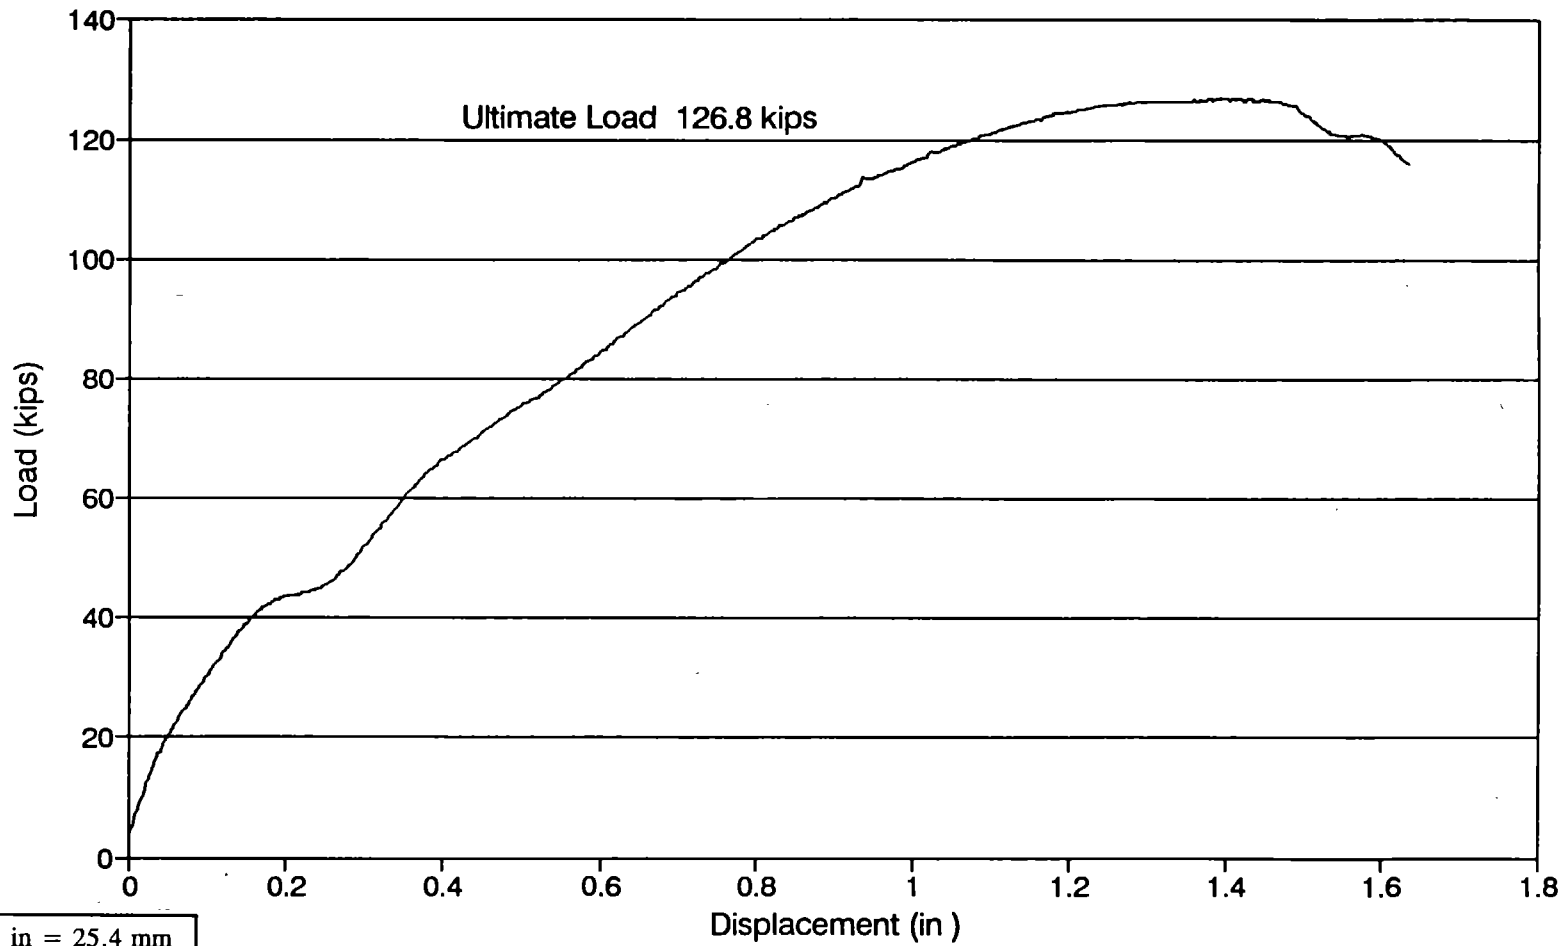
LOAD vs. DISPLACEMENT OF RAM HEAD SAMPLE 3

Figure 51. Load vs. displacement graph, sample three.

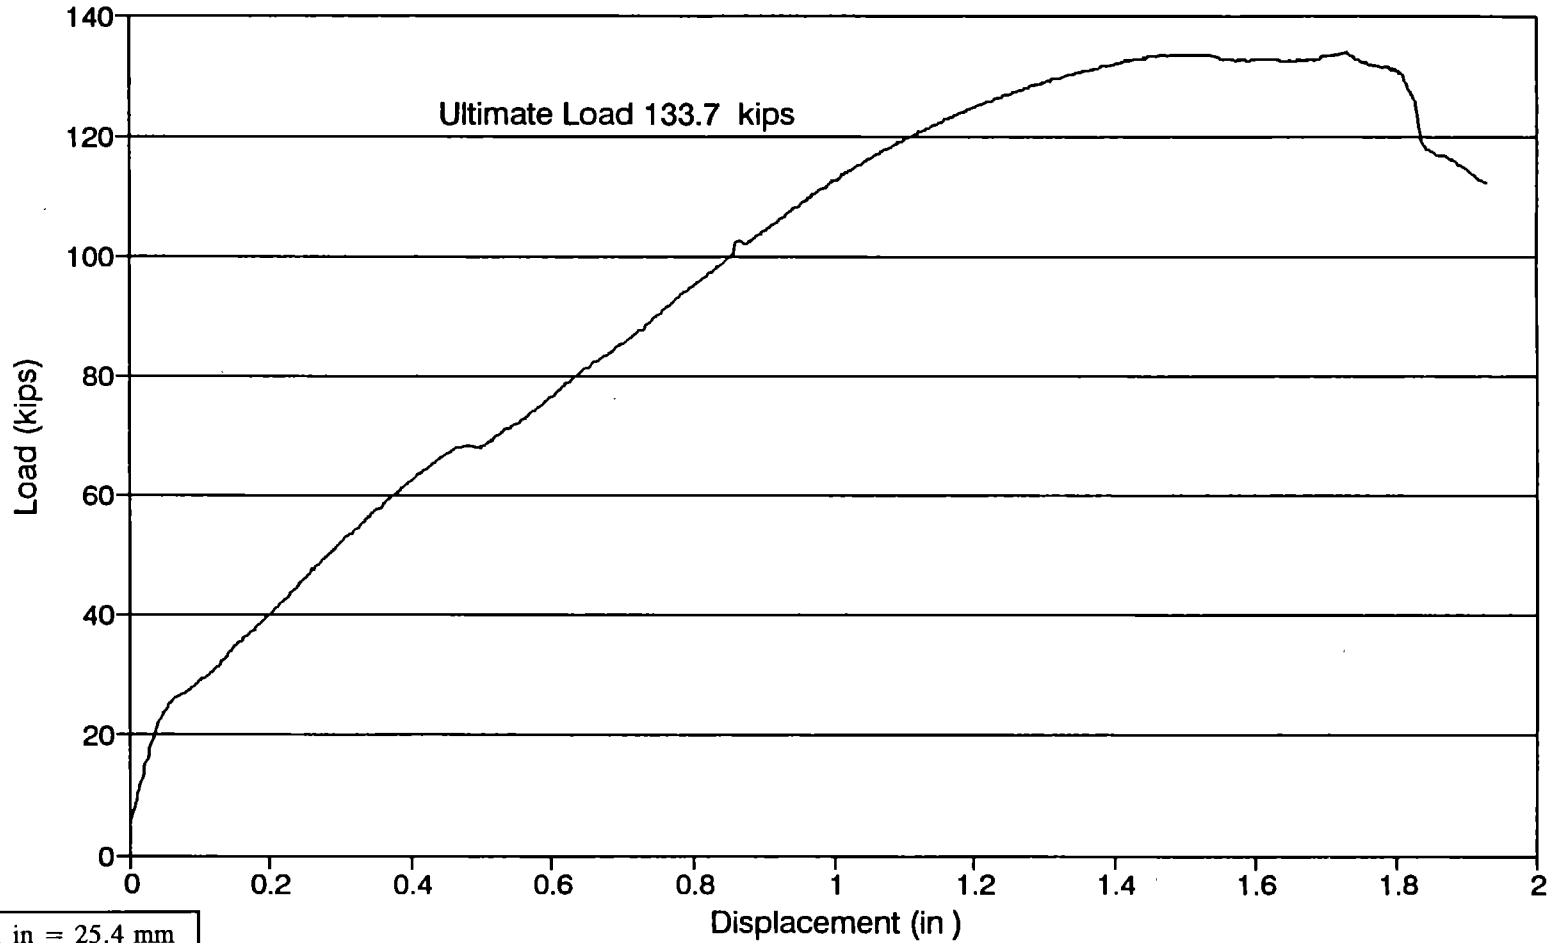
LOAD vs. DISPLACEMENT OF RAM HEAD SAMPLE 4

Figure 52. Load vs. displacement graph, sample four.

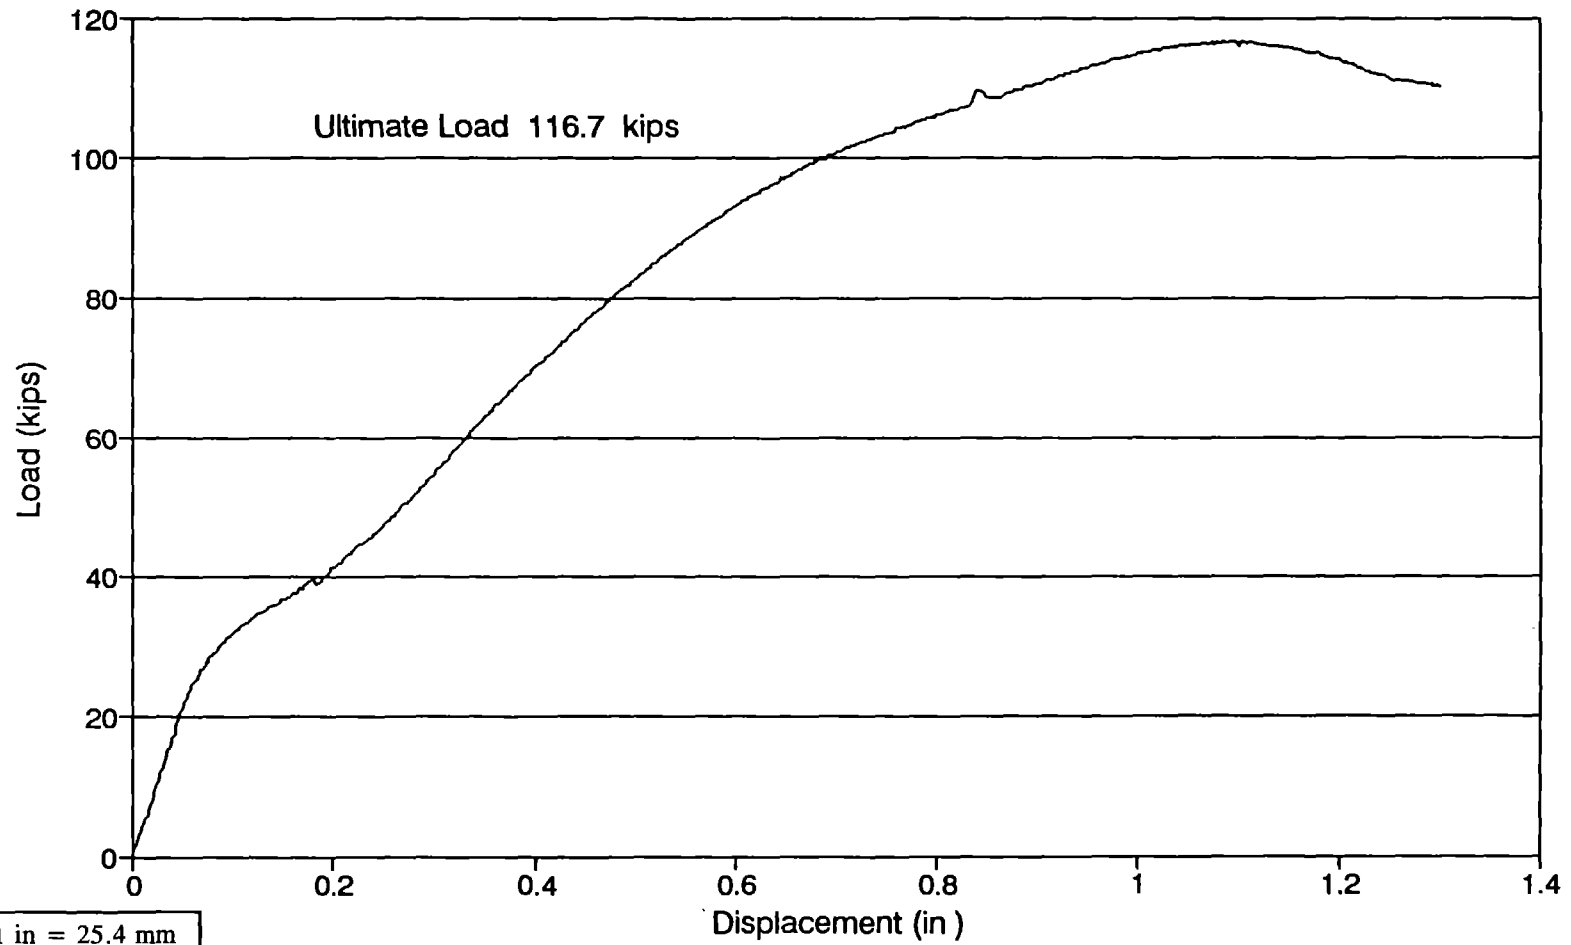
LOAD vs. DISPLACEMENT OF RAM HEAD SAMPLE 5

Figure 53. Load vs. displacement graph, sample five.

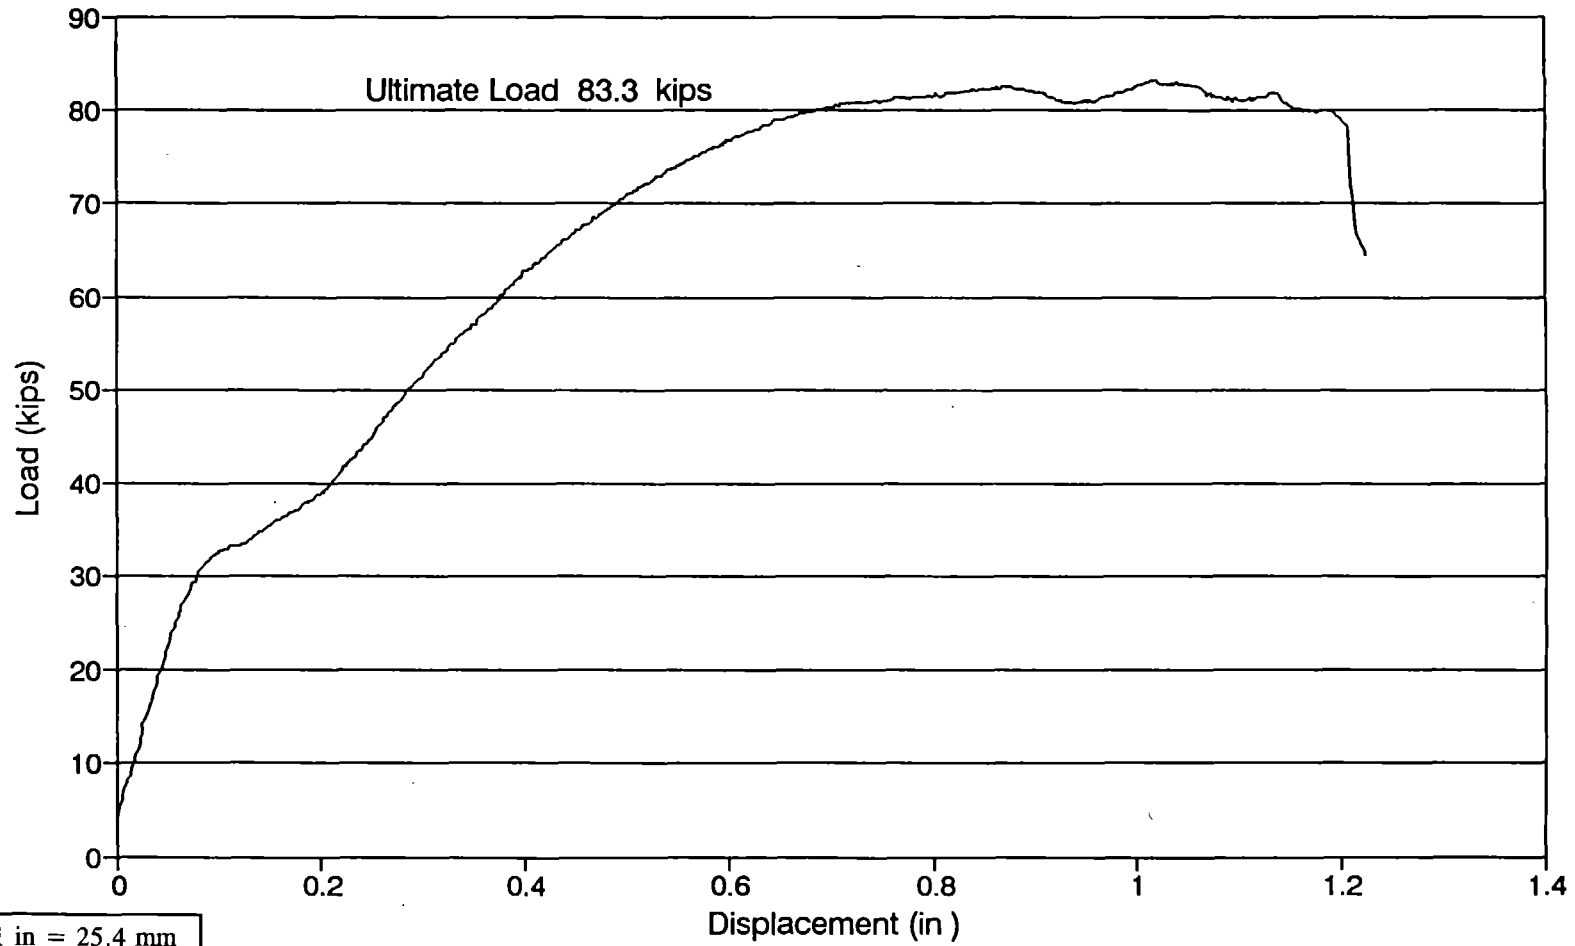
LOAD vs. DISPLACEMENT OF RAM HEAD SAMPLE 6

Figure 54. Load vs. displacement graph, sample six.

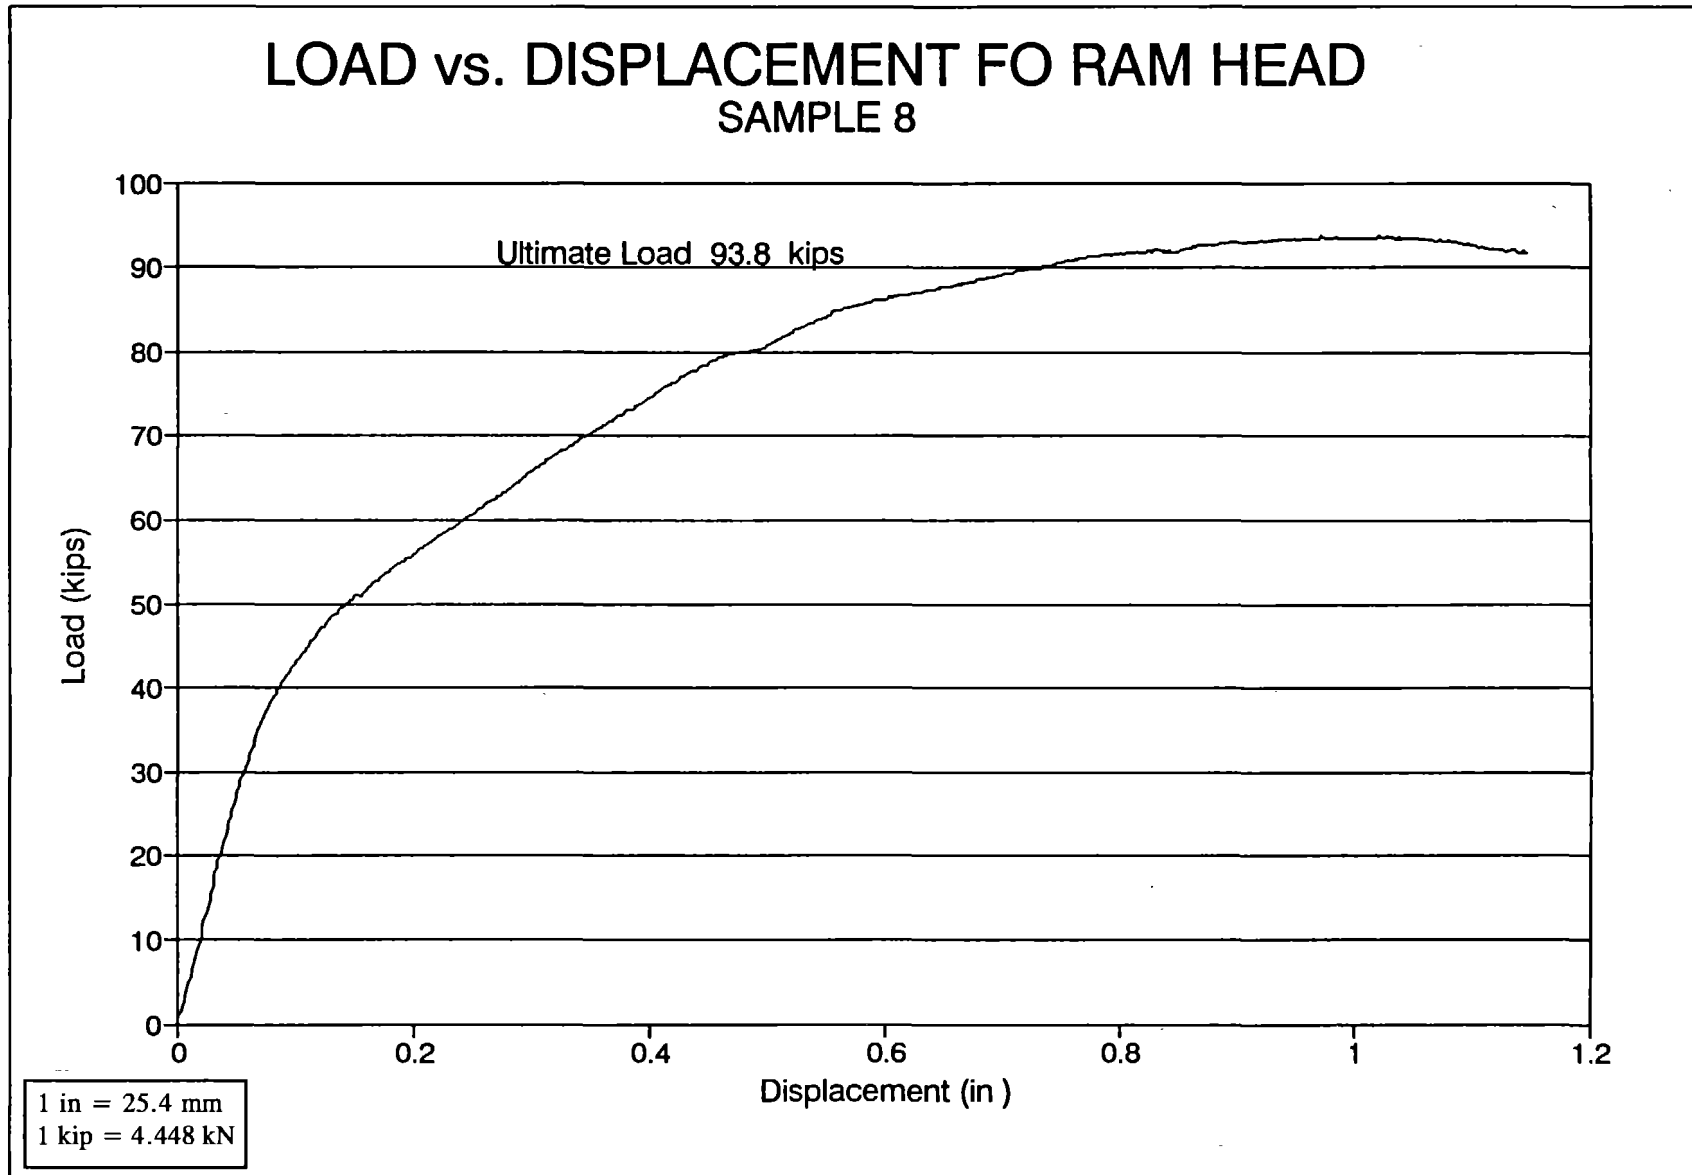
Figure 55. Load vs. displacement graph, sample eight.

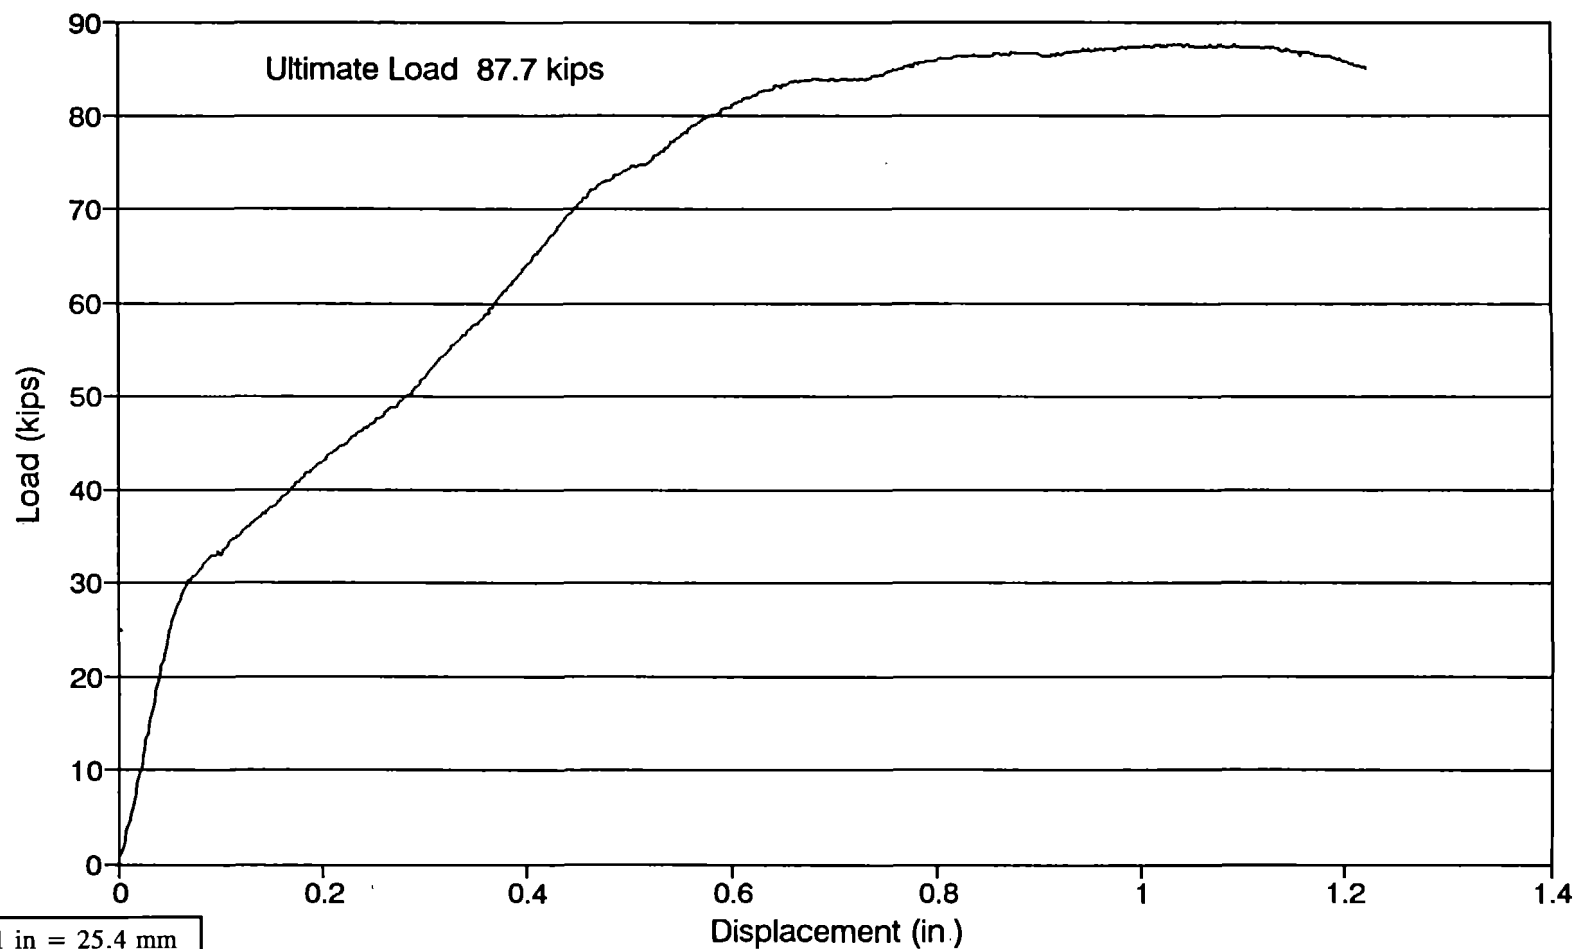
LOAD vs. DISPLACEMENT OF RAM HEAD SAMPLE 9

Figure 56. Load vs. displacement graph, sample nine.

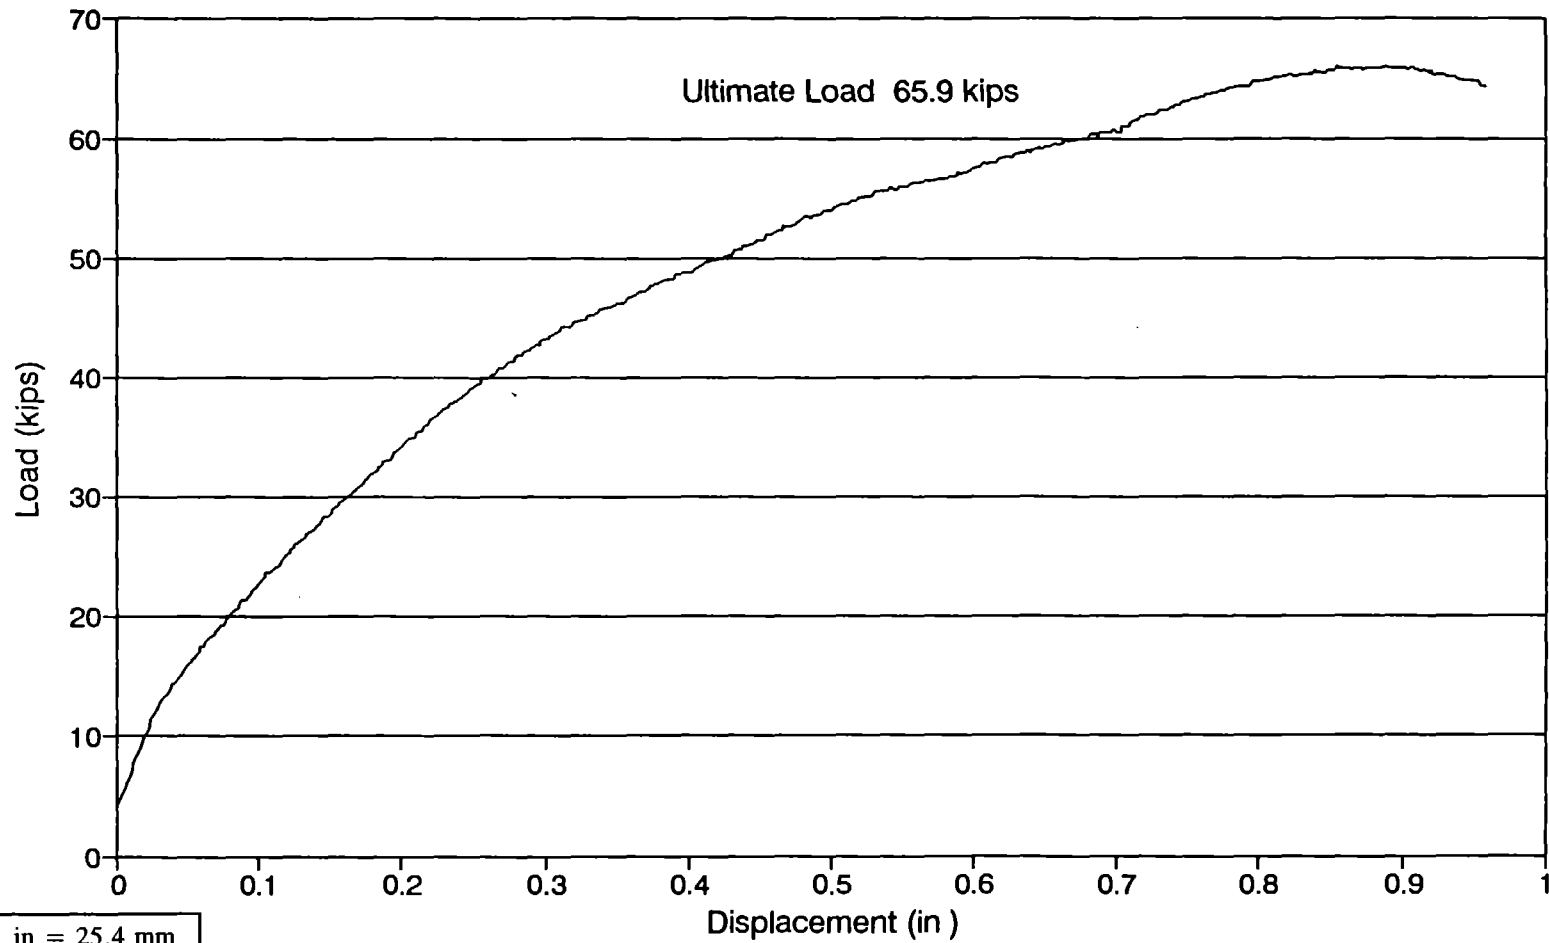
LOAD vs. DISPLACEMENT OF RAM HEAD SAMPLE 10

Figure 57. Load vs. displacement graph, sample ten.

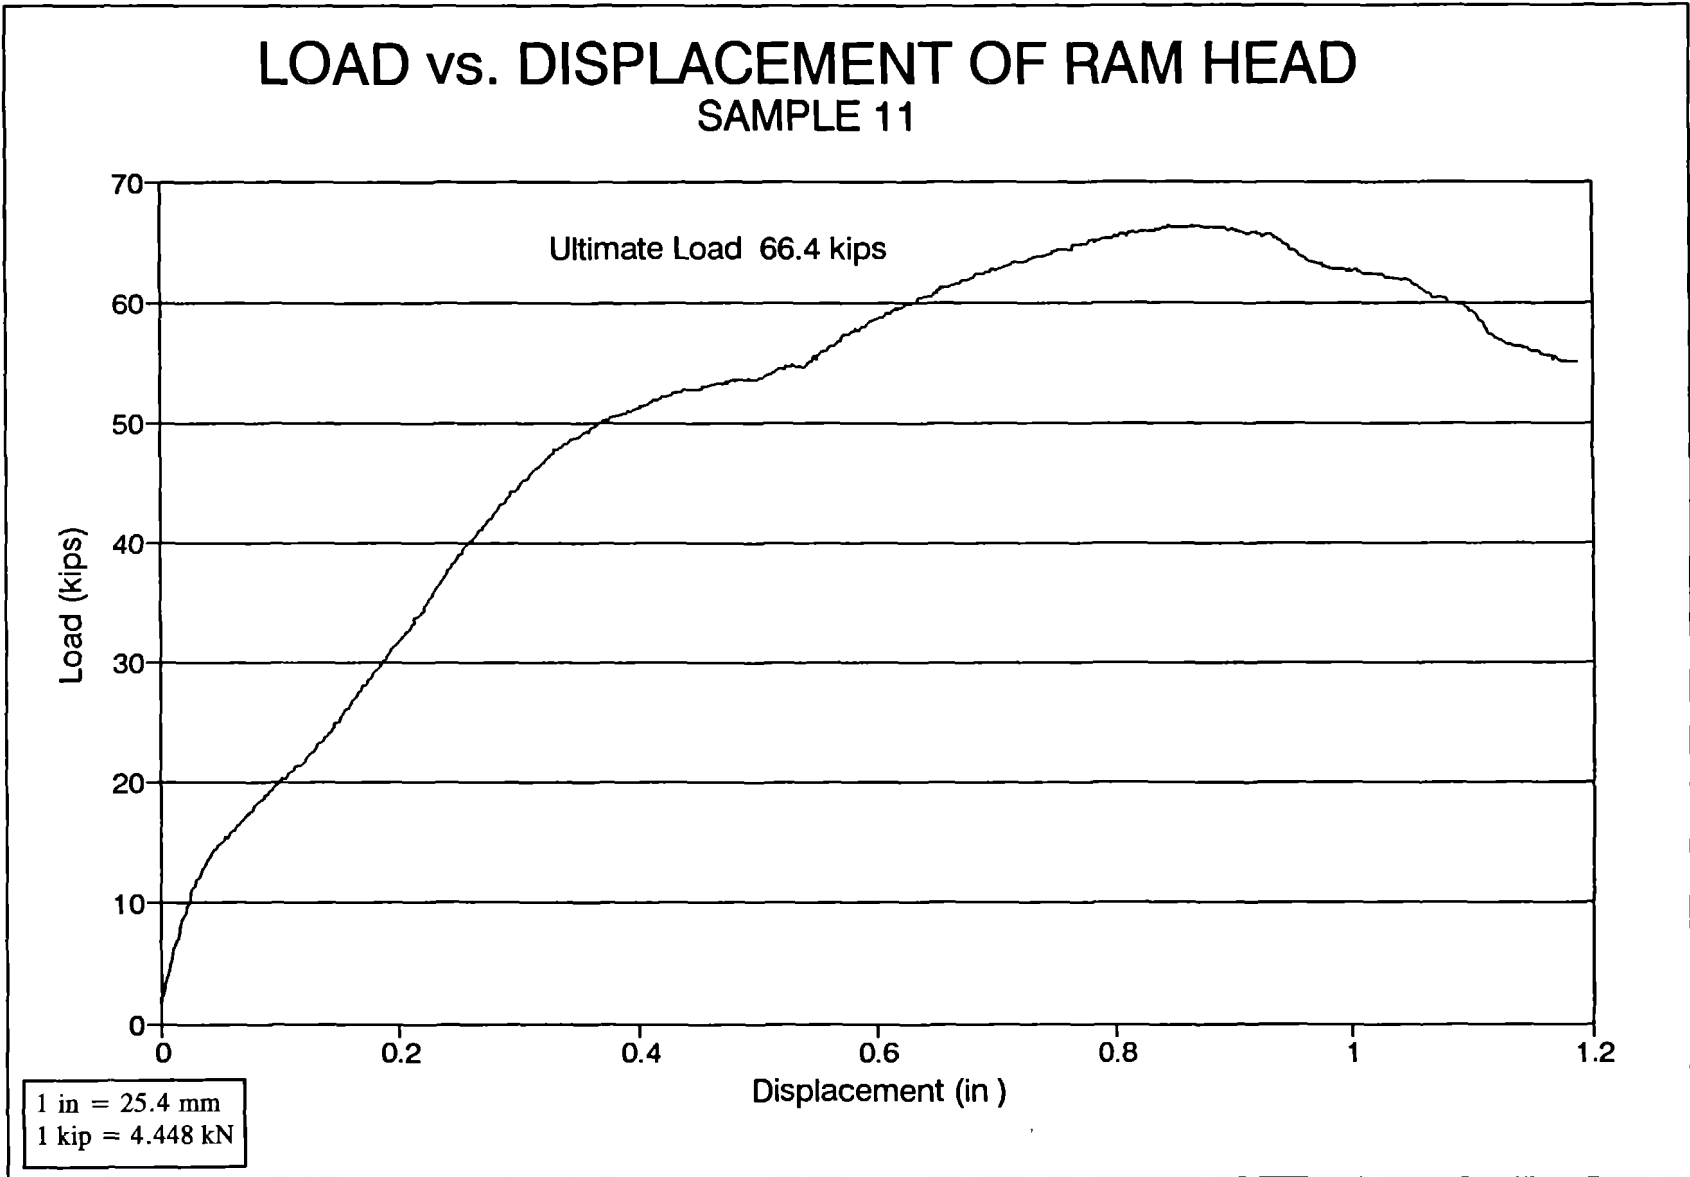
Figure 58. Load vs. displacement graph, sample eleven.
