Testing of New Bridge Rail and Transition Designs

Volume XIV: Appendix M

Axial Tensile Strength of Thrie and W-Beam Terminal Connectors

PUBLICATION NO. FHWA-RD-93-157

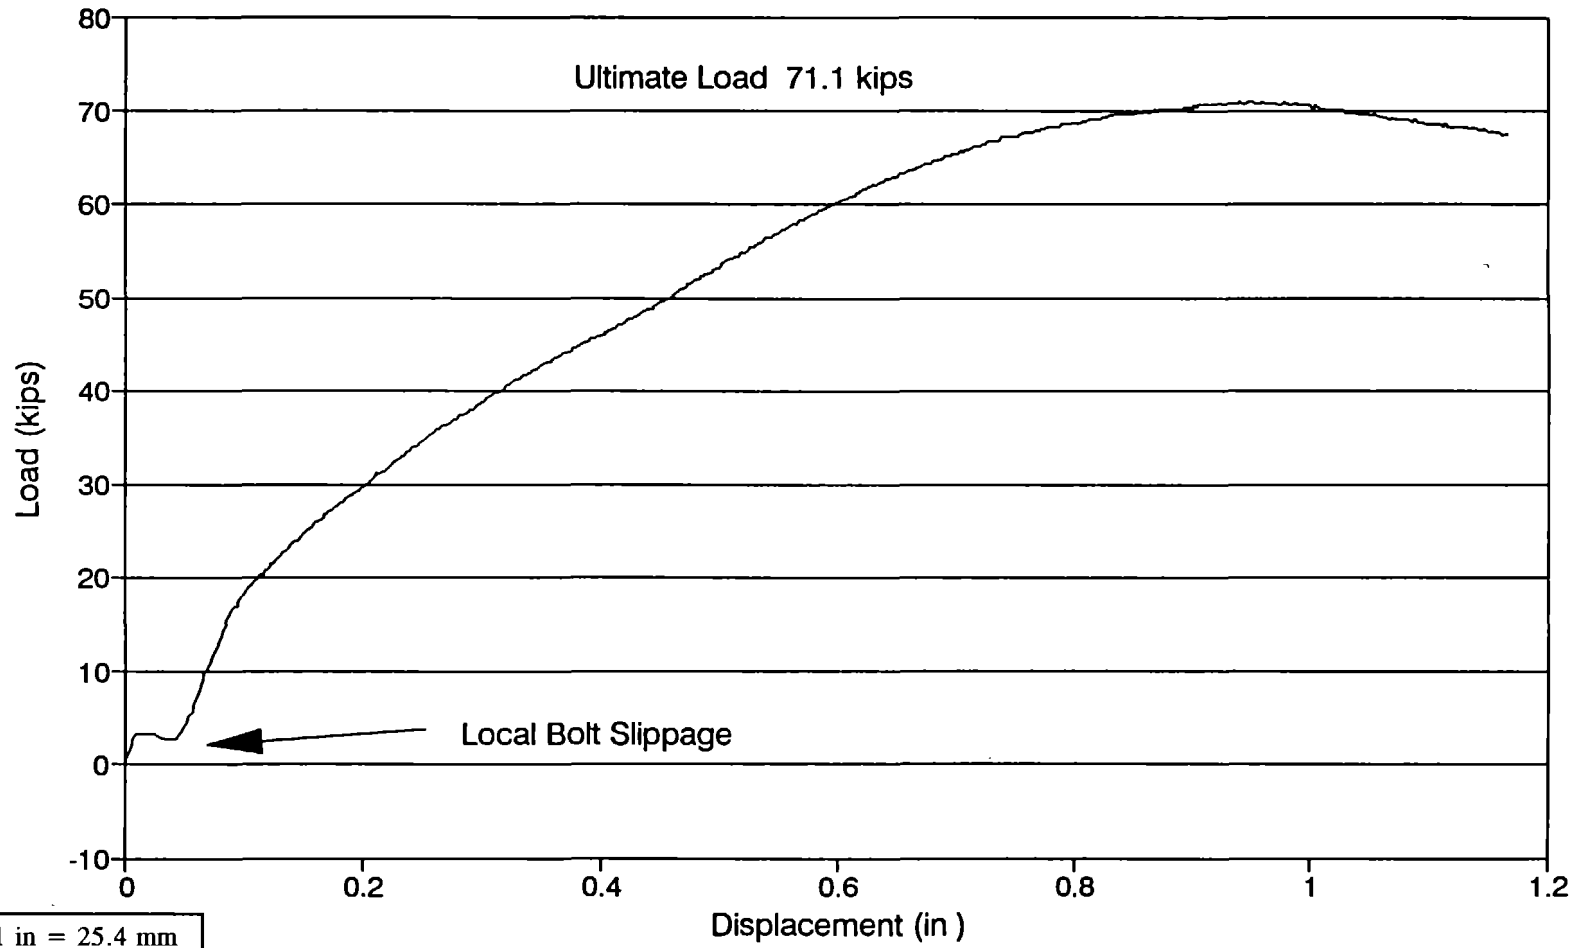
LOAD vs. DISPLACEMENT OF RAM HEAD SAMPLE 12

Figure 59. Load vs. displacement graph, sample twelve.

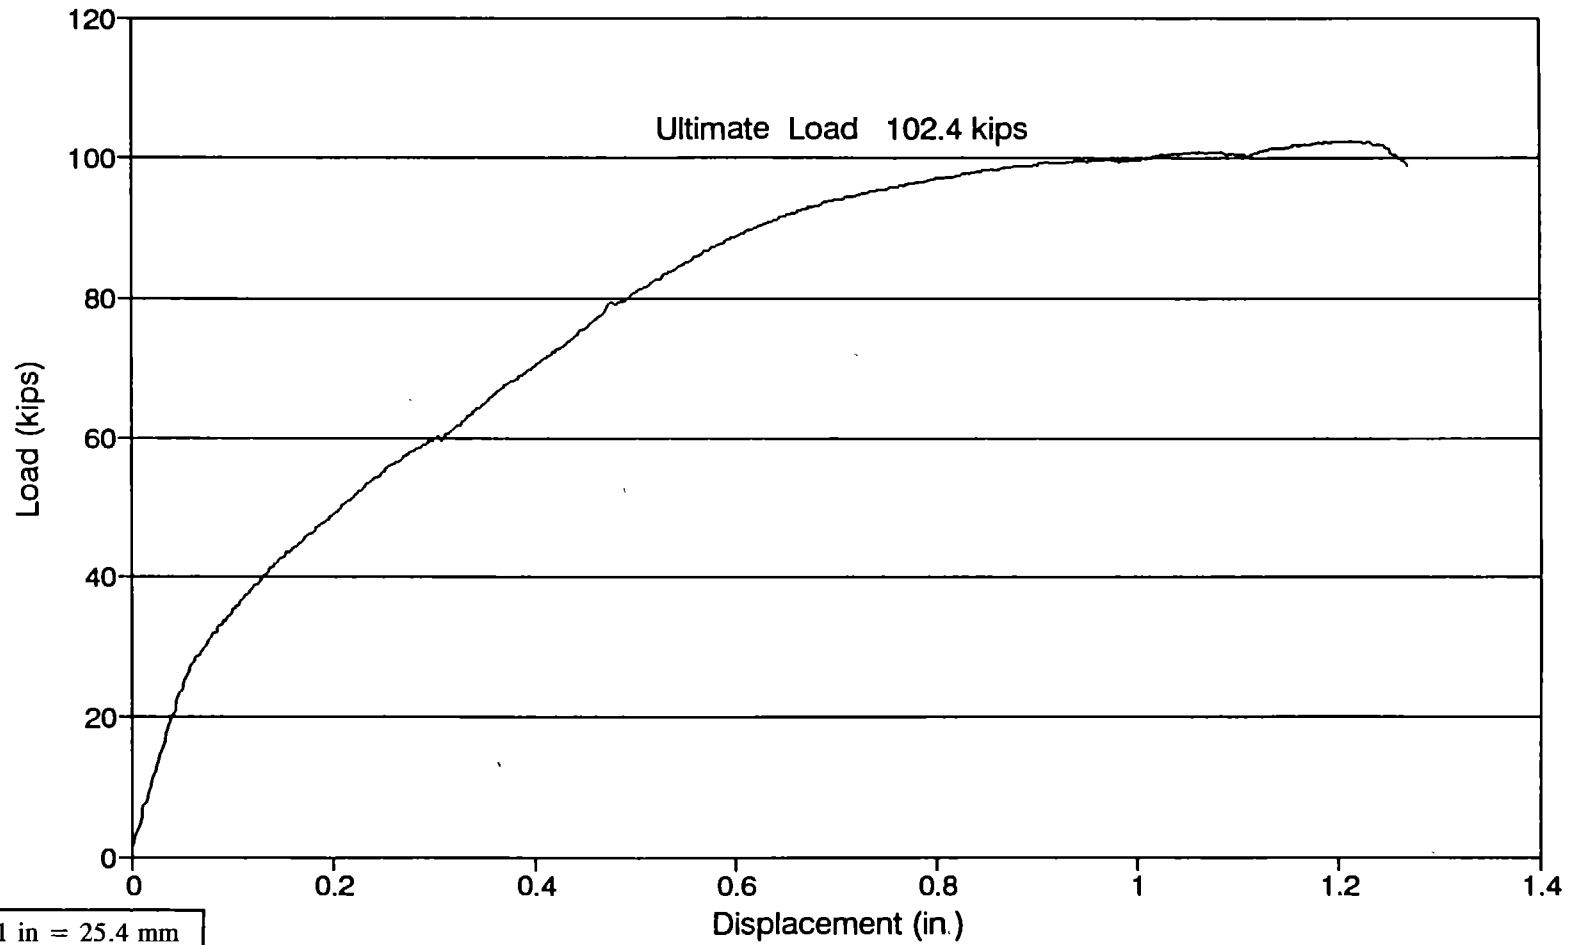
LOAD vs. DISPLACEMENT OF RAM HEAD SAMPLE 13

Figure 60. Load vs. displacement graph, sample thirteen.

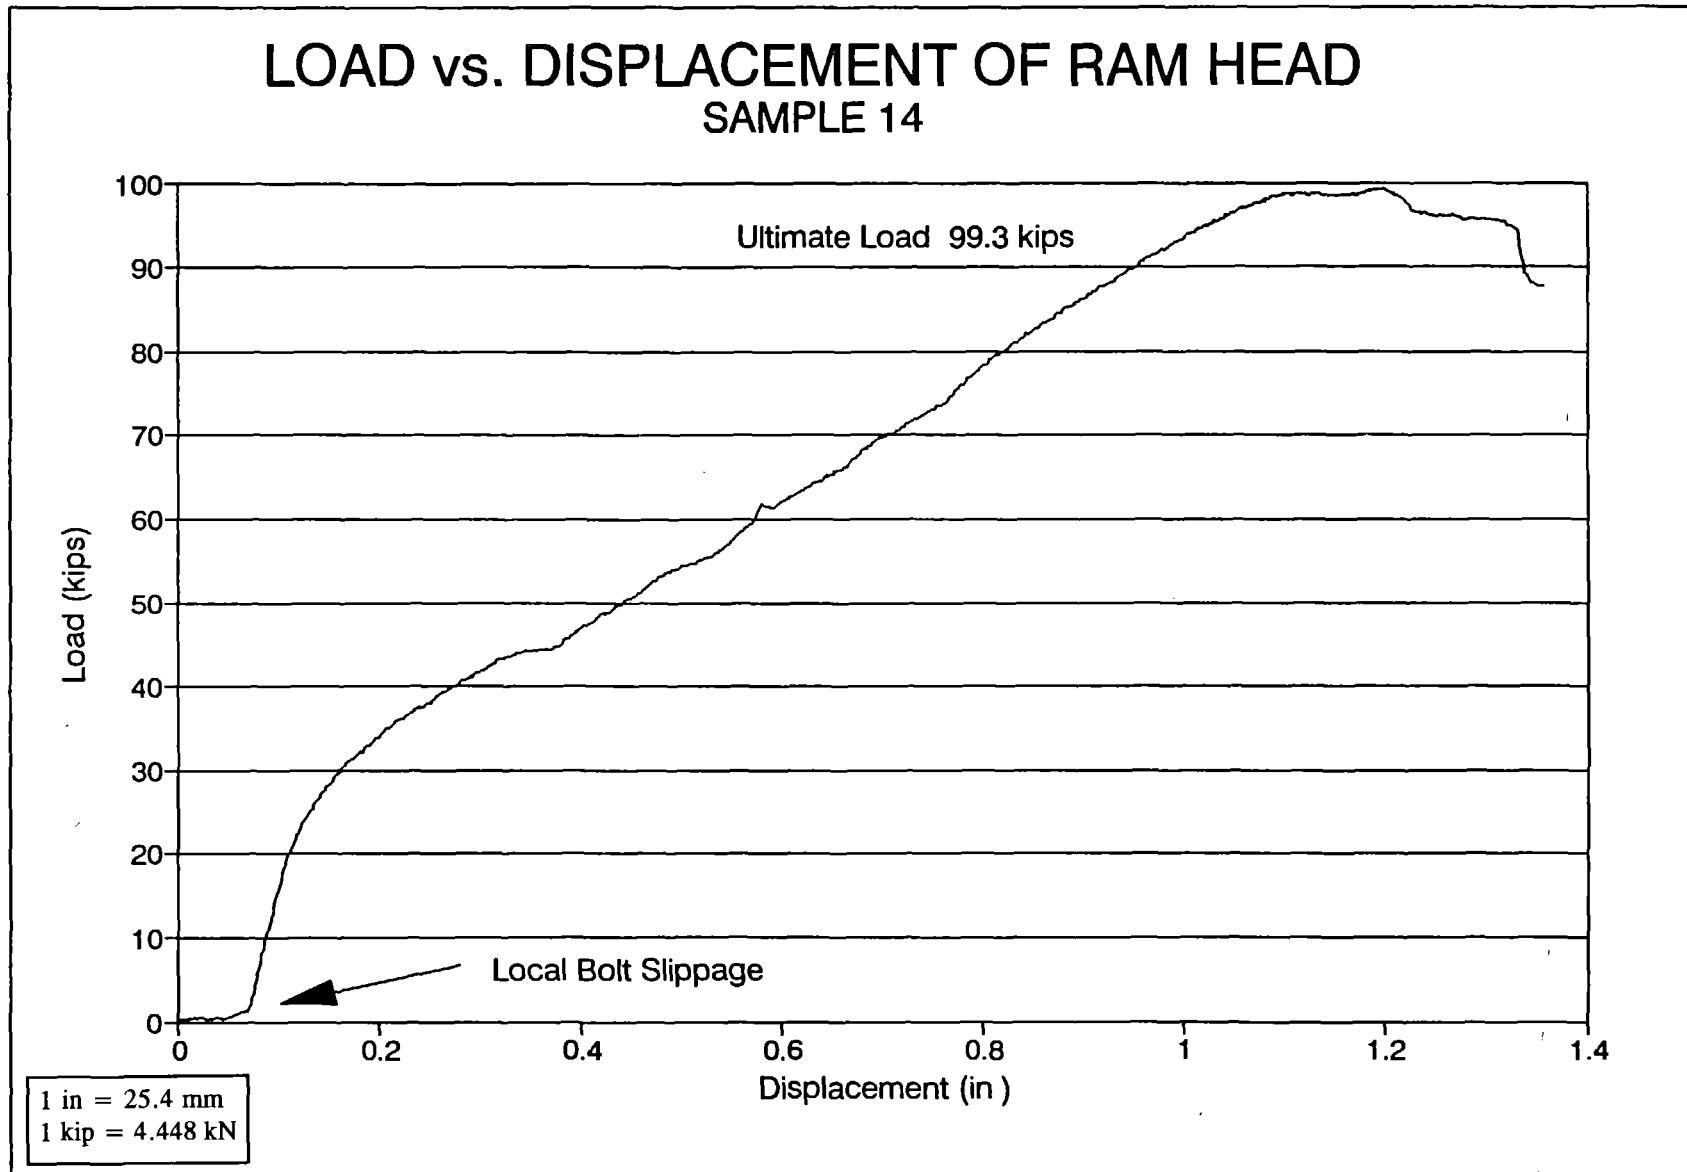
Figure 61. Load vs. displacement graph, sample fourteen.

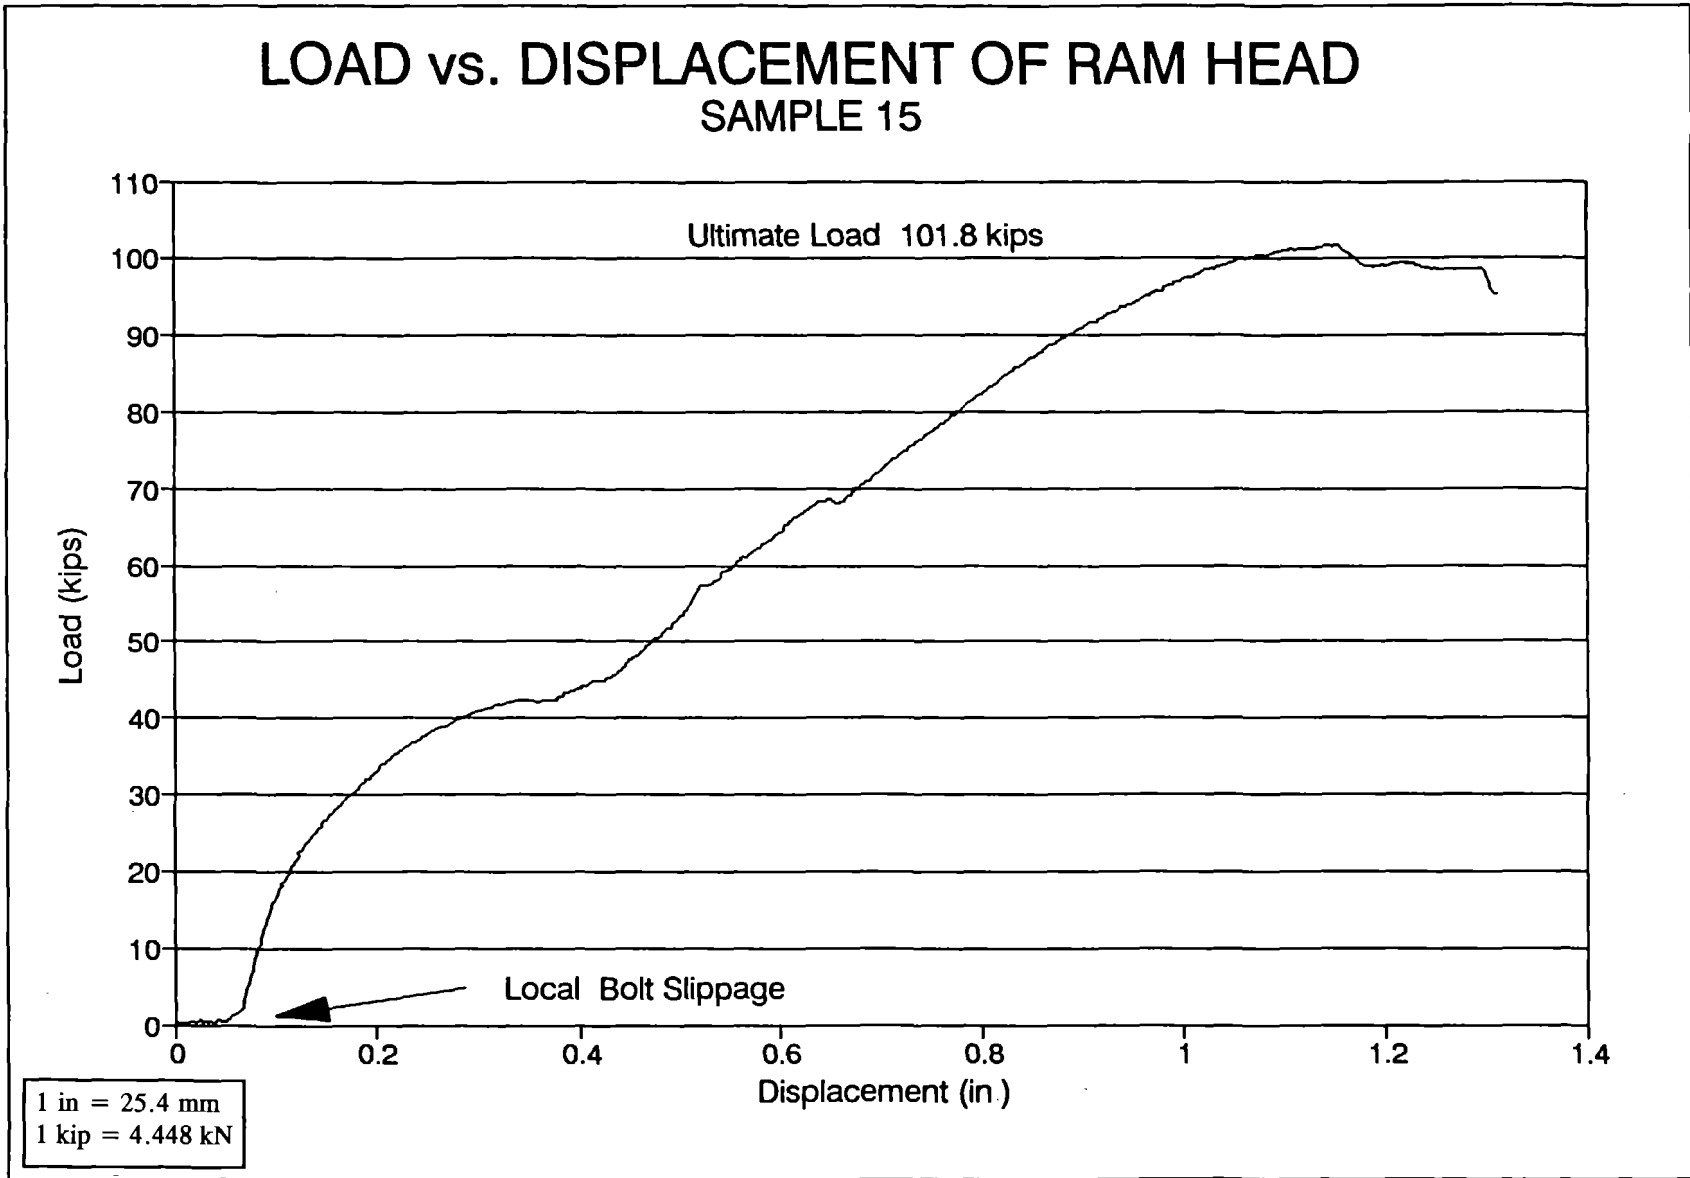
Figure 62. Load vs. displacement graph, sample fifteen.
