DRILLED AND GROUTED MICROPILES STATE-OF-PRACTICE REVIEW VOLUME 4. CASE HISTORIES

Drilled and Grouted Micropiles: State-of-Practice Review

Volume IV: Case Histories

PUBLICATION NO. FHWA-RD-96-019

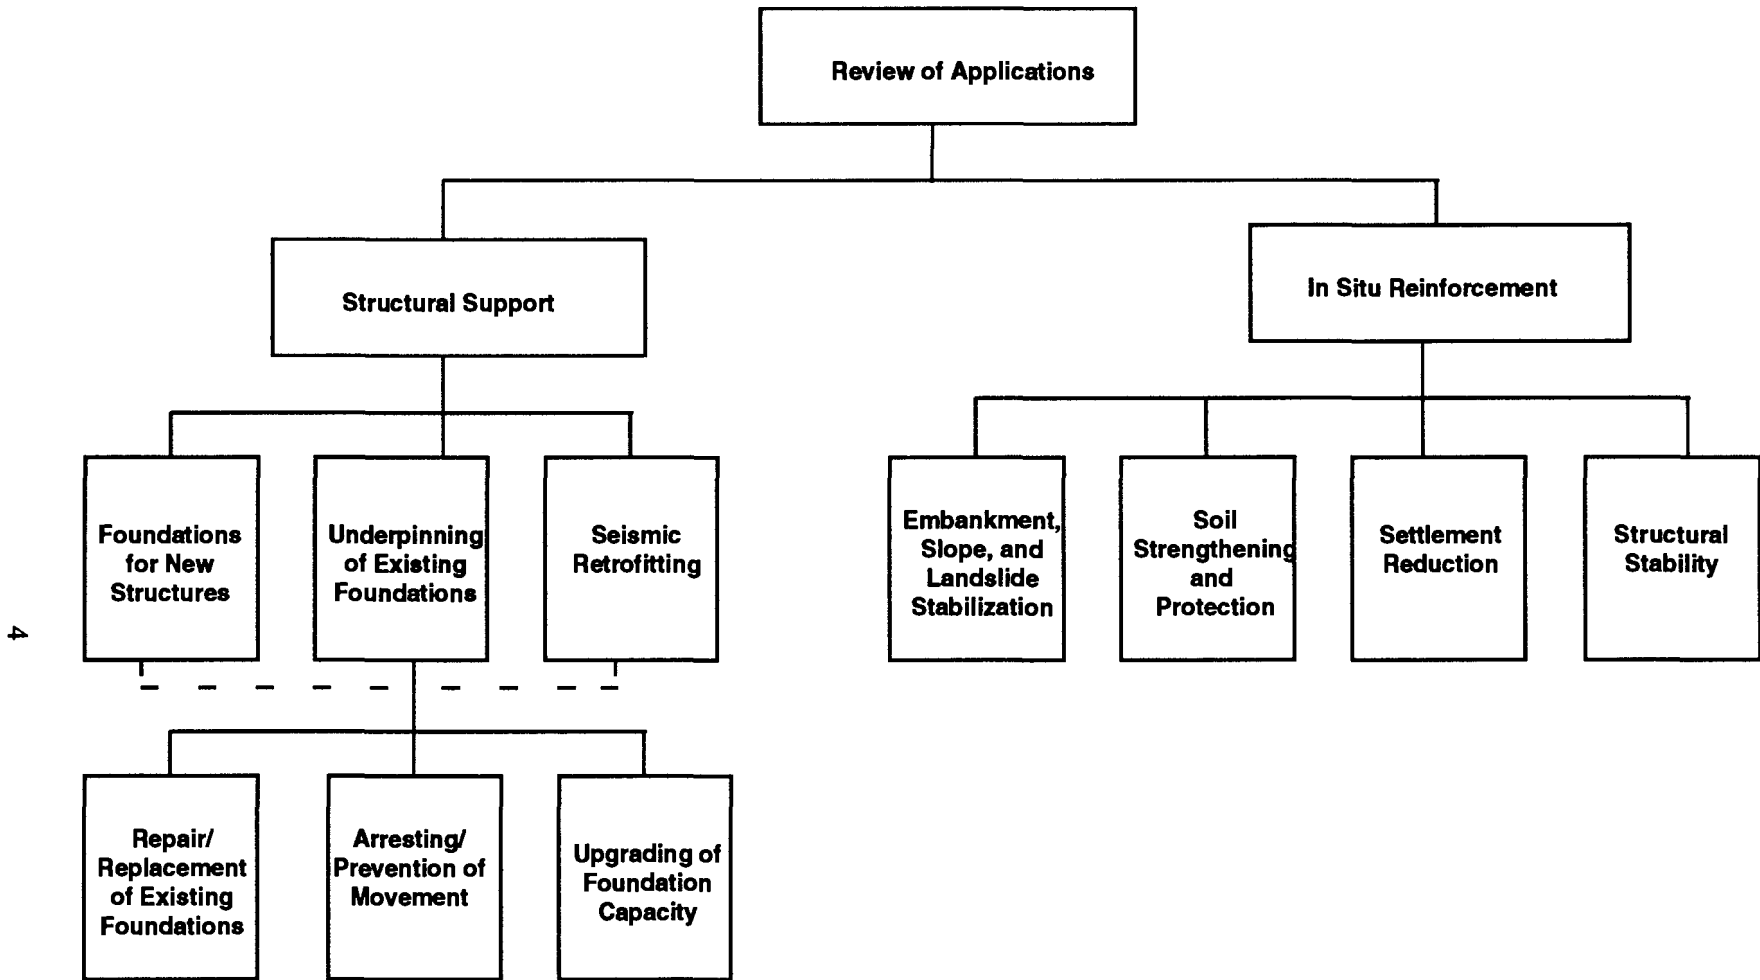
Figure 1. Classification of micropile applications.
