**TESTING OF NEW BRIDGE RAIL AND TRANSITION  
DESIGNS. VOLUME 5. APPENDIX D. 32-IN  
(813-MM) CONCRETE PARAPET BRIDGE RAILING**

# Testing of New Bridge Rail and Transition Designs

### 32-in (813-mm) Concrete Parapet Bridge Railing

PUBLICATION NO. FHWA-RD-93-062

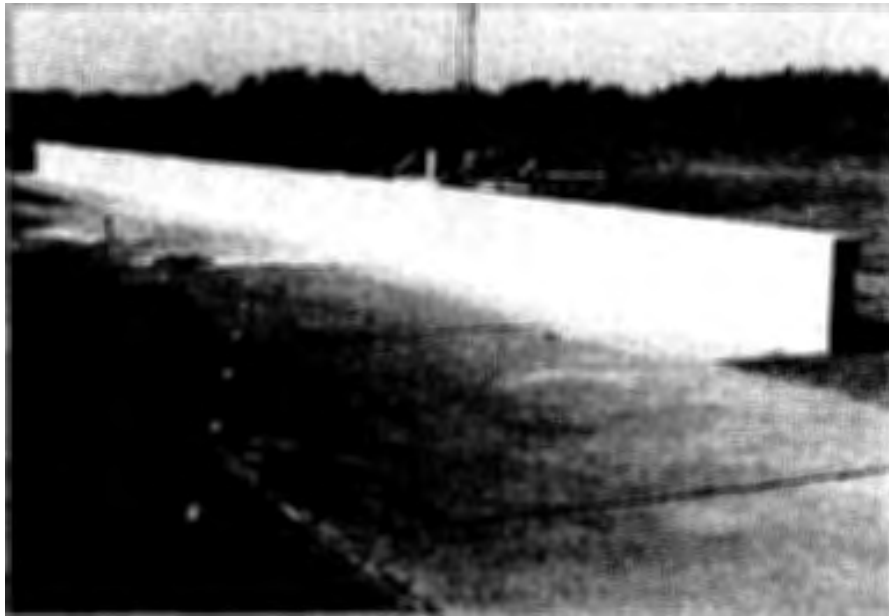
Figure 2. 32-in (813-mm) concrete parapet before test 7069-5.

Test 7069-5 involved an impact on the 32-in (813-mm) concrete parapet (figure 2) at the nominal conditions of 1,800 lb (817 kg) | 60 mi/h (96.5 km/h) | 20 degrees. A 1981 Honda (see figure 3) was directed into the bridge railing using a cable reverse tow and guidance system. Test inertia mass of the vehicle was 1,800 lb (817 kg) and its gross static mass was 1,965 lb (892 kg). The height to the lower edge of the vehicle bumper was 14.0 in (356 mm) and it was 19.5 in (495 mm) to the top of the bumper. Other dimensions and information on the test vehicle are given in figure 4. The vehicle was free-wheeling and unrestrained just prior to impact.

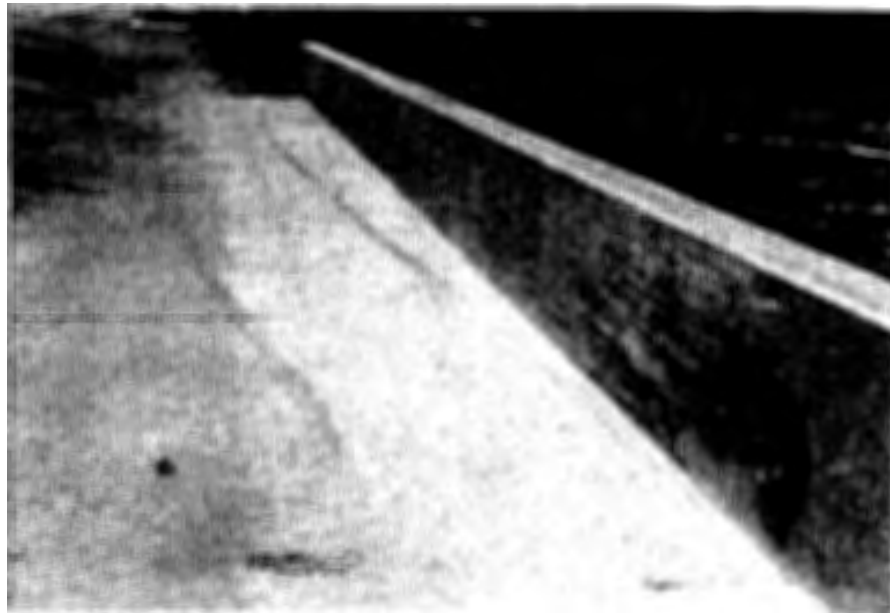
Figure 5. 32-in (813-mm) concrete parapet after test 7069-5.

The 32-in (813-mm) concrete parapet contained and smoothly redirected the vehicle with no lateral movement of the parapet. There were no debris or detached elements. There was no intrusion into the occupant compartment although some deformation of the compartment occurred. The vehicle trajectory at loss of contact indicated minimum intrusion into adjacent traffic lanes. The vehicle remained upright and stable during the entire test period (see table 1).

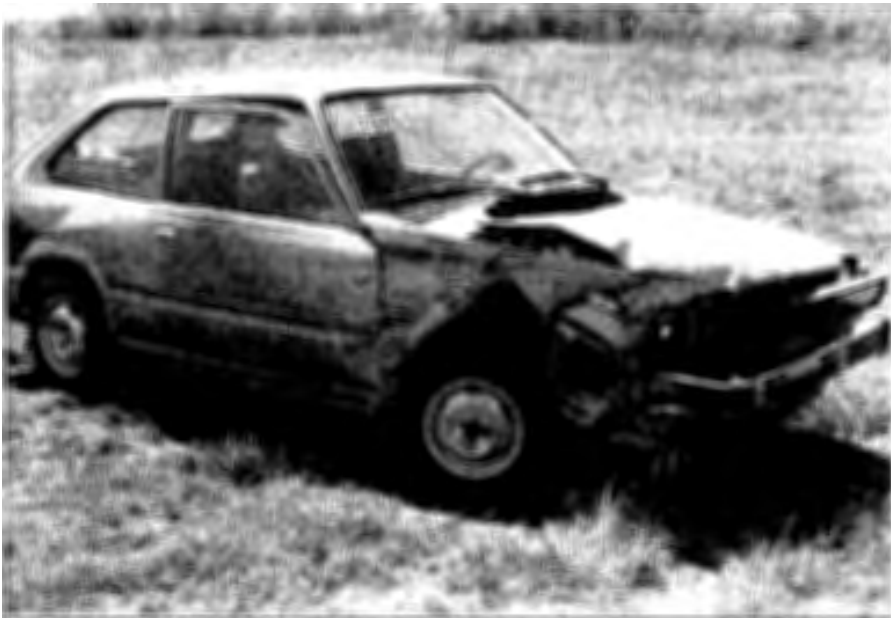
Figure 6. Vehicle after test 7069-5.

The vehicle sustained extensive damage to the right front as shown in figure 6. Maximum crush at the right front corner at bumper height was 5.0 in (127 mm). The right front and right rear wheel rims were bent and the right front strut was bent. The passenger door was bent and jammed and the right side was dented and scraped. The hood was bent and shifted to the left. The windshield frame was bent and the windshield was cracked. The roof of the vehicle was buckled and twisted.

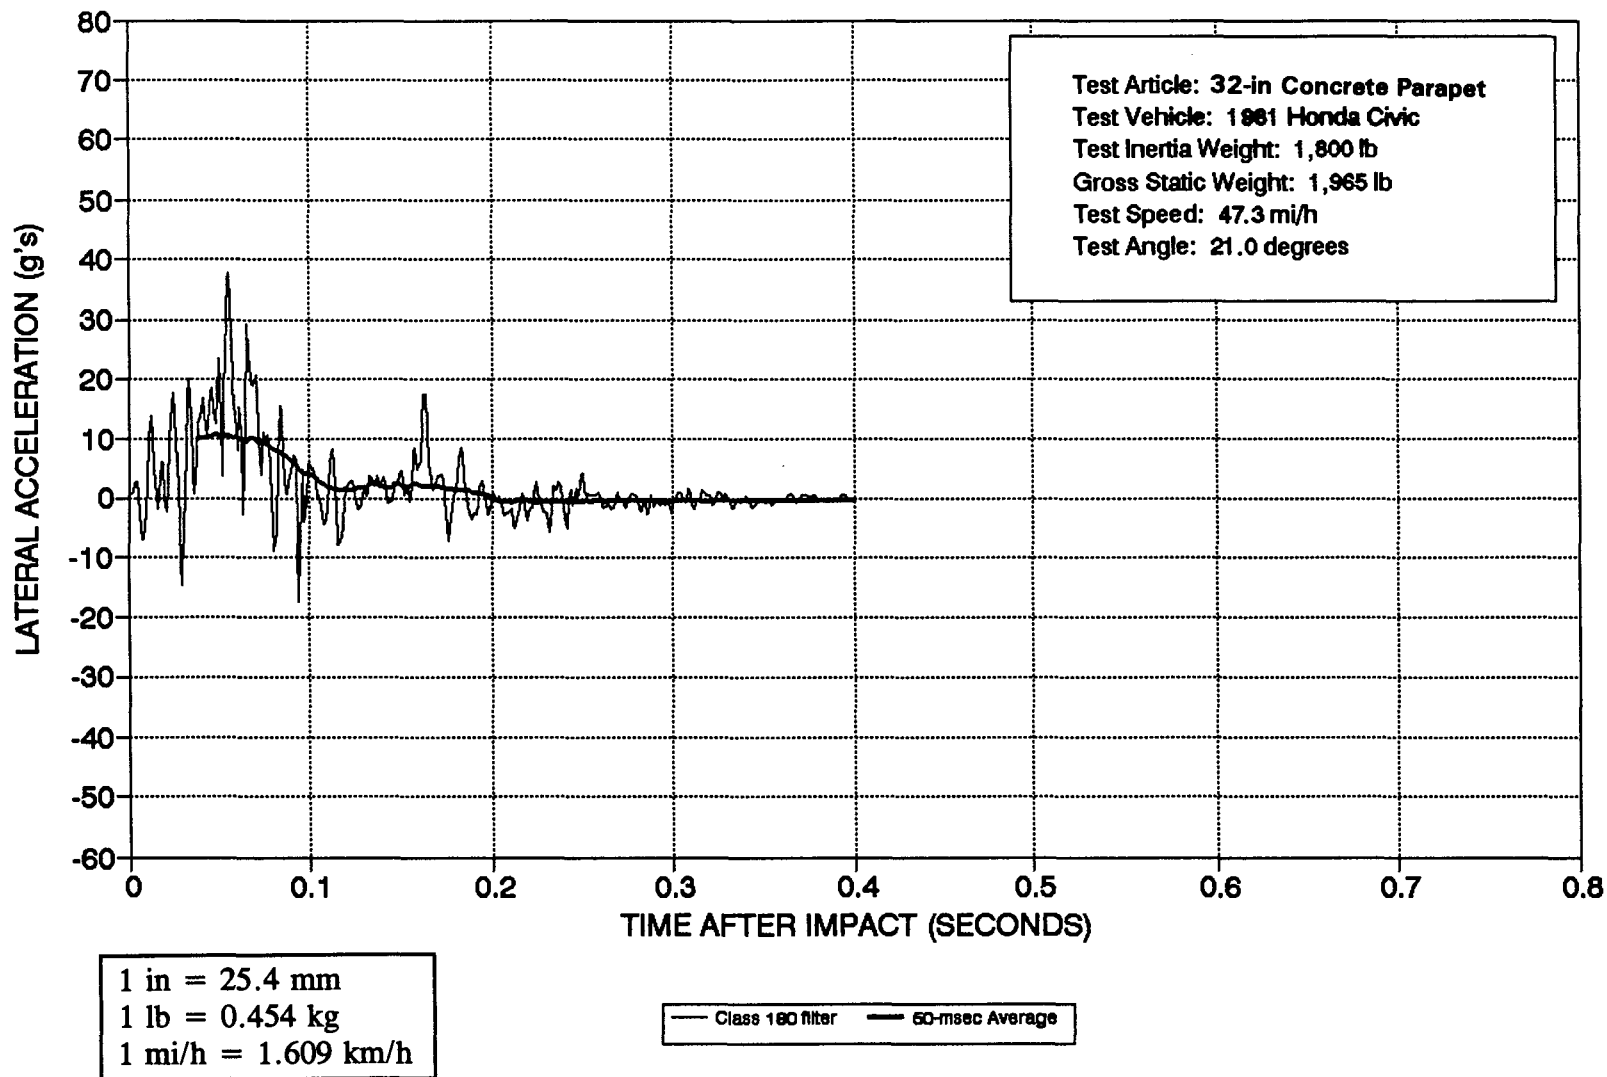
Figure 12. Vehicle lateral accelerometer trace for test 7069-5 (accelerometer located near center-of-gravity).

**CRASH TEST 7069-5**  
Accelerometer near center-of-gravity

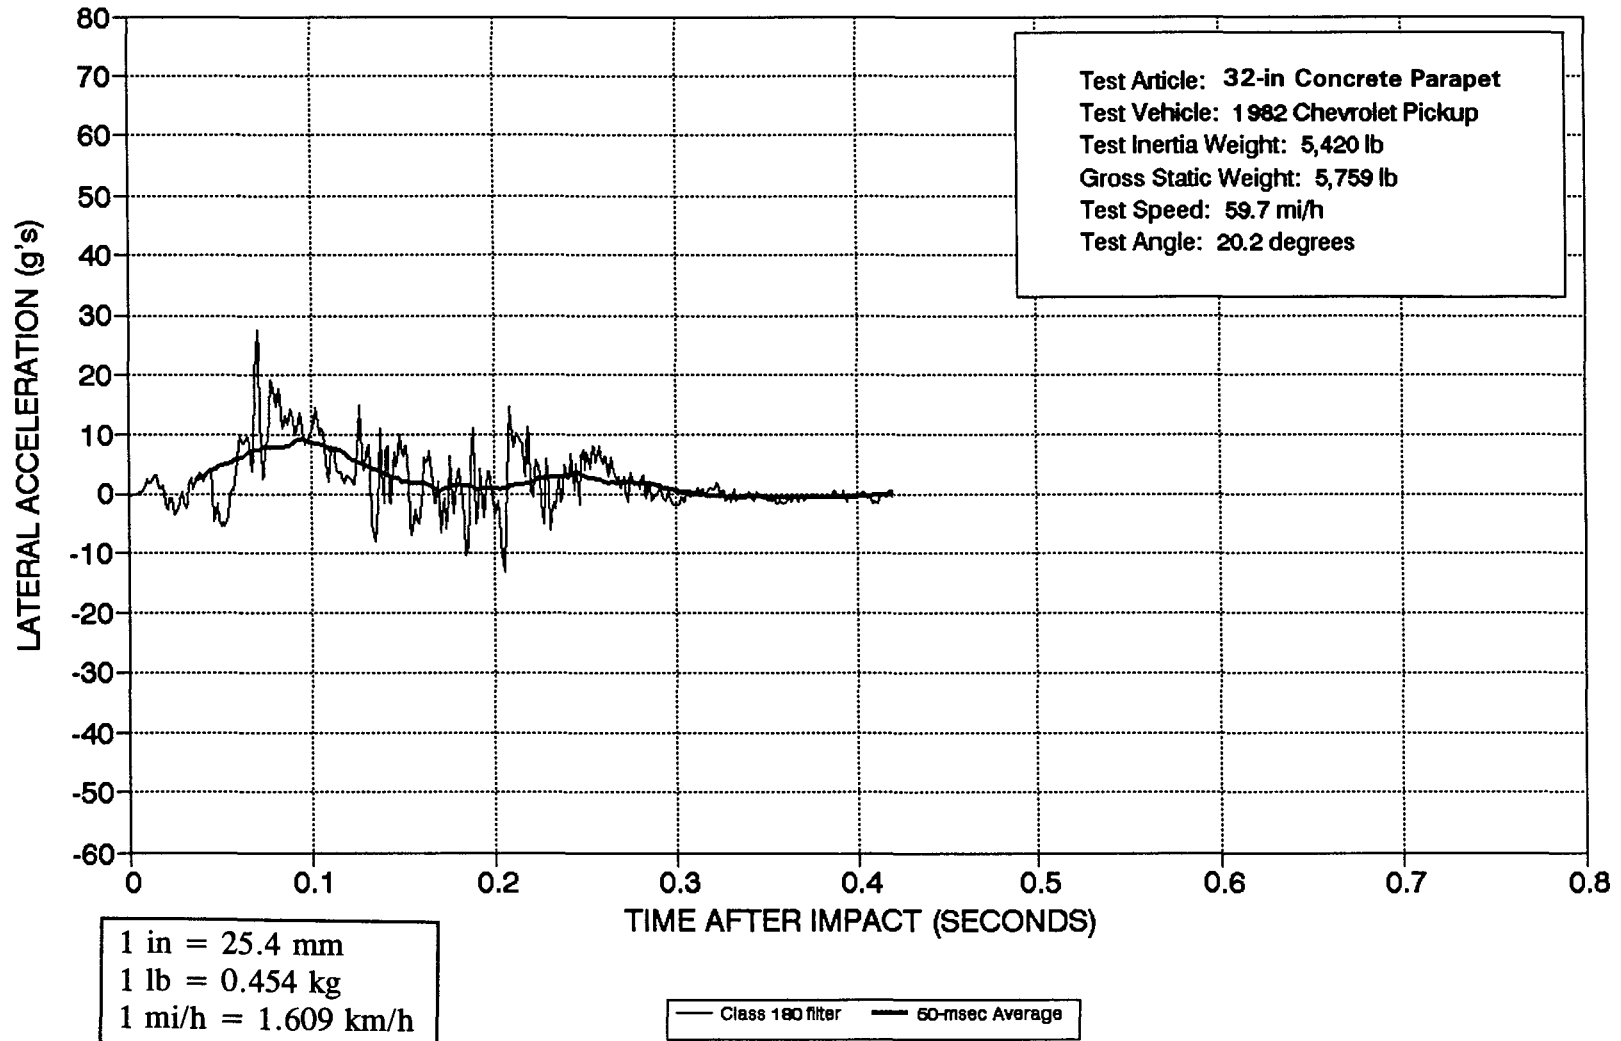
Figure 24. Vehicle lateral accelerometer trace for test 7069-6 (accelerometer located near center-of-gravity).

**CRASH TEST 7069-6**  
Accelerometer near center-of-gravity

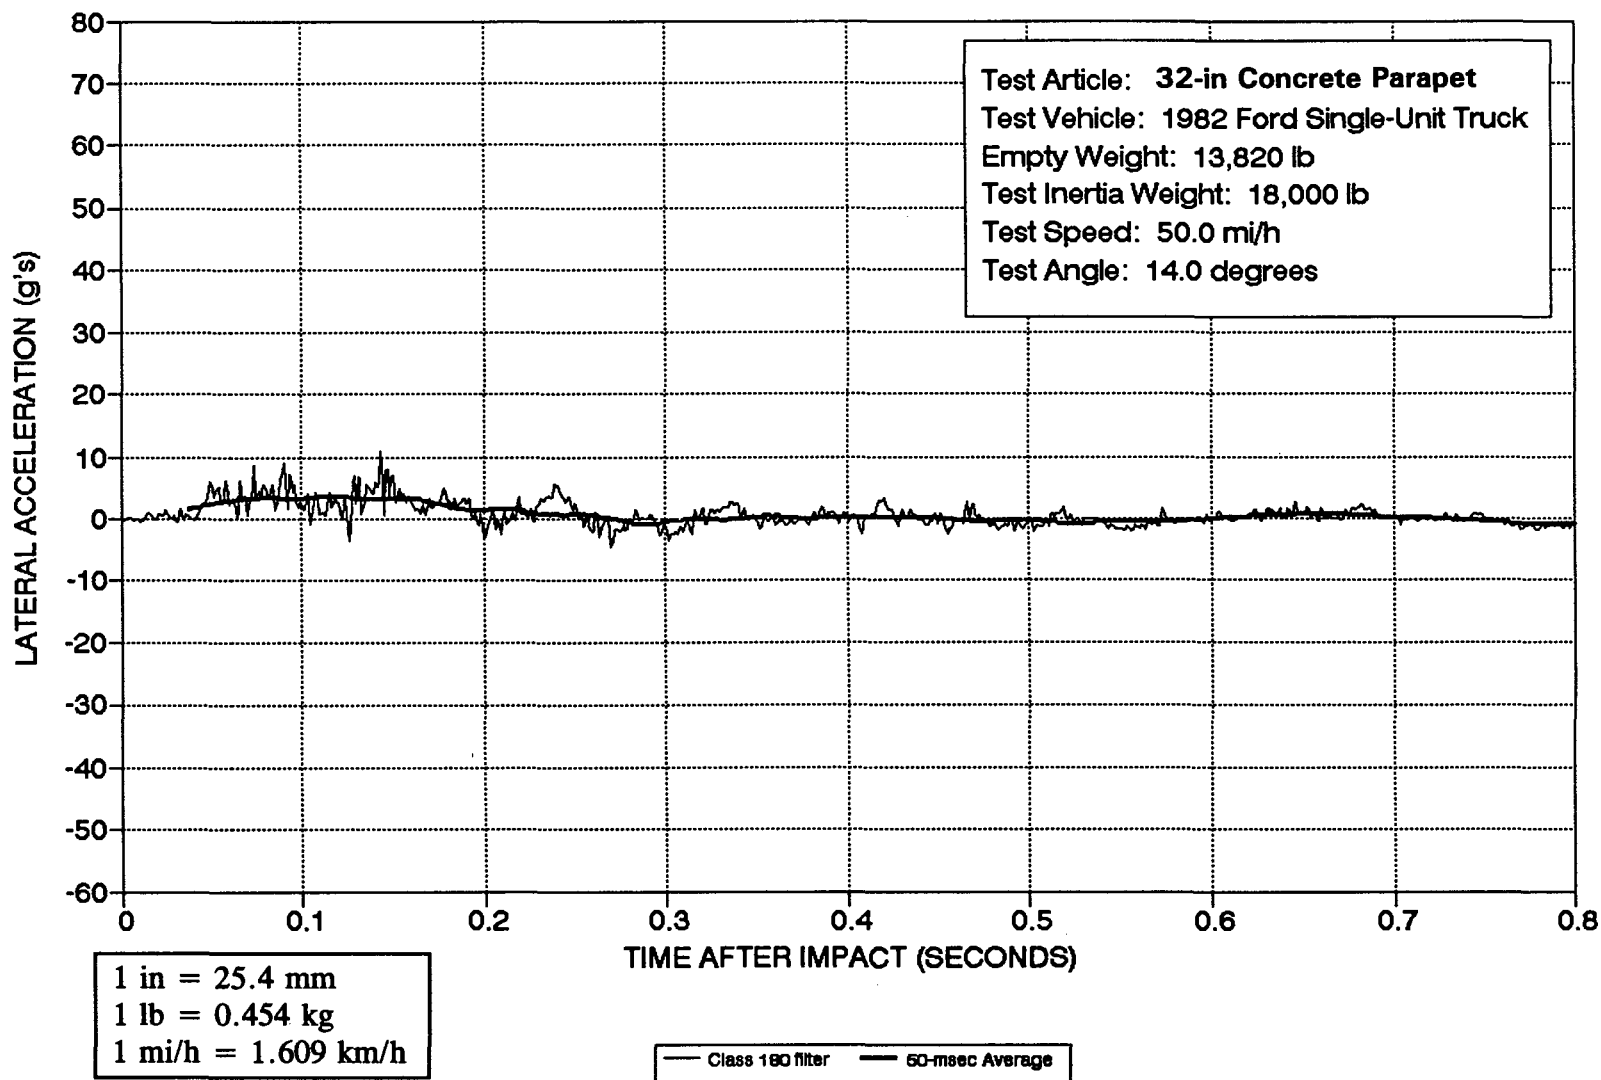
Figure 46. Vehicle lateral accelerometer trace for test 7069-16 (accelerometer located at front of vehicle).

CRASH TEST 7069-16  
Accelerometer at front of vehicle
