**TESTING OF NEW BRIDGE RAIL AND TRANSITION
DESIGNS. VOLUME 7. APPENDIX F. 32-IN
(813-MM) F-SHAPE BRIDGE RAILING**

Testing of New Bridge Rail and Transition Designs

Volume VII: Appendix F

32-in (813-mm) F-Shape Bridge Railing

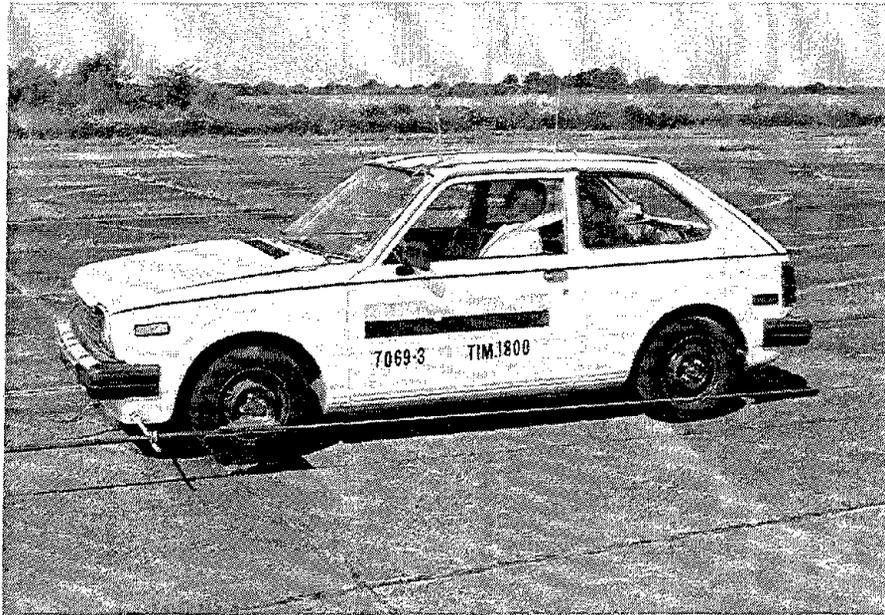
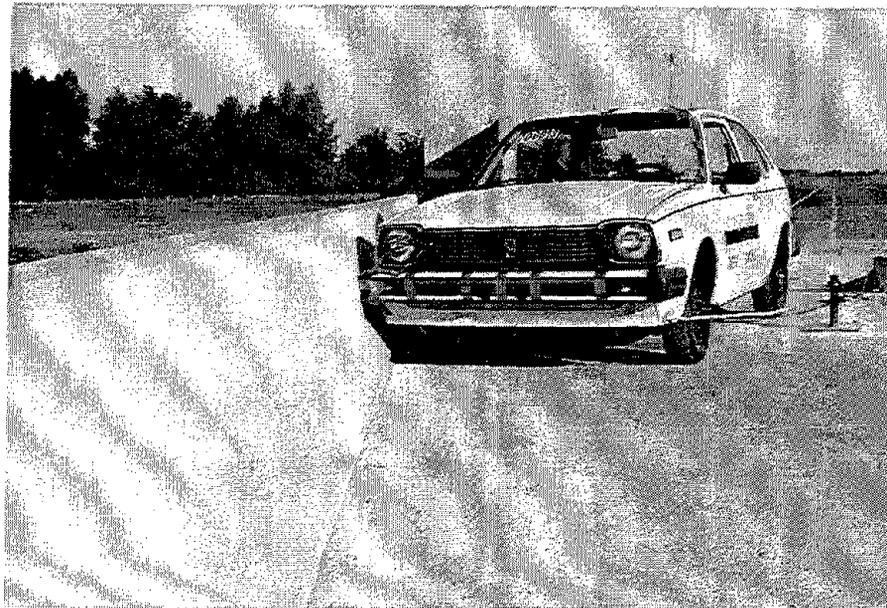
Figure 2. Vehicle before test 7069-3.

The 1980 Honda (see figure 2) was directed into the 32-in (813-mm) F-shape bridge railing (figure 3) using a cable reverse tow and guidance system. Test inertia mass of the vehicle was 1,800 lb (817 kg) and its gross static mass was 1,966 lb (893 kg). The height to the lower edge of the vehicle bumper was 14.0 in (356 mm) and it was 19.5 in (495 mm) to the top of the bumper. Other dimensions and information on the test vehicle are given in figure 4. The vehicle was free-wheeling and unrestrained just prior to impact.

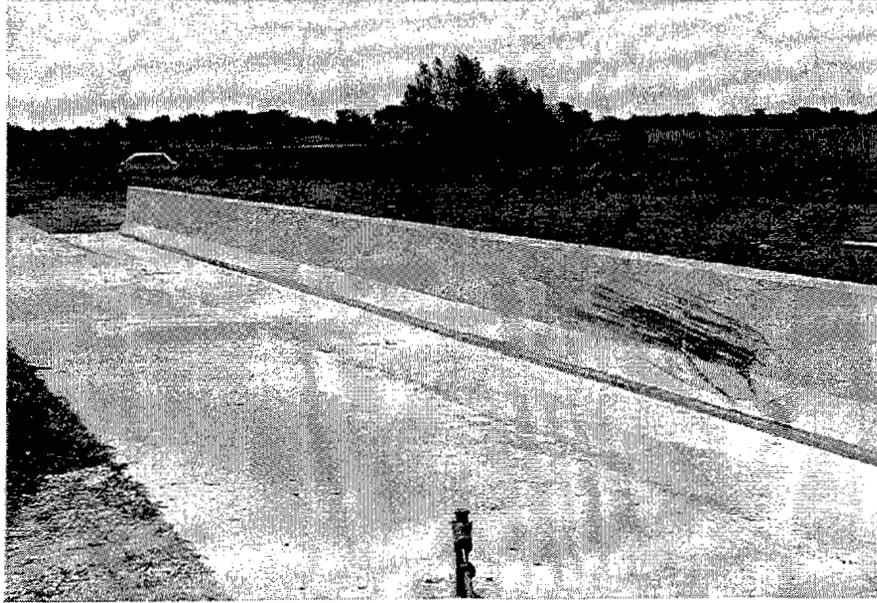
Figure 5. 32-in (813-mm) F-shape bridge railing after test 7069-13.

As can be seen in figure 5, the bridge railing received cosmetic damage only. There were tire marks on the face of the bridge railing indicating the vehicle rose a maximum height of about 27 in (686 mm). The vehicle was in contact with the bridge railing for 10.3 ft (3.1 m).

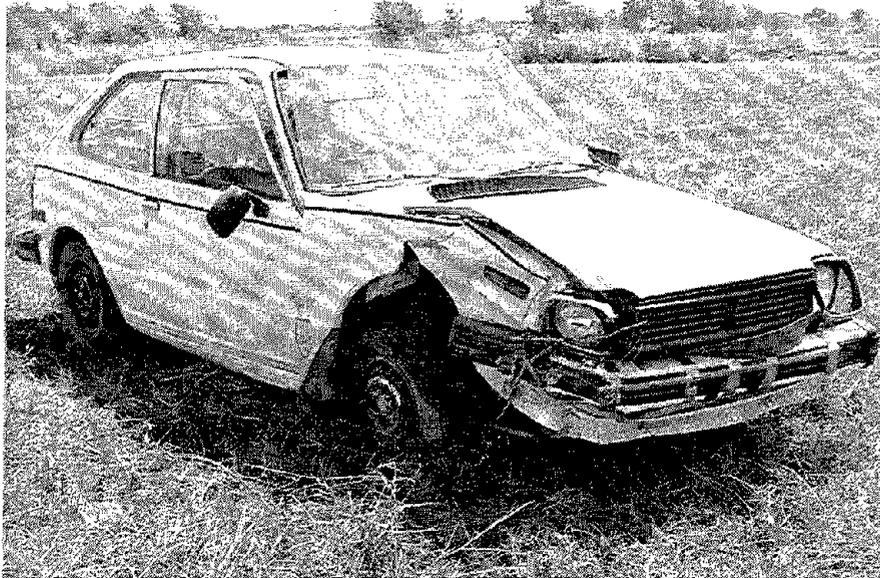
Figure 6. Vehicle after test 7069-3.

The vehicle sustained extensive damage to the right front as shown in figure 6. Maximum crush at the right front corner at bumper height was 9.0 in (229 mm). The right front and right rear wheel rims were bent and the wheel assembly and suspension damaged. The passenger door was bent and jammed and the right side was dented and scraped. The hood was bent and shifted to the left. The windshield frame was bent and the windshield was cracked. The roof of the vehicle was buckled and twisted.

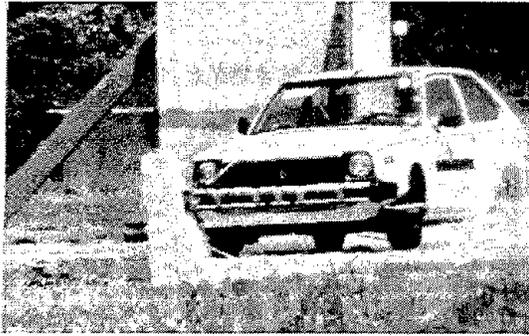
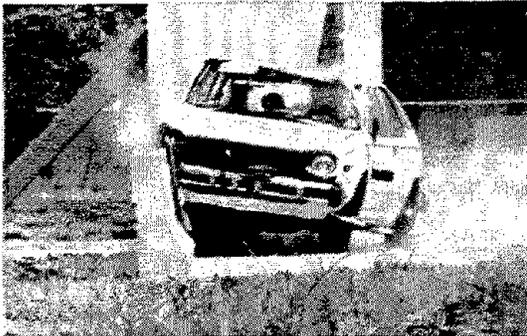
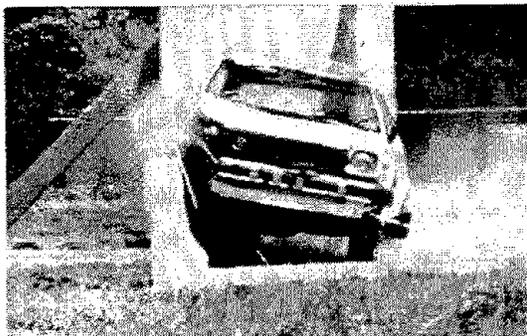
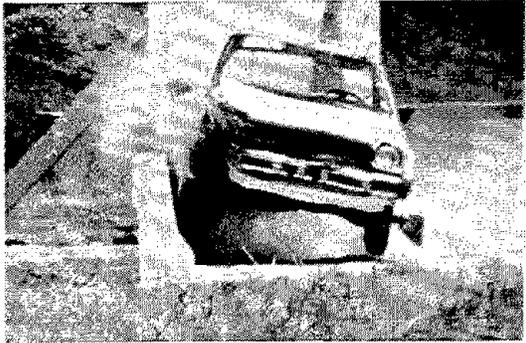
Figure 8. Sequential photographs for test 7069-3.

Sequential photographs of the test are shown in figures 8 and 9. Vehicular angular displacements are displayed in figure 10. Vehicular acceleration versus time traces filtered with SAE J211 filters are presented in figures 11, 12, and 13. These data were further analyzed to obtain 0.050-s average accelerations versus time. A 0.050-s interval immediately prior to impact was averaged to establish zero acceleration. The data were then processed with a moving 0.050-s average window with the first 0.050-s average plotted at 0.026 s for each trace. The maximum 0.050-s averages were -8.0 g (longitudinal) and 12.8 g (lateral).

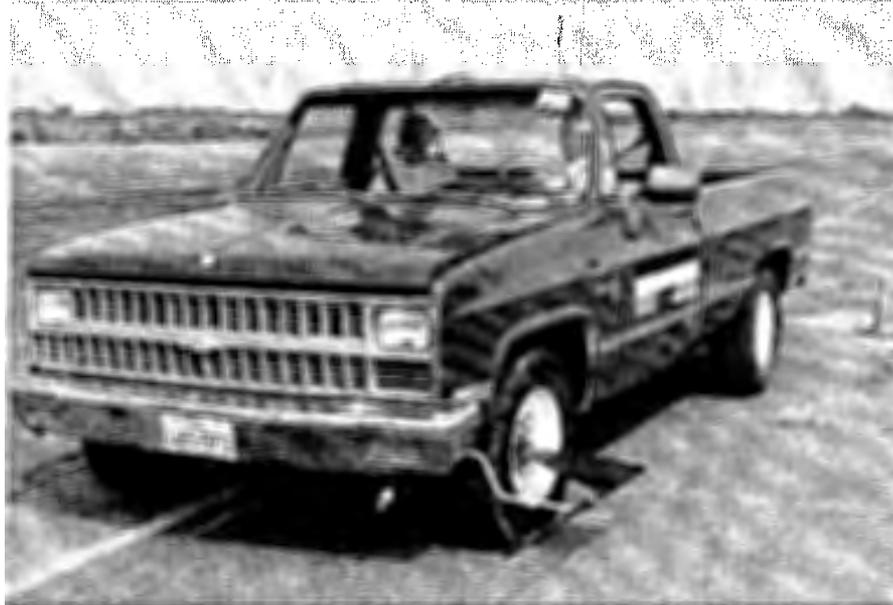
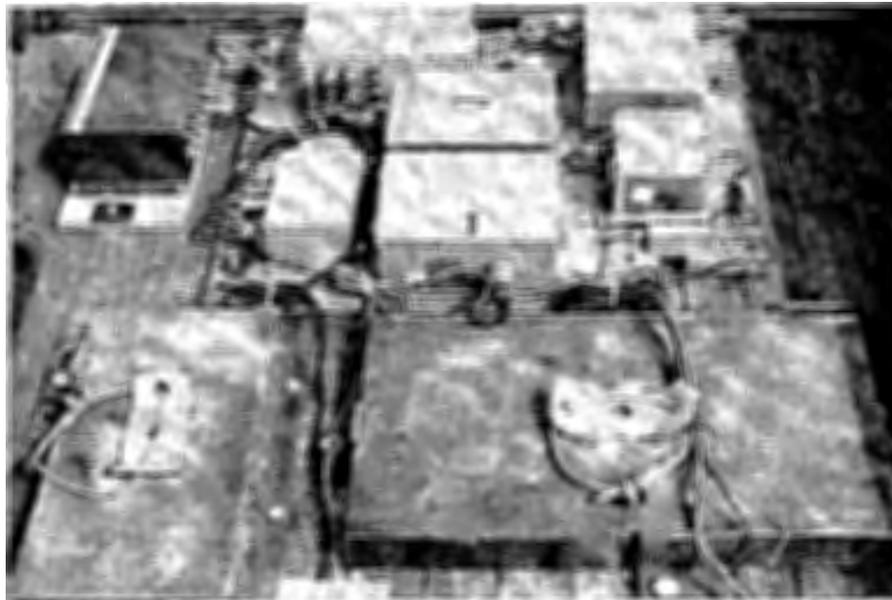
Figure 14. Vehicle and instrumentation before test 7069-4.

The 1981 Chevrolet pickup (figures 14 and 15) was directed into the bridge railing (figure 16) using a cable reverse tow and guidance system. Test inertia mass of the vehicle was 5,440 lb (2 470 kg) and its gross static mass was 5,780 lb (2 624 kg). The height to the lower edge of the vehicle bumper was 17.0 in (432 mm) and it was 26.25 in (667 mm) to the top of the bumper. Other dimensions and information on the test vehicle are given in figure 17. The vehicle was free-wheeling and unrestrained just prior to impact.

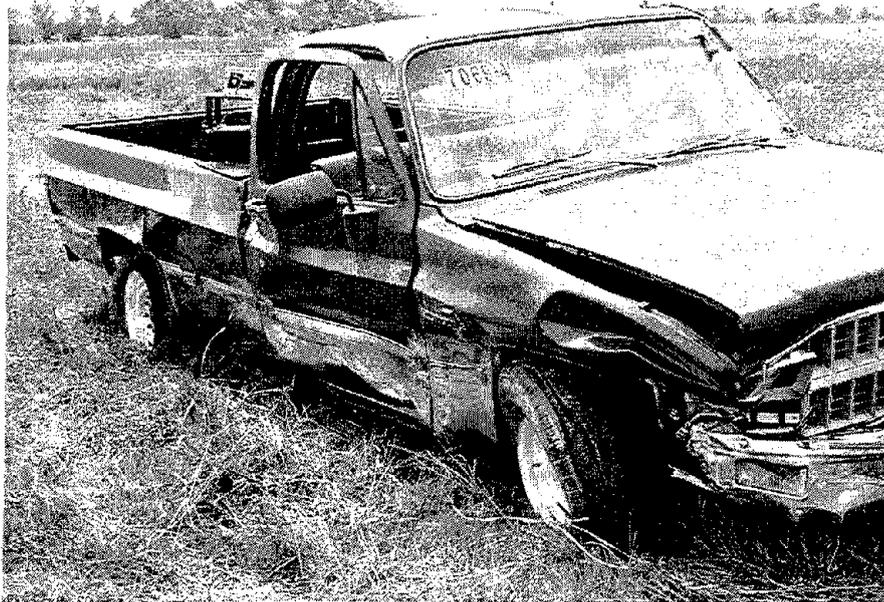
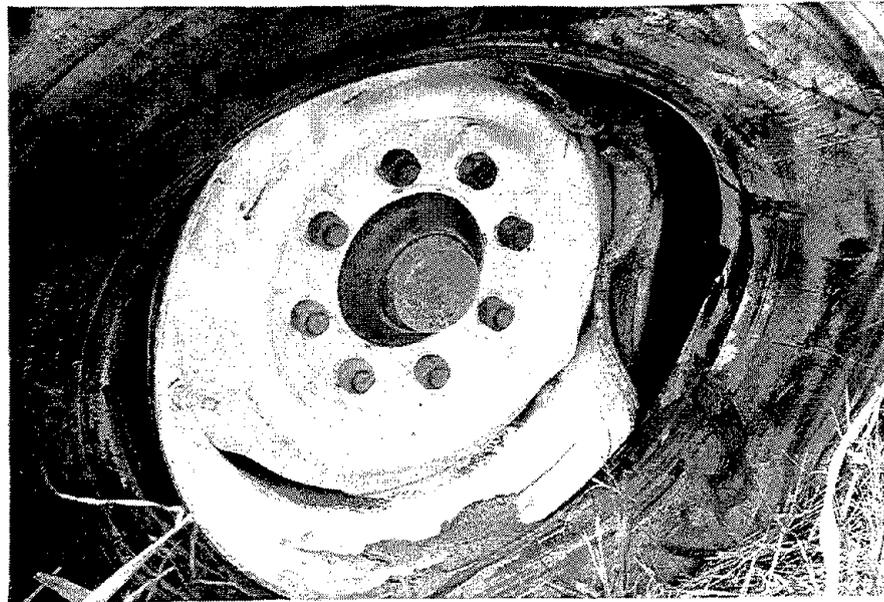
Figure 19. Vehicle after test 7069-4.

The vehicle sustained extensive damage to the right side as shown in figure 19. Maximum crush at the right front corner at bumper height was 5.0 in (127 mm). The right front and right rear wheel rims were bent and the tires aired out. The wheel assembly and suspension was damaged. The passenger door was bent and jammed and the window broken out. The right rear panel was dented and scraped. The hood was bent and shifted to the left. The cab of the vehicle was twisted.

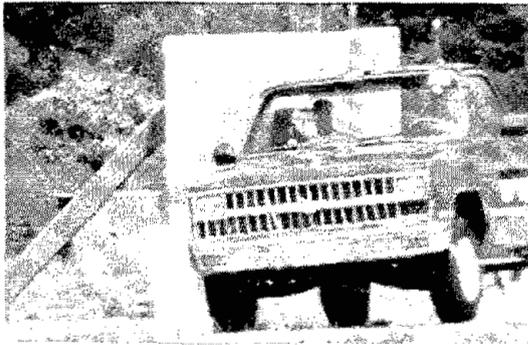
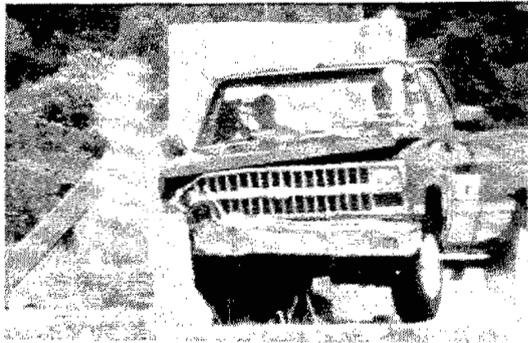
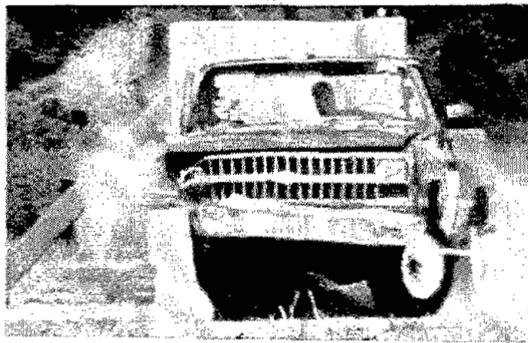
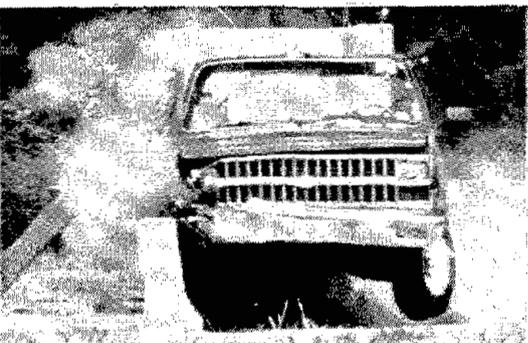
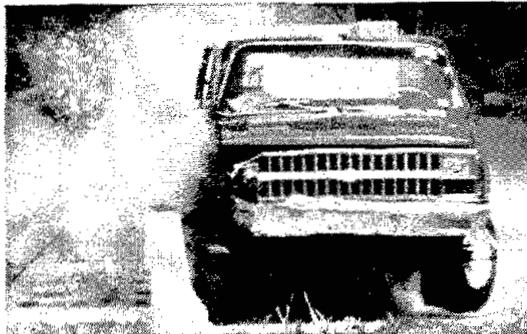
Figure 21. Sequential photographs for test 7069-4.

0.010-s occupant ridedown accelerations were -1.2 g (longitudinal) and 5.9 g (lateral). These data and other pertinent information from the test are summarized in figure 20 and table 3. Sequential photographs are shown in figures 21 and 22. Vehicular angular displacements are displayed in figure 23. Vehicular accelerations versus time traces filtered with SAE J211 filters are presented in figures 24 through 28. These data were further analyzed to obtain 0.050-s average accelerations versus time. A 0.050-s interval immediately prior to impact was averaged to establish zero acceleration. The data were then processed with a moving 0.050-s average window with the first 0.050-s average plotted at 0.026 s for each trace. The maximum 0.050-s averages were -4.7 g (longitudinal) and 13.1 g (lateral).

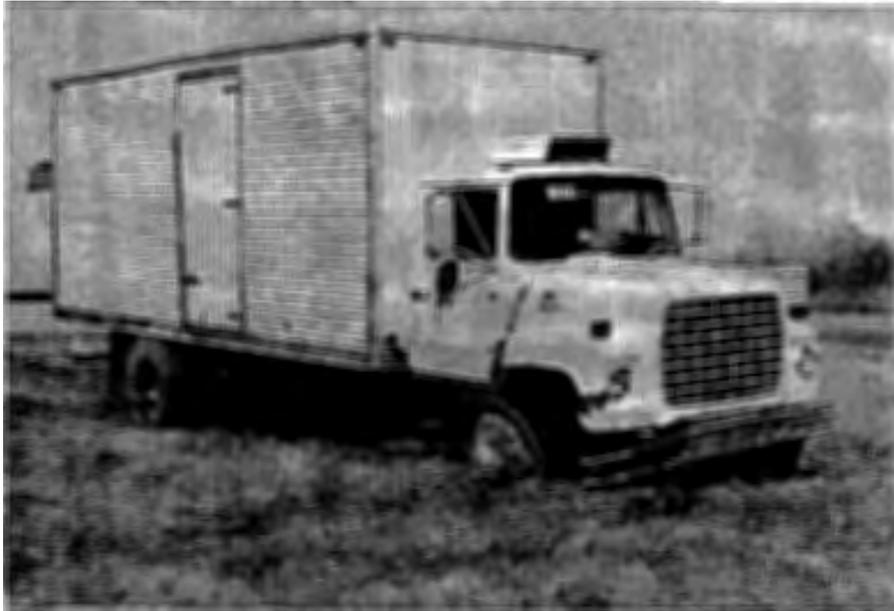
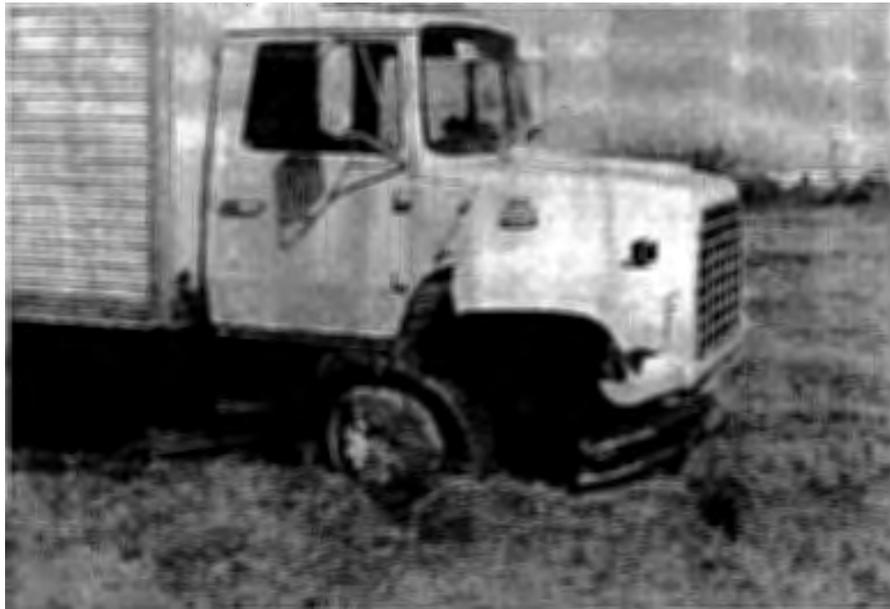
Figure 35. Vehicle after test 7069-8.

The vehicle sustained extensive damage to the right side as shown in figure 35. Maximum crush at the right front corner at bumper height was 6.0 in (152 mm). The right front wheel rim was bent and the tire damaged. The spring and spring shackle were broken loose from the axle. The steering gear box and steering cylinder were damaged. Also, the fuel tank broke loose from the truck.

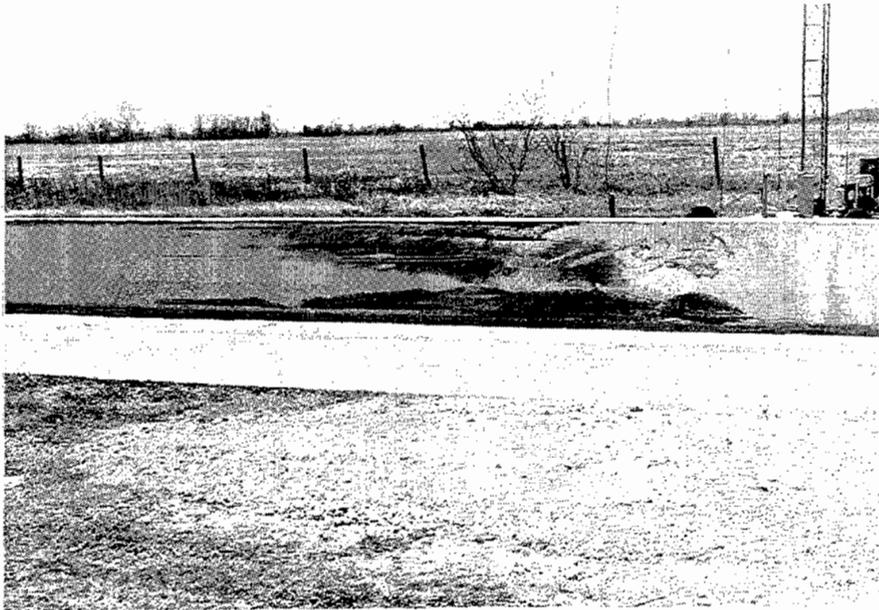
Figure 49. 32-in (813-mm) F-shape bridge railing after test 7069-9.

As can be seen in figure 49, the railing received cosmetic damage and some scraping. There were tire marks on the face of the bridge railing and along the top. The top of the bridge railing was scraped along the remaining length from the lower edge of the bed of the truck (see figure 50). The vehicle was in contact with the bridge railing for 58 ft (18 m).

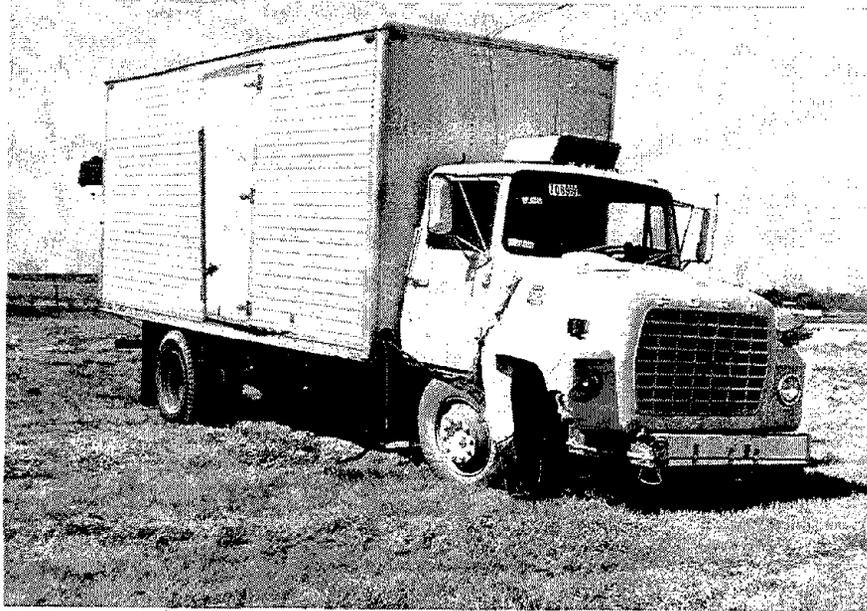
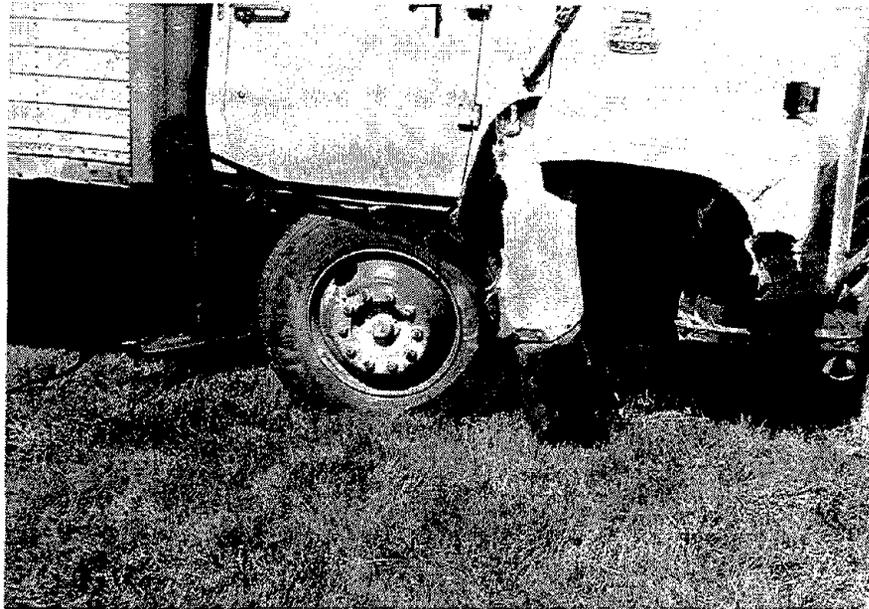
Figure 51. Vehicle after test 7069-9.

The vehicle sustained extensive damage to the right side as shown in figure 51. Maximum crush at the right front corner at bumper height was 16.0 in (406 mm). The right front wheel rim was bent and the tire damaged. The spring and spring shackle were broken loose from the axle and the axle torn loose on the left side. The steering gear box and steering cylinder were damaged. Also, the fuel tank broke loose from the truck.

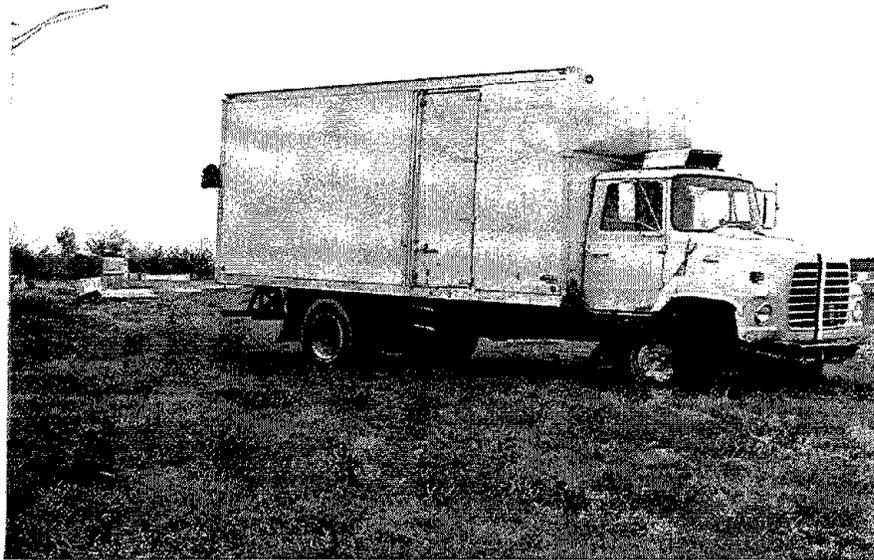
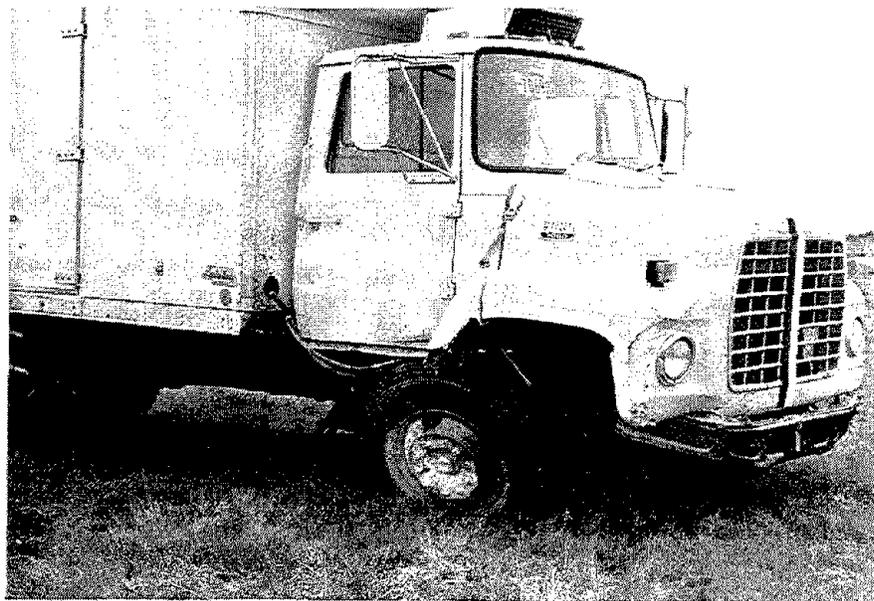
Figure 69. Vehicle after test 7069-11.

The vehicle sustained extensive damage to the right side as shown in figure 69. Maximum crush at the right front corner at bumper height was 20.0 (508 mm). The front axle was torn loose which caused damage to the springs, shackles, U-bolts, and tie rods. The steering arm and cylinder were damaged and the oil pan was dented. Also, the fuel tank broke loose from the truck.
