Publication No. FHWA-RD-94-079
June 1995

Crush Characteristics for 1981 through 1983 Honda Civics

14. Sponsoring Agency Code	
16. Abstract <p>This test report contains the test results from a series of four crash tests conducted at the Federal Outdoor Impact Laboratory (FOIL) located at the Turner-Fairbank Highway Research Center (TFHRC) in McLean, Virginia. The tests were frontal crash tests involving 1981 through 1983 Honda Civic two-door sedans. Three Honda Civics impacted the FOIL's instrumented rigid pole and one impacted a single leg 6-kg/m (4-lb/ft) u-channel sign post embedded in strong soil. The objective of these tests was to provide crush characteristic data in support of a computer simulation effort to model a 1981 through 1983 Honda Civic. The results are presented as data plots of acceleration vs. time, velocity vs. time, displacement vs. time, force vs. displacement, and force vs. time. The data plots were derived from vehicle accelerometer data and rigid pole load cell data. The data from the three rigid pole tests serve as a good baseline for modeling the front-end crush of a Honda Civic. The one u-post sign support test provides good data to help model the inter

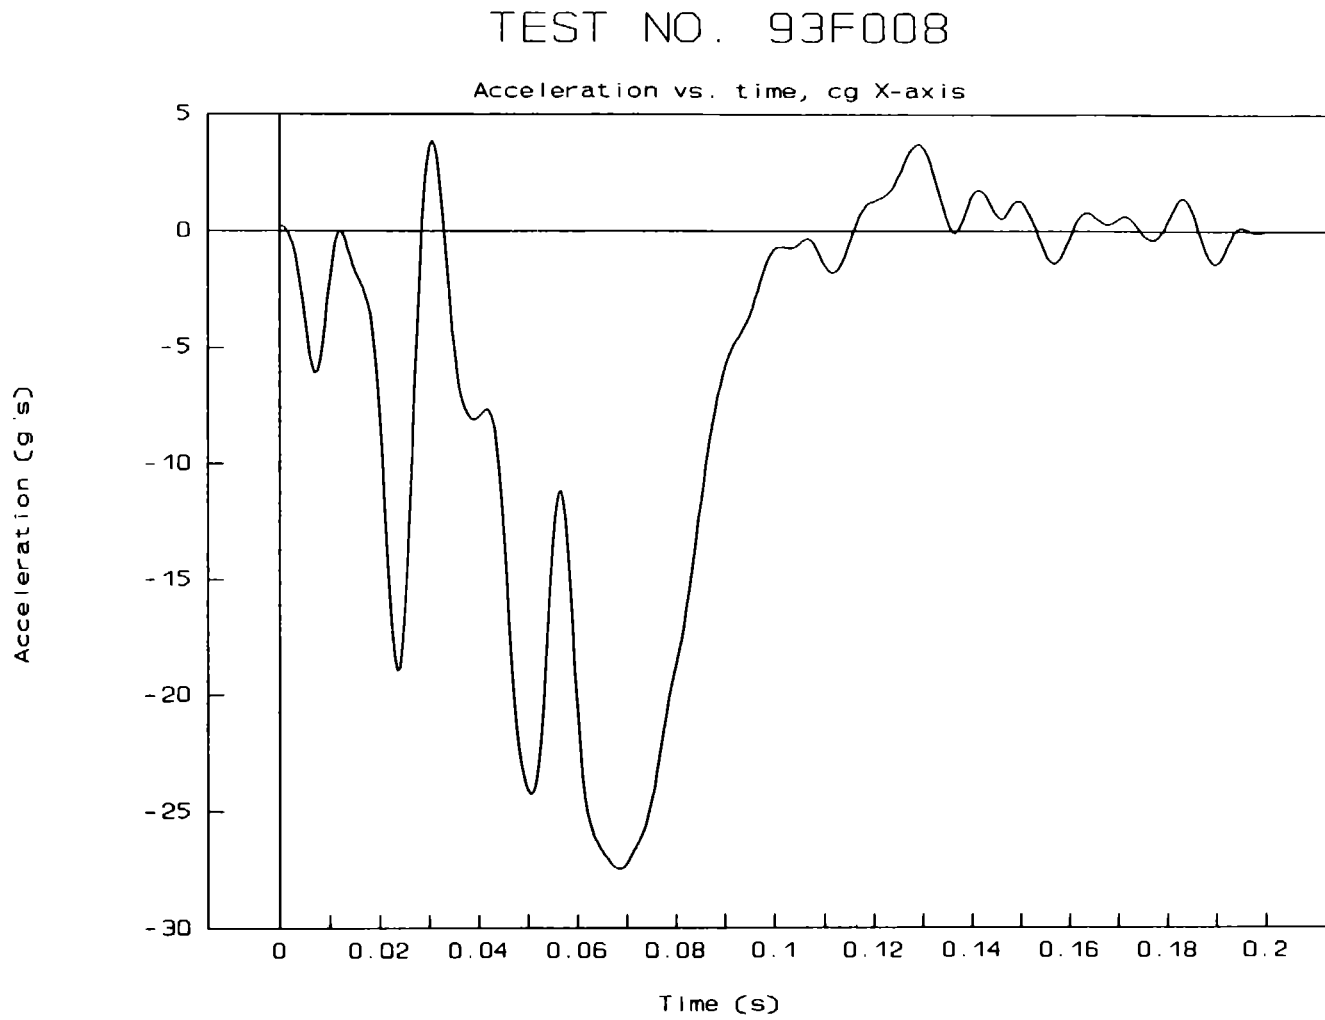
Figure 23. Acceleration vs. time, cg X-axis, test 93F008.

The center-of-gravity accelerometer data were integrated twice to produce velocity and displacement traces. A force vs. time trace was generated by multiplying the acceleration data by the mass of the vehicle and plotting the product with time. Acceleration vs. time traces were plotted for all FMVSS 208 accelerometers. Displacement traces were generated for the rear seat accelerometers by double integrating the rear seat acceleration and plotting the result vs. time.

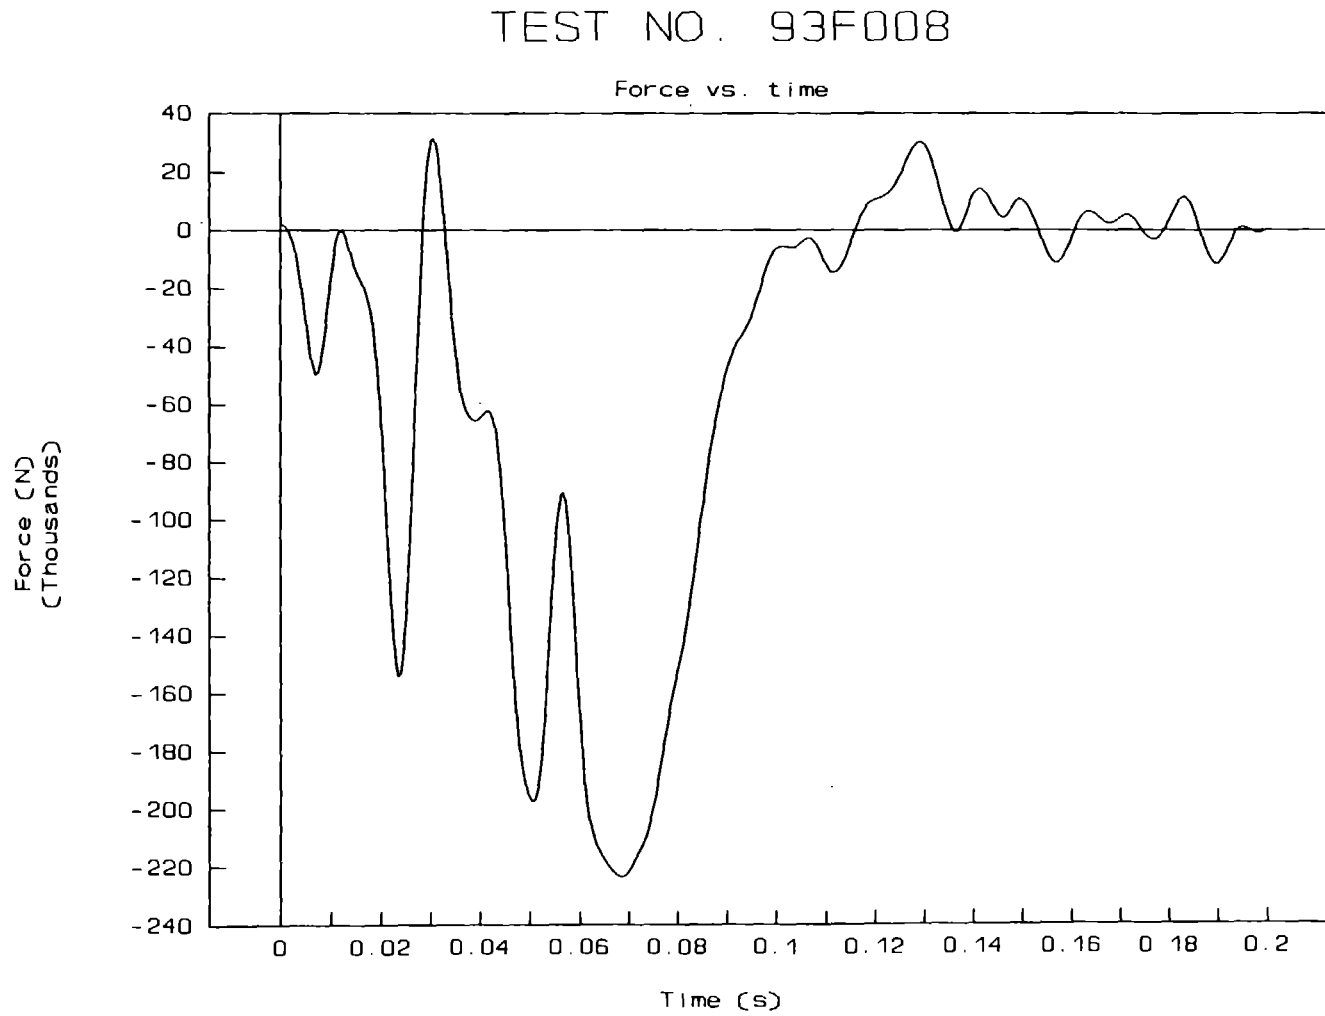
Figure 26. Force vs. time, test 93F008.
