Research Report and Findings: Light Rail Technology Scan and Case Studies

OCTOBER 2022

FTA Report No. 0234

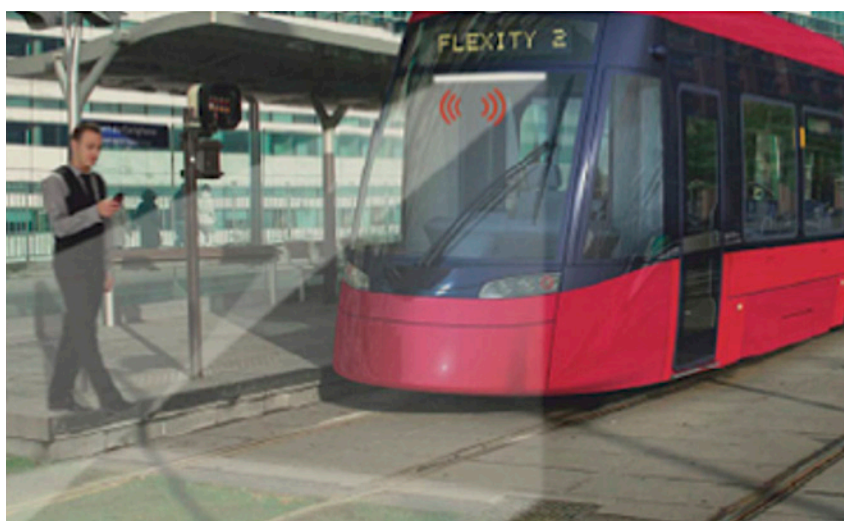
Figure 2-2 *Bombardier Flexity vehicle*

(motor vehicles and pedestrians), and collisions with static objects in the track. The system uses “3D Stereovision” technology from AIT that has been adapted for LRVs. The DAS is based on picture-dependent sensor technology using three 3D cameras mounted behind the windshield and an associated evaluation unit and software. The software detects objects such as pedestrians and vehicles within the swept path and derives their distance from the LRV, size, direction of movement, and speed; it then determines the associated braking distance of the LRV and if there is a collision risk. If a collision risk is established, the system alerts the operator. In 2016, Bombardier had completed two initial trials of this system in Frankfurt and Berlin, Germany. In 2017, Bombardier received the Innovation Leader in Rail Transport Award by the European Railways Clusters Initiative (ERCI) for its Obstacle Detection Assistance System for trams and LRVs. In December 2017, Duisburg, Germany, purchased 47 Bombardier Flexity vehicles (Figure 2-2), and in April 2018, Brussels, Belgium, purchased 175 Flexity Trams, all outfitted with this technology. CUTR/TTCI researchers will monitor these and subsequent deployments of the Bombardier obstacle detection system.

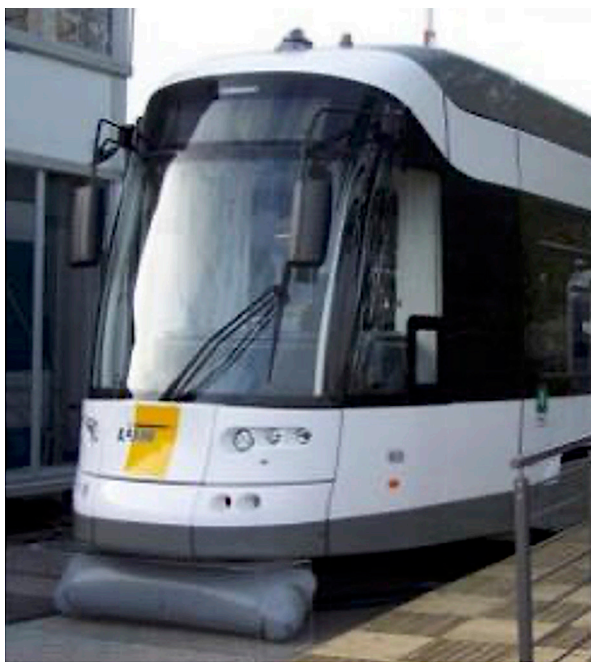
Figure 2-3 *Bombardier BodyGuard™*

Bombardier BodyGuard™, as shown in Figure 2-3, is an external airbag for trams that prevents pedestrians from being trapped under a moving tram. Stereovision cameras mounted on LRVs identify and track movement on or near the track. In the event the monitors identify an imminent collision, the airbag deploys.

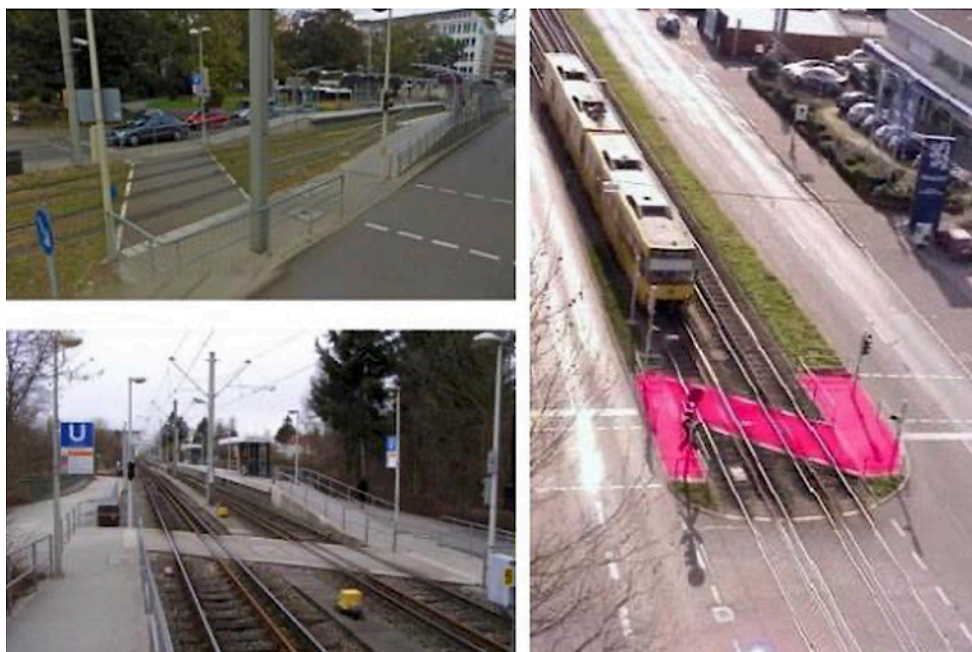
passenger collisions. The success story was from Stuttgart, Germany, which uses the “Z-standard” (see Figure 2-4) at many of the city’s 500 pedestrian grade crossings. Although no data were provided that indicate a reduction in pedestrian interactions, the researchers identified this treatment as successful.¹⁴

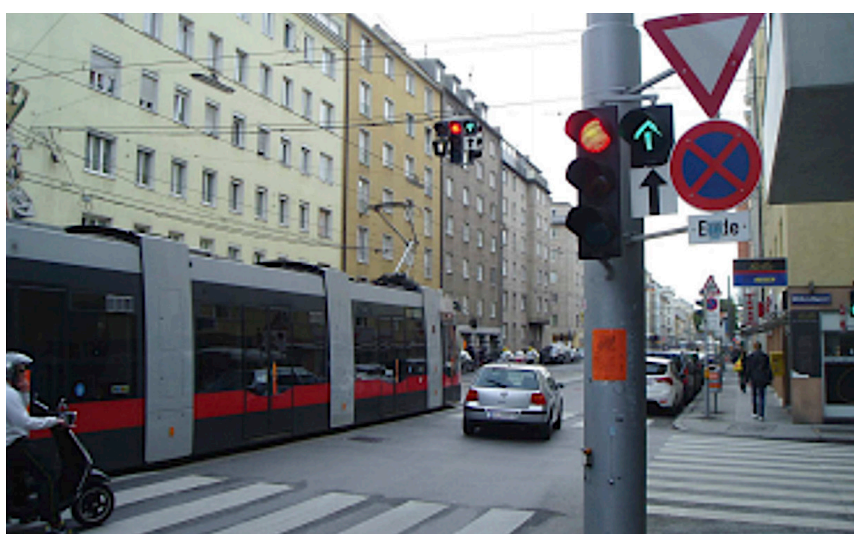
Figure 2-5 Vienna traffic signal, green arrow

Changes in traffic signaling were highlighted as a success in Vienna, Austria. At the Quellenstraße/ Herndlgasse crossing, the tracks are located in the central position of the street with a designated left-turn lane for cars. Herndlgasse, the cross street, is one-way. Prior to the signal changes, there were no separate signals for left turns, visibility of the signals was described as “not good,” and there were no physical barriers between trams and cars. Traffic signal modifications included an additional separate green arrow signal for cars and other private vehicles going straight that is activated when the tram approaches from behind. Although the main traffic signal is red (meaning no left turns), vehicles traveling straight have a green arrow signal. The agency reported a “significant reduction in accidents” after these changes.

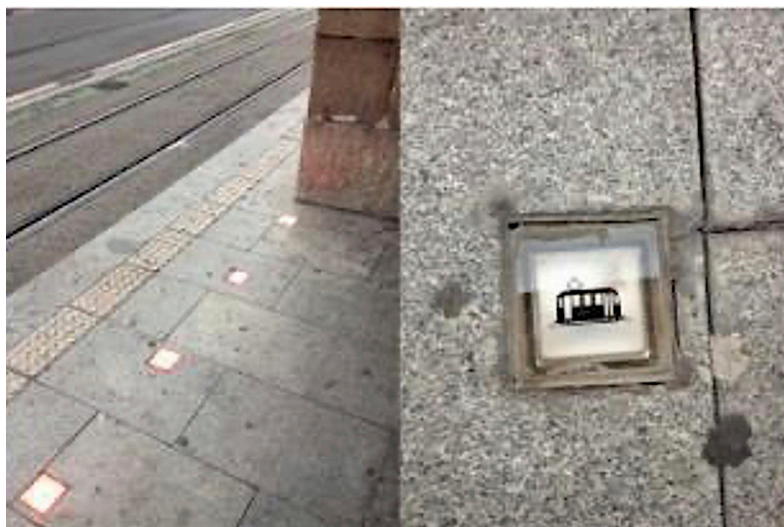
Figure 2-8 In-pavement lighting, Bilbao, Spain

In Bilbao, Spain along Ribera Street, pedestrian events were countered using in-pavement illuminated signs alerting pedestrians of approaching trams (Figure 2 8). The lights were installed in June 2009, and as of 2014, pedestrian collisions in the area had been reduced by 60%.

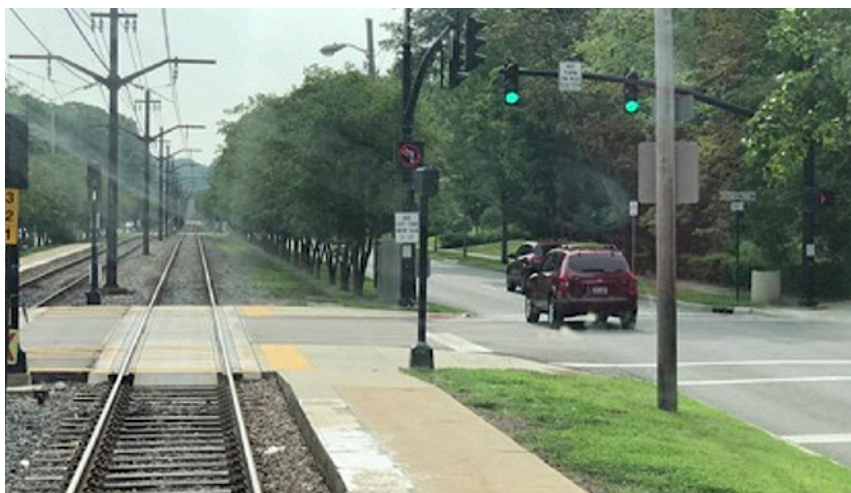
Figure 3-6 *Left-turn situation*

Although GCRTA is operating an aging light rail system that runs through a historic bedroom community, the frequency of collisions is low. The most challenging type of collisions are left-turning personal vehicles, especially illegal left turns (examples of configurations where left turns present challenges are shown in Figures 3-6 and 3-7) and unfamiliar roadway users. GCRTA event data provided and analyzed for this research supports the stated challenges, with about 34% of all collisions involving POVs. GCRTA considered the possibility of adding parking lot-style gates to prevent some illegal turning movements; however, due to the historic nature of the communities served by the light rail line, parking lot-style gates were not acceptable. One way to minimize the severity of light rail collisions, especially with personal vehicles, is through low operating speeds. GCRTA has a maximum operating speed of 45 mph; however, light rail trains typically do not exceed 25 mph.

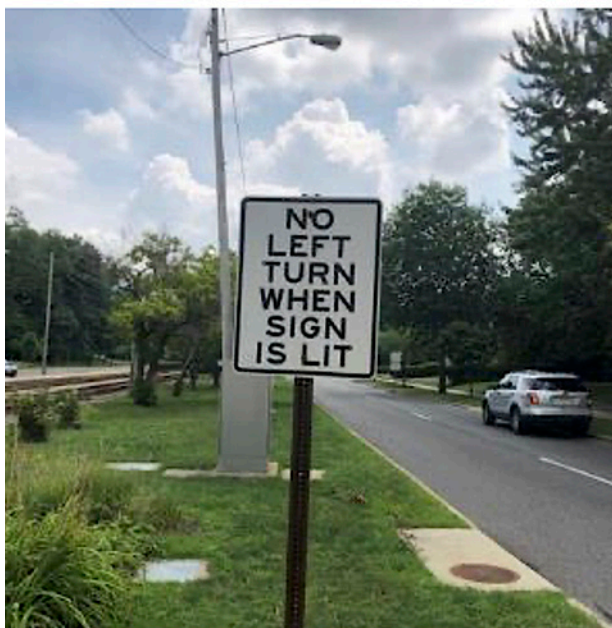
Figure 3-8 “No Left Turn” static sign

To combat left-turning personal vehicle challenges, GCRTA uses a combination of static and active blank-out signage to warn drivers of an approaching train, prohibiting left turns into the path of the light rail vehicle. Examples of static and blank-out signage are shown in Figures 3-8 and 3-9.

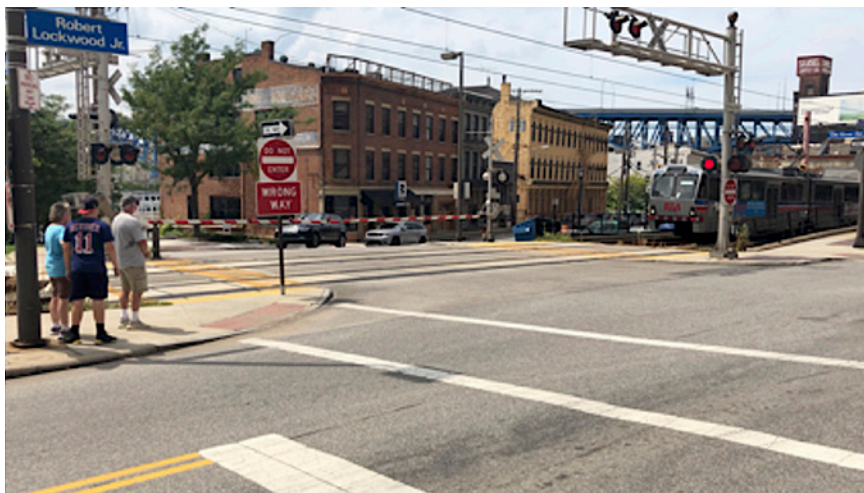
Figure 3-10 Double-gated crossing

GCRTA also employs crossing gate protection at rail crossing signals on the Waterfront Line, as shown in Figure 3-10. Fencing is also frequently used at GCRTA to deter pedestrians from crossing the tracks in unwanted areas, as shown in Figure 3-11.

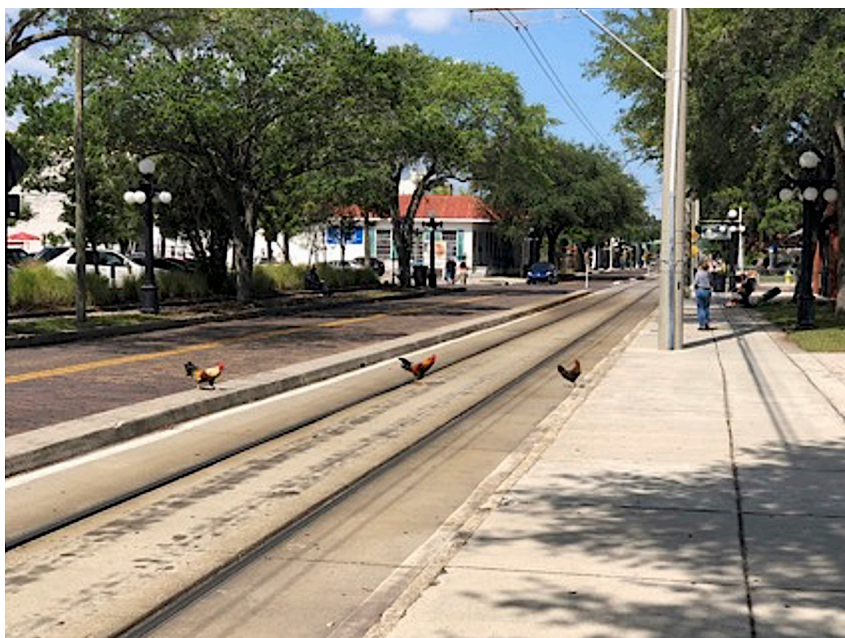
Figure 3-12 Typical track configuration

The 2.7-mile streetcar line connects downtown Tampa and the Channelside District through historic Ybor City, and expansion is being discussed to accommodate the growing downtown area and the Marion Street Transitway. The entire track system operates at street grade on a dedicated right-of-way with one freight interlock crossing. There are 11 stops and 18 at-grade vehicle intersections along the track and additional pedestrian crosswalks. HART's typical streetcar track configuration has the track off to one side of the road using a small concrete median to separate the streetcar lane from vehicular traffic, as shown in Figure 3-12.

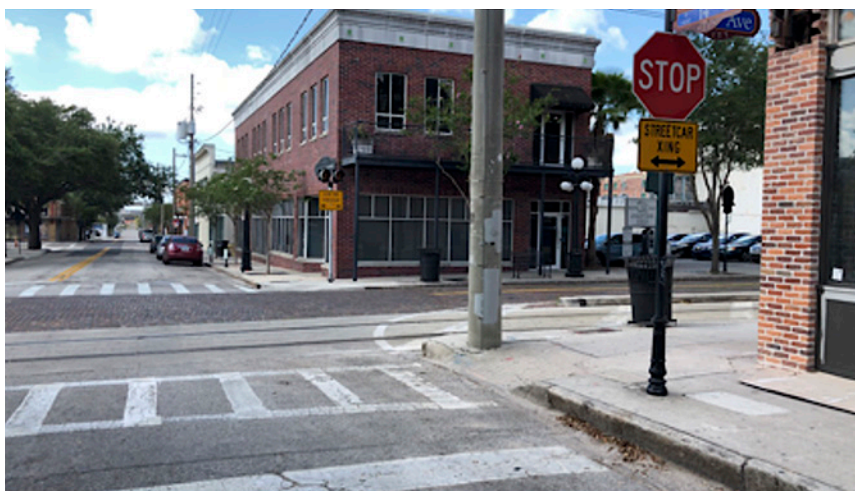
Figure 3-16 *Poor line of sight from cross street*

HART experiences one specific type of collision more than any other. Due to the track configuration being off to one side of the street, vehicles approaching from a cross street on the side nearest the track often encroach onto the tracks while attempting to turn, increasing the risk of getting struck by an oncoming streetcar that cannot immediately stop. The problem motorists encounter when coming to a stop at the designated point is a lack of visibility of traffic on the street where the tracks are located. Having the streetcar tracks and a crosswalk in front of them when stopped at a stop sign often puts motorists in a position where there is not a clear line of sight to the left and/or right to see oncoming traffic, as shown in Figure 3-16.

If a vehicle wants to turn left in the example given in Figure 3-16, it has to move forward onto the tracks to see traffic approaching from the right. Meanwhile, a streetcar could be approaching from the left with no time to stop before colliding with the vehicle on the tracks. This situation also occurs from parking areas located on the track side of the street.

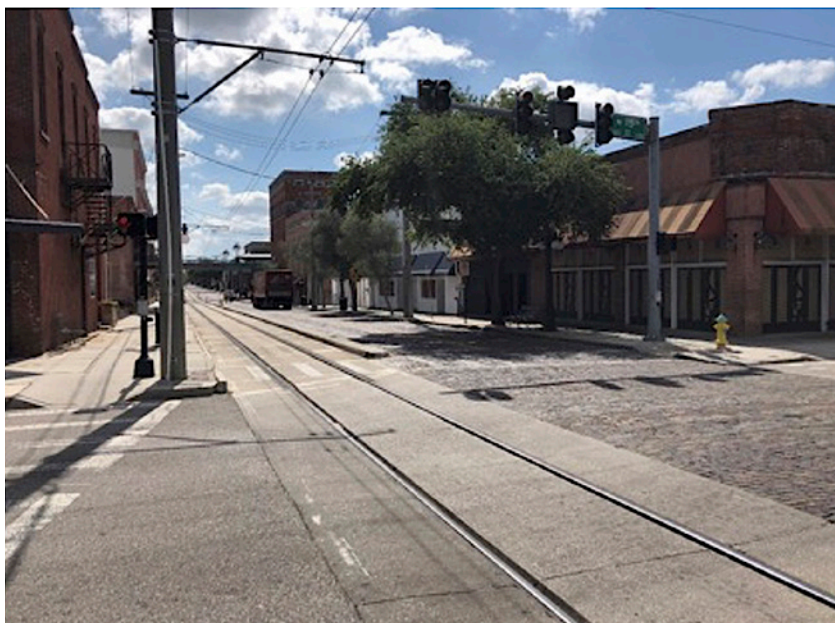
Figure 3-17 Potential right-turn conflict

Another potential hazard in this configuration could arise from vehicles traveling in the same direction as the streetcar; a vehicle driver may not notice the streetcar in their blind spot and turn right into the path of a streetcar. Figure 3-17 shows an example of an intersection at which this potential right-turn conflict could occur.

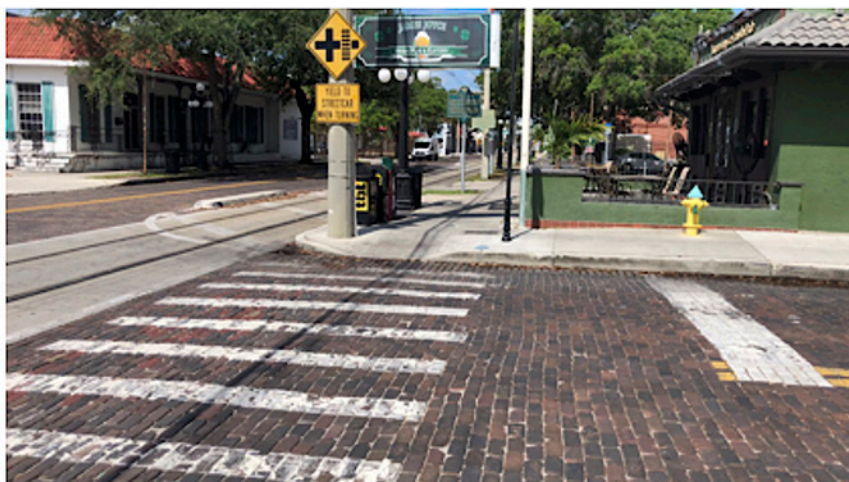
Figure 3-19 *Passive warning signage*

HART uses passive and active signage at grade crossings to warn vehicle operators of the streetcar. An example of active signage is shown in Figure 3-18, which illuminates only when a streetcar is approaching. An example of the passive signage employed at HART is displayed in Figure 3-19.

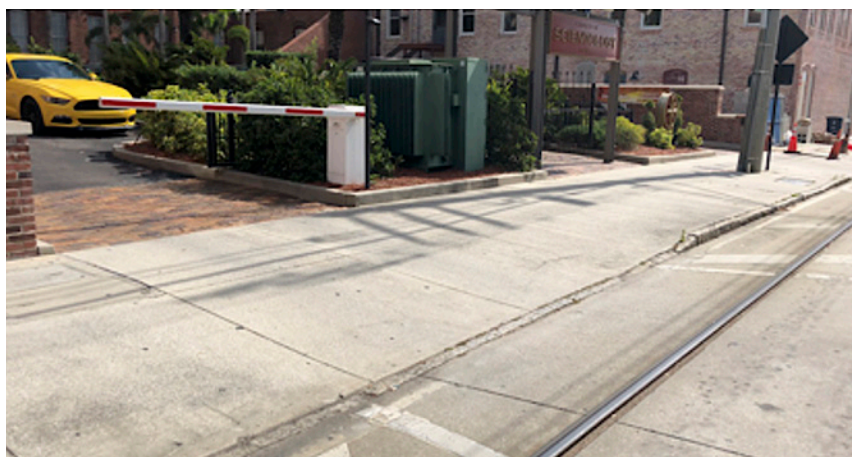
Figure 3-20 *Parking lot-style exit gate*

At one location a parking lot-style gate is used at the exit of a parking lot to prevent vehicles from encroaching onto the tracks when a train is approaching (Figure 3-20). The parking lot-style gate is working well, given the limited space available for mitigation measures in this area.

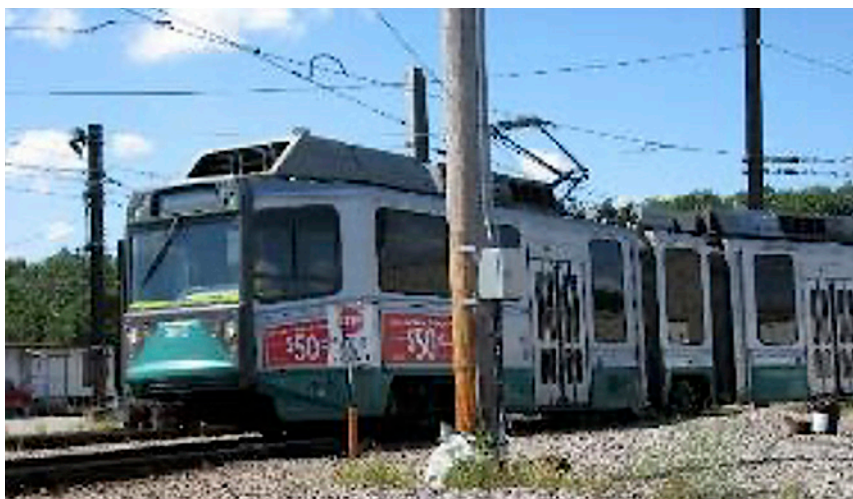
Figure 3-21 Ansaldo Breda Type 8 LRV 3800-3894

- Ansaldo Breda Type 8 LRV 3800-3894 – age 1998–2007 (Figure 3-21)
- Presidents' Conference Committee (PCC) Streetcar vehicles (Figure 3-22)
- Kinki-Sharyo Type 7 LRV vehicles 3700-3719 – age 1997 (Figure 3-23)
- Kinki-Sharyo Type 7 LRV vehicles 3600-3699 – age 1986-1988

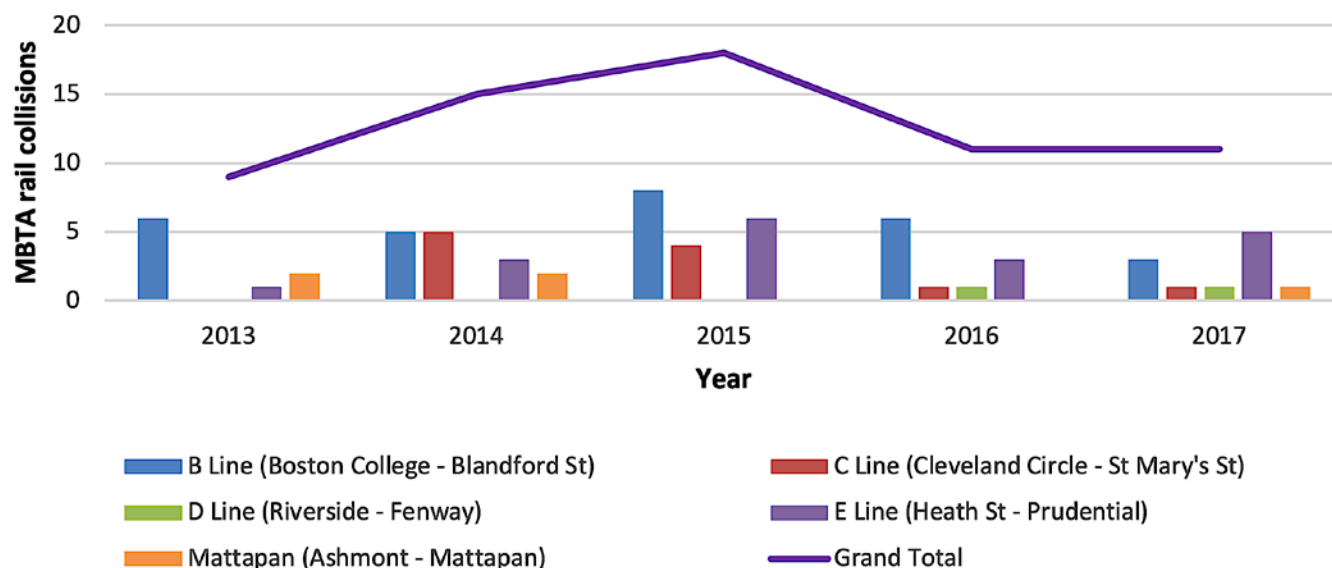
Figure 3-25 MBTA collisions by type, 2013–2017

The onsite review highlighted several areas with potential for collisions due to the age and operating nature of the system. Figure 3-25 shows the number of accidents by location, revealing a low number of recent events in those locations.

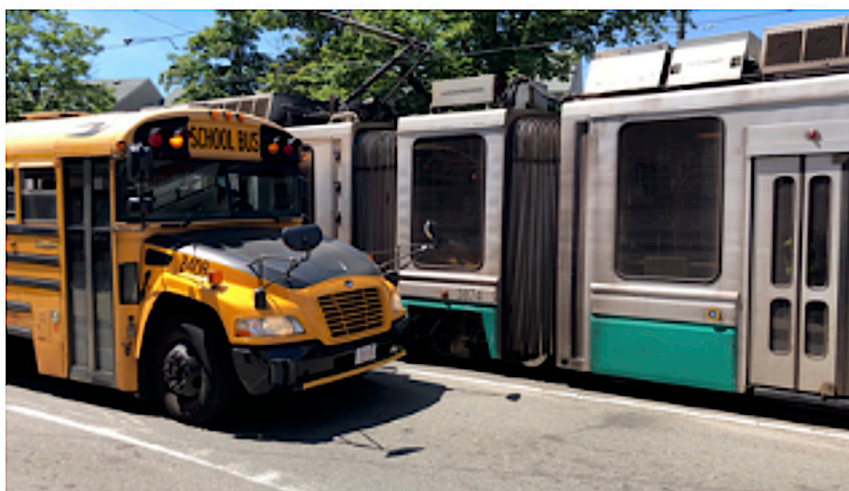
Figure 3-30 *Reduced clearance situation*

MBTA's main light rail segment of concern is the E branch on the Green Line, where the trolley operates in mixed-use traffic, as shown in Figure 3-28. In this area, most collisions are due to public inclination to turn in front of the train, both legally and illegally (Figure 3-29). The agency studied the possibility of implementing guarding systems such as gates, but this segment of the line has limited space for these types of improvements. In shared-lane environments, clearance is also an issue (Figure 3-30), which can result in track fouling and "sideswipe" incidents.

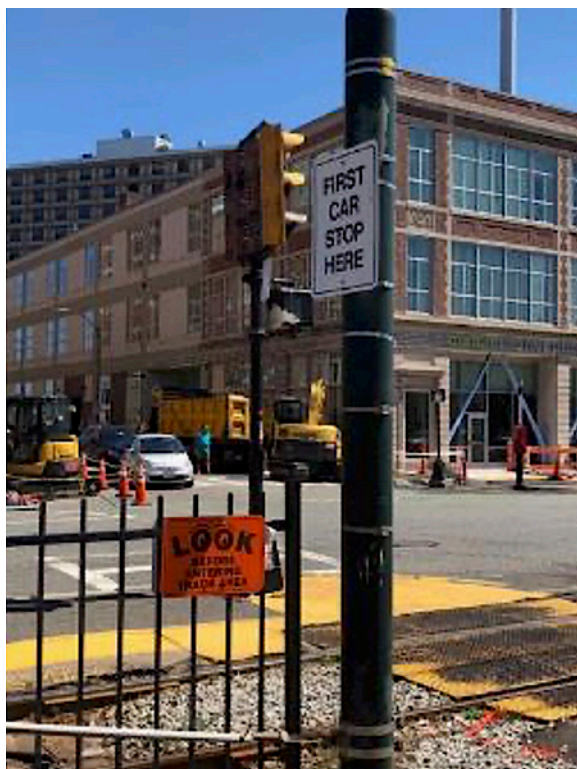
Figure 3-32 Pedestrian signage

There appeared to be minimal physical mitigation implementations for collision avoidance in high-risk locations such as crossings, aside from typical traffic and pedestrian signaling and signage. Signage encouraging pedestrians to look for trains at pedestrian crossings has been installed (Figure 3-32), and most pedestrian crossings are painted yellow to increase their visibility, especially at night (Figure 3-33).

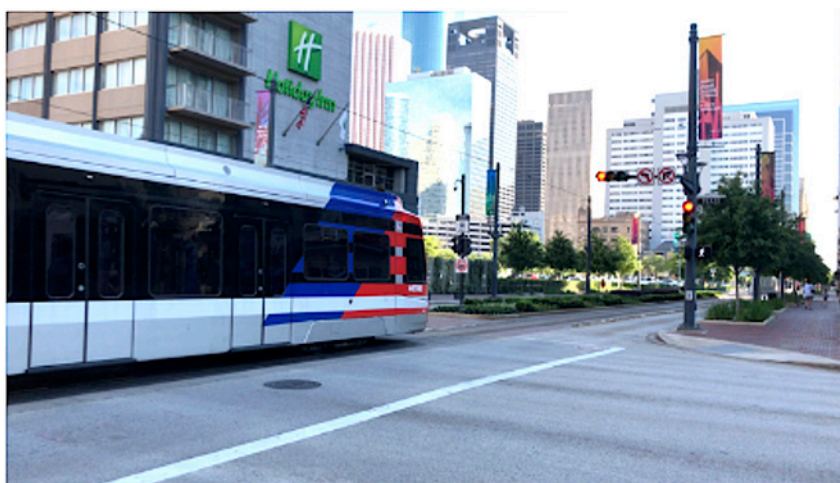
Figure 3-35 Common track configuration

Allowable maximum speeds can vary depending upon location. In most areas where there is high pedestrian and vehicular traffic, this speed is 25 mph; in other locations where the system operates on exclusive right-of-way with gated crossings, maximum speeds reach 40 mph. Figure 3-35 shows a common track configuration, particularly along the Red Line, which consists of two parallel tracks located along street medians with median platforms intermittently placed between the tracks for patron train access. METRO employs approximately 150 train operators, most of whom have fewer than three years of train operating experience.

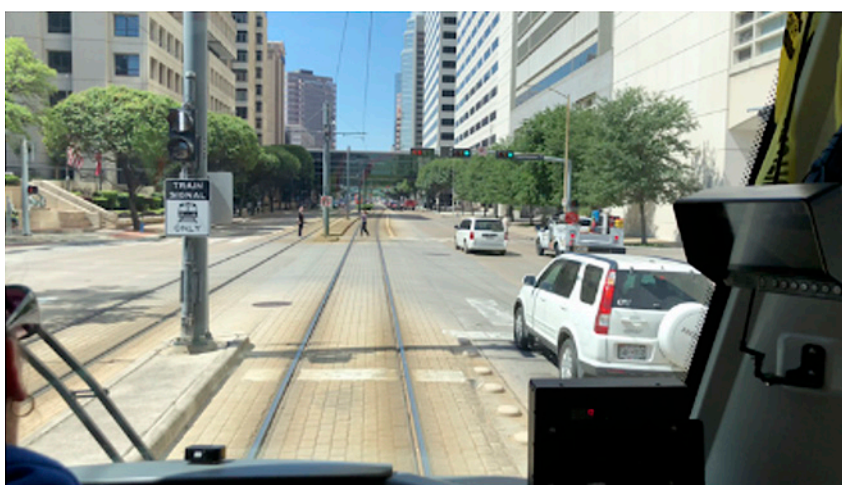
Figure 3-39 Legal left turn from adjacent lane

Another left-turn situation involves a non-shared left-turn lane. In this configuration, the train may strike vehicles attempting to make a left turn from the adjacent lane. This occurs at intersections where it is both legal (with signaling) and illegal (without signaling) to turn left at the intersection. Figure 3-39 and 3-40 are examples of both situations. “Turtleback” delineators are used to prevent vehicles from encroaching upon the rail in these areas.

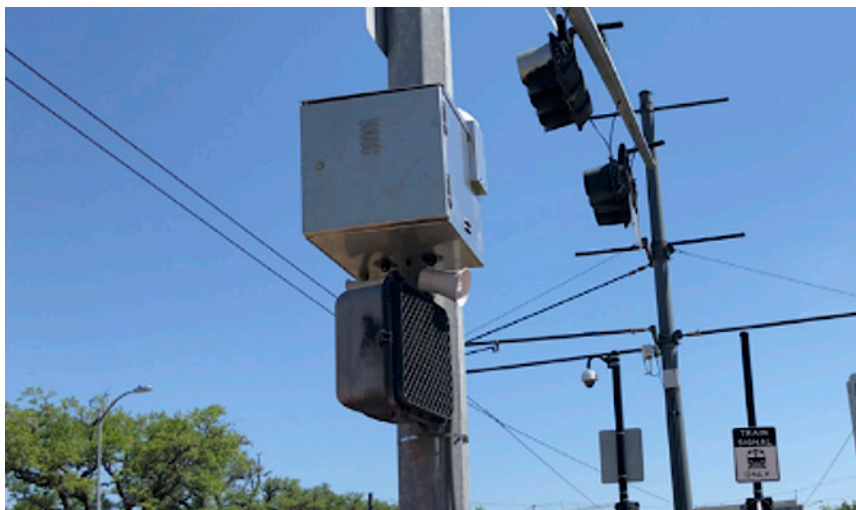
Figure 3-41 Bluetooth-enabled audio warning device

The Red Line that operates in the Medical District presents unique challenges for the agency. Emergency vehicle traffic, substantial pedestrian volumes, and personal vehicle drivers present light rail operators with challenges. METRO, at least partially, credits its thorough and ongoing operator training that focuses on defensive driving and anticipating actions with the successful 13% reduction in incidents along this corridor since 2015. METRO does not rely solely on training to improve system safety. In this section of track, METRO is also piloting a Bluetooth Proximity Alert System (BPAS) technology to alert pedestrians when a train is approaching (Figure 3-41). This system is activated by a Bluetooth beacon on the train when it approaches and begins audible English and Spanish messages that warn pedestrians of an approaching train with an intermittent bell sound. However, it is also activated as the train leaves because there is a Bluetooth beacon at both ends of the train, which potentially causes confusion about whether a train is approaching or departing the area.

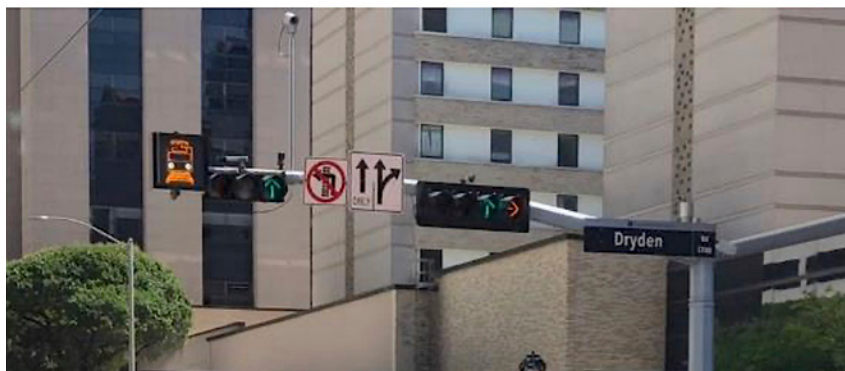
Figure 3-43 Traffic signaling no left turns permitted

METRO uses magnetic train stop technology, which automates a forced stop if a train operator runs a red signal. This technology was implemented to prevent train-on-train collisions. It also uses various high-visibility signage, lighting, and blank-out signs to alert motorists and pedestrians of train traffic, as shown in Figures 3-42 and 3-43.

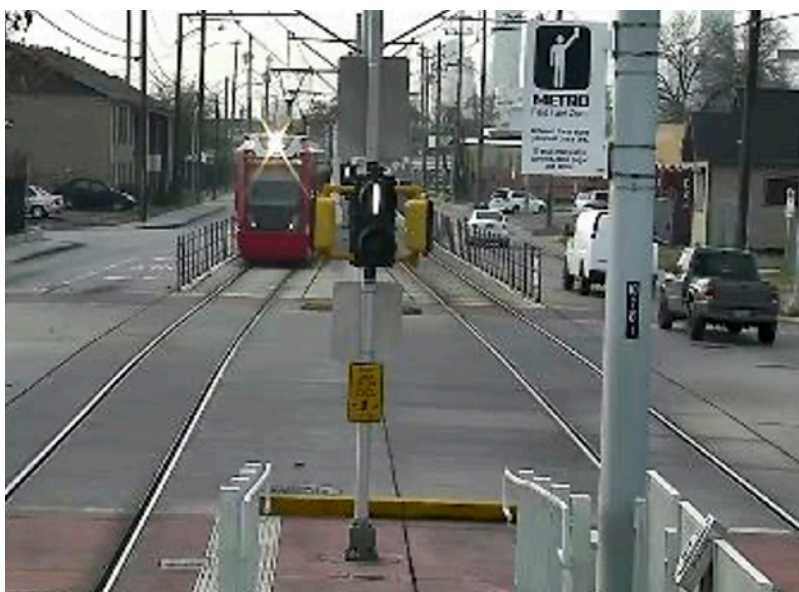
Figure 3-45 Fencing around school zone

areas. By making pedestrian crossing more difficult, the fencing allows for the channelization of pedestrian traffic to the safest crossing areas, where light rail operators are more vigilant and expect pedestrian traffic. METRO has also implemented fencing around school zones to encourage safe behavior, as shown in Figure 3-45.

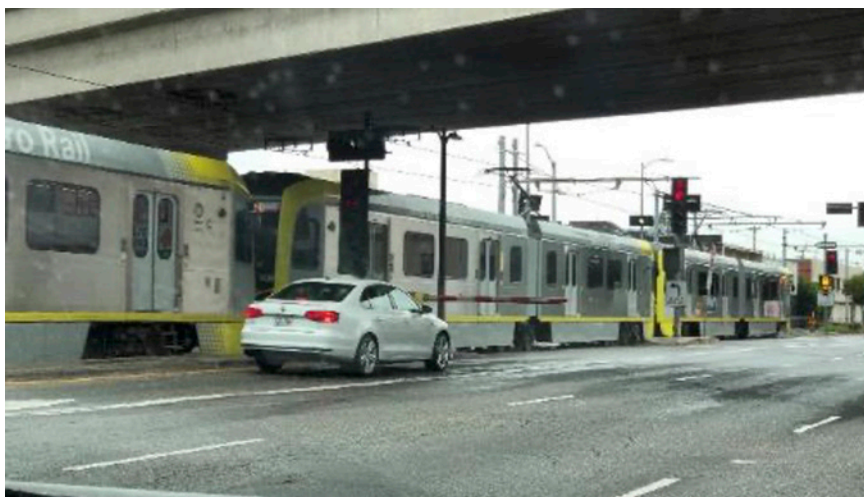
Figure 3-52 Left-turn gate arm

LA Metro is proactive at identifying, analyzing, and mitigating safety issues and concerns and is piloting a new method to reduce collisions between left-turning personal vehicles and trains. This new method consists of installing a gate on the left-turning lane that prevents personal vehicles from entering the track while the train is approaching, as shown in Figure 3-52. The gate arm is interconnected with the traffic signal and is considered a supplemental warning system. The primary safety system is the traffic signal itself. Once the left-turn arrow changes to red, the gate lowers, blocking the lane. LA Metro has been tracking the effectiveness of the pilot; the gating system is expected to be incorporated into the standard design of the Crenshaw Line.

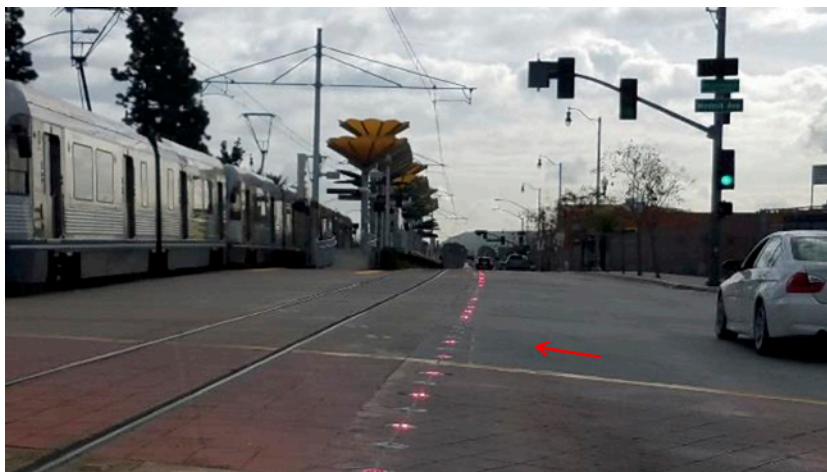
In addition to the left-turn gate pilot project, LA Metro employed internally-illuminated raised pavement markers (IIRPM) at certain crossings along the Gold and Blue lines as a pilot project to mitigate illegal left-hand turns. The IIRPMs can be installed where there is insufficient space to install a left-turn gate system. These red lights, which are installed parallel to the tracks, switch on when the train is approaching the intersection and provide an additional warning to personal vehicle drivers of prohibited left turns. The agency found these lights to be very effective and is evaluating the feasibility of expanding installation at additional locations. The IIRPMs are installed so they can be observed by motorists in the left-turn pocket lane, those who travel perpendicular to the tracks through the intersection, and by pedestrians who use the crosswalk and cross perpendicular to the tracks

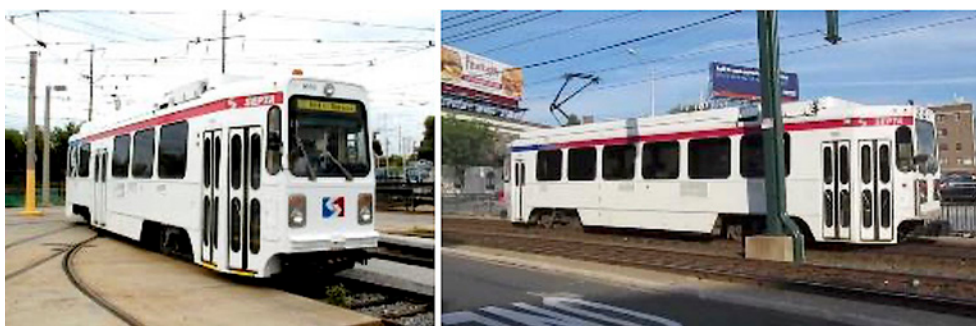
Figure 3-61 Kawasaki Heavy Industries single-ended (left) and double-ended (right) cars

- Kawasaki Heavy Industries (1980–1981) – 141 cars (112 single and 29 double) (Figure 3-61)
- SEPTA Norristown N-5 by ABB Sweden (1993–1994) – 26 cars in total (Figure 3-62)
- President’s Conference Committee (PCC II) car by St. Louis Car – 18 cars used exclusively on Route 15 Trolley Line (Figure 3-63)

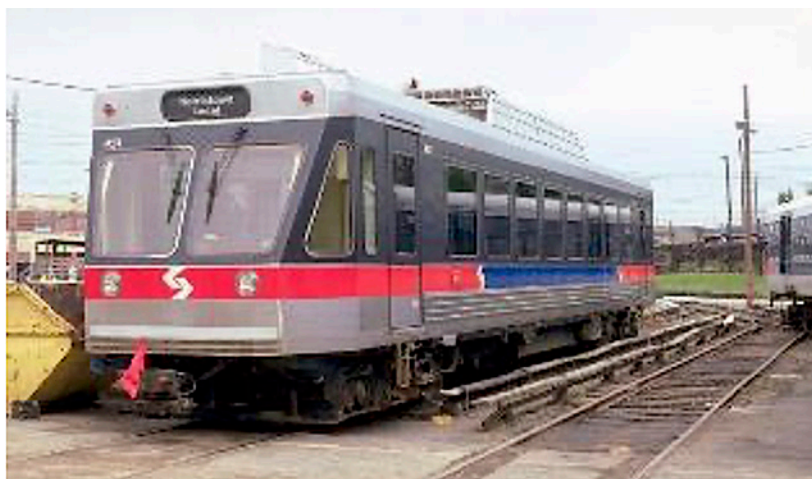
Figure 3-62 Norristown car

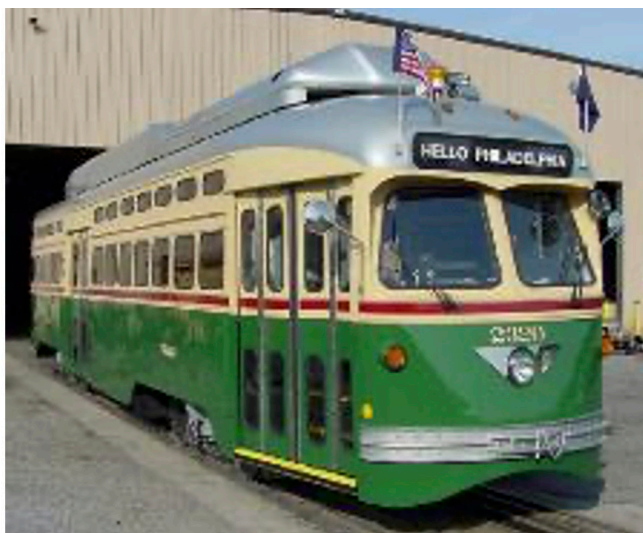
Figure 3-63 PCC II car

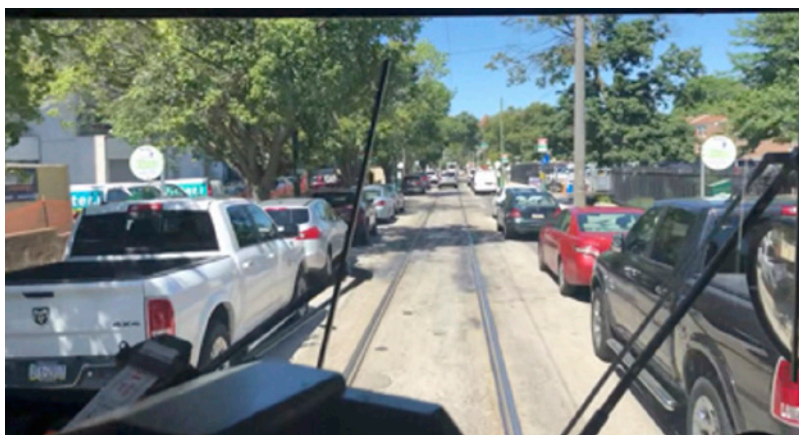
Figure 3-70 Clearance issue due to parked cars

SEPTA's light rail service and trolley lines operate in an environment where trains share lanes with motor vehicles, which is a contributing factor to increased incident rates. Motor vehicles contribute to the many hazards identified by the research team on the case study site visit. The first identified hazard is associated with vehicles either unexpectedly turning or switching lanes in front of an oncoming trolley. As the track transitions from a dedicated lane to a shared lane, the necessary merges (Figure 3-68) create hazard risk. The potential for a hazard occurs where there is a shared lane on a multilane street, as well as at intersections with turn lanes (Figure 3-69). Another common type of collision with vehicles occurs from clearance issues and track fouling. There are single-lane streets where very little clearance is available between the light rail vehicle and parked cars. Operators are trained to recognize the situation, stop service, and have the vehicle moved if necessary (Figure 3-70).

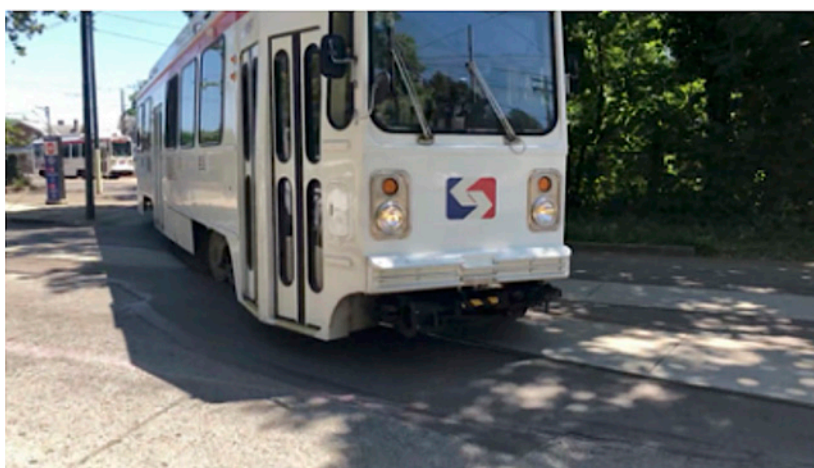
Figure 3-71 Corner of trolley swinging out in curve

Related to clearance and track fouling, one of the most common hazards is due to the front and rear of the trolley swinging out into adjacent traffic lanes on a curve. If operators and motorists are not cognizant of these situations and do not maintain proper lateral distances, resulting collisions could occur (Figures 3-71 and 3-72). To combat this potential hazard, light rail vehicle swing clearance issues are emphasized in new hire training and in annual re-certification training.

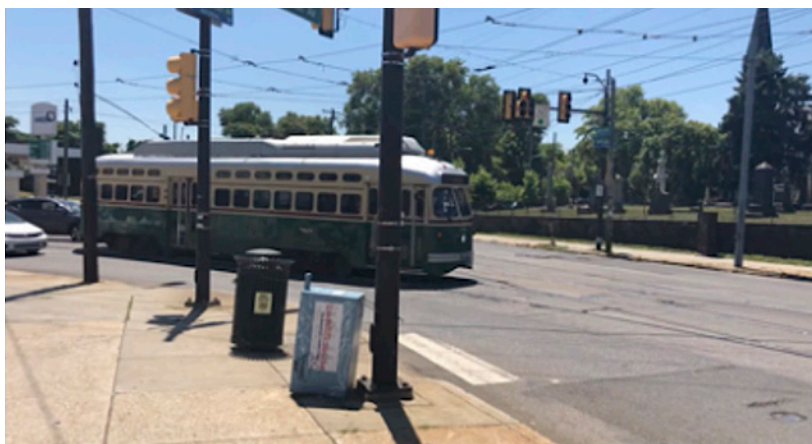
Figure 3-72 Center of PCC II encroaching inside lane

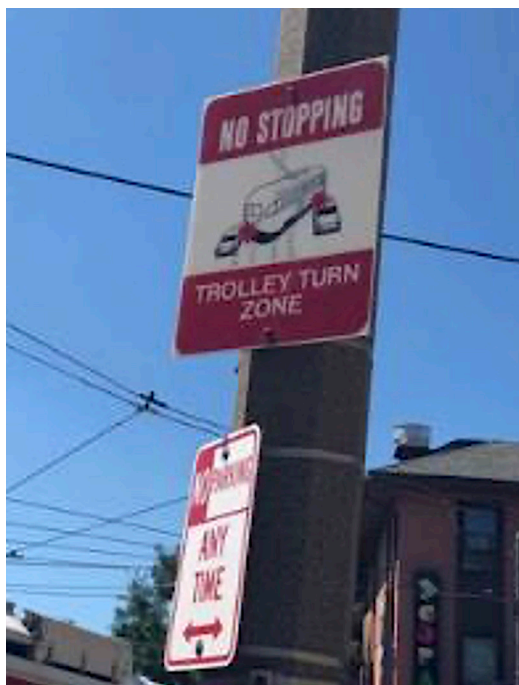
Figure 3-74 Sign illustrating clearance in turn zone

SEPTA uses various signage and common traffic signaling to help maintain public awareness and prevent collisions (Figures 3-73 and 3-74). The agency also conducts extensive public outreach to educate customers and the public on how to stay safe around rail environments.

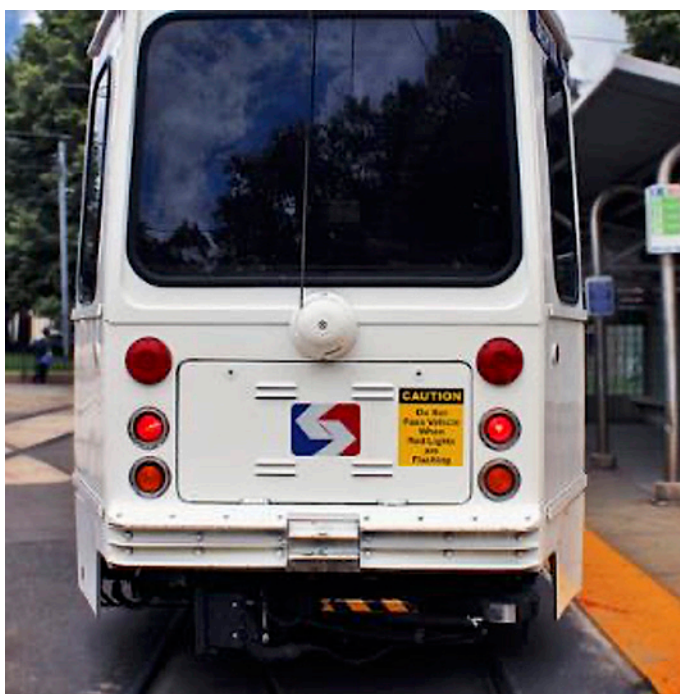
Figure 3-75 “Do Not Pass On Right” sign, back of trolley

SEPTA emphasizes that its light rail operation in Philadelphia predominantly includes traditional streetcar movements in a mixed-traffic, congested, urban environment on narrow streets. Crossings negotiated by SEPTA trolley routes are merely multimodal street intersections. SEPTA's main mitigation actions include operator training (initial and annual refresher), ongoing rules and compliance testing focused on street operations, and signage on the rear of the trolleys alerting drivers to not pass on the right (Figure 3-75).

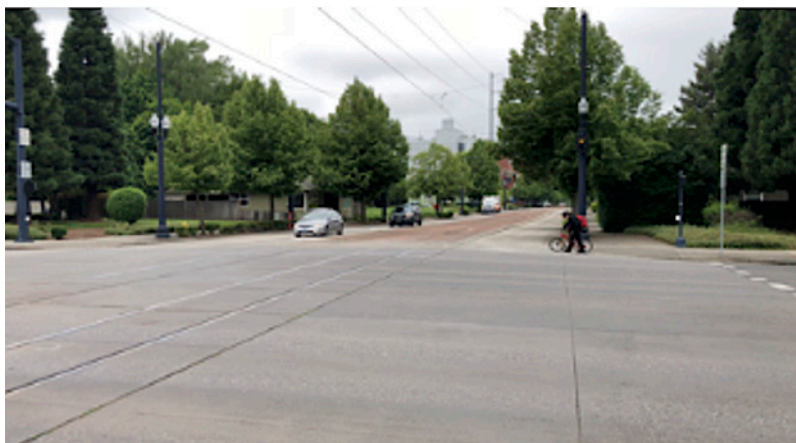
Figure 3-81 *Intersection with tracks in middle*

Along the Blue Line, one intersection in particular tracks transition from the middle of the street to the edge of the roadway and run parallel to traffic, there is potential risk due to reduced line of sight for vehicles (Figures 3-81 and Figure 3-82).

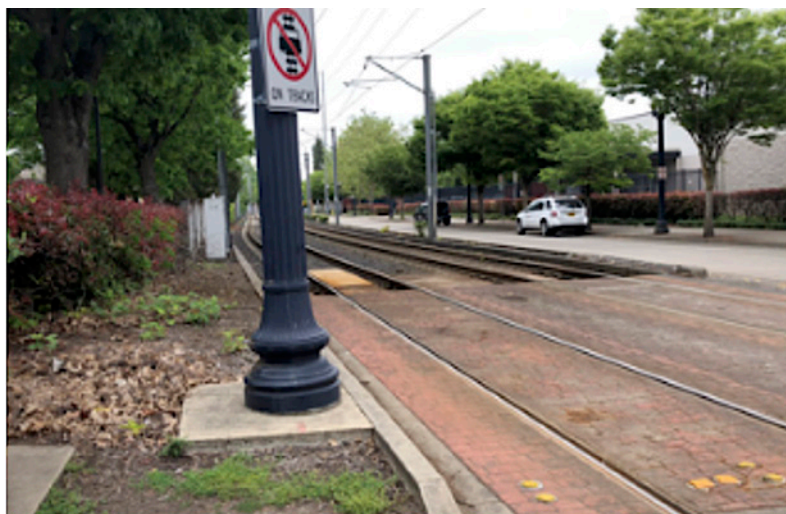
Figure 3-82 *Intersection with tracks to side*

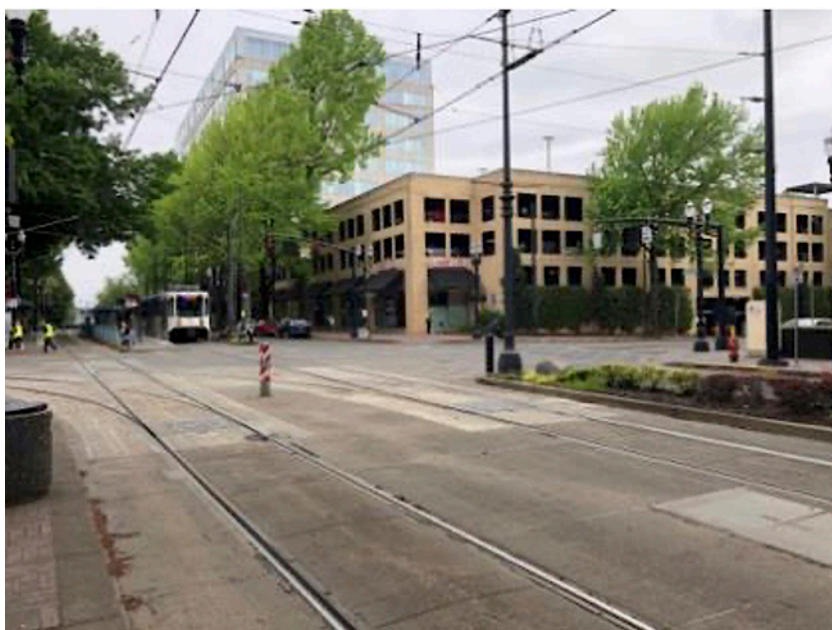
Figure 3-86 Wide rail right-of-way with hazard

The intersection configuration shown in Figure 3-86 highlights the width of the dedicated light rail lane and poor marking visibility, both of which appear to exacerbate the risk of collision with turning personal vehicles, although the number of collisions at this location have been minimal.

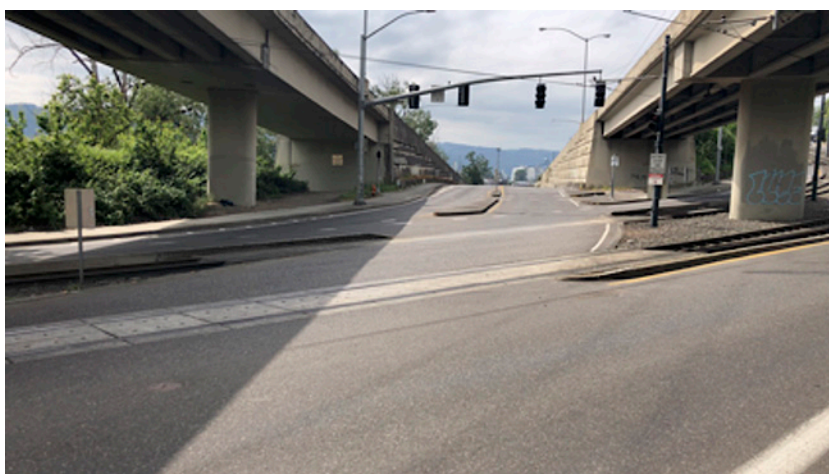
Figure 3-87 Overpass column

Although it does not necessarily occur in similar configurations, the risk of collisions with personal vehicles due to poor line of sight is a hazard at TriMet. Two examples can be seen under Portland bridges where the line of sight is blocked due to an overpass column (Figure 3-87) or due to nearby buildings (Figure 3-88).

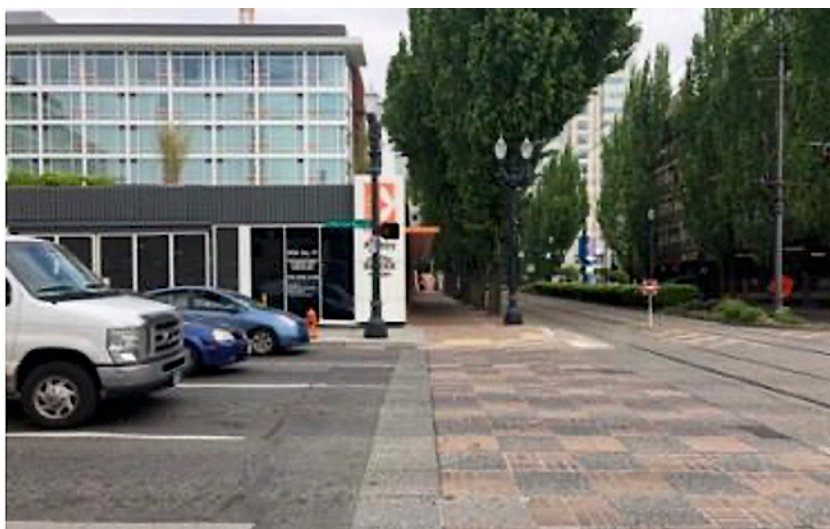
Figure 3-88 Building and vegetation

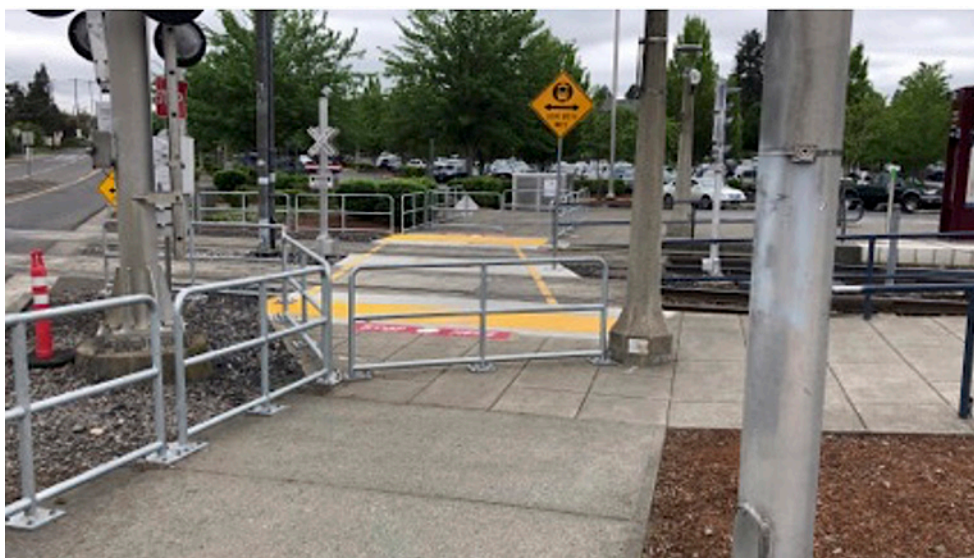
Figure 3-92 Channelized pedestrian crossing

TriMet recently improved more of its pedestrian crossings using channelization (Figure 3-92) and one-way swing gates (Figure 3-93). The agency has employed these types of treatments at higher collision risk intersections since the late

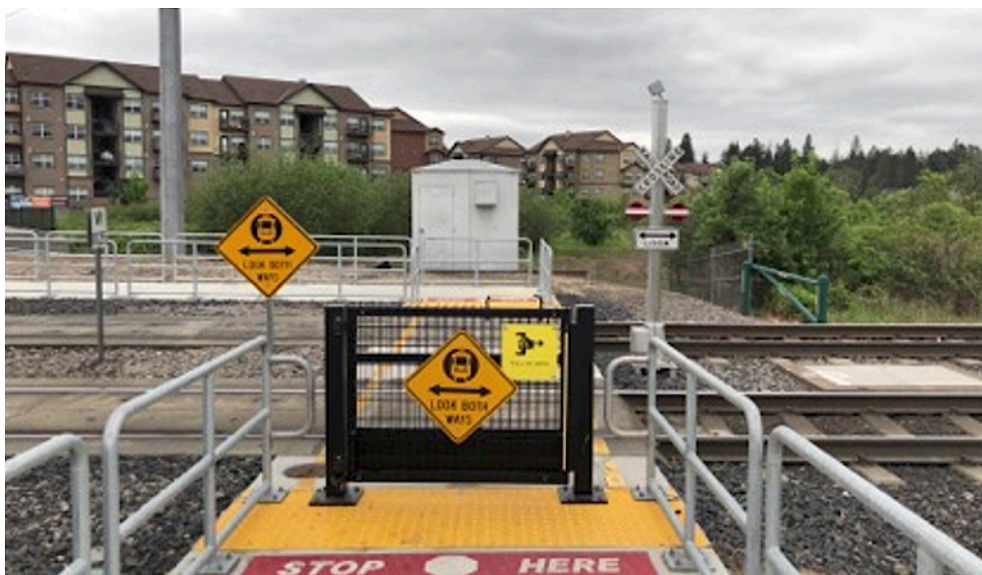
Figure 3-93 Swing gate

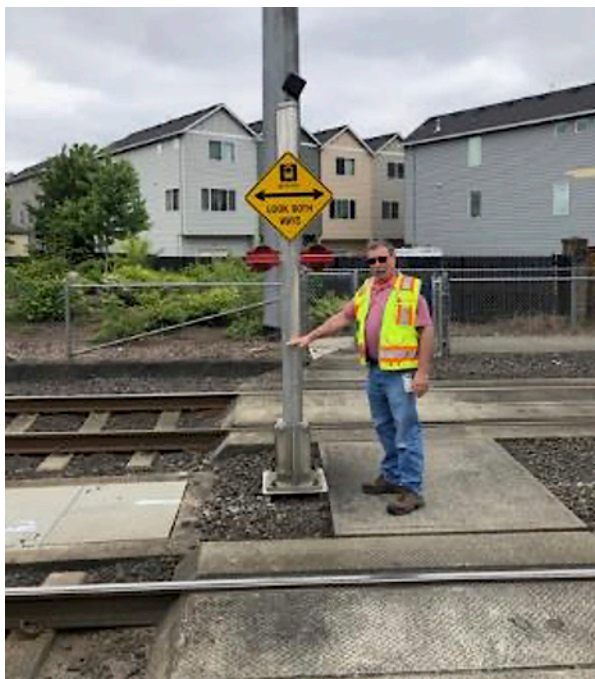
Figure 3-94 Pedestrian warning polder

1990s. It also installed a newly-designed pedestrian warning pole equipped with an audible warning bell, flashing red lights, and a passive “Look Both Ways” warning sign (Figure 3-94).
