Research Report and Findings: Light Rail Technology Scan and Case Studies

OCTOBER 2022

FTA Report No. 0234

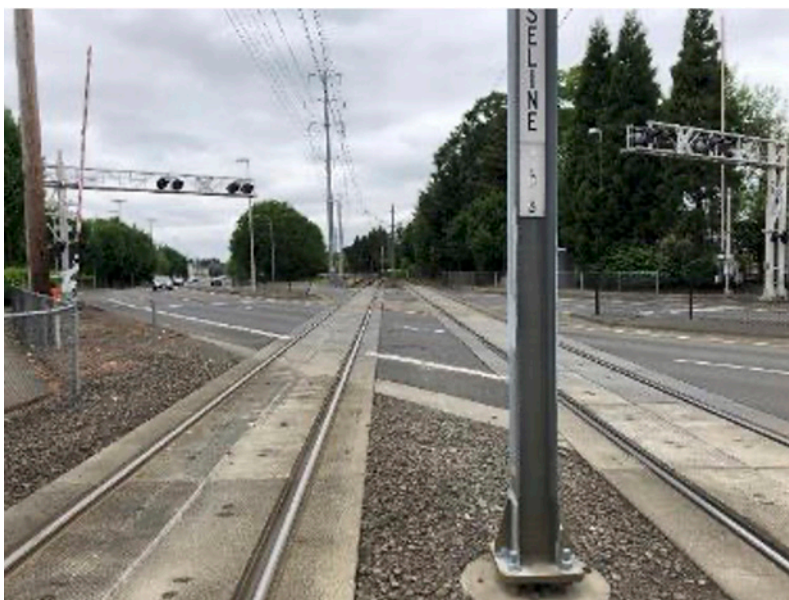
Figure 3-95 Gated crossing

Where the space for installation is available, many of TriMet’s crossings are protected by gates (Figure 3-95). Additionally, it is important to note that the MAX service traverses through several different municipalities, each of which is responsible for signage and traffic signaling. TriMet, however, maintains the crossing gates. The agency uses coordinated communication to ensure that all signage and gating are regularly maintained.

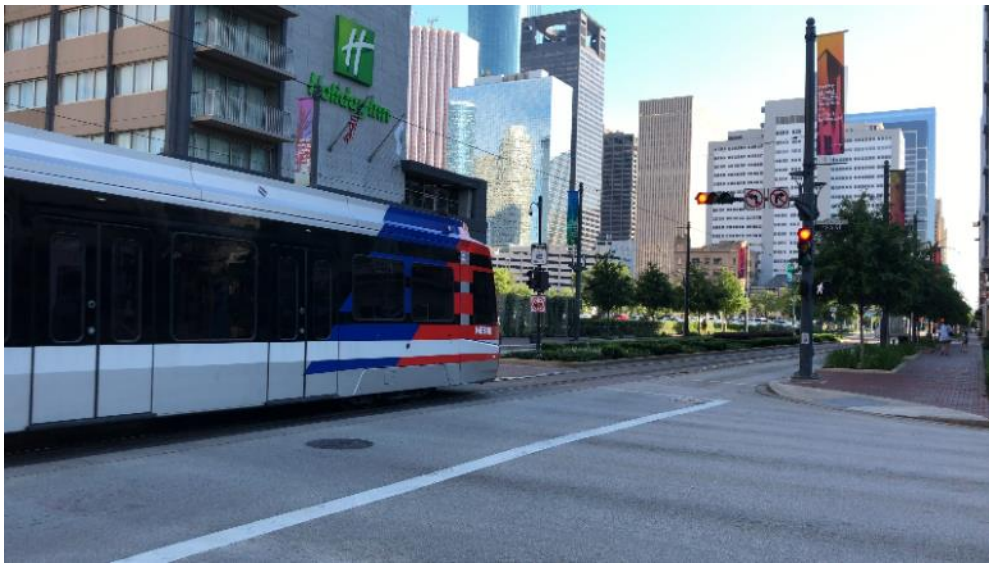
The Metropolitan Transit Authority of Harris County, Texas, operates in the greater metropolitan area of Houston. The light rail service, known as METRORail, is approximately a 23-mile system comprising three lines of service—Red, Green, and Purple. The system is constructed almost entirely at-grade with street level, having both dedicated and shared lanes with vehicular traffic in densely populated areas. Allowable maximum speeds vary depending upon location. In most areas where there is high pedestrian traffic and vehicular traffic, this speed is 25 mph. In other locations where they have exclusive right-of-way with gated crossings maximum speeds can reach 45 mph. Figure 1 illustrates a common track configuration, particularly along the Red Line, consisting of two parallel tracks located along the street median with platforms intermittently placed between the tracks in the median for patron access.

Figure 1: Common track configuration

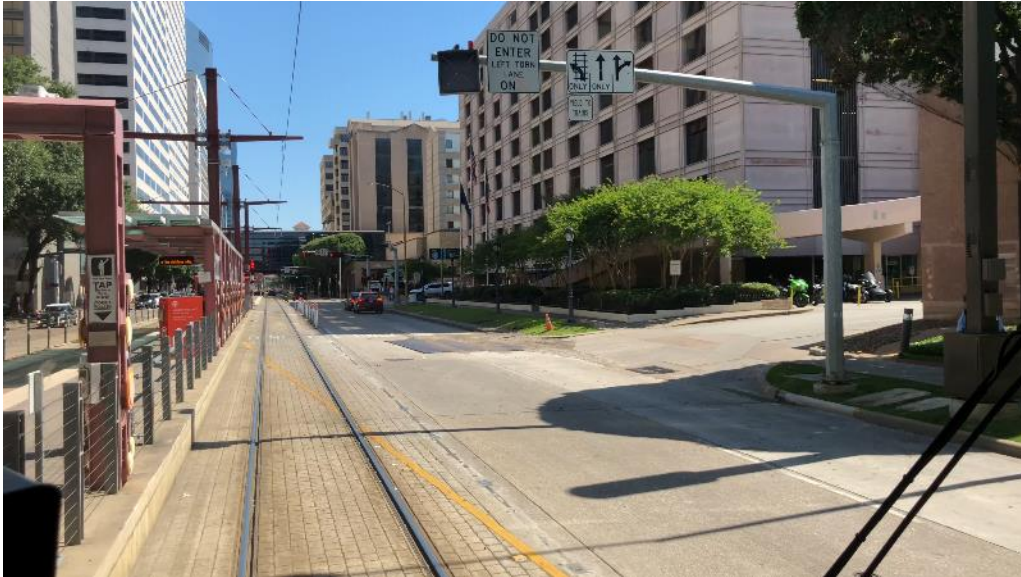
Figure 2: Shared left turn lane

The majority of collisions METRORail experiences with the public are with personal vehicles. Among these collisions, the majority can be categorized into two types of events. The most common involves vehicles turning into the path of the train. More specifically, these turning incidents are usually left-hand turns. Given the common track configuration of having the tracks in the middle of the street, vehicles making left-hand turns need to cross the track to do so. In locations where it is legal to do so, the left-hand turn lane is sometimes shared with the train. See Figure 2. In this configuration, personal vehicles will attempt to enter the left-turn lane while a train is approaching from behind, likely in the vehicle's blind spot, and get struck by the train despite signage warning vehicles of approaching trains.

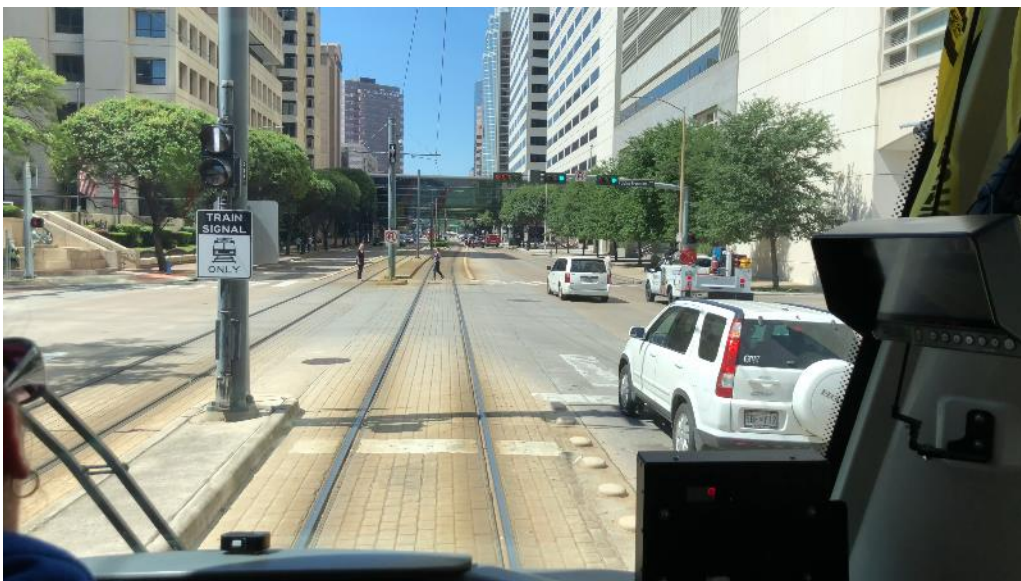
Figure 3: Legal left turn from adjacent lane

The other common occurrence involving left turns is in situations where there is no shared left-turn lane. In this configuration, vehicles will attempt to make a left turn from the adjacent lane and get struck by the train. This occurs at intersections where it is both legal (when signaled to do so) and illegal (always) to turn left at the intersection. Figures 3 and 4 are examples of both situations. The second most common type of collision event involves vehicles running red lights at cross street intersections. Some of the higher-incident cross streets appear to have relatively higher volumes of traffic that lead to highway access points.

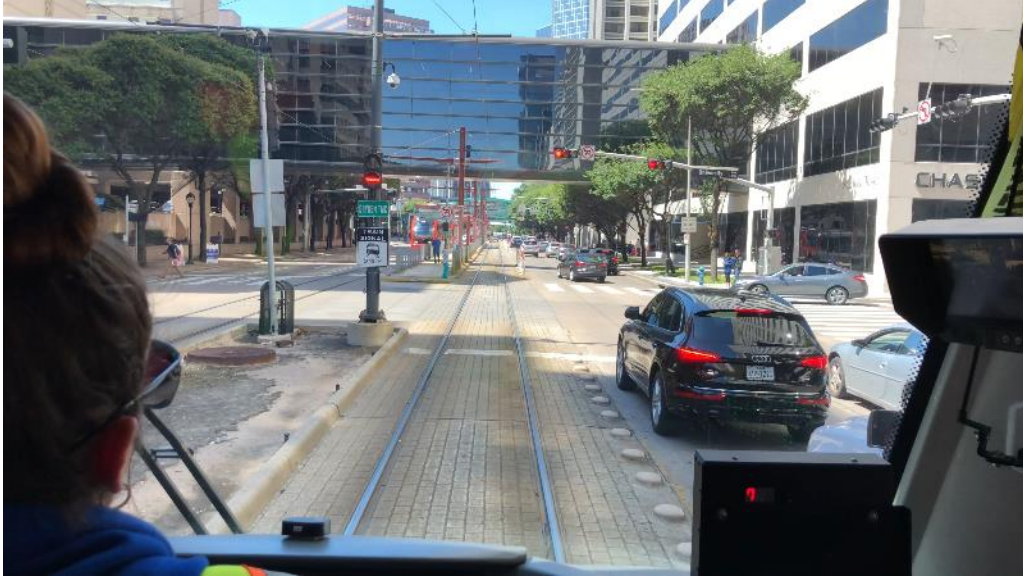
Figure 4: Illegal left turn from adjacent lane

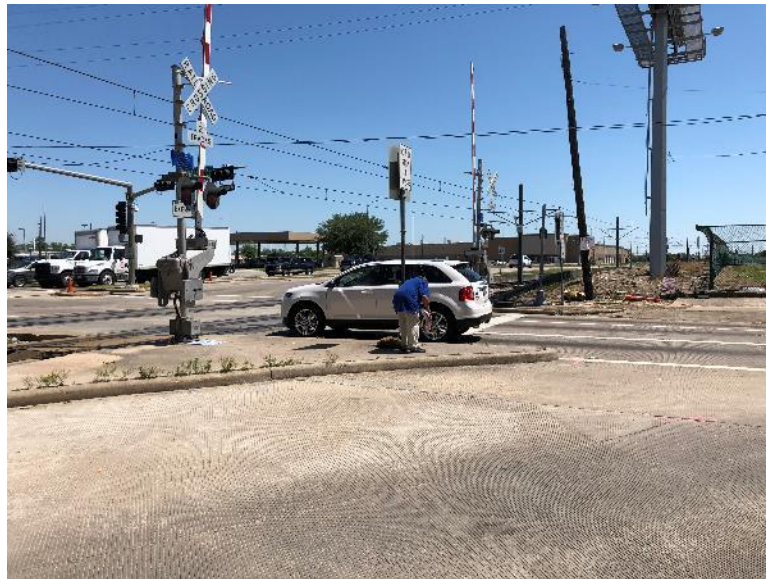
Traditional gated crossings tend to be used when there is enough space to employ them (Figure 7). Physical barriers also are employed to delineate and separate dedicated lanes. In some areas where dedicated lanes become shared left-turn lanes, plastic delineators are used (Figure 8). “Turtlebacks” also are used as deterrents to prevent cars from encroaching into a dedicated rail lane (Figure 9). Finally, fencing appears to be used where there is less cross traffic (Figure 10).

Figure 7: Gated crossing

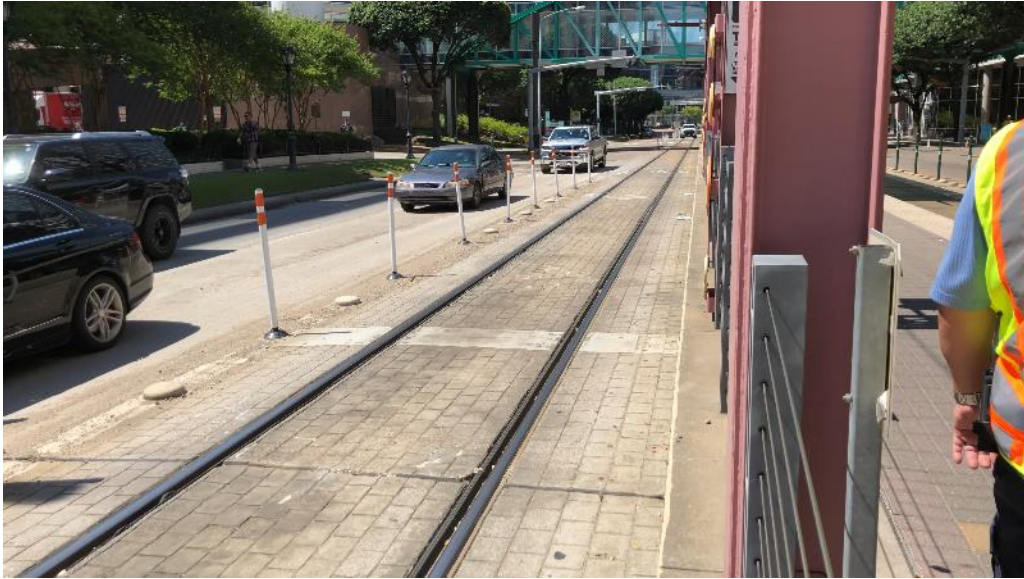
Figure 8: Plastic delineators

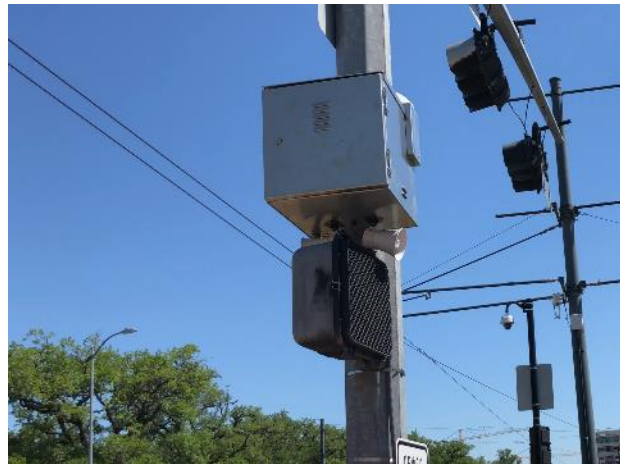
Figure 11: Bluetooth-enabled audio warning device

Pedestrian crossings usually have well-defined crosswalks providing areas of refuge where needed. In one particular area where a high-profile fatality occurred with a cyclist, an experimental audible system is employed for approaching trains. This system is activated by a Bluetooth beacon on the train when it approaches and begins an audible message in both English and Spanish warning pedestrians of an approaching train with an intermittent bell sound. See Figure 11. Unfortunately, it also was activated as the train left due to the fact that there is a Bluetooth beacon at both ends of the train. This caused some confusion about whether or not a train was coming or going at times.

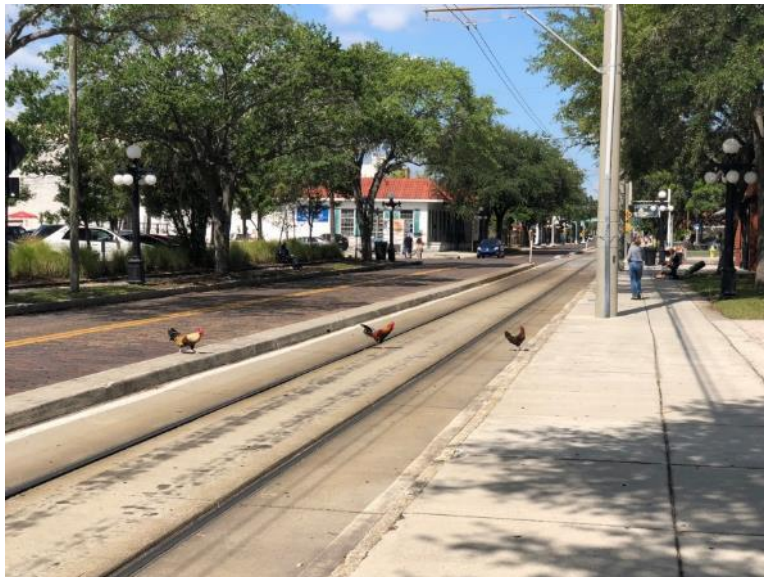
Hillsborough Area Regional Transit, also known as HART, services the area of Tampa, Florida. HART has a small streetcar system on a single line that is about 2.7 miles long servicing the downtown and some of the surrounding areas of Tampa Bay. It operates at street grade in its own separated lane; occasionally, it operates on ballasted track in an exclusive right-of-way. The maximum operating speed is approximately 20 mph. A typical track configuration has the track off to one side of the road using a small concrete median to separate the streetcar lane from vehicular traffic. See Figure 12.

Figure 12: Typical track configuration

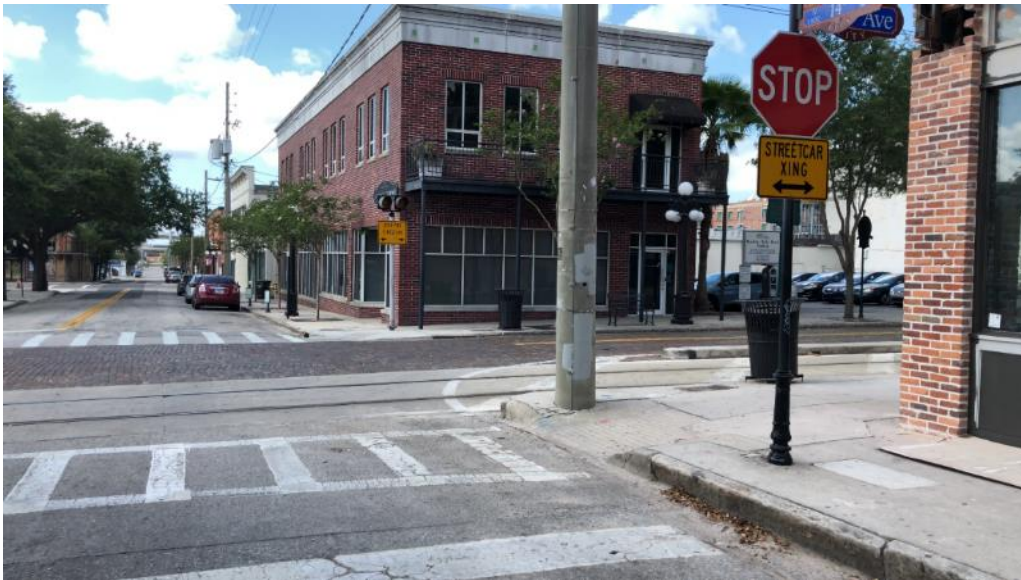
Figure 13: Poor line of sight from cross street

HART experiences one specific type of collision more than any other. Due to the given track configuration being off to one side of the street, vehicles approach from a cross street on the side where the track is often encroached while attempting to turn and get struck by an oncoming streetcar that has no time to stop. The problem some motorists encounter is a lack of visibility of traffic on the street where the tracks are when coming to a stop at the designated point. Having the streetcar tracks and a crosswalk in front of them when stopped at a stop sign often puts them in a position where there is not a clear line of sight to the left and or right to see oncoming traffic. See Figure 13 for an example of this situation.

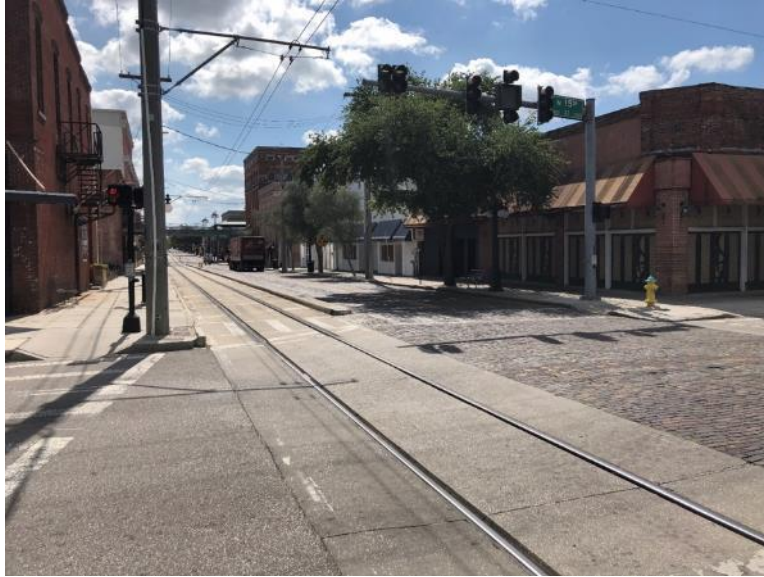
Figure 14: Potential right-turn conflict

Another potential hazard given this configuration could arise from vehicles traveling in the same direction as the streetcar. In this situation, a vehicle may not notice the streetcar in their blind spot and turn right into the path of a streetcar. See Figure 14 for an example of an intersection where this could occur.

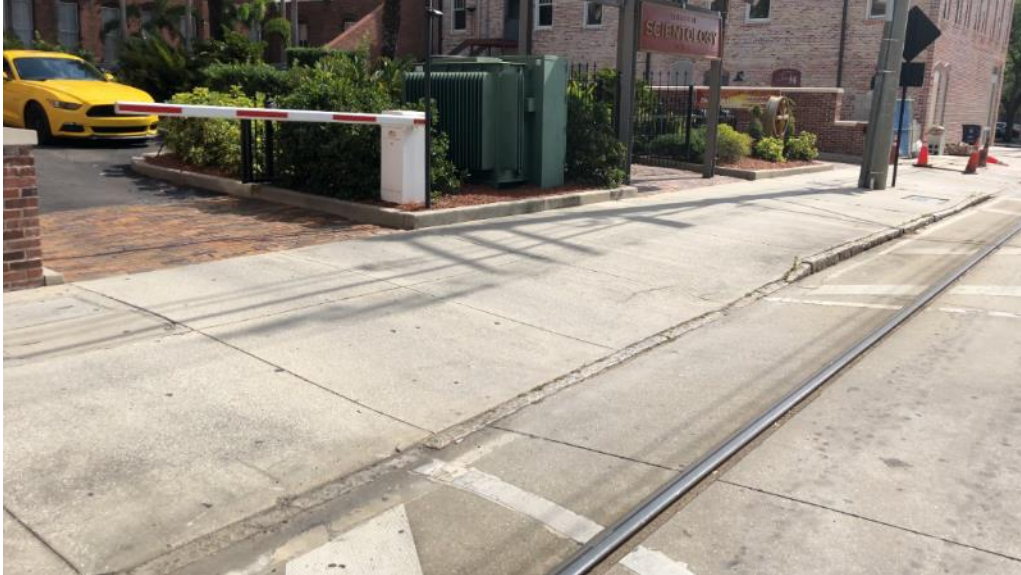
HART employs the use of signage and lights at crossings like those shown in Figure 15. There is one location where a parking lot-style gate is used at the exit of a parking lot to prevent vehicles from encroaching onto the tracks when a train is approaching (Figure 16).

Figure 16: Parking lot exit gate

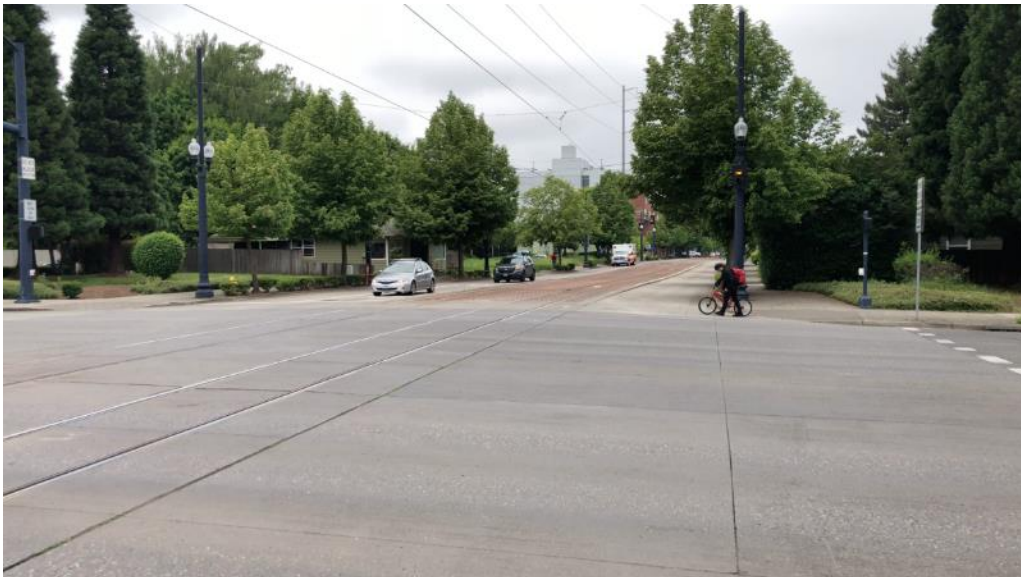
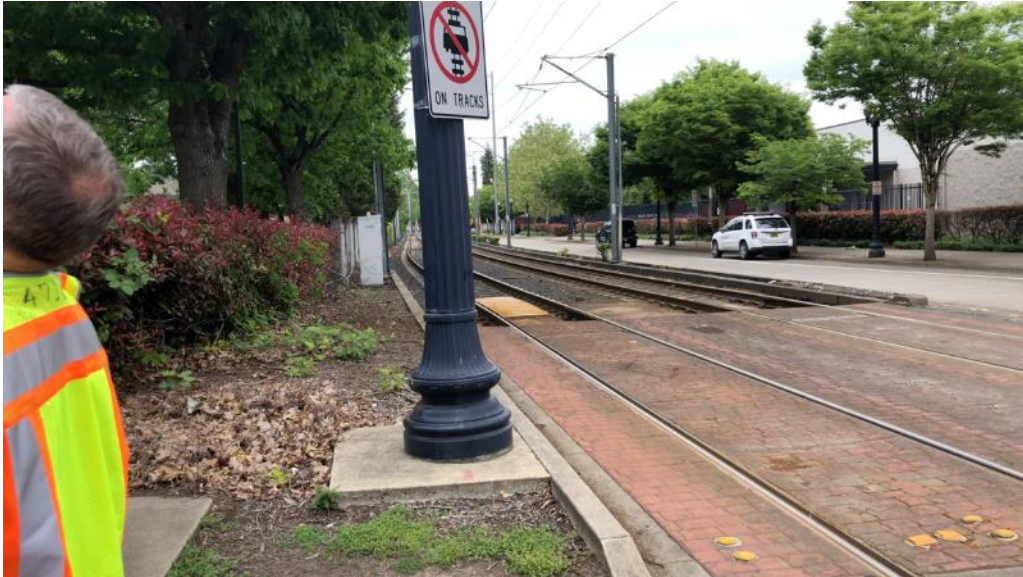
The 10th Avenue and Washington Street intersection in the Hillsboro Area, along the Blue Line, is where the tracks transition from the middle of the street on one side of the intersection to the side of the street on the other side of the intersection. This causes line of sight issues for vehicles coming from one direction. See Figures 17 and 18.

Figure 17: West side of intersection (tracks in middle)

Figure 18: East side of intersection (tracks to side)

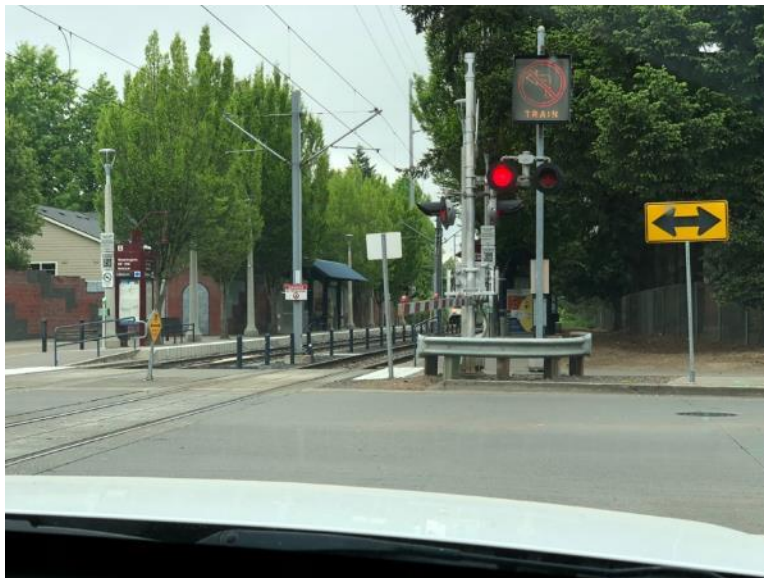
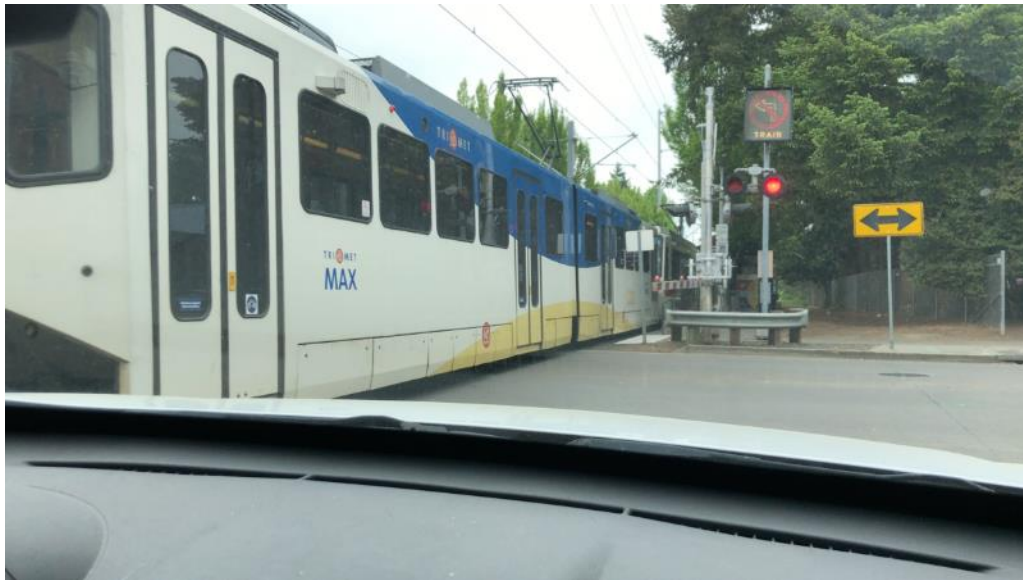
At another intersection, 12th Avenue and Washington Street (also Hillsboro), Washington Street runs parallel with the tracks that comes to a gated cross street, 12th Avenue. The gate controls traffic only on 12th Avenue, making it easy for traffic to potentially make a left turn onto the tracks from Washington Street. See Figures 19 and 20.

Figure 19: Parallel street at gated crossing

Figure 20: Parallel street at gated crossing

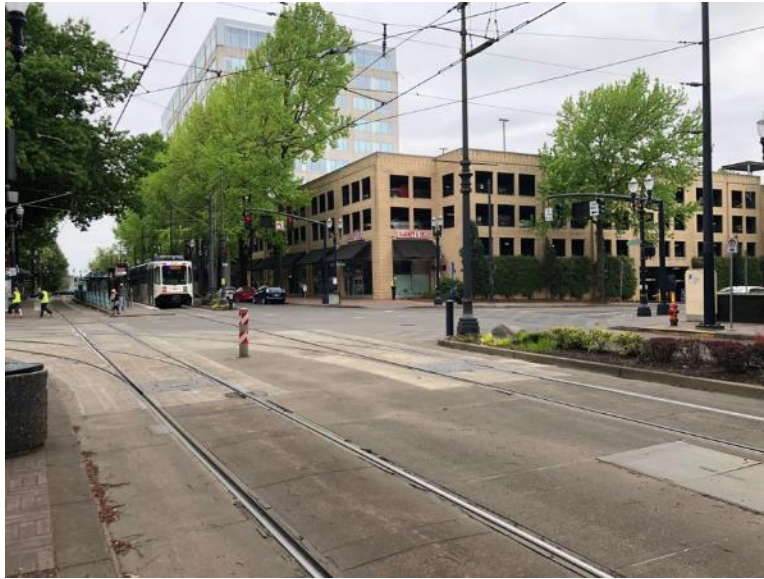
Figure 22: Holladay and 11th turning hazard

At Holladay and 11th Avenue, MAX light rail experiences a high risk of collisions with personal vehicles turning into the path of the train. Given the configuration, this could occur from multiple directions. The width of the dedicated light rail lane with poor markings appears to exacerbate the situation. See Figure 22.

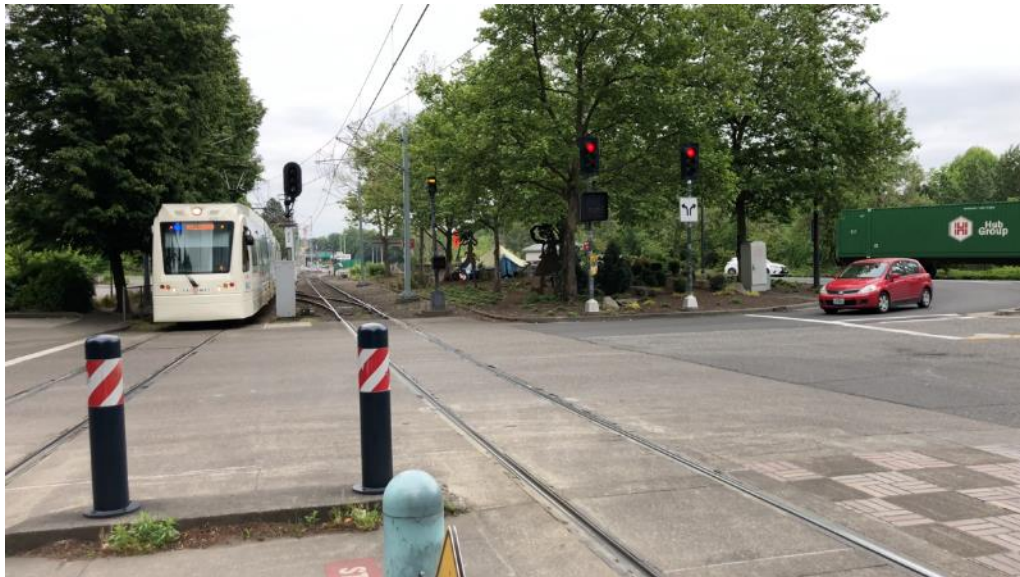
Figure 23: Exit ramp hazard

Not far from Holladay and 11th is a location where an exit ramp from a highway, I-84, unloads at a location next to the tracks. See Figure 23. In the figure, the exit ramp is to the right. Vehicles exiting the highway are traveling at relatively high speeds and come around a blind curve that deposits them right at a crossing. This is a potentially dangerous situation that requires better traffic control of personal vehicles on the exit ramp.

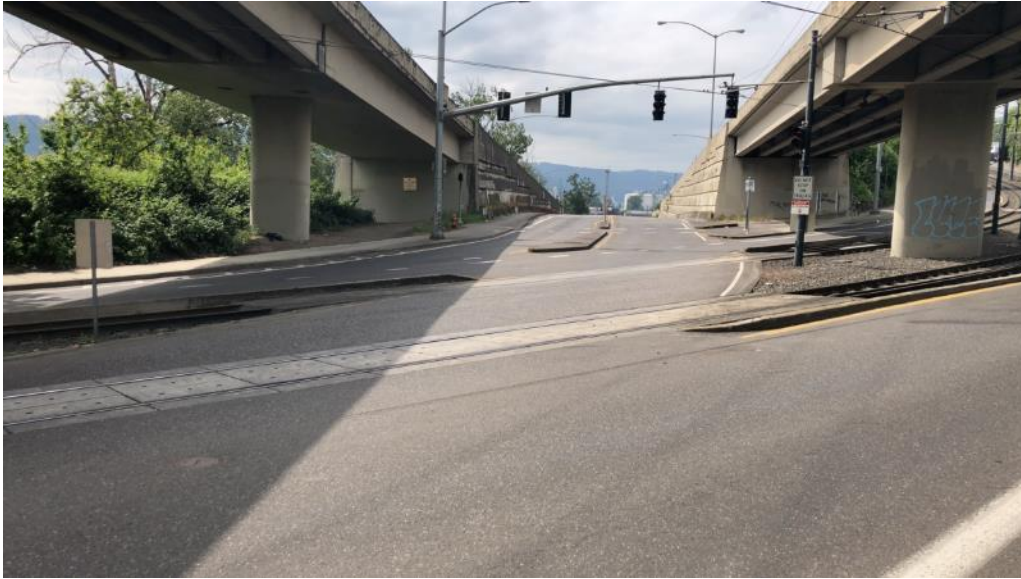
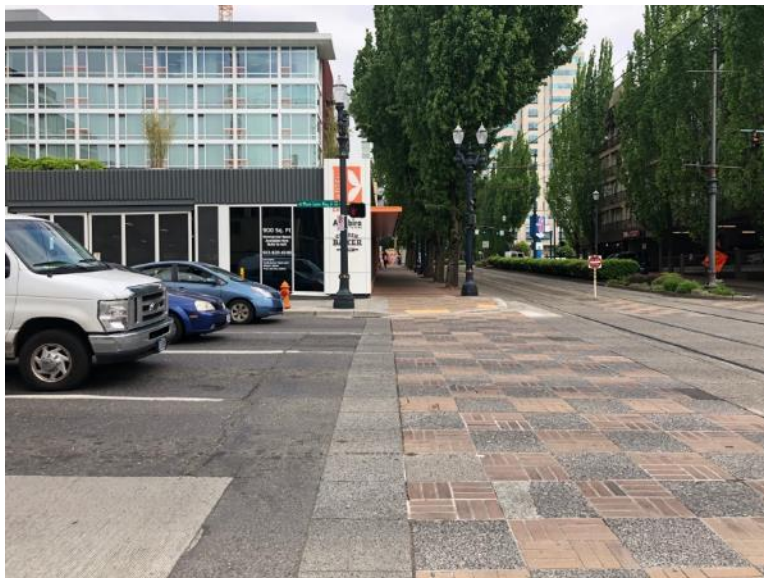
Although they do not necessarily occur in similar configurations, collisions with personal vehicles due to poor line of sight is an occurrence of note in Portland. Figure 24 illustrates an example where line of sight is blocked due to an overpass column. Figure 25 shows an example of poor line of sight due to nearby buildings.

Figure 24: Overpass column

Figure 25: Buildings and vegetation

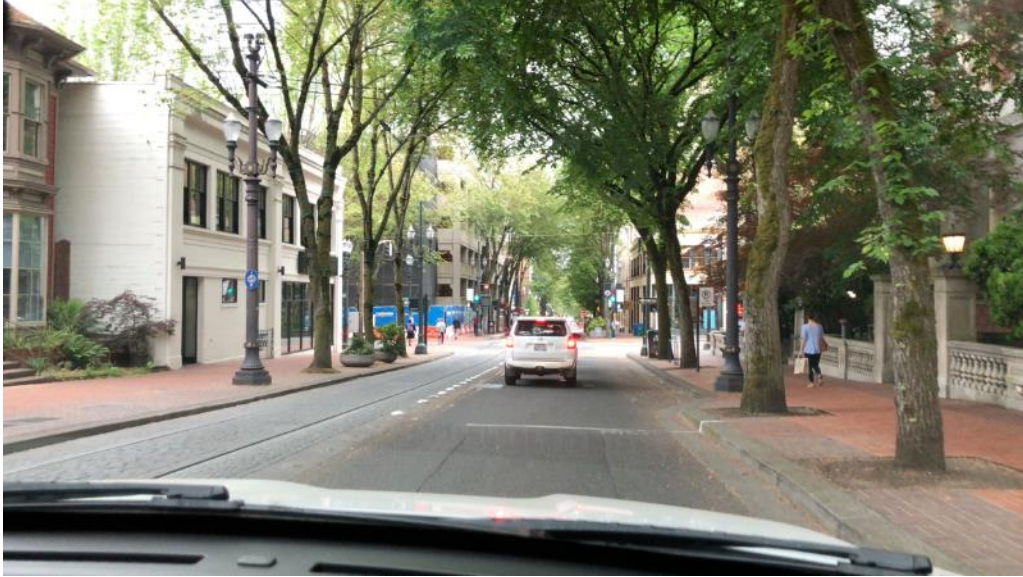
Figure 26: Downtown Portland

The downtown area poses a special situation that causes collisions with personal vehicles as well. Like most downtown areas, there are many one-way streets, and the tracks are located to one side of the street in a dedicated lane. However, the only thing delineating the two lanes is turtlebacks, many of which are either missing or degraded. The street lanes are narrow, and it is common for a vehicle to stop in the street, blocking traffic behind. The blocked traffic will then proceed to go around the parked car using the light rail lane to the left. Sometimes when doing so, they go directly into an approaching train's path. See Figure 26.

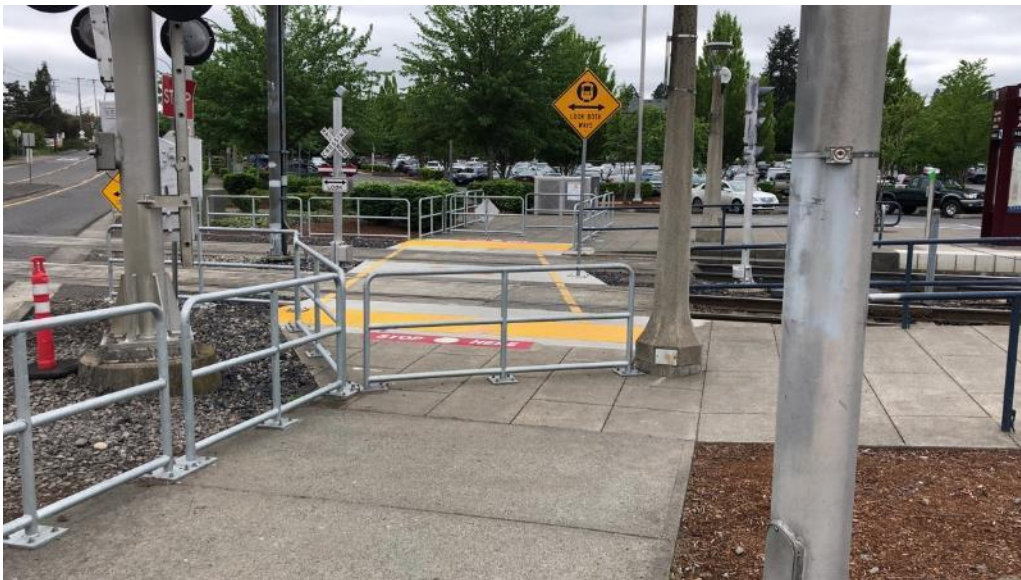
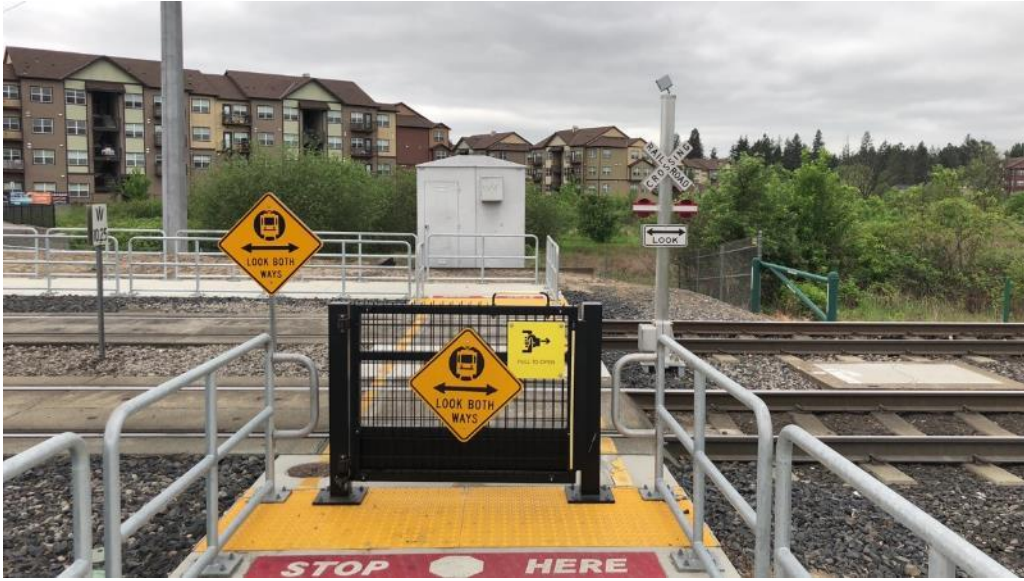
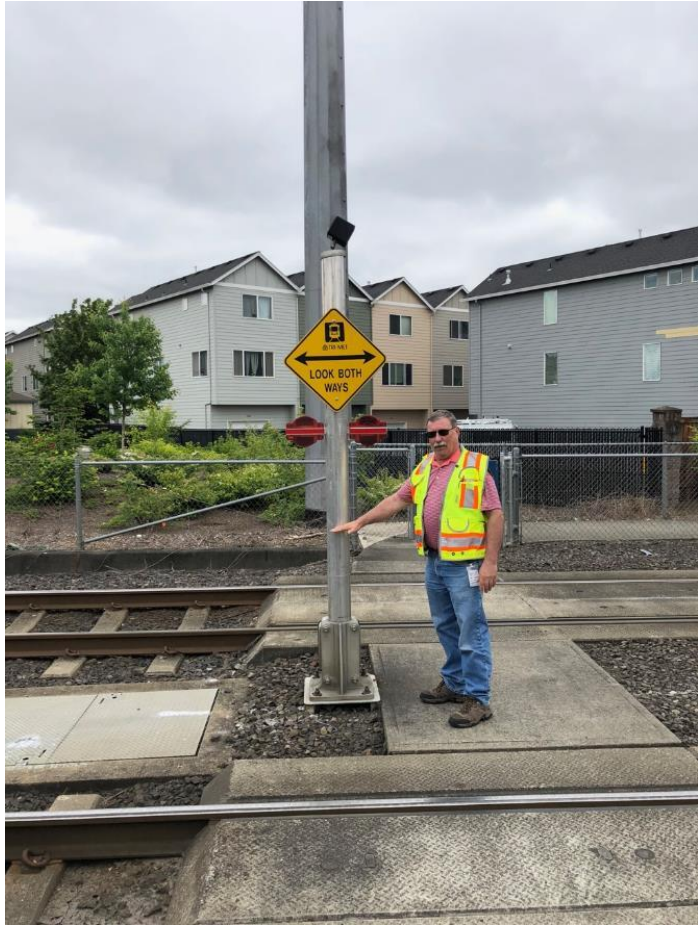
TriMet recently improved some of its pedestrian crossing treatments by making them more channelized and installing one way swing gates. See Figures 29 and 30. It also installed a newly designed pedestrian warning pole equipped with an audible warning bell, flashing red lights, and a passive “Look Both Ways” warning sign. See Figure 31.

Figure 29: Channelized pedestrian crossing

Figure 30: Swing gate

Figure 31: Pedestrian warning pole

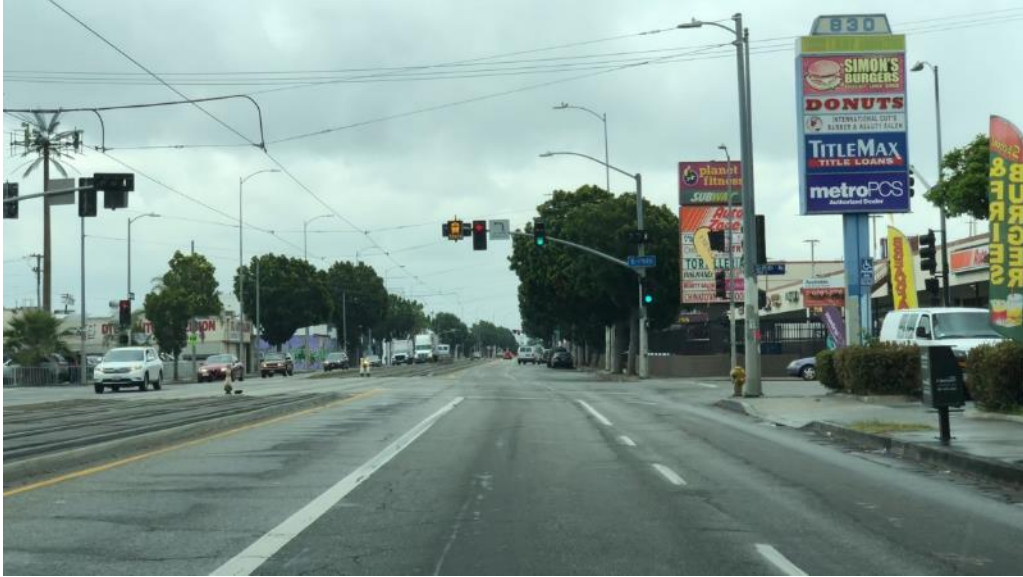
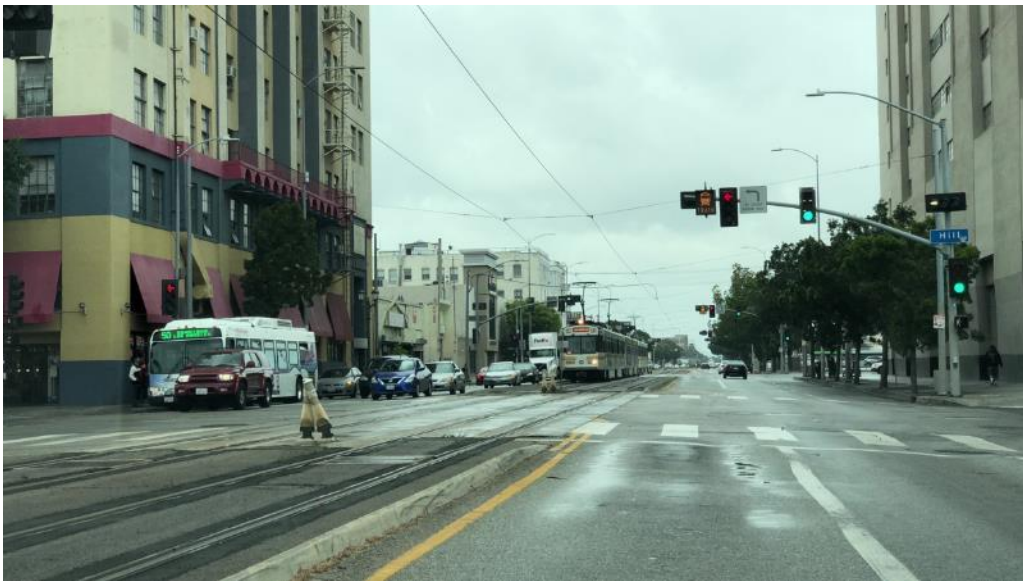
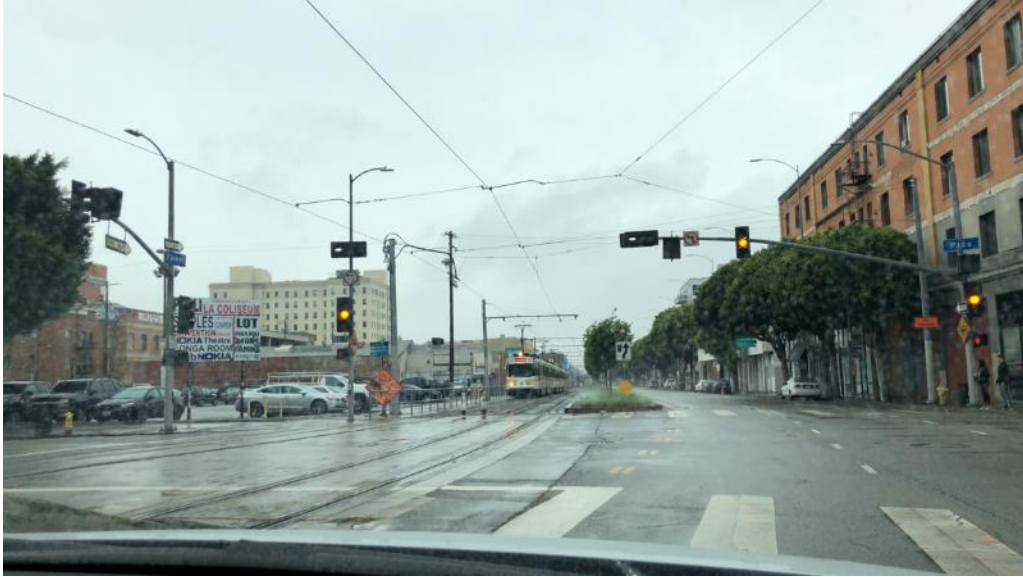
LA Metro Rail experiences the majority of its collisions with the public along its Blue Line of service. This line extends from the Metro Center (downtown Los Angeles) to Long Beach. The majority of this line is at street grade, and most collisions are with personal vehicles. The primary hazard is from vehicles turning left across the tracks. See Figures 32, 33, and 34.

Figure 32: Left turn

Figure 33: Left turn

Figure 34: Illegal left turn

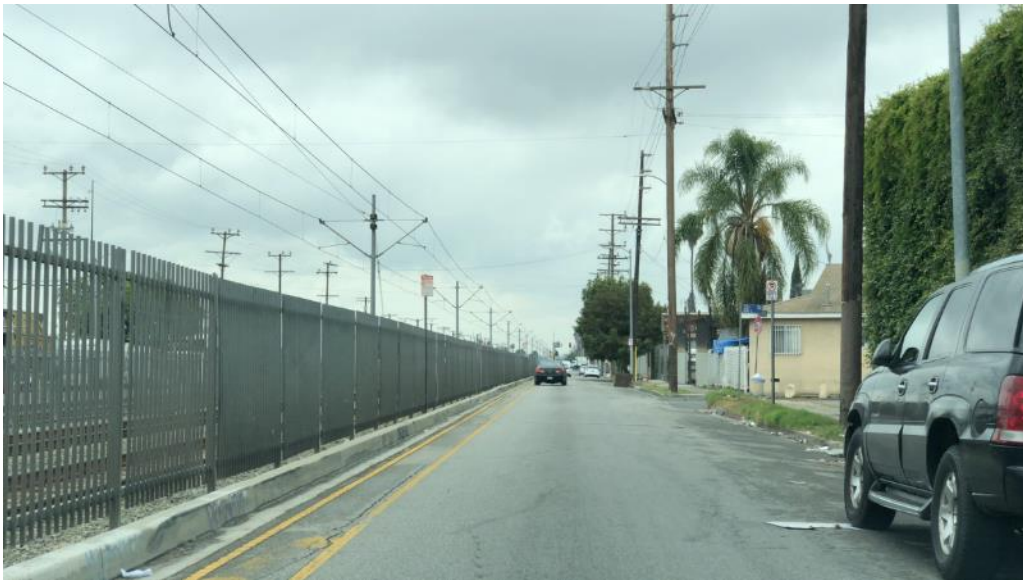
Figure 35: Fencing

LA Metro has implemented significant mitigation measures in areas where it has experienced more collisions. There is a section of the Blue Line where the train has exclusive right-of-way that has recently received attention to control access to intersections. This area begins with having substantial fencing to prevent trespassing. See Figure 35.

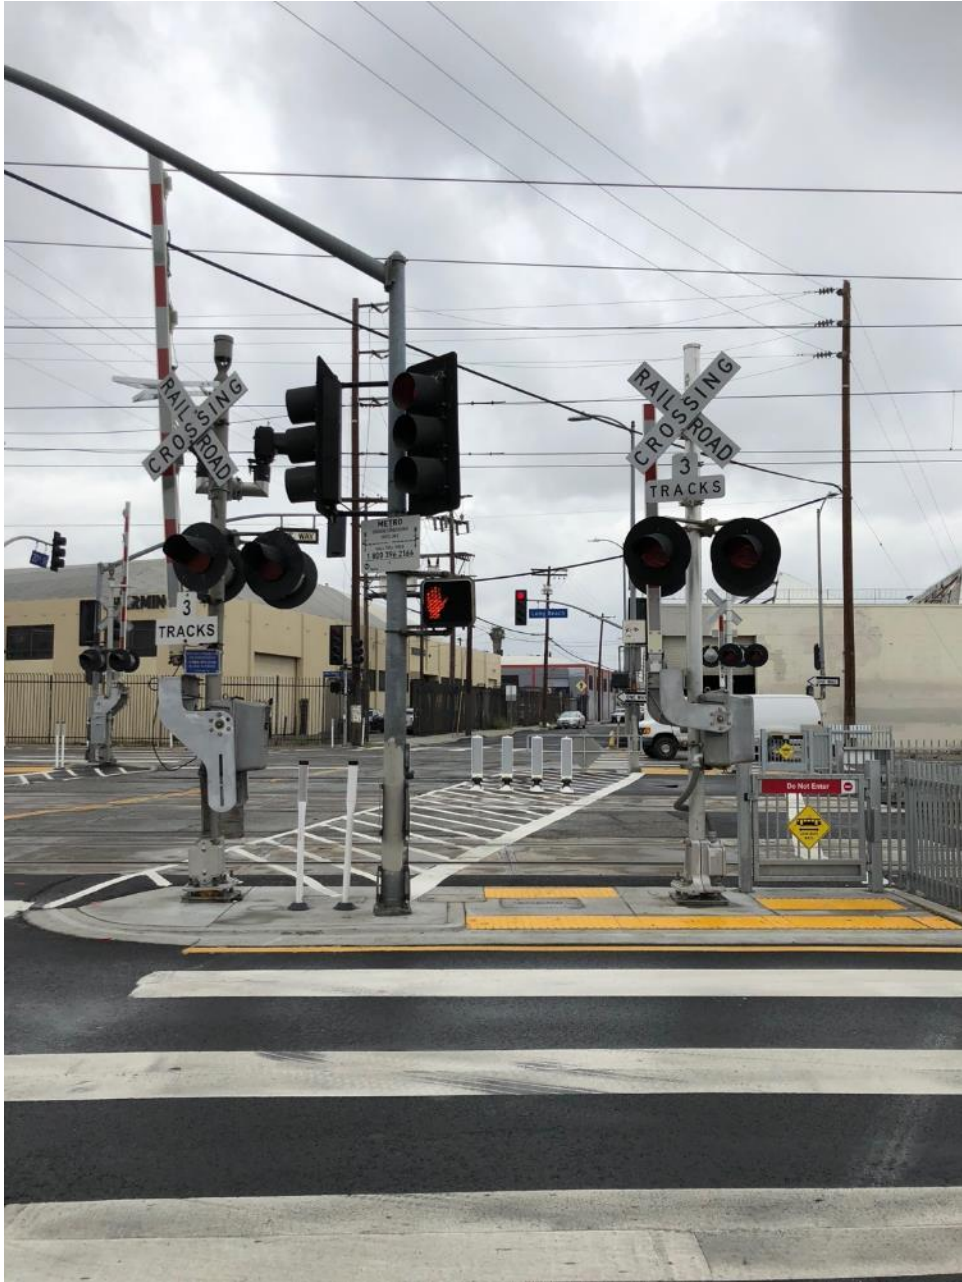
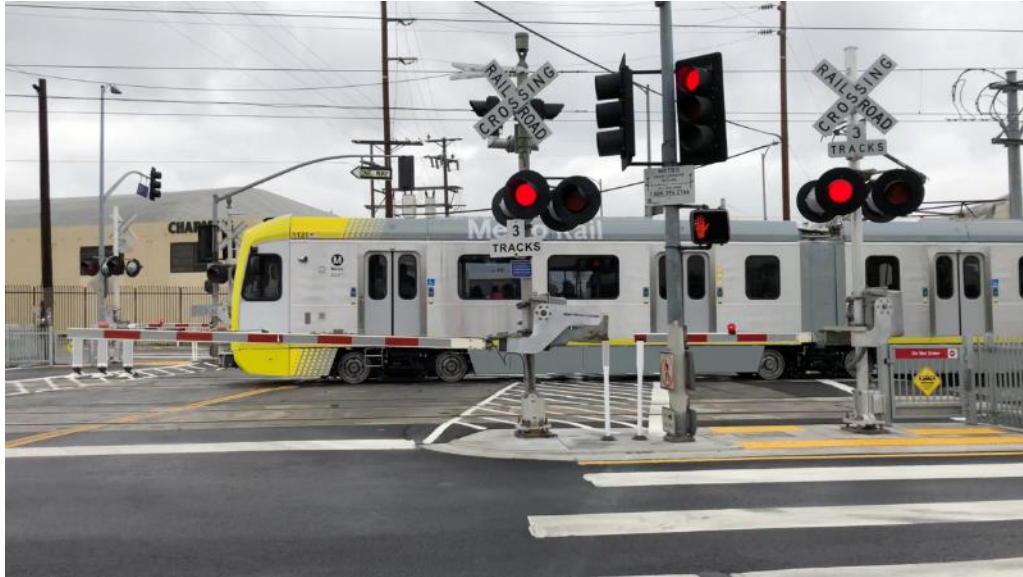
The intersections appear to be effectively controlled with the use of gated crossings for both the vehicles and pedestrians. See Figures 36 and 37.

Figure 36: Gated crossings

Figure 37: Gated crossings

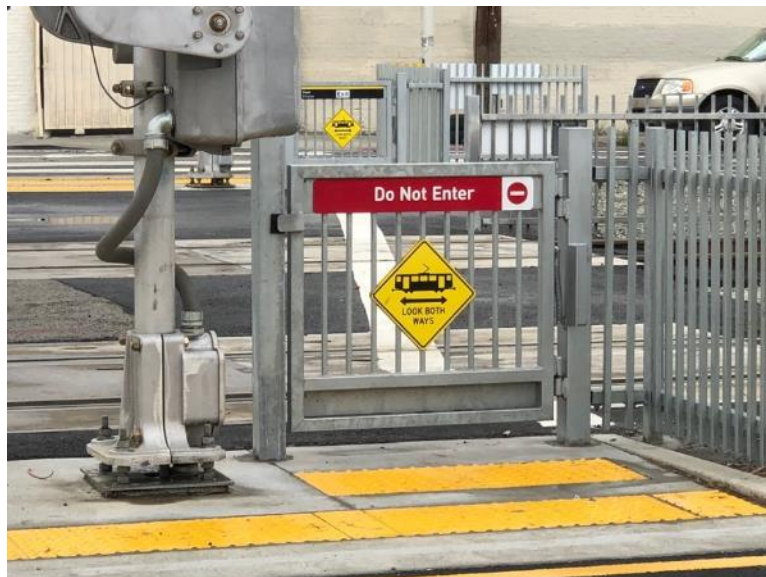
Note that the pedestrian crossings are equipped with swing gates (Figure 38) designed to open in a manner that will allow pedestrians to exit the crossing if they find themselves in the crossings with the other crossings gates down.

Figure 38: Pedestrian swing gates

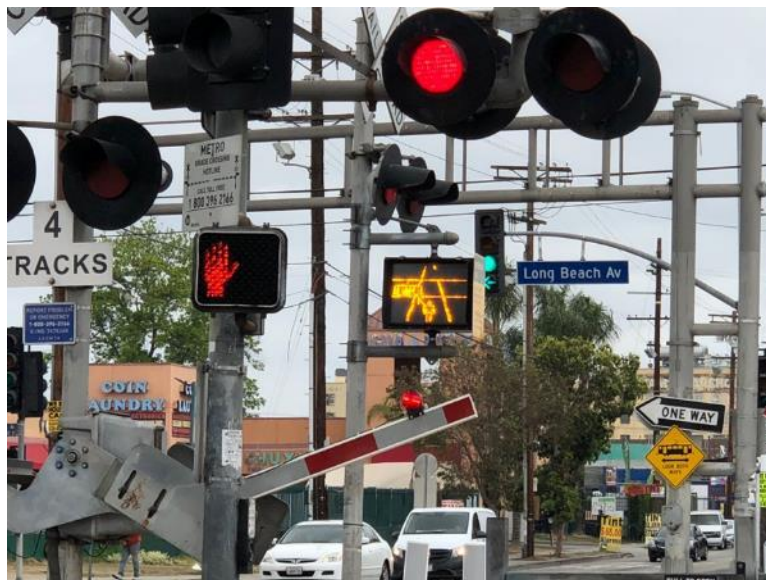
Figure 40: Signage and lighting

In addition to the use of gates, these crossings have a substantial amount of signage, lighting, and audible warnings, so much that it may be more than what the public can digest at once. See Figures 39 and 40.

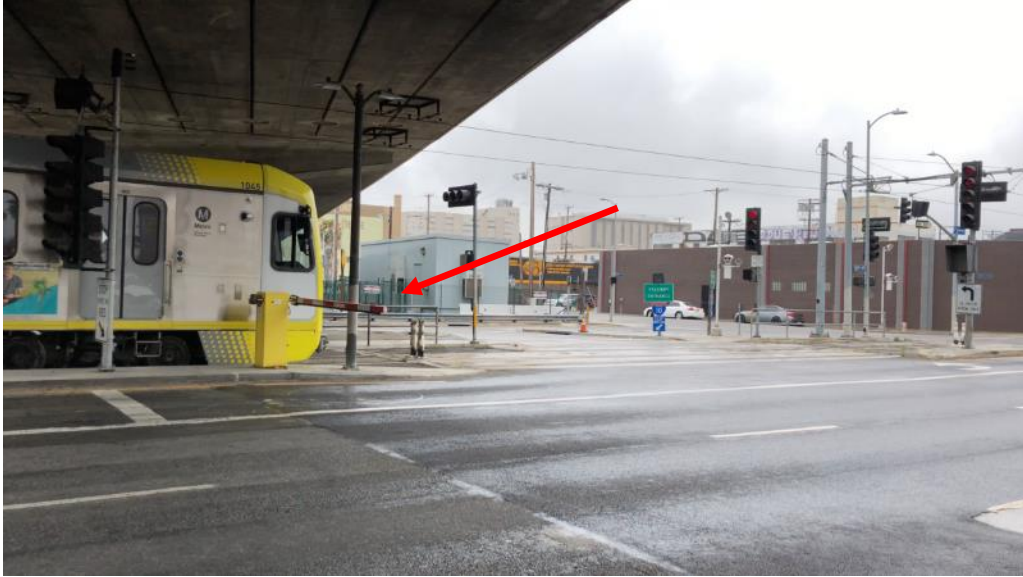
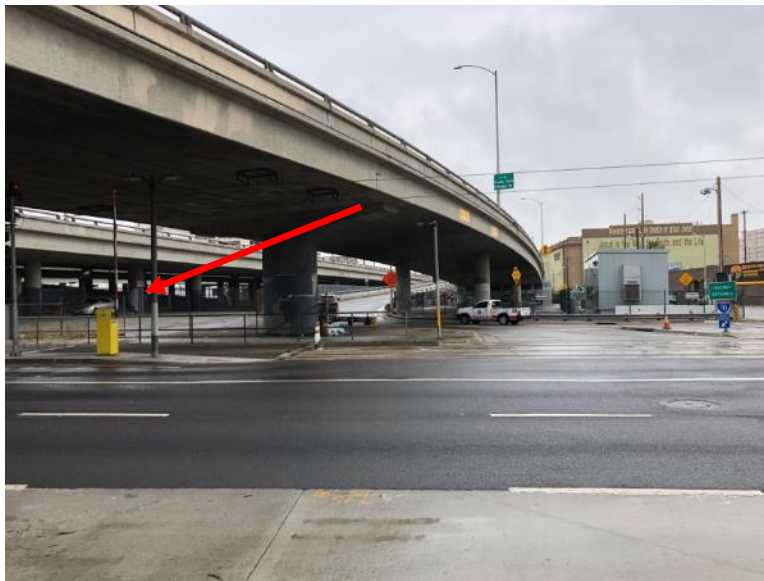
The Blue Line has some issues with vehicles turning left in front of the train. In many of these locations, there is no room to implement gated crossings as in other areas. Therefore, LA Metro has implemented a pilot project for a parking garage-style gate in one location that has a history of collisions. Figures 41 and 42 illustrate a location where vehicles turn left onto a freeway entrance ramp controlled by one of these gates.

Figure 41: Parking lot-style gate

Figure 42: Parking lot-style gate
