Research Report and Findings: Light Rail Technology Scan and Case Studies

OCTOBER 2022

FTA Report No. 0234

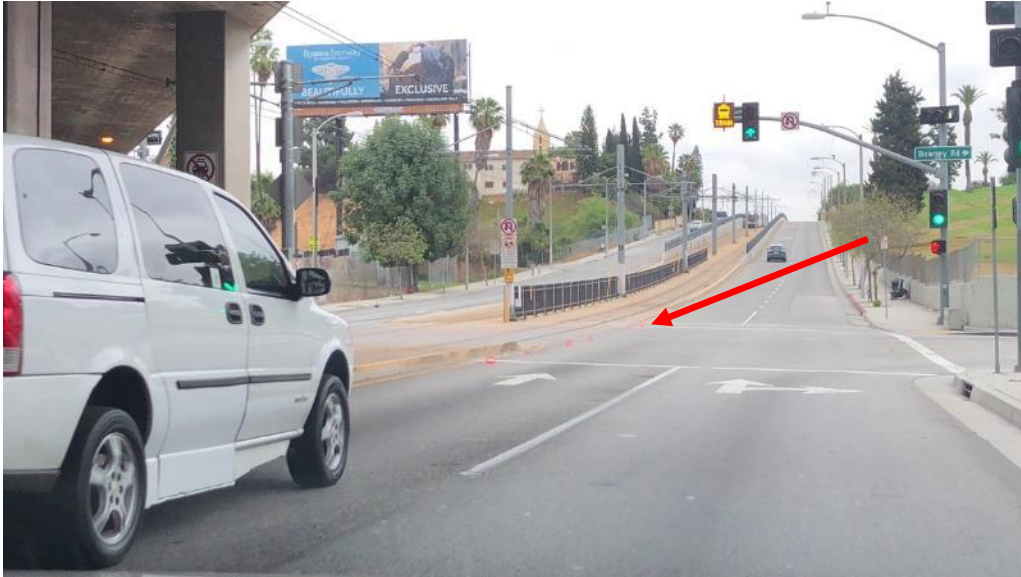
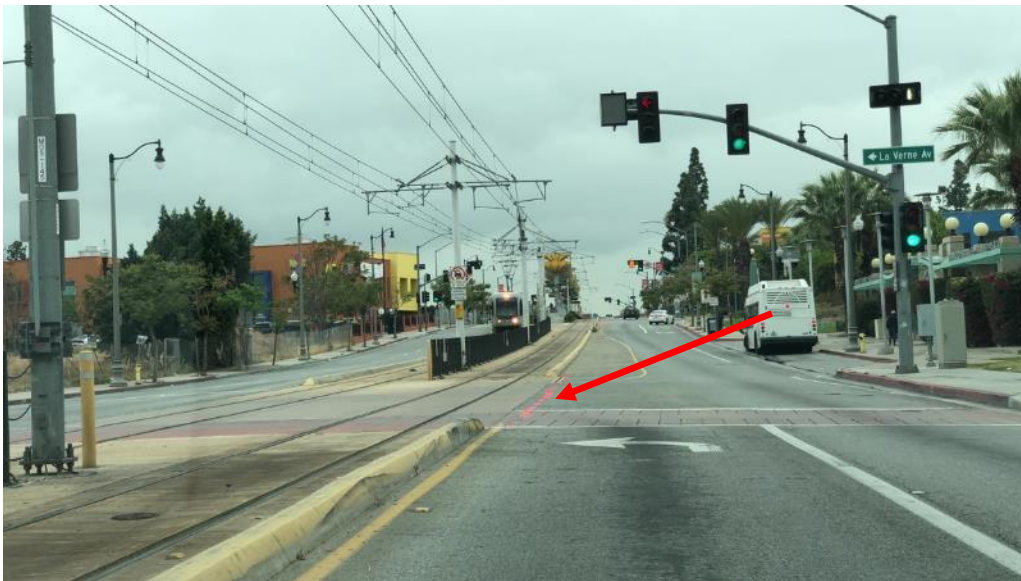
On the Gold Line, LA Metro has installed embedded lighting in the road to act like a virtual barrier in an effort to prevent vehicles from turning left into a train's path. See Figures 43 and 44.

Figure 43: Embedded lighting

Figure 44: Embedded lighting

If a physical barrier is not practical, street lighting can be used in a virtual barrier. LA Metro Rail has implemented something like this, as shown in Figures 43 and 44. There also are other forms of this technology meant for rail. Figure 8 Figure 9 are two examples.

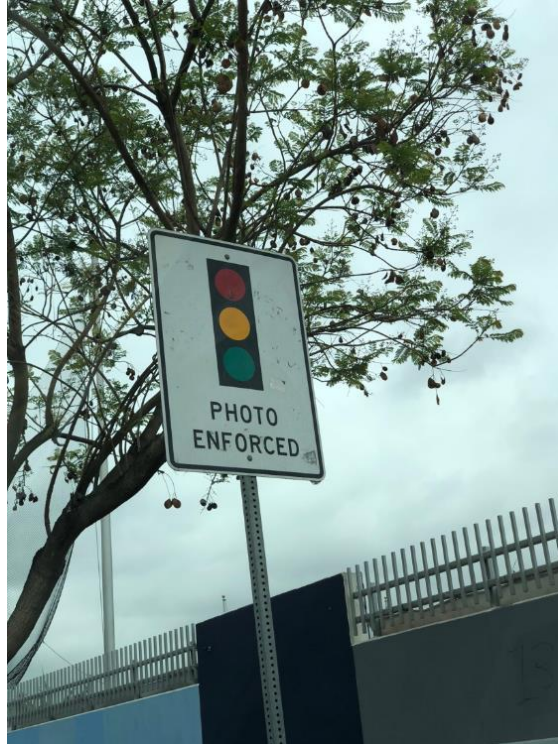
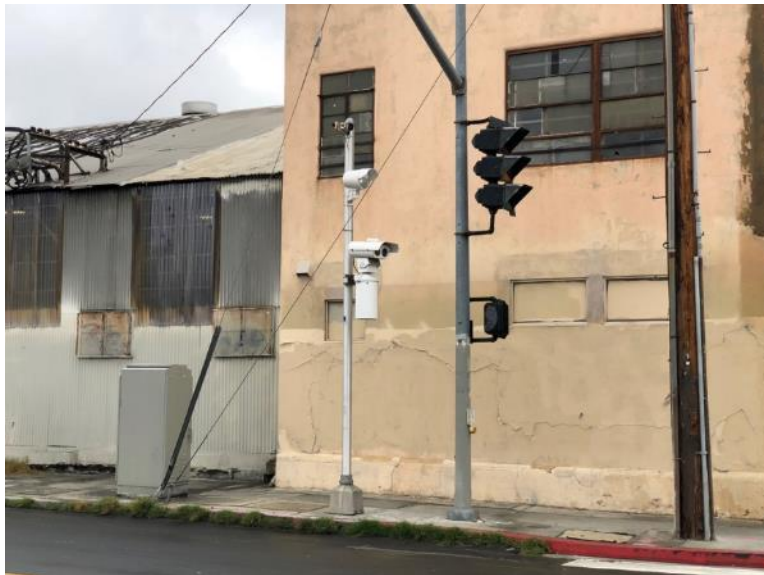
For some crossings where vehicles tend to violate traffic signaling and enter the crossing, LA Metro has implemented a camera system that detects when personal vehicles commit dangerous traffic violations and takes a picture of the offending vehicle. The license plate number of the personal vehicle is recorded, and the registered owner of the vehicle is fined \$400. Figures 45 and 46 show one of these systems installed on the Blue Line.

Figure 45: Photo enforcement

Figure 46: Photo enforcement

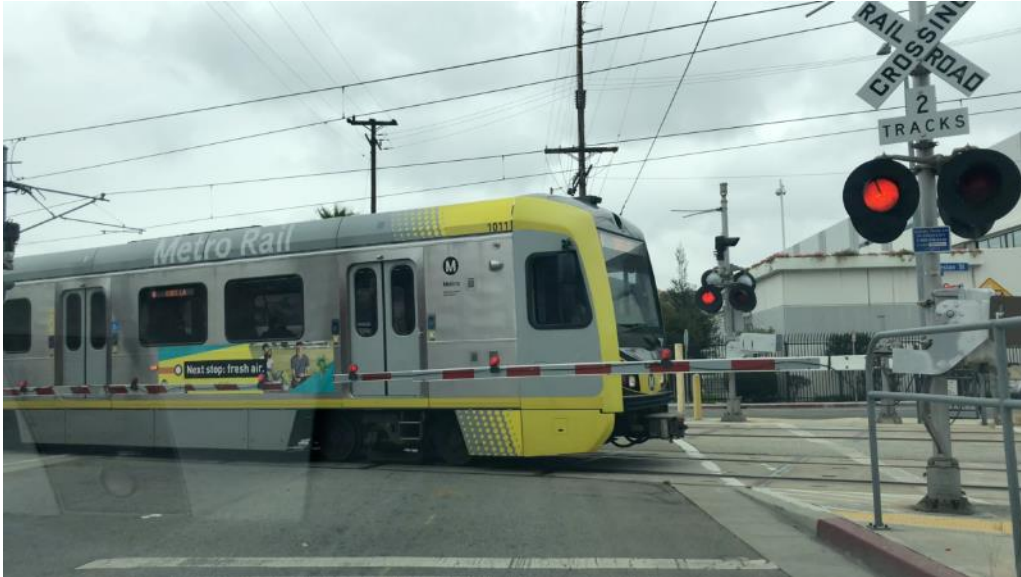
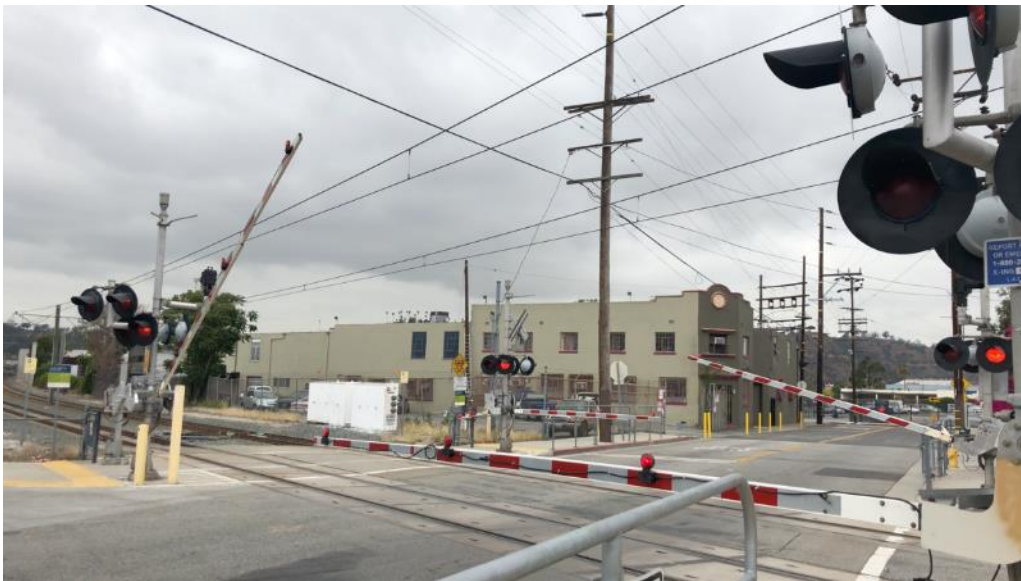
Finally, there are some crossings where four-quadrant crossings have been installed in an effort to reduce the possibility of personal vehicles going around crossing gates. See Figures 47 and 48.

Figure 47: Four-quadrant gated crossing

Figure 48: Four-quadrant gated crossing

Preventing access to hazardous areas is an effective way to prevent collisions with the public. Hence, the use of traditional railroad gates at crossings, such as those pictured in Figure 48, and fencing, as pictured in Figure 35, are examples. Unfortunately, this is not always possible for a variety of reasons, one of which is space limitations. Traditional railroad crossings require a large amount of space. An alternative to this is the use of parking lot-style gates like those used by HART and LA Metro Rail (Figure 16Figure 45). These gates were placed in specific locations identified as problem areas with limited space. Sometimes, there may not be enough space for a gate of this nature. In those circumstances, having some kind of barrier that deploys from the ground could be considered. Retractable bollards may be one of those options. Another possibility is wedge barriers that are frequently used at security gates; wedge barriers are used at some railroad crossings in Europe. See Figure 6Figure 7 for examples.

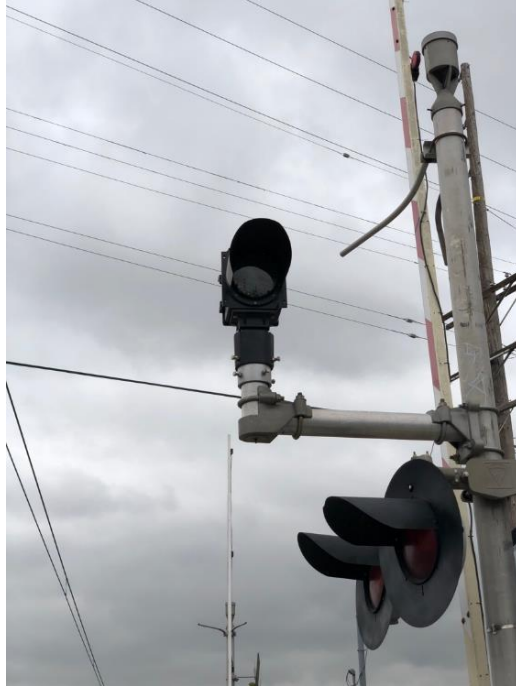
LA Metro has installed a system on some crossings that detects if a personal vehicle is inside the crossing via mass detection when a train is approaching and signals the train in an effort to alert the operator. Figure 49 shows one of these aspects directed towards the direction of the train, which lights up if a vehicle is detected in the crossing.

Figure 49: Vehicle detection warning system

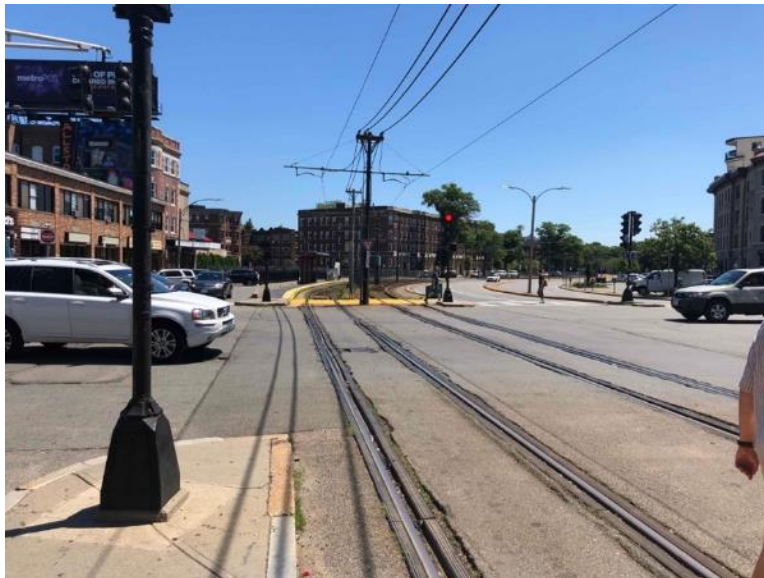
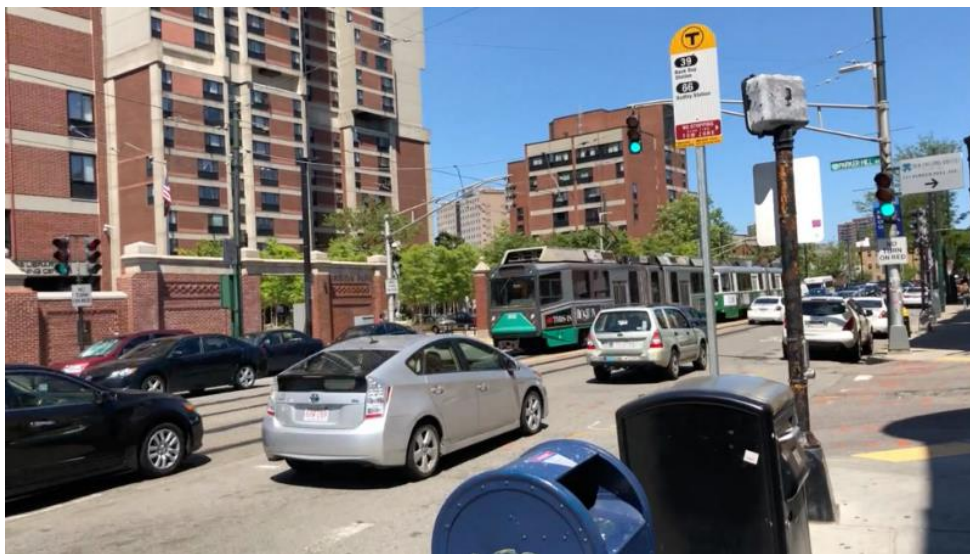
The majority of the collisions experienced by MBTA are with vehicles. According to data provided by MBTA, the frequency of collisions with vehicles is approximately 3 to 4 times that of collisions with pedestrians and cyclists. This can be attributed to the congested nature of the operating environments, with frequent crossings and shared lanes with motor vehicles. See Figures 50 and 51 for examples of typical operating environments.

Figure 50: Typical level crossing

Figure 51: Shared-lane environment

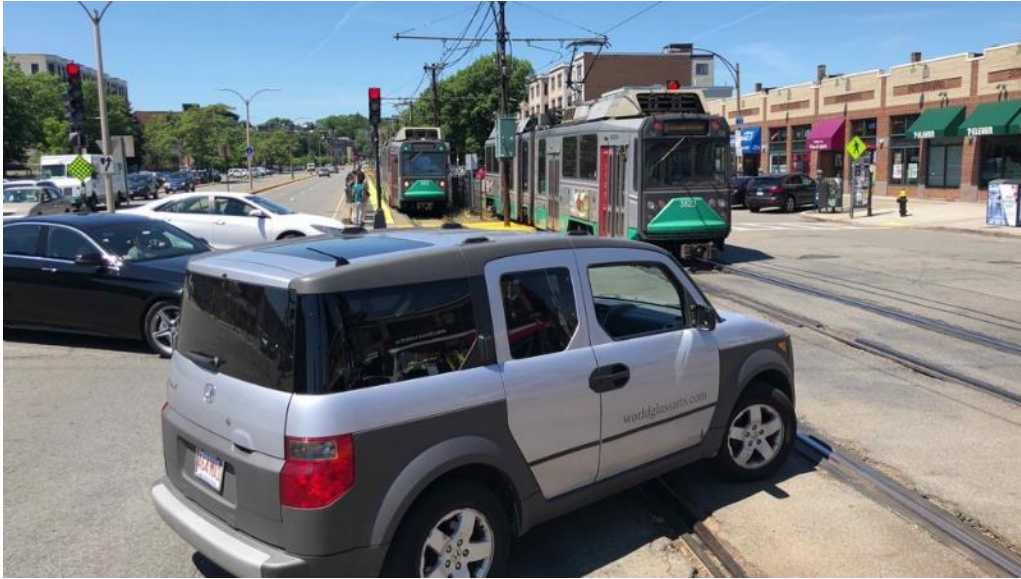
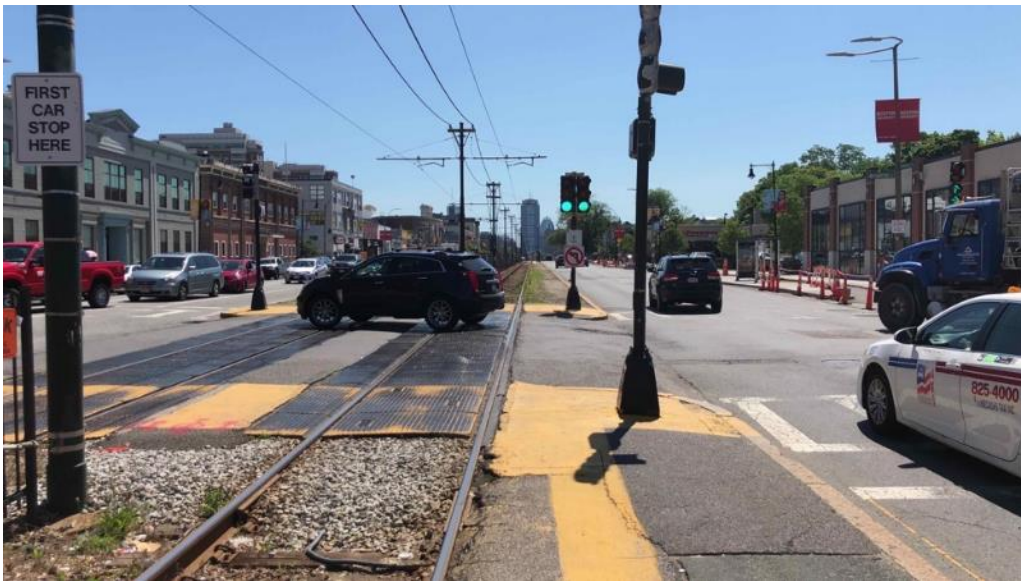
One area of particular concern at crossings is the inclination for the public to turn in front of a train, both legally and illegally. In either case, the train operator has little to no time to react. Figure 52 illustrates several cars making both left and right turns onto a crossing, and Figure 53 shows an illegal left turn, which is a common occurrence, according to MBTA personnel.

Figure 52: Turning vehicles

Figure 53: Illegal left turn

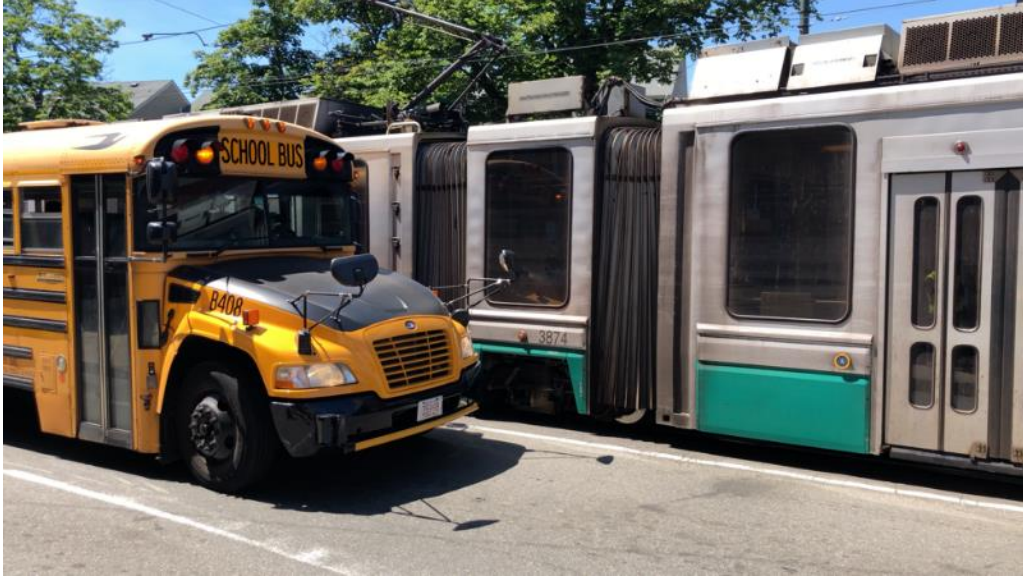
In shared-lane environments, clearance is another issue. There is little room for trains to operate in this environment, which can result in track fouling and “sideswipe” incidents. Figure 54 shows a clearance situation where the rear-view mirror of a school bus comes close to making contact with a passing train. In this instance, the bus driver realized the potential collision and stopped to allow the train to pass before proceeding.

Figure 54: Clearance example

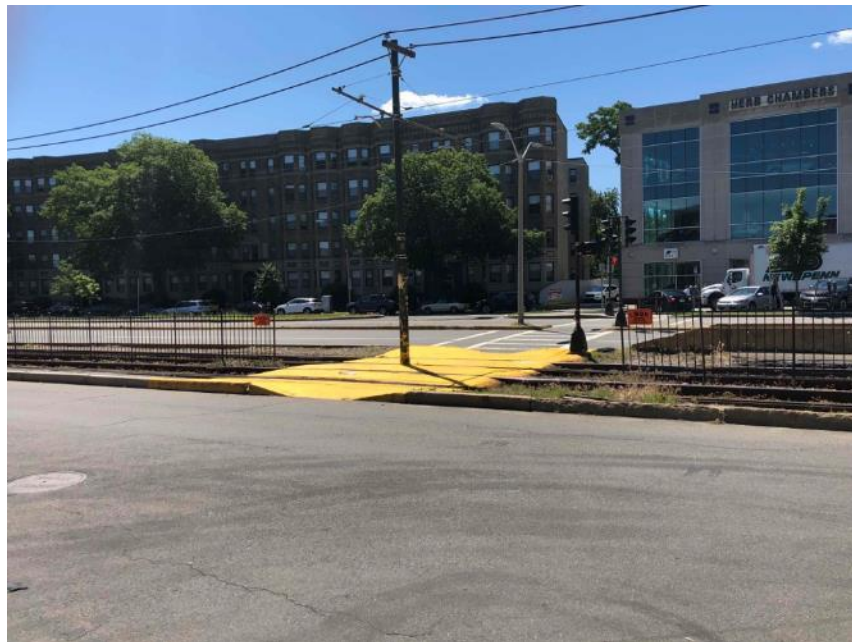
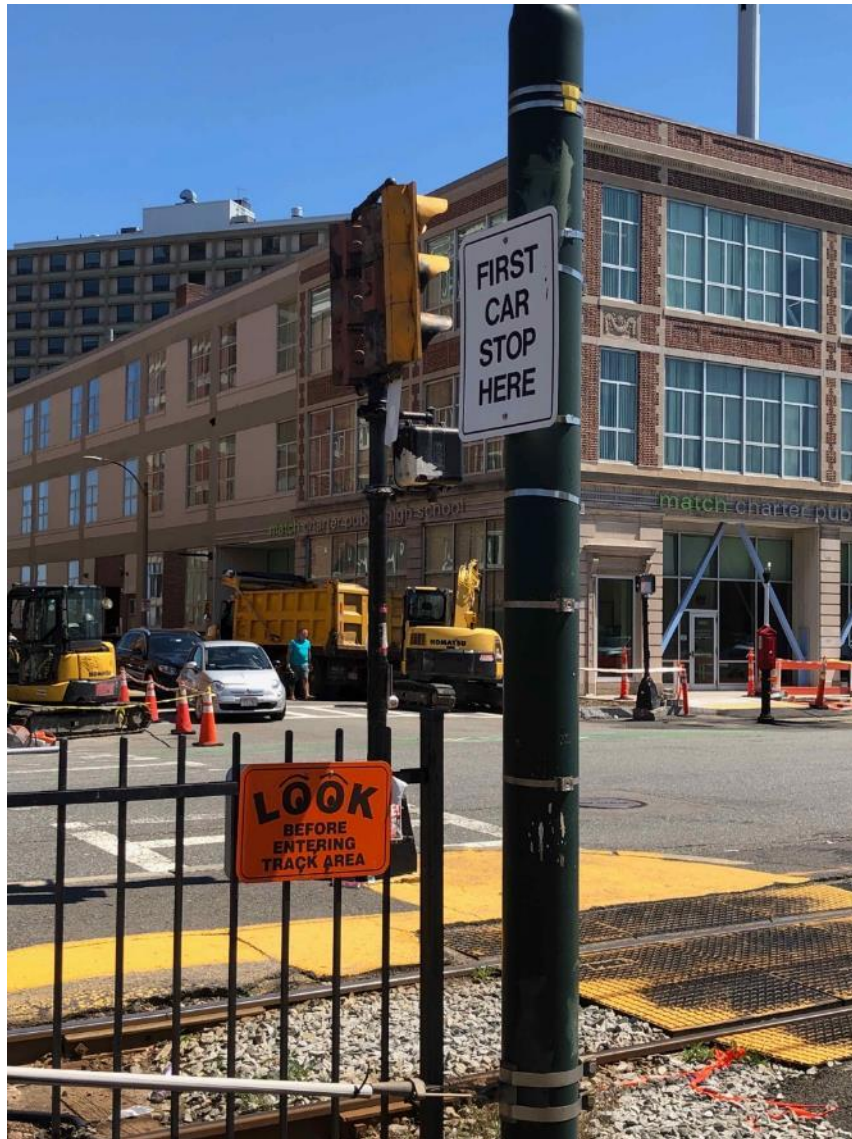
There appear to be minimal physical mitigation implementations for collision avoidance in high-risk locations like crossings, aside from typical traffic and pedestrian signaling and signage. Some signage encourages pedestrians to look for trains at pedestrian crossings. Fencing also is placed in many locations to prevent pedestrians from crossing the tracks, and most pedestrian crossings were also painted yellow. See Figures 55 and 56 for examples.

Figure 5: Typical pedestrian crossing

Figure 6: Pedestrian signage

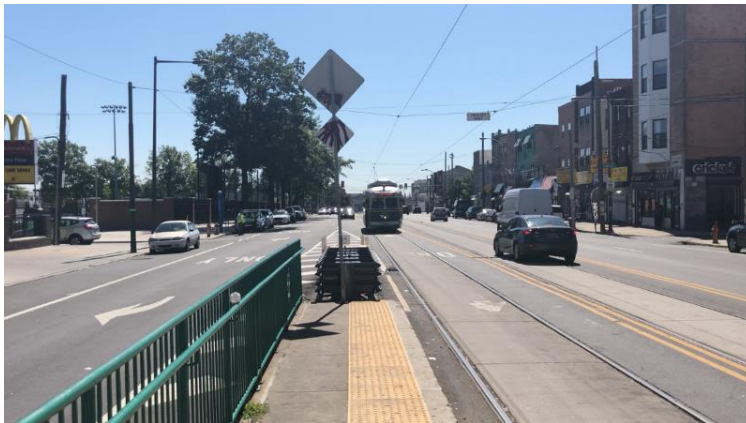
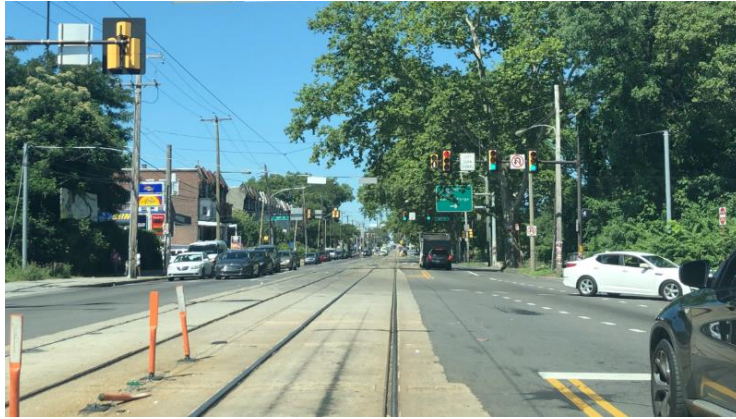
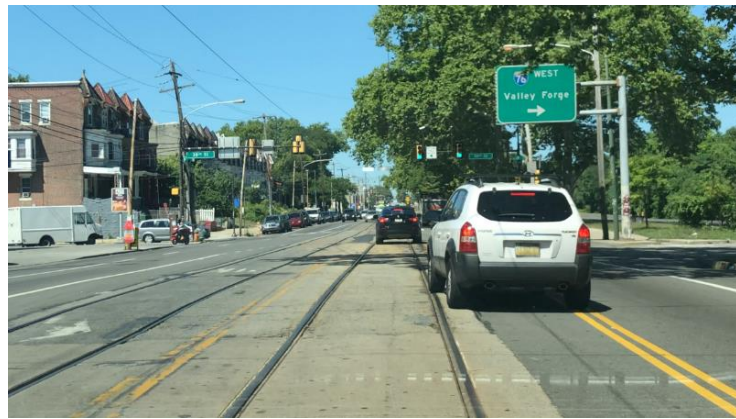
Given its operating environment, the majority of collisions that occur are with motor vehicles on shared streets. During a site visit, several hazards with motor vehicles were identified and noted by SEPTA personnel. The first is from vehicles either unexpectedly turning or switching lanes in front of an oncoming trolley. It is common for the trolley to merge into a shared lane from a dedicated lane, which also facilitates the hazard. The potential for this hazard presents itself where there is a shared lane on a street of multiple lanes and at intersections with turn lanes. See Figures 57 through 60 for examples.

Figure 57: Trolley emerging from dedicated lane to shared turn lane

Figure 59: Turning scenario

Figure 60: Traffic merging into a dedicated lane

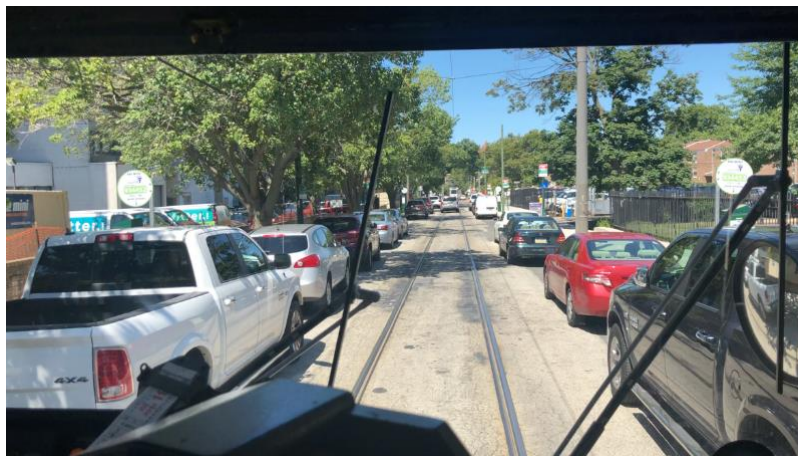
The other common type of collision with vehicles occurs from clearance issues and track fouling. There are many single-lane streets where there is little clearance between the trolley and parked cars. Occasionally, a trolley will come into contact with a parked vehicle. Usually, the operator will recognize the situation and will stop service and have the vehicle moved. See Figure 61 for an example of this situation.

Figure 61: Parked cars

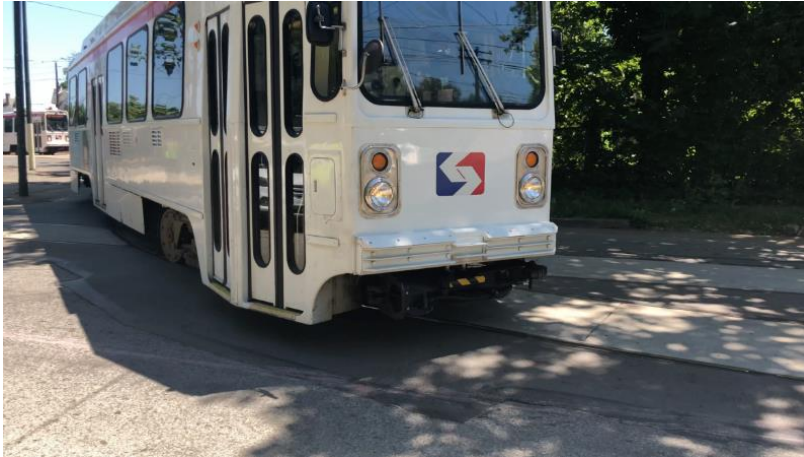
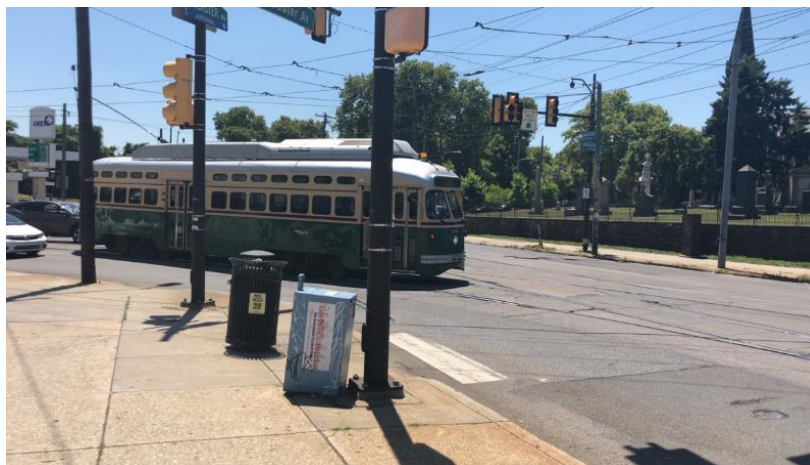
Related to clearance and track fouling, one of the most common collisions occurs due to the front and rear of the trolley swinging out into adjacent traffic lanes in a curve. Also, due to the length of the trolley, its center will encroach into an adjacent lane on the inside of a curve. Some motorists are not cognizant of these situations and do not maintain proper distance from the trolley and its tracks, resulting in collisions. See Figures 62 and 63.

Figure 62: Corner of trolley swinging out in curve

Figure 63: Center of trolley encroaching inside lane

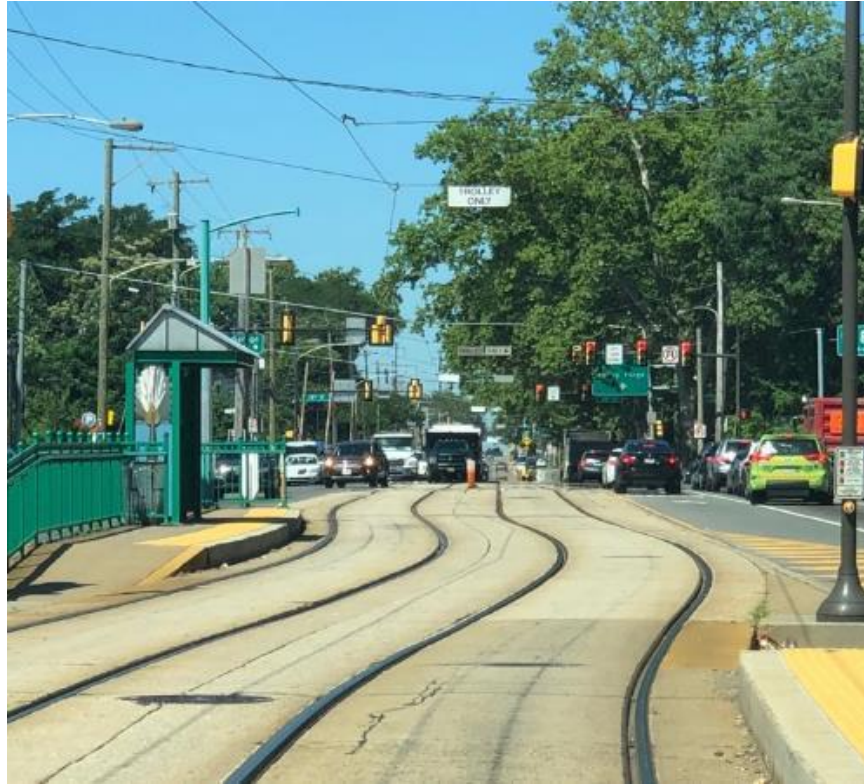
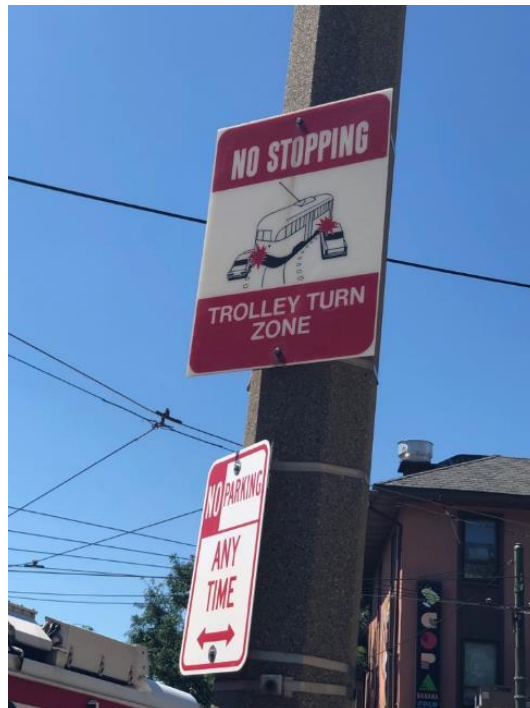
SEPTA relies upon various signage and common traffic signaling to help maintain public awareness and prevent collisions. Figures 64 and 65 illustrate some of the trolley specific signage used.

Figure 64: Trolley-only sign for dedicated lane

Figure 65: Sign illustrating clearance in turn zone

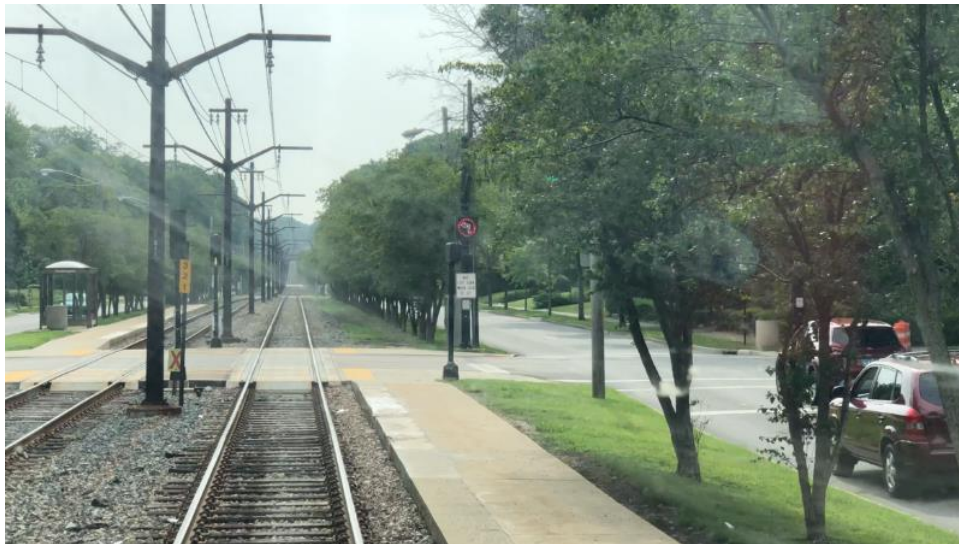
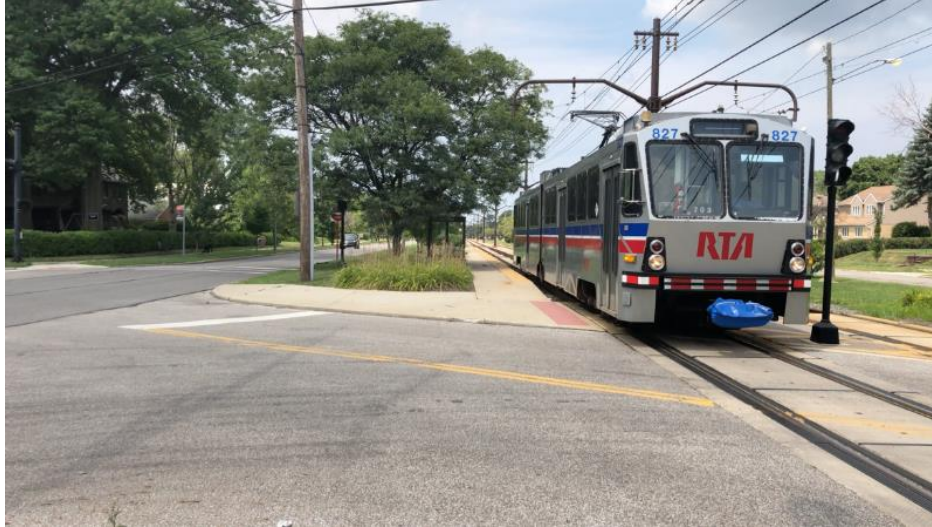
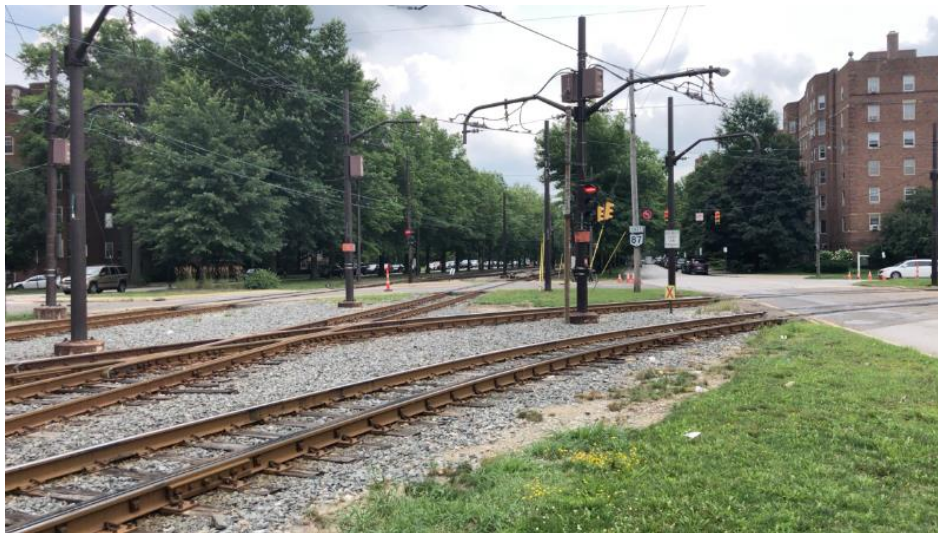
Of the few collisions the GCRTA light rail service experiences, the majority occur at grade crossings with vehicles making left turns despite the clear signaling and signage prohibiting traffic to do so when a train is approaching and in a crossing. In these instances, the tracks are generally located in a wide median, with vehicular traffic traveling one way on either side. See Figures 68, 69, and 70.

Figure 68: Left turn situation

Figure 69: Left turn situation

Figure 70: Left turn situation where Blue and Green lines meet

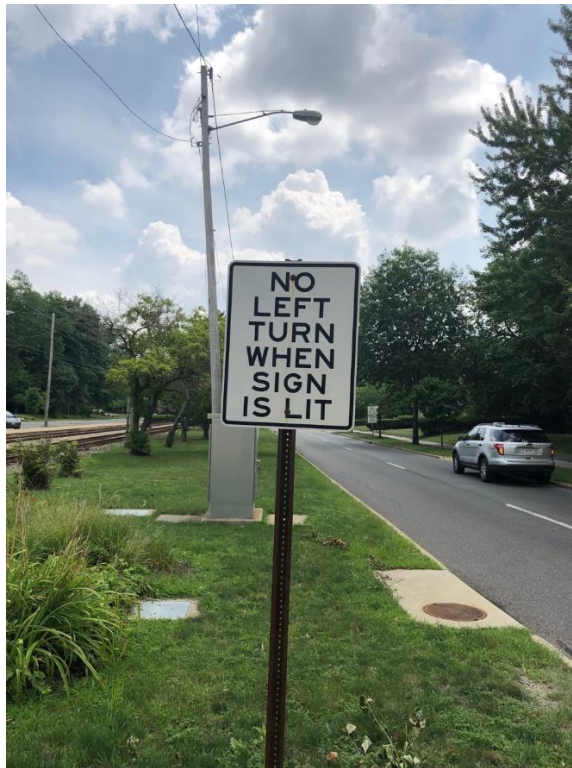
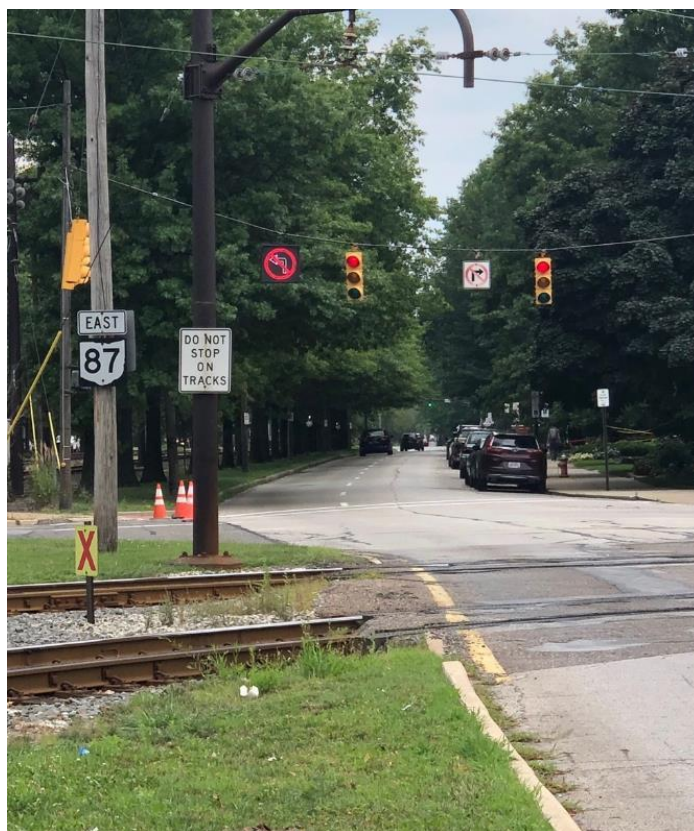
The GCRT uses a combination of static and blank out signs to warn drivers of an approaching train prohibiting them from making a left turn onto its path. See Figures 71, and 72.

Figure 71: No left turn static sign

Figure 72: No left turn blank out sign

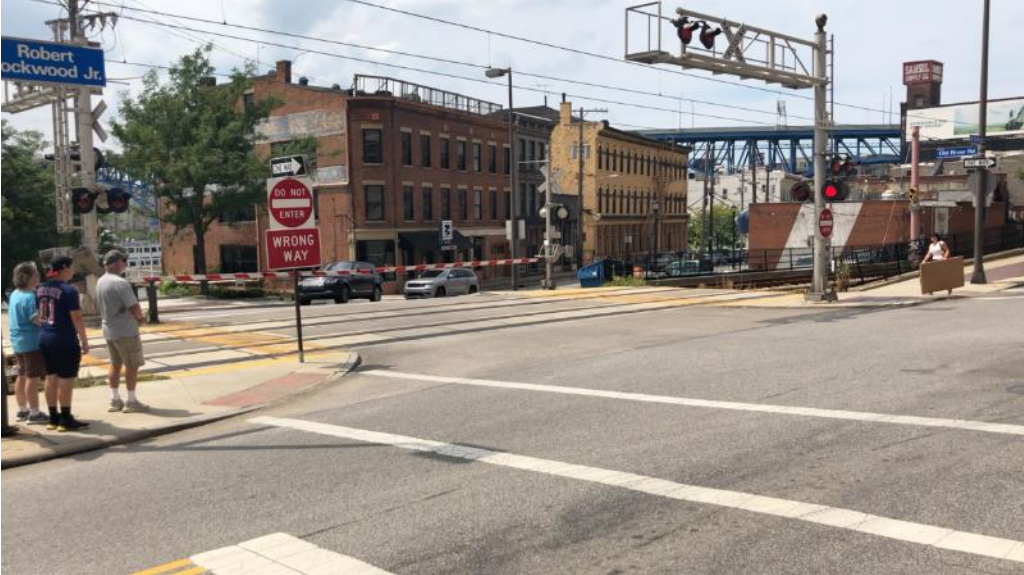
When permitted to do so, GCRTA also employs the use of gated crossings. There are several locations where it would like to do so; however, they are not permitted by the local municipality due to aesthetic reasons according to GCRTA personnel. Figure 73 illustrates a location where they are in place.

Figure 73: Double gated crossing

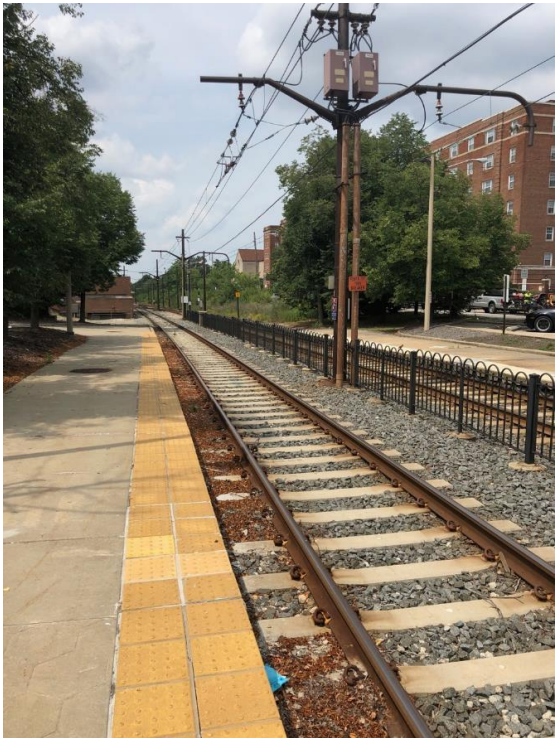
Fencing is also frequently used to deter pedestrians from crossing the tracks, as shown in Figure 74.

Figure 74: Fencing

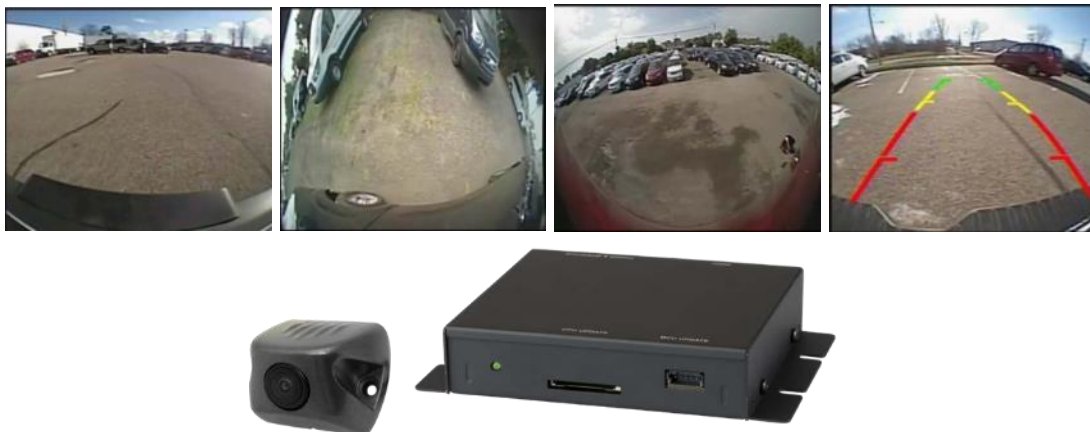
Systems of this nature have been extensively evaluated for use in buses in the past, suggesting that they are effective at reducing side collisions.¹ An example of this technology is provided by a company called SEON. In a bus application, four cameras are strategically placed on each side of the vehicle. Images from these cameras are then blended together and displayed to the driver as a single image on a dash-mounted monitor. See Figure 75.

Figure 75: SEON's inView 360 Collision Avoidance System²

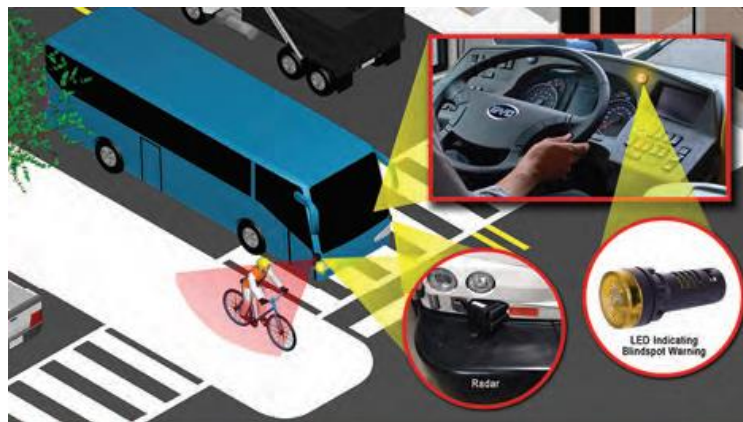
There are applications of this technology for large vehicles such as buses and semi-trailer trucks. Two examples of this technology already were noted in the case study for SEPTA. Protran's Blind Spot Awareness System uses radar to detect objects in the blind spot of the vehicle and then provides an audible and visual warning to the operator. The visual warning comes in the form of an LED indicating light. Figure 76 illustrates this application on a bus.³

Figure 1: Protran blind spot awareness

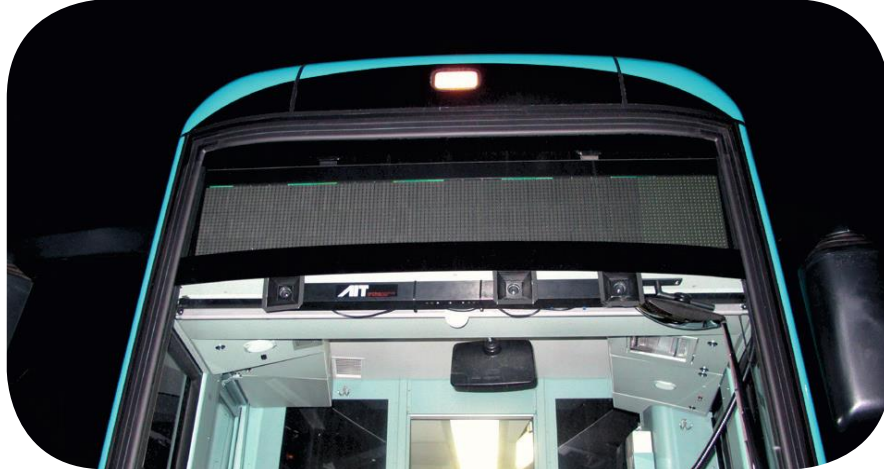
Bombardier and the Austrian Institute of Technology (AIT) developed a Driver Assistance System specifically for light rail vehicles. This system uses stereo cameras focused on the area in front of the vehicle. Software algorithms evaluate the vehicle envelope in real time along the

track for obstacles and the related collision risk. The driver is alerted visually and acoustically when a collision risk is detected. The system can be applied as a new or a retrofit installation. This system was deployed in Frankfurt, Germany, in 2015.⁵ See Figures 79 and 80 for illustrations of the Driver Assistance System.⁶

Figure 79: Bombardier Driver Assistance System

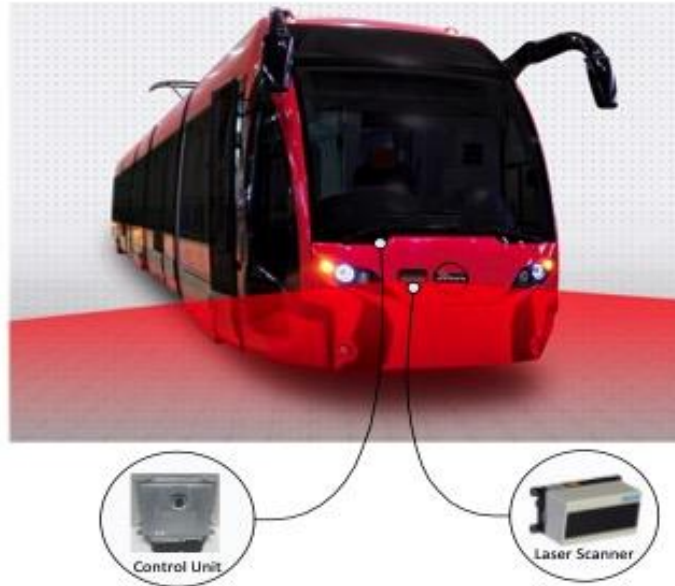
Another example of a collision avoidance system that active scans for potential collisions and is capable of controlling the vehicle if necessary to avoid the collision was recently developed and tested on a tram known as the “Silkworm,” manufactured by Durmazalar Machine, Inc., in Bursa, Turkey.⁸ See Figure 4. The testing was performed in a controlled environment at the Durmazalar facilities. The system architecture, as shown in Figure 5, is composed of three parts—a sensor module, an object recognition and tracking module, and a collision avoidance module. The sensor module is a Lidar Digital-Multilayer Range Scanner by Sick, Inc., that is positioned on the nose of the vehicle. It is used to detect obstacles in front of the tram up to 50 meters away with an accuracy of ± 5 centimeters. Once detected, the object recognition and tracking module uses algorithms to classify the object and track it; then the collision avoidance module assesses the risk. If necessary, it will alert the operator and apply the brakes depending upon the collision probability. Testing results were positive overall, and there are plans for future work in real-world environments and developing a system incorporating both radar and lidar or camera and lidar.

Figure 4: “Silkworm” with collision avoidance system

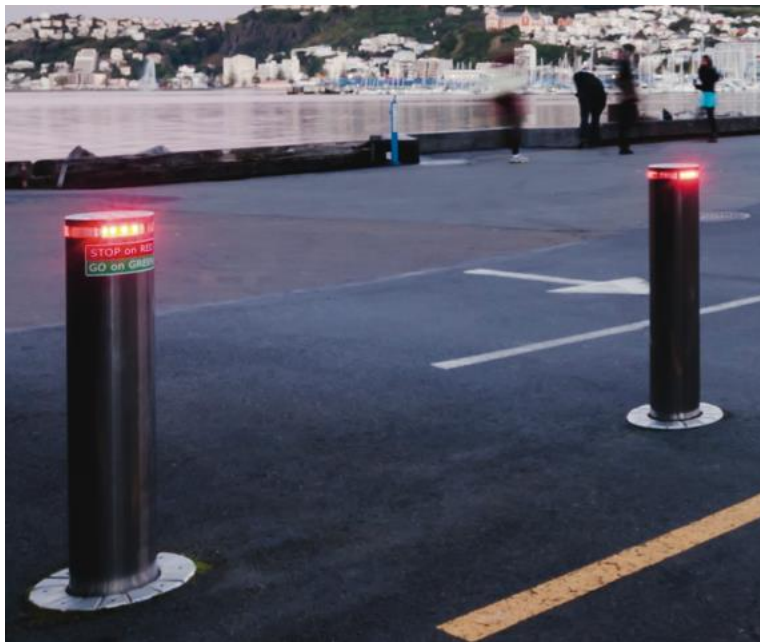
Figure 6: Automatic bollard by Bullyboy LTD⁹
